**Hamilton Township (Mercer County)
Stormwater Basin Assessment Summary
Past Priority Addendum (Year 5B)**

Developed by the Rutgers Cooperative Extension Water Resources Program
Funded by Hamilton Township, Mercer County, New Jersey

November 27, 2019

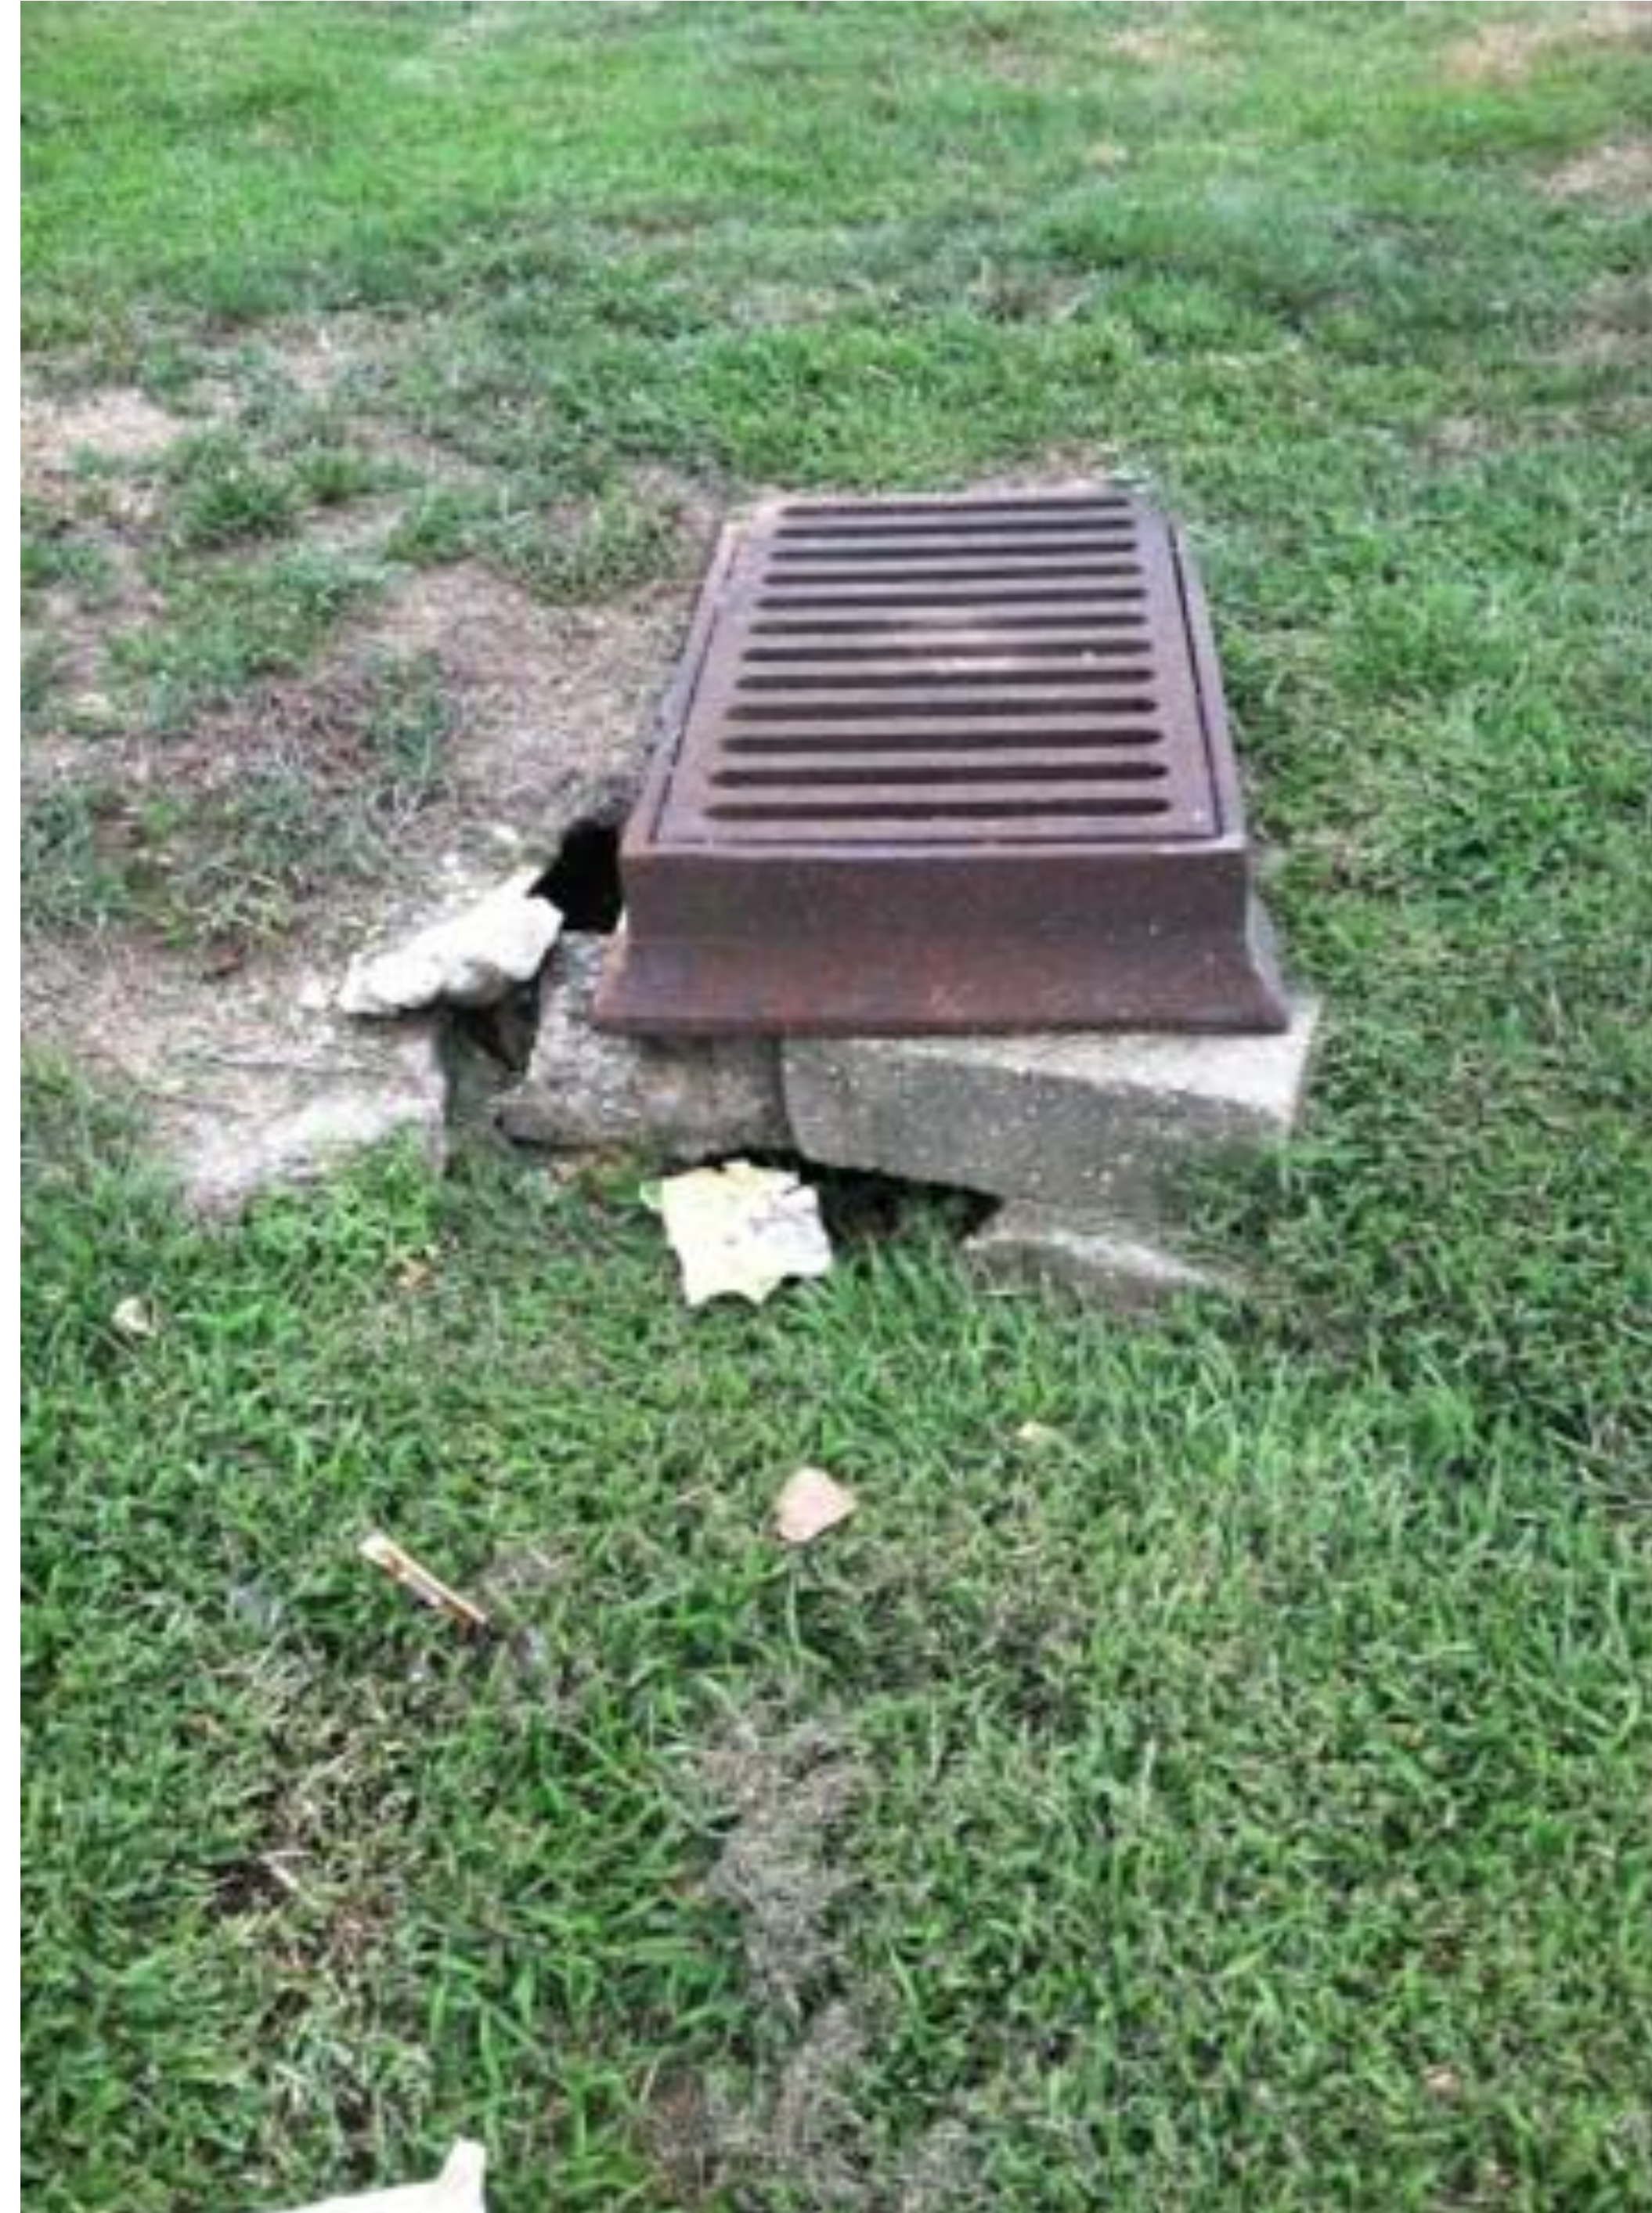
Erosion at inlet

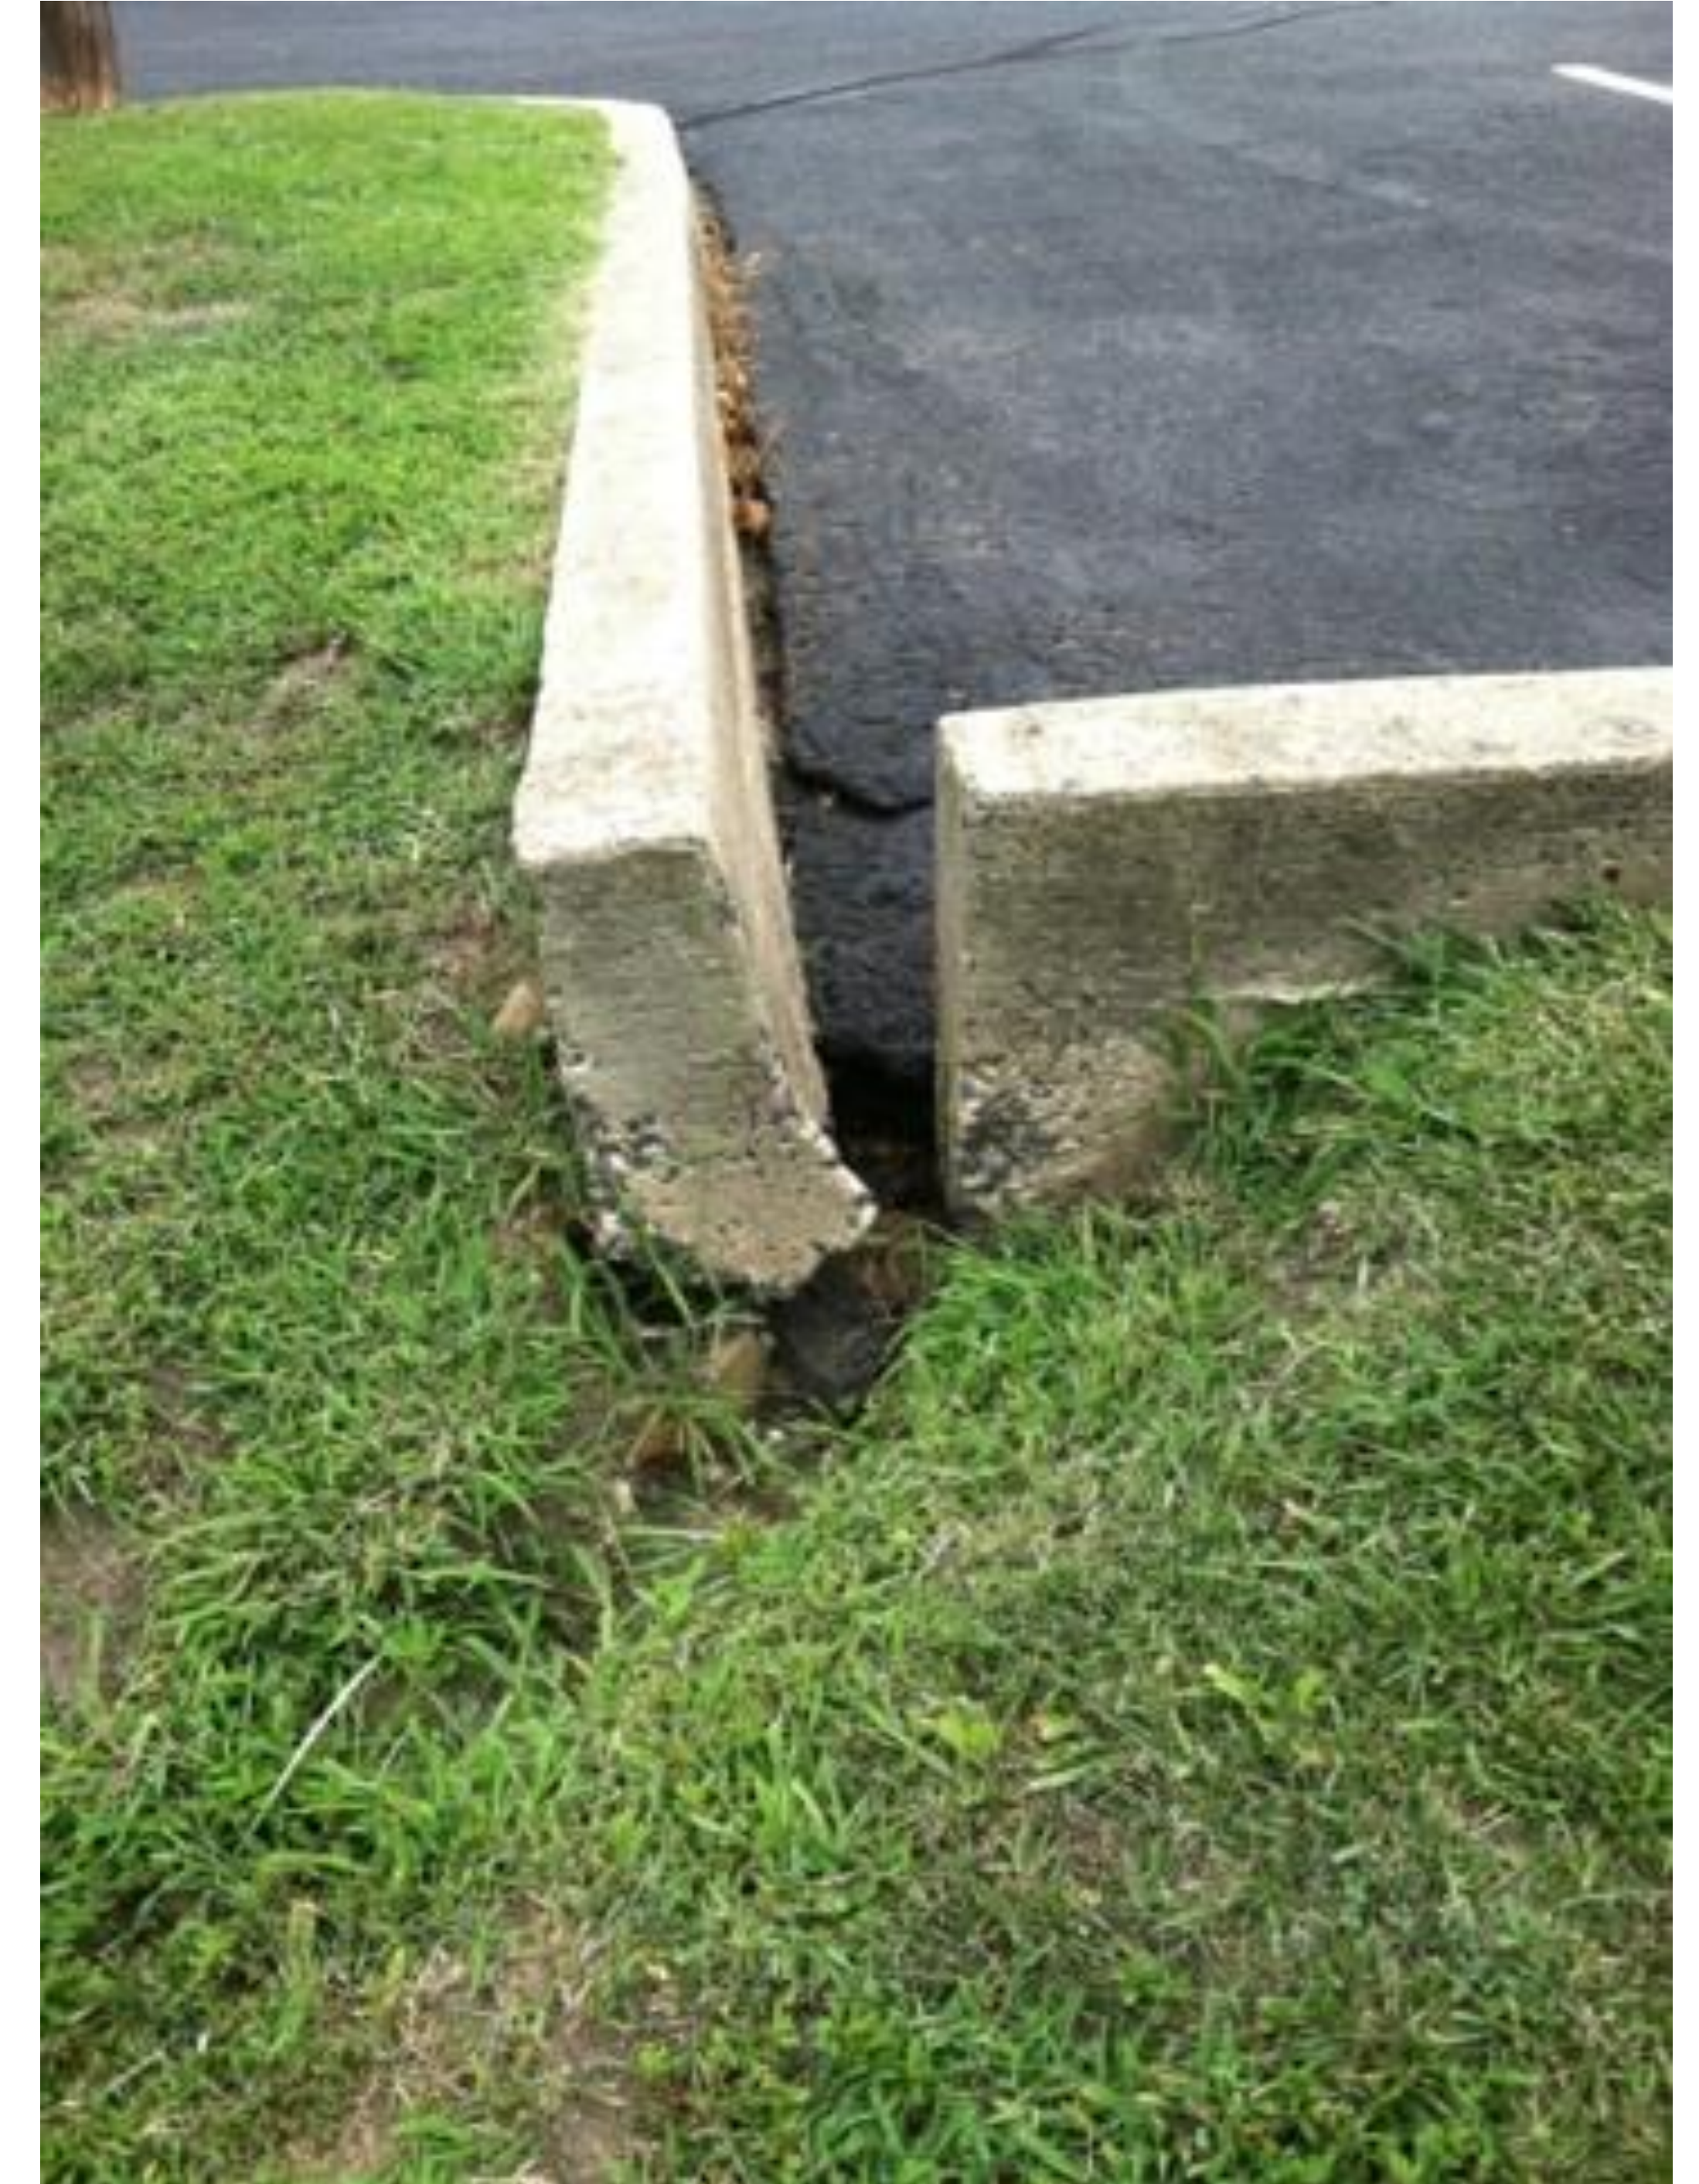
Damaged outlet

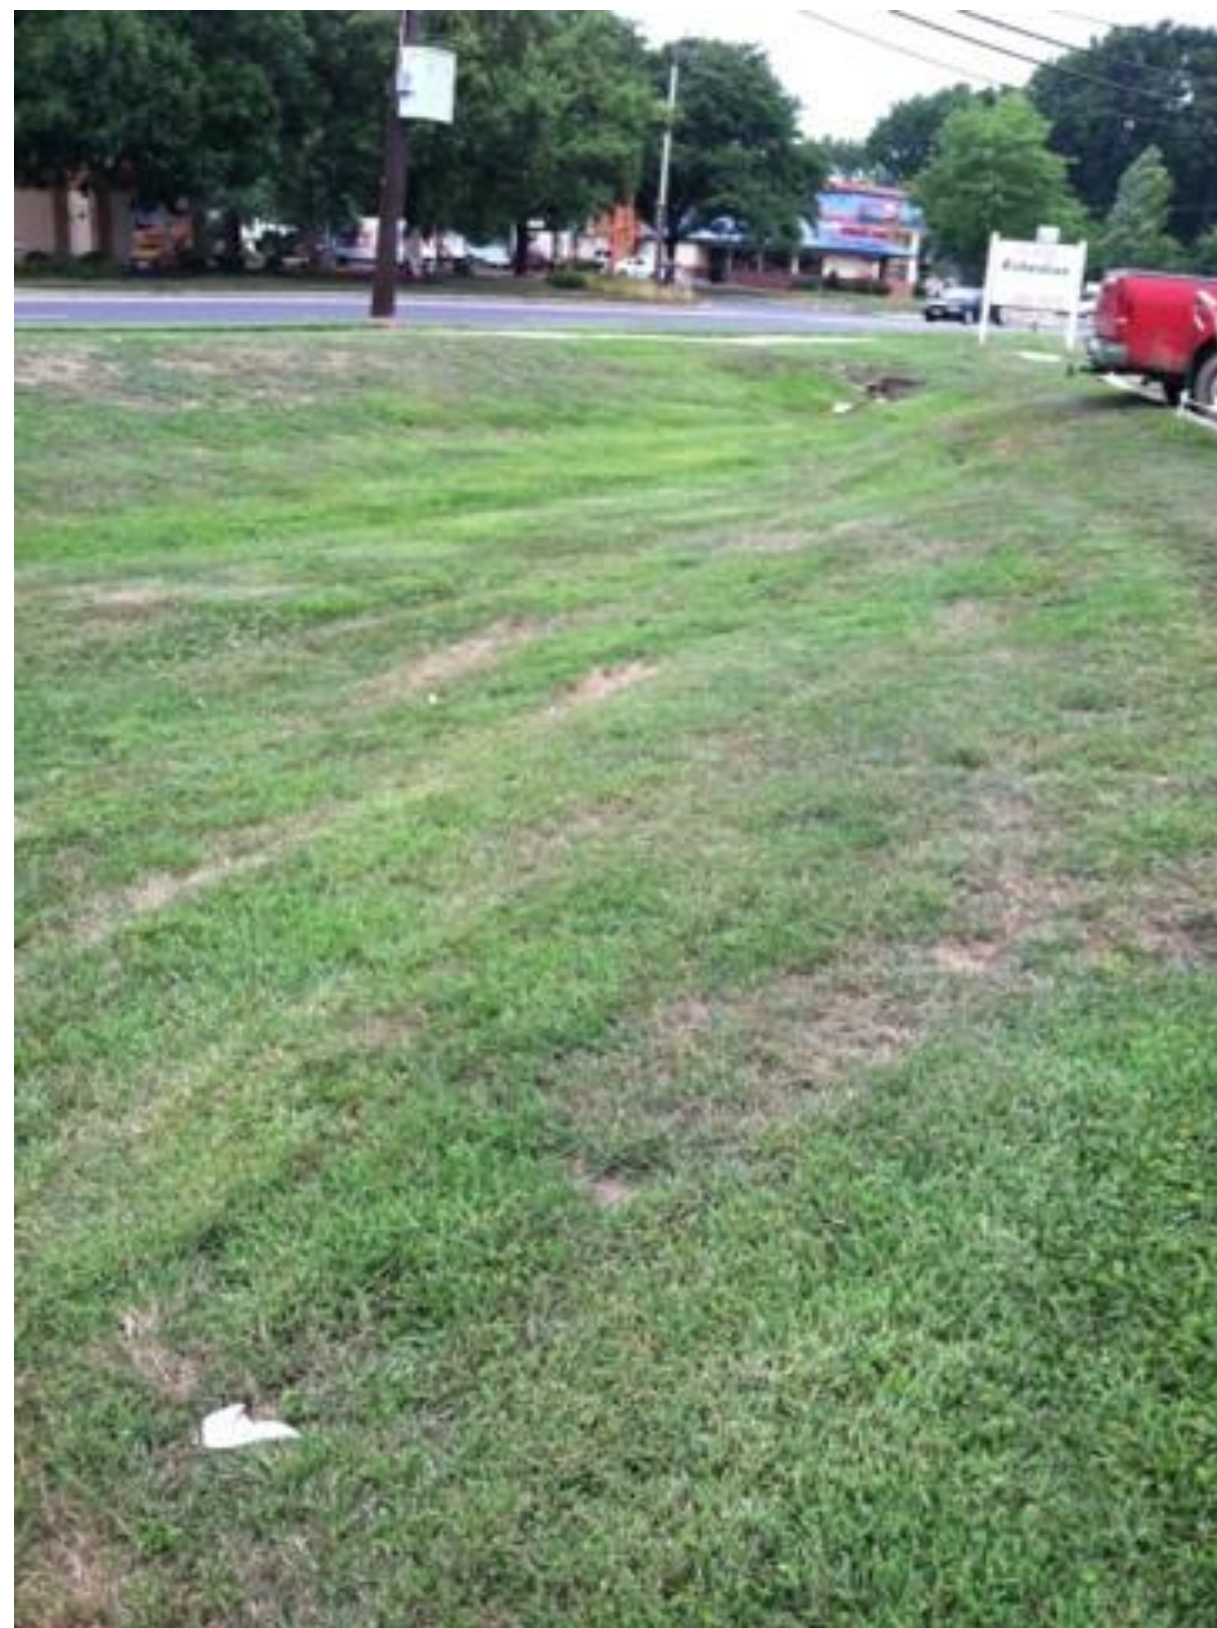
Damaged inlet

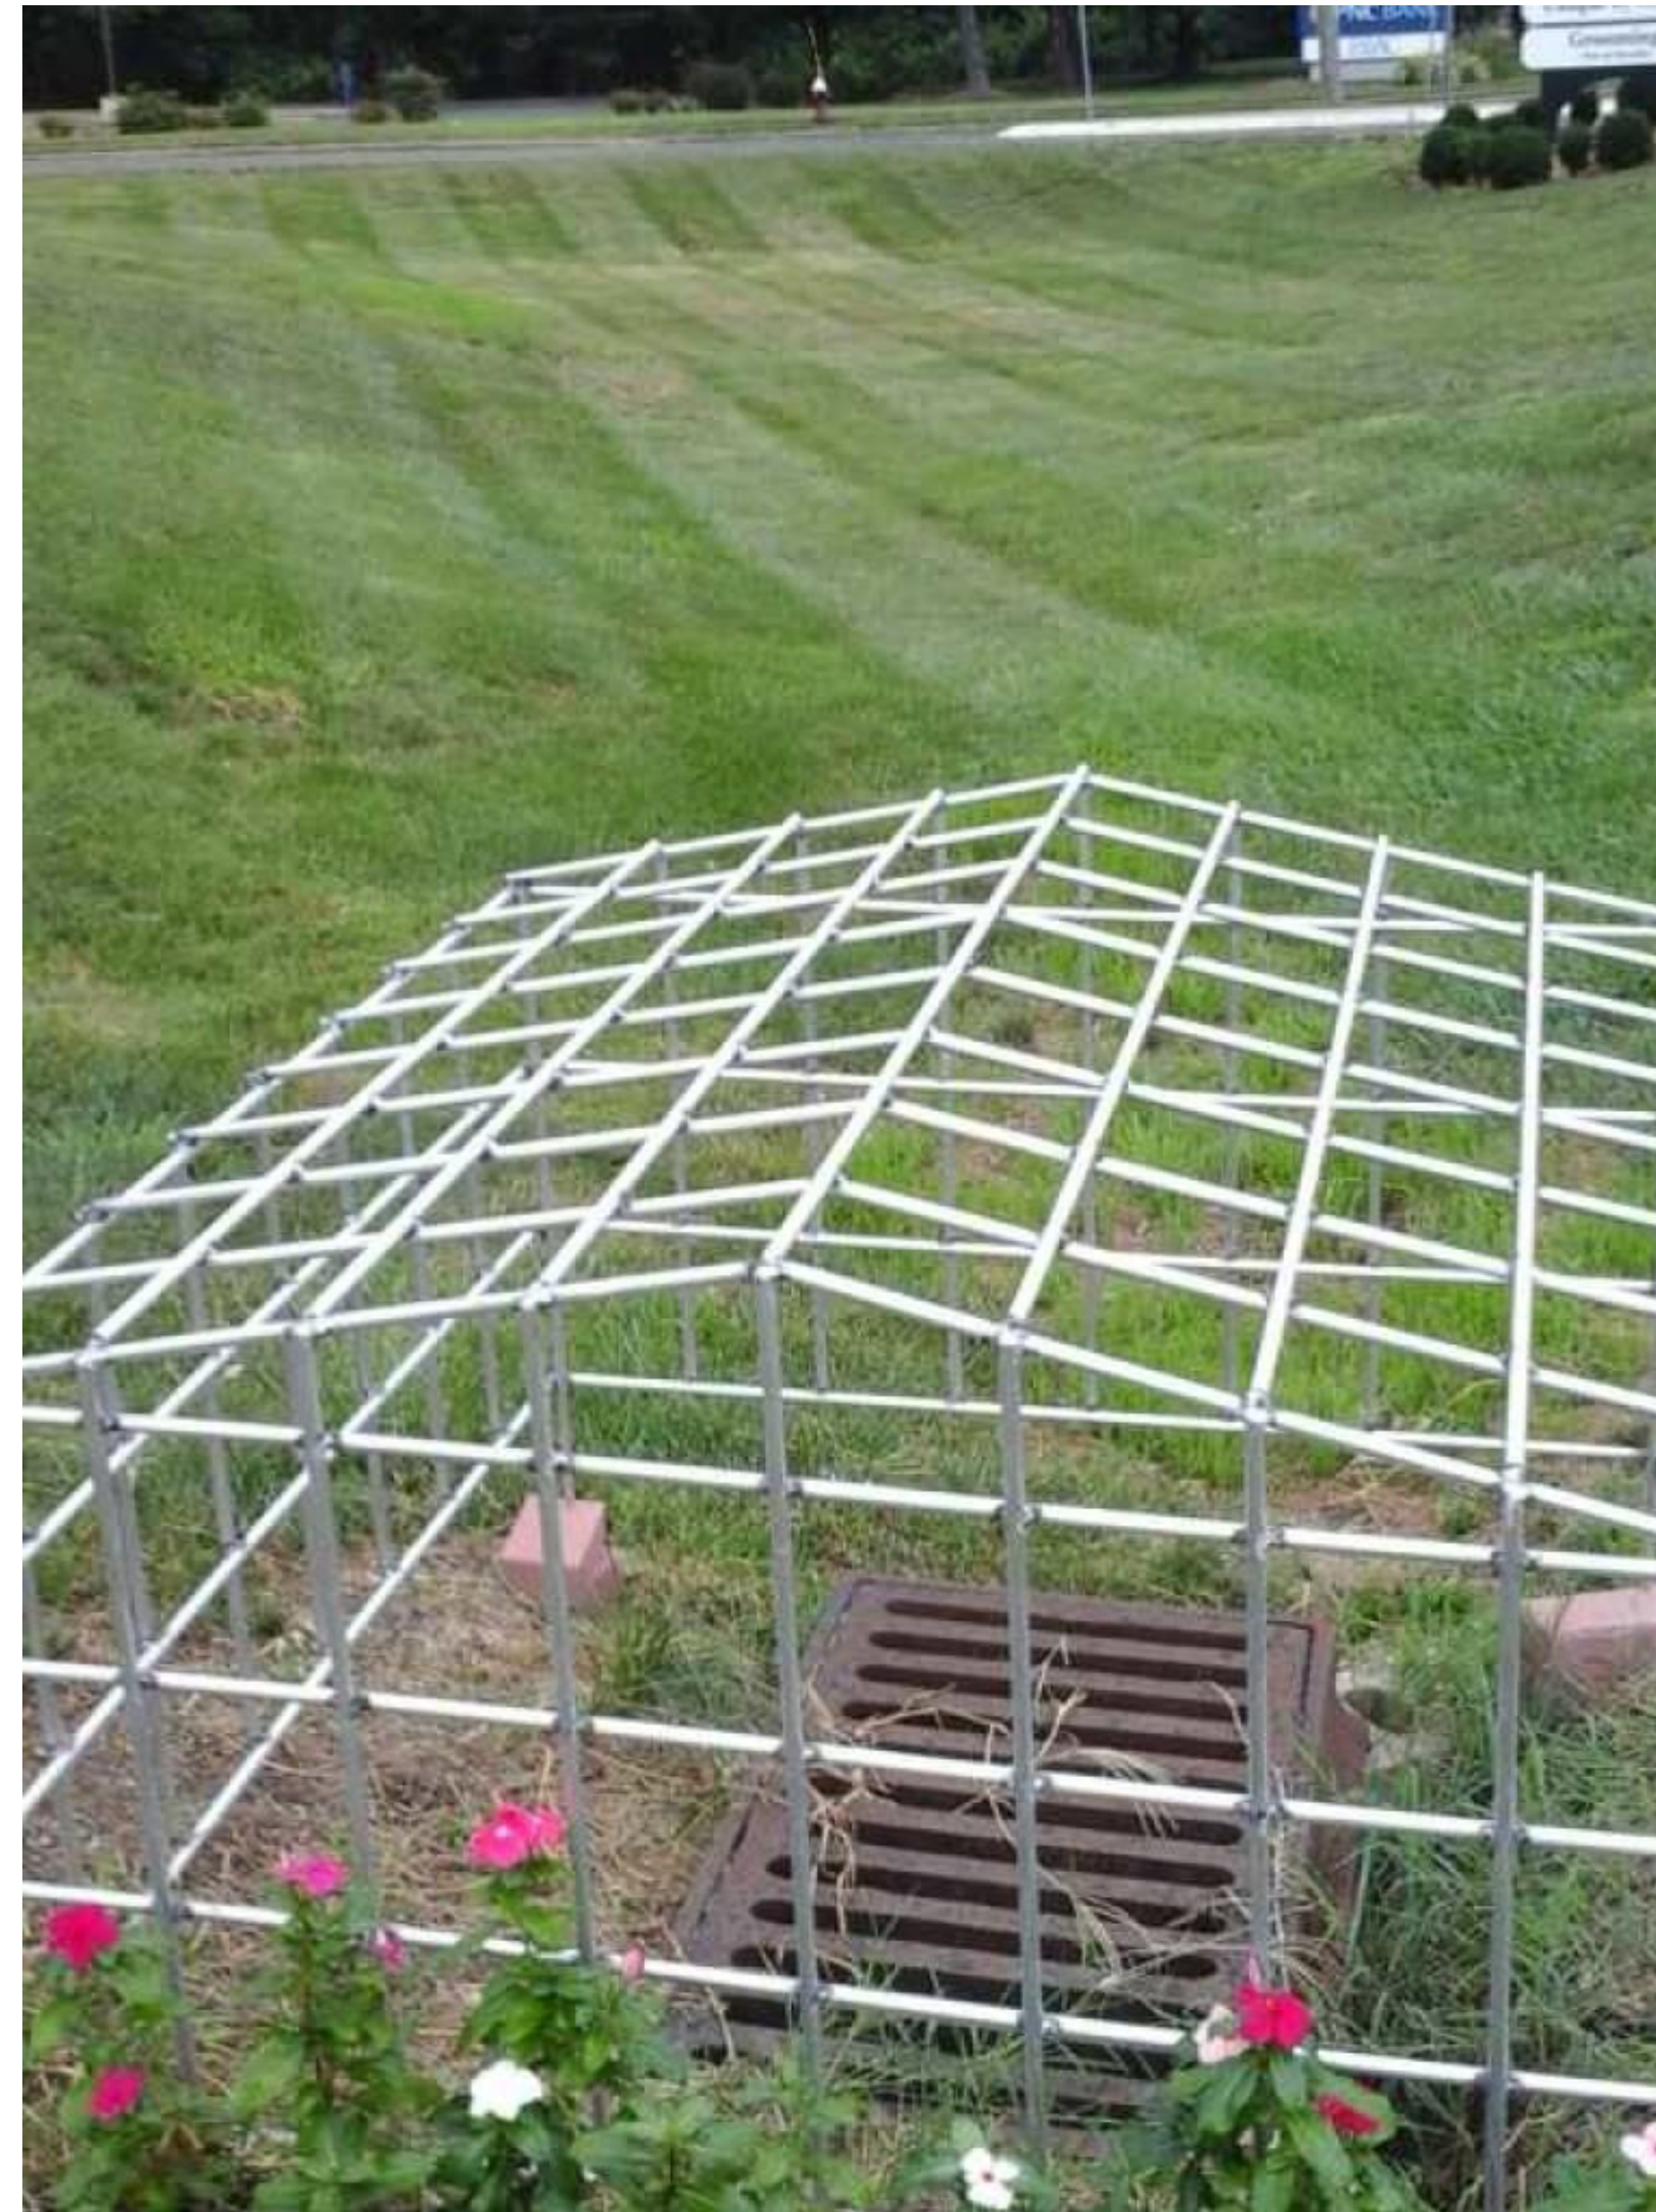
21. ShopRite Liquors of Hamilton Basin

- Large grass basin with outflow
- Grate added around outlet structure, but still could use repairs
- Erosion problem from parking lot still present

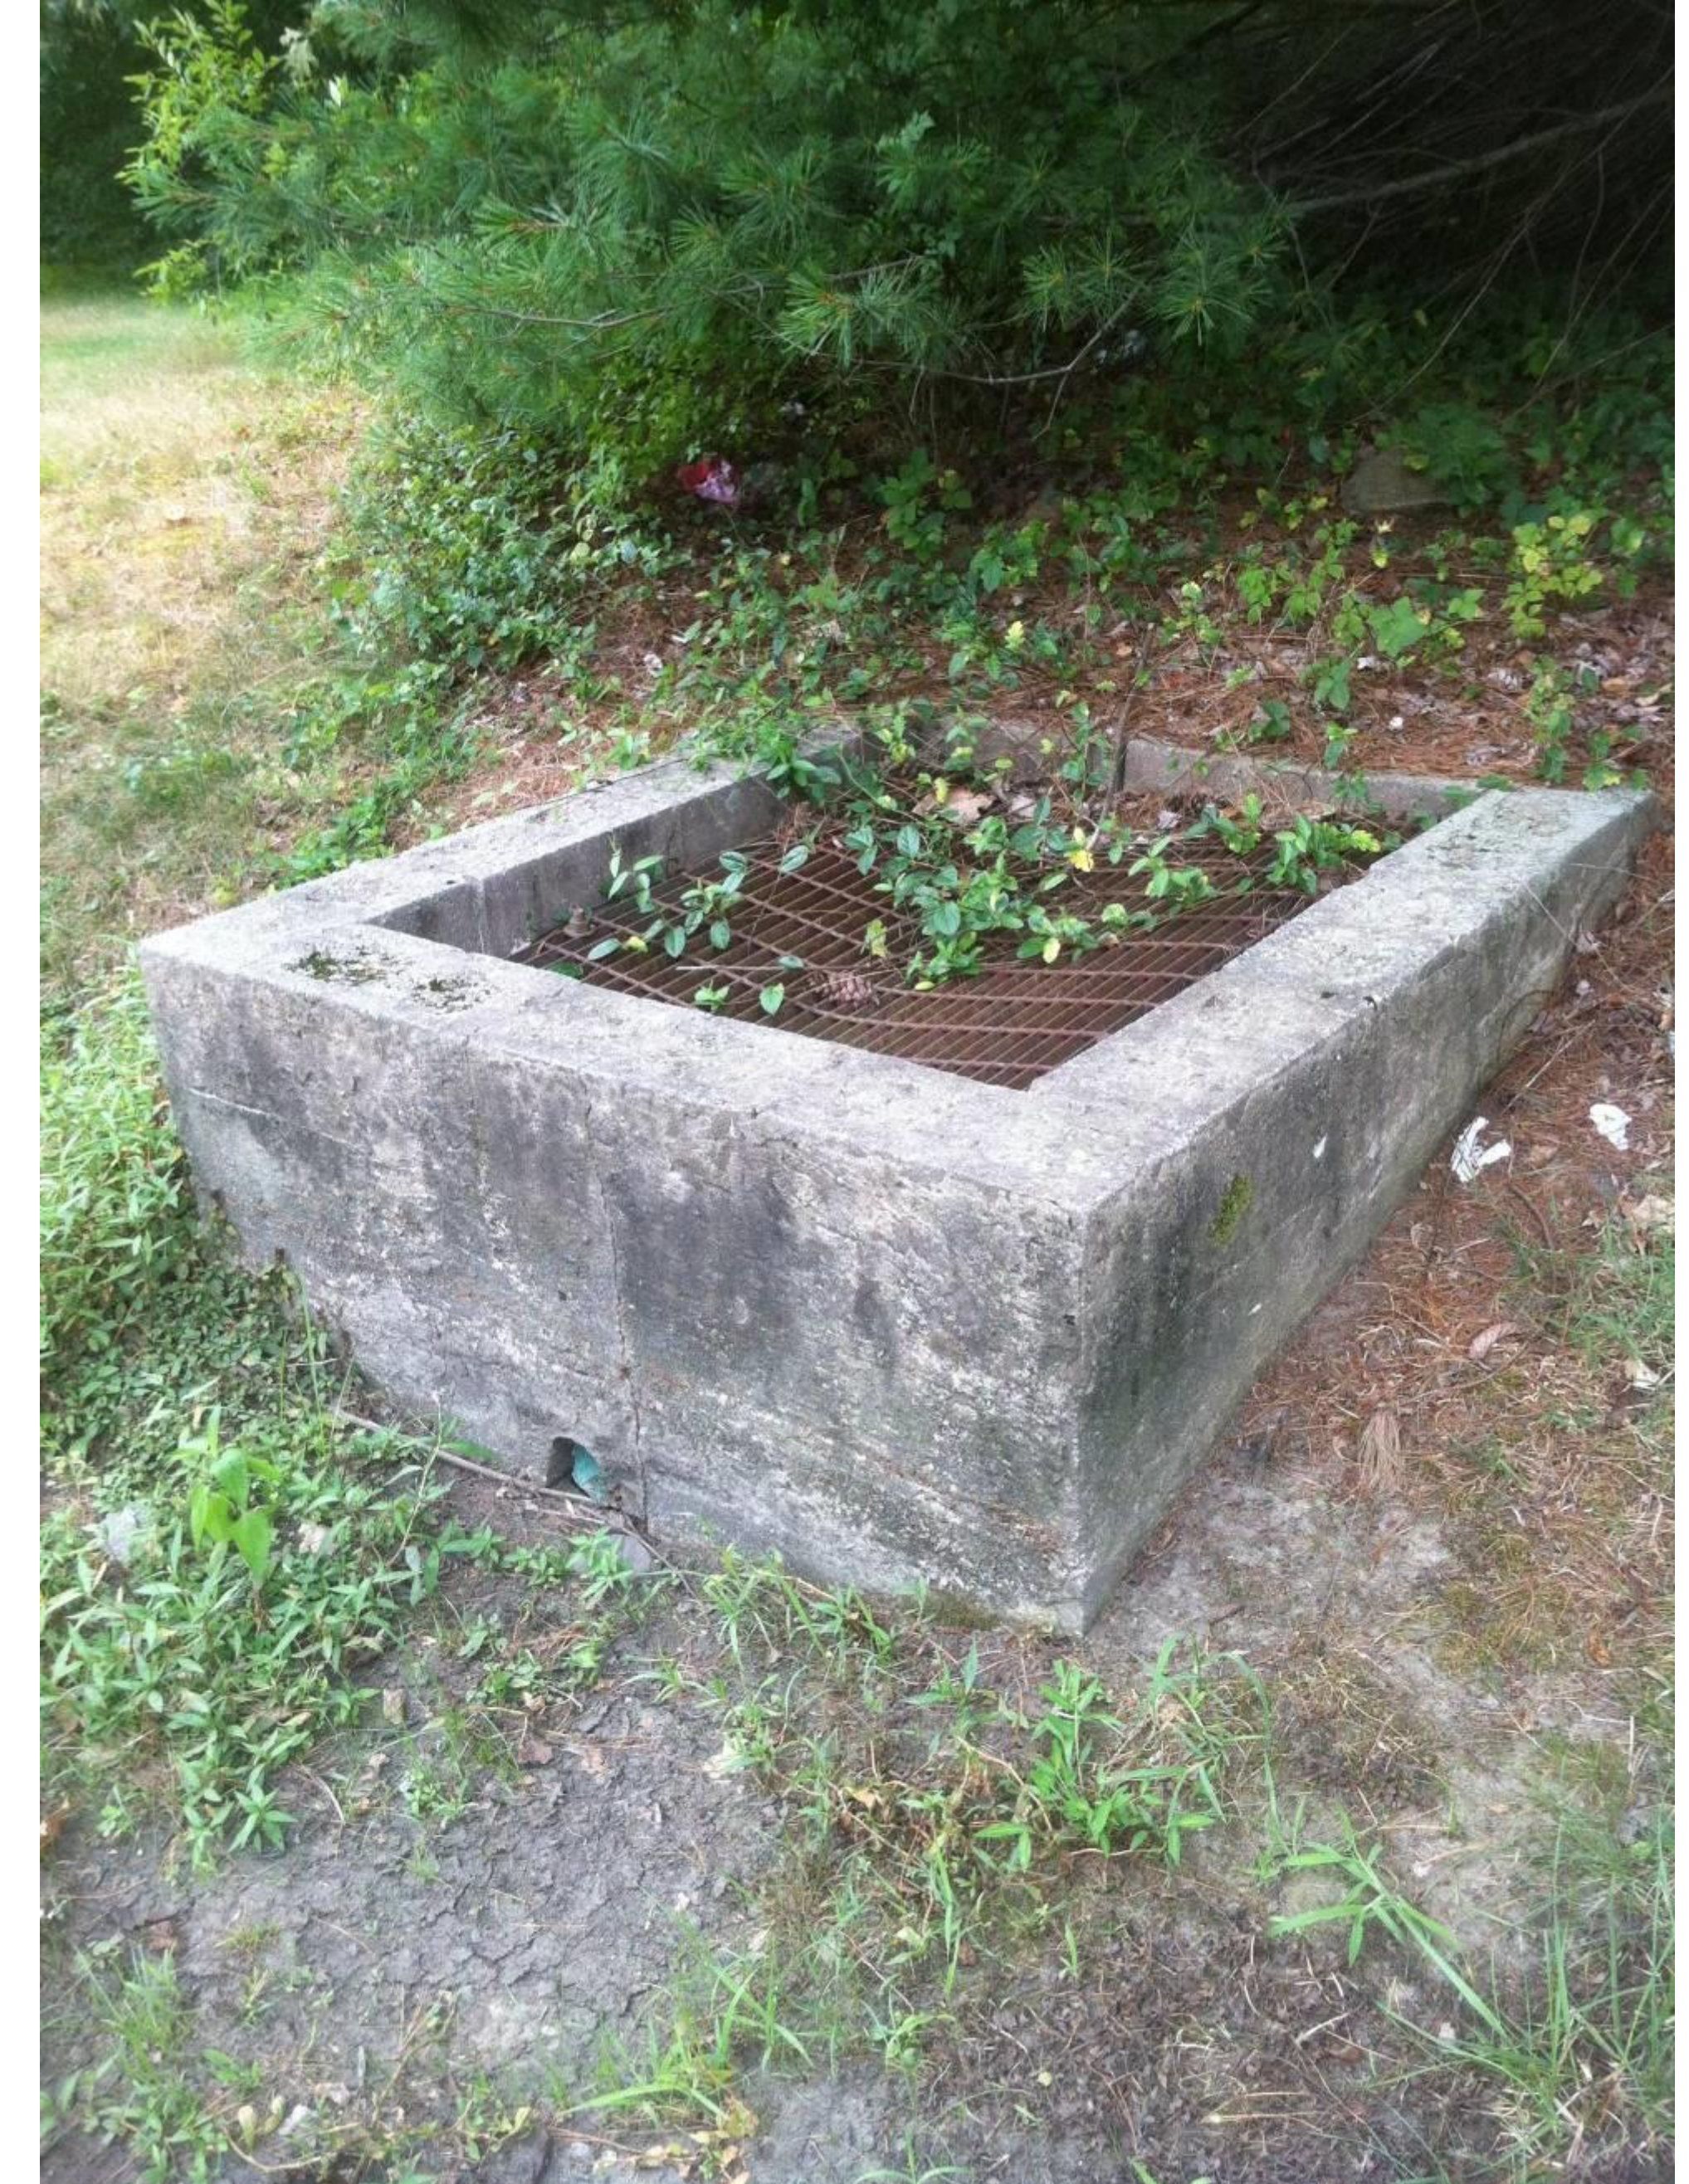
Sediment in low flow channel

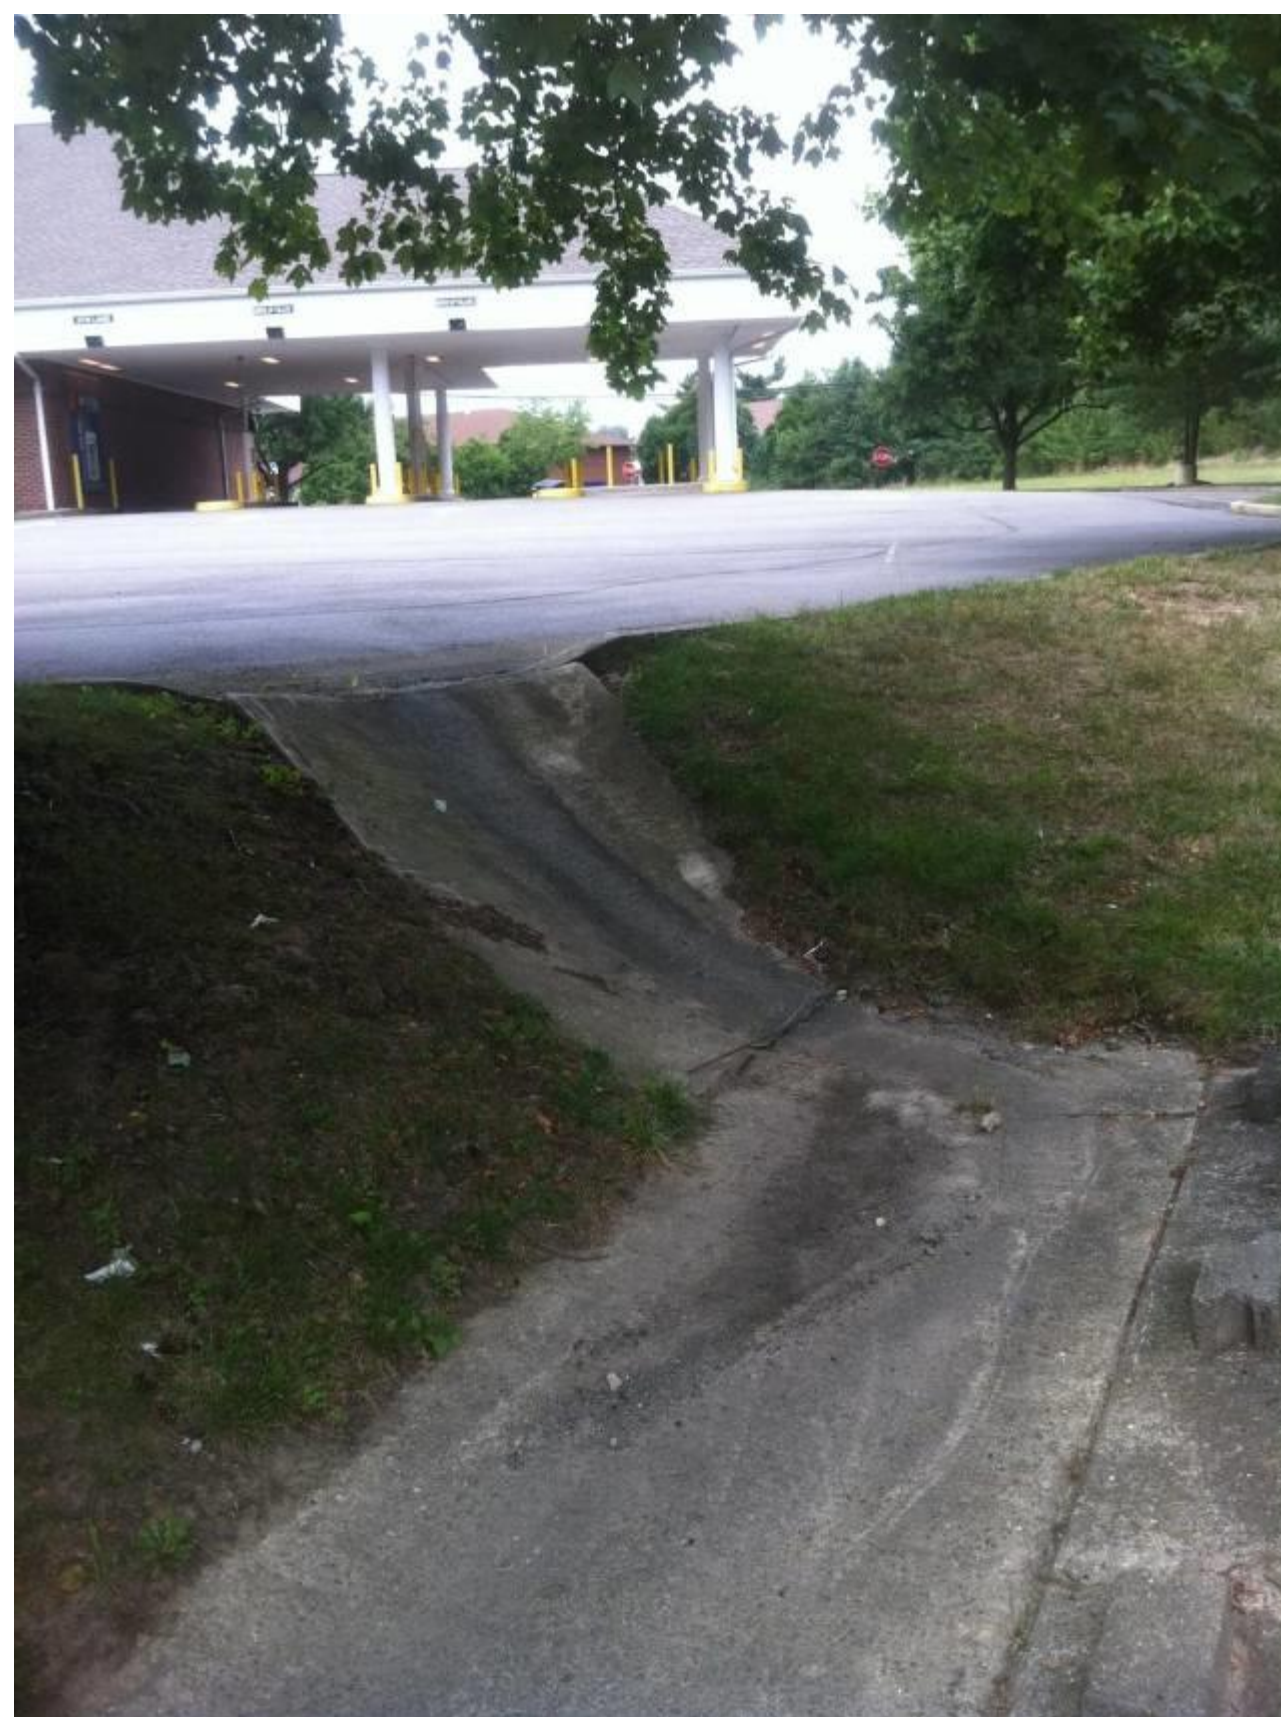
Damaged outlet

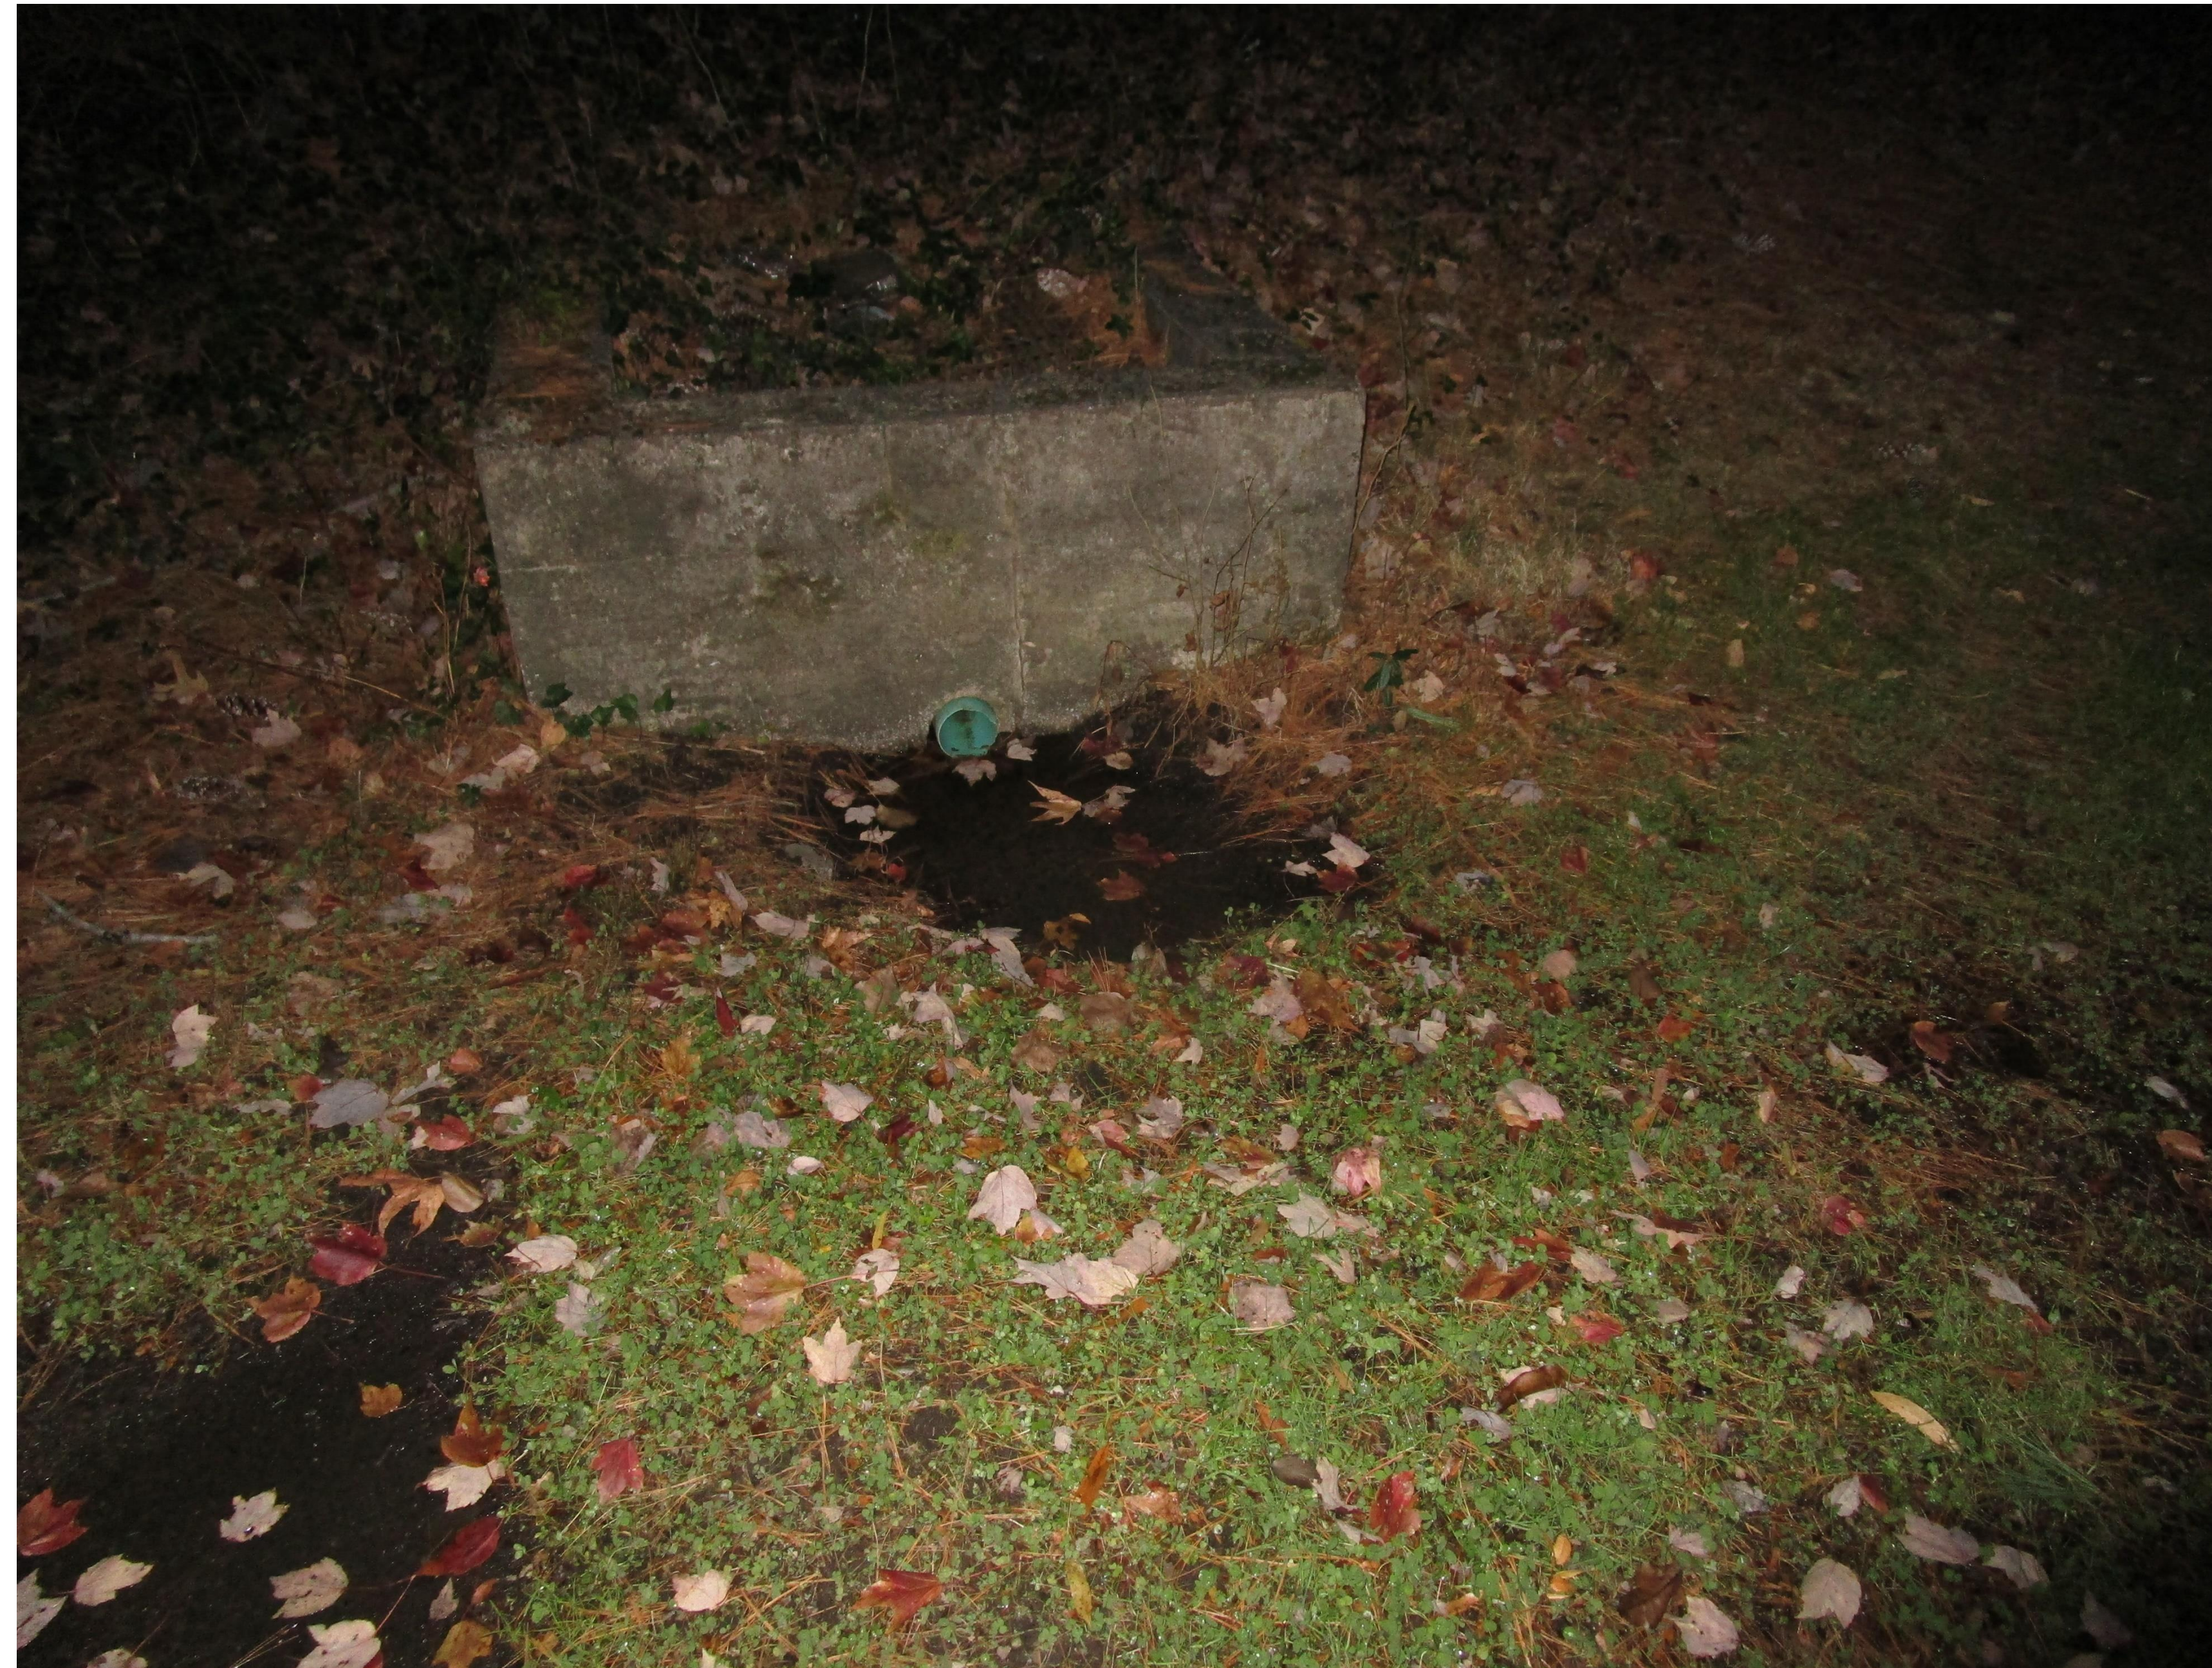
Address:
3111 Quakerbridge Road
Trenton, NJ 08619

- Basin overall is in good condition
- Significant sediment buildup in low flow channel with grass growing over, resulting in standing water in low flow channels
- Potential retrofit by removing low flow channels to promote infiltration or naturalizing into a meadow with reduced mowing
