**Hamilton Township (Mercer County)
Stormwater Basin Assessment Summary
Past Priority Addendum (Year 5B)**

Developed by the Rutgers Cooperative Extension Water Resources Program
Funded by Hamilton Township, Mercer County, New Jersey

November 27, 2019

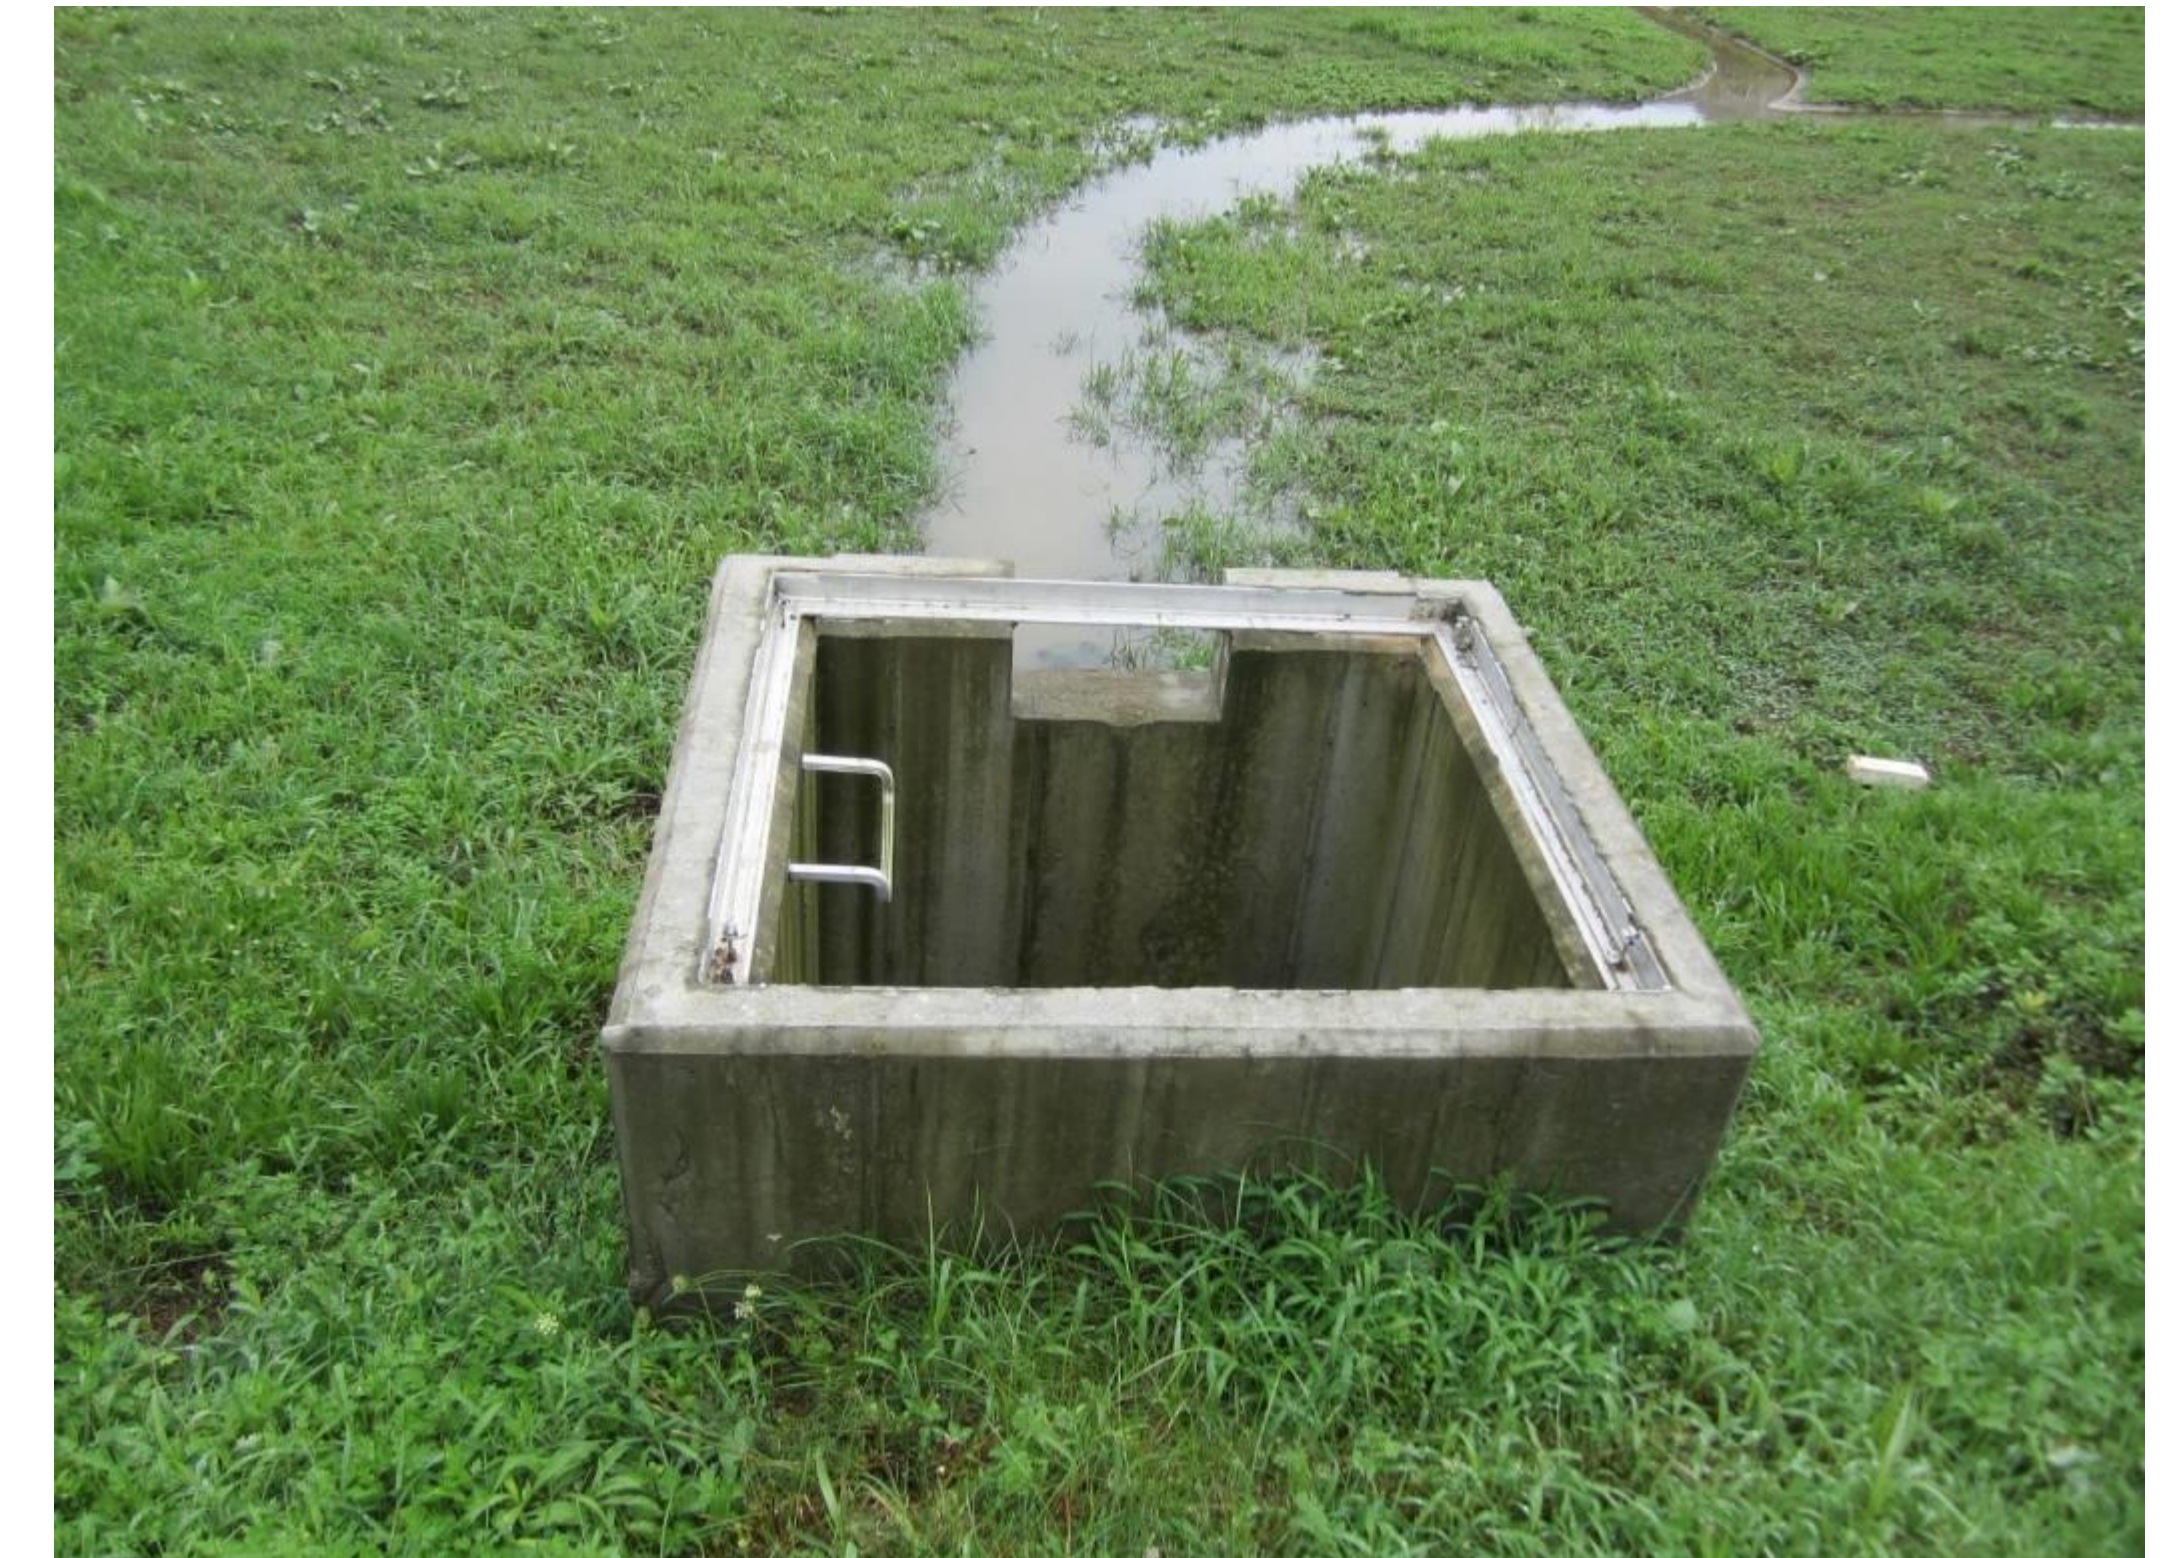
Inlet

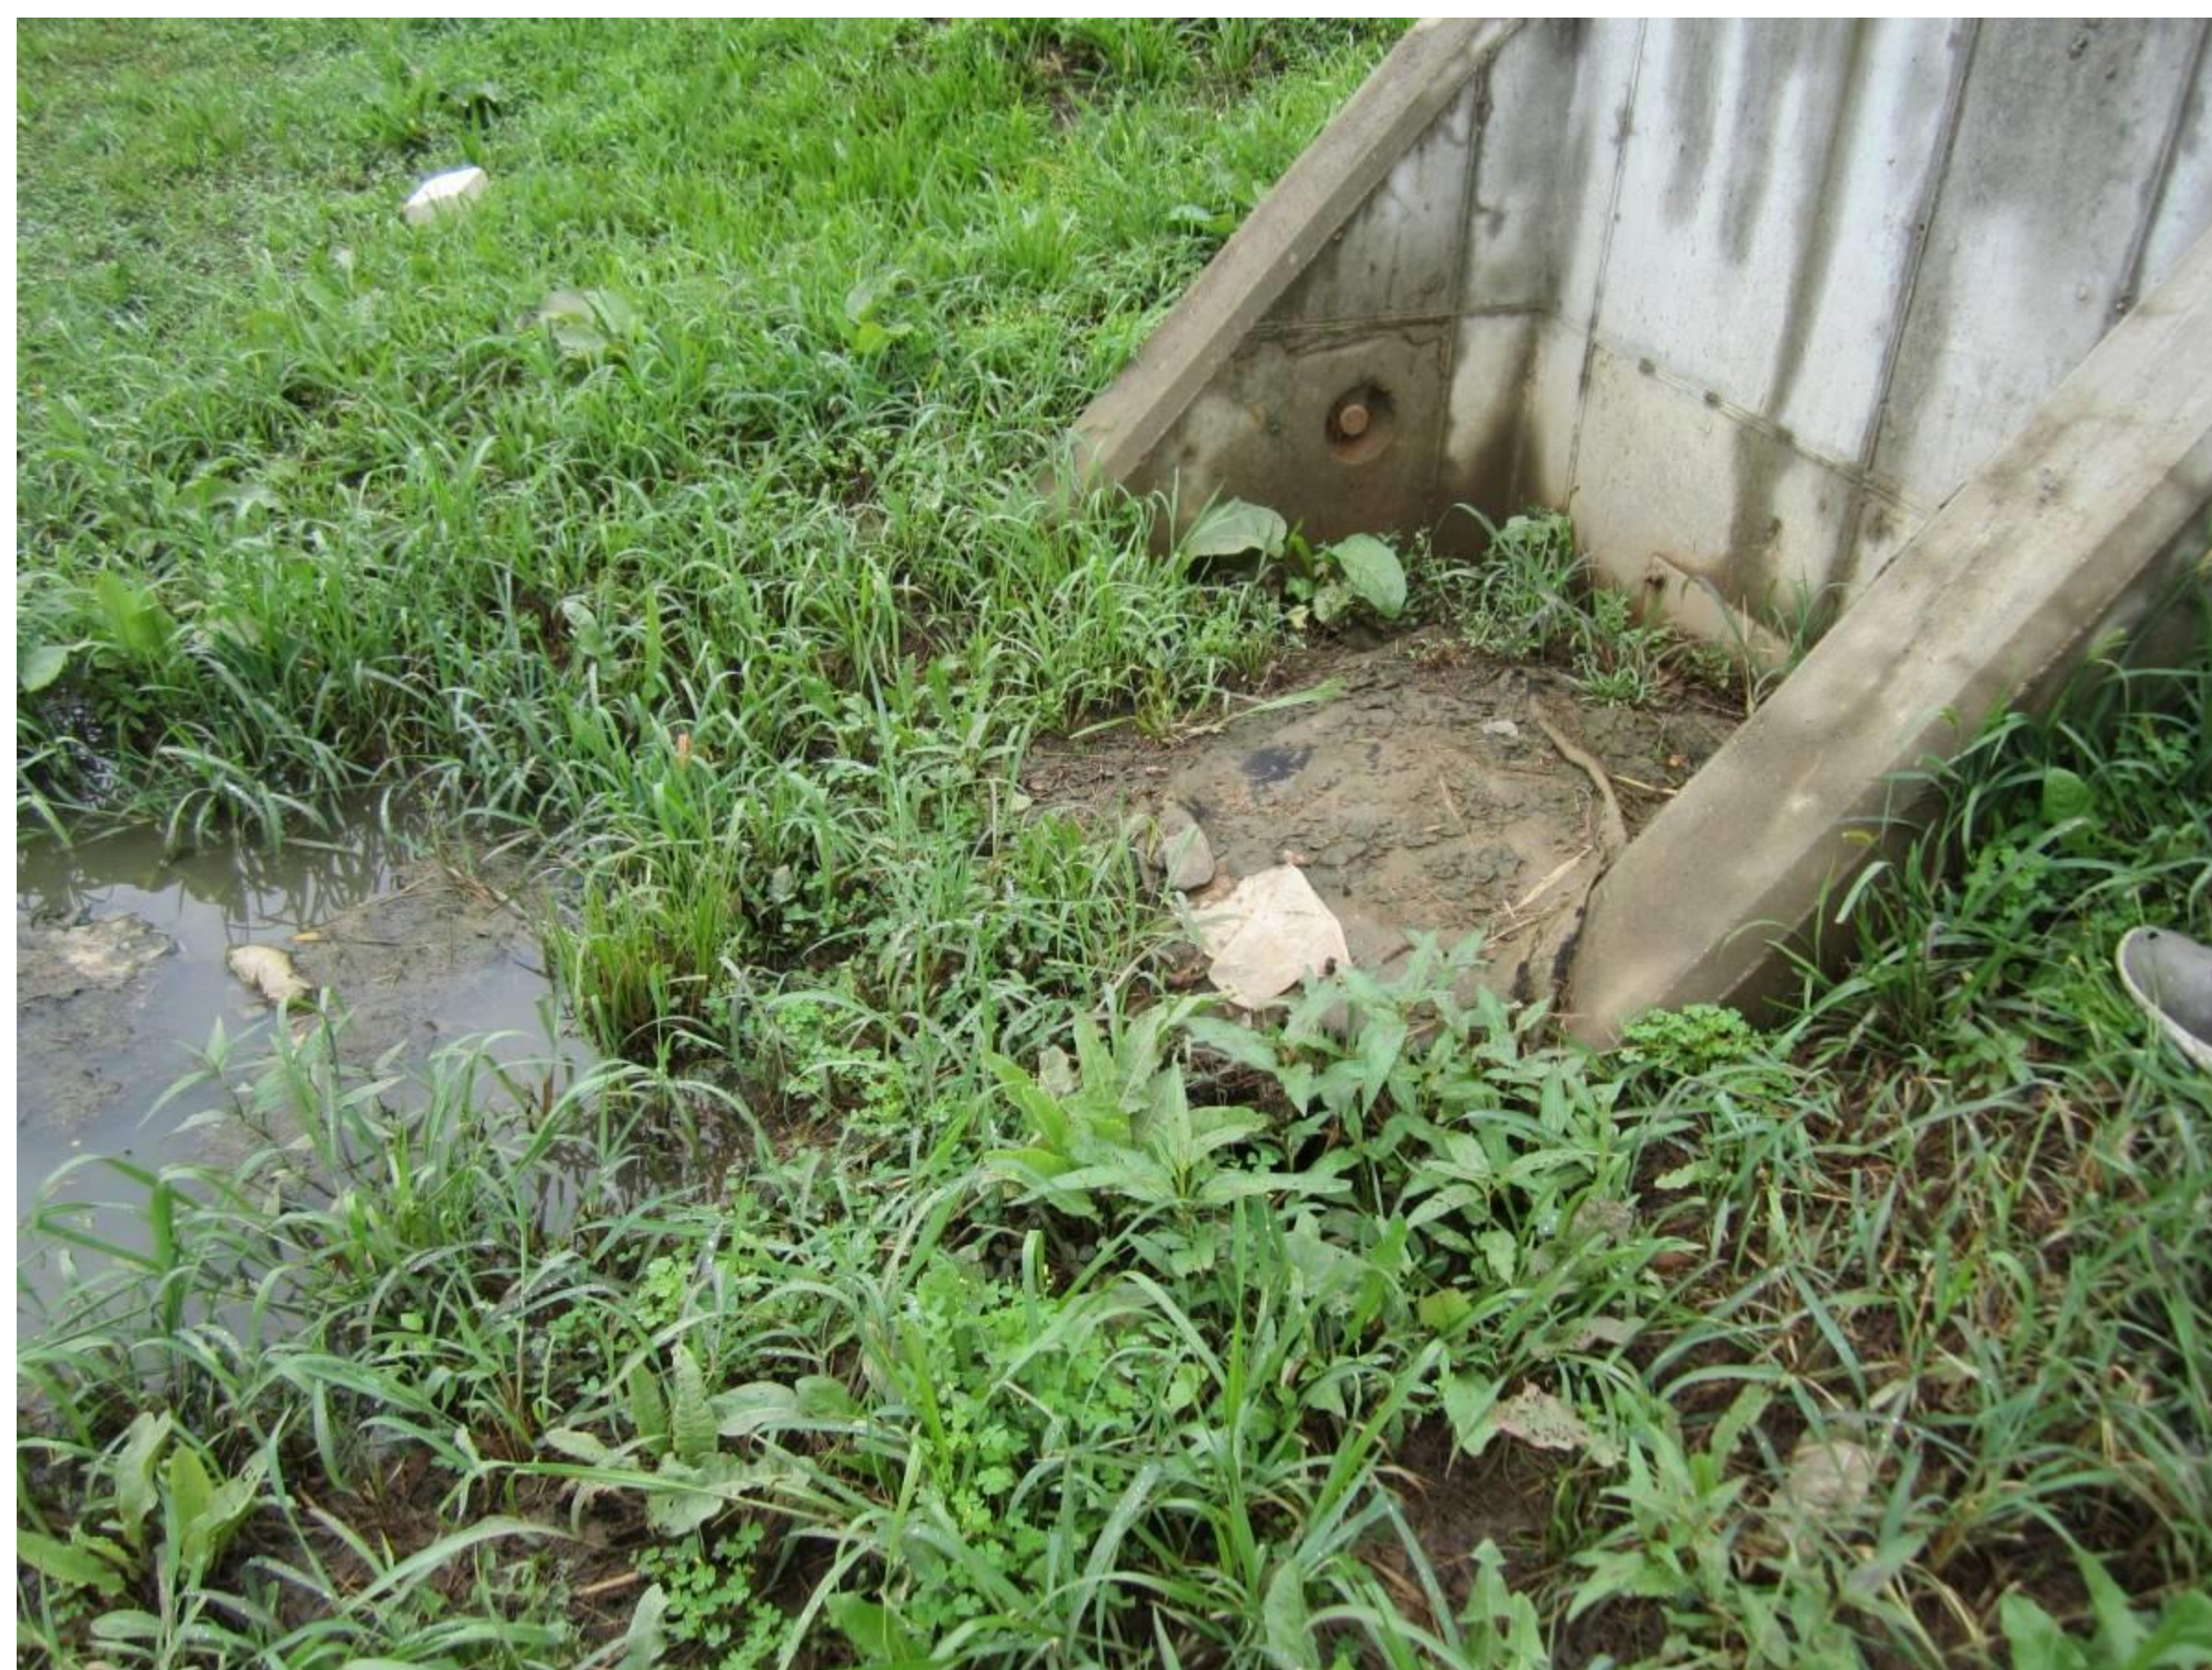
Outlet structure missing grate

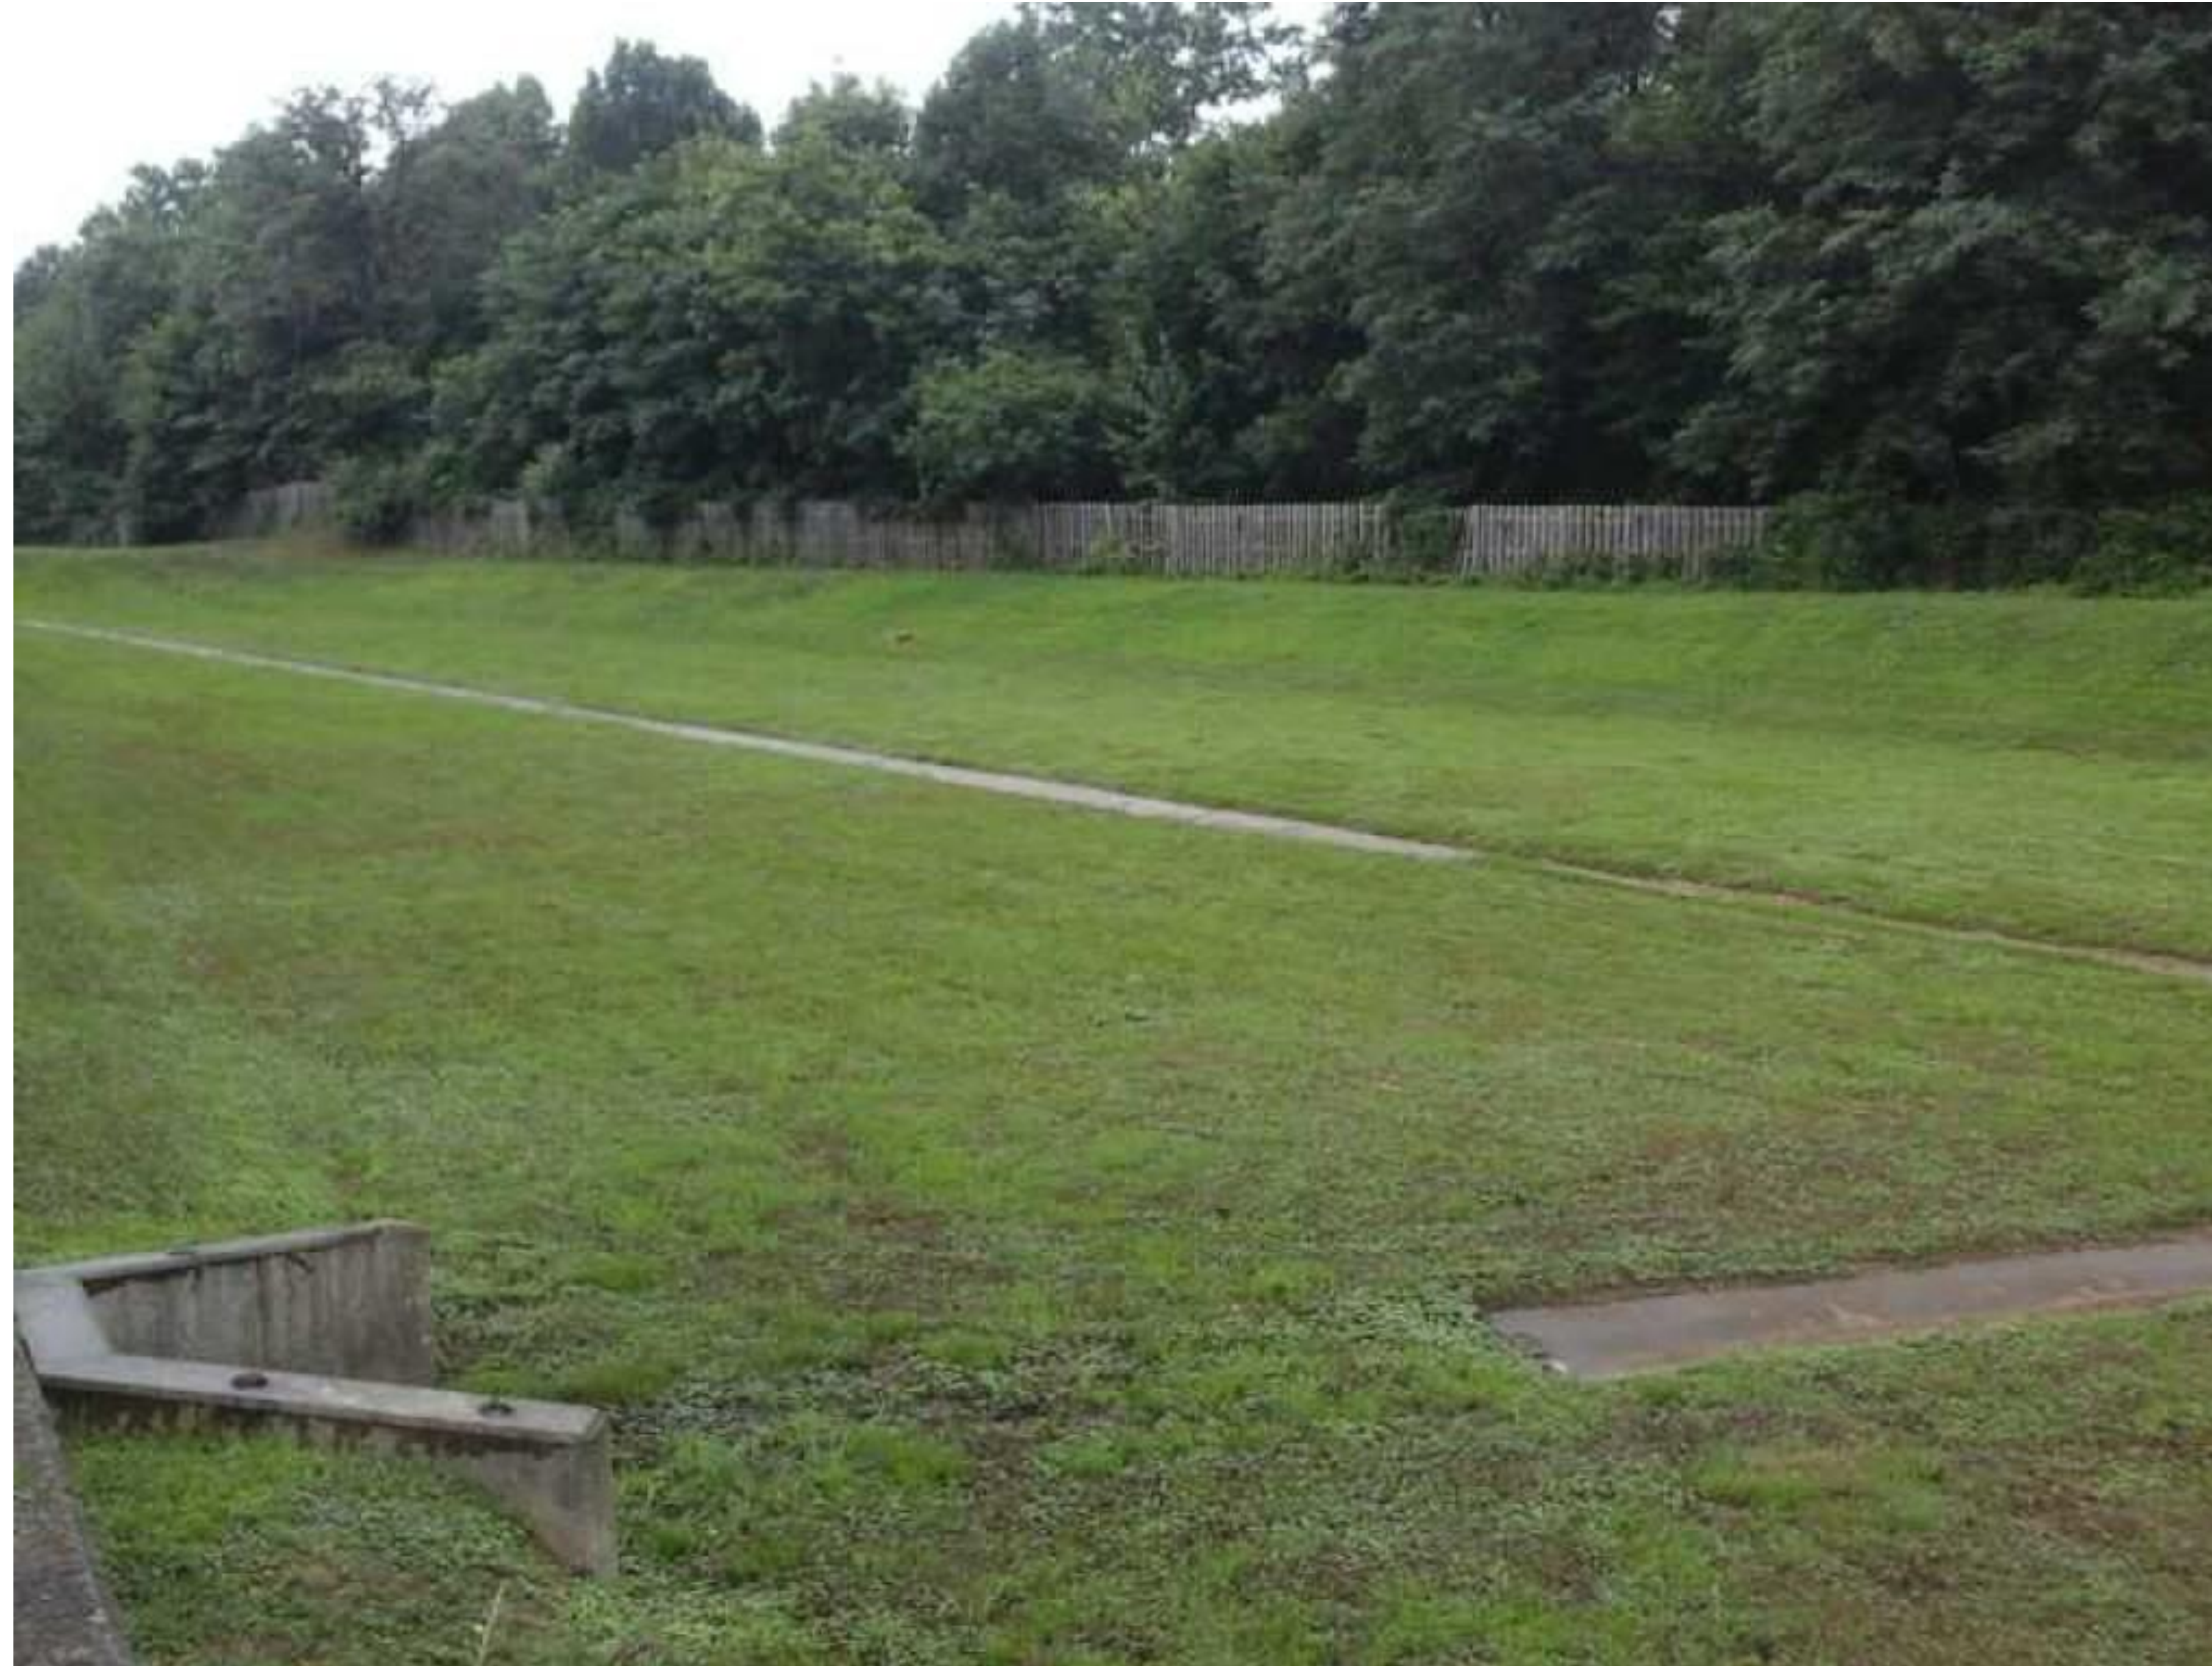
Address:
Basin Rd and American Metro Blvd
Hamilton Township, NJ 08619

- Some signs of soil erosion by inlet
- Low flow channels can be removed to promote more infiltration

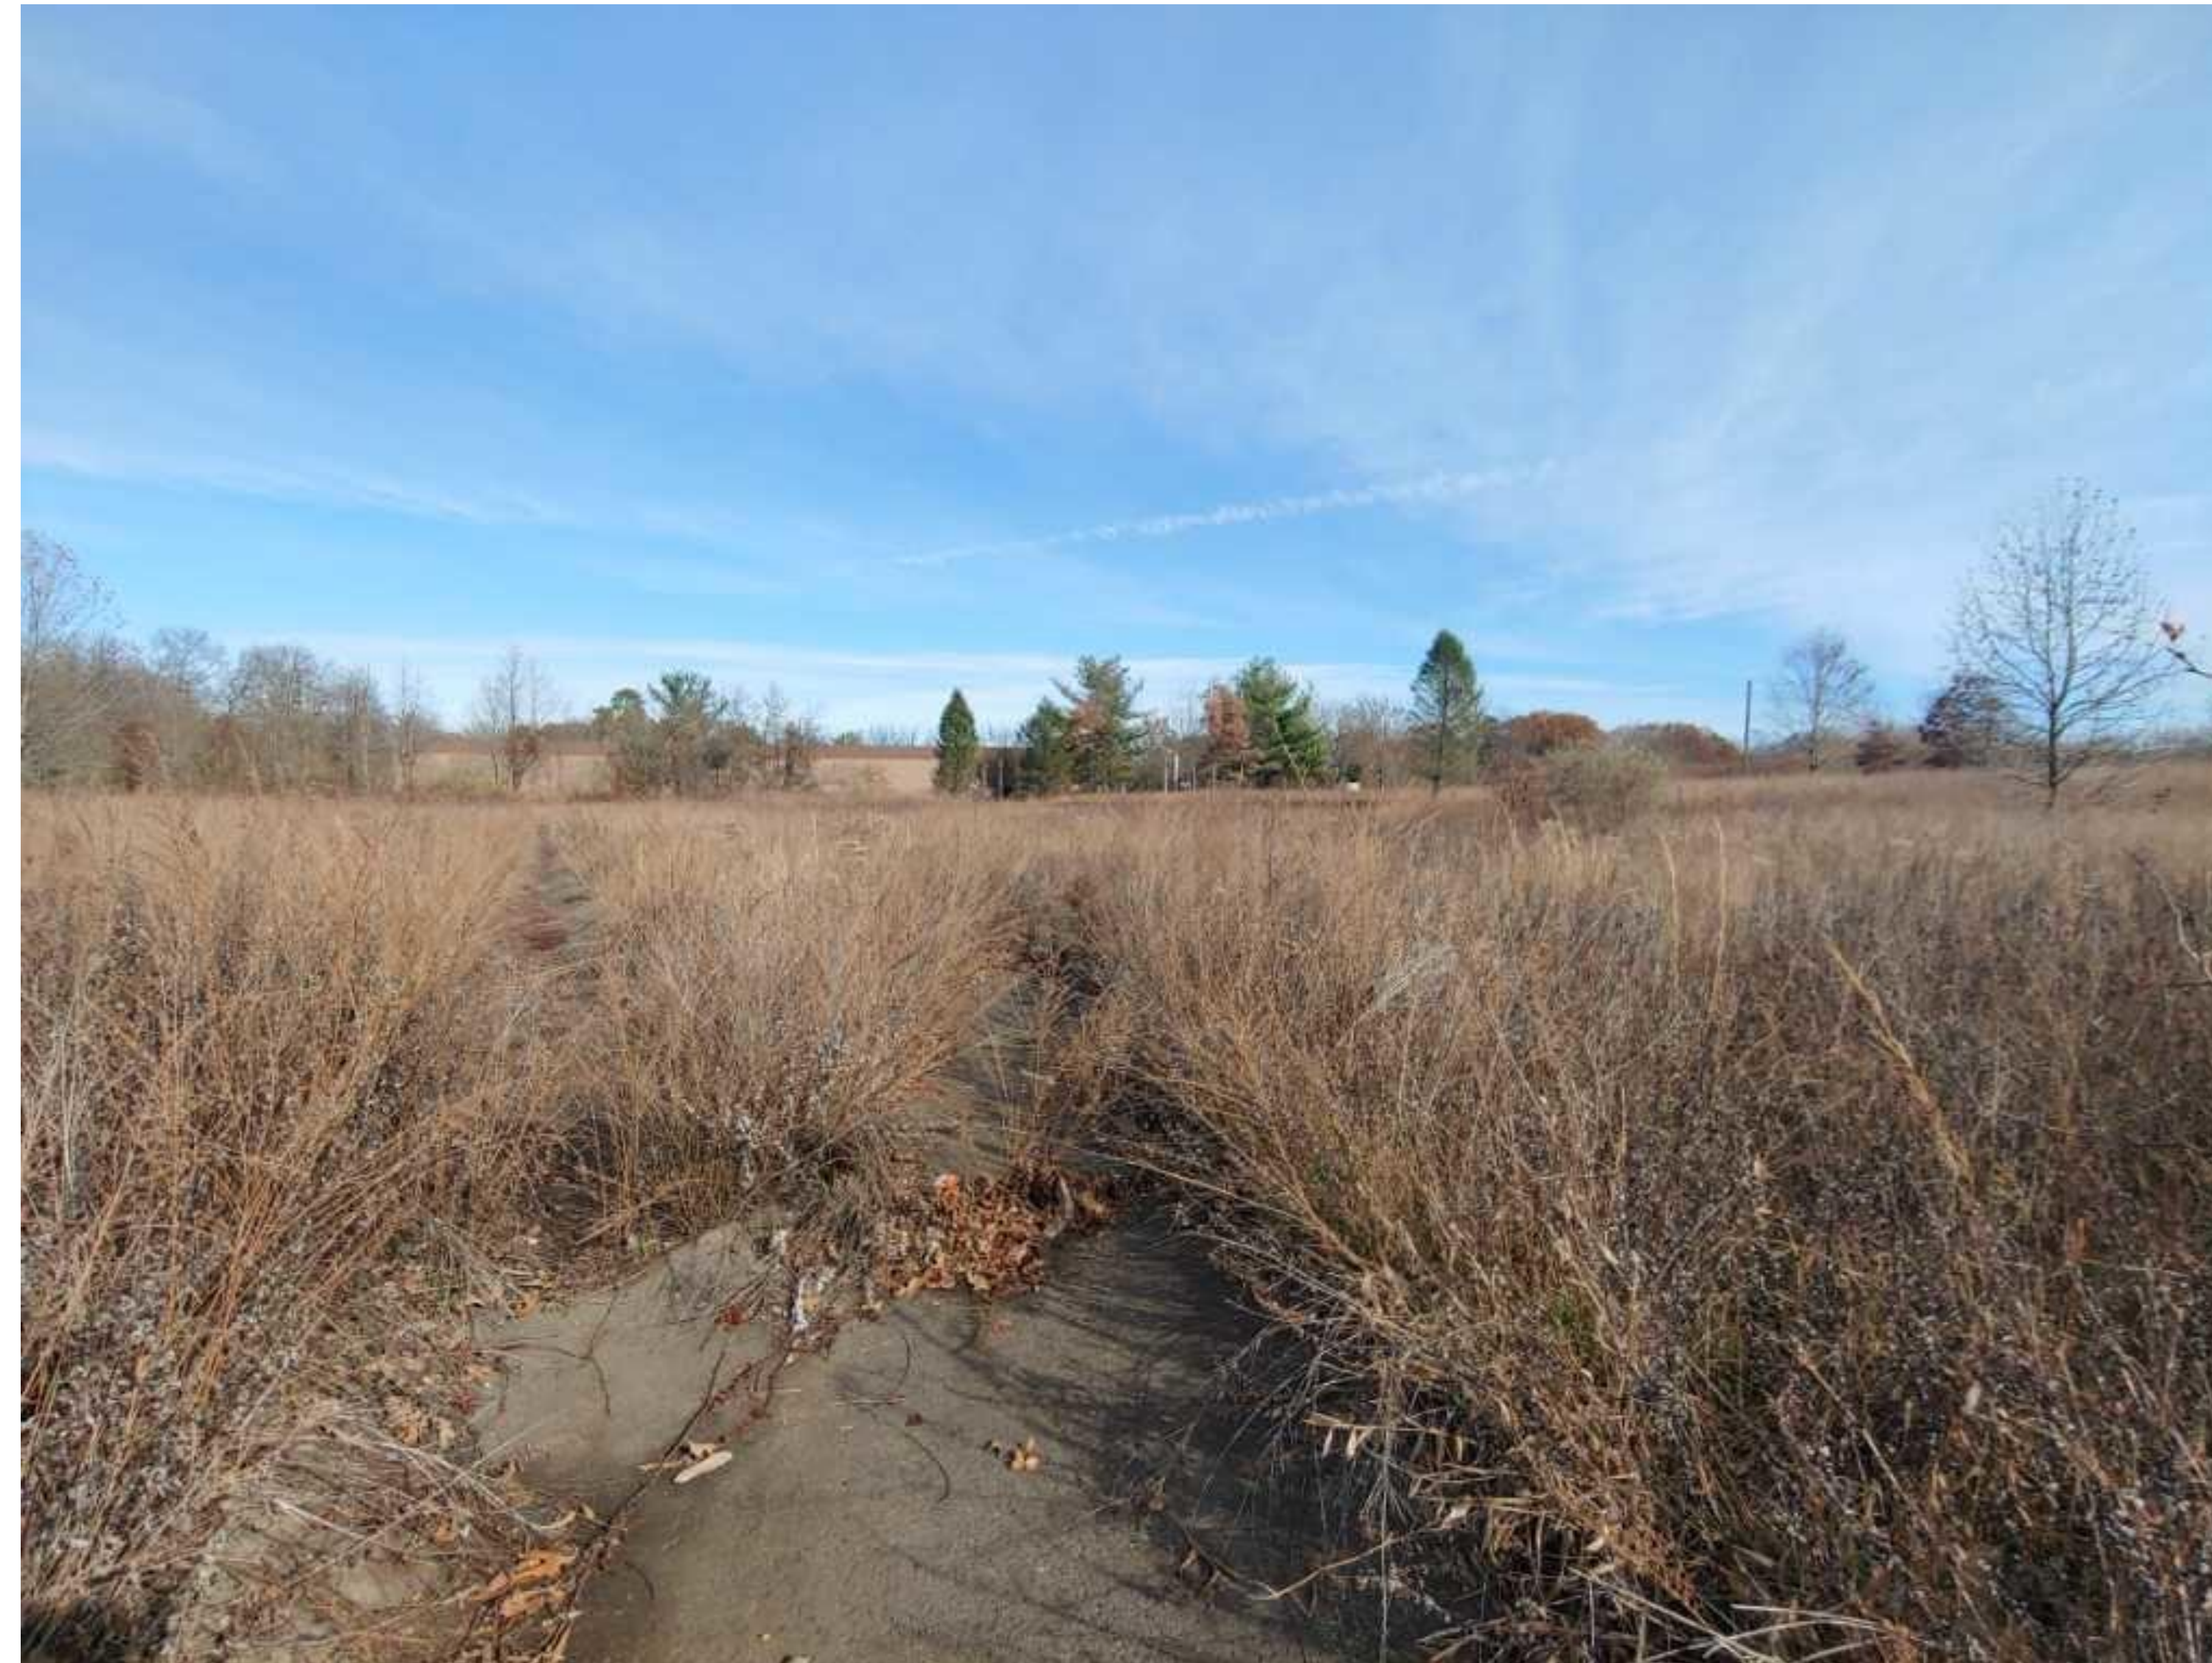
Address:
21 Thomas J Rhodes Industrial Drive
Hamilton Township, NJ 08619

- Portion of basin near outlet appears to have significant sediment accumulation as low flow is buried and covered with sediment
- Basin partly naturalized with primarily herbaceous and some woody vegetation
- Remove low flow channel to promote infiltration in upper portions of basin

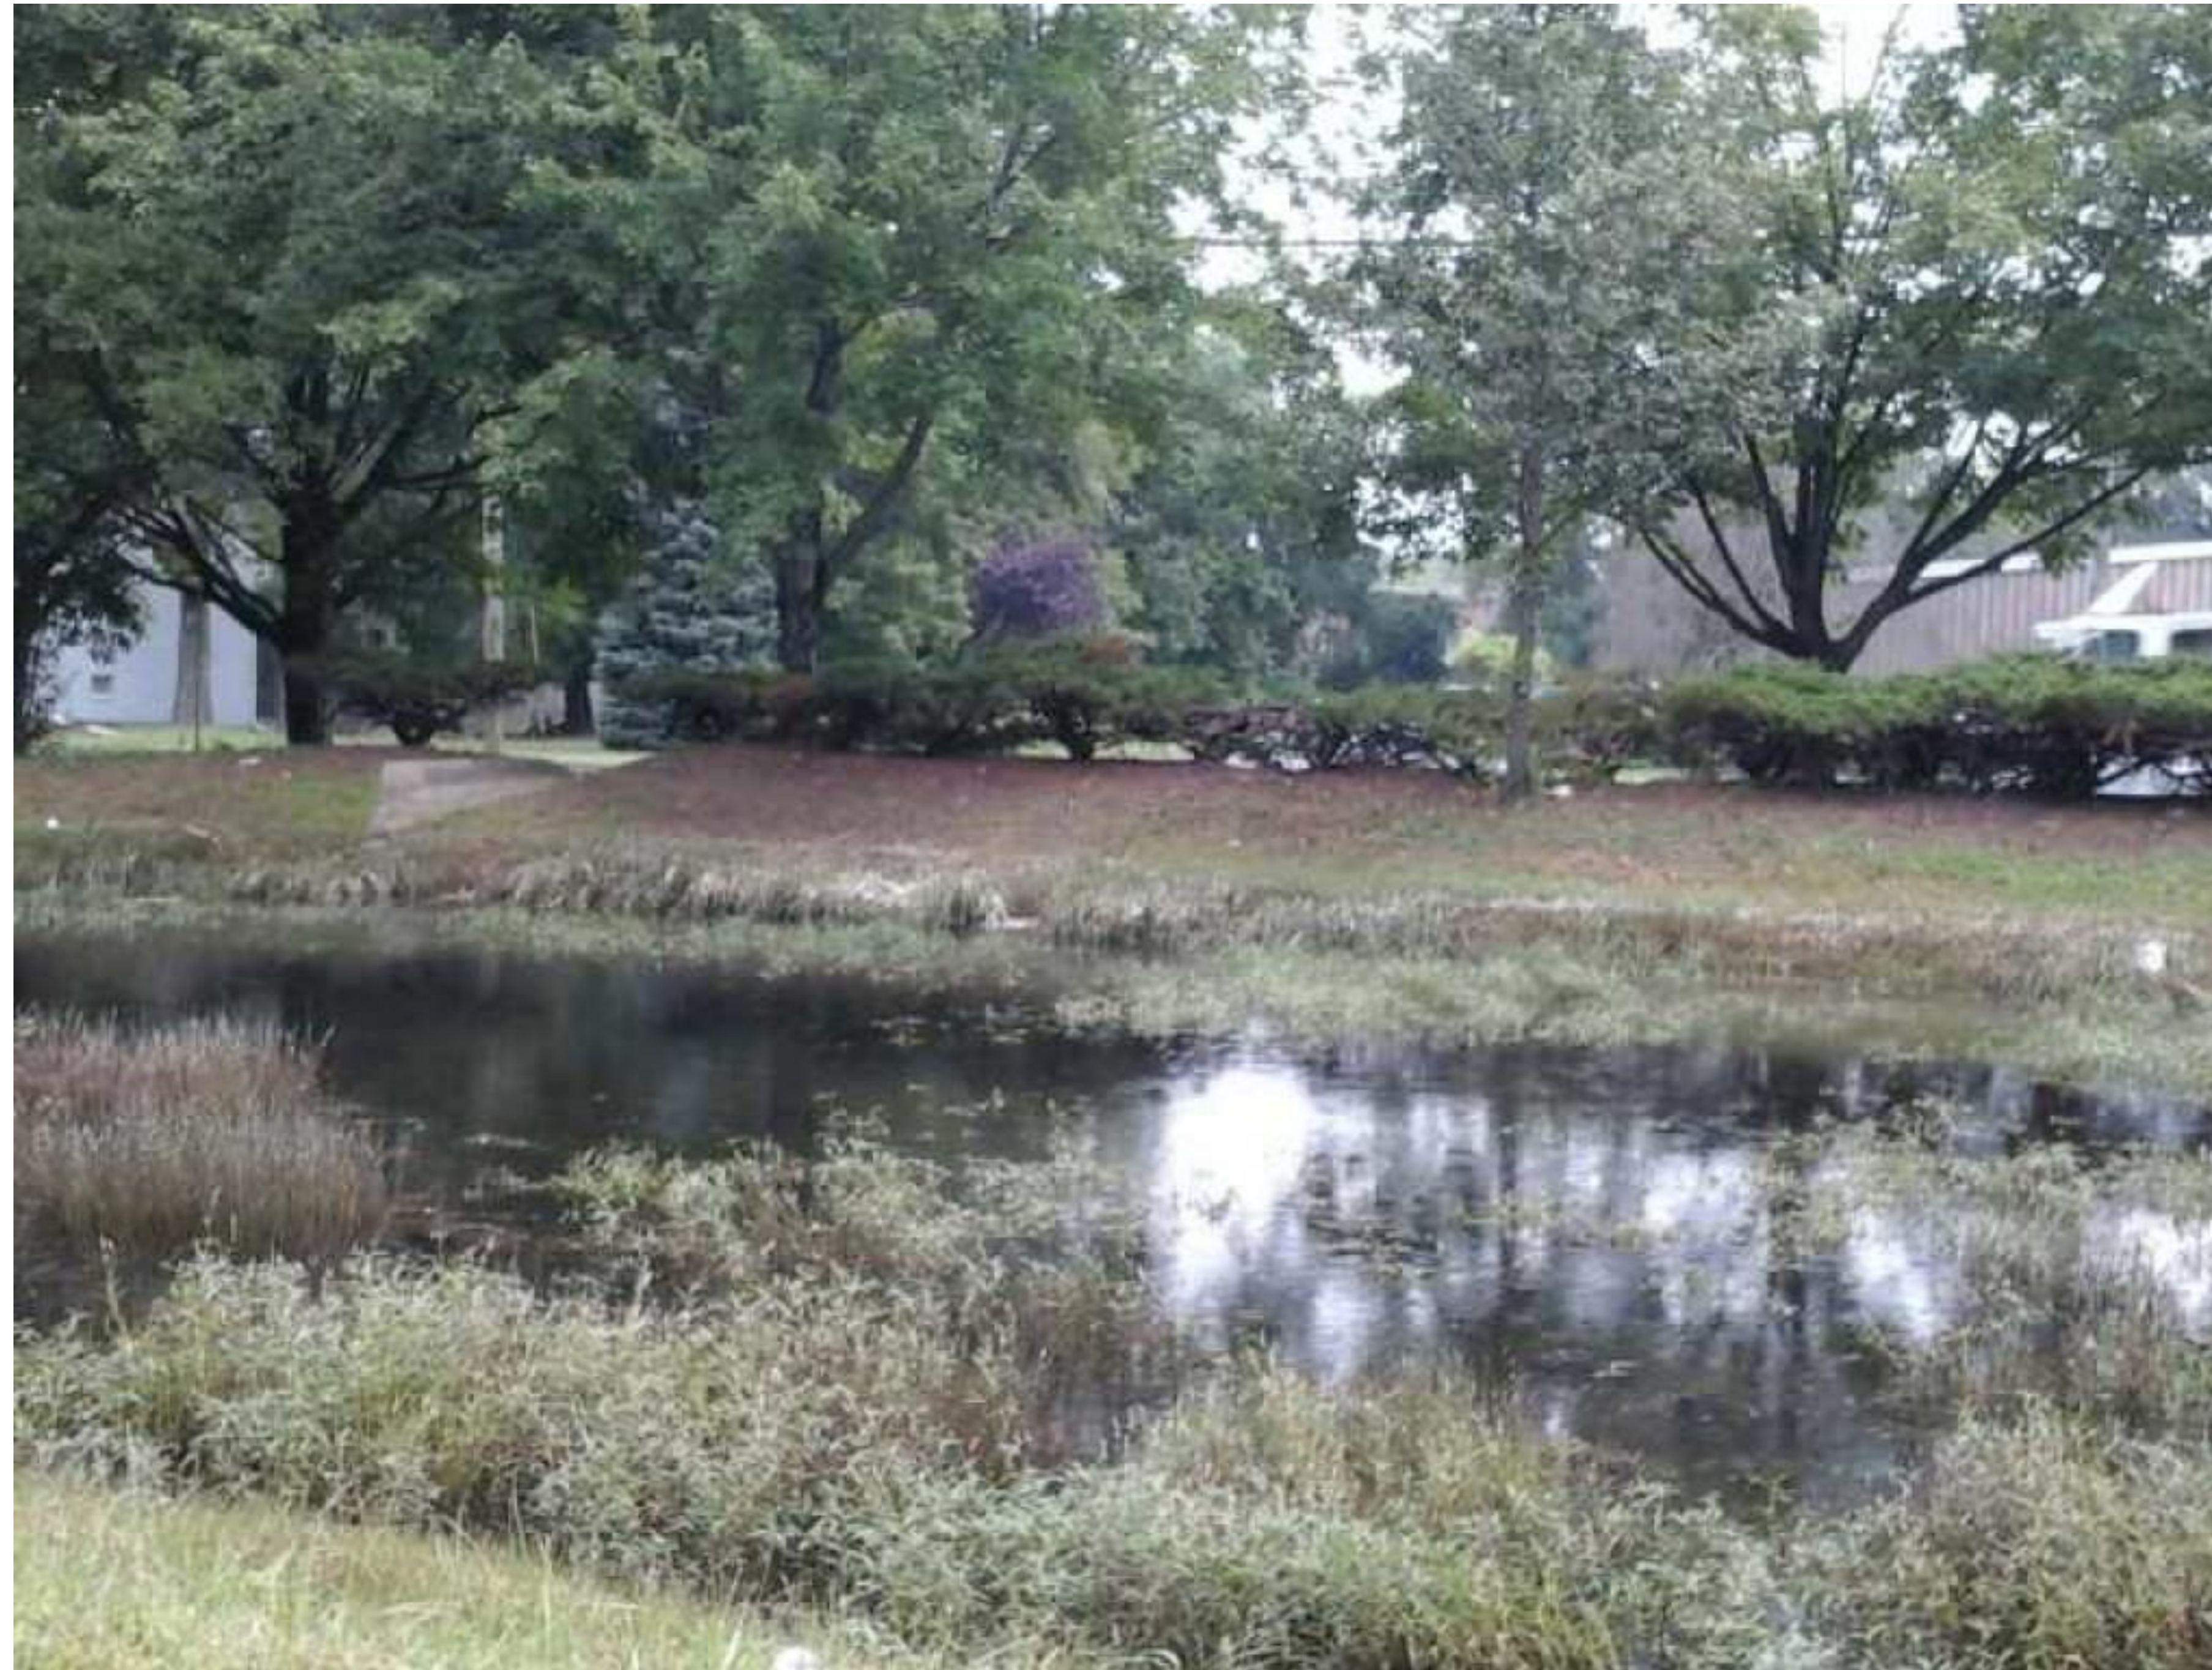
Address:
133 Youngs Road
Hamilton Township, NJ 08619

- Large ponding about a foot deep likely formed due to poor infiltration and an outlet set to high.
- Investigation should be done to determine what is causing this ponding that has been seen in both years this basin was assessed

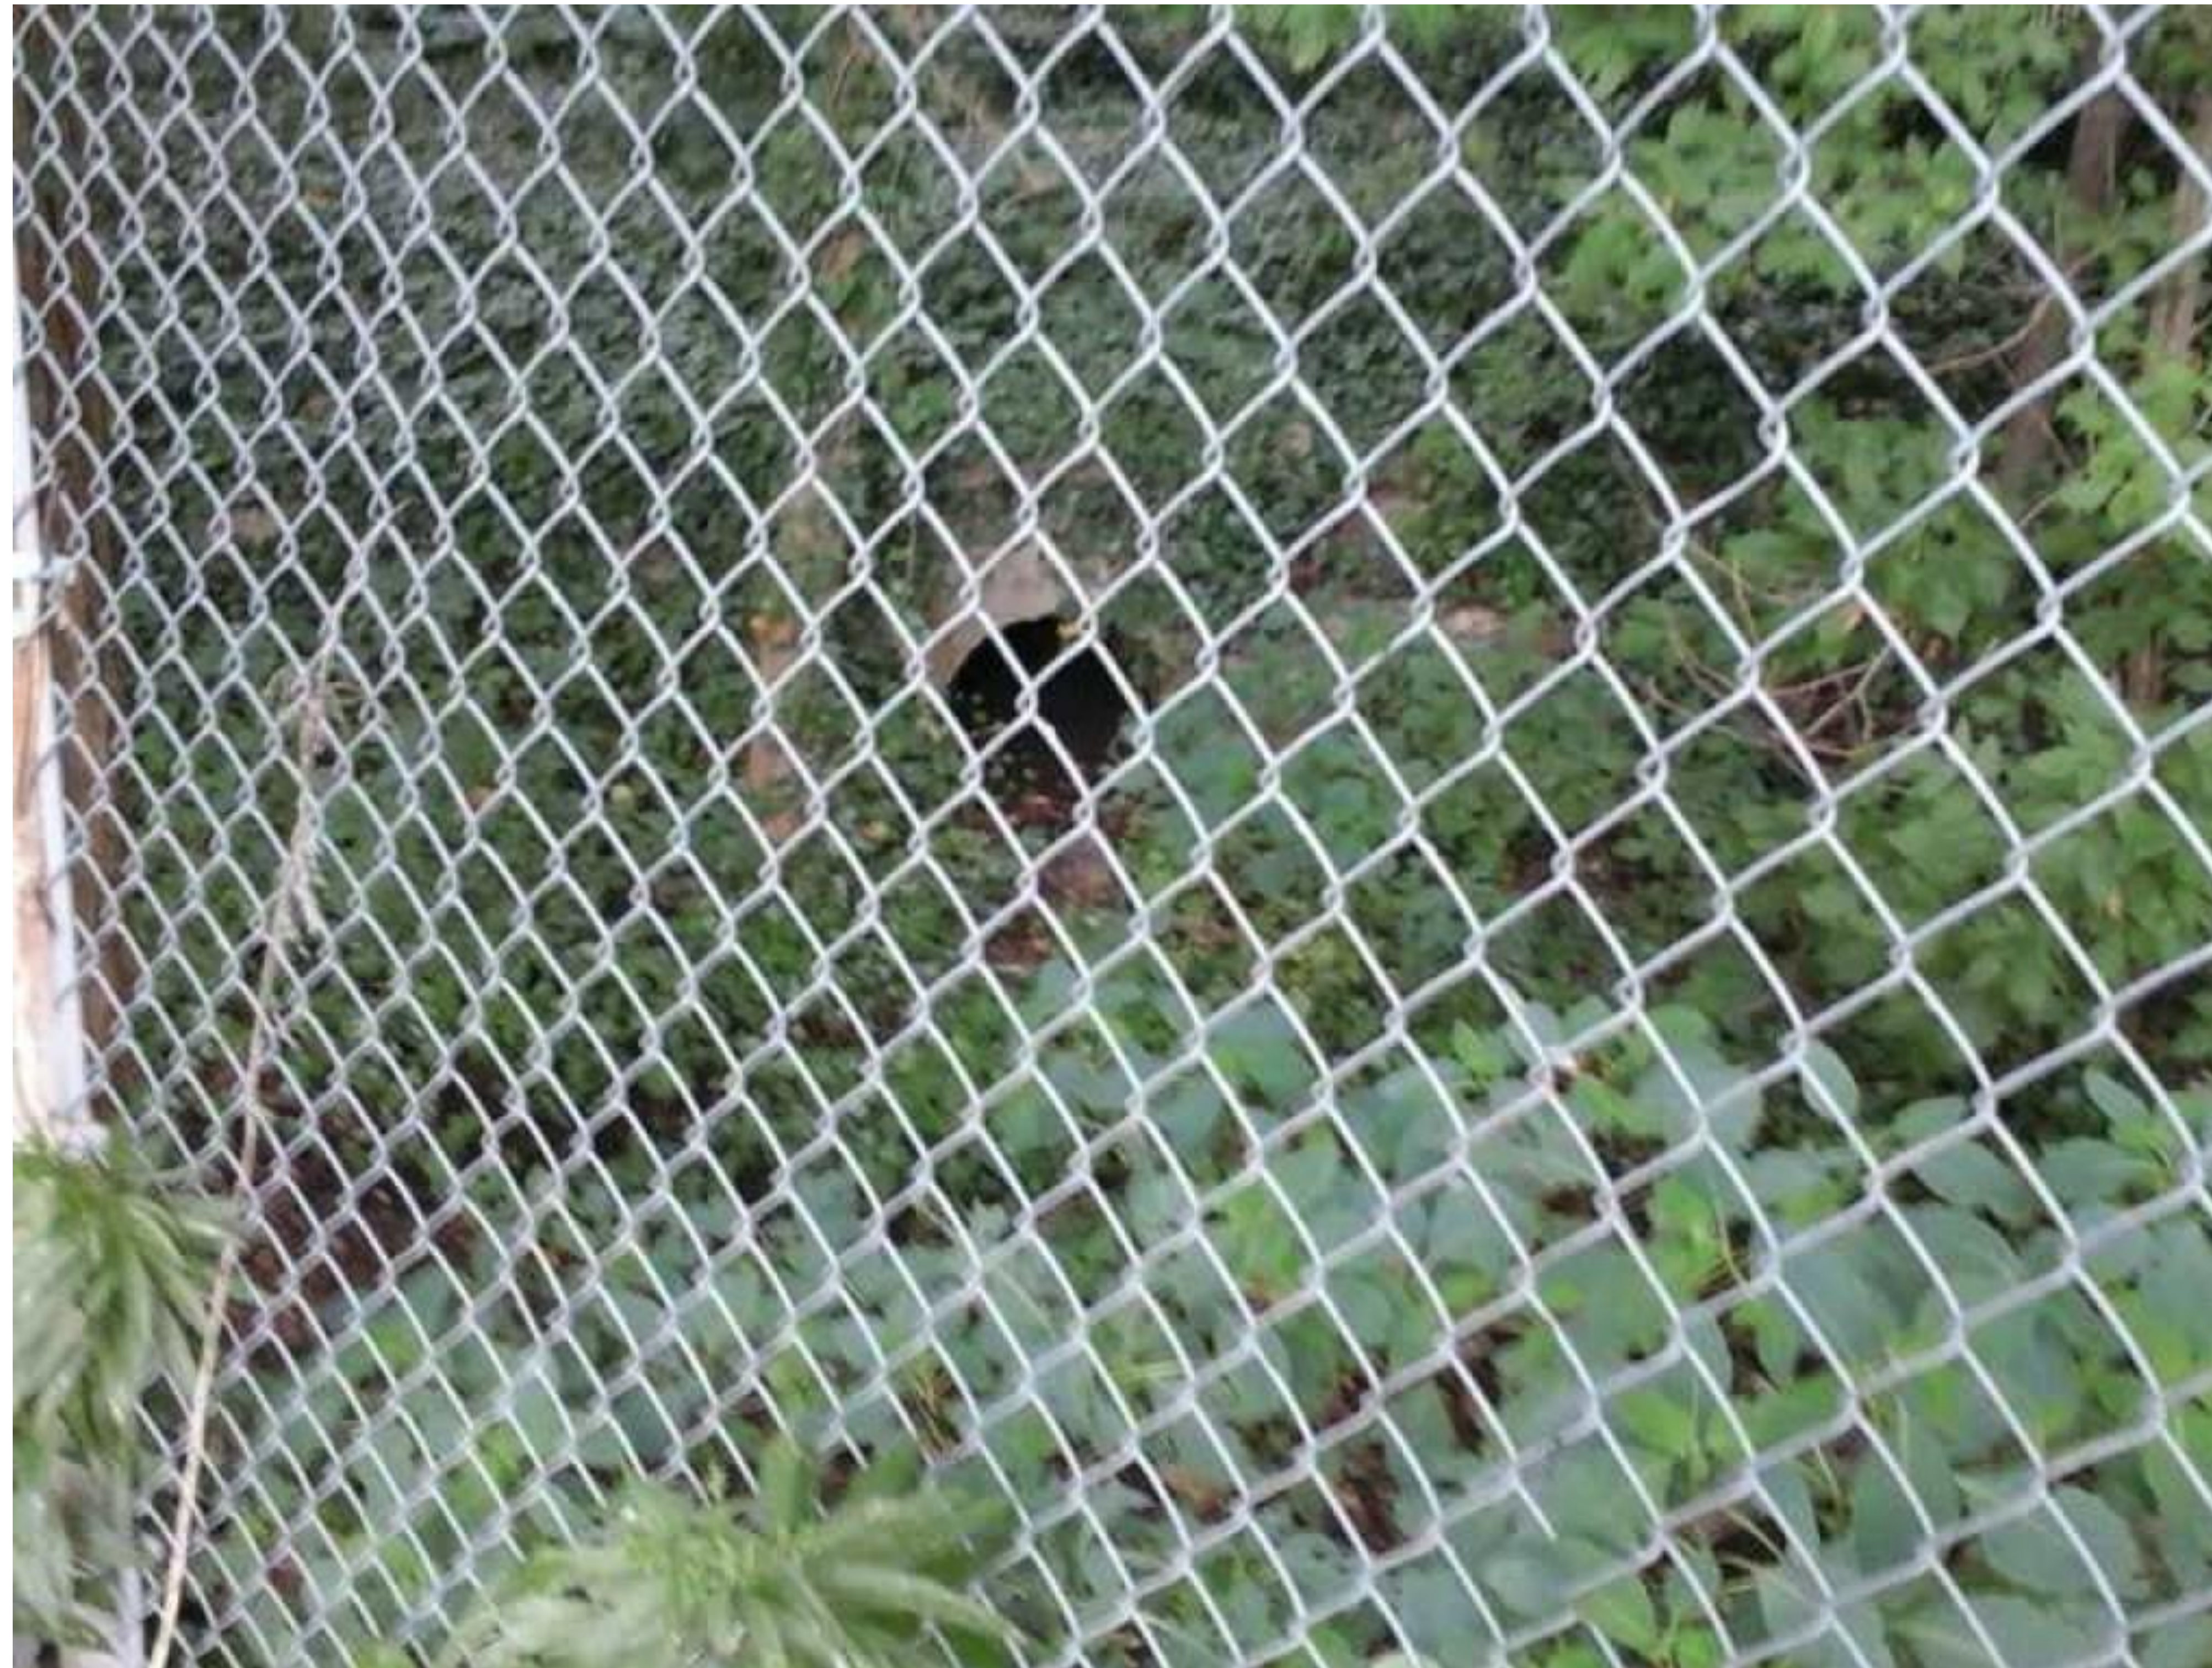
Address:
630 New Jersey 33
Hamilton Township, NJ 08619

- Basin behind the building leading into a wooden area
- Recommend cleaning out location
