**Hamilton Township (Mercer County)
Stormwater Basin Assessment Summary
Past Priority Addendum (Year 5B)**

Developed by the Rutgers Cooperative Extension Water Resources Program
Funded by Hamilton Township, Mercer County, New Jersey

November 27, 2019

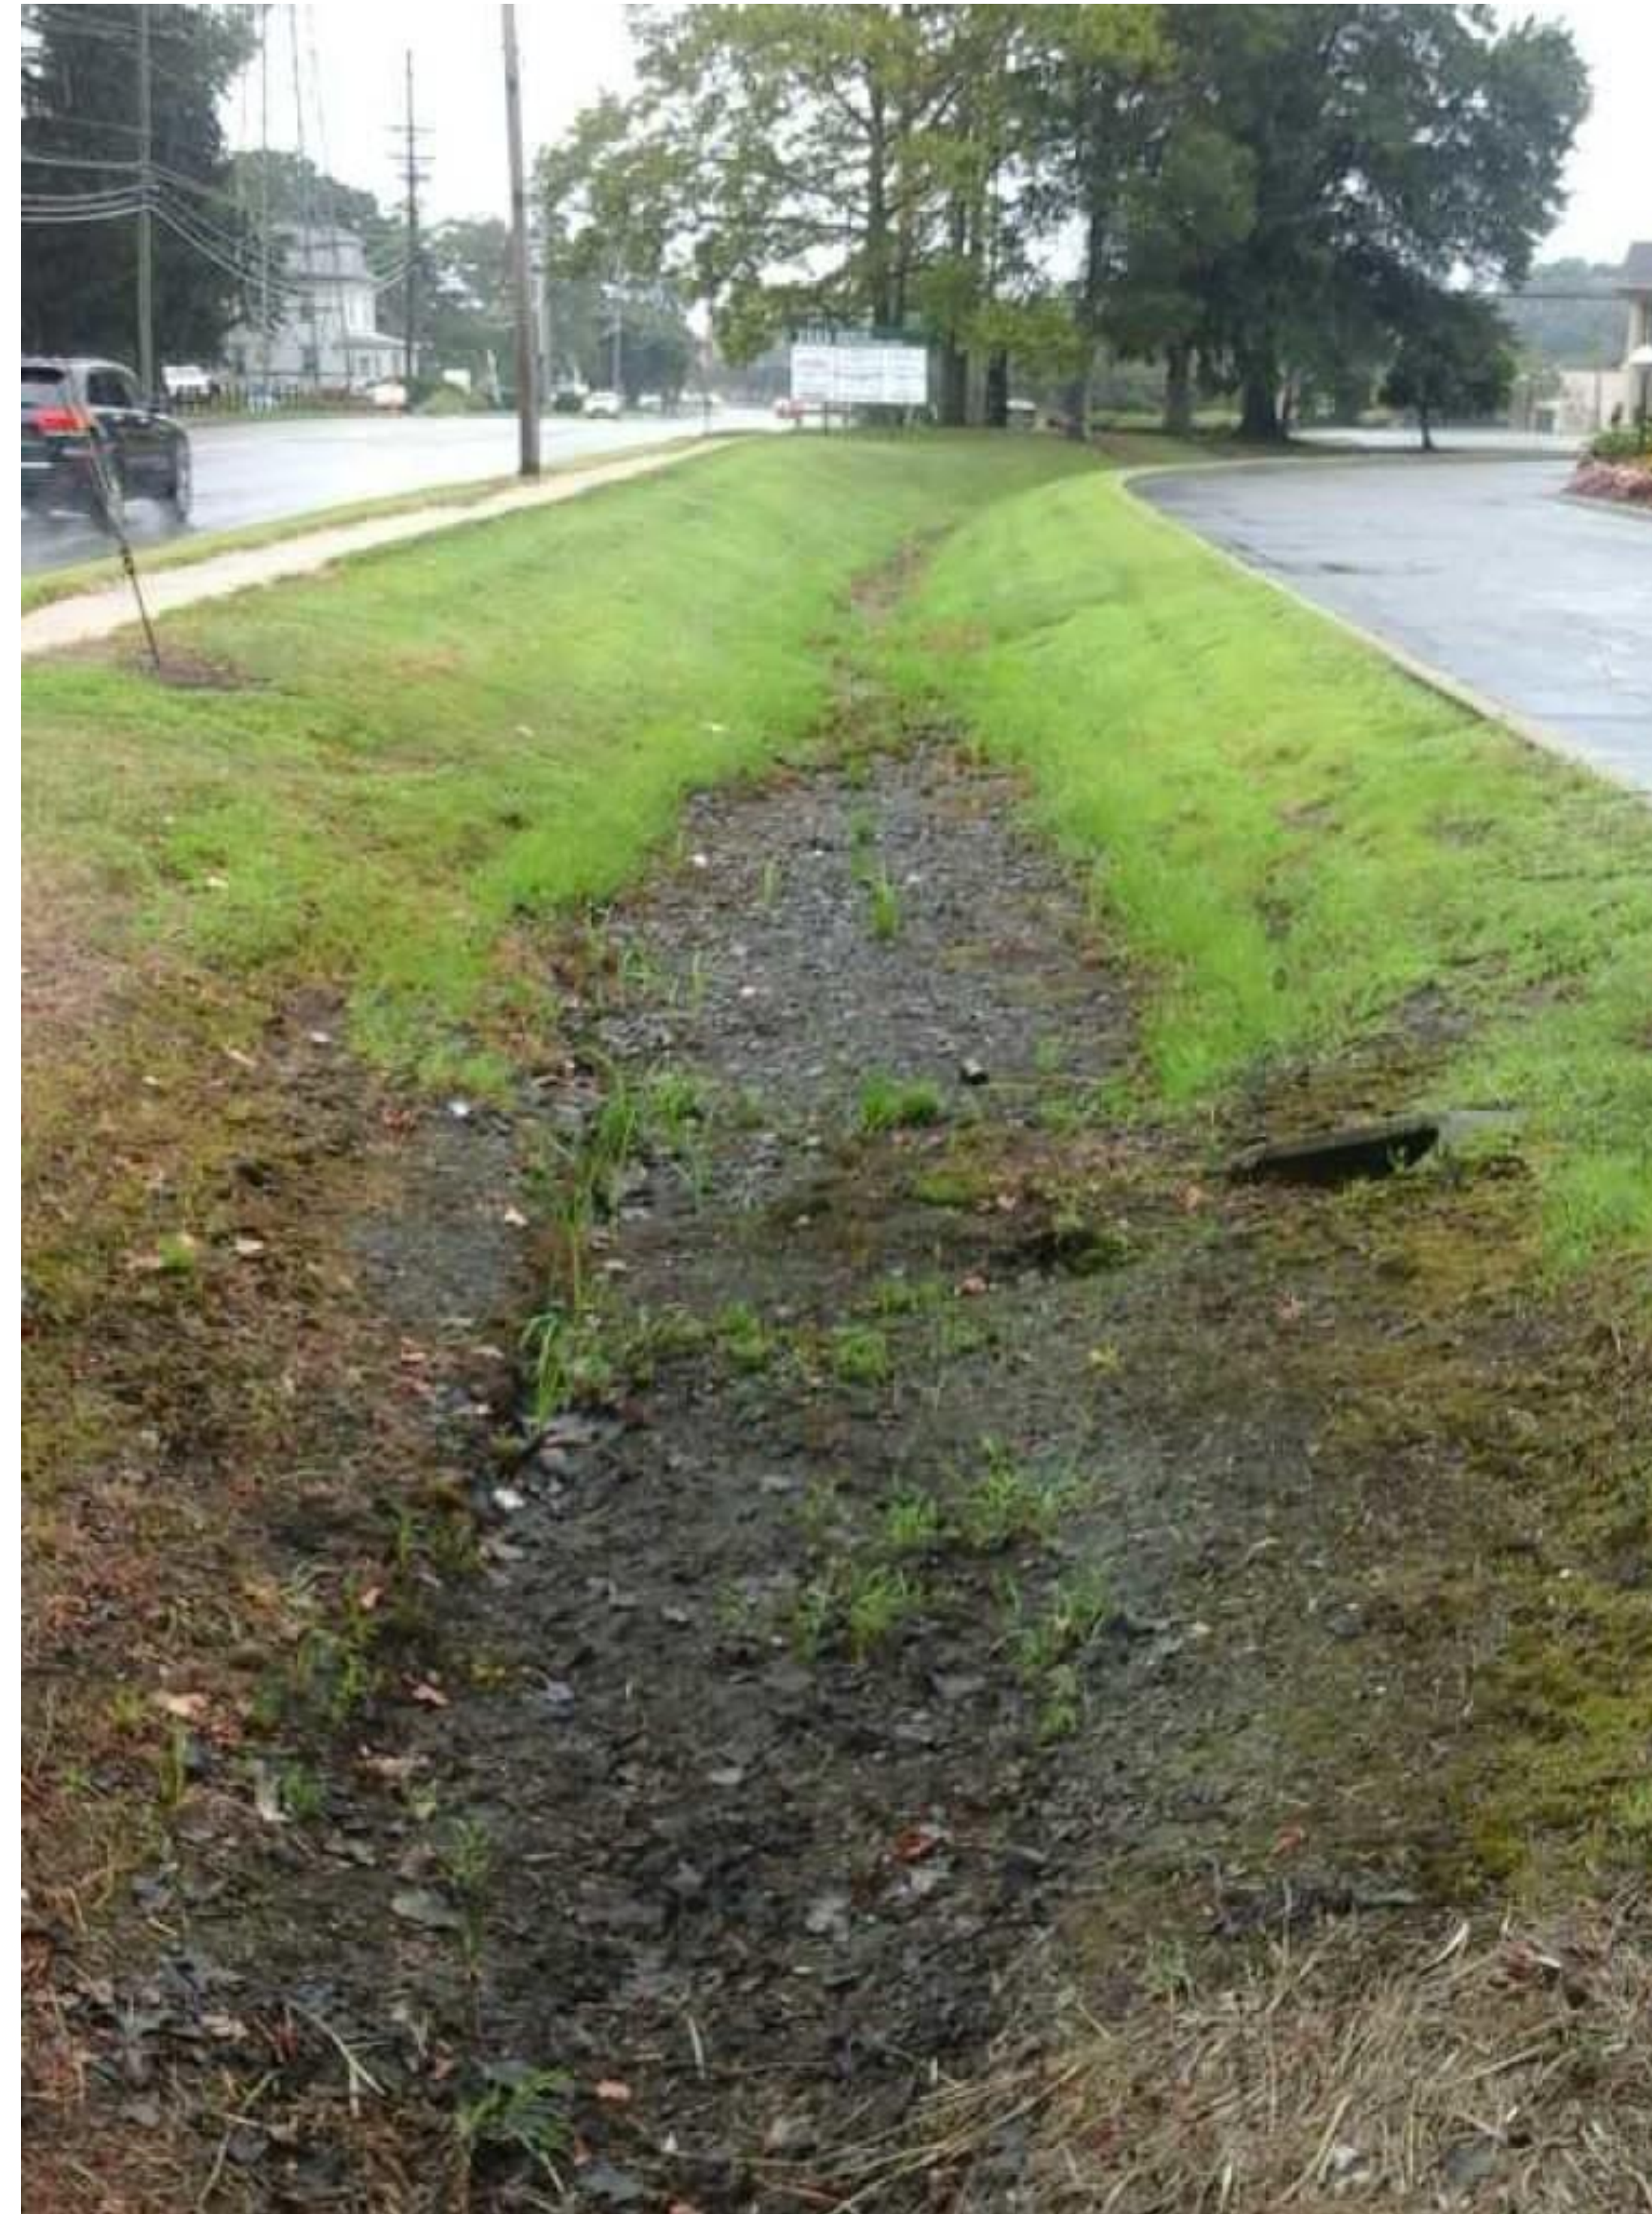
Address:
2333 Whitehorse Mercerville Road
Hamilton Township, NJ 08619

- Basin has 2 inlets, some erosion appears to be caused by them
- Naturalize with herbaceous plants and add stone near inlets to control erosion

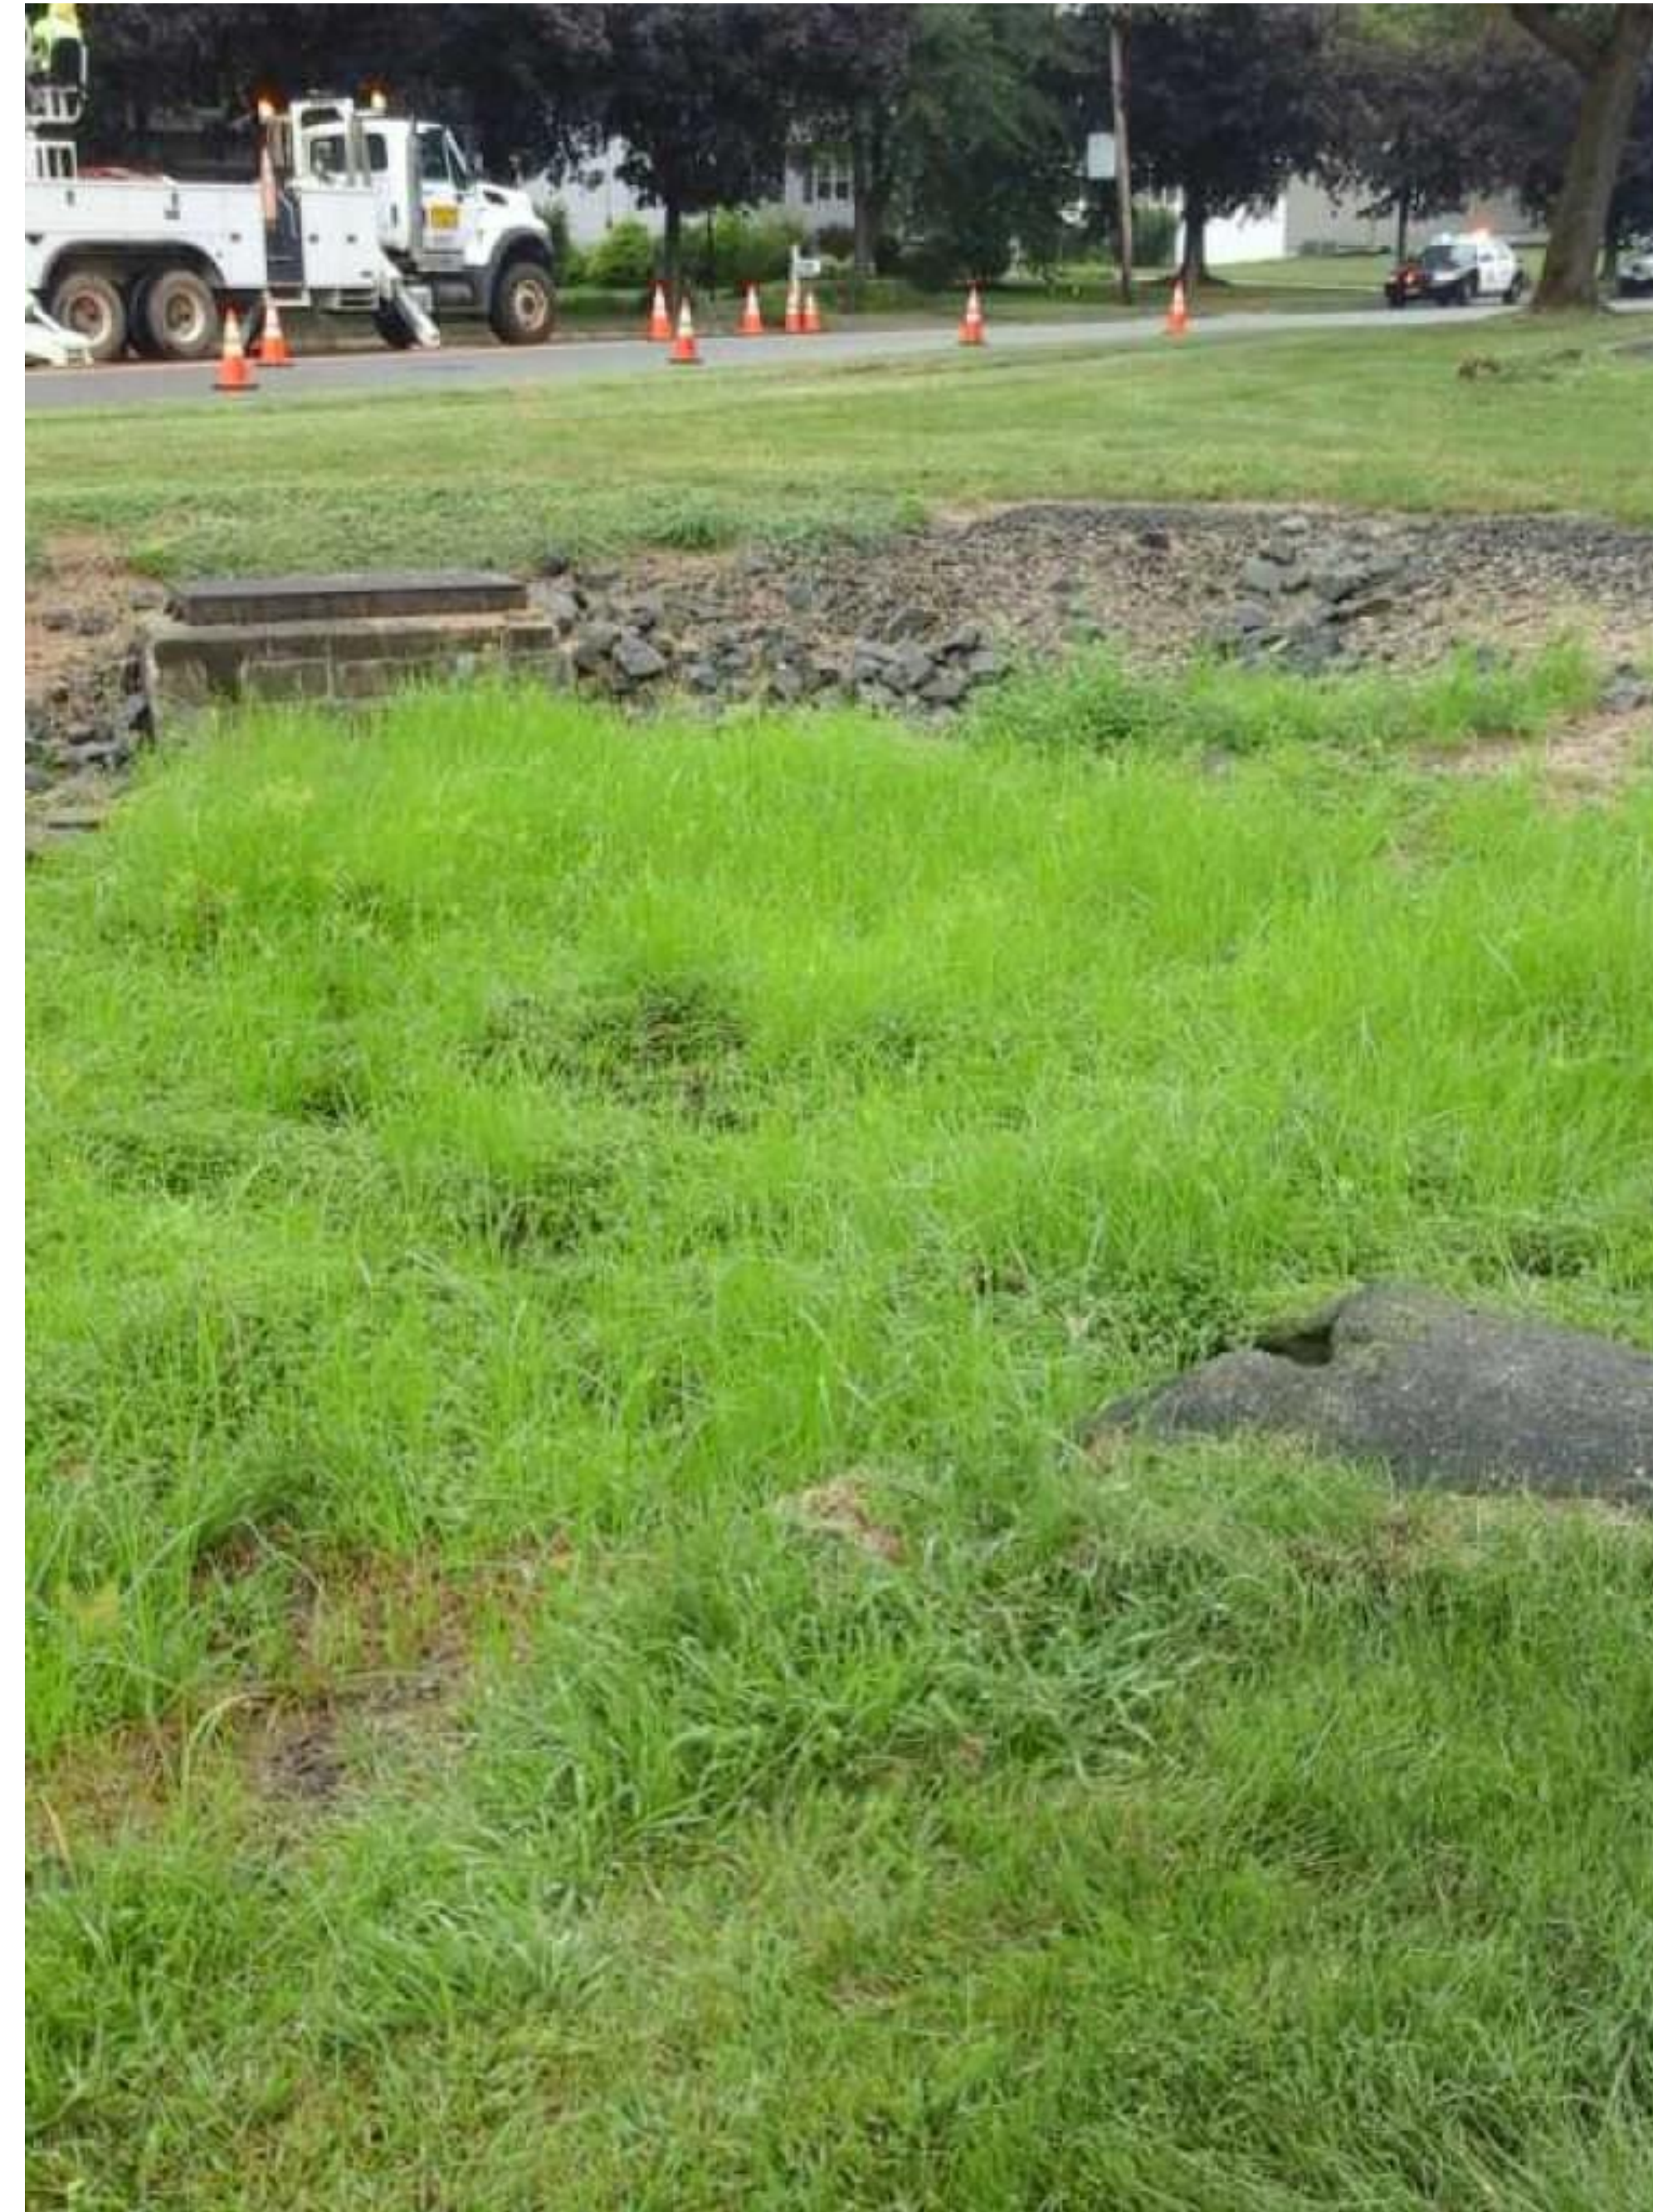
Address:
2239 Whitehorse Mercerville Road
Mercerville, NJ 08619

- Small basin with one inlet
- Inlet still appears damaged and may need repair
- Naturalize basin with herbaceous plants

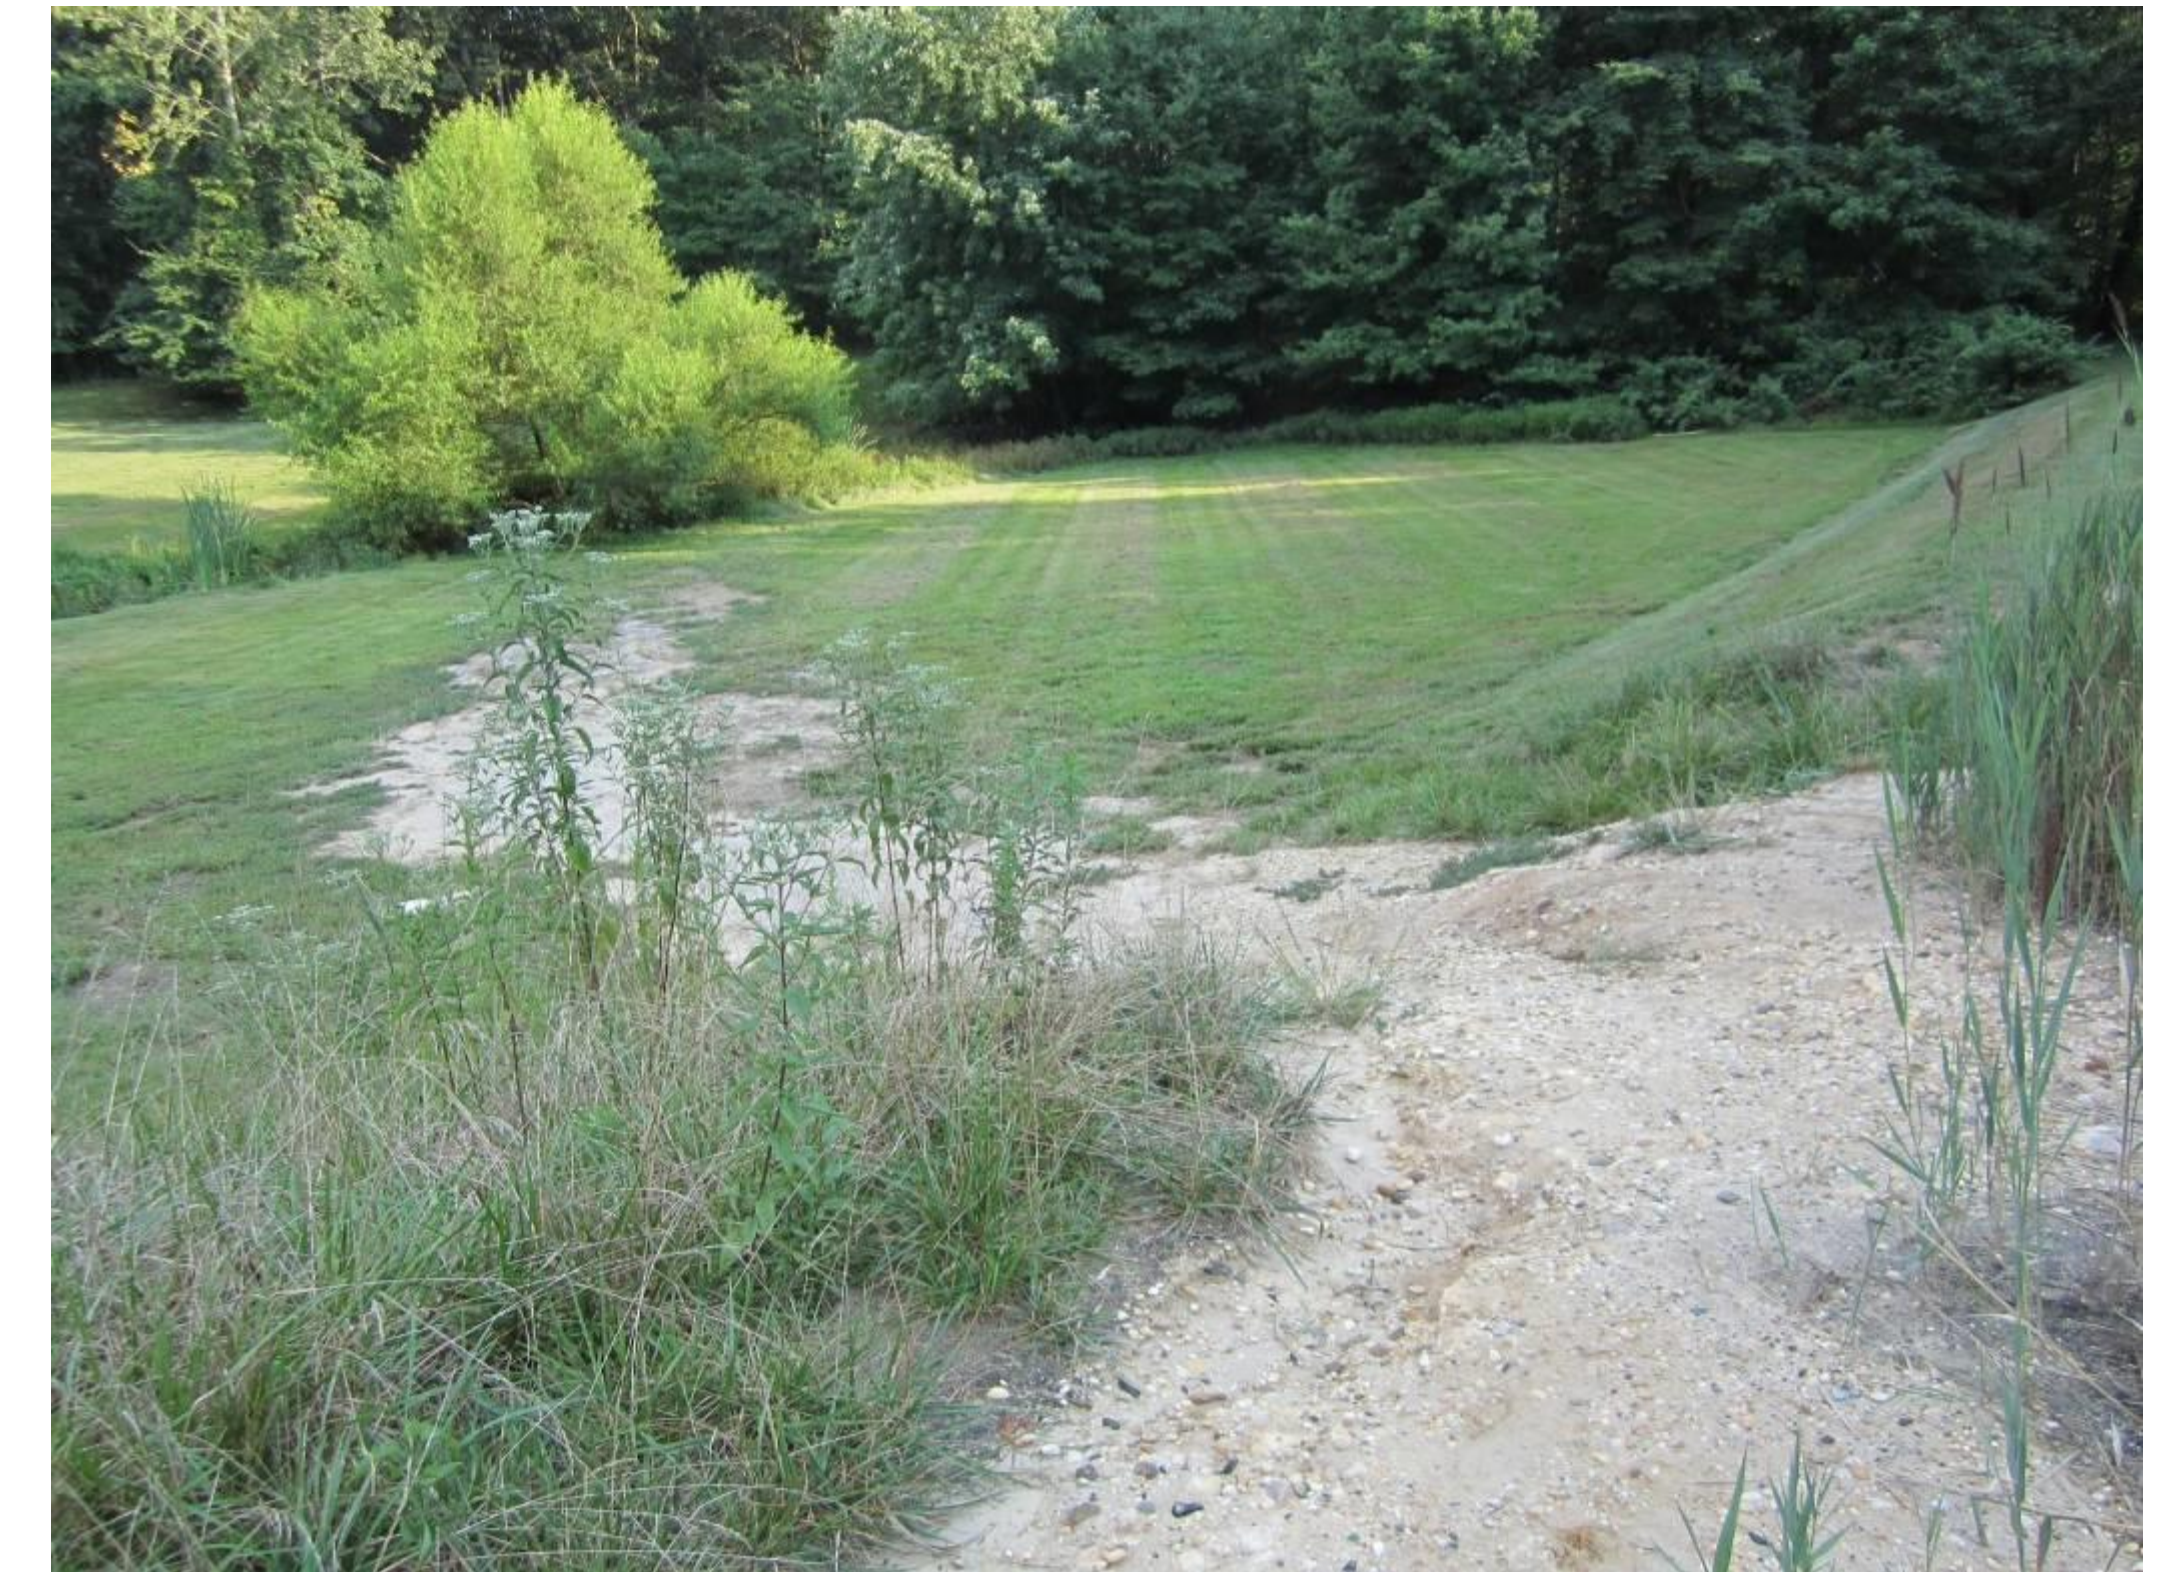
Outlet structure obstructed with litter

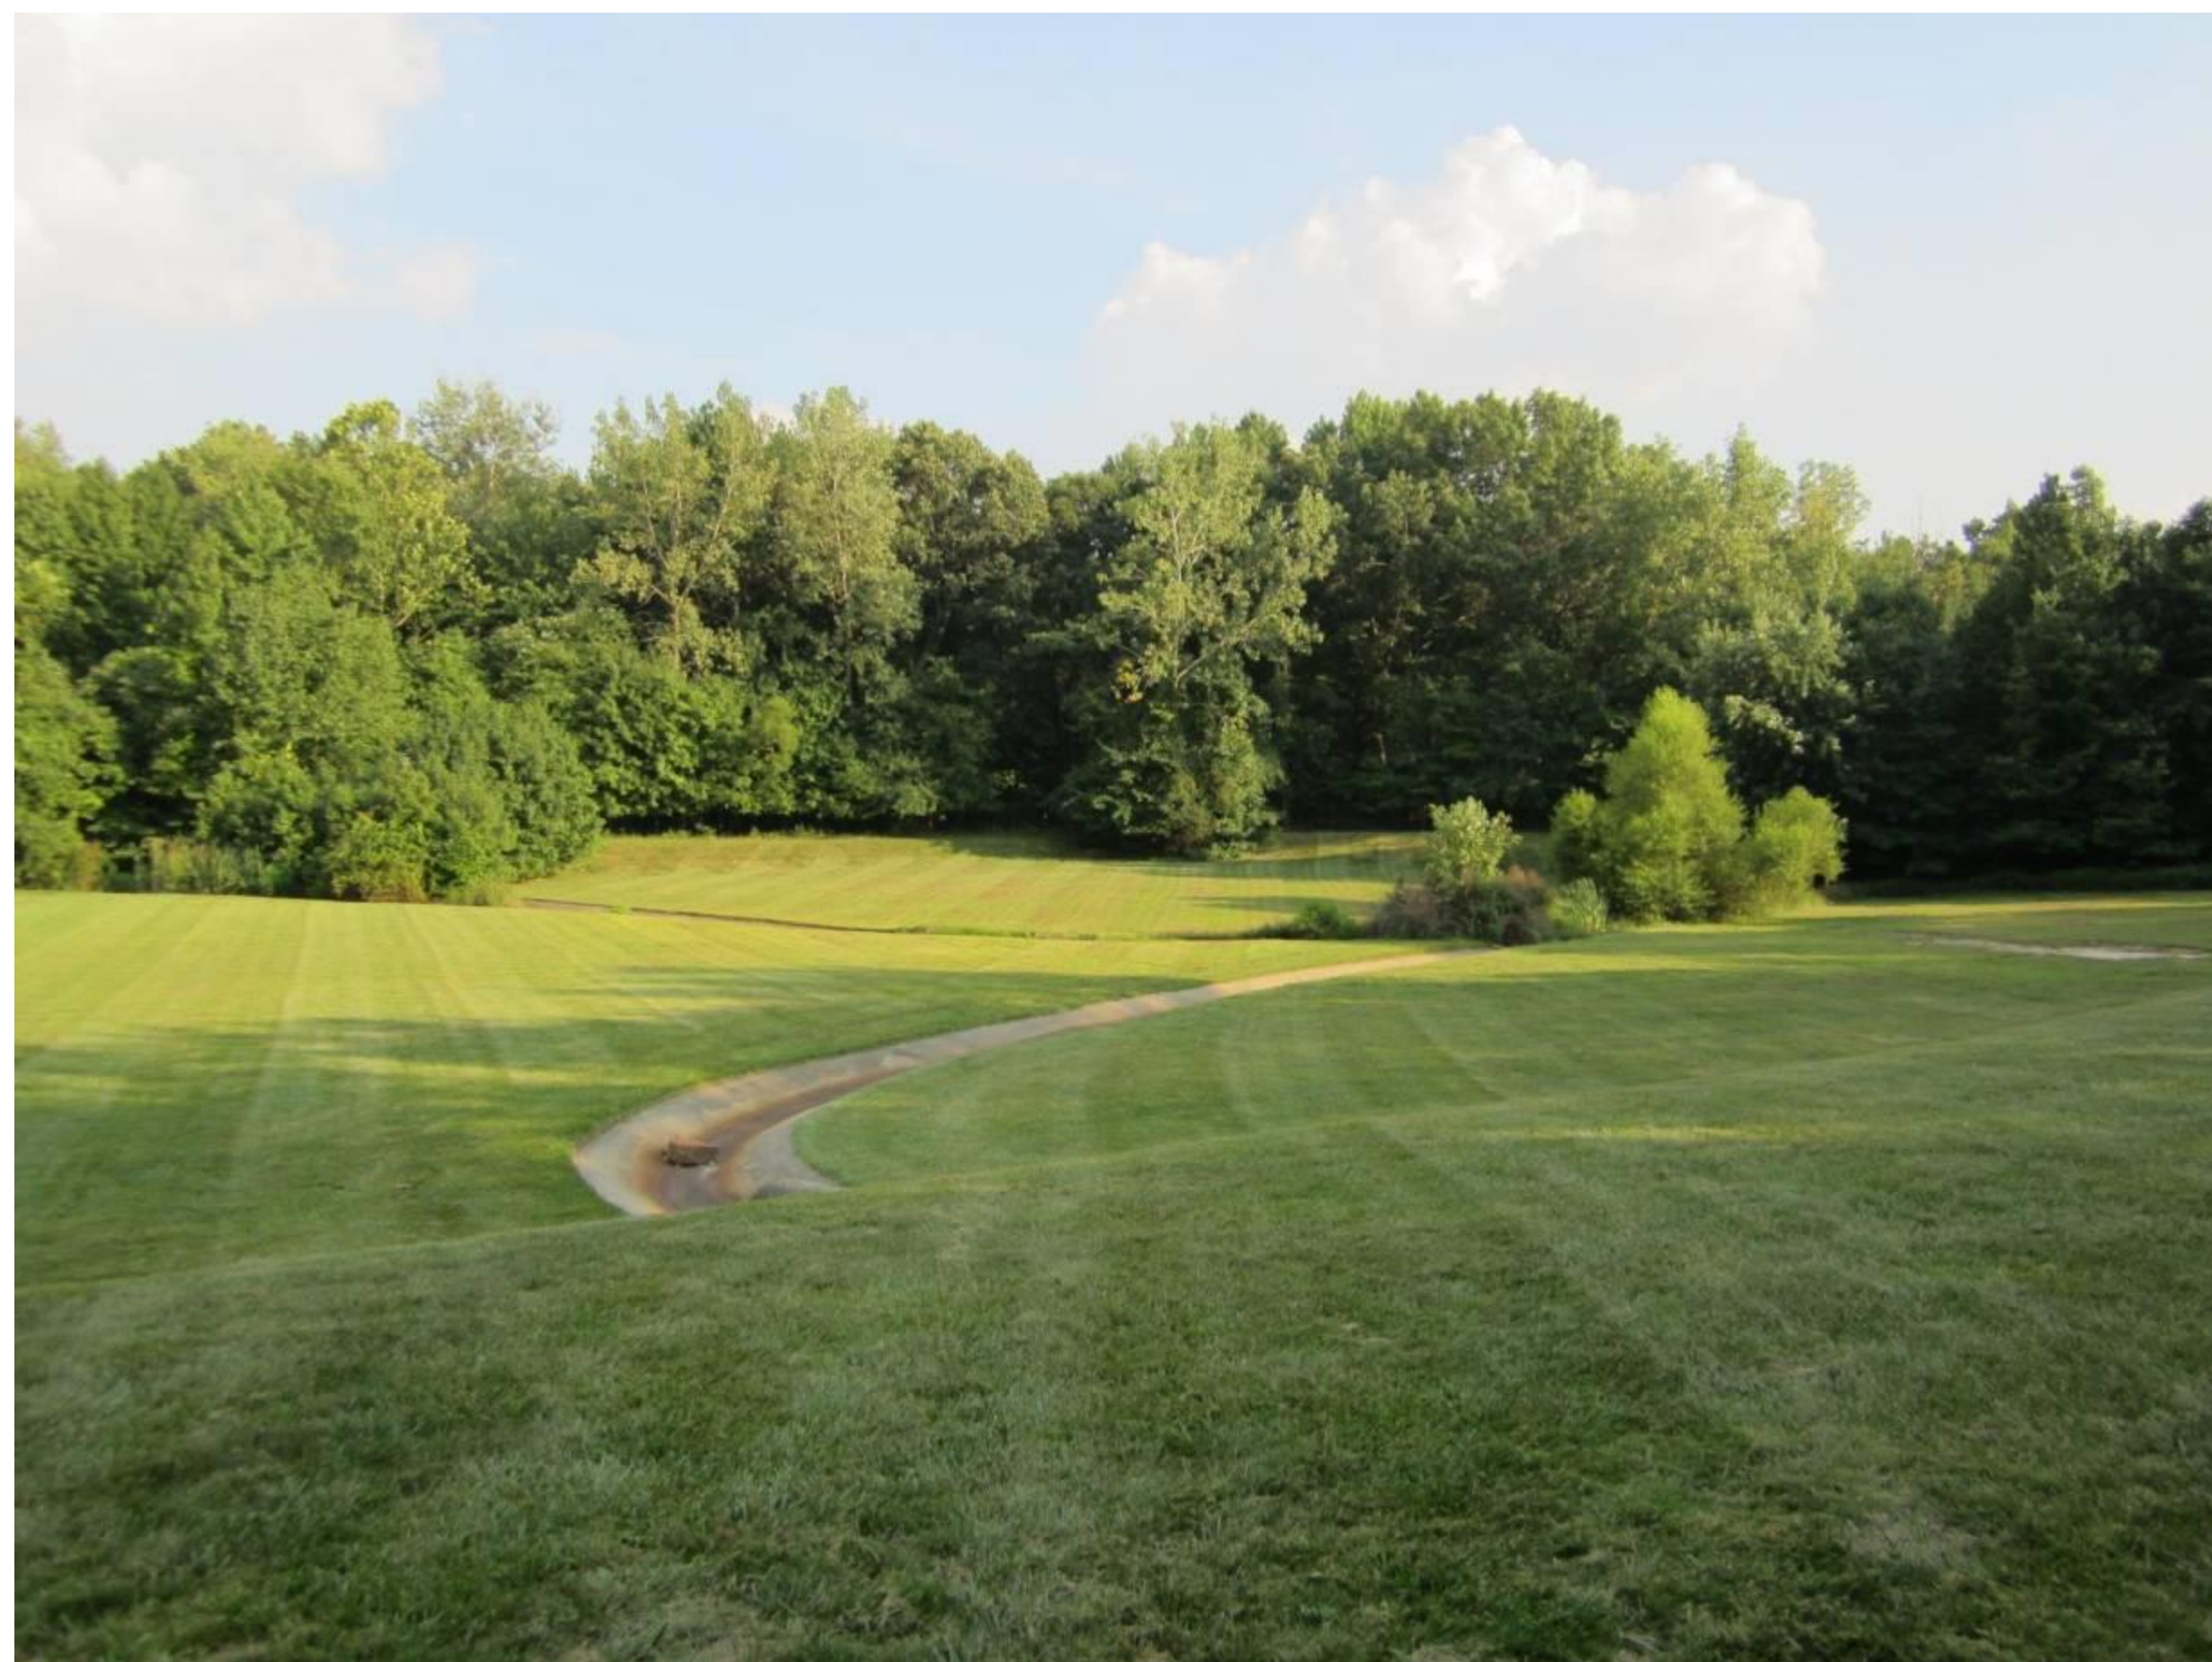
Slumping/failing basin embankment

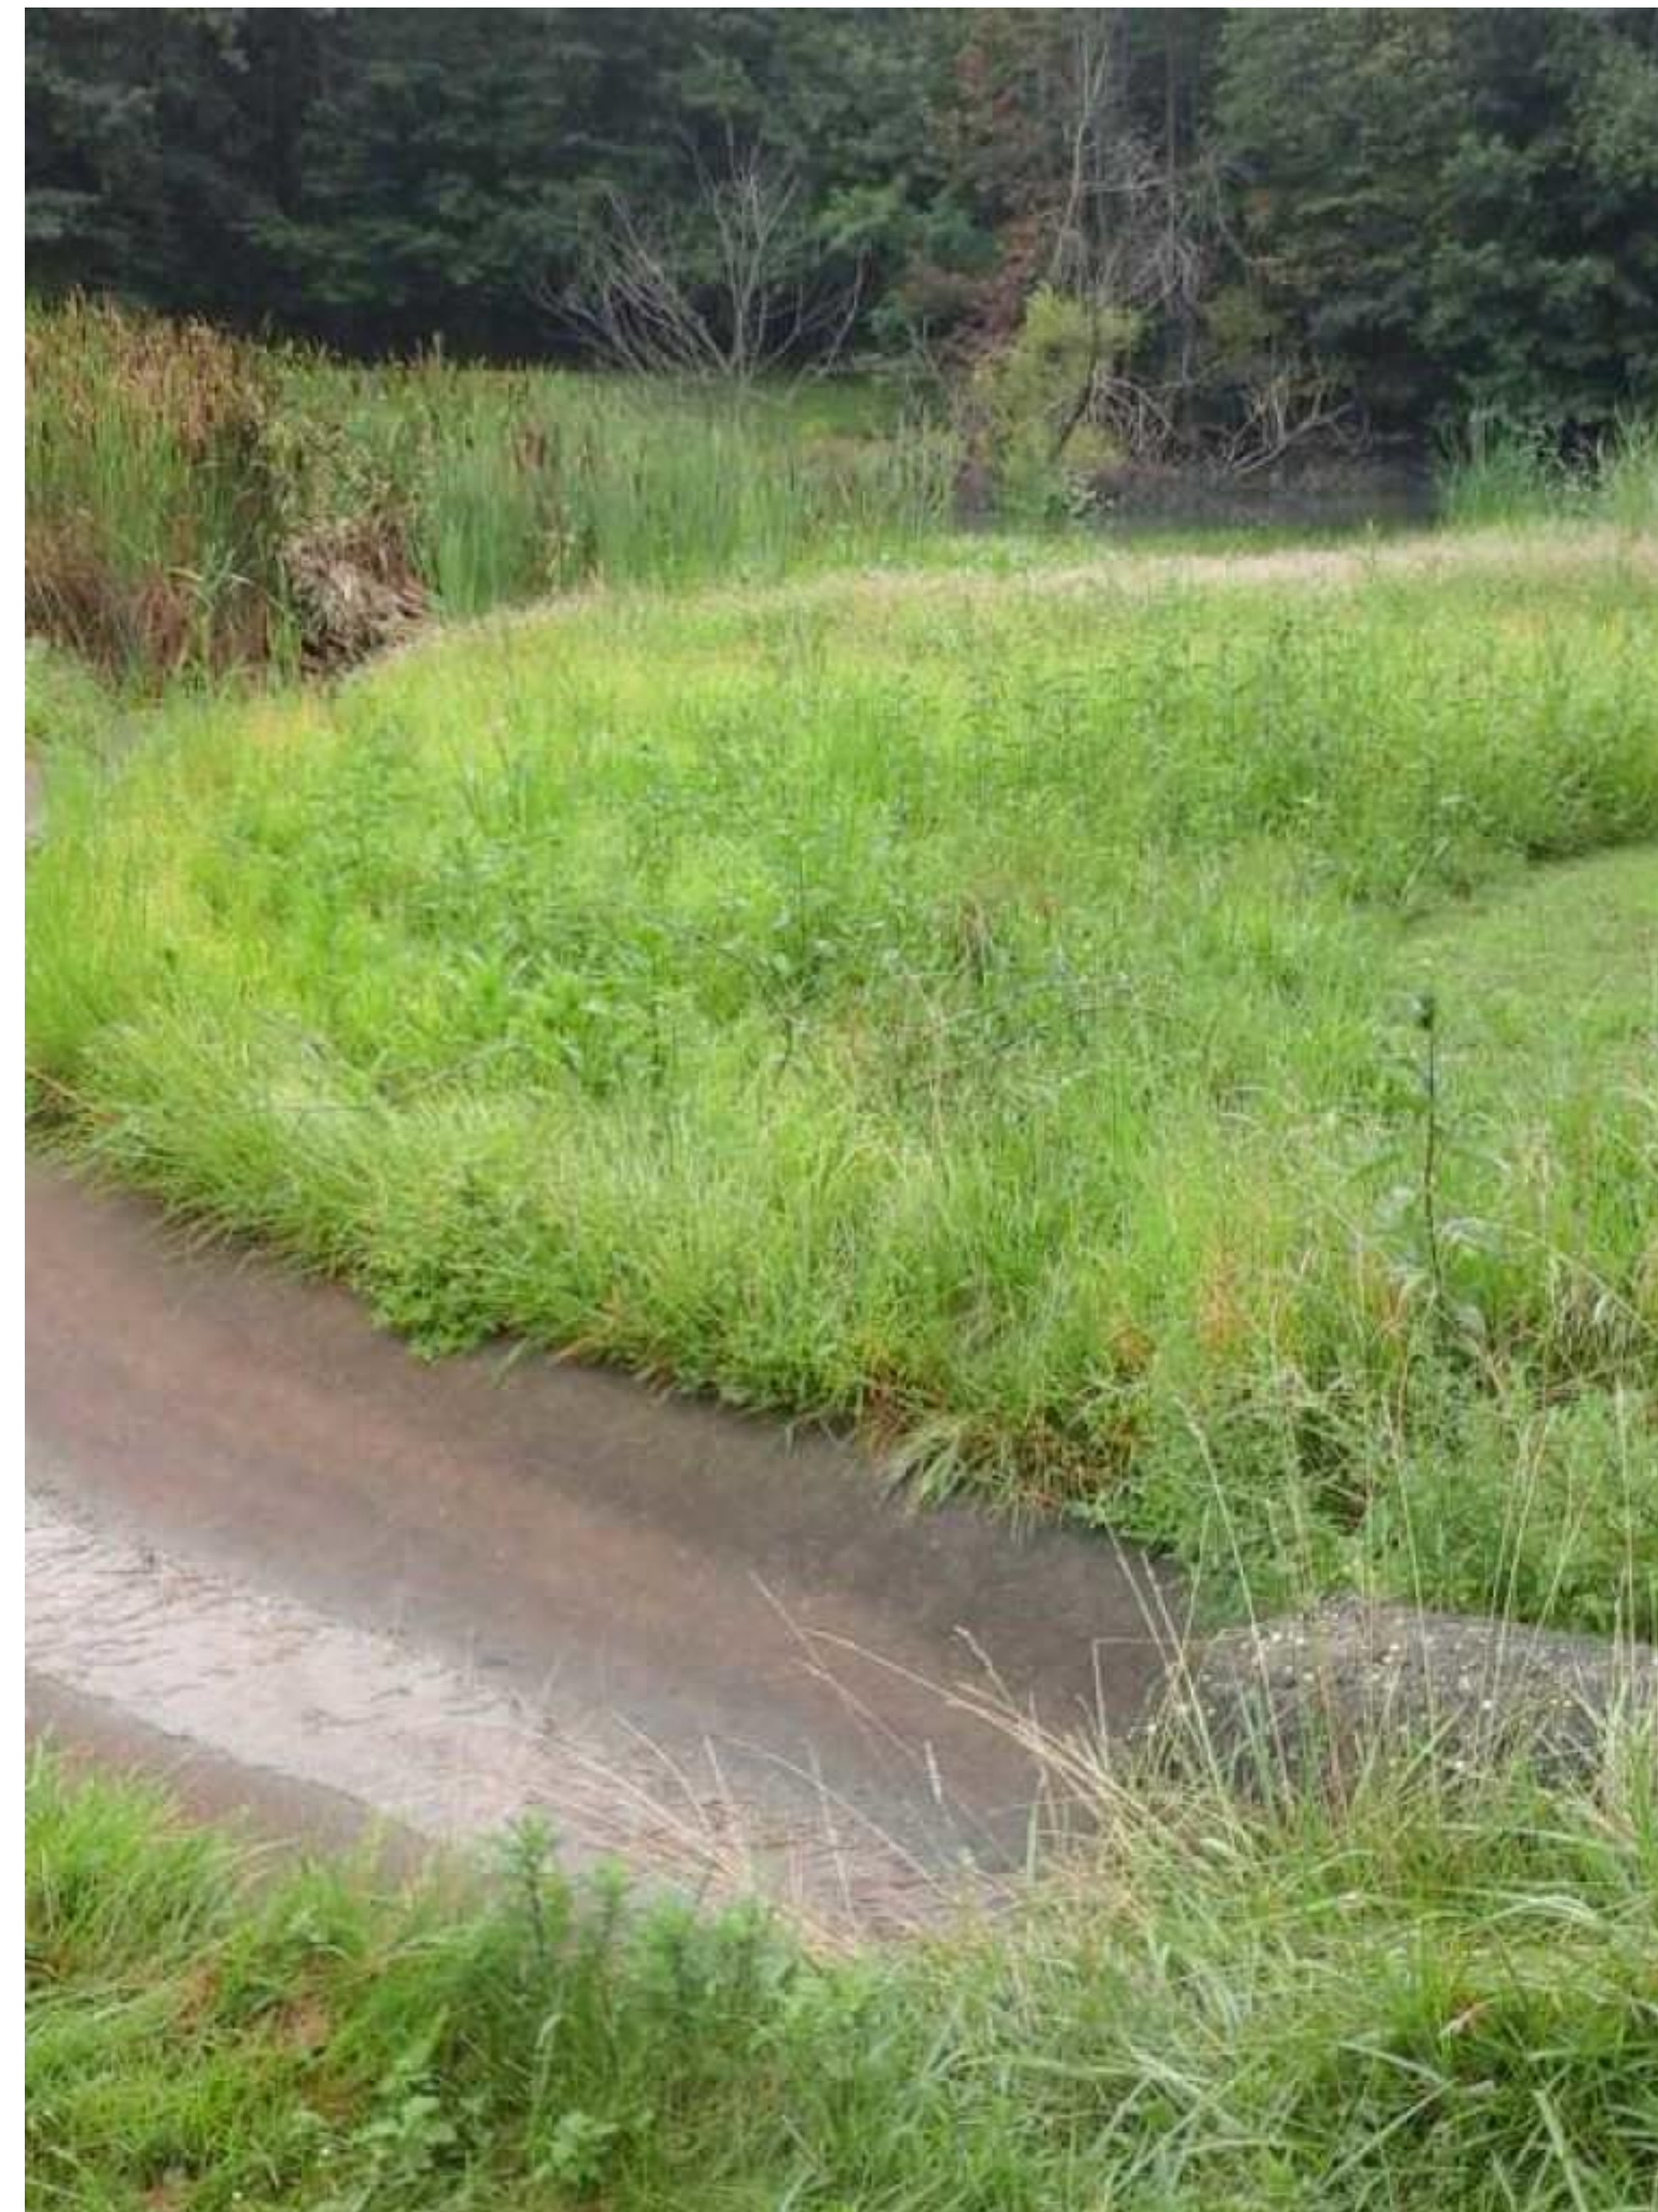
Address:
Lamont Ave
Trenton, NJ 08619

- Well naturalized basin
- Some oil observed leaking in about halfway down the channel

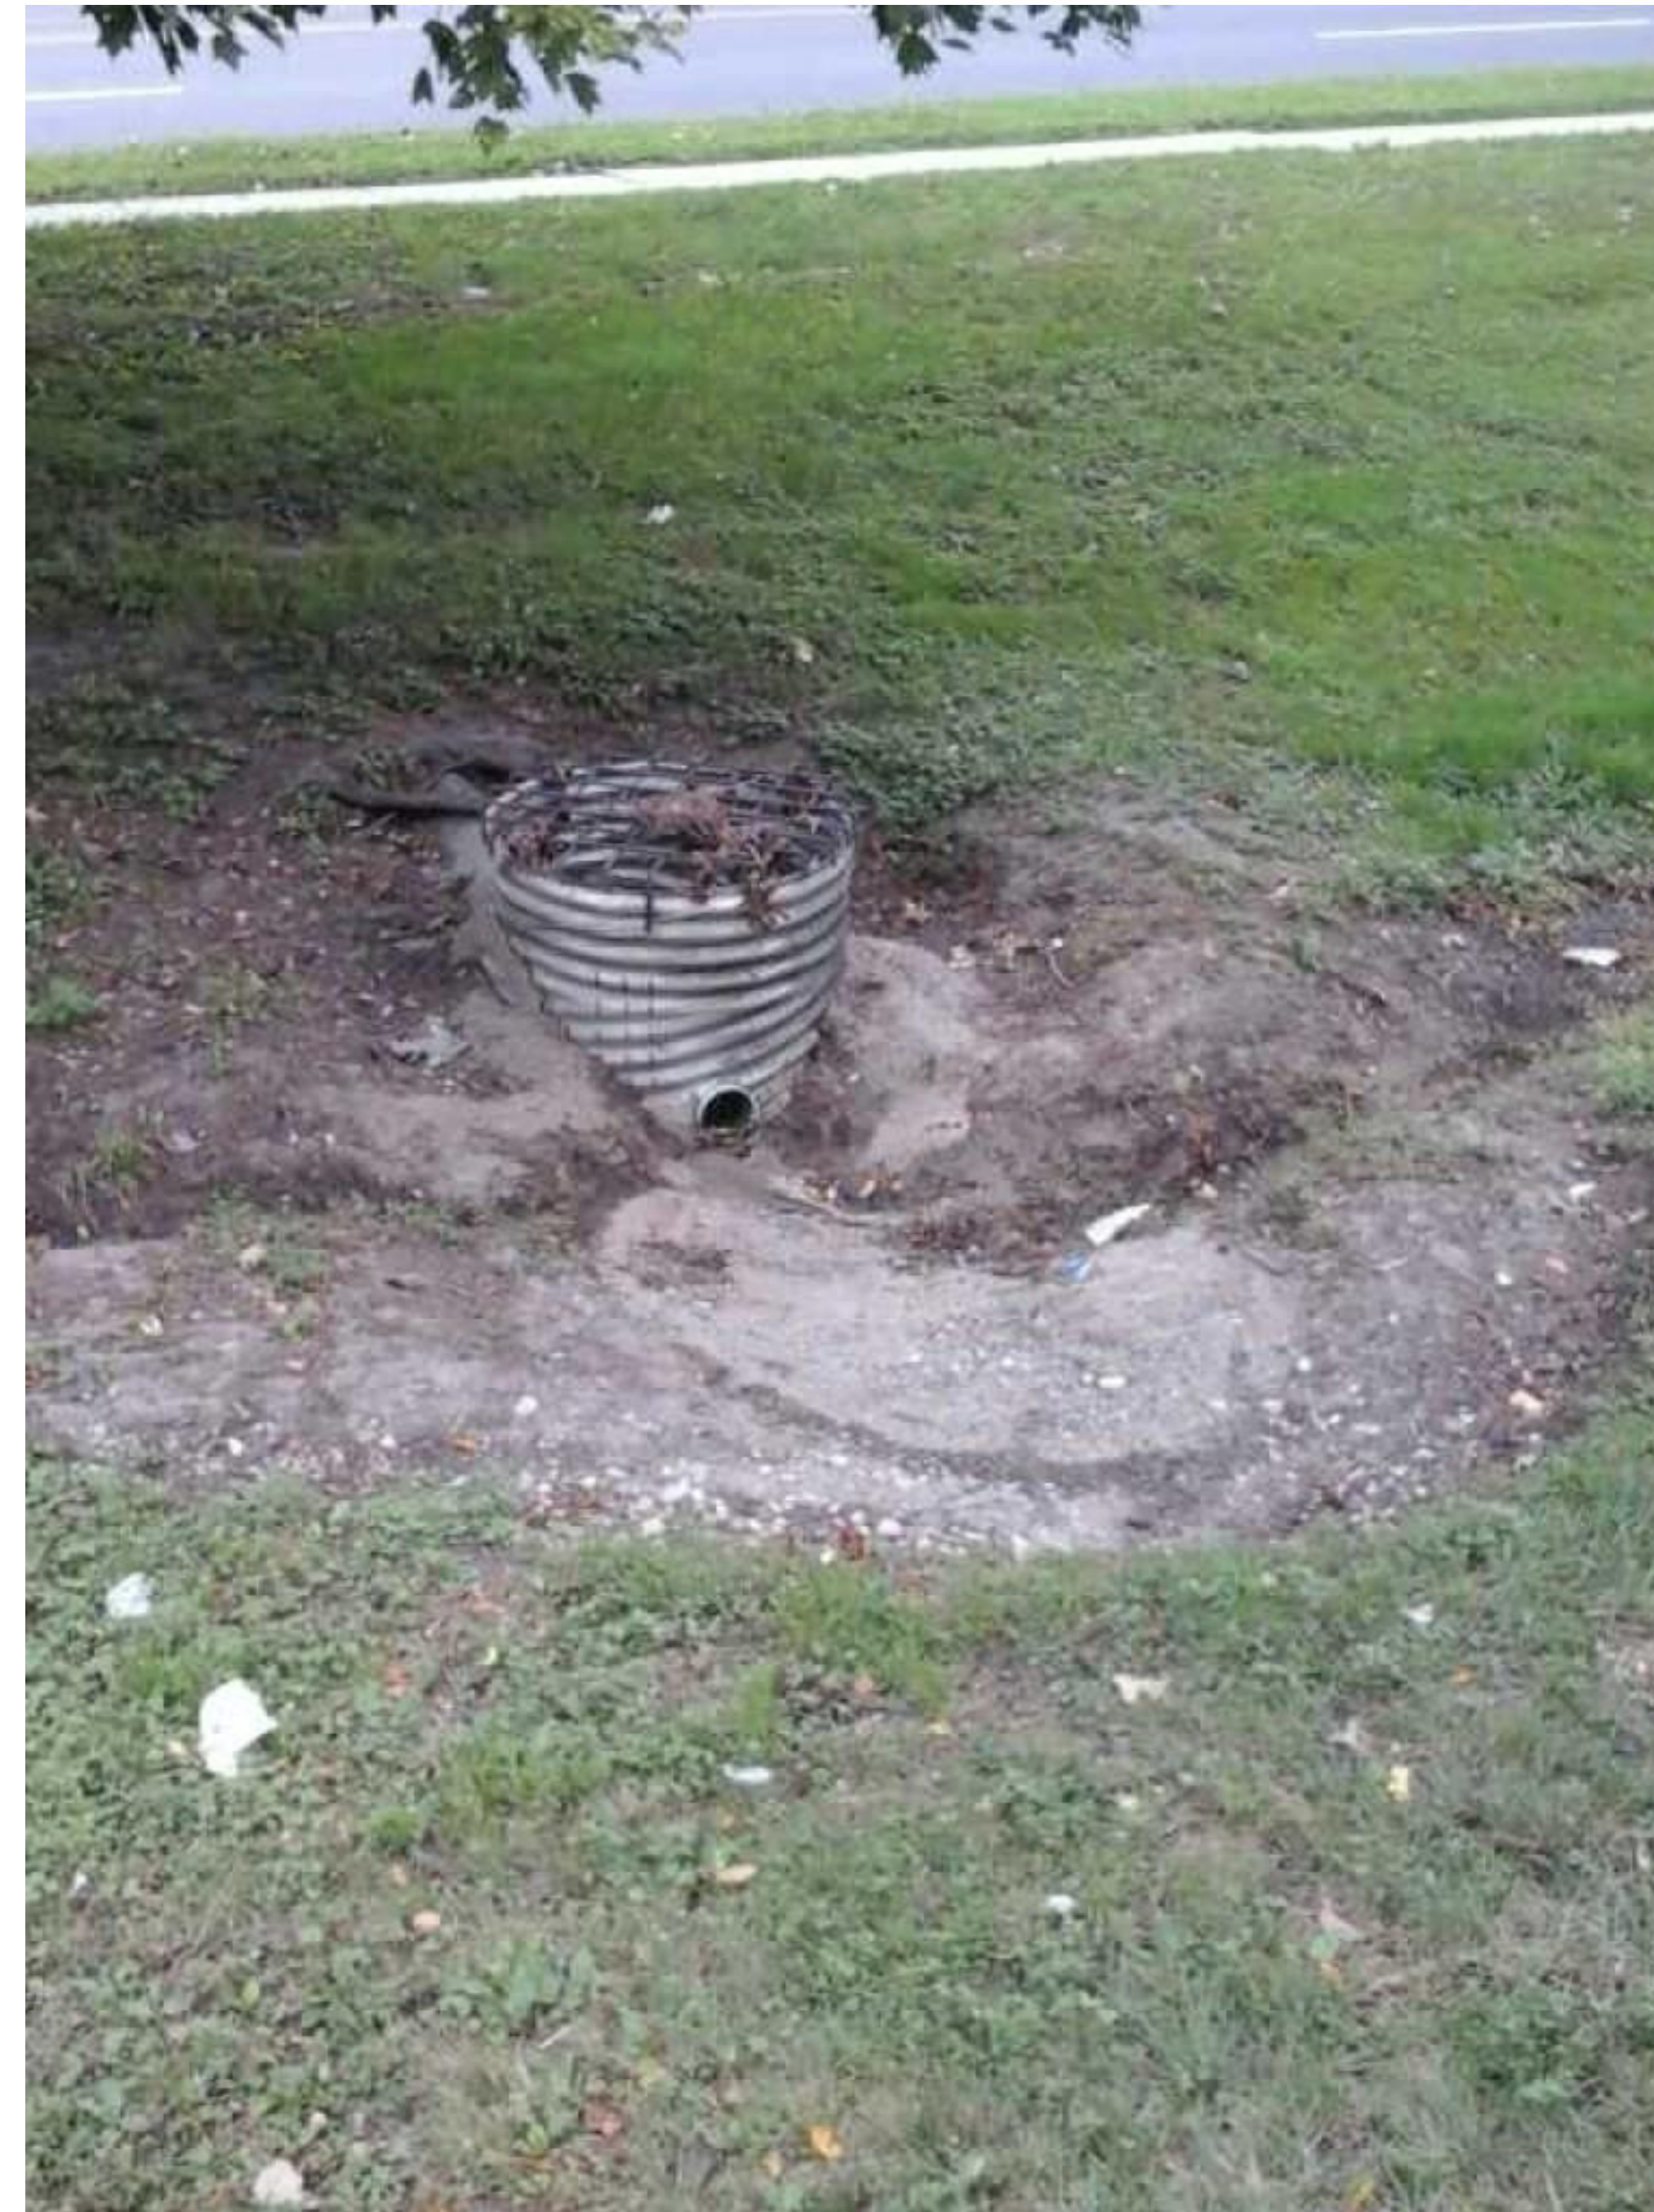
Address:
E State St and Sculptors Way
Trenton, NJ 08619

- Sediment buildup and soil erosion present in basin especially near outlet structure
- Outlet appear to be of old design, could be replaced for better management
- Low flow channels could be removed to promote more infiltration
