**Hamilton Township (Mercer County)
Stormwater Basin Assessment Summary
Past Priority Addendum (Year 5B)**

Developed by the Rutgers Cooperative Extension Water Resources Program
Funded by Hamilton Township, Mercer County, New Jersey

November 27, 2019

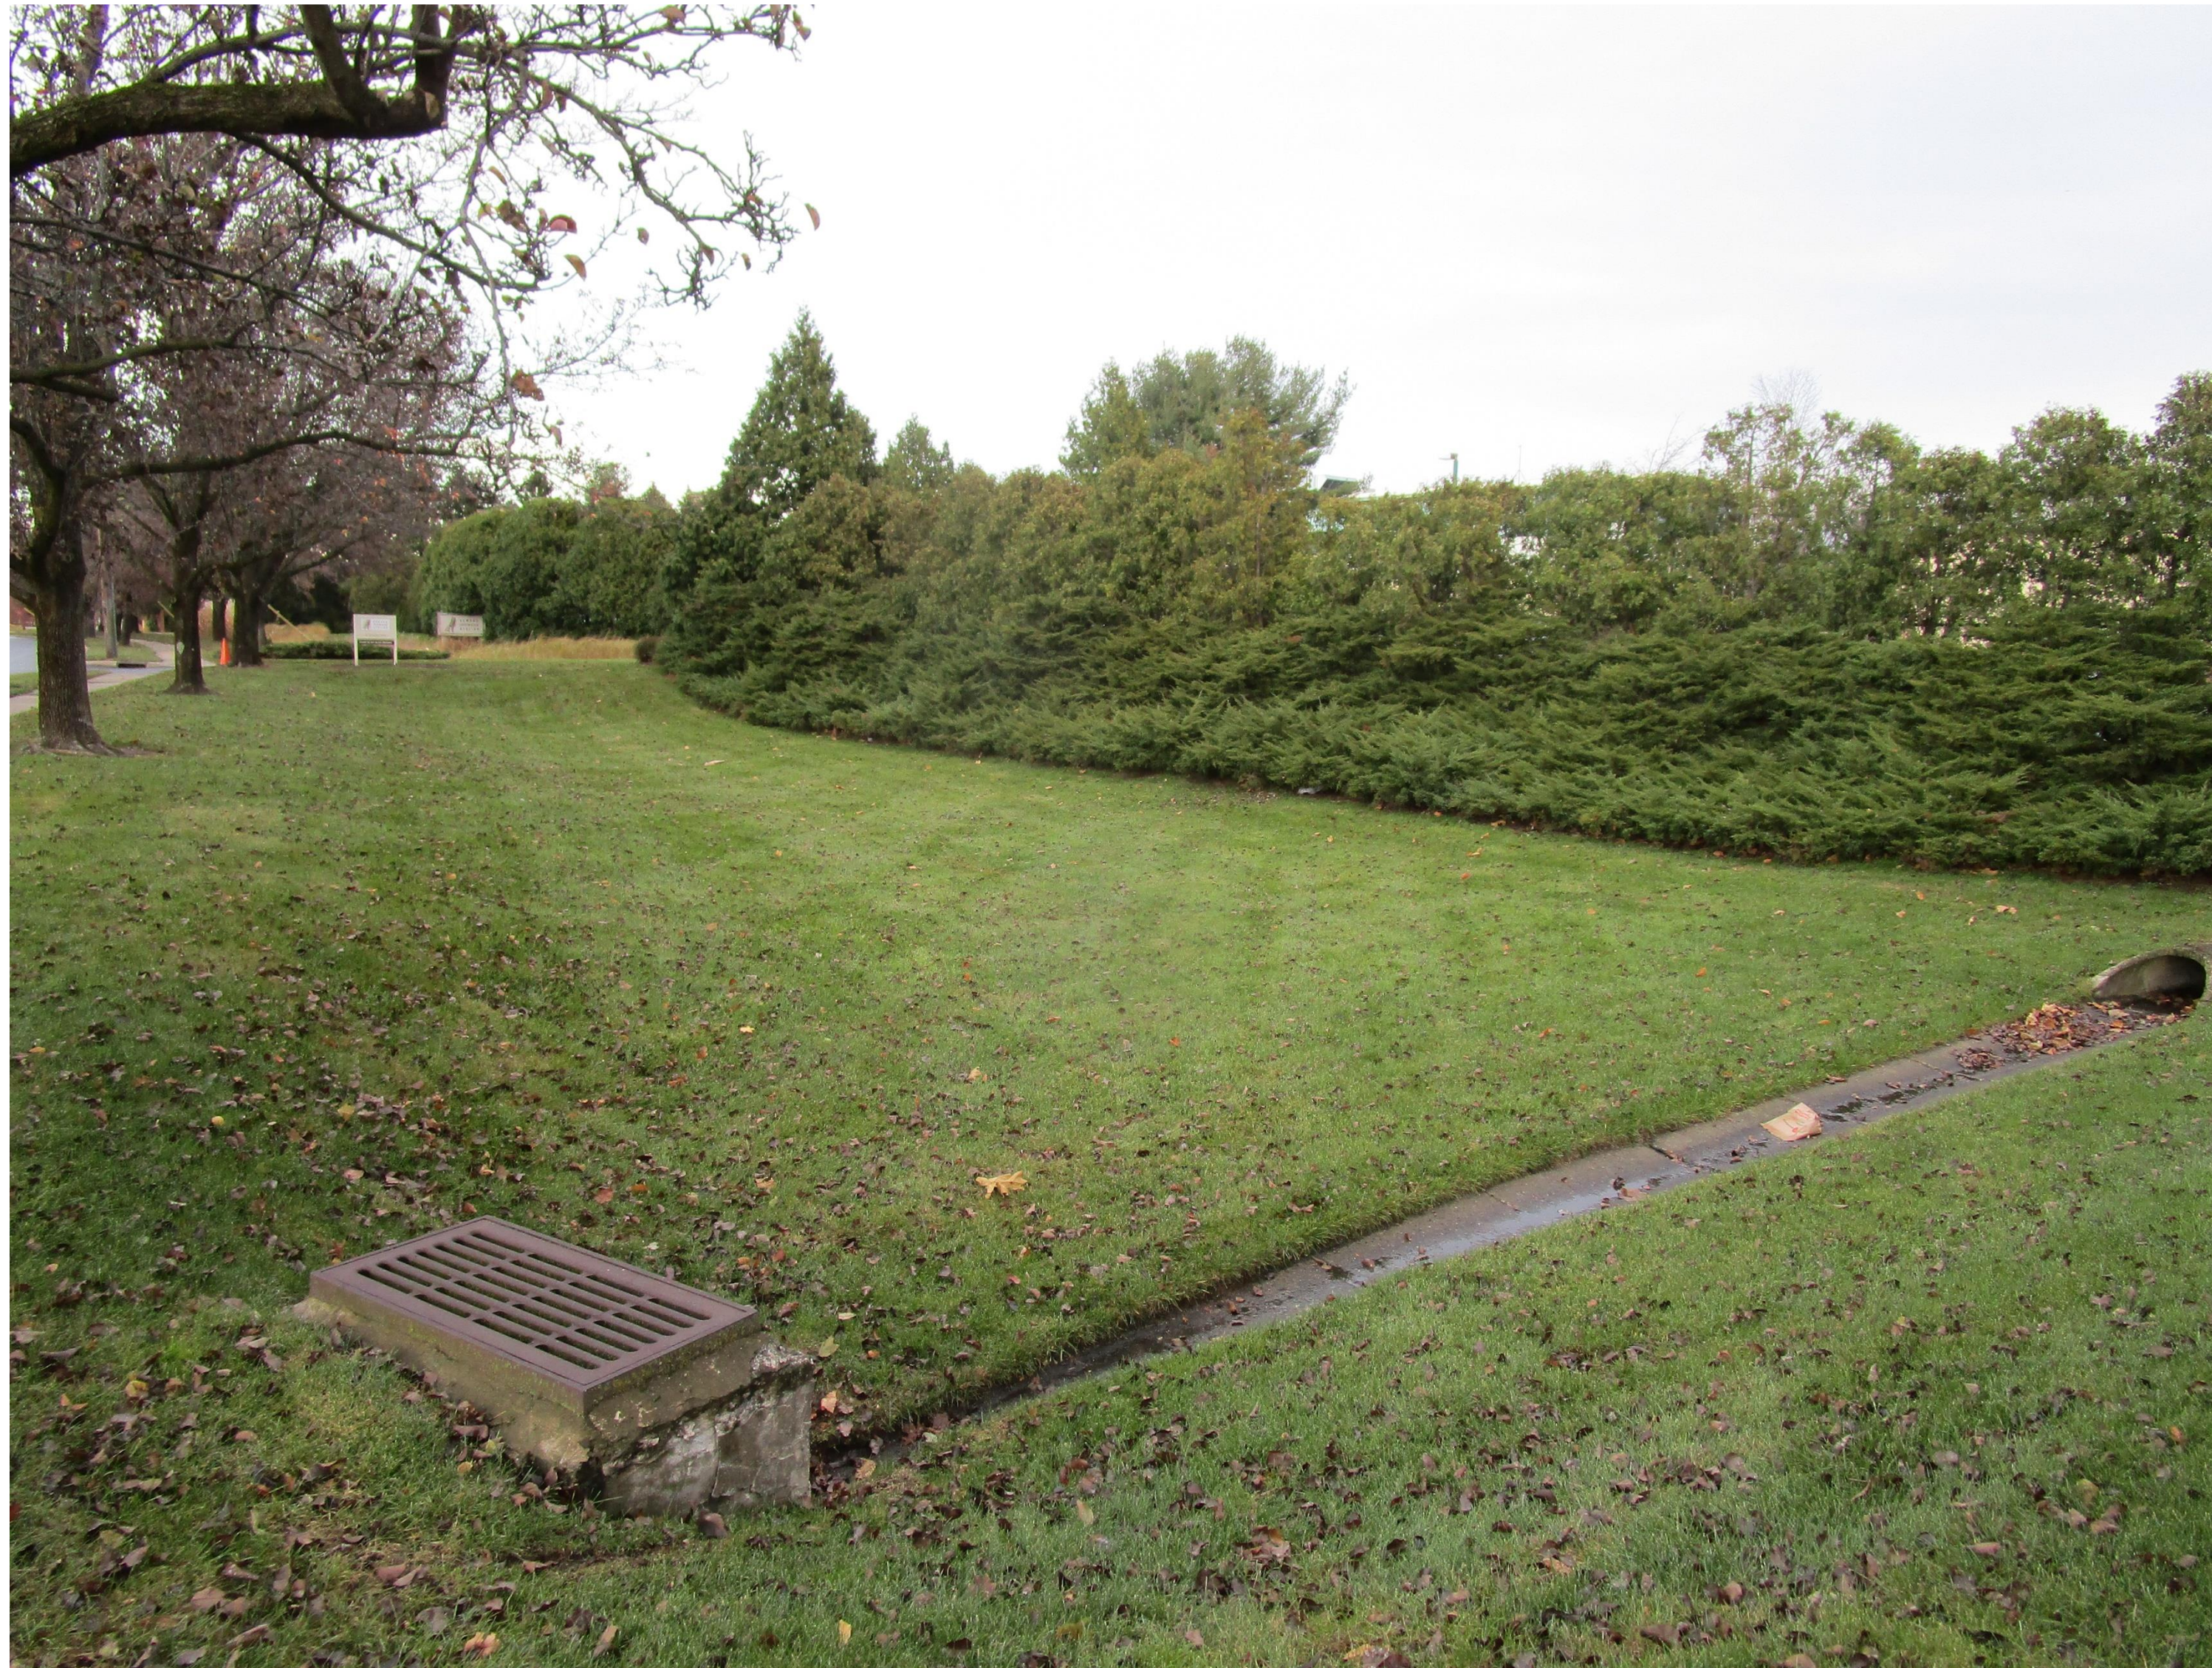
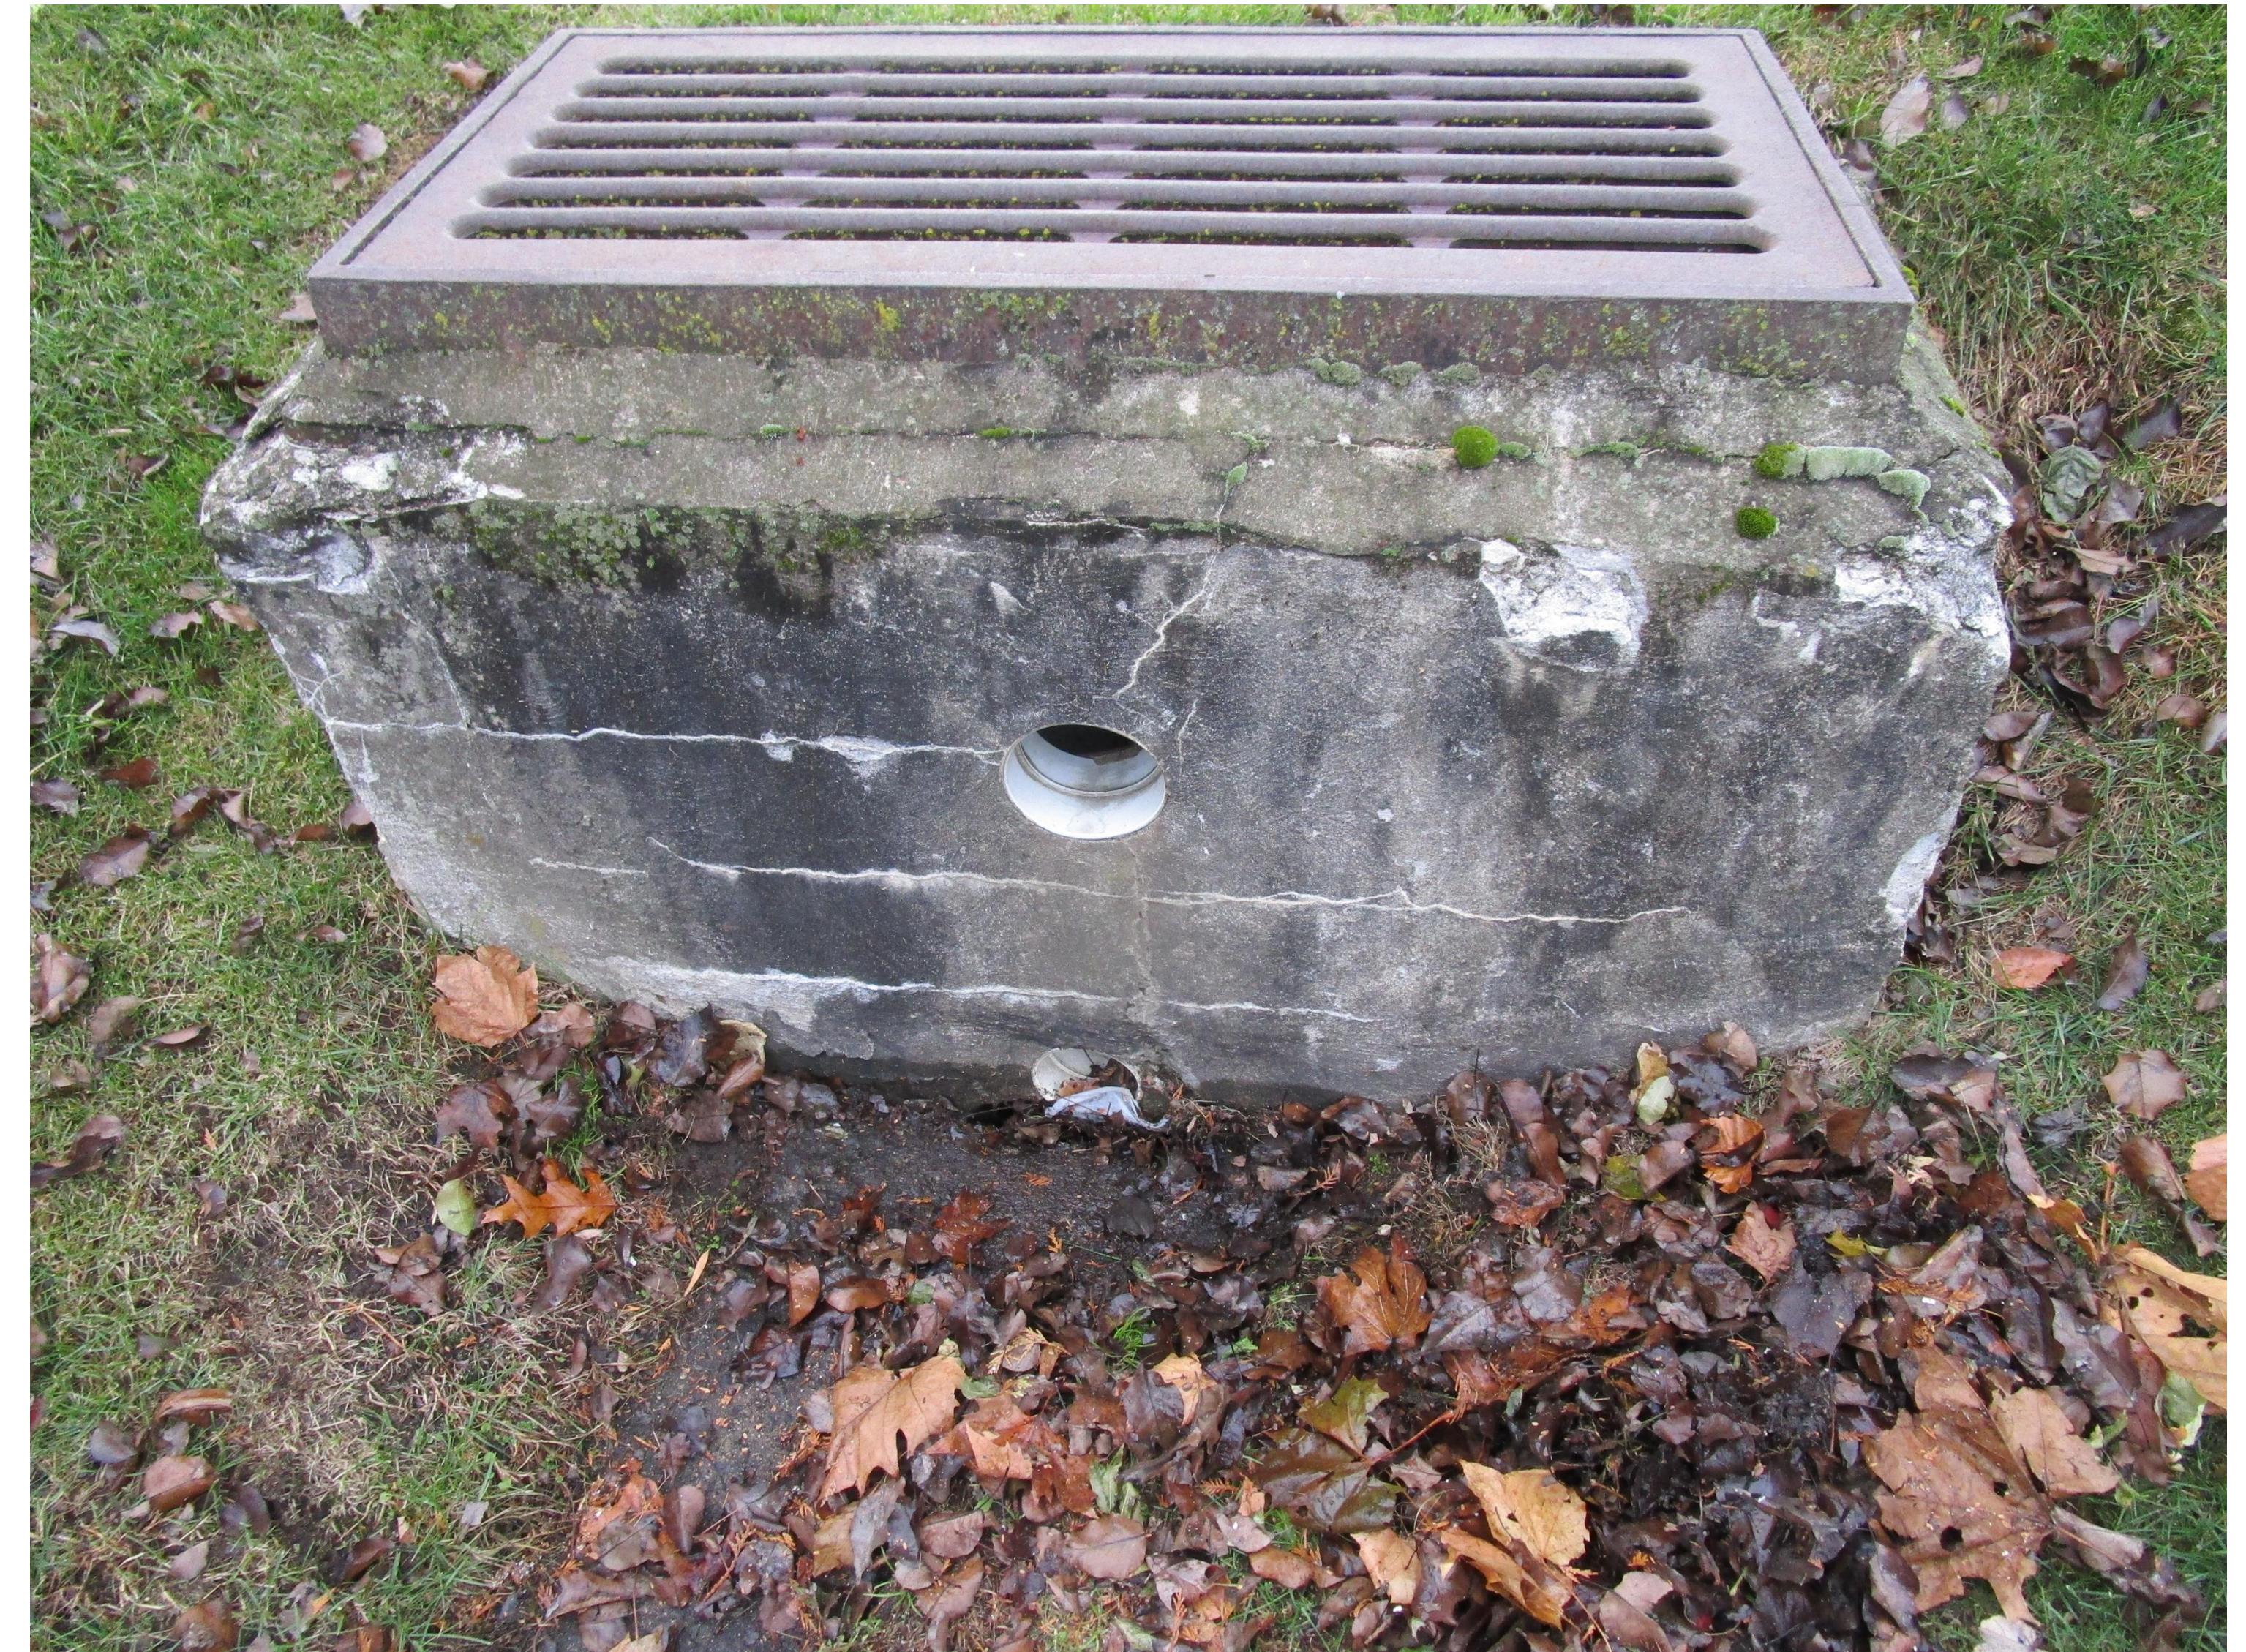
Address:
130 Sculptors Way
Trenton, NJ 08619

- Basin in overall good condition
- Outlet structure has some structural damage with water flowing under the low flow orifice, repair suggested to ensure it is operating as intended
- Low flow channel could be removed to allow more infiltration
- Naturalization by reducing mowing would provide additional benefits

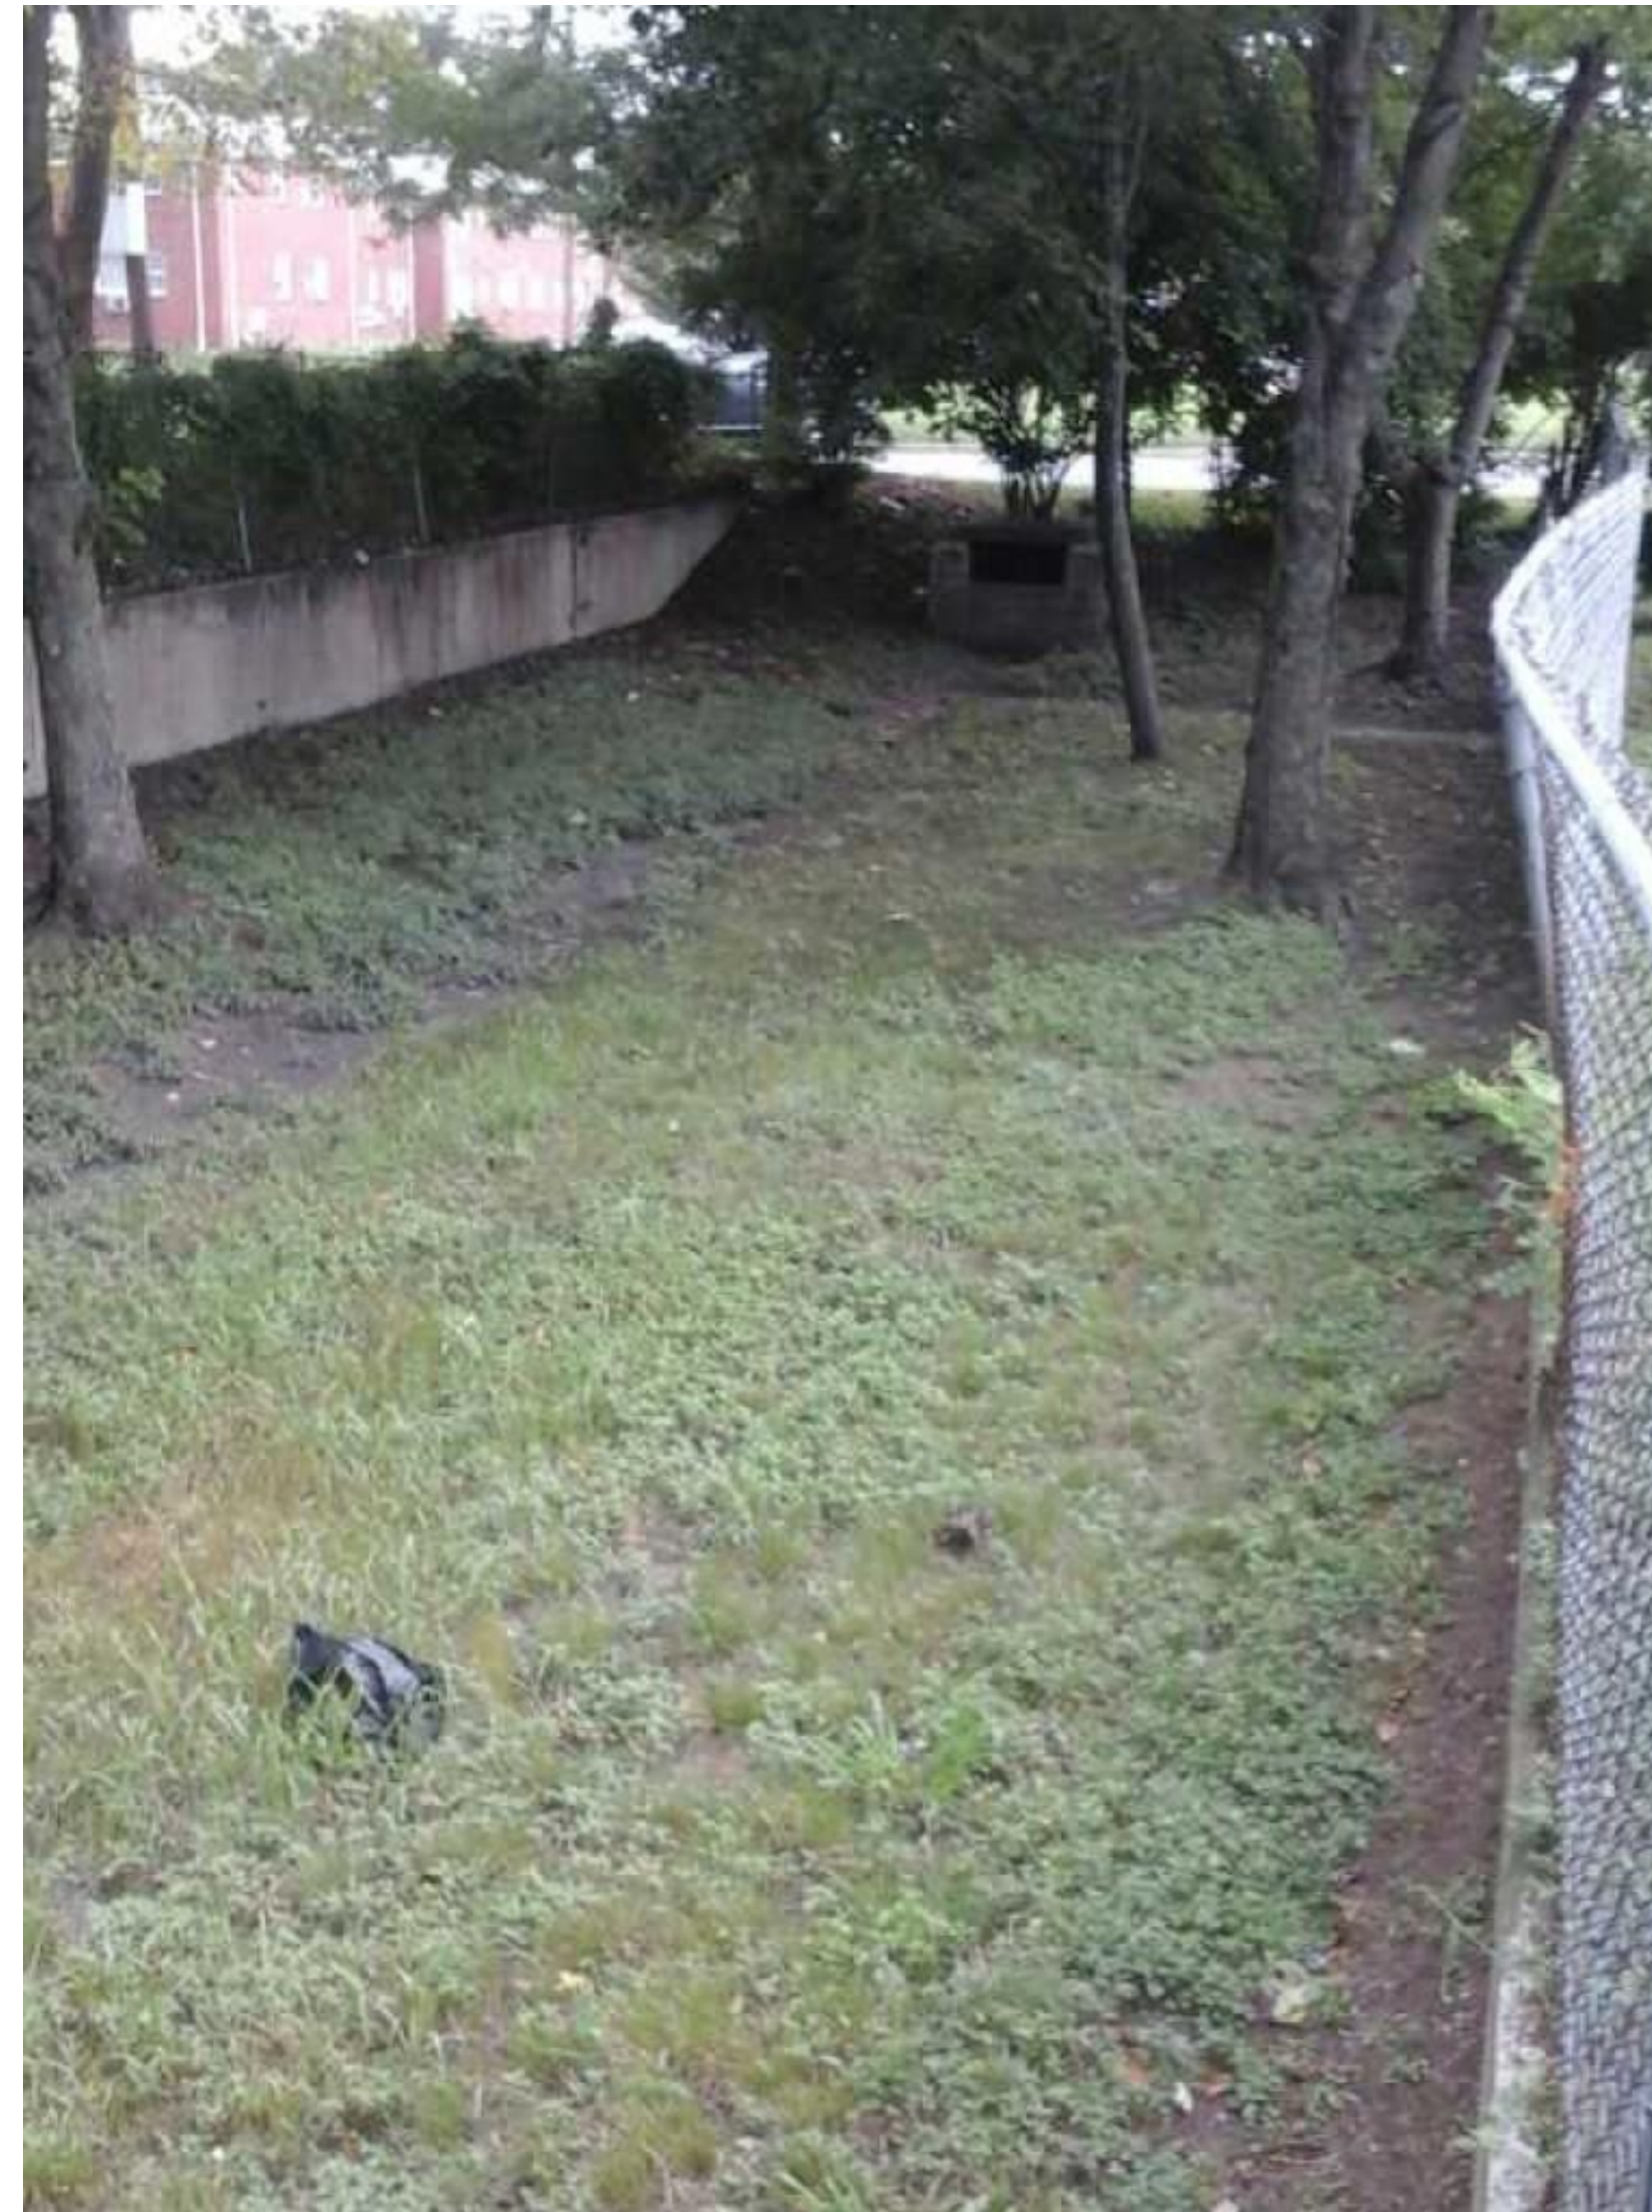
Address:
1475 Nottingham Way
Trenton, NJ 08609

- Basin overall in good condition
- Significant amounts of trash present in basin
- Lot flow channel can be removed and replaced with stone channel to promote infiltration

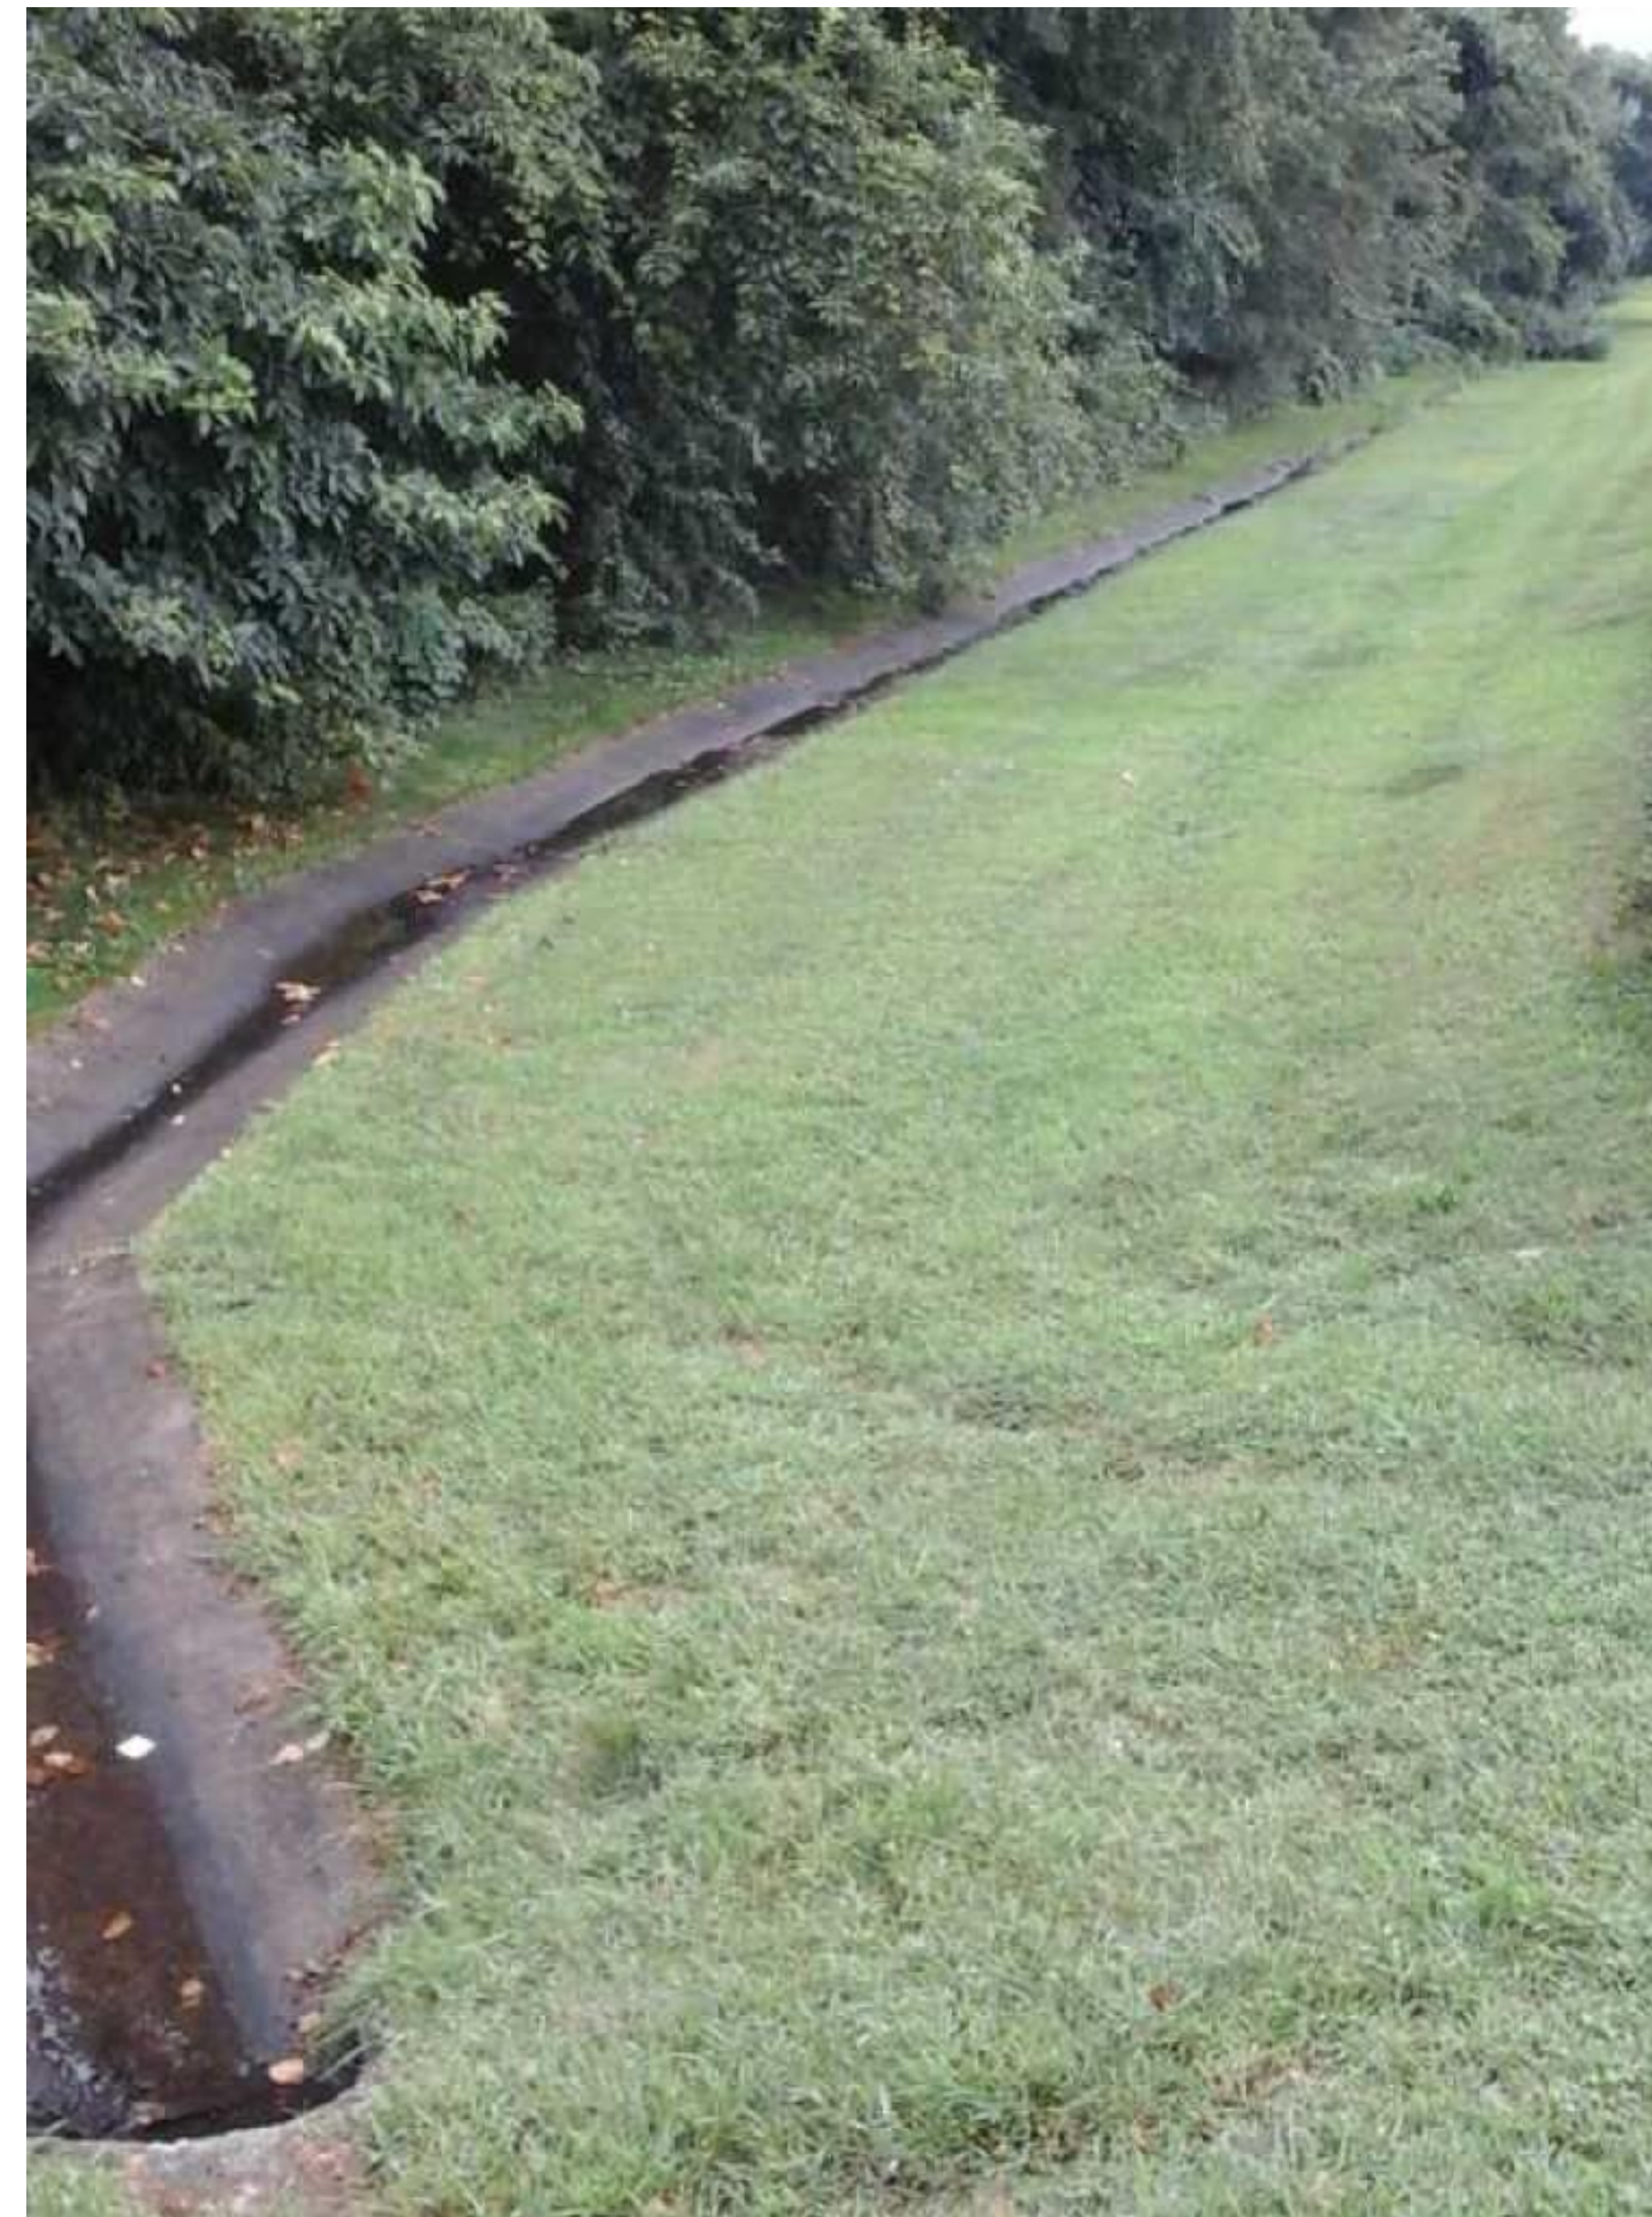
Address:
949 RT-33
Trenton, NJ 08690

- Some vegetation growing within low flow channel
- Clean buildup in low flow channel
- Opportunity to remove low flow channel and replace with rock channel to help deal with standing water issues

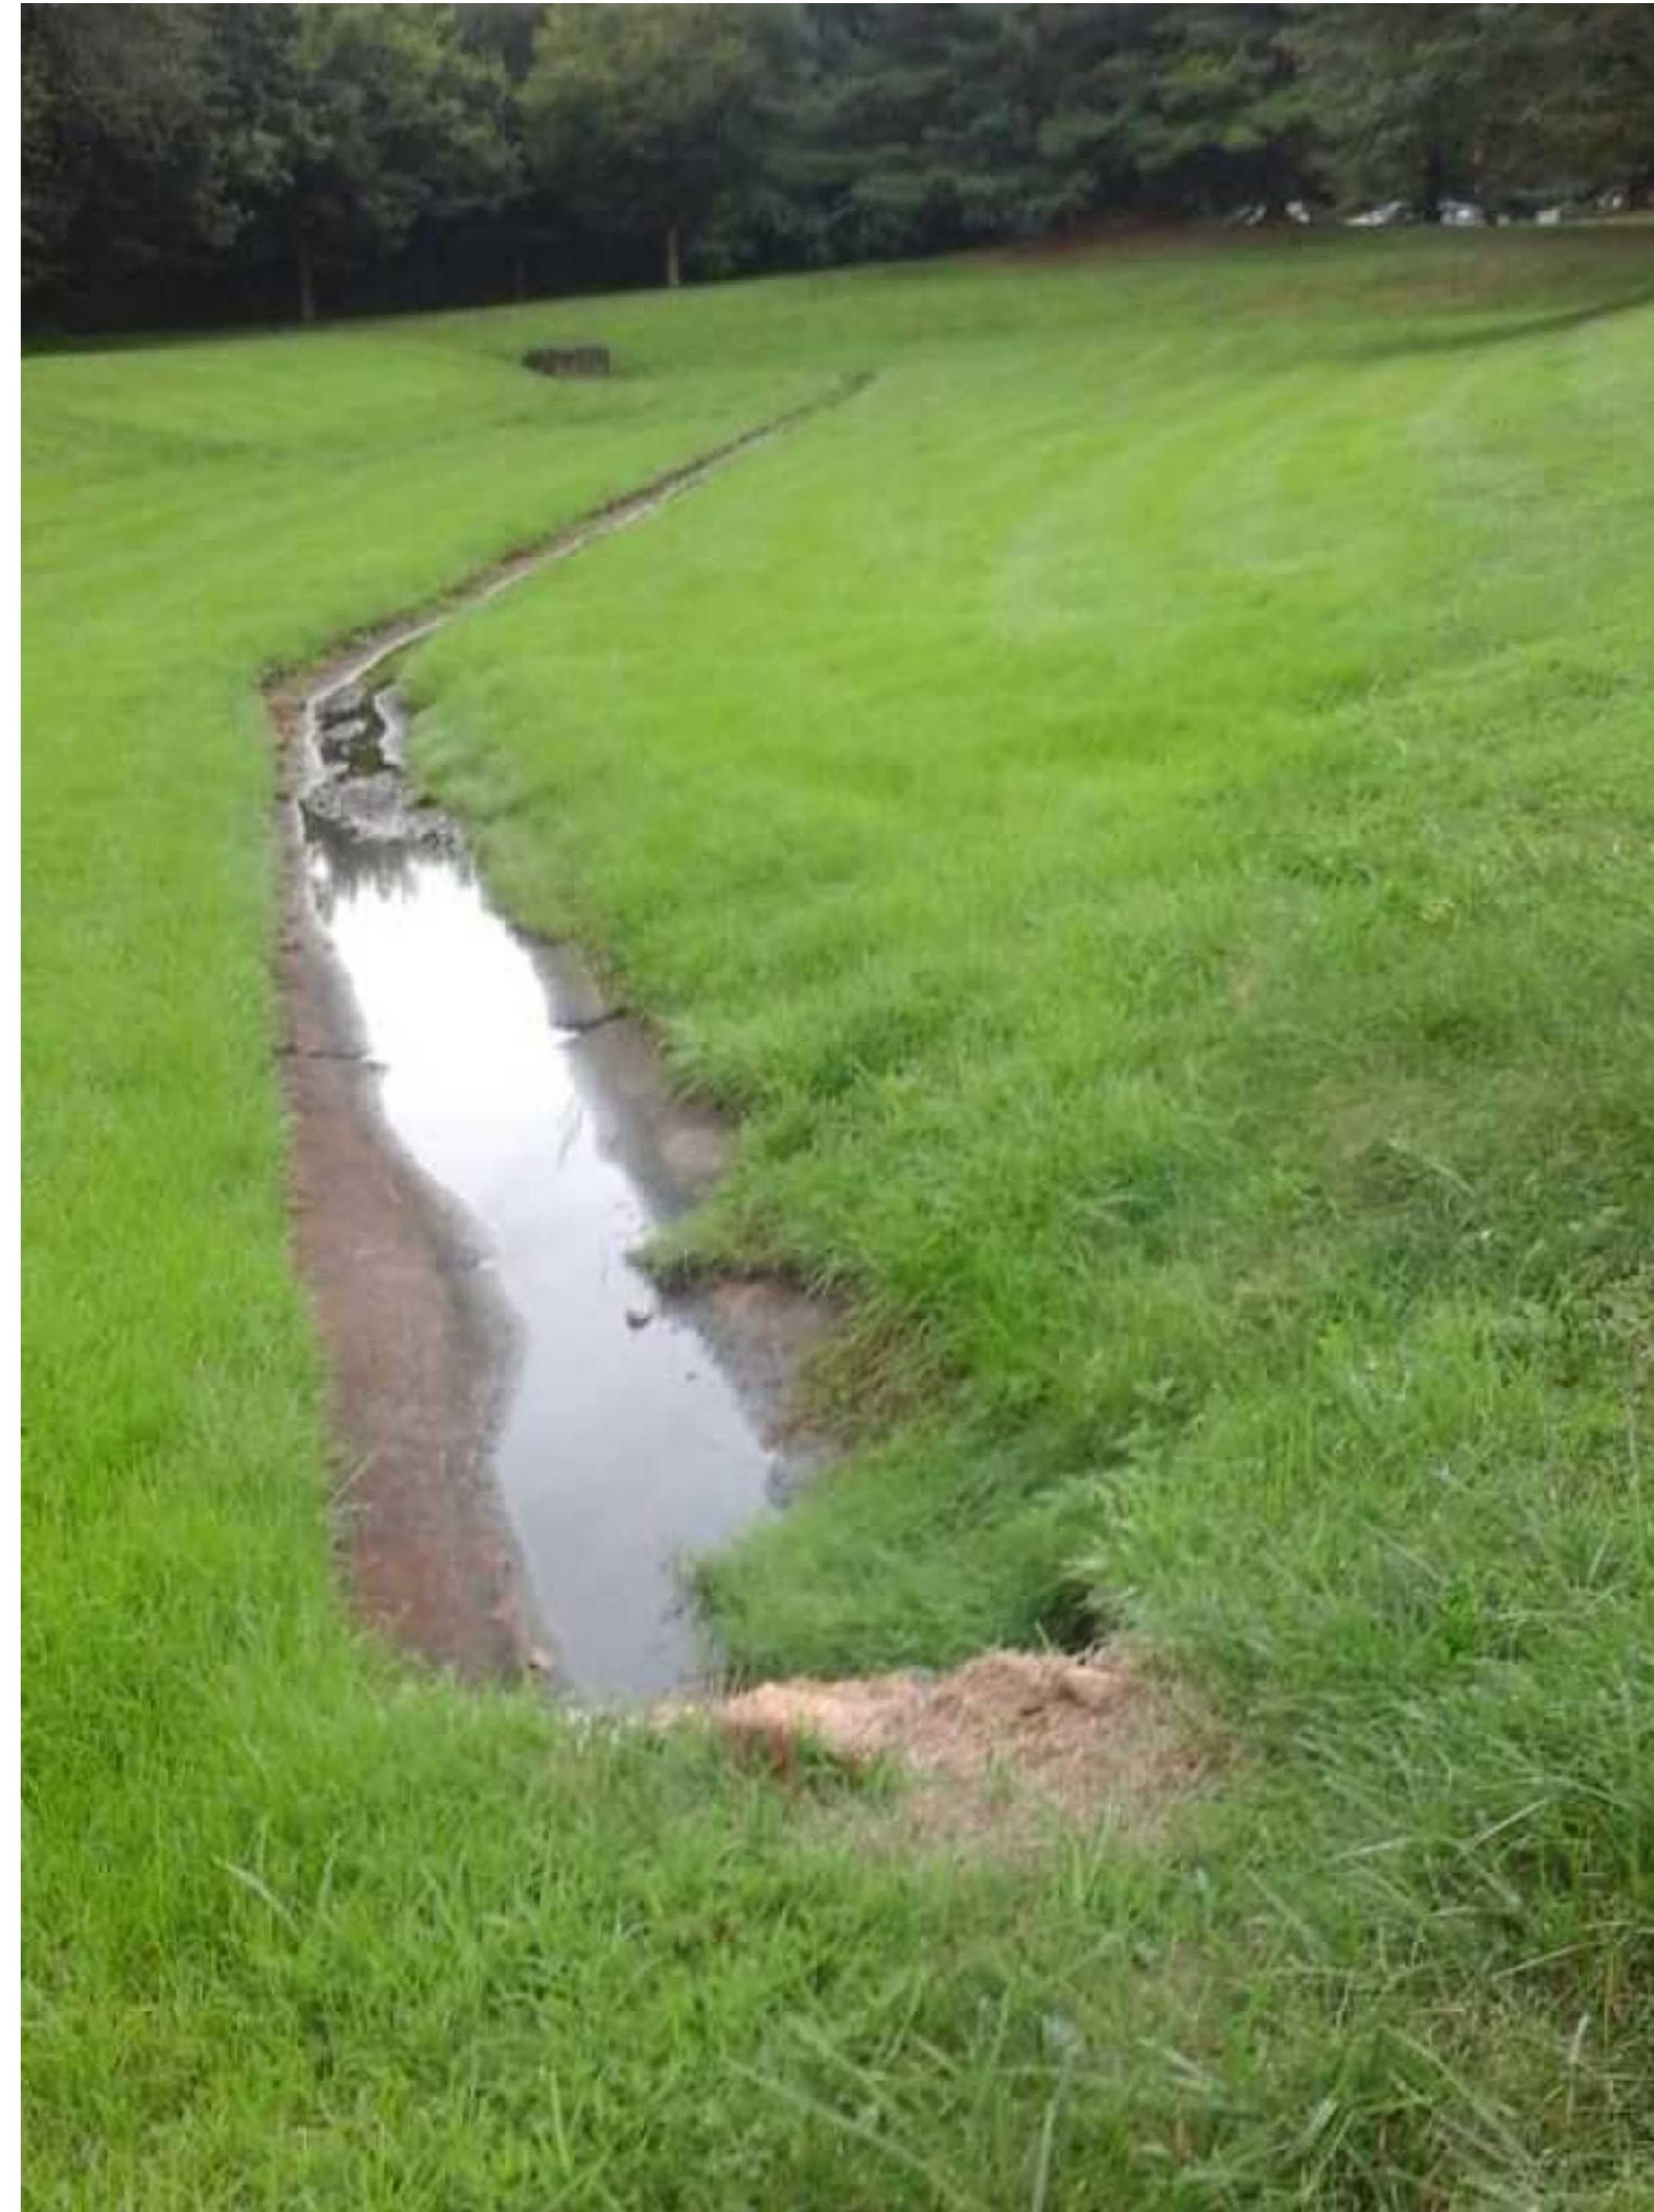
Address:
1991 Klockner Rd
Trenton, NJ 08619

- Basin has two inlets and low flow channel
- Some standing water present in the low flow channel
- Opportunity to remove low flow channel and replace with stone channel to help with standing water issues

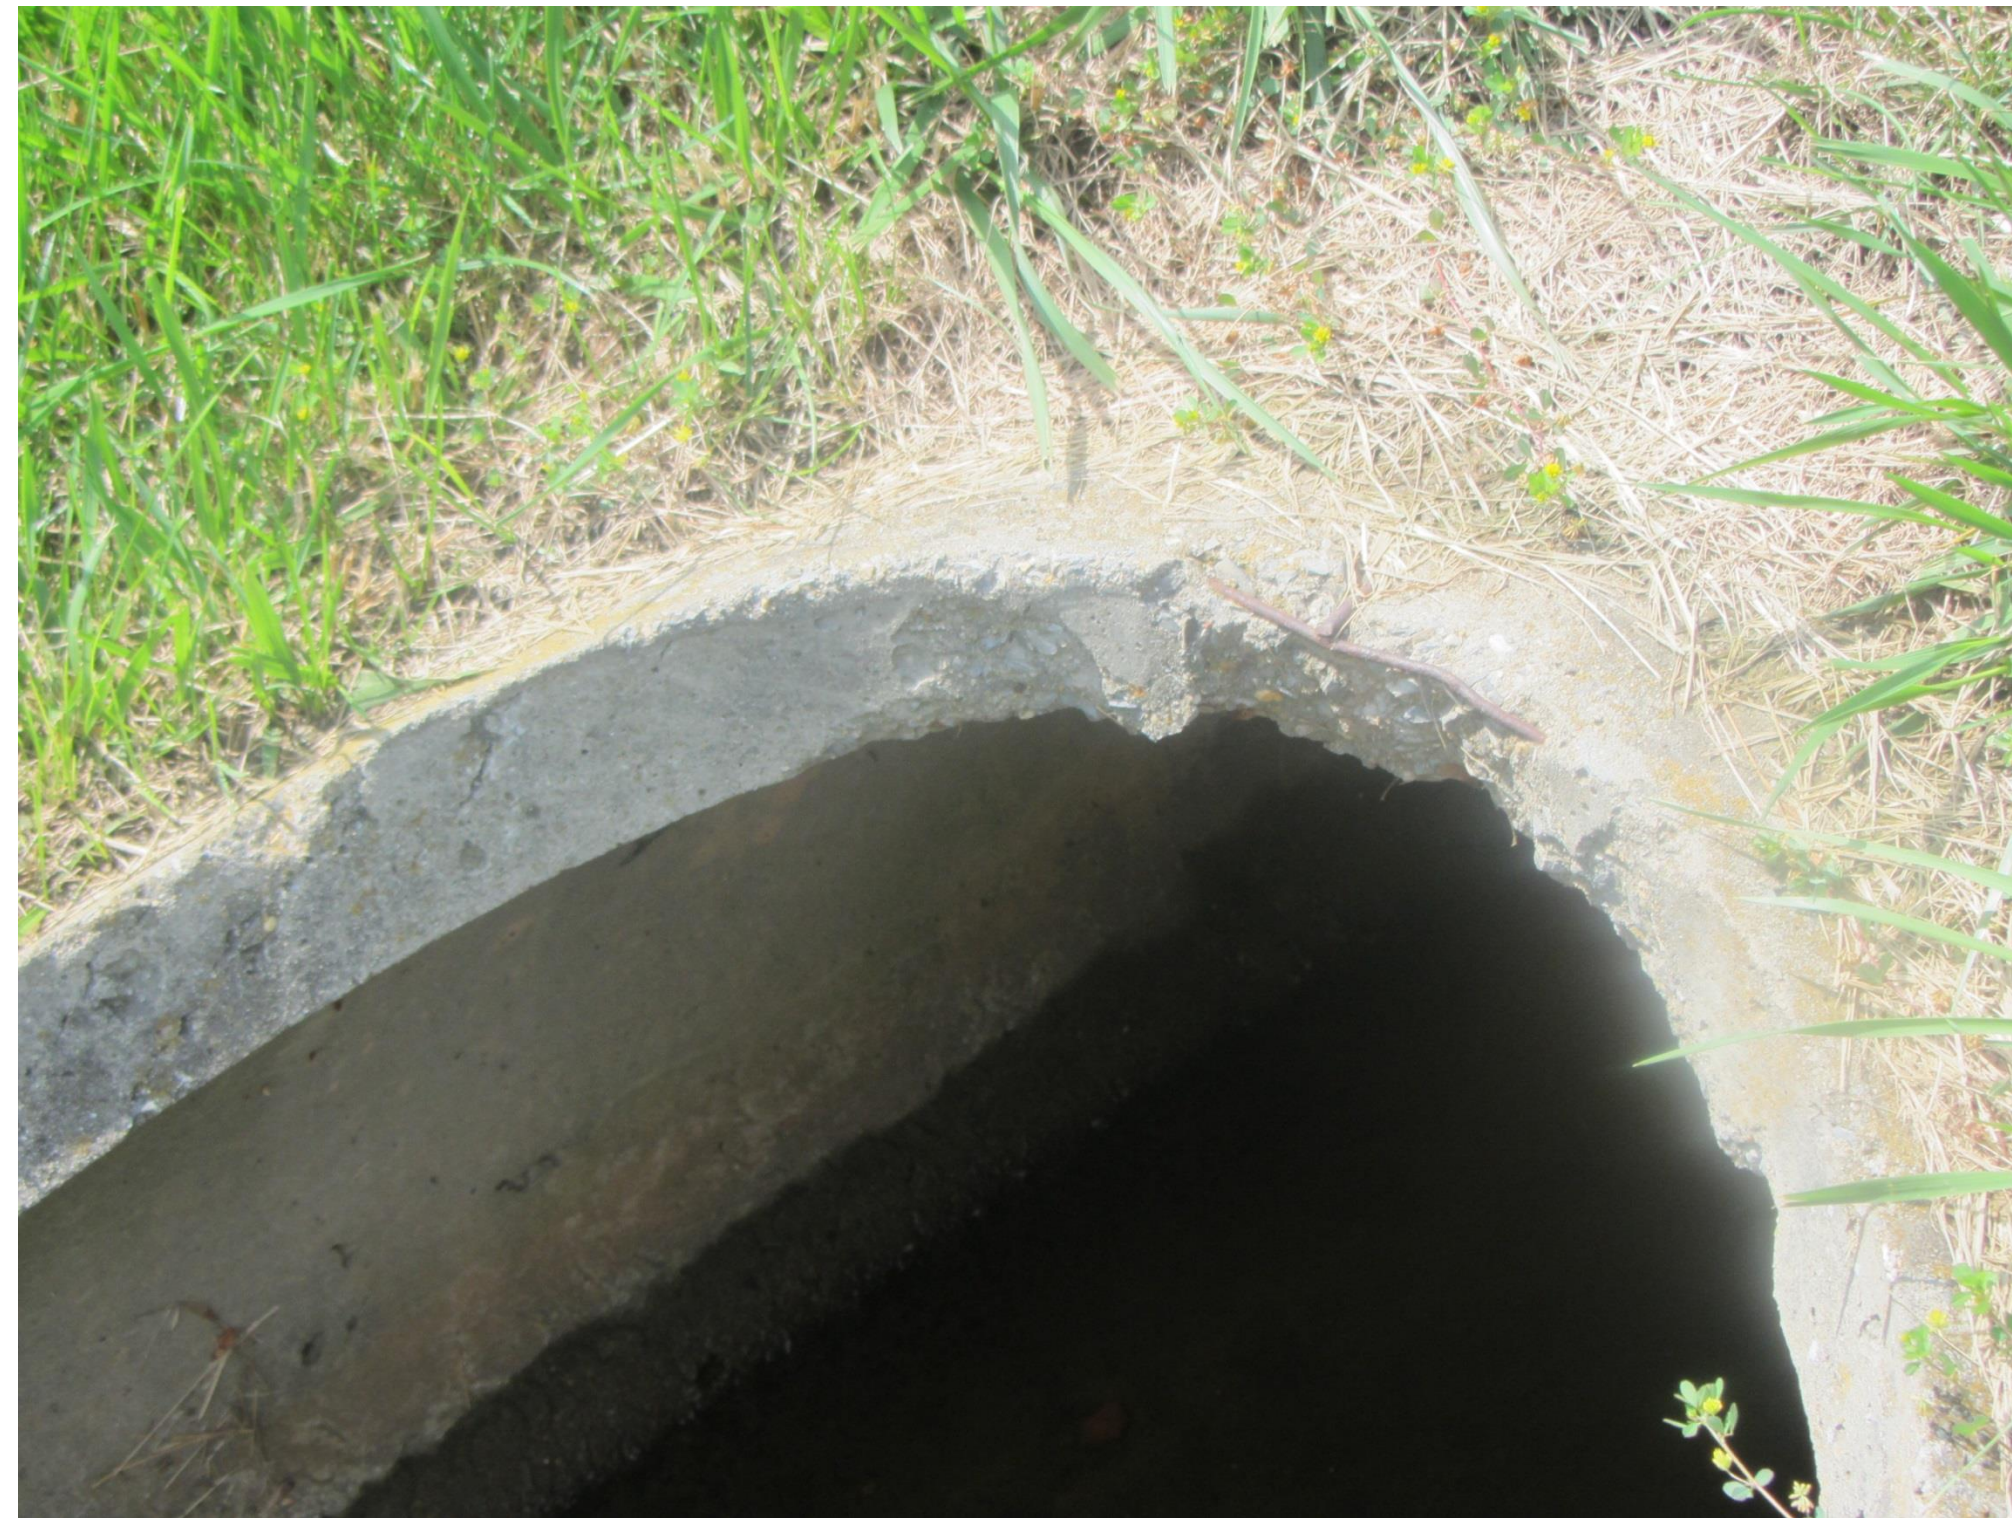
Concrete deterioration on eastern inlet
