**Hamilton Township (Mercer County)
Stormwater Basin Assessment Summary
Past Priority Addendum (Year 5B)**

Developed by the Rutgers Cooperative Extension Water Resources Program
Funded by Hamilton Township, Mercer County, New Jersey

November 27, 2019

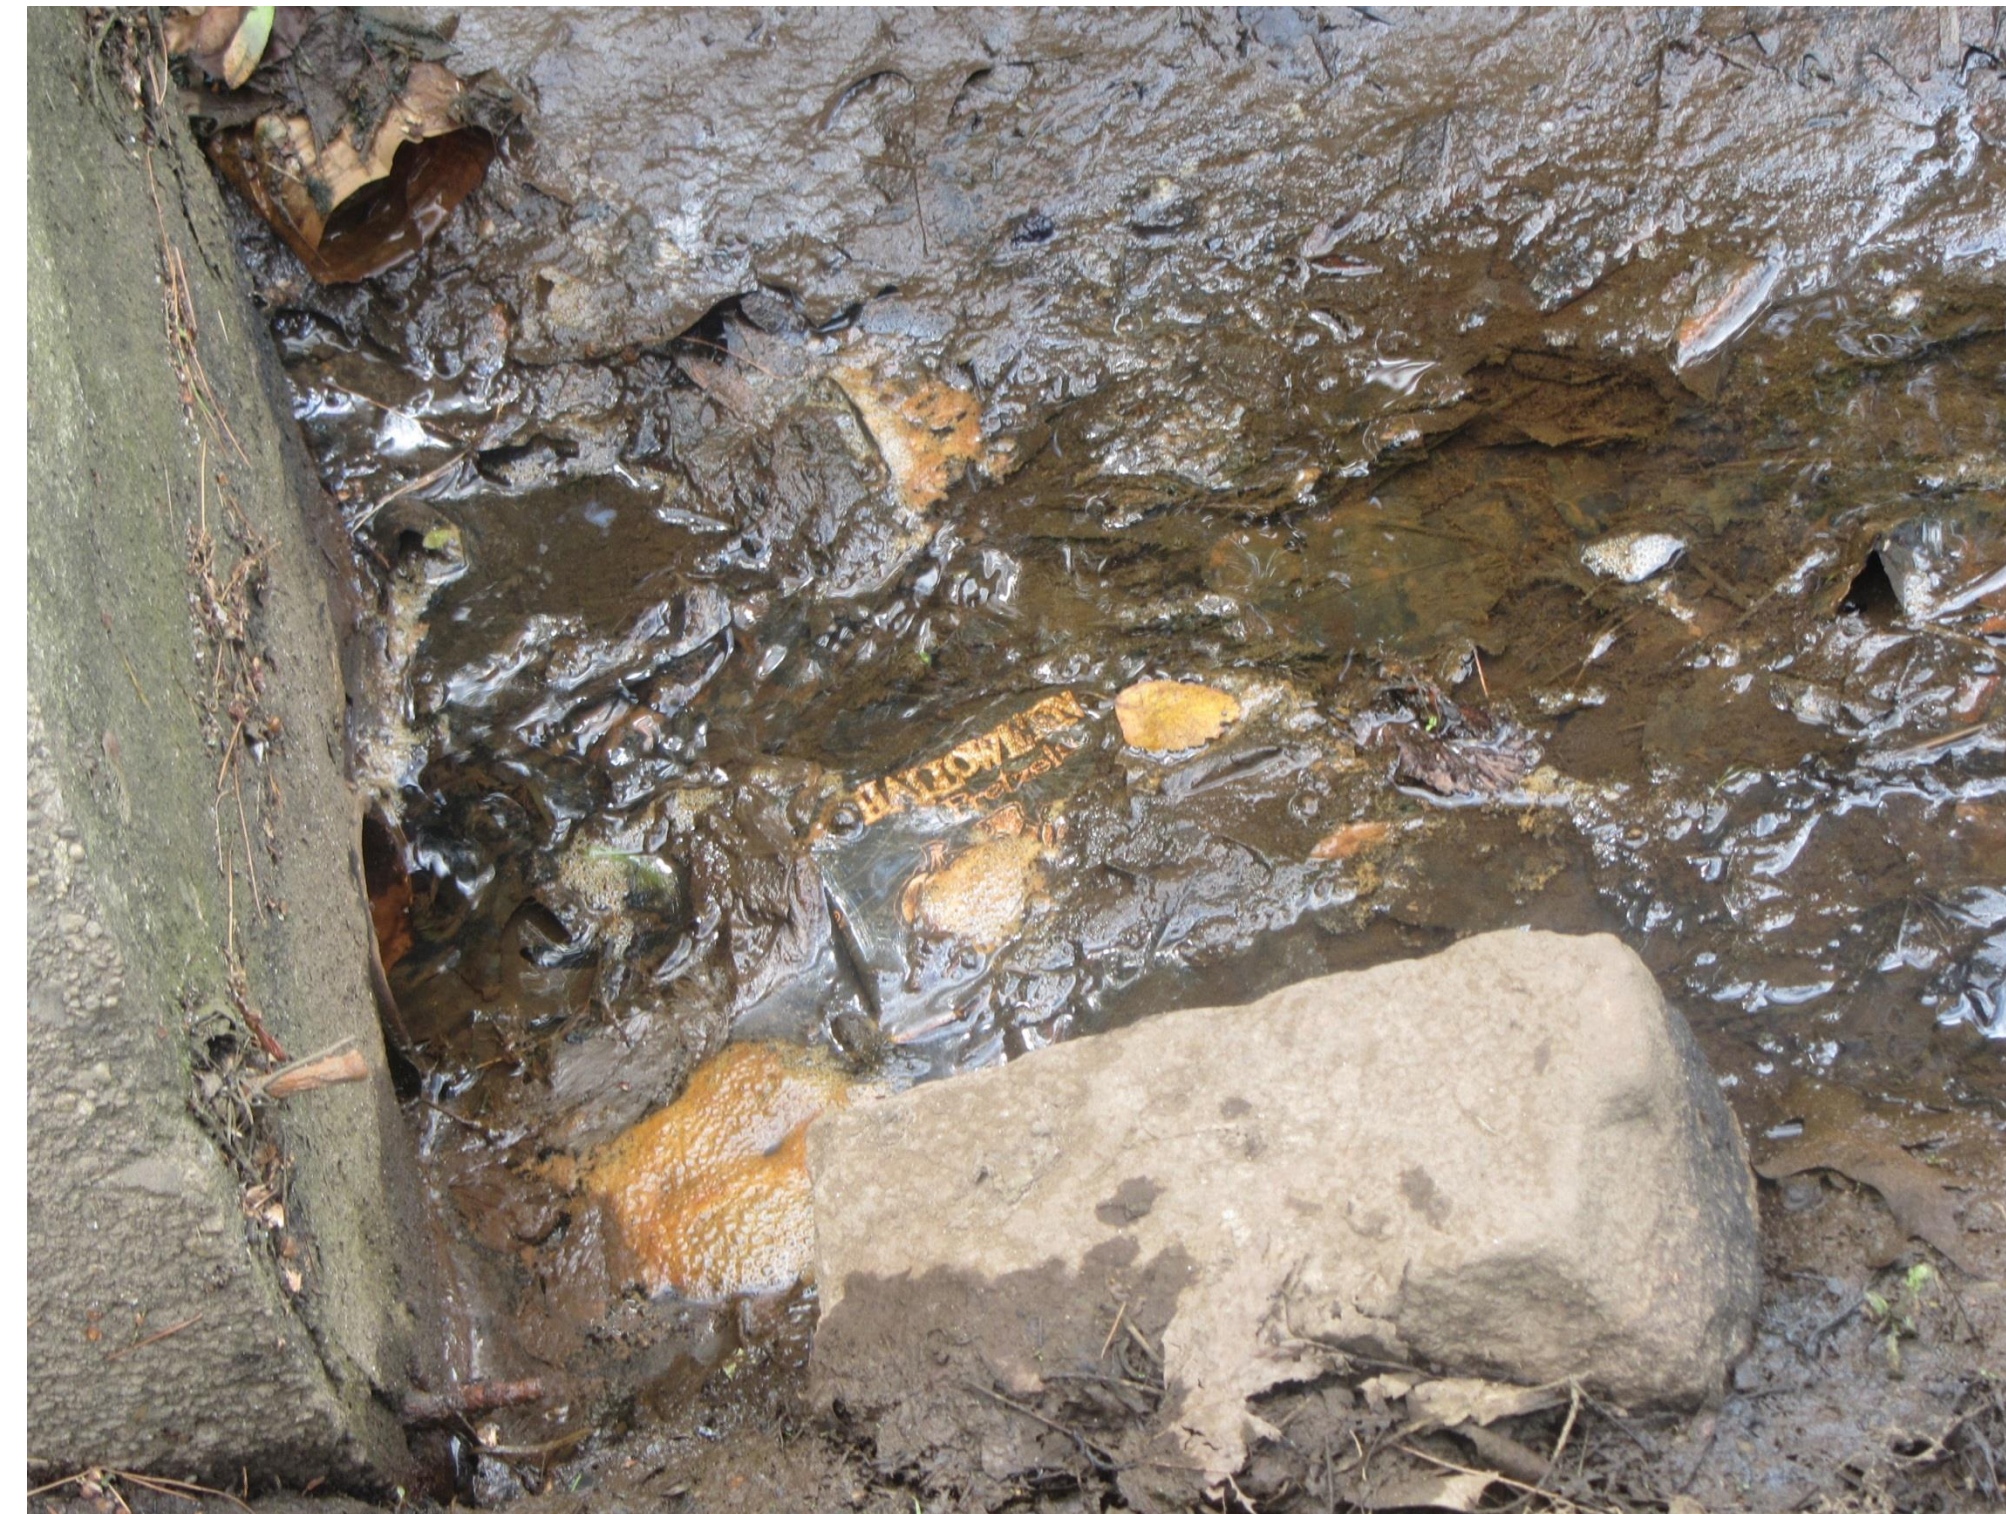
Clogged outlet low flow orifice

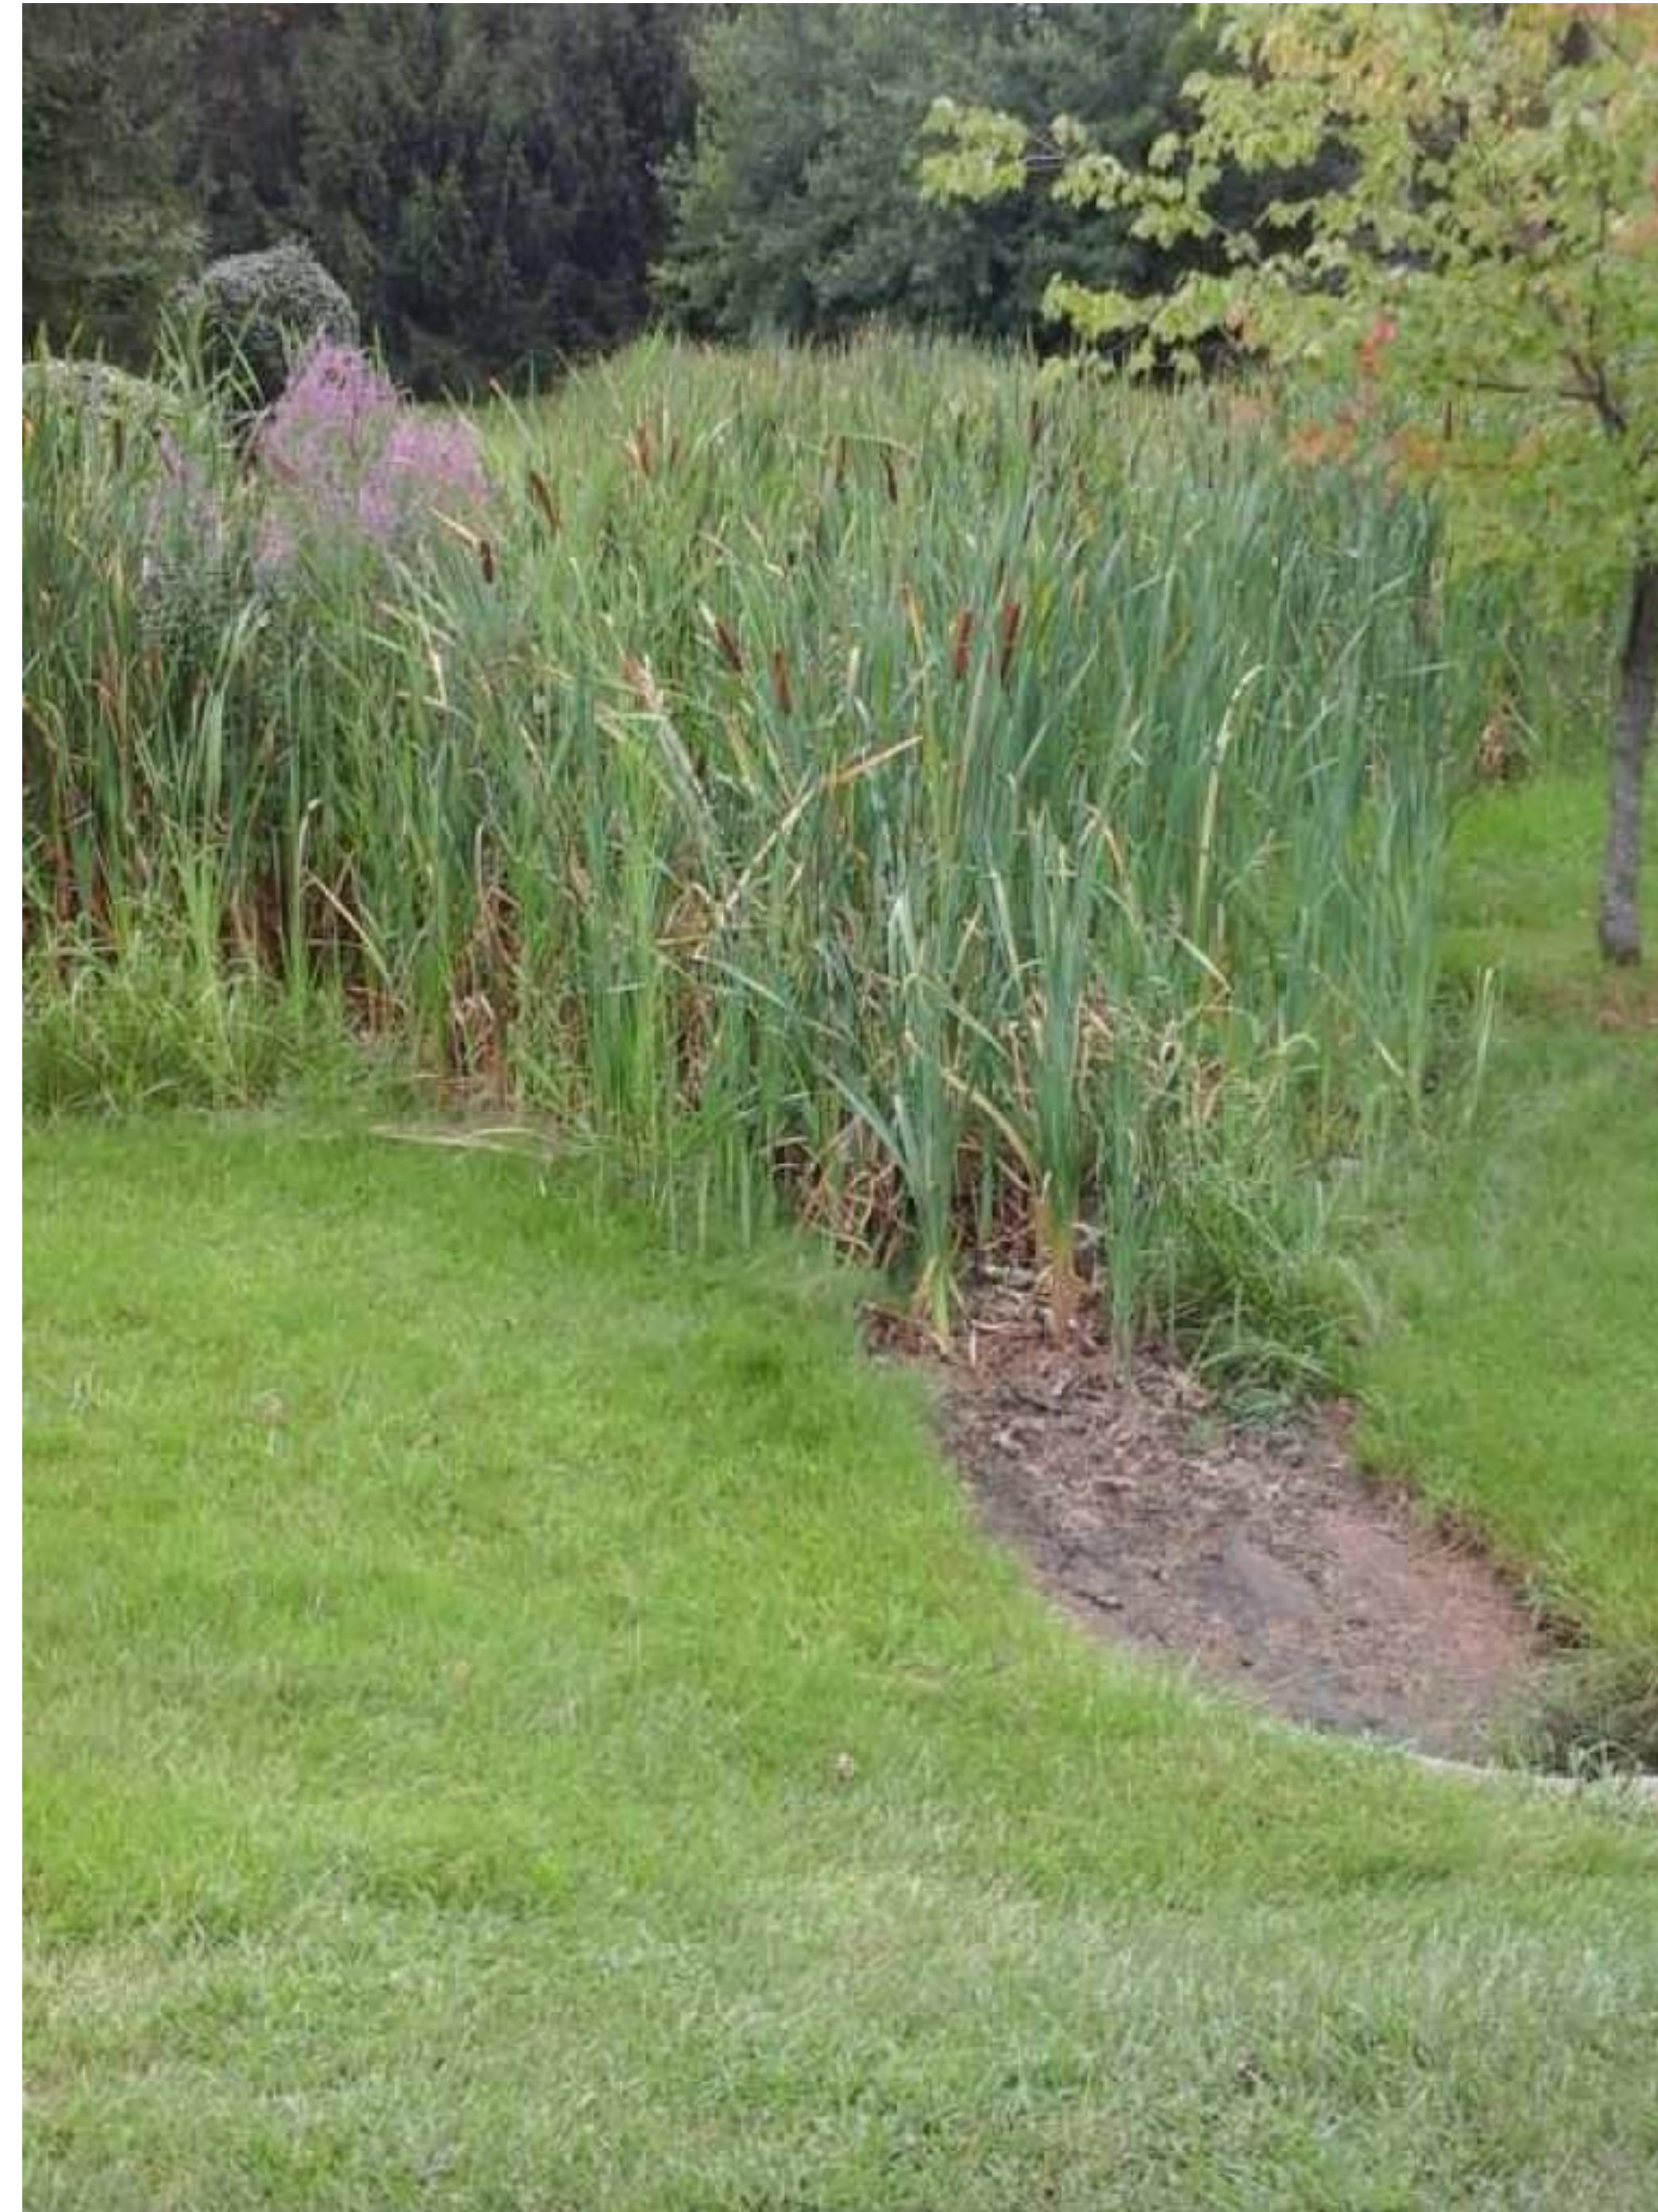
Address:
1673 Whitehorse Mercerville Rd
Trenton, NJ 08619

- Basin looks to be in better condition than 2013 overall
- Basin center allowed to naturalize, appears to have reduced some issues, low flow channel should be removed from a proper naturalization
- Clean oil existing in inlet with standing water under it

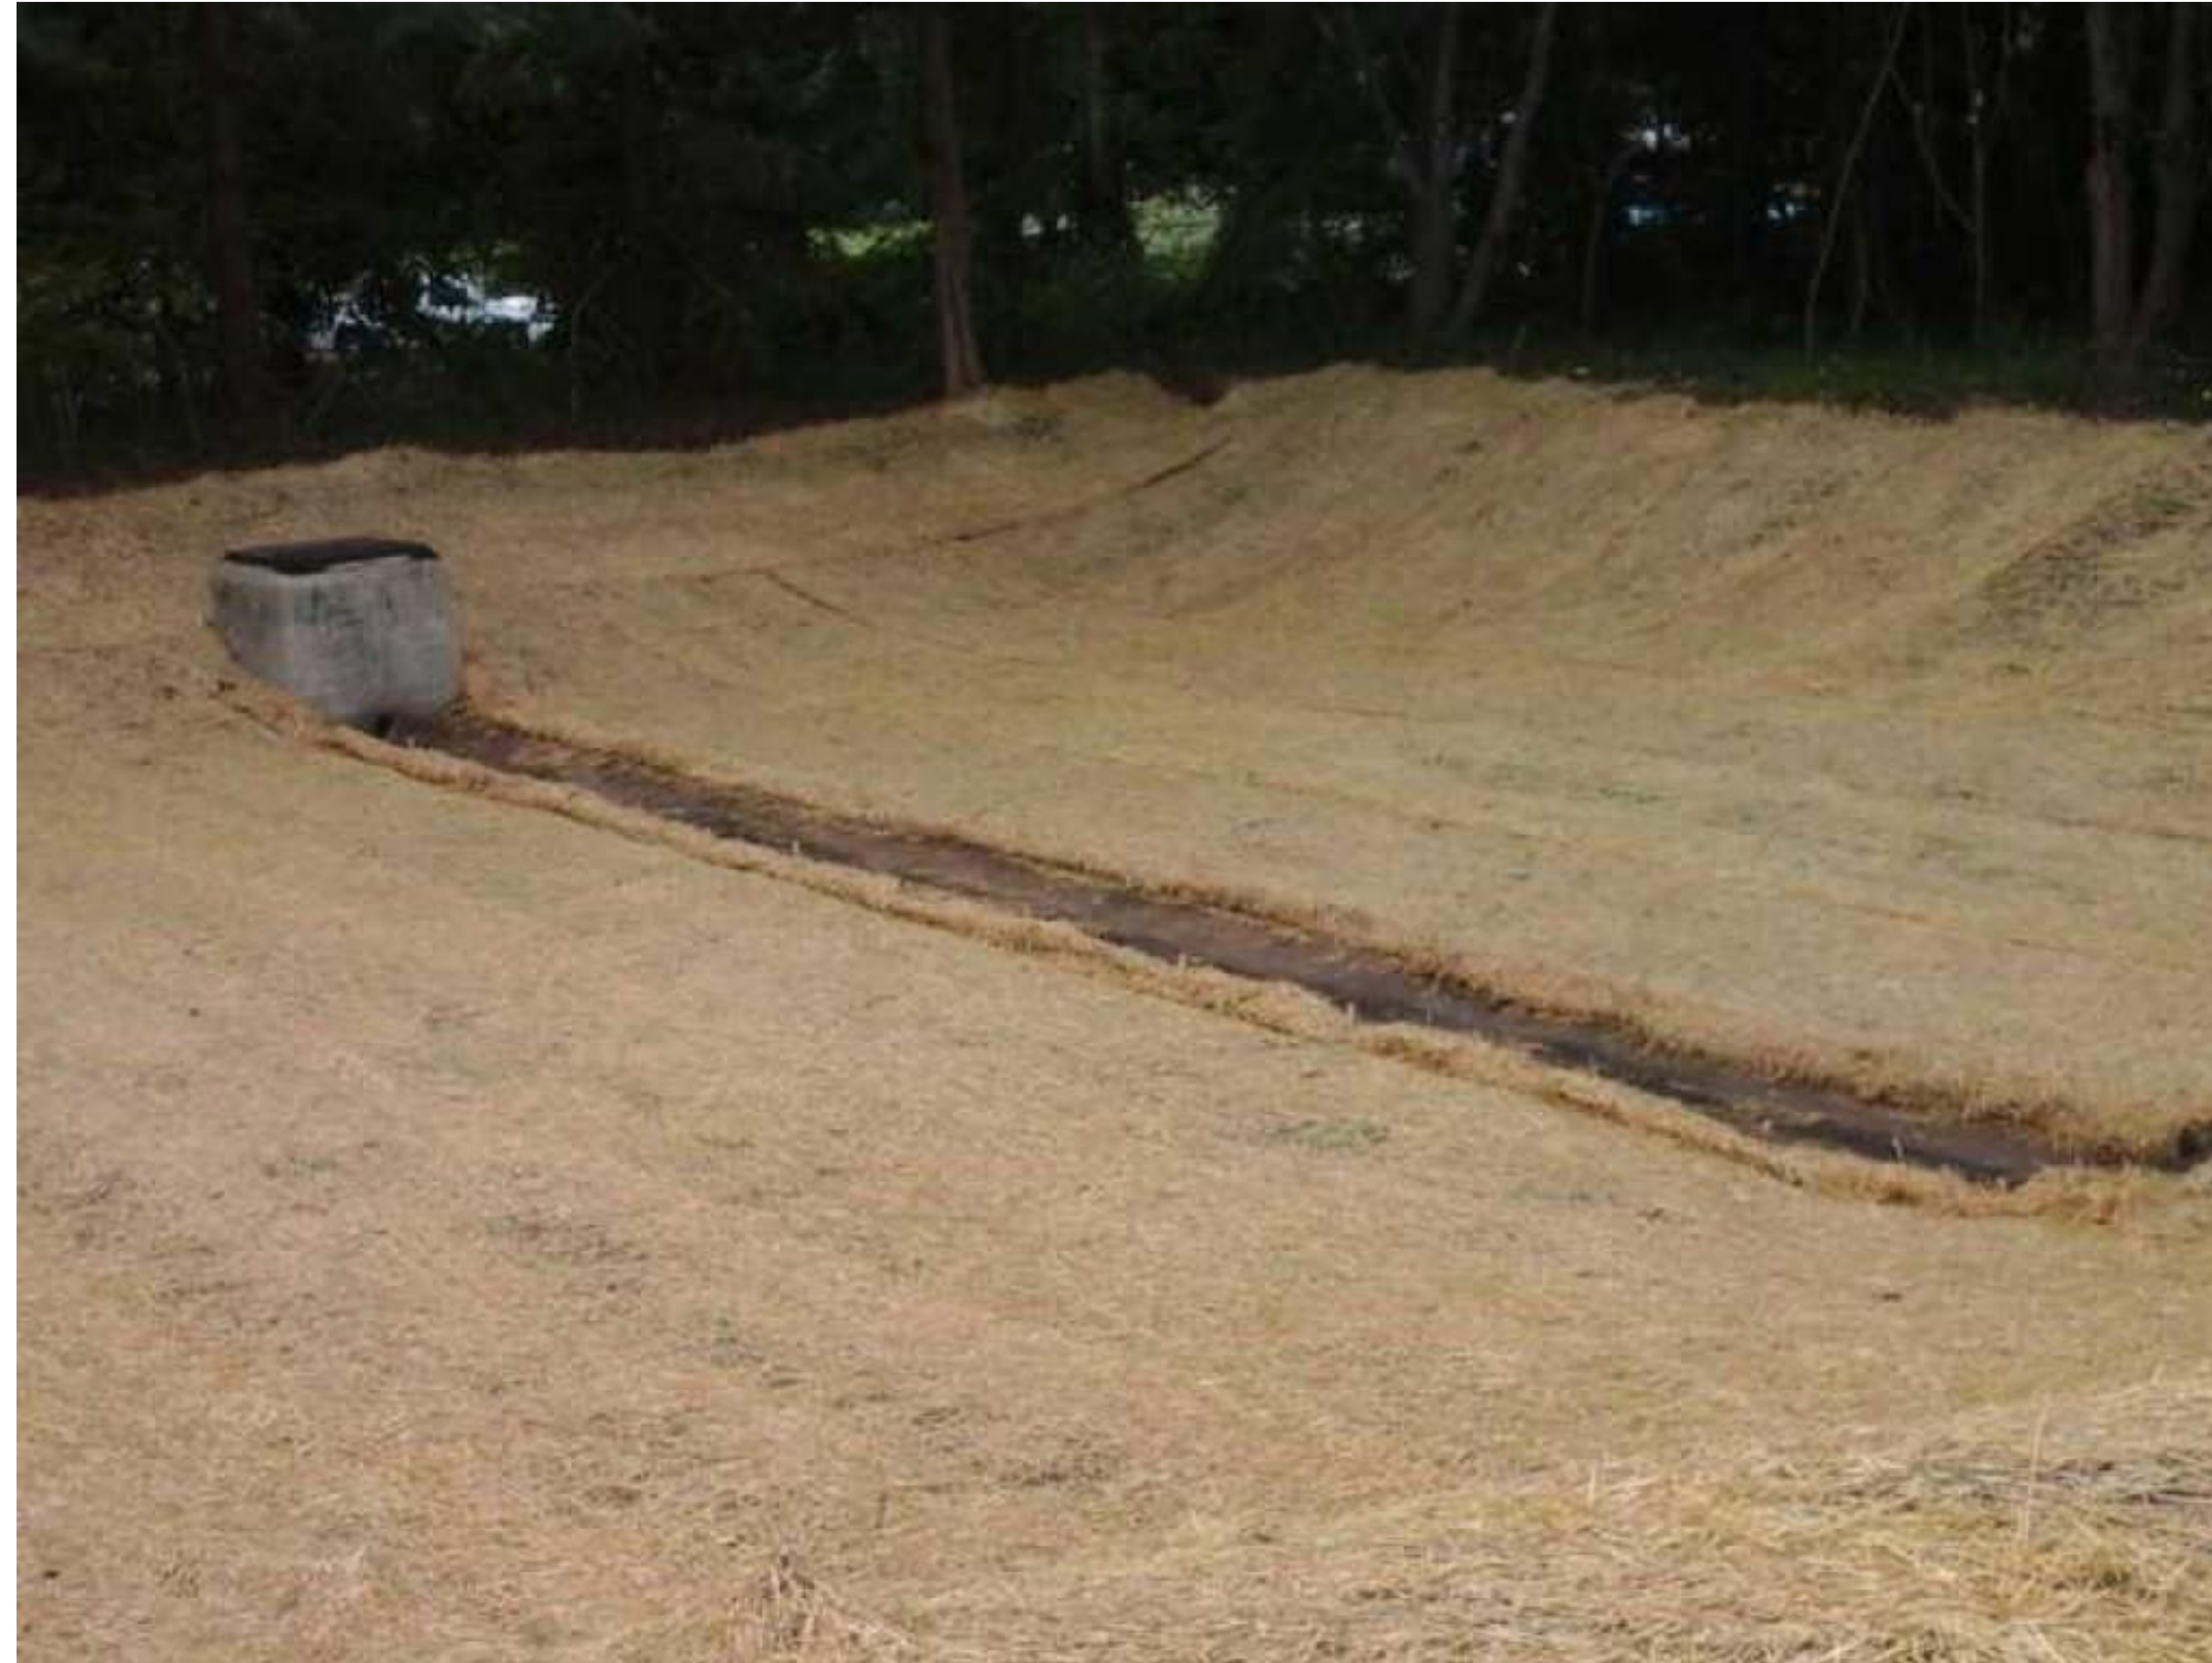
Address:
1702 Kruser Rd
Trenton, NJ 08690

- Area appears to have been recently cleared and cleaned out
- No standing water observed
- Continue to monitor to ensure alterations have resolved issues
- Basin could be naturalized with herbaceous plants

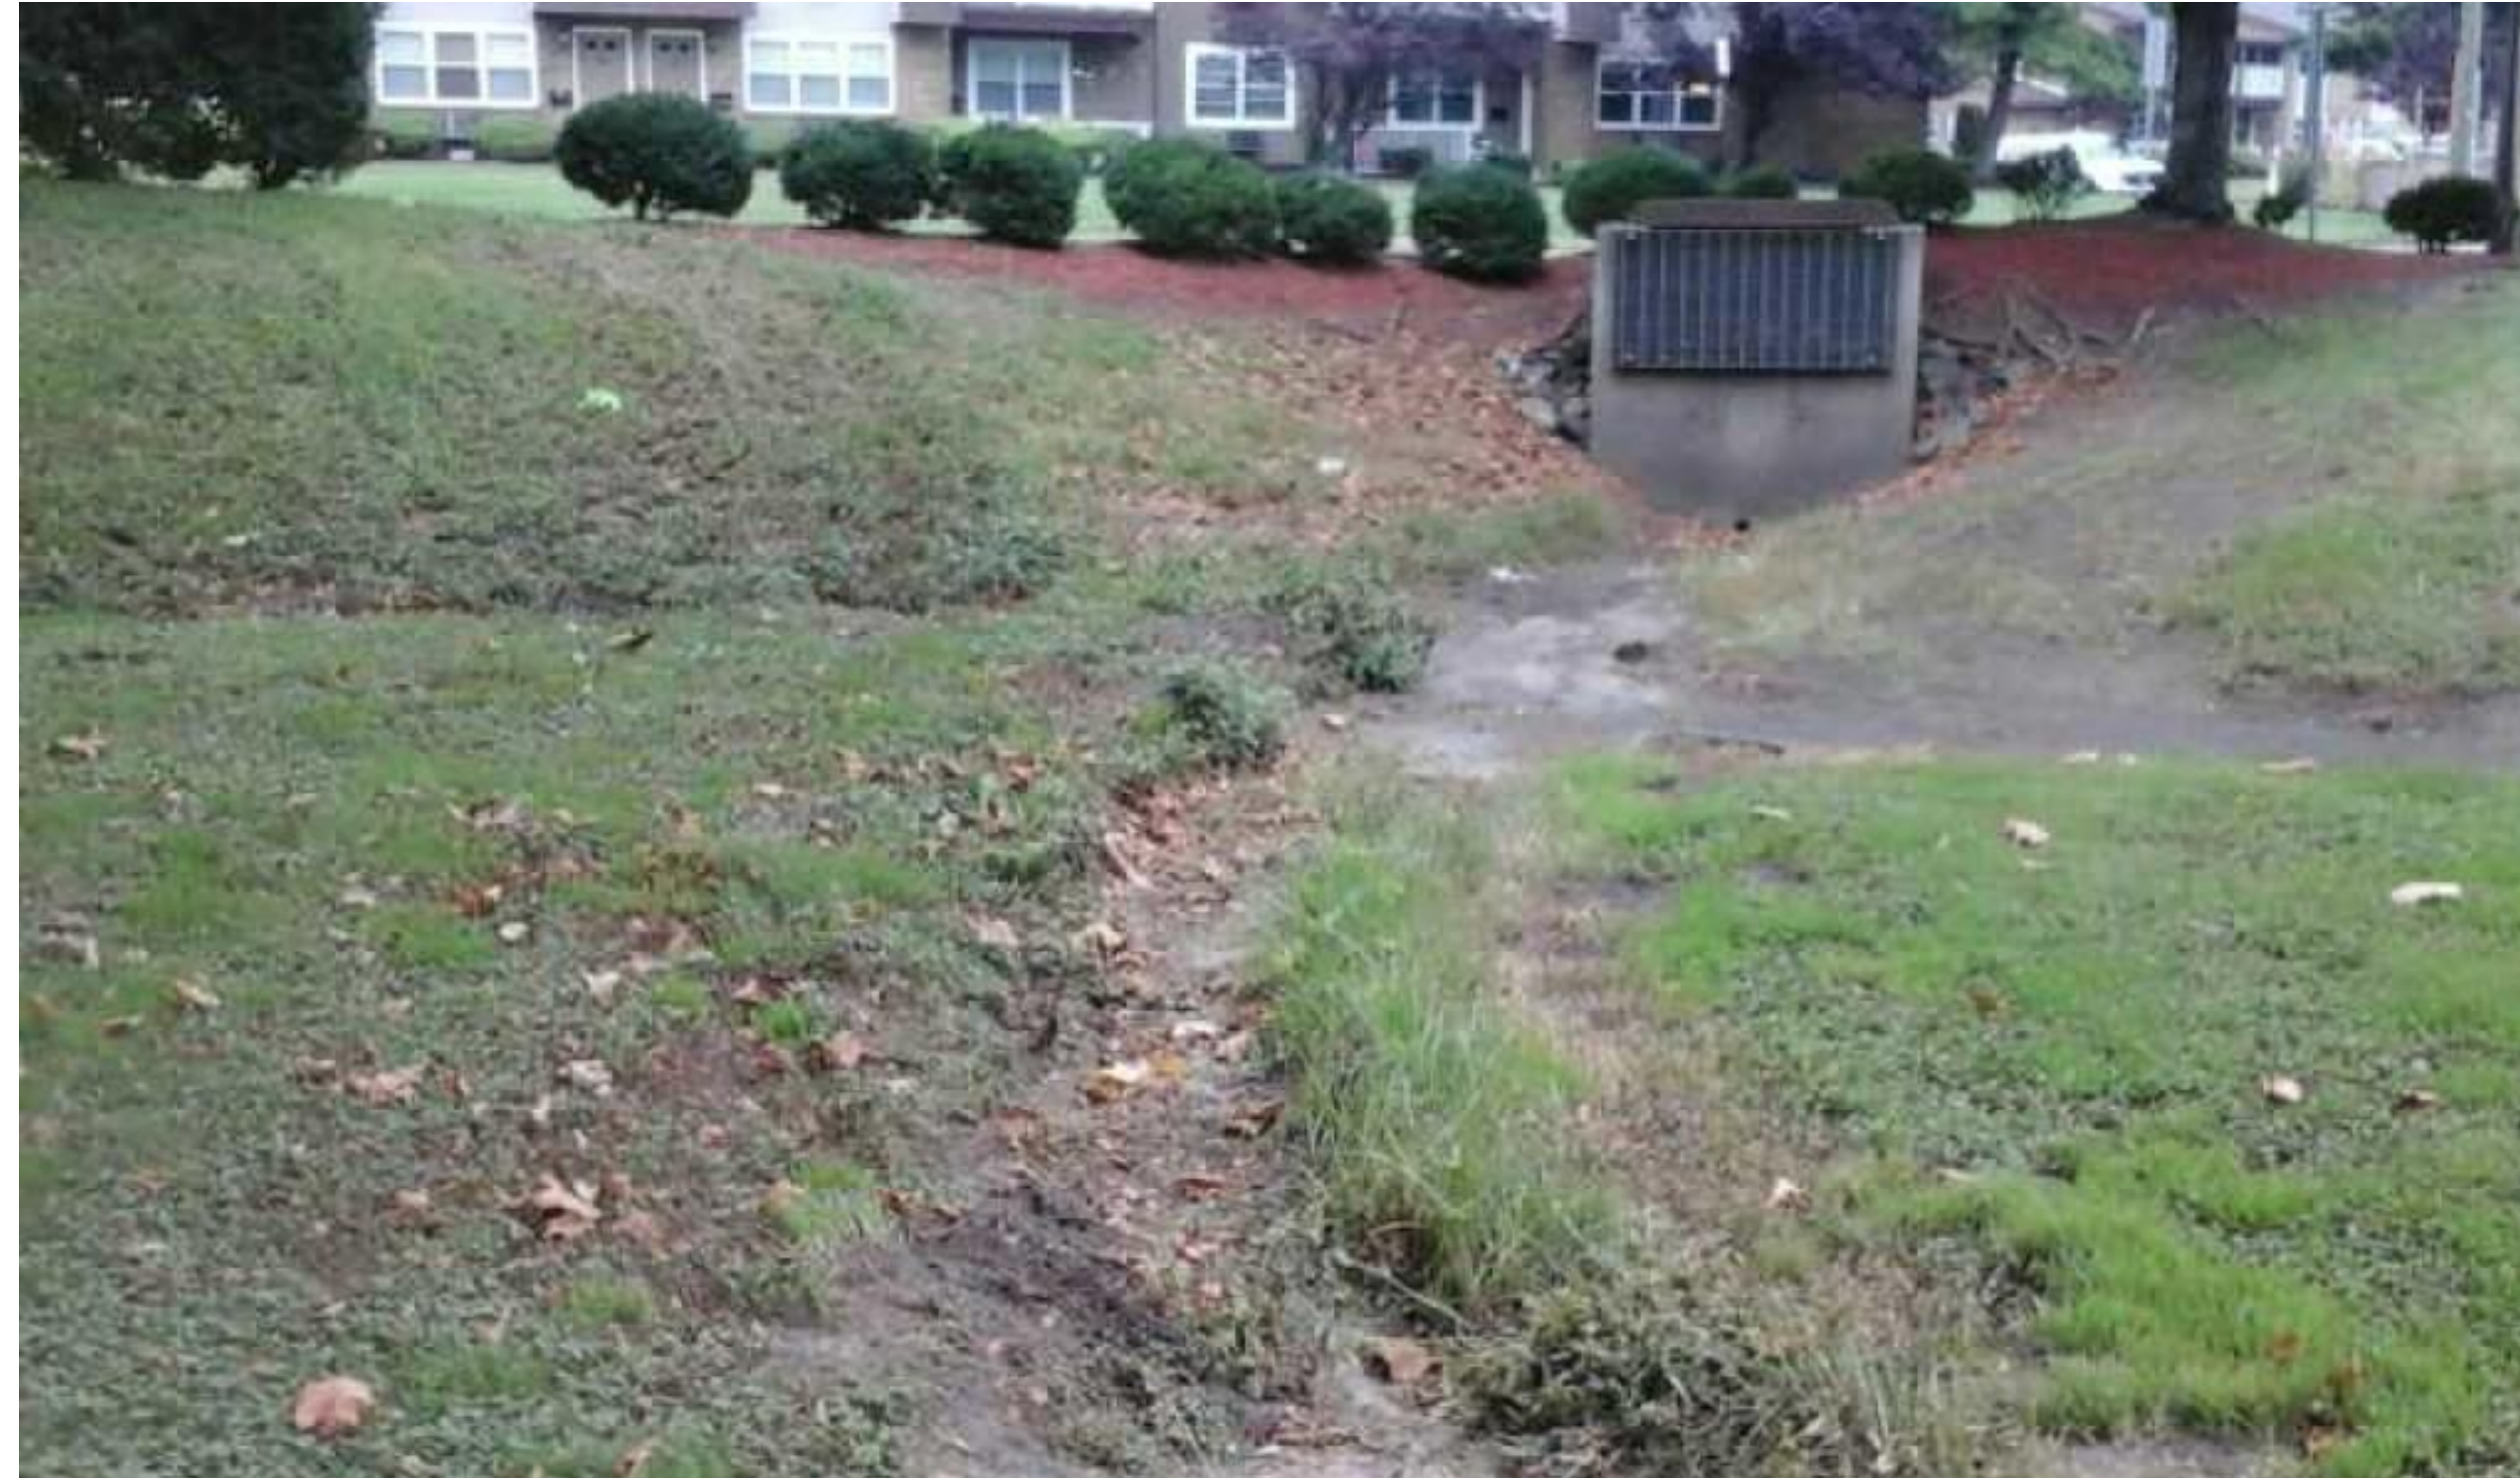
Address:
1763 Kruser Rd
Trenton, NJ 08619

- Low flow channel largely filled with sediment
- Either clear low flow channels or replace with rock channel

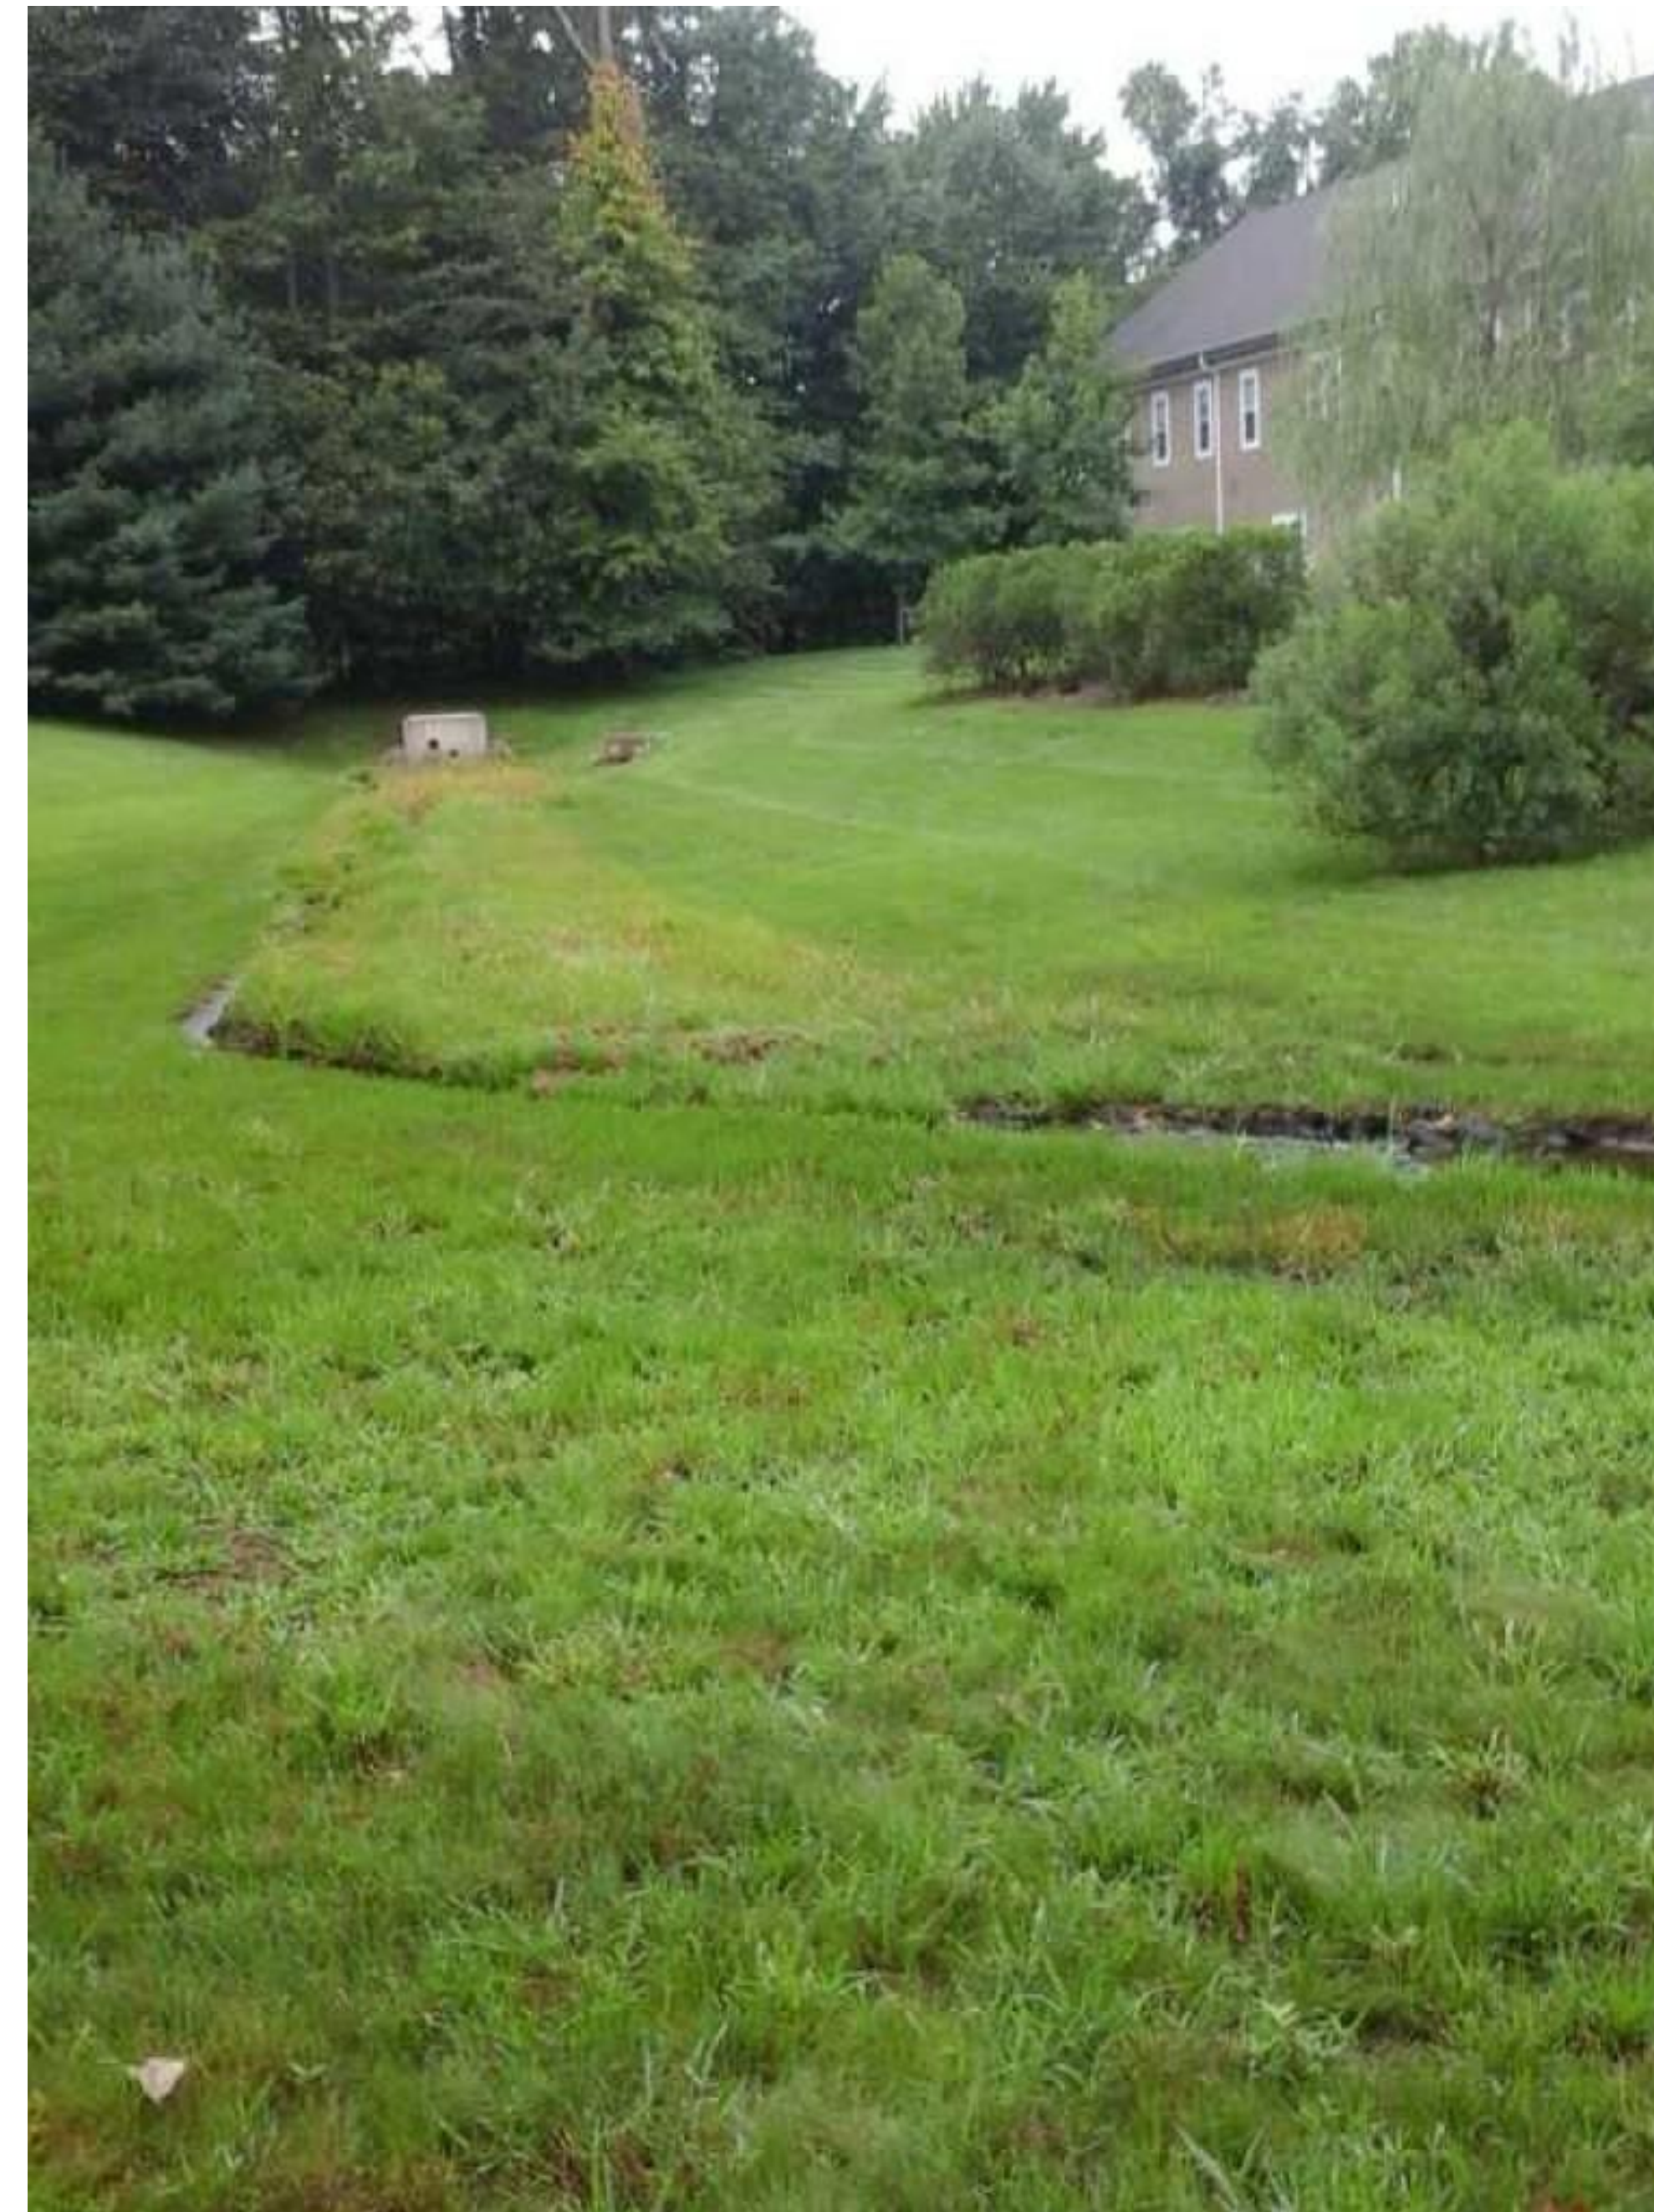
Address:
1580 Whitehorse Hamilton Square Rd
Trenton, NJ 08690

- Severe standing water problem observed in previous assessment not observed
- Low flow channel has significant sediment build up and vegetation leading to standing water in the channel
- Opportunity to remove replace channel with stone to allow more infiltration in small storm events

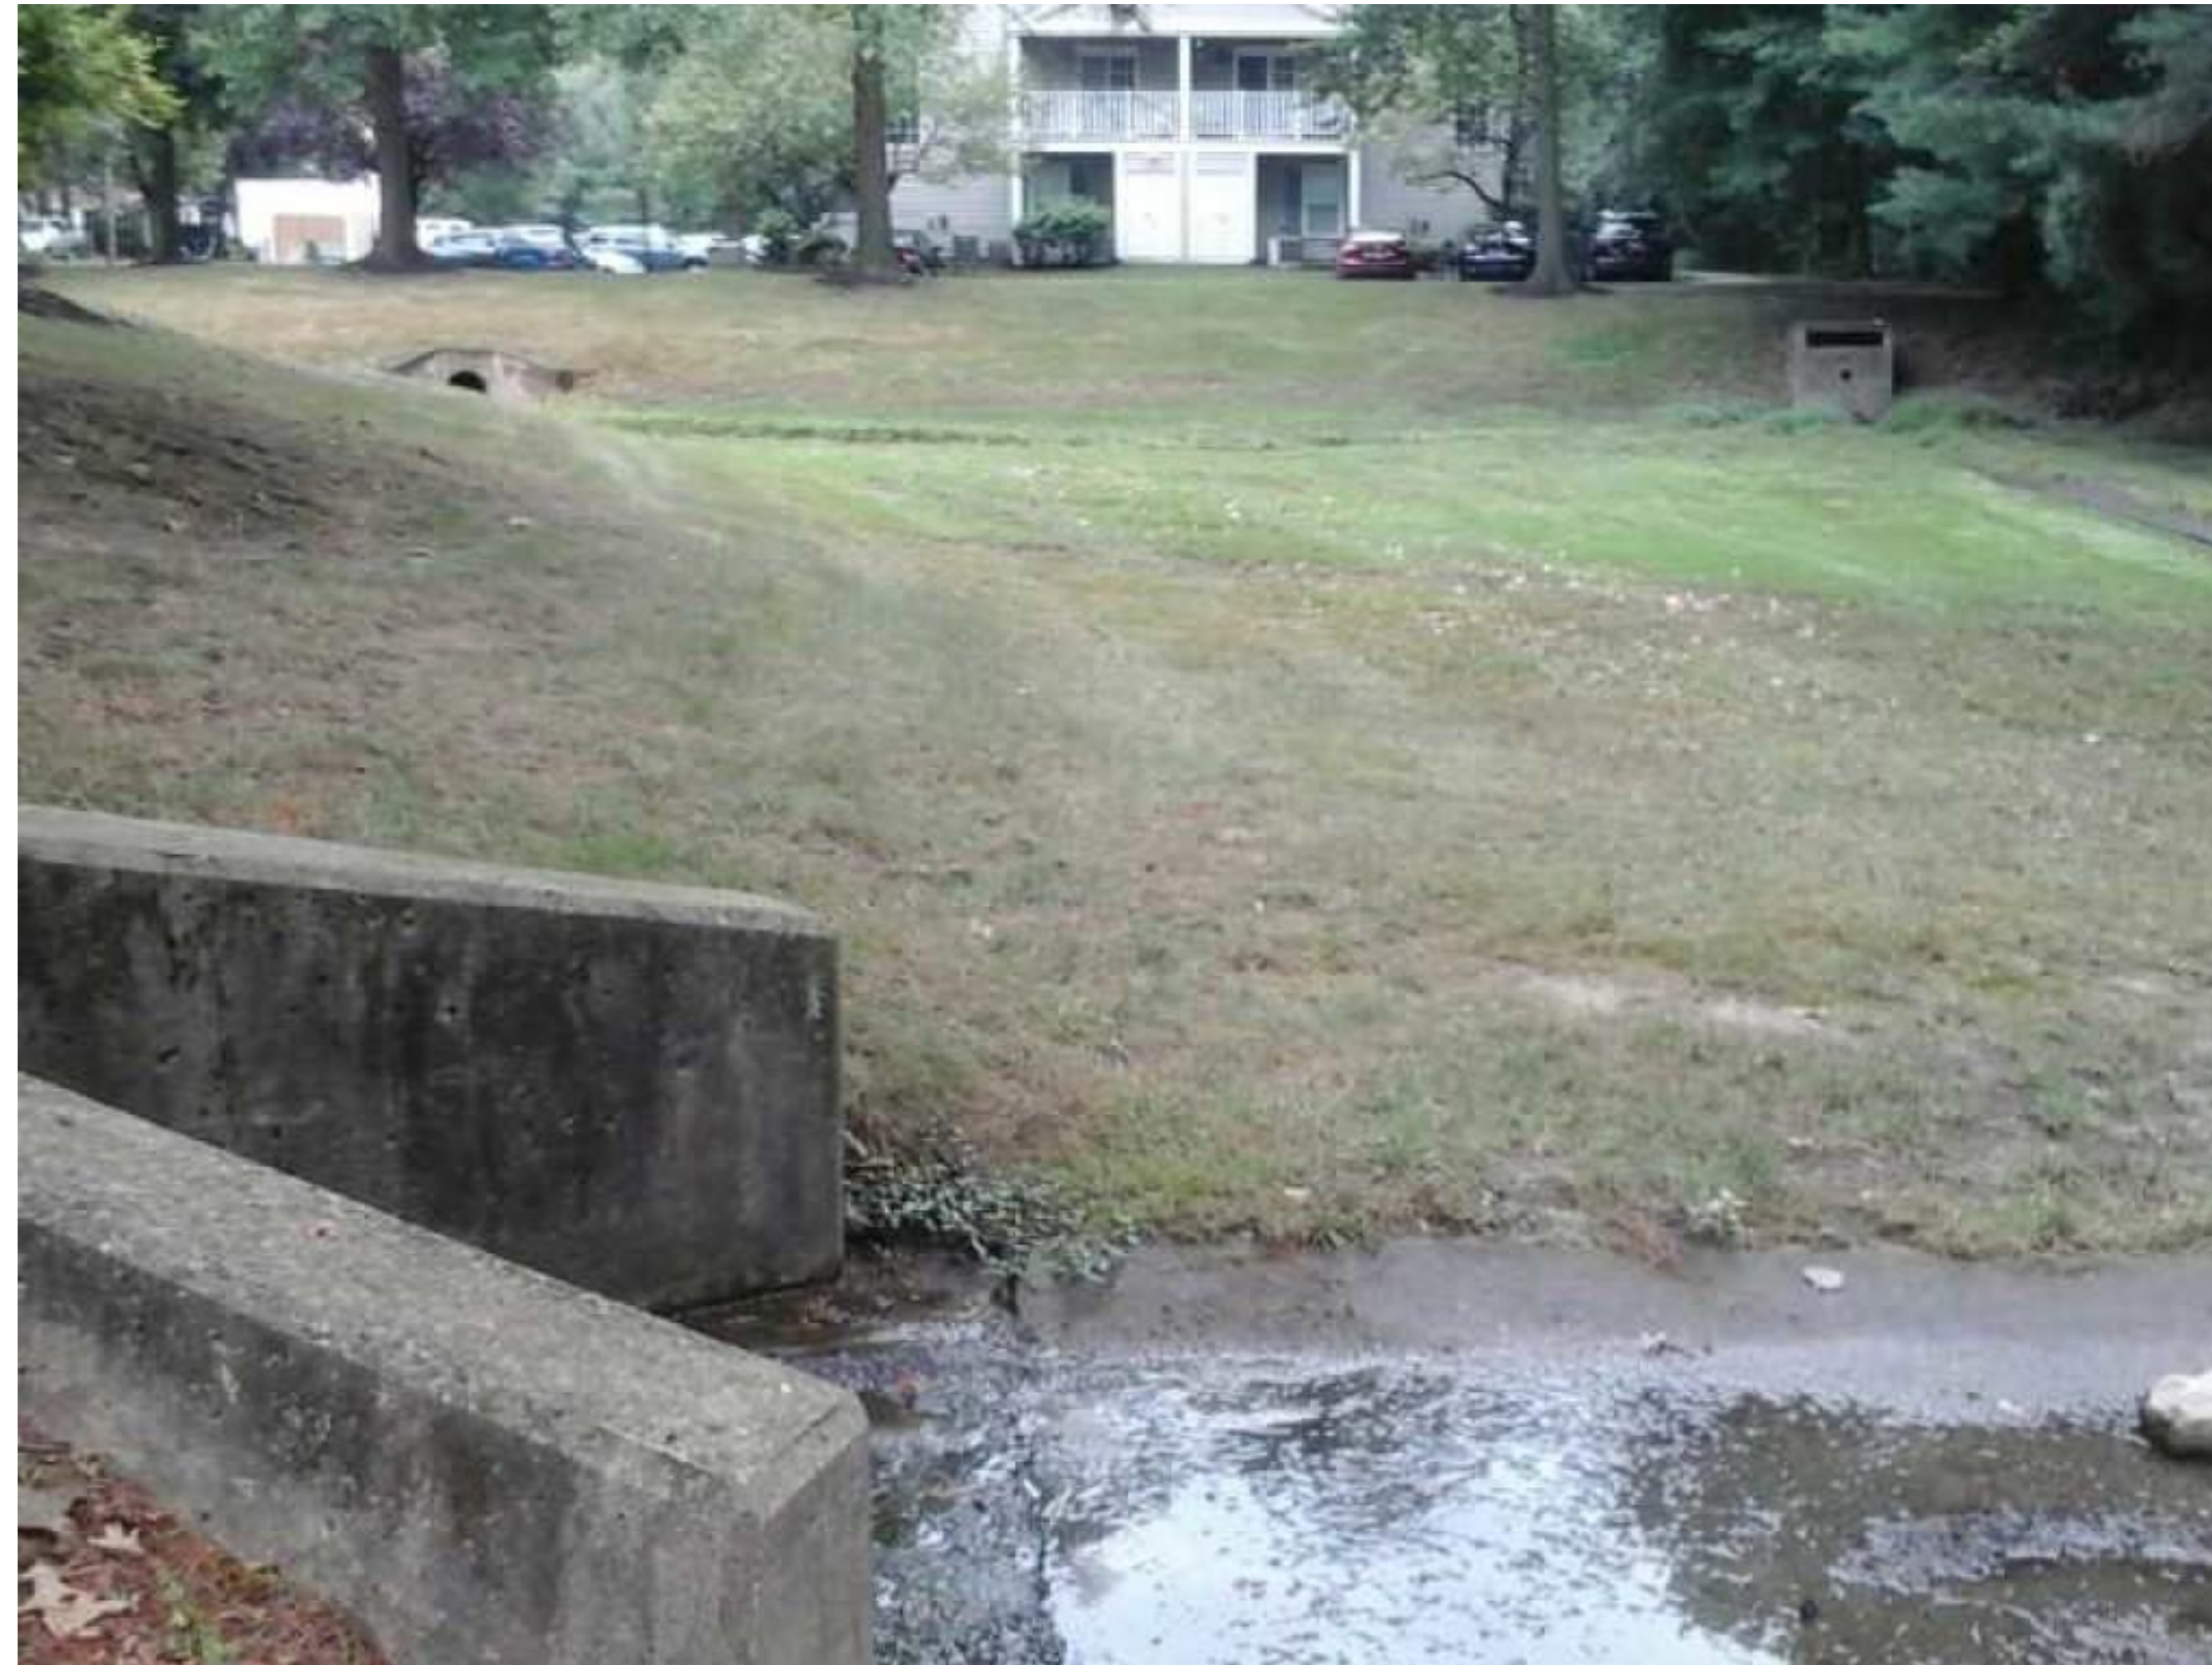
Address:
Cheverny Ct
Trenton, NJ 08690

- Significant standing water in low flow channel likely caused by blockages in the low flow orifice at the outlet
- Clear outlet structure and replace low flow with stone channel to allow infiltration
