**Hamilton Township (Mercer County)
Stormwater Basin Assessment Summary
Past Priority Addendum (Year 5B)**

Developed by the Rutgers Cooperative Extension Water Resources Program
Funded by Hamilton Township, Mercer County, New Jersey

November 27, 2019

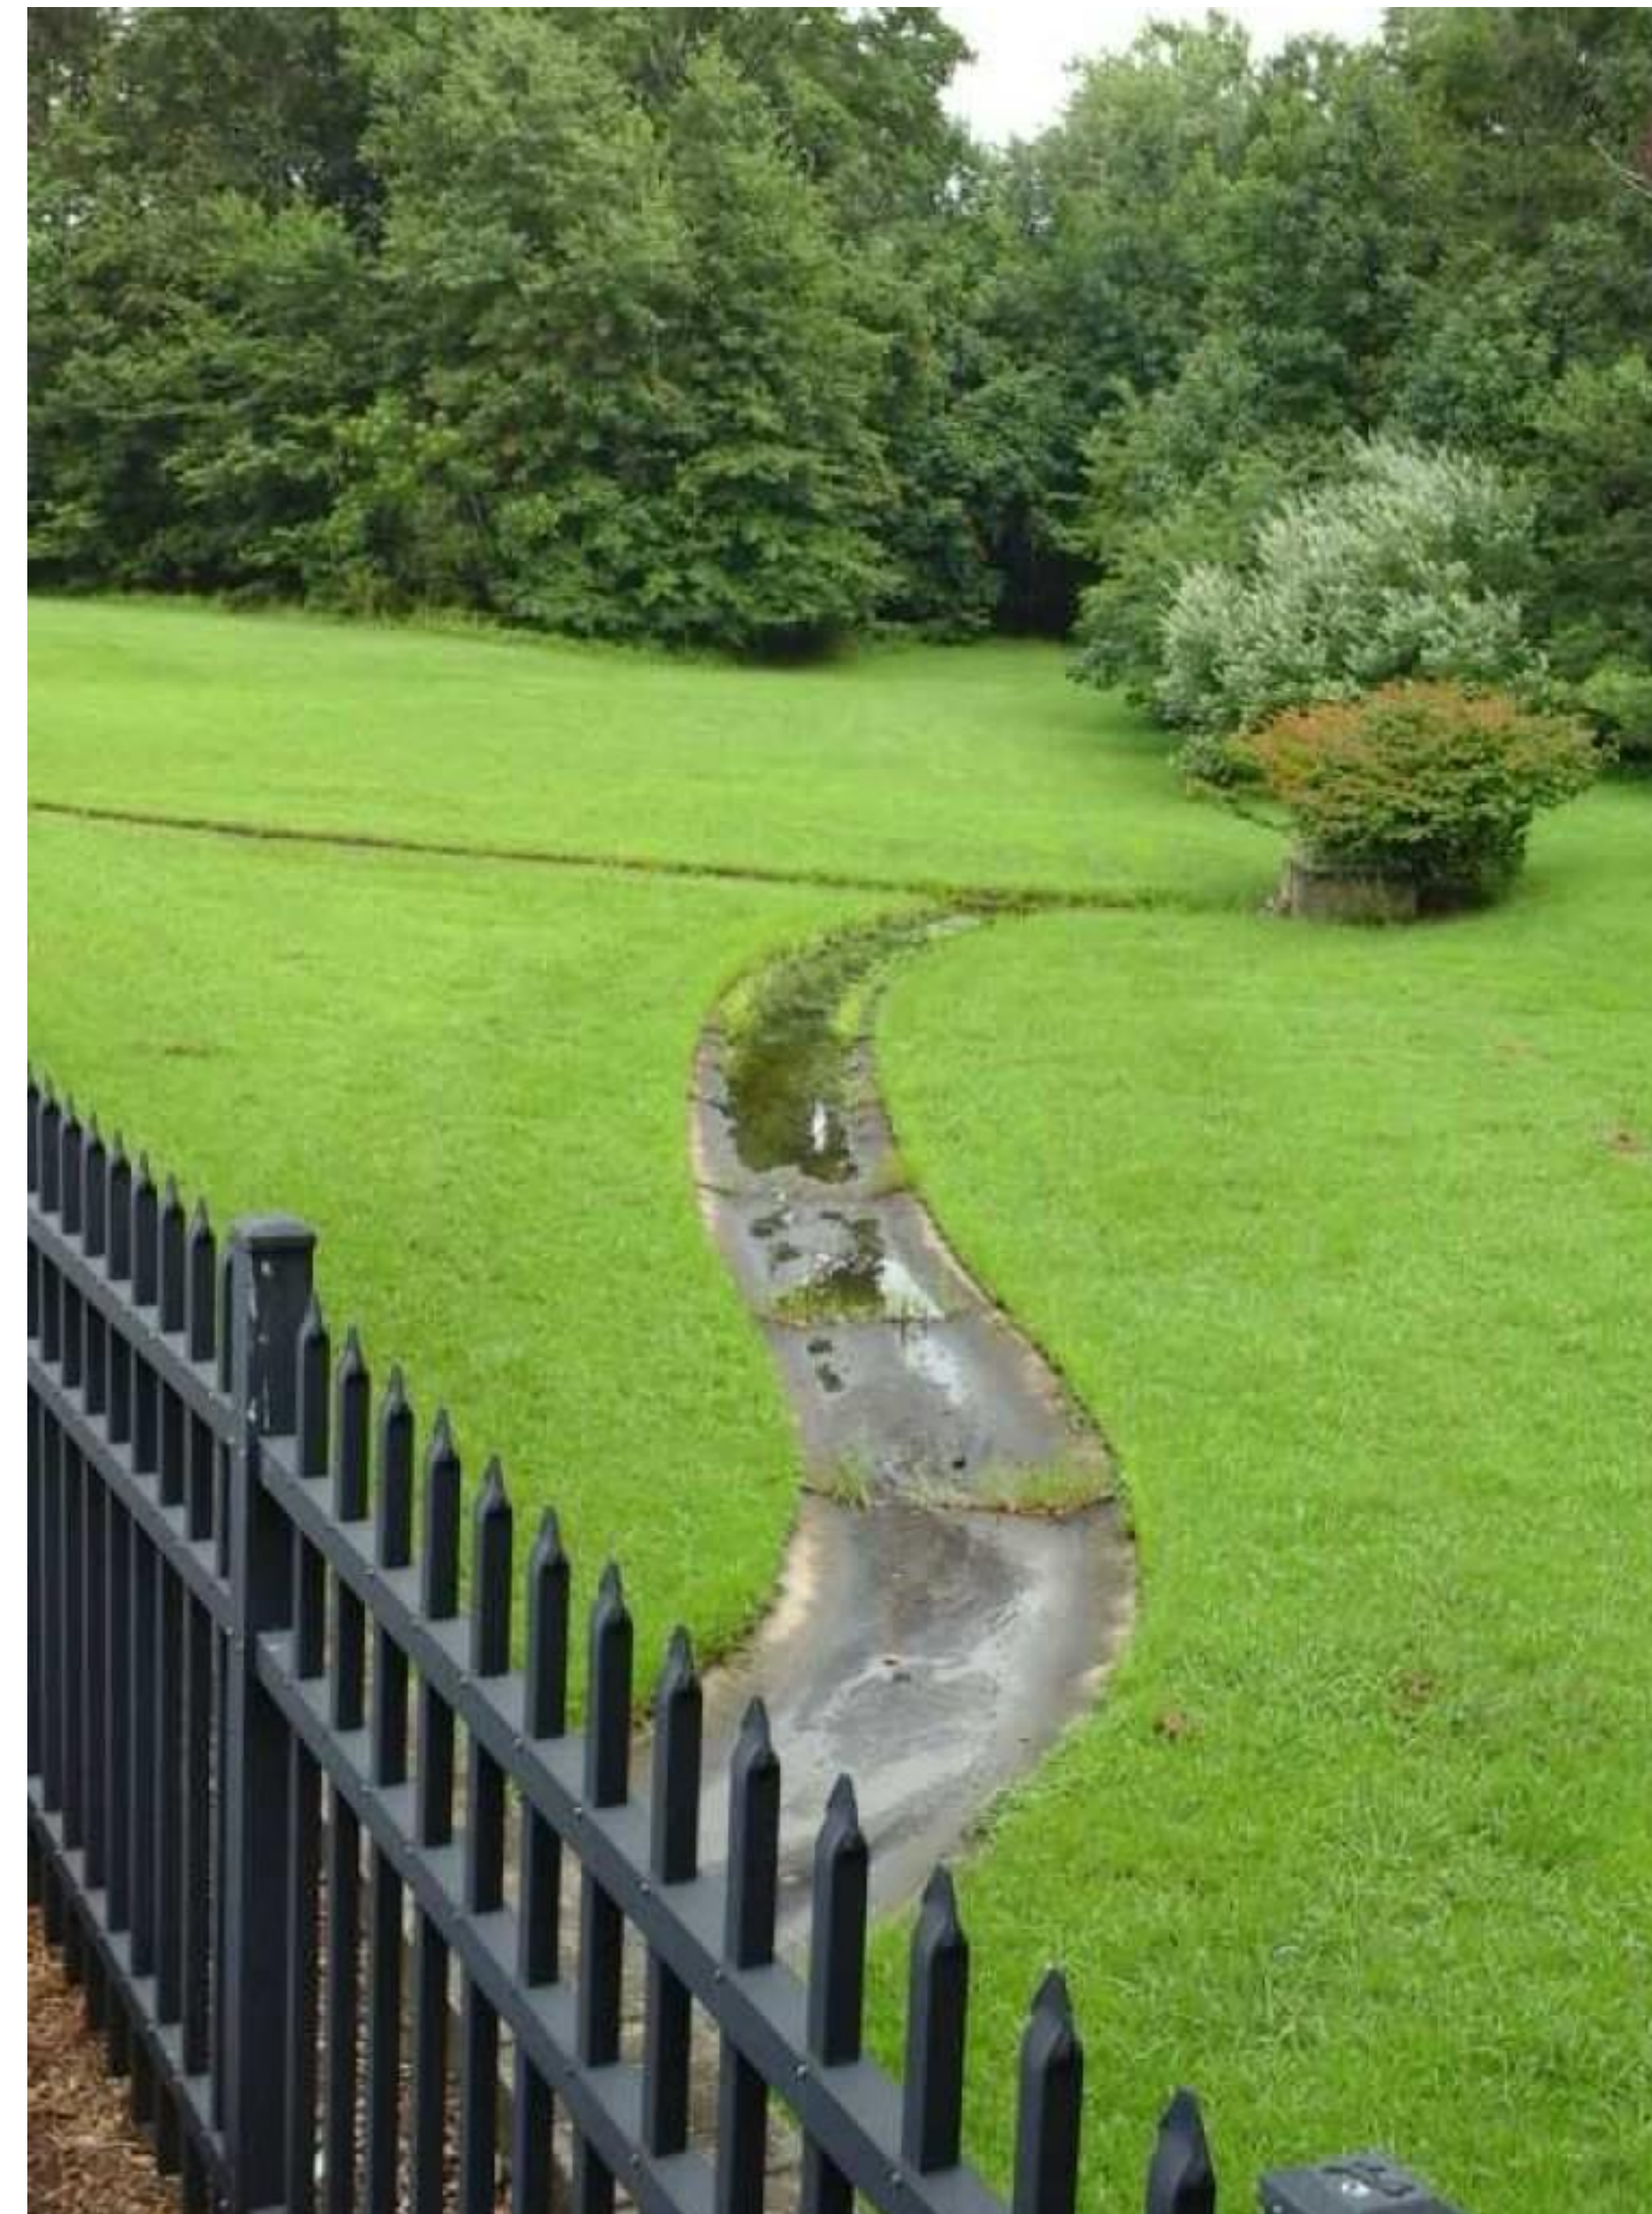
Address:
63 Hamilton Health Pl
Trenton, NJ 08690

- Conditions appears somewhat improved from the conditions in 2013
- Sediment needs to be removed from the low channel as it is restricting flow
- Opportunity to replace low flow channel with rock channel

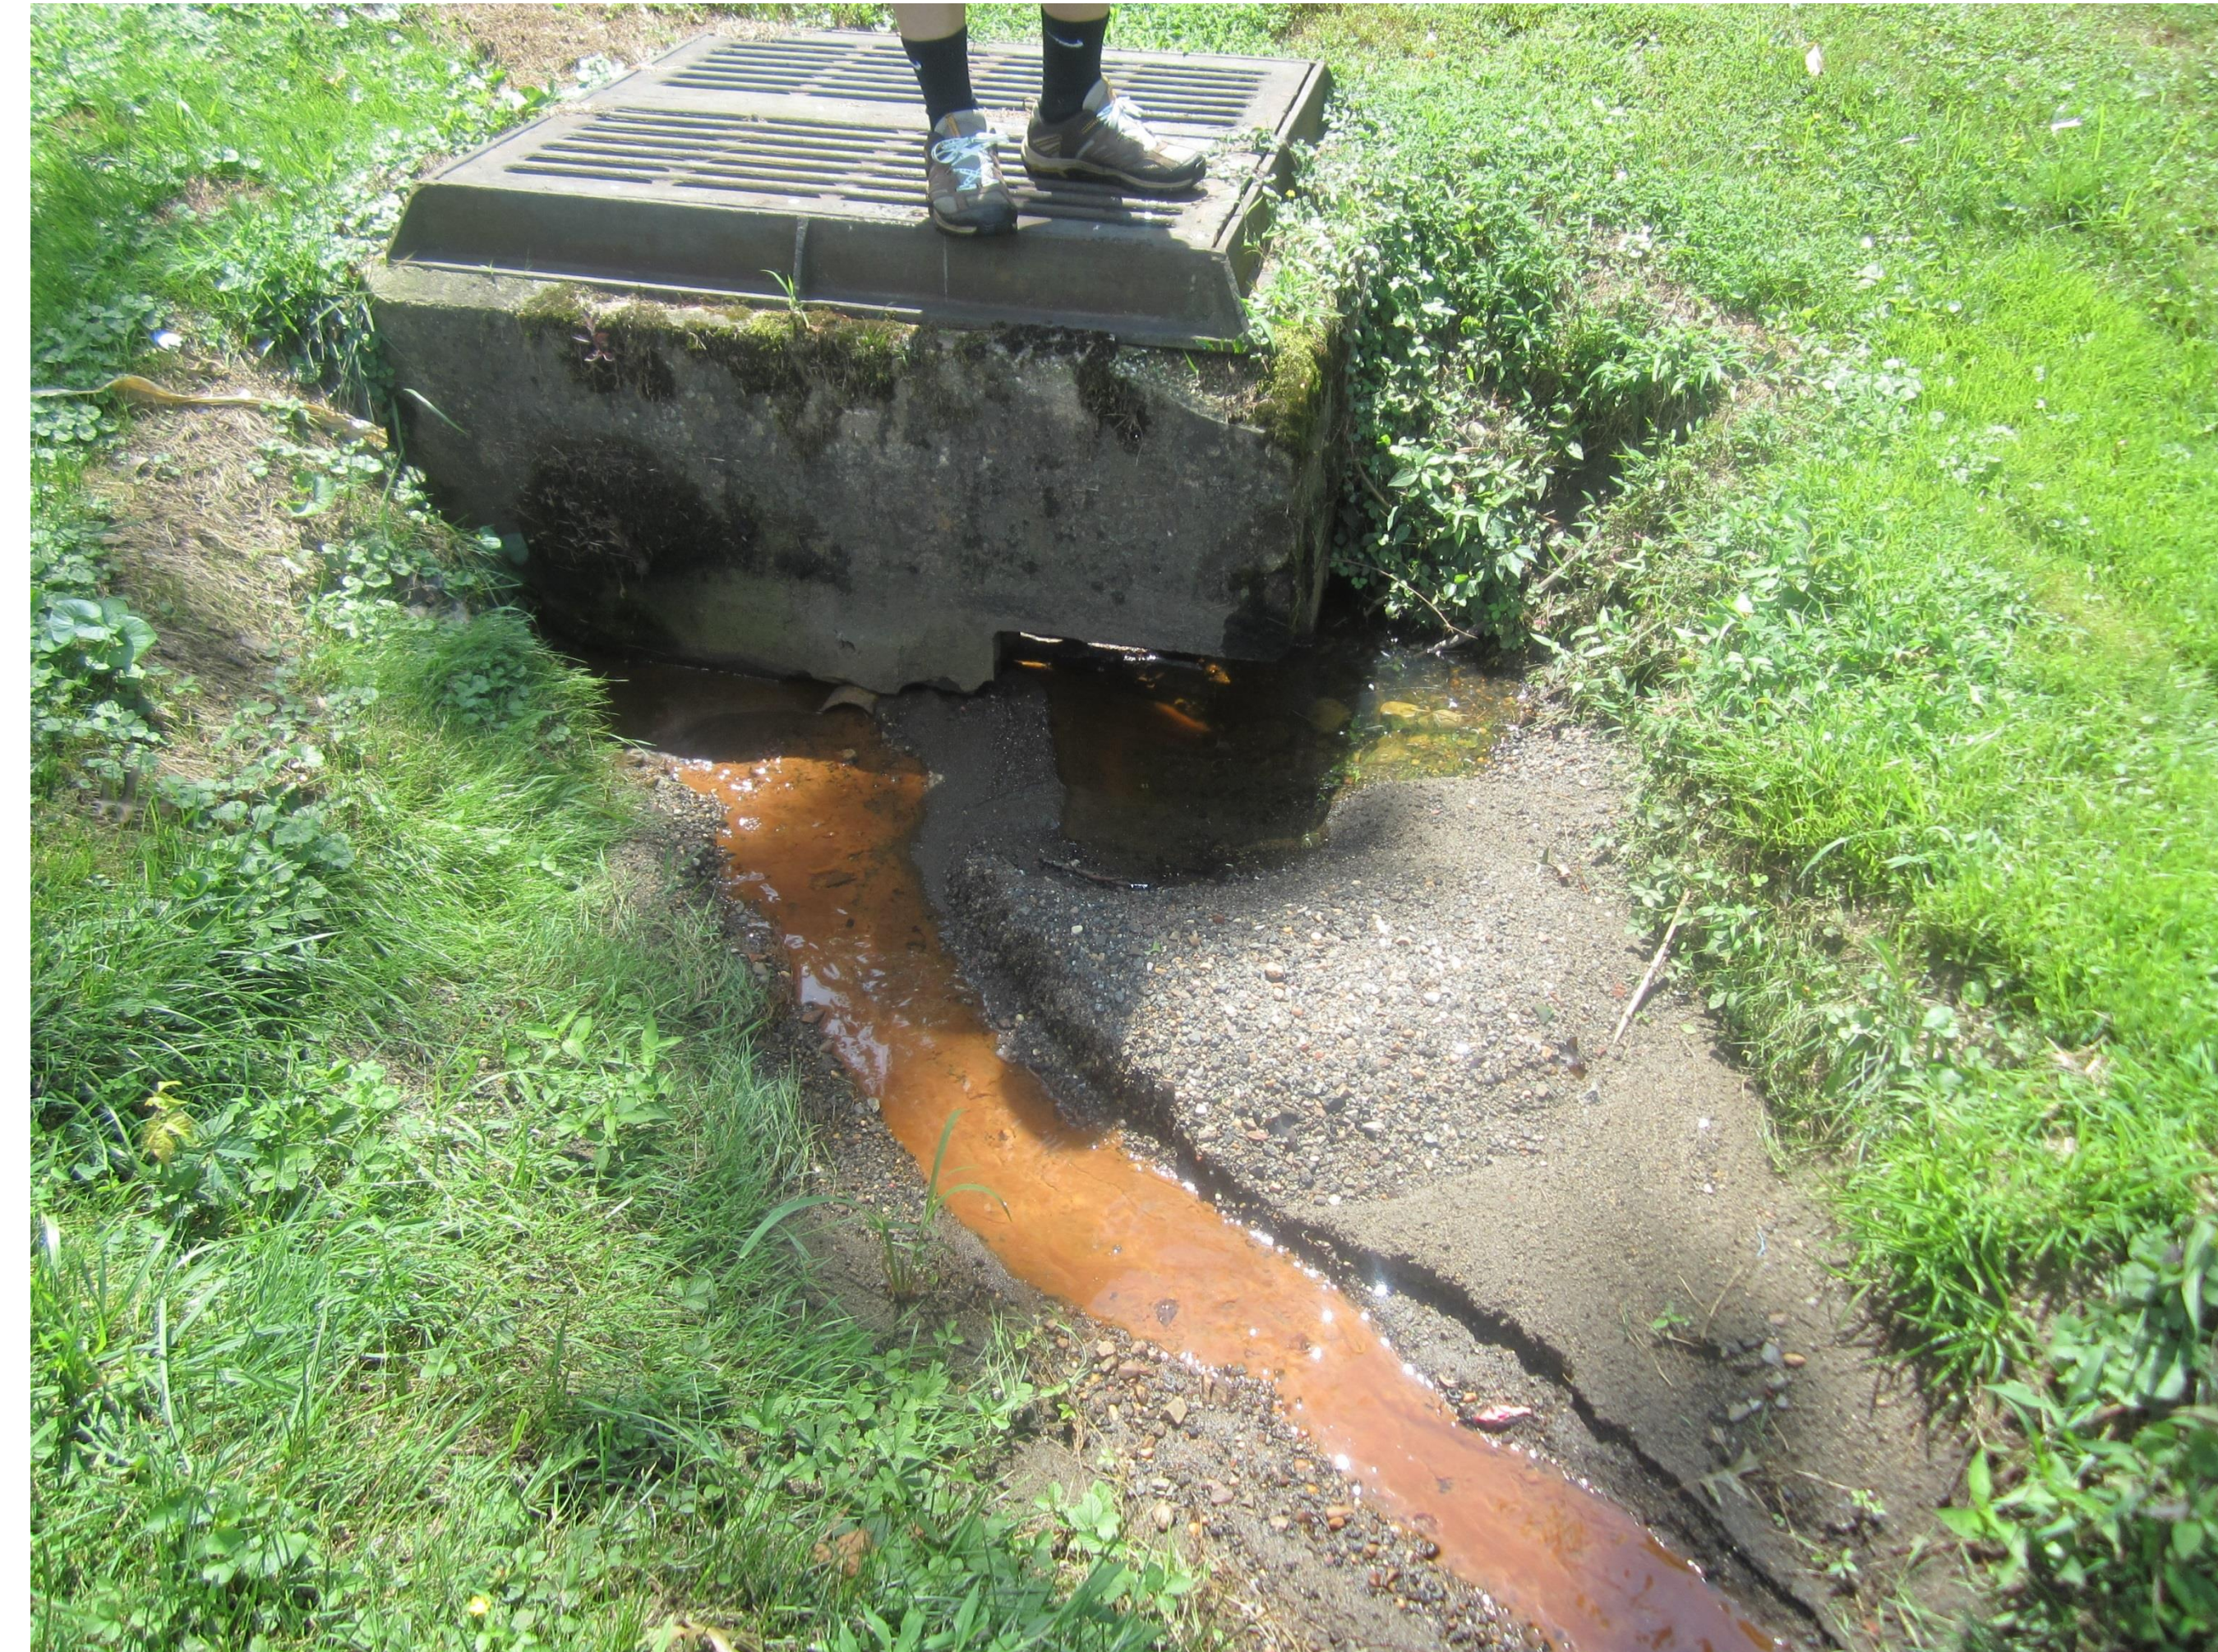
Erosion in basin bottom

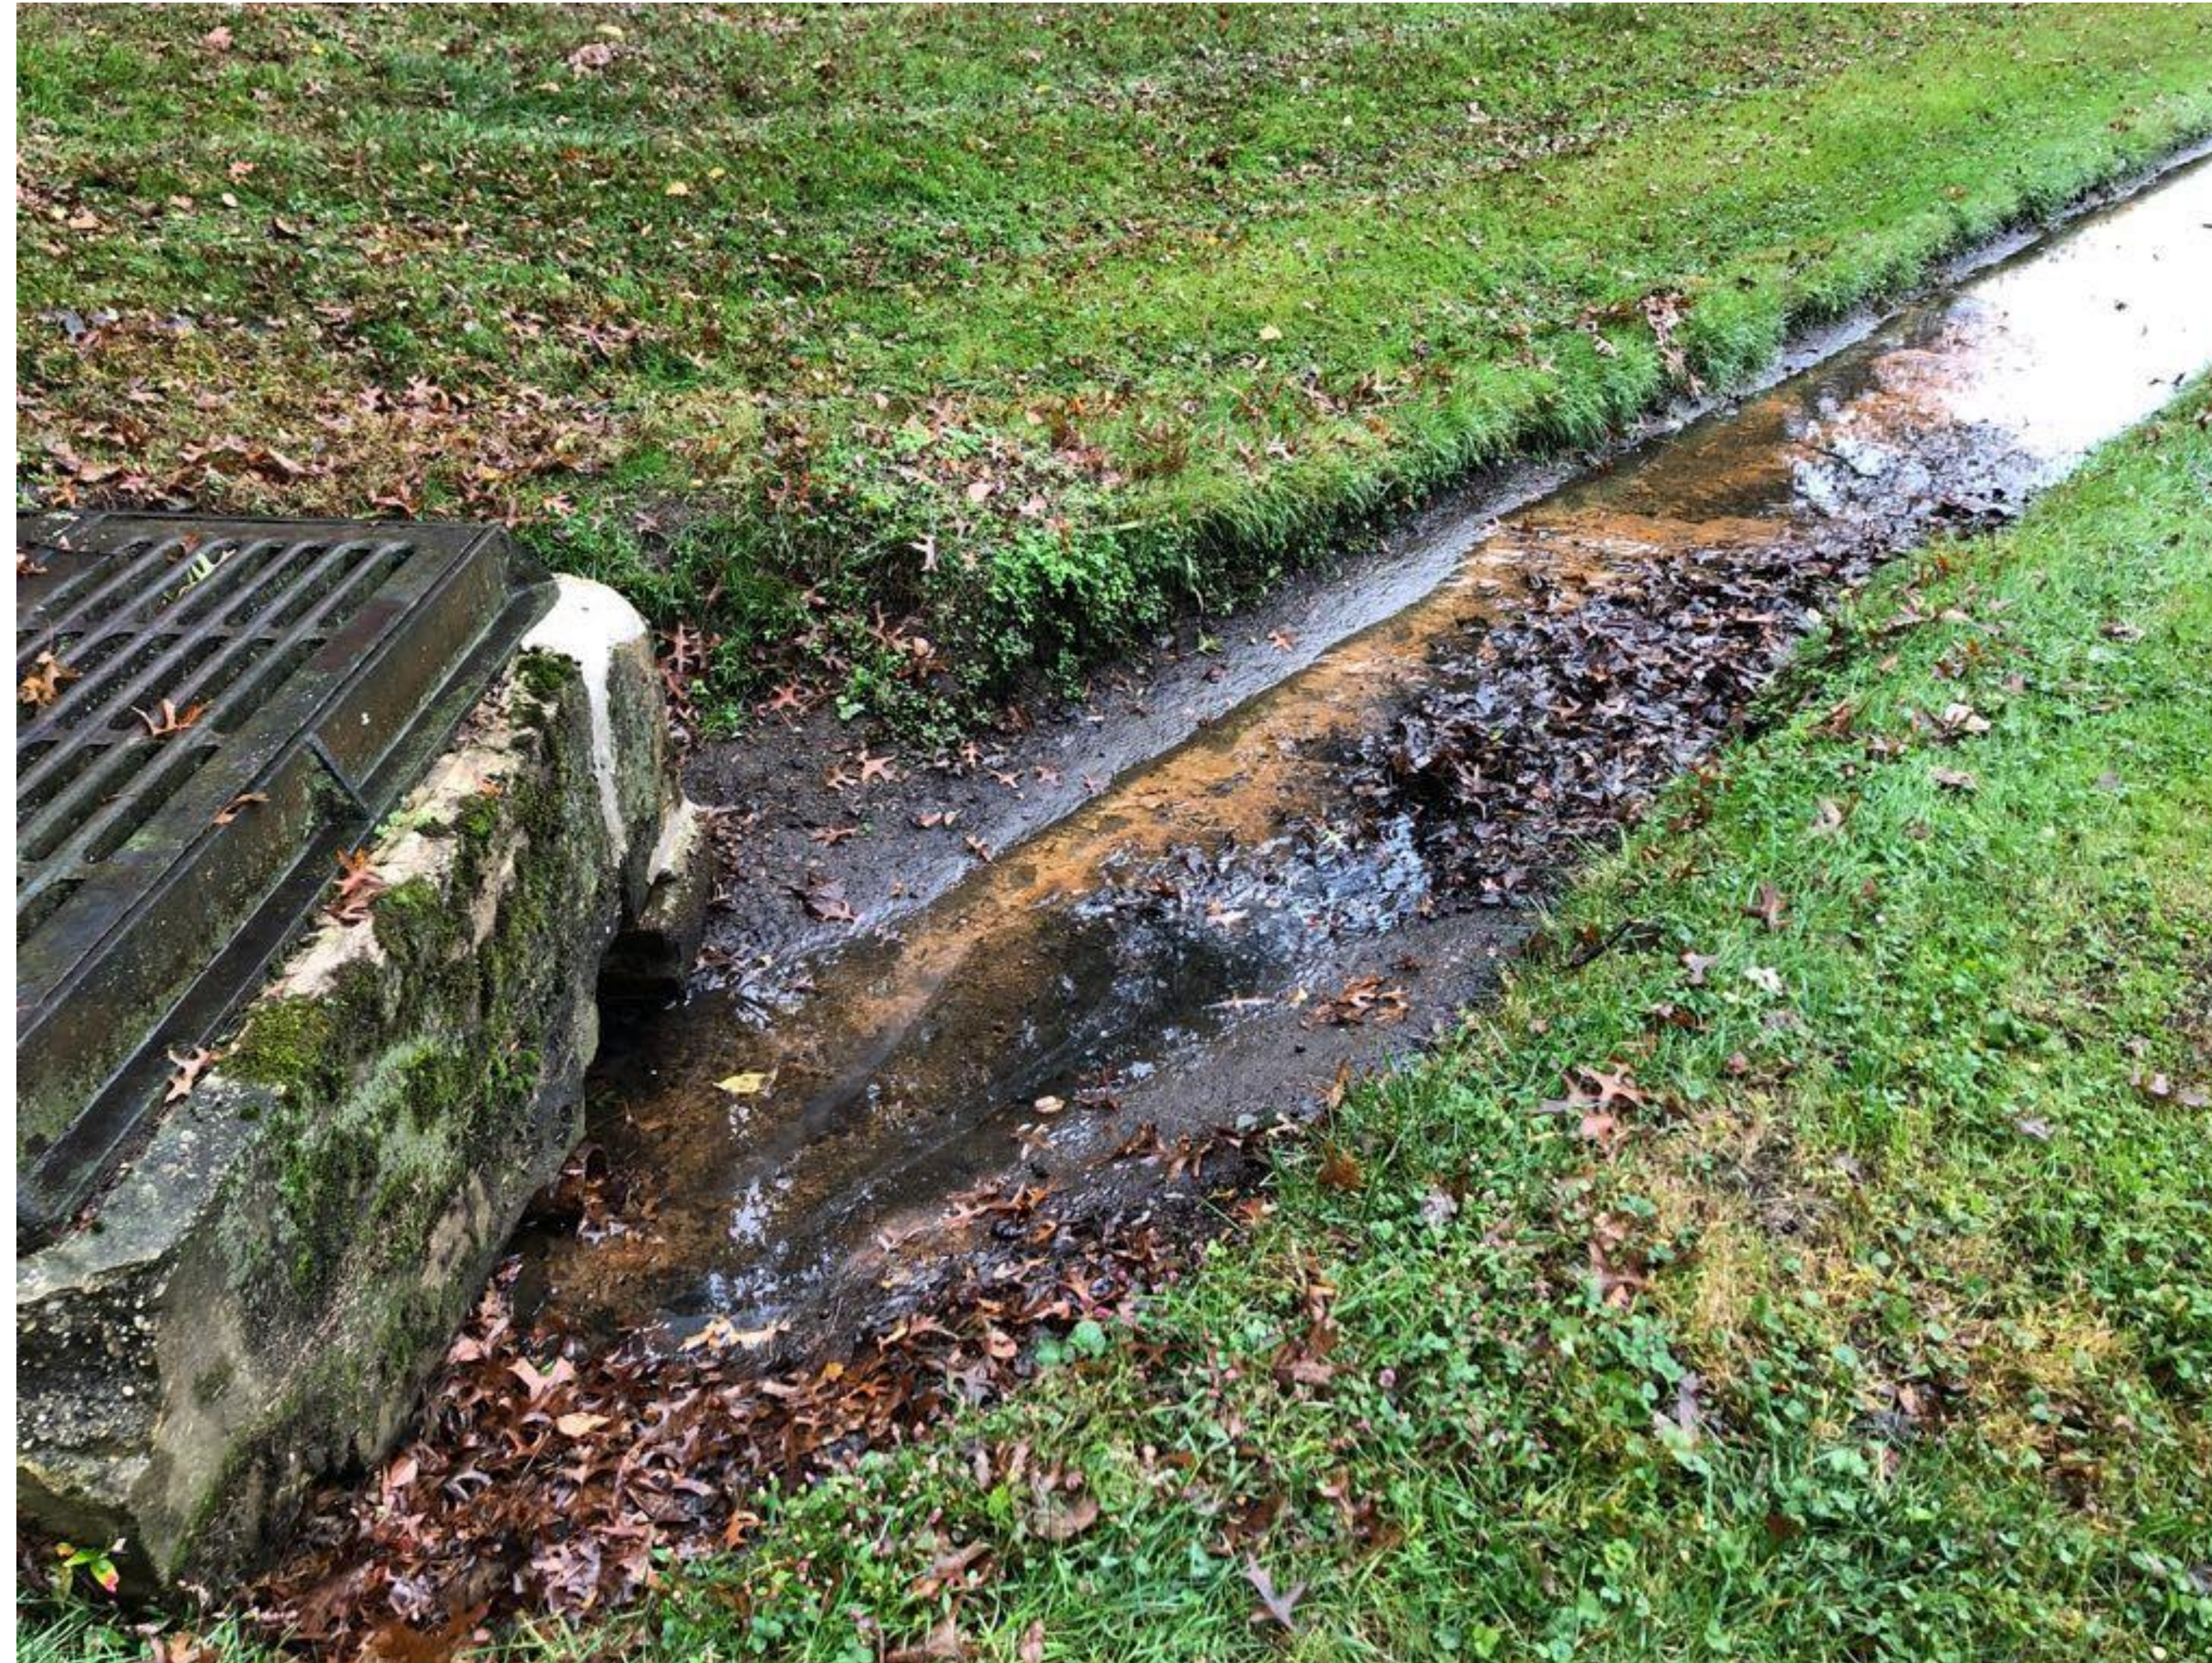
Address:
Limewood Dr and RT-33
Trenton, NJ 08690

- Outlet concrete structure is in need of replacement, there is some sheen on surface of water and brown sediment on bottom present in concrete flow channel.
- Opportunity to also replace low flow channel with stone to allow more infiltration

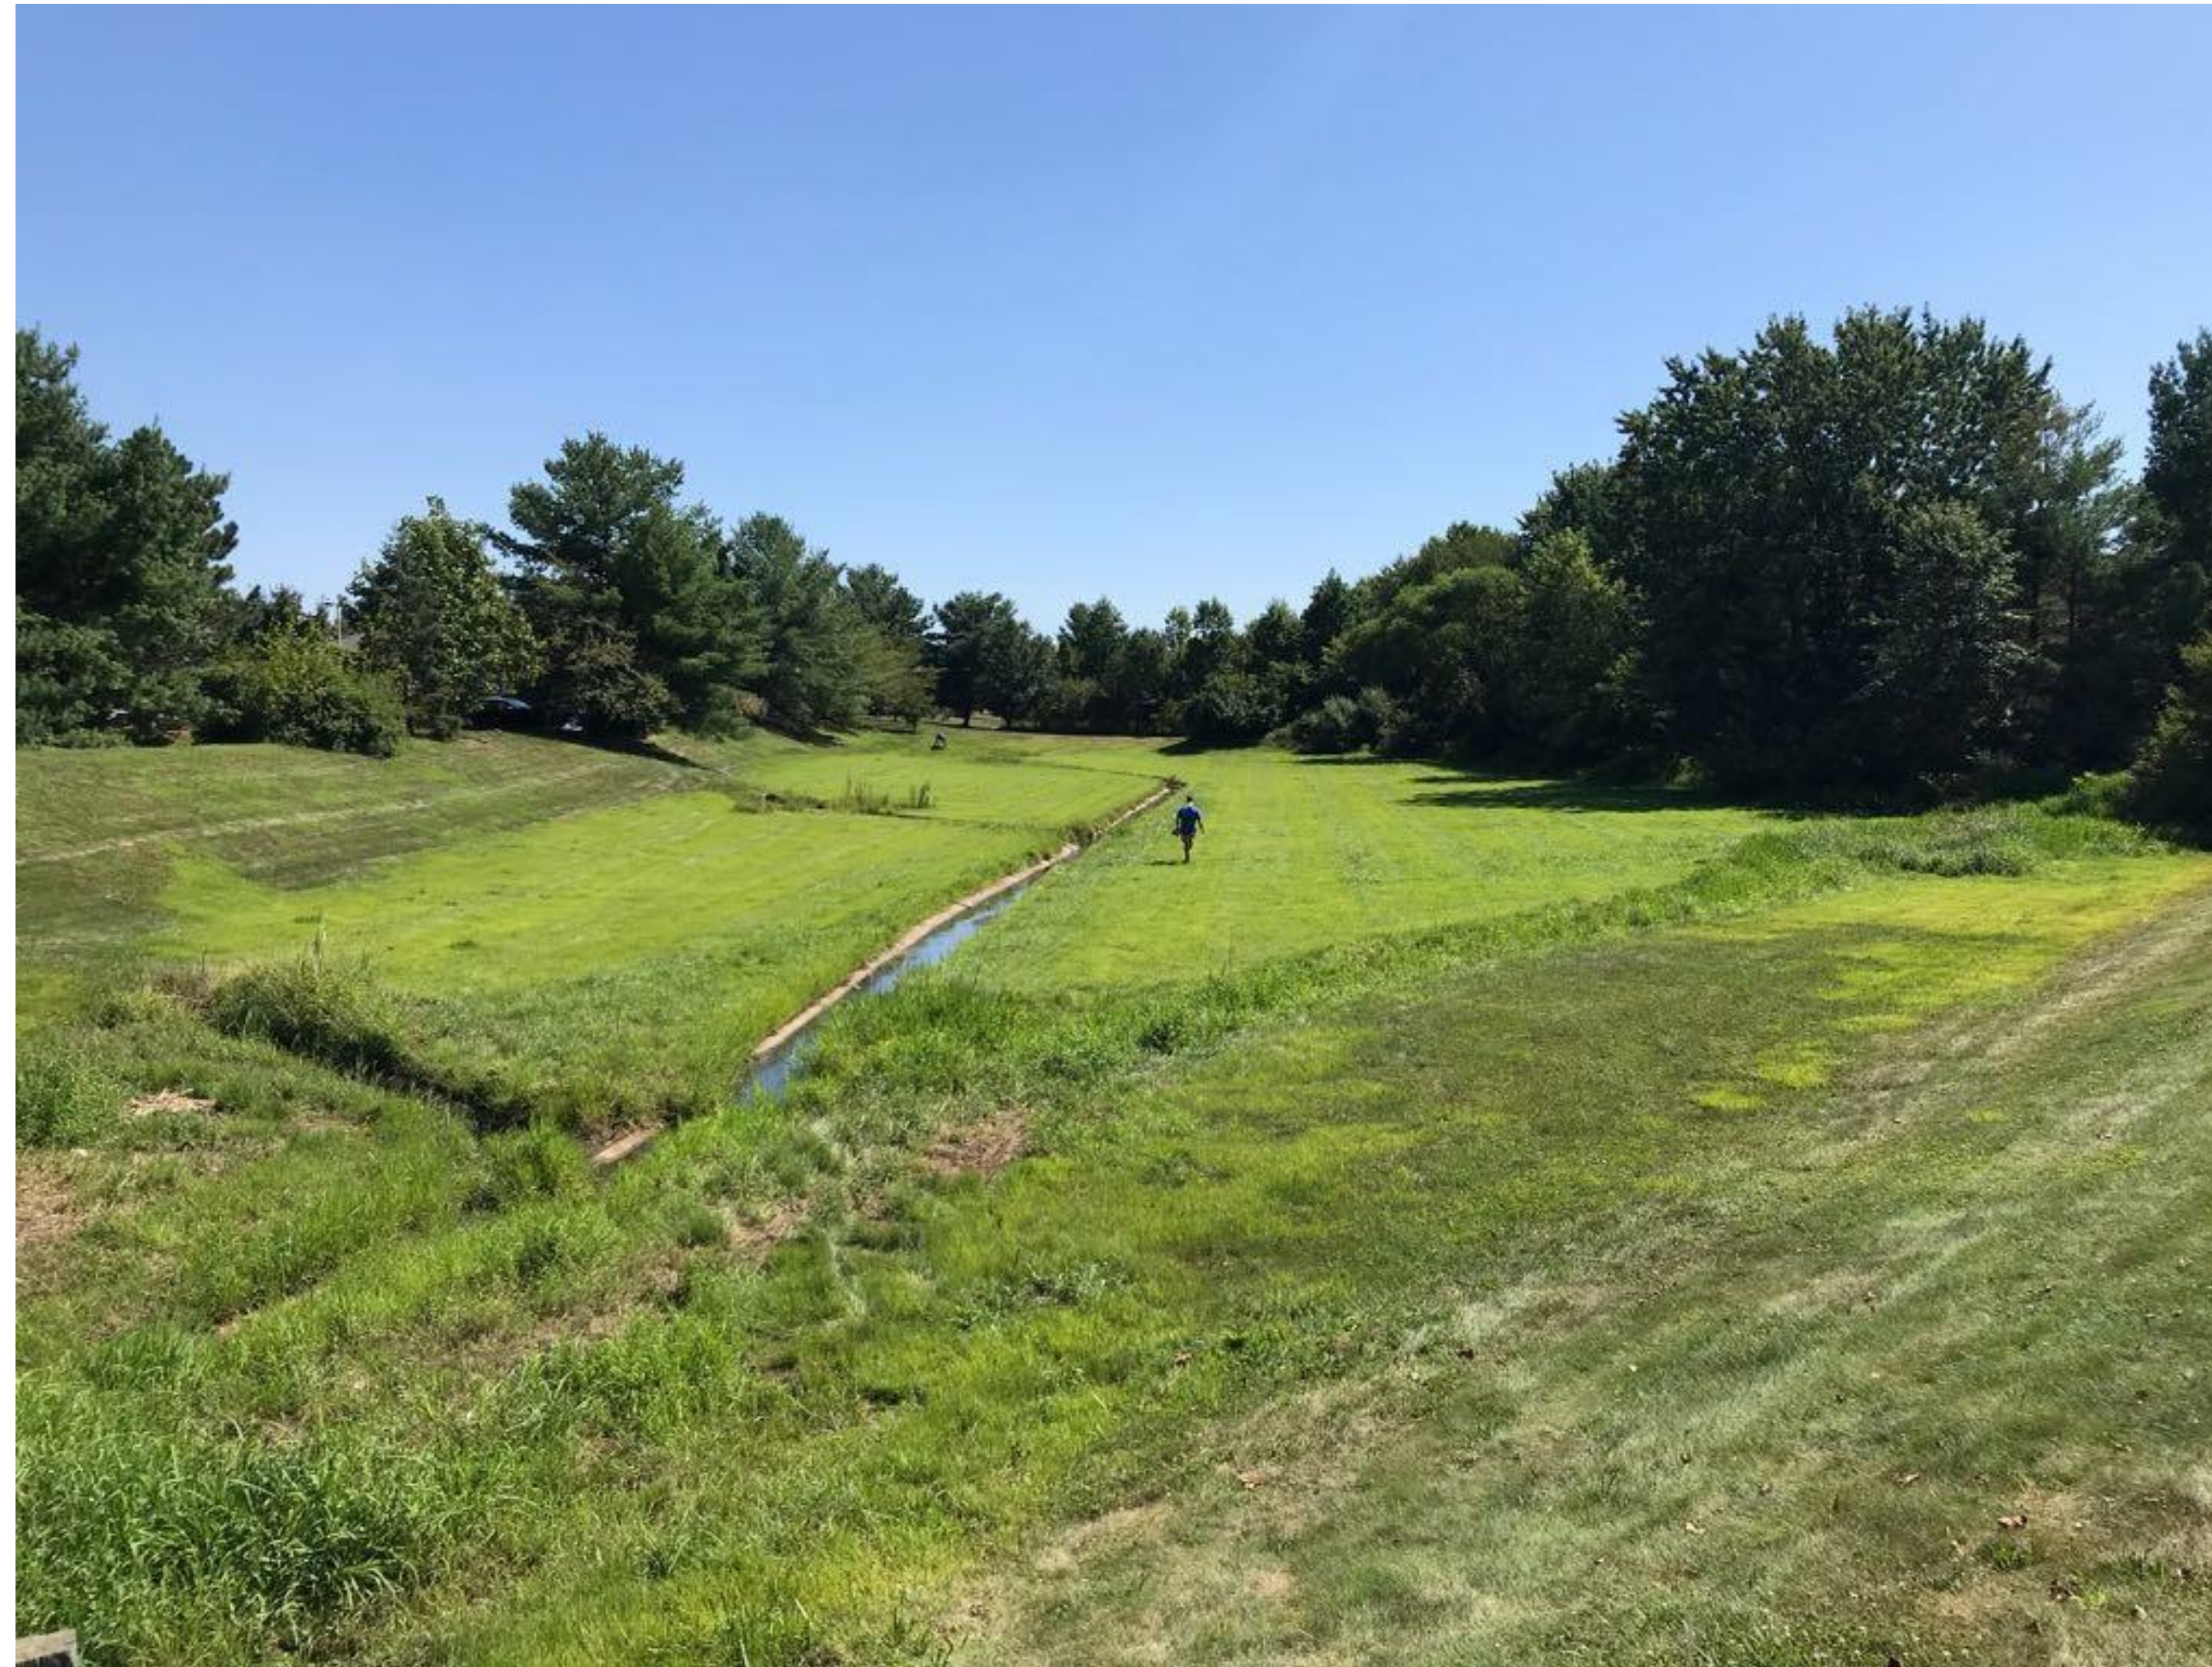
Address:
Innocenzi Dr and Great Oak Rd
Trenton, NJ 08690

- Large basin with 4 inlets
- Large vegetation growth around the low flow channel and inlets creating standing water in low flow channel
- Maintain inlets and outlets areas
- Clear low flow channels to stop standing water or replace with stone channel

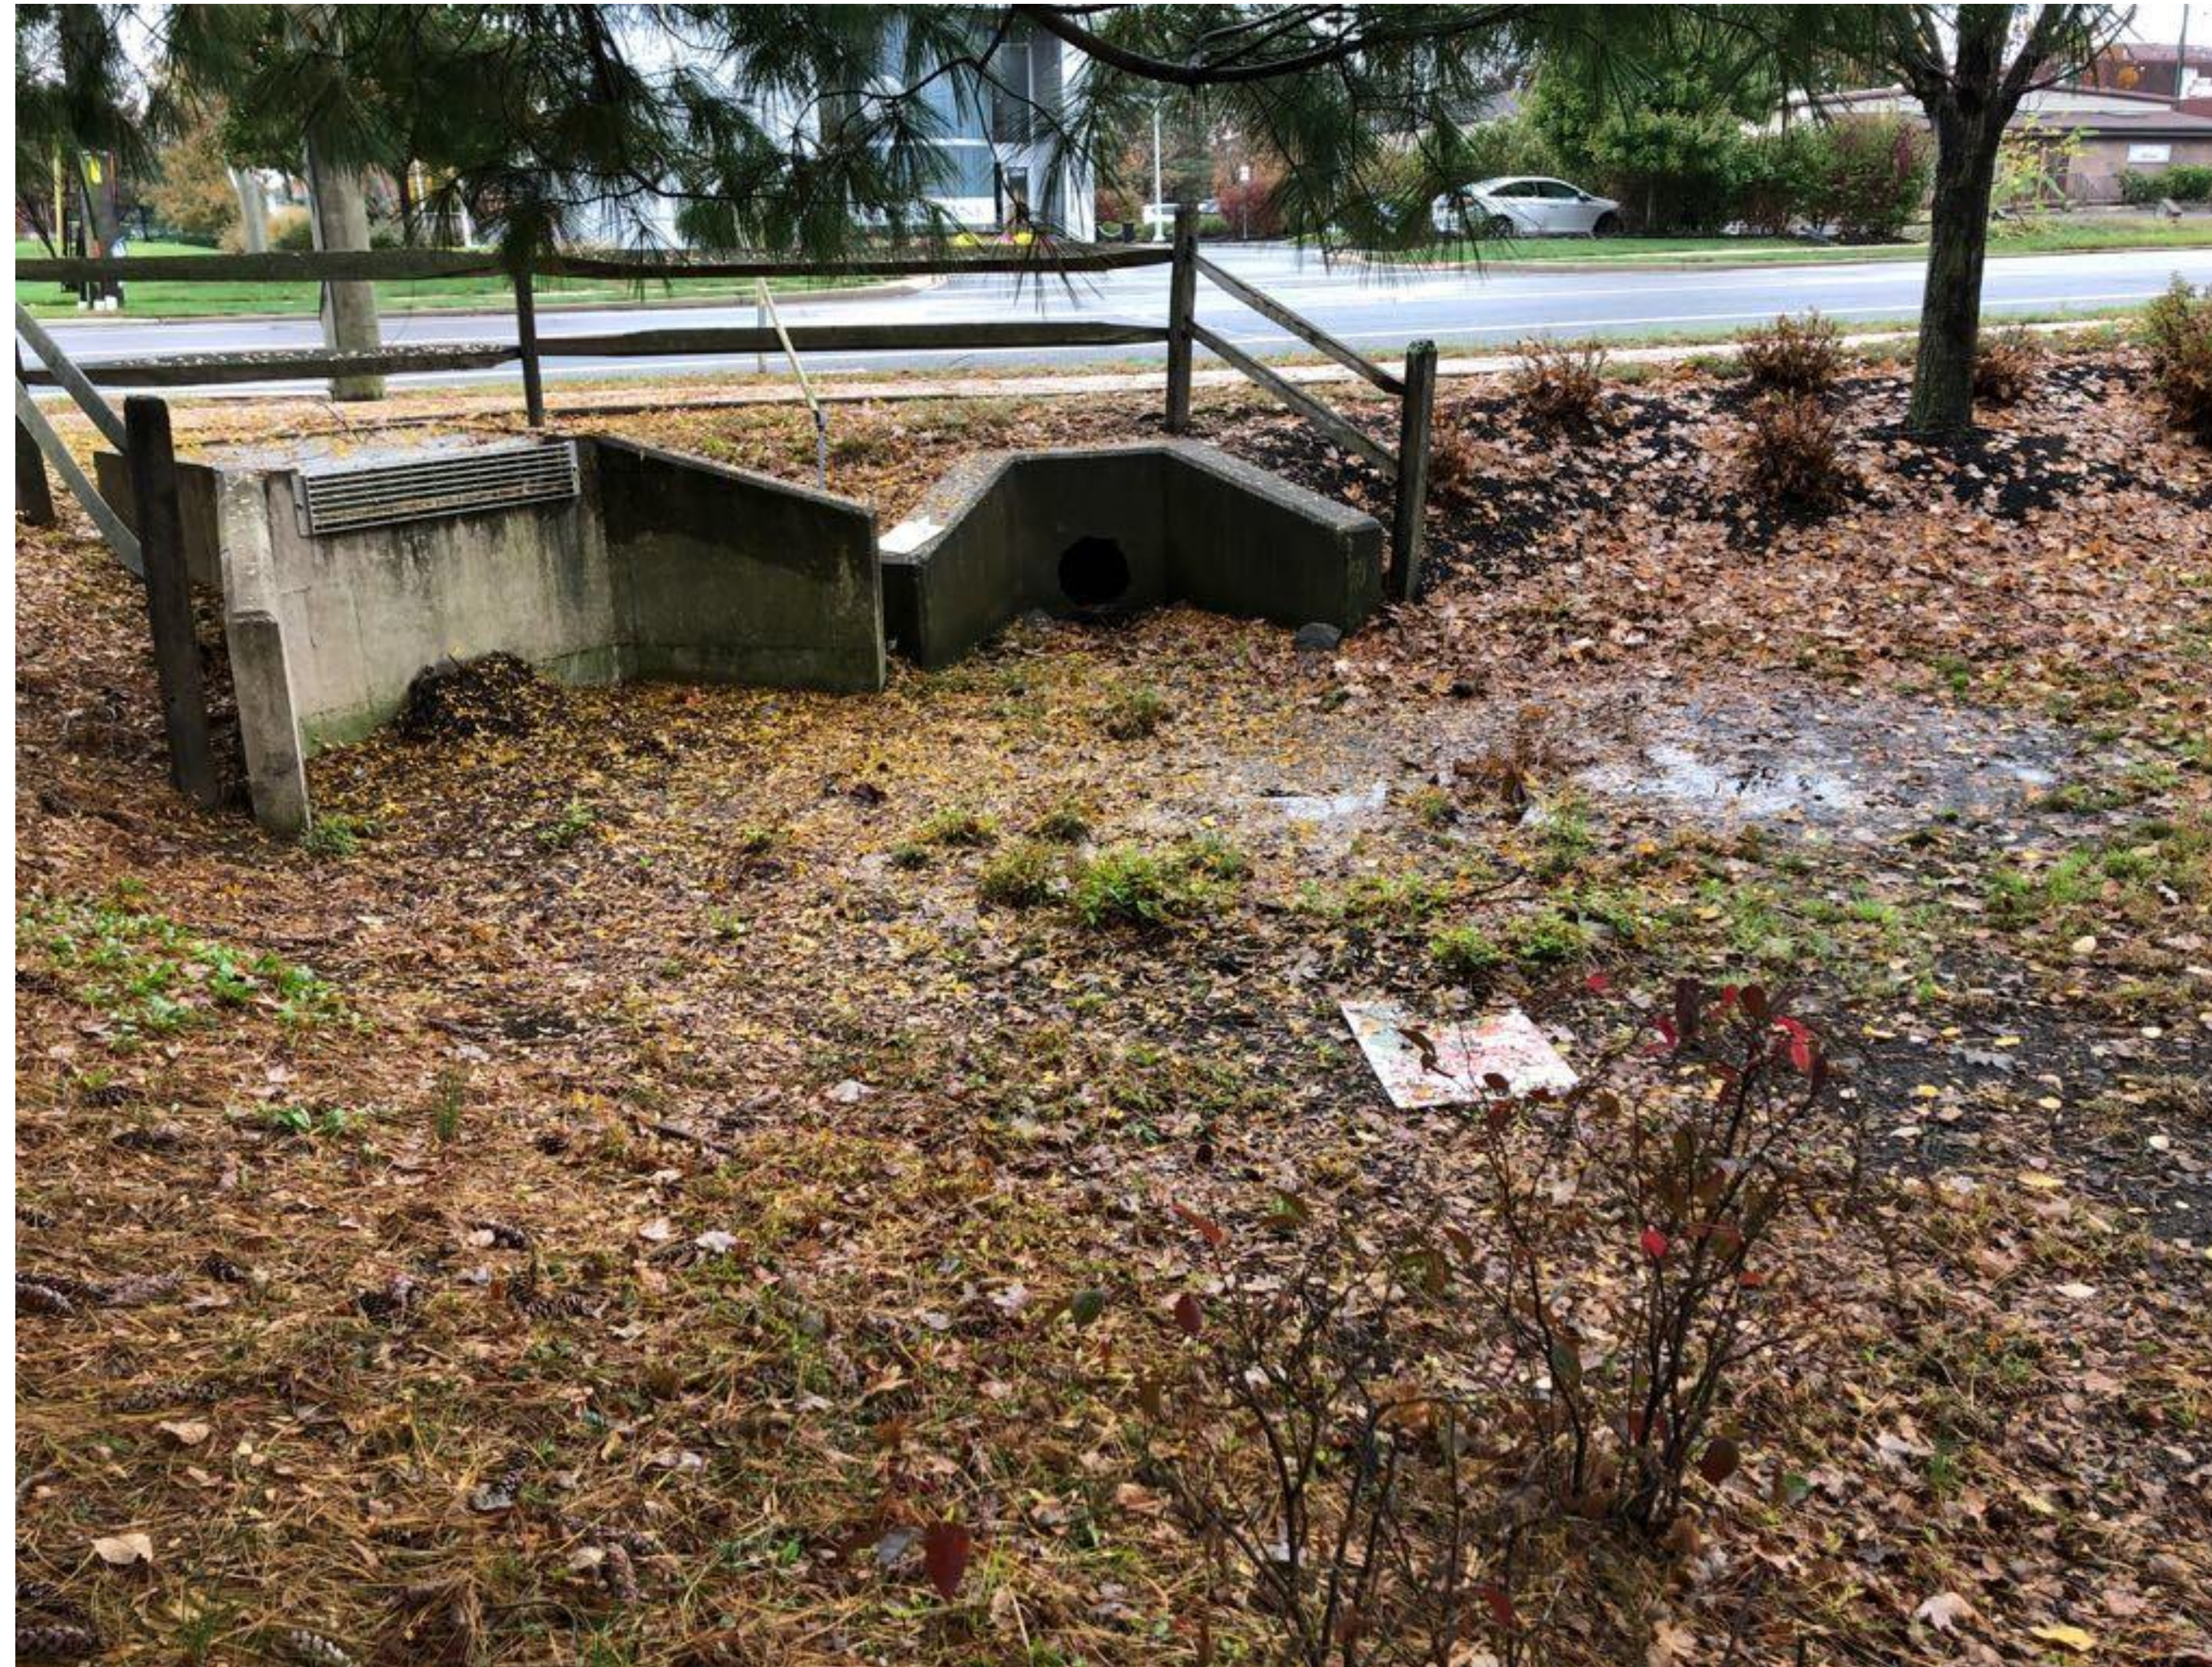
Address:
4265 RT-33
Trenton, NJ 08690

- Outlet to basin is clogged with leaves and debris. Inlet number five for this from Route 33 has standing water. Mosquitoes present at time of inspection October 30
- Clear outlet and repair inlet five to allow remove the standing water issue

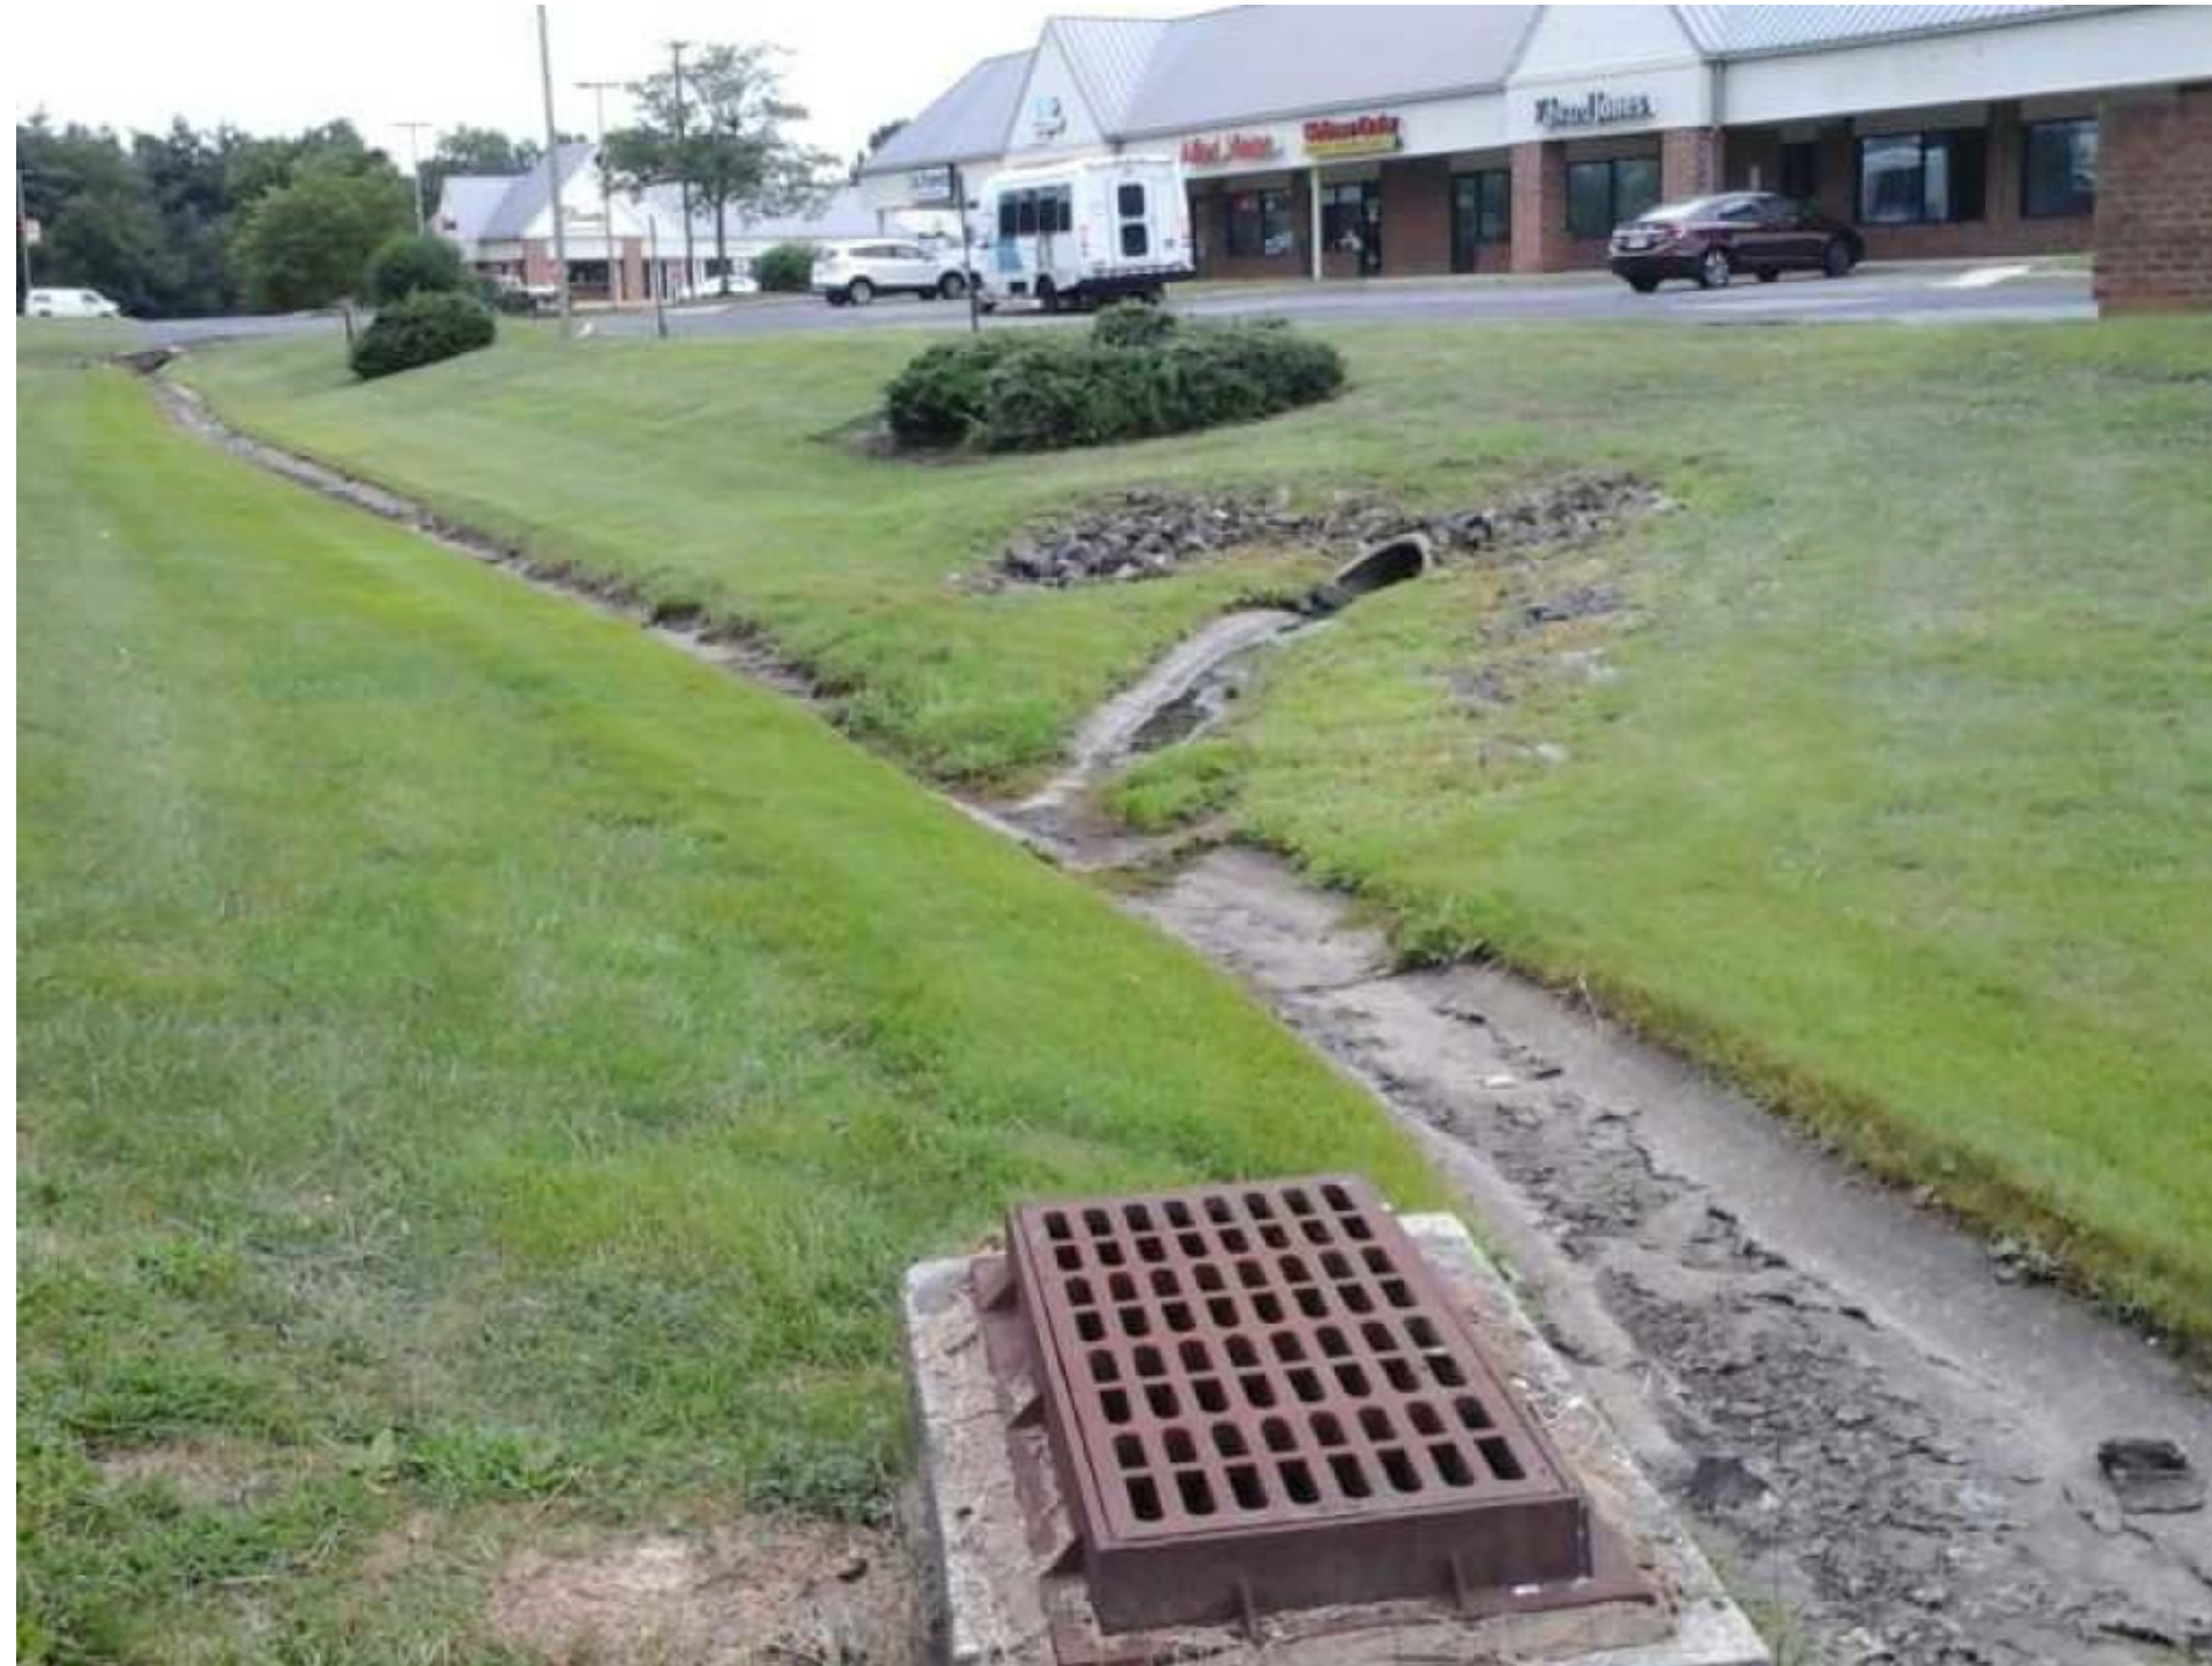
Address:
1027 Washington Blvd
Trenton, NJ 08691

- Five inlets with low flow channel
- Low flow channel has been cleared since last assessment, but some sediment has accumulated again and some minor standing water present
- Clean out concrete flow channels and repair outlet structure that is still damaged from last assessment
