**Hamilton Township (Mercer County)
Stormwater Basin Assessment Summary
Past Priority Addendum (Year 5B)**

Developed by the Rutgers Cooperative Extension Water Resources Program
Funded by Hamilton Township, Mercer County, New Jersey

November 27, 2019

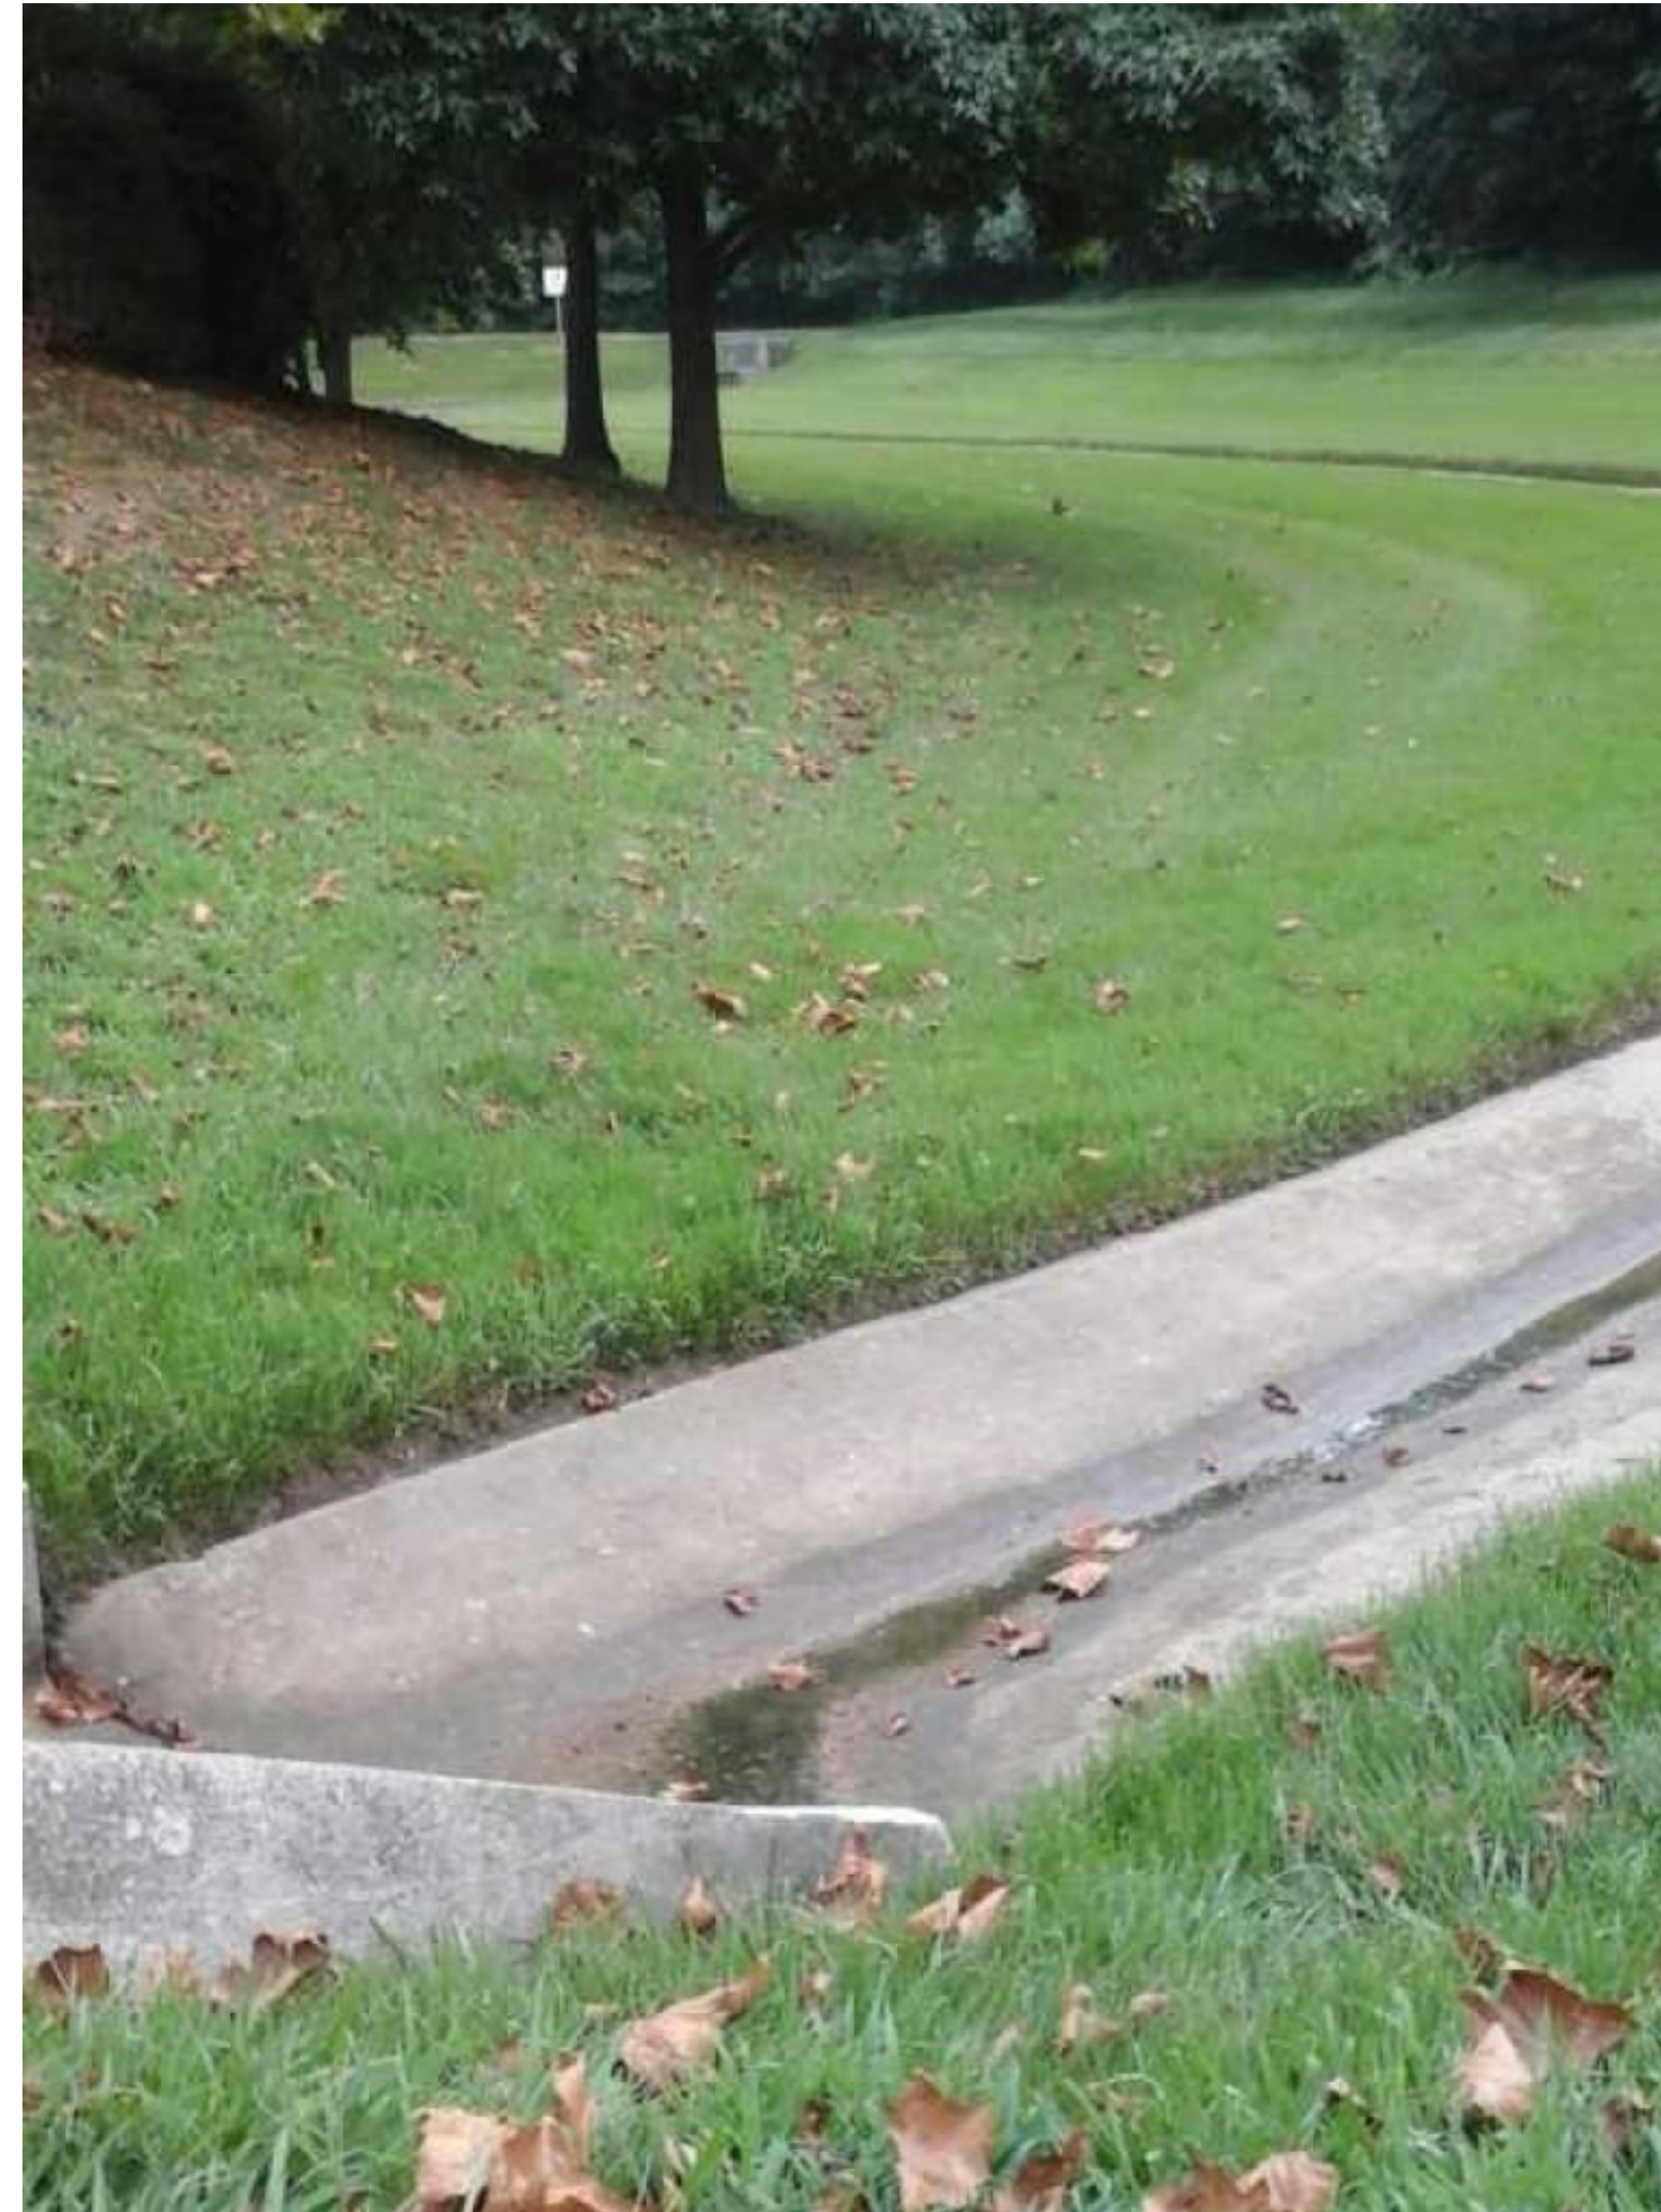
Address:
314 Mowat Cr
Hamilton Township, NJ 08690

- Two inlets leading into a outlet by low flow channel
- Basin heavily remediated from previous assessment, appears to be in good condition
- Remove low flow channel for stone channel
- Naturalize with herbaceous plants to help with erosion of banks

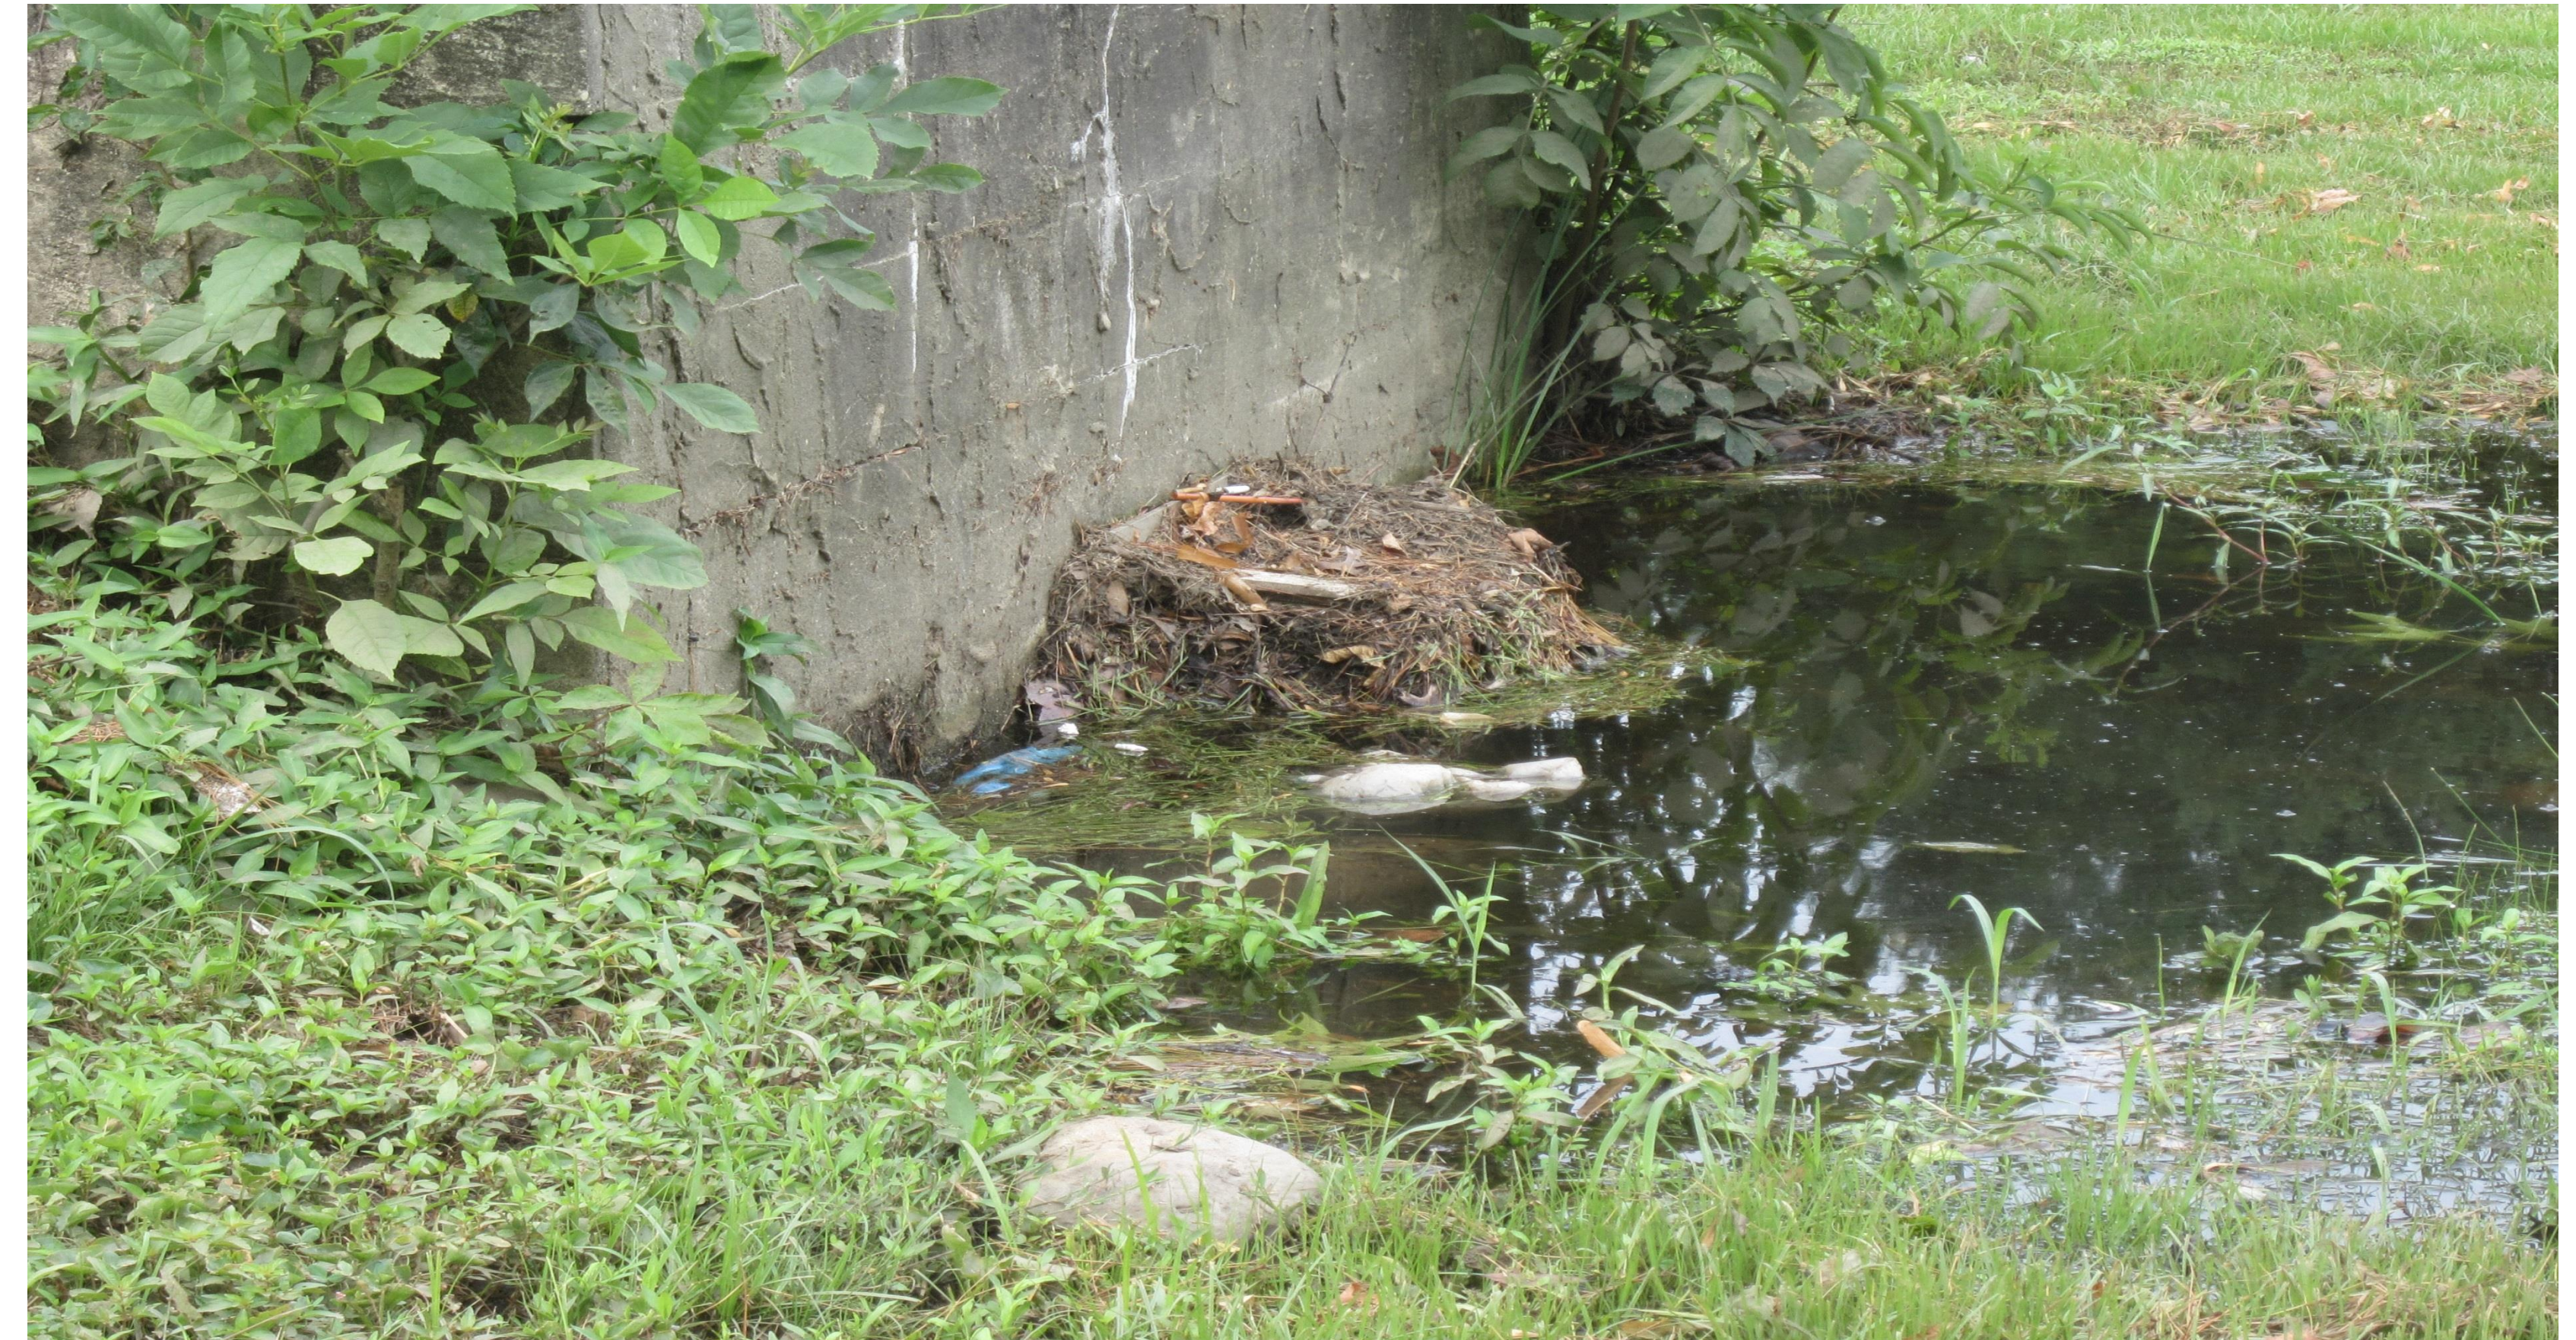
Standing water in low flow channel

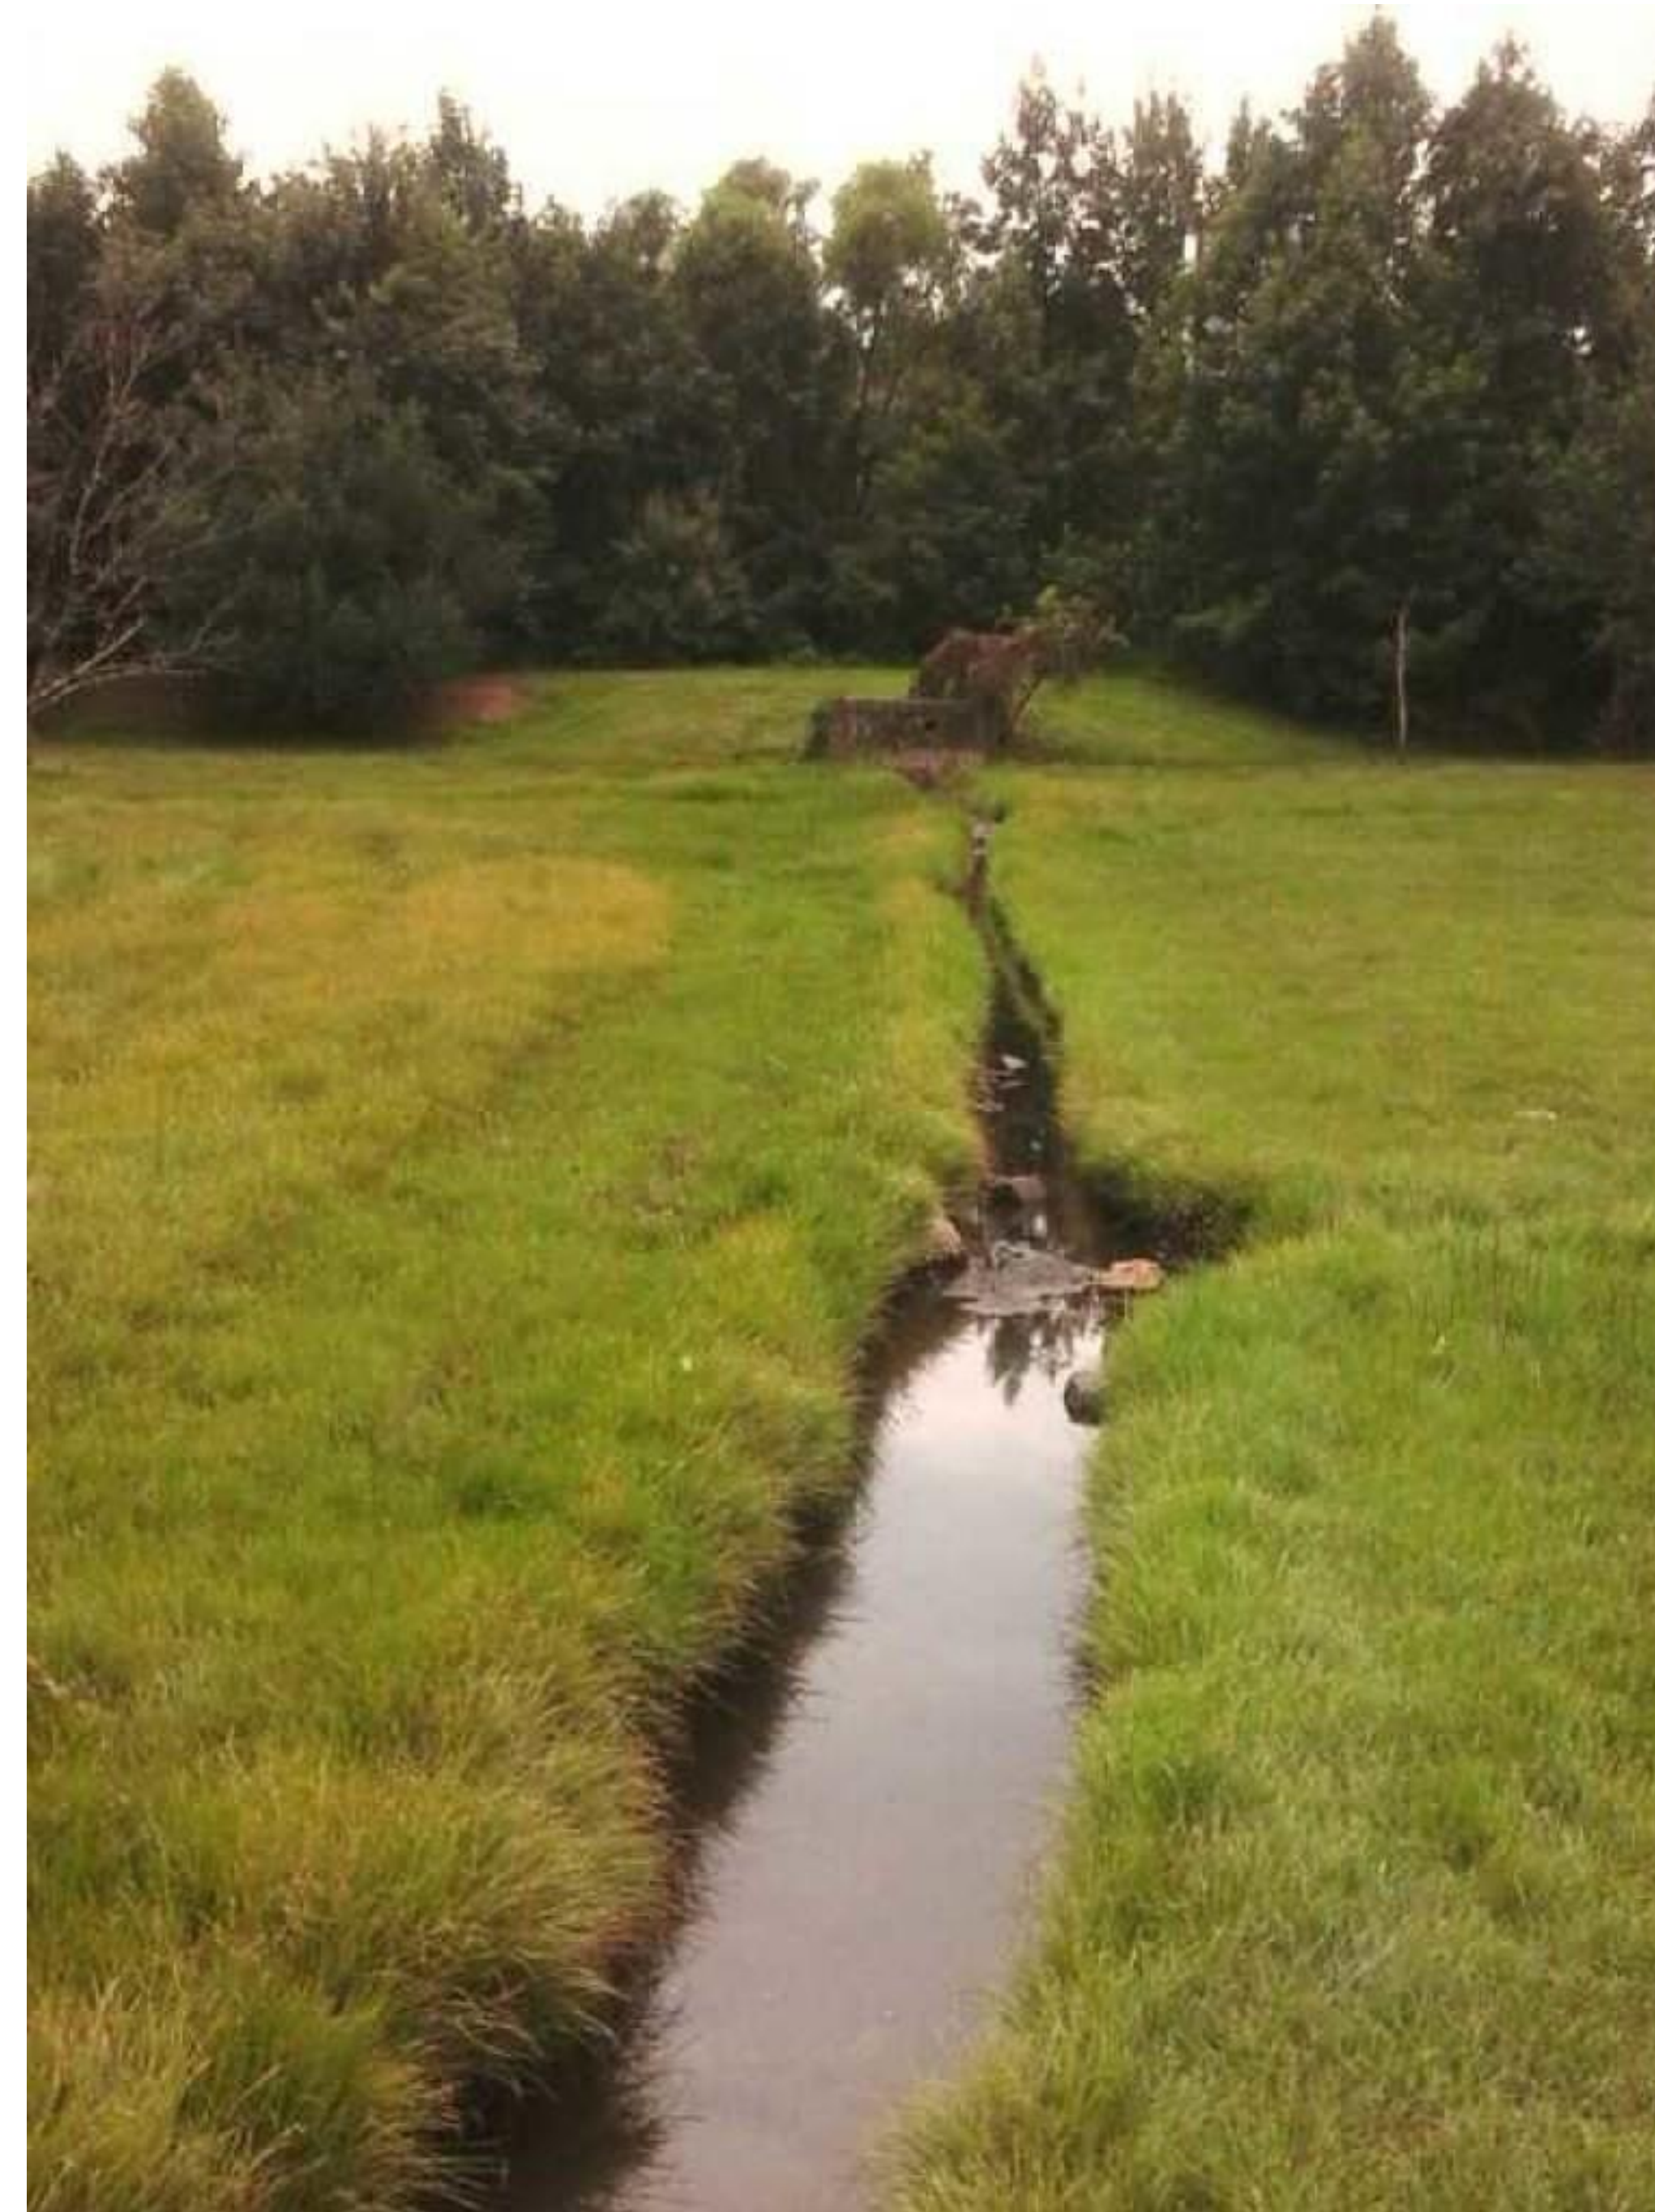
Address:
160 Commerce Way
Hamilton Township, NJ 08610

- Severe standing water in low flow channels caused by outlet structure that needs maintenance
- Remove low flow channel for rock channel
- Plant native herbaceous plants to help naturalize

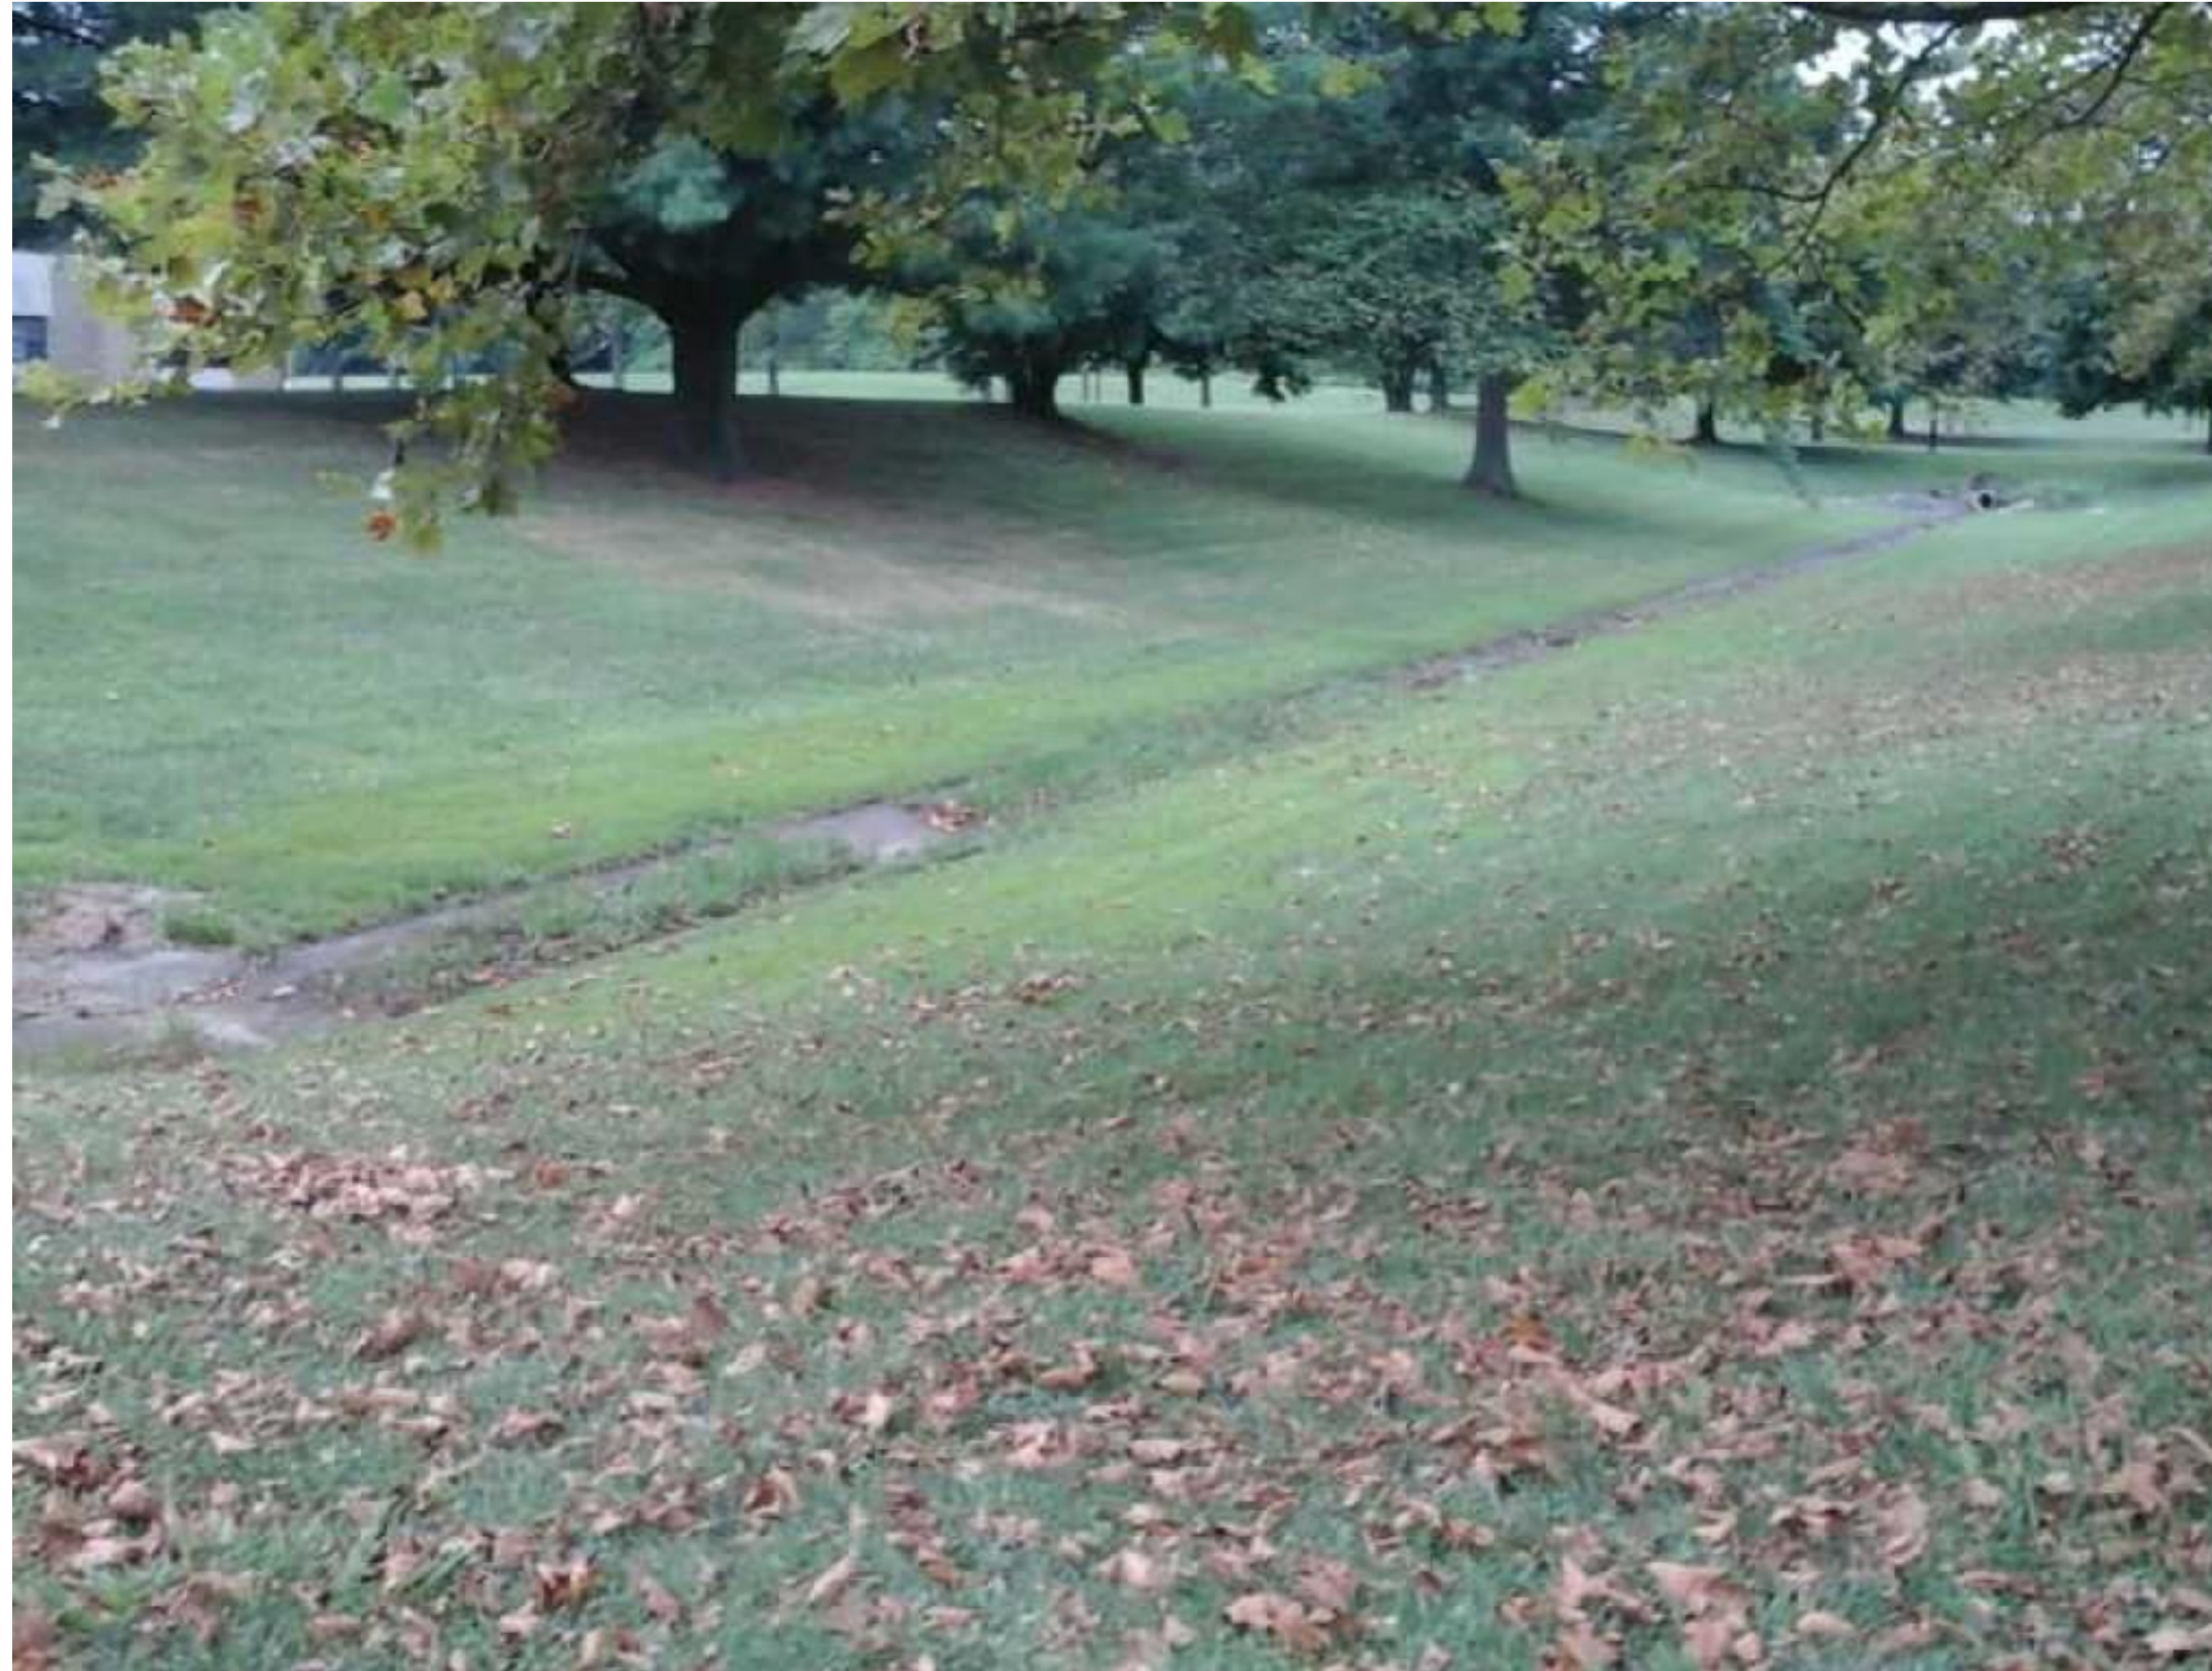
Address:
2631 Kruser Rd
Hamilton Township, NJ 08691

- Detention basin with large erosion and sediment build up
- Repair and maintain the area by removing unwanted plants and sediment
- Replace low flow channel with stone to allow infiltration

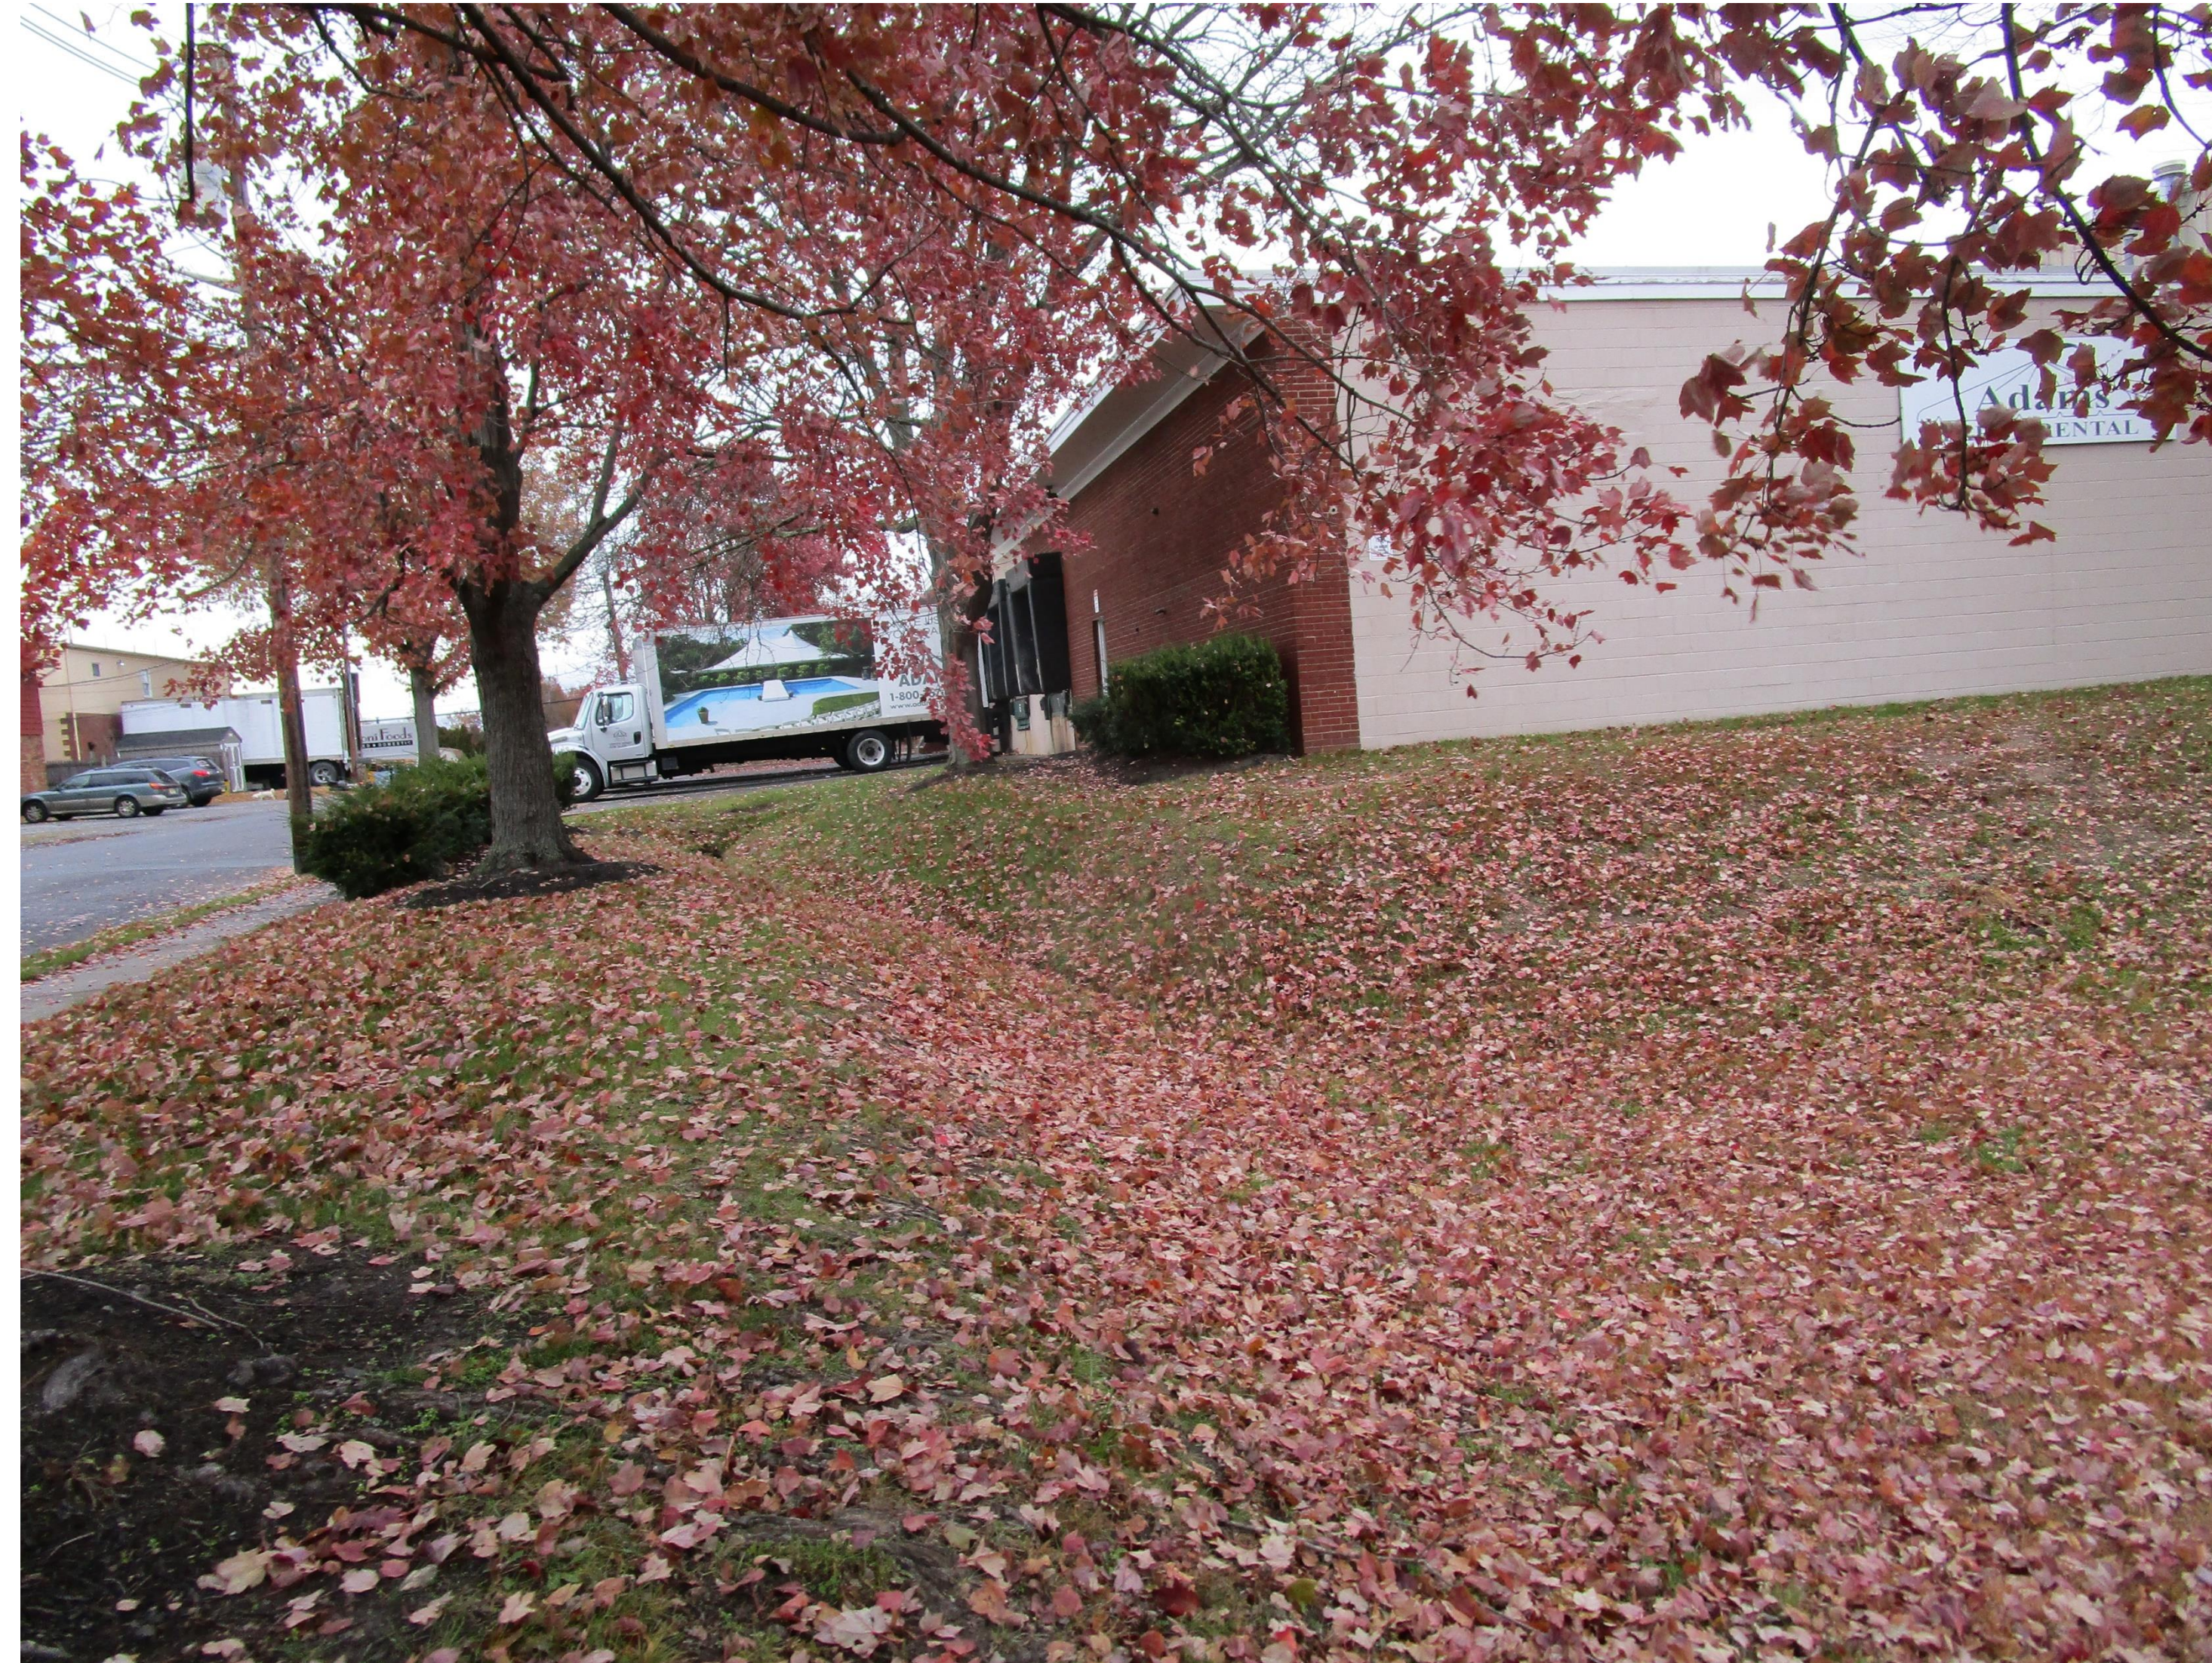
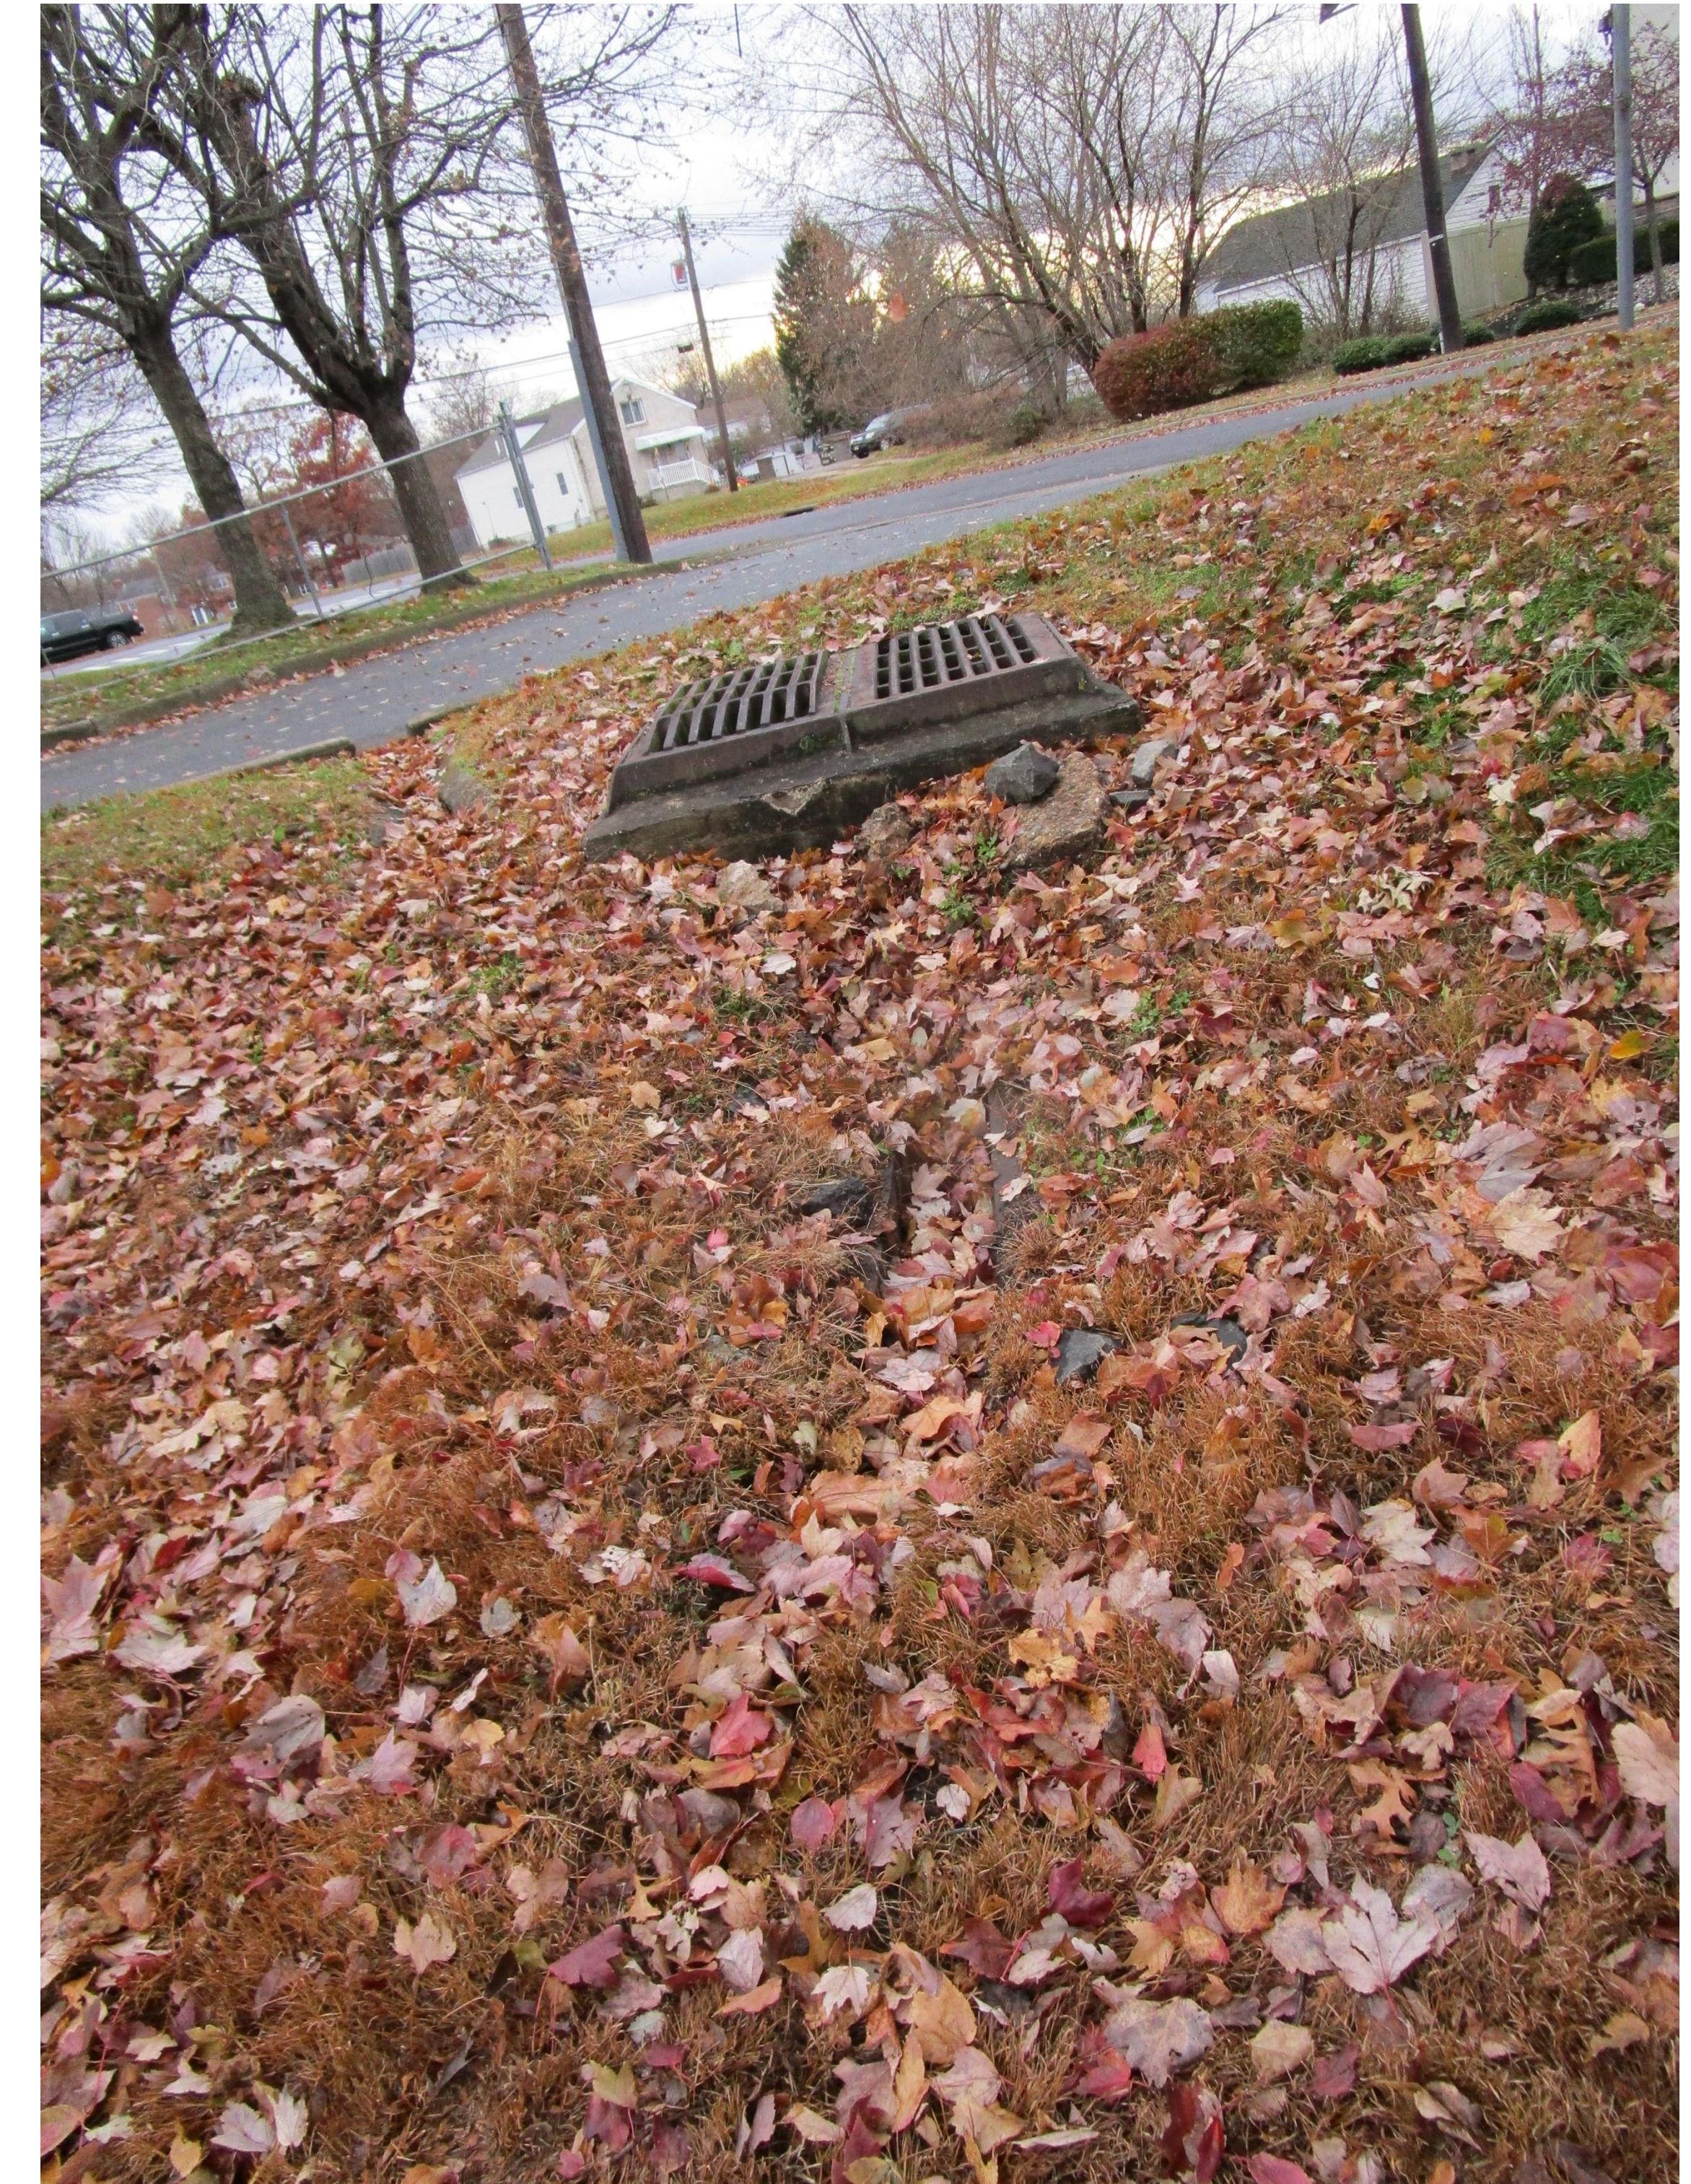
Address:
154 Turnbull Ave
Hamilton Township, NJ 08610

- Basin is in overall conditions, no clear signs of prolonged standing water seen in previous assessment
- Outlet is severely clogged with leaf litter
