**Hamilton Township (Mercer County)
Stormwater Basin Assessment Summary
Past Priority Addendum (Year 5B)**

Developed by the Rutgers Cooperative Extension Water Resources Program
Funded by Hamilton Township, Mercer County, New Jersey

November 27, 2019

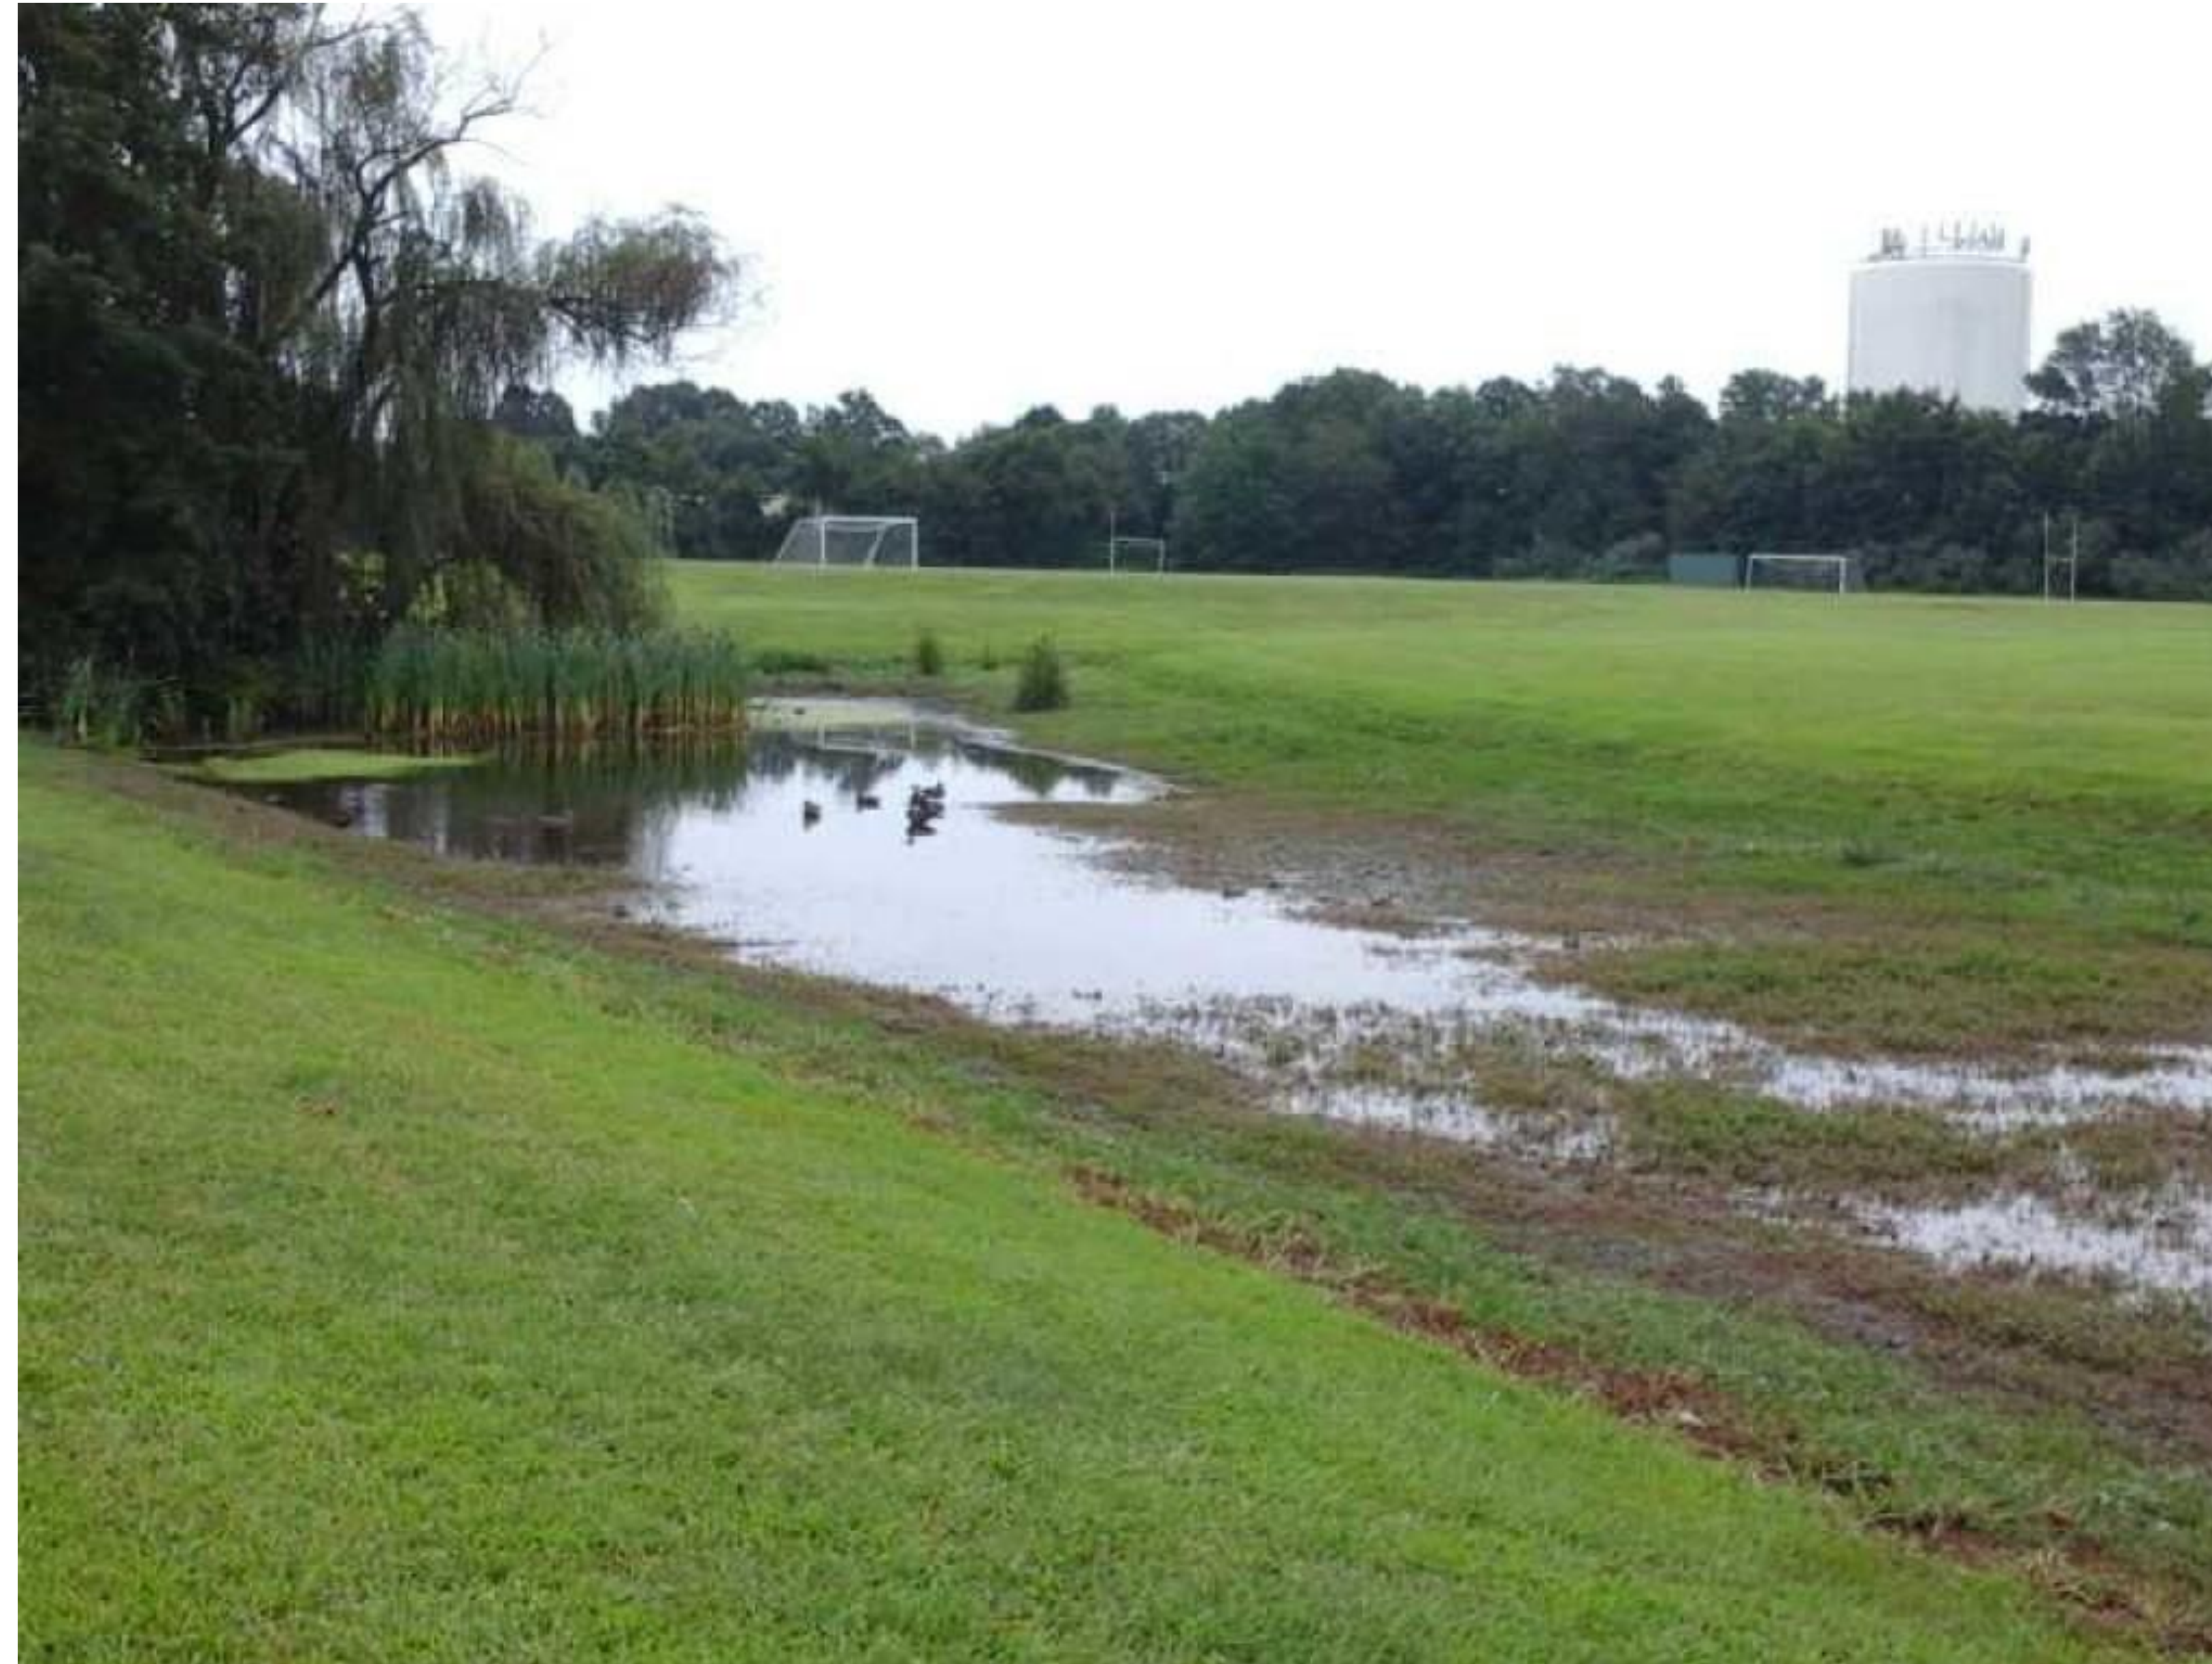
Address:
2631 Kuser Rd
Hamilton Township, NJ 08691

- Basin has large volume of water remaining, unimproved from the previous assessment
- Outlet structure is not working properly, needs repair/redesign
- Look at adding soil remediation to convert to an infiltration basin

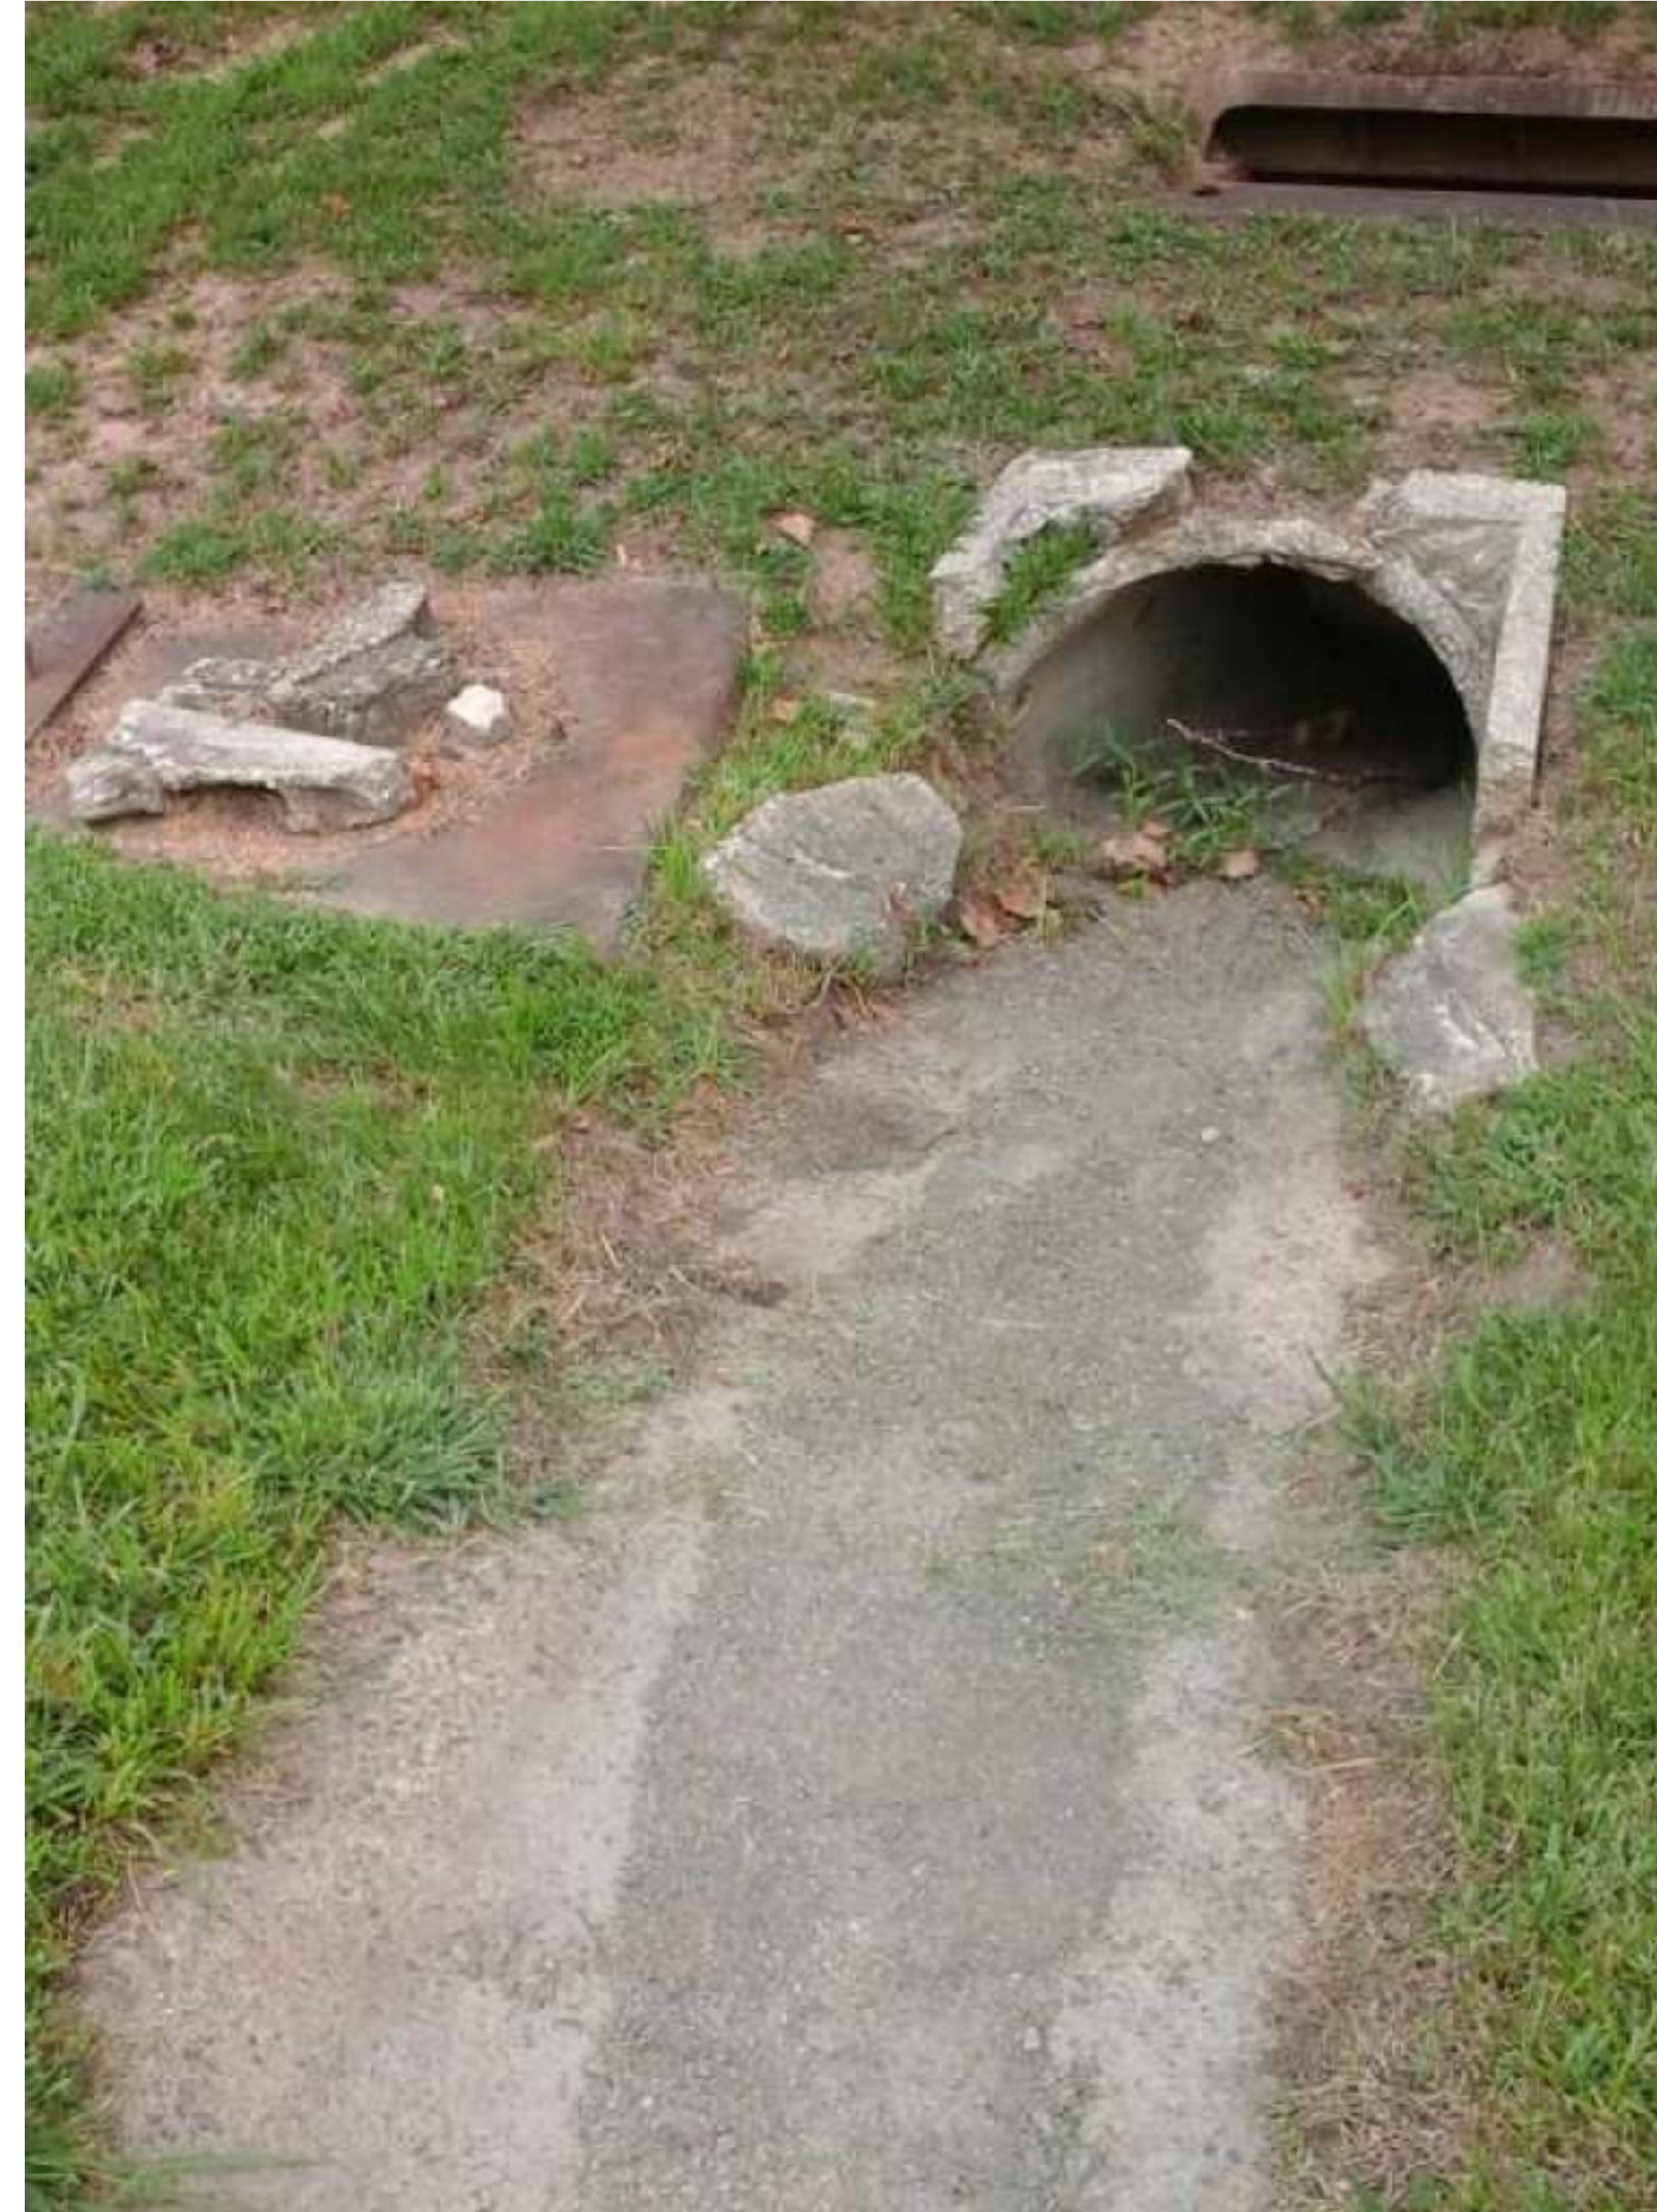
Address:
211 Yardville Hamilton Square Rd
Hamilton Township, NJ 08620

- Sediment buildup in outlet area, cover to portion of outlet catch basin is not attached
- Outlet is outdated and could be retrofitted to a more modern design to allow better stormwater management
- Remove low flow channels to provide infiltration and naturalize with herbaceous plants

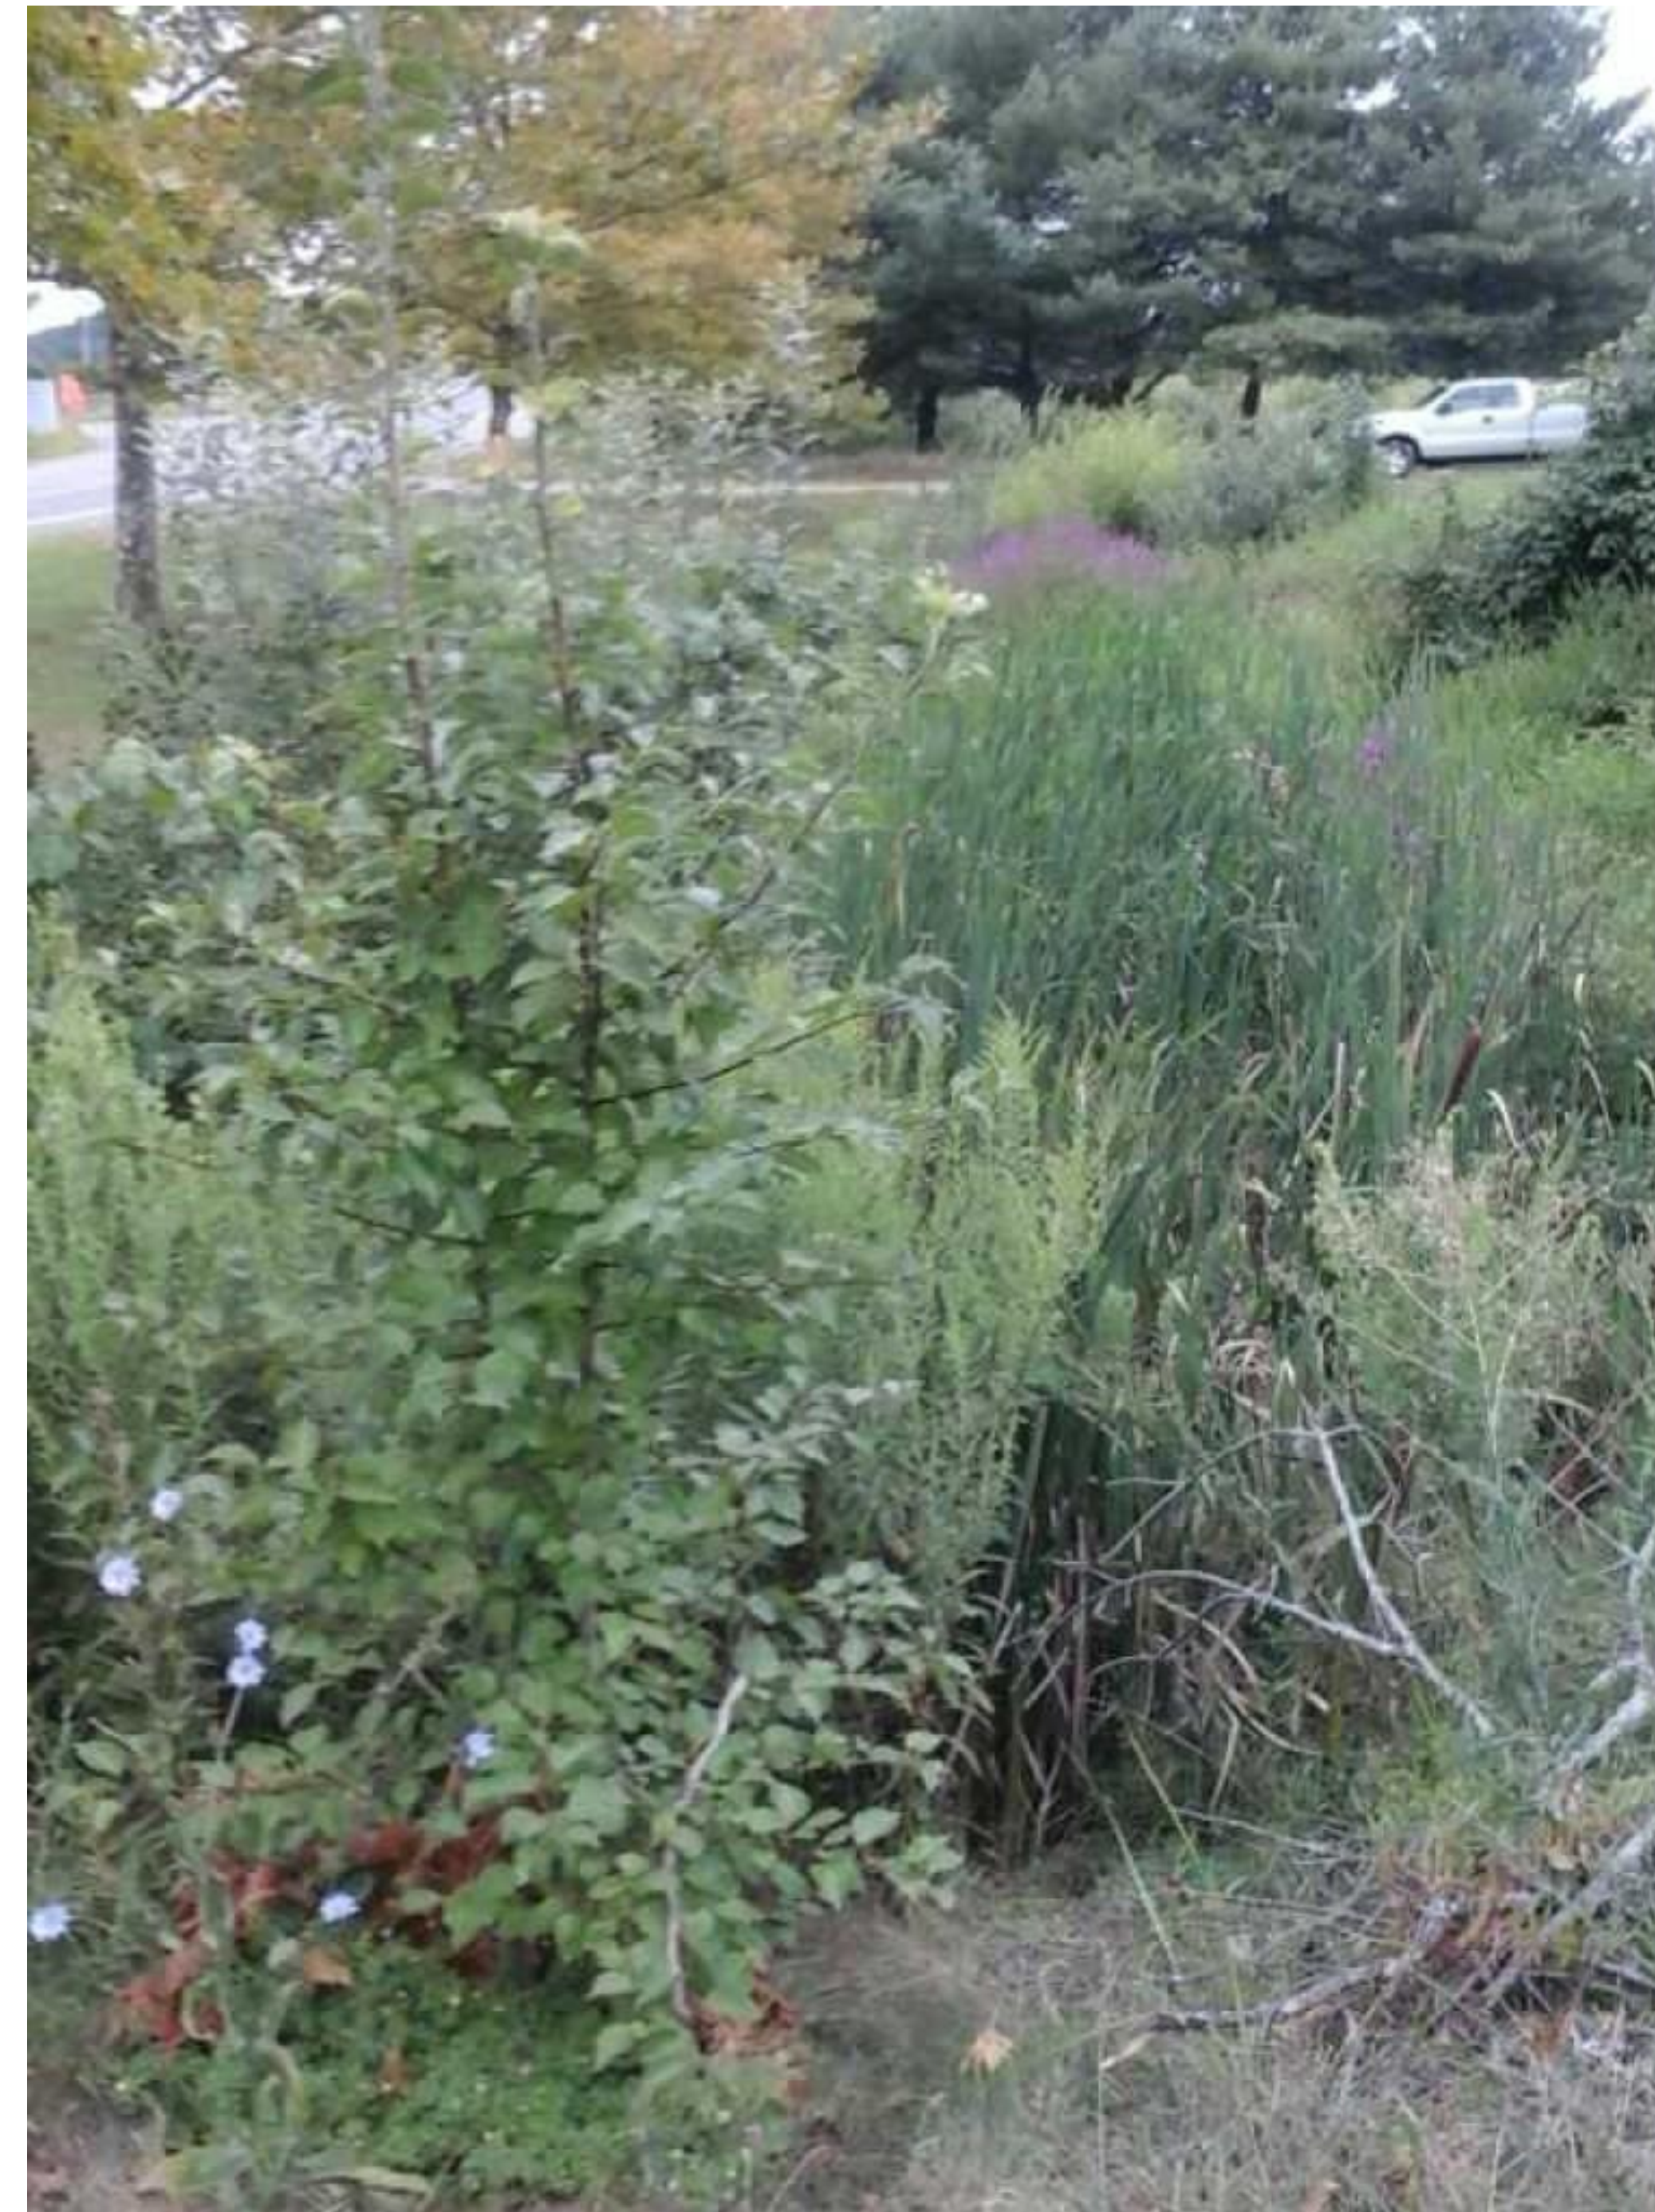
Address:
1040 Yardville Allentown Rd.
Hamilton Township, NJ 08691

- Looks like someone took the steps to retrofit this into an infiltration basin since the low flow outlet pipe is sealed
- Naturalized with herbaceous and woody vegetation recently compared to aerial
- Basin in good condition and naturalized, no recommendations

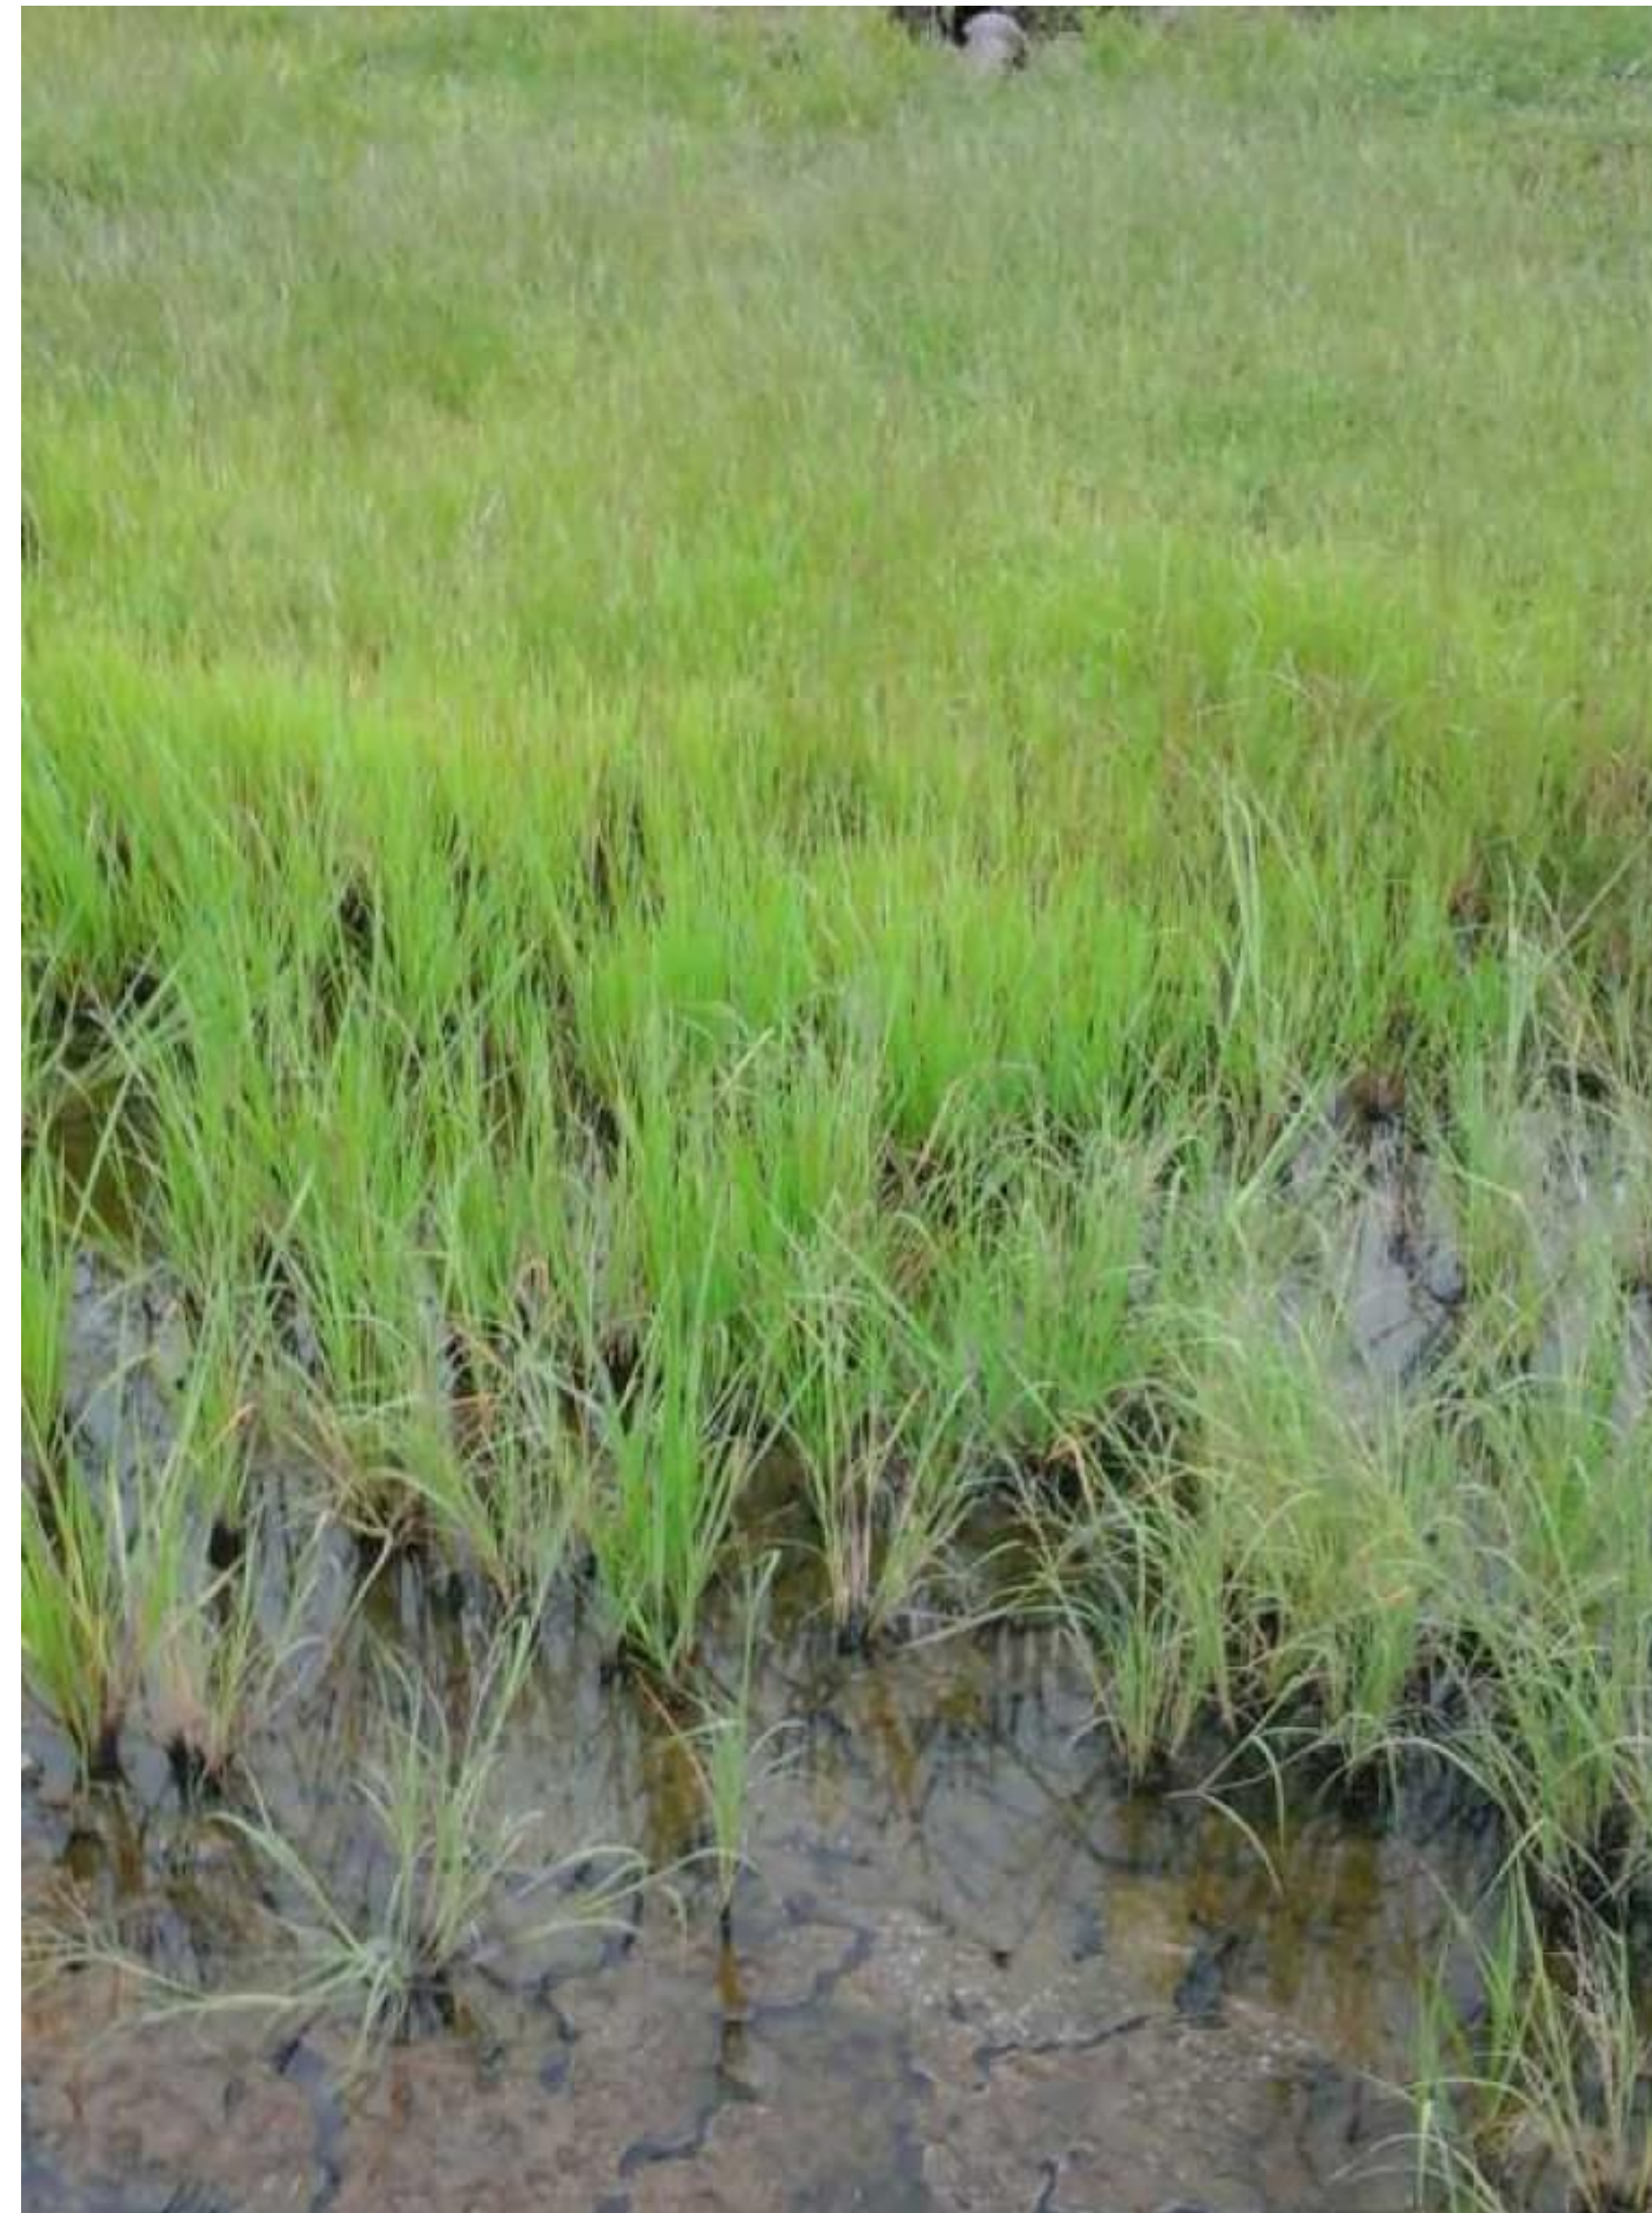
Address:
1325 Klockner Road
Hamilton Township, NJ 08610

- Does not appear to be a true basin, just a bad ponding area
- Establish meadow system to promote better infiltration
