## Hamilton Township (Mercer County)

# REVIEW AND EVALUATION OF TOTAL MAXIMUM DAILY LOADS (TMDLs)

Developed by the Rutgers Cooperative Extension Water Resources Program  
Funded by Hamilton Township, Mercer County, New Jersey

December 5, 2019

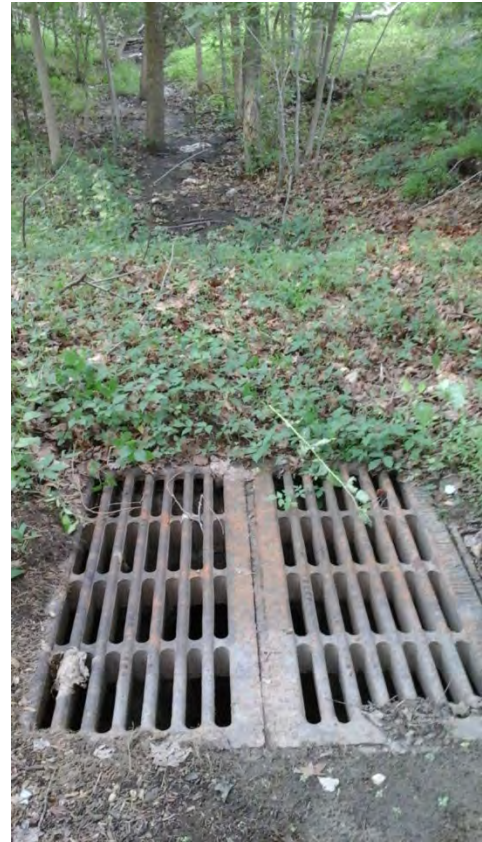
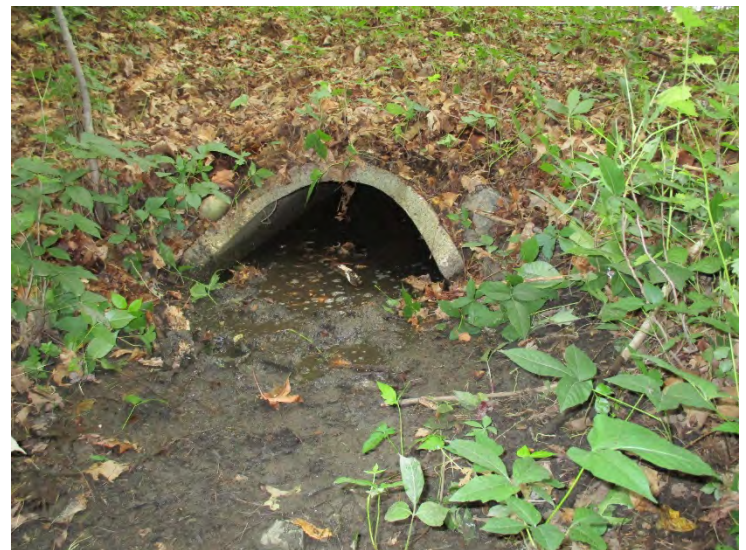
- 16" diameter concrete pipe
- Sediment deposits
- Sediment is partially blocking the pipe
- Outfall pipe is beginning to deteriorate (minor cracking)

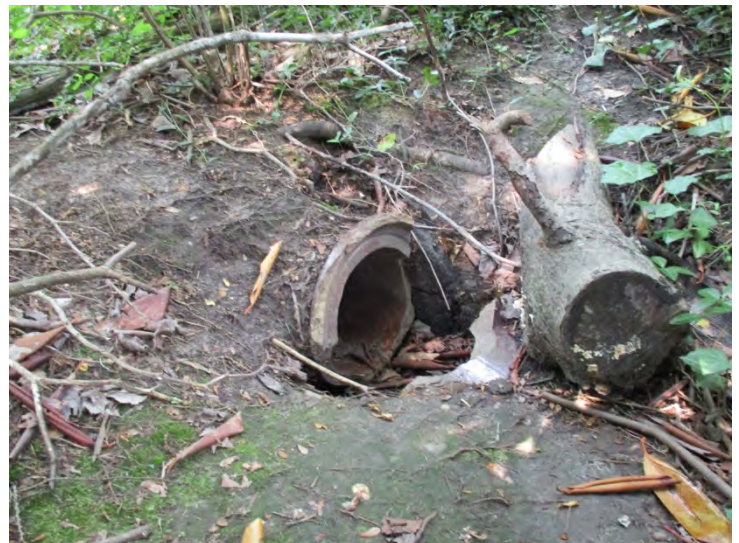
- 9" diameter clay pipe
- Sediment deposits
- Excessive vegetation growth
- Pipe has deteriorated and broken
- Moderate erosion has been caused by the outfall

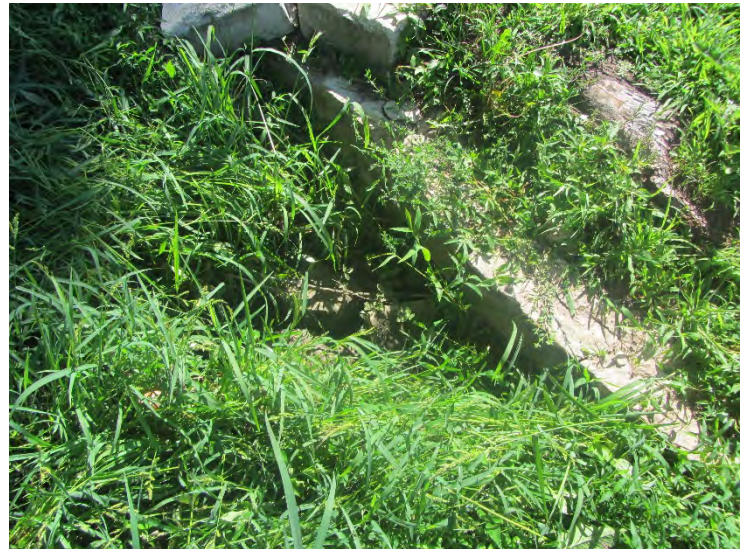
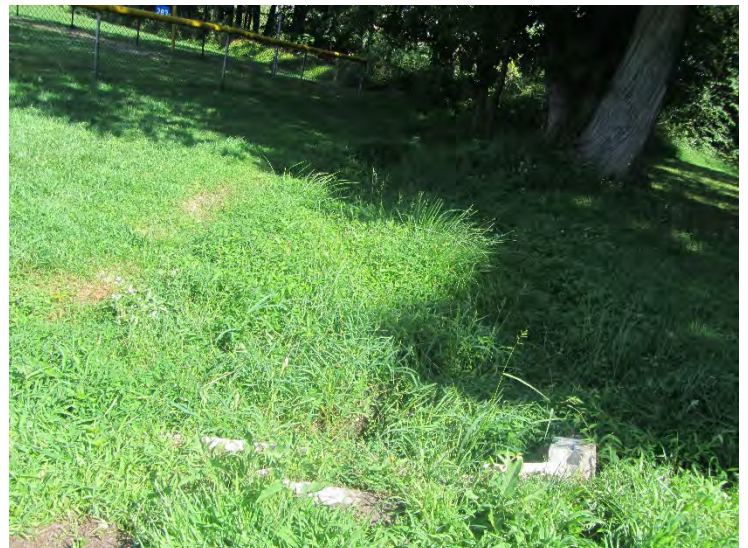
- Outfall pipe is estimated to be 16" in diameter
- Reinforced concrete pipe
- Known commercial discharges
- Grey water
- Sediment deposits
- Headwall has collapsed
- Excessive vegetation growth is causing standing water conditions

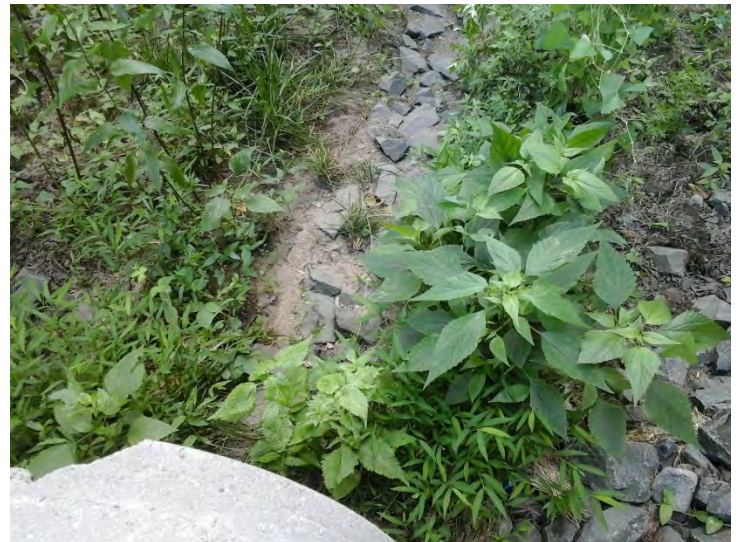
- 25" diameter concrete pipe
- Sediment deposits
- Outfall has excessive sediment accumulation
- Outfall pipe is cracking

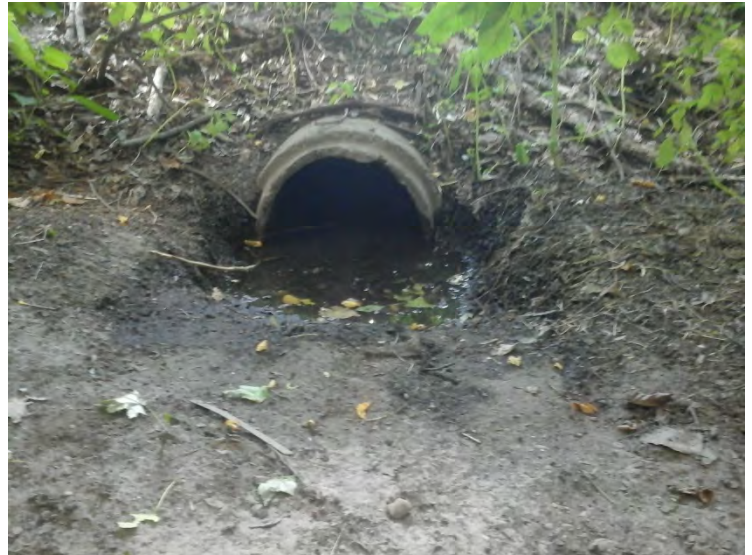
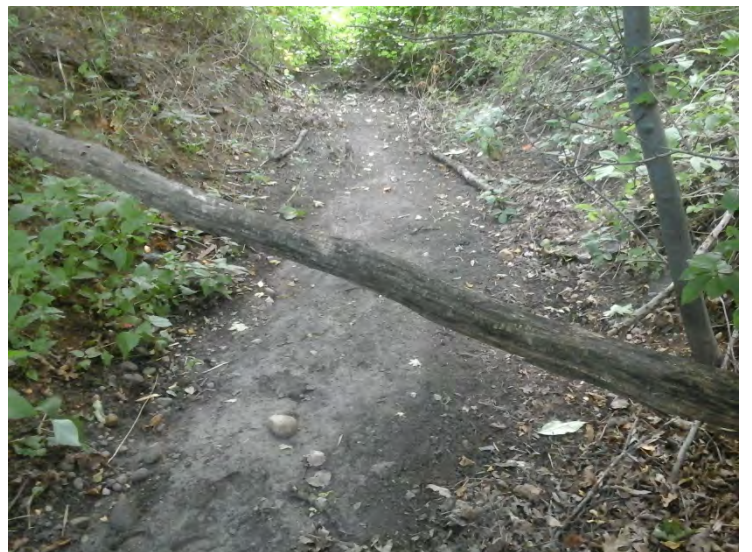
- 16" diameter concrete pipe
- Brown water
- Sediment deposits
- Outfall pipe is cracking
- Erosion has undermined outfall stability

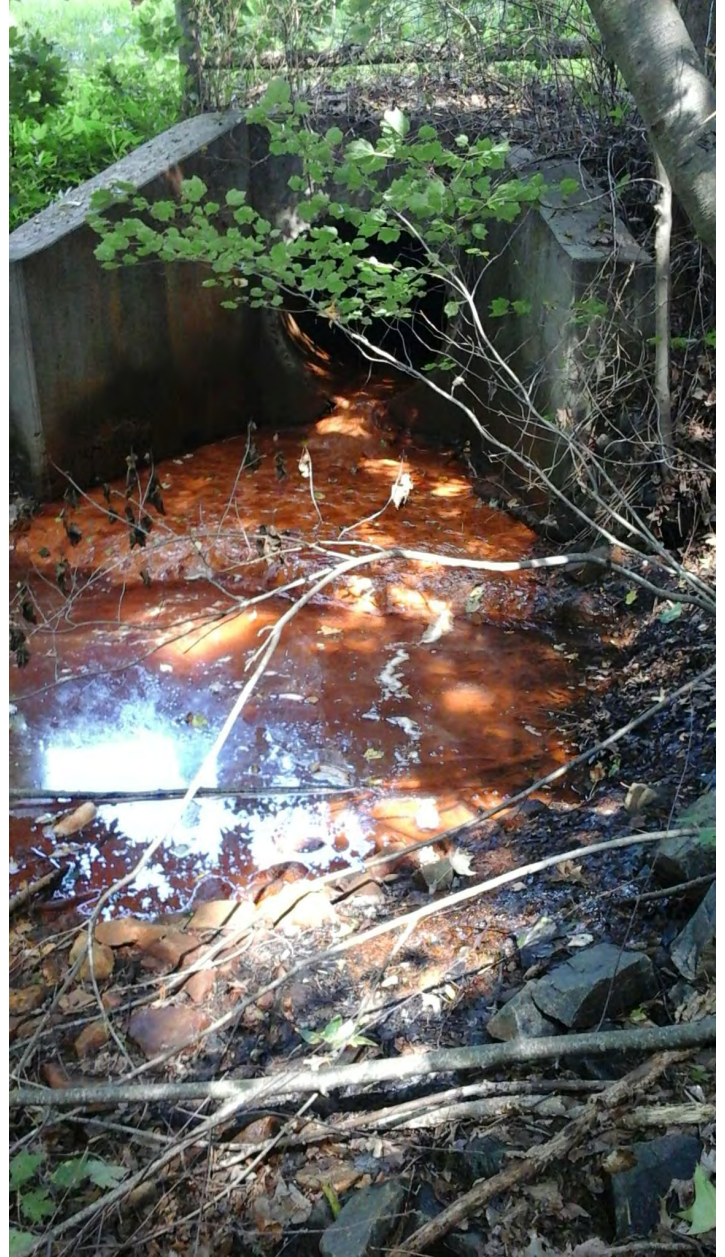
- 38" diameter concrete pipe
- No erosion identified
- Red-orange, cloudy water
- Some cracking in outfall pipe

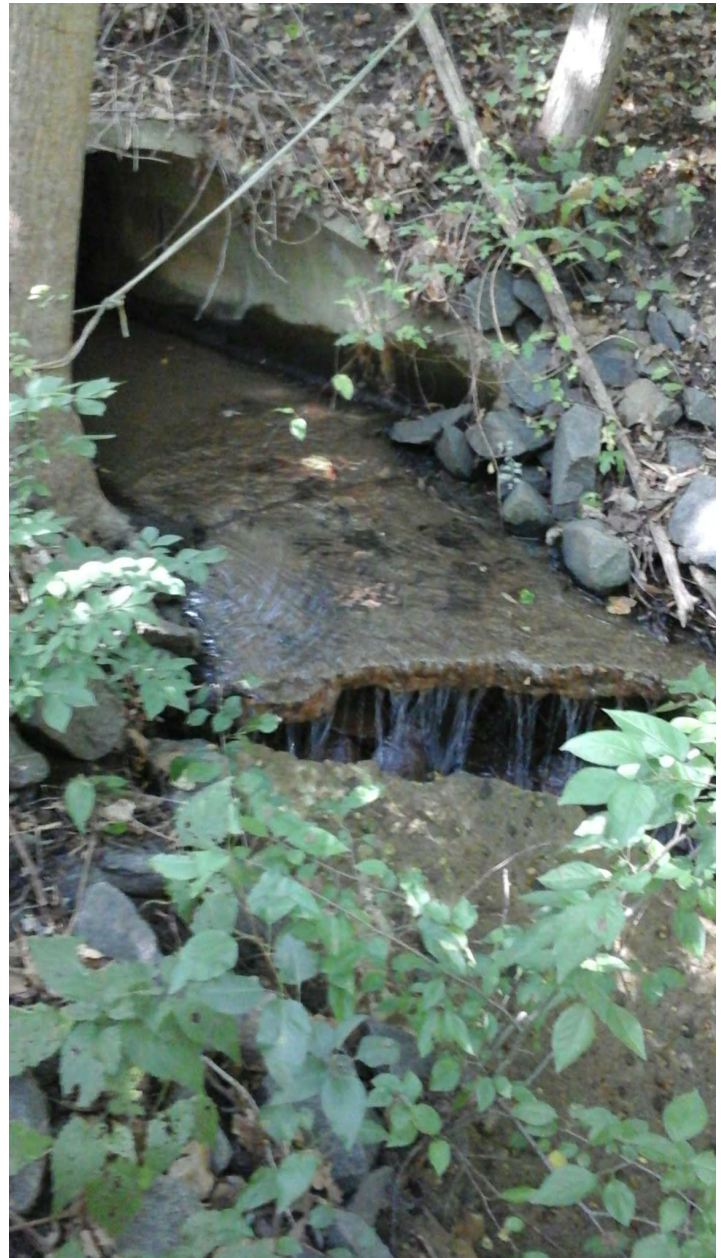
- 24.5" diameter concrete pipe
- Significant erosion is occurring due to drop caused by deteriorating outfall
- Erosion is undermining the stability of outfall with severe deterioration of the concrete flow pad
- Brown, clear water
- Excessive vegetative growth

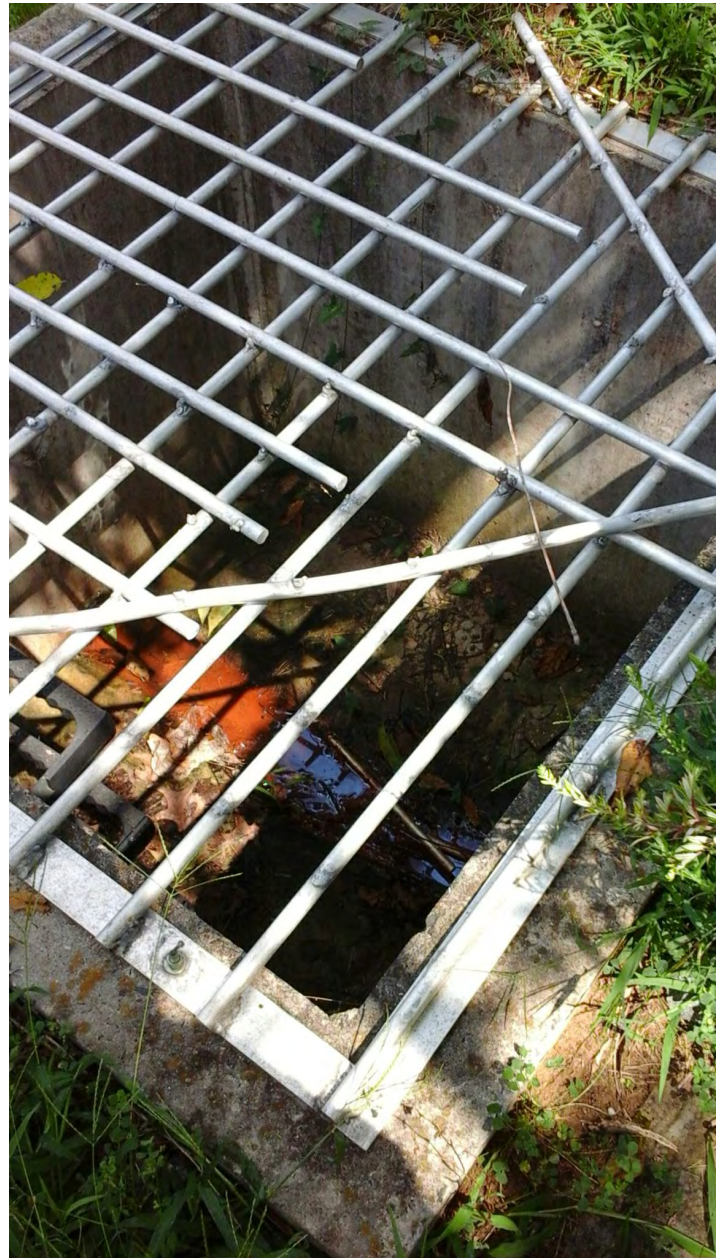
- 16" diameter concrete pipe
- No erosion identified
- Outfall grate damaged
- Brown, cloudy water
- Oil deposits
- Excessive vegetative growth

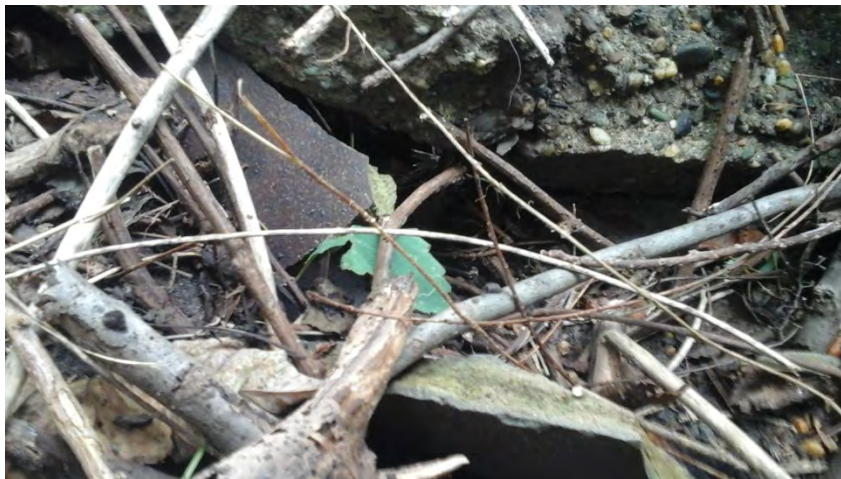
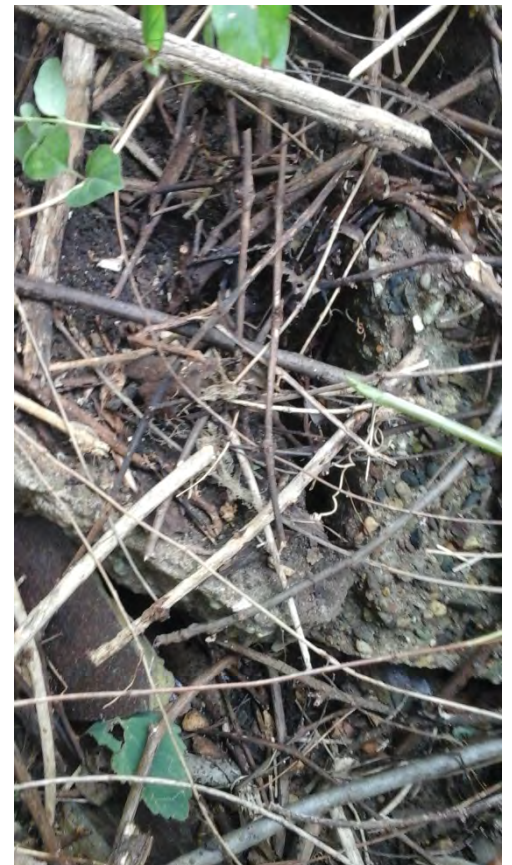
- 20" diameter concrete pipe
- Clear water
- Sediment deposits
- Excessive vegetation growth
- Erosion has undermined the stability of the outfall. The extent of erosion damage is under 100 sq. ft.
- Outfall completely destroyed.

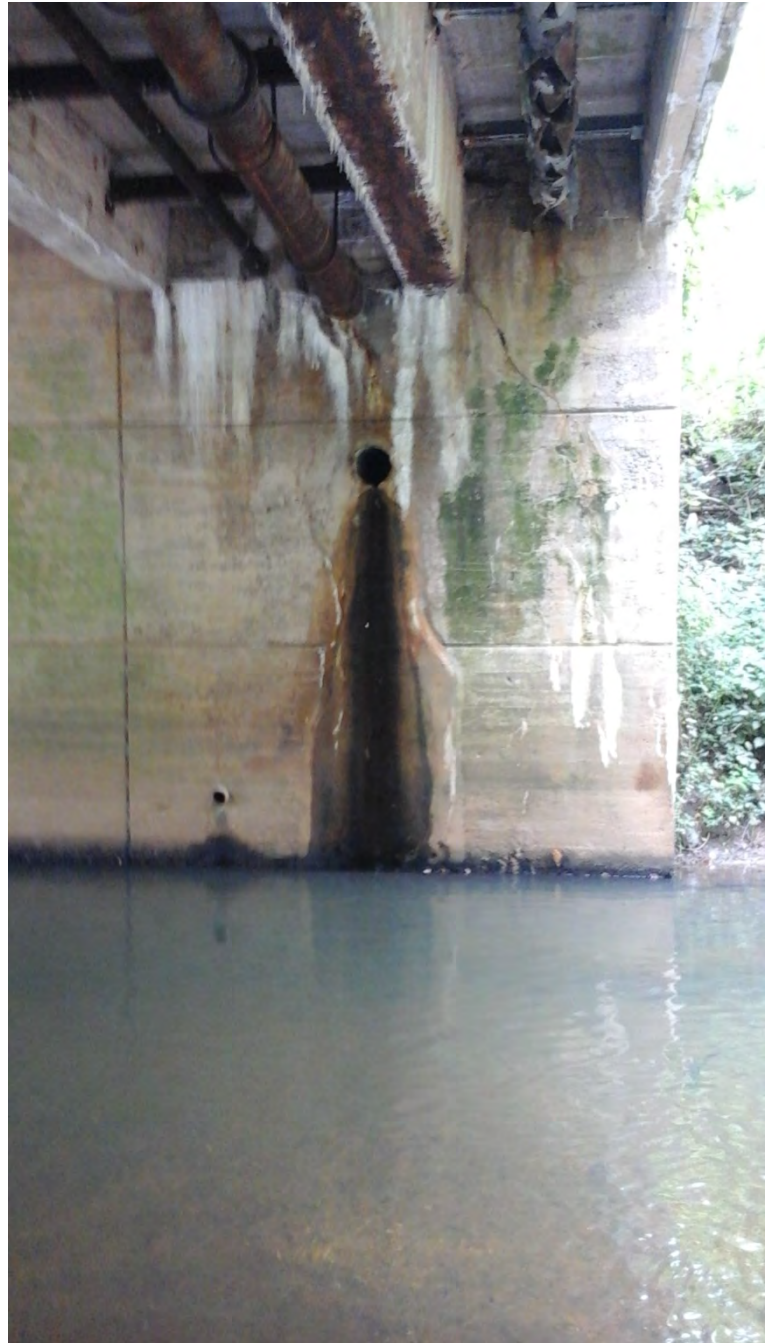
- 15" metal pipe
- Cloudy, brown water
- Outfall pipe is cracking

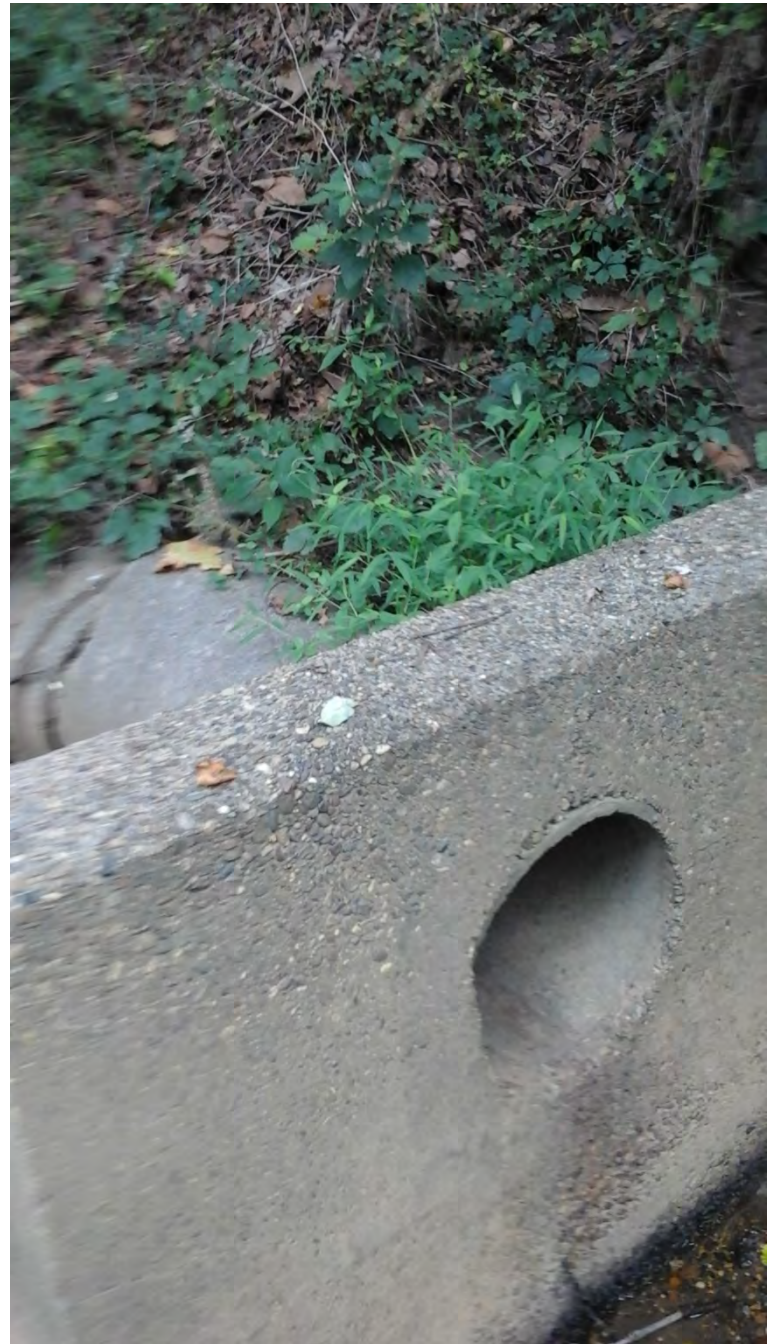
- 19" diameter concrete pipe
- Cloudy, green water
- Sediment deposits
- Outfall pipe is cracking
- Erosion has undermined the stability of the outfall. The extent of erosion damage is under 100 sq. ft.

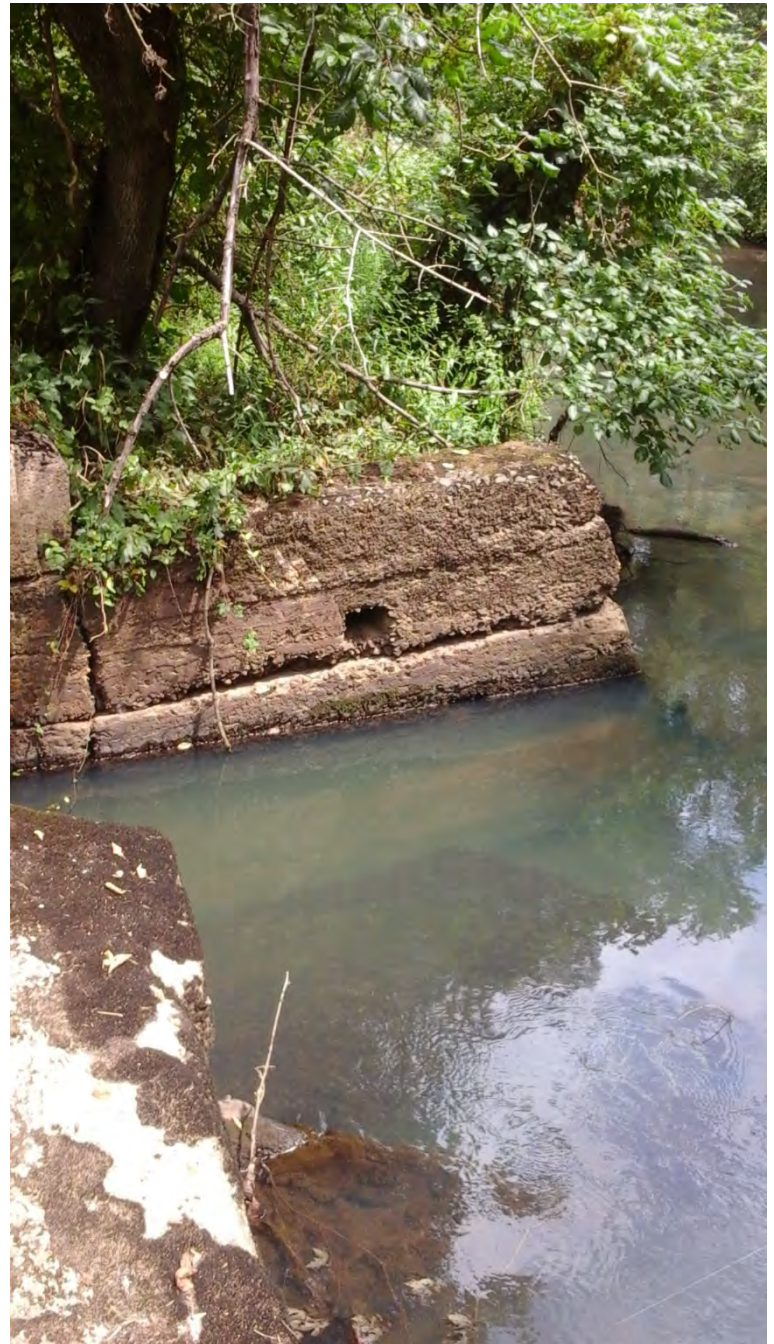
- 9" diameter concrete pipe
- Cloudy, green water
- Outfall pipe corrosion
- Erosion has undermined the stability of the outfall. The extent of erosion damage is under 100 sq. ft.

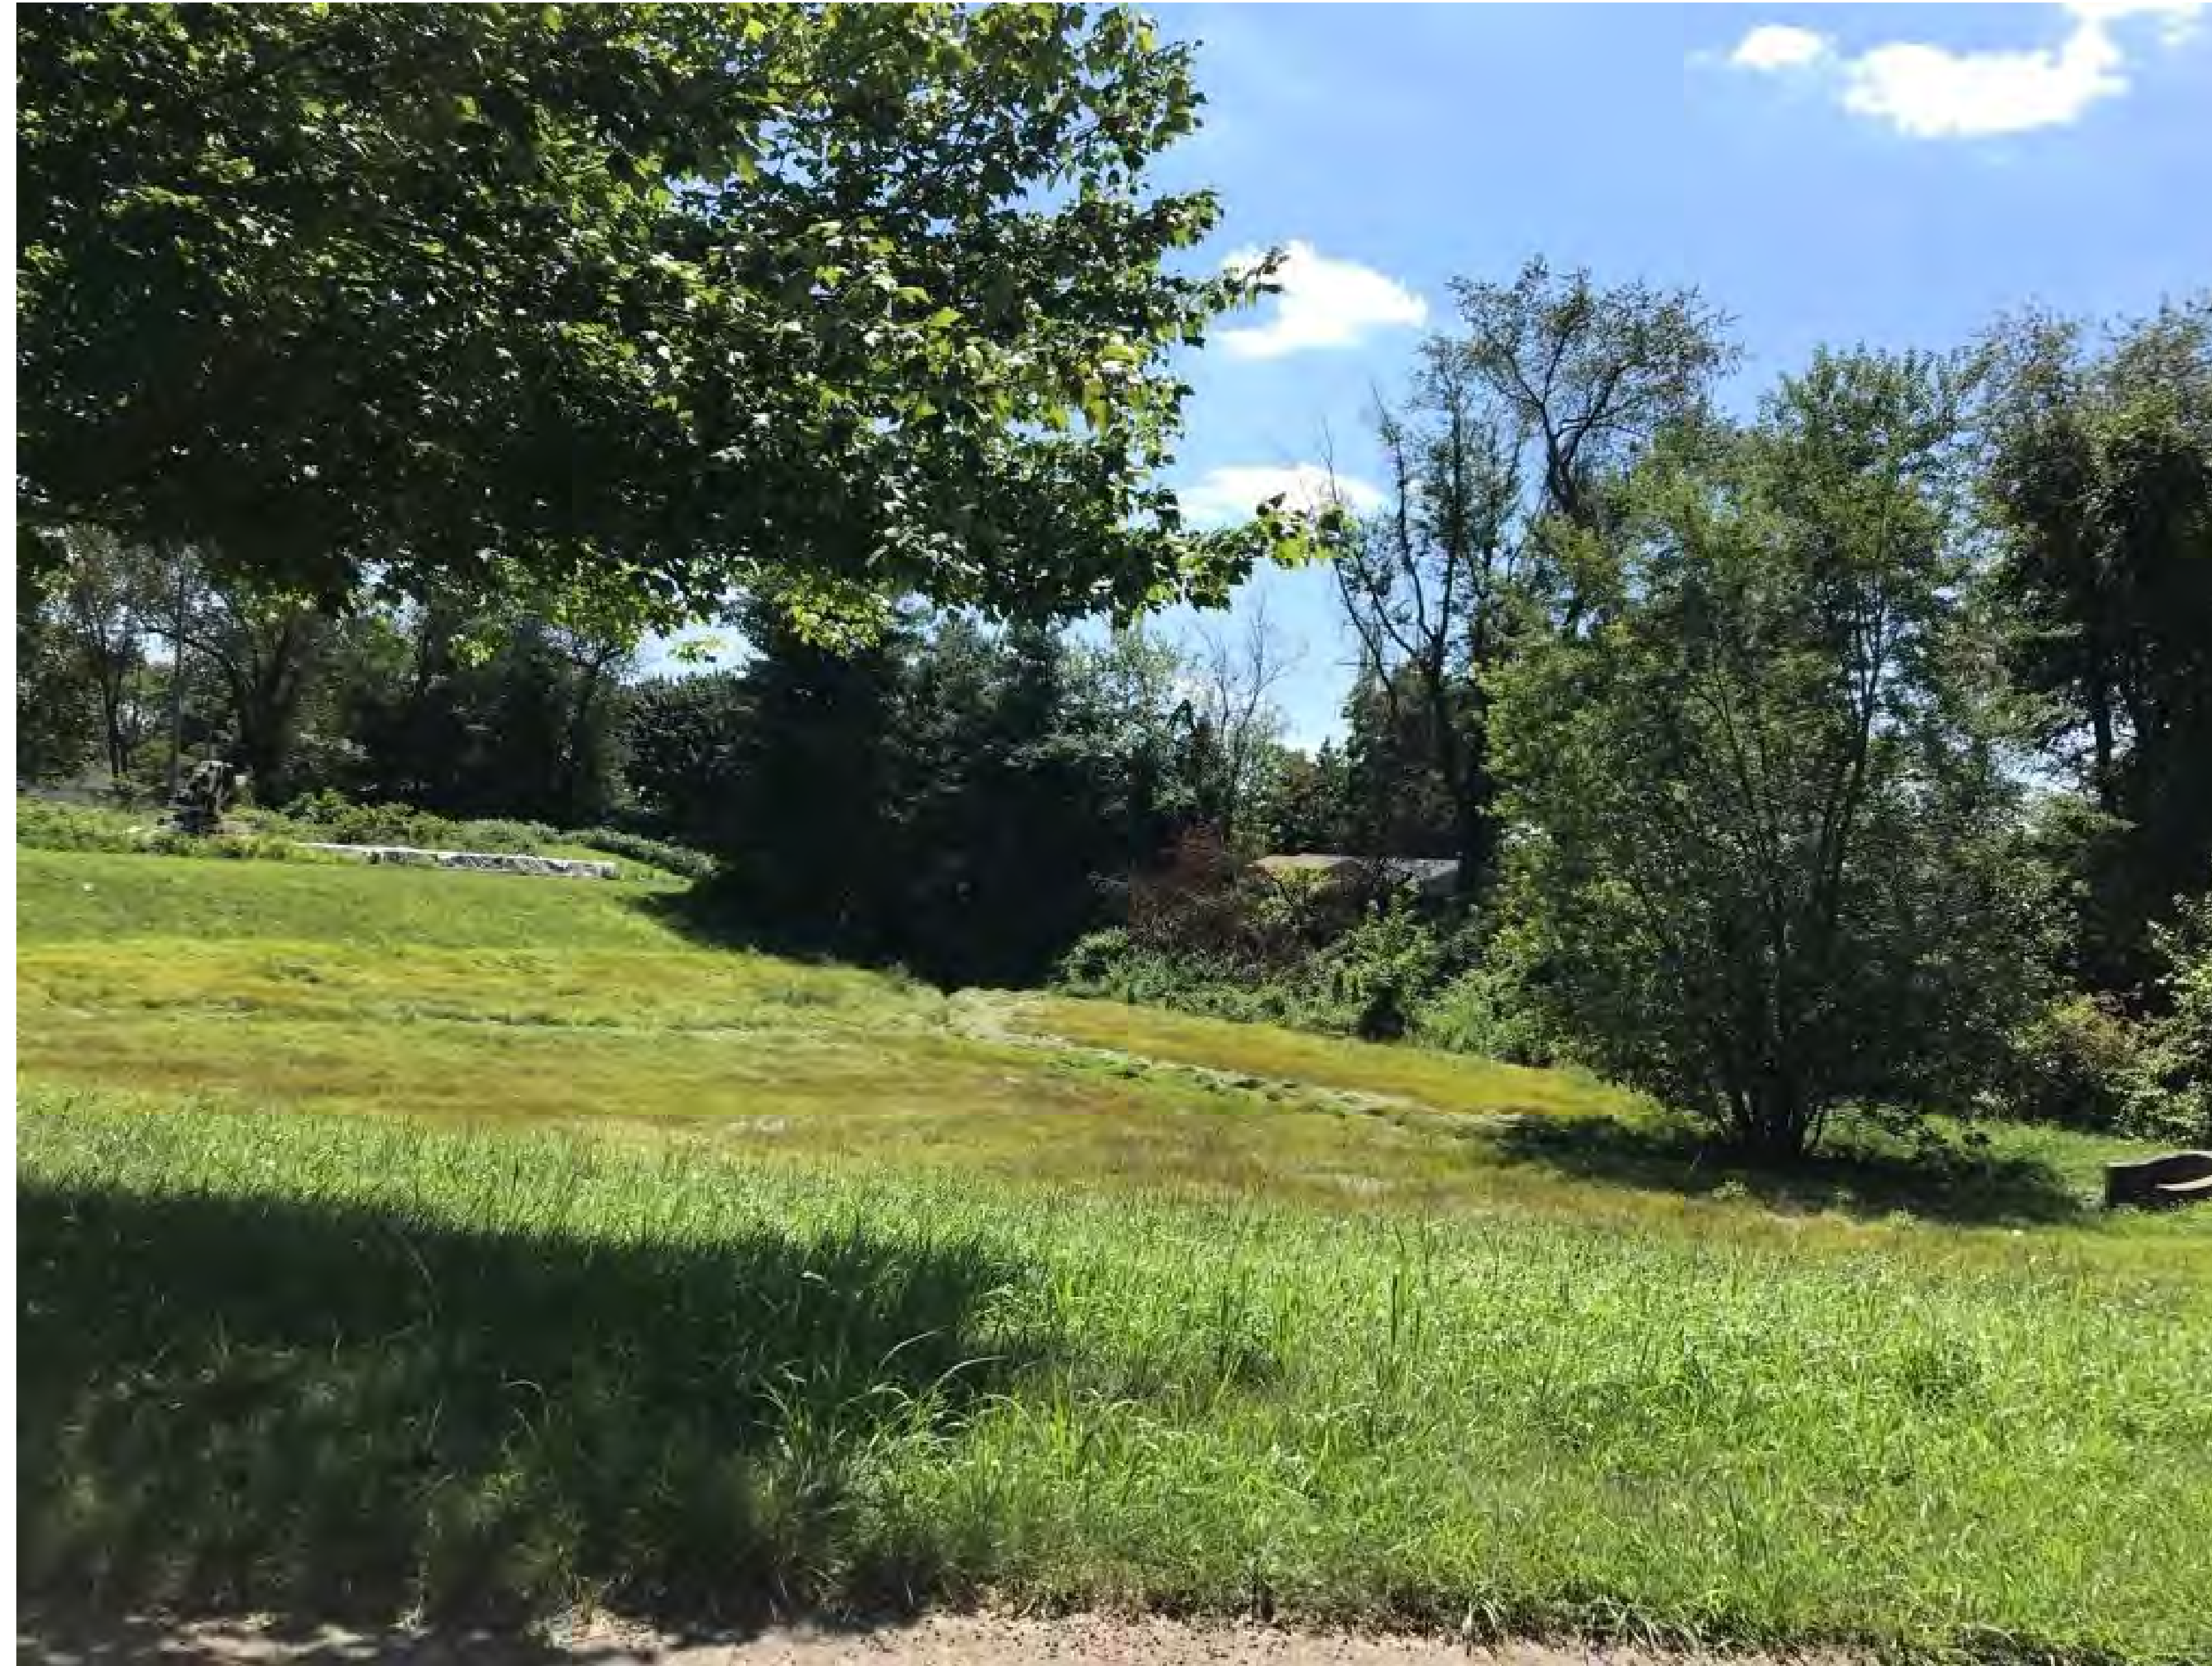
Address:  
4 Tara Ct  
Trenton, NJ 08619

- Two inlets and one outlet
- Concrete low flow channel has grass growing over it
- Opportunity to remove concrete low flow channels and replace with a stone channel

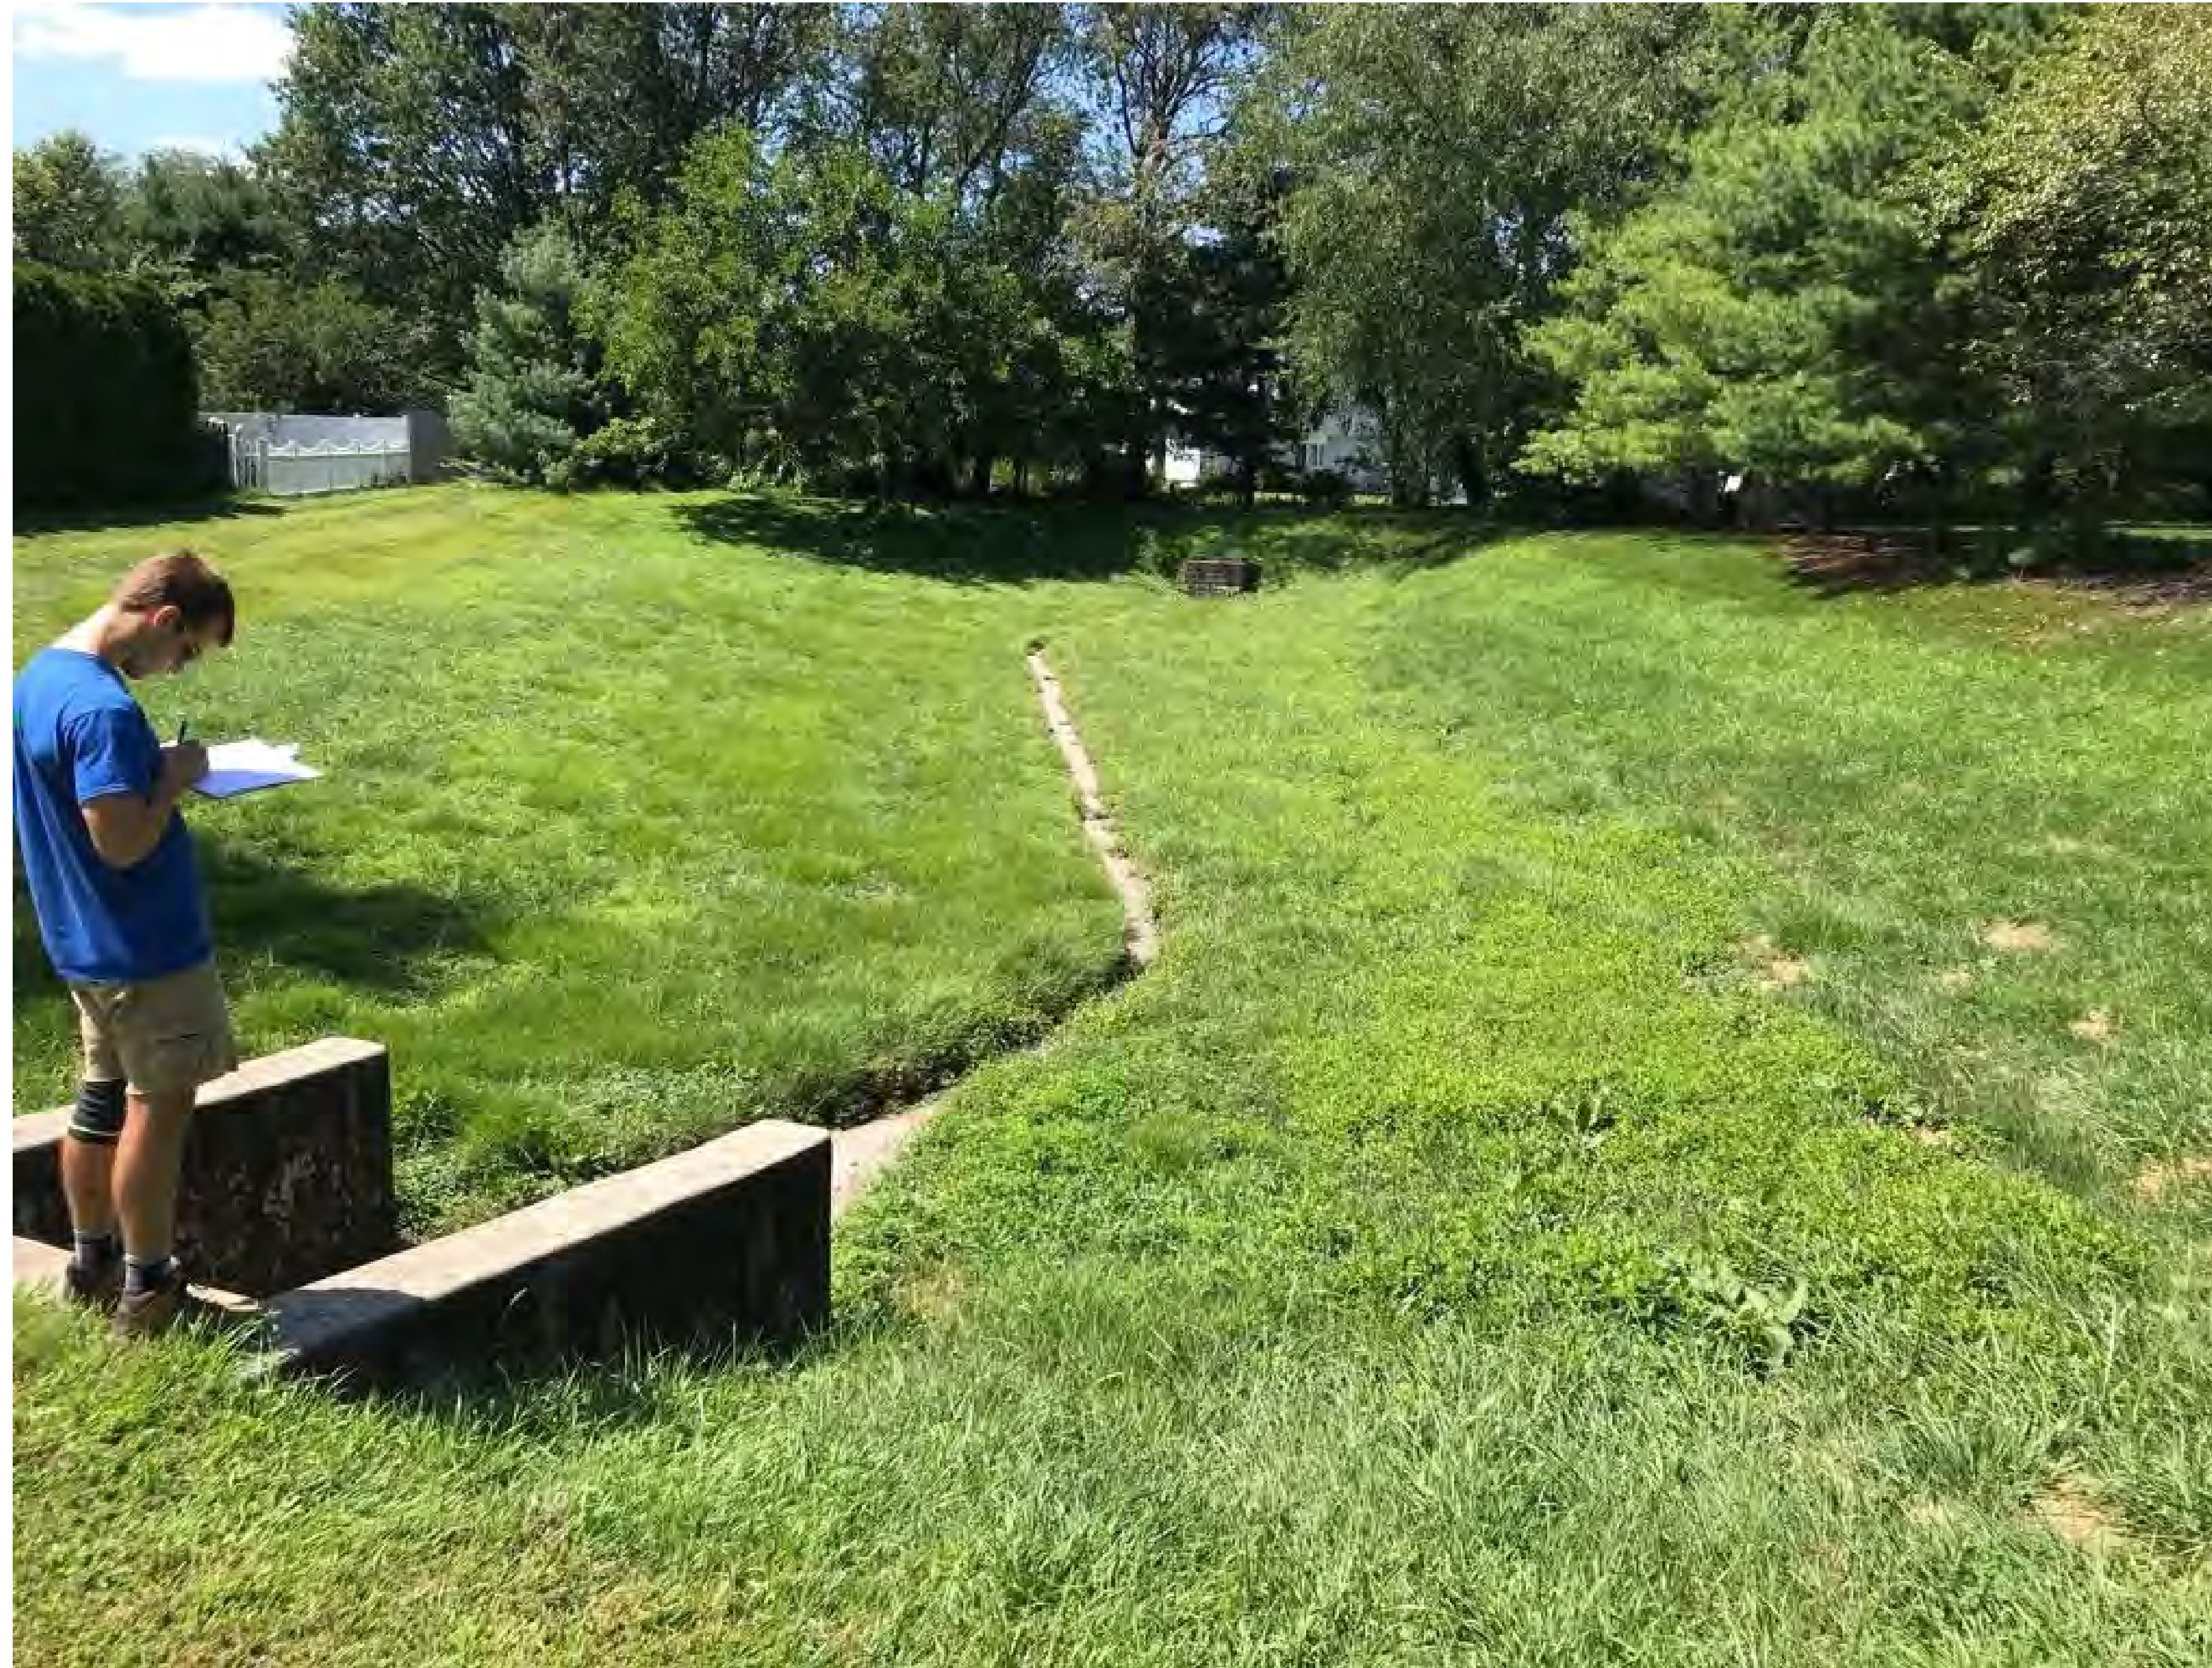
Address:  
30 Tar Heels Rd E  
Hamilton Township, NJ 08619

- Typical detention basin in good condition with one inlet and one outlet
- Rock flow channel opportunity
- Low flow channel could be removed and basin allowed to naturalize by reducing mowing

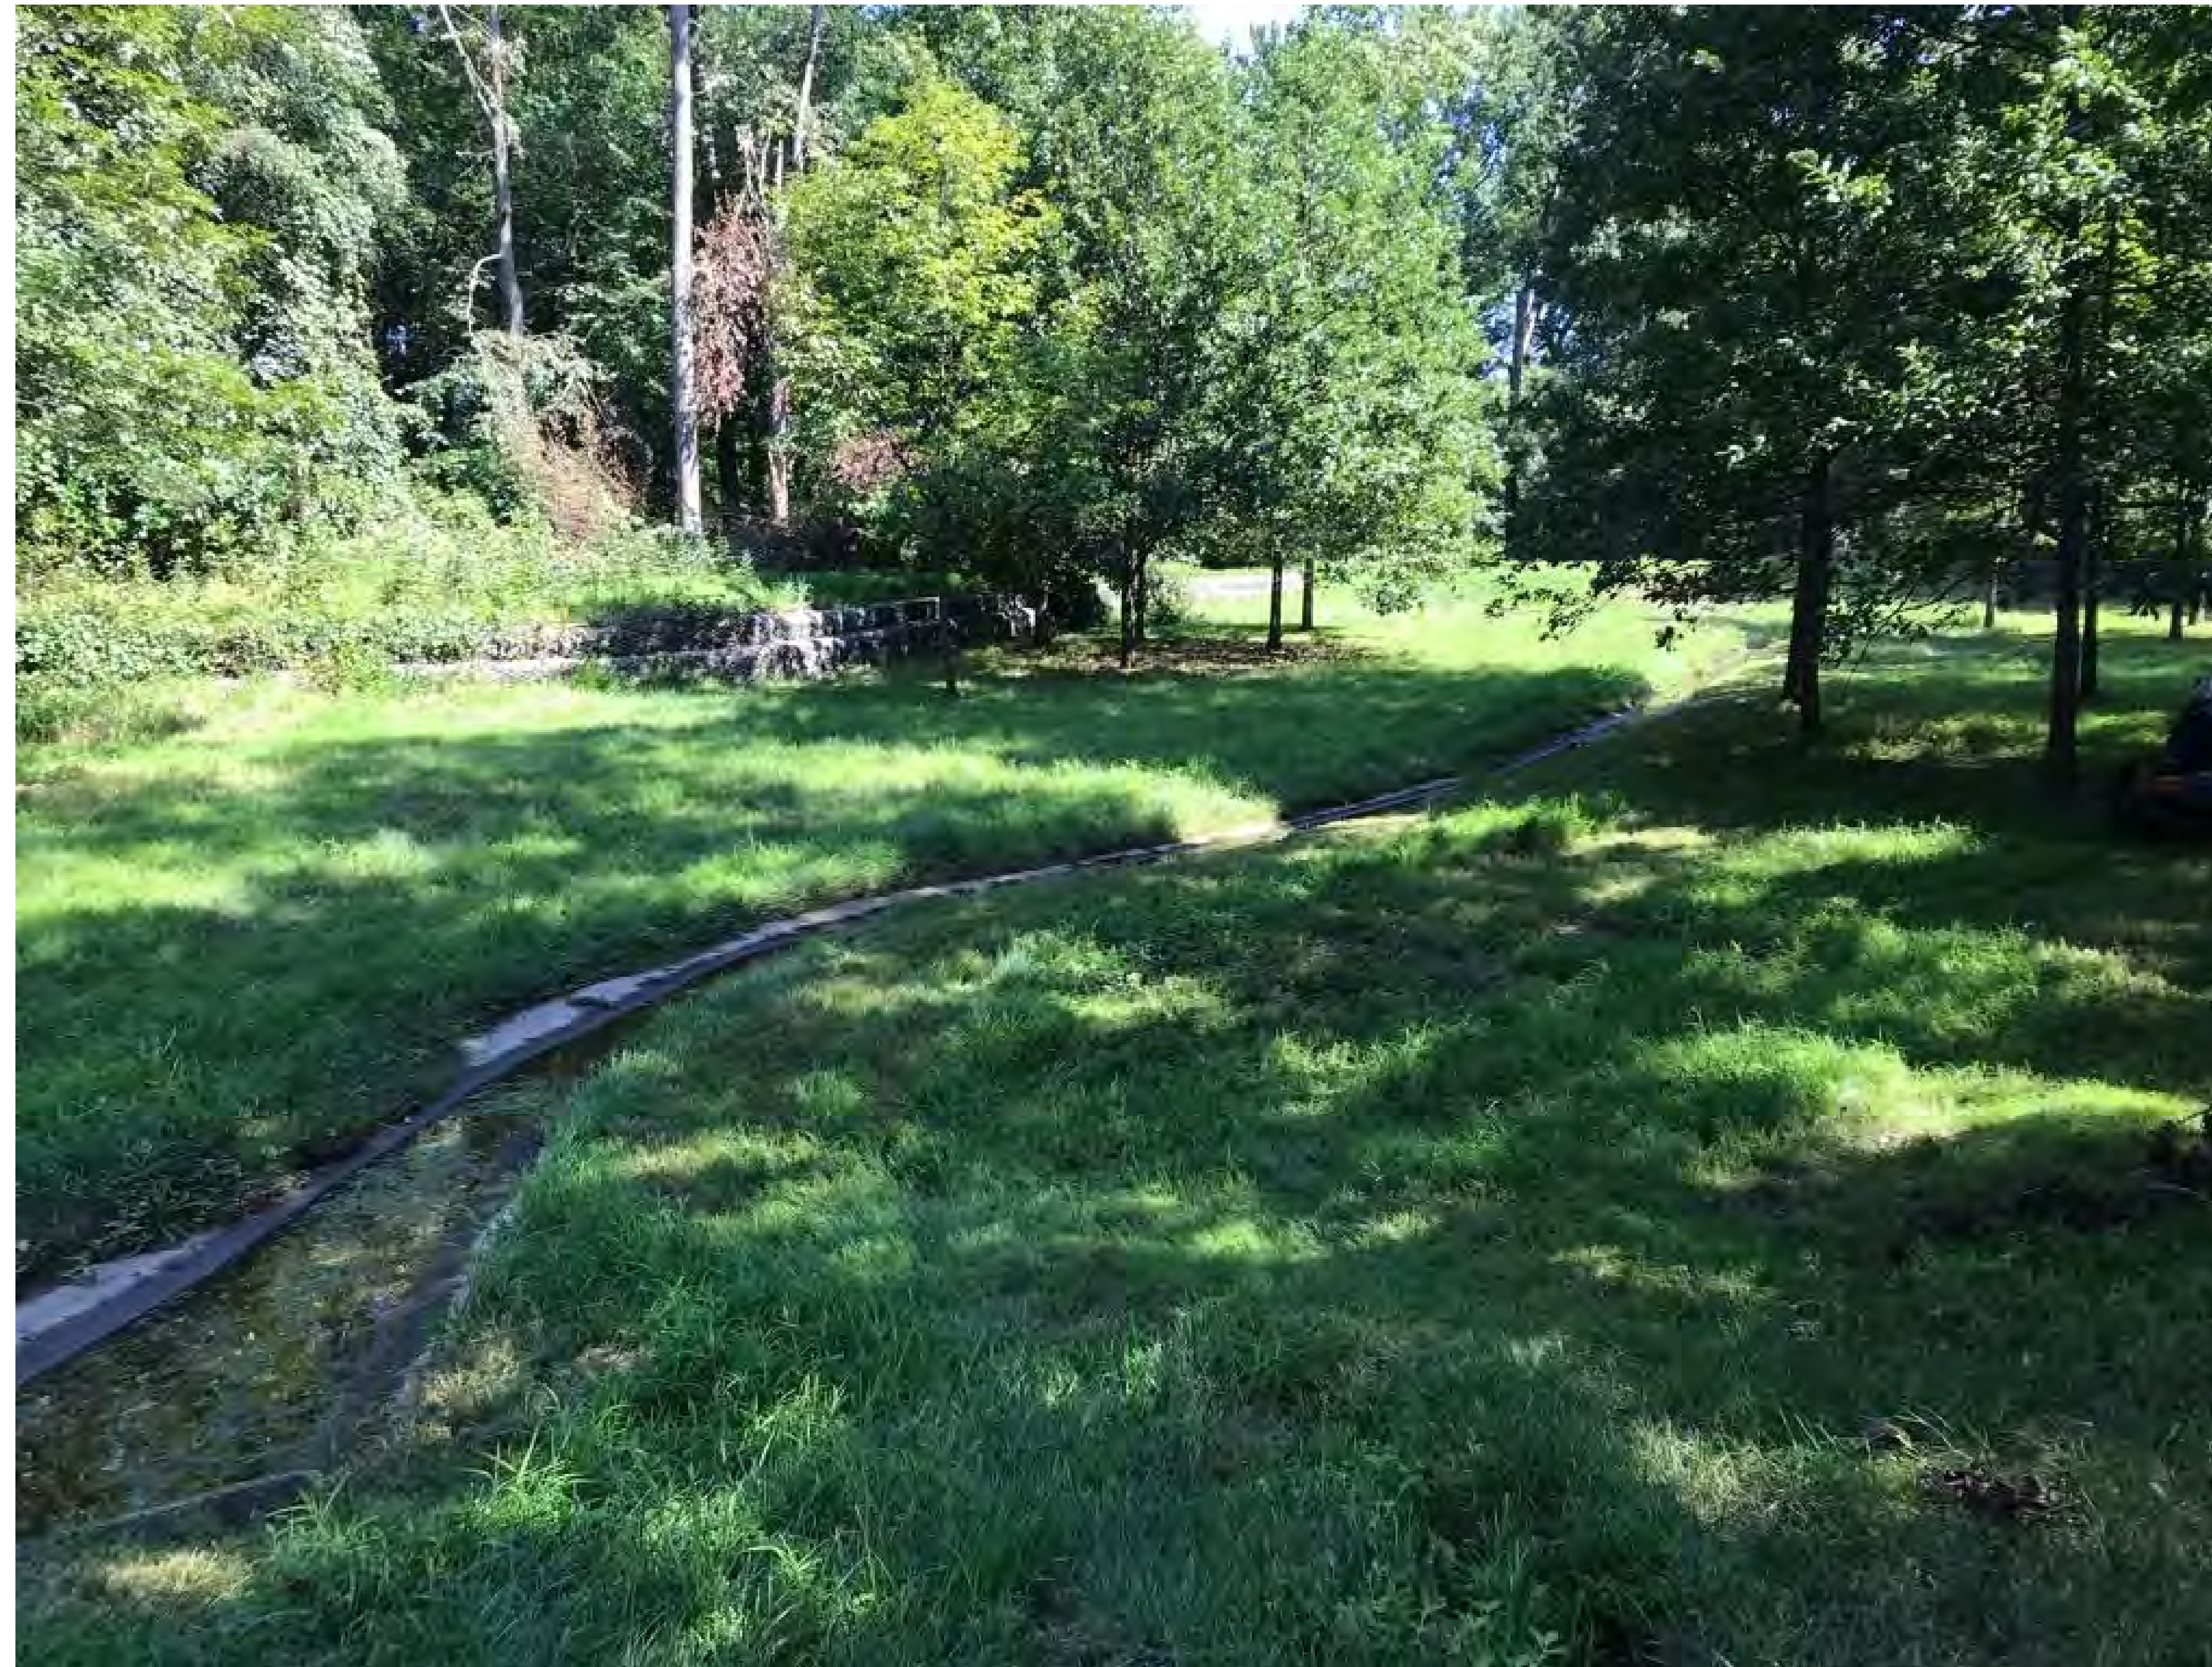
Address:  
5 Fordham Dr  
Trenton, NJ 08619

- Standing water present in the low flow channel, and large amounts of vegetation around basin
- Low flow channel could be removed to promote infiltration instead of the standing water that is present.
