## Hamilton Township (Mercer County)

# REVIEW AND EVALUATION OF TOTAL MAXIMUM DAILY LOADS (TMDLs)

Developed by the Rutgers Cooperative Extension Water Resources Program  
Funded by Hamilton Township, Mercer County, New Jersey

December 5, 2019

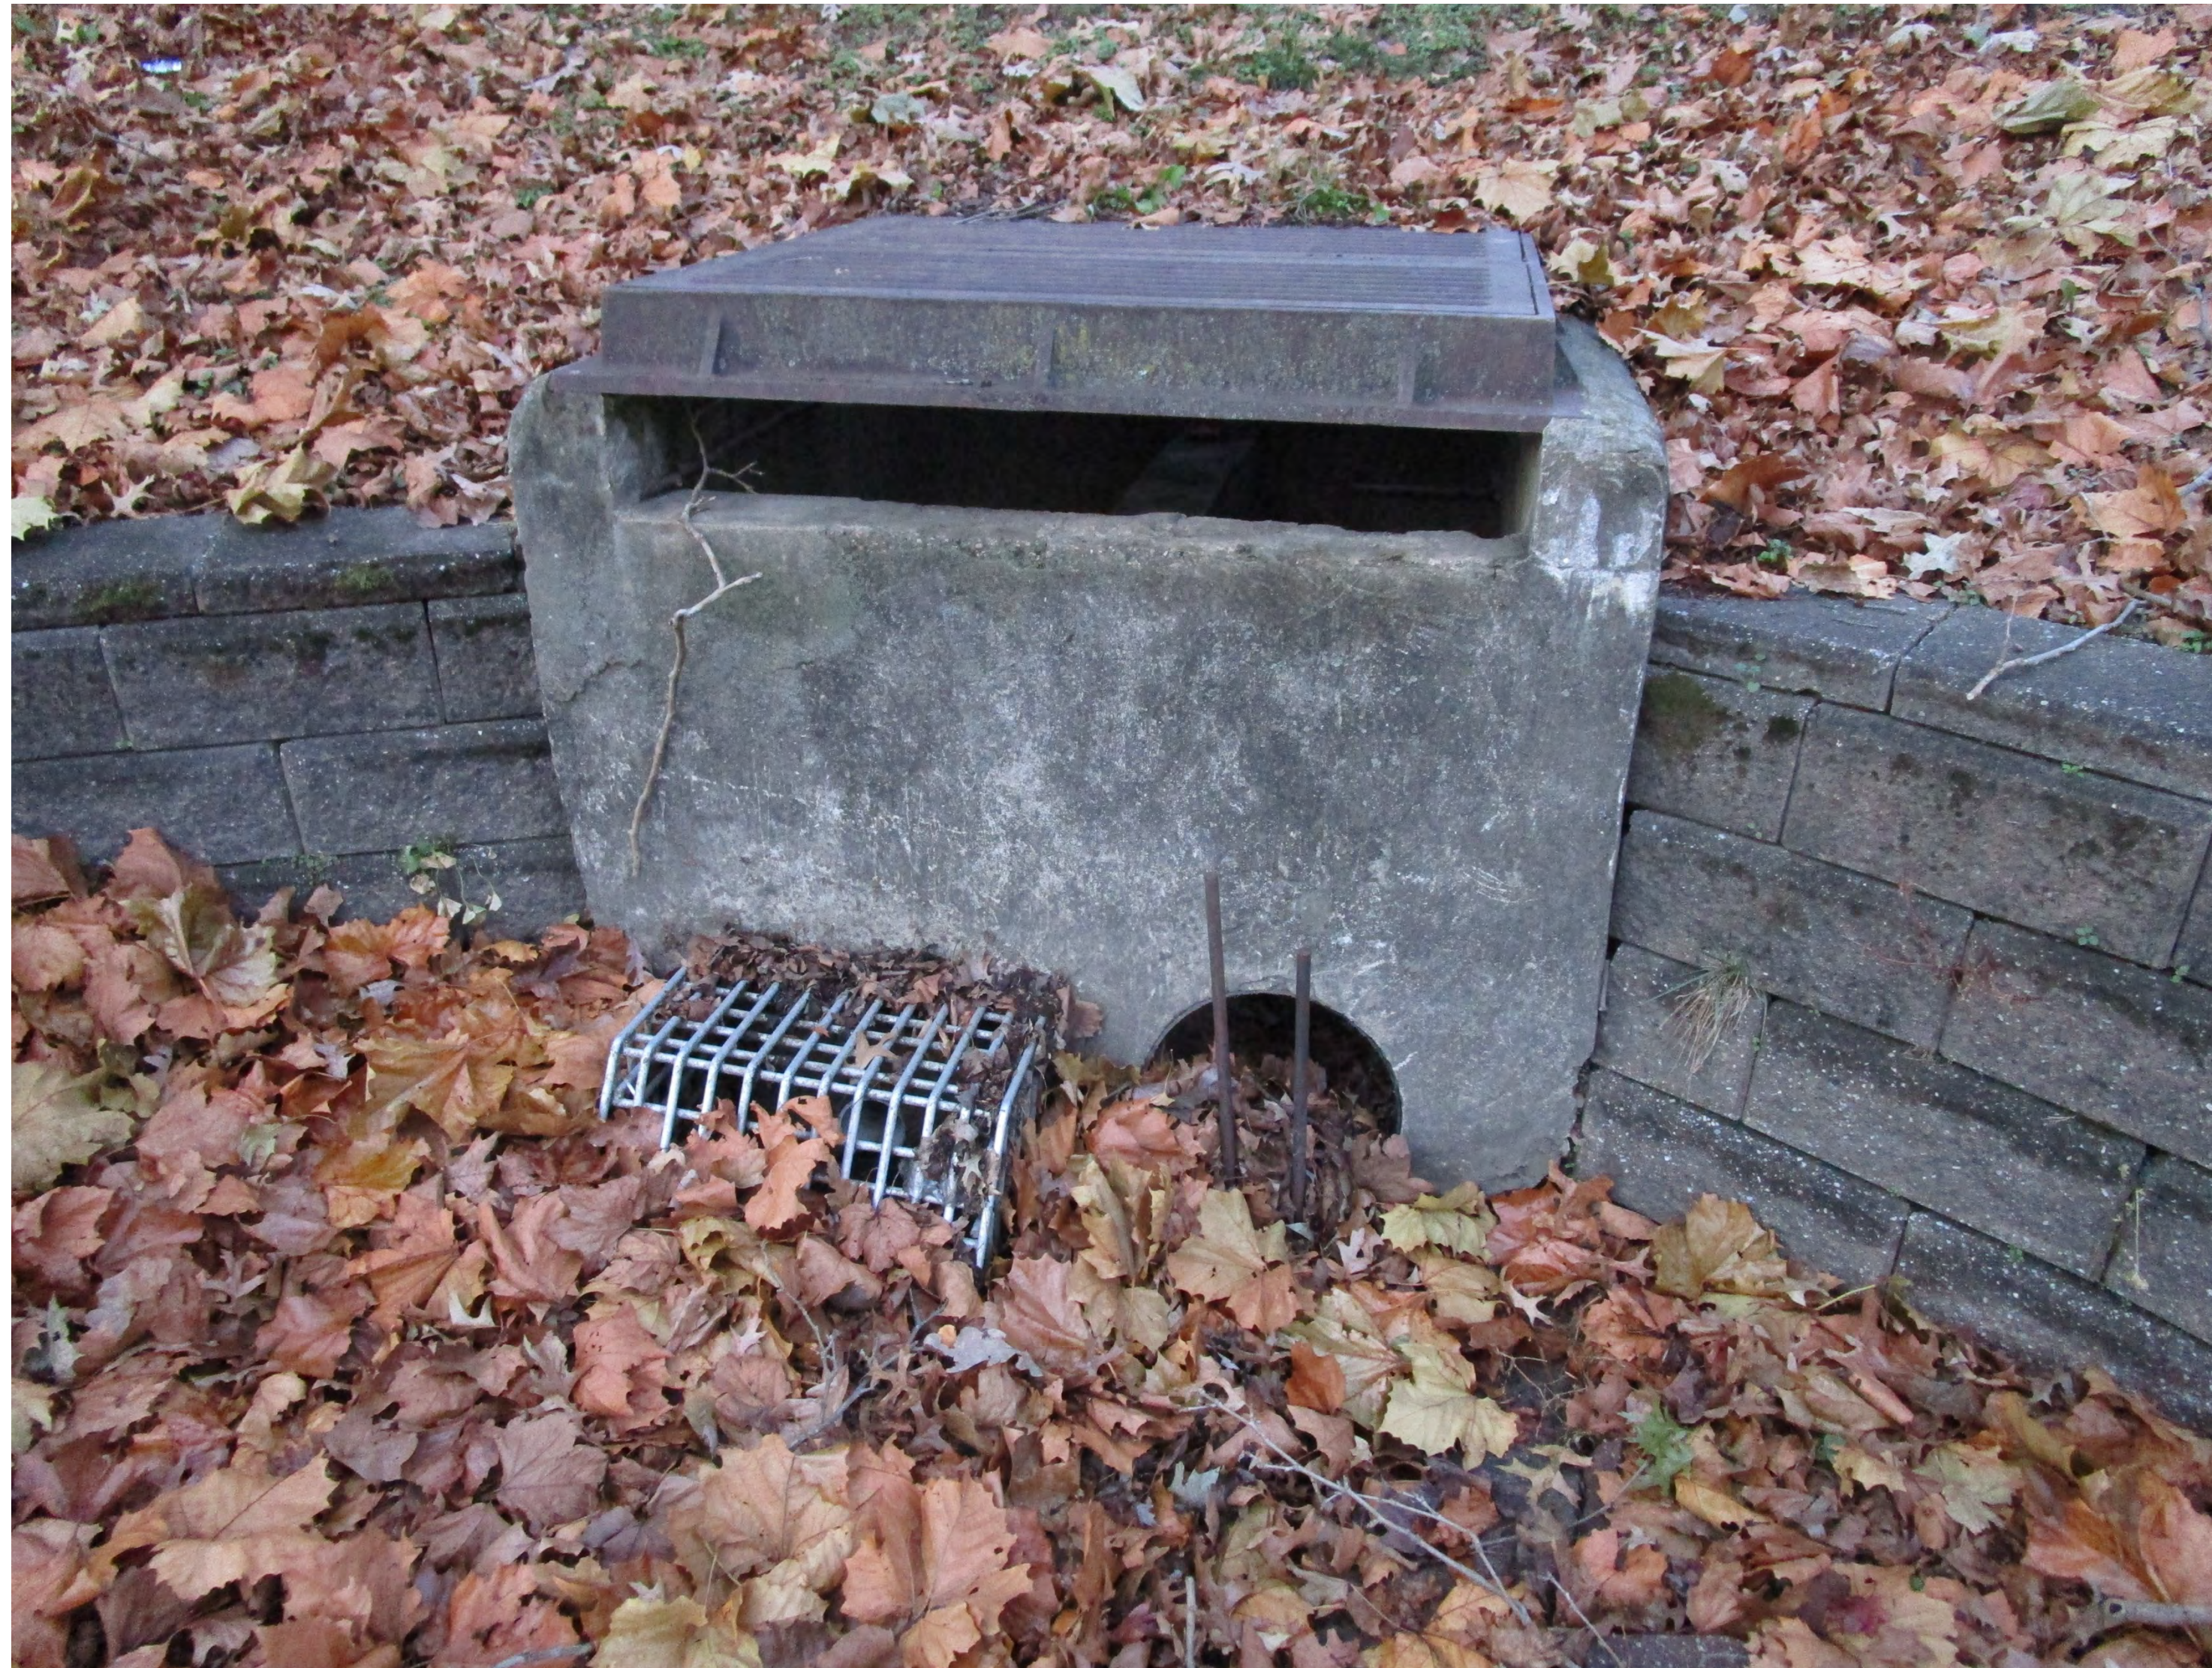
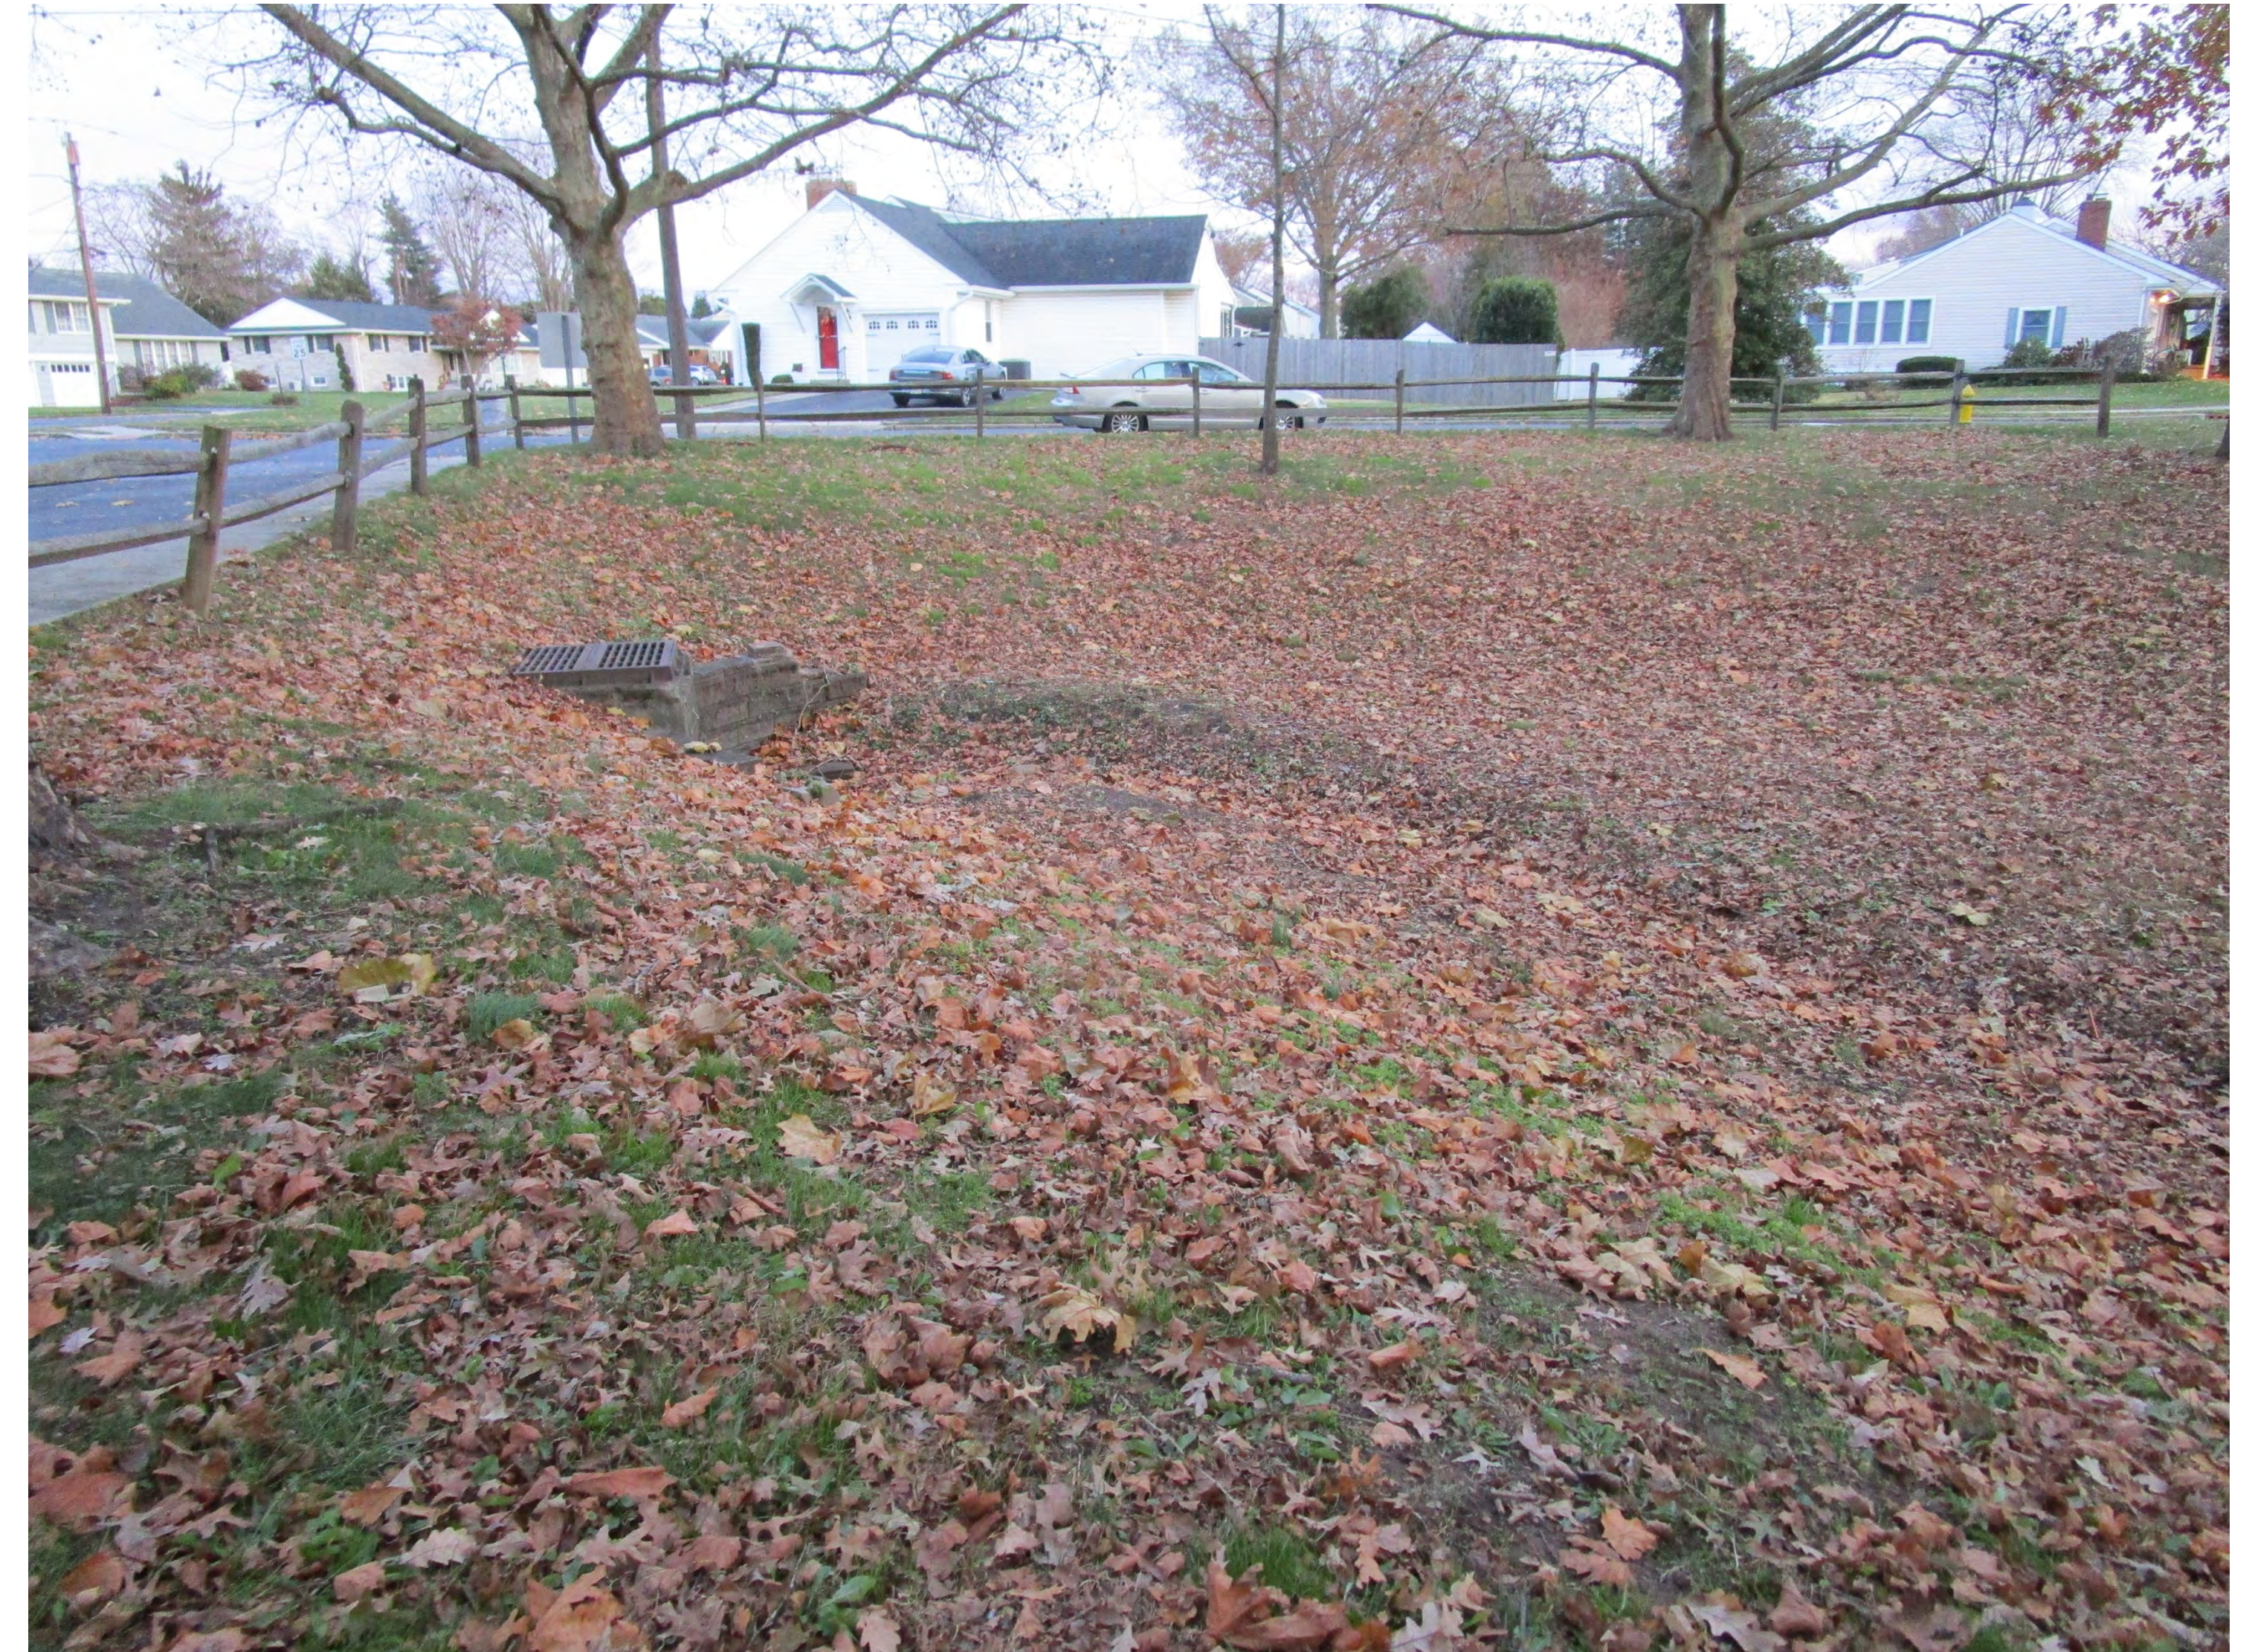
Address:  
200 Mercer Street  
Trenton, NJ 08690

- Basin in overall good condition
- Some slight scouring along main flow channel
- Outlet clogged with leaves

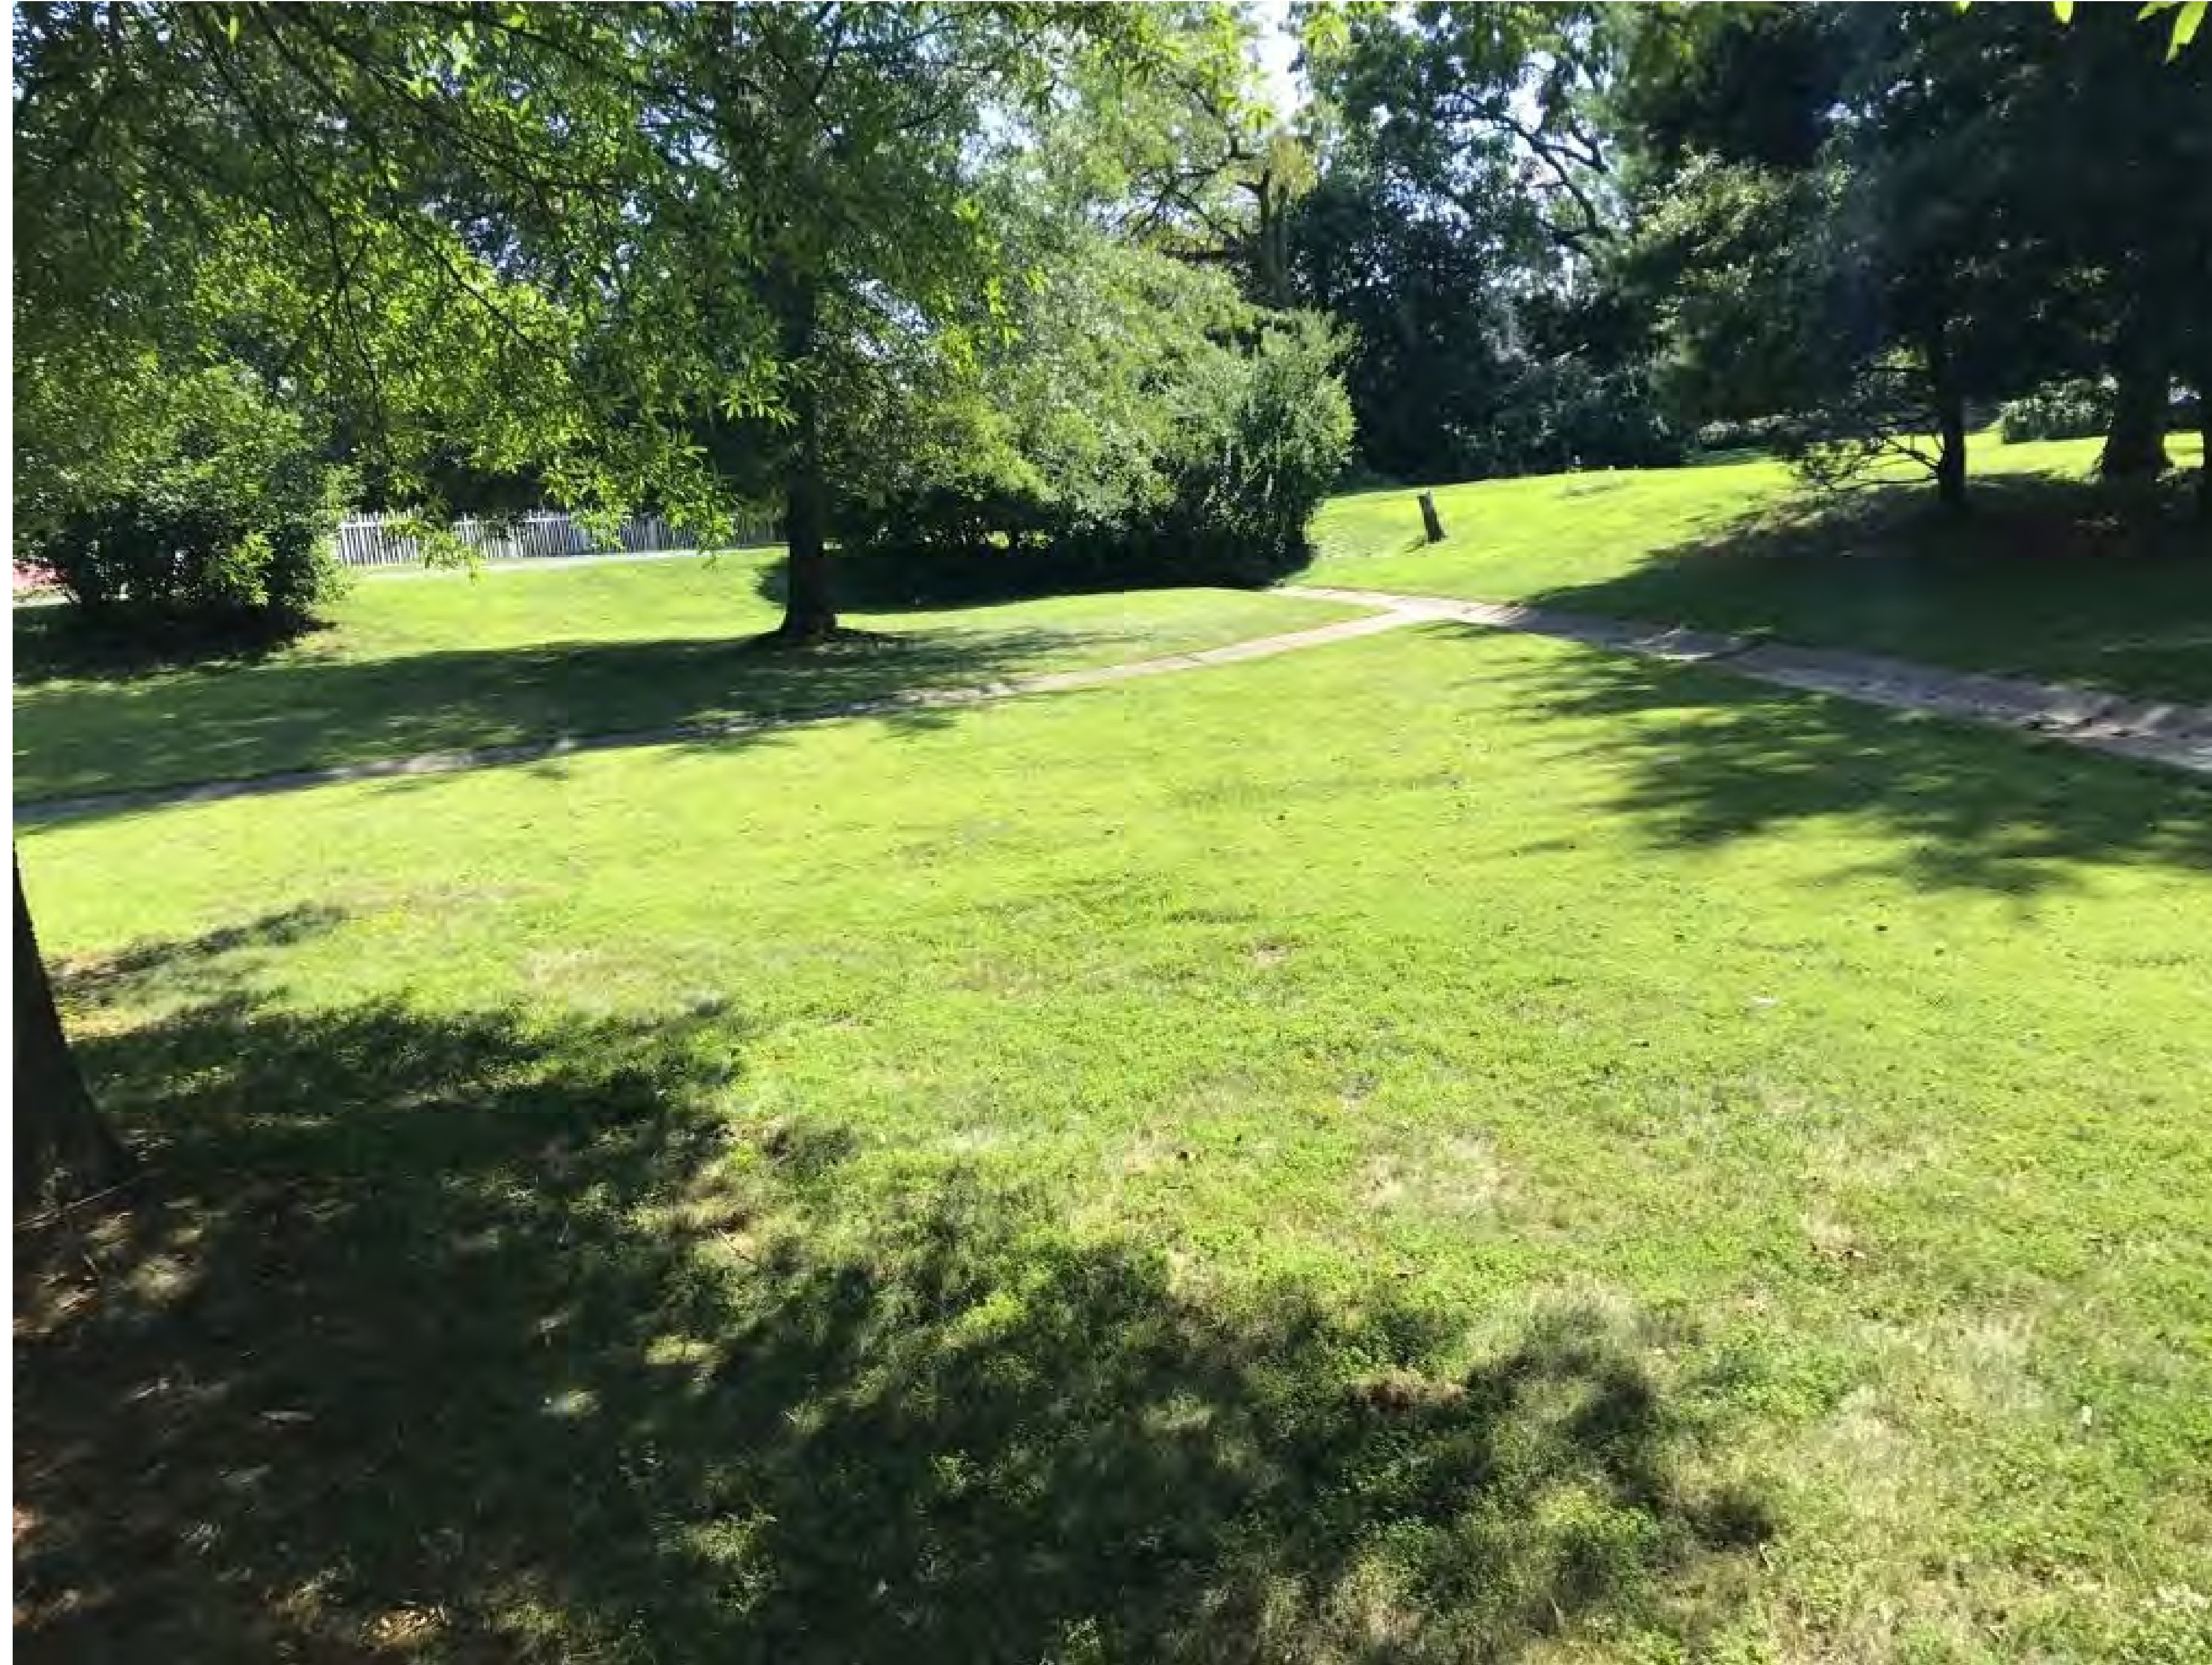
Address:  
10 Emily Pl  
Hamilton Township, NJ 08690

- Heavily maintained detention basin in good condition
- Mown with trees around perimeter
- Remove low flow channel to promote more infiltration

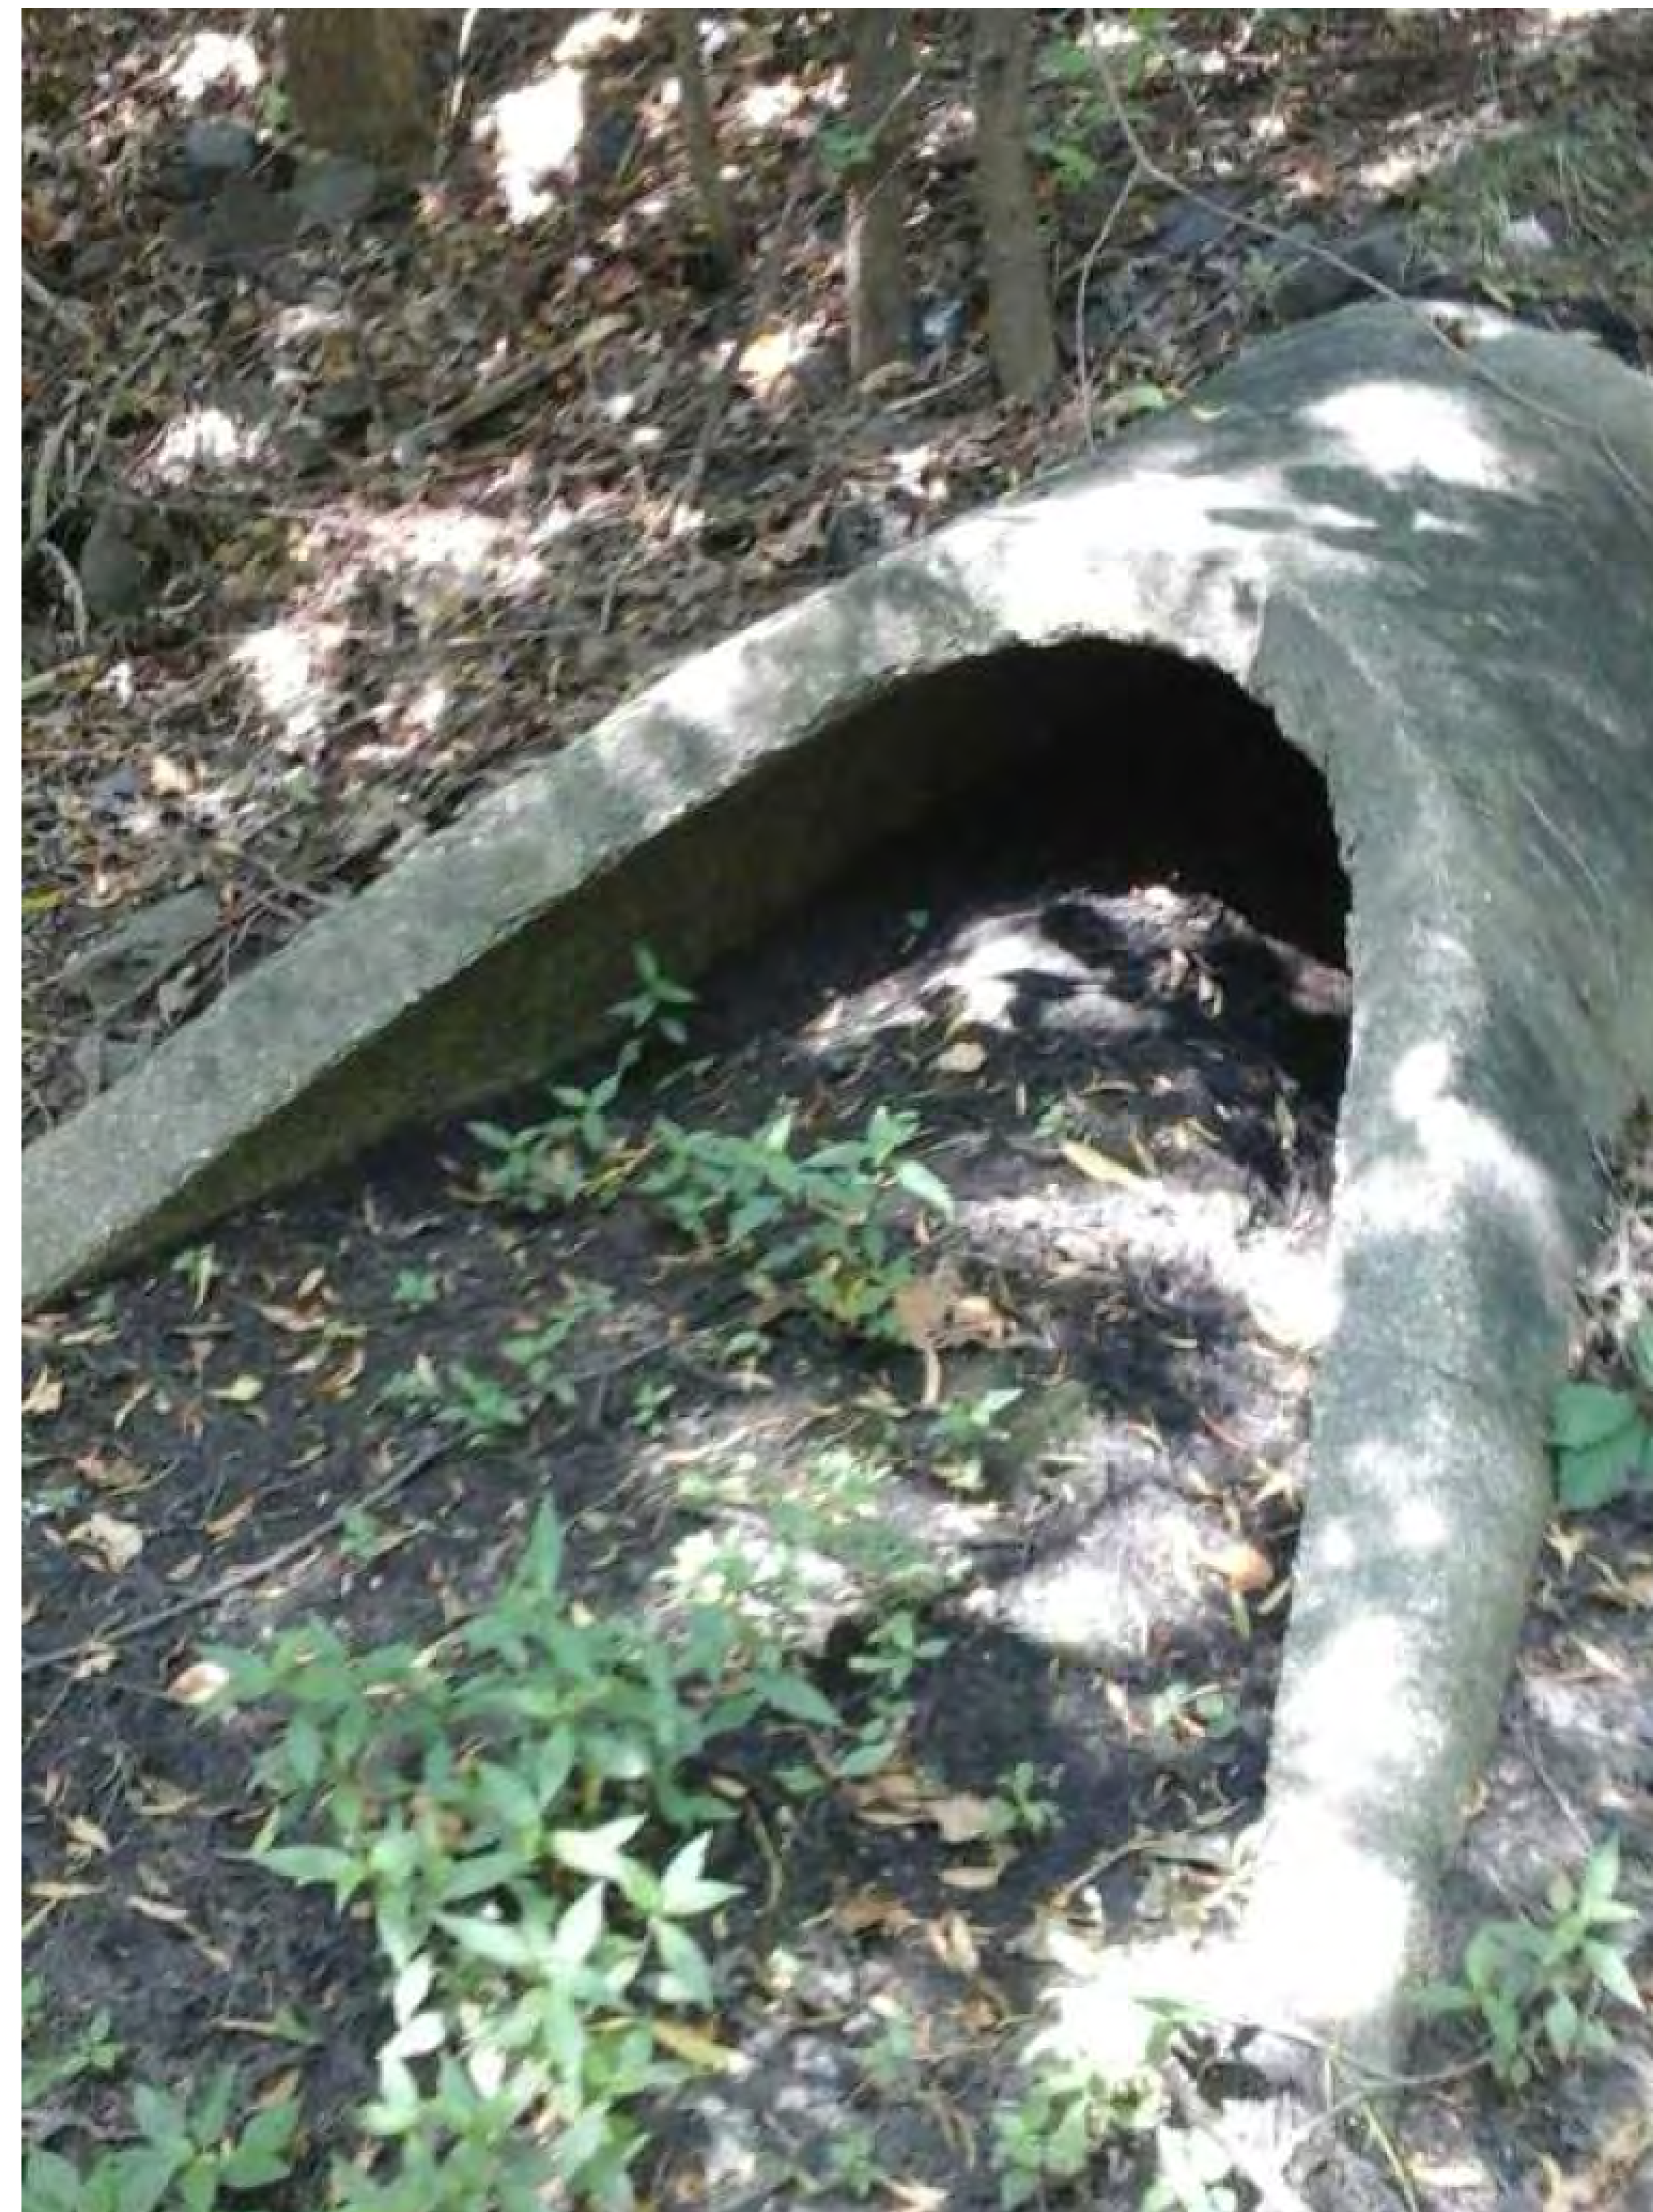
Address:  
Estates Blvd and Trenton Ave  
Hamilton Township, NJ 08619

- Basin in good condition overall with two inlets
- Clean out inlets as they have accumulated sediment and restrict inflow

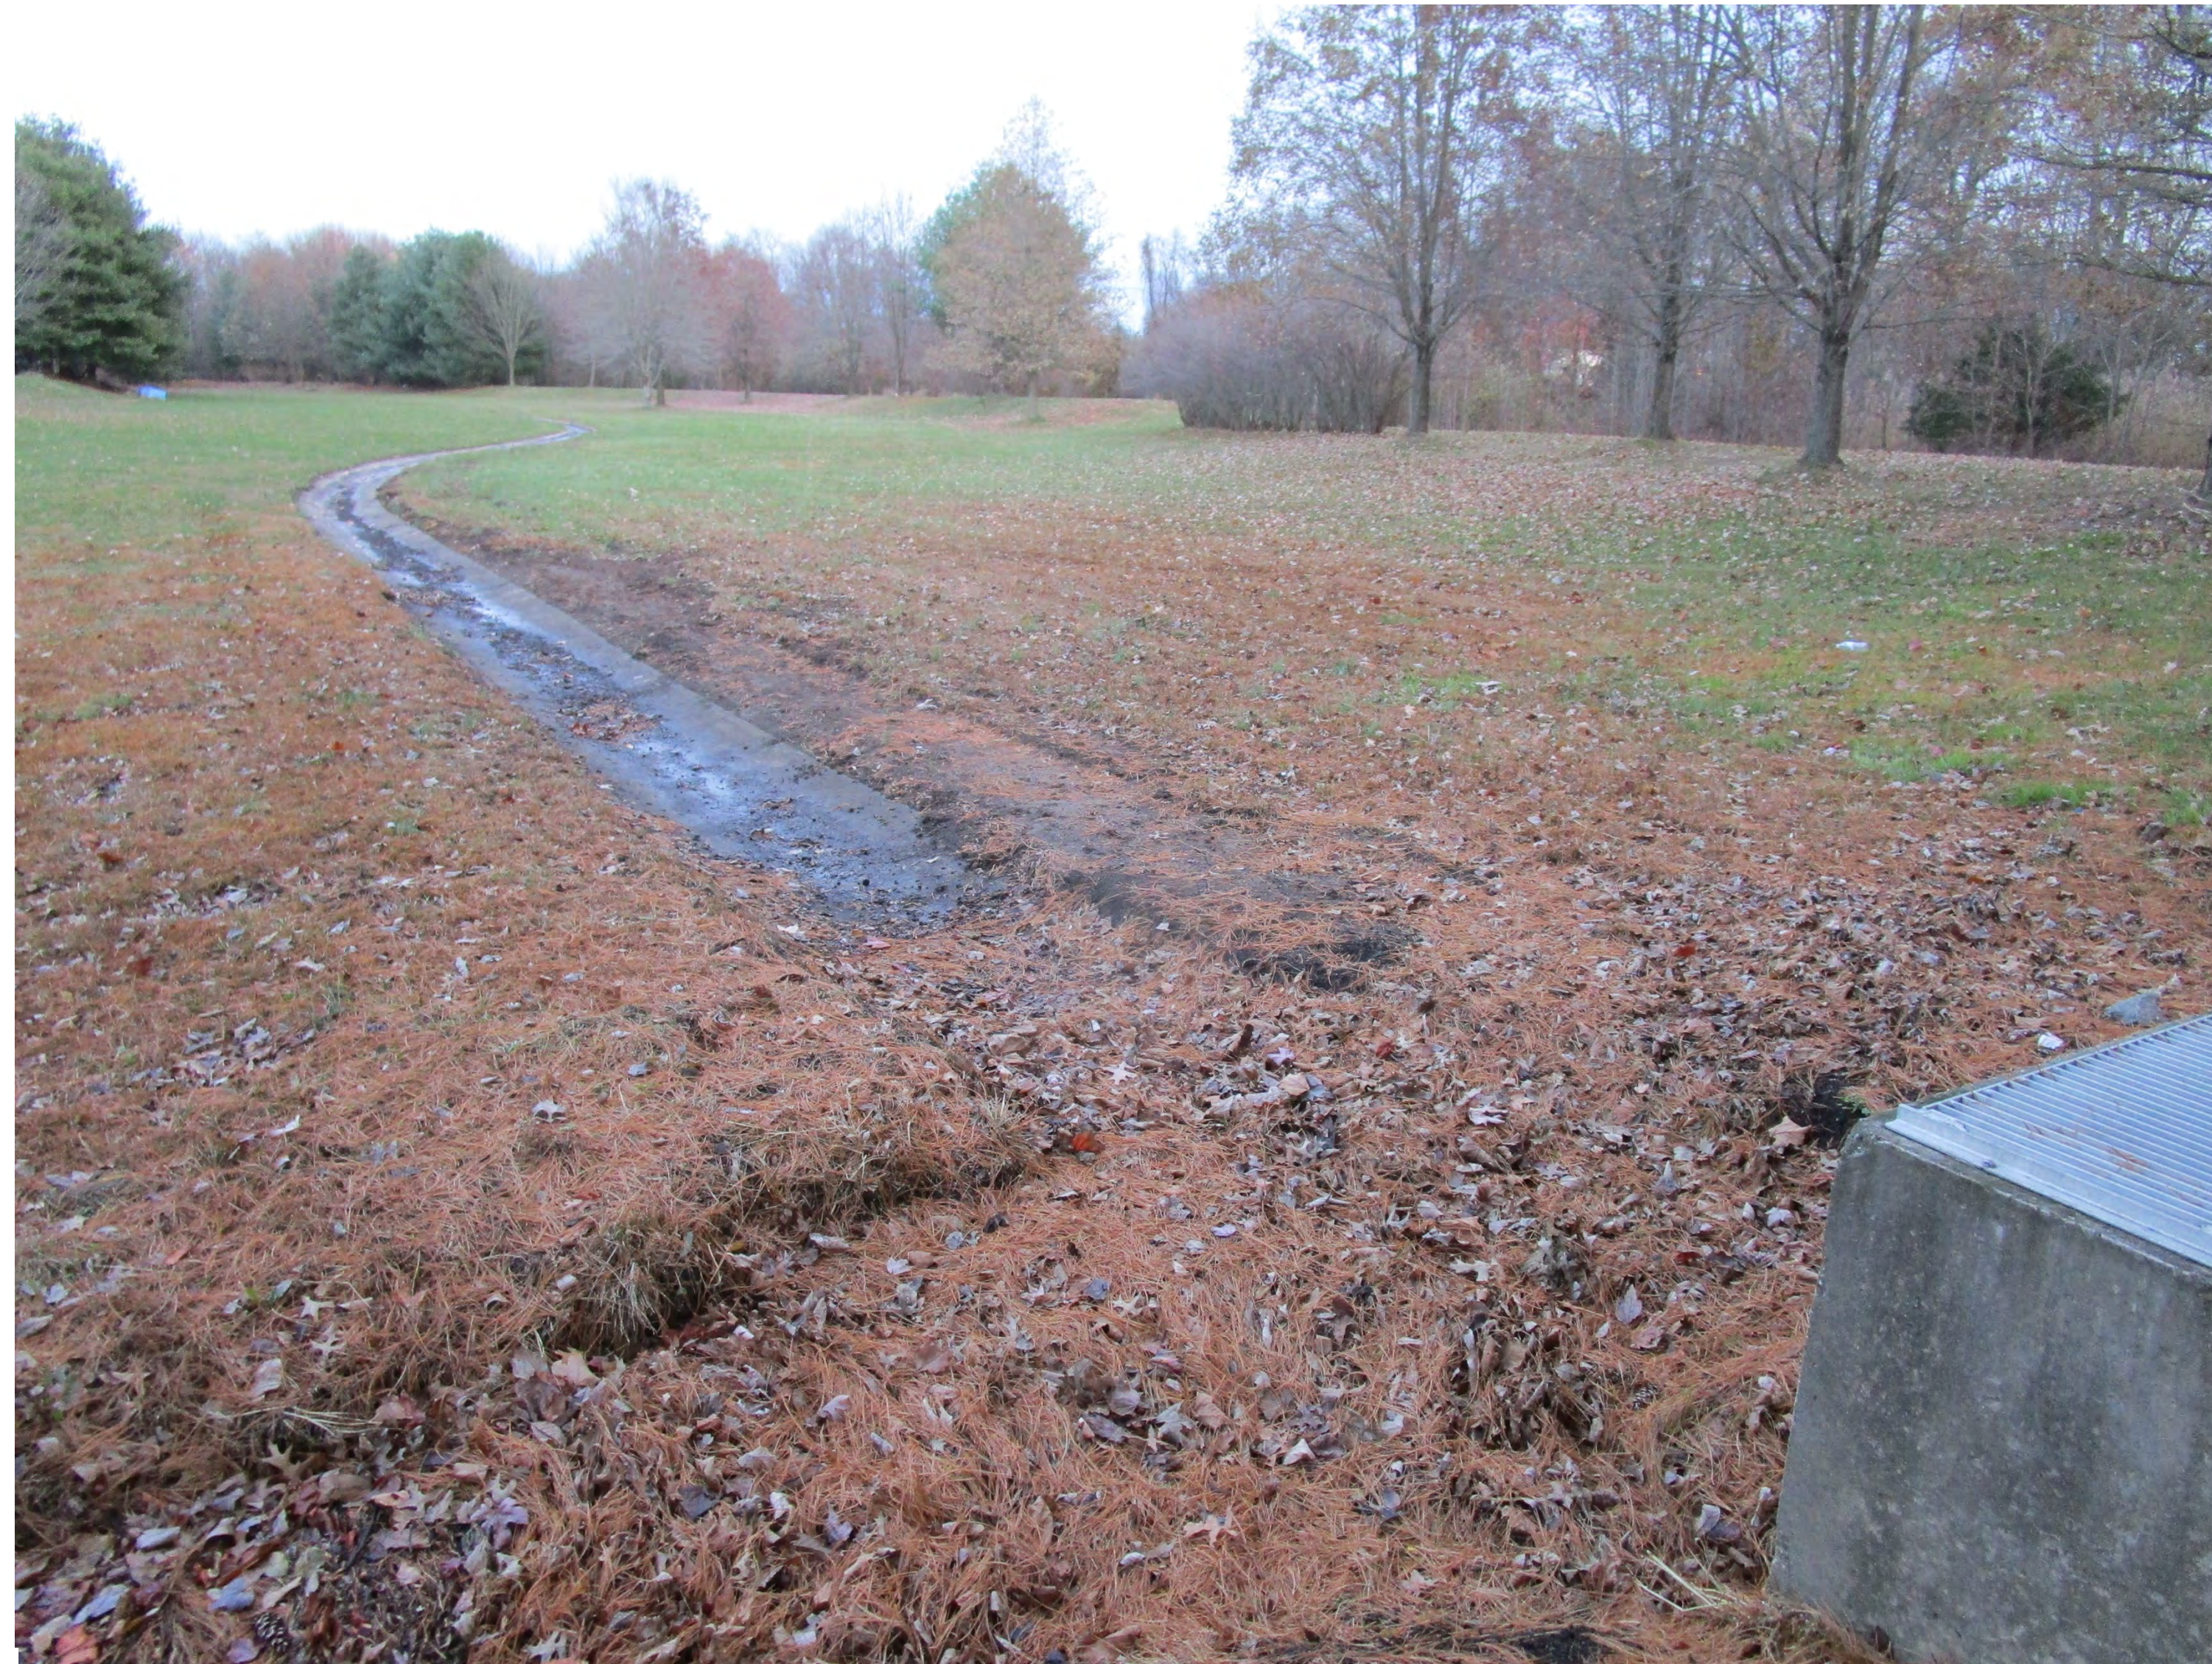
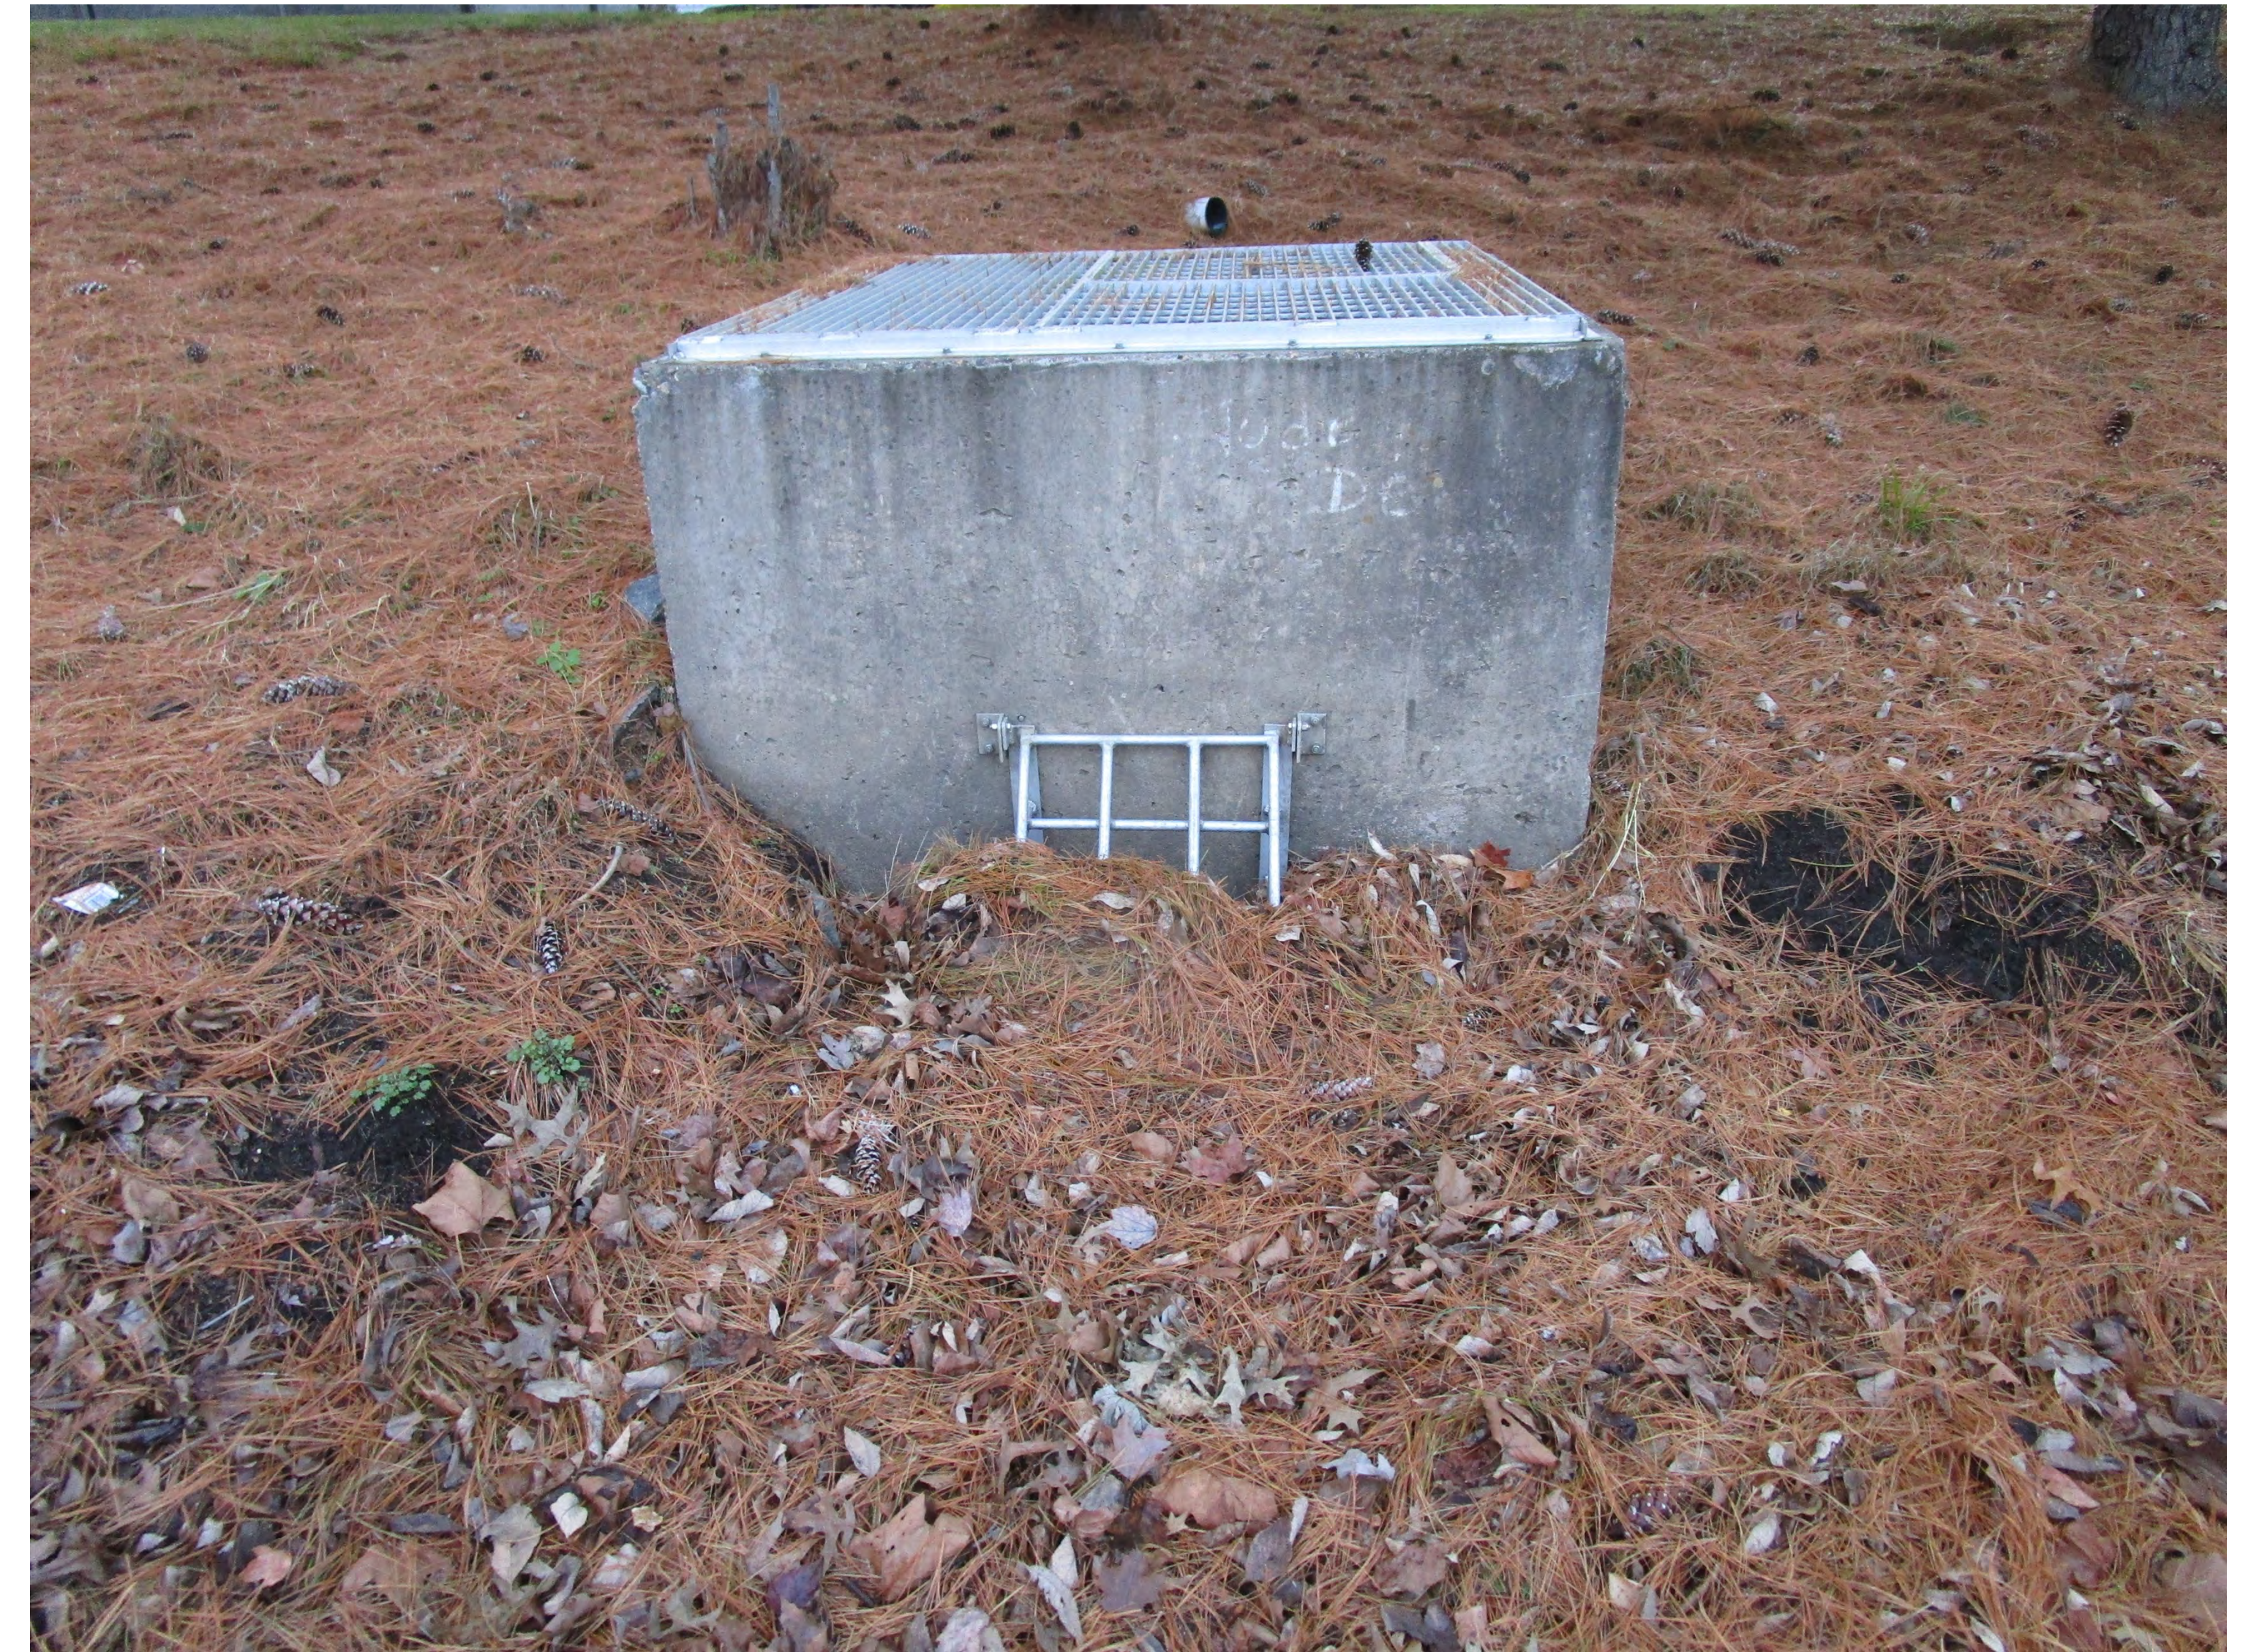
Address:  
12 Imperial Dr  
Trenton, NJ 08690

- Basin in overall good condition, much improved from previous assessment with all inlet and outlets cleared
- Significant leaf litter clogging outlet structure
- Low flow channels could be removed to promote more infiltration throughout the basin
