## Hamilton Township (Mercer County)

# REVIEW AND EVALUATION OF TOTAL MAXIMUM DAILY LOADS (TMDLs)

Developed by the Rutgers Cooperative Extension Water Resources Program  
Funded by Hamilton Township, Mercer County, New Jersey

December 5, 2019

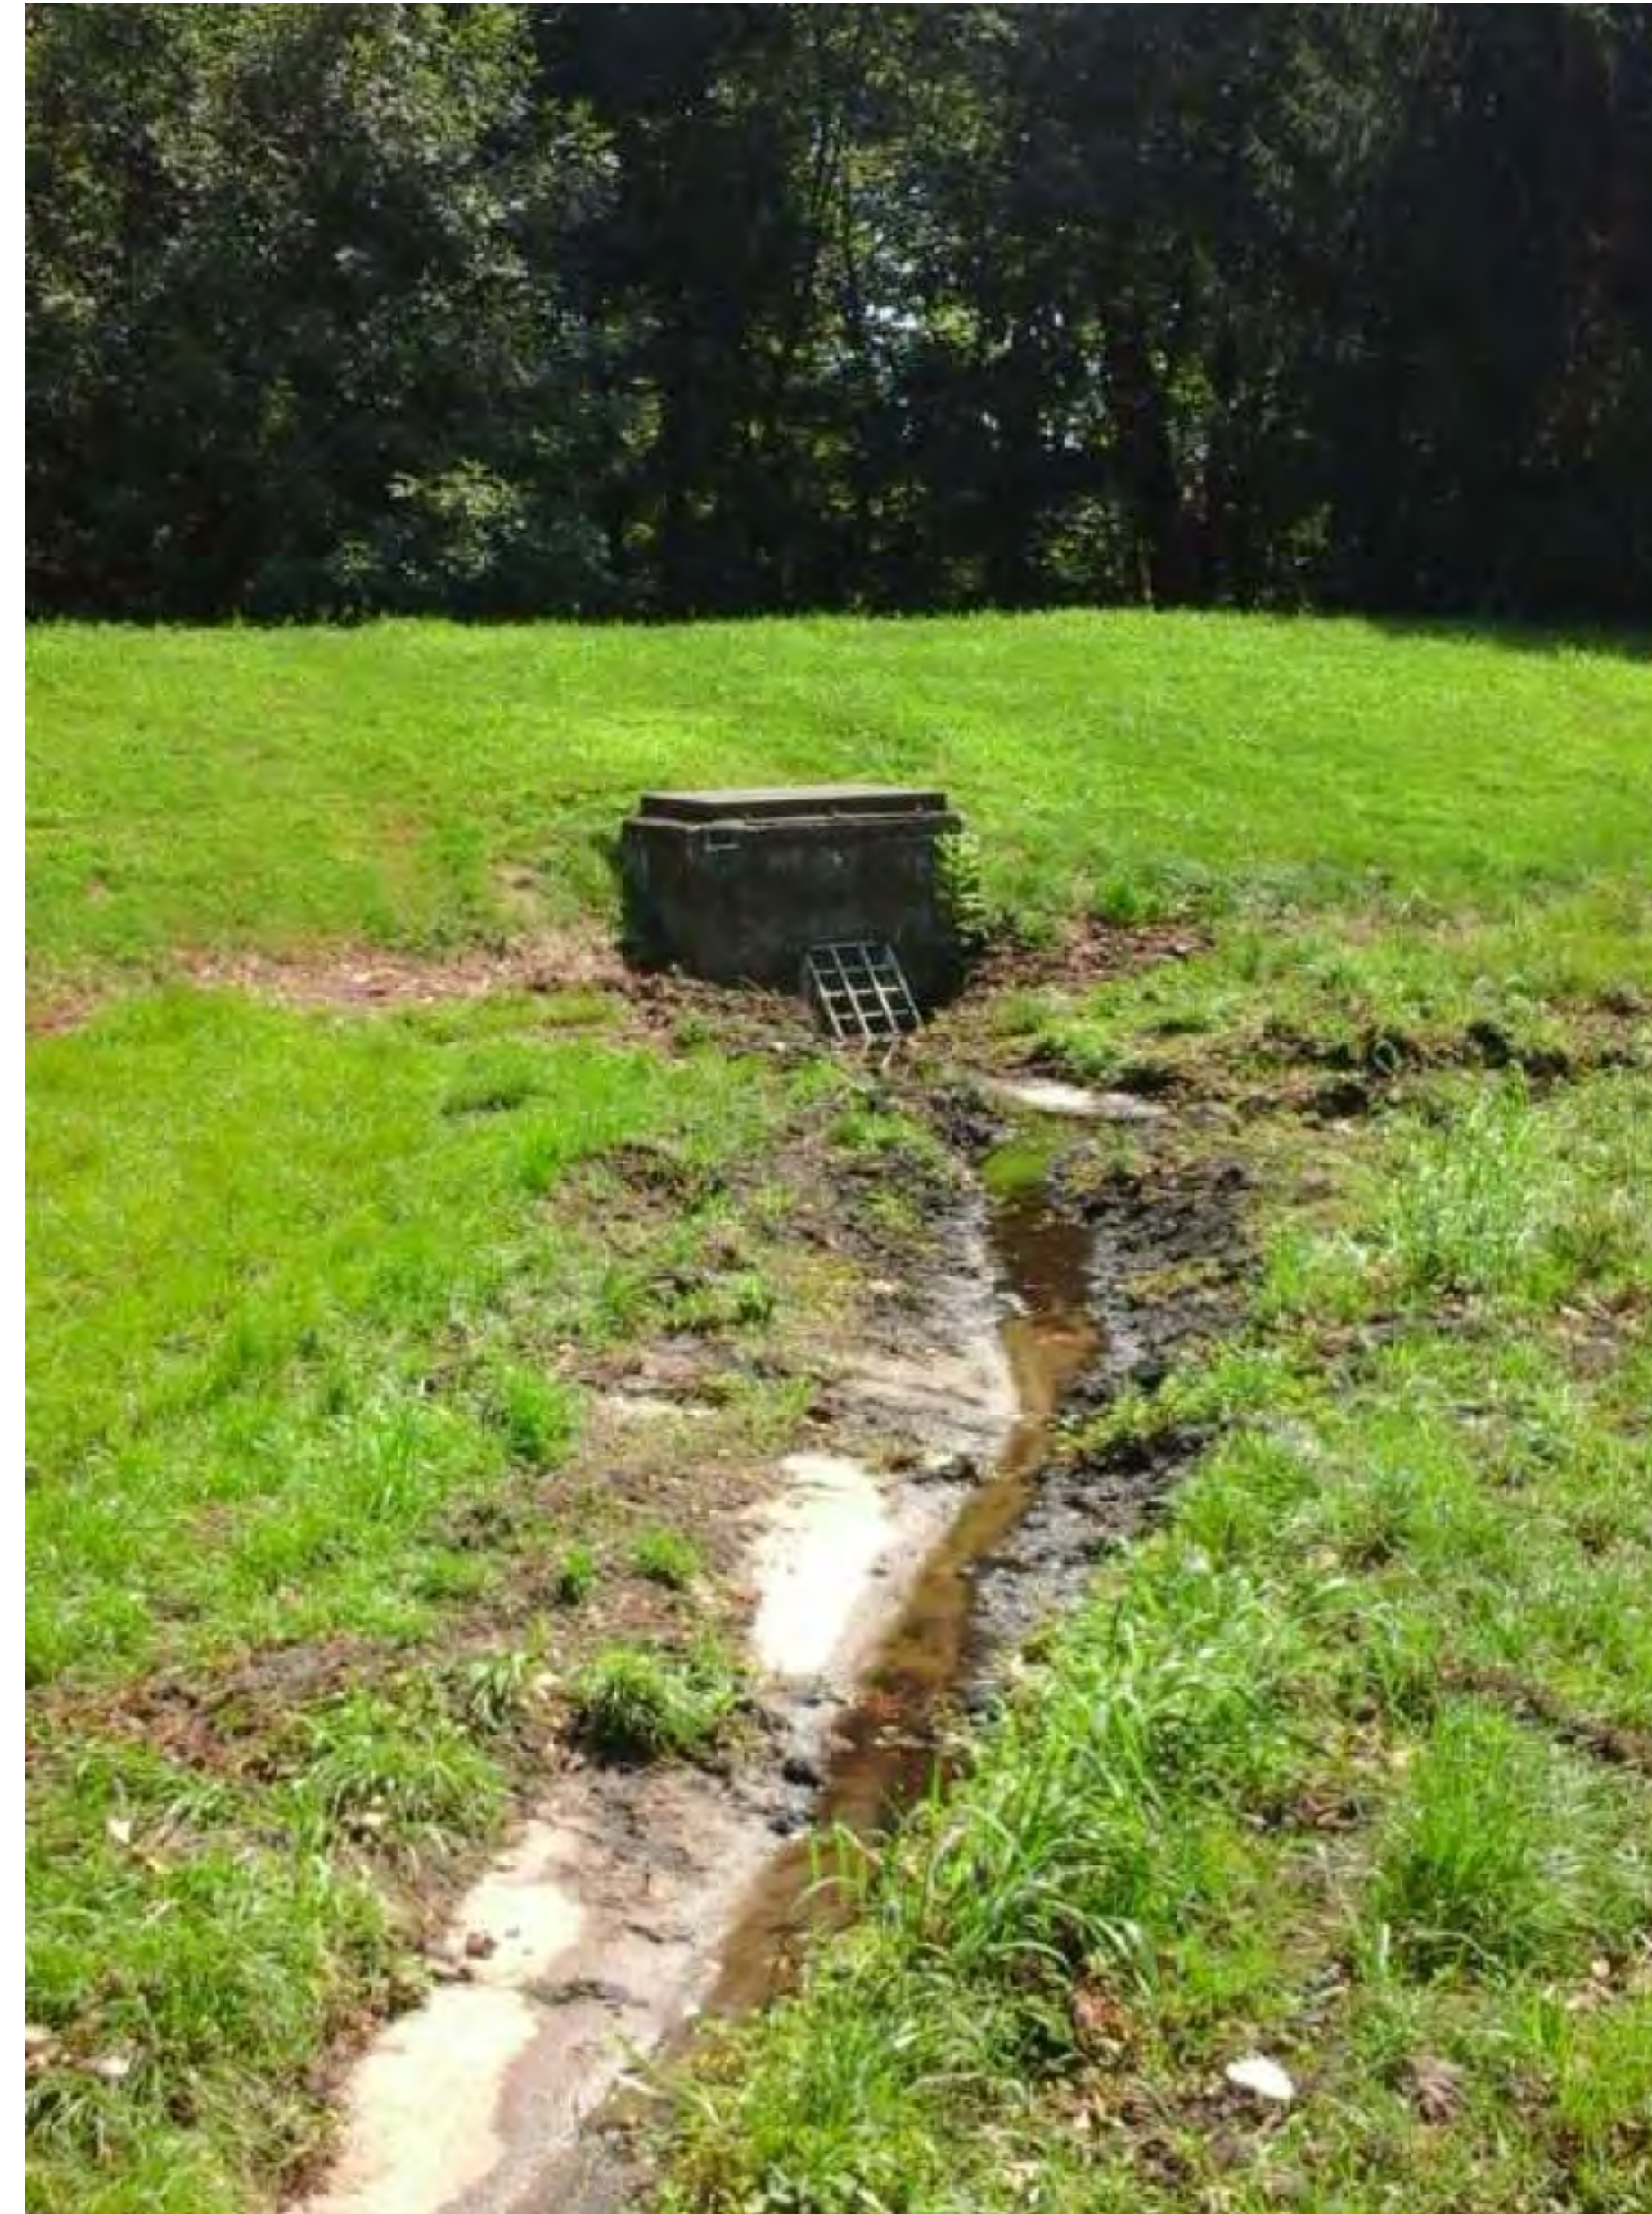
Address:  
1 Foy Dr  
Trenton, NJ 08690

- Built up sediment in channel is leading to some standing water
- Clean out channel and potentially replace concrete channel with stone channel

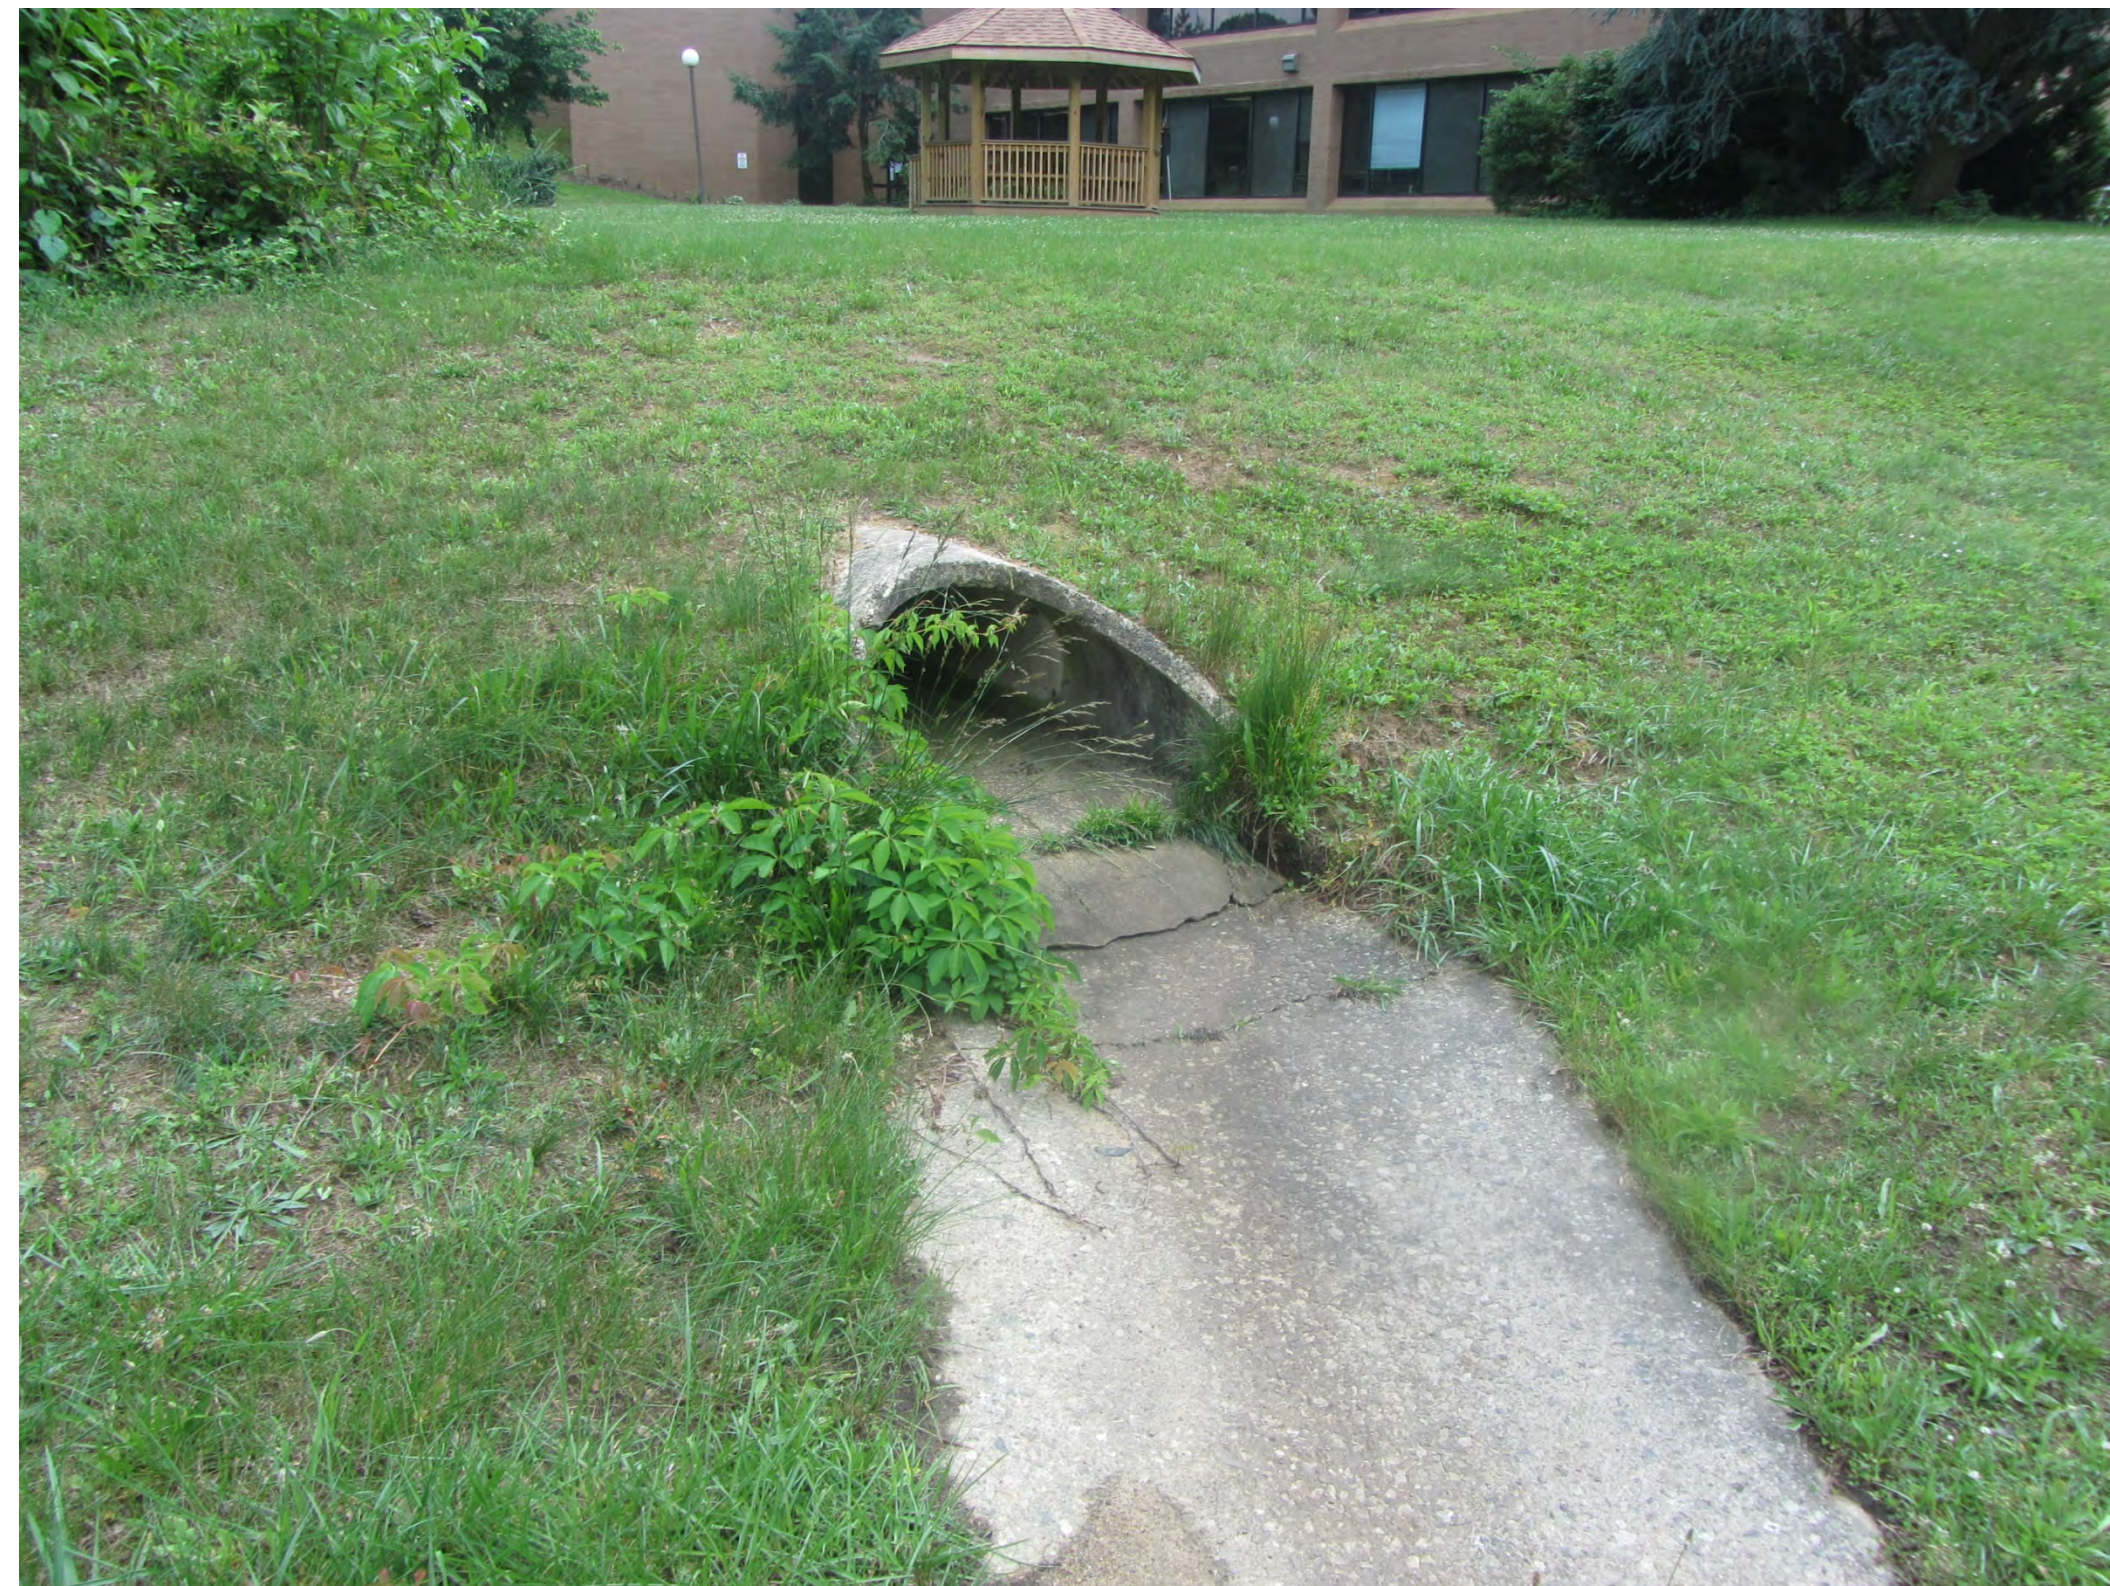
Concrete deterioration on southern inlet

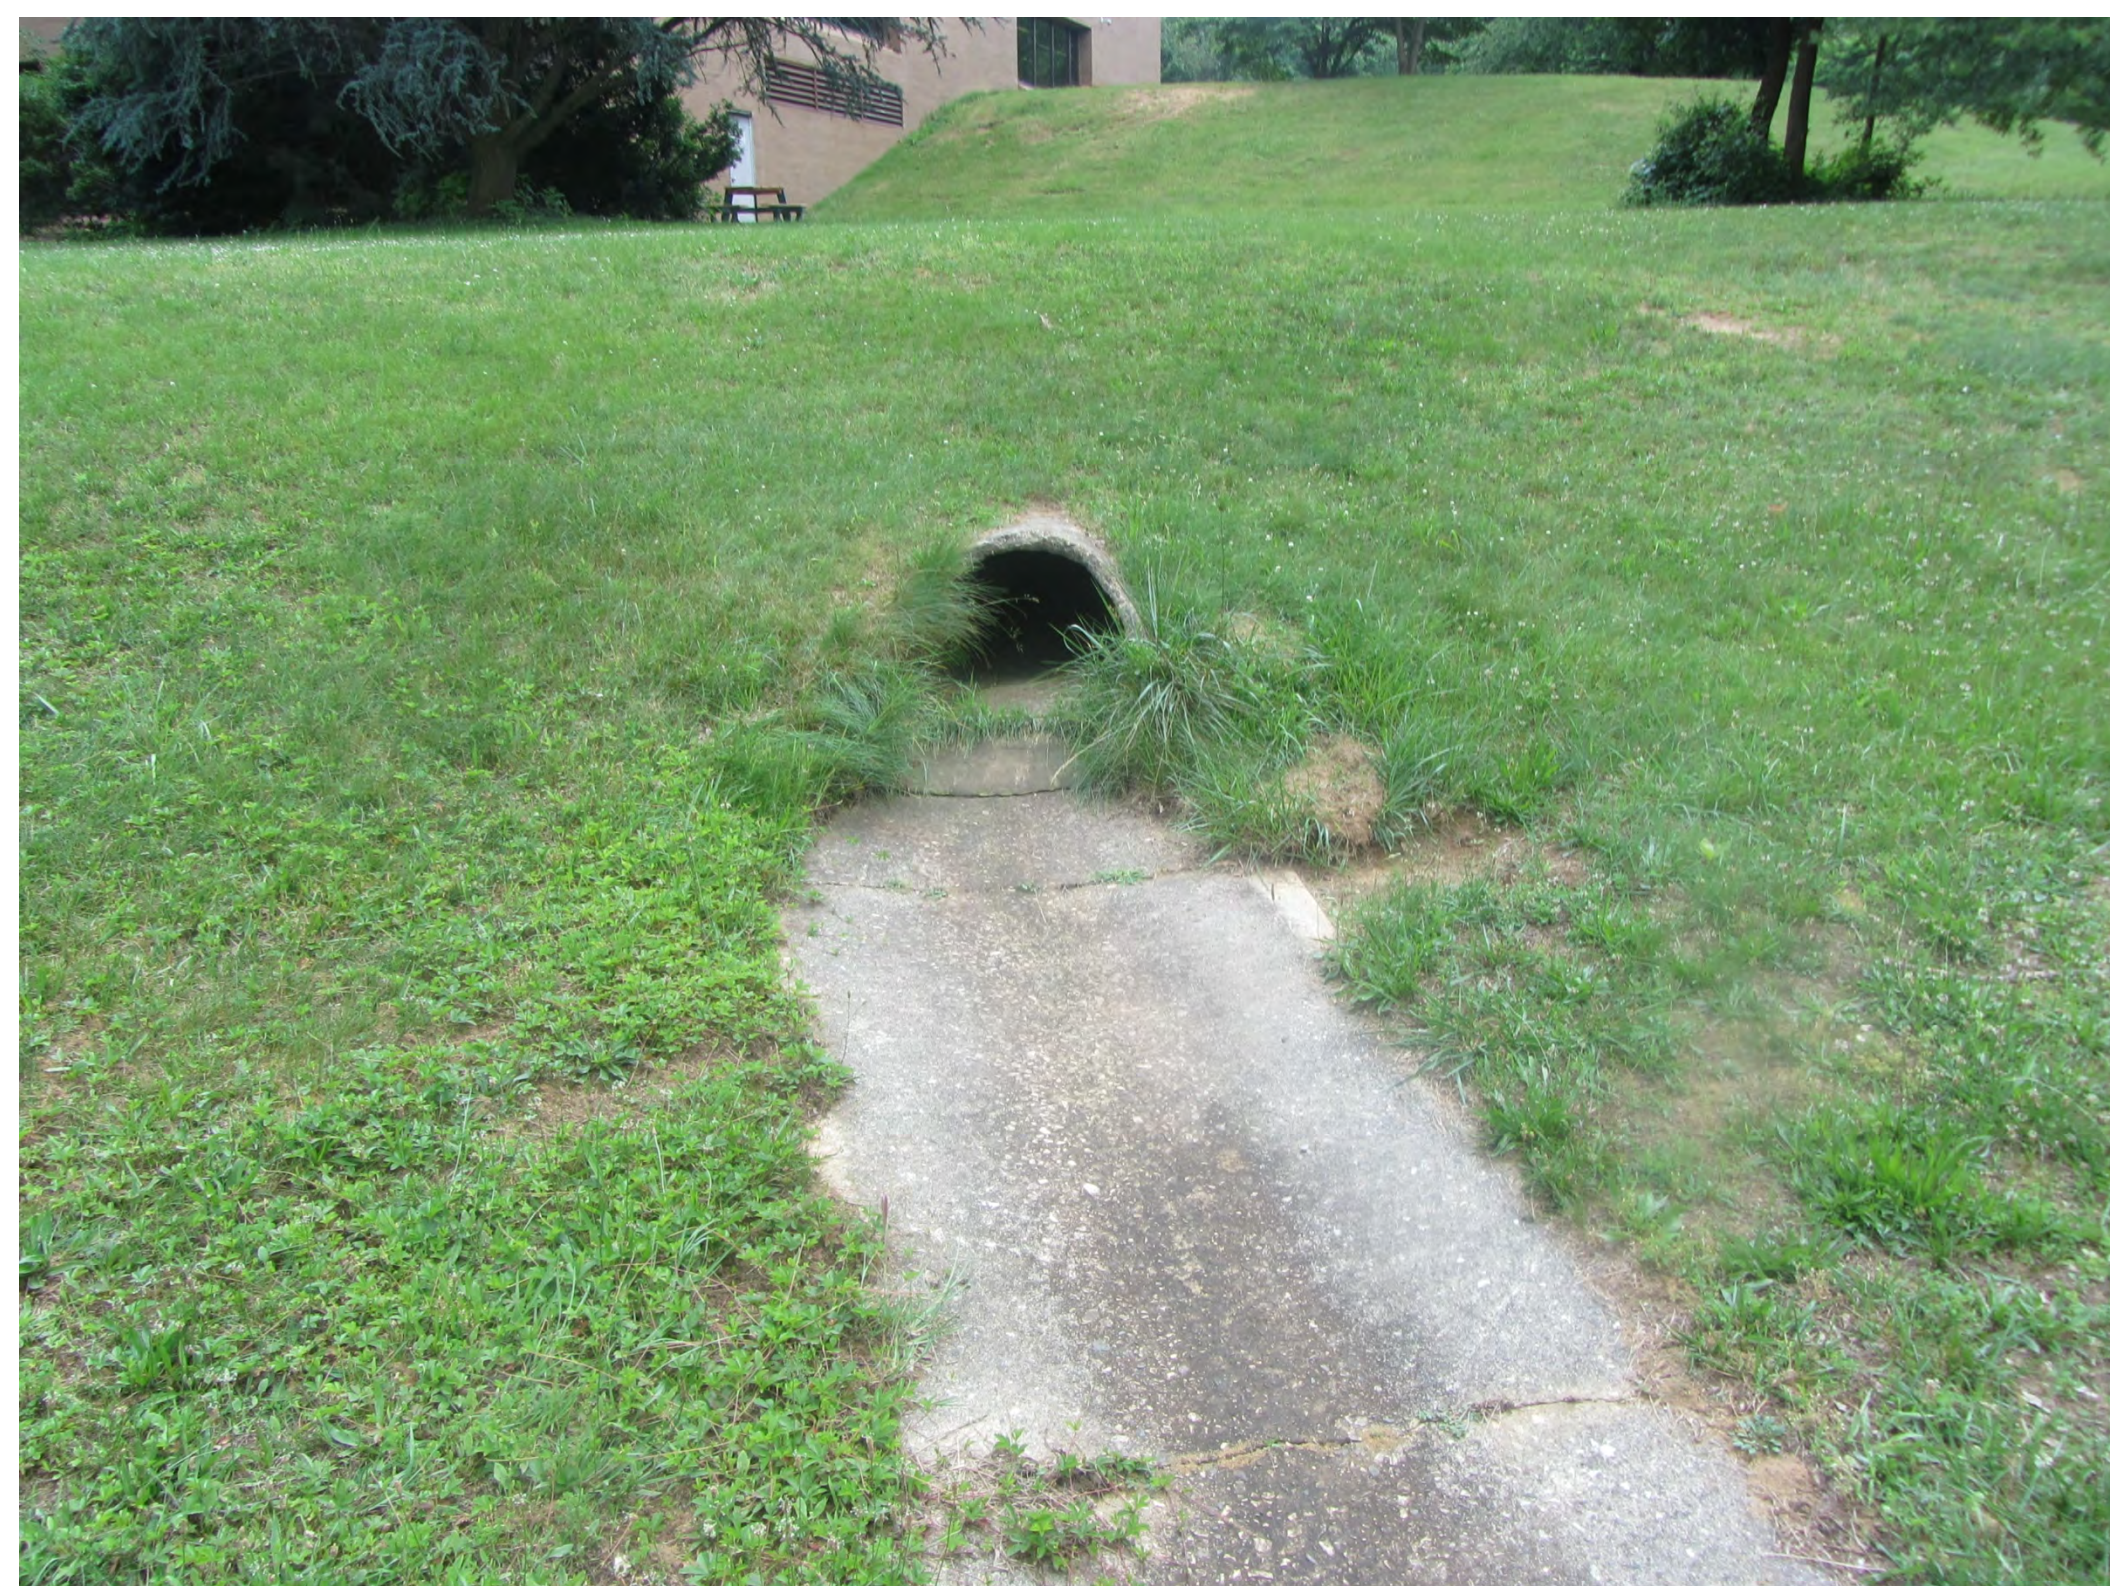
Concrete deterioration on northern inlet

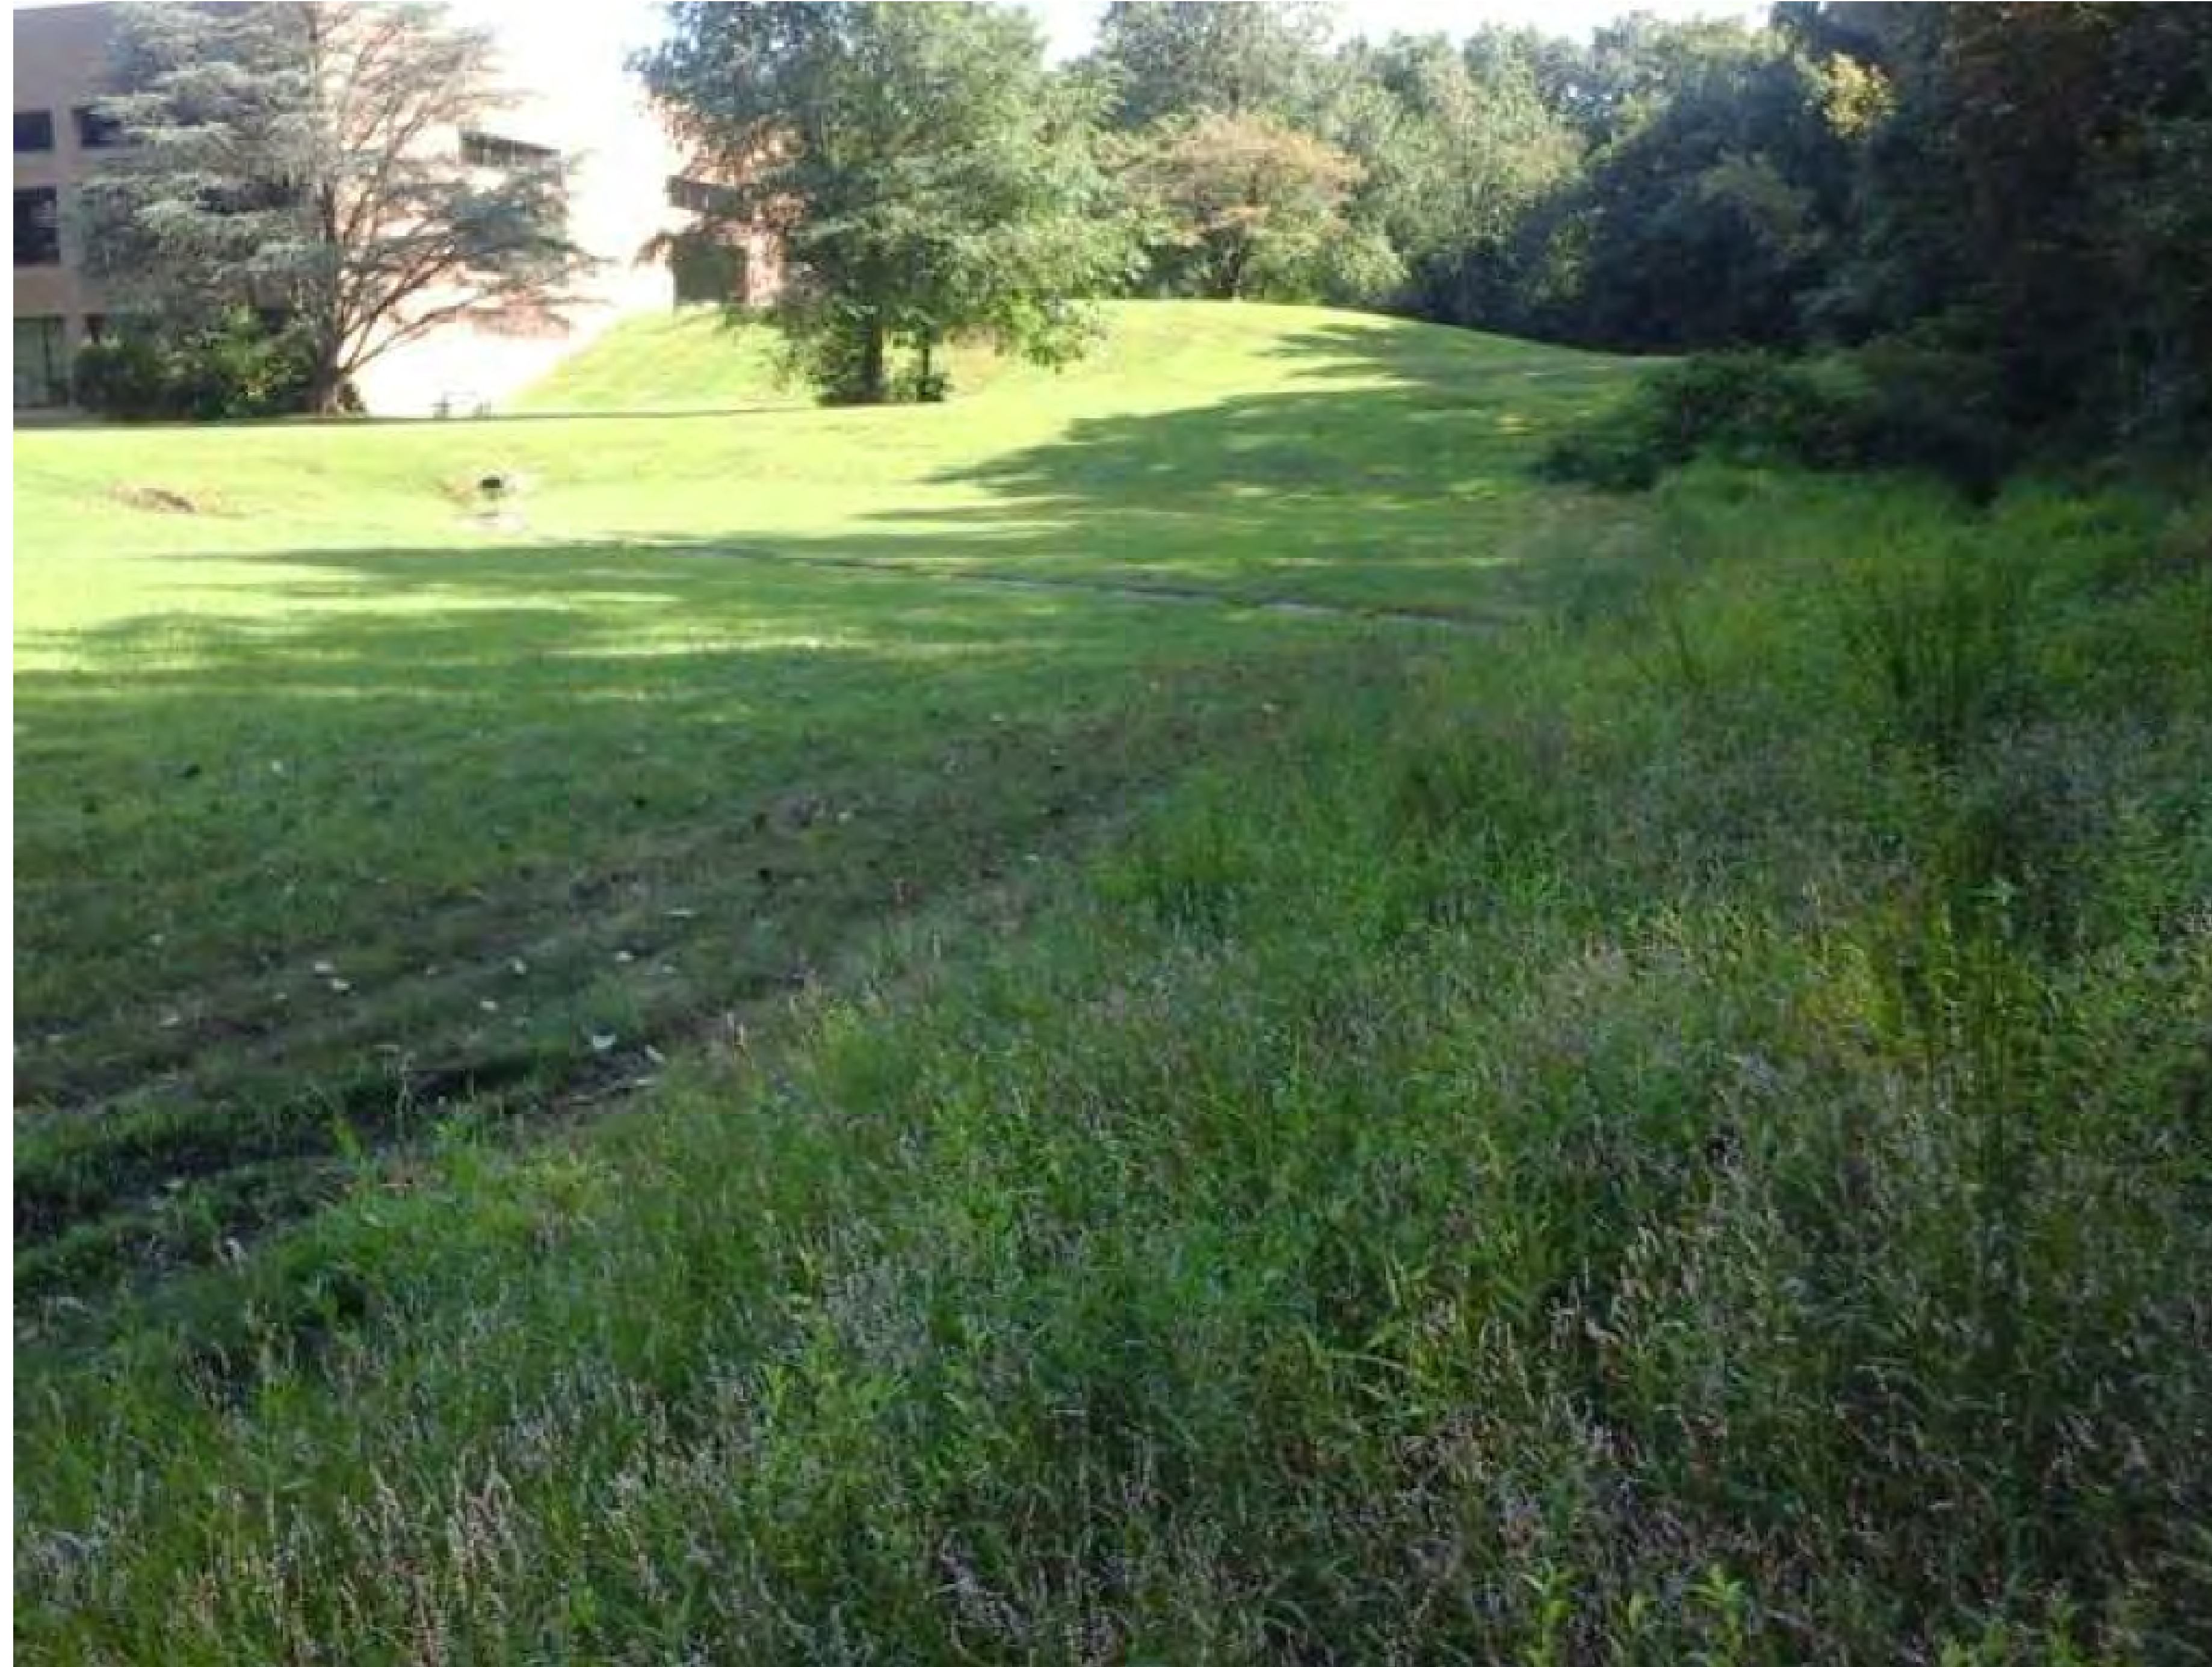
Address:  
19 Justice Samuel A. Alito Jr. Way  
Trenton, NJ 08619

- Low flow channel from two inlets flow into a vegetated swale to the outlet
- Standing water issues observed in previous assessment were not identified
- Basin can be naturalized with herbaceous plants

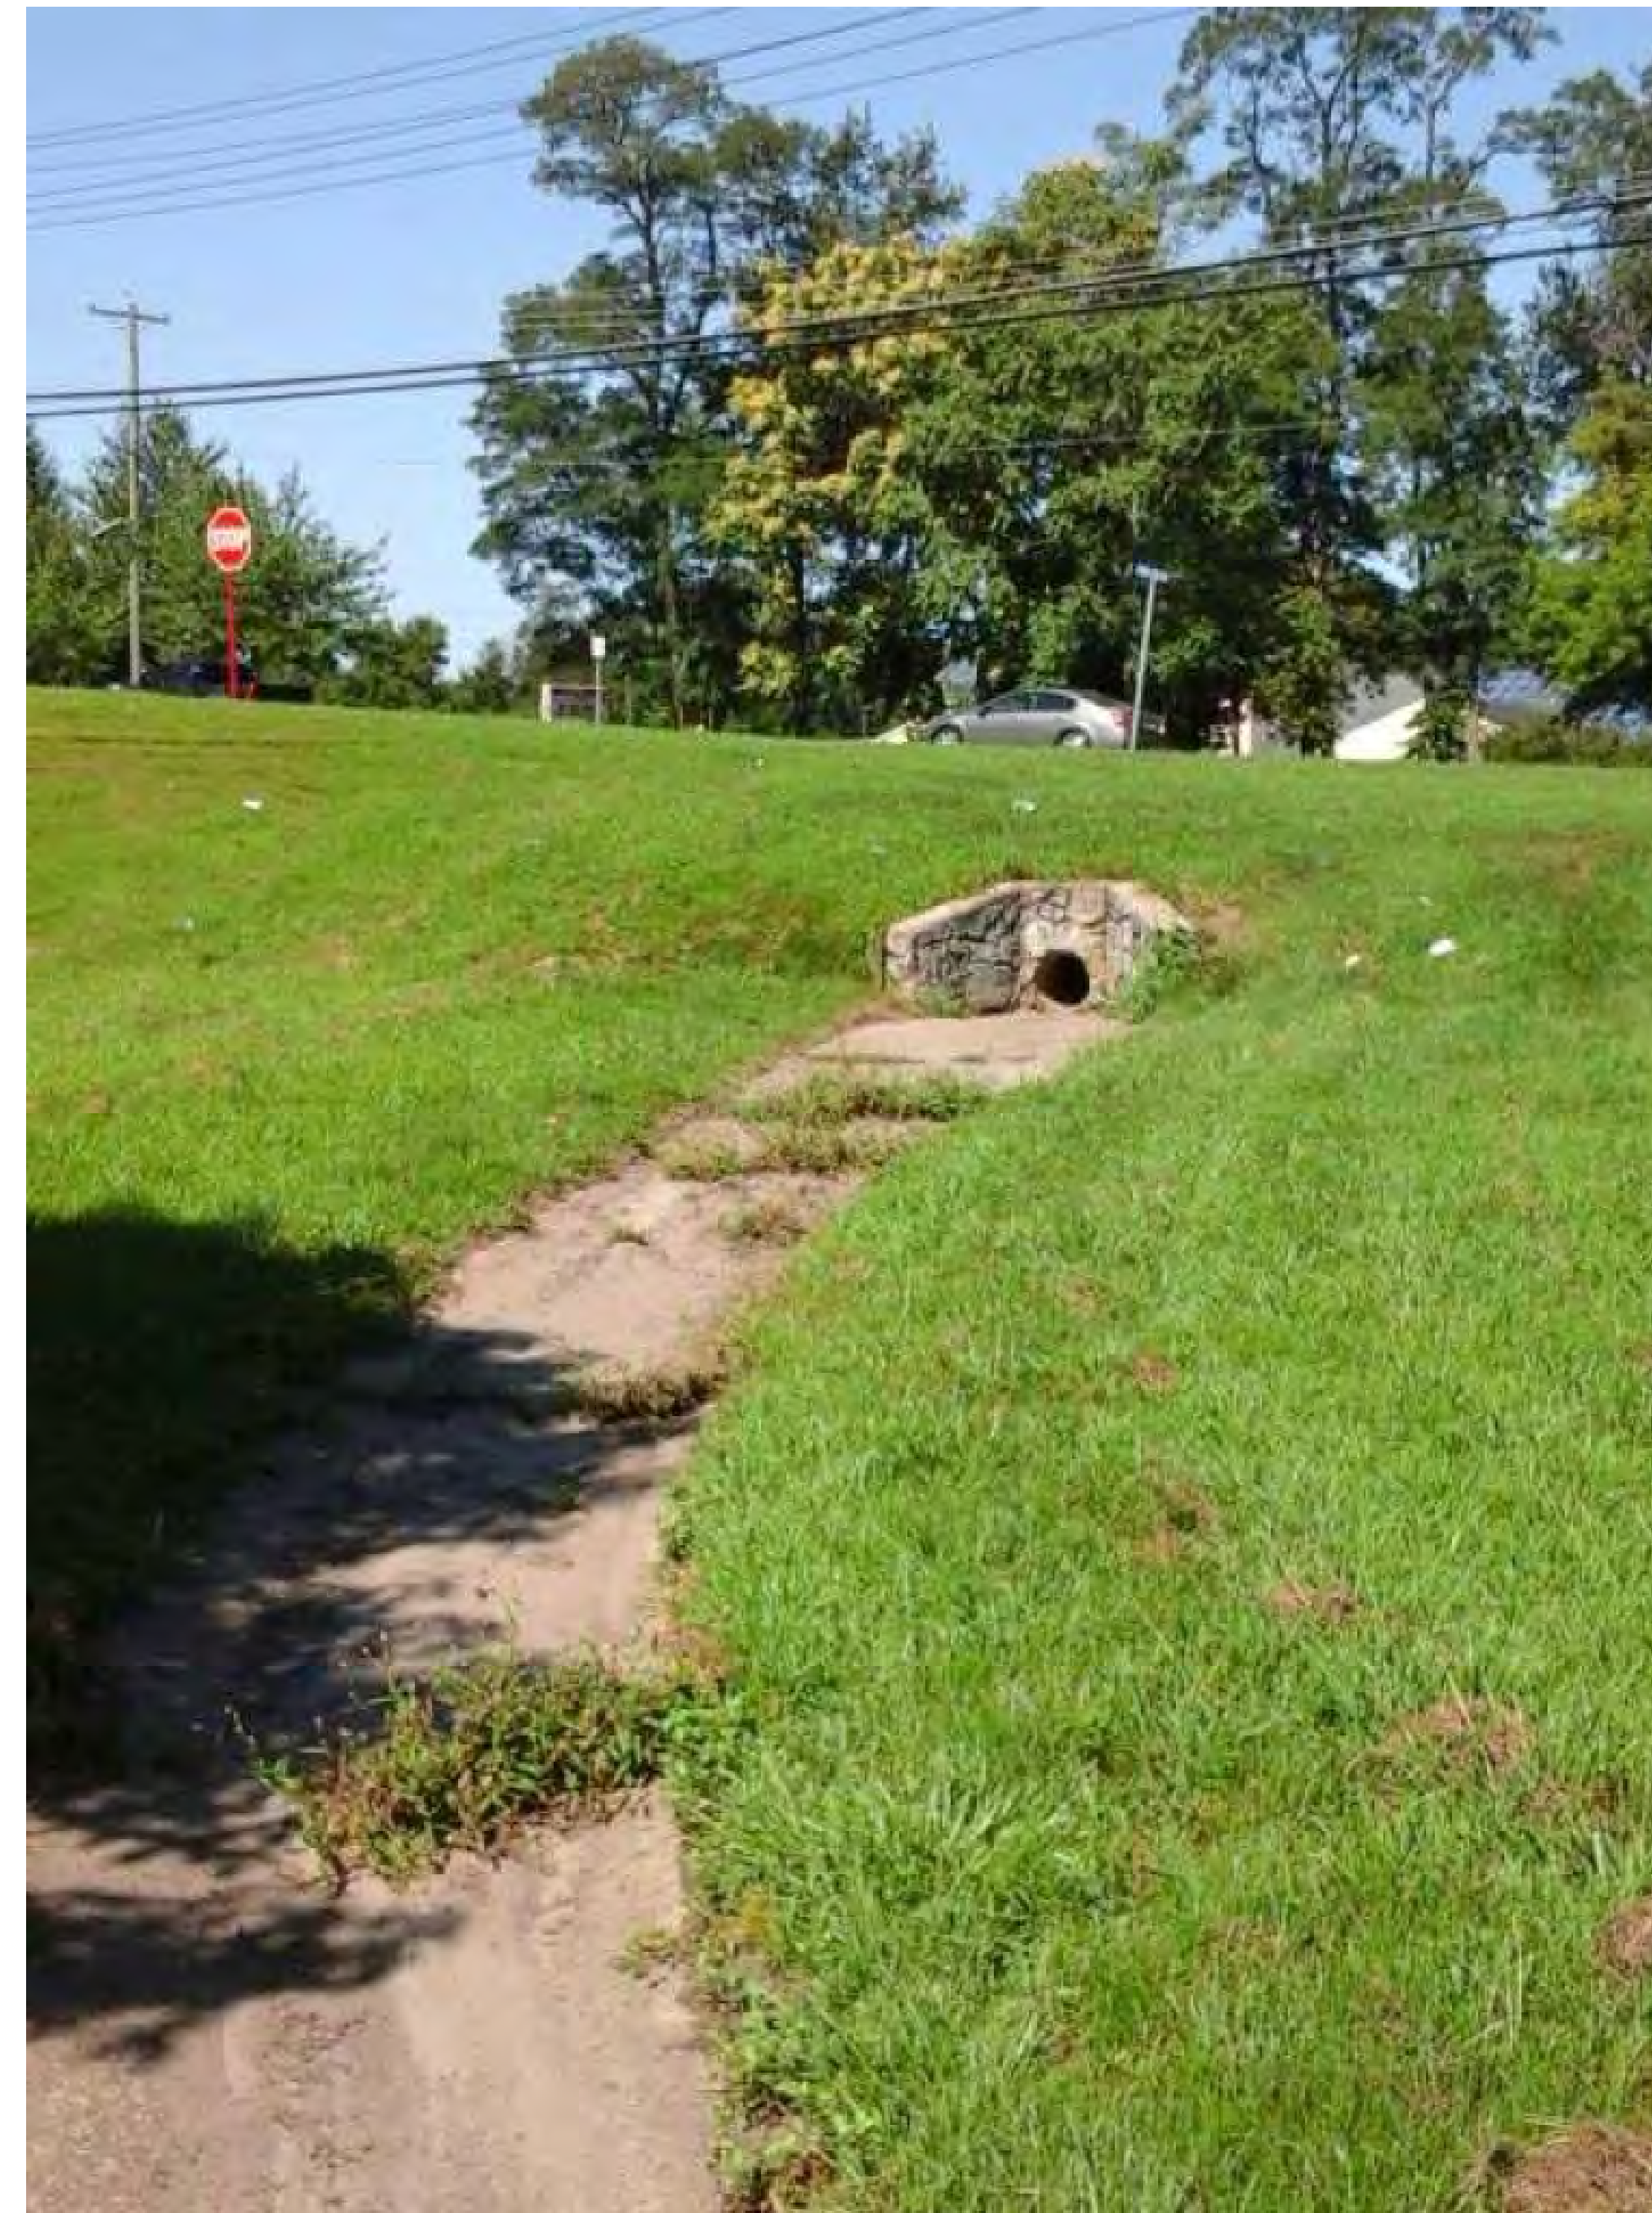
Address:  
76 Noa Ct  
Trenton, NJ 08690

- Excessive sediment build up in front of outlet structure, grass growing over low flow channel
- Excess sediment and litter should be removed
- Opportunity to replace low flow channel with a stone channel to promote infiltration

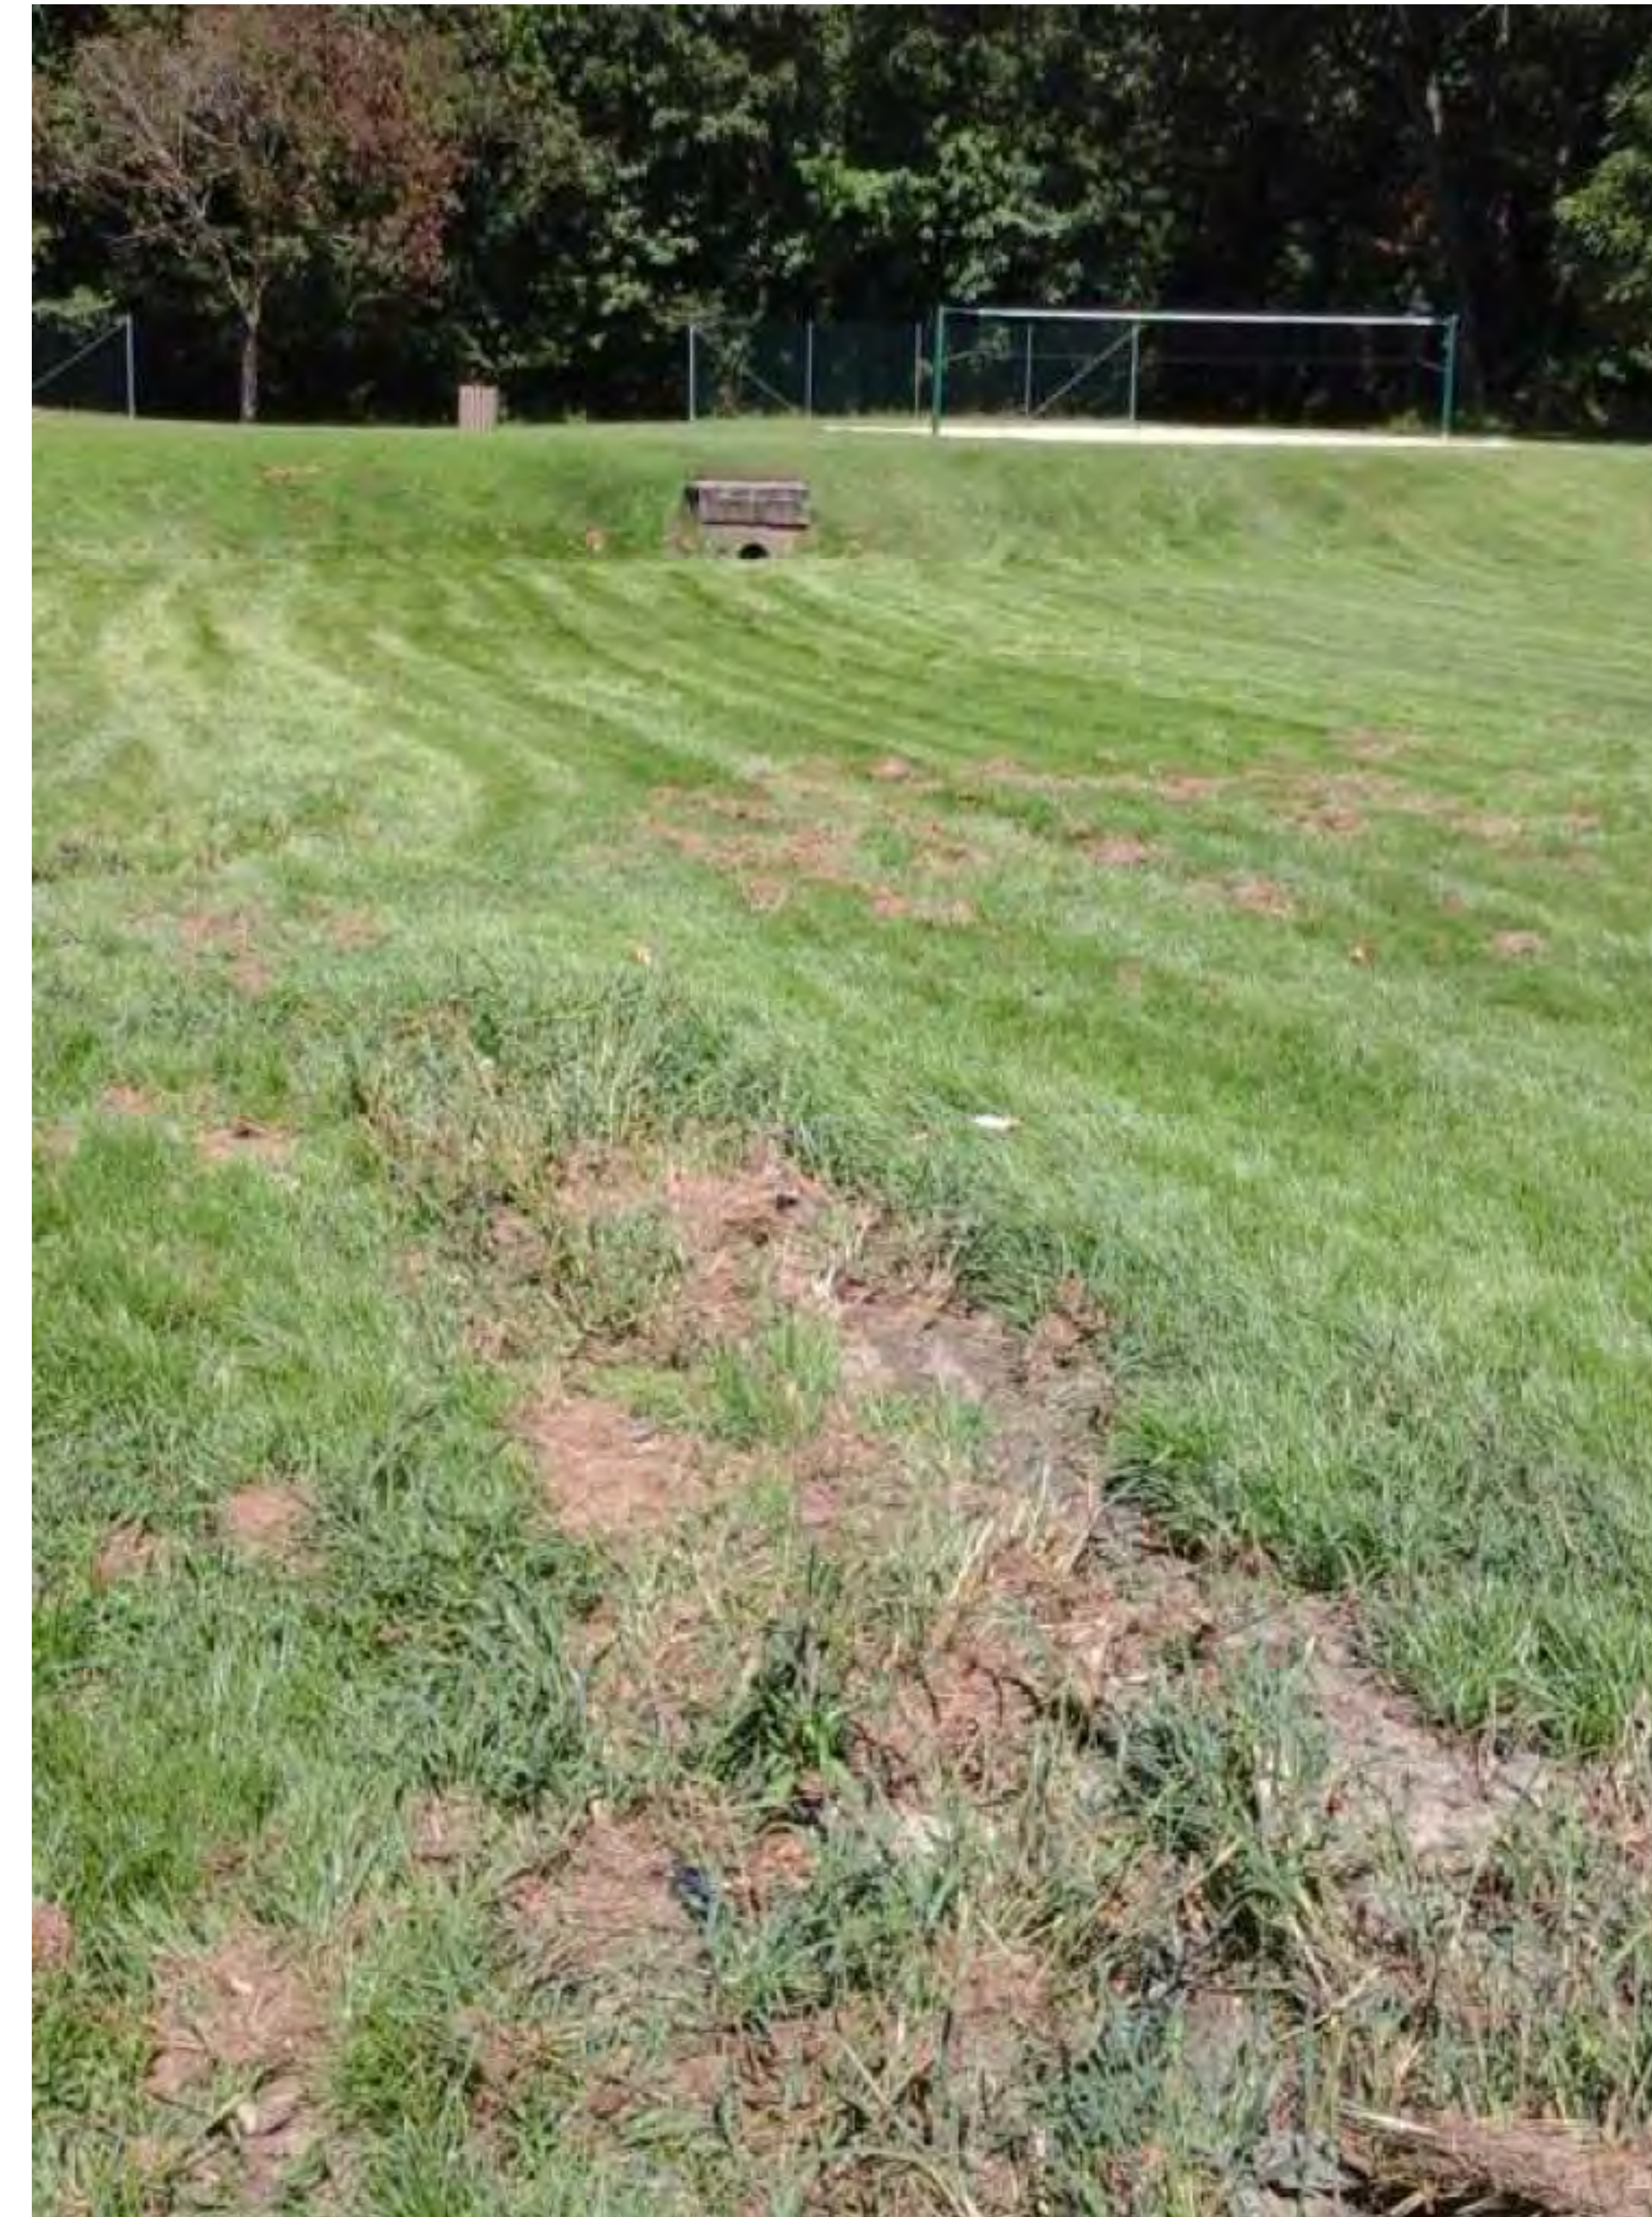
Address:  
224 Kruser Rd  
Trenton, NJ 08690

- Basin overall in good condition
- Inlets have signs of erosion, implement rip rap aprons to prevent erosion
- Natural basin with herbaceous plants
