## Hamilton Township (Mercer County)

# REVIEW AND EVALUATION OF TOTAL MAXIMUM DAILY LOADS (TMDLs)

Developed by the Rutgers Cooperative Extension Water Resources Program  
Funded by Hamilton Township, Mercer County, New Jersey

December 5, 2019

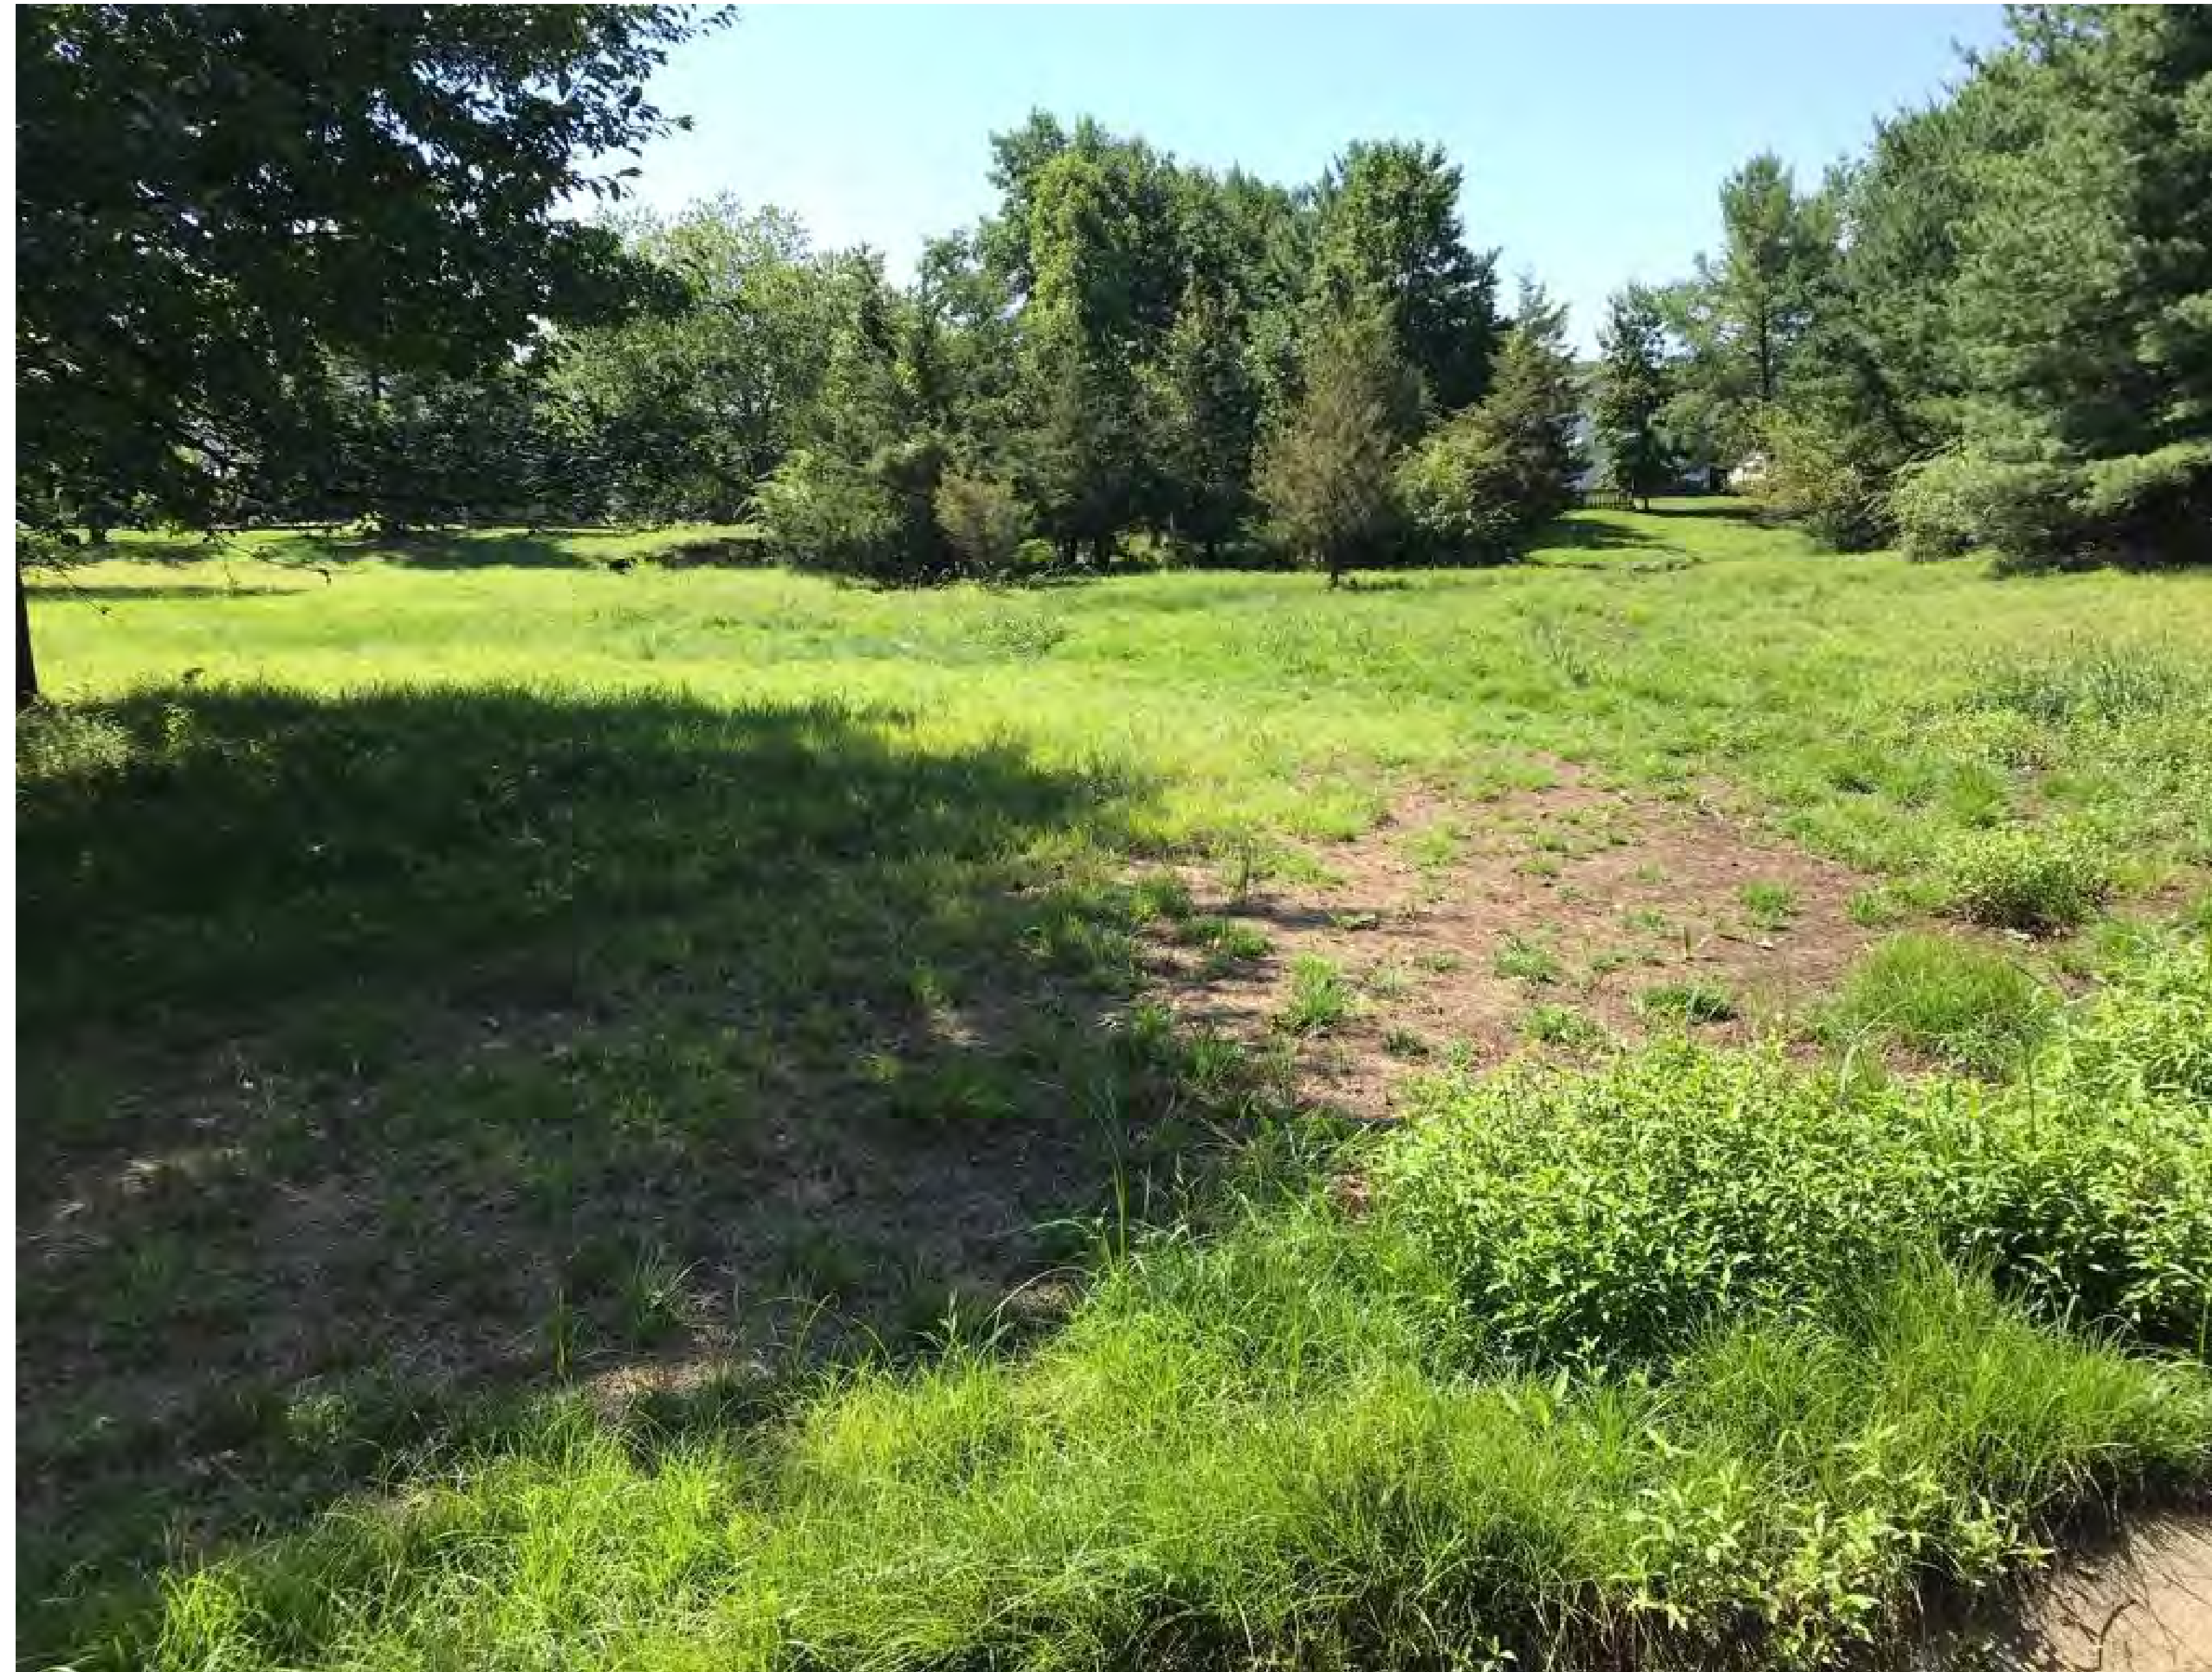
Address:  
Great Oak Rd and Dukoff Dr  
Trenton, NJ 08690

- Large Infiltration basin with sediment filled low flow channels
- Vegetated with grasses and trees
- Clean out low flow channels and maintain areas with over grown vegetation
- Opportunity to remove low flow channels and replace with stone channels to allow infiltration

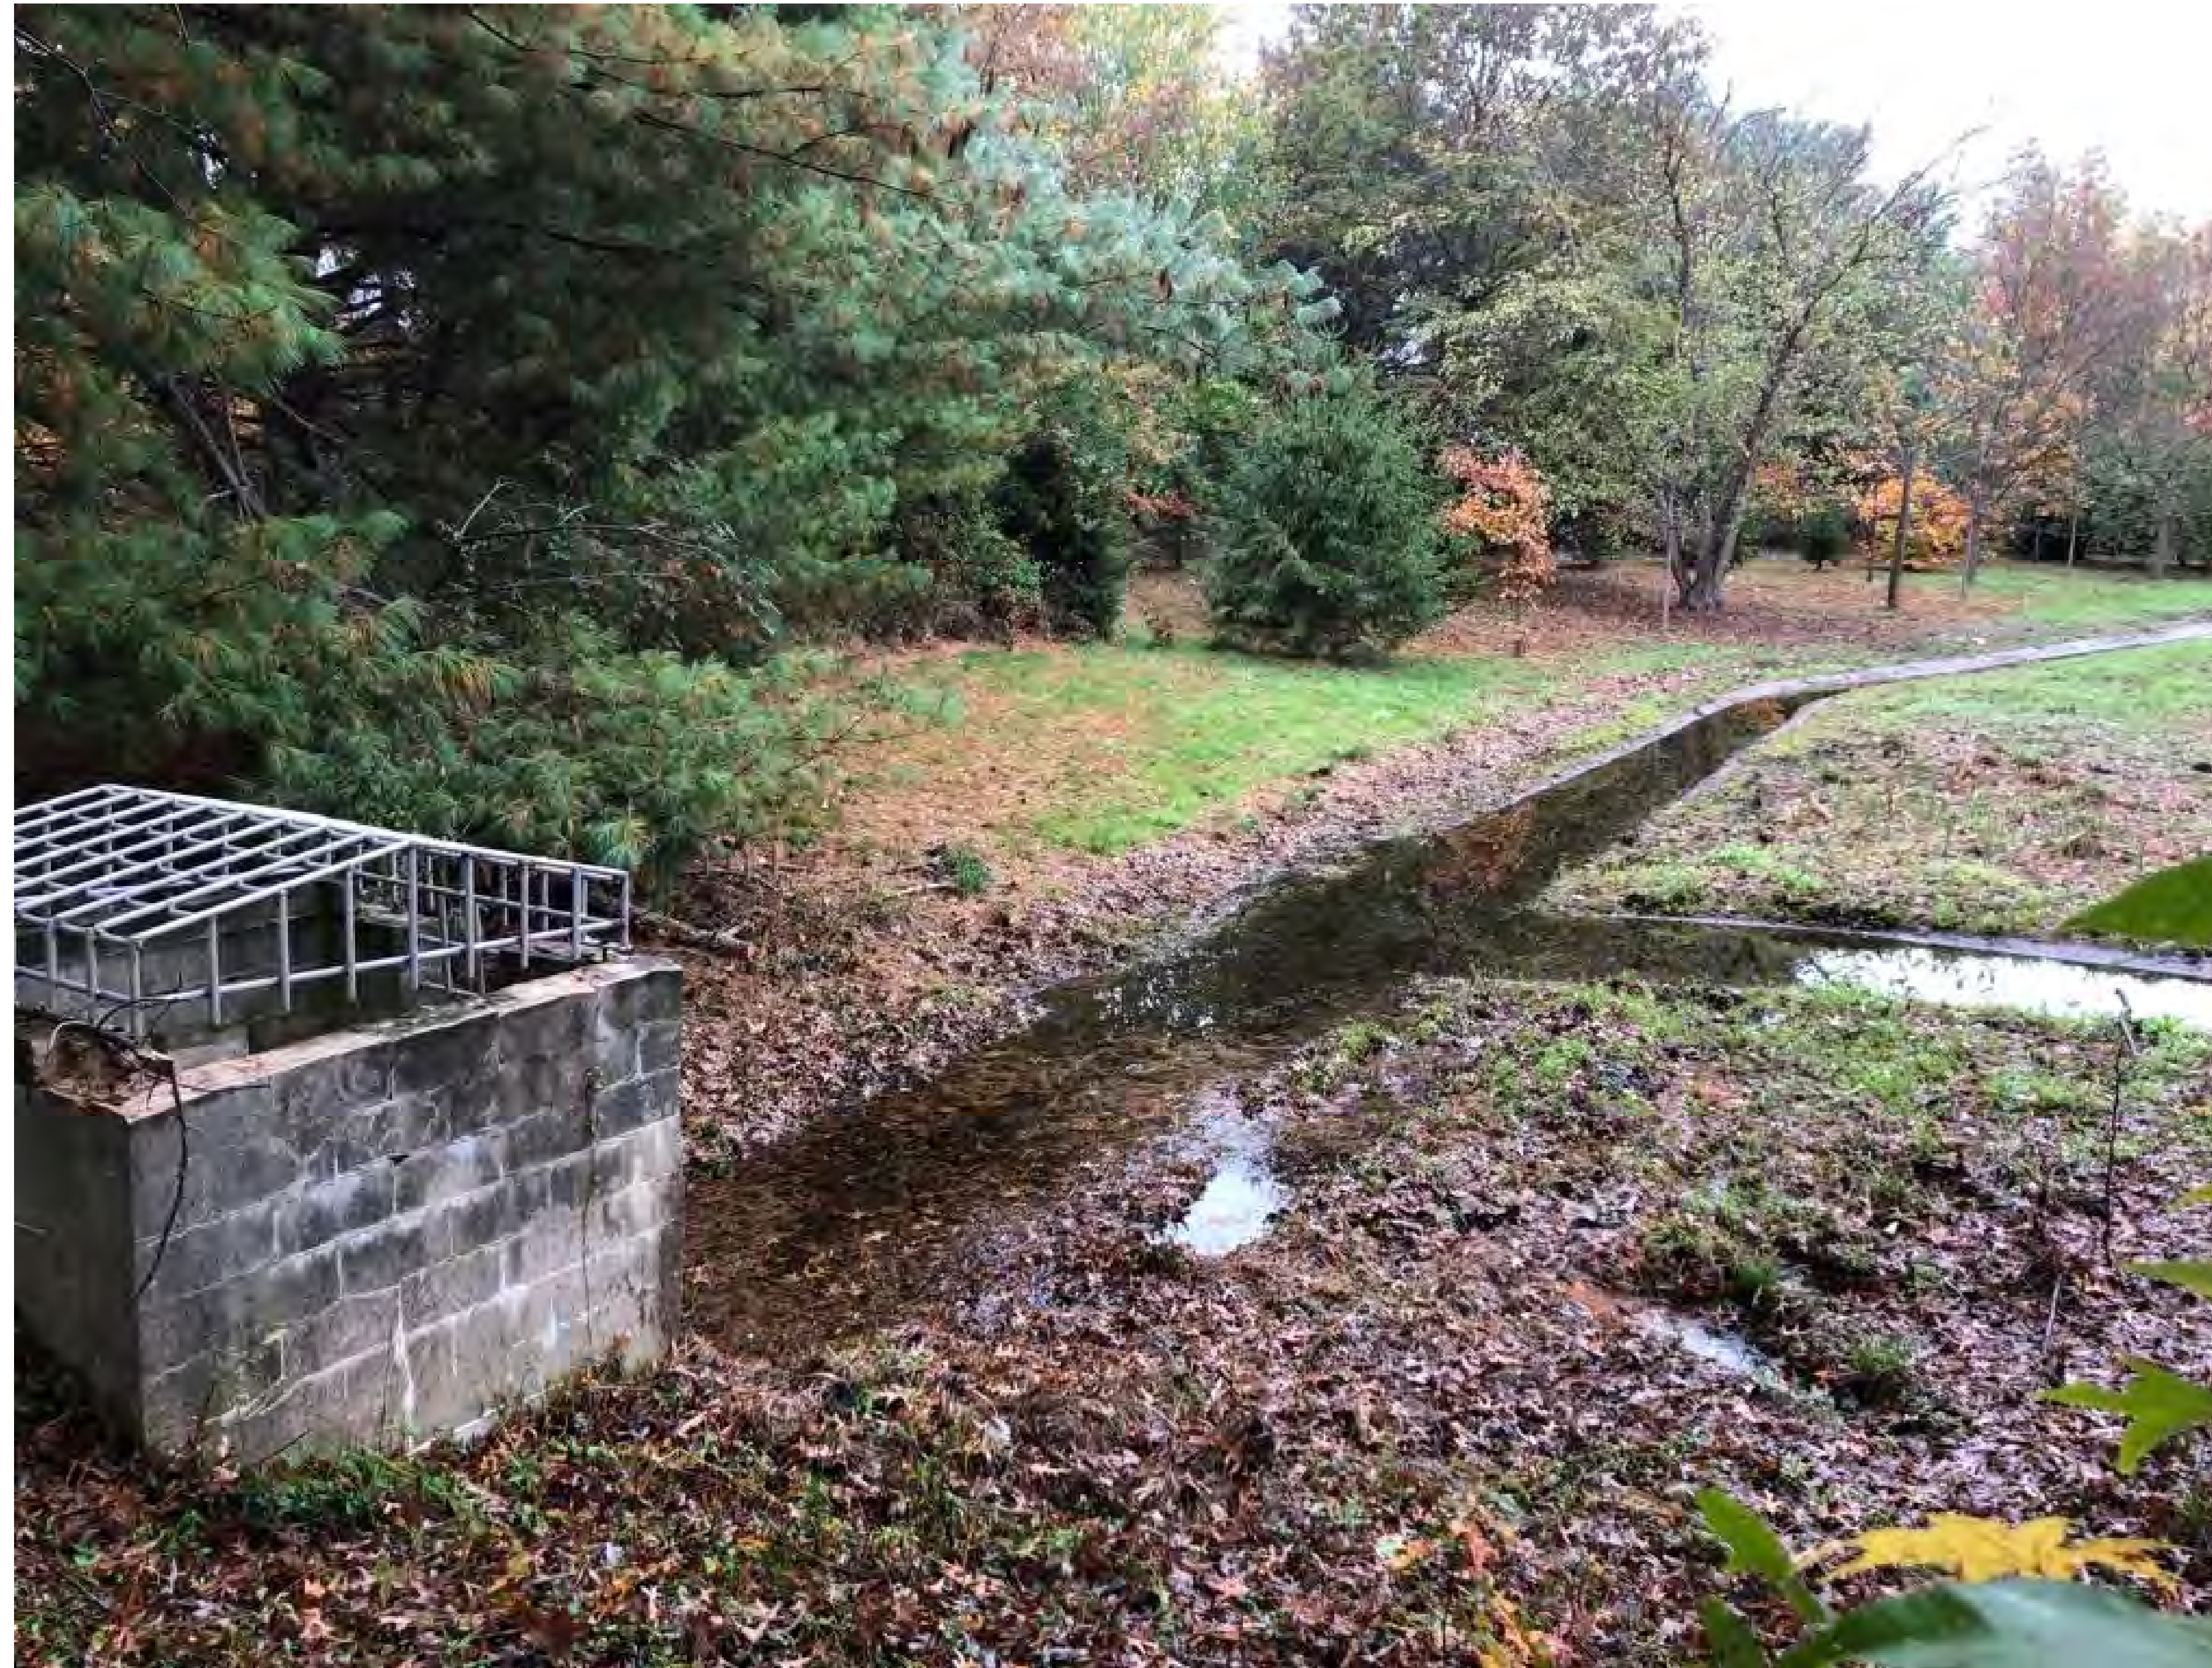
Address:  
Innocenzi Dr and Great Oak Rd  
Trenton, NJ 08690

- Significant standing water in low flow channel and near outlet likely due to clogged low flow orifice
- Clear out outlet to allow basin to drain properly
- Low flow channel can be removed and replaced with a stone channel to allow more infiltration in smaller storm events

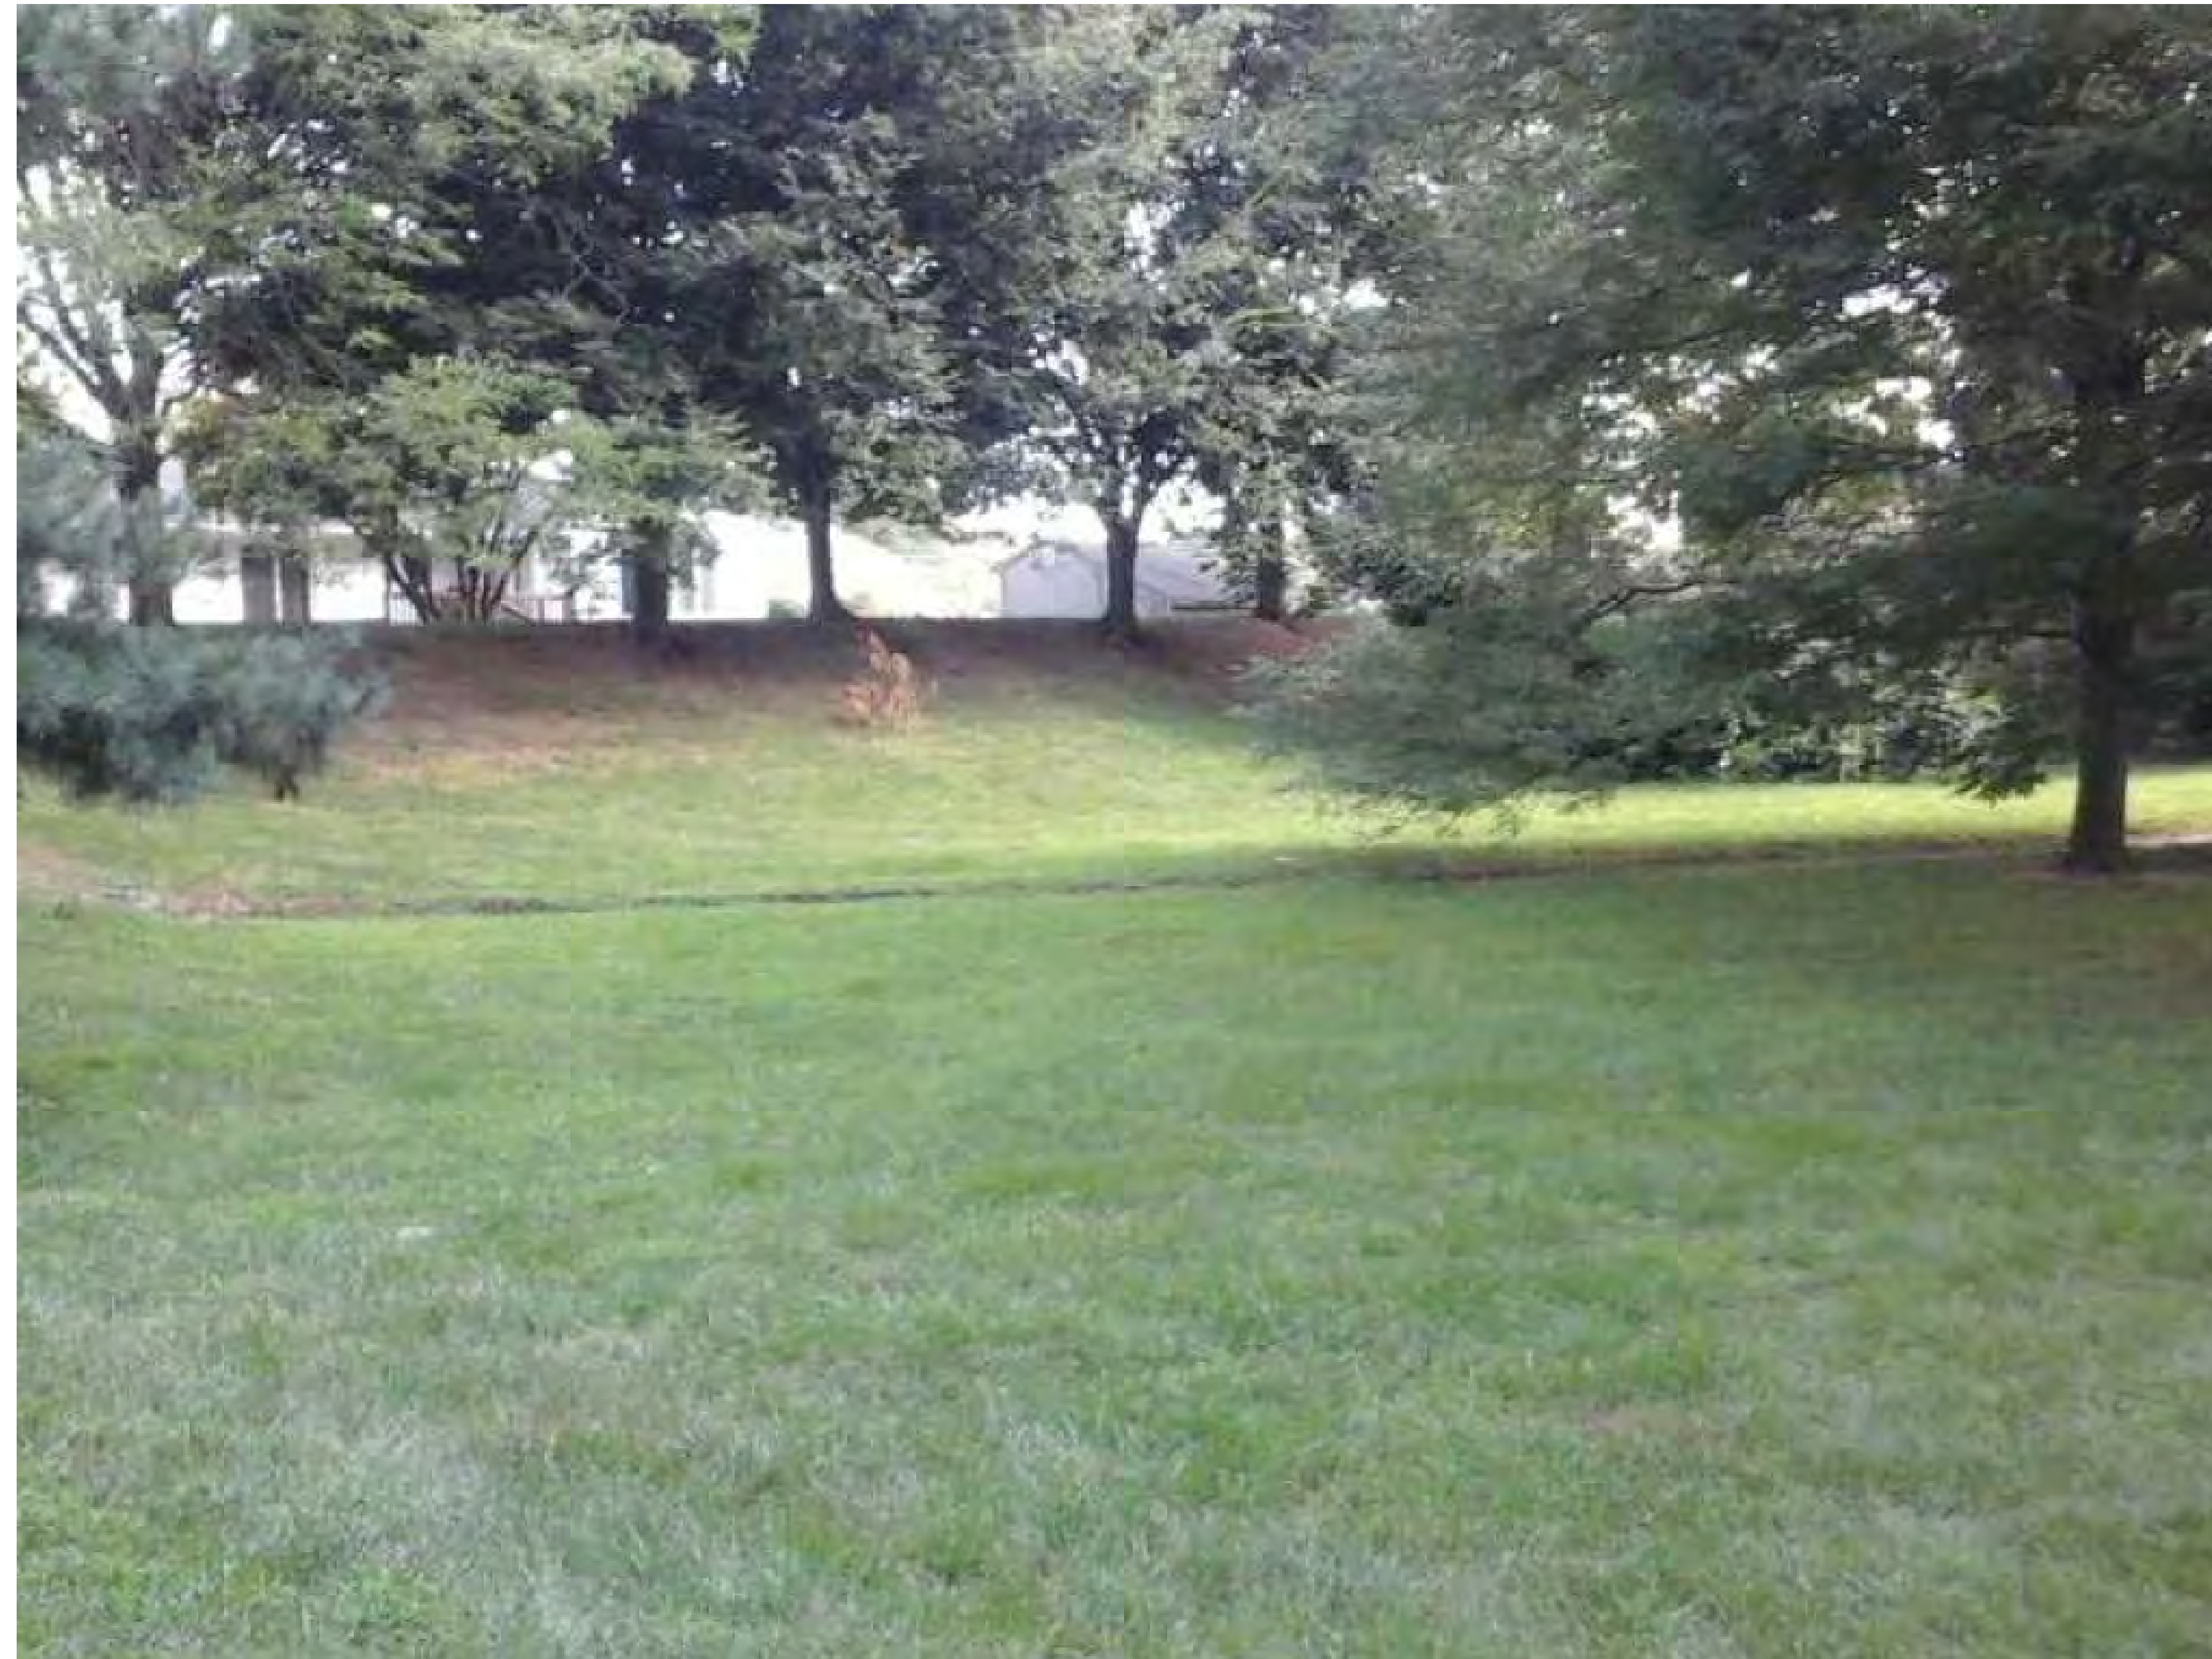
Address:  
255 Sharps Ln  
Hamilton Township, NJ 08610

- Trees existing in basin, some standing water present, fallen tree
- Replace low flow channel with stone channel to reduce standing water and allow infiltration
- Naturalize with herbaceous plants

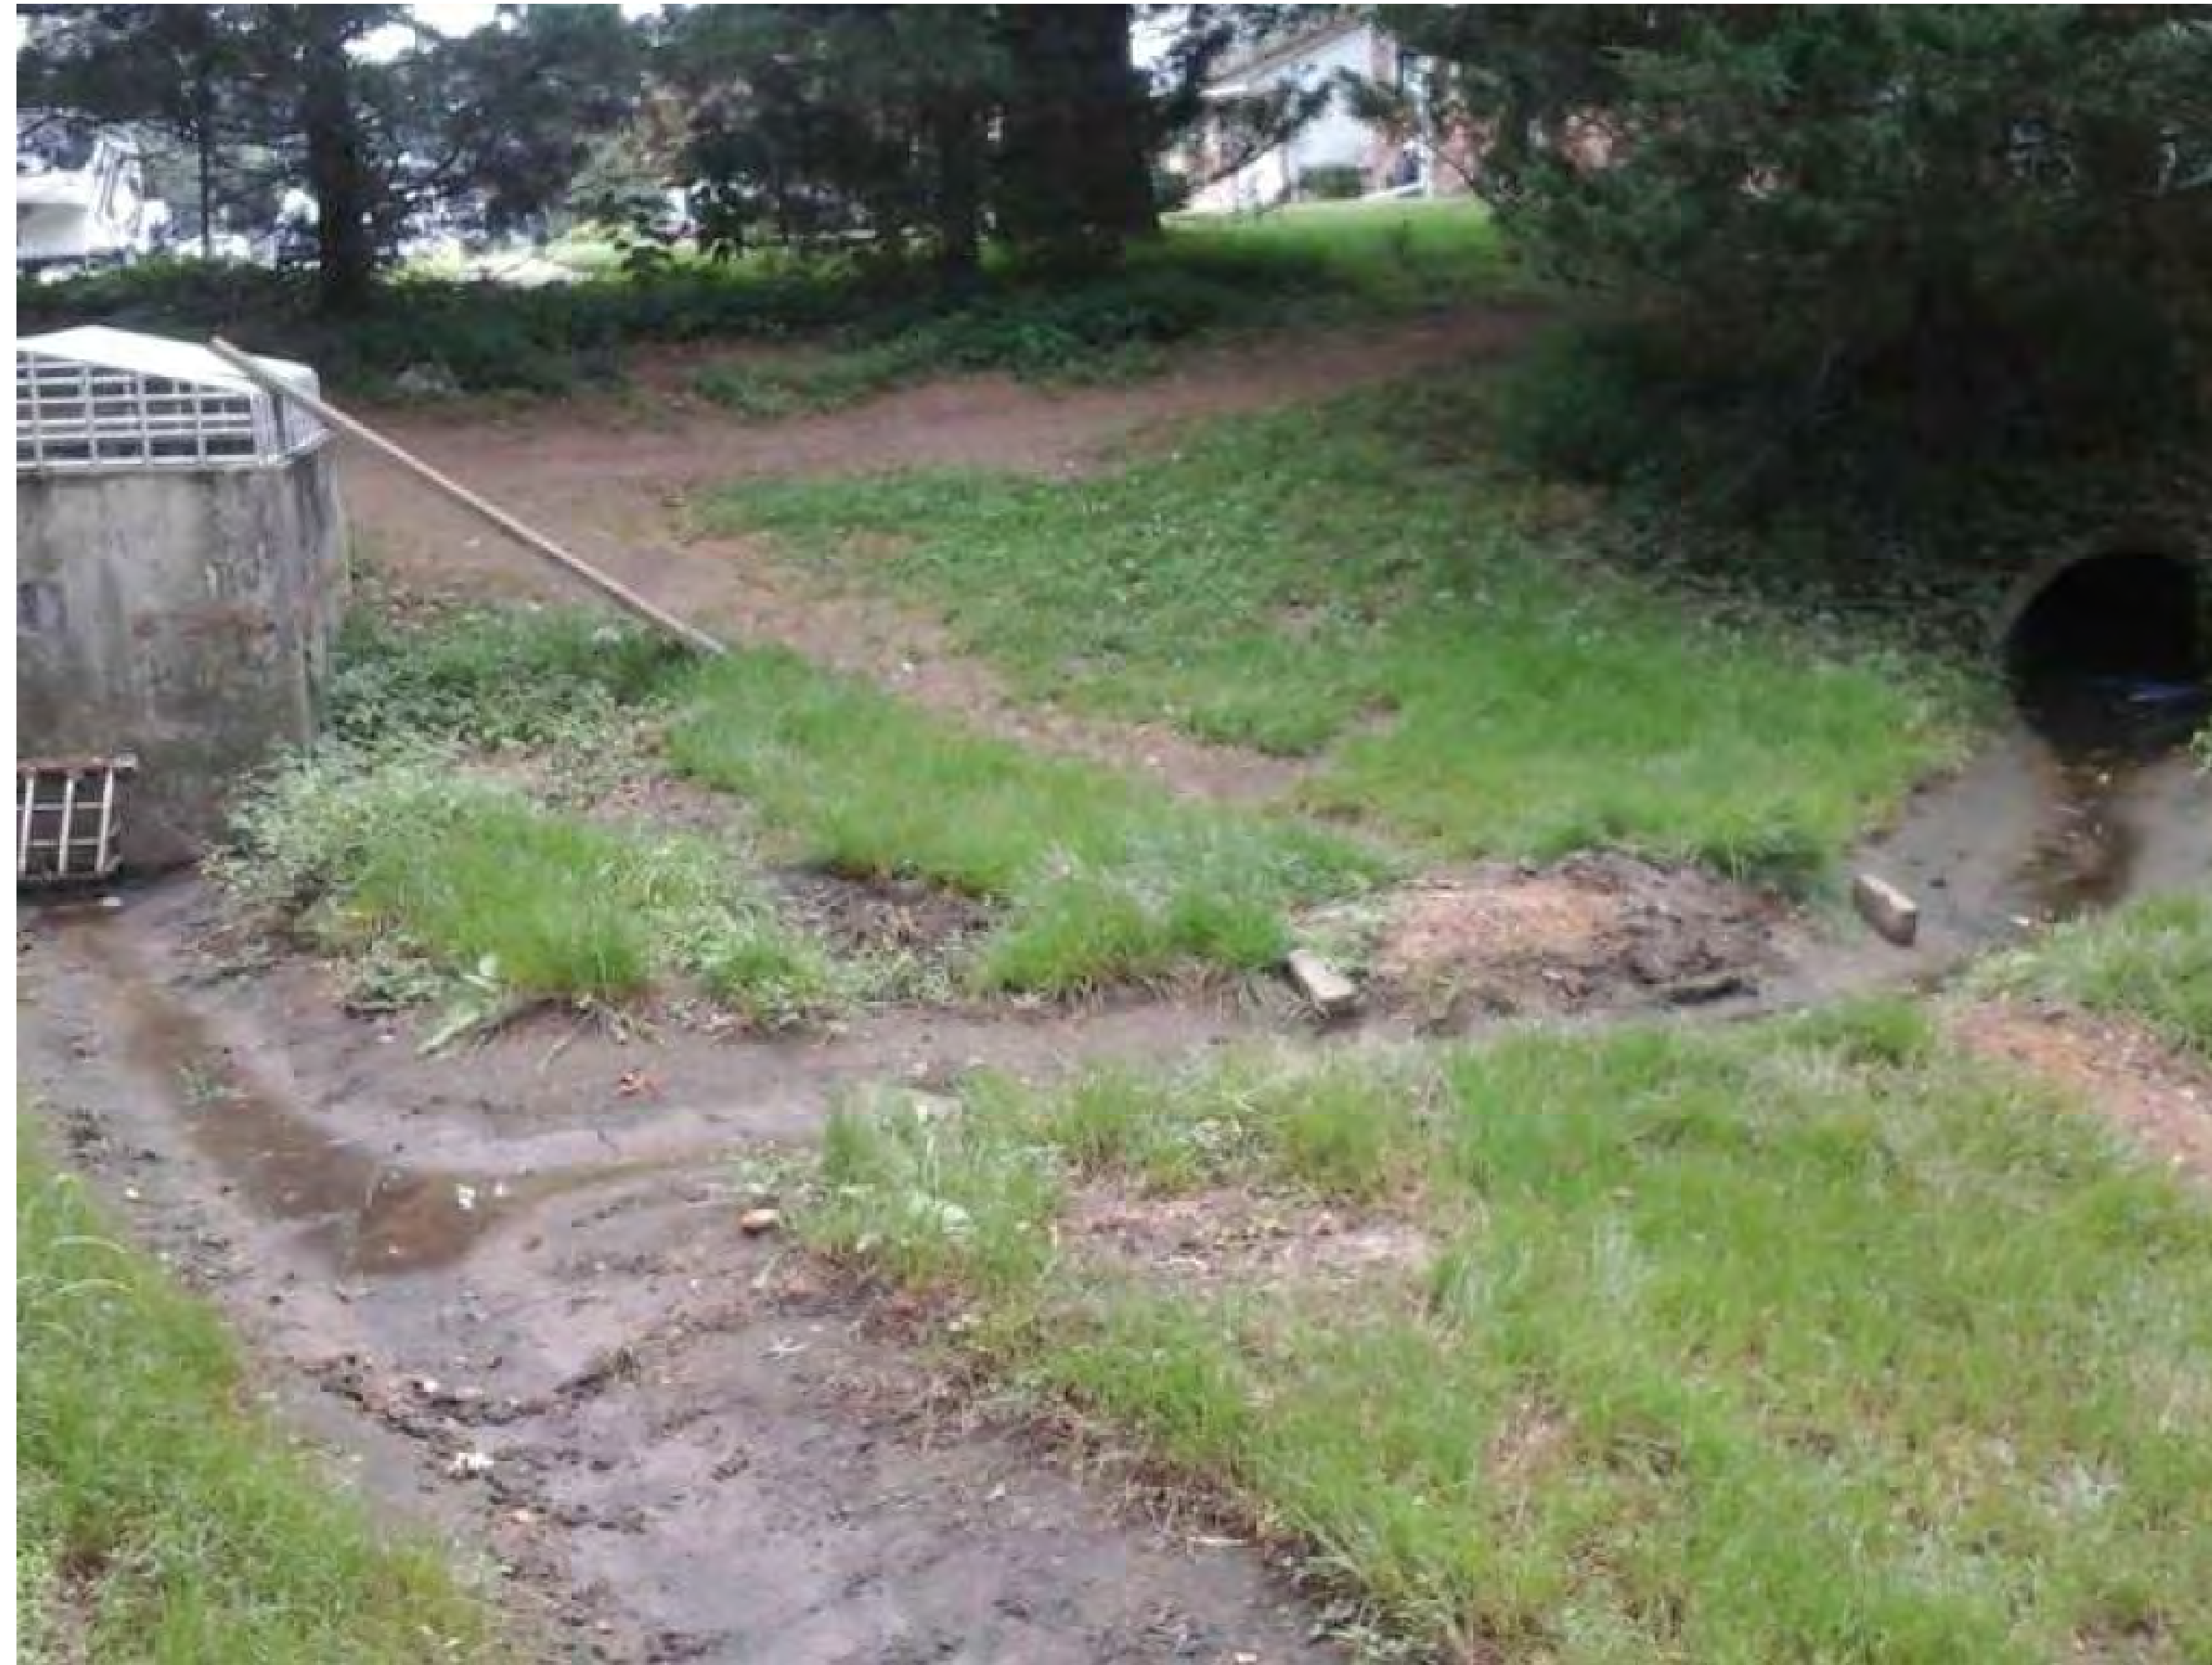
Address:  
41 Dark Leaf Dr  
Hamilton Township, NJ 08610

- Erosion present in basin
- Slight standing water in low flow channels
- Remove low flow channel to allow more infiltration
- Naturalize with herbaceous plants to help reduce erosion

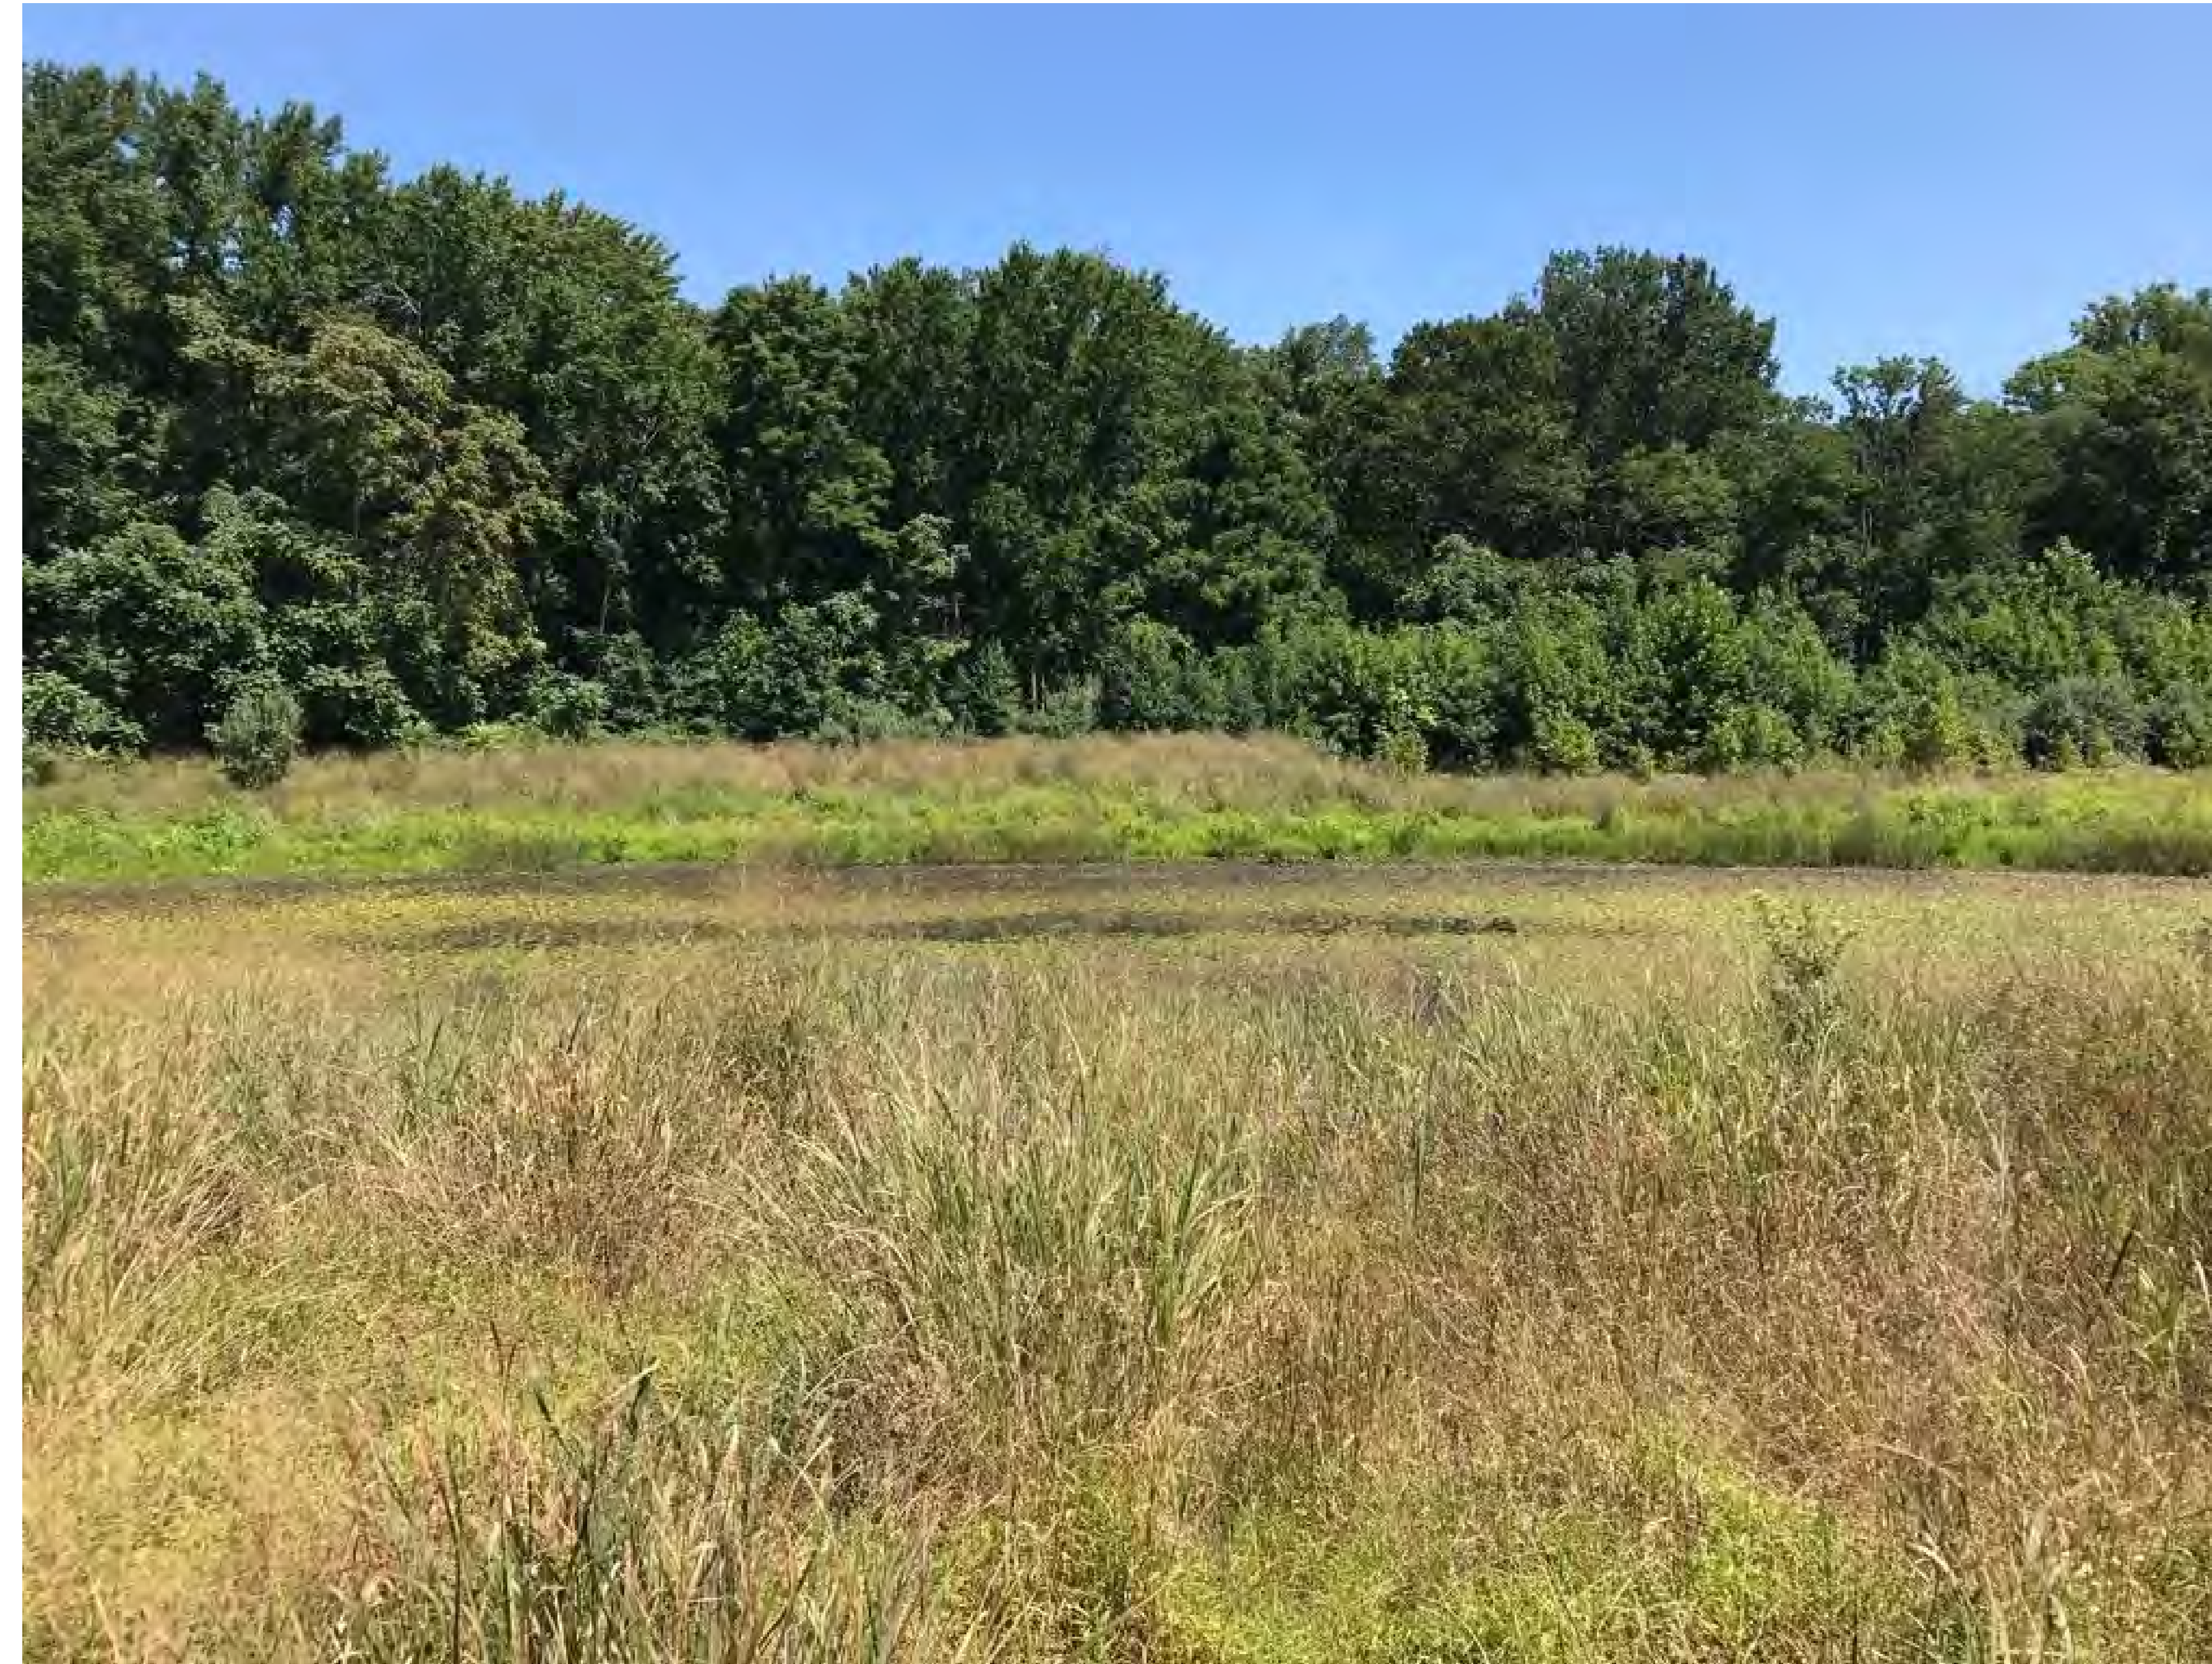
Address:  
9 Weathersfield Dr  
Hamilton Township, NJ 08620

- 2014 report did not include notes for this basin as retention basins were not being fully assessed at the time
- Massive retention basin surrounded by thick vegetation
- Appears in good condition, no recommendation

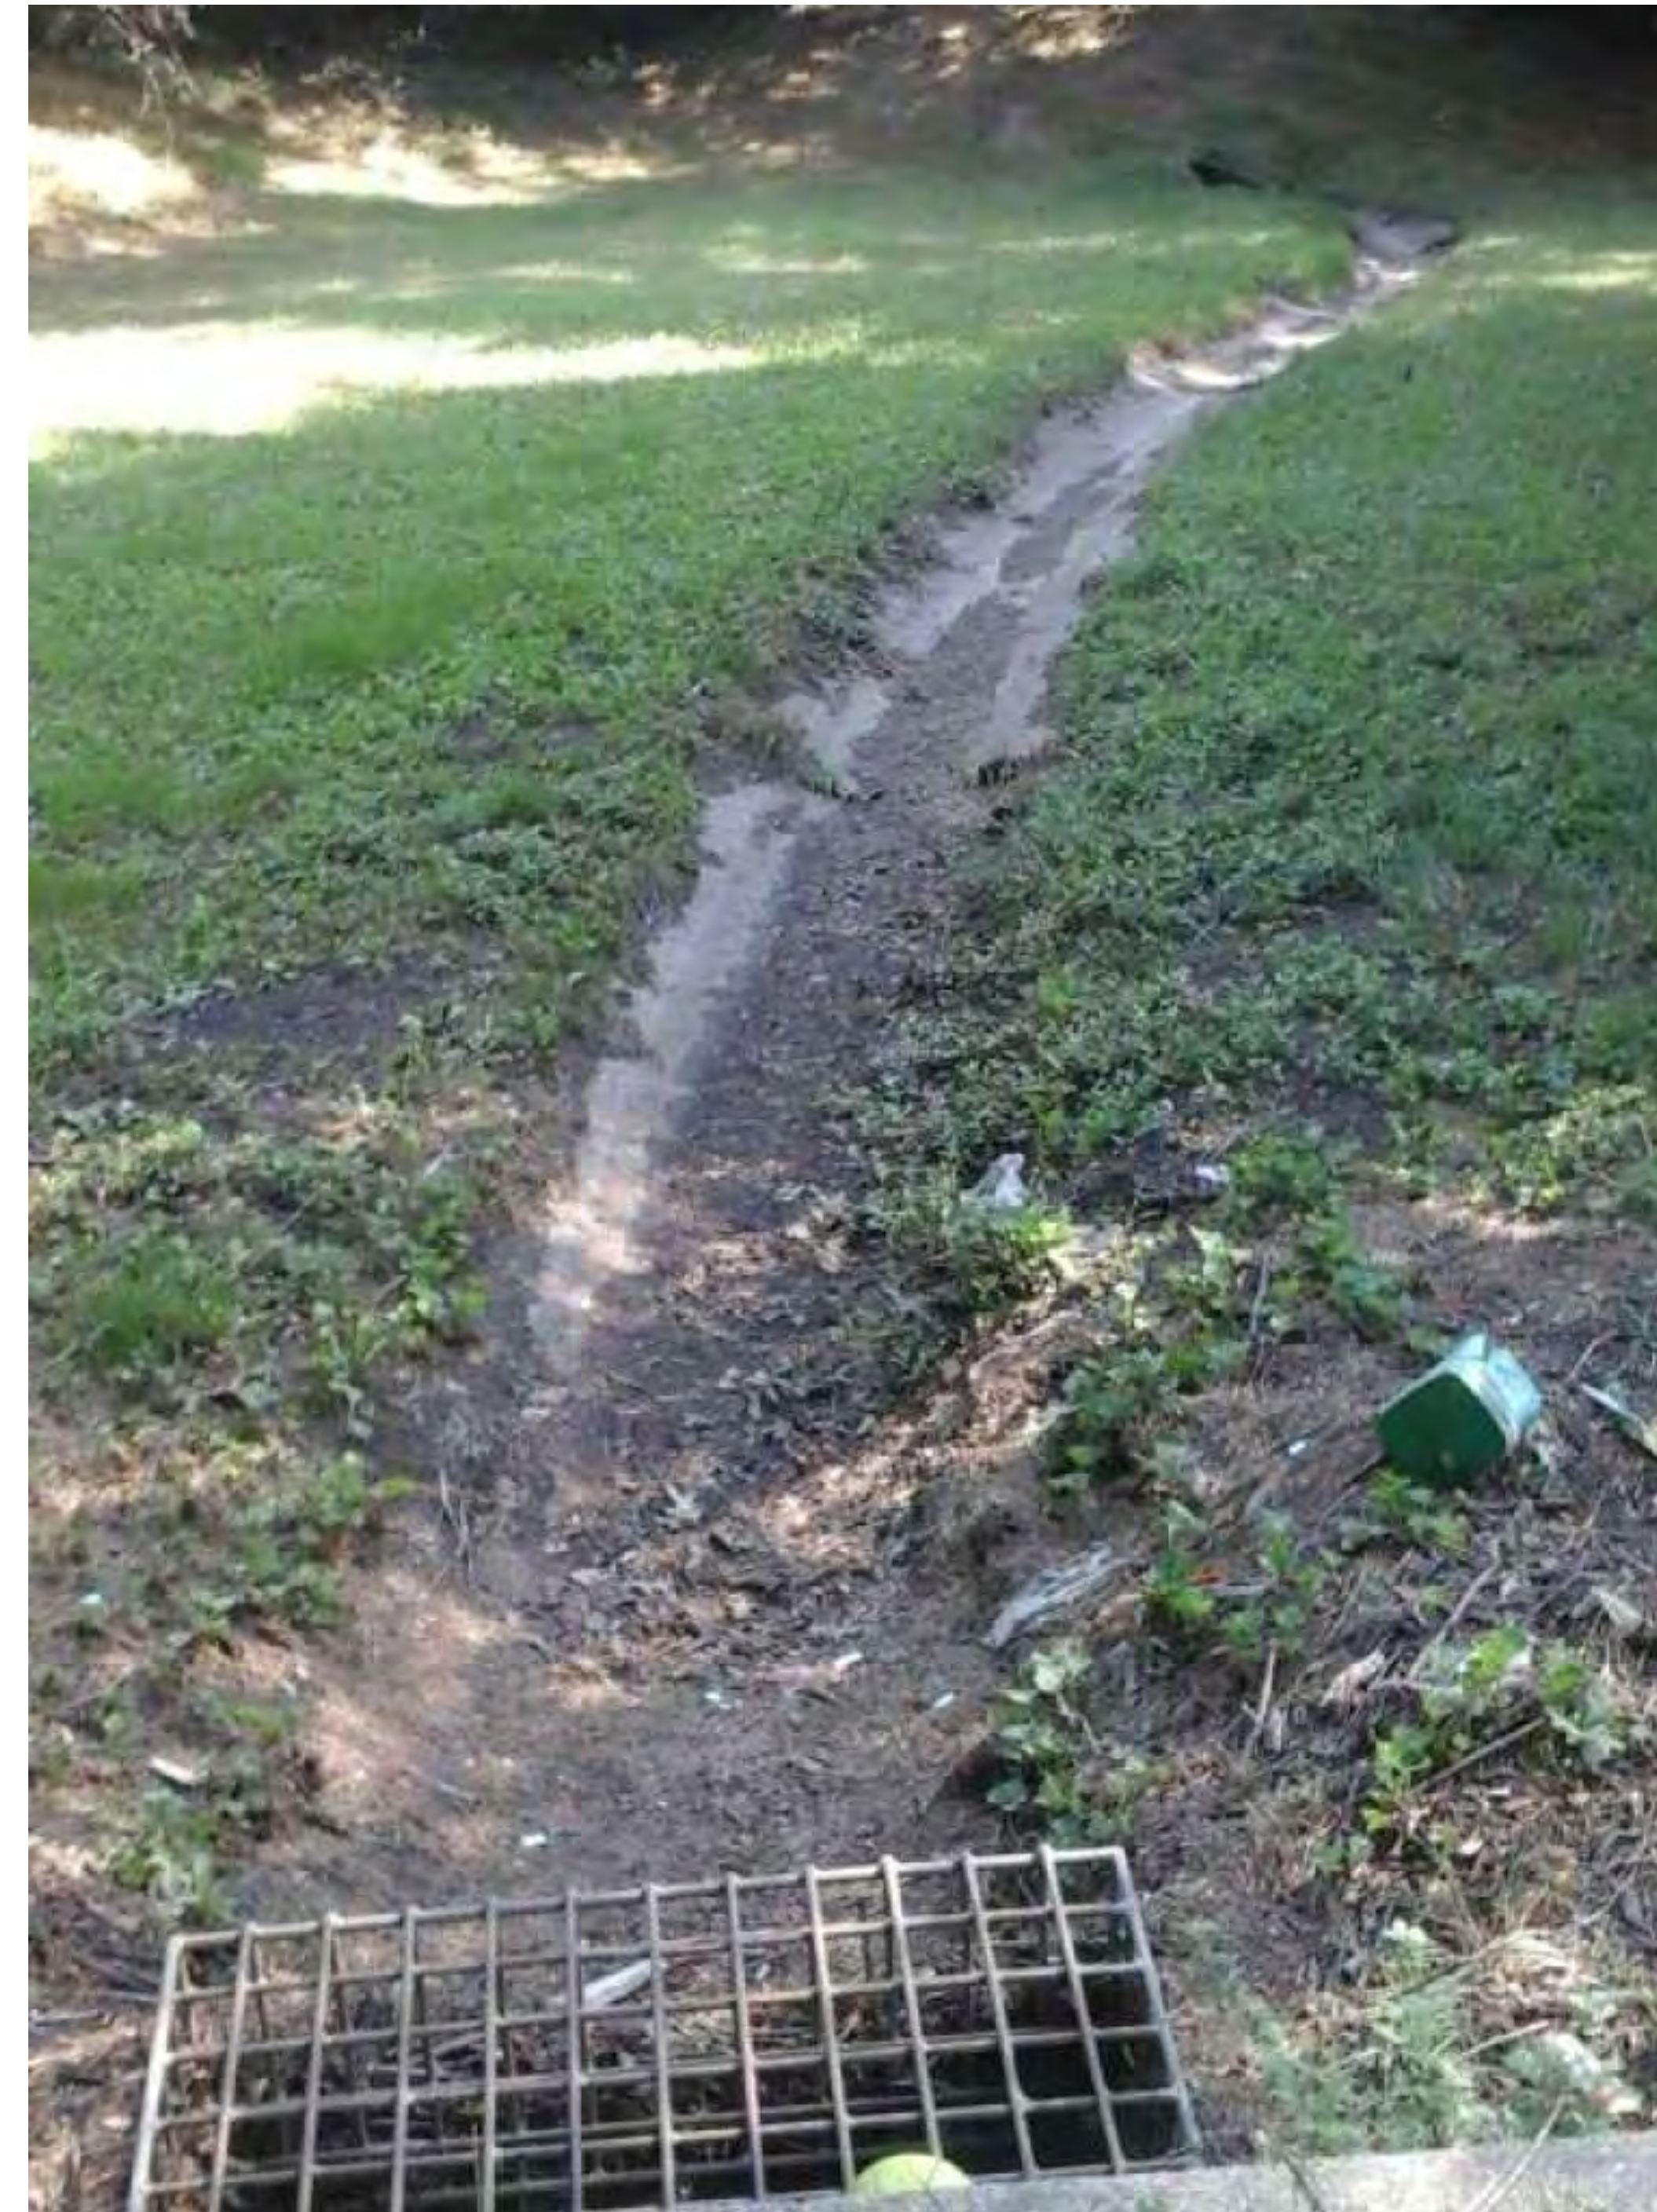
Address:  
39 Perilli Dr  
Hamilton Township, NJ 08610

- Outlet has excessive sediment accumulation clogging low flow orifice
- Remove low flow channel and replace with a rock-lined channel to allow infiltration
- Naturalize with herbaceous plants
