## Hamilton Township (Mercer County)

# REVIEW AND EVALUATION OF TOTAL MAXIMUM DAILY LOADS (TMDLs)

Developed by the Rutgers Cooperative Extension Water Resources Program  
Funded by Hamilton Township, Mercer County, New Jersey

December 5, 2019

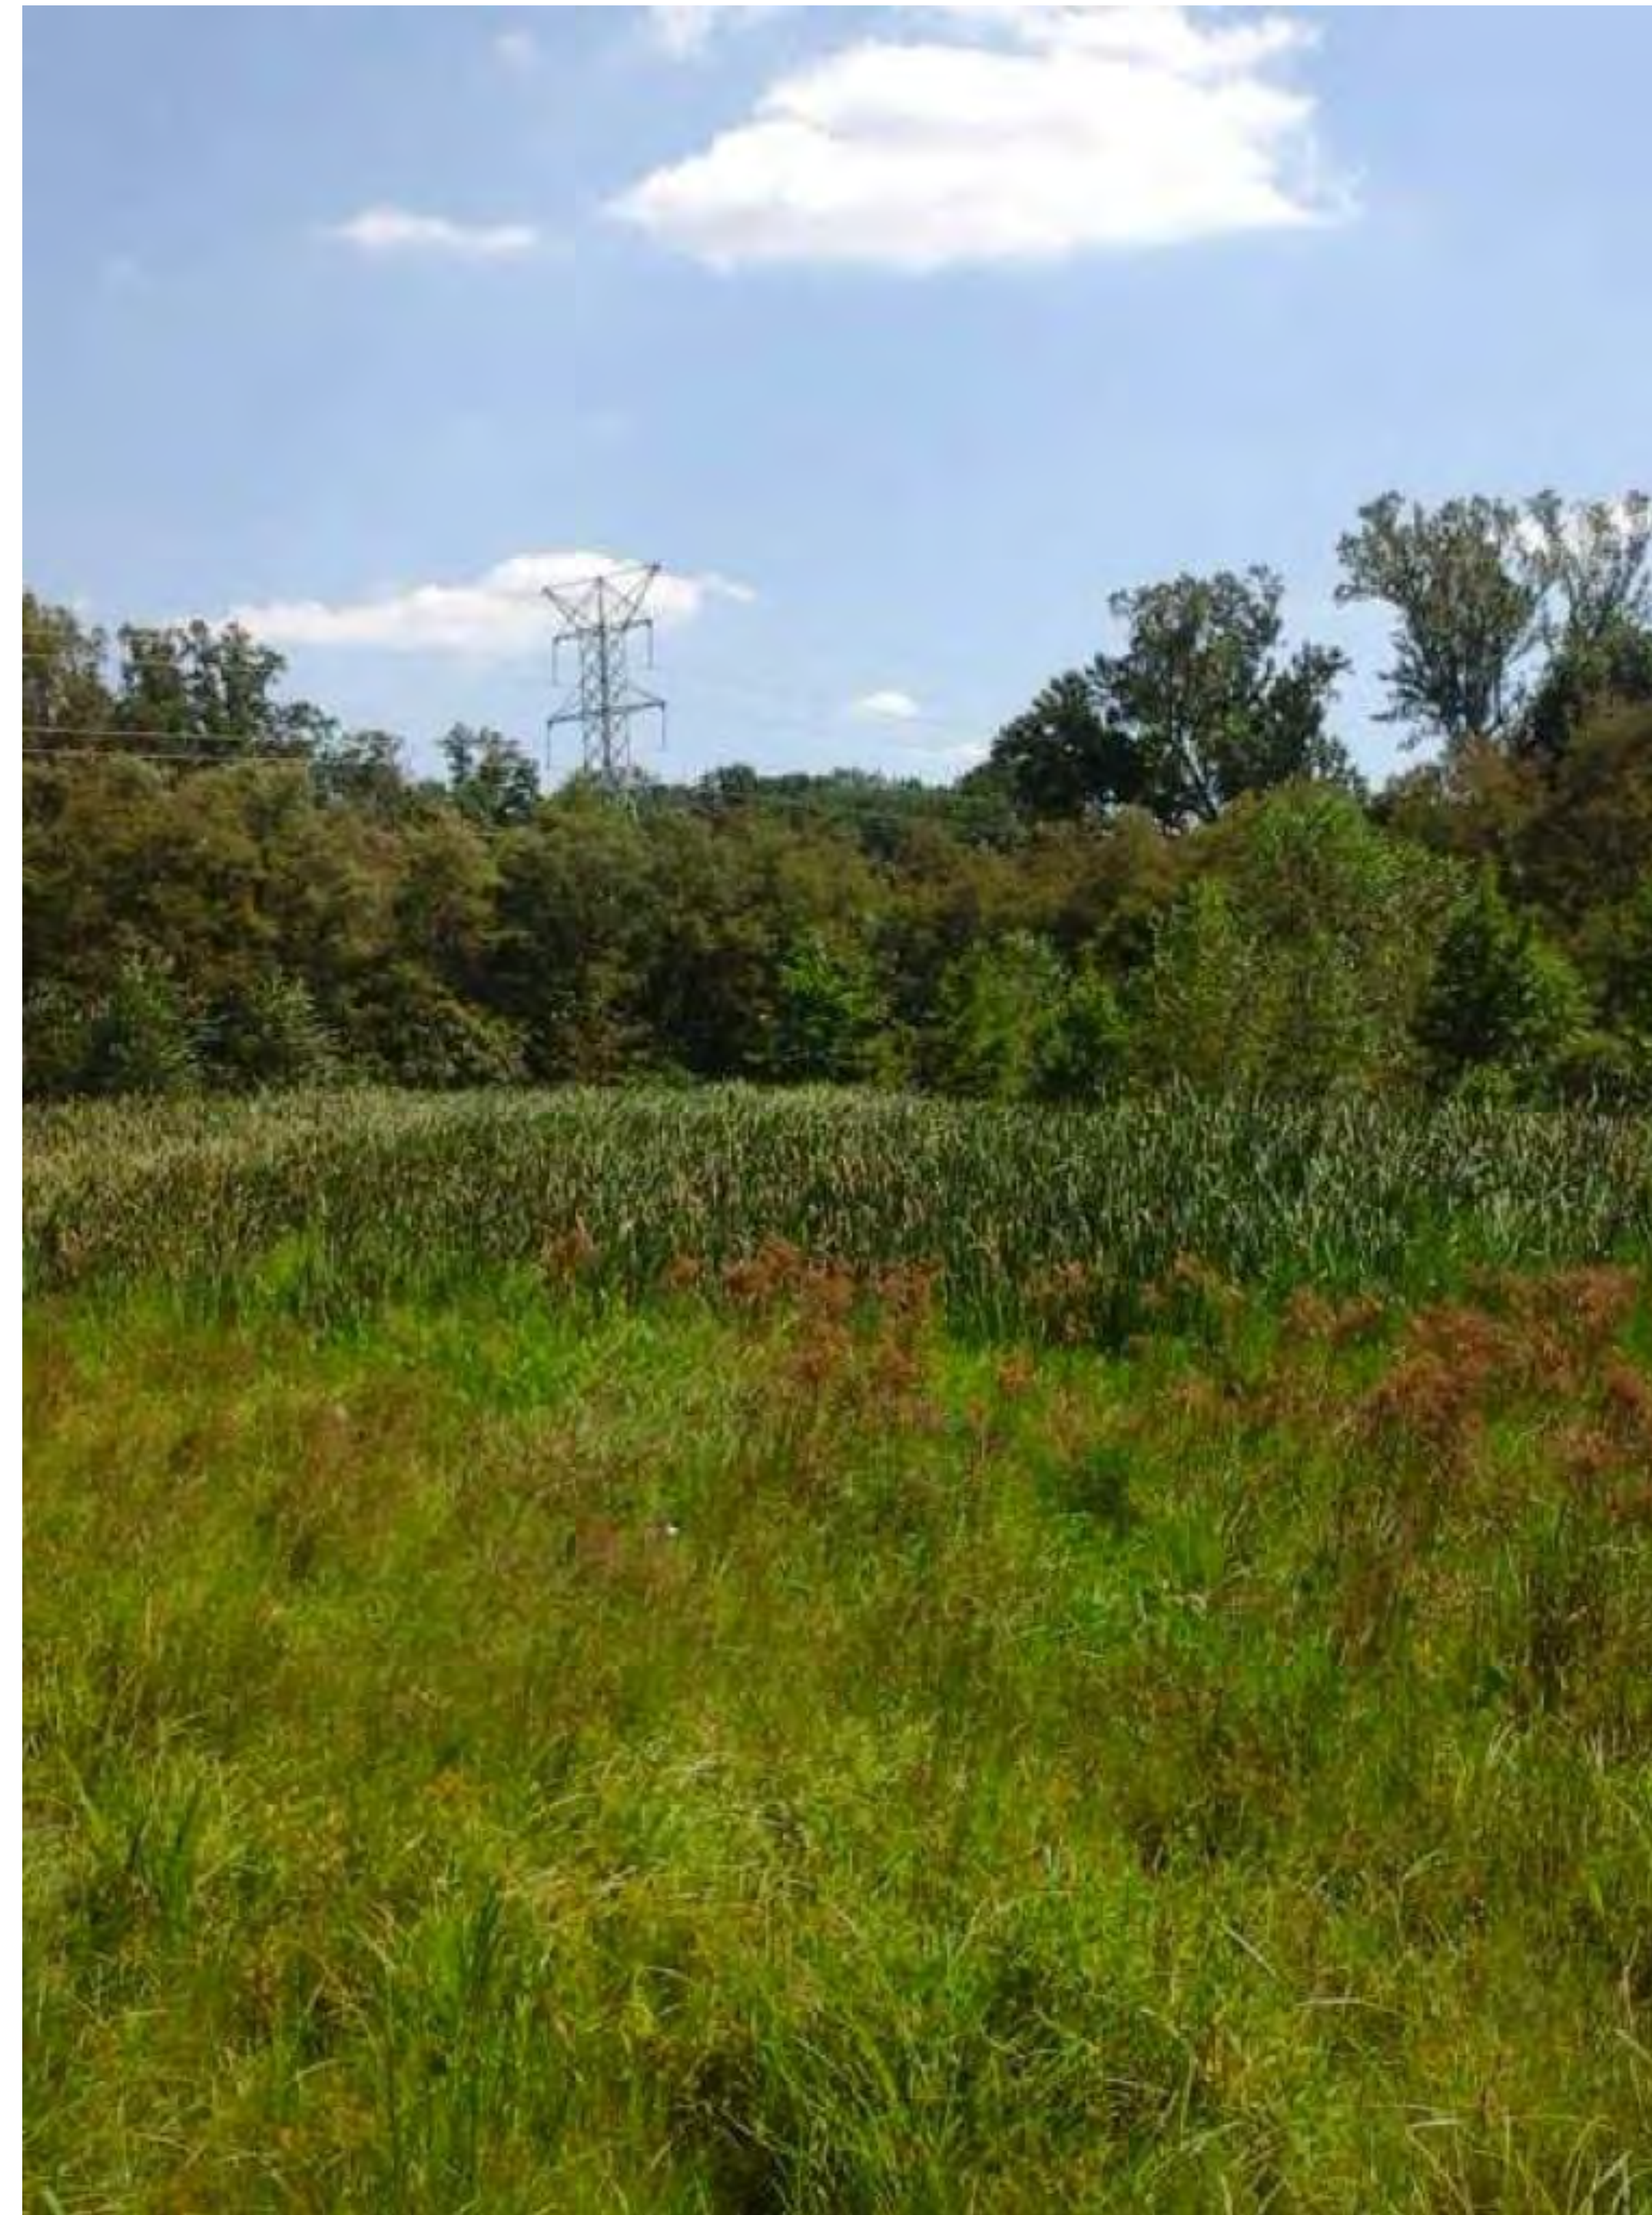
Address:  
56 Kristopher Dr  
Hamilton Township, NJ 08620

- Well establish meadow in basin with vegetation in good condition
- Better access to inlets and outlet could be added

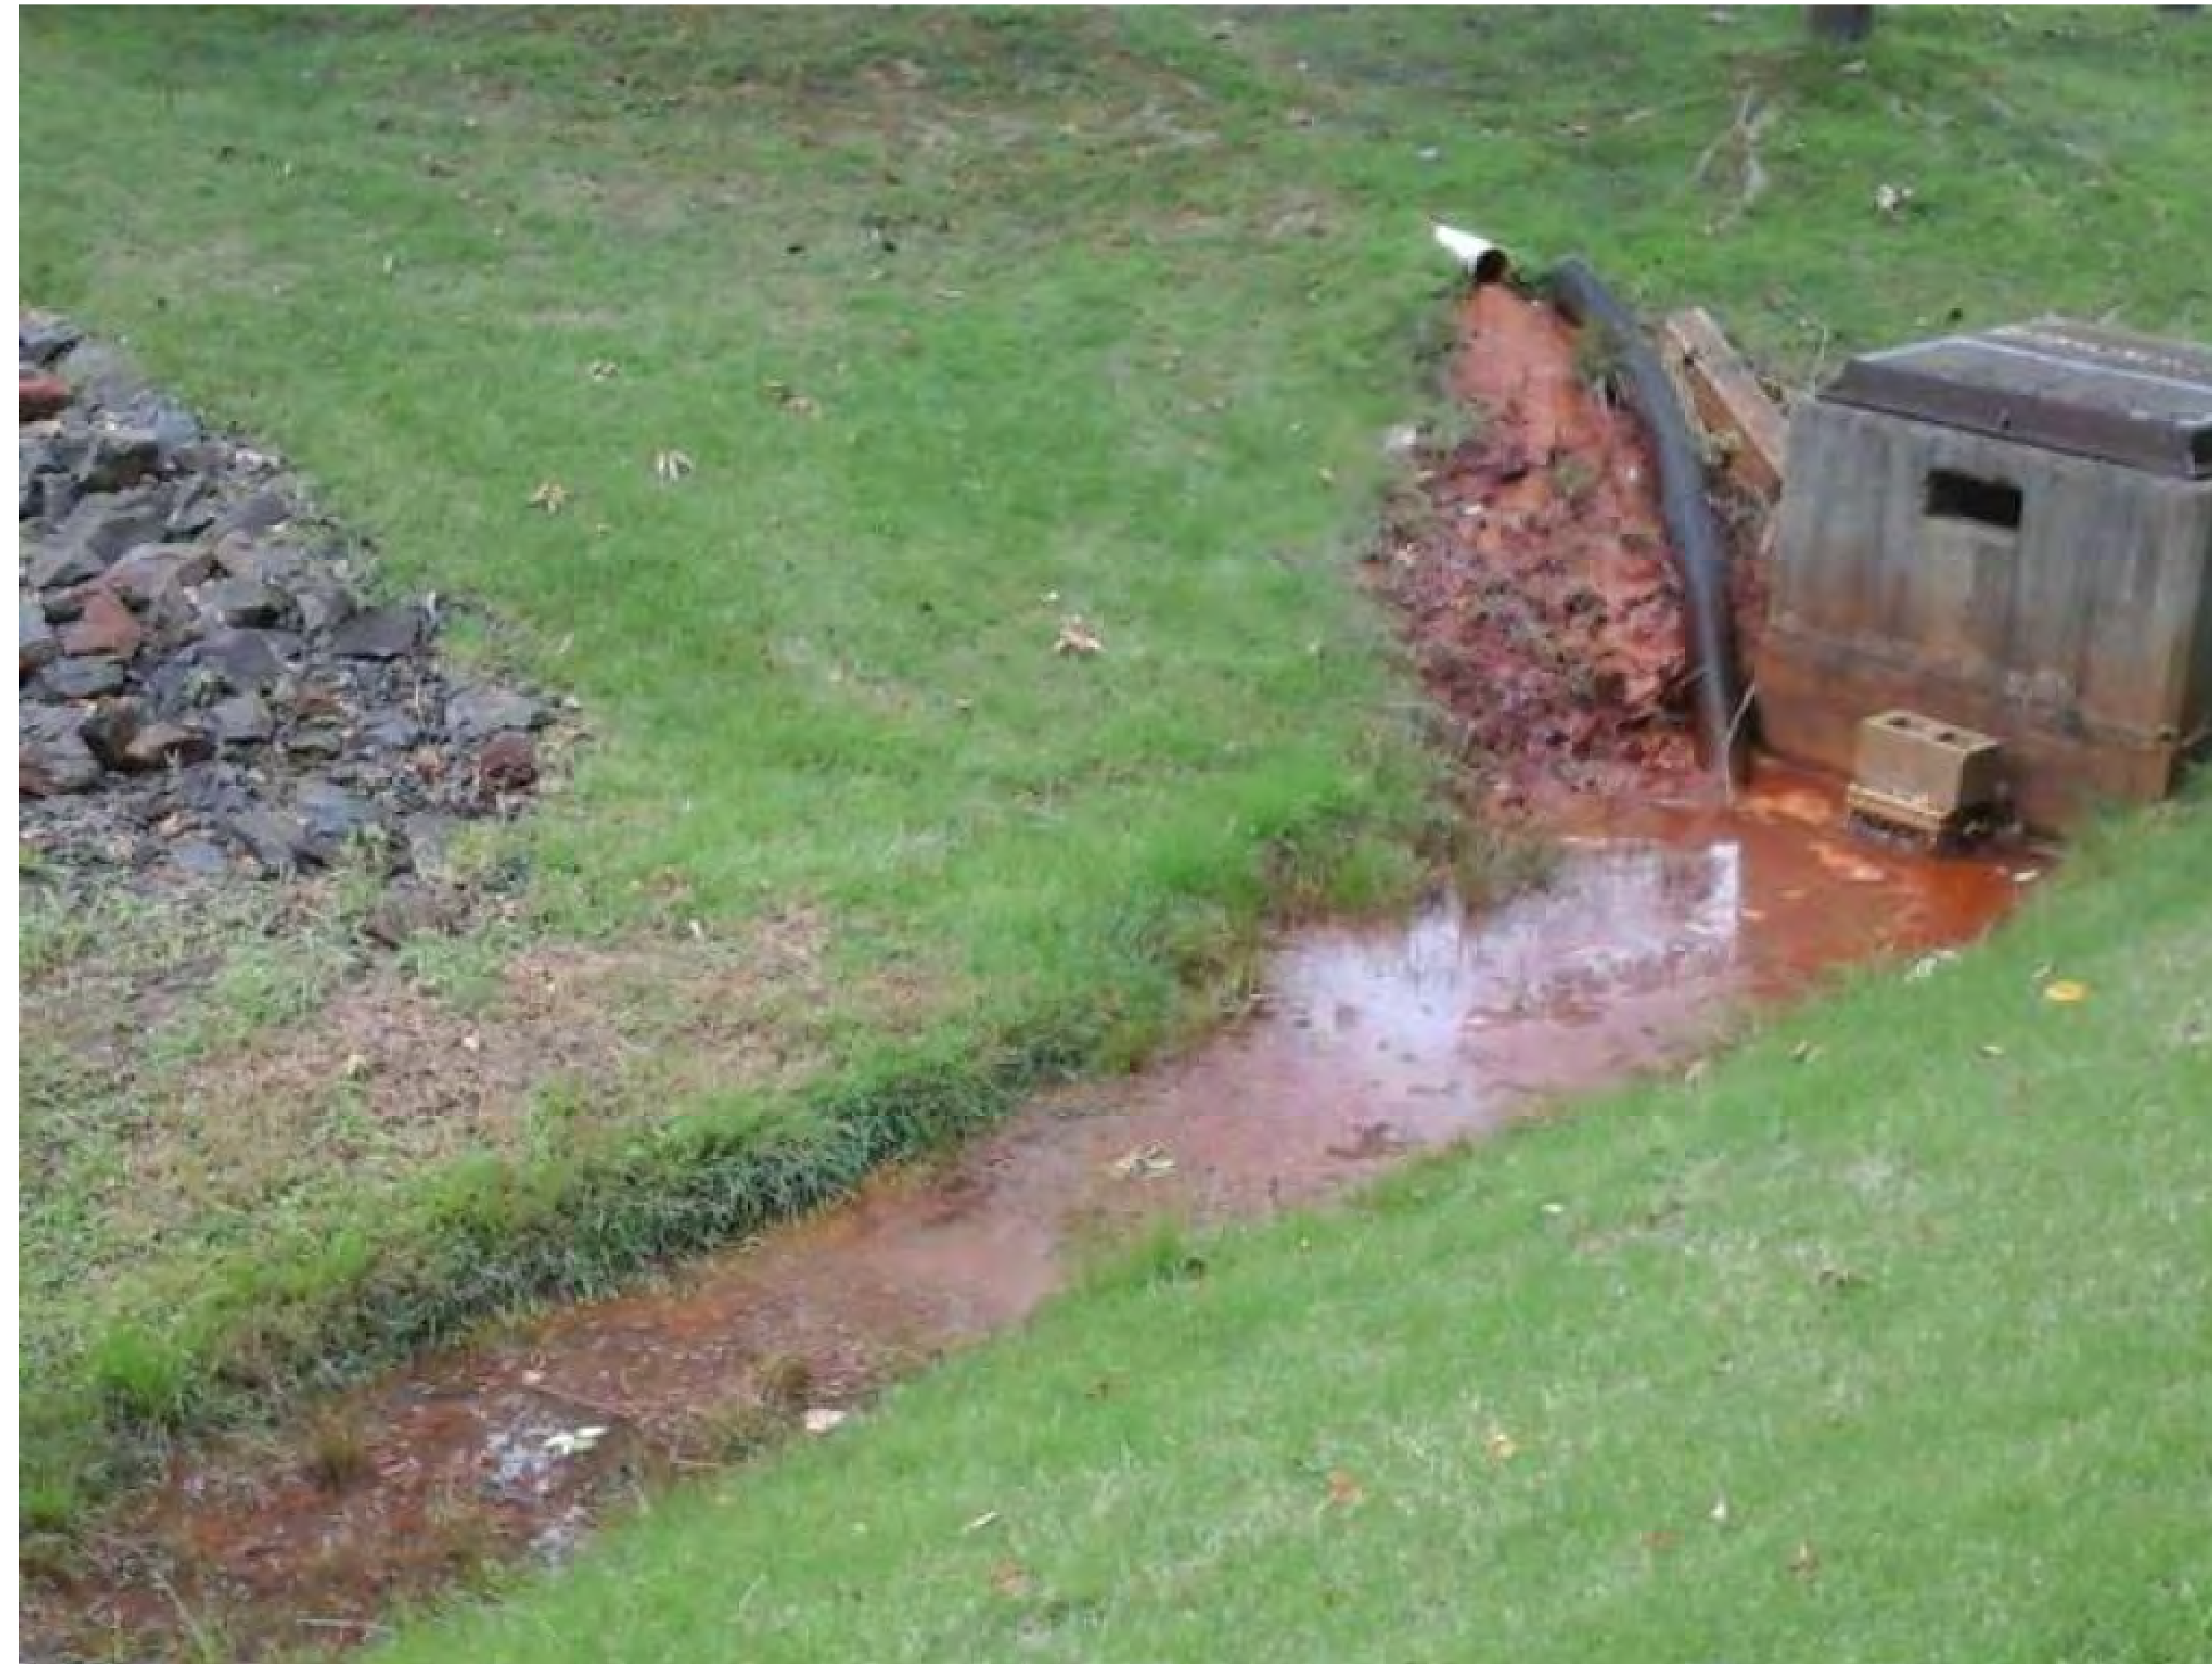
Address:  
1989 Arena Dr  
Trenton, NJ 08610

- The low flow outlet appears to be clogged leading to significant standing water in low flow channel
- Heavy erosion caused by small inlet pipe should be remediated
- Low flow channel can be replaced with a stone channel to provide better infiltration in smaller storm events

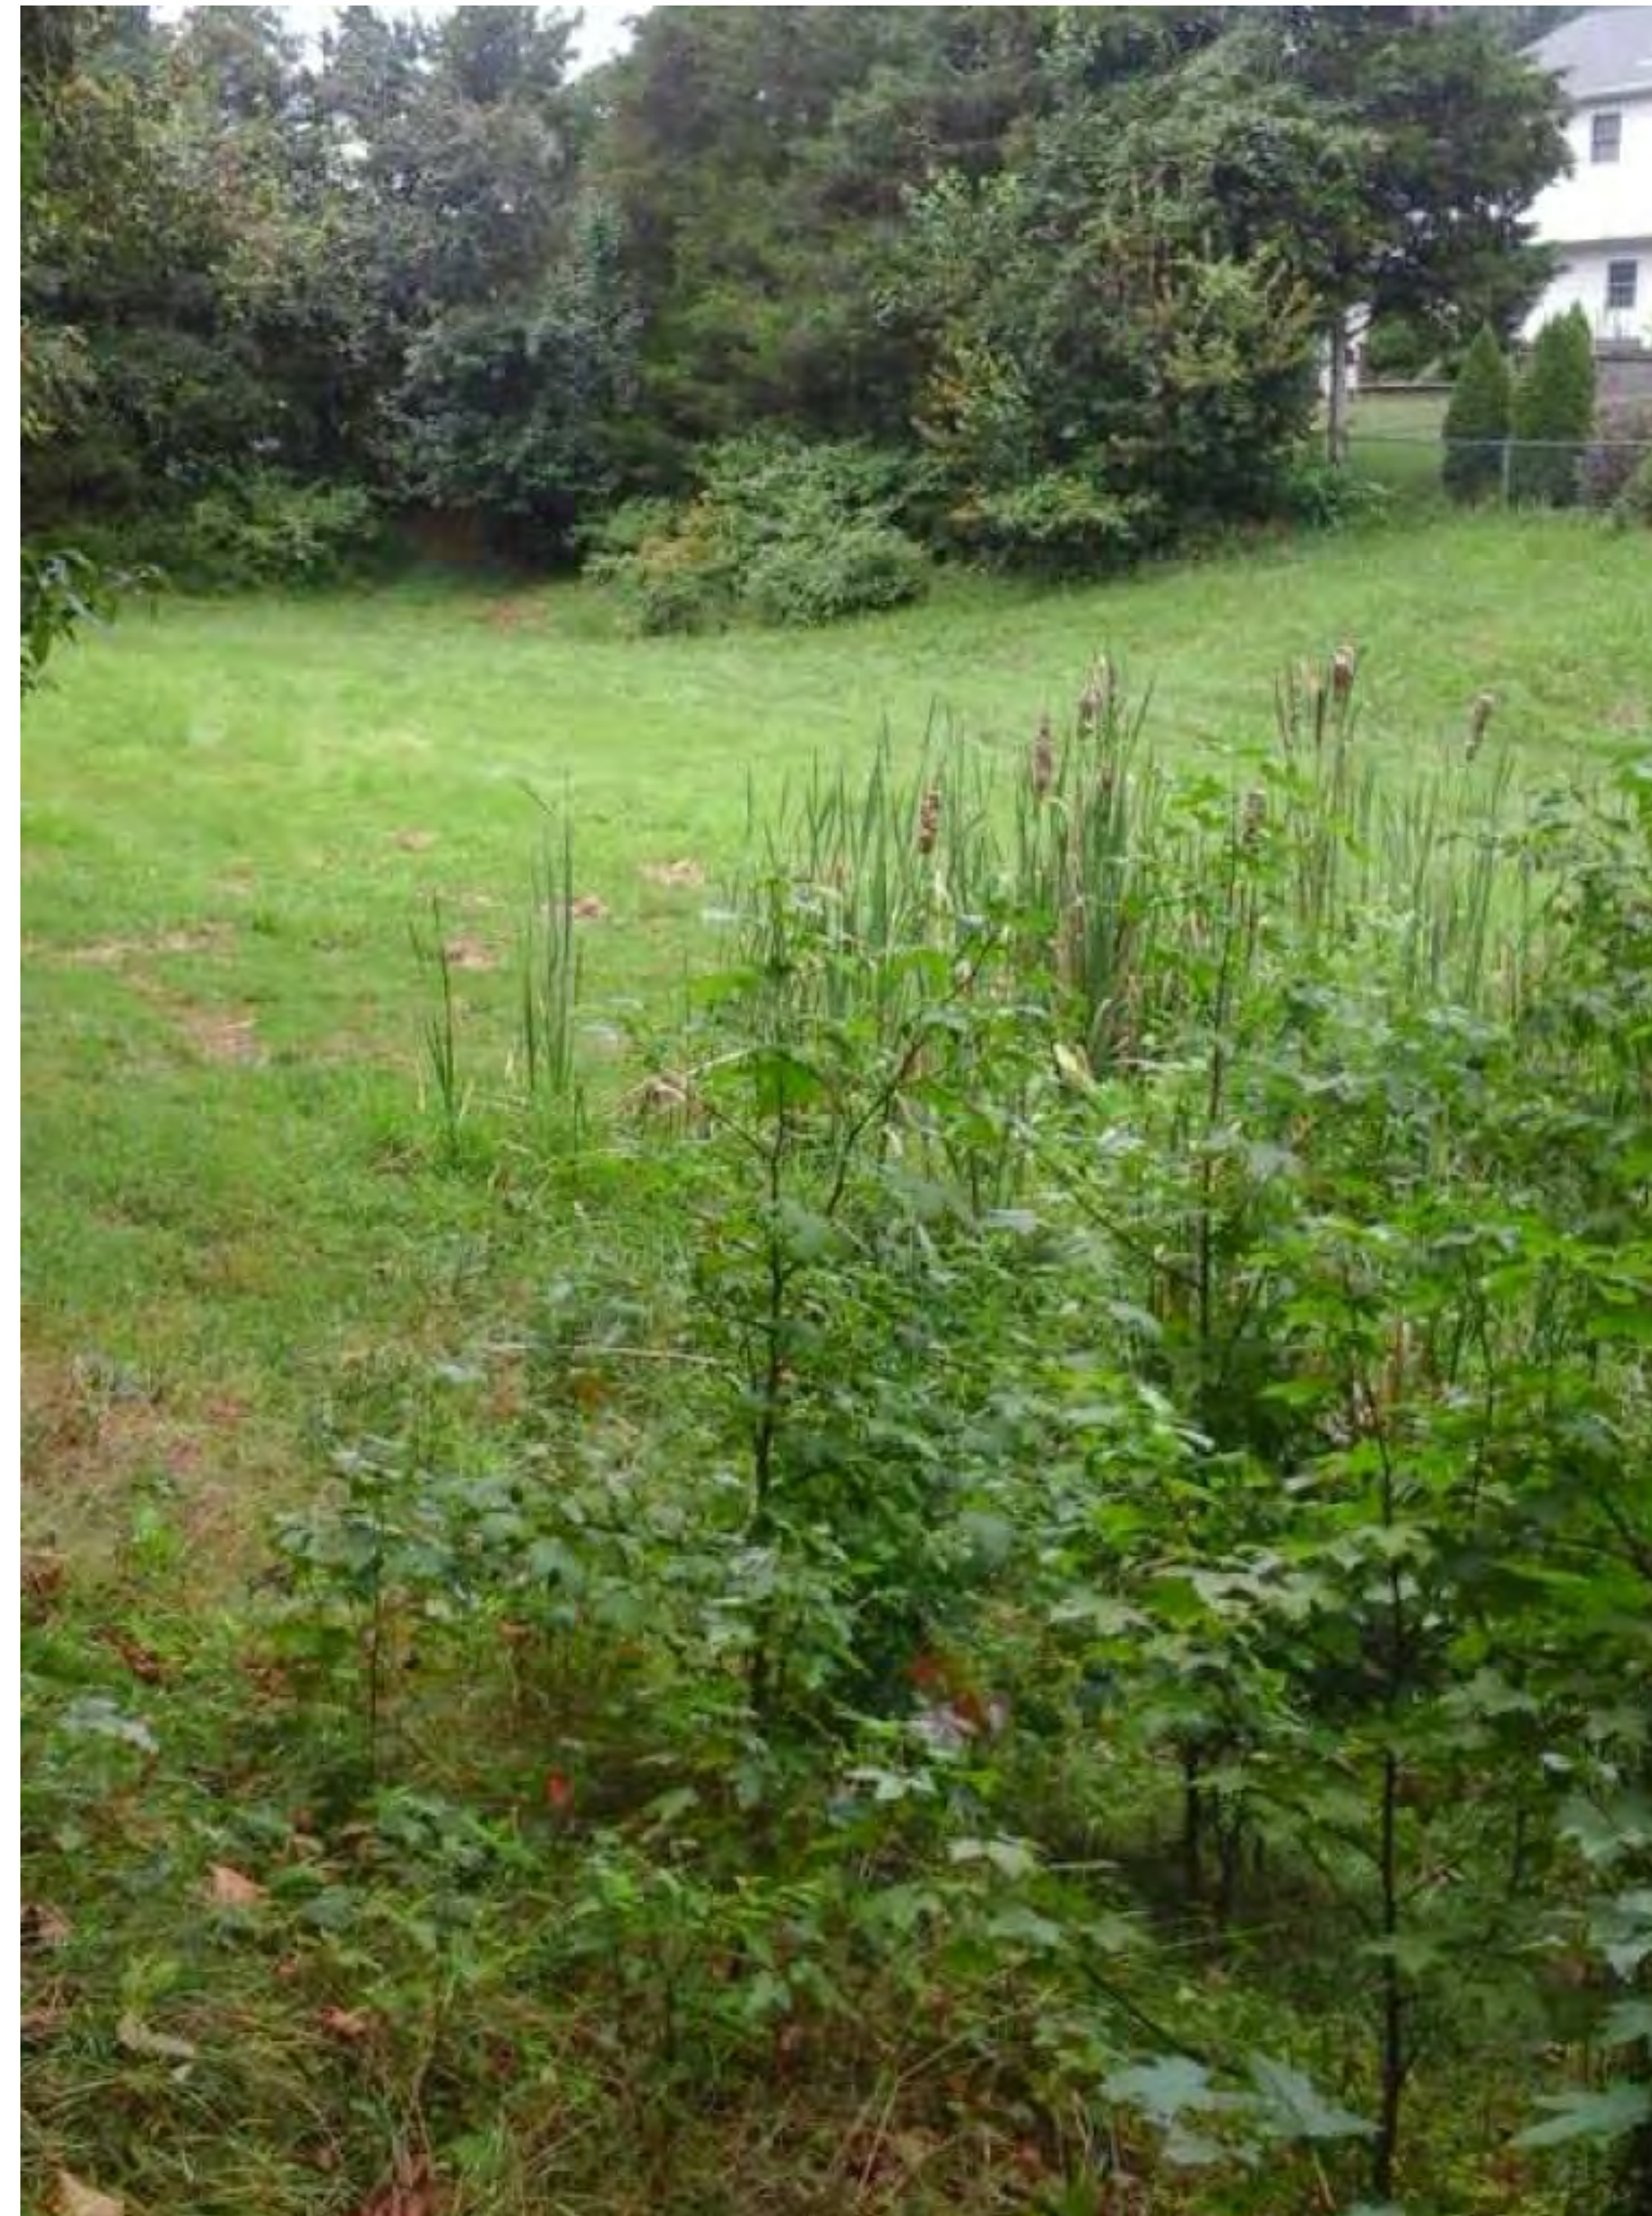
Address:  
123 Englewood Blvd  
Hamilton Township, NJ 08610

- No notes from 2014, was believed to be a retention basin which were not fully assessed at the time
- May be detention or infiltration basin and is adjacent to a natural pond in the forested area
- Lots of herbaceous vegetation growing in portion of basin

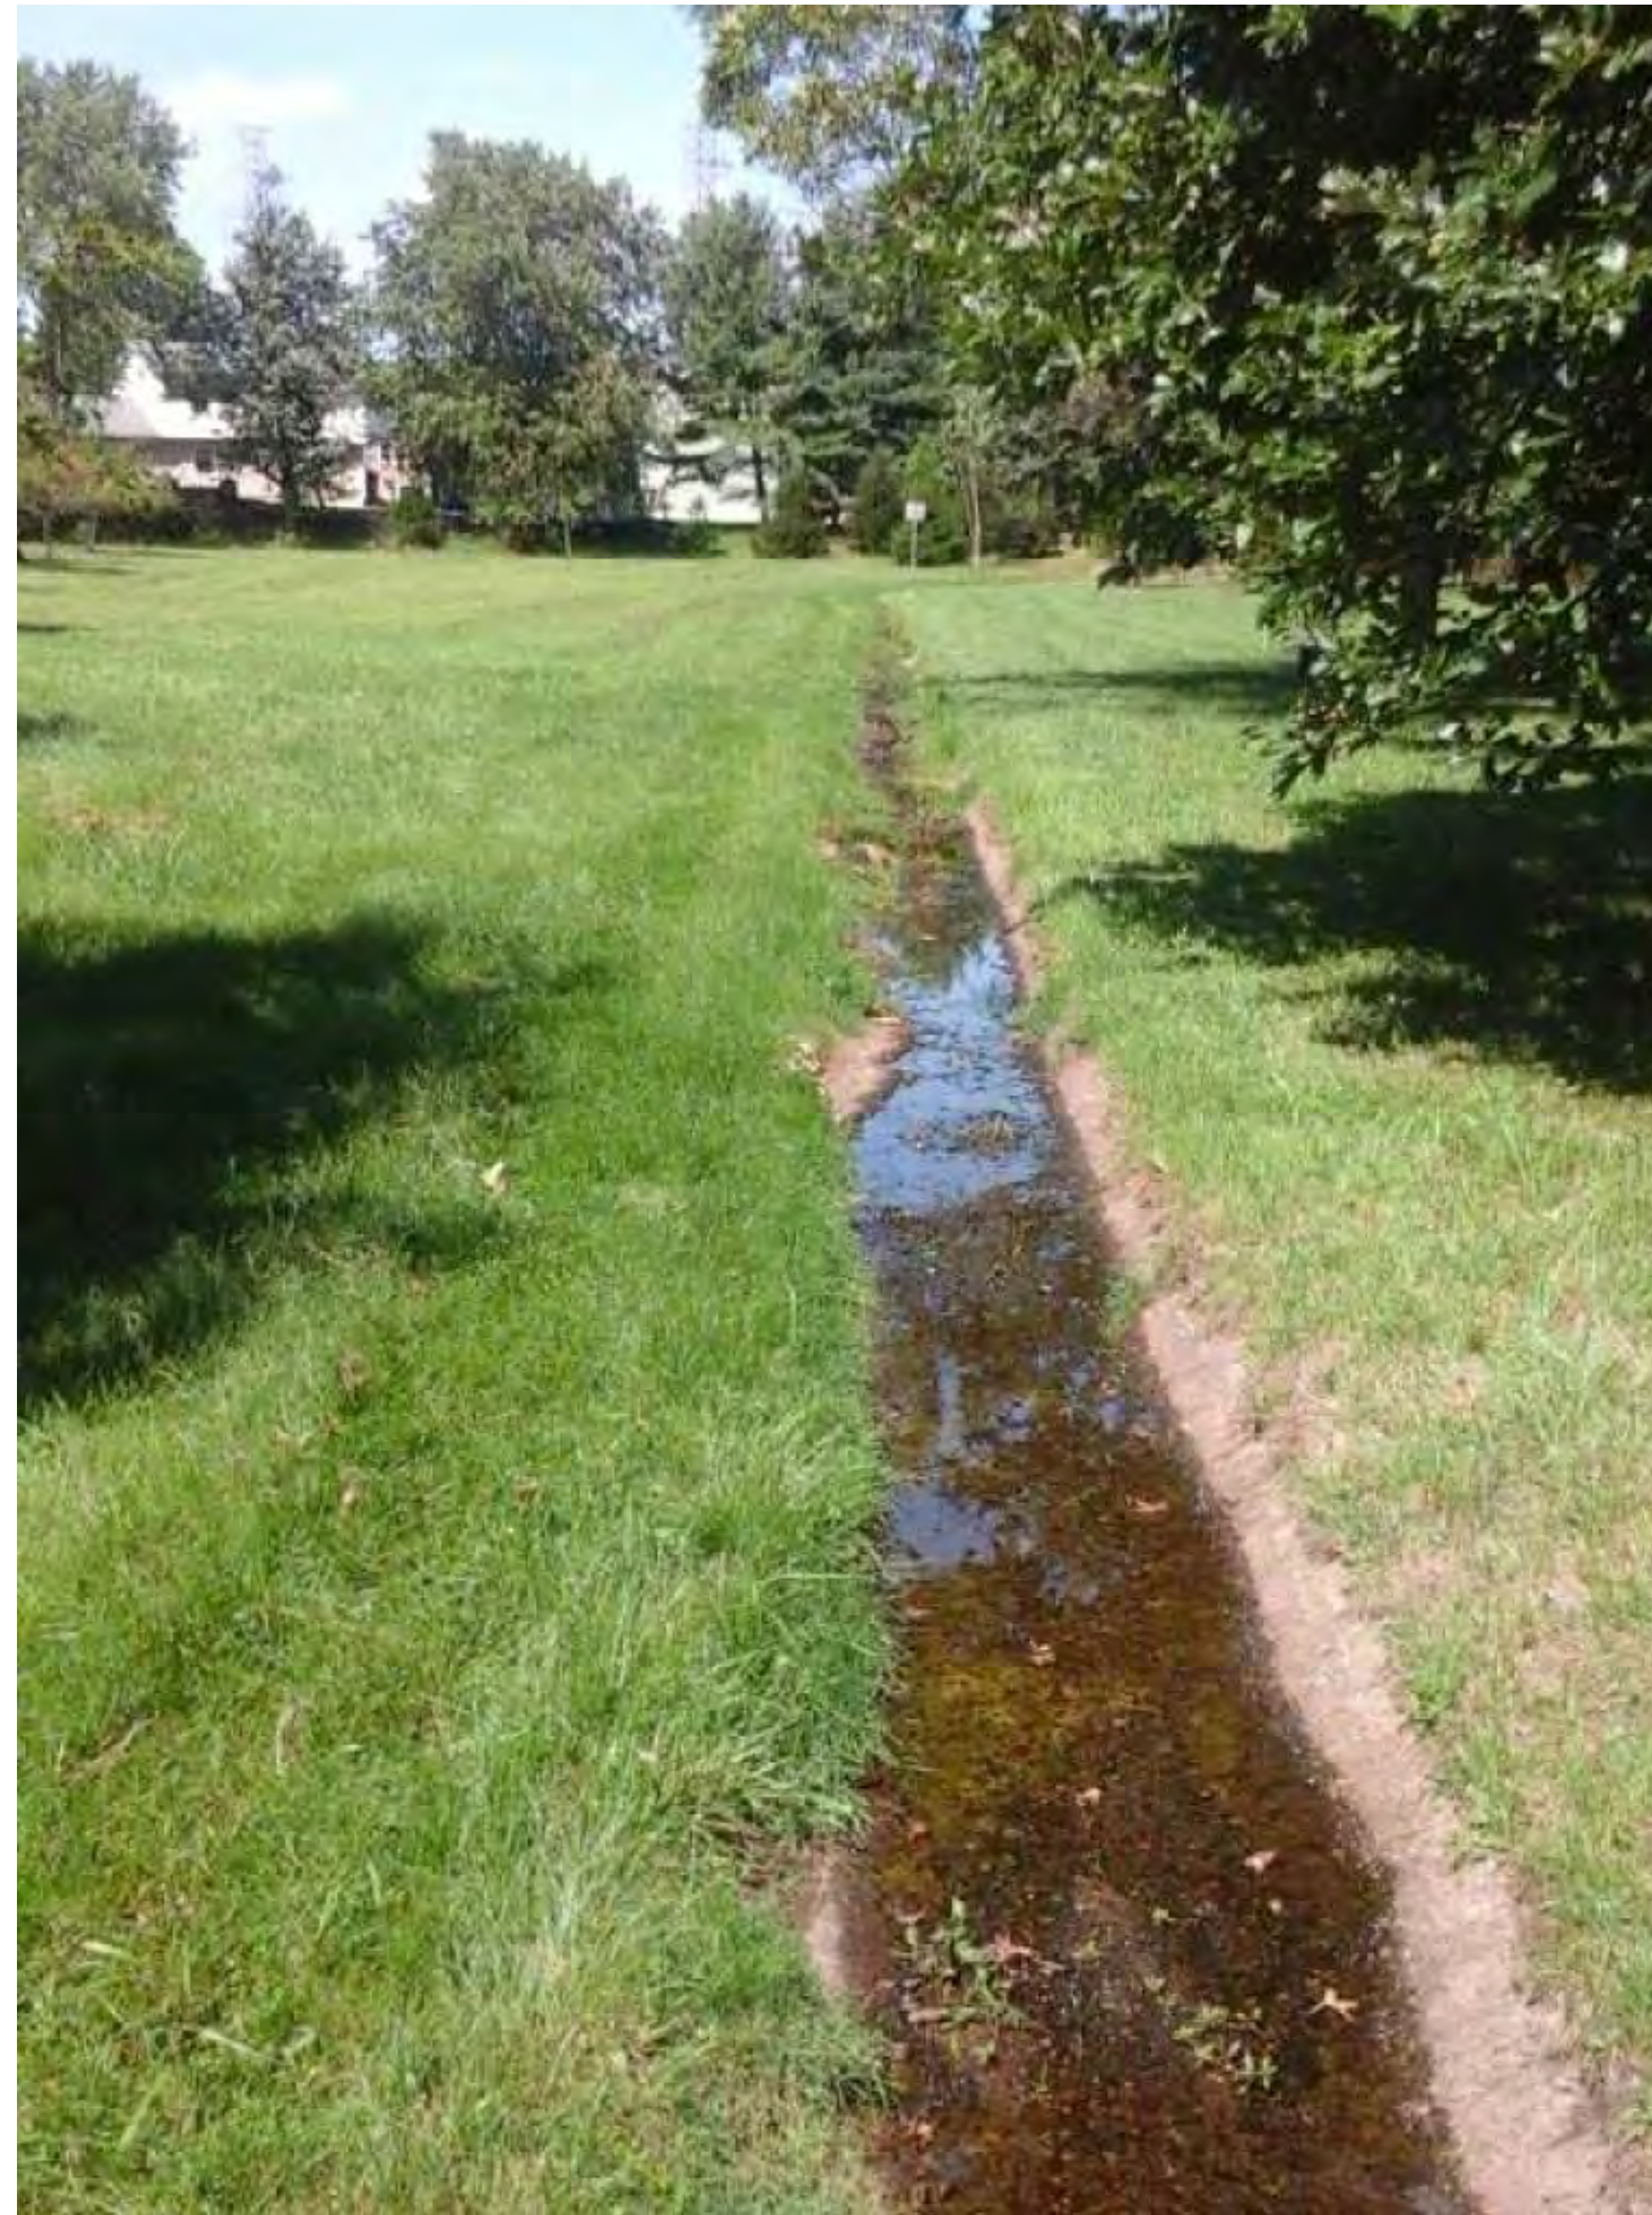
Address:  
390 Cypress Lane  
Hamilton Township, NJ 08610

- Sediment build up and grass in low flow channel leading to standing water
- Raise primary catch basin outlet and add low flow orifice to increase detention capacity
- Remove concrete low flow and add stone channel to enhance infiltration capacity
- Naturalize with herbaceous plants
