Hamilton Township (Mercer County) Stormwater Basin Assessment Summary (Year 1)

Developed by the Rutgers Cooperative Extension Water Resources Program
Funded by Hamilton Township, Mercer County, New Jersey

December 6, 2012

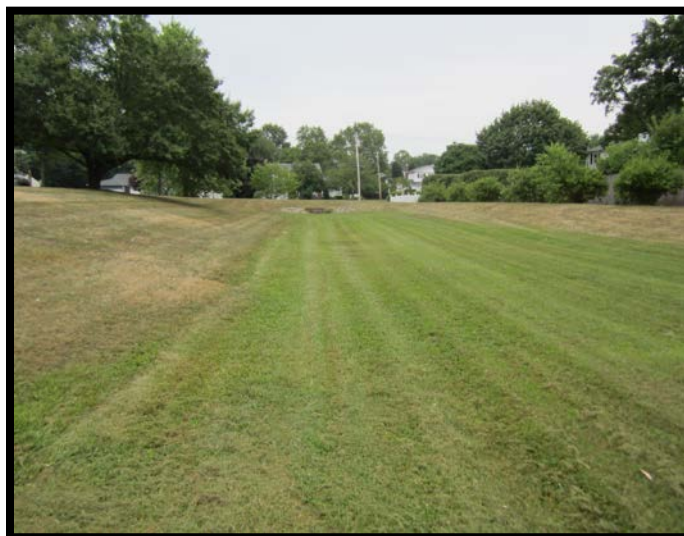
10. University Heights Elementary School (HIGH PRIORITY)

The detention basin at the University Heights Elementary School is a suitable site for a retrofit design, specifically the naturalization of the basin bottom. This basin should be considered highly suitable for an infiltration retrofit. Simply naturalizing the basin and maintaining it as a meadow could improve infiltration rates and reduce stormwater runoff volumes at the site. Current routine maintenance including mowing in the detention basin results in grass clippings that clog the inlet and outlet, limiting its function and increasing maintenance needs. Naturalizing the basin will reduce this problem as mowing will only be necessary once or twice each year. Improving the ability of this basin to treat stormwater runoff can also be a great learning experience for classes at the school.

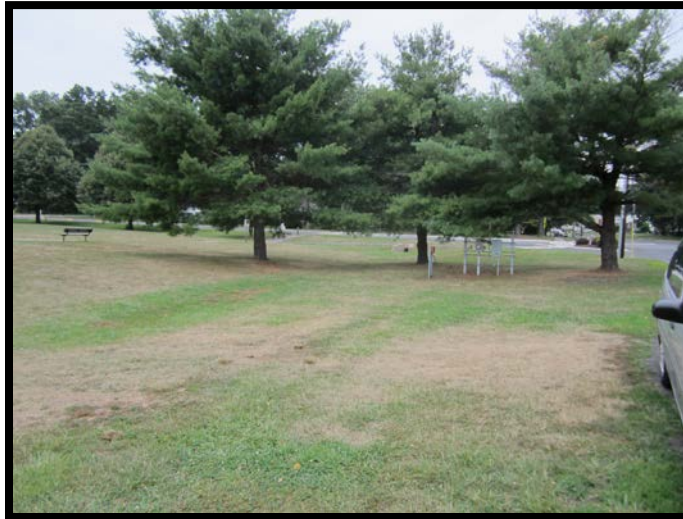
12. Mercer County Park Entrance Basin (HIGH PRIORITY)

The basin or swale near the entrance to Mercer County Park is located in an area that is considered highly suitable for an infiltration retrofit. It is a priority candidate for a retrofit design involving the implementation of a 1,500 square foot rain garden. A rain garden would increase the detention time and allow infiltration of stormwater runoff which improves water quality and recharges groundwater. Overflow from the rain garden would exit to the existing outlet structure. The entrance of the County Park is a great location to demonstrate stormwater best management practices (BMPs) while reducing stormwater runoff to the municipal storm sewer system.

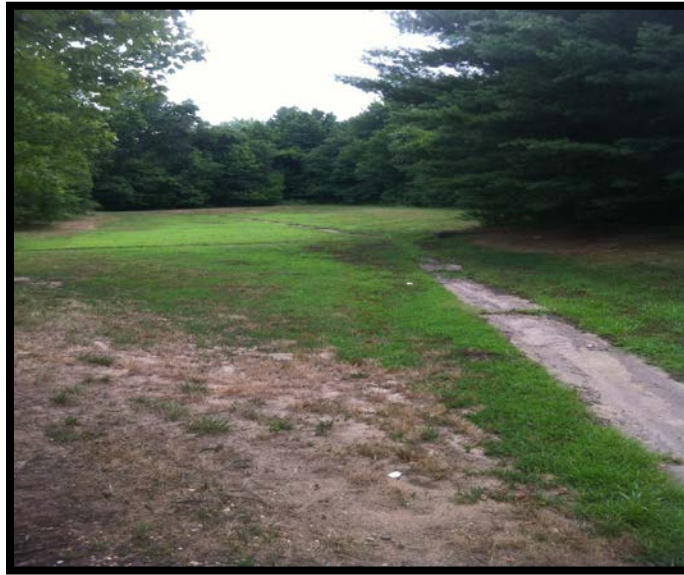
22. PNC Bank Basin

The basin located behind the PNC Bank branch on Quakerbridge Road appears to be in an area unsuitable for infiltration and groundwater recharge. However, it is a good candidate for a retrofit design that would utilize the size and extent of the basin to lengthen the flow path of stormwater runoff entering the basin during smaller, more frequent storm events. As this basin does not appear to have soils with good infiltration rates, increasing the flow path will also increase the detention time. An increase in detention time also improves the basin's ability to remove suspended solids improving water quality downstream. To increase the flow path, a shallow berm would be installed to direct stormwater from the two inlets towards the west end of the basin where sediments can settle out before discharging through the basin outlet structure. Naturalizing the basin and/or removing some sections of the concrete low flow channel would also help increase detention time and protect water quality.

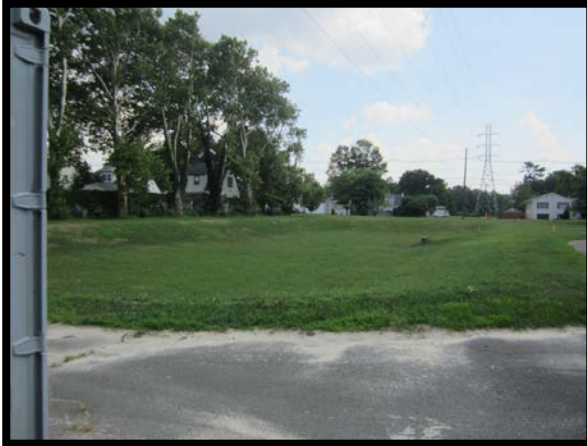
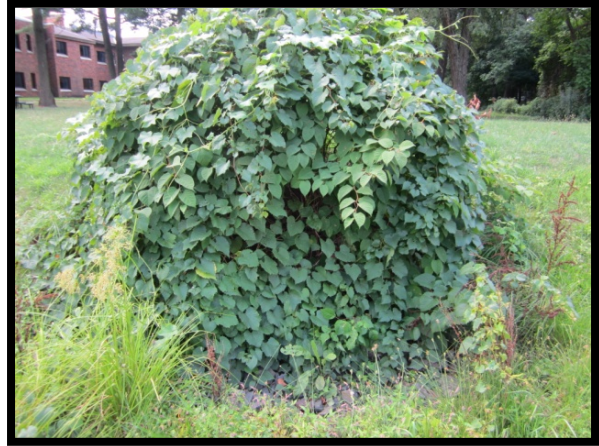
37. County of Mercer: Administration Basins

The basins located next to the County of Mercer Administration Building on Hamilton Avenue are located in an area considered suitable for retrofits that would transform these detention basins into infiltration systems. The basins currently do not have low flow channels, making the transition to an infiltration basin easier. The recommended retrofit would involve tilling the upper layer of topsoil and potentially amending the soils with bioretention media to increase infiltration. In addition, implementing a meadow landscape would decrease routine maintenance while helping to maintain infiltration. However, the first priority for these basins would be to clear the dense vegetation, especially woody growth, around the inlet and outlet structures.

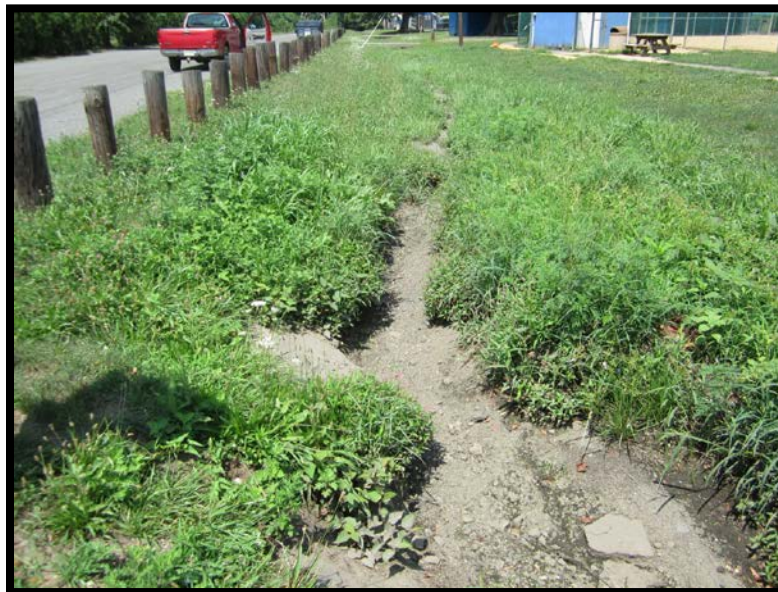
39. George Dick Field Basin

The basin at George Dick Field is a swale-like feature that discharges directly to the Miry Run. This facility is located in an area considered unsuitable for an infiltration retrofit. However, the basin is a candidate for retrofitting as a vegetated bioswale. As soil infiltration rates are limited at this site, it will be important to amend soils and install a 12-16 inch bioretention media layer to promote infiltration and storage. In addition, low check dams would be installed at intervals along the swale to increase stormwater detention time during small storm events but still allow larger events to pass through the system. Currently, the facility is showing signs of erosion. Retrofits will include stabilization to reduce the velocity of stormwater flowing through the swale preventing future erosion, filtering pollutants, and infiltrating volumes prior to discharging to the Miry Run.

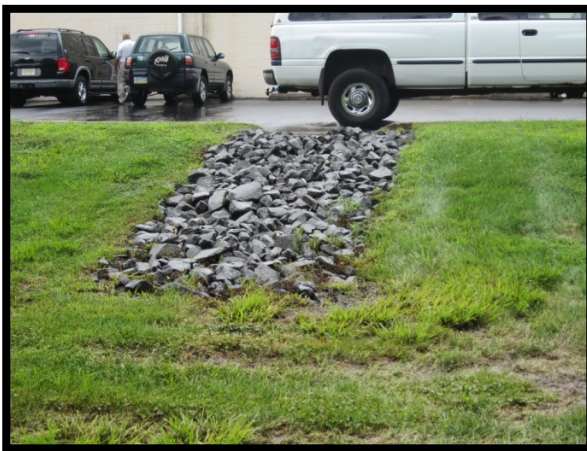
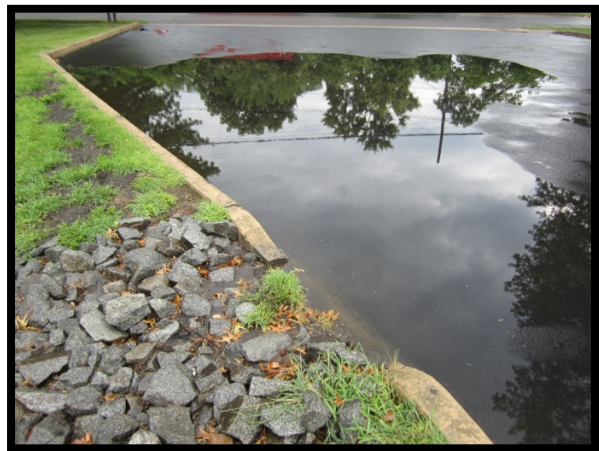
53. Custom Millwork Detention Basin

The stormwater basin at Custom Millwork is located in an area considered suitable for an infiltration retrofit. It is a candidate site for retrofits that would include plantings and modifications to the curb cut inlets. Planting around the rip rap and low flow channel would intercept and filter stormwater that enters the basin, keep low flows out of the concrete low flow channels, and promote infiltration. The existing curb cut inlet is clogged with sediment which is blocking the flow of water into the basin. Replacing the first 2-3 feet of rip rap with a sloped concrete channel would eliminate the ponding in the parking area and roadway.

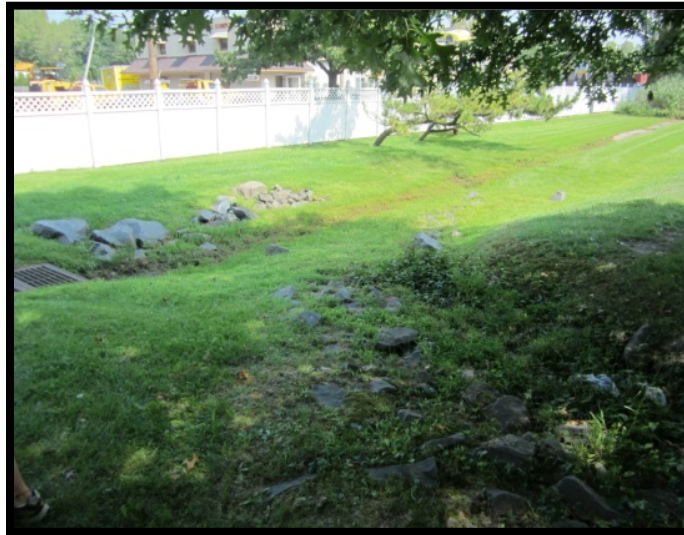
68. Clarici Graphics Basin

The stormwater basin at Clarici Graphics on Youngs Road is located in an area considered unsuitable for an infiltration retrofit. However, this basin is a good candidate for a retrofit approach that includes alternative planting materials. Evidence of standing water was noted during the assessment. This problem can be alleviated by clearing the outlet orifice and planting the basin with additional vegetation with deep and extensive root systems to open soil pores and promote infiltration. As this basin includes a concrete low flow channel, removal of the low flow channel should be considered. If desired, a stone or gravel-lined stream bed feature could replace the concrete to promote further infiltration. At a minimum planting vegetation in and around the inlet and low flow channel will intercept stormwater during smaller storm events, increasing detention time and filtering pollutants.

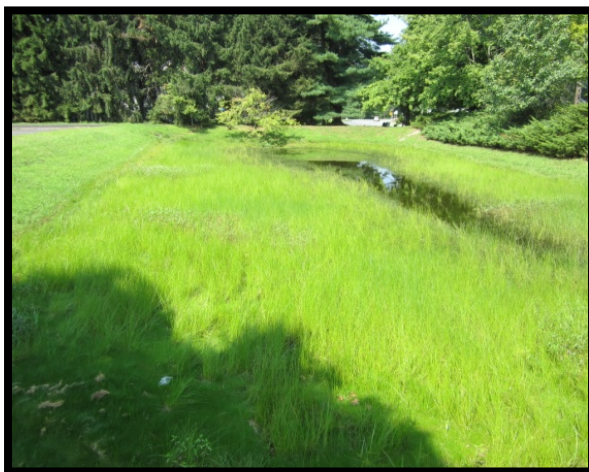
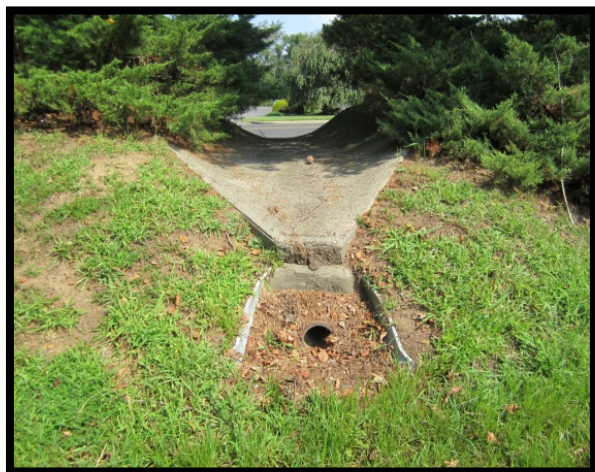
69. Hamilton Fitness Center Basin (HIGH PRIORITY)

The basin at Hamilton Fitness Center on Youngs Road is located in an area considered highly suitable for infiltration retrofit. The retrofit design should include implementing a stone-lined channel, outlet modifications and plantings in the basin. While preliminary data indicate that soils will infiltrate, standing water remains in the basin for extended periods of time. Initial retrofit efforts should include remediating any compacted soils which would inhibit infiltration. Tilling topsoil and installing a stone-lined underdrain together will improve infiltration and reduce ponding in the basin. Also, a modification to the outlet structure will allow for extended detention time. Planting and maintaining the facility much like a landscaped rain garden will also increase infiltration and aesthetics of the basin.

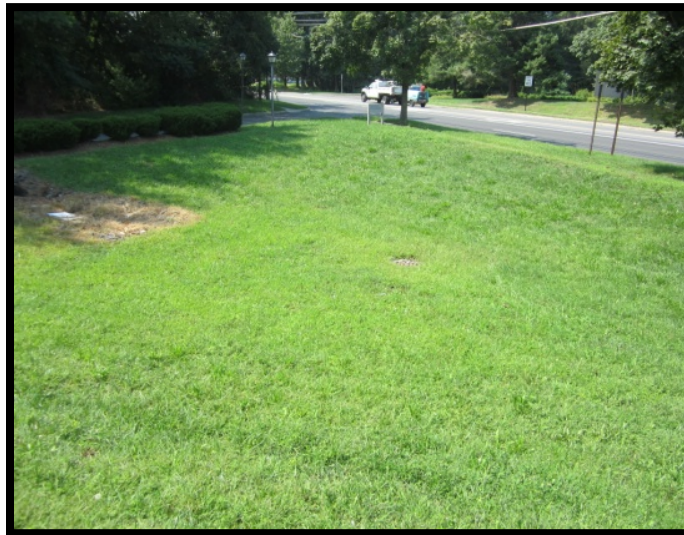
70. Bank of America Basin (HIGH PRIORITY)

The basin at Bank of America on Quakerbridge Road is located in an area considered suitable for infiltration. With minimal effort and cost a retrofit design can be implemented in this small facility that will promote groundwater recharge and remove nonpoint source pollutants. Through landscape plantings and a minor modification to the outlet structure the basin can be transformed from a turf grass depression to a highly functional rain garden.

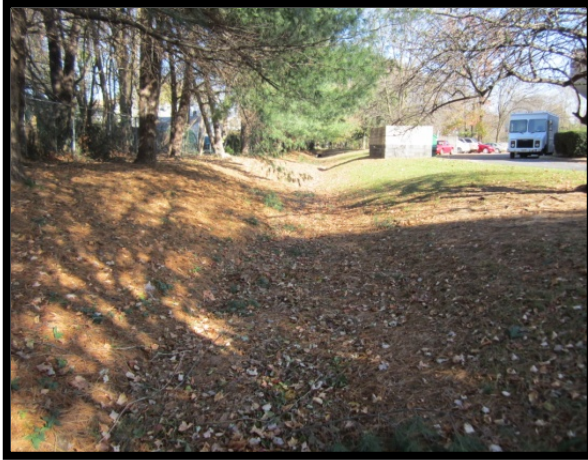
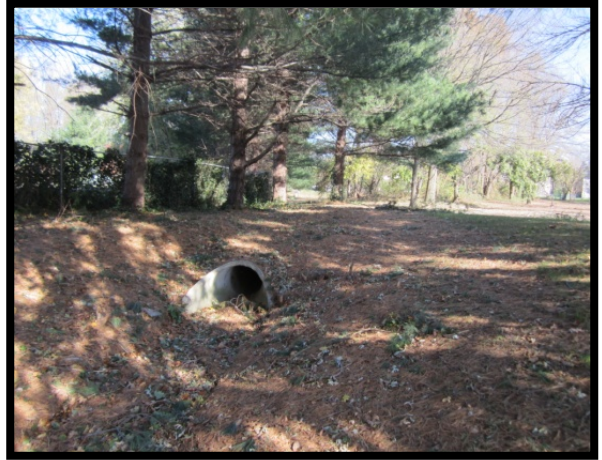
75. Poor Boy Subs

The facility located at Poor Boy Submarines on Route 33 features a large basin area with three inlets: 16", 12", and 24" as well as an outlet structure with a 3" orifice. The source of stormwater for the 24" inlet is a curb cut that first flows into a turf swale which discharges to the inlet pipe. Ideal retrofits for the site include a design which would transform the existing swale into a pretreatment bioswale. The facility is located in an area considered unsuitable for infiltration, therefore a bioswale with amended soil and a 12"-16" bioretention media layer will be essential to promote limited infiltration of the stormwater flow and treatment of pollutants to reduce the volume of runoff and protect water quality.

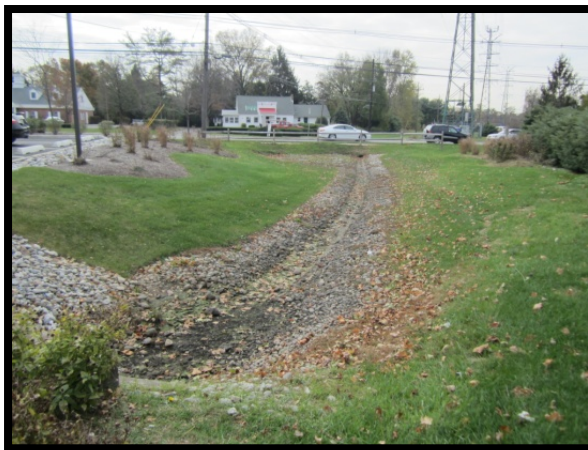
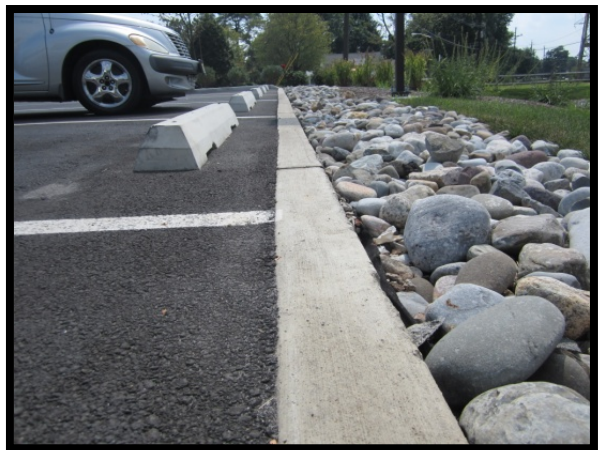
80. McDonald's Basin

The basin at McDonalds Restaurant on Route 33 is a candidate site for a retrofit design involving the naturalization/planting of the basin bottom, an outlet modification, and/or removal of concrete low flow channel sections. This basin is located in an area considered suitable for an infiltration retrofit. Naturalizing or planting the basin would further promote infiltration and filtering of stormwater runoff from the parking area before it reaches the low flow channel. An outlet modification to reduce the size

of the outlet orifice would increase detention time, thus increasing infiltration and groundwater recharge. Additional modifications to consider would involve disconnecting sections or the entire concrete low flow channel and replacing it with a gravel or stone-lined feature allowing stormwater volumes generated during small storms to be quickly infiltrated into underlying soils.

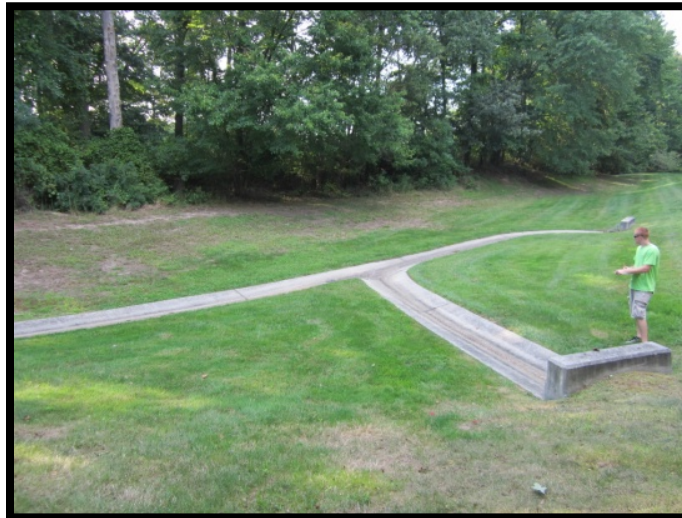
98. Klockner Senior Citizens Basin

The basin at to the Klockner Senior Citizens Center is located in an area considered highly suitable for infiltration. It is a candidate site for a retrofit design involving naturalization/planting, an outlet modification, and/or removal of concrete low flow channel sections. The naturalization/planting of this basin would improve water quality and the capacity of the basin to infiltrate stormwater runoff. This existing outlet structure has a large diameter outlet orifice. It is possible to increase the detention time by modifying the outlet discharge by installing a porous barrier that will detain flows in smaller storm events and more slowly release water downstream. The low flow channels are preventing infiltration of smaller storms; removal of sections in and around the inlet and outlet structures would promote infiltration of runoff from the smaller more frequent storms.

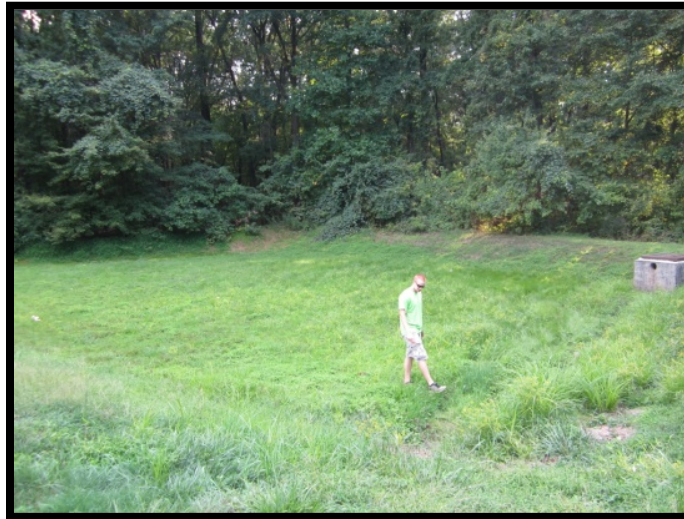
99. Vintage Court Basin

The basin located at the end of Vintage Court is in an area considered unsuitable for infiltration due to existing soils. However, it is a good candidate for a retrofit design involving a naturalization/planting and outlet modification. This basin does not currently have low flow channels. Naturalization or planting of native species with extensive root systems is a simple way to improve infiltration. Evidence of erosion was noted during the assessment and an increase in dense healthy plant growth would aid in managing erosion. During the site visit to assess this site, the owner of the property expressed interest in the possibility of a retrofit improving water quality and aesthetics.

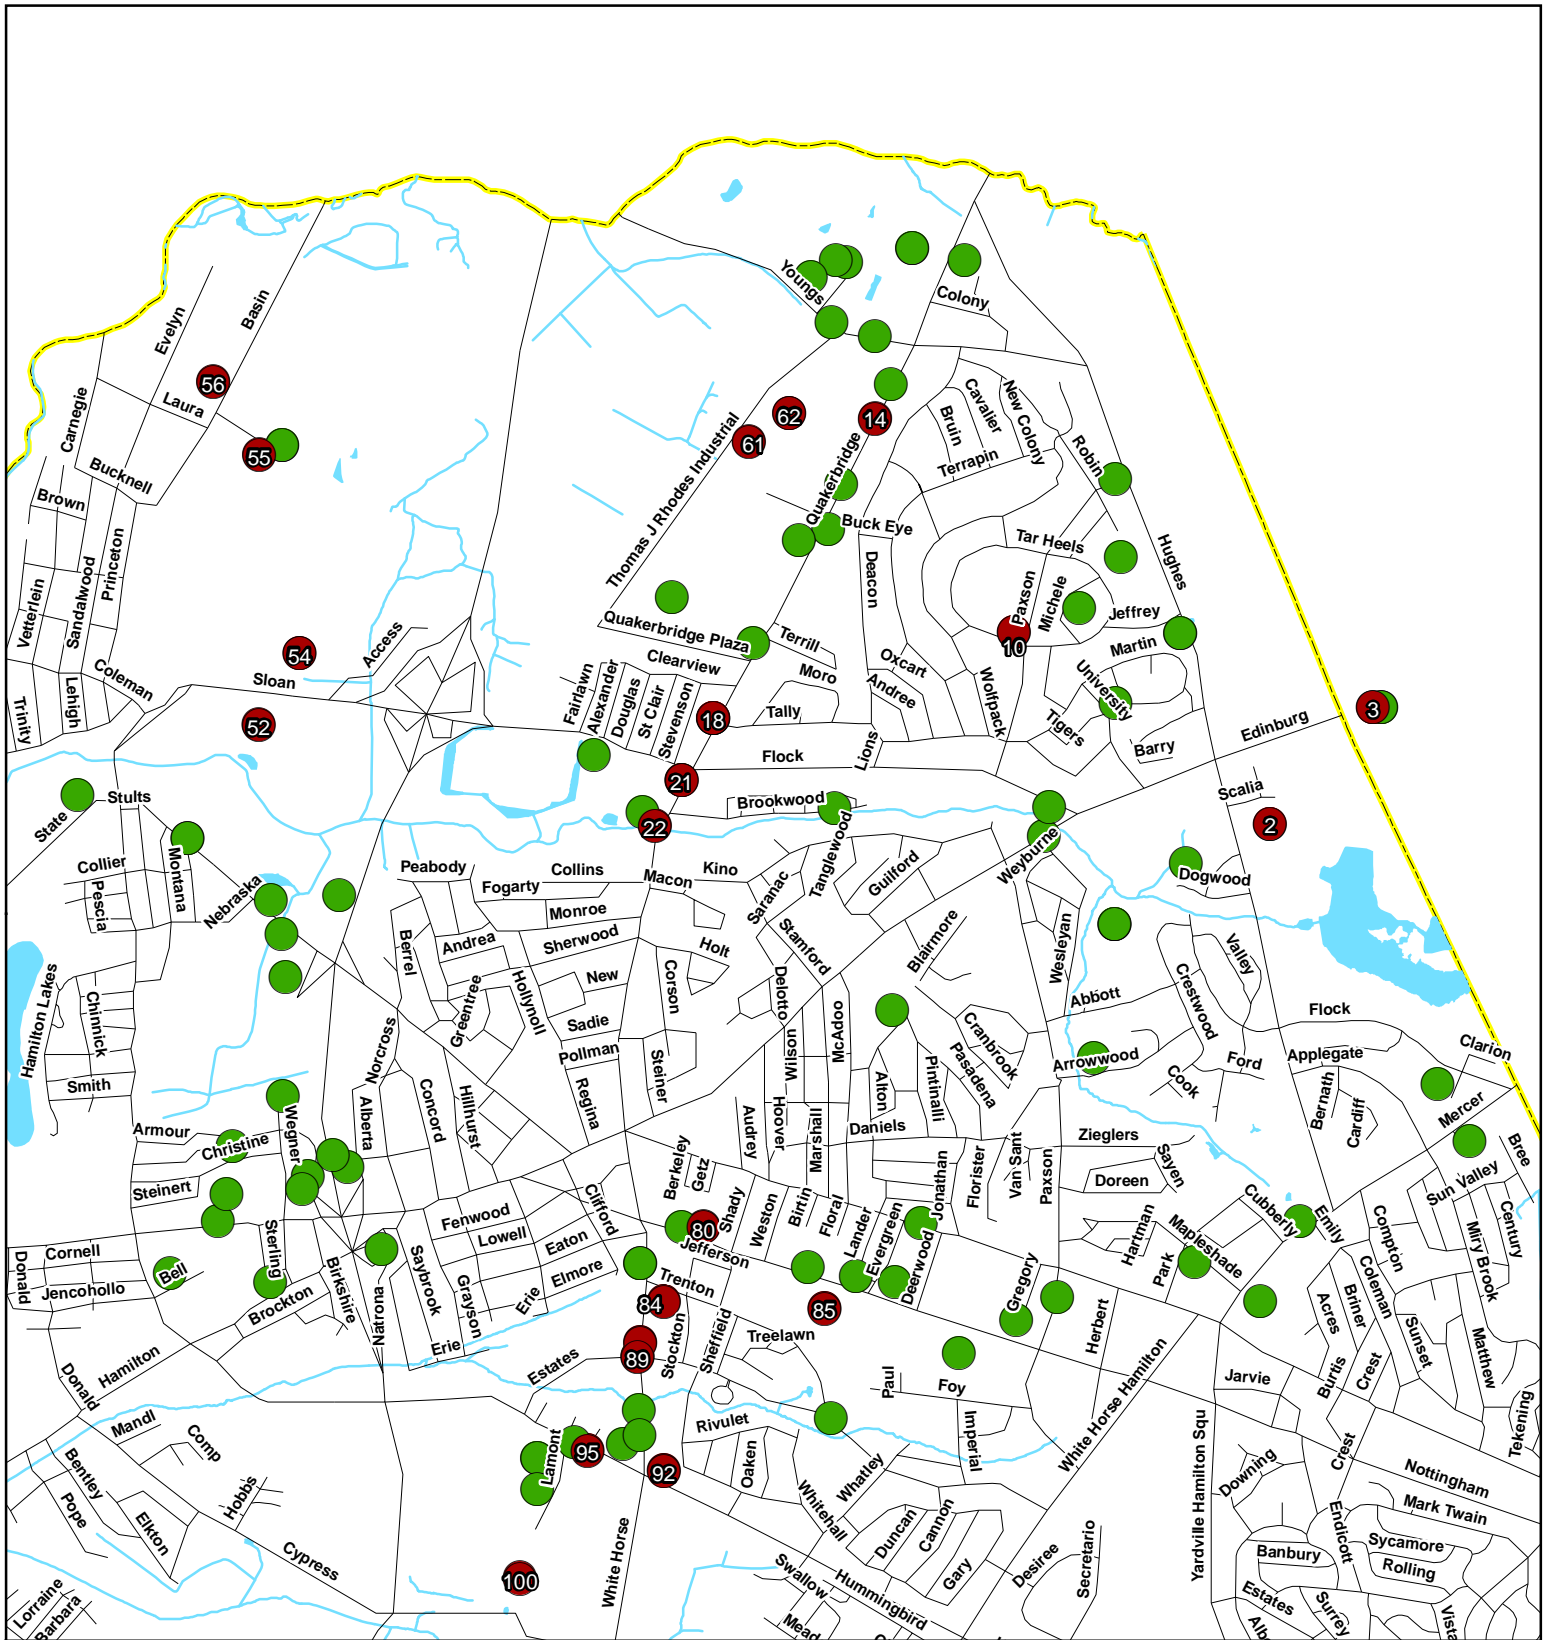
Basins in Northern Hamilton Township, NJ that Require Inlet and Outlet Repair

This map (Attachment 2C) identifies stormwater basins that have structural components that are broken, deteriorated, and/or missing. The system is no longer functioning as designed and may be a safety hazard. Immediate action is needed to make the facility operational and safe.

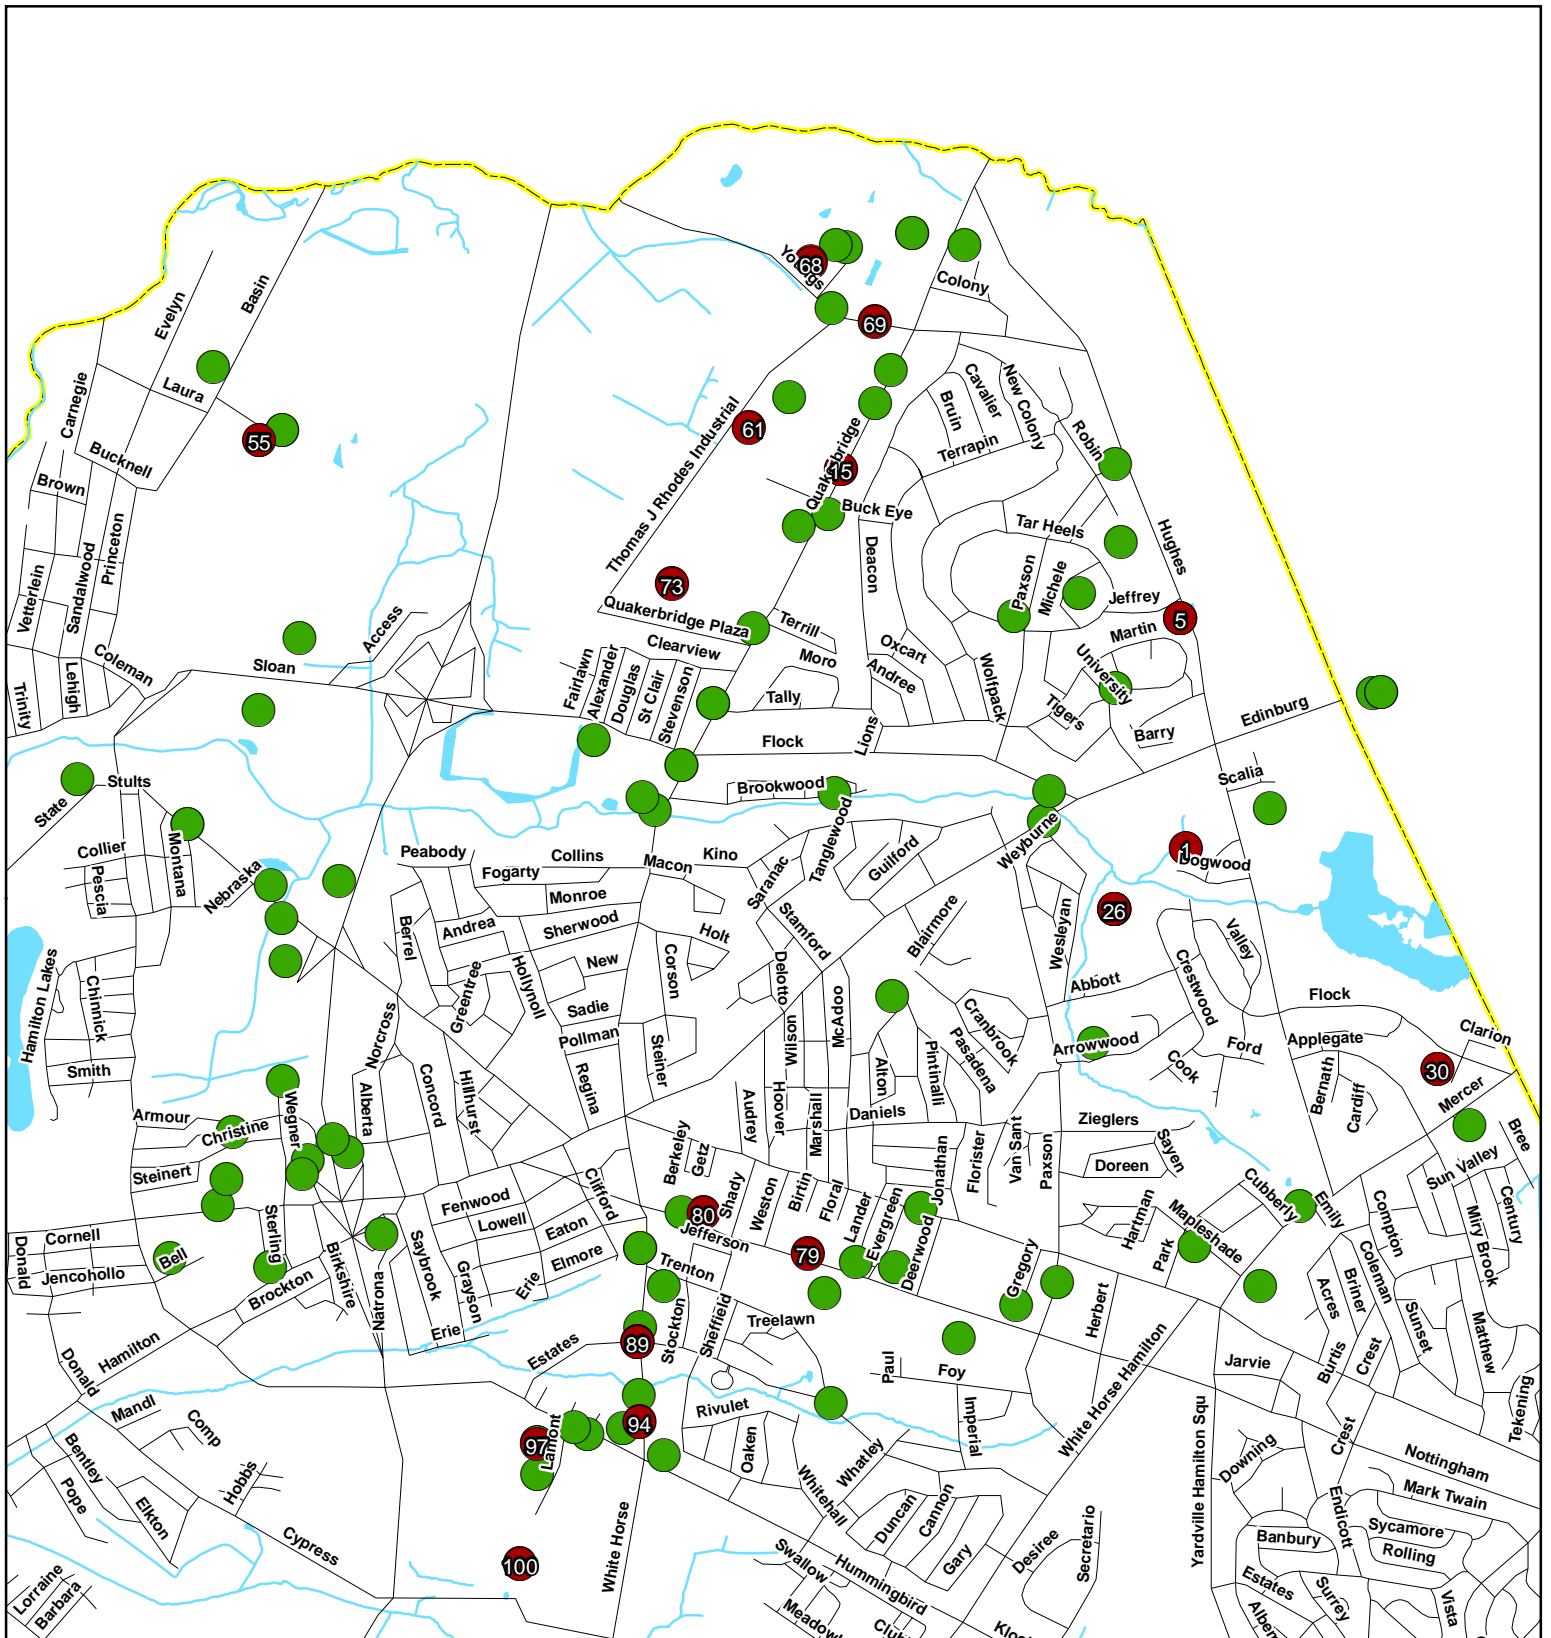
Detention Basins with Standing Water in Northern Hamilton Township, NJ

This map (Attachment 2D) identifies stormwater basins where evidence of standing water was noted during the site visit. Standing water in basins for a period longer than 72 hours after a storm event can present a serious health risk. Immediate action should be taken to further investigate these basins and determine the reason for standing water remaining in the systems. It is anticipated that repairs will be necessary in many of these facilities to drain and ensure the facility functions properly.

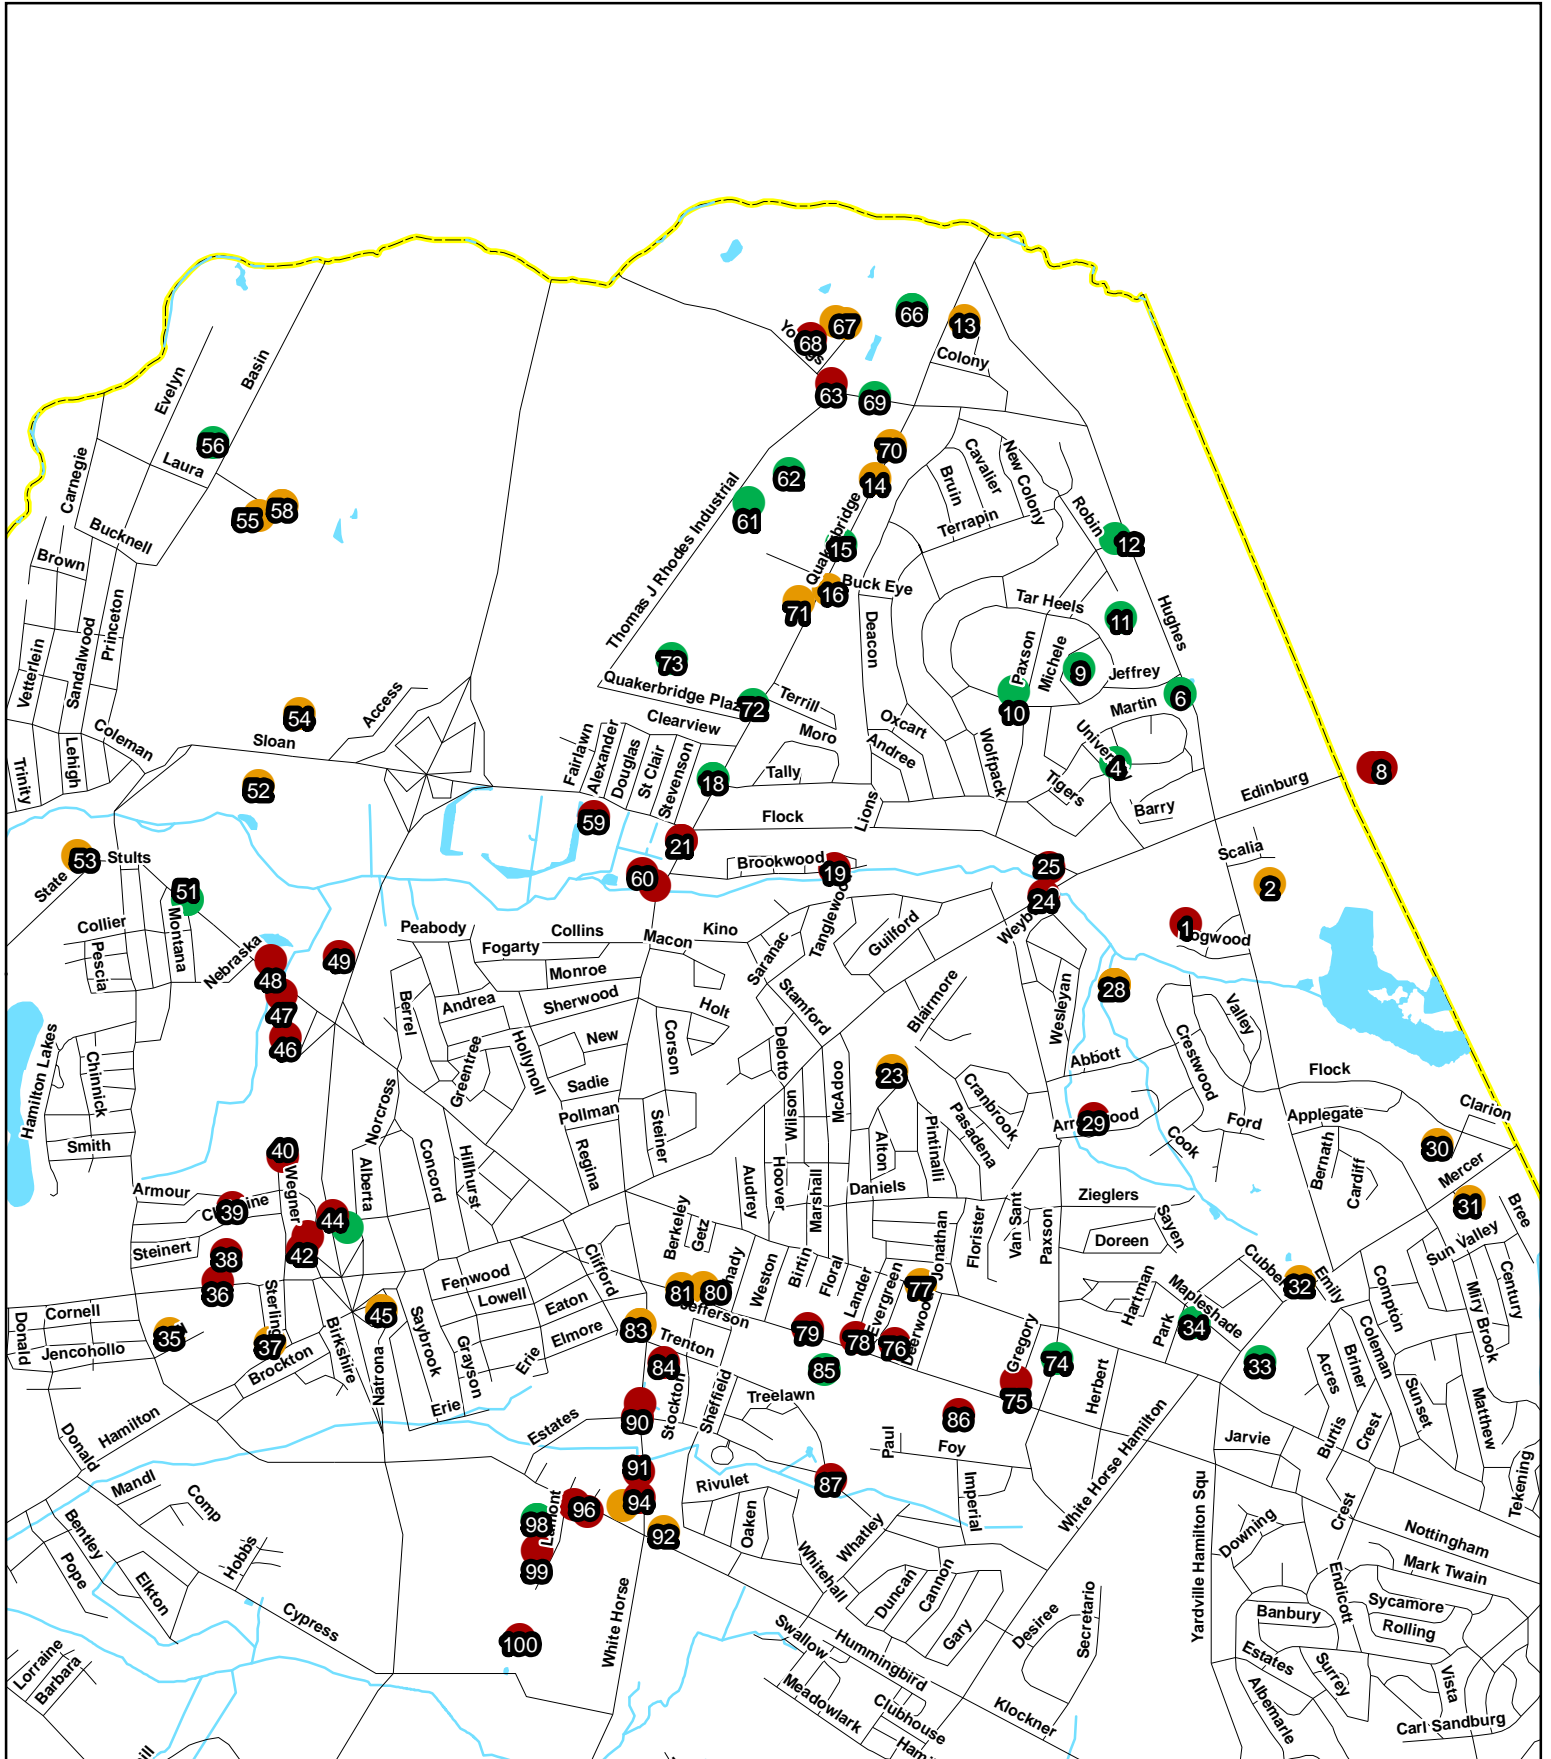
Basins Suitable for Infiltration Retrofits in Hamilton Township, New Jersey

This map (Attachment 2F) identifies stormwater basins where simple, cost-effective modifications to the facility could be made to increase the basin's ability to capture, filter, and infiltrate runoff during smaller storm events to protect water quality and promote groundwater recharge. Basins were selected in areas where available soils data indicates that infiltration is possible. Basins located in areas with Hydrologic Soil Group A or B soils and where groundwater recharge rates are in excess of four (4) inches per hour were considered highly suitable. Basins in areas where at least one of these conditions are met were considered suitable. Basins where neither of these conditions exist were considered unsuitable. Please note that site specific soil conditions and infiltration rates still need to be field verified to confirm that infiltration retrofits would be successful.

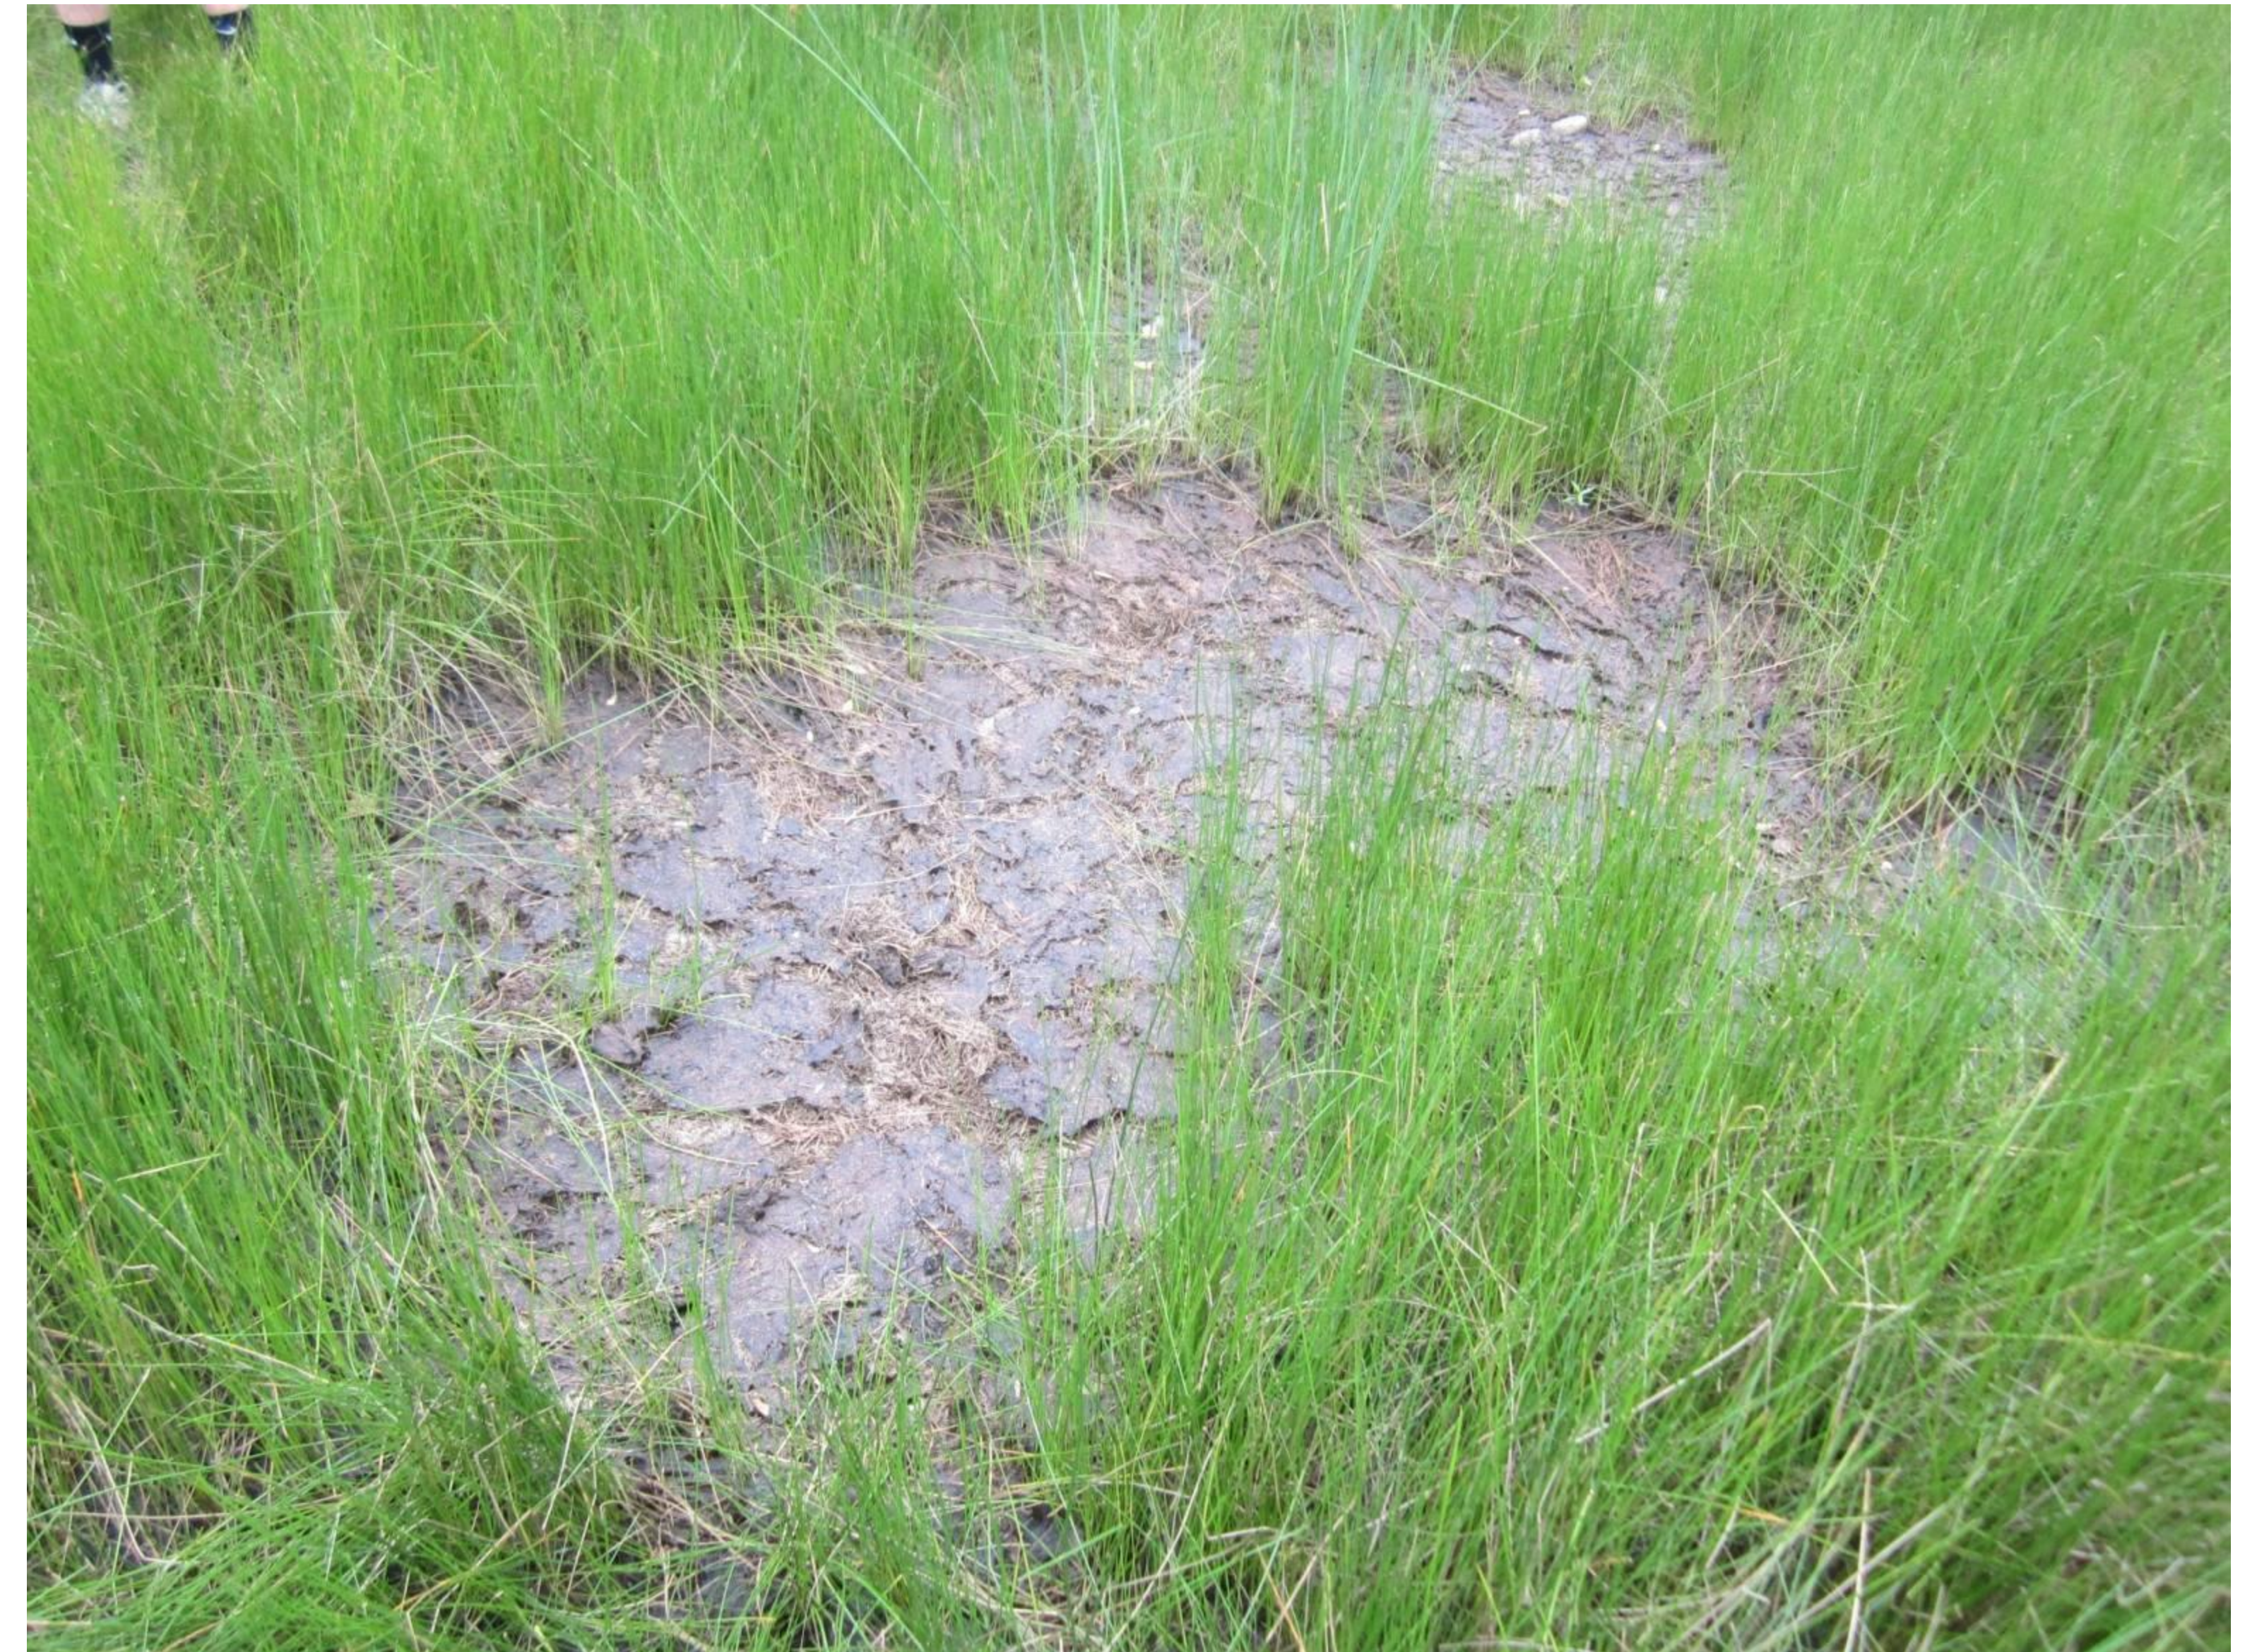
Dry cracking soil in basin bottom

- No outlet structure, water discharges from basin via infiltration
- Excessive plant growth around inlet
