Hamilton Township (Mercer County) Stormwater Basin Assessment Summary (Year 1)

Developed by the Rutgers Cooperative Extension Water Resources Program
Funded by Hamilton Township, Mercer County, New Jersey

December 6, 2012

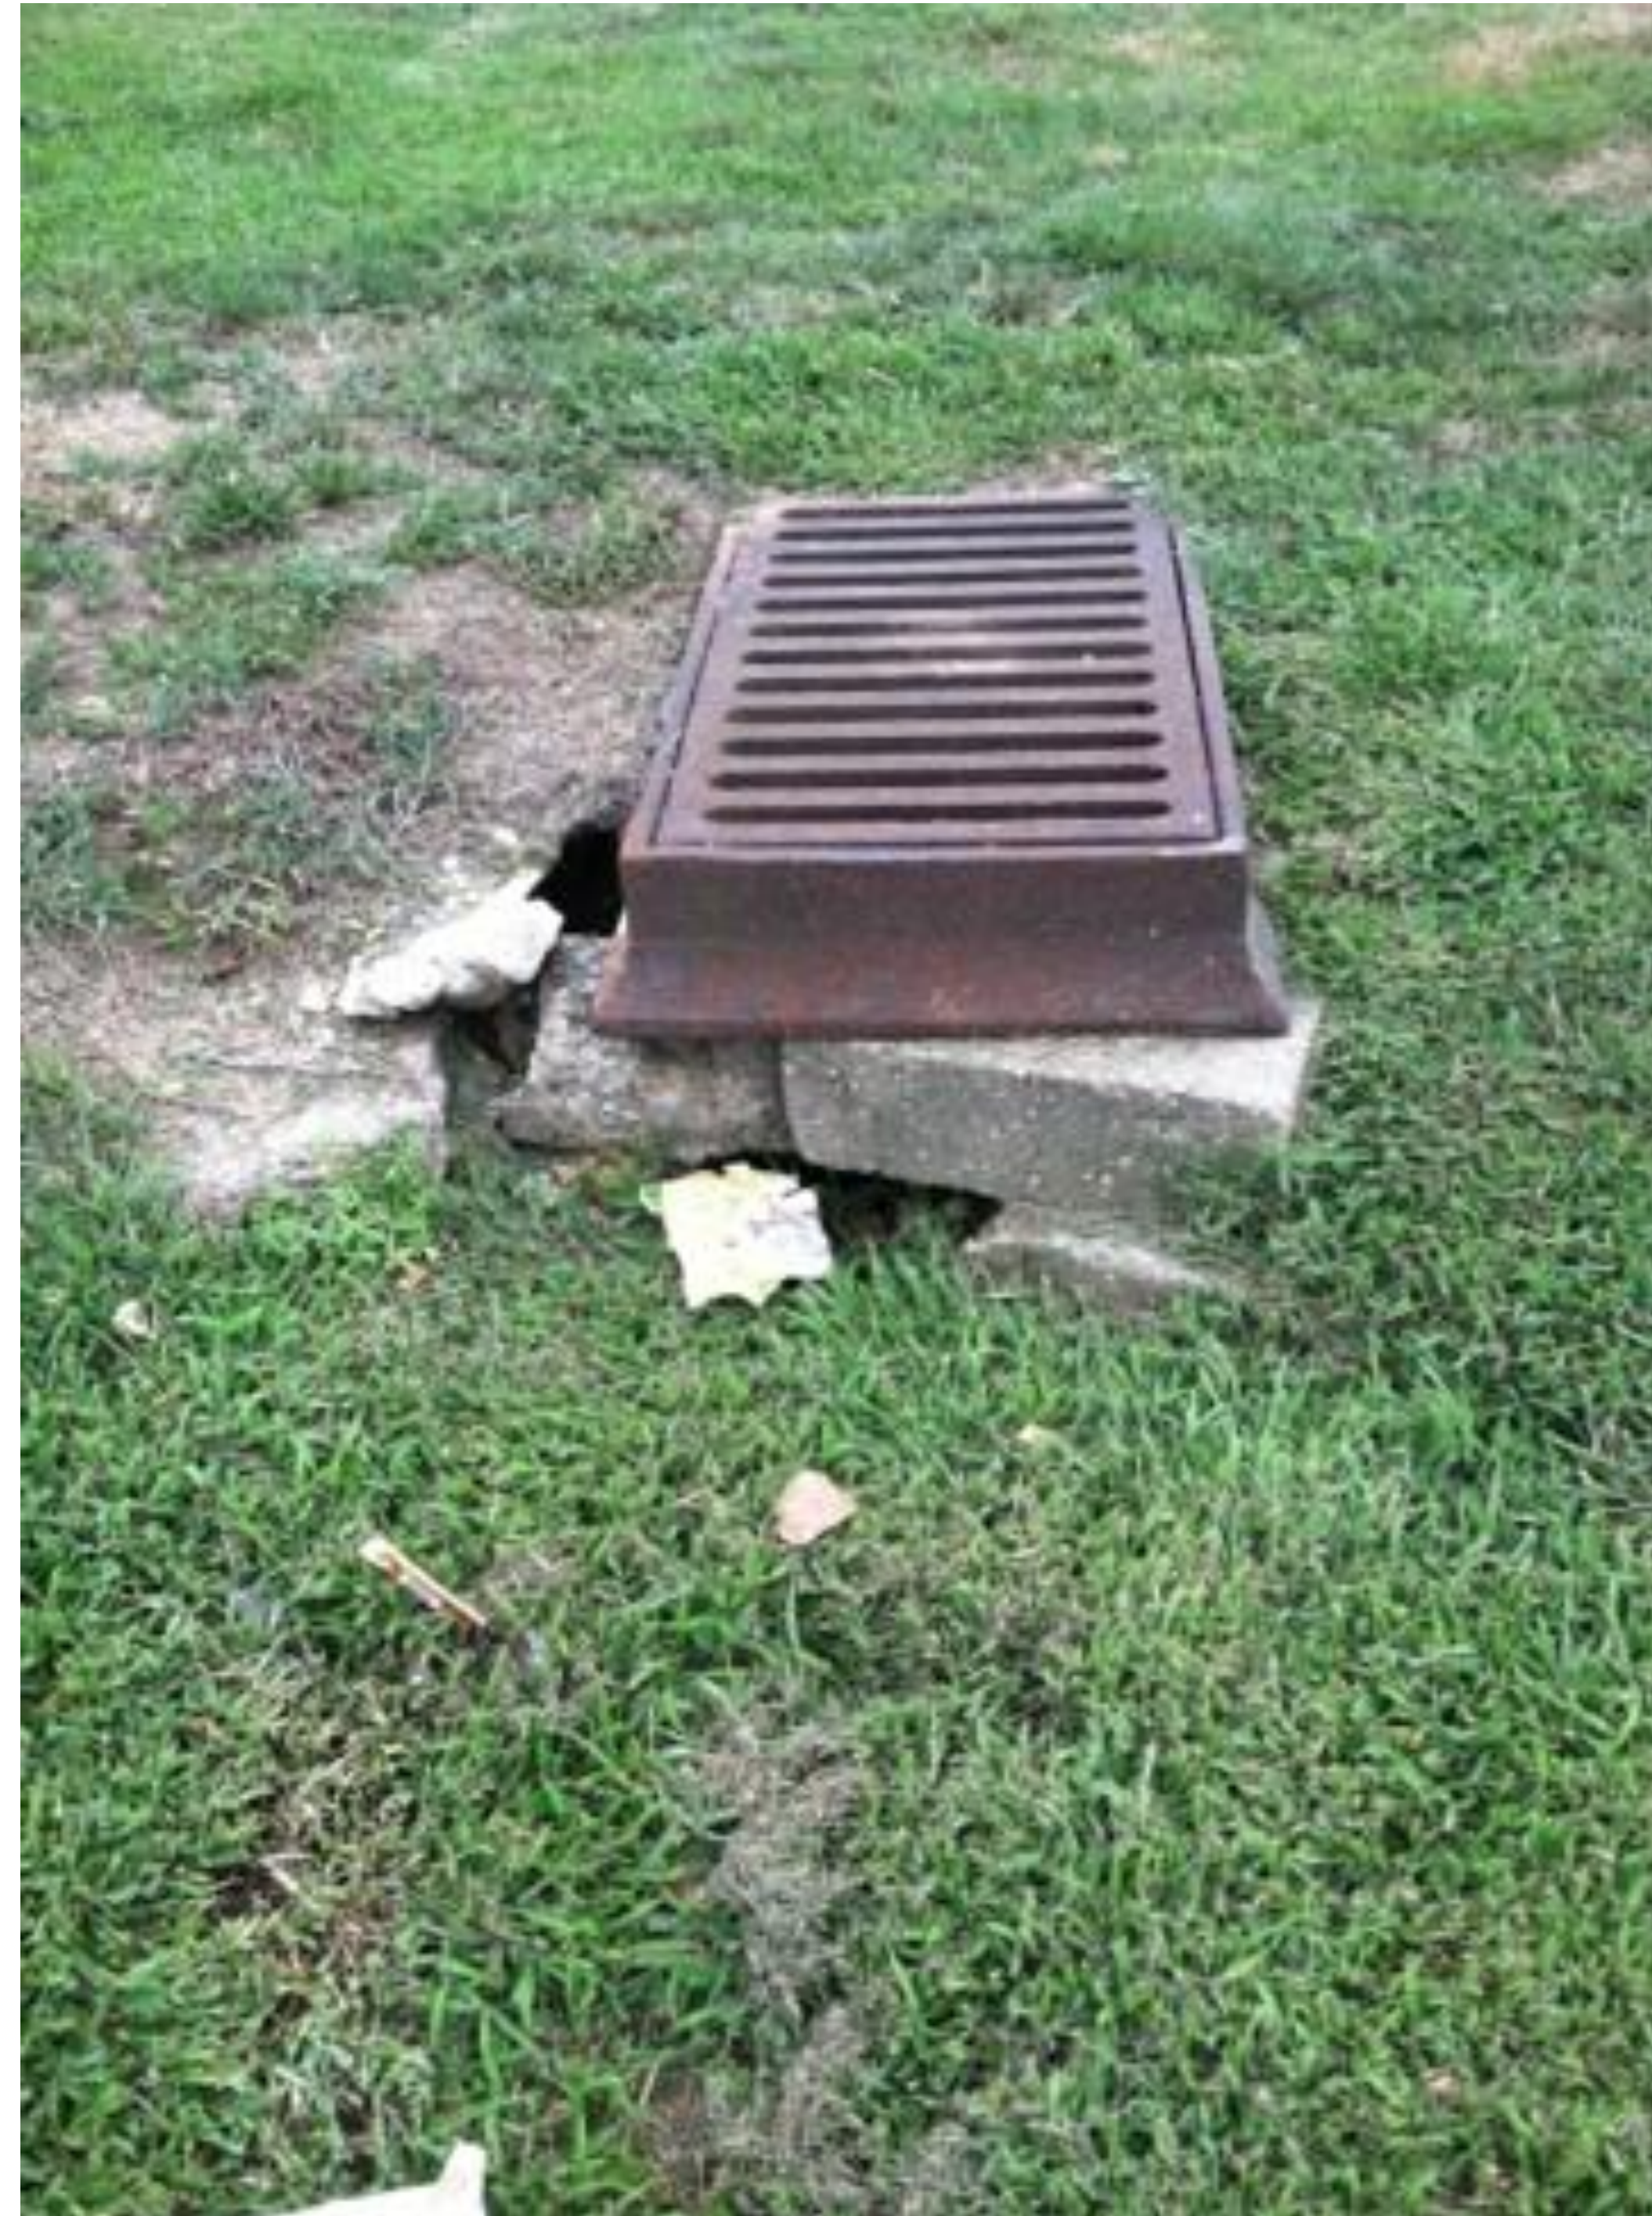
Erosion at inlet

- Curb cuts (inlets) are damaged with erosion evident
- Outlet has structural damage and erosion

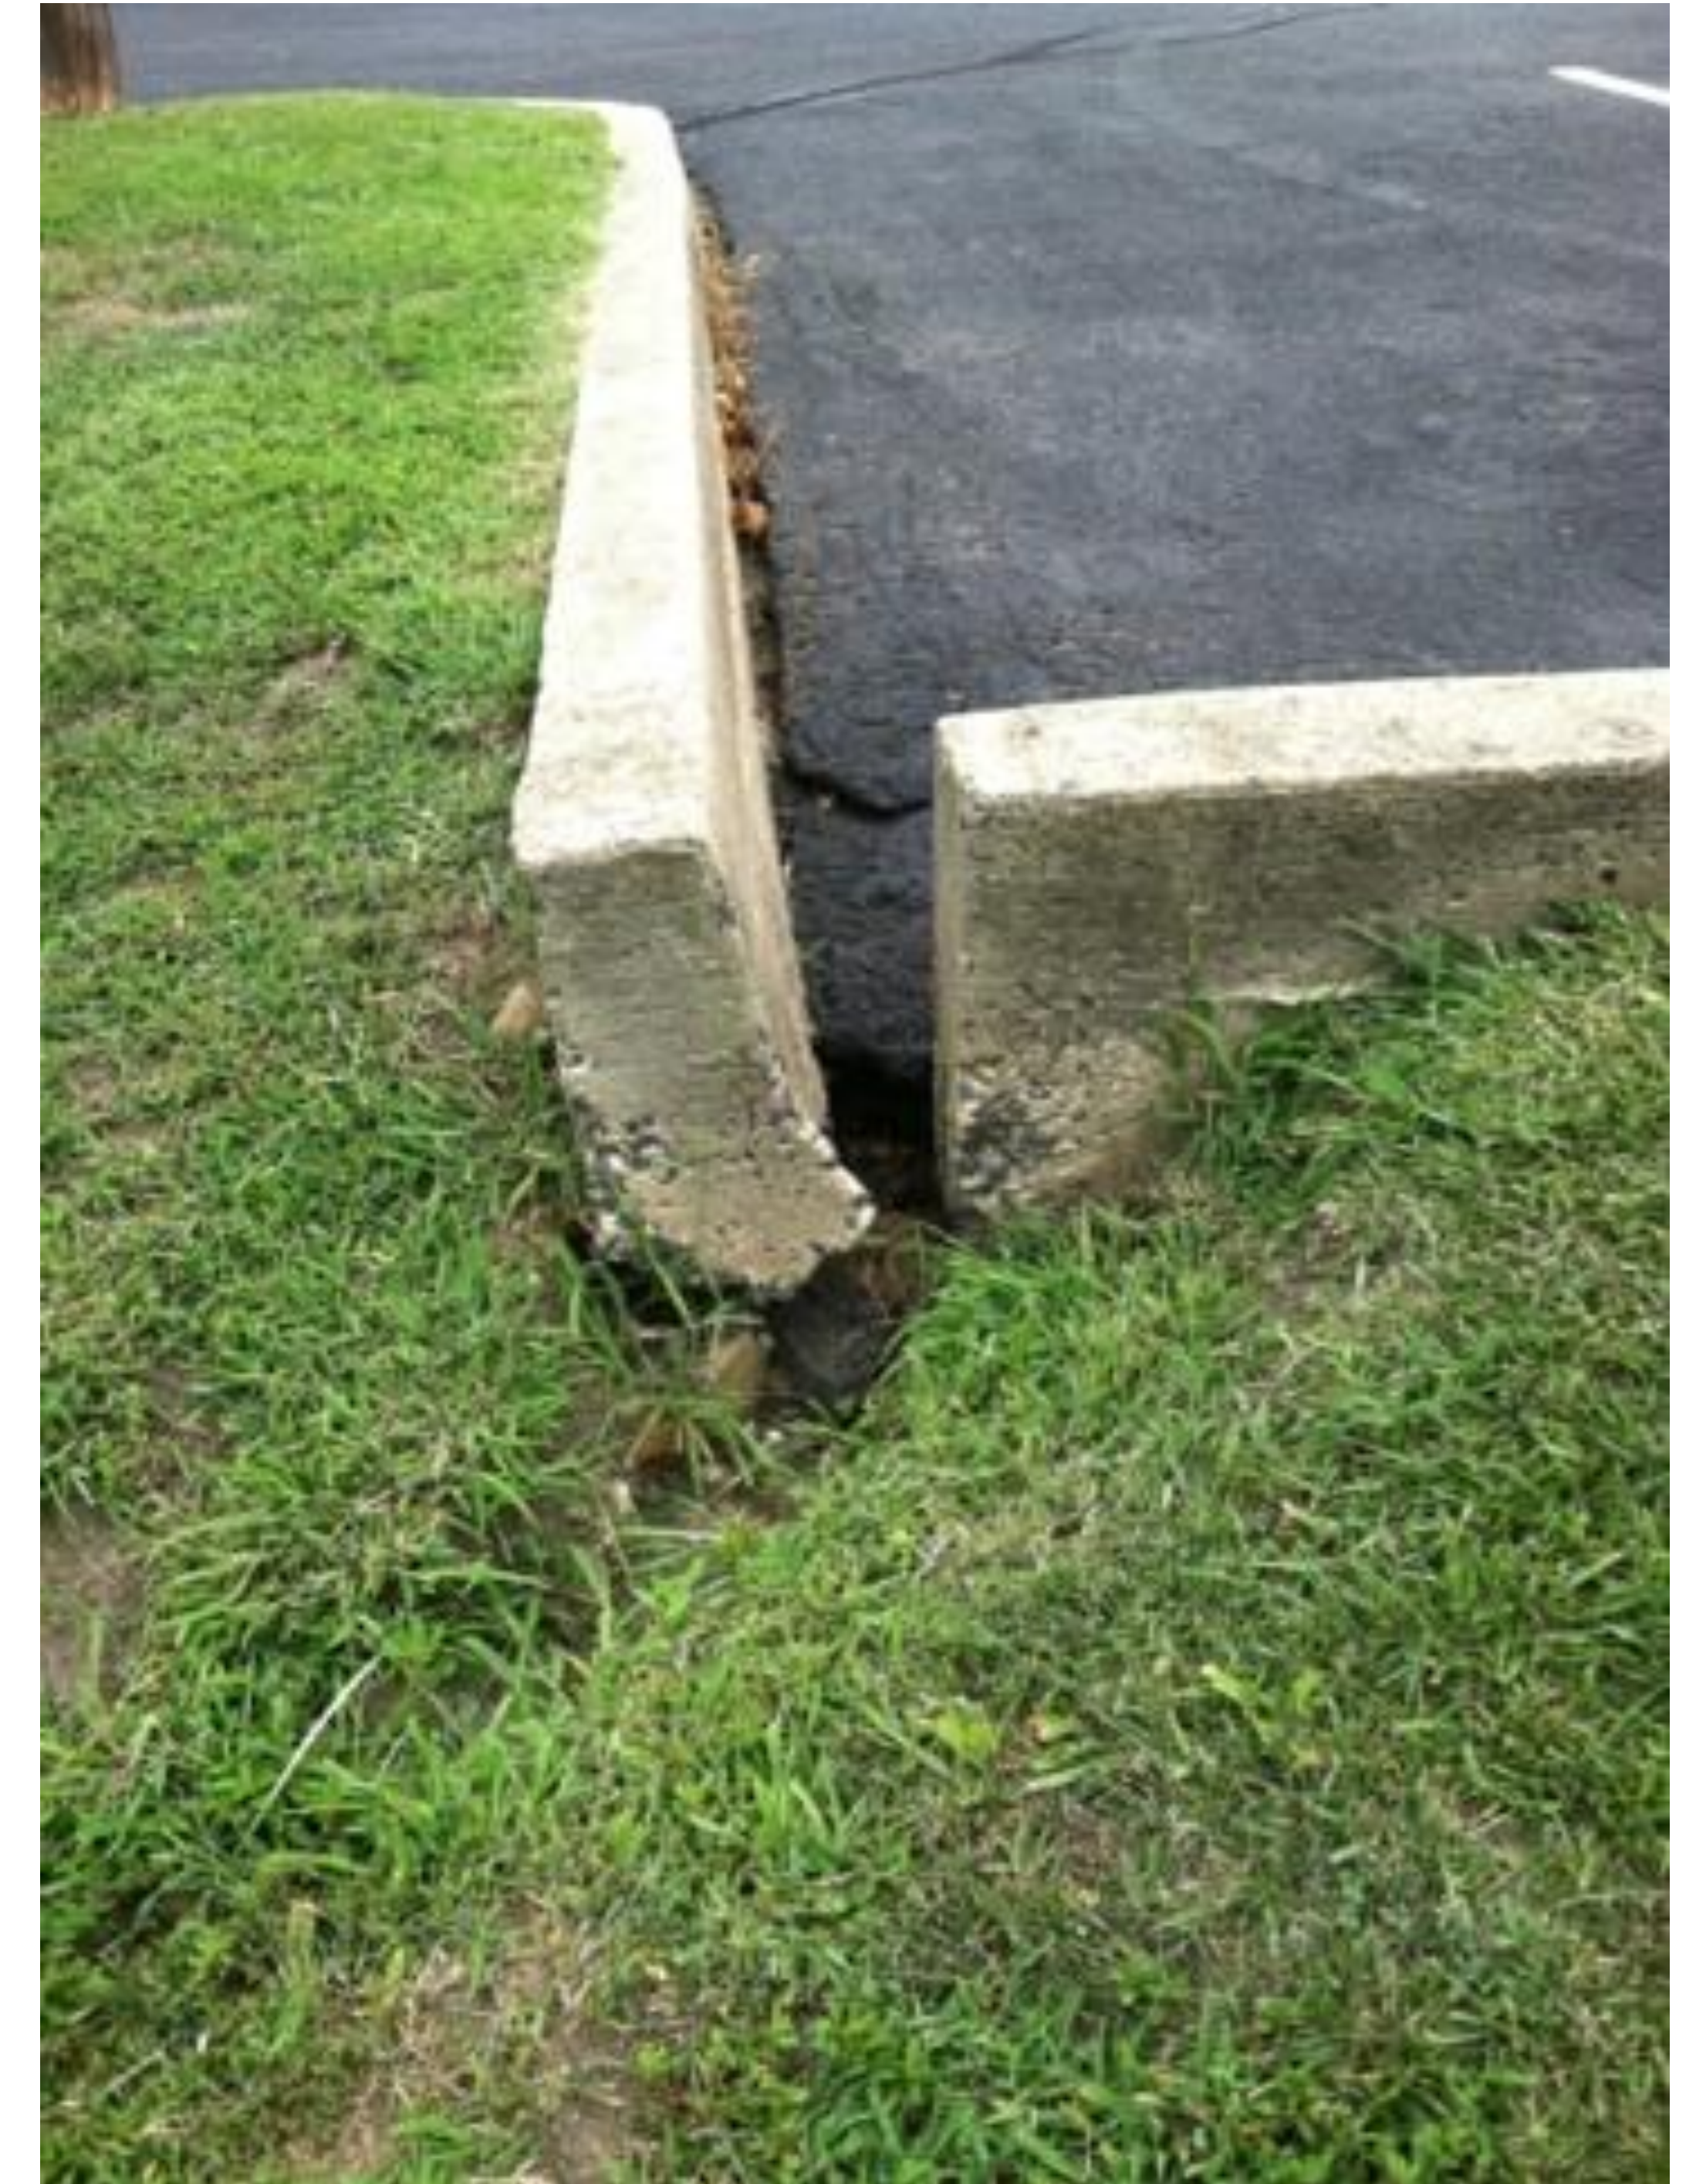
Damaged outlet

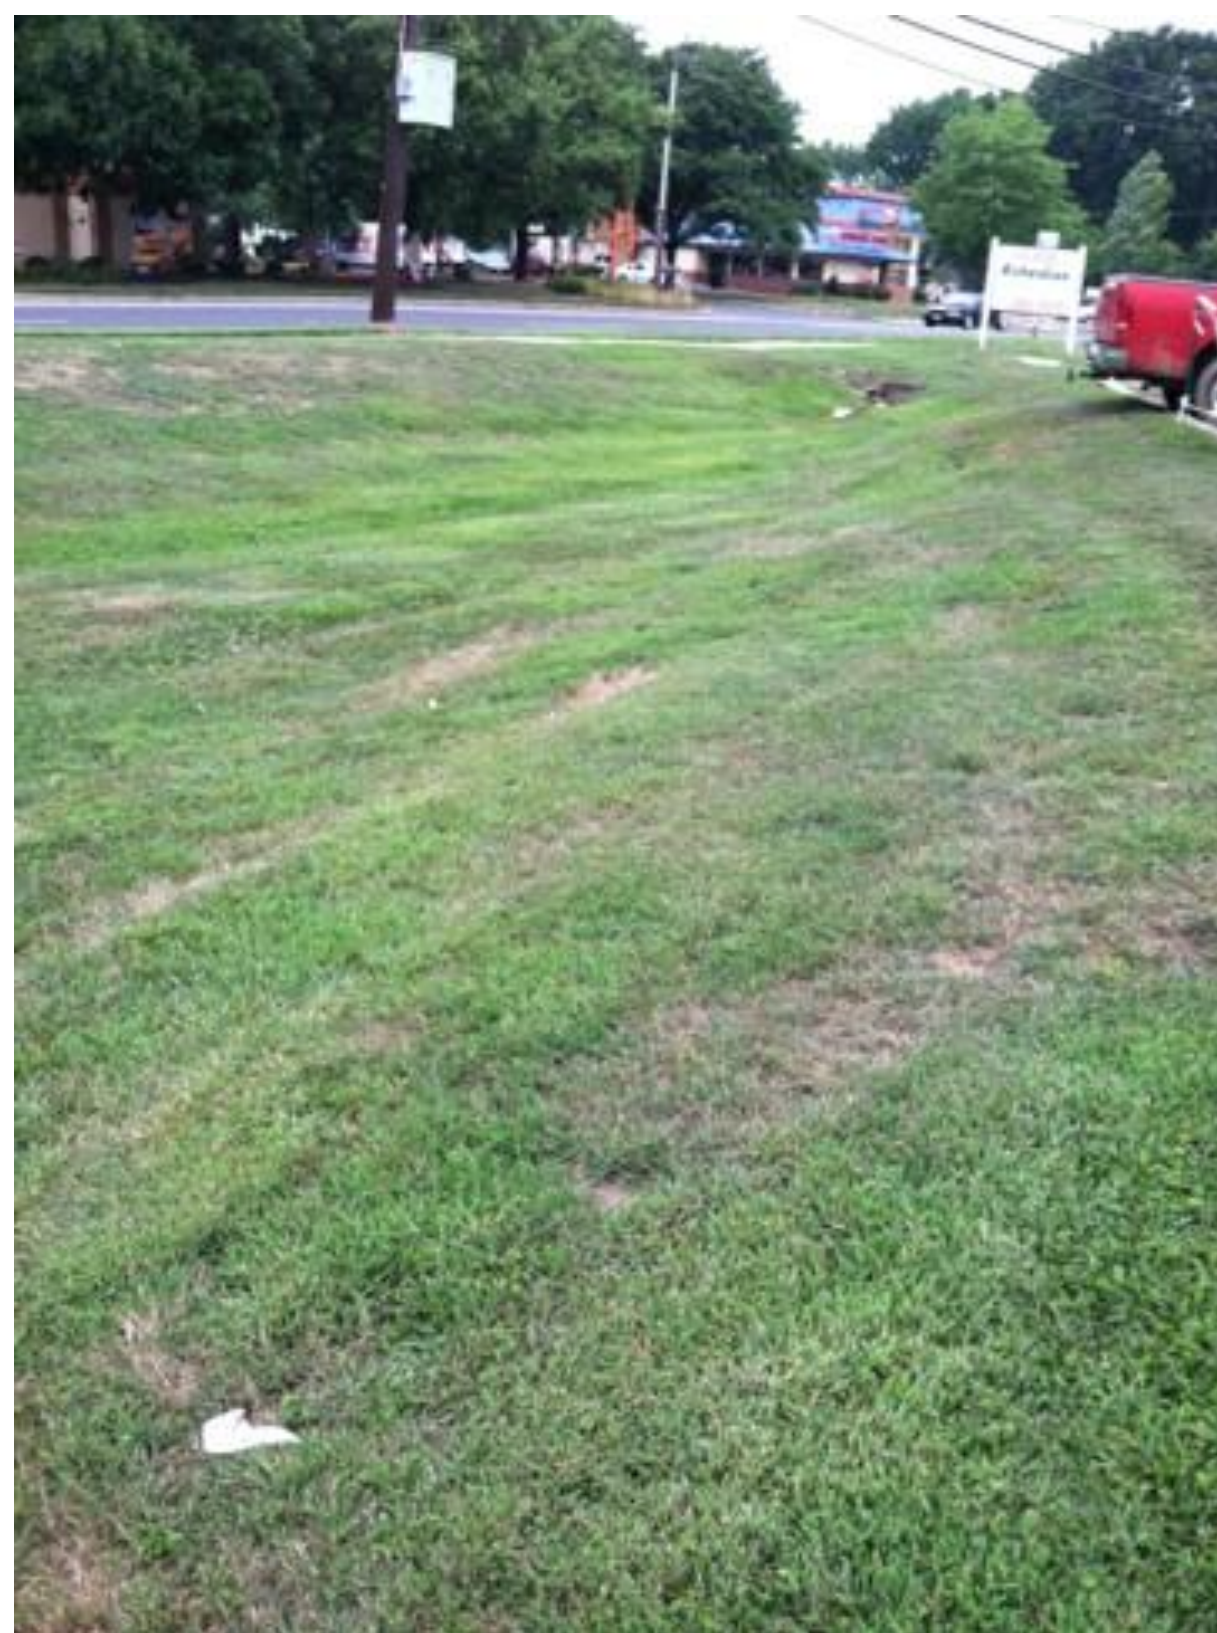
Damaged inlet

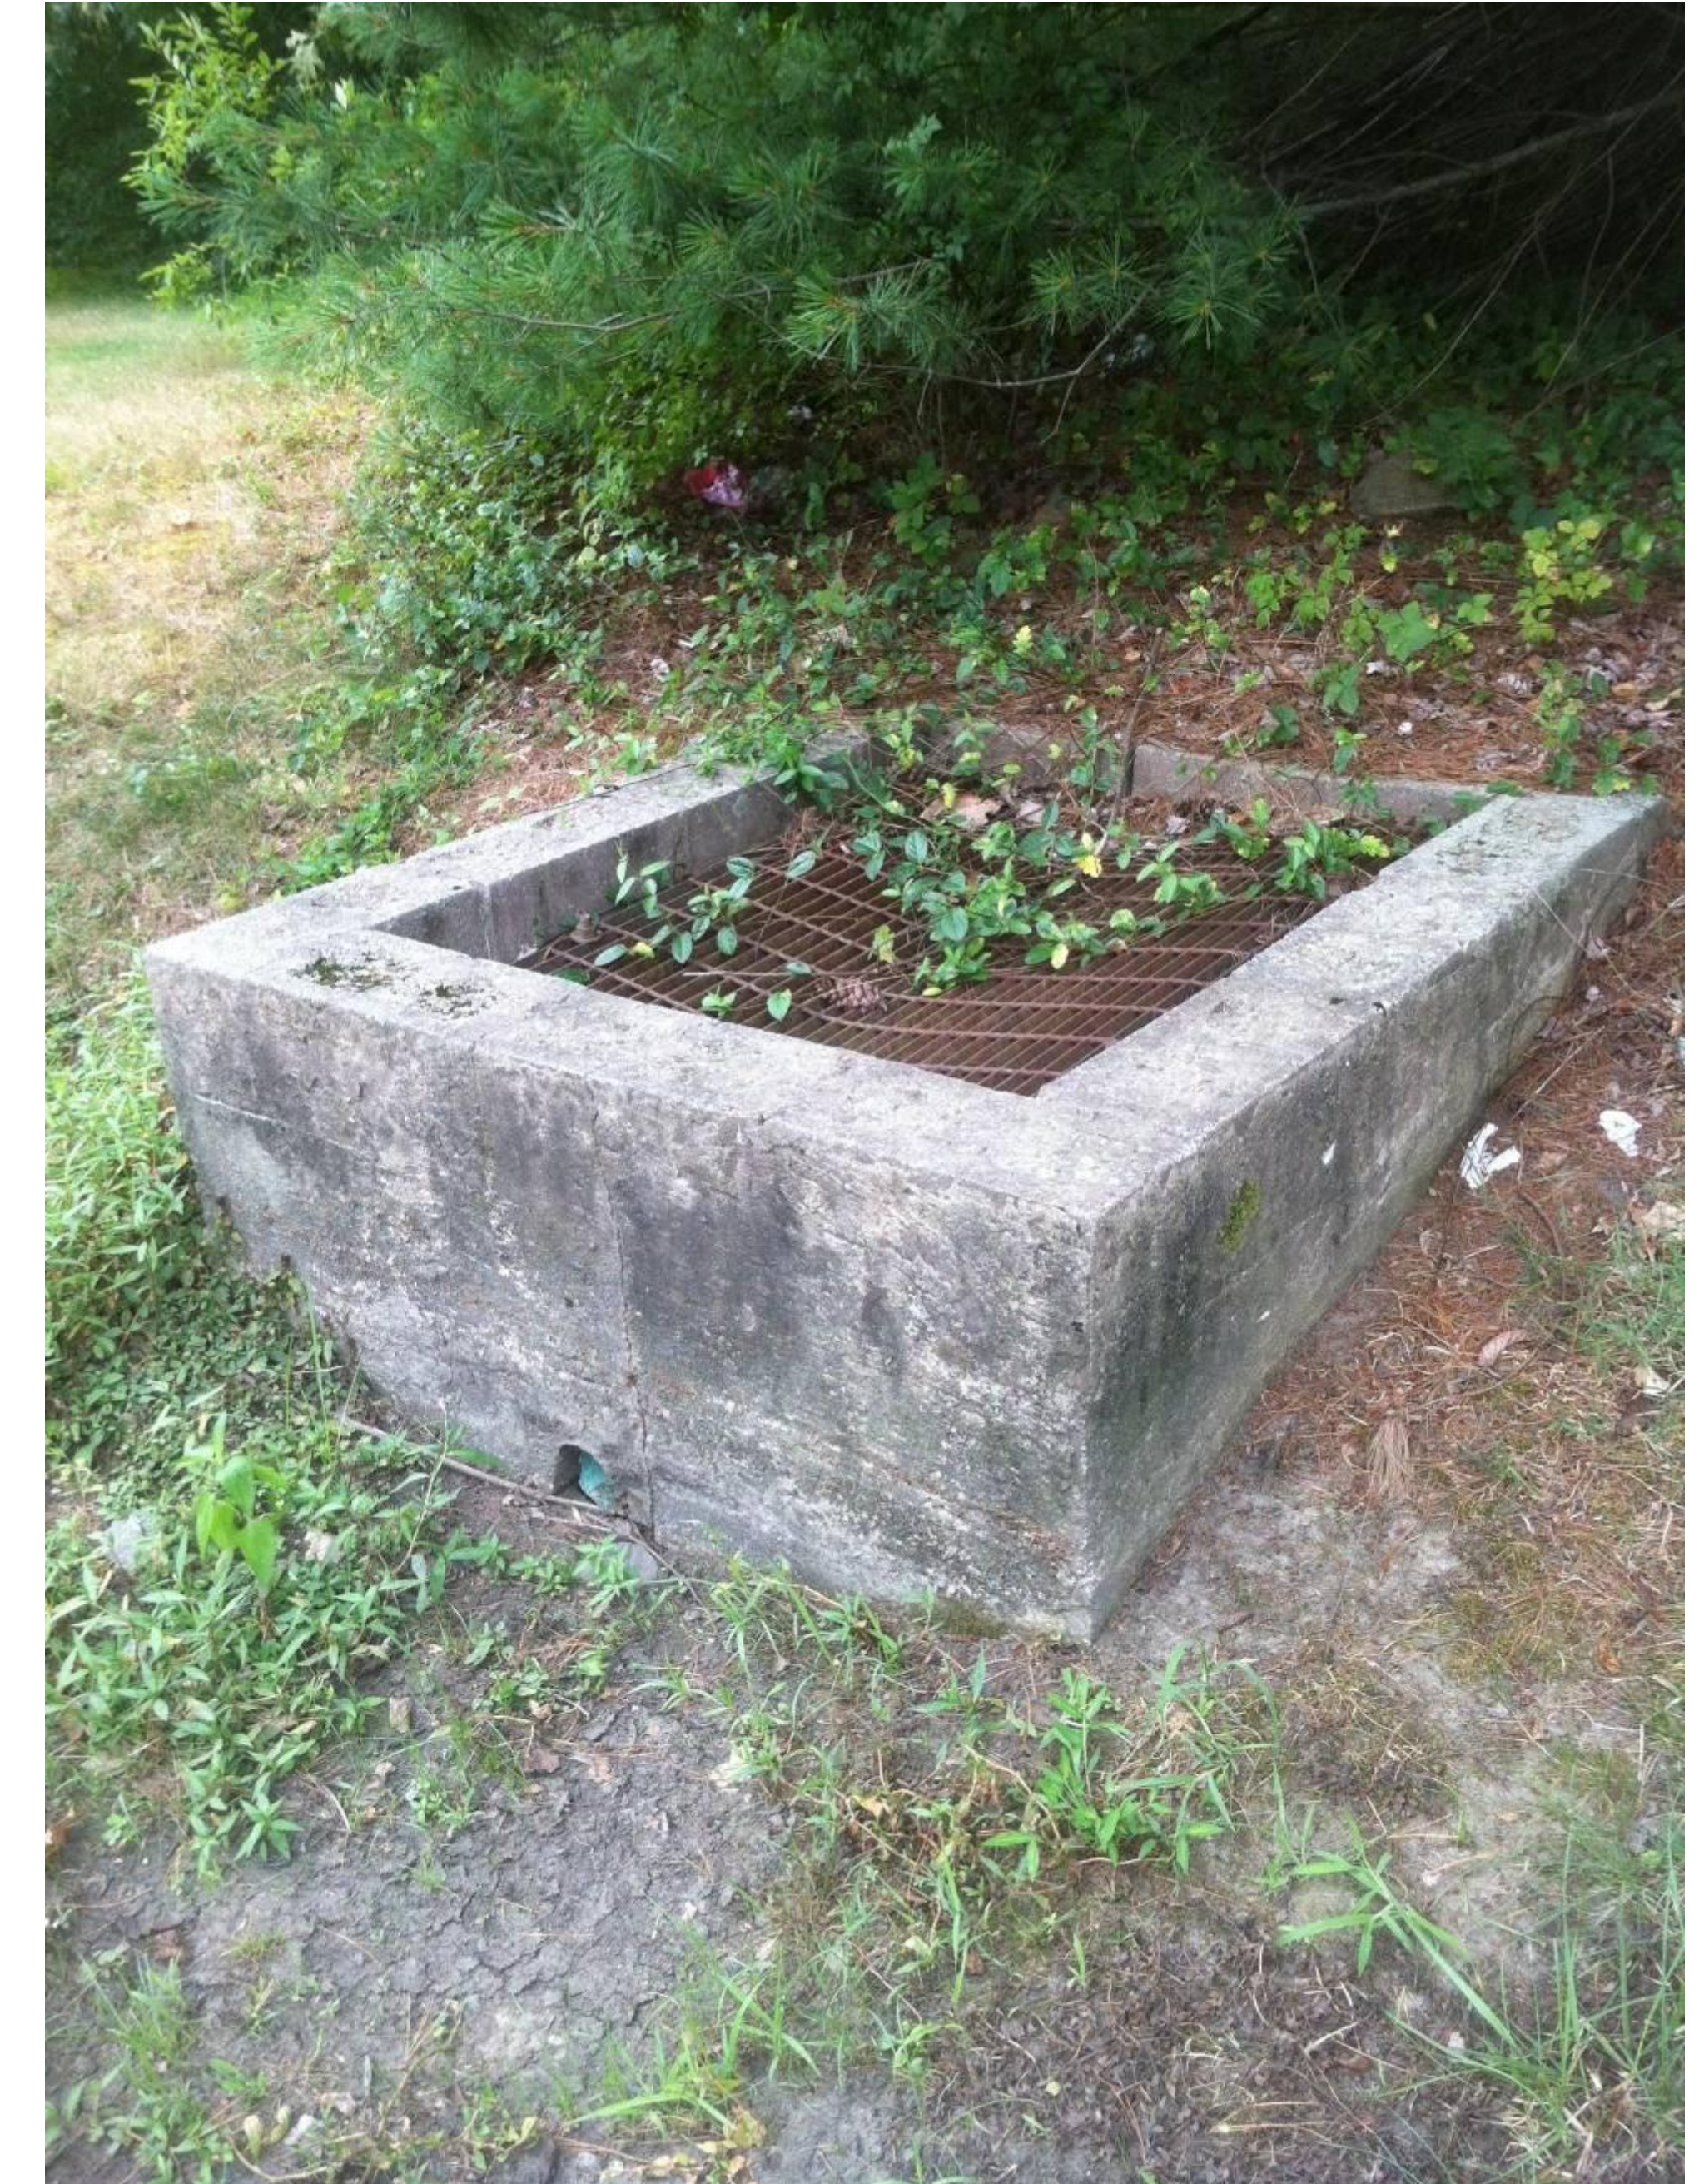
Sediment in low flow channel

- Excess sediment accumulation in low flow channels
- Outlet has structural damage
- Discharges directly to Miry Run

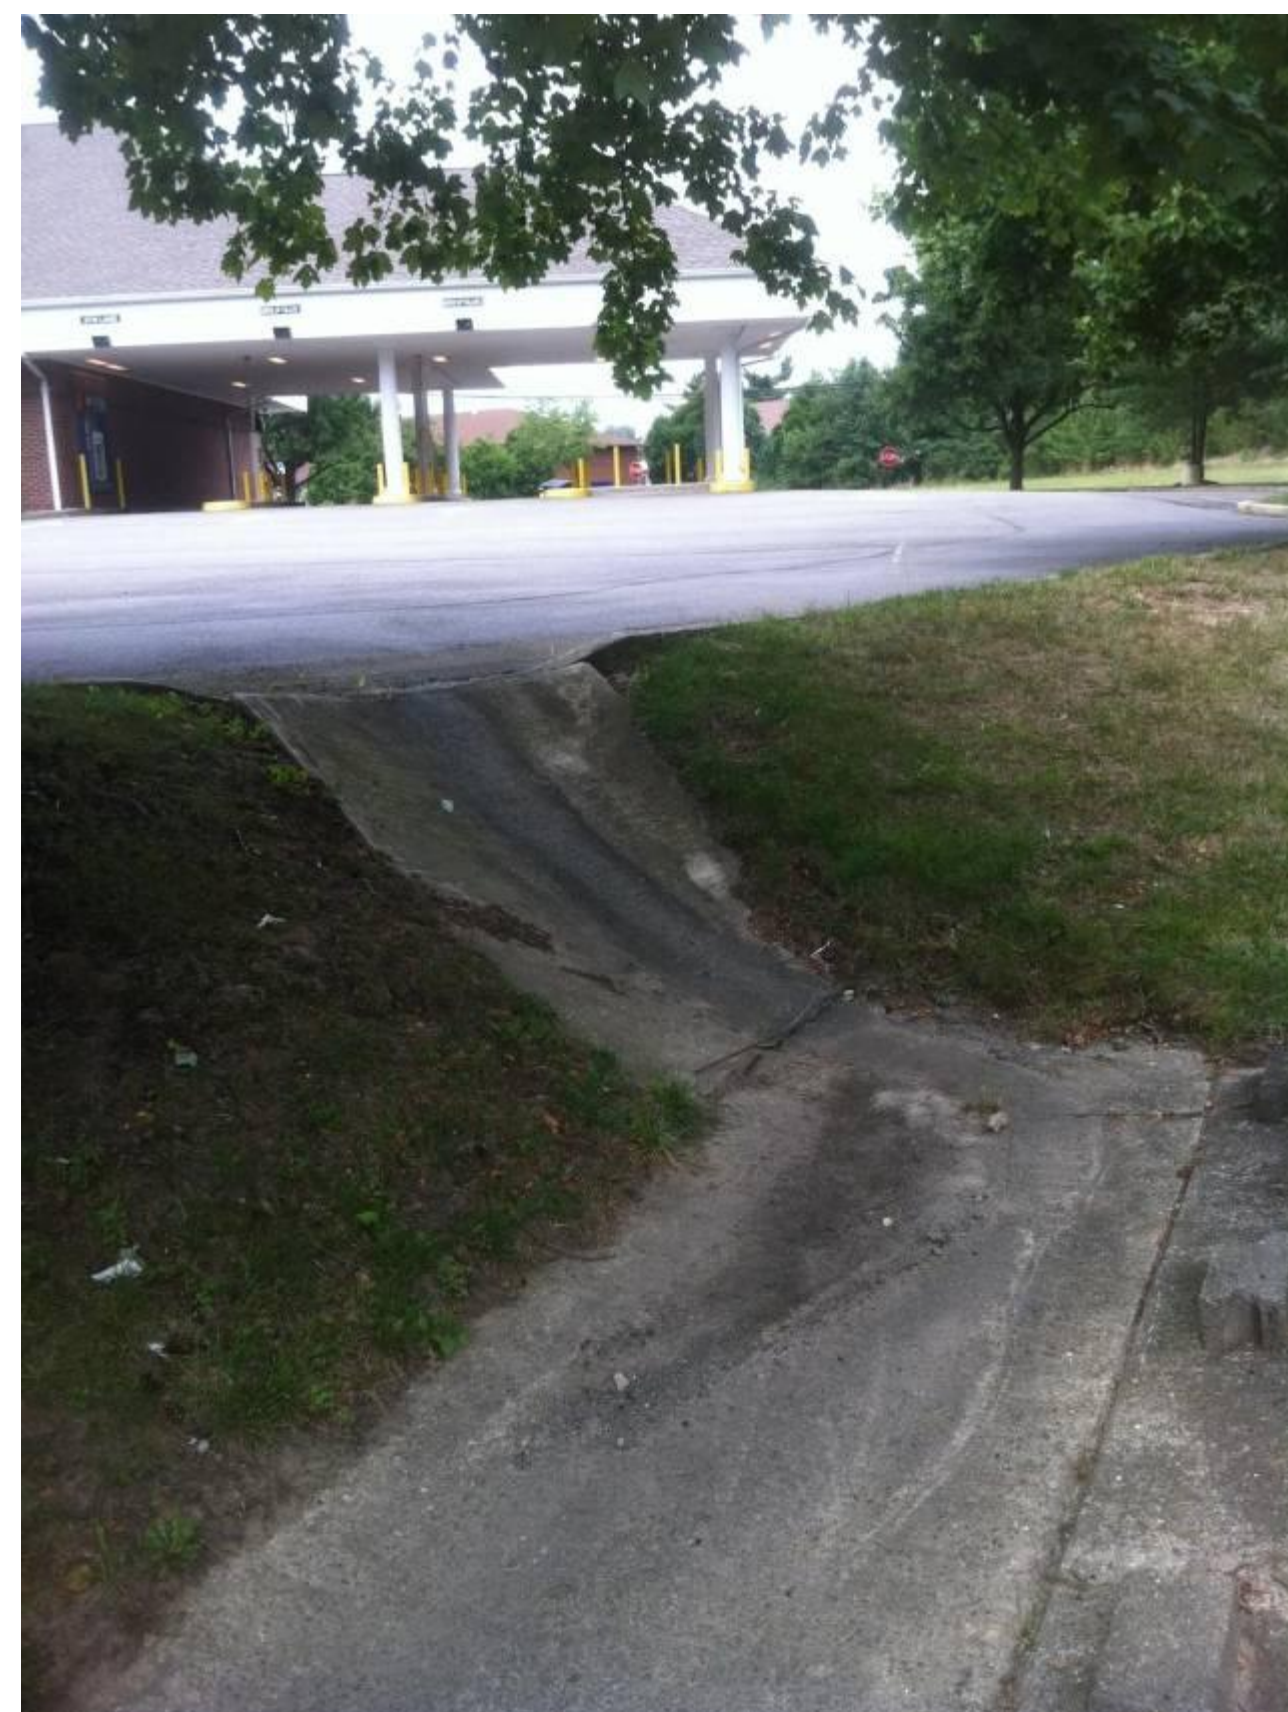
Damaged outlet

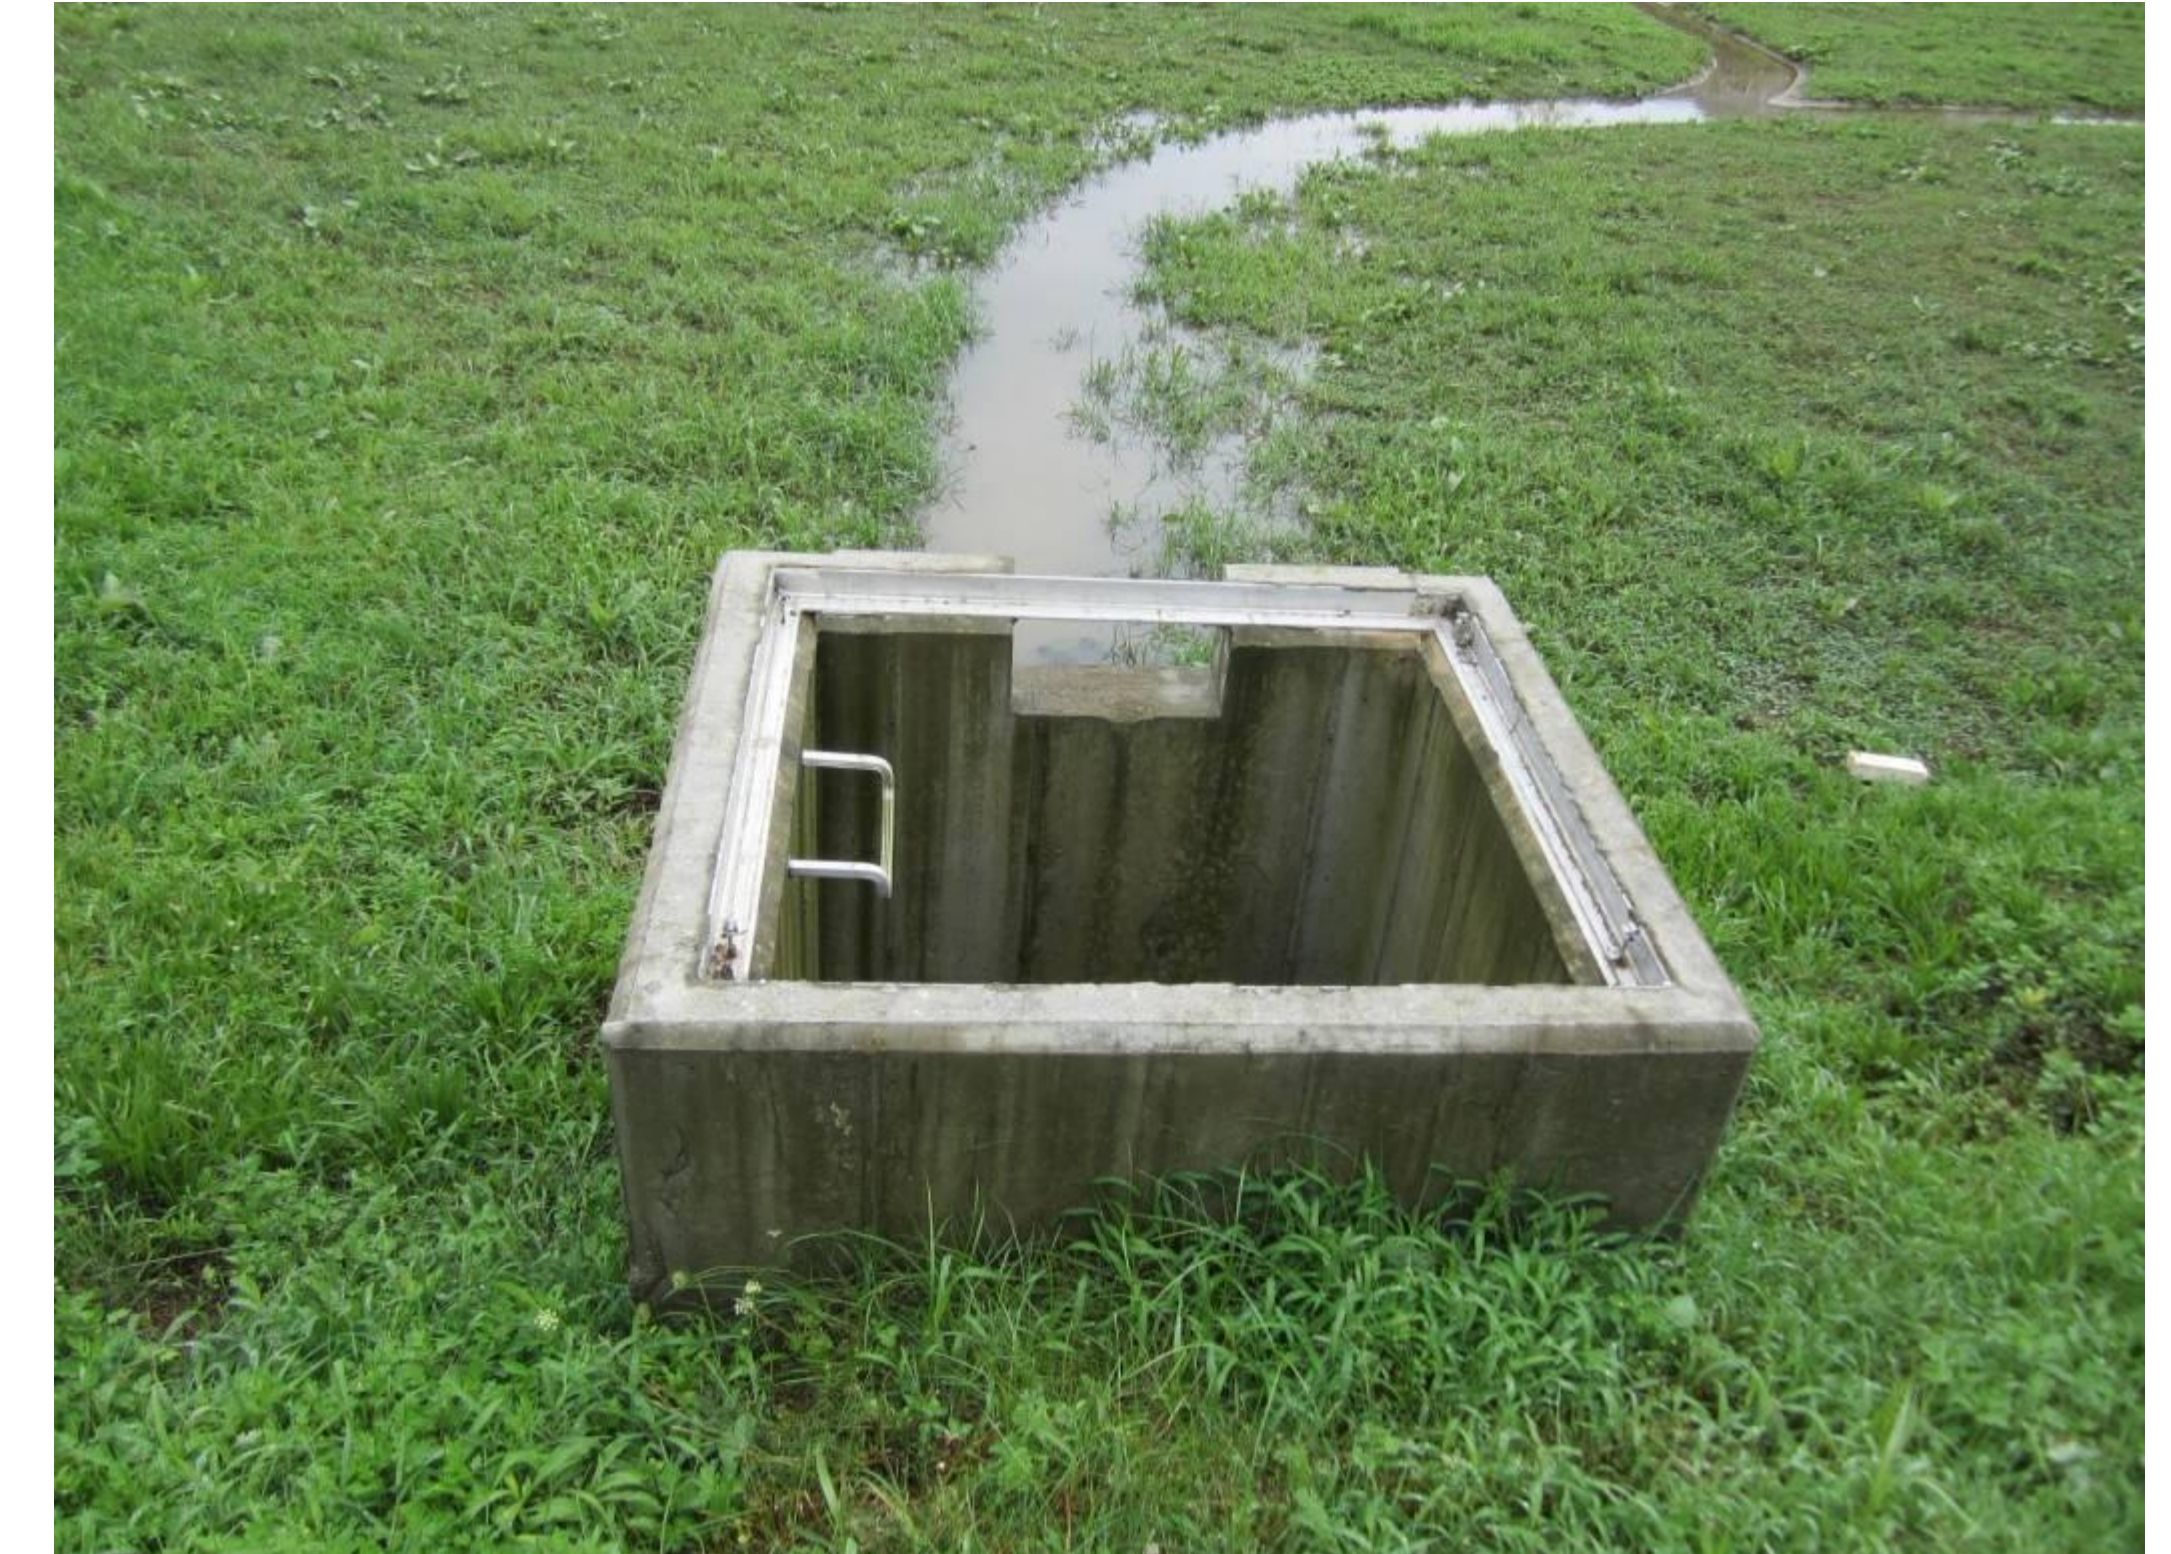
Inlet

- Inlets and outlet have excess sediment accumulation obstructing flow
- Standing water in low flow channel and basin bottom
- Outlet has structural damage and missing grate

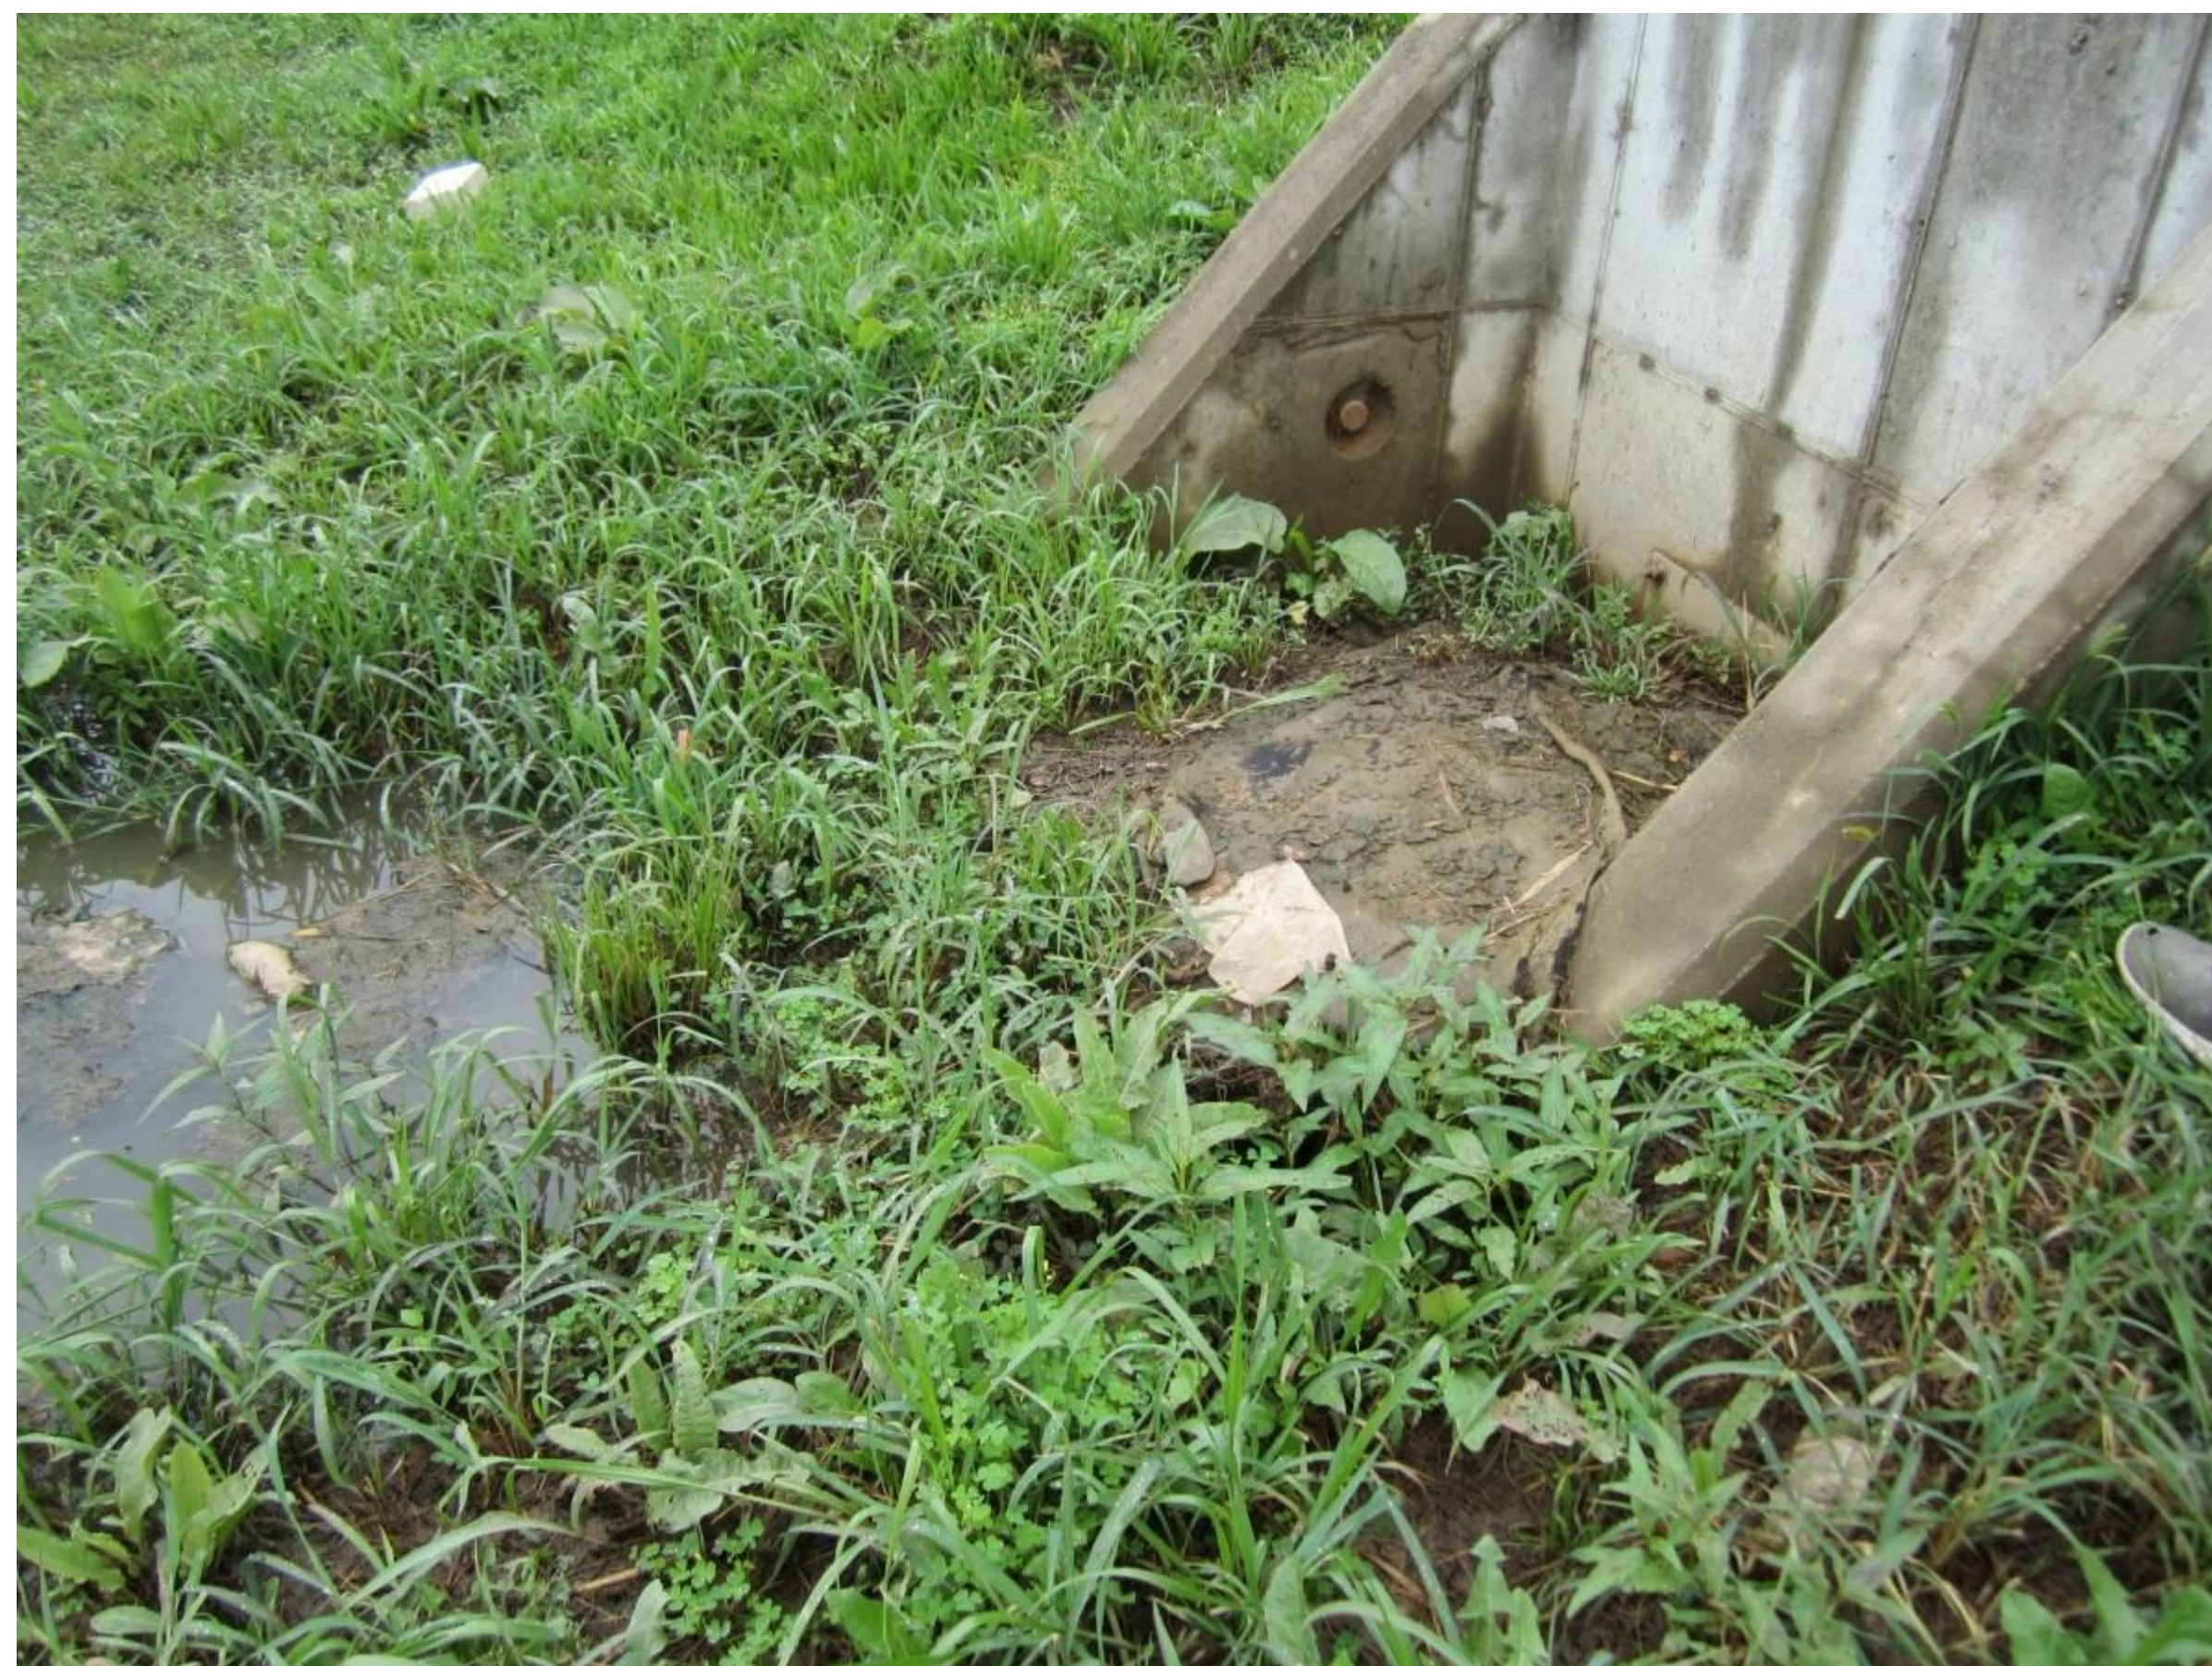
Outlet structure missing grate
