Hamilton Township (Mercer County) Stormwater Basin Assessment Summary (Year 1)

Developed by the Rutgers Cooperative Extension Water Resources Program
Funded by Hamilton Township, Mercer County, New Jersey

December 6, 2012

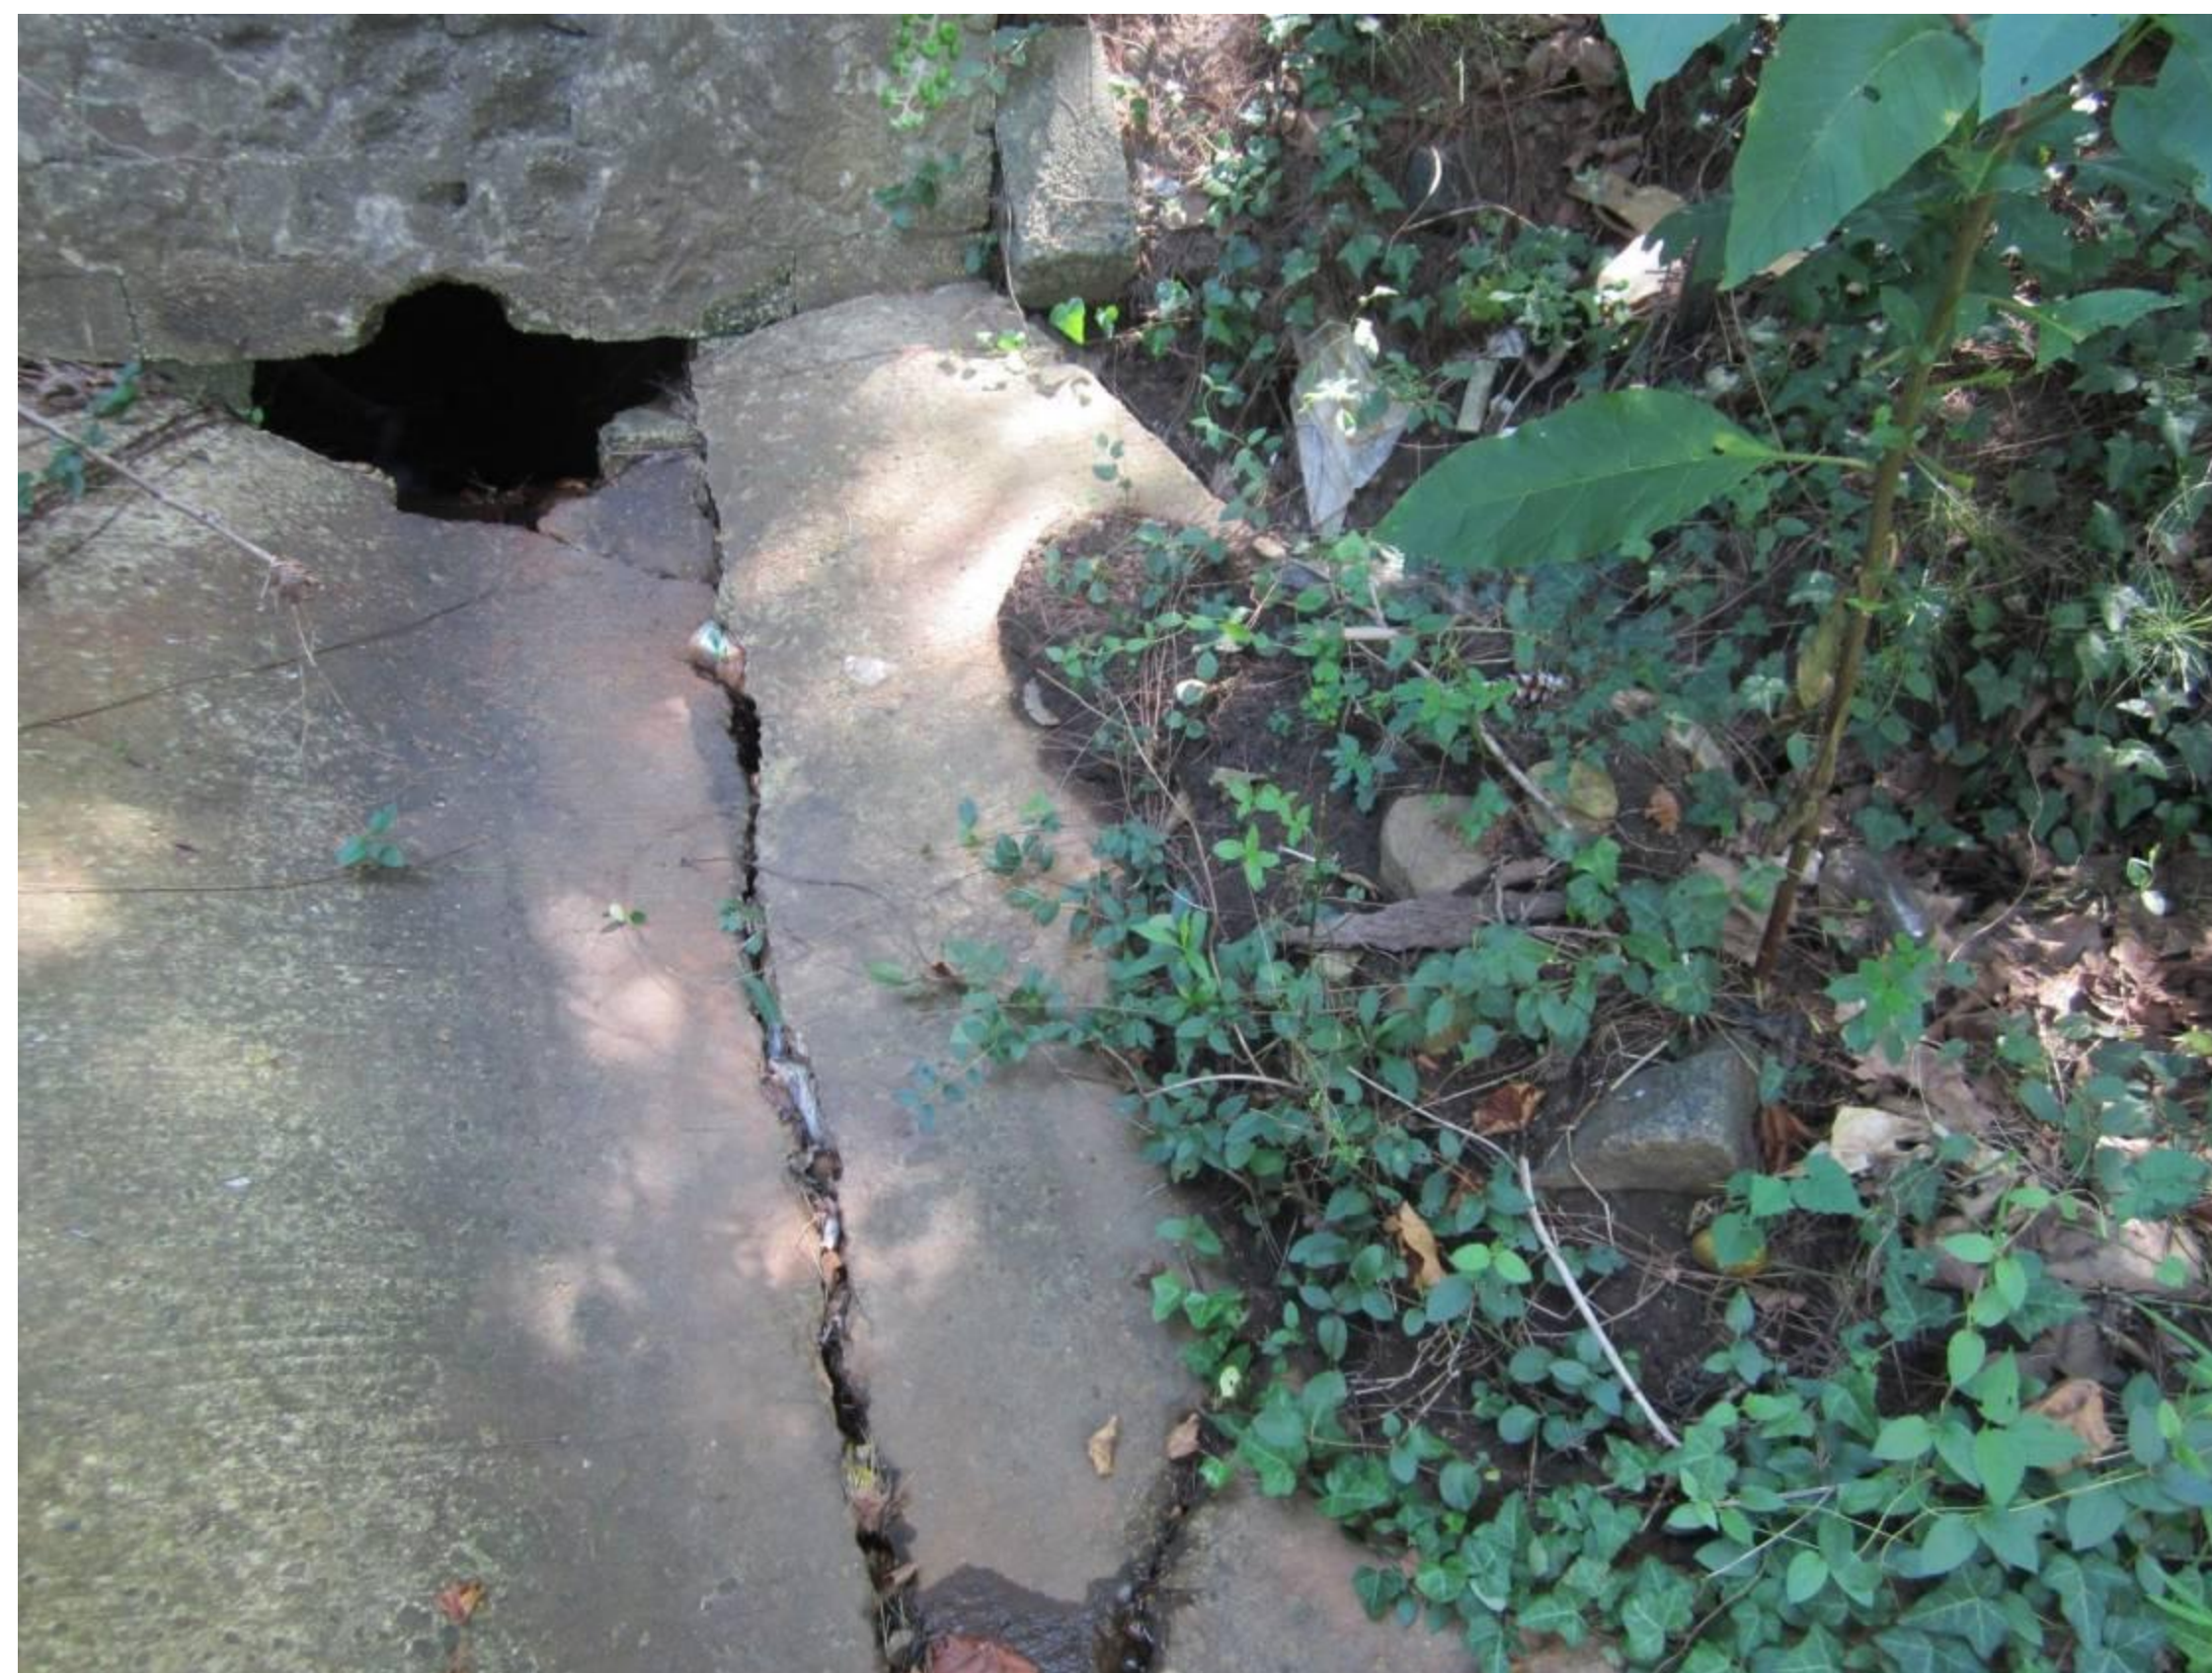
Low flow channel with flowing water

- Basin is naturalized
- Outlet has structural damage, signs of erosion and woody vegetation growth
- Apparent dry weather flow

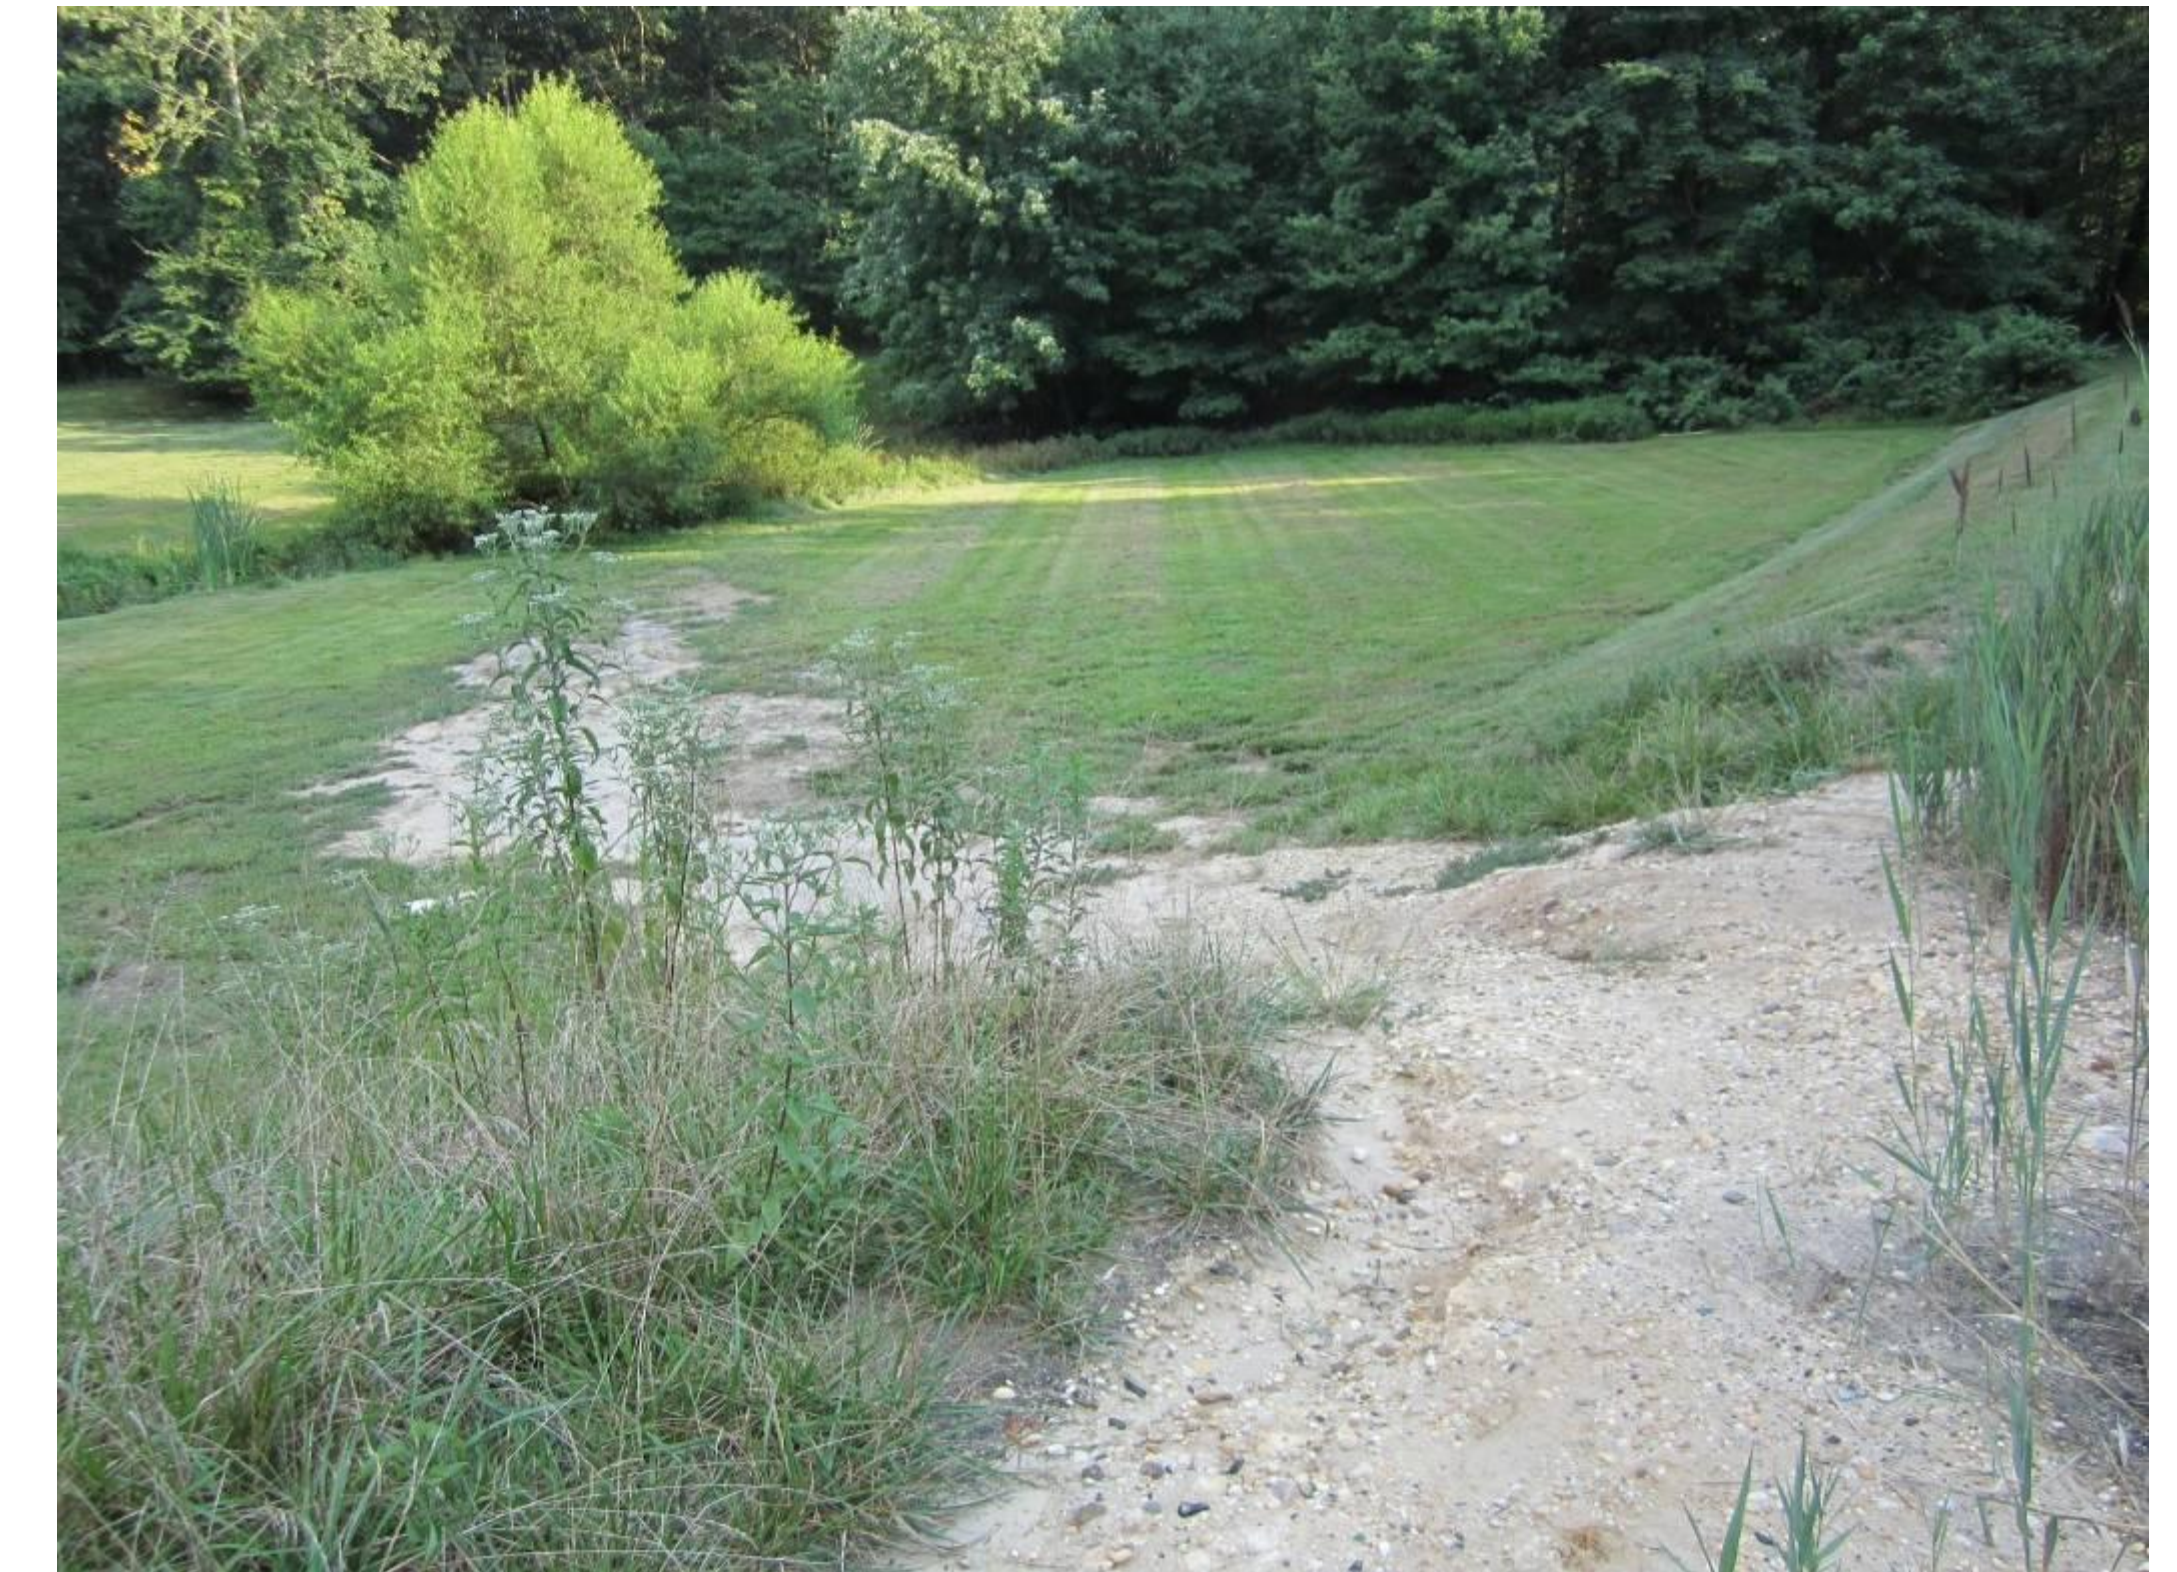
Outlet structure obstructed with litter

- Sediment, debris and litter accumulation at inlets and outlet
- Excess sediment accumulation and standing water in low flow channel with algae growth
- Northwestern basin embankment slumping/failing
- Evidence of deterioration at inlets
- Woody vegetation growth around outlet
- Basin outfall area shows evidence of erosion

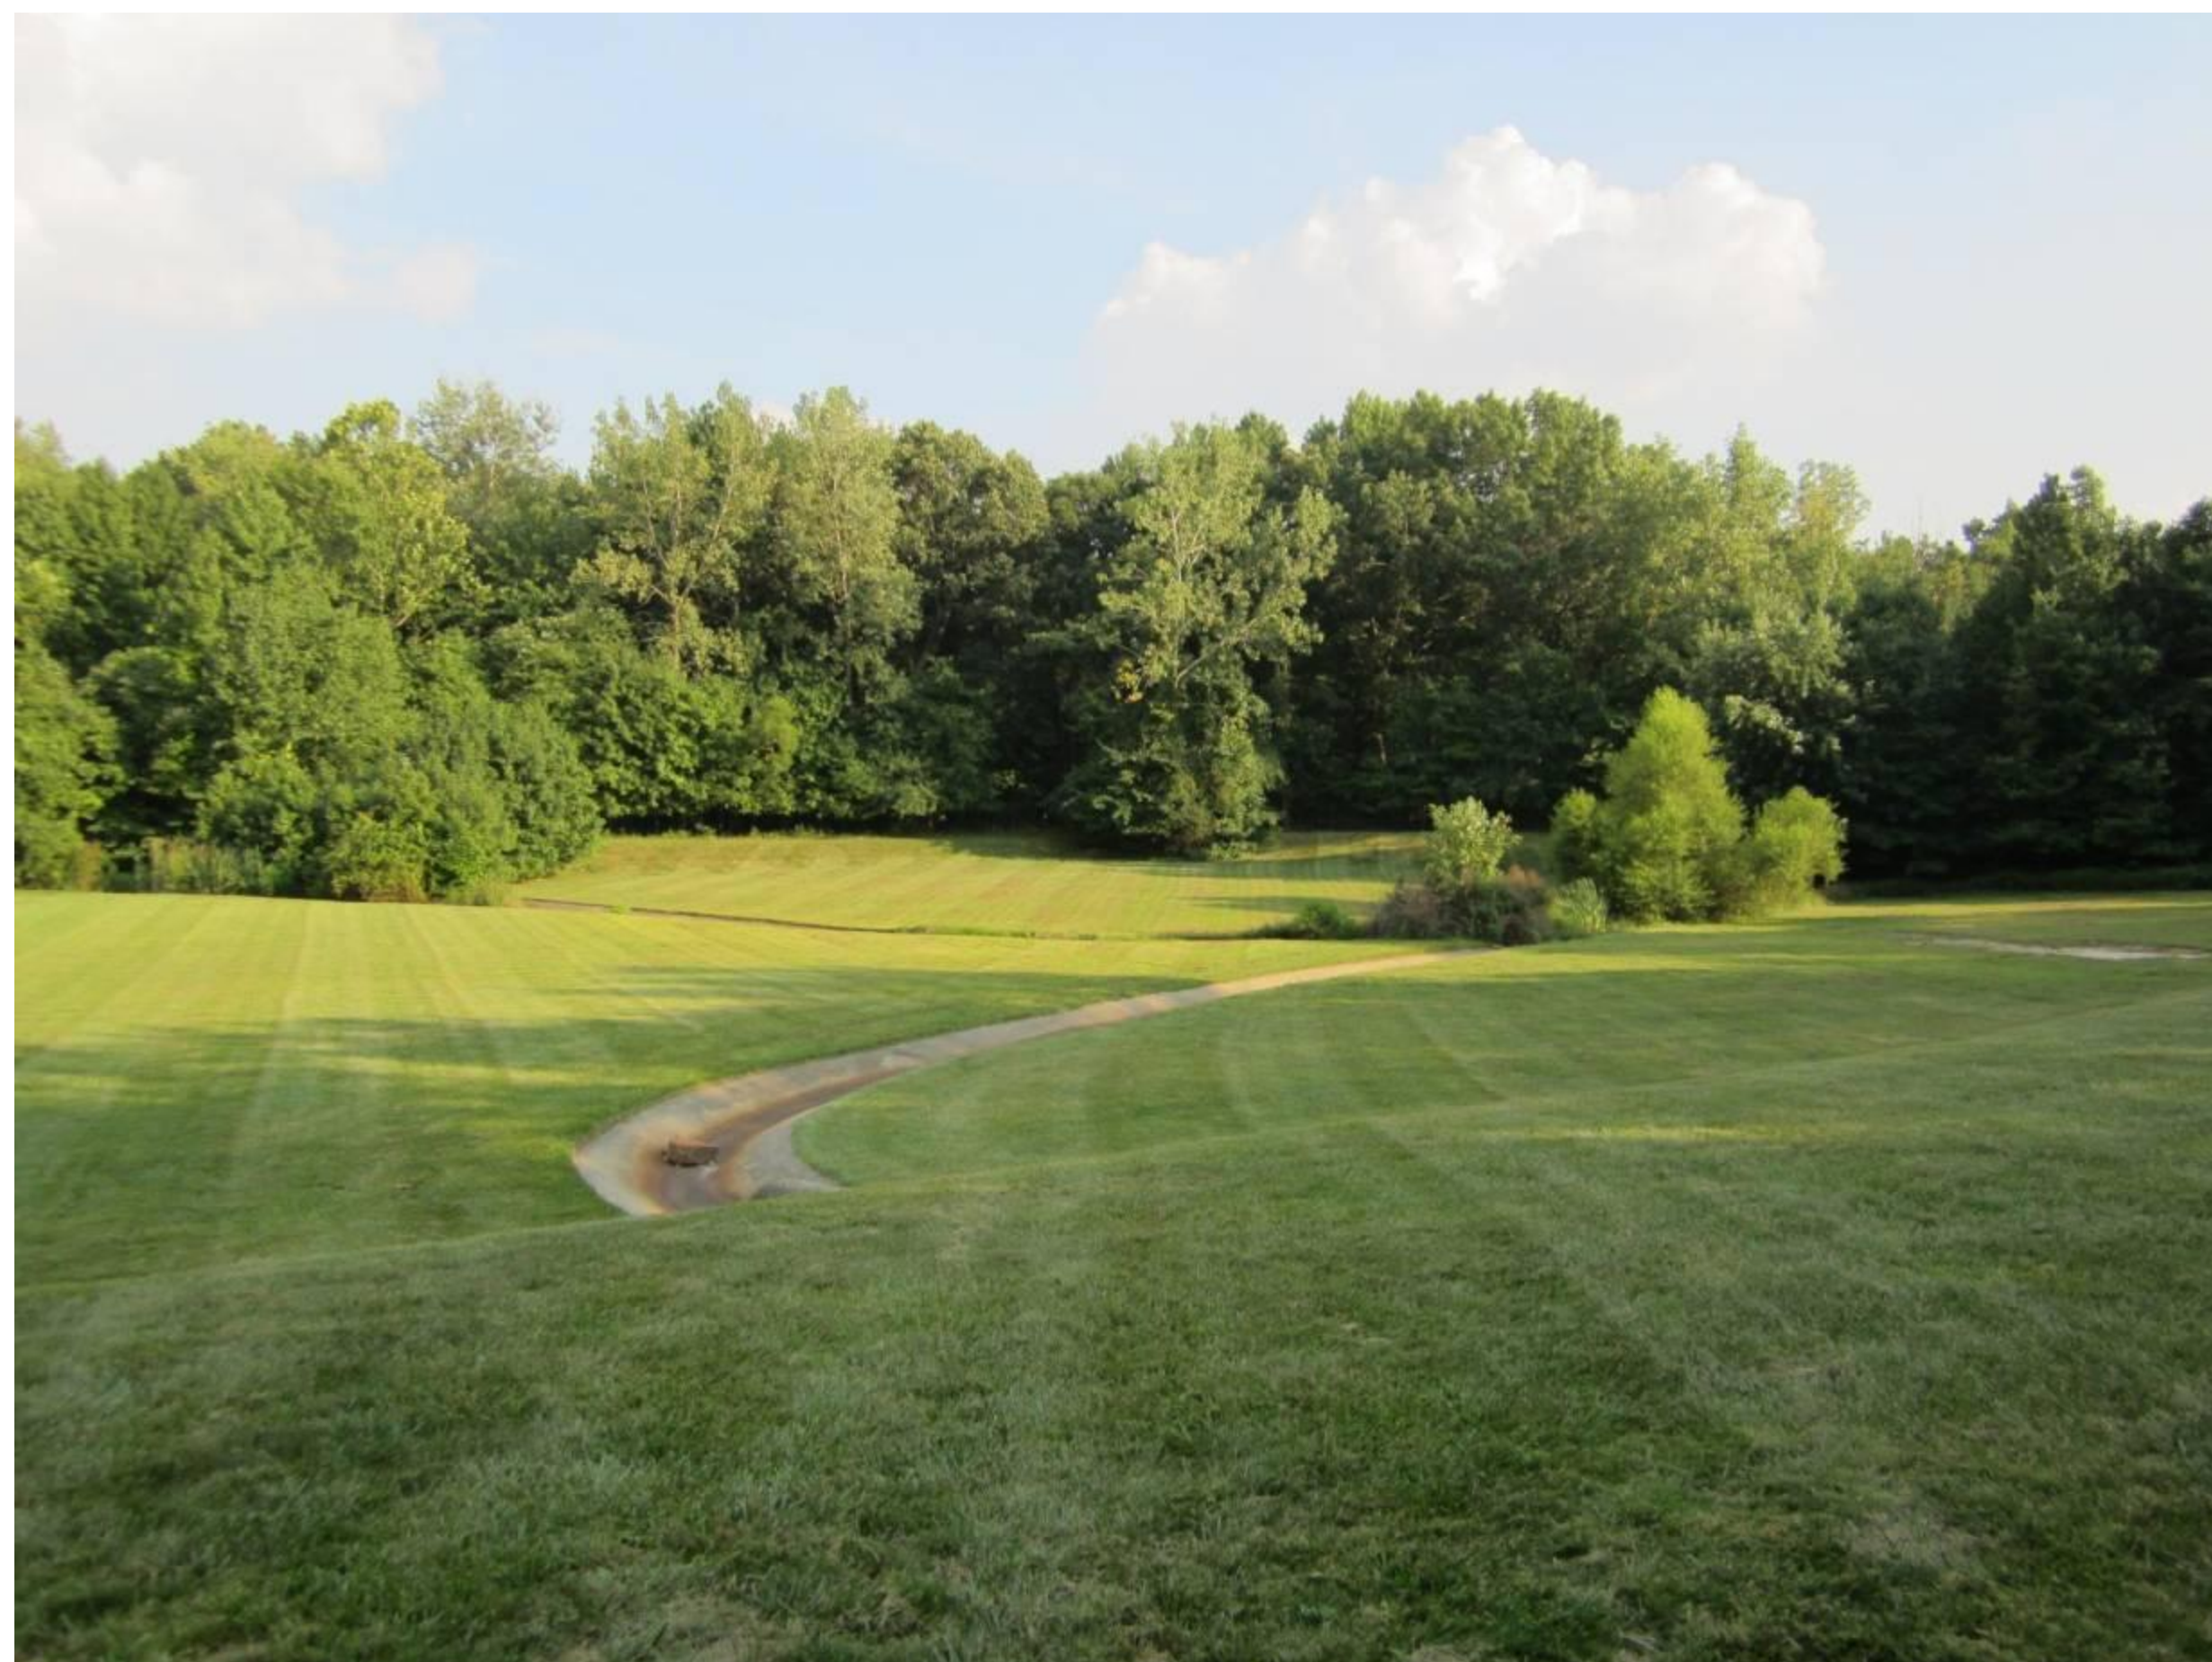
Slumping/failing basin embankment
