## **Hamilton Township (Mercer County) Stormwater Outfall Assessment Summary 2022: Assunpink Creek & Miry Run (Region 1)**

Developed by the Rutgers Cooperative Extension Water Resources Program  
Funded by Hamilton Township, Mercer County, New Jersey  
December 22, 2022

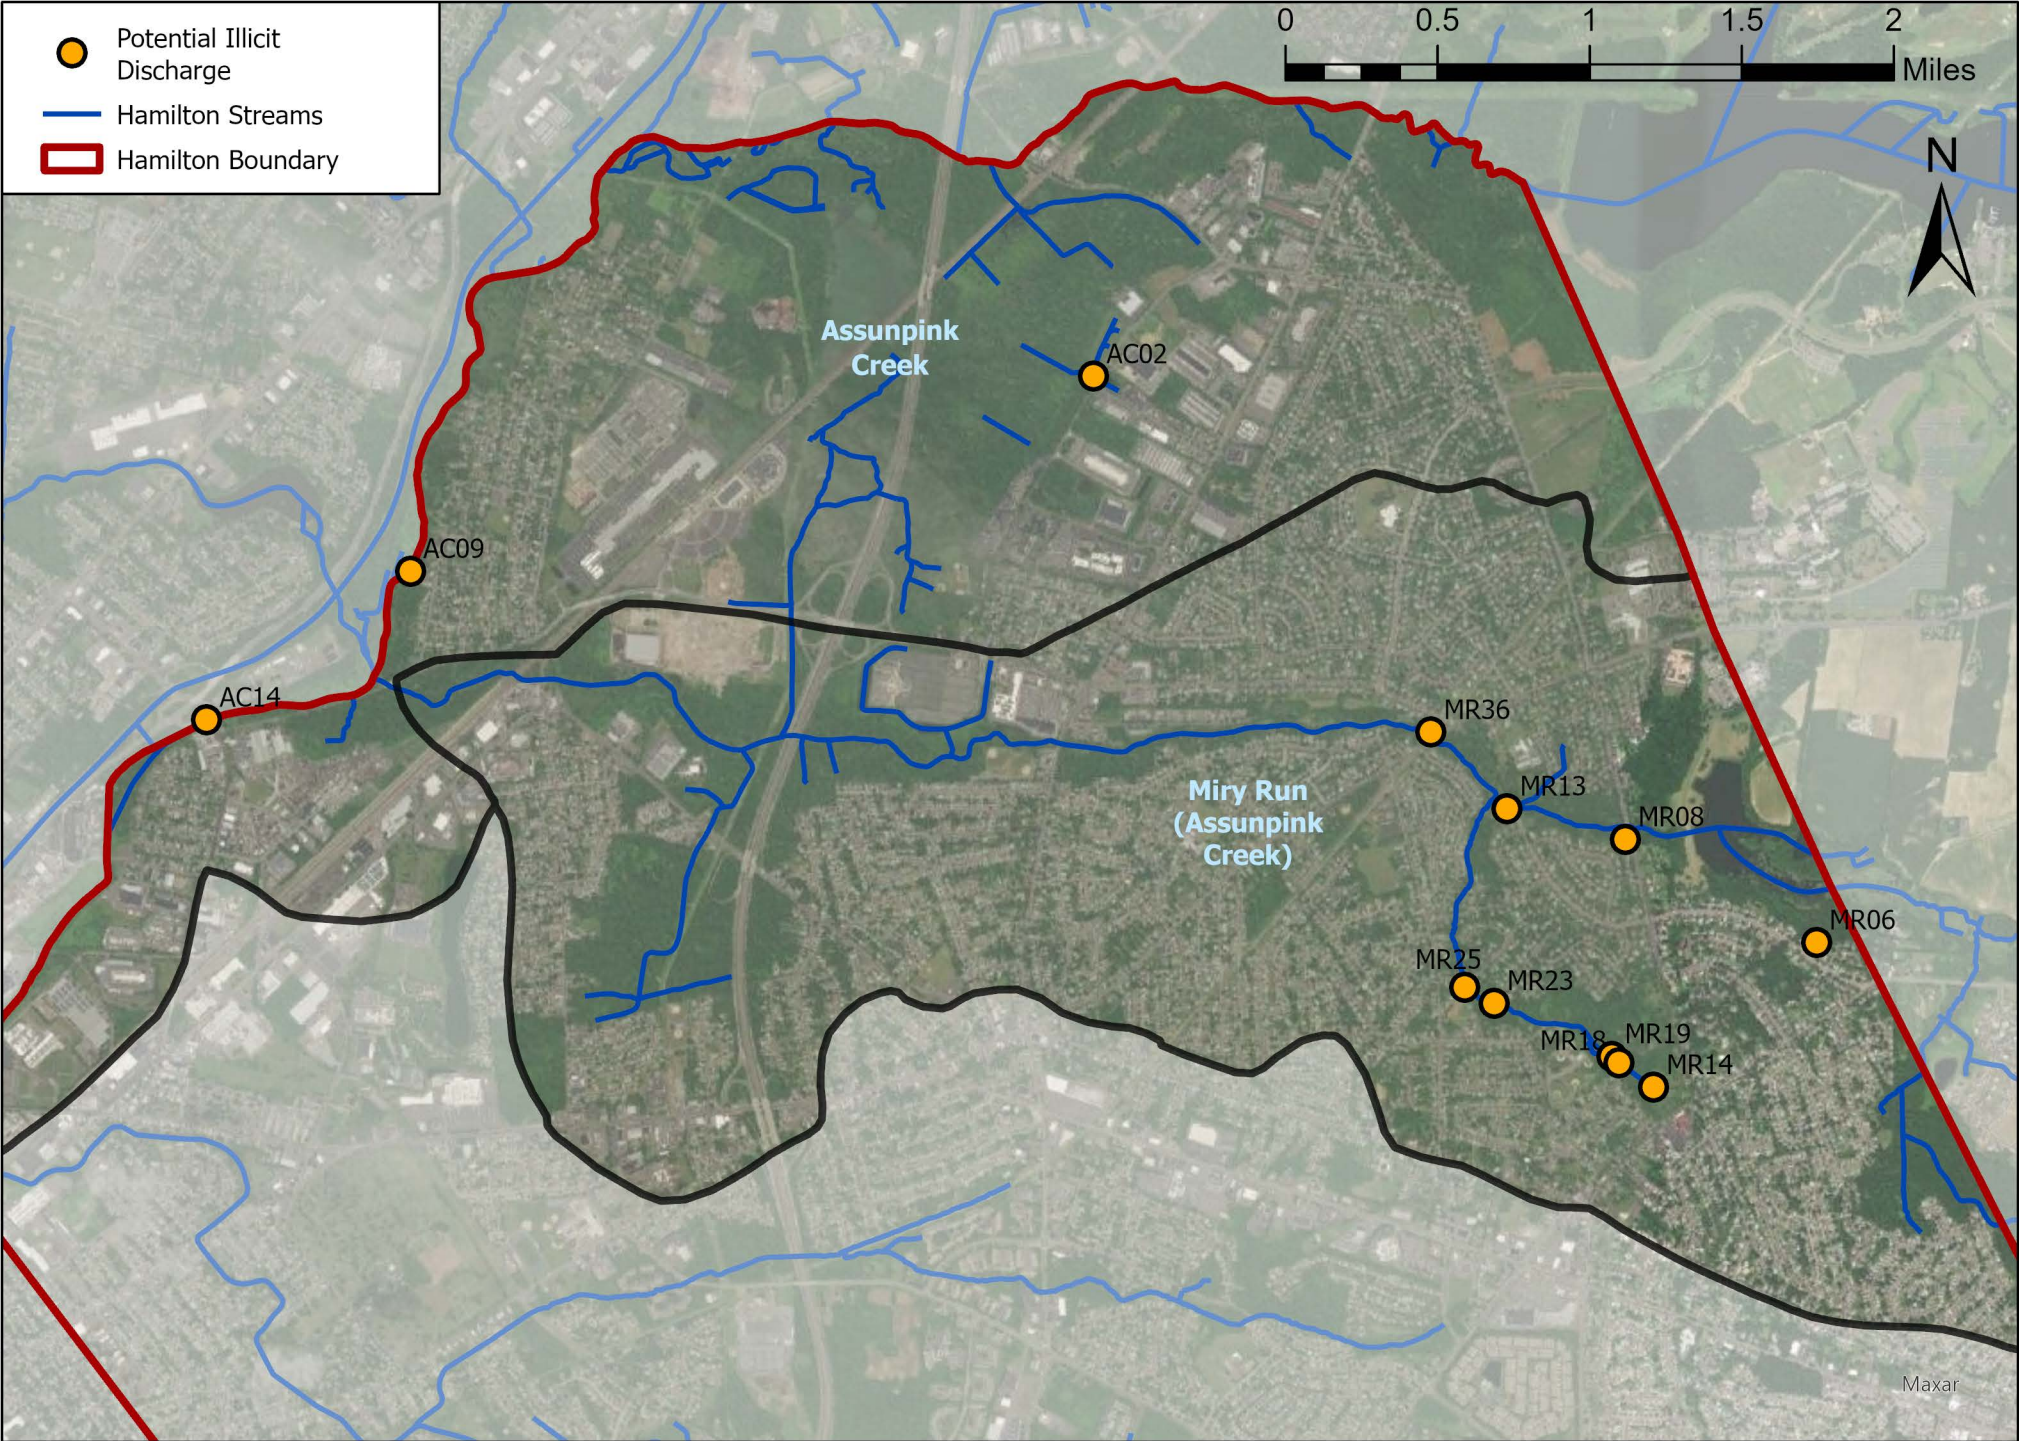
# Hamilton Outfall Region 1: Potential Illicit Discharges

A total of 12 outfalls were suspected of illicit discharges during the initial investigation, during a repeat inspection for sampling, only eight (8) were found to be flowing during dry weather and were sampled. See the Illicit Discharge Detection Investigation report for more details.
