MILESTONE 4 OF REGIONAL STORMWATER MANAGEMENT PLAN FOR THE ROBINSON'S BRANCH
NEW JERSEY DEPARTMENT OF ENVIRONMENTAL PROTECTION

UNNATURAL CONSTRICTION FLOODING

JOB	CONCEPT SHEET #
BRANCH	5
B/O	TOTAL
4	7

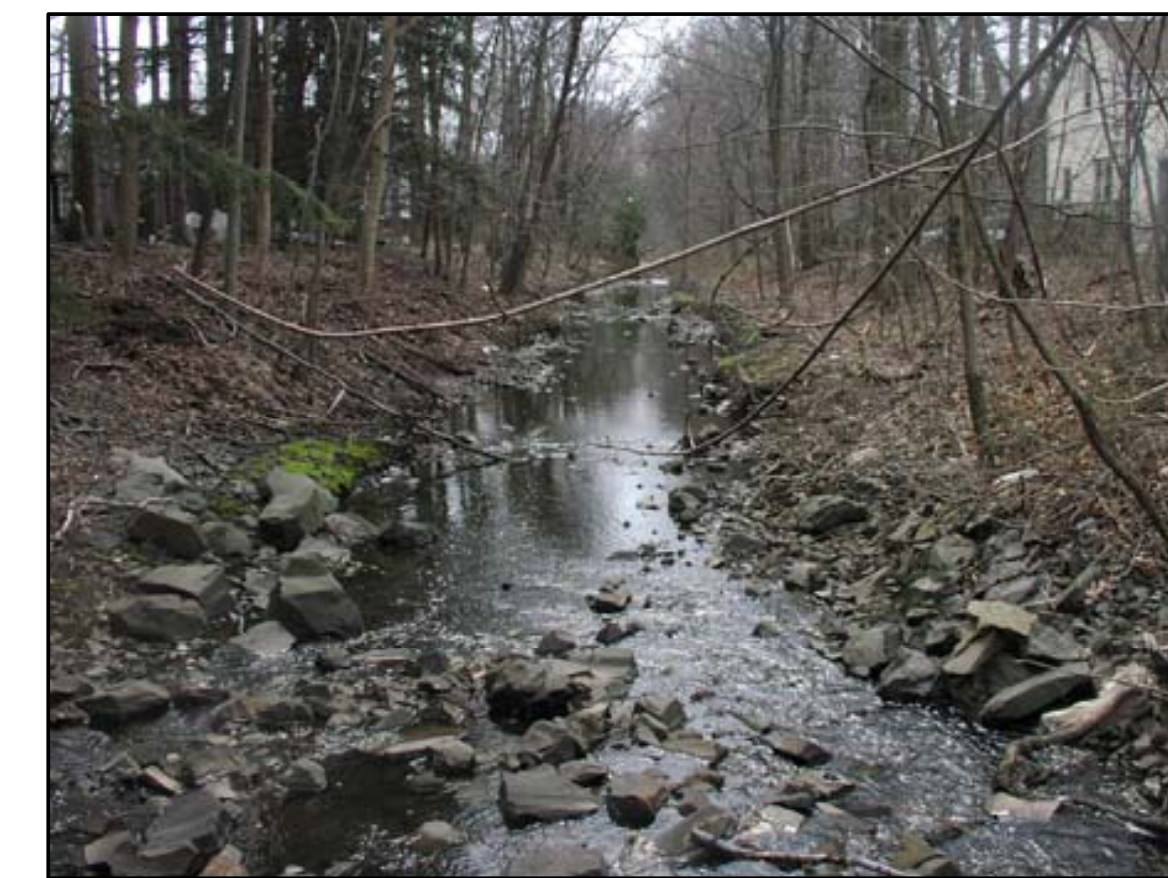
PICTURE 1: UPSTREAM FROM WHERE CONSTRICTION BEGINS.

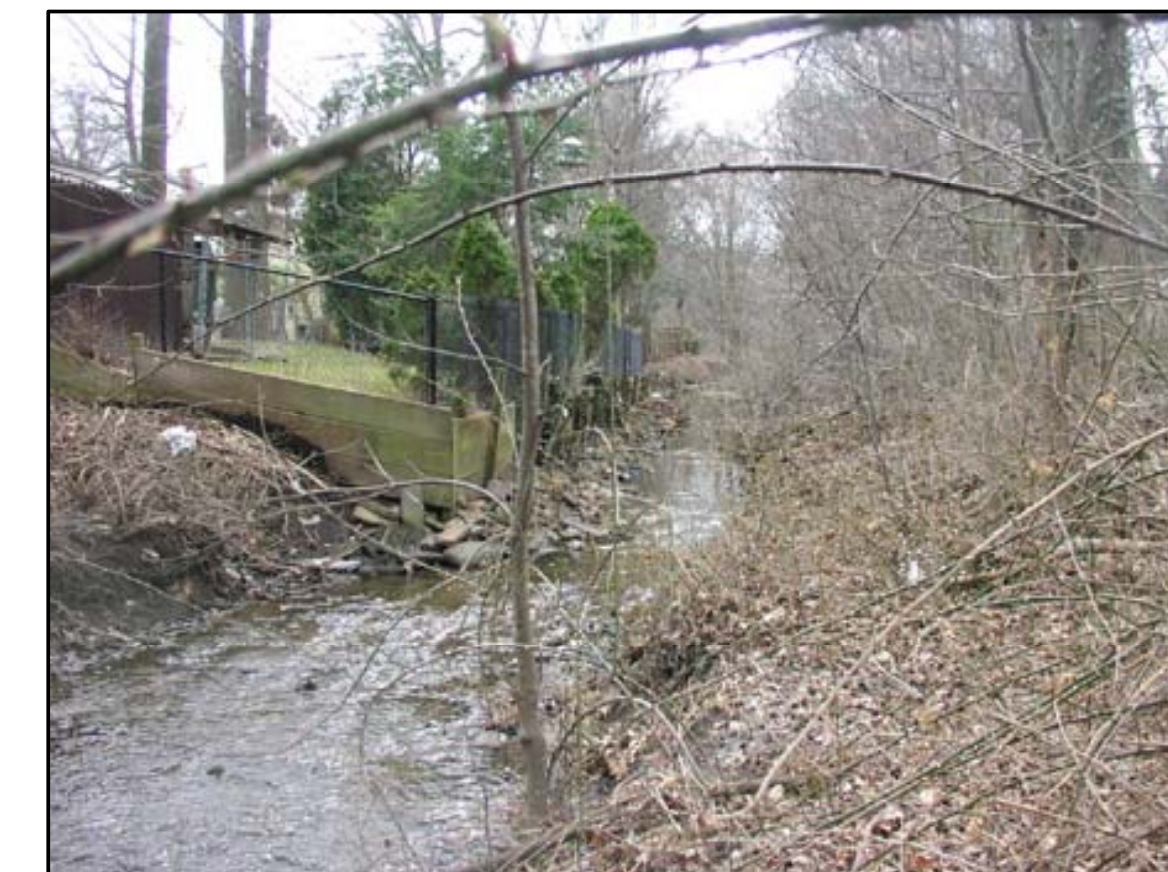
1. THE MAP ABOVE SHOWS THE LOCAL STREAMS, WHERE IT BECOMES CONSTRICTED AND WHERE FLOODING OCCURS DUE TO THIS CONSTRICTION.
2. THE CONSTRICTION BEGINS WHERE STERLING STREET DEAD ENDS AT THE STREAM BANK. THE CONSTRICTION BEGINS AS THE OCCASIONAL BUILT UP BACK YARD (SEE PICTURE 3) TO A RESIDENT OF WALD STREET BUT IT QUICKLY PROGRESSES INTO A 2 FOOT WIDE CONCRETE CHANNEL (SEE PICTURE 4). THIS CHANNEL PROVIDES VERY LITTLE ROOM FOR INCREASE FLOW DURING THE STORMS. IT IS THE UNDERSTANDING OF RUTGERS UNIVERSITY THAT THIS CONSTRICTION FORCES THE WATER TO BACK UP TO THE END OF THE CONSTRICTION BEHIND WALD STREET AND FLOOD WALD ST DURING HEAVY RAIN STORMS.

PICTURE 3: CONSTRICTION OF THE STREAM BEGINS HERE AND INCREASES DOWN STREAM.

4. THE BEST SOLUTION TO THIS PROBLEM WOULD BE TO RELAX THE CONSTRICTION OF THE STREAM AROUND 497 LELAND AVENUE. UNFORTUNATELY, THIS WOULD MOSTLY LIKELY MEAN THAT THE MUNICIPALITY WOULD HAVE TO BUY EASEMENTS OR WHOLE PROPERTIES FROM RESIDENTS LIVING THERE NOW.

7. A LAND AQUISTION ACTION MAY BE REQUIRED ON THE PART OF THE MUNICIPALITY OR COUNTY TO WIDEN THE STREAM TO MEET RUNOFF CAPACITY.

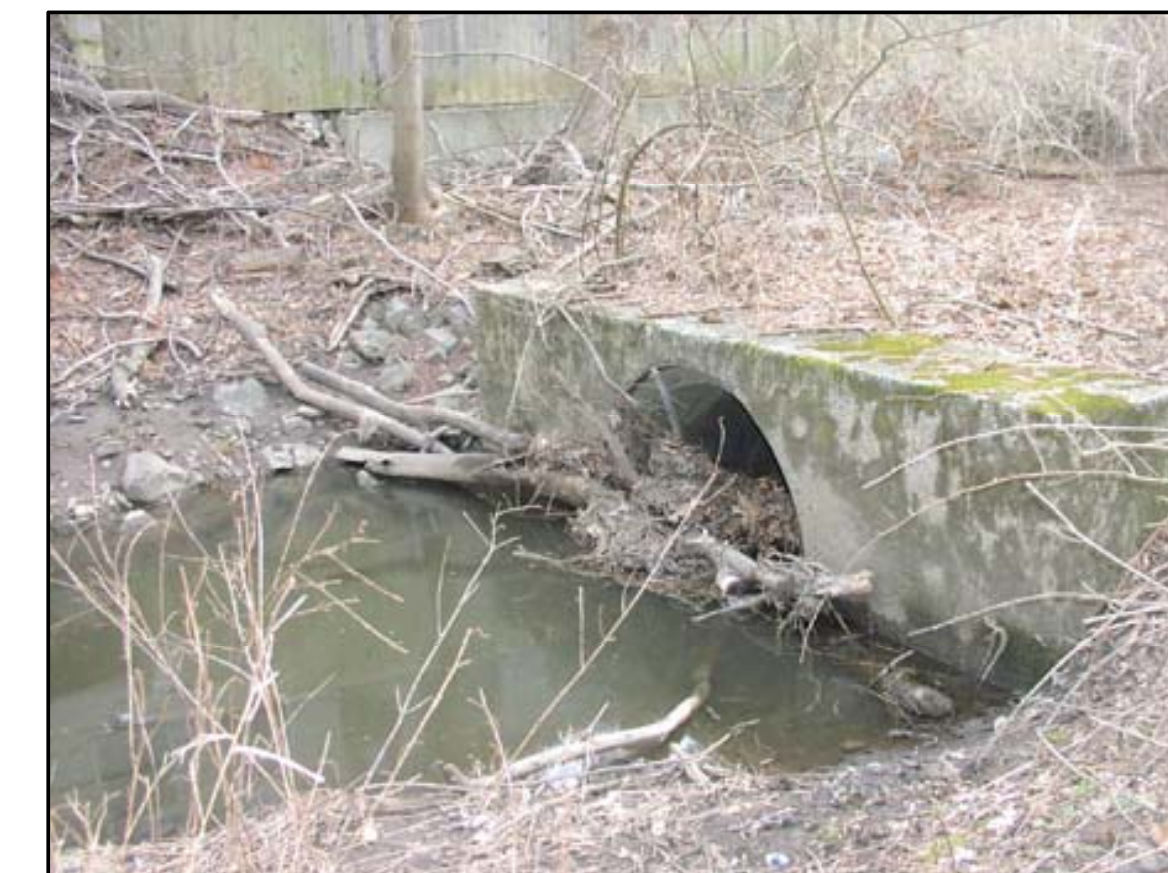
3. STORMWATER IS COLLECTED FROM THE WETLAND NORTH OF THE FLOODING AND THE SURROUNDING NEIGHBORHOODS. IT IS COLLECTED INTO THE STORMWATER SEWER SYSTEM AND PIPED INTO THE STREAM SHOWN ABOVE. PICTURE 2 SHOWS THE STORMWATER OUTFALL STRUCTURE THAT DEPOSITS THE STORMWATER FROM THE SURROUNDING NEIGHBORHOOD TO THE STREAM. IN THE INLET OF THE STRUCTURE IS OBSTRUCTED BY DEBRIS. THIS SLOWS THE FLOW FROM THE WETLAND, REDUCING THE FLOOD AT THIS POINT IS REDUCING THE FLOODING DOWNSTREAM AT WALD STREET.

PICTURE 2: OBSTRUCTED INLET, REDUCES THE FLOW ENTERIN THE CONSTRICTED AREA.

2. MUNICIPALITY NEEDS TO MAP OUT THE STORMWATER SEWER SYSTEM THAT FEEDS INTO THIS STREAM. FROM OUT SITE VISITS THE STORMWATER STRUCTURE IN PICTURE IS OBVIOUSLY CONNECTED TO A GREATER SYSTEM BUT IT IS UNCLER AT THIS POINT HOW EXTENSIVE THIS SYSTEM IS.

6. PICTURE TWO SHOWS AN OBSTRUCTED INLET FOR THE STREAM. IT IS RECOMMENDED THAT THIS OBSTRUCTION BECOME PERMANENT. THE MUNICIPALITY SHOULD REDUCE THE SIZE OF THE INLET TO ENSURE THERE IS A REDUCED FLOW COMING FROM UPSTREAM TO HELP REDUCE TO PREVENT AN INCREASE IN FLOODING WALD STREET.

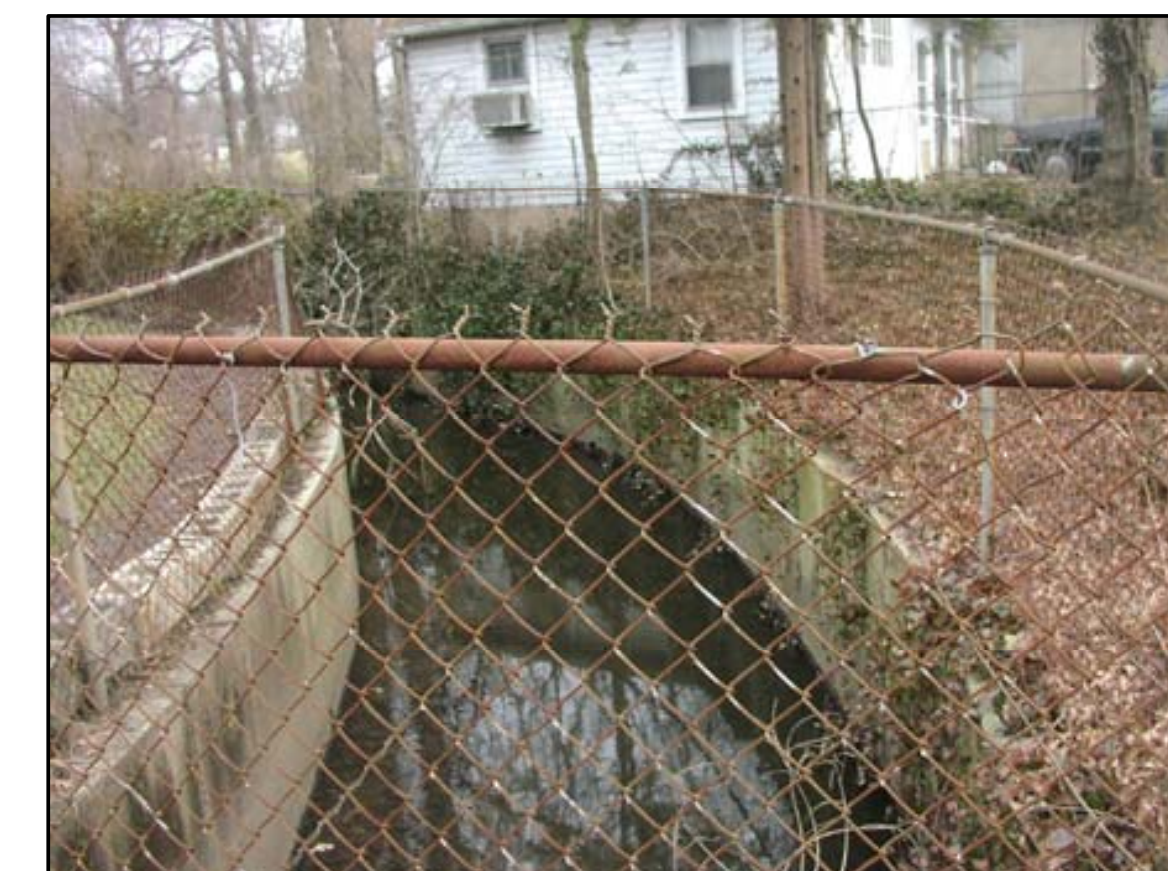
PICTURE 4: STREAM IS CONSTRICTED TO A 2 FOOT WIDE CONCRETE CHANNEL.
