# Assessing Your Stormwater Infrastructure

Rutgers Cooperative Extension (RCE) Water Resources Program

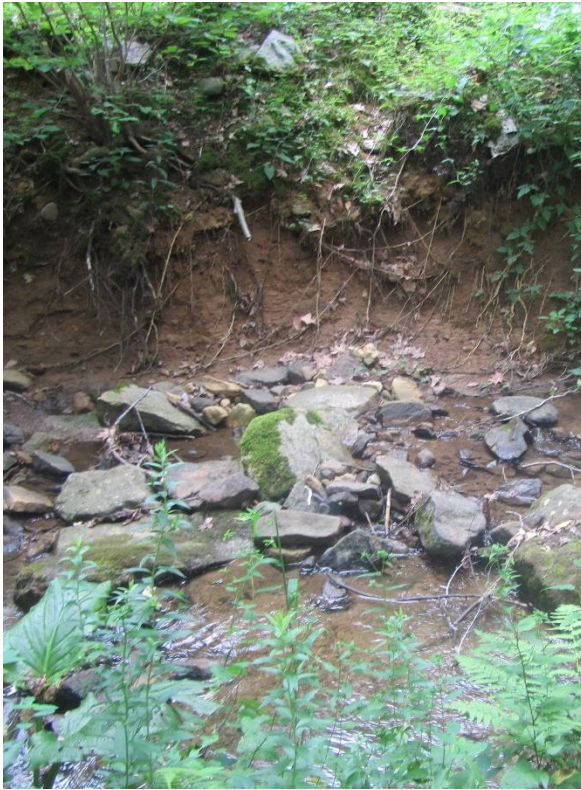
Embankment  
Destabilization

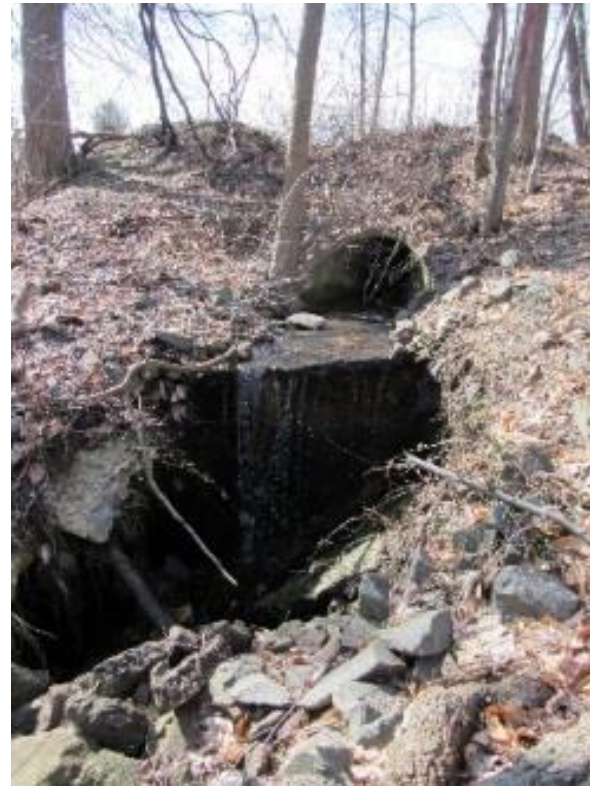
Outlet Destabilization

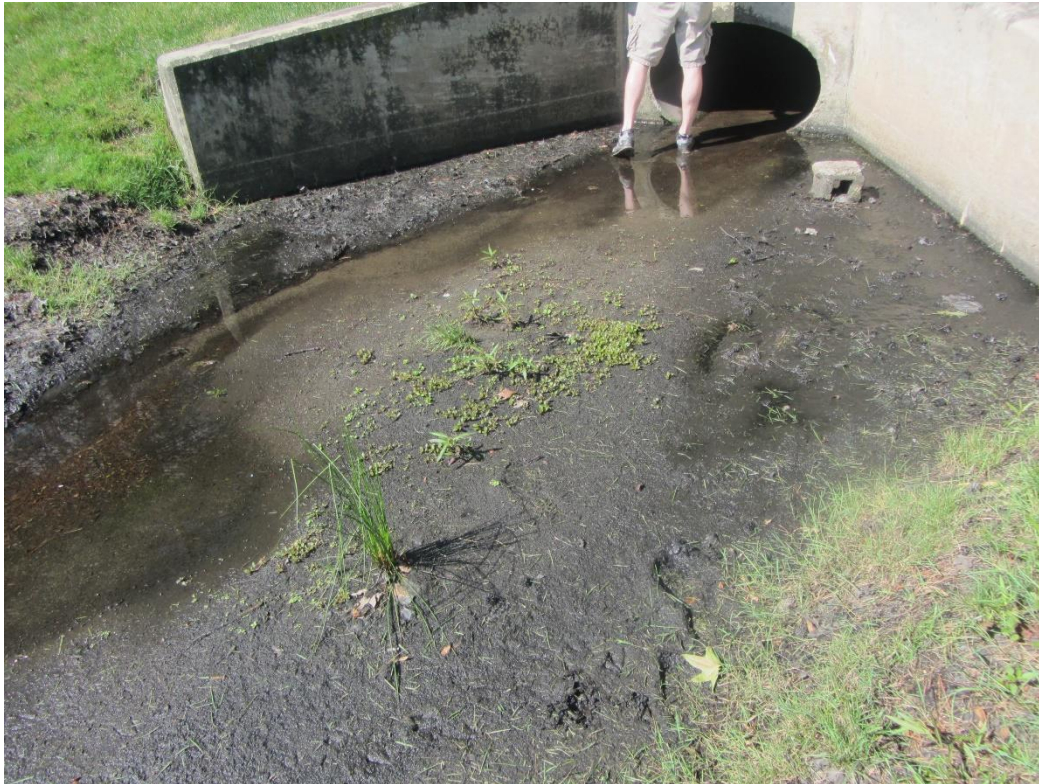
Accumulation of sediment in basin

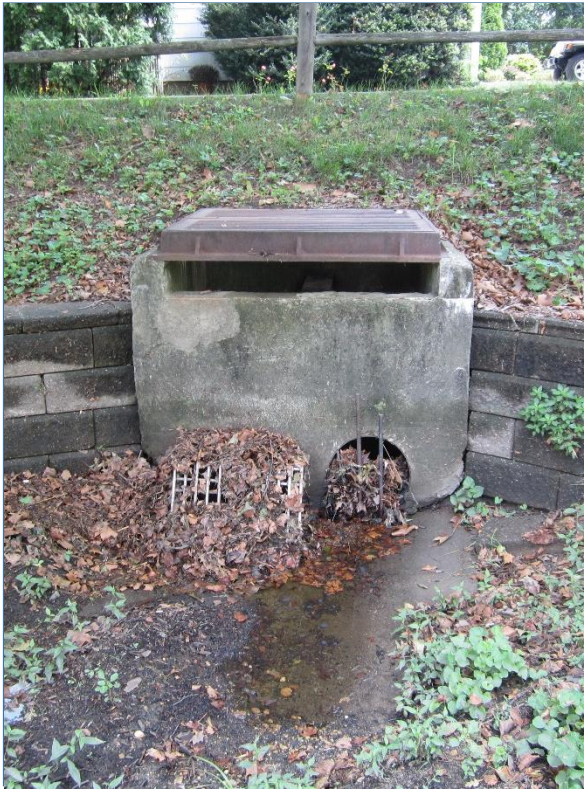
Outlet blockage by  
debris

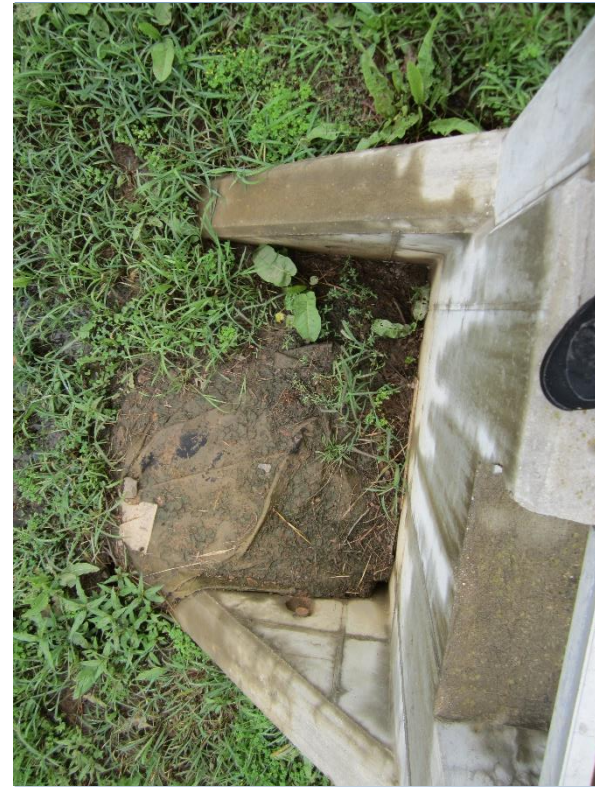
Outlet blockage by  
sediment

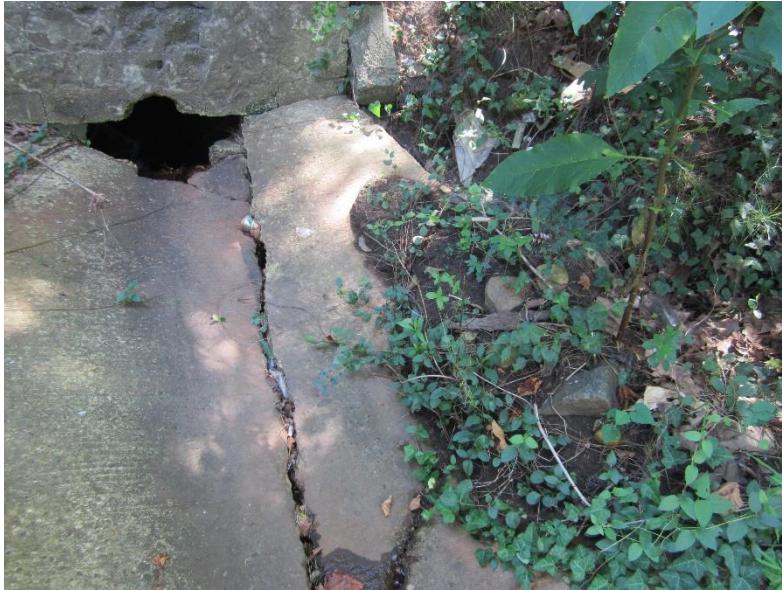
Broken low-flow  
channel

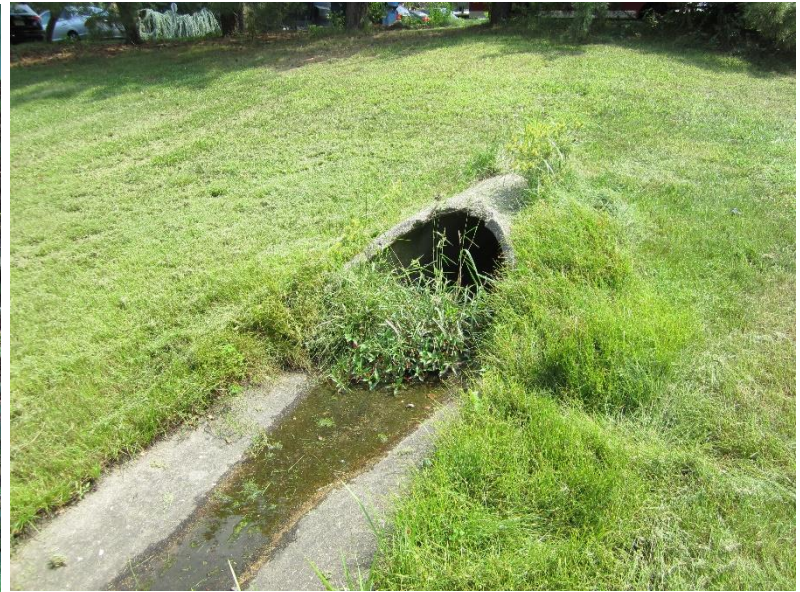
Clogged low-flow  
channel

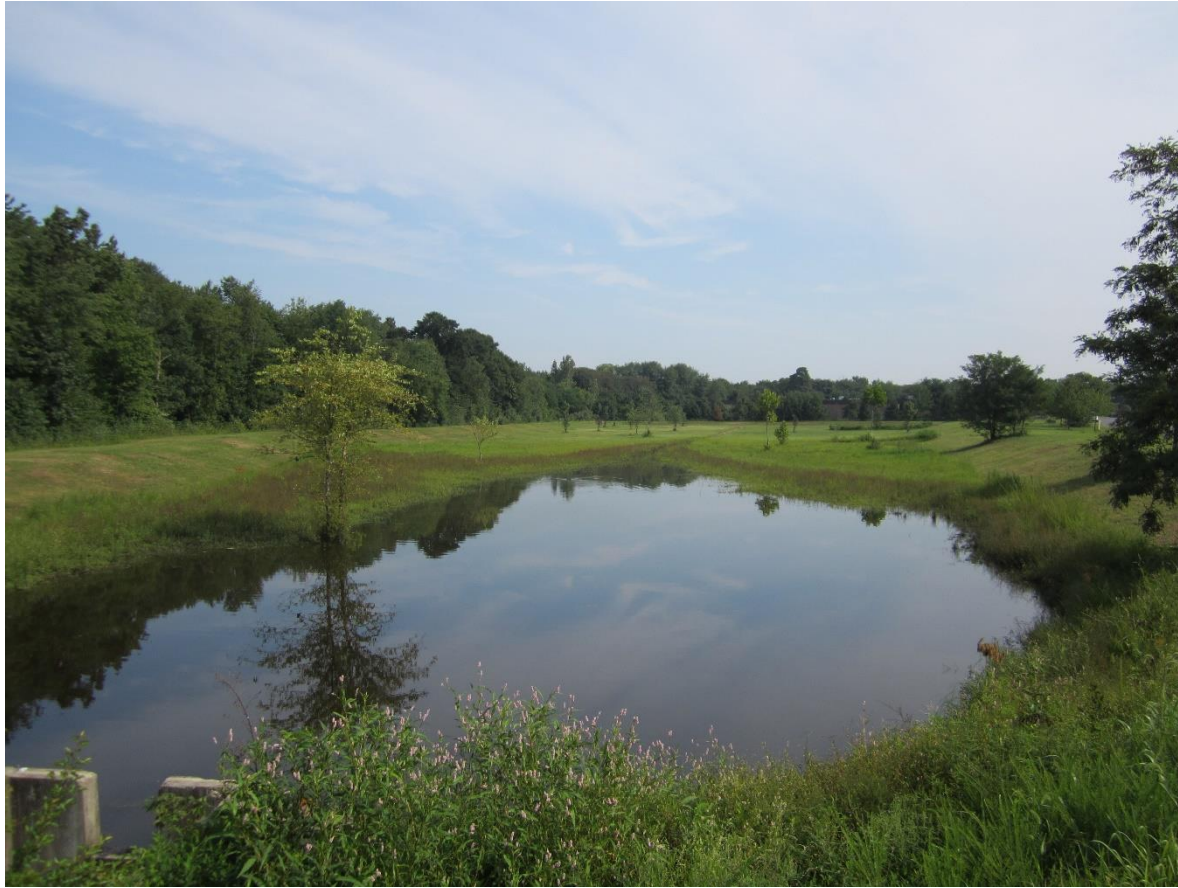
Standing water in detention basin

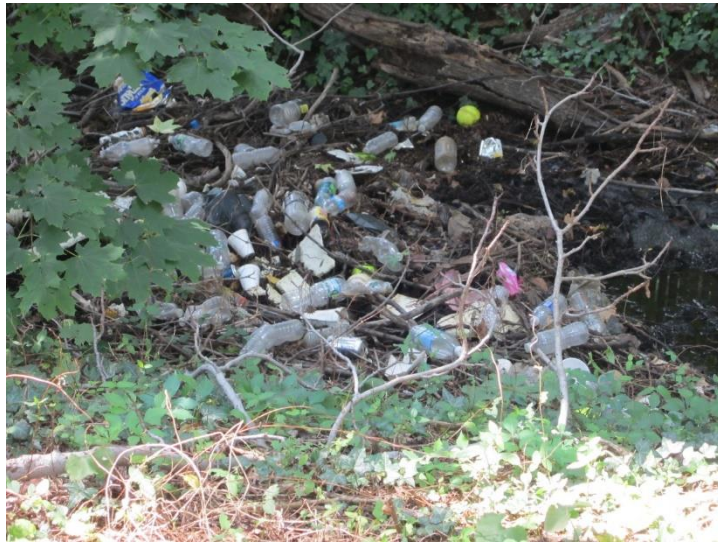
Accumulation of floatables in basin

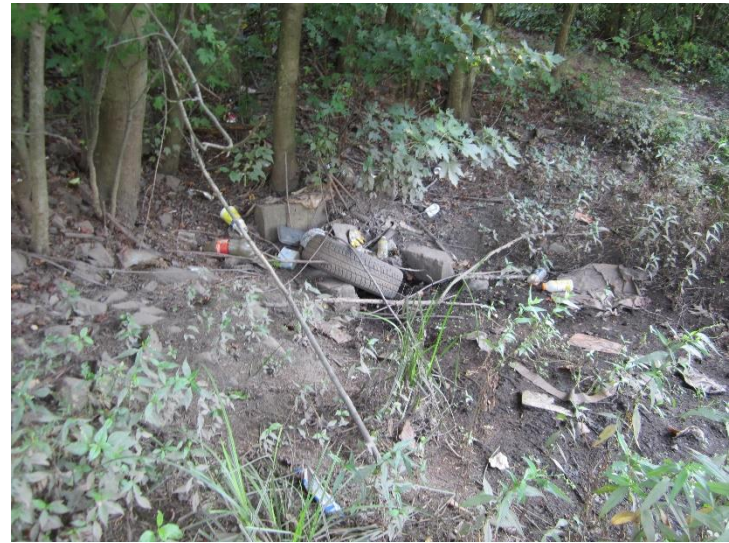
Basin is a dumping ground

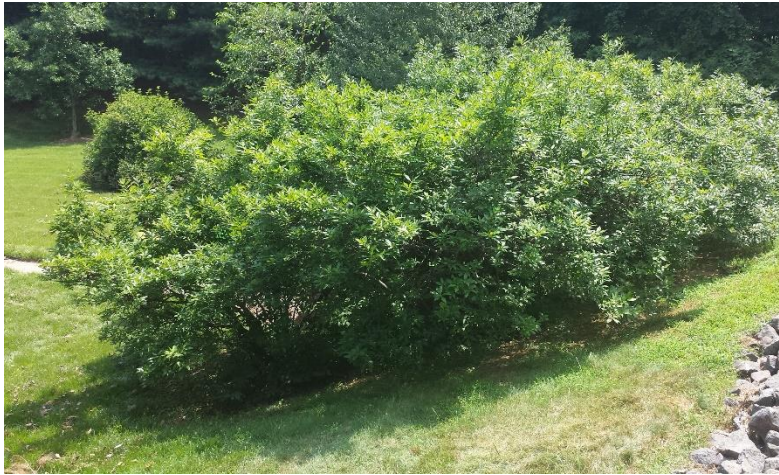
Woody vegetation in  
basin

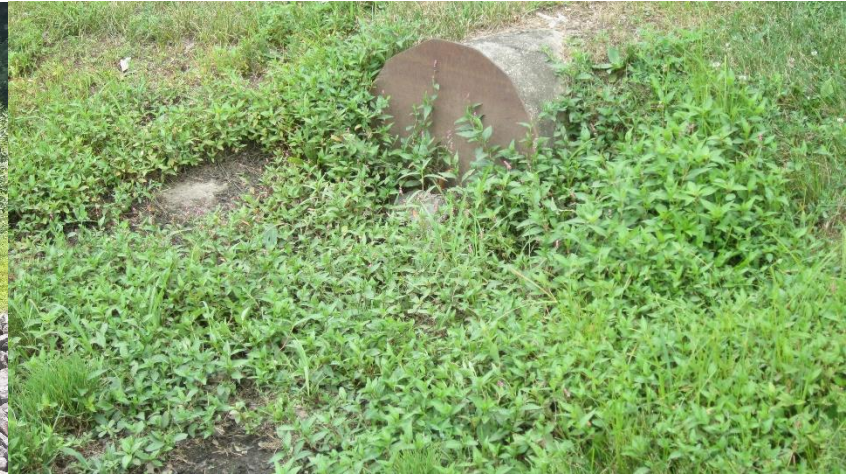
Invasive species have  
overtaken the basin

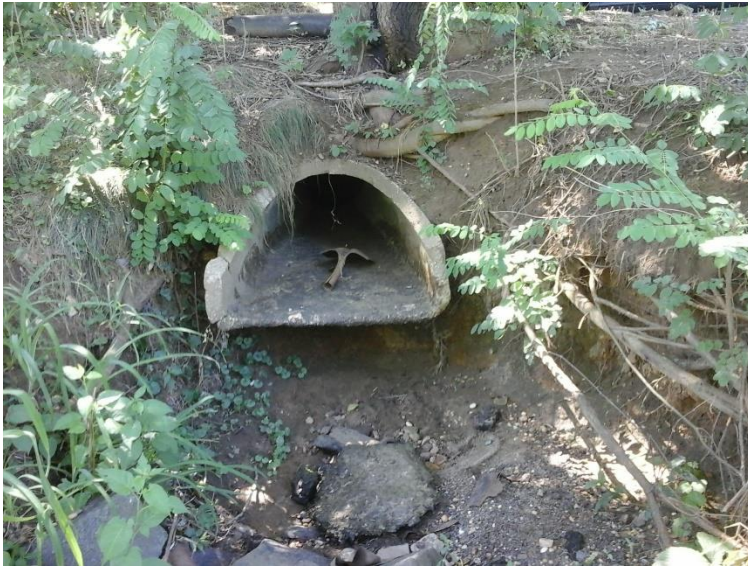
Outfall is causing erosion

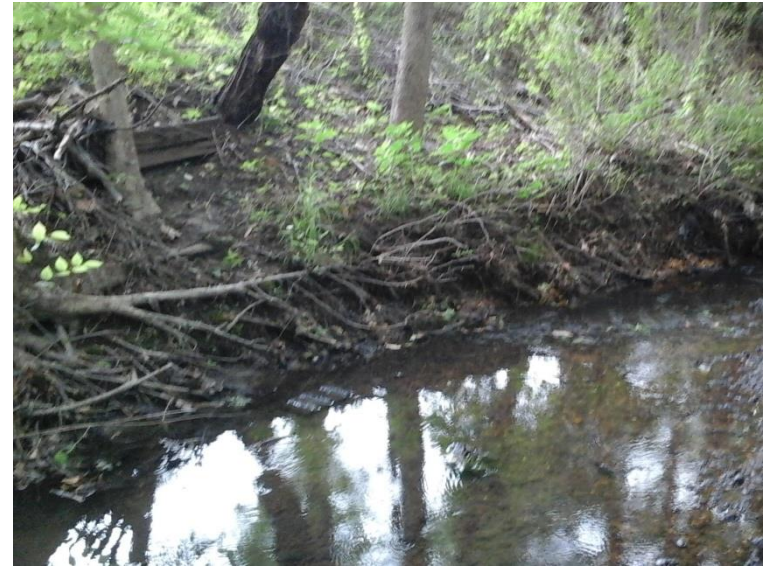
Outfall is causing scouring

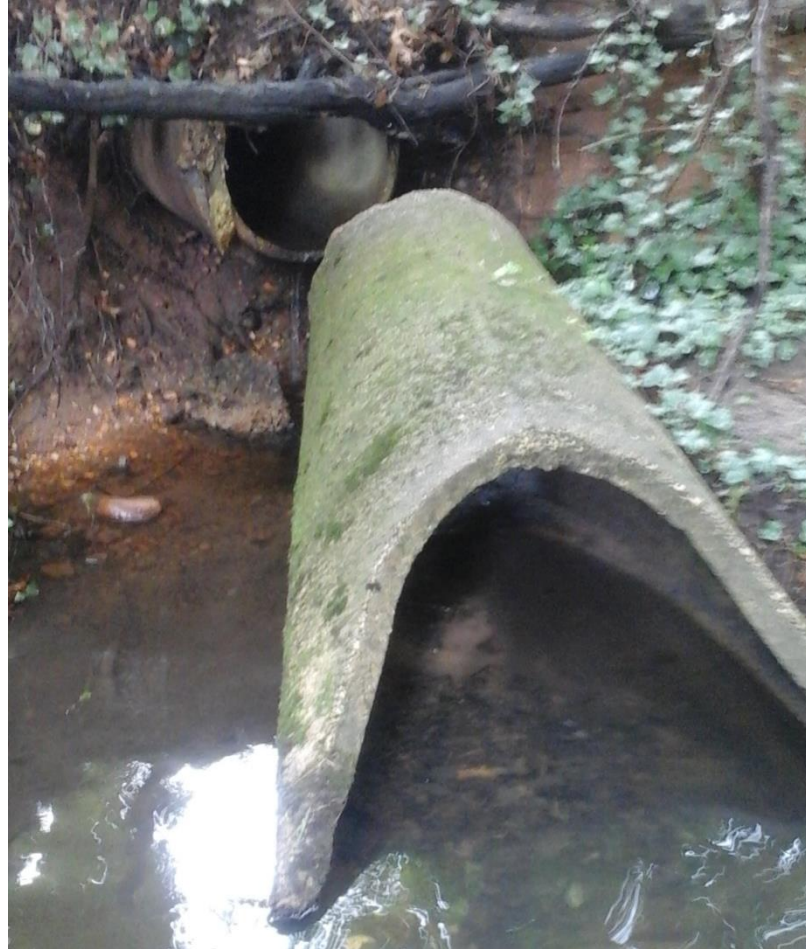
Crumbling concrete outfall pipe or pipe sections falling into stream

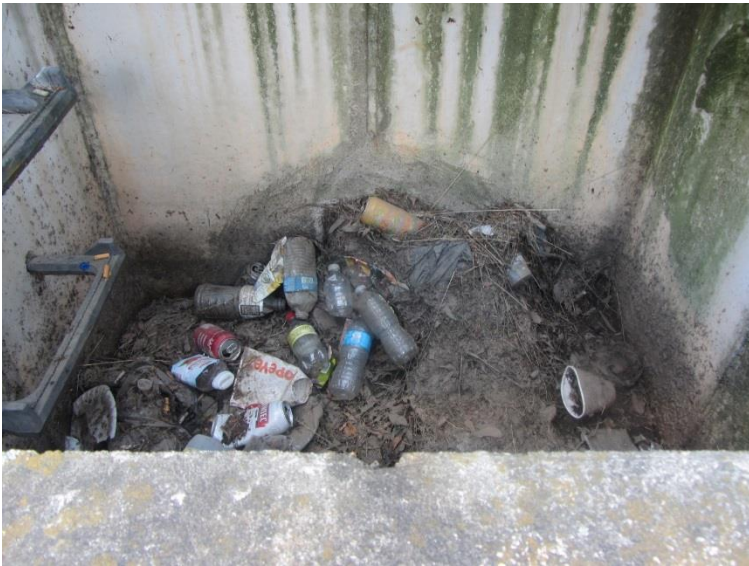
Accumulation of floatables from outfall

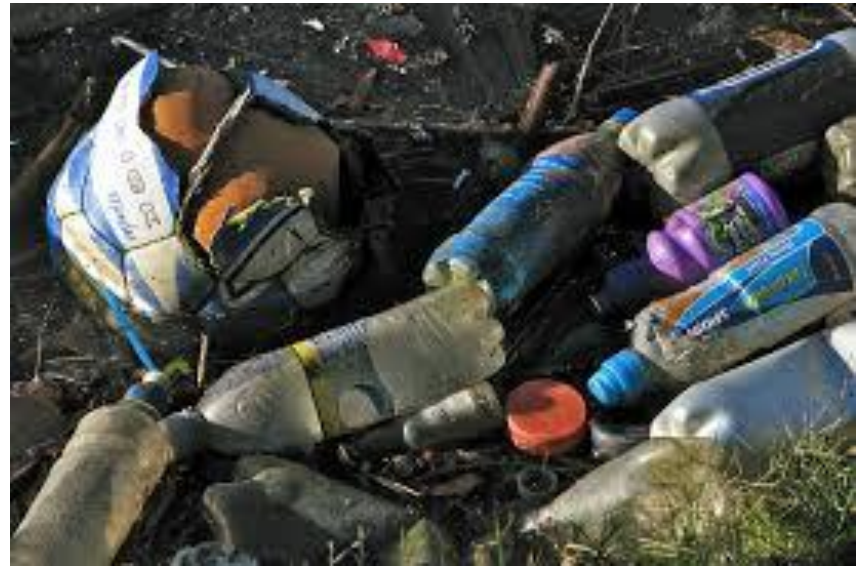
Garbage in the stream

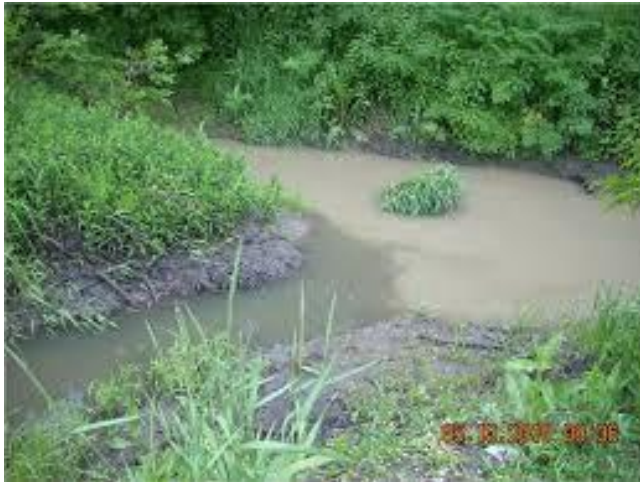
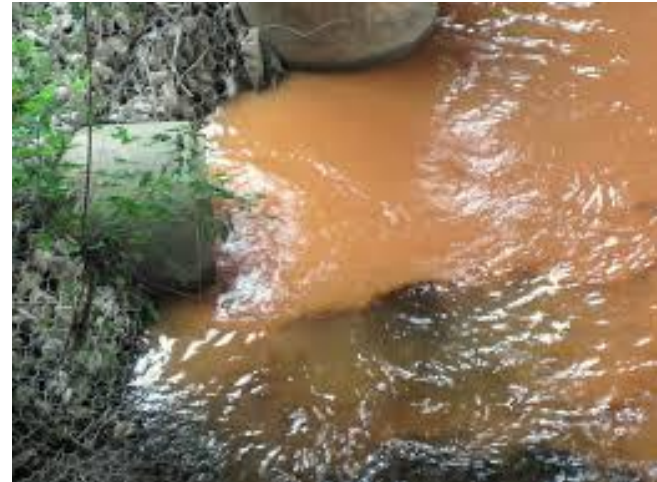
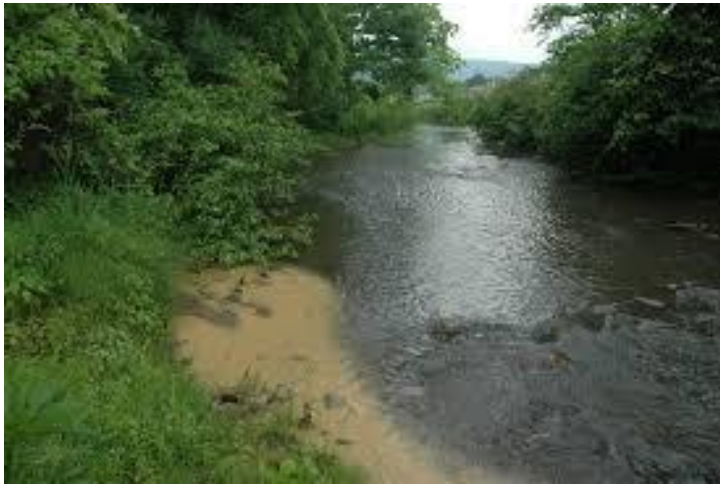
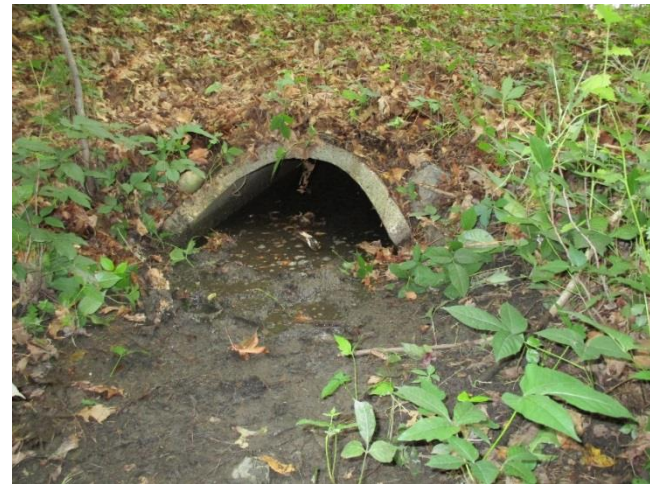
Outfall pipes can discharge excessive sediment into the local waterway

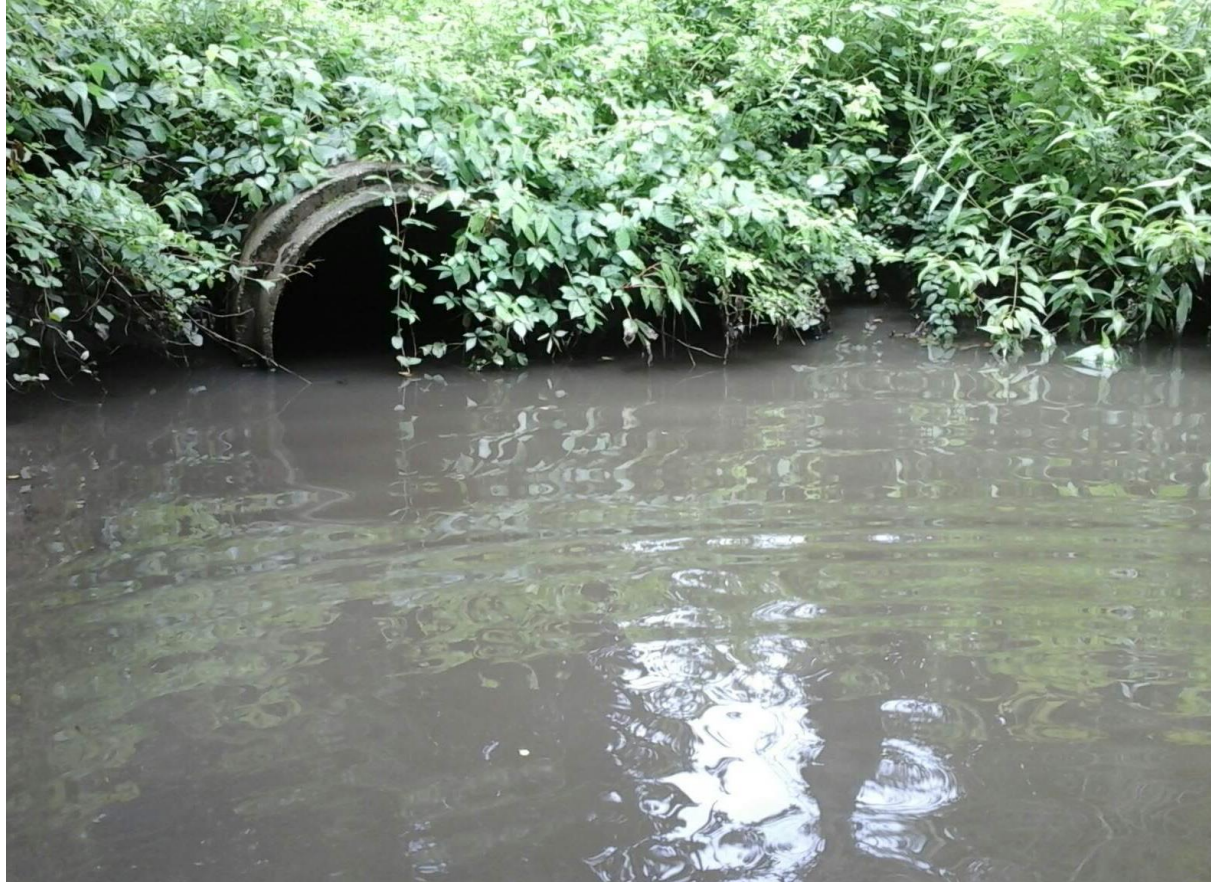
Stormwater seems very cloudy – could be a cross connection with sanitary sewer pipe

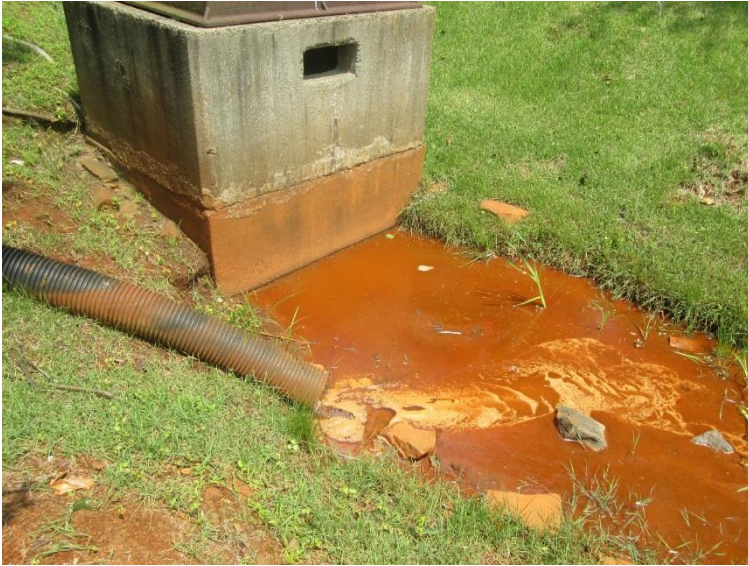
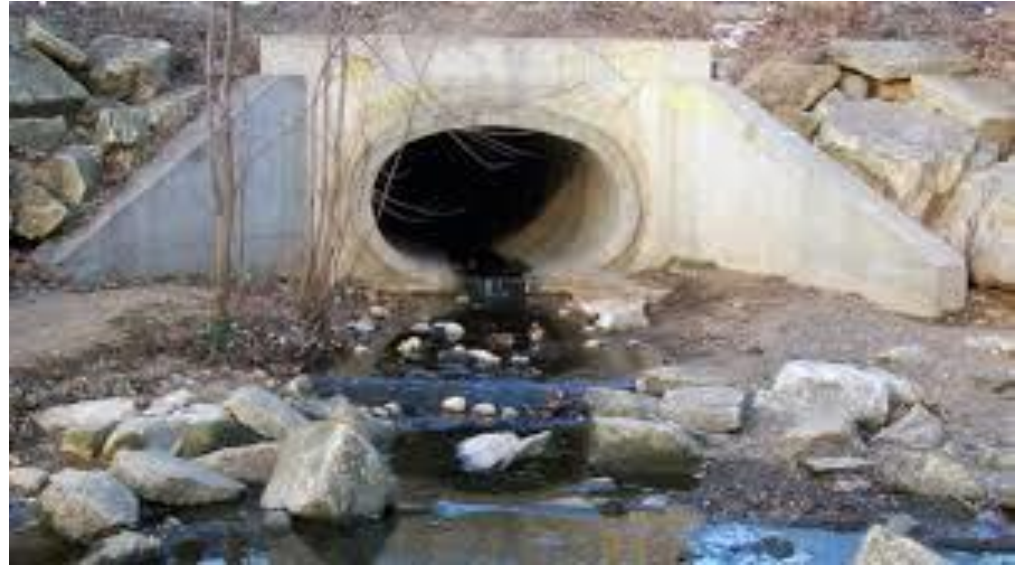
Could be an illicit connection – water quality testing should be done

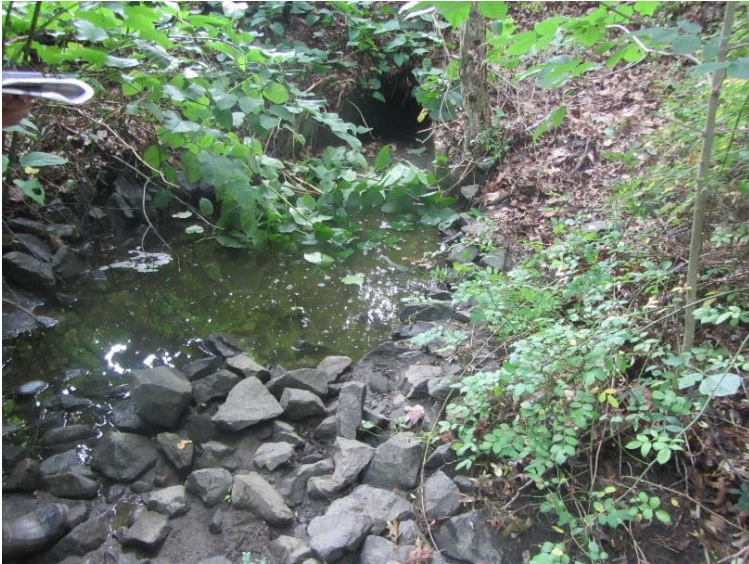
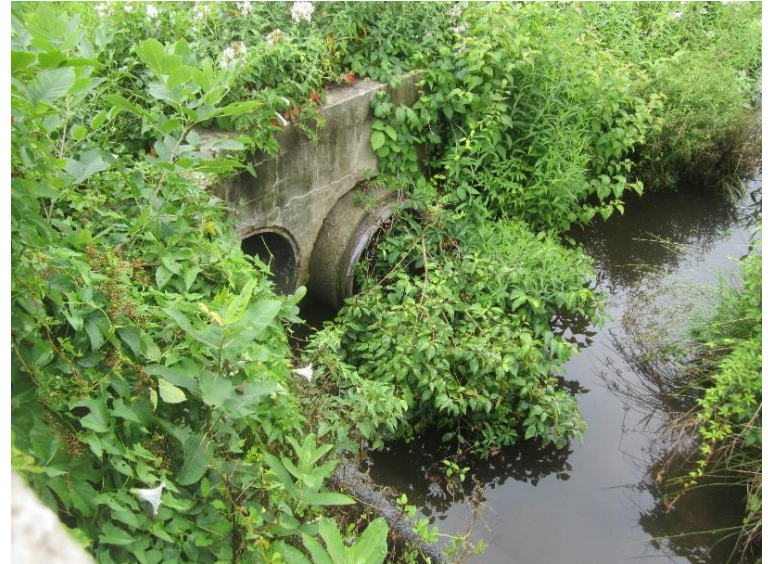
Outfall capacity is limited due to overgrowth of vegetation

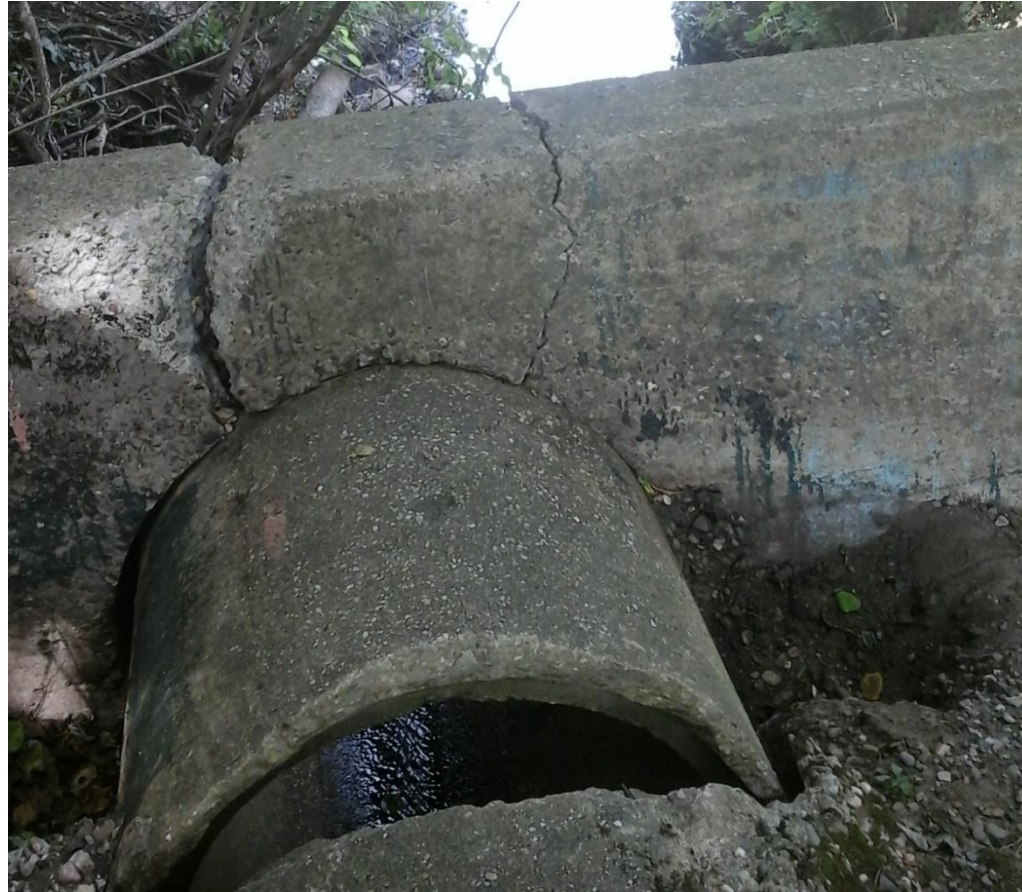
Concrete headwall is crumbling
