# Oldmans Creek Watershed Restoration and Protection Plan

Rutgers New Jersey Agricultural Experiment Station  
Cooperative Extension  
Water Resources Program

**September 2009**

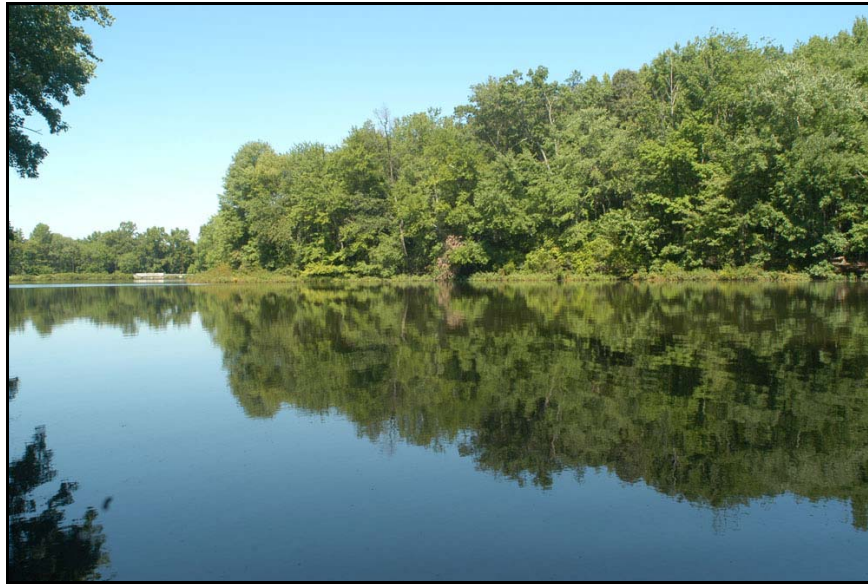
**Figure 6: Algonkin Lake**  
Photo Credit: Mike Hogan

Invasive species such as Japanese stiltgrass have been noted as being present during the SVAP evaluation at Algonkin Lake. Invasive species have the potential to destroy healthy ecosystems and create a mono-culture that eliminates biodiversity. Notoriously difficult to combat, parks departments or volunteer organizations can create long term plans to address this issue.

Two impoundments are located in the upper portions of the watershed. Algonkin Lake (12 acres) is found in the upper most HUC14 (02040202160010) between Upper Pittsgrove in Salem County and South Harrison in Gloucester County. Harrisonville Lake (18 acres) is found in the central portion of the next downstream HUC14 (02040202160020) between South Harrison in Gloucester and Pilesgrove Township in Salem County. Many other small impoundments are found along the tributaries and the main stem of the Oldmans Creek. The main stem of the creek experiences tidal fluctuations to a point just upstream of where the New Jersey Turnpike crosses over the Creek, in the area of Rainey Run in Woolwich Township. The lower watershed contains a large area of wetland/freshwater tidal marsh known locally as the Pedricktown Marsh. This marsh has been noted for being an important stopover site for migratory waterfowl.

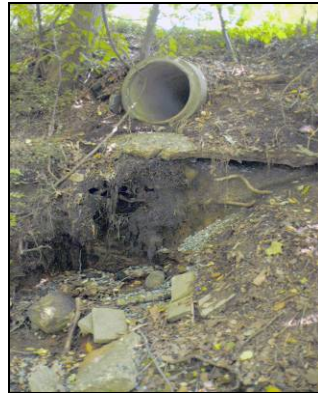
**Figure 7: Erosion under outfall**

The next tributary in South Harrison HUC02, named Oldmans, is located northwest of Lincoln Stream and joins the mainstem just above Harrisonville Lake. This tributary is the earliest classification of C1 stream. The drainage area consists primarily of agricultural lands, with significant buffers (300 feet or greater) in the upper reach, somewhat adequate (150 to 200 feet) buffers in the lower reach and areas of minimal buffer (less than 50 feet) in the center between Monroeville and Lincoln Mill Roads and west of Monroeville. This C1 classified tributary achieved an overall SVAP score of 8.4, but displayed aging stormwater infrastructure (Figure 7).

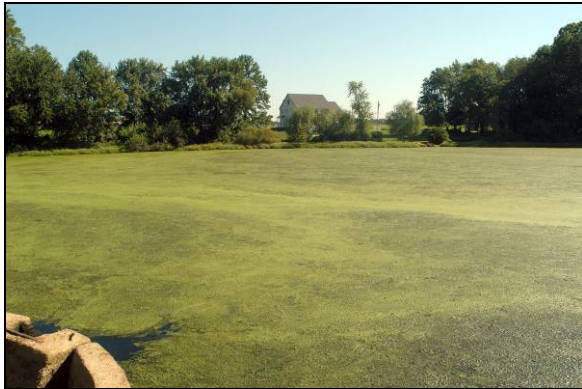
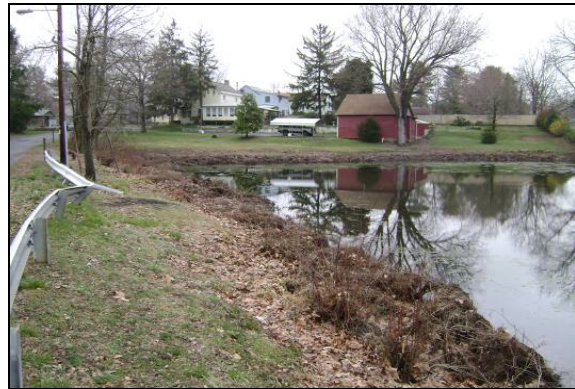
**Figure 8: Harrisonville Lake**

The main stem of this Category 1 stream passes through a State owned open space containing Harrisonville Lake. Harrisonville Lake often exhibits algal growth thereby increasing concerns for the eutrophication of a resource to this community. Land use in the Harrisonville Lake Road area appears to contain minimal buffers that may be being short circuited by pipes directly draining to the lake. The dam has recently been restored, but residents have reported that these repairs appear inadequate and that the dam continues to show signs of leakage. The downstream side of the dam is a hard structure, which may have been deemed necessary for stability but provides no pollutant filtering capacity for overland flow to the stream.

A lake management plan is recommended that will consider all drainage connections to lake (020SHR04). Residential land that borders Harrisonville Lake on Harrisonville Lake Road may be maintaining lakeside property that is within the State owned open space land and mowing to the edge of the lake. This soil should be properly secured with a buffer, estimated to be 120 linear feet along the shoreline. Another three residences on the shoreline of the Harrisonville Lake may also share the shoreline with the state owned open space, and should be encouraged to stabilize shoreline soil and enhance a vegetative buffer. Approximately 250 linear feet (020SHR07 and 020SHR08) of enhanced buffer system would improve the quality of runoff from these areas.

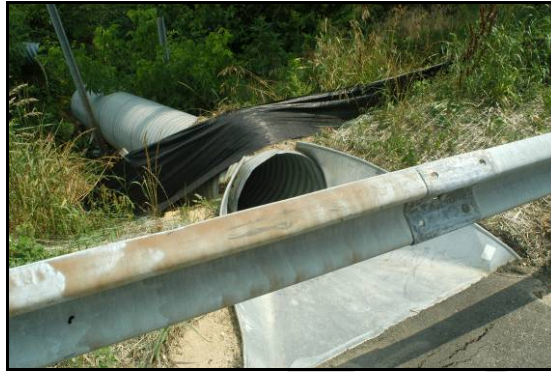
**Figure 9: Stormwater conduit on Marl Run**

Several stormwater infrastructure facilities have been identified as having the need for an appropriate upgrade. (Figure 9). Stormwater runoff from some roads is routed through large pipes directly to the stream. The lack of proper catch basins allows large floatables direct access to the stream.

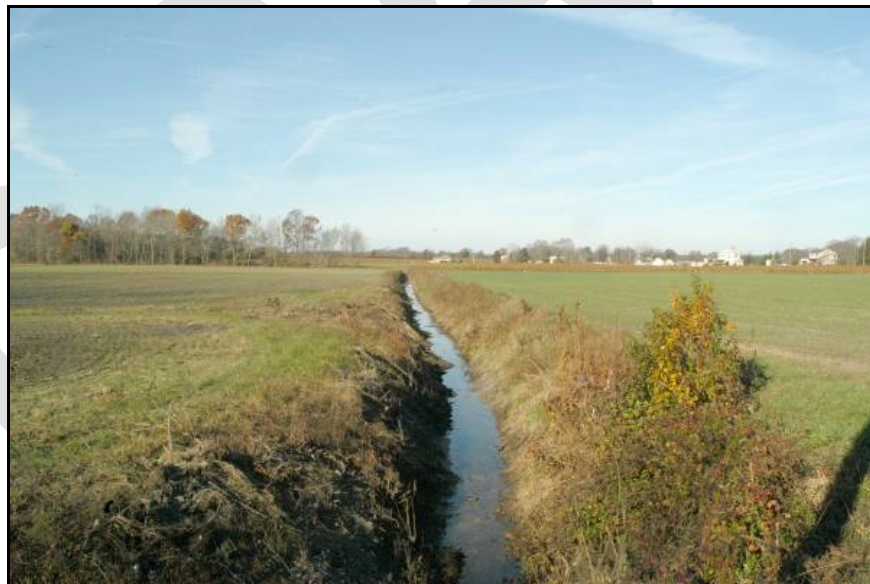
**Figure 10: Unbuffered stream**  
Photo Credit: Mike Hogan

Below Route 643, the stream flows through large agricultural fields without riparian buffers (Figure 10). The stream appears to have been straightened and is deeply incised. Aquatic life appears to be impaired and moderate algae was seen on stream substrates.

This area to the west of Straughens Mill Road (643) would greatly benefit by installing riparian buffers along the streams that flow through the farm fields. Stream buffer installation projects have been identified in recommendations 040OLD08 through 040OLD13. Two online impoundments also receive unbuffered drainage from agricultural lands. The water quality of

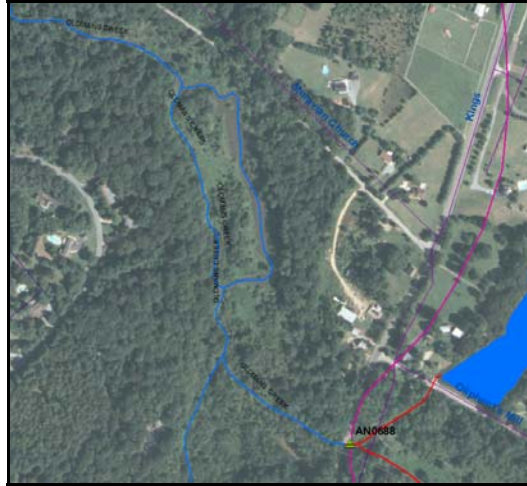
Figure 11: Stream division at Monrovia Church Road

Upon entering this HUC, the stream has been divided (downstream of Kings Highway, behind Monrovia Church Road, Woolwich) for approximately 1,000 feet (Figure 11).

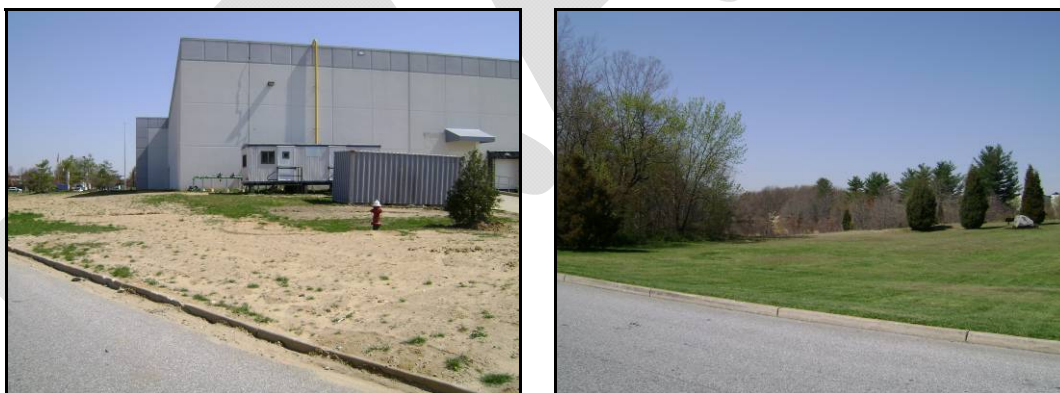
**Figure 12: Commercial Sites for BMP installation**  
(Photo Credits: Greg Rusciano)

The presence of industrial parks in close proximity to the stream also raises the potential for disconnection and infiltration projects. Businesses between Center Square Road and 295 and around Heron Drive (i.e., Pureland) can be evaluated for disconnection opportunities on this site and also for the presence of geese populations on expansive lawns that may contribute to the pathogen contamination of the waters. Businesses along Technology Drive also have opportunities to increase the riparian buffers off the back of their parking lots. (See projects 050LOG03, 04 and 05)

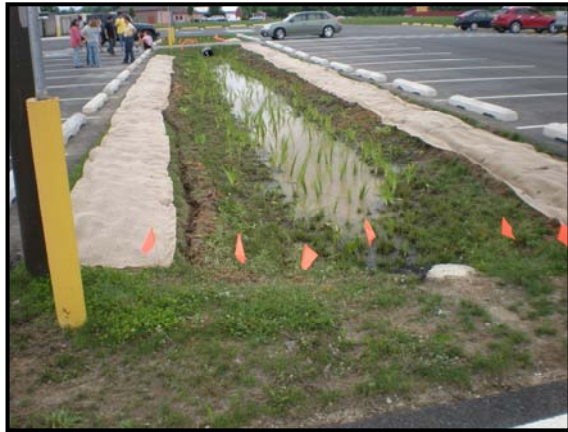
**Goal:** The goal of this project was to retrofit this piece of stormwater infrastructure by enhancing it with native vegetation that would increase the infiltration properties of the swale, as well as create wildlife habitat. The use of native vegetation would also negate the need for regular mowing, saving the time and fuel of the maintenance crew.

**Situation:** South Harrison Elementary School is located on Mullica Hill Road in South Harrison, New Jersey. Stormwater runoff from the impervious areas of the school's property was being diverted to a long depression in the middle of the parking lot. This depression was planted with turf grass and was regularly mowed. The lower portions of this swale were devoid of vegetation and often had standing water at the base. This site also presented an ideal environmental educational component for the students in this school.

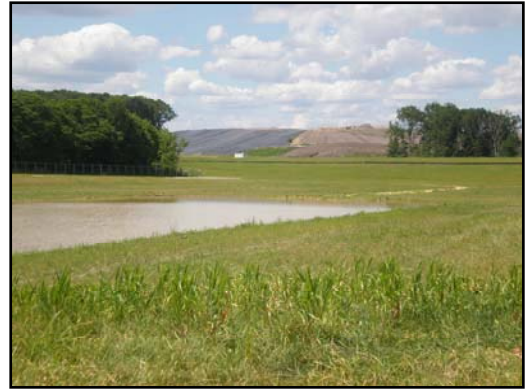
**Situation:** The Gloucester County Solid Waste Complex is a sanitary landfill located on a 540-acre tract of land. Portions of this landfill site are set aside for grassland bird habitat and stormwater management. A 36-acre stormwater basin on this site was identified as an area that could be retrofitted to improve stormwater infiltration and wildlife habitat. This basin was planted with cool season grasses and mowed regularly. It also included a 1.6 acre wet pond situated before the outlet. This basin attracted nuisance wildlife, such as the Canada goose, thereby increasing the sources of bacteria in the Oldman's Creek Watershed. The soil was found to be highly compacted and therefore infiltrated stormwater runoff at a low rate.

**Goal:** The goal of this project was to create a naturalized area using native vegetation that would promote increased infiltration for the recharge of the groundwater. Additional goals included the creation of vital habitat for ground nesting birds that have lost habitat to increased development, as well as discouraging nuisance wildlife such as the Canada goose from taking up residence.

**Action:** The plan for the site included dividing the basin into three distinct sections. The 2000 square foot section surrounding the wet pond was treated as a wetland area and was densely vegetated with obligate wetland species such as fox sedge (*Carex vulpinoidea*) and soft rush (*Juncus effusus*). The buffer around the pond was extended outward with more than 4,000 square feet of additional plantings, including upland species such as lurid sedge (*Carex lurida*), little blue stem (*Schizachyrium scoparium*) and switch grass (*Panicum virgatum*). The third region of this project covered the remainder of the 36 acres. This area was seeded with a special seed mix designed for naturalization of stormwater basins. The seeds were a mix of up to twelve native varieties, including Autumn Bentgrass (*Agrostis perennans*), Partridge Pea (*Chamaecrista fasciculata*), Butterfly Milkweed (*Asclepias tuberosa*) and other species that will blanket the grounds with native meadows.

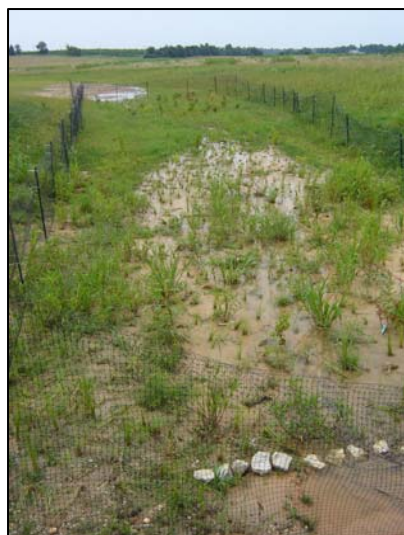
**Action:** The hydrologic activity on this site divided the area into two distinct sections that would support wetland species and upland species.

The wetland species were located closer to the outlet and in the center whereas the upland vegetation was located as the gradient of the land slowly increased away from the center. Native shrubbery such as red osier dogwood, buttonbush and inkberry holly were densely planted at the far end of the outlet area, and herbaceous wetland grasses were planted at location where the high energy of the outflow and the longest duration of wetness would be expected.

**Goal:** The goal of this project is to stabilize the soil in the area where the stormwater basin releases its overflow. The planting of native vegetation will serve to stabilize the soil and filter the overflow, as it serves as a wildlife habitat for ground nesting birds and other small wildlife. Another goal of this project is to reduce the need for regular mowing, saving on time and fuel consumption.

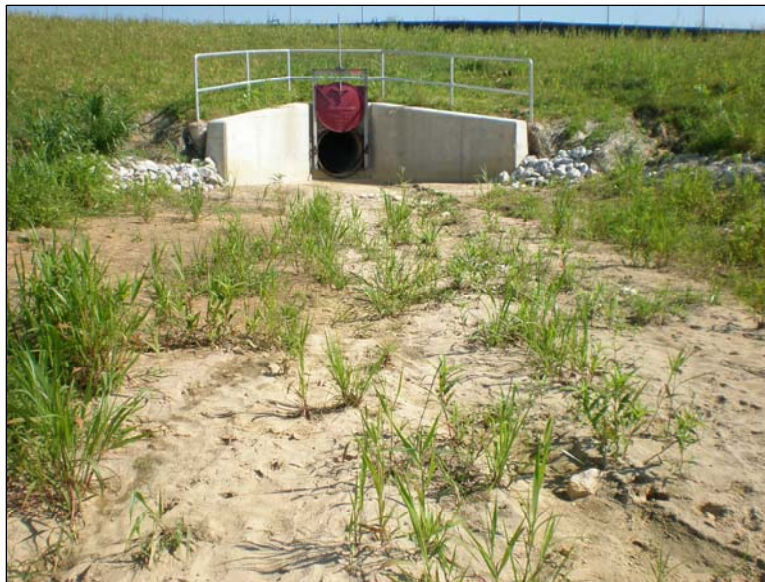
**Impact:** The proper vegetation for the hydrology experienced by this area, as well as the soil types present in this area, are expected to achieve a level of soil stabilization that will serve to keep the soil onsite, and not wash into nearby farm fields. As this vegetation matures, a valuable filter will serve to remove solids emanating from the outfall. Given the location of this outfall area, the dense native vegetation will also serve to continue a large area of wildlife habitat.
