**Impervious Cover Reduction Action Plan
for
Bound Brook Borough, New Jersey**

*Prepared for Bound Brook Borough by the
Rutgers Cooperative Extension Water Resources Program*

September 23, 2015

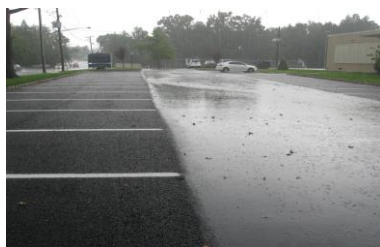
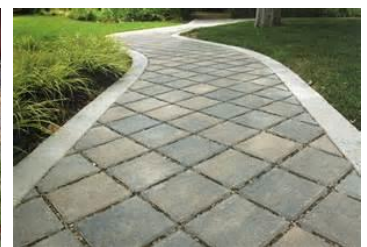
There are several types of permeable pavement systems including porous asphalt, pervious concrete, permeable pavers, and grass pavers. These surfaces are hard and support vehicle traffic but also allow water to infiltrate through the surface. They have an underlying stone layer to store stormwater runoff and allow it to slowly seep into the ground.

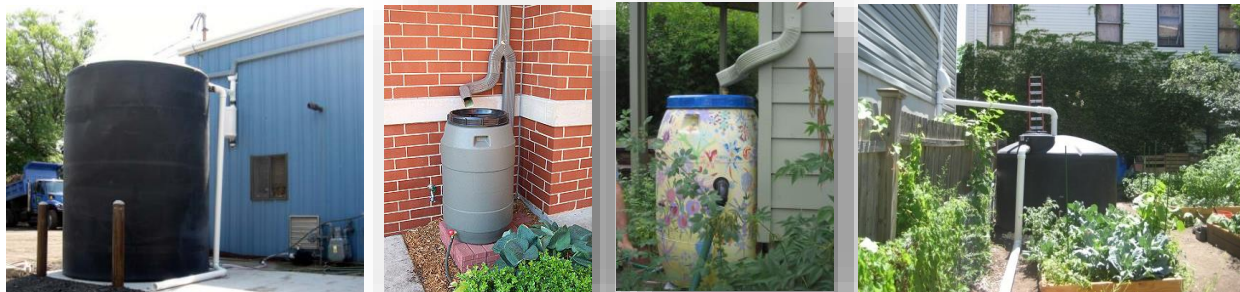
These systems capture rainwater, mainly from rooftops, in cisterns or rain barrels. The water can then be used for watering gardens, washing vehicles, or for other non-potable uses.

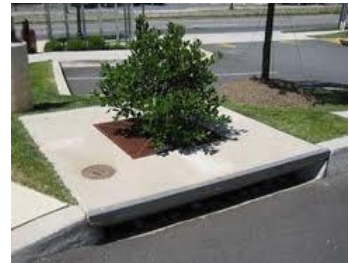
These are pre-manufactured concrete boxes that contain a special soil mix and are planted with a tree or shrub. They filter stormwater runoff but provide little storage capacity. They are typically designed to quickly filter stormwater and then discharge it to the local sewer system.

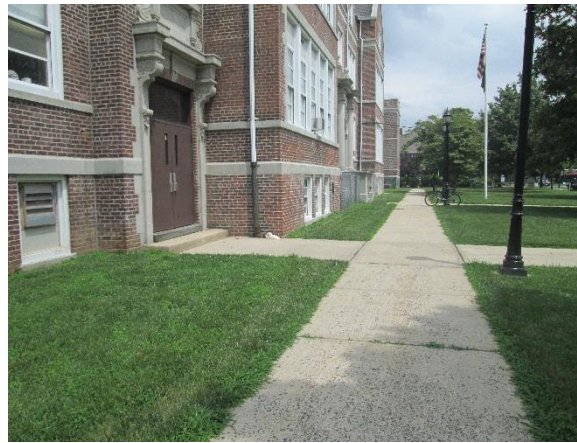
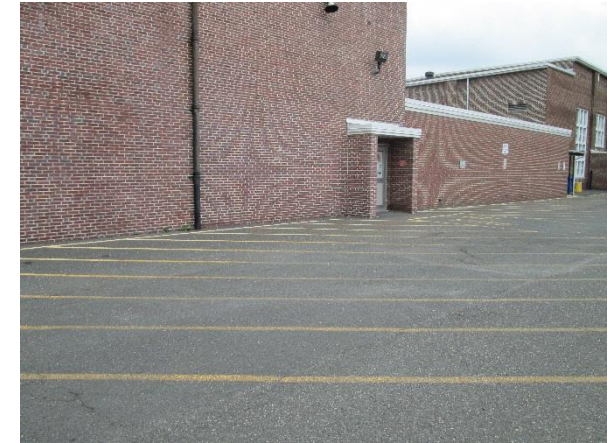
Subwatershed: Green Brook
Site Area: 142,026 sq. ft.
Address: 111 West Union Avenue
Bound Brook, NJ 08805
Block and Lot: Block 76, Lot 7

Parking spaces can be replaced with pervious pavers to infiltrate runoff. Two rain gardens can also capture, treat, and infiltrate runoff and serve as educational sites. Downspout planter boxes and stormwater planters can be used to capture some of the roof runoff. A preliminary soil assessment suggests that the soils have suitable drainage characteristics for green infrastructure.

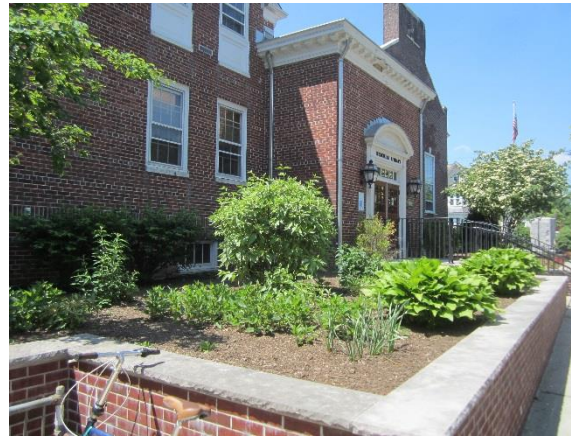
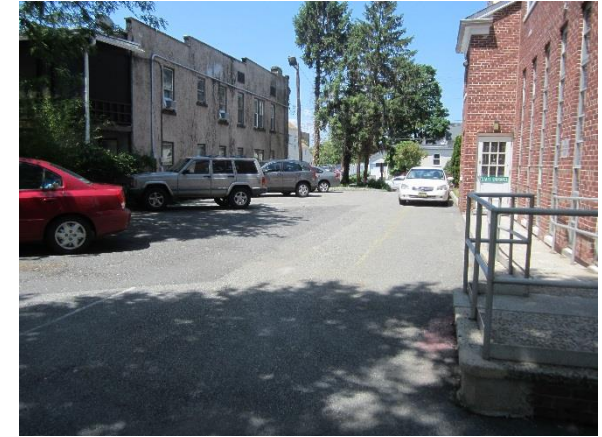
Subwatershed: Green Brook
Site Area: 15,754 sq. ft.
Address: 402 East High Street
Bound Brook, NJ 08805
Block and Lot: Block 12, Lot 14

Four downspouts can be disconnected into rain gardens to capture, treat, and infiltrate roof runoff. A row of parking spaces can be replaced with pervious pavement to infiltrate stormwater. A preliminary soil assessment suggests that the soils have suitable drainage characteristics for green infrastructure.

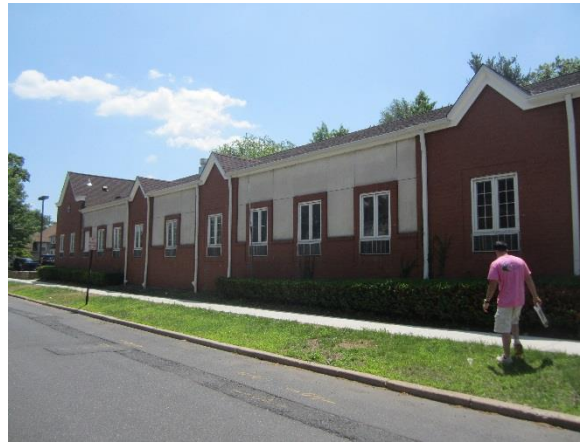
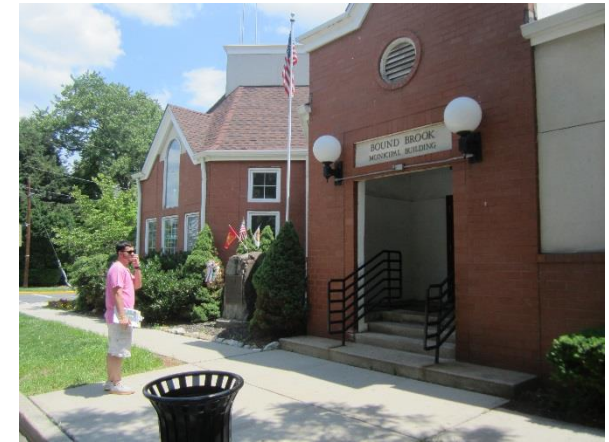
Subwatershed: Green Brook
Site Area: 34,633 sq. ft.
Address: 230 Hamilton Street
Bound Brook, NJ 08805
Block and Lot: Block 52, Lot 1

Parking spaces can be repaved with pervious pavement to infiltrate runoff. Several downspouts can also be disconnected into downspout planter boxes. A preliminary soil assessment suggests that the soils have suitable drainage characteristics for green infrastructure

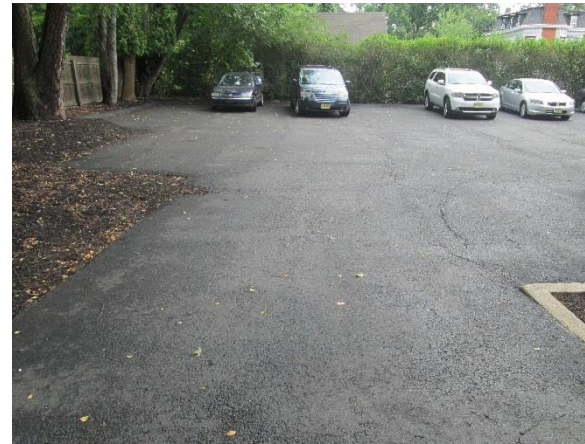
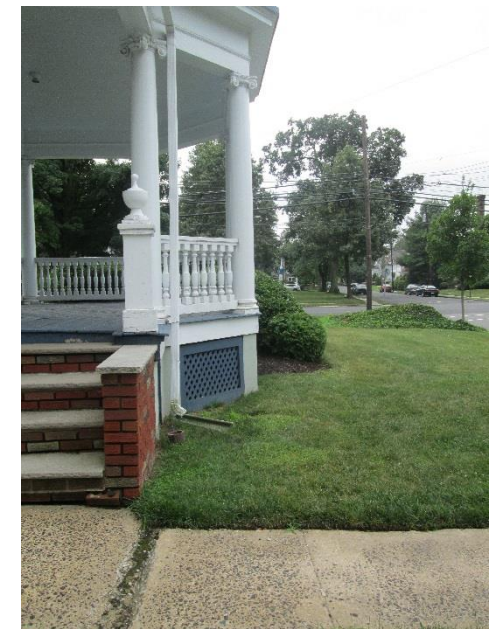
Subwatershed: Green Brook
Site Area: 36,658 sq. ft.
Address: 515 Church Street
Bound Brook, NJ 08805
Block and Lot: Block 87, Lot 9

Parking spaces can be replaced with porous asphalt to capture runoff from the parking lot and a portion of the roof. A preliminary soil assessment suggests that the soils have suitable drainage characteristics for green infrastructure

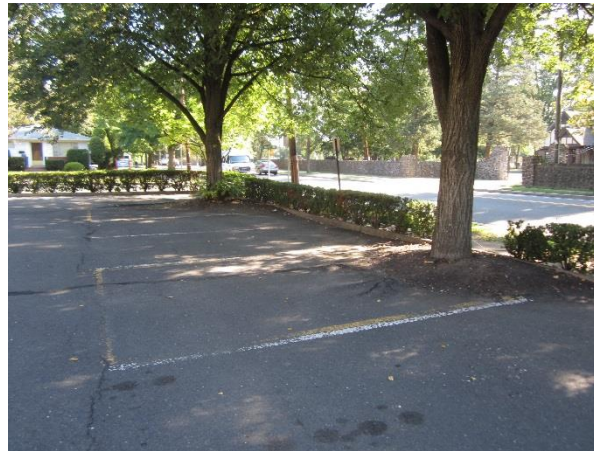
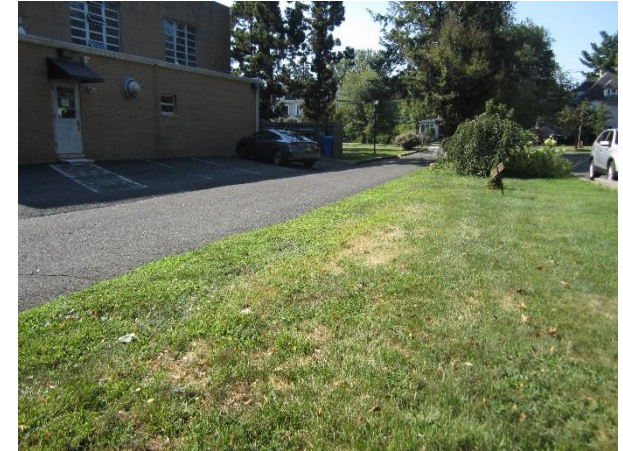
Subwatershed: Green Brook
Site Area: 65,904 sq. ft.
Address: 409 Mountain Avenue
Bound Brook, NJ 08805
Block and Lot: Block 78, Lot 9

Two rain gardens can be installed to capture, treat, and infiltrate runoff. A portion of the parking lot can be repaved with pervious pavement and a series of downspout planters can be installed around the building. A preliminary soil assessment suggests that the soils have suitable drainage characteristics for green infrastructure

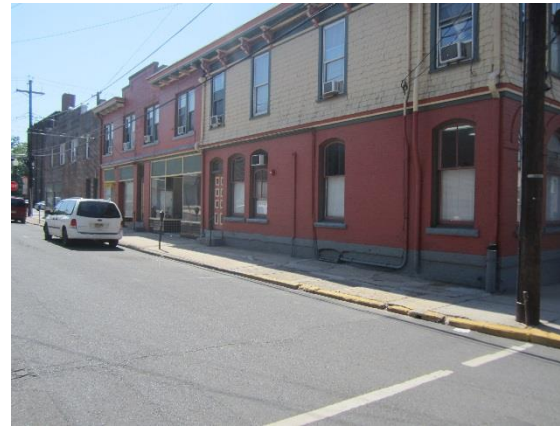
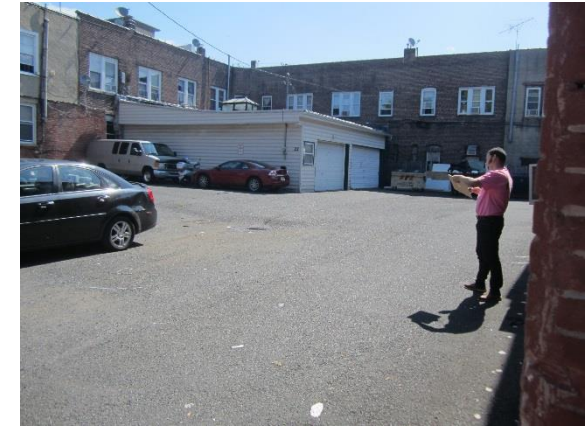
Address: 20-22 Maiden Lane
Bound Brook, NJ 08805

Downspouts can be disconnected into downspout planter boxes and parking spaces can be converted into pervious pavement to capture and infiltrate runoff. A preliminary soil assessment suggests that the soils have suitable drainage characteristics for green infrastructure.

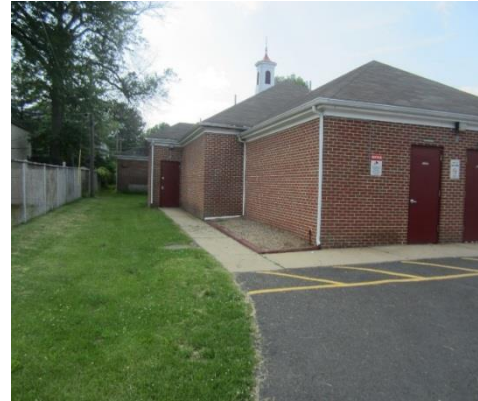
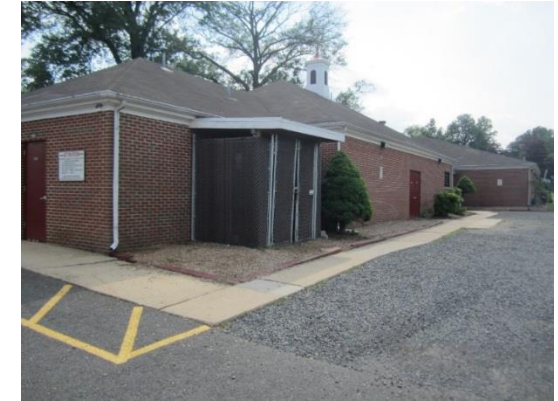
Address: 279 Crusader Way
Bound Brook, NJ 08805

A rain garden can be installed to capture, treat, and infiltrate roof runoff. Additionally, two areas can be converted into pervious pavement to infiltrate runoff before it reaches a catch basin. A preliminary soil assessment suggests that more soil testing would be required before determining the soil's suitability for green infrastructure.

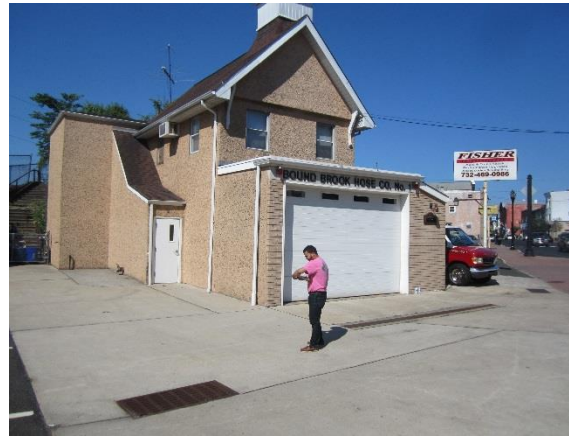
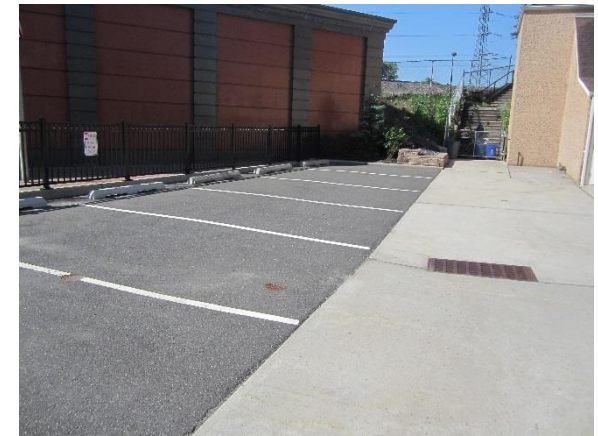
Address: 510 East Main Street
Bound Brook, NJ 08805

Downspouts can be directed into a cistern to harvest rainwater to use for washing vehicles. An area near the cistern can be repaved with pervious pavement to infiltrate runoff. A preliminary soil assessment suggests that the soils have suitable drainage characteristics for green infrastructure.

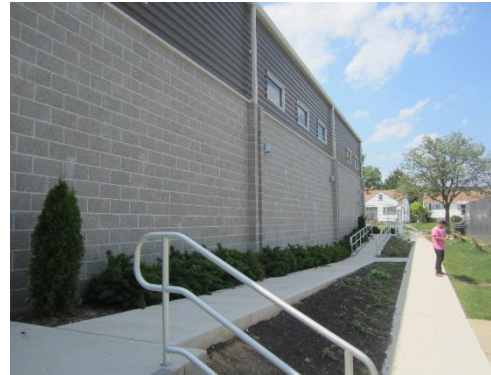
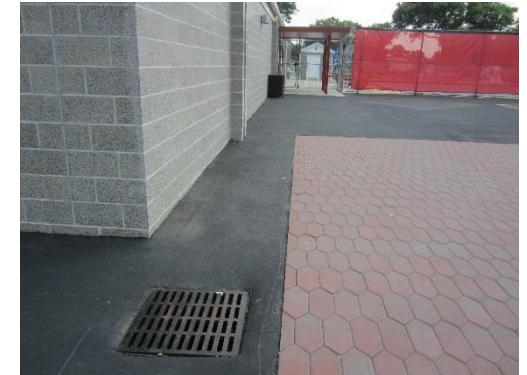
Address: Thompson and Grove Avenues
Bound Brook, NJ 08805

Tennis and basketball courts can be replaced with pervious pavement to infiltrate runoff. Downspouts can also be disconnected to downspout planter boxes and stormwater planters. A preliminary soil assessment suggests that the soils have suitable drainage characteristics for green infrastructure.

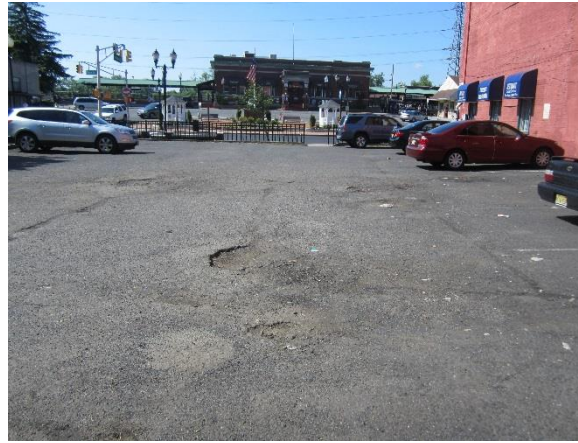
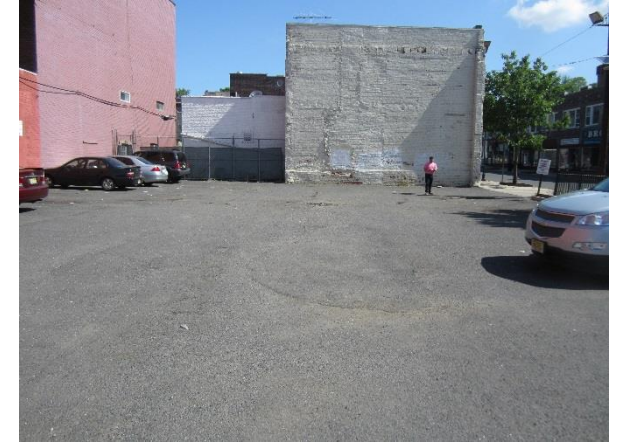
Address: 307 East Main Street
Bound Brook ,NJ 08805

The parking lot is currently in fair condition. Parking spaces can be replaced with pervious pavement to infiltrate runoff. A preliminary soil assessment suggests that the soils have suitable drainage characteristics for green infrastructure.

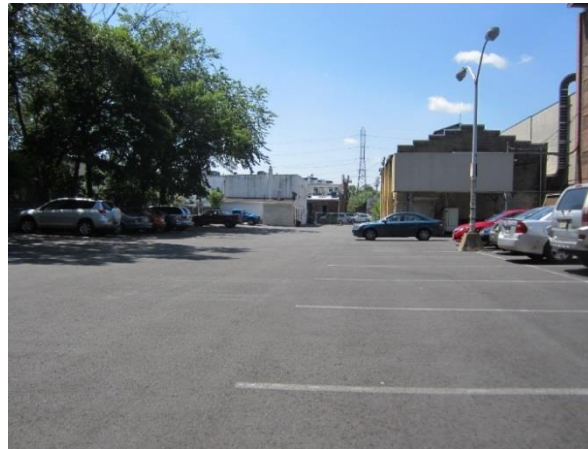
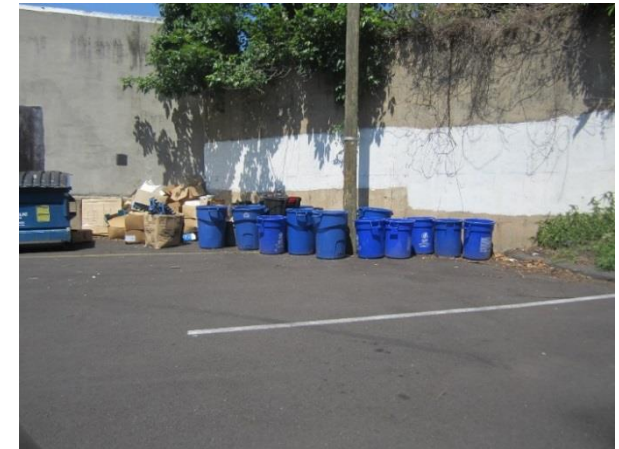
Address: East High Street
Bound Brook, NJ 08805

Two rows of parking spaces can be replaced with pervious pavement to infiltrate runoff. A preliminary soil assessment suggests that the soils have suitable drainage characteristics for green infrastructure.

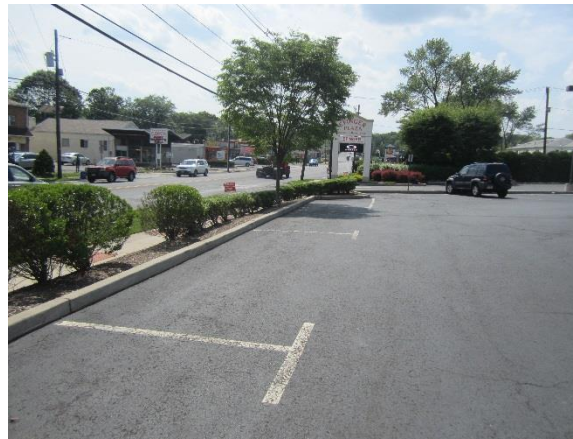
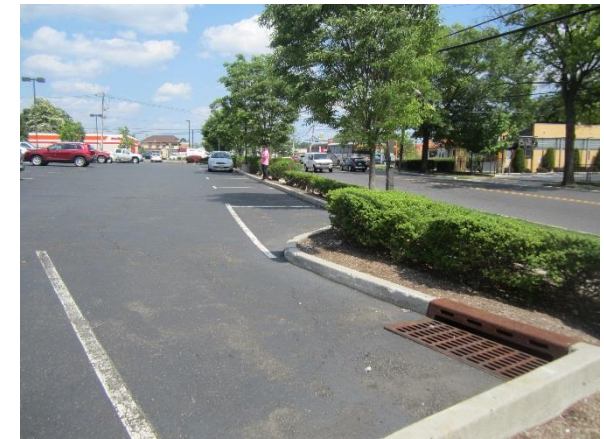
Address: 513 W Union Avenue
Bound Brook, NJ 08805

Parking spaces can be replaced with pervious pavement to capture and infiltrate runoff. A preliminary soil assessment suggests that more soil testing would be required before determining the soil's suitability for green infrastructure.

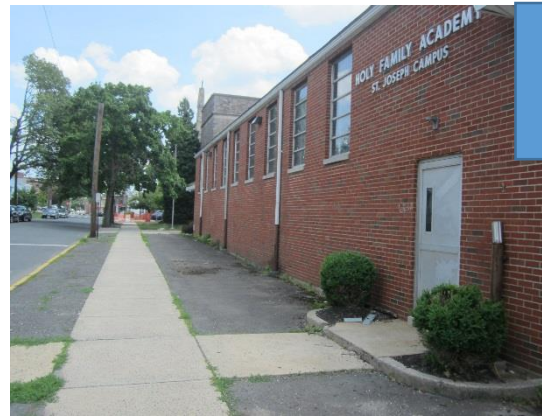
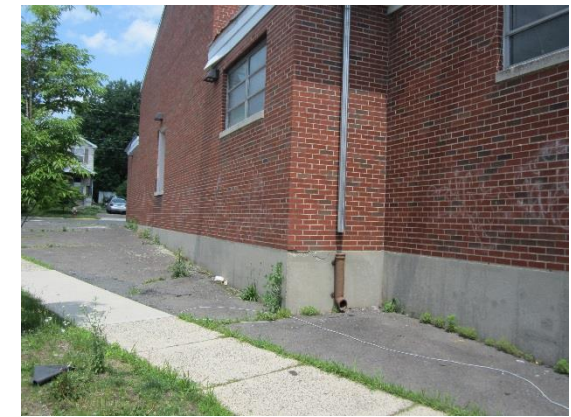
Address: 120 East 2nd Street
Bound Brook, NJ 08805

Several areas can be replaced with pervious pavement to infiltrate runoff. A rain garden can be installed to capture, treat, and infiltrate roof runoff. A preliminary soil assessment suggests that the soils have suitable drainage characteristics for green infrastructure.

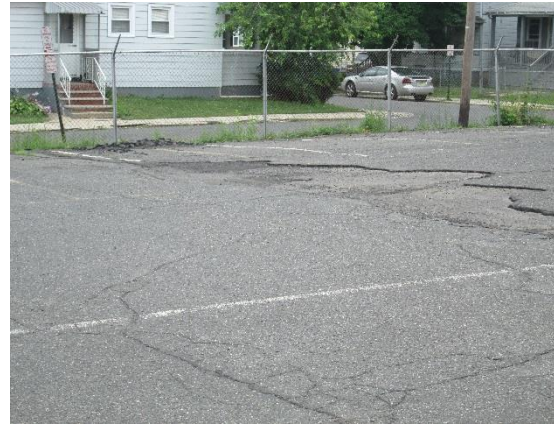
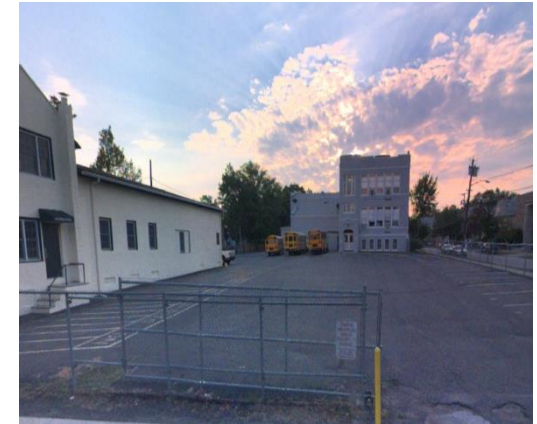
Address: 337 West 2nd Street
Bound Brook, NJ 08805

Runoff currently flows into street-side catch basins. Three areas can be replaced with pervious pavement to infiltrate this runoff. A downspout can also be disconnected into a planter box to allow roof runoff to be reused. A preliminary soil assessment suggests that the soils have suitable drainage characteristics for green infrastructure.

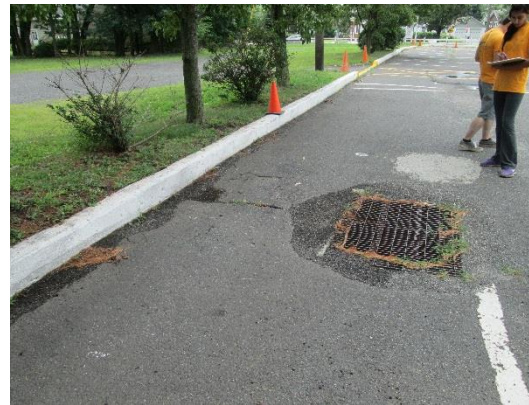
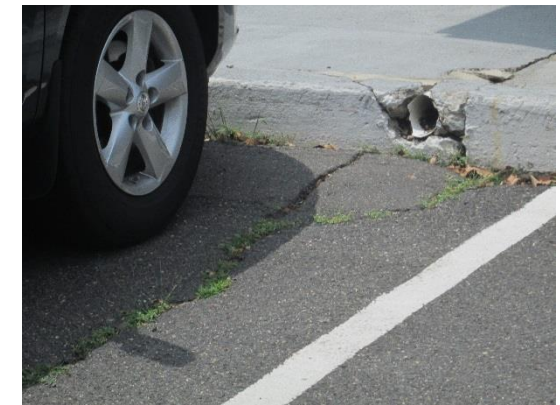
Address: 518 Vosseller Avenue
Bound Brook, NJ 08805

Two catch basins are currently in fair condition. Two rows of parking spaces can be replaced with pervious pavement to infiltrate runoff before it reaches the catch basins. A preliminary soil assessment suggests that the soils have suitable drainage characteristics for green infrastructure.

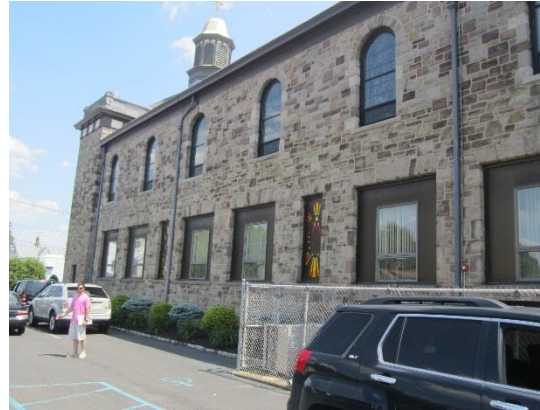
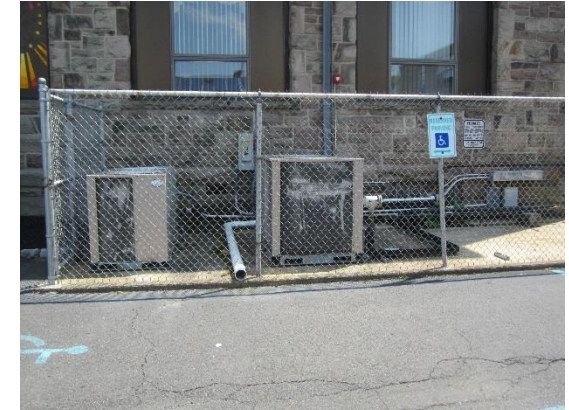
Address: 201 Vosseller Avenue
Bound Brook, NJ 08805

Three downspouts can be disconnected and redirected into pervious pavement to be infiltrated into the ground. A preliminary soil assessment suggests that the soils have suitable drainage characteristics for green infrastructure.

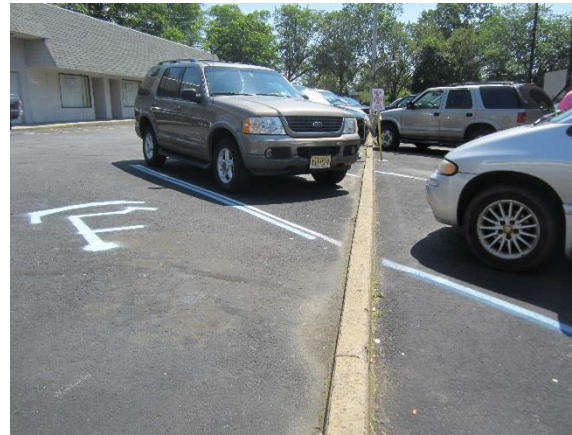
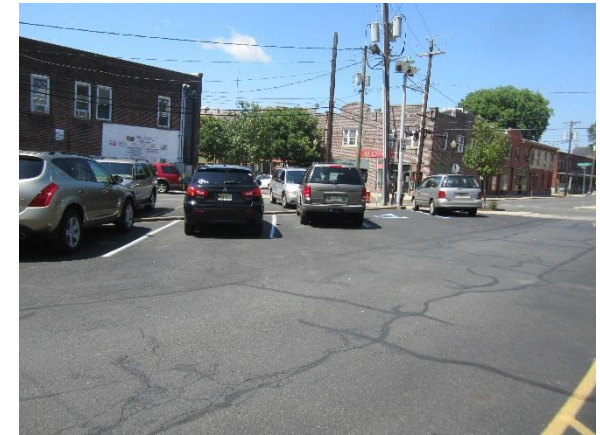
Address: 22 Hamilton Street
Bound Brook, NJ 08805

Two rows of parking spaces can be replaced with pervious pavement to infiltrate runoff and curb cuts can allow additional stormwater to be infiltrated. A preliminary soil assessment suggests that the soils have suitable drainage characteristics for green infrastructure.

Recommended Green Infrastructure Practices	Recharge Potential (Mgal/yr)	TSS Removal Potential (lbs/yr)	Maximum Volume Reduction Potential (gal/storm)	Peak Discharge Reduction Potential (cu. ft./second)	Estimated Size (sq. ft.)	Estimated Cost
Pervious pavements	0.454	76	33,301	1.25	3,707	\$92,675

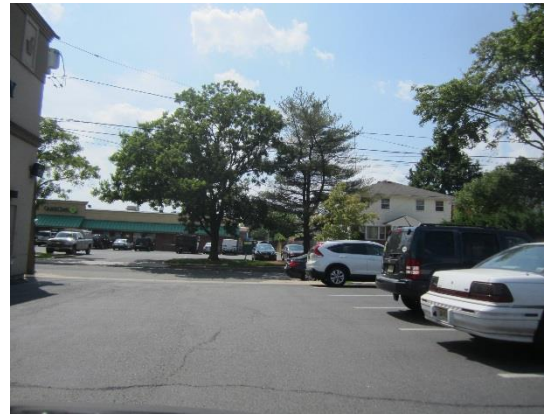
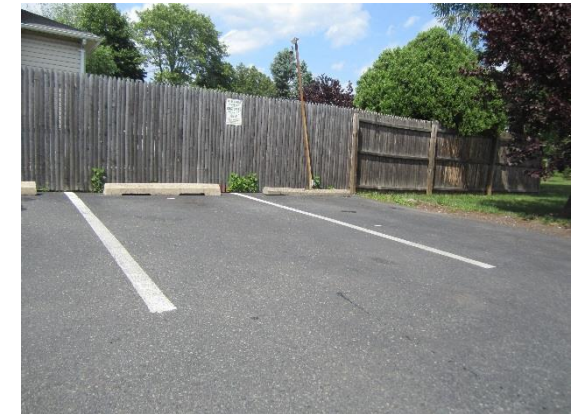
Address: 433 West Union Avenue
Bound Brook, NJ 08805

Stormwater is currently directed into street-side catch basins. Parking spaces can be replaced with pervious pavement to capture and infiltrate runoff. A preliminary soil assessment suggests that the soils have suitable drainage characteristics for green infrastructure.

Recommended Green Infrastructure Practices	Recharge Potential (Mgal/yr)	TSS Removal Potential (lbs/yr)	Maximum Volume Reduction Potential (gal/storm)	Peak Discharge Reduction Potential (cu. ft./second)	Estimated Size (sq. ft.)	Estimated Cost
Pervious pavements	0.091	15	6,672	0.25	1,270	\$31,750

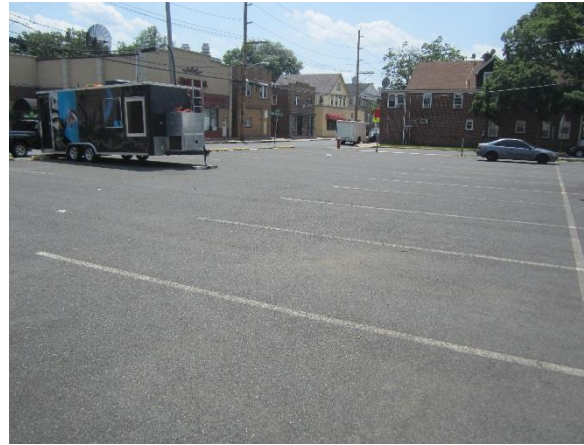
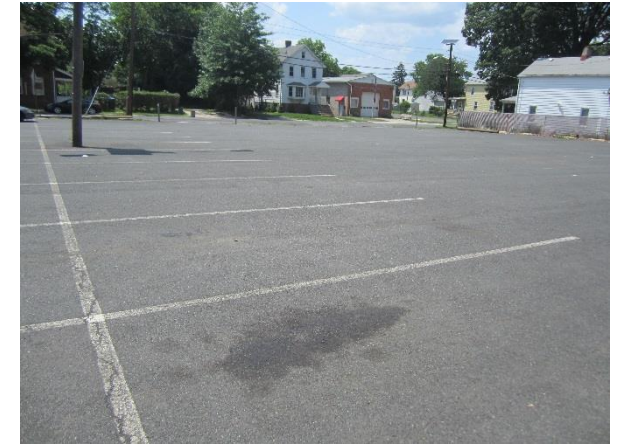
Address: Van Keuren Avenue
Bound Brook, NJ 08805

Three rows of parking spaces can be replaced with pervious pavement to infiltrate runoff. A preliminary soil assessment suggests that the soils have suitable drainage characteristics for green infrastructure.

Recommended Green Infrastructure Practices	Recharge Potential (Mgal/yr)	TSS Removal Potential (lbs/yr)	Maximum Volume Reduction Potential (gal/storm)	Peak Discharge Reduction Potential (cu. ft./second)	Estimated Size (sq. ft.)	Estimated Cost
Pervious pavements	0.501	84	36,779	1.38	5,722	\$143,050

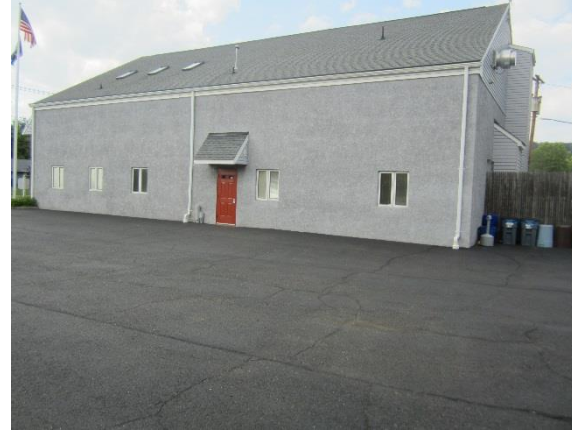
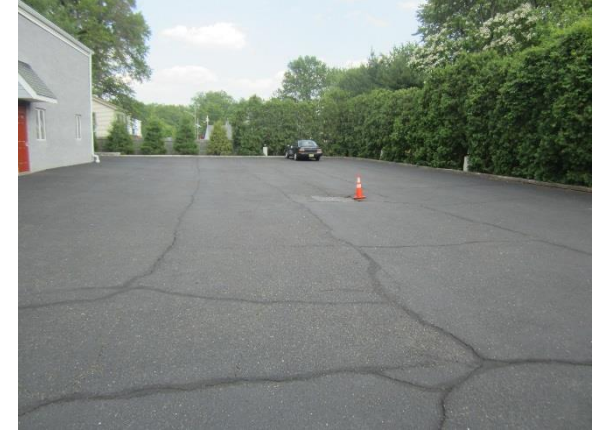
Address: 616 Vosseller Avenue
Bound Brook, NJ 08805

Downspouts can be redirected into a cistern to harvest rainwater to use for washing vehicles. A row of parking spaces can be converted into pervious pavement to infiltrate runoff. A preliminary soil assessment suggests that the soils have suitable drainage characteristics for green infrastructure.

Recommended Green Infrastructure Practices	Recharge Potential (Mgal/yr)	TSS Removal Potential (lbs/yr)	Maximum Volume Reduction Potential (gal/storm)	Peak Discharge Reduction Potential (cu. ft./second)	Estimated Size (sq. ft.)	Estimated Cost
Pervious pavements	0.057	9.50	4,166	0.16	590	\$14,750
Rainwater harvesting systems	0.033	5.58	2,000	0.15	2,000 gal.	\$4,000
