1ENTAL PROJ DELRAN,NJ

DRAFT

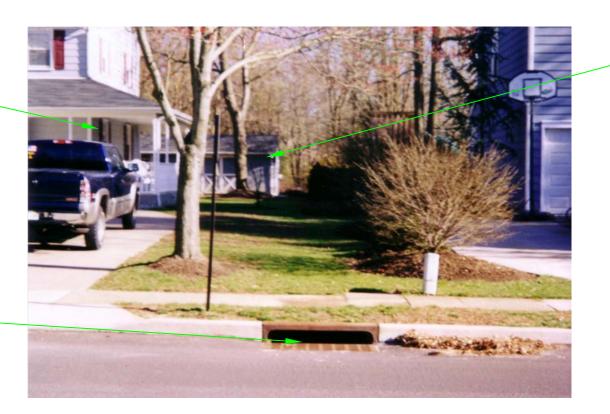
FIGURE C

808 WATERFORD AVE. RESIDENTS COMPLAIN OF MOSQUITOS IN THE CATCH BASIN AND FROM THE OUTLET PIPE BEHIND THEIR HOUSE.

CATCH BASIN CONNECTED TO OUTLET PIPE, ALWAYS HAS STANDING WATER IN IT.
