**APPENDIX C: PROJECTS TO ADDRESS KNOWN WATER
QUALITY IMPAIRMENTS IN THE TENAKILL BROOK
WATERSHED**

Tenakill Brook Watershed Restoration & Protection Plan
7/10/2012

Tenakill Brook Watershed Restoration Plan BMP Detail Sheets

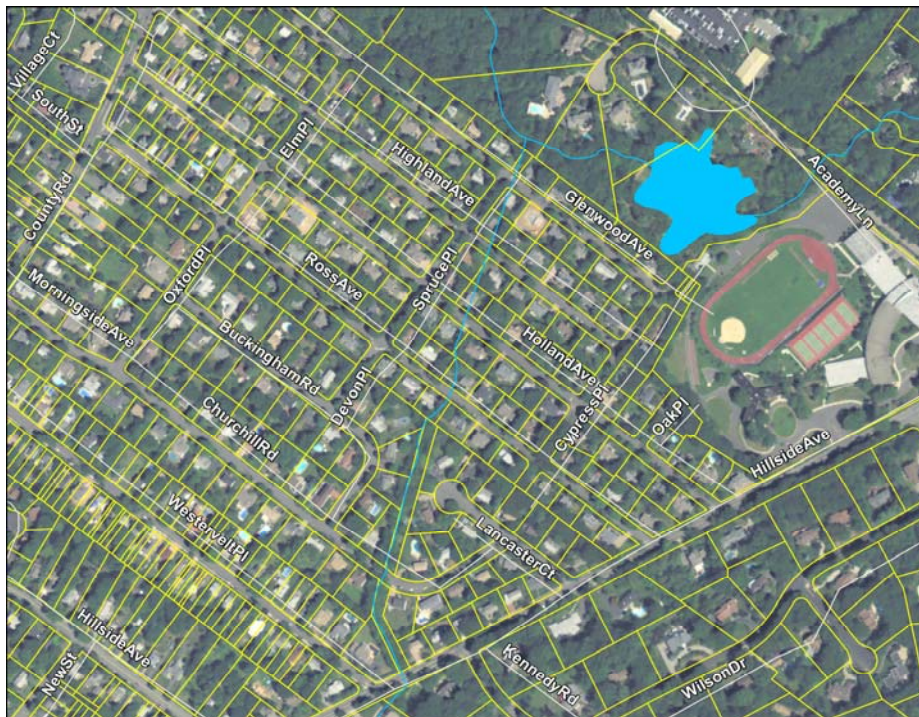
Figure 1: Aerial photograph of a portion of the Cresskill Brook running through several residential properties.

<u>Existing Conditions:</u> During stream surveys in the Tenakill Brook Watershed, several residential properties along the streams were noted as having little to no riparian buffer. Riparian buffers are needed to absorb nutrients and pollutants, stabilize soil and stream banks, resist erosion, trap sediment, and slow rainwater runoff. There were also some properties close to the stream that exhibited the use of pesticides and fertilizers. The combination of the uses of these materials in excessive amounts and a lack of substantial riparian buffers can result in a majority of the pesticide and fertilizers ending up in streams.	
<u>Proposed Solutions:</u> The municipalities should each conduct a Streamside Living Education Program for residents. The education should include teaching residents to do the following: limit the use of pesticides and herbicides; establish a no-mow zone along stream banks; protect storm drains from debris; plant native trees, shrubs, perennials and grasses; identify and remove invasive plants; leave woody debris and rocks; avoid applying fertilizer near streams; never dumping chemicals down storm drains; and avoid storing waste or loose soil near a stream. The education program should also include appropriate state and local regulations. The Water Resources Program also recommends that municipalities inspect the properties of streamside owners periodically to ensure adherence to the recommended actions included in the Streamside Living Education Program.

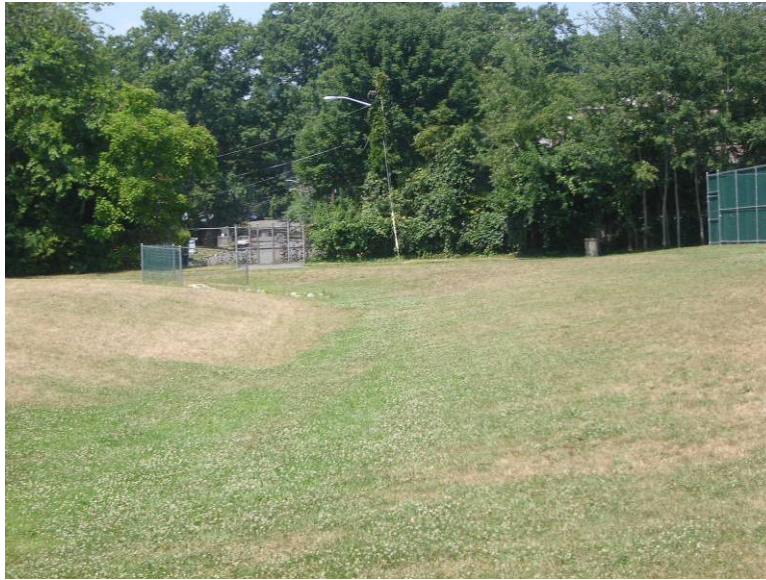
Figure 2: Photograph of swale to be vegetated.

<p><u>Existing Conditions:</u> The drainage swale and detention basin are located behind Tenaflly High School near the athletic fields. Athletic fields and parks attract large populations of Canada geese. The drainage swale discharges into a detention basin and both of these structures manage the stormwater runoff from all the athletic fields. The drainage area for this stormwater management system is approximately 16.25 acres of fields. The vegetation in the drainage swale and detention basin currently consists solely of turfgrass. The existing stormwater management system is not sufficient to treat runoff from the athletic fields. Studies have shown that detention basins alone do not remove pollutants from stormwater runoff very well and only reduce the quantity of stormwater. Considering the system's potential for poor removal of pollutants and the drainage area includes known areas with Canada goose waste, this site is a source of bacteria in the Tenakill Brook Watershed that needs to be mitigated.</p>

<p><u>Proposed Solutions:</u> The Water Resources Program proposes a two part solution for the Tenaflly High School athletic fields.</p> <p>The first part is re-vegetating the detention basin and swale. Clusters of turfgrass will be replaced with native warm season grasses, herbaceous plants, sedges, ferns and a minimum amount of woody vegetation. Over time, this new vegetation will expand past the boundaries of the initially-planted clusters to cover the entire basin and swale. The new vegetation will increase the infiltration capacity of the detention basin. The basin will not need to be mowed on a weekly basis, as it is now. The vegetation should be allowed to grow tall to increase its ability to filter nutrients and sediment out of stormwater runoff. The tall vegetation will have a deeper and more complex root structure allowing the basin to infiltrate greater amounts of water during each storm event.</p> <p>The second part of the solution is to create a small berm or series of berms that surround the outlet of the basin. The berm(s) would only be about 1 foot high and composed of a permeable material, such as coconut fiber logs or ¾ inch clean stone secured with fabric. The purpose of the berm(s) is to increase the amount of time stormwater is retained in the basin. The berm(s) would constrict the flow of runoff for small but frequent storms while not interfering with the basin's ability to prevent flooding for larger storms because larger flows of runoff would flow over the berm(s).</p>

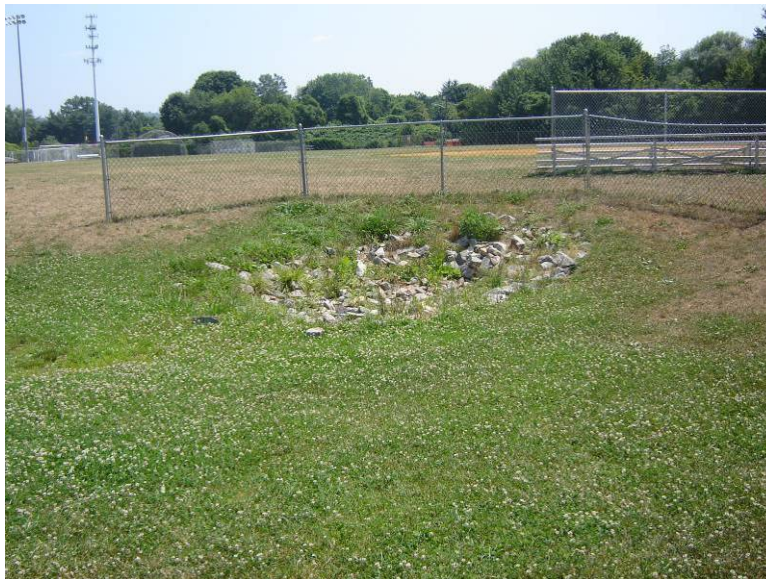
Figure 3: Photograph of swale inlet to undergo a retrofit.

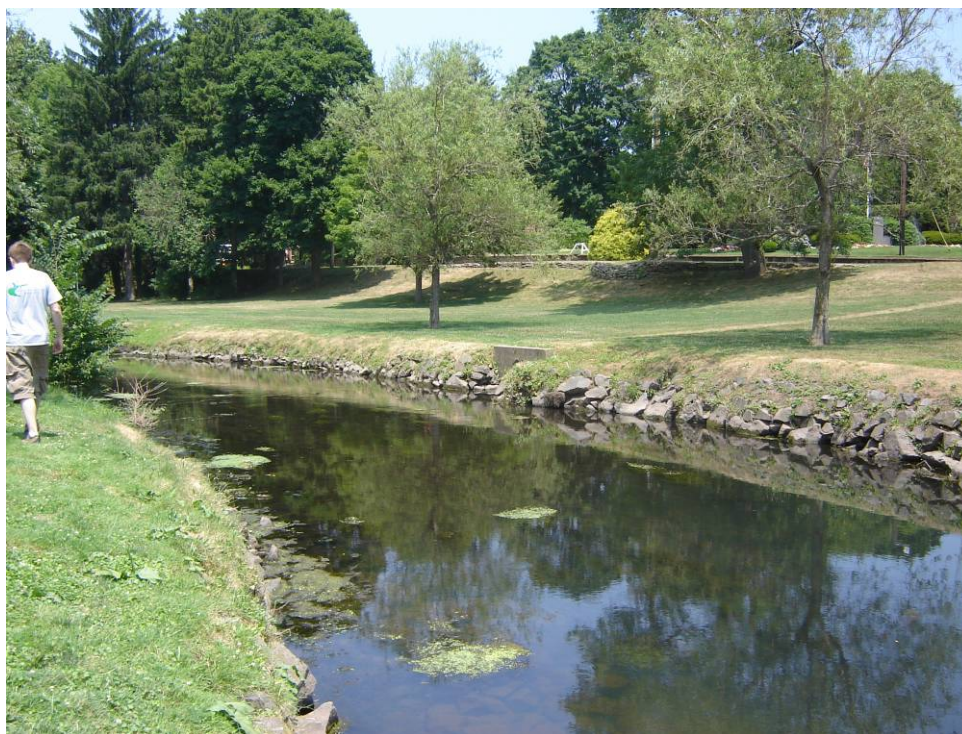
Figure 2: Portion of Demarest Pond unprotected by buffers (facing downstream).

<p><u>Existing Conditions:</u> Demarest Pond Park is approximately 7.8 acres. About half of the pond is surrounded by a buffer. There is approximately 1,280 linear feet of unprotected shoreline. The park is mostly comprised of turf grass with the exception of some trees and a few shrubs. On each side of the pond, the landscape gently slopes towards the pond. The park provides a great feeding ground for Canada geese. Canada geese can always be found at the park, as well as goose waste throughout the park. This goose waste is one of the sources of bacteria found in the Tenakill Brook Watershed. Goose waste can stay on the ground for several weeks. Stormwater runoff gathers bacteria from the waste on the surface and carries it to the pond. The park also provides many access points for the geese to enter the water due to the lack of a vegetated buffer in spots surrounding Demarest Pond making the park even more attractive to the geese.</p>

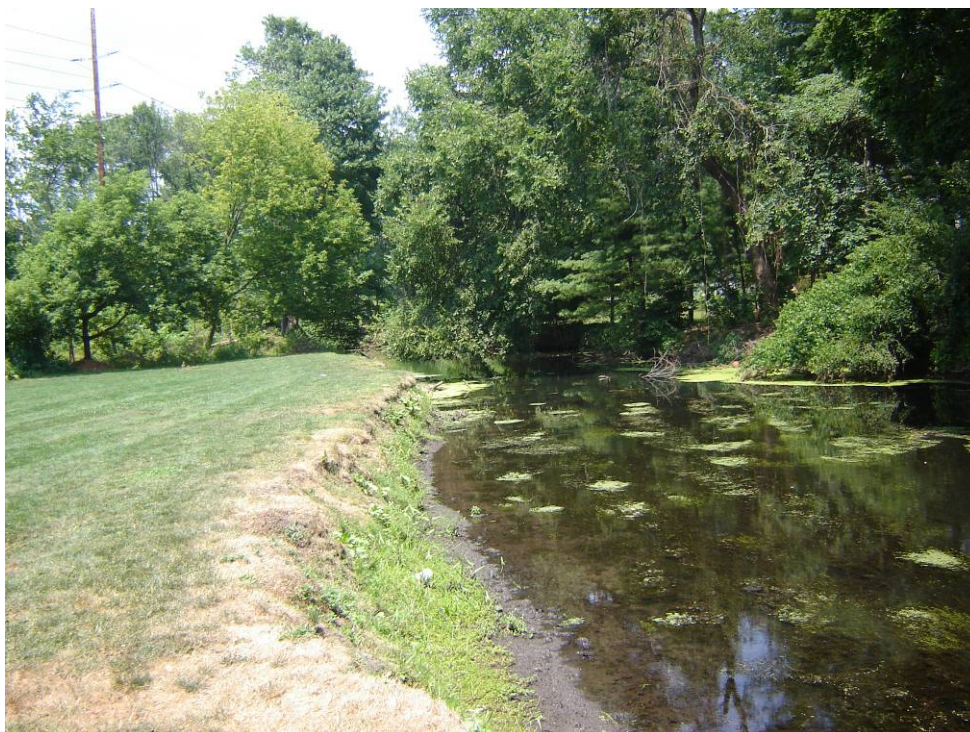
Figure 3: Unprotected shoreline along Demarest Pond.

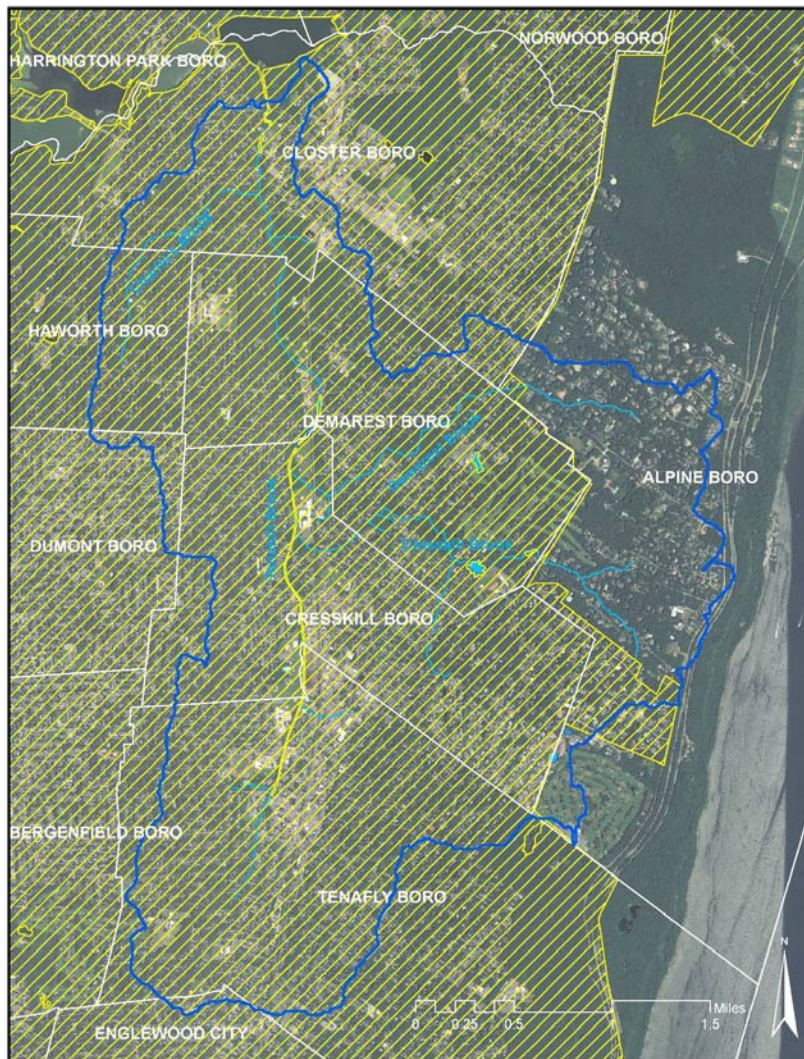
Figure 1: Sewer service areas in the Tenakill Brook Watershed overseen by the Bergen County Utilities Authority.

<p><u>Existing Conditions:</u> During a brief survey of one subwatershed in the Tenakill Brook Watershed, at least three possible illicit connections were found entering the Tenakill Brook. Three different pipes on different properties were found in the stream bank of the Tenakill Brook. These pipes could be connected to basement sump pumps, kitchen sinks, etc. The effluent from these pipes should be connected to a sanitary sewer system for treatment before it is discharged to surface water. The Water Resources Program reviewed sanitary sewer inspection video from Haworth Borough (a small portion of Haworth is in the Tenakill Brook Watershed). The inspection video showed broken and/or clogged pipes. The infrastructure of the municipalities in this watershed is around the same age. The Water Resources Program believes that if the sanitary sewer lines in Haworth Borough are damaged then the sanitary sewer lines of the other municipalities in the Tenakill Brook Watershed could be damaged and potentially leaching sewage into the surface water.</p>

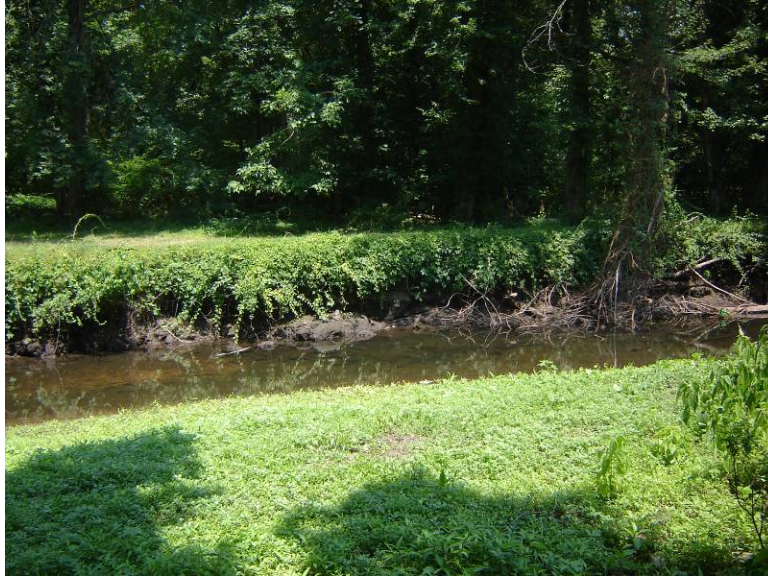
Figure 2: Photograph of unstable streambanks along Tenakill Brook at Memorial Park.

<p><u>Existing Conditions:</u> Memorial Park is located in Closter Borough along Harrington Avenue. Memorial Park covers approximately 6.3 acres, and the entire park drains to the Tenakill Brook. Geese are often found at the park, contributing to excessive amounts of bacteria in the water from their feces. There is little to no vegetative buffer in certain areas along the Tenakill Brook, so water is easily accessible by Canada geese from the grassy areas of the park. Also, the streambanks are heavily incised and very unstable. Upon conducting the Channel Evolution Model, the Water Resources Program determined that the Brook is in stage 2. A stream in stage 2 has headcuts present, exposed bedrock, exposed cultural features, sediment deposits are absent or sparse, and the streambank slopes are greater than 1:1, which are contributing factors to excessive erosion of the banks as sediment is washed into the Tenakill Brook.</p>
