The Assiscunk Creek Watershed Restoration and Protection Plan

Developed by the Rutgers Cooperative Extension Water Resources Program

April 2011

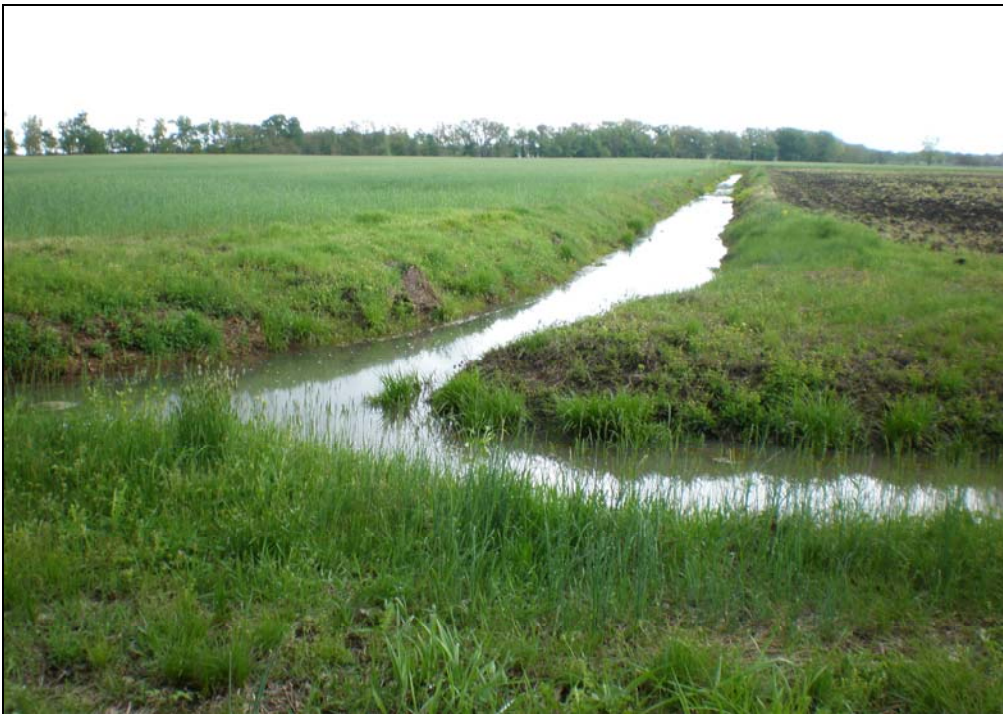
Figure 11: Drainage Swale

The Assiscunk Creek Watershed is generally a low gradient watershed, so man-made drainage routes have been carved into the landscape throughout the watershed (Figure 11). These drainage swales route overland flow and near surface flow to the edges of the farmed field for quicker water removal. If these drainage swales do not contain sufficient vegetation in or around them, the flows leaving the area are generally of higher velocity and lower water quality.

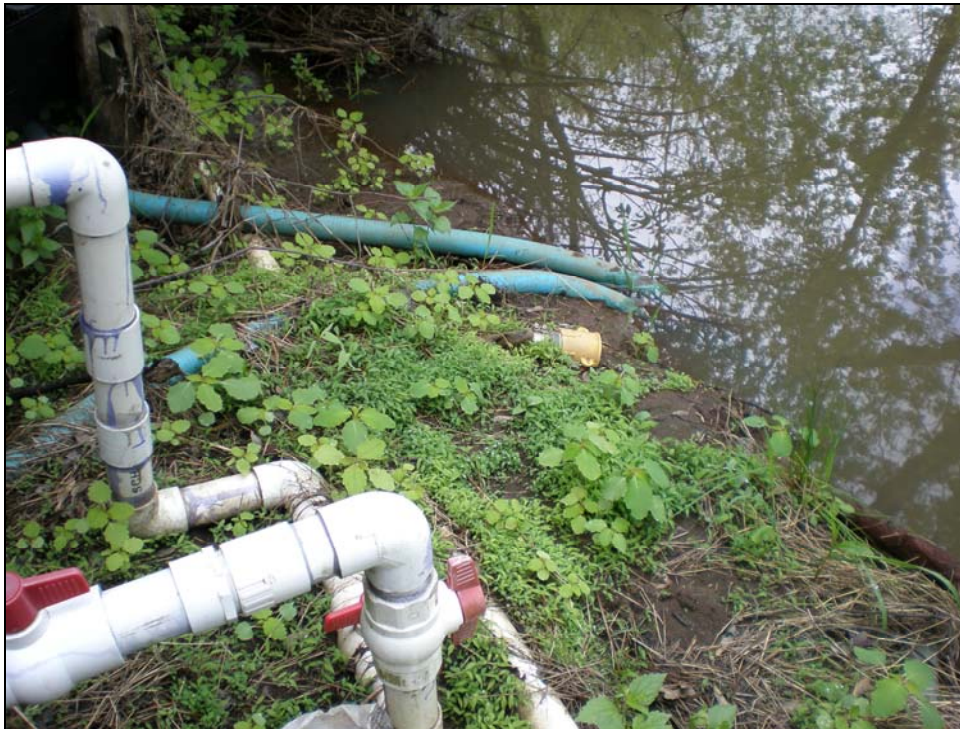
Figure 12: Irrigation Pipes

Irrigation for agricultural purposes has also modified the hydrologic cycle in this watershed. Irrigation pipes pulling freshwater from the streams of the Assiscunk Creek, Annaricken and Upper Barkers Brook are ubiquitous (Figure 12). The change in irrigation needs over time could be a significant factor not only in the water quantity of the stream, but also the water quality, although many factors will play a role in reduced baseflow and reduced groundwater recharge. Site surveillance has frequently found sampling sites in this watershed having little to no flow. In September of 2010, three of the headwater sampling sites (ASK1, ANR and BB1) were found to have no flow. This occurred after an unusually dry summer season.

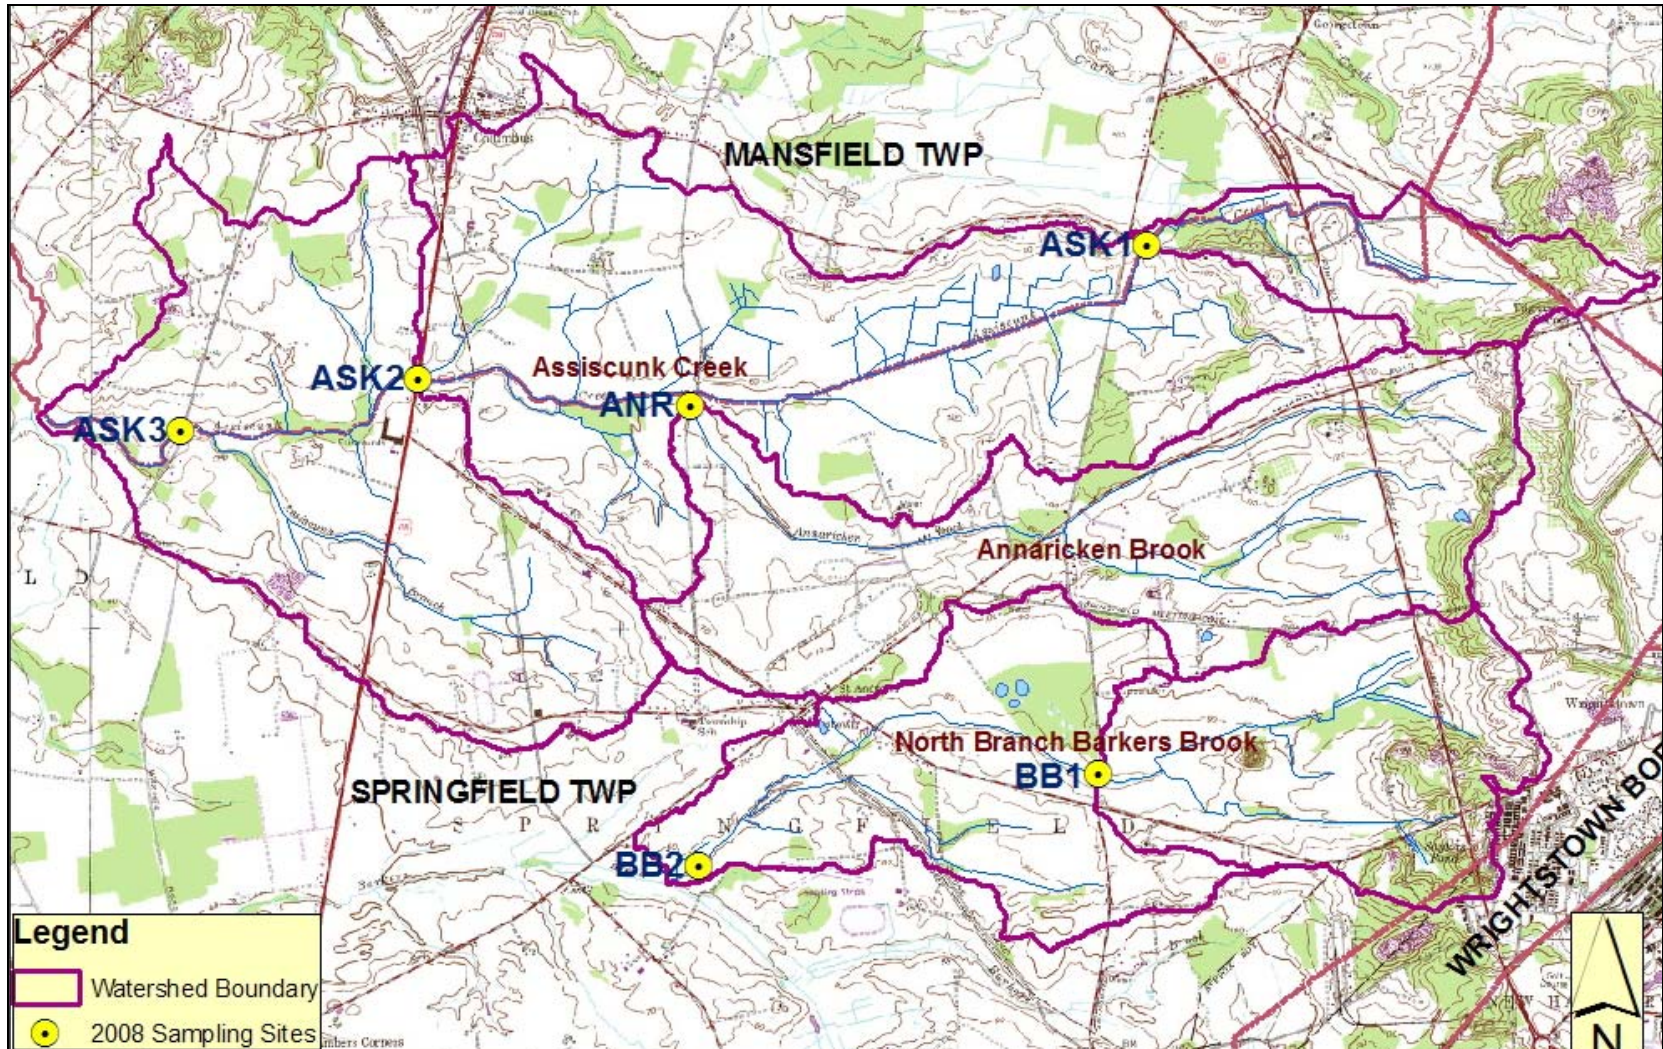
Figure 13: Assiscunk Creek Watershed Water Quality Sampling Site Locations

Site ID	Site Description	HUC14	Coordinates
ASK3	Assiscunk Creek at Petticoat Bridge Road	2040201100040	40°03'13.91"N, -74°44'35.70"W
ASK2	Assiscunk Creek at United States Highway 206	2040201100010	40°03'24.91"N, -74°43'25.96"W
ANR	Annaricken Brook at Island Road (also AN0139)	2040201100010	40°03'18.91"N, -74°42'08.19"W
ASK1	Assiscunk Creek at Columbus-Georgetown Road (also AN0138)	2040201100010	40°03'55.35"N, -74°40'01.00"W
BB2	Barkers Brook North at Juliustown Road (also AN0140)	2040201100020	40°01'38.85"N, -74°42'05.52"W
BB1	Barkers Brook North southeast of Monmouth Road	2040201100020	40°01'57.83"N, -74°40'12.48"W

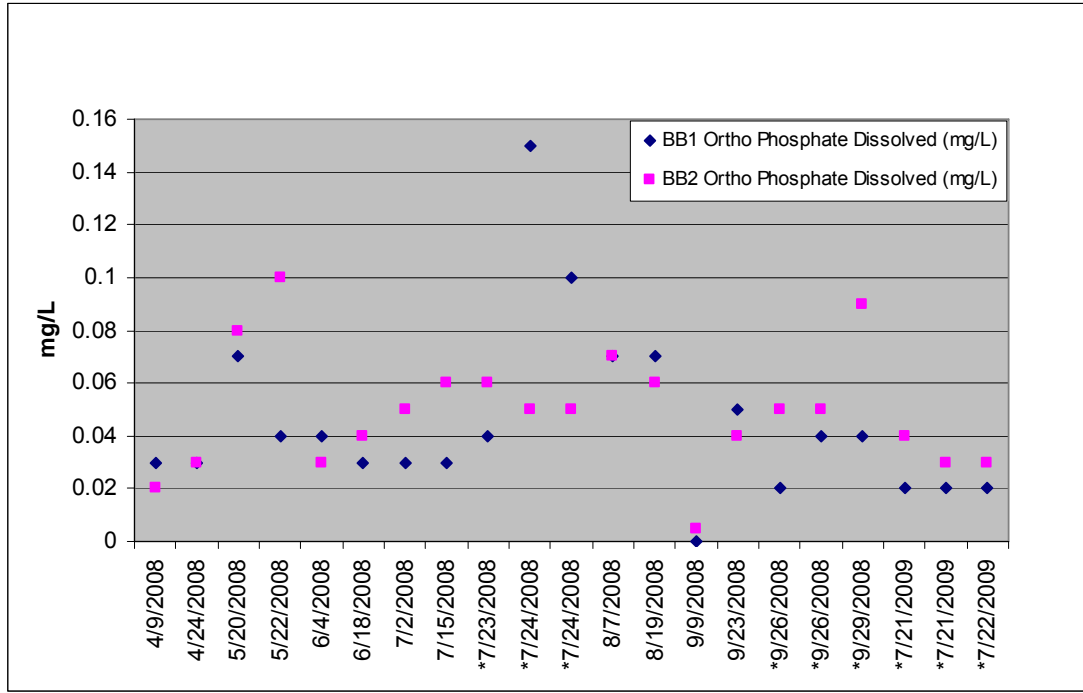
Figure 15: Barkers Brook Orthophosphate (*Storm Event)

Upon evaluation of the total phosphorus and phosphate-phosphorus ($\text{PO}_4^{3-}\text{-P}$) data, several sampling events have higher concentrations at the downstream site when compared with the upstream site (Figures 15 and 16). Orthophosphate is that portion of the total phosphorus that is readily available for plant uptake. Upon evaluation of the

data collected at these two sites for this study, there appears to be no trend that allows a correlation of phosphorus concentrations to the location of the point source discharge.
