Water Quality Survey and Assessment for the Township of Piscataway

Louis Berger & Associates, Inc.

December 1995

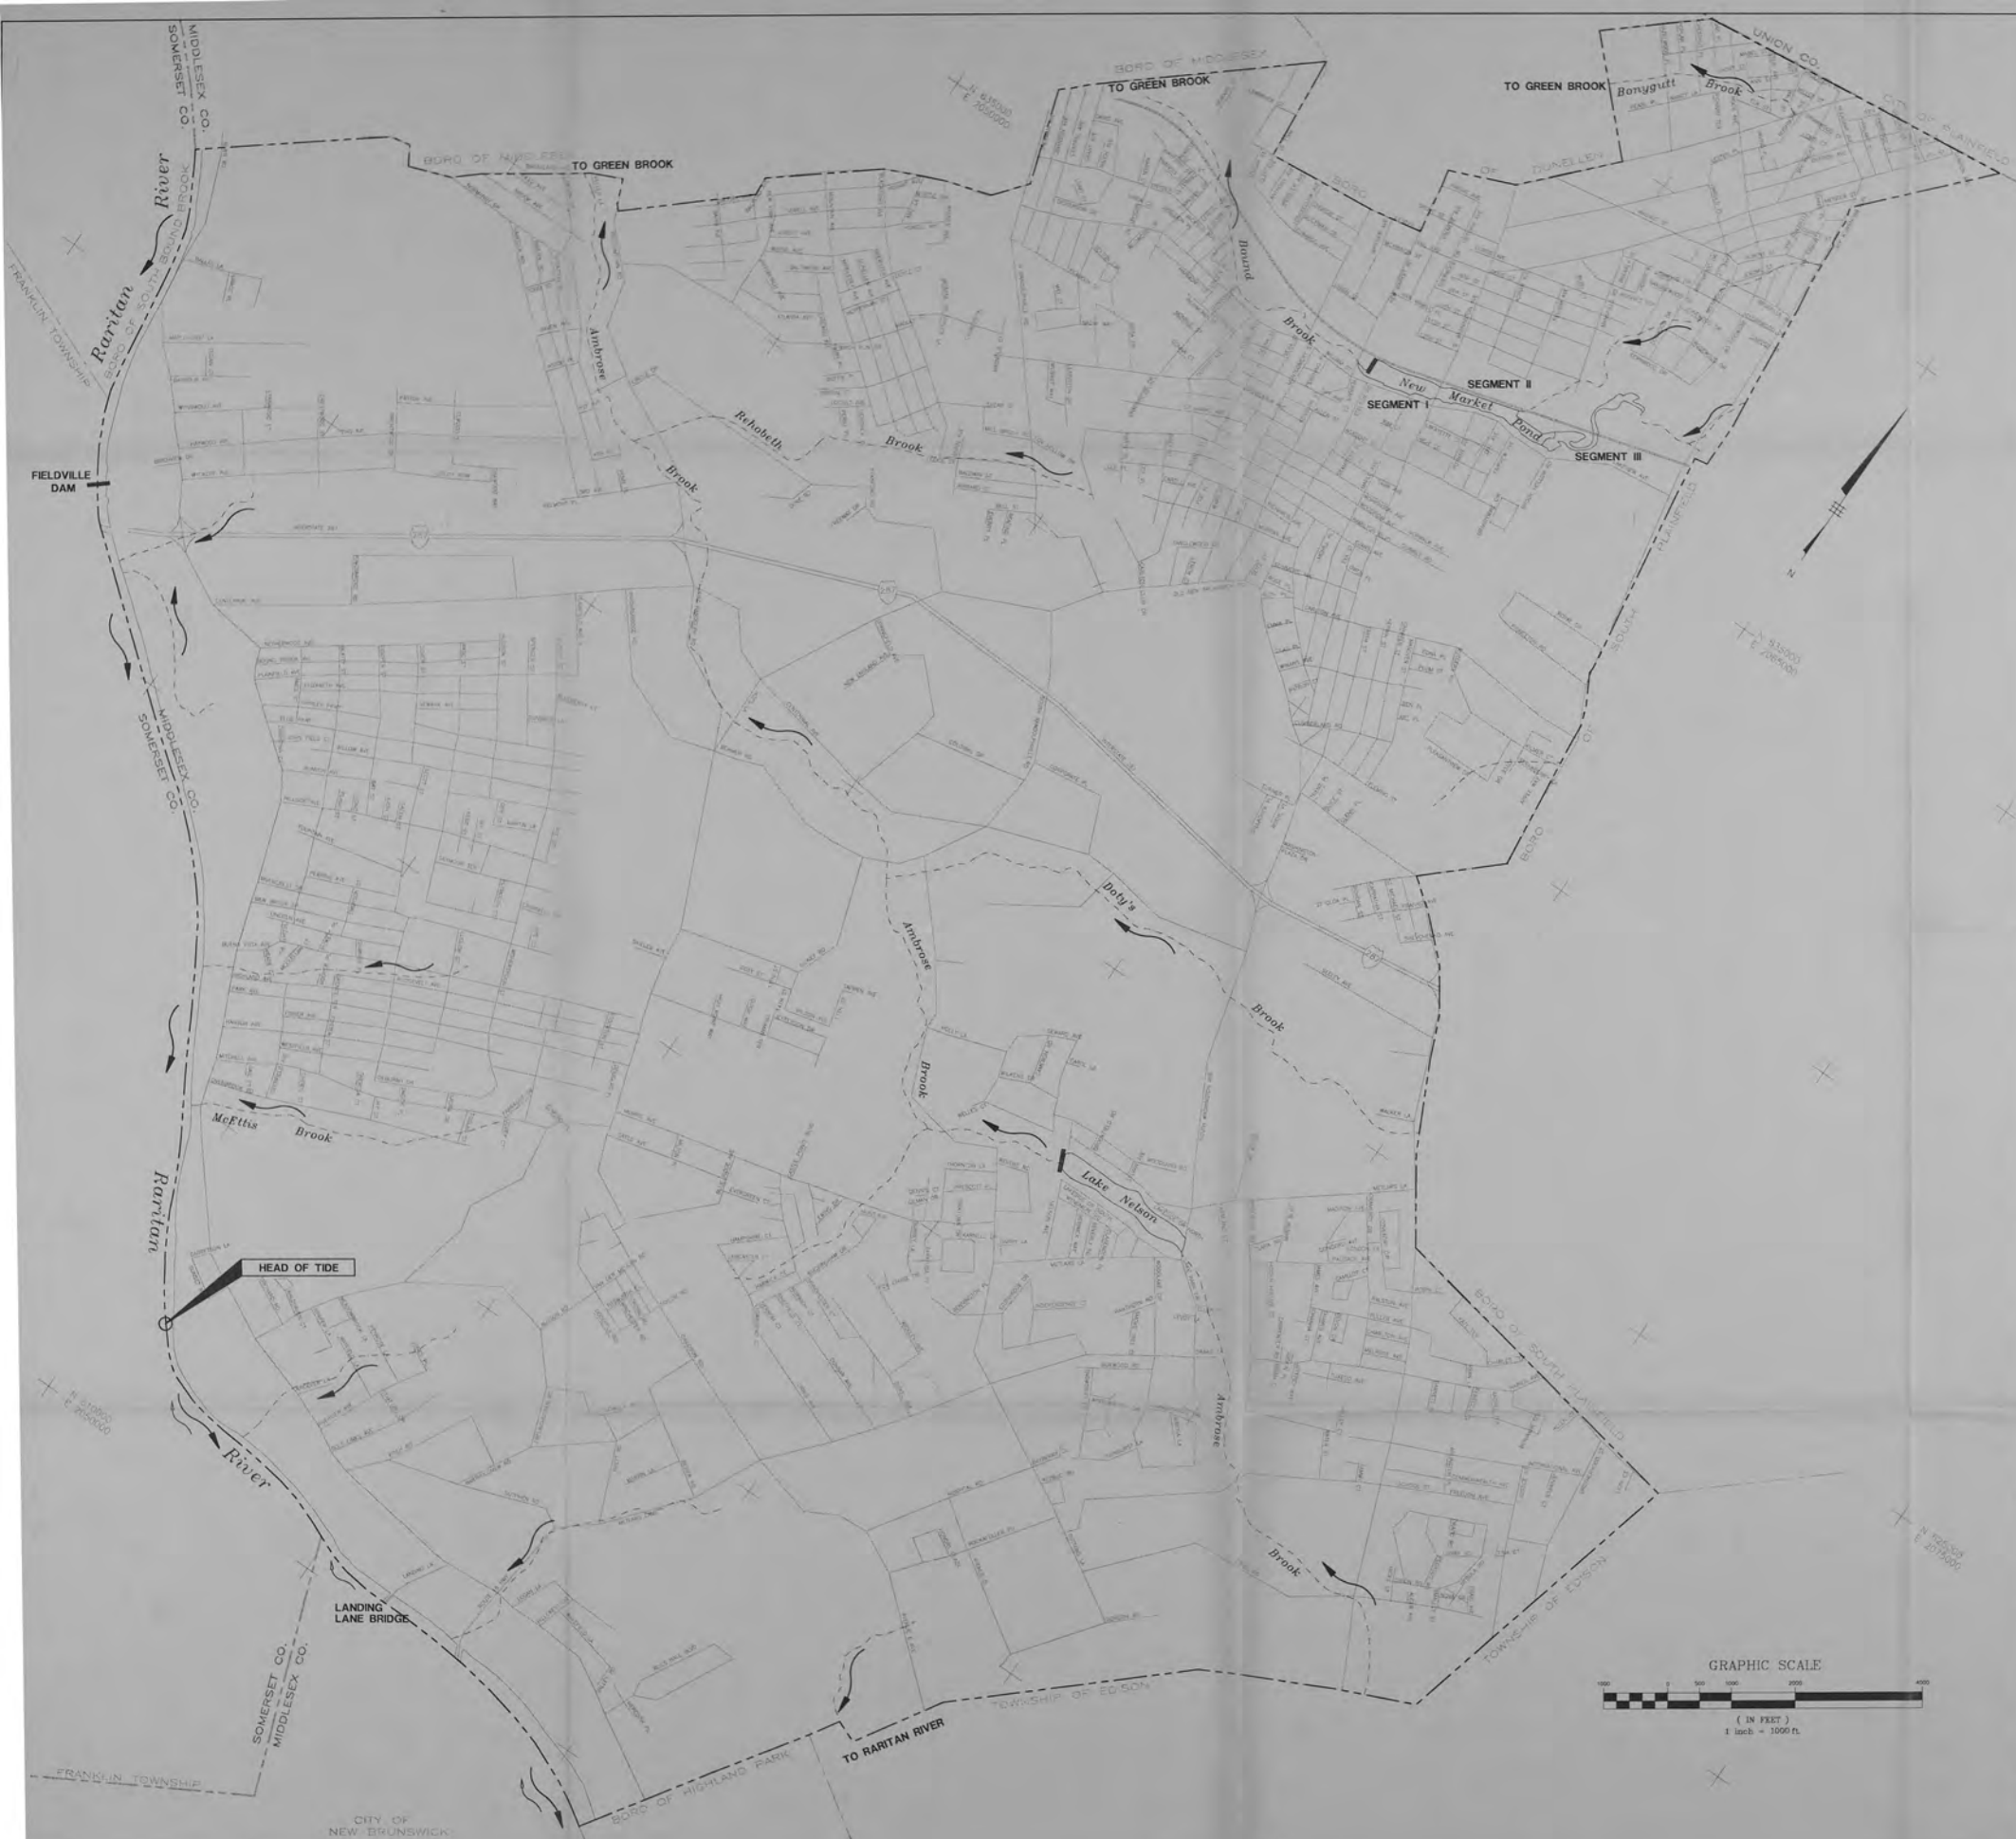
- ROADWAY
- STREAM
- TOWNSHIP/BORO BOUNDARY
- COUNTY BOUNDARY
- STREAM FLOW DIRECTION
- TIDAL FLOW DIRECTION
- NEW MARKET POND SEGMENTS (SEE TEXT) SEGMENT II
- EXISTING DAM

Field reconnaissance visits to the pond in August and December 1995 found that the pond can be divided into three distinct morphologic segments: the downstream segment (I) with the dam near New Market Road on the west and the bridge at South Washington Avenue on the east; the central segment (II) with the South Washington Avenue bridge on the west; the upstream segment (III) receiving inflow from Bound Brook.

New Market Pond segment I is wider than the other two segments. Railroad embankment fill at South Washington Avenue reduces the width of the lake nearly in half and, thus, constricts the flow between segments I and II. Two aeration fountains were observed in operation in segment I in August. The presence of vegetation is more prominent in central segment II (e.g., *Phragmites* stands). Segment II also receives tributary inflow. Upstream segment III receives flow from Bound Brook and is more removed from roadway sources of stormwater runoff than the other segments.
