Hamilton Township (Mercer County) Watershed Inventory Report

Developed by the Rutgers Cooperative Extension Water Resources Program Funded by Hamilton Township, Mercer County, New Jersey January 31, 2024

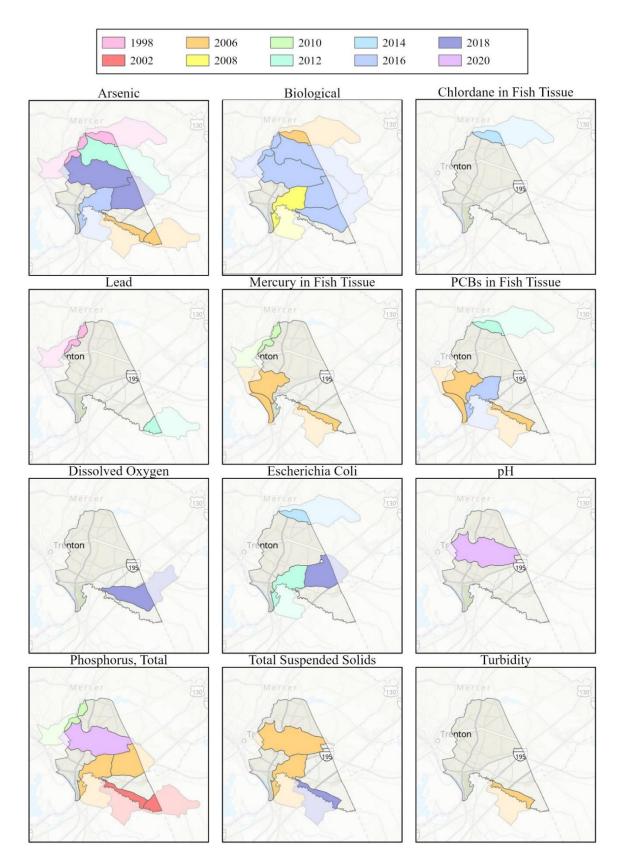
Figure 8: 303(d) impaired waters by year first listed

Section 303(d) of the Clean Water Act requires states to identify and list waters that do not meet water quality standards after the implementation of technology-based controls. These waters are impaired, meaning they do not meet water quality standards designed to protect public health and the environment. If a water body is found to be impaired, it is included in the 303(d) list, and a total maximum daily load (TMDL) may be developed for that impairment. Table 1 and Table 2 summarize the impairments identified by the 303(d) list published in 2020 for each subwatershed in Hamilton Township. Figure 8 depicts the areas to which each of these impairments apply, and the sections are formatted by the year the Impairment was first listed in the 303(d) list.
