**Impervious Cover Assessment
for
Metuchen Borough, Middlesex County, New Jersey**

*Prepared for Metuchen Borough by the
Rutgers Cooperative Extension Water Resources Program*

February 1, 2015

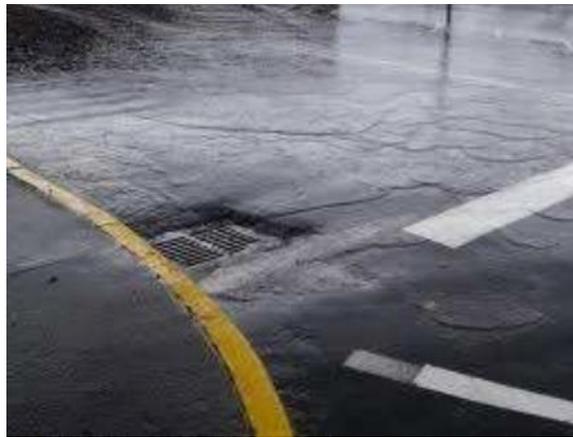
Figure 1: Stormwater draining from a parking lot

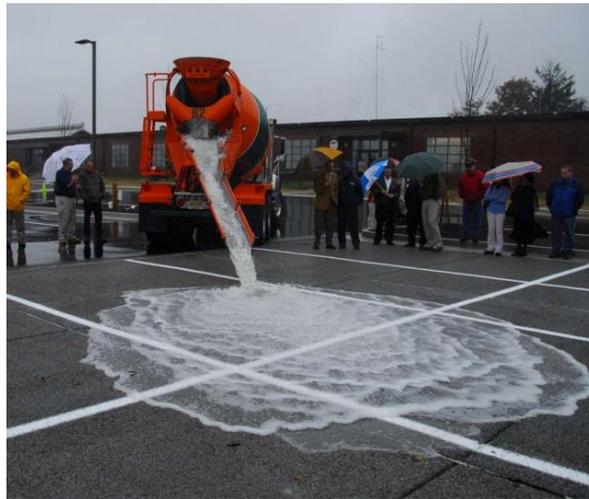
Figure 2: Rapid infiltration of water through porous pavement is demonstrated at the USEPA Edison New Jersey test site

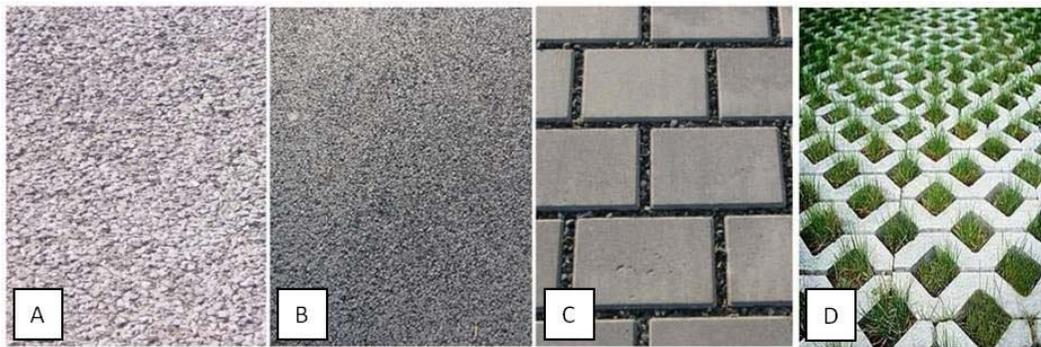
Permeable surfaces: (A) pervious concrete, (B) porous asphalt, (C) interlocking concrete pavers, (D) grid pavers (Rowe, 2012)

Pervious concrete and porous asphalt are the most common of the permeable surfaces. They are similar to regular concrete and asphalt but without the fine materials. This allows water to quickly pass through the material into an underlying layered system of stone that holds the water allowing it to infiltrate into the underlying uncompacted soil.

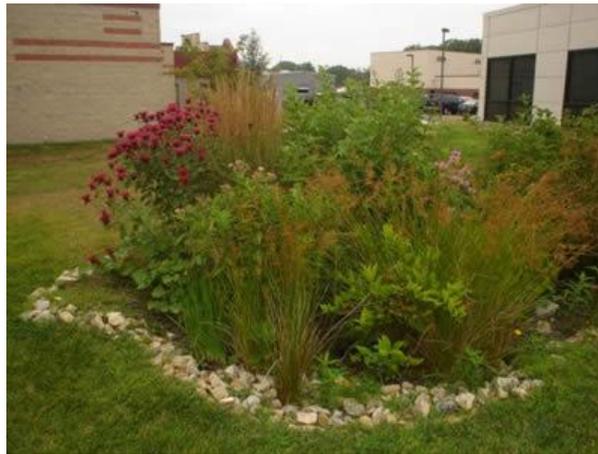
Figure 7: Rain garden outside the RCE of Gloucester County office which was designed to disconnect rooftop runoff from the local storm sewer system

- Rain Gardens: Stormwater can be diverted into shallow landscaped depressed areas (i.e., rain gardens) where the vegetation filters the water, and it is allowed to soak into the ground. Rain gardens, also known as bioretention systems, come in all shapes and sizes and can be designed to disconnect a variety of impervious surfaces (Figure 7).

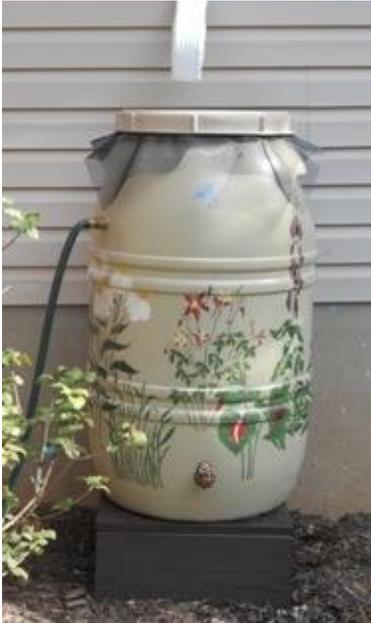
Figure 8a: Rain barrel used to disconnect a downspout with the overflow going to a flower bed

- Rainwater Harvesting: Rainwater harvesting includes the use of rain barrels and cisterns (Figures 8a and 8b). These can be placed below downspouts to collect rooftop runoff. The collected water has a variety of uses including watering plants and washing cars. This practice also helps cut down on the use of potable water for nondrinking purposes. It is important to divert the overflow from the rainwater harvesting system to a pervious area.

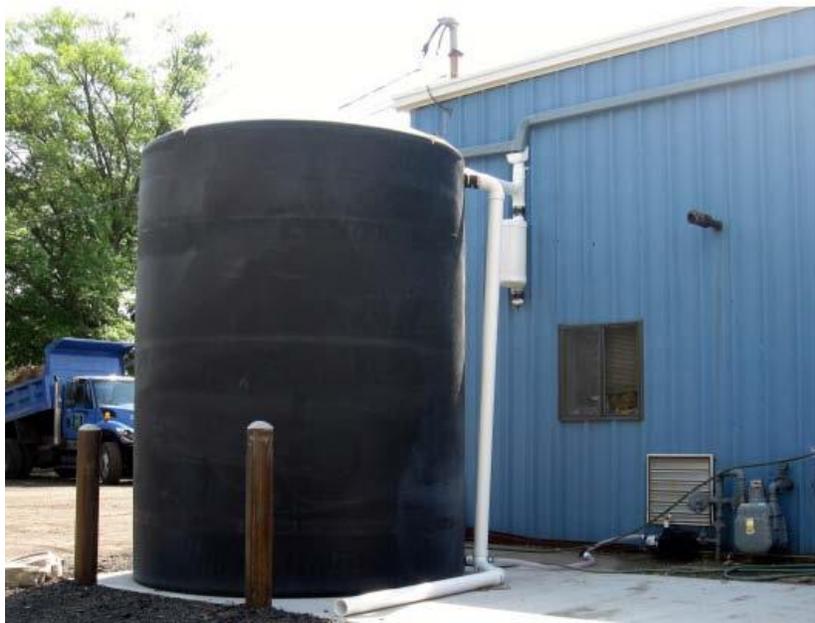
Figure 8b: A 5,000 gallon cistern used to disconnect the rooftop of the Department of Public Works in Clark Township to harvest rainwater for nonprofit car wash events

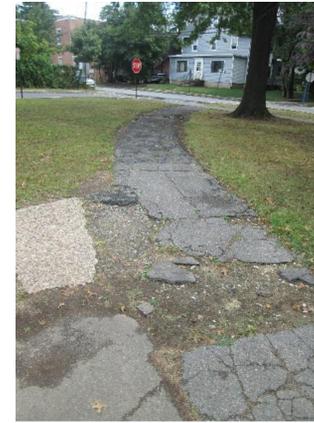
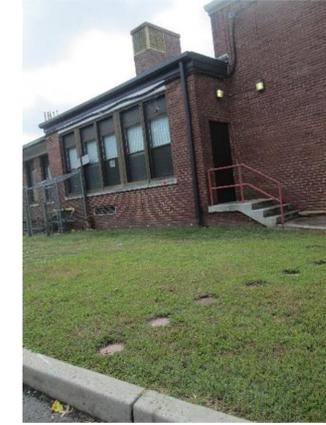
1 BIORETENTION SYSTEM: A bioretention system could be installed along the northeastern side of the building to intercept runoff from a downspout. A bioretention system will reduce runoff and allow stormwater infiltration, decreasing the amount of contaminants that reach catch basins.

2 POROUS PAVEMENT: The walking path near the southeast part of the site, that is in poor condition, could be replaced with porous pavement, which will promote groundwater recharge and filter stormwater.

<p>Location: 24 Durham Avenue Metuchen, NJ 08840</p>	<p>Municipality: Metuchen Borough</p>
<p>Green Infrastructure Description: bioretention system (rain garden) downspout disconnection educational program porous pavement</p>	<p>Subwatershed: South Fork of Bound Brook</p> <p>Targeted Pollutants: total nitrogen (TN), total phosphorous (TP), and total suspended solids (TSS) in surface runoff</p>
<p>Mitigation Opportunities: recharge potential: yes stormwater peak reduction potential: yes TSS removal potential: yes</p>	<p>Stormwater Captured and Treated Per Year: bioretention system: 15,600 gal. porous pavement: 10,600 gal.</p>
<p>Existing Conditions and Issues: This site contains several impervious surfaces including driveways, parking areas, walkways, and a school complex. These impervious surfaces are directly connected to a storm sewer system. The pavement throughout the property is in good condition with the exception of the sidewalk near Durham Avenue, which is cracked and broken in many places. At the time of the site visit, there was visible accumulation of sediment and debris around the sidewalk. Several directly connected downspouts were observed outside of the school complex.</p>

<p>Proposed Solution(s): A downspout can be disconnected and routed to a bioretention system on the eastern side of the property. The sidewalk on the southeastern side of the property near Durham Avenue could be replaced with porous pavement. An educational program also could be delivered at this school.</p>	
<p>Anticipated Benefits: Since the bioretention systems would be designed to capture, treat, and infiltrate the entire 2-year design storm (3.3 inches of rain over 24 hours), these systems are estimated to achieve a 95% pollutant load reduction for TN, TP, and TSS. A bioretention system would also provide ancillary benefits such as enhance wildlife habitat and aesthetic appeal. Porous pavement allows stormwater to penetrate through to soil layers which will promote groundwater recharge as well as intercept and filter stormwater runoff. This system will achieve the same level of pollutant load reduction for TN, TP and TSS as a bioretention system. This system will also reduce localized flooding and erosion. Rutgers Cooperative Extension could additionally present the <i>Stormwater Management in Your Schoolyard</i> program to students and include them in bioretention system planting efforts to enhance the program.</p>

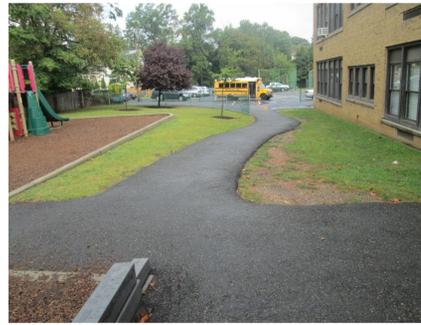
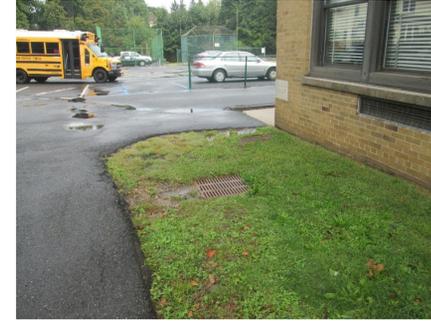
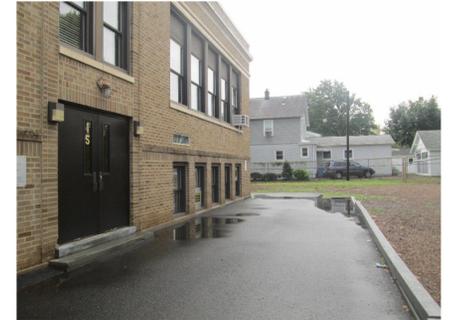
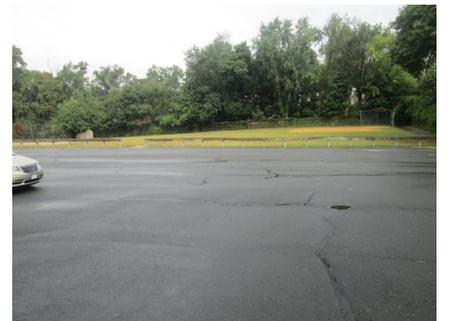
1 BIORETENTION SYSTEM: Three bioretention systems could be installed at the Moss School. The first (1) could be installed in the corner of the walkway before the playground with a curb cut; the second (2) bioretention system could be installed in the eroded turf grass area along the walkway using the existing catch basin as an overflow, and the third (3) could go below the parking lot near the entrance to the ball fields. All systems would intercept runoff from the surrounding paved areas. Bioretention systems will reduce runoff and allow stormwater infiltration, decreasing the amount of contaminants that reach catch basins.

<p>Location: 16 Simpson Place Metuchen, NJ, 08840</p>	<p>Municipality: Metuchen Borough</p> <p>Subwatershed: Mill Brook / Martins Creek</p>
<p>Green Infrastructure Description: bioretention systems curb cut(s) education program</p>	<p>Targeted Pollutants: total nitrogen (TN), total phosphorous (TP), and total suspended solids (TSS) in surface runoff</p>
<p>Mitigation Opportunities: recharge potential: yes stormwater peak reduction potential: yes TSS removal potential: yes</p>	<p>Stormwater Captured and Treated Per Year: bioretention system #1: 10,400 gal. bioretention system #2: 10,400 gal. bioretention system #3: 104,200 gal.</p>
<p>Existing Conditions and Issues: This site contains several impervious surfaces including driveways, walkways, a parking lot, and a school complex. These impervious surfaces are directly connected to a storm sewer system. Three areas of interest were identified through a site visit. Two of these areas are located at the southwest corner of the building along its walkway. Ponding was observed in the southwestern corner of the walkway at the time of the site visit. A grass area along the building's western edge was also visibly eroded at the time of the visit, and a catch basin was identified nearby. An overland flow path for runoff appears to run through the grass and along its western edge. A third area of interest was identified where the grass of the ball fields meets the parking lot. Erosion has taken place at this location and bare soil was exposed at the time of the site visit. The pavement throughout the property is in good condition. Ponding and soil erosion were observed in various locations around the property at the time of the site visit. Inefficient drainage around the perimeter of the building should be remedied to prevent seepage into the building's basement.</p>

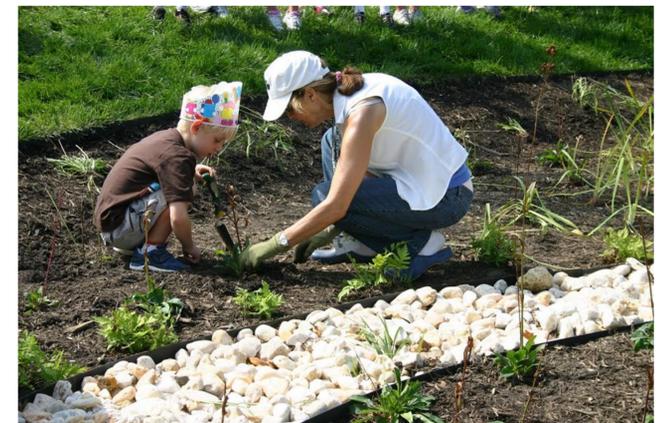
EDUCATIONAL PROGRAM

EDUCATIONAL PROGRAM: The RCE Water Resources Program's *Stormwater Management in Your Schoolyard* program can be delivered at the Moss School to educate the students about stormwater management and engage them in building the bioretention systems.
