# Richland Fire Company

**Subwatershed:** South River  
**Site Area:** 144,978 sq. ft.  
**Address:** 876 Main Avenue  
Buena, NJ 08310  
**Block and Lot:** Block 4529, Lot 4

# GREEN INFRASTRUCTURE RECOMMENDATIONS

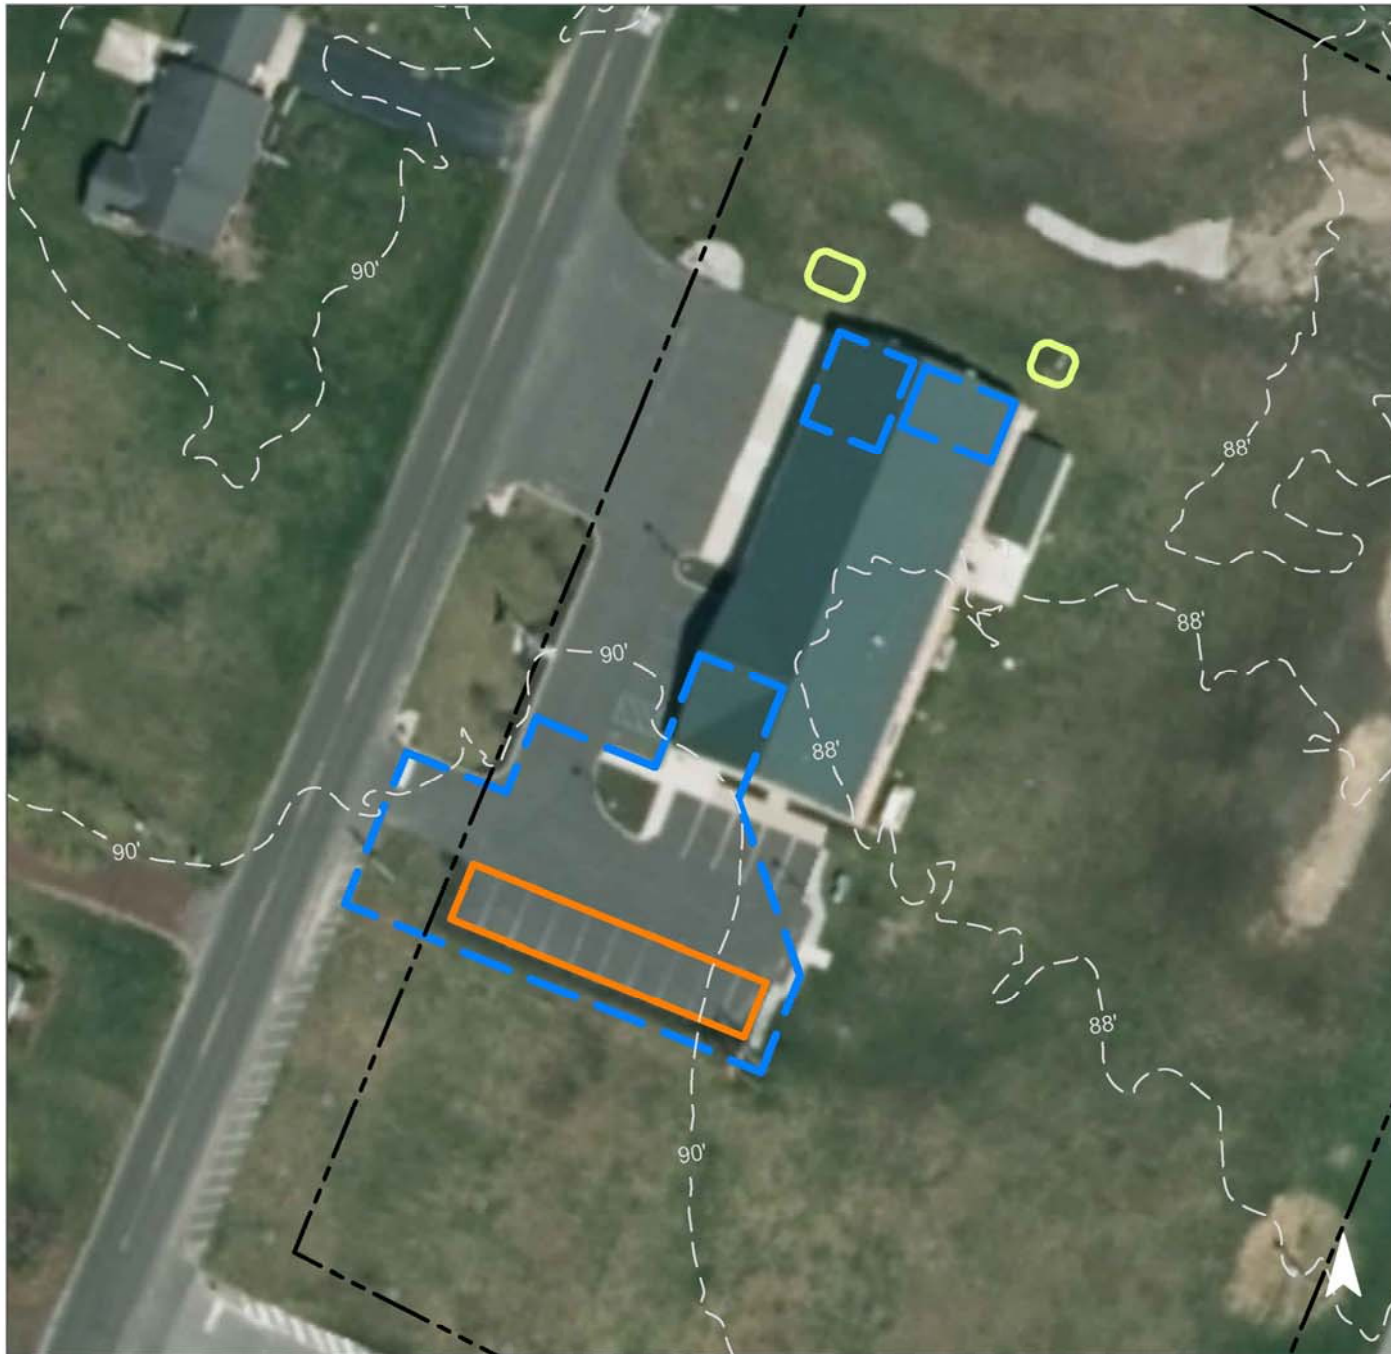
## Richland Fire Company

Two rain gardens can be installed at the two north corners of the building to capture, treat, and infiltrate rooftop runoff. The southernmost row of parking spaces can be replaced with pervious pavement to capture and infiltrate stormwater. A preliminary soil assessment suggests that more soil testing would be required before determining the soil's suitability for green infrastructure.

Recommended Green Infrastructure Practices	Recharge Potential (Mgal/yr)	TSS Removal Potential (lbs/yr)	Maximum Volume Reduction Potential (gal/storm)	Peak Discharge Reduction Potential (cu. ft./second)	Estimated Size (sq. ft.)	Estimated Cost
Bioretention systems	0.035	6	2,580	0.10	340	\$1,700
Pervious pavement	0.327	55	24,000	0.90	1,825	\$45,625
