**Hamilton Township (Mercer County)
Stormwater Basin Assessment Summary
Past Priority Addendum (Year 5B)**

Developed by the Rutgers Cooperative Extension Water Resources Program
Funded by Hamilton Township, Mercer County, New Jersey

November 27, 2019

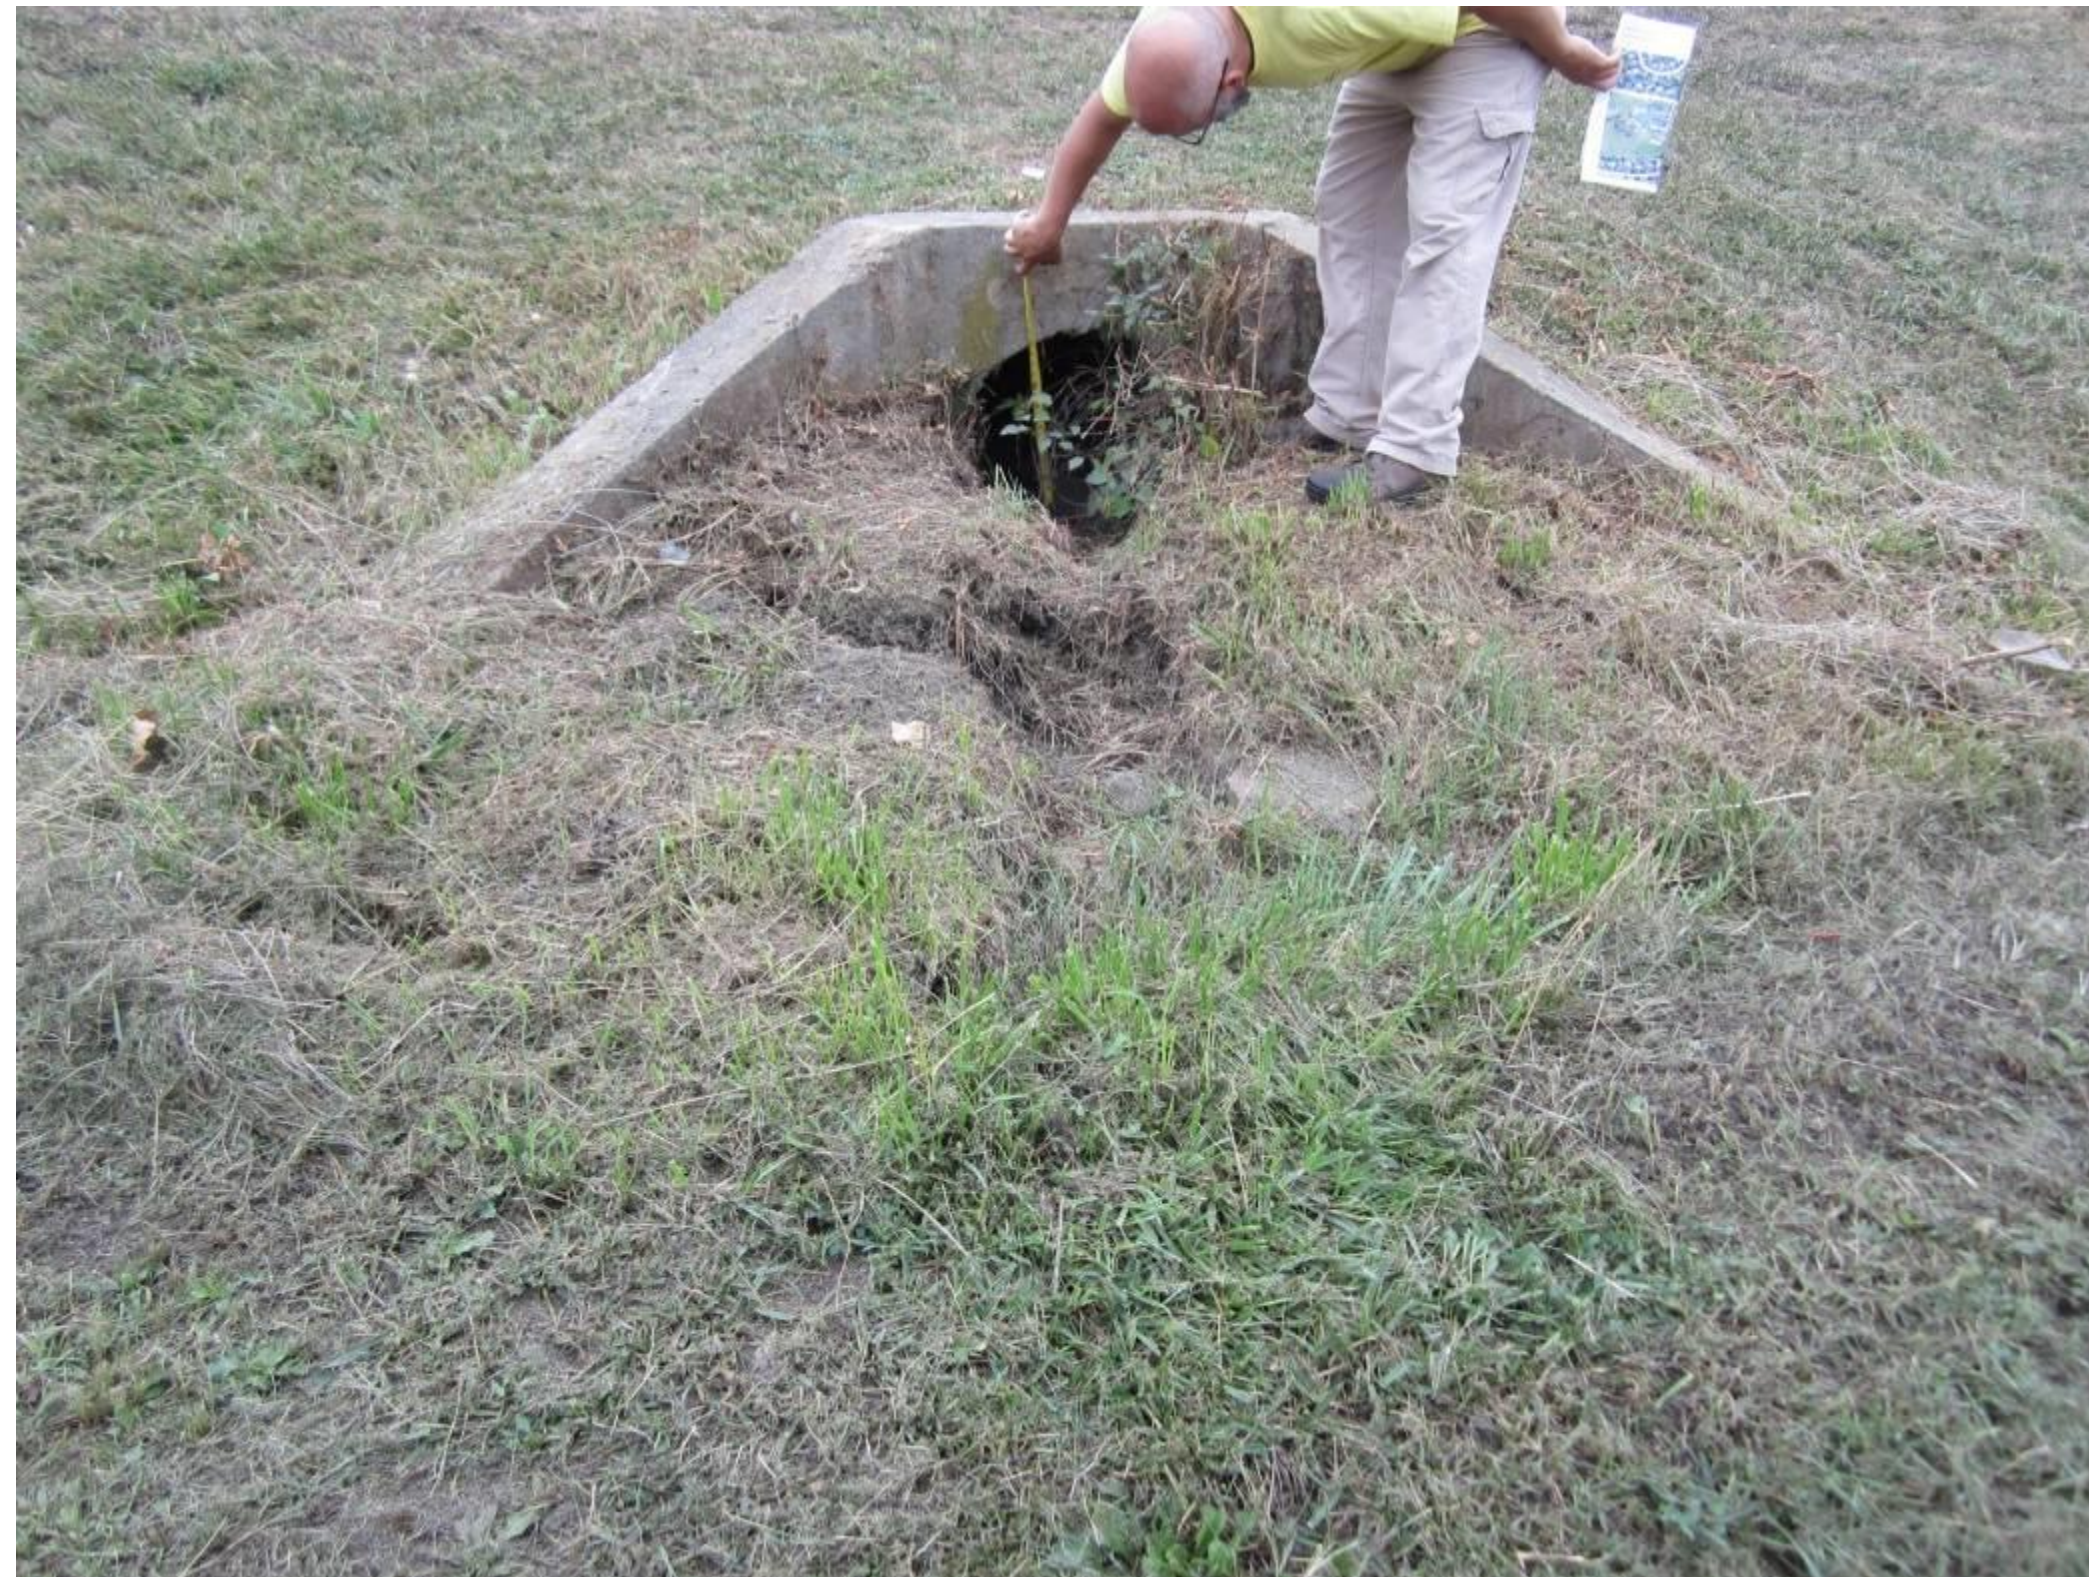
Sediment accumulation in the inlet

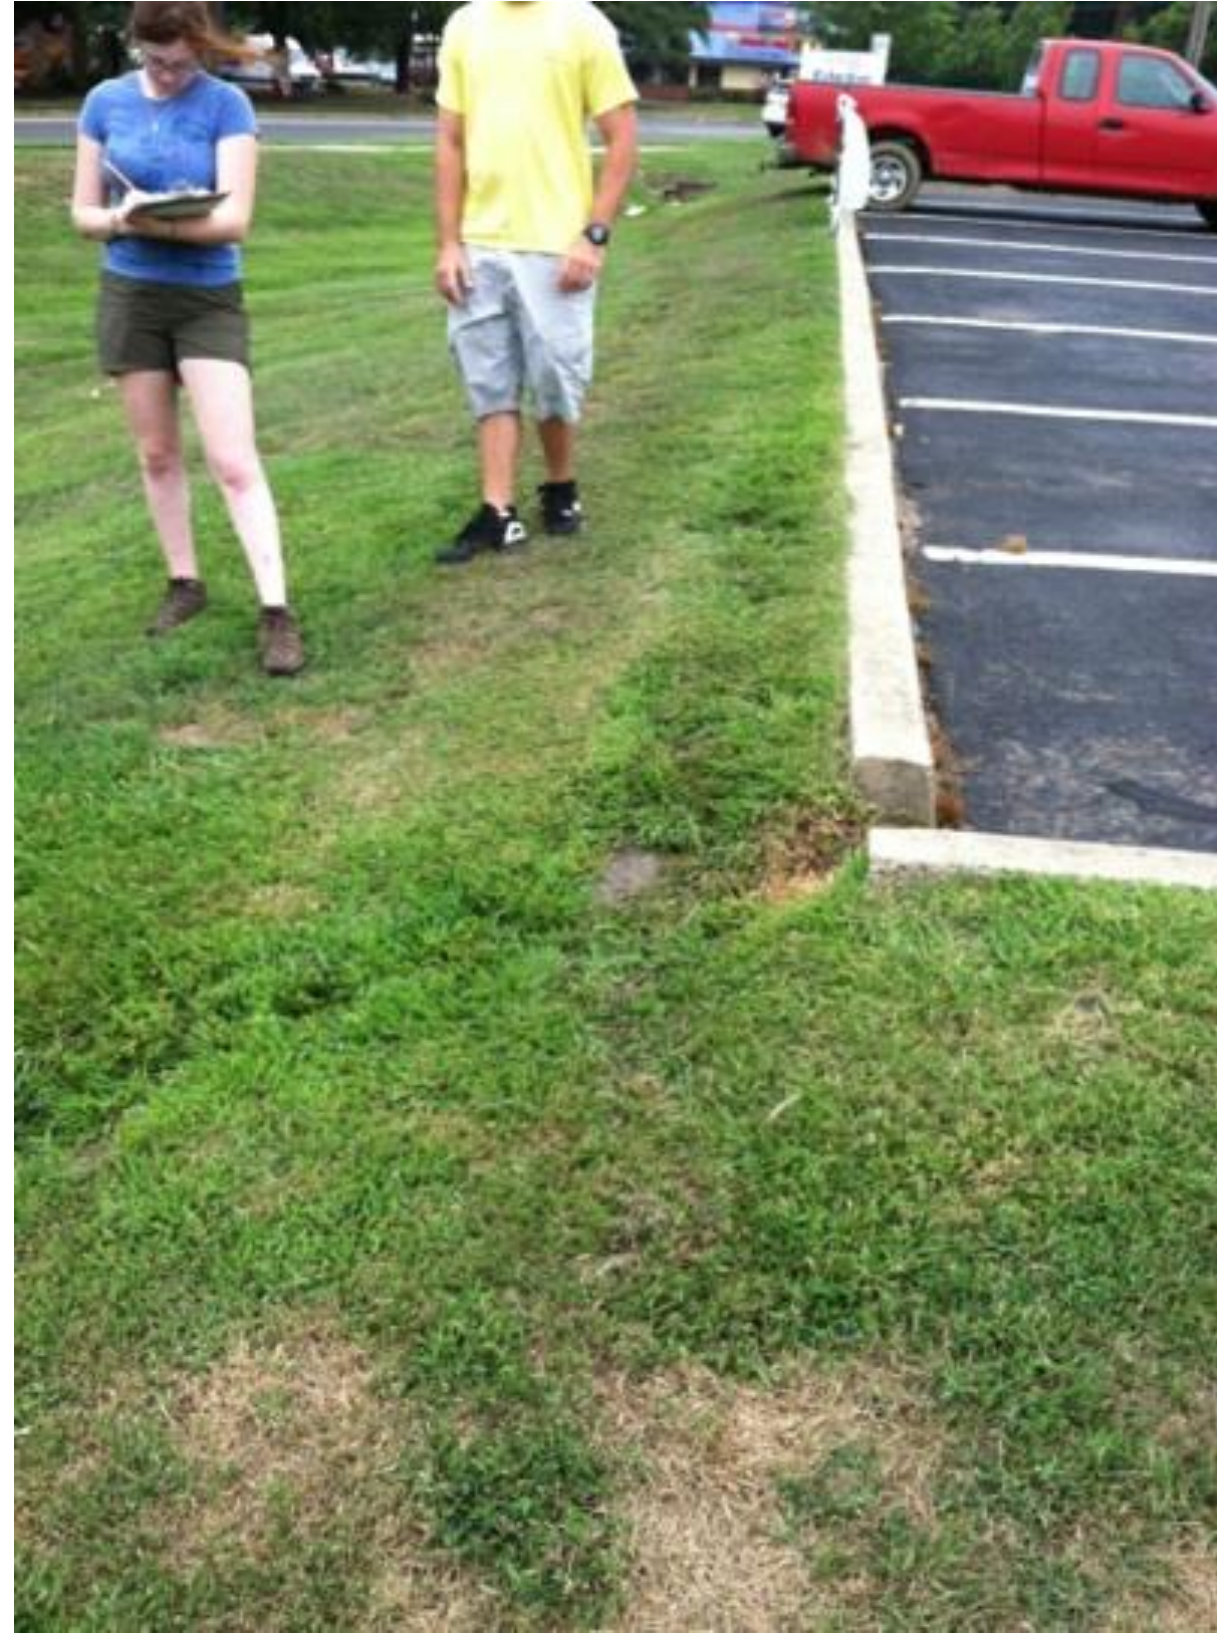
Erosion at inlet

- Curb cuts (inlets) are damaged with erosion evident
- Outlet has structural damage and erosion

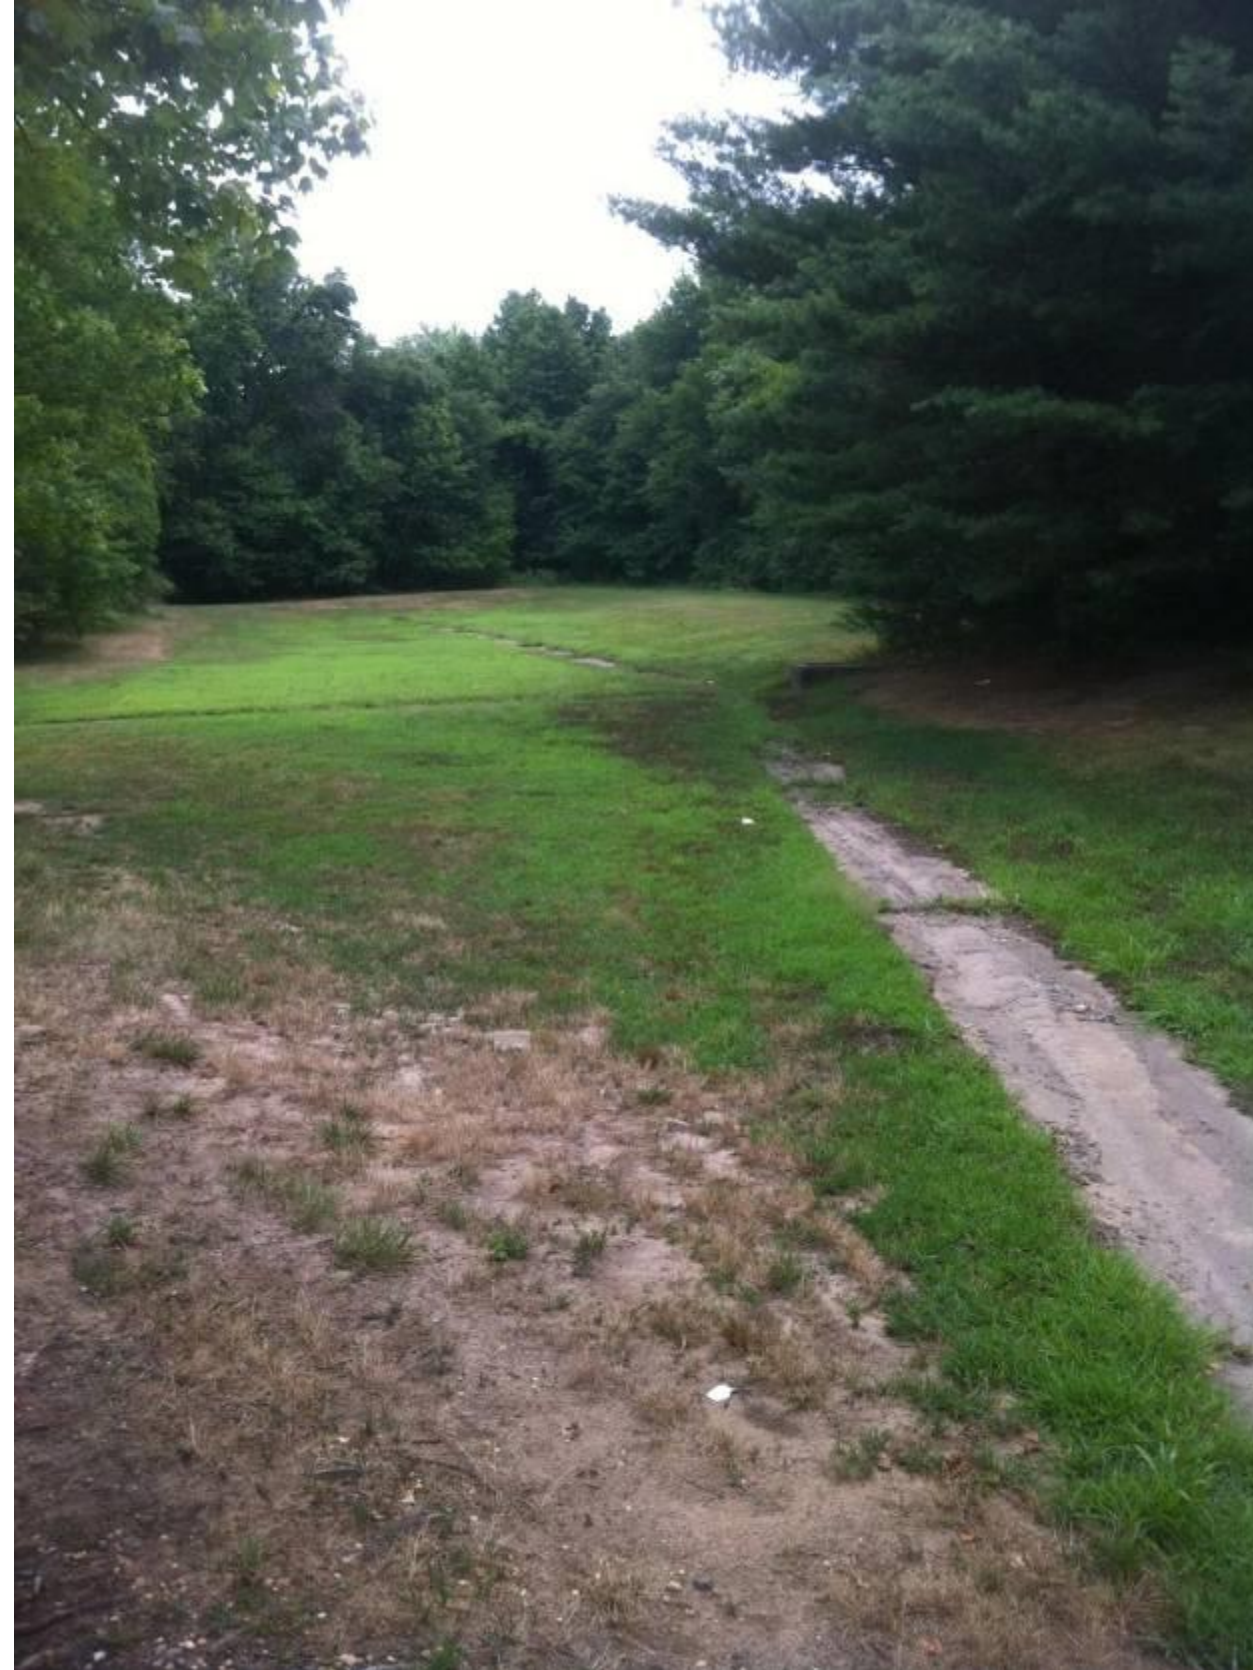
Basin bottom looking east

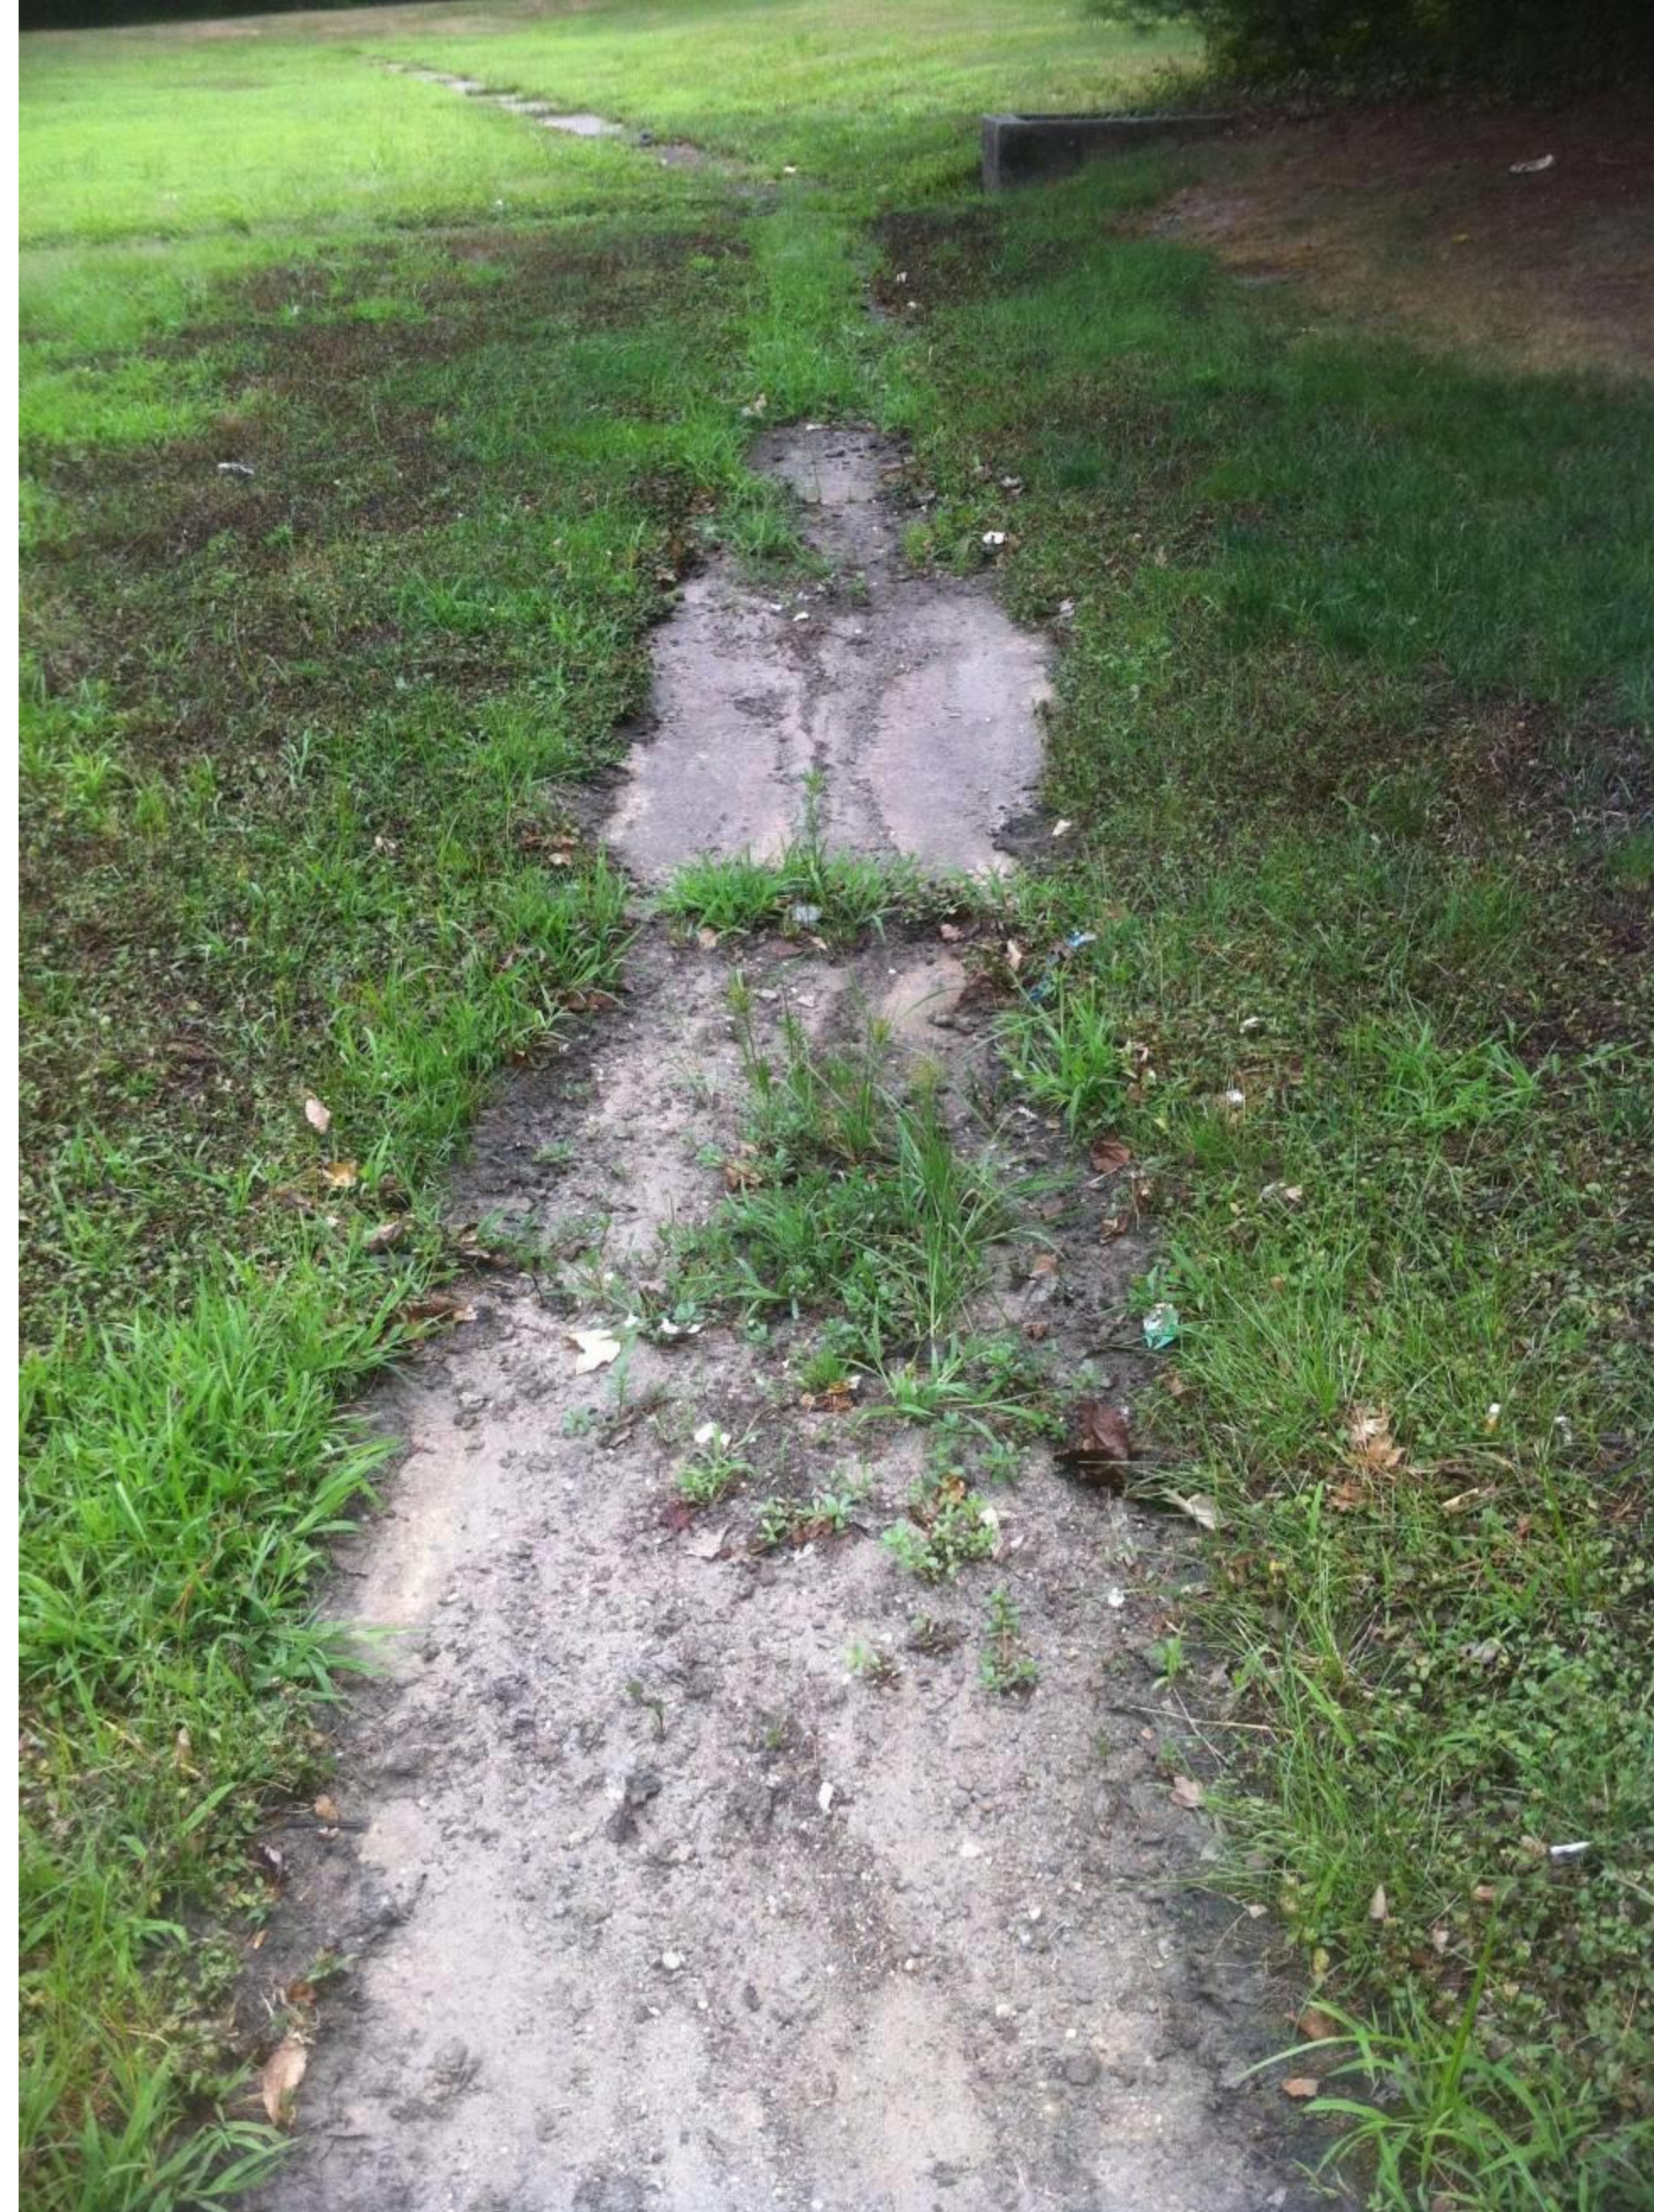
Sediment in low flow channel

- Excess sediment accumulation in low flow channels
- Outlet has structural damage
- Discharges directly to Miry Run

- Basin overall is in good condition
- Significant sediment buildup in low flow channel with grass growing over, resulting in standing water in low flow channels
- Potential retrofit by removing low flow channels to promote infiltration or naturalizing into a meadow with reduced mowing

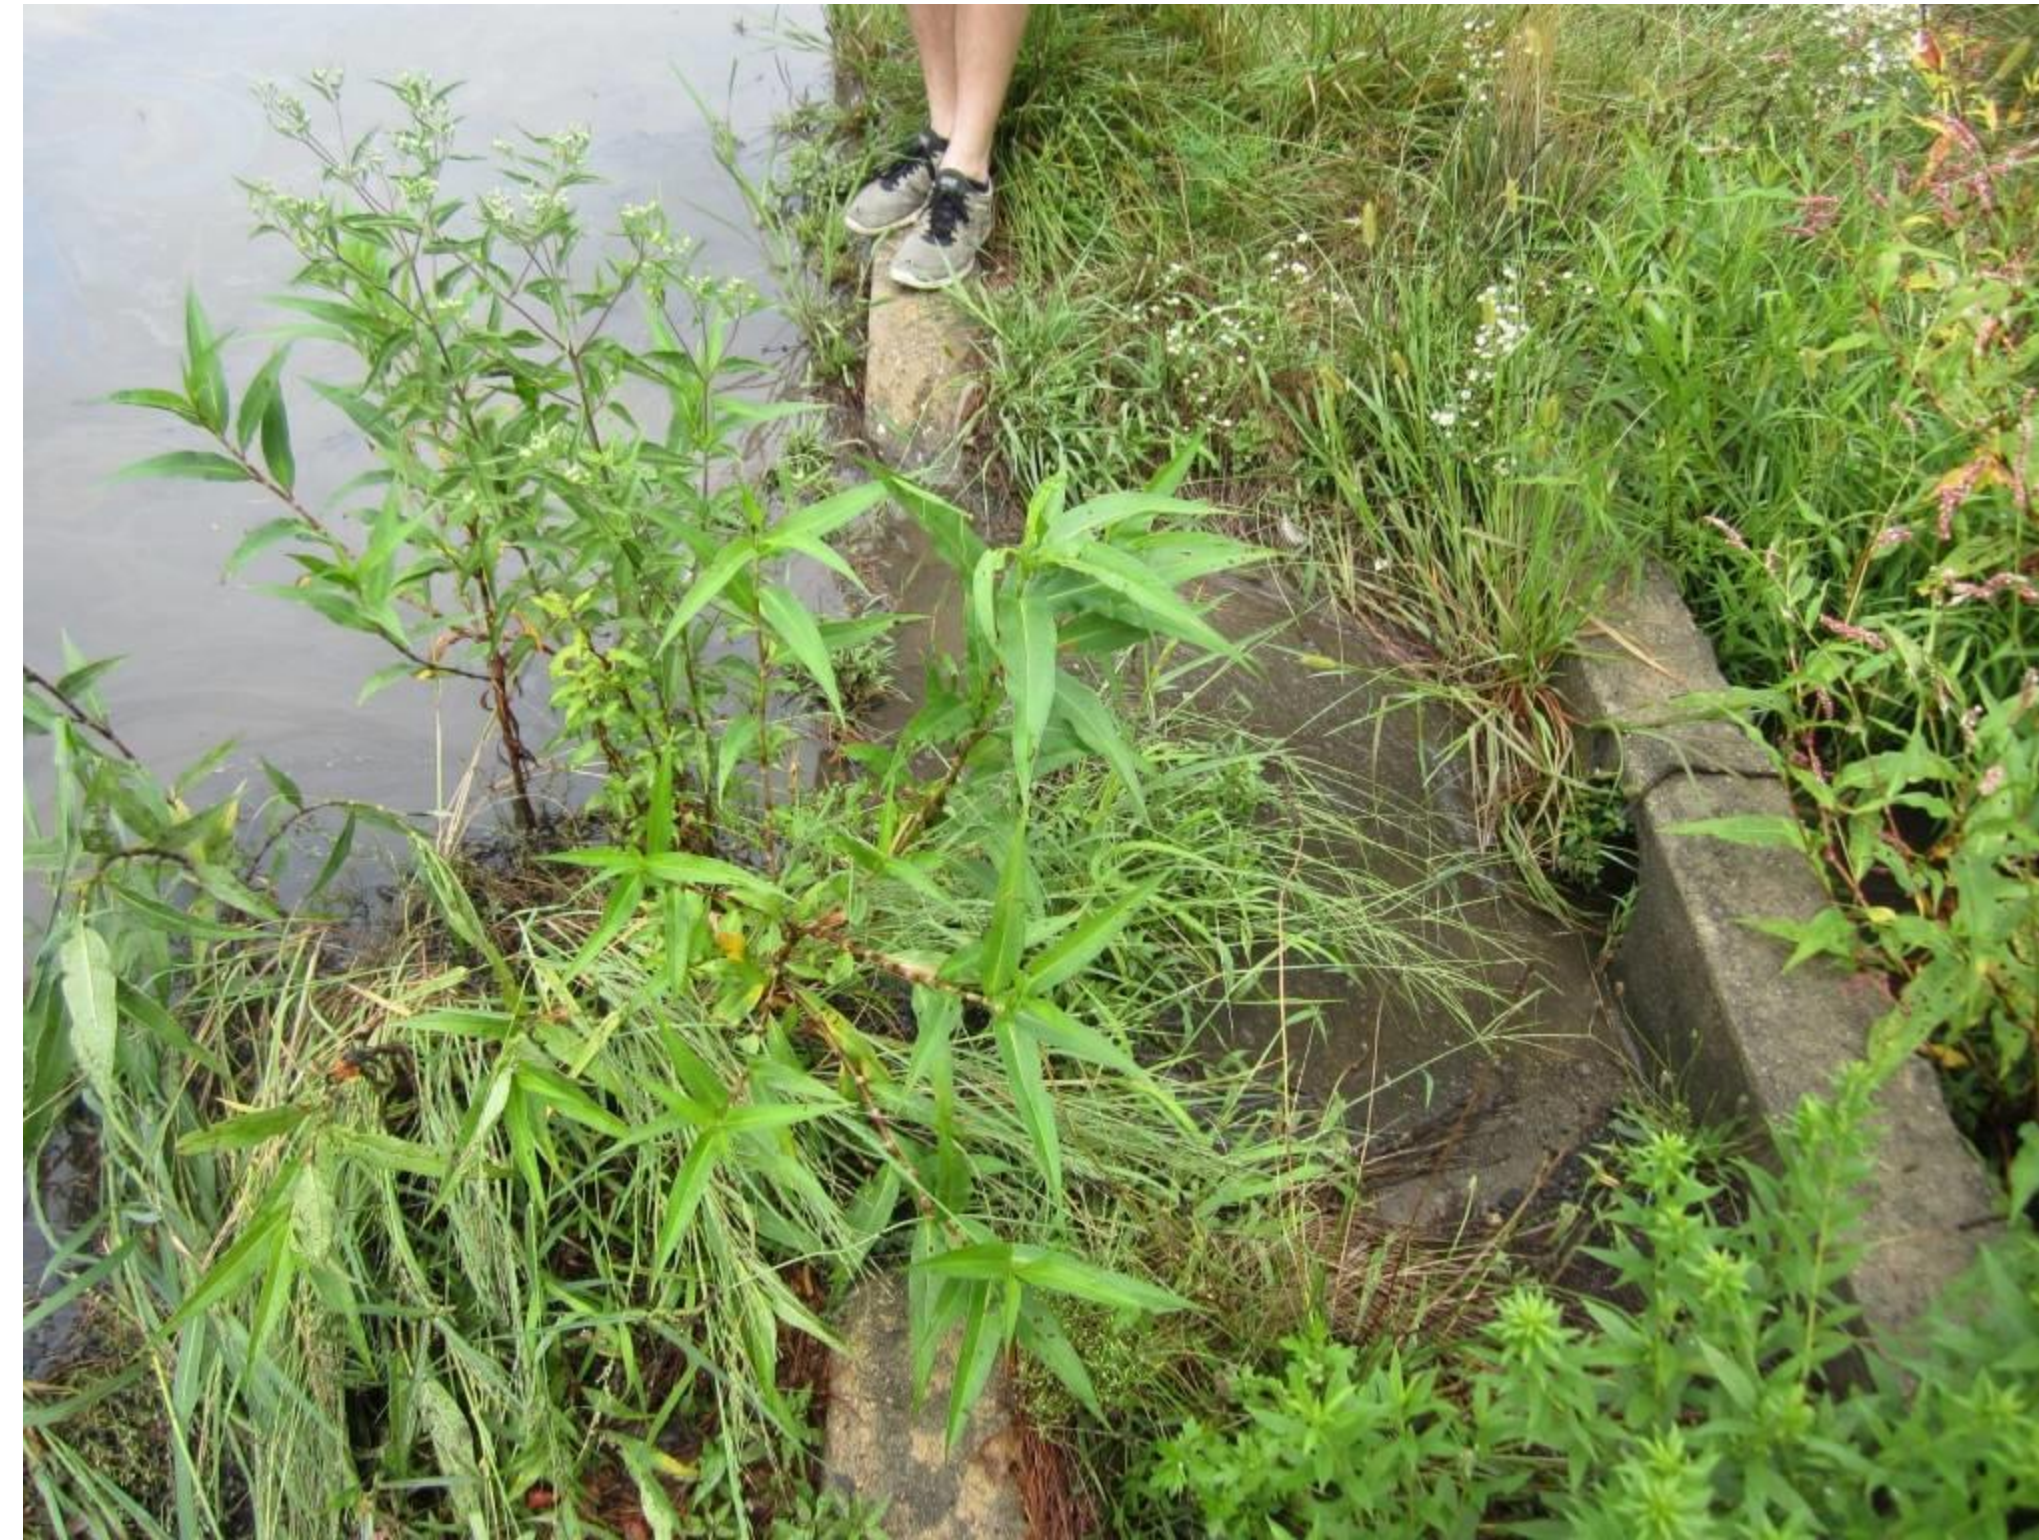
Inlet – curb cut

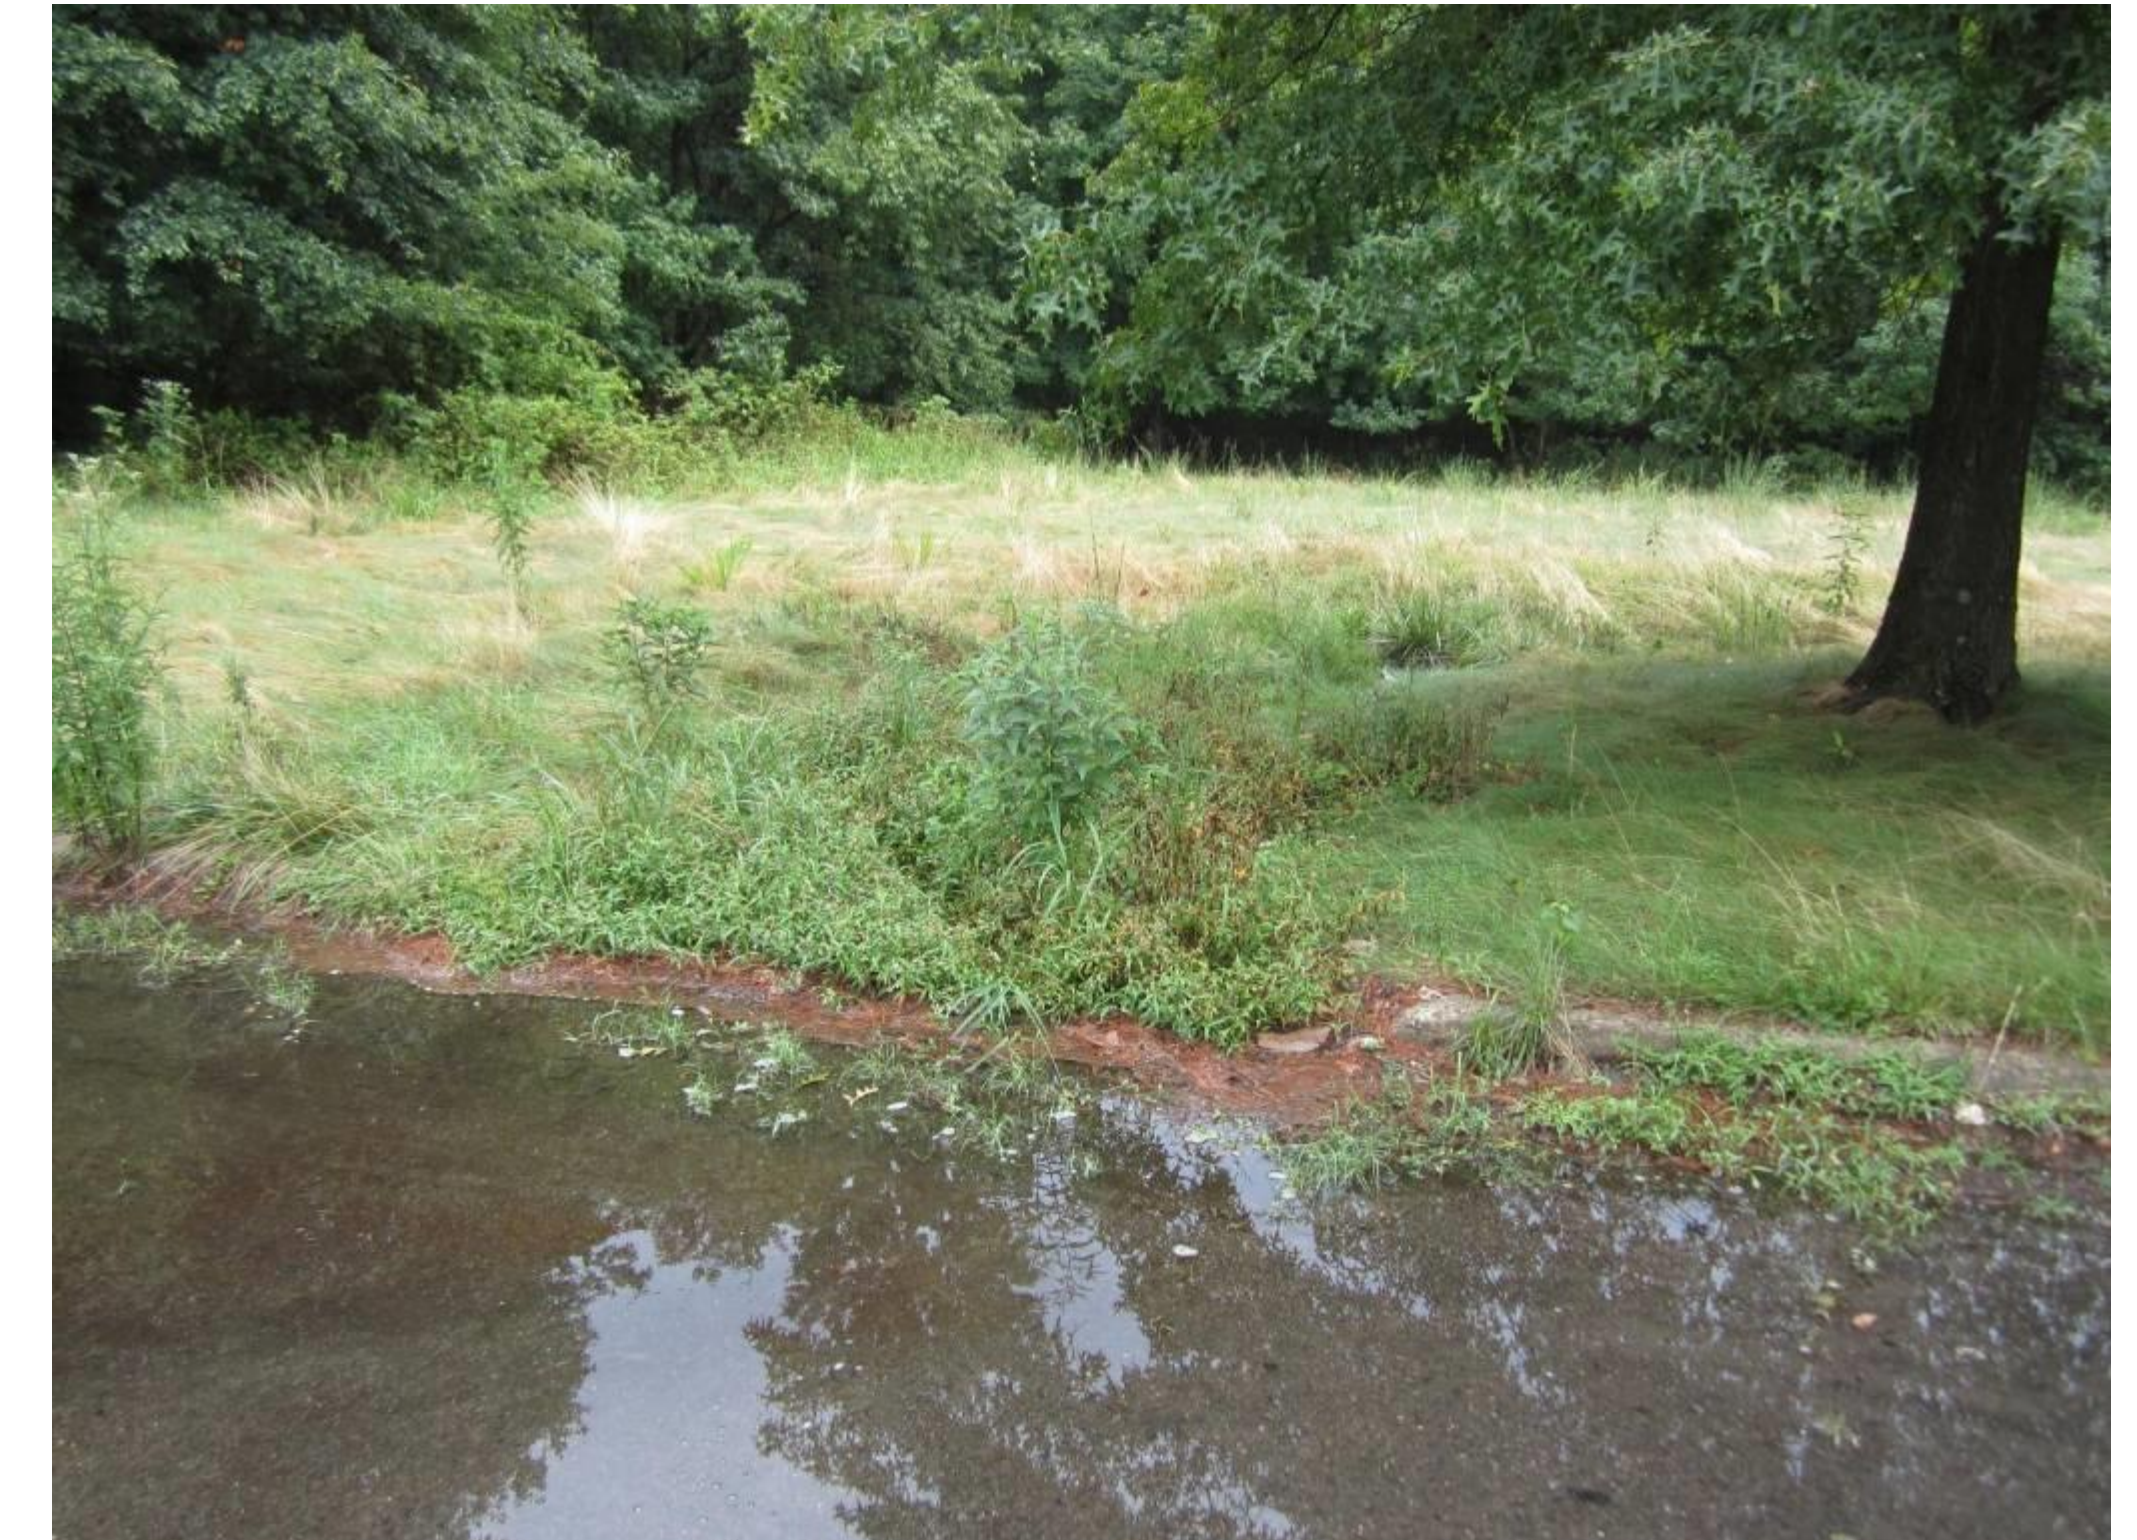
Clogged curb cut, ponding

- Severe standing water in parking lot, clear curb cut inlet to allow flow of water into the basin
- Establish meadow among grasses

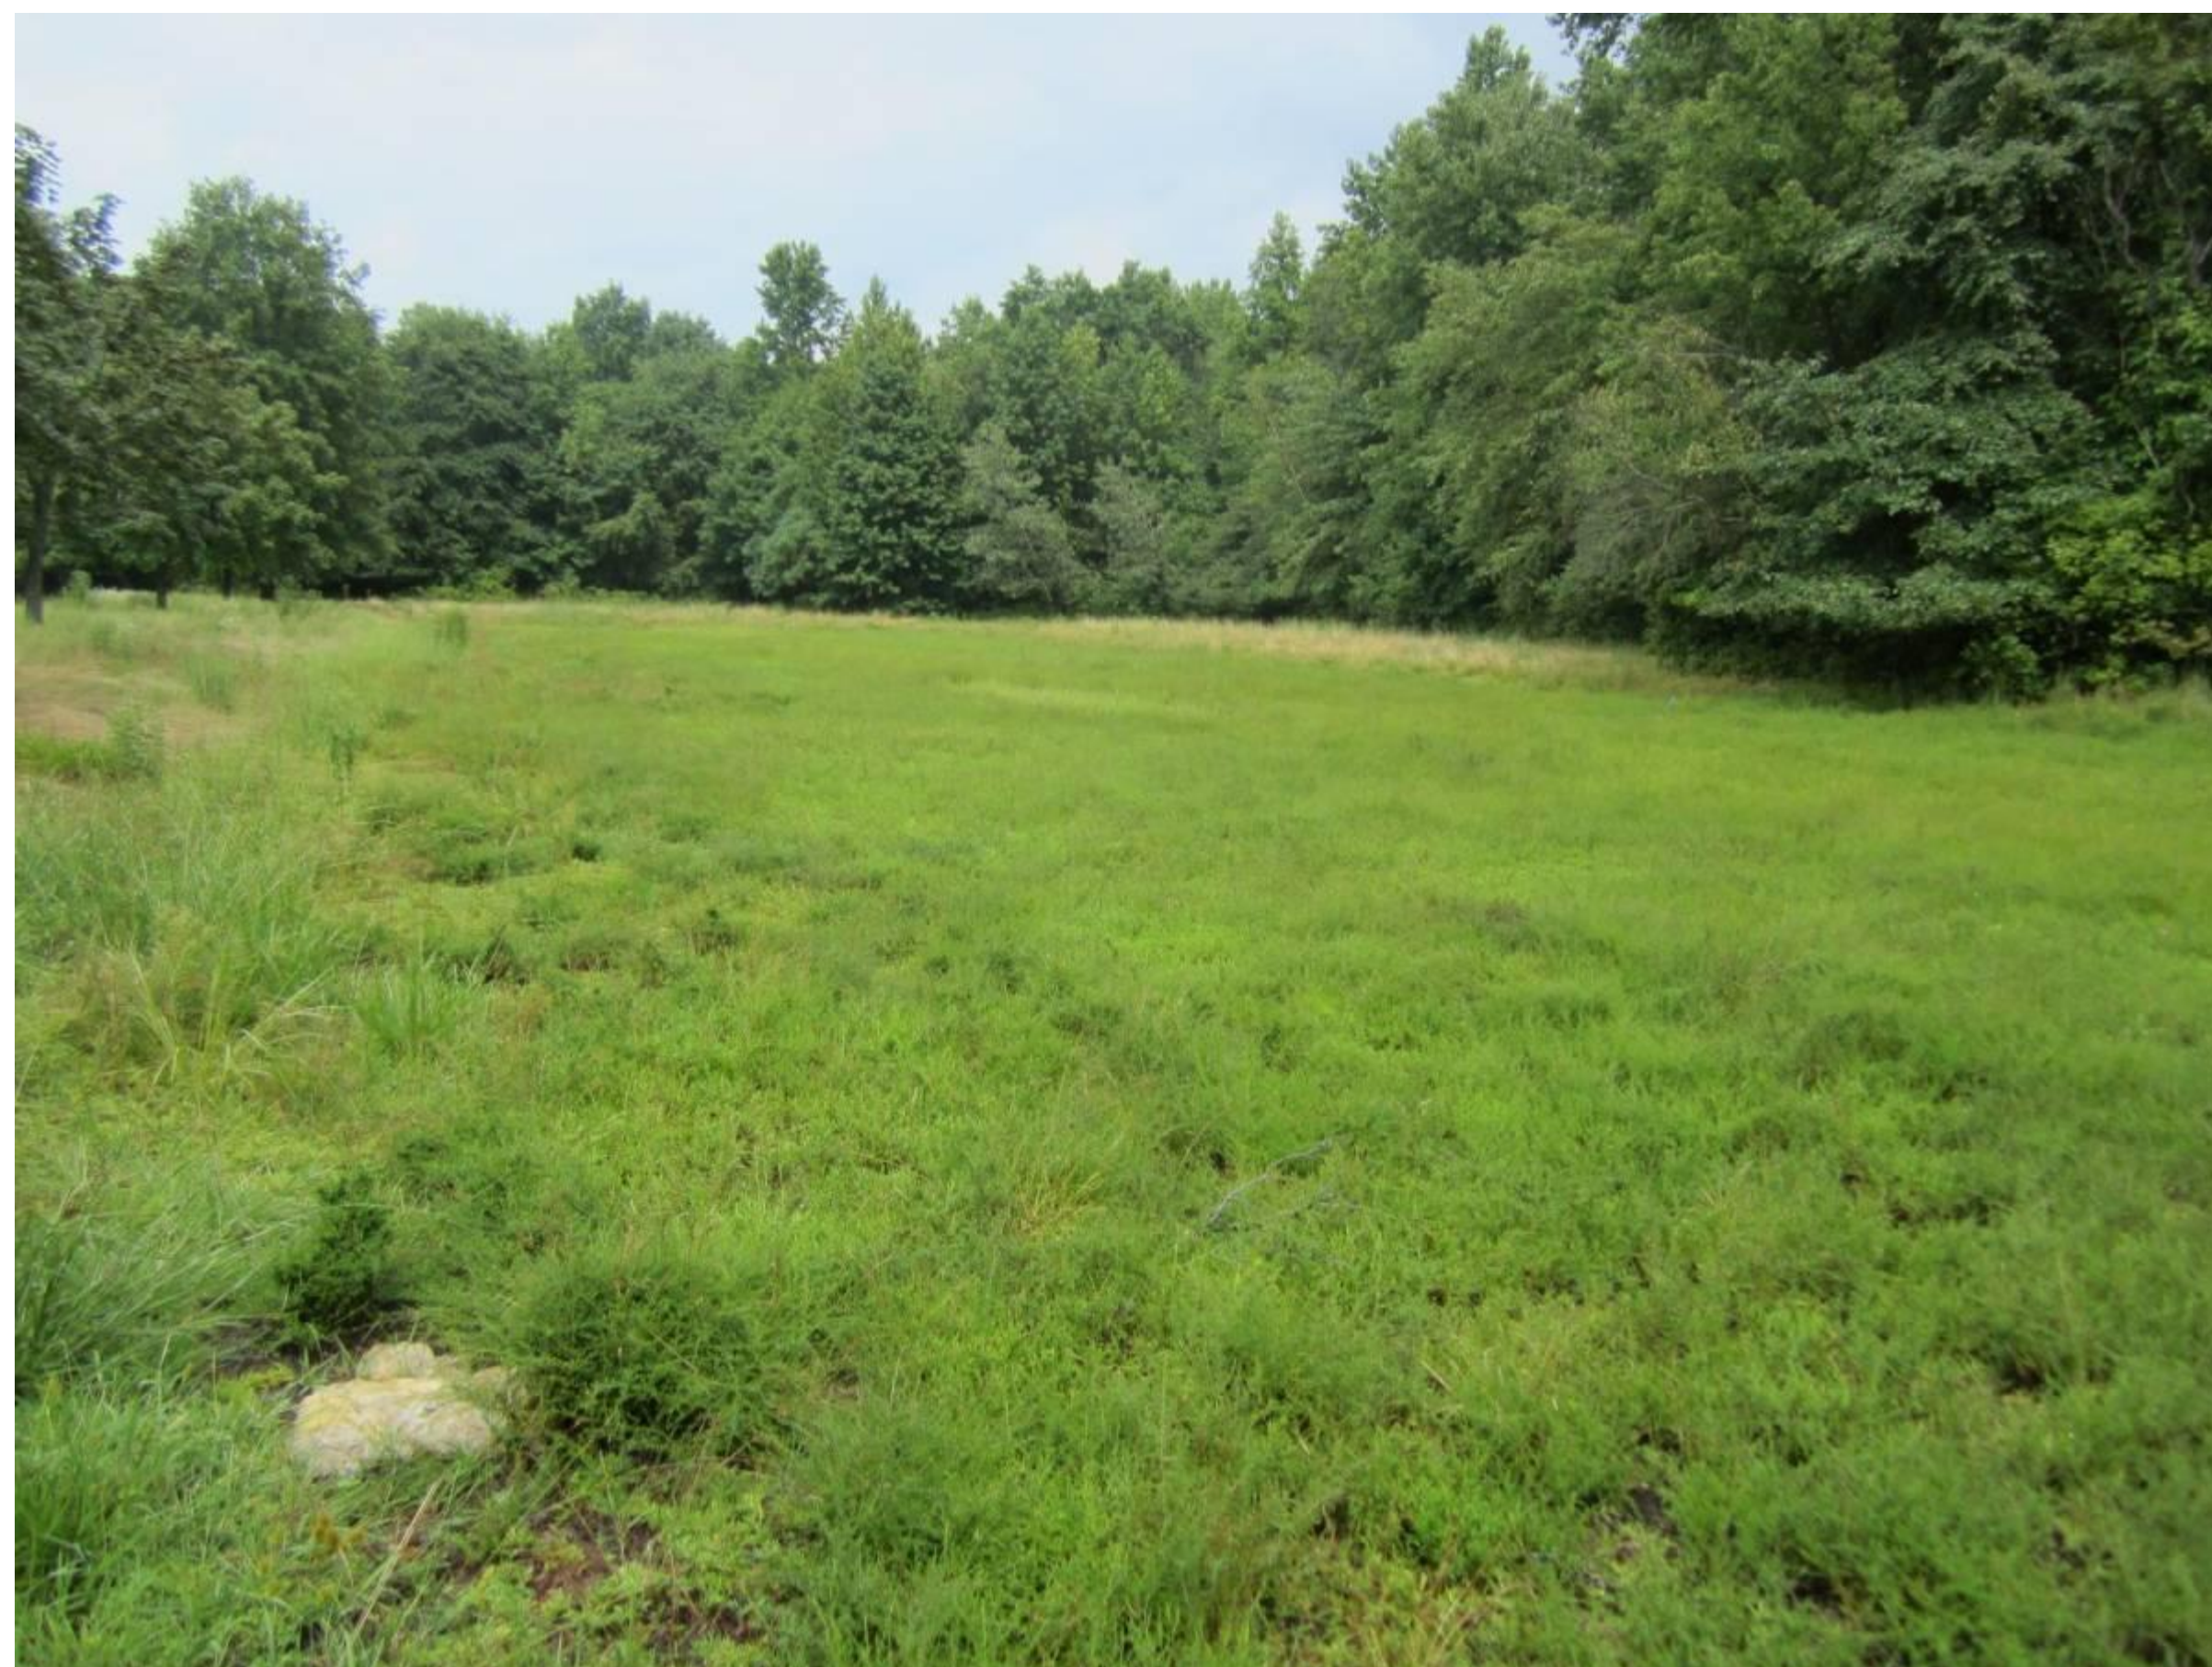
Basin bottom looking north
