**Hamilton Township (Mercer County)
Stormwater Basin Assessment Summary
Past Priority Addendum (Year 5B)**

Developed by the Rutgers Cooperative Extension Water Resources Program
Funded by Hamilton Township, Mercer County, New Jersey

November 27, 2019

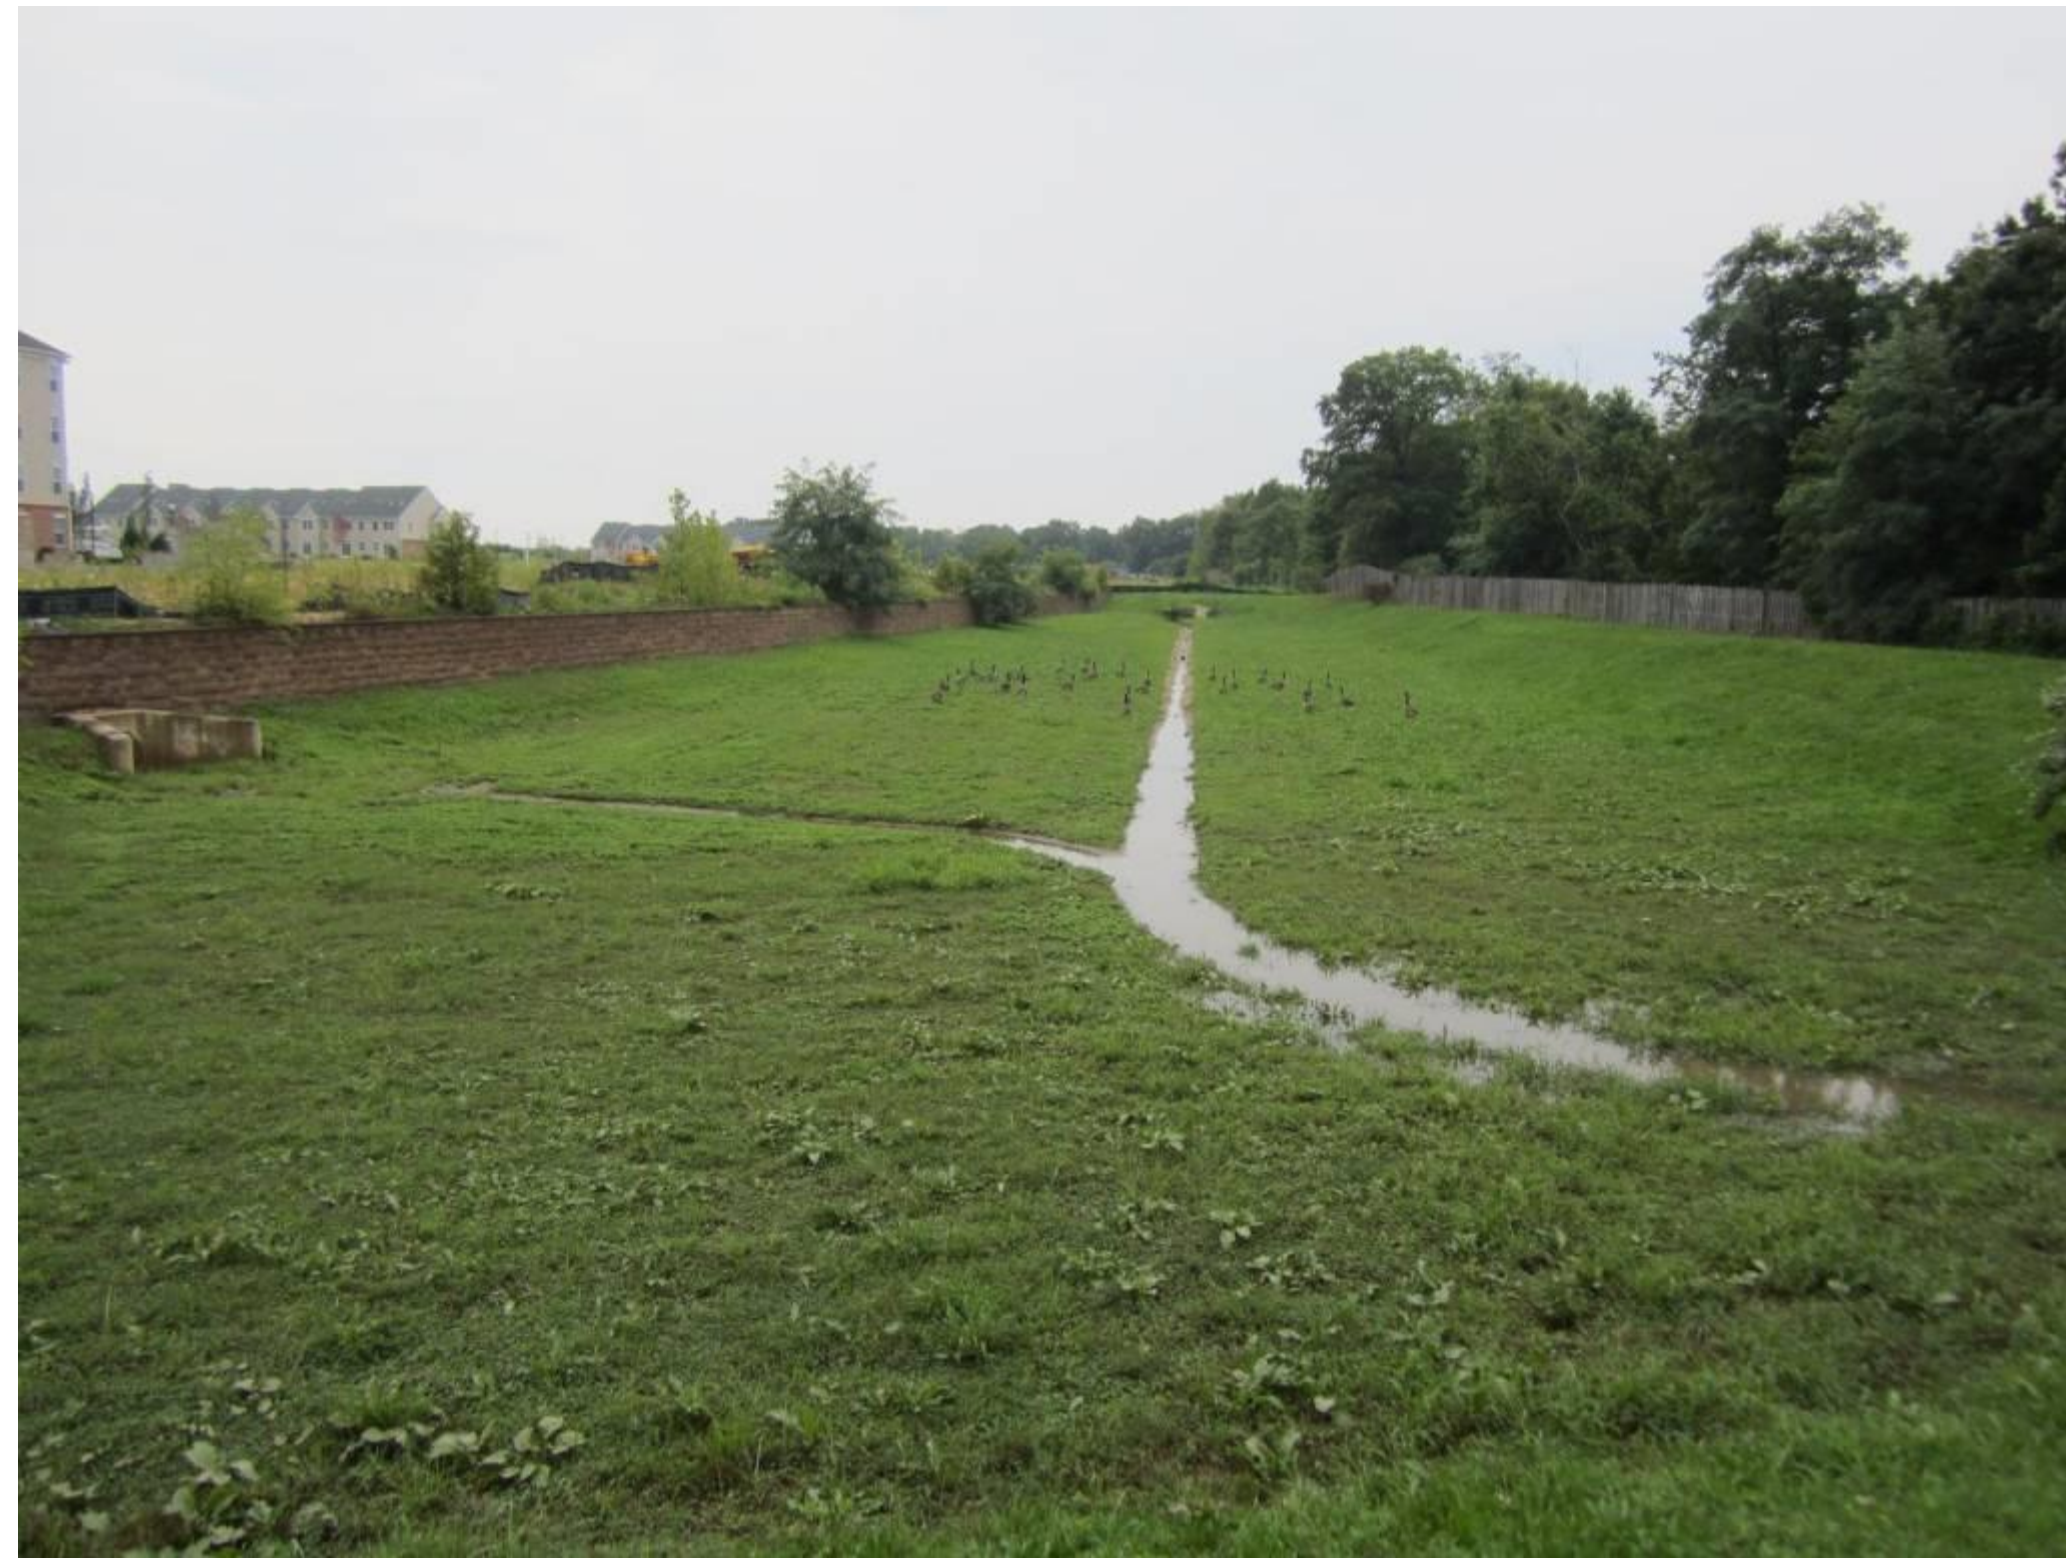
Basin bottom looking southwest

- Inlets and outlet have excess sediment accumulation obstructing flow
- Standing water in low flow channel and basin bottom
- Outlet has structural damage and missing grate

- Some signs of soil erosion by inlet
- Low flow channels can be removed to promote more infiltration

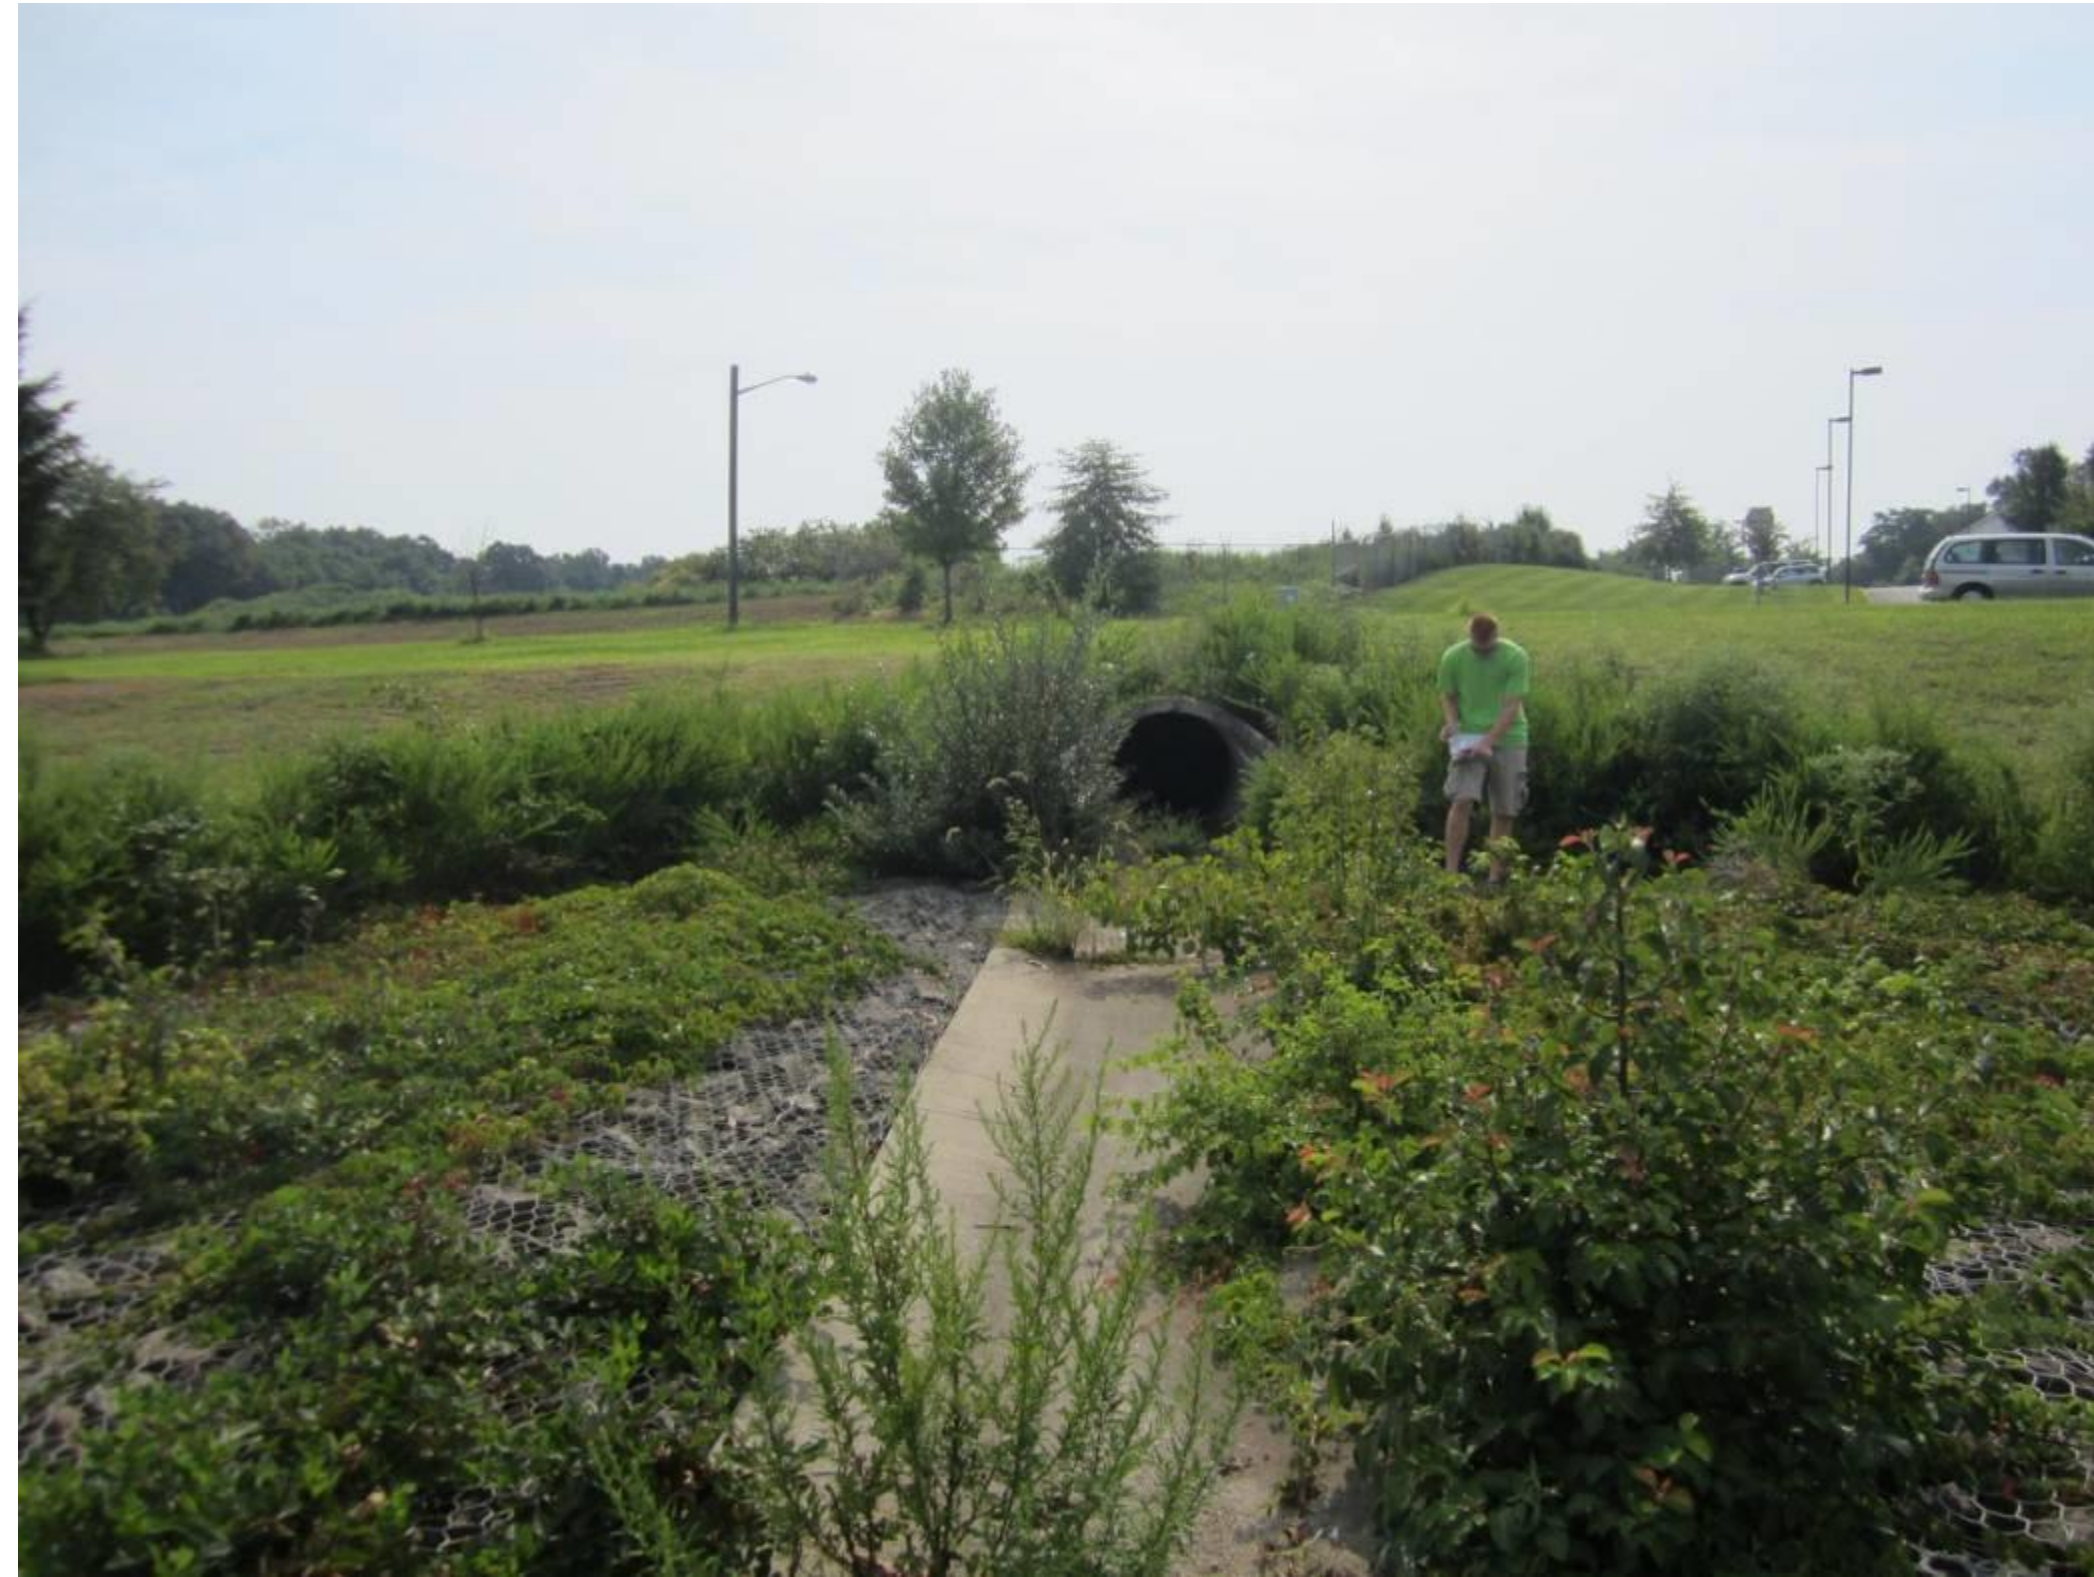
Inlet and rip rap protection

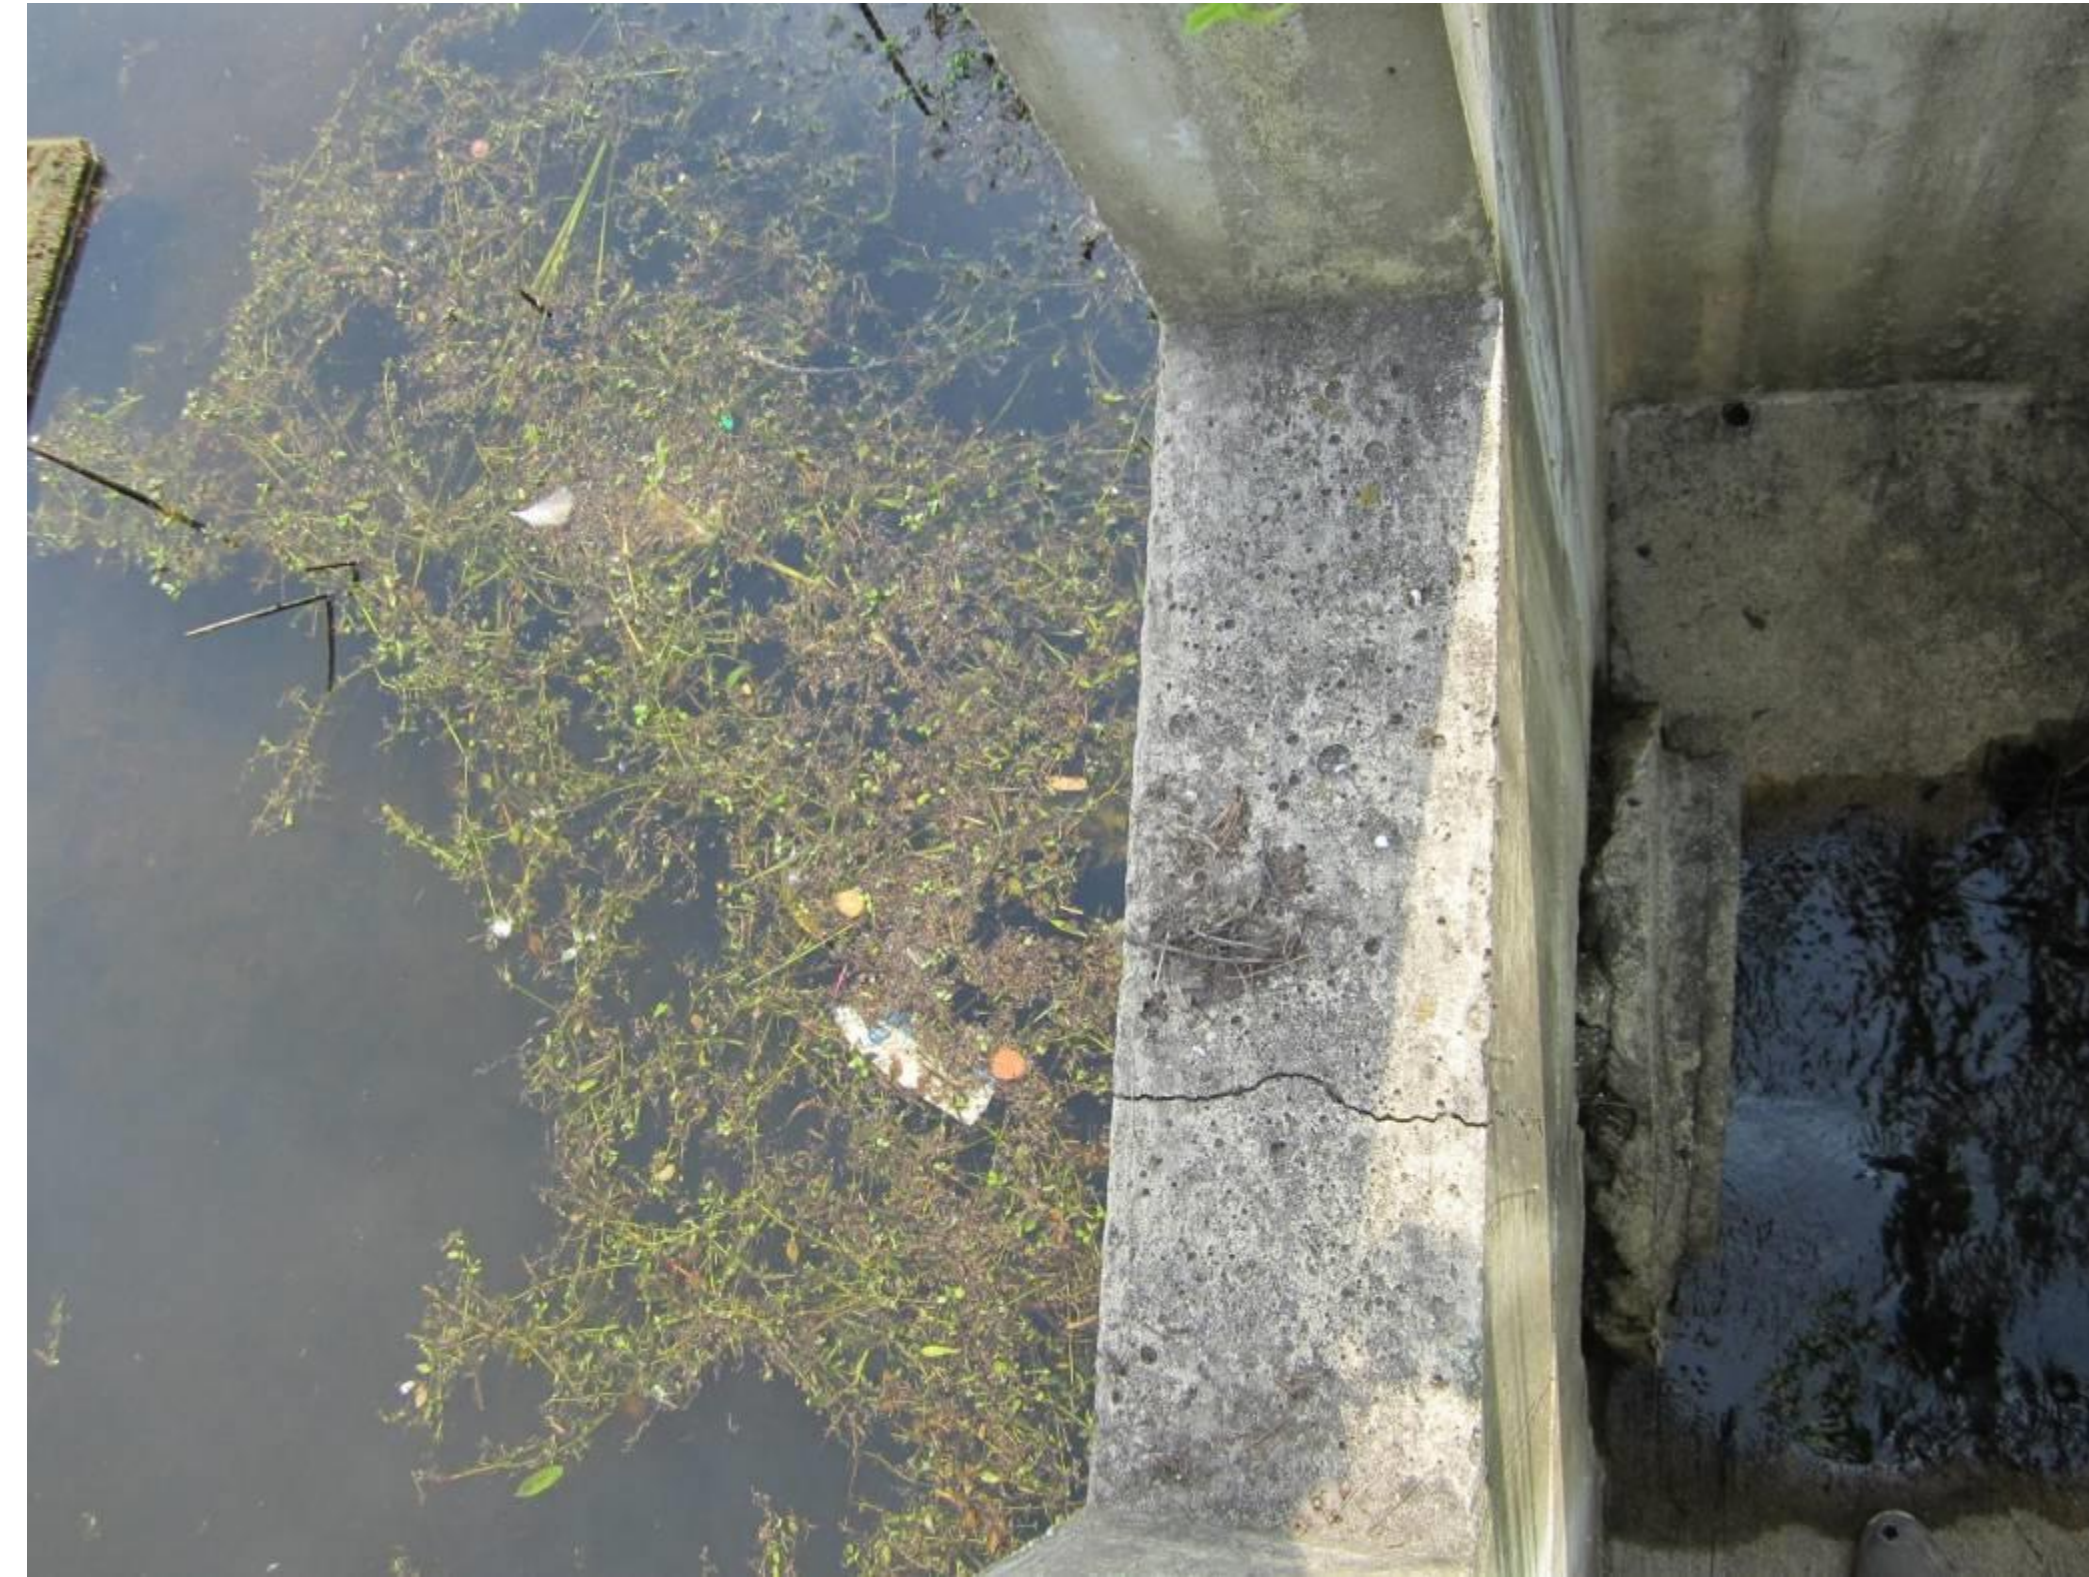
Clogged outlet structure

- Outlet has structural damage, significant debris/sediment accumulation obstructing flow
- Woody vegetation growth in and around basin
- Excessive ponding in front of outlet in entire south end of basin
- Significant mosquito population

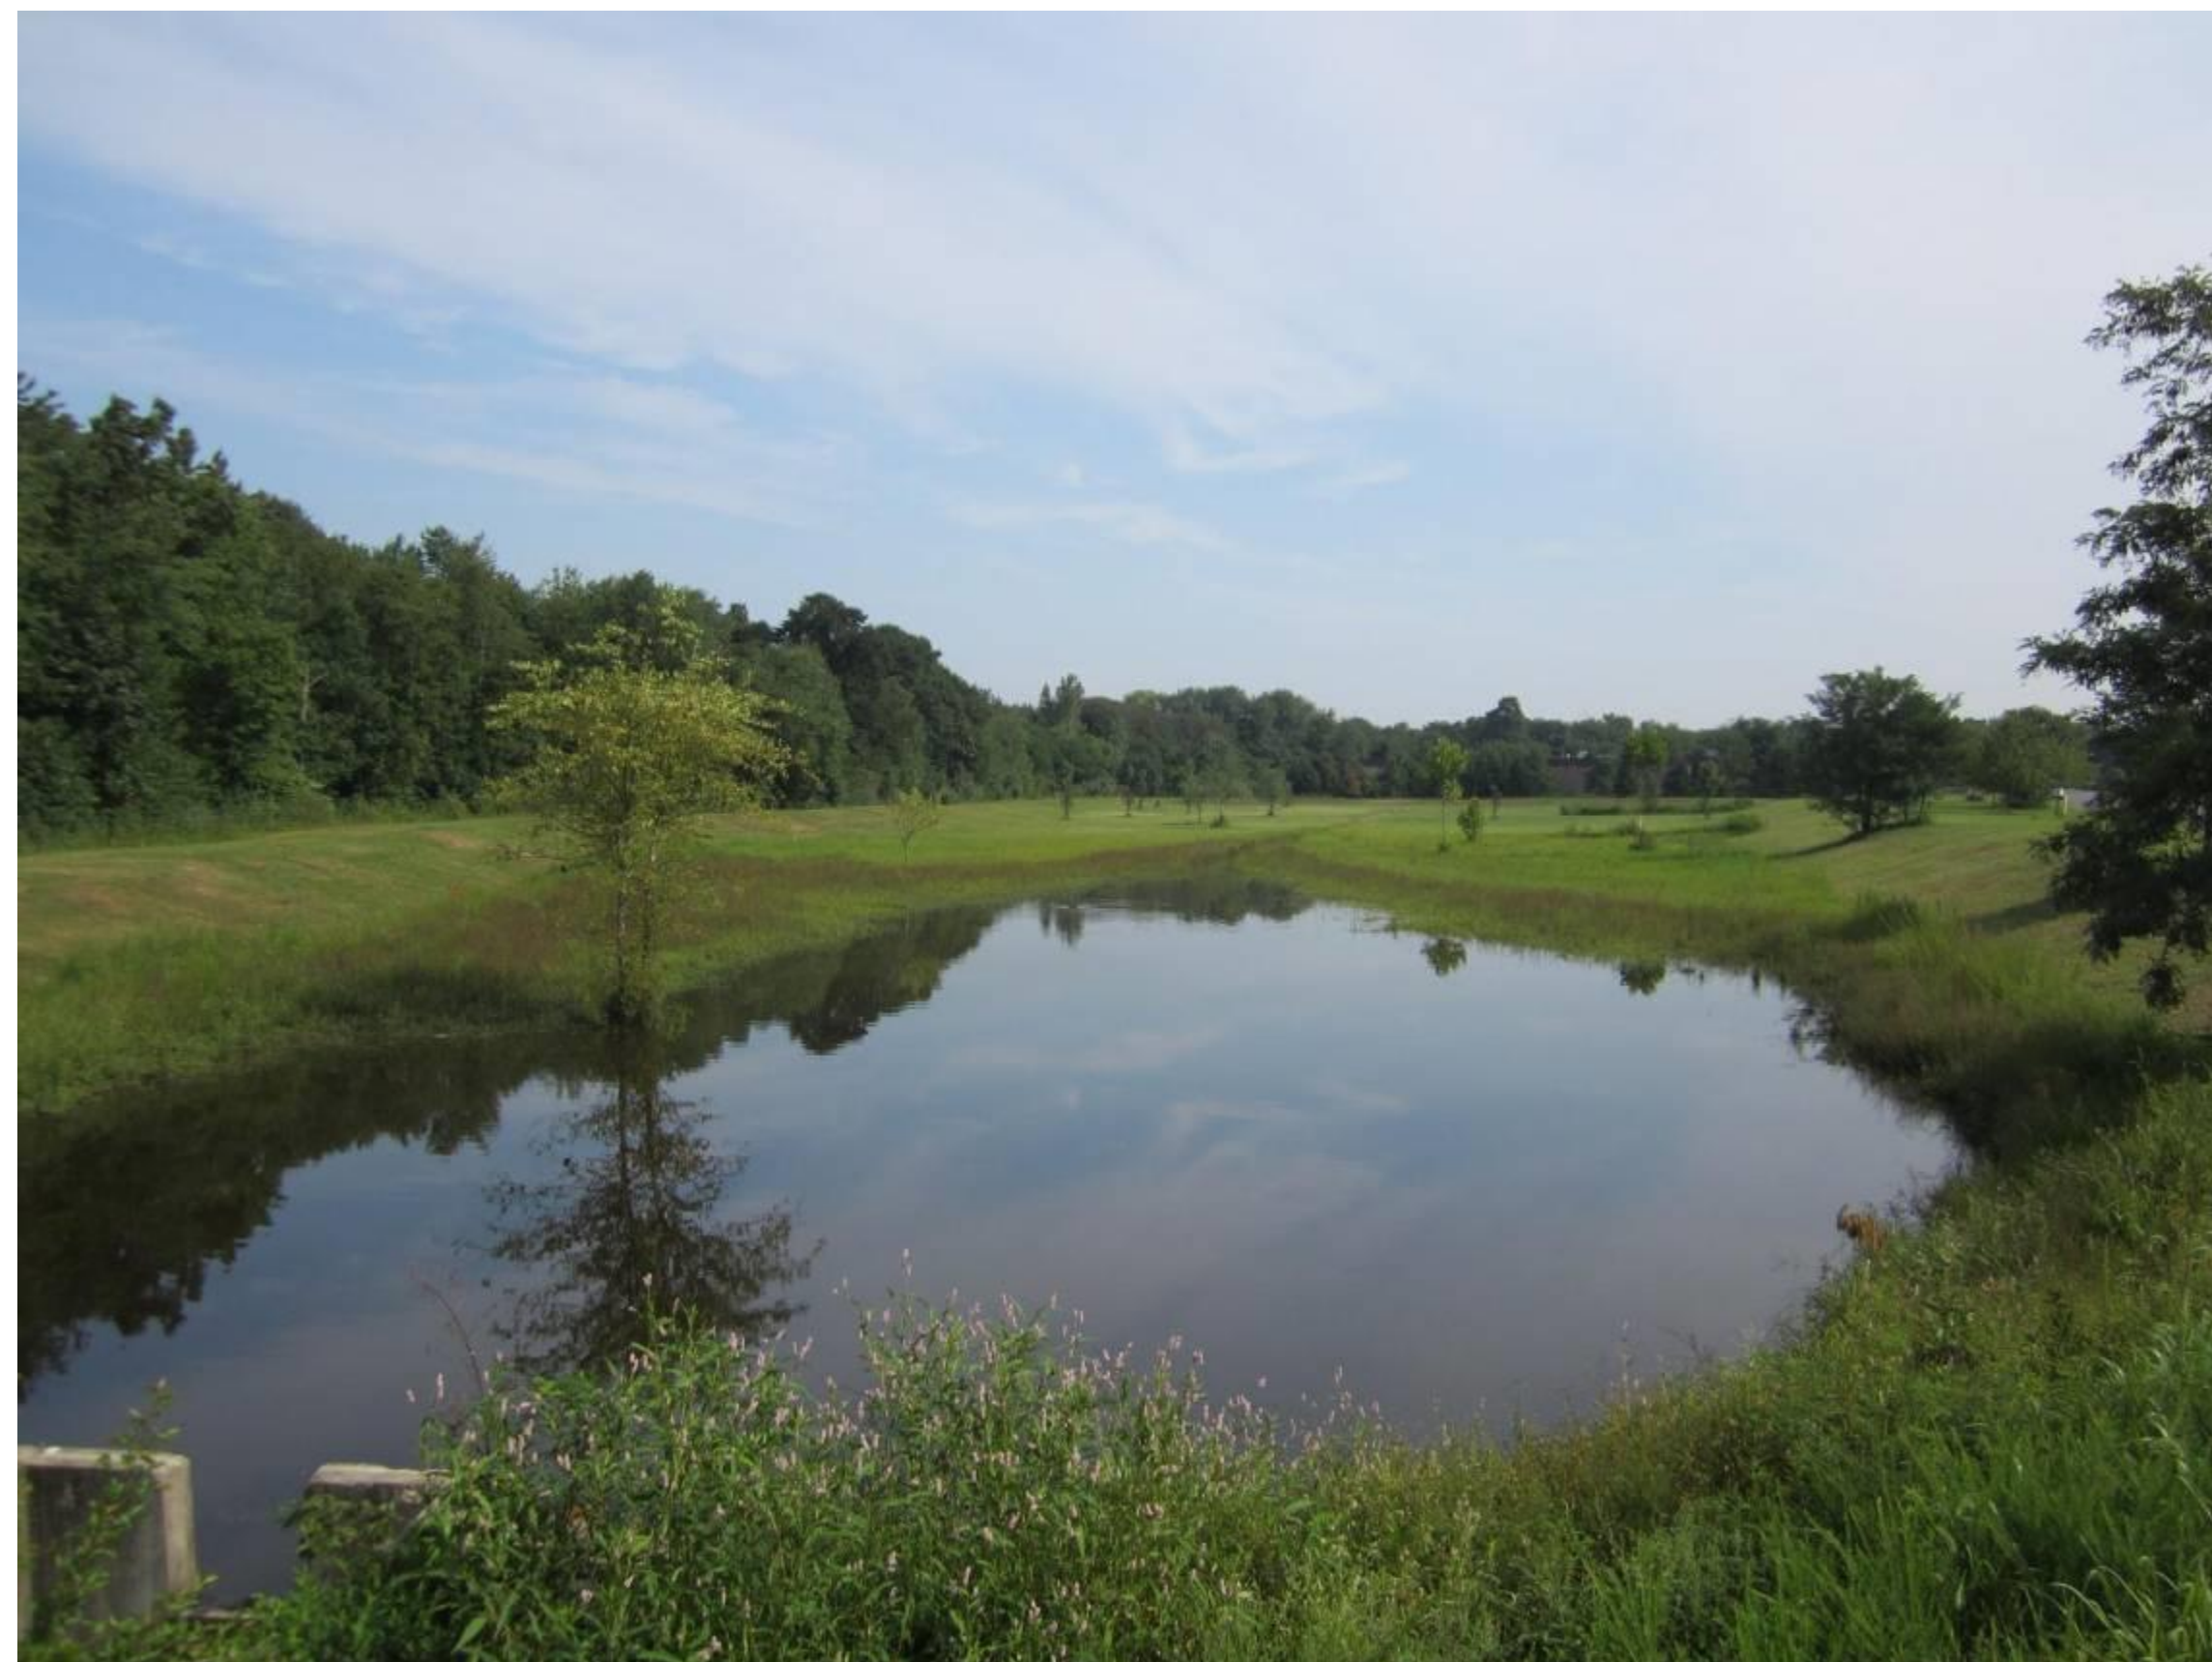
Ponding in front of outlet

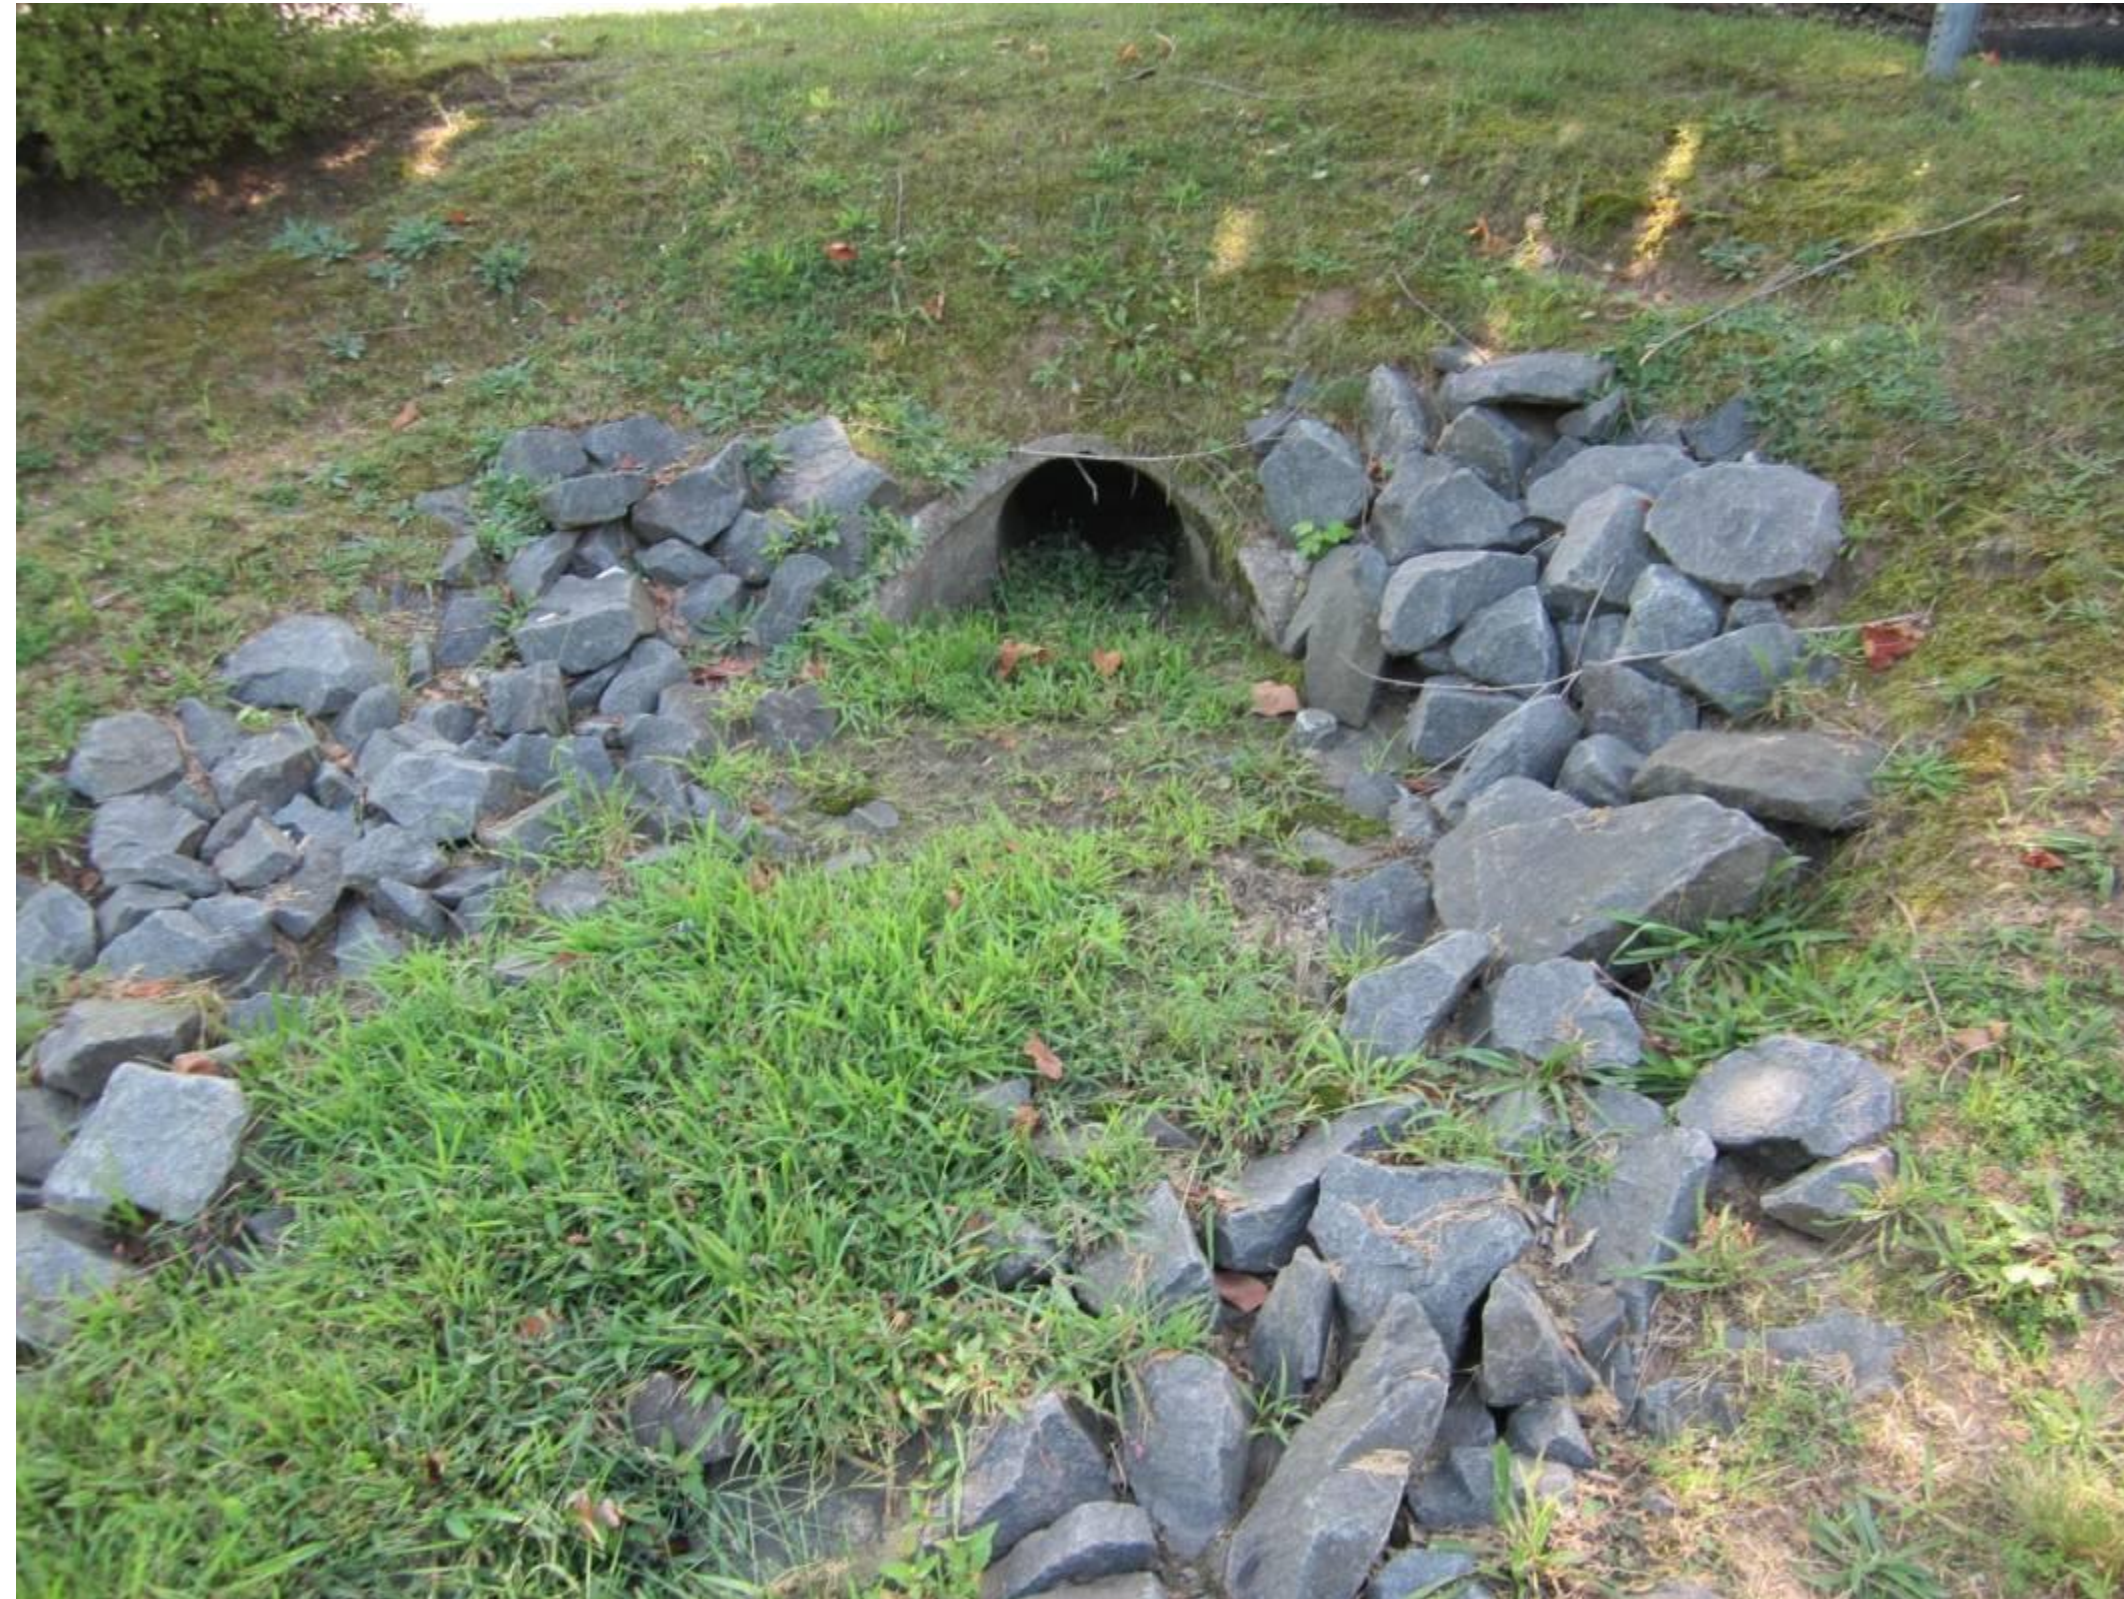
Inlet with sediment accumulation

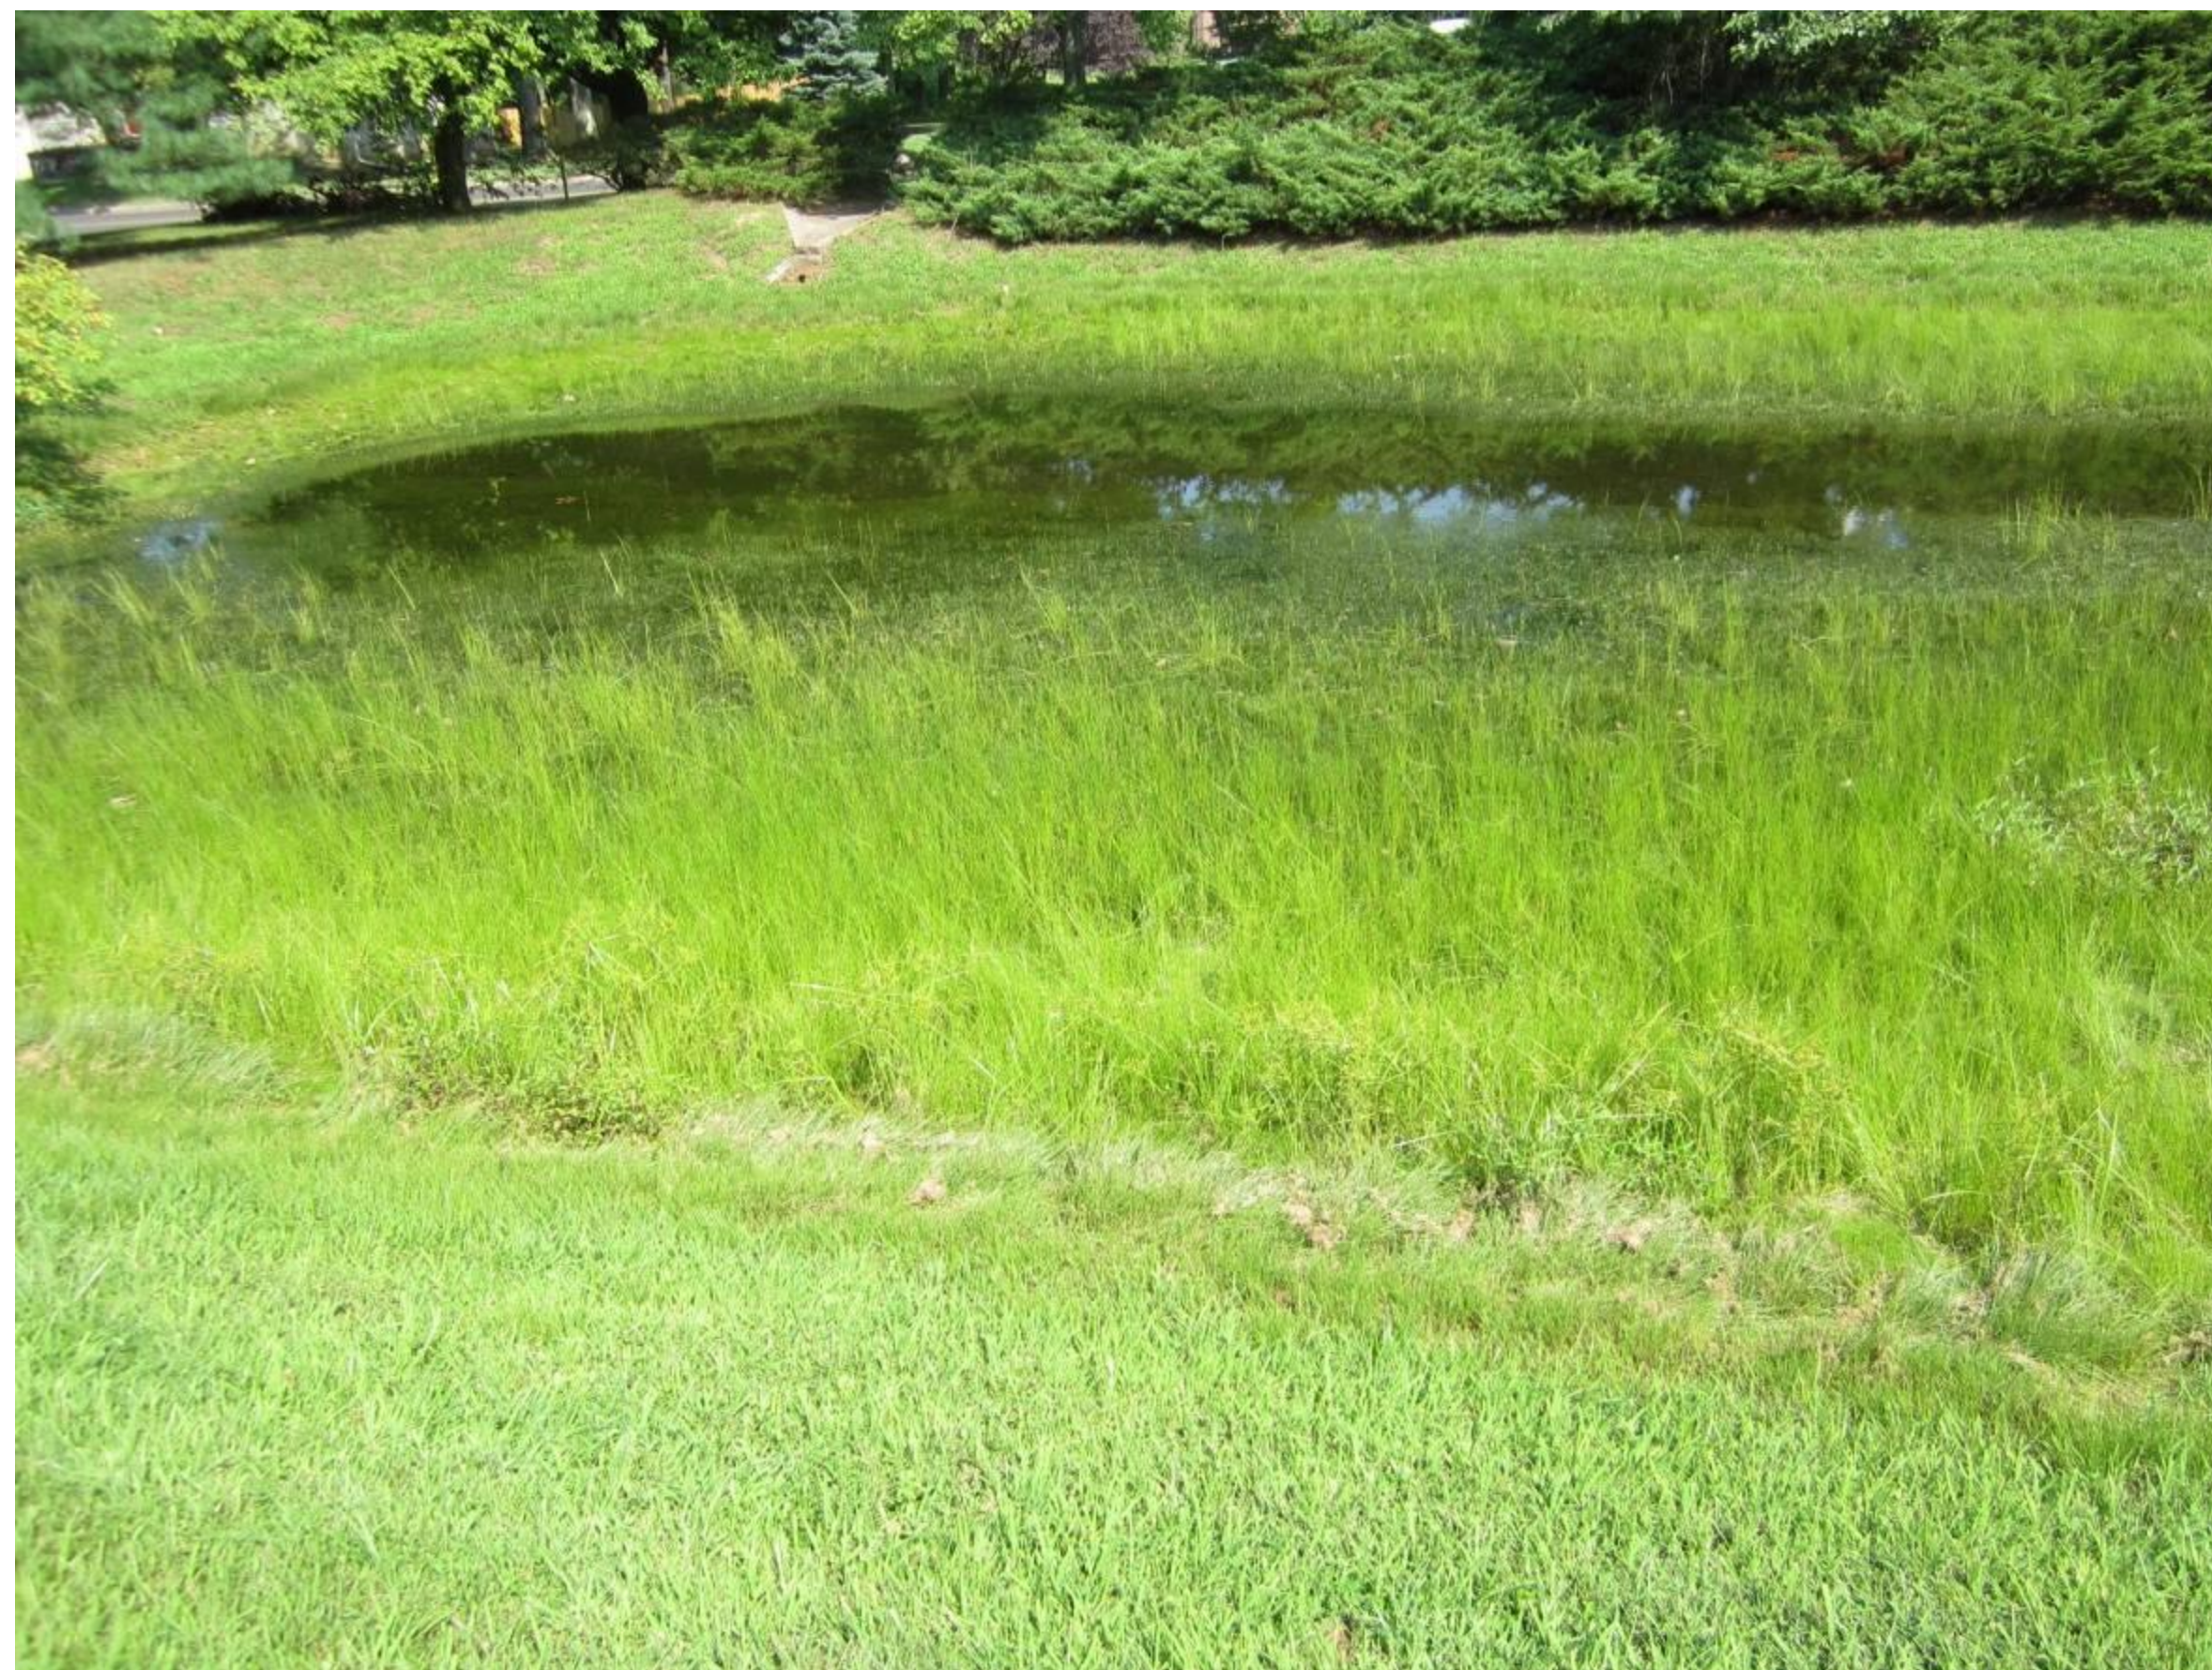
Ponding in basin bottom

- Large ponding about a foot deep likely formed due to poor infiltration and an outlet set to high.
- Investigation should be done to determine what is causing this ponding that has been seen in both years this basin was assessed
