**Hamilton Township (Mercer County)
Stormwater Basin Assessment Summary
Past Priority Addendum (Year 5B)**

Developed by the Rutgers Cooperative Extension Water Resources Program
Funded by Hamilton Township, Mercer County, New Jersey

November 27, 2019

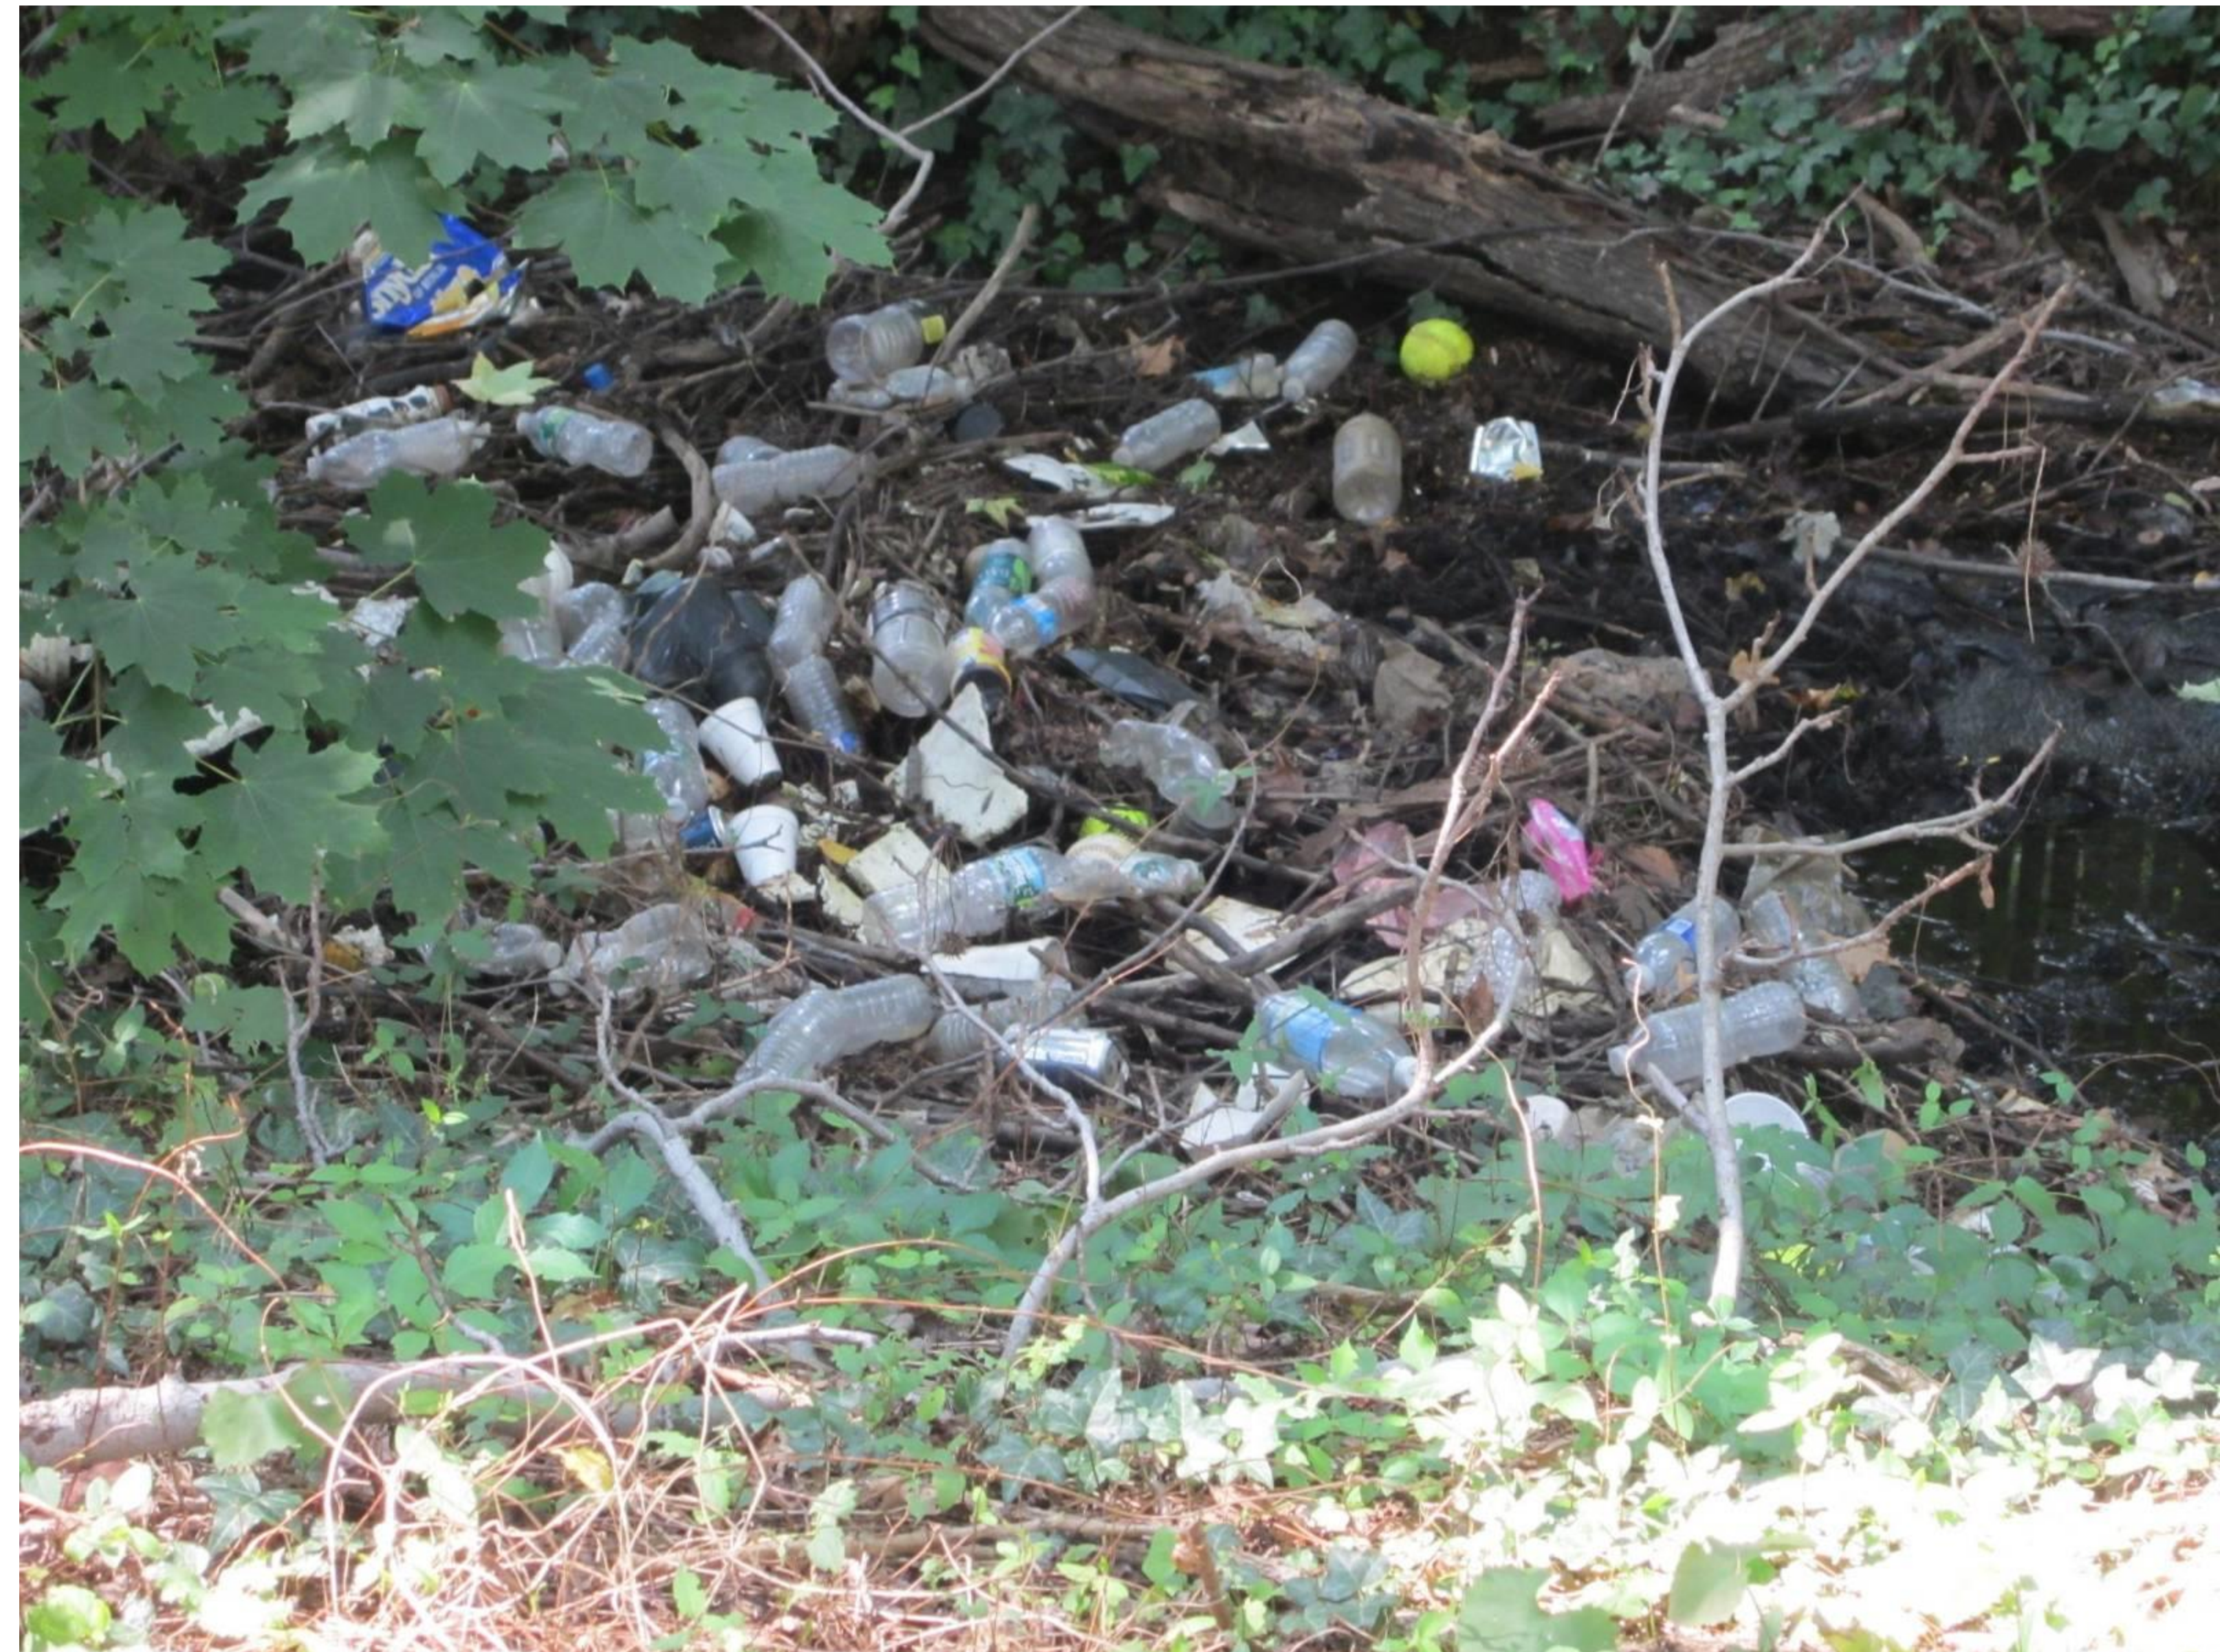
Litter and debris accumulation

- Basin behind the building leading into a wooden area
- Recommend cleaning out location

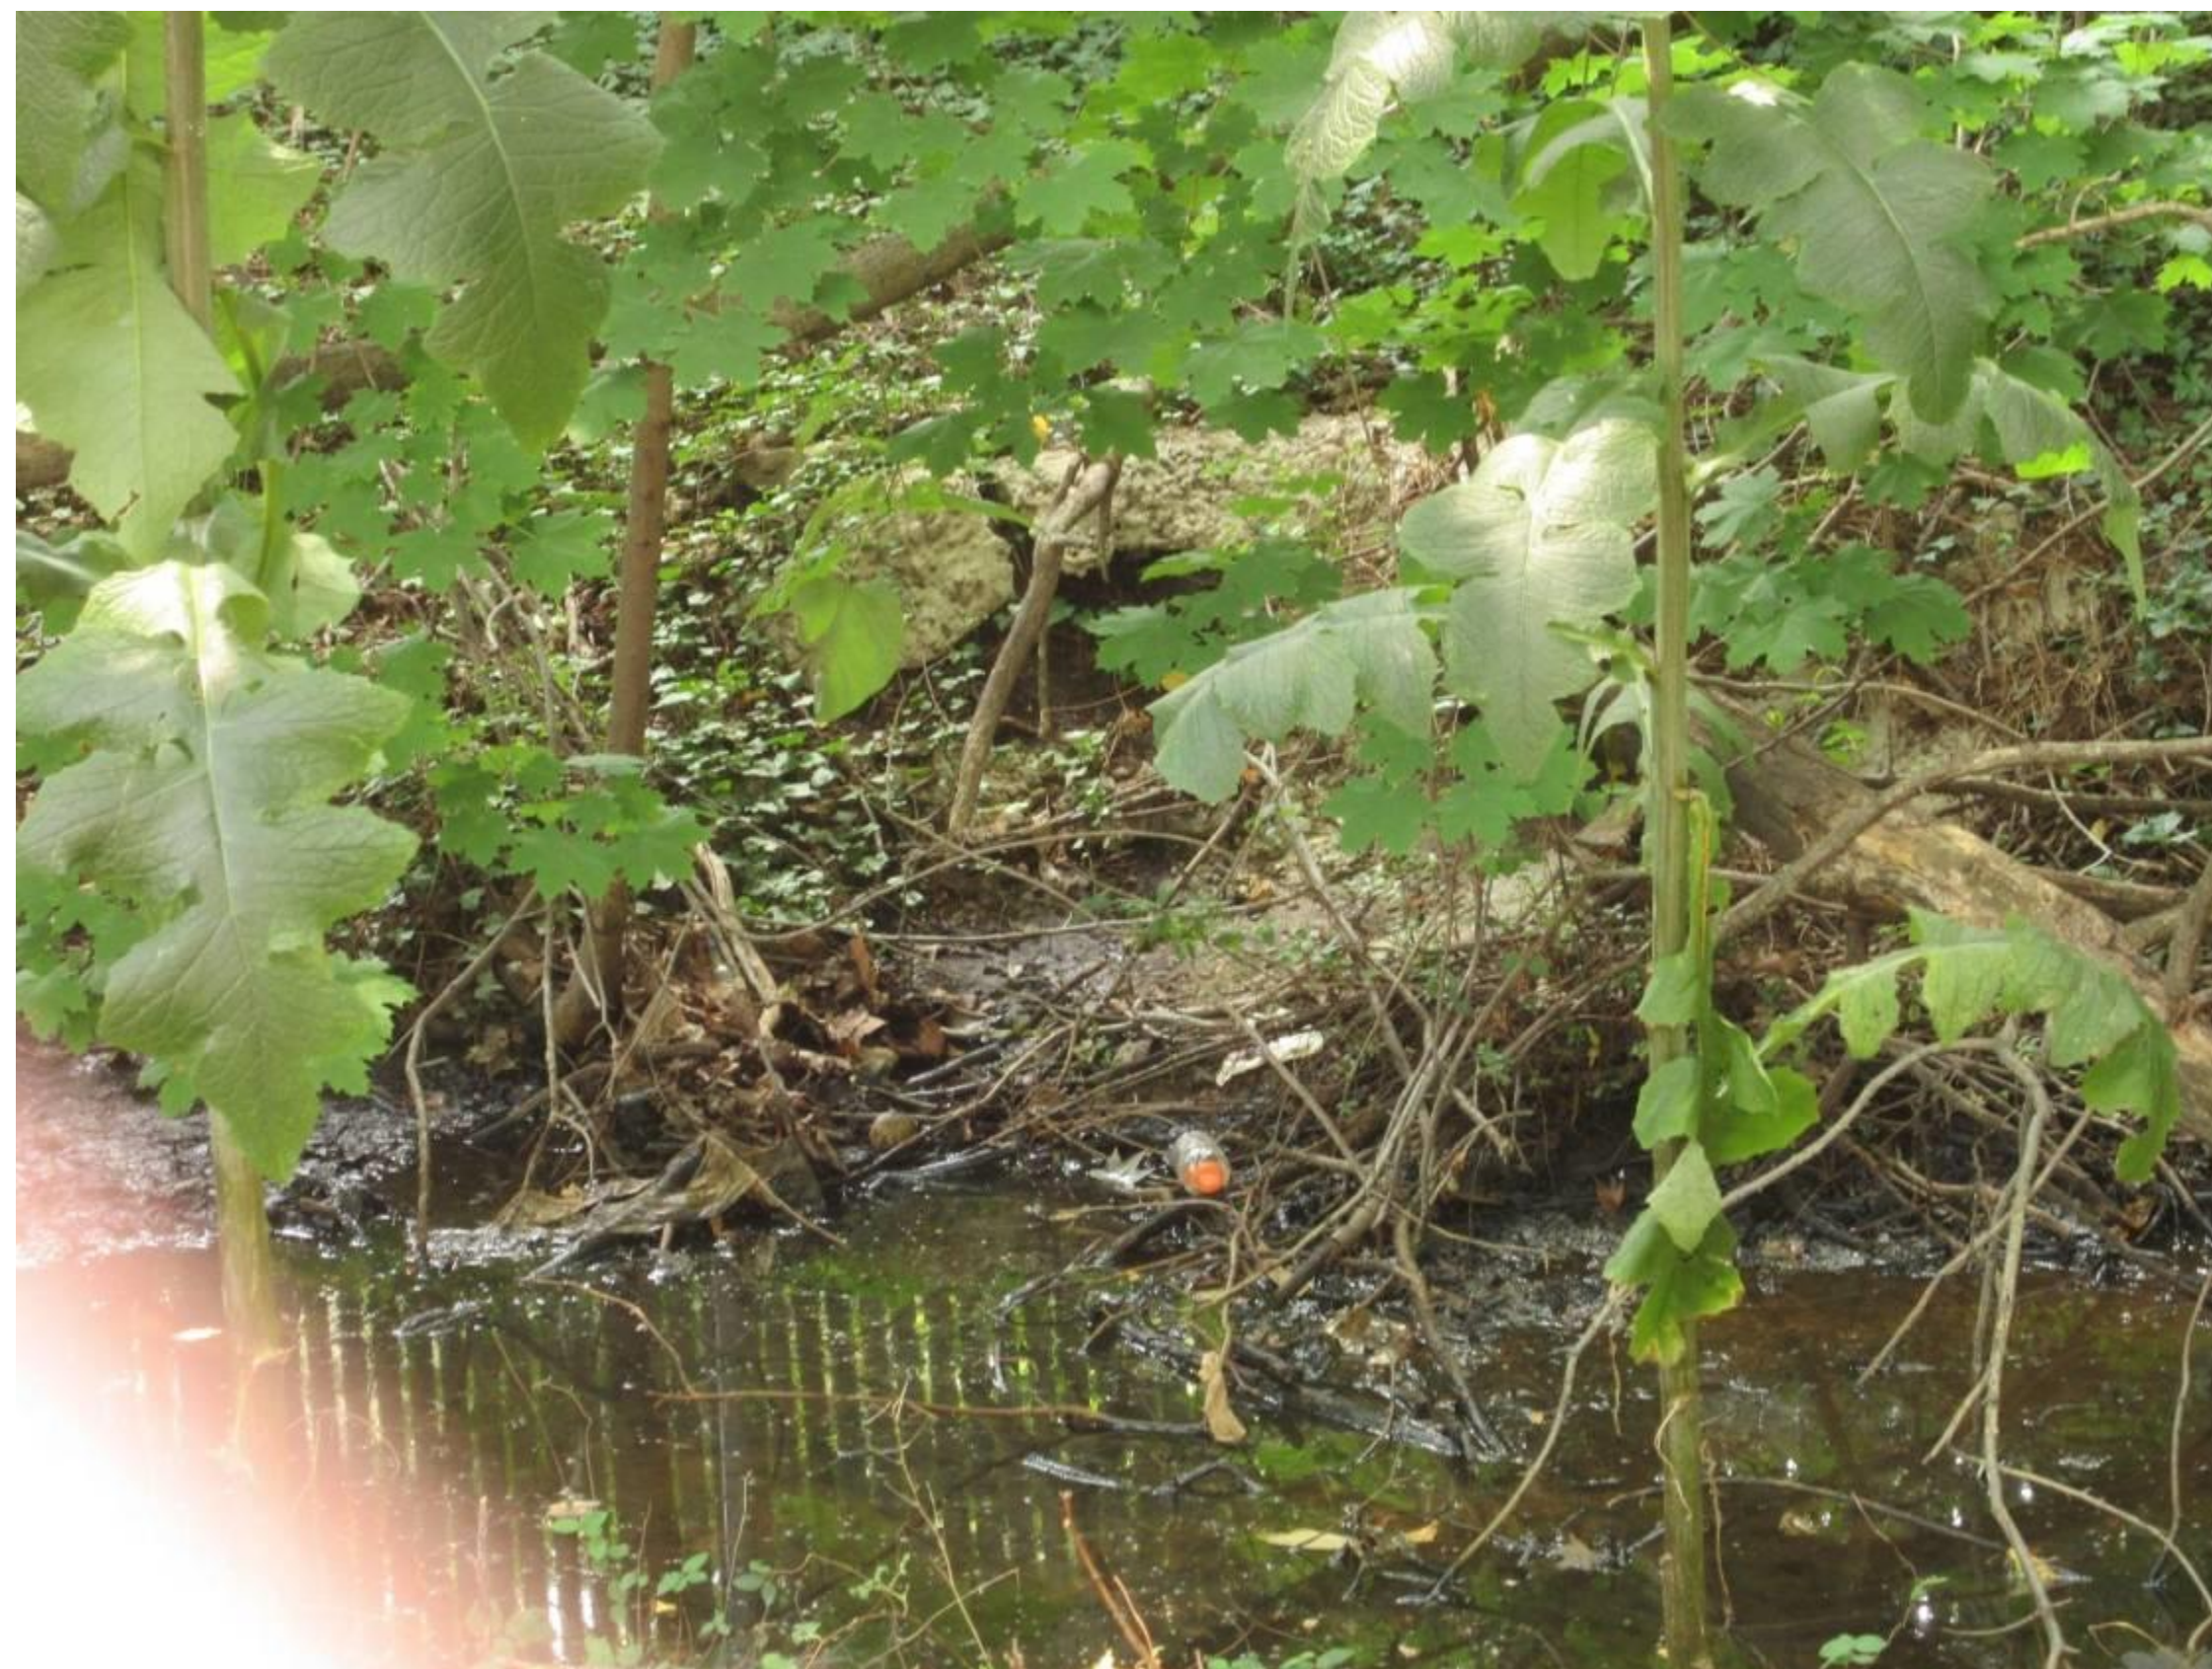
Ponding in basin bottom

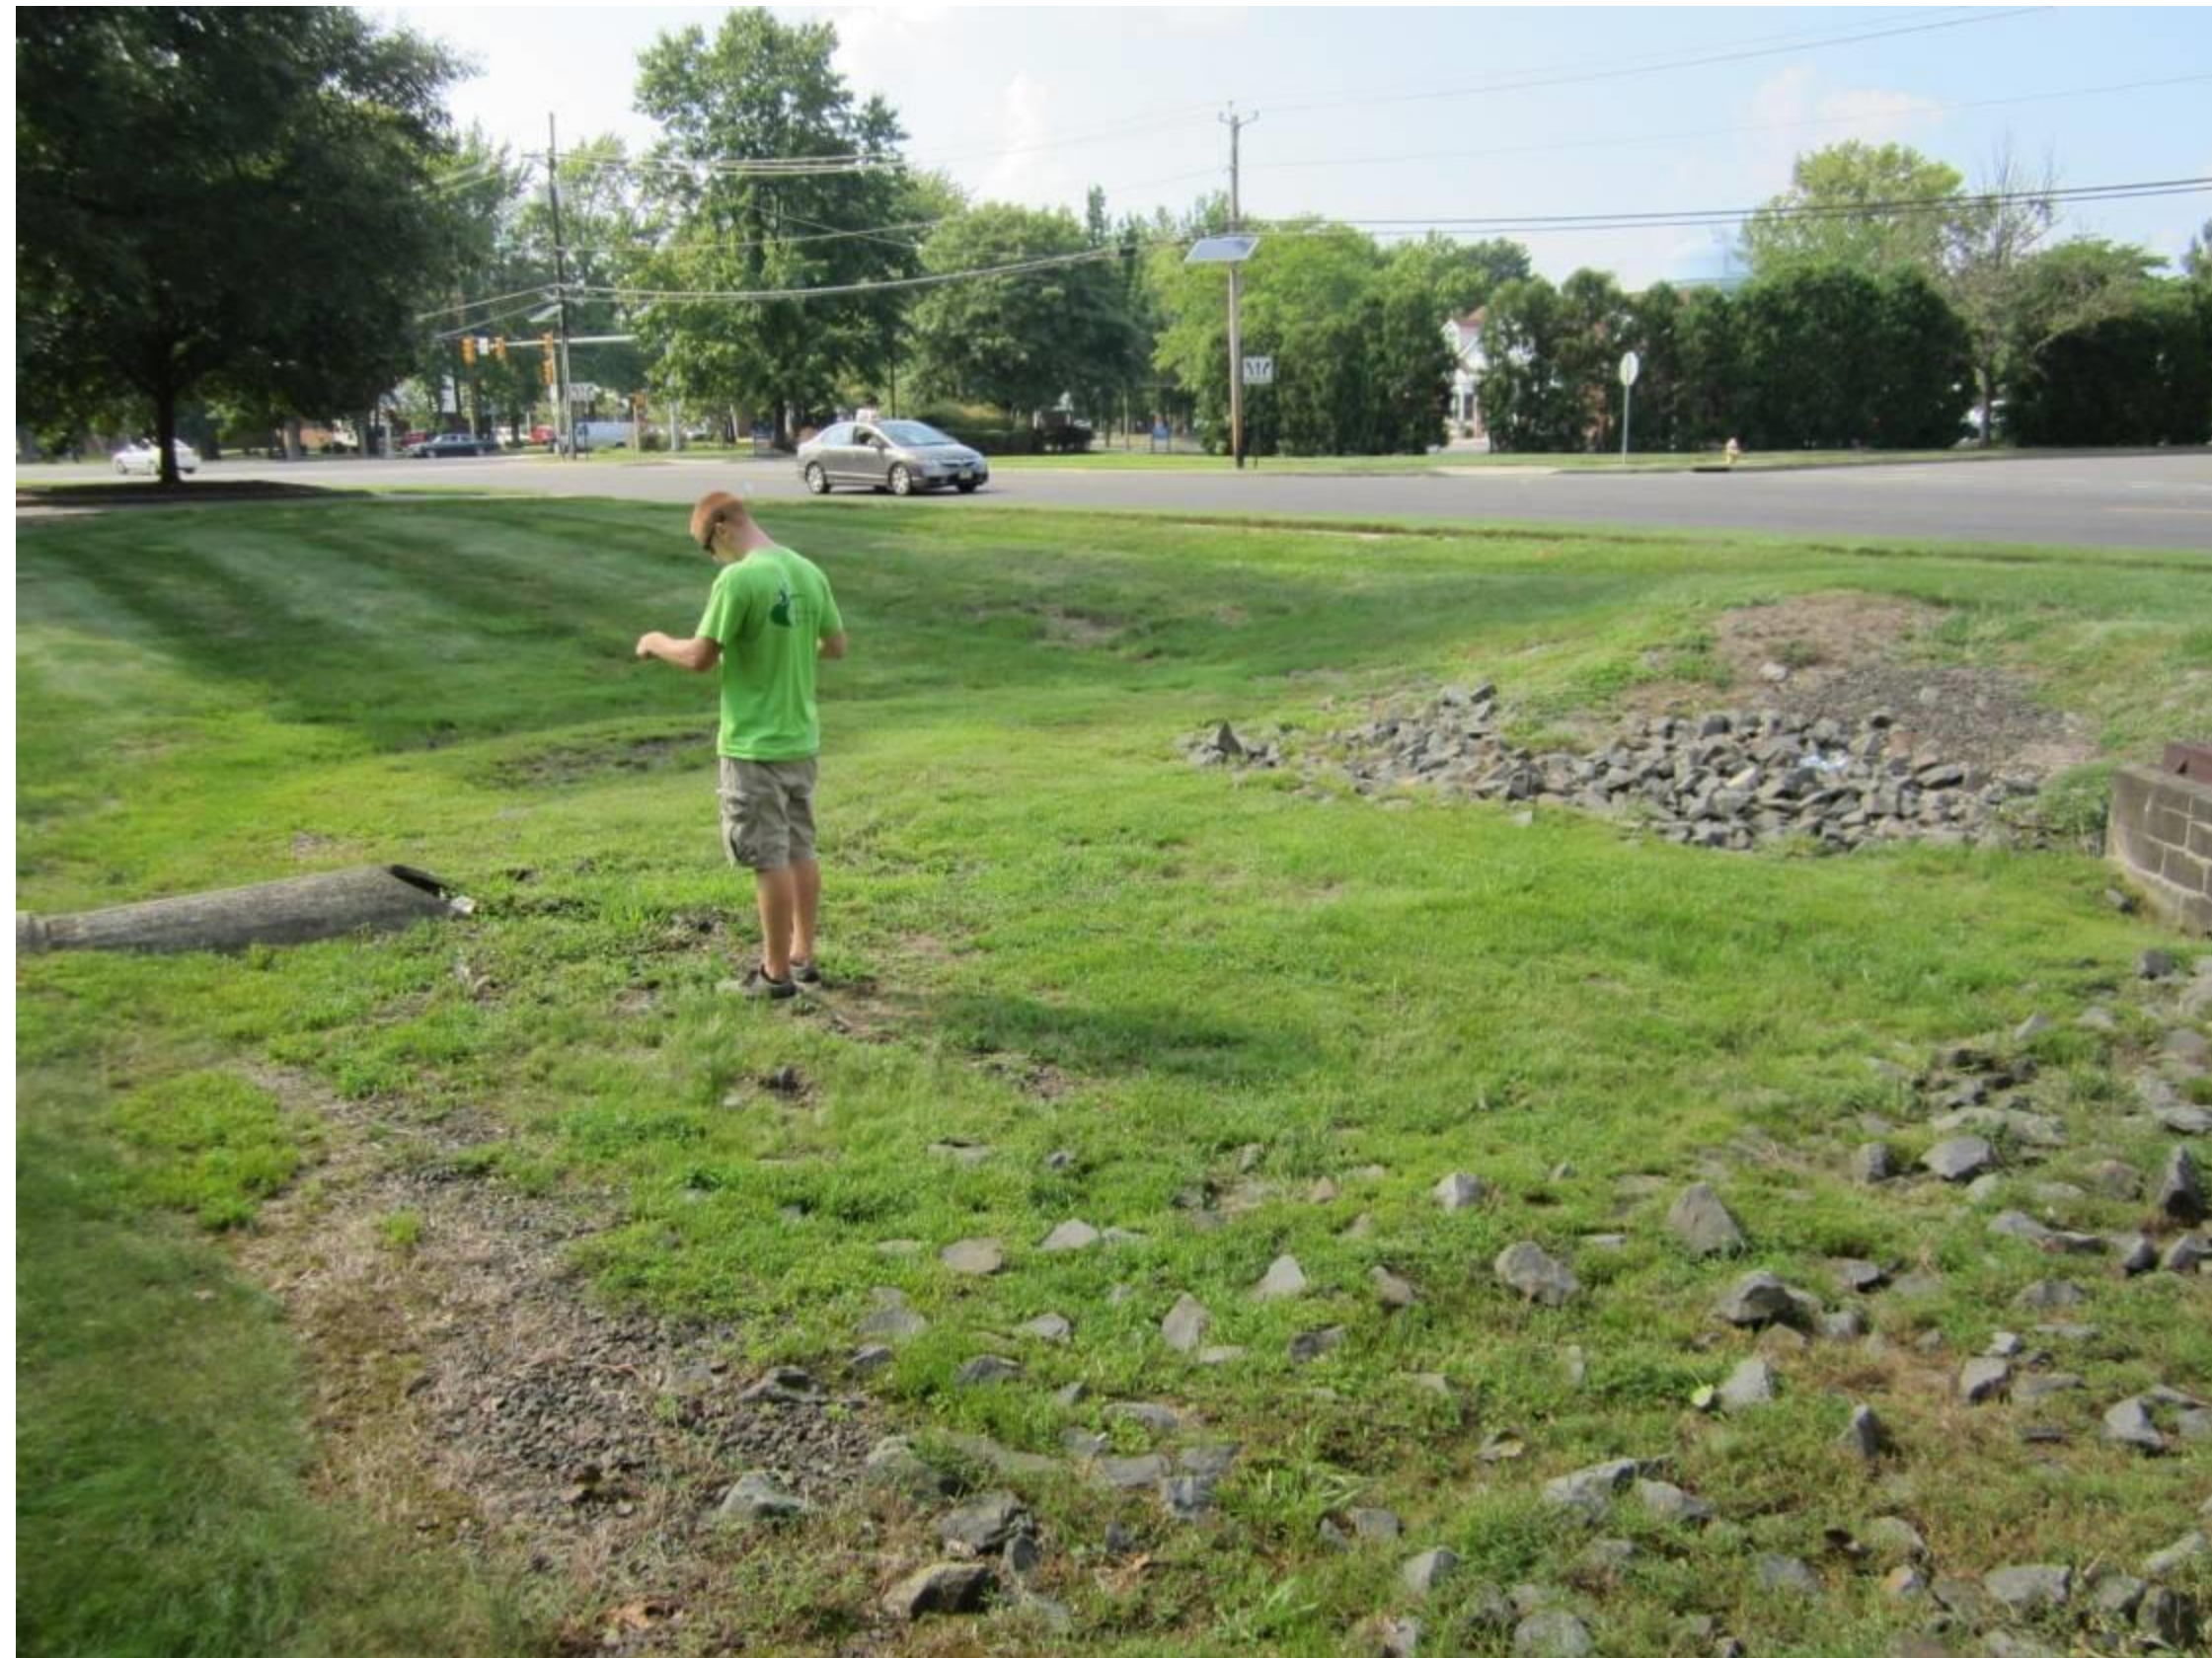
Basin bottom looking west

- Standing water in inlet
- Accumulation of litter, sediment and debris AT outlet, inlet and basin bottom
- Exposed soil in basin bottom
- Evidence of erosion in front of inlet
- Inlet shows evidence of deterioration

- Small basin with one inlet
- Inlet still appears damaged and may need repair
- Naturalize basin with herbaceous plants

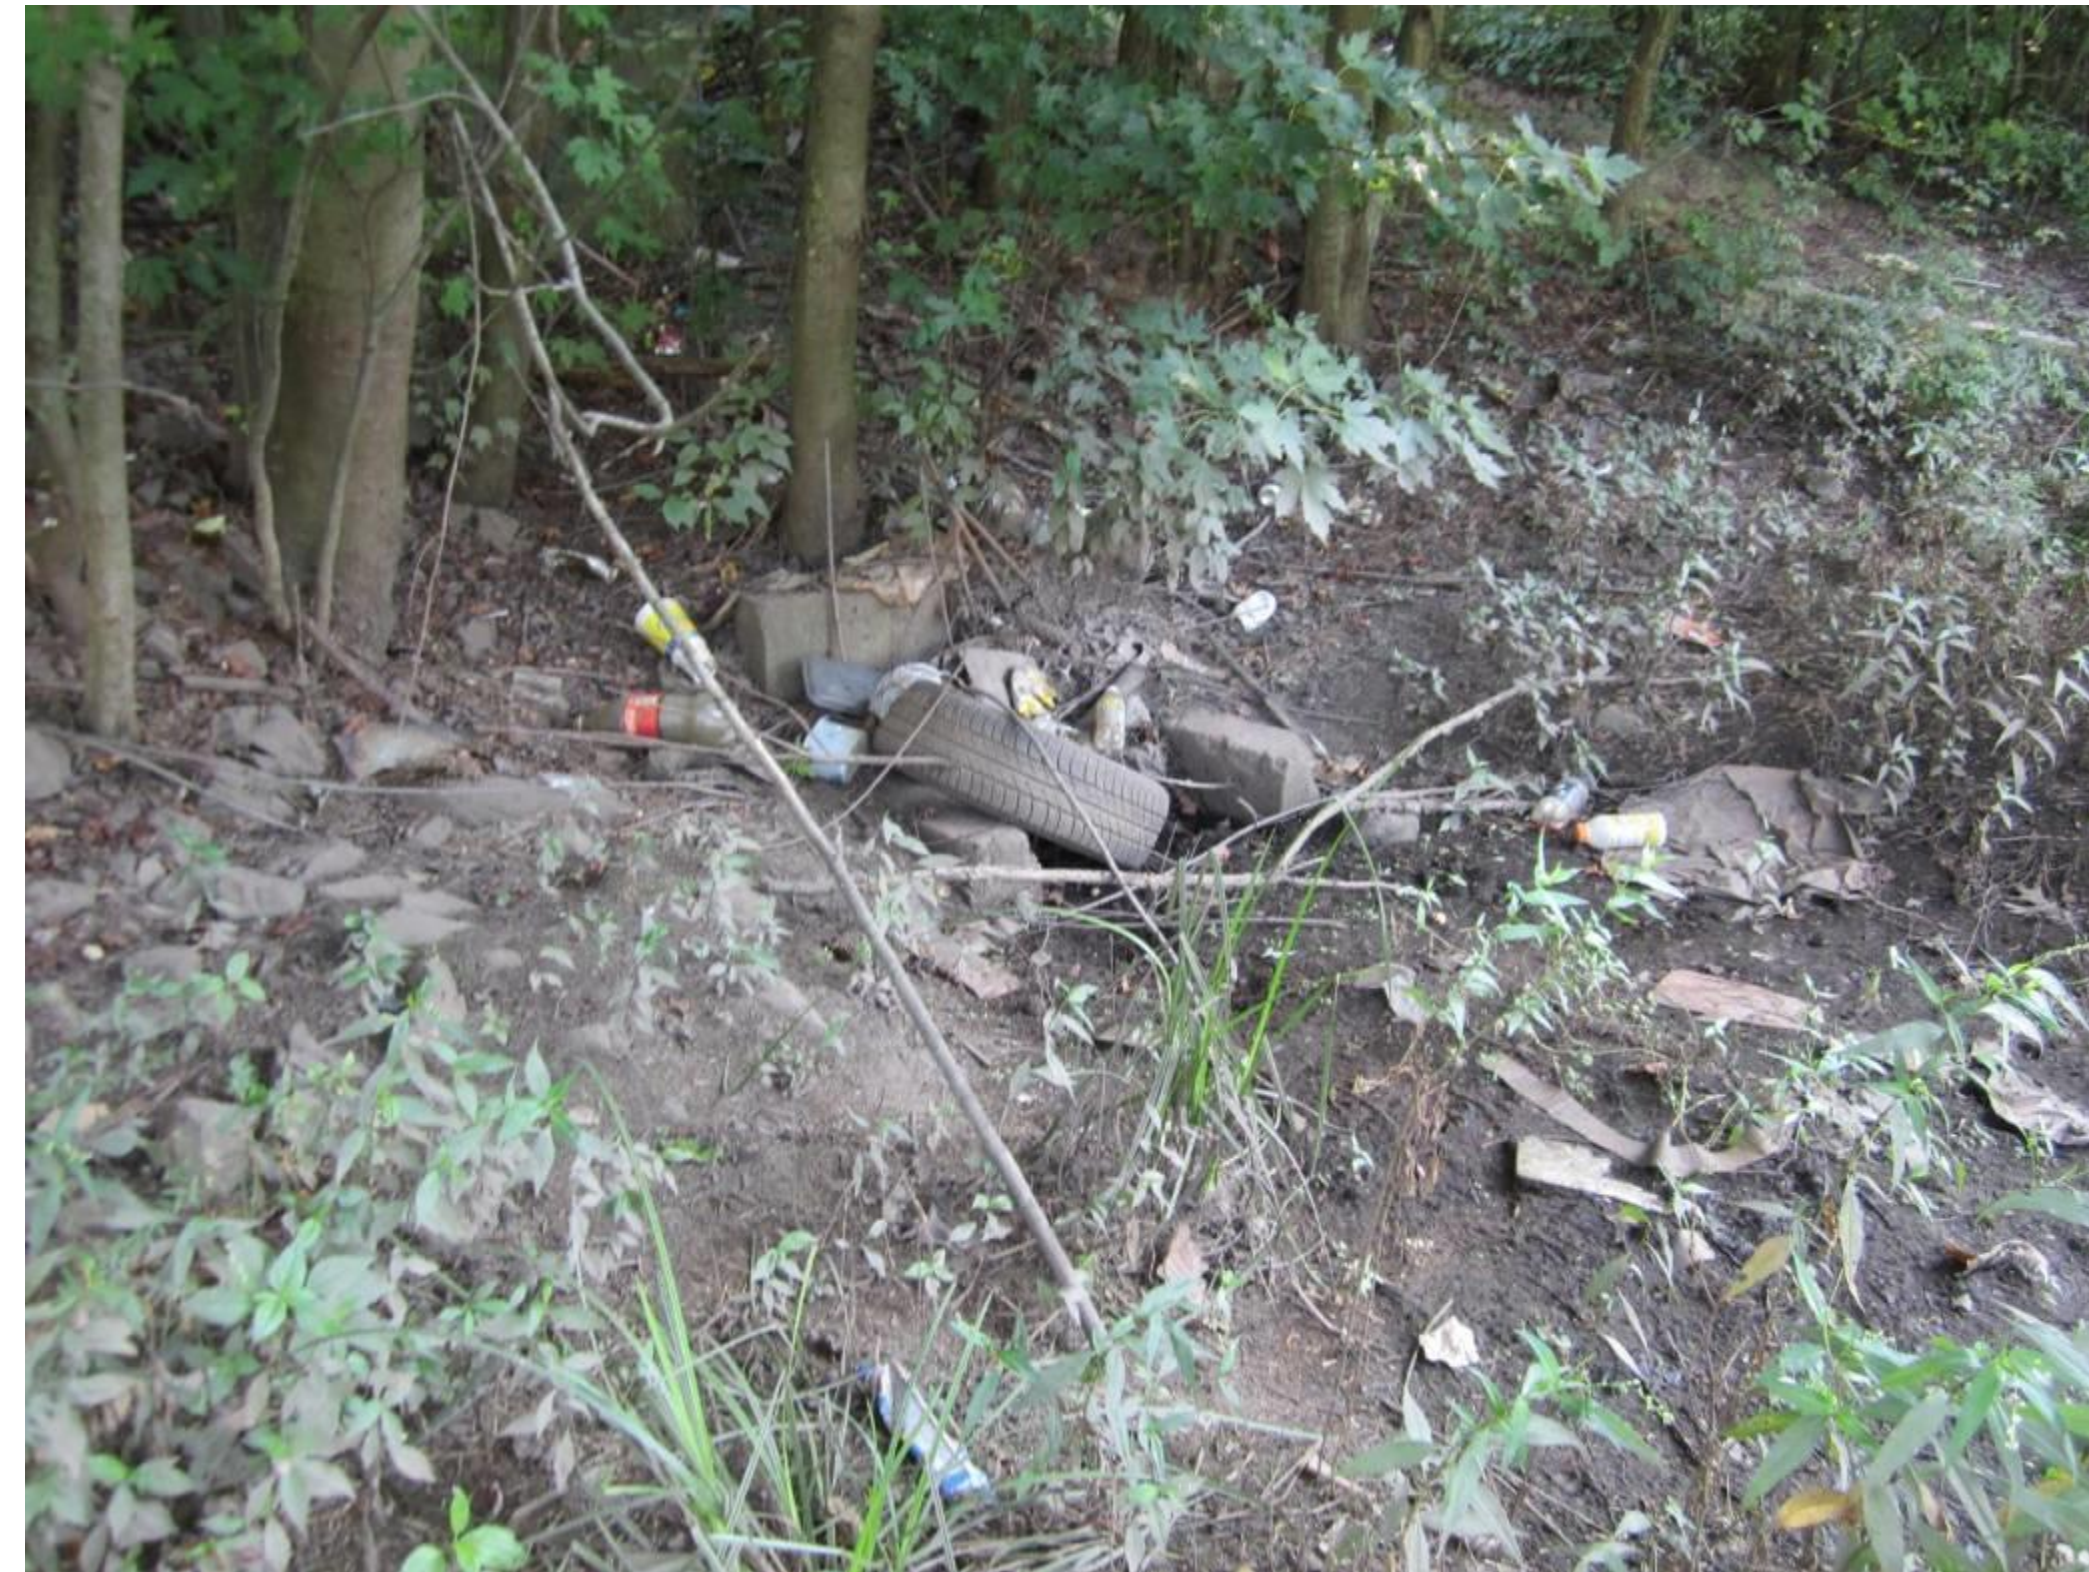
Outlet structure obstructed with litter

- Sediment, debris and litter accumulation at inlets and outlet
- Excess sediment accumulation and standing water in low flow channel with algae growth
- Northwestern basin embankment slumping/failing
- Evidence of deterioration at inlets
- Woody vegetation growth around outlet
- Basin outfall area shows evidence of erosion

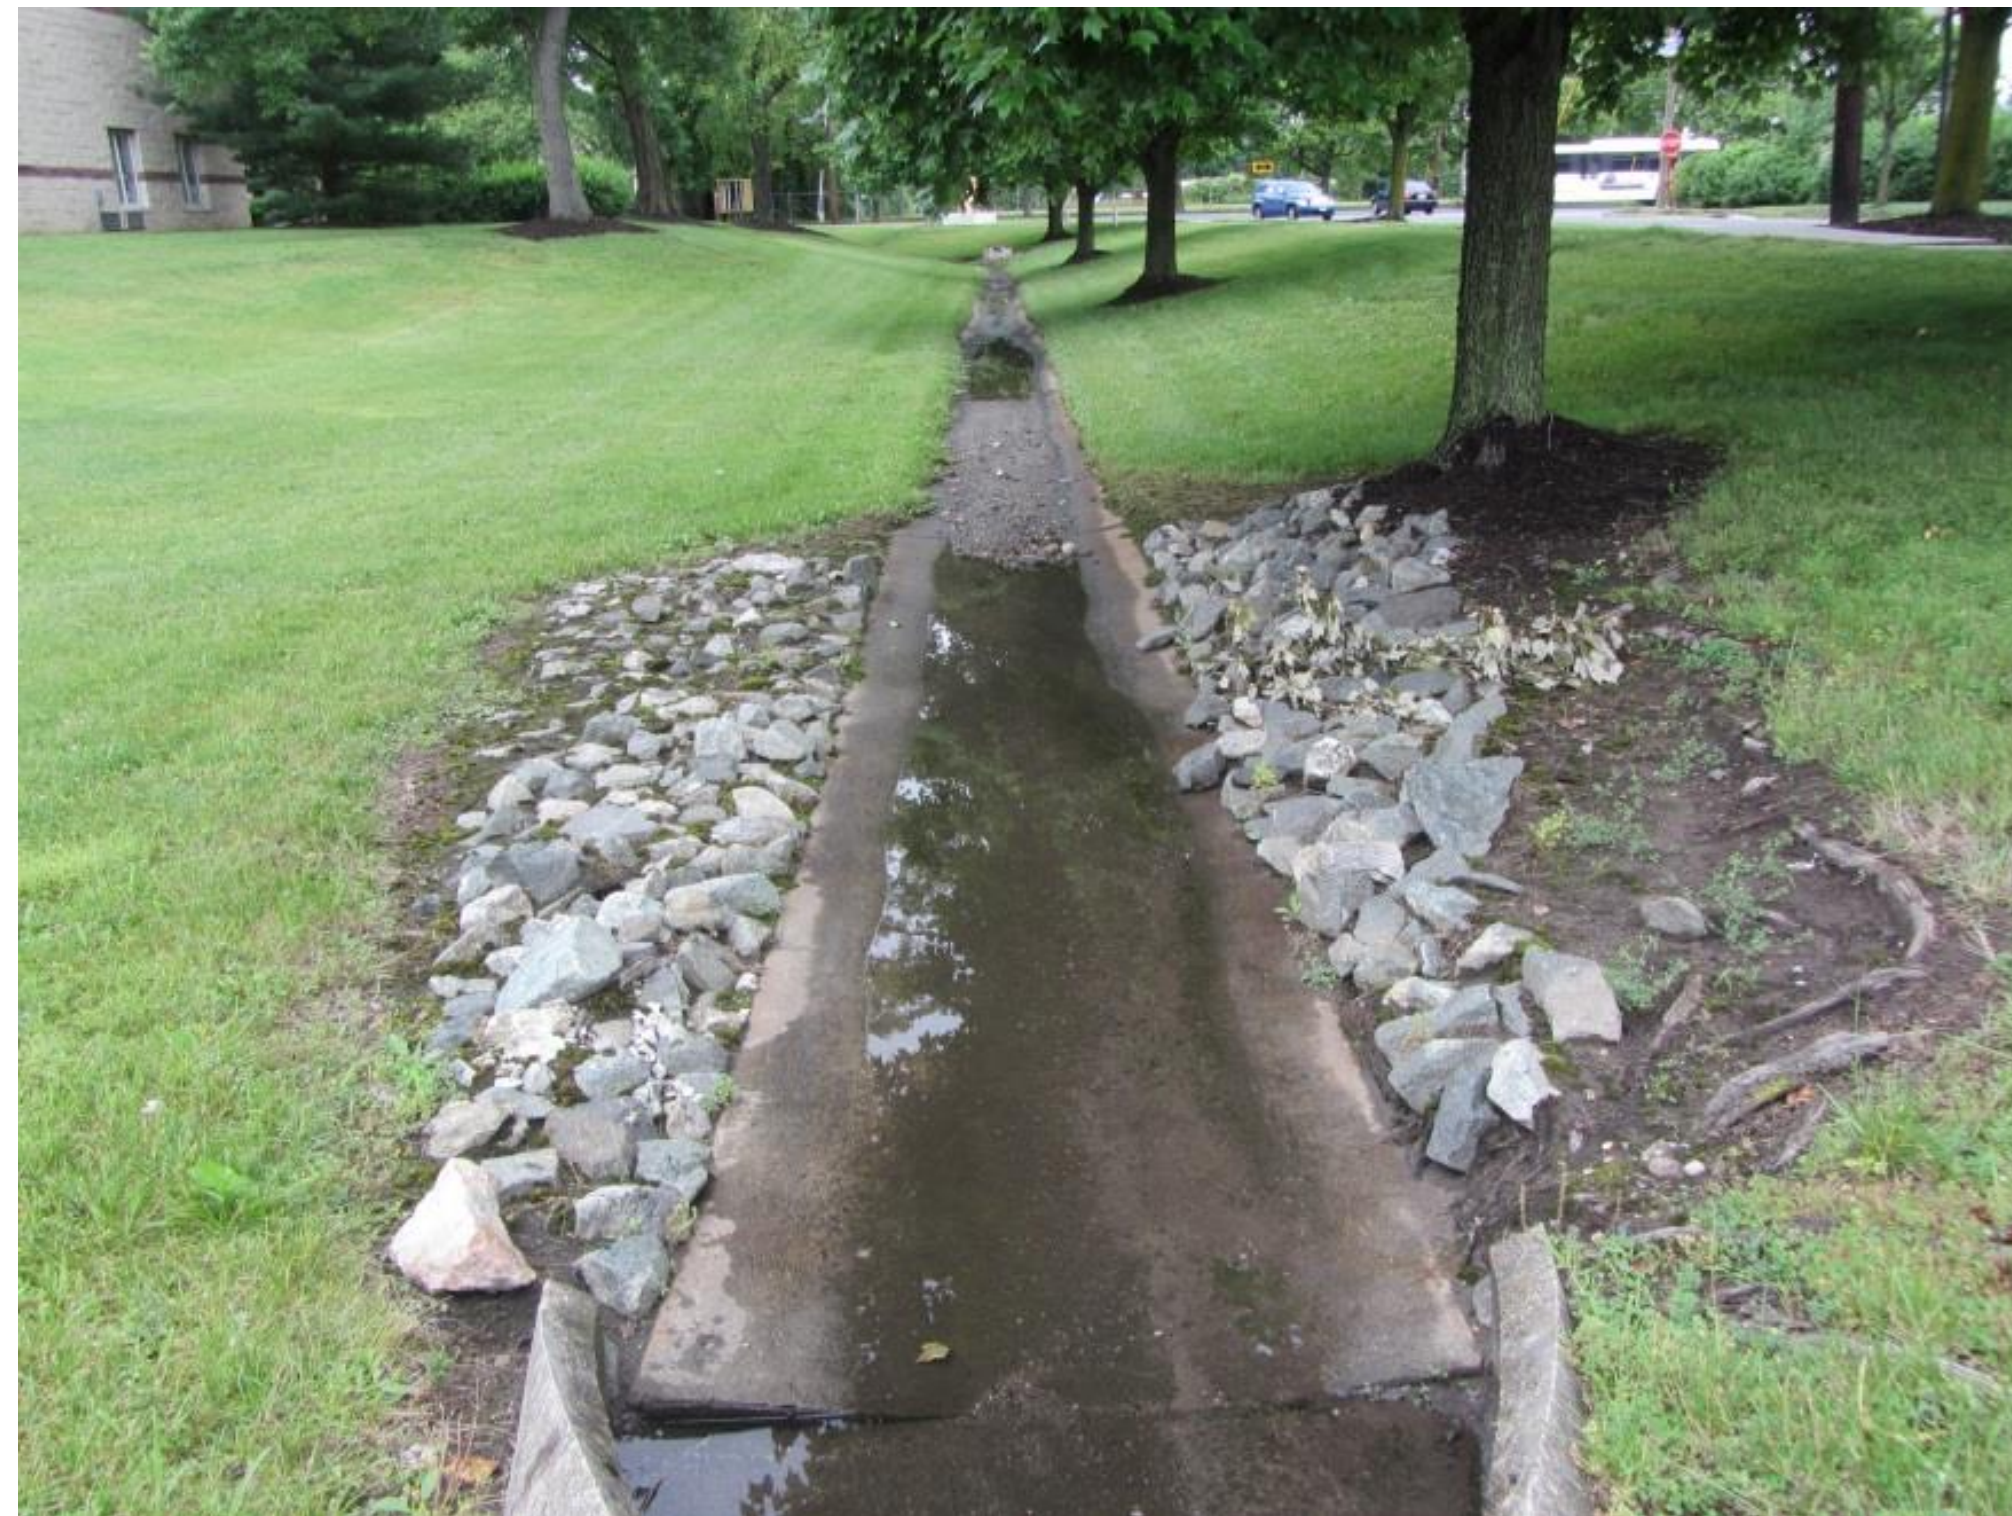
Basin bottom looking northwest

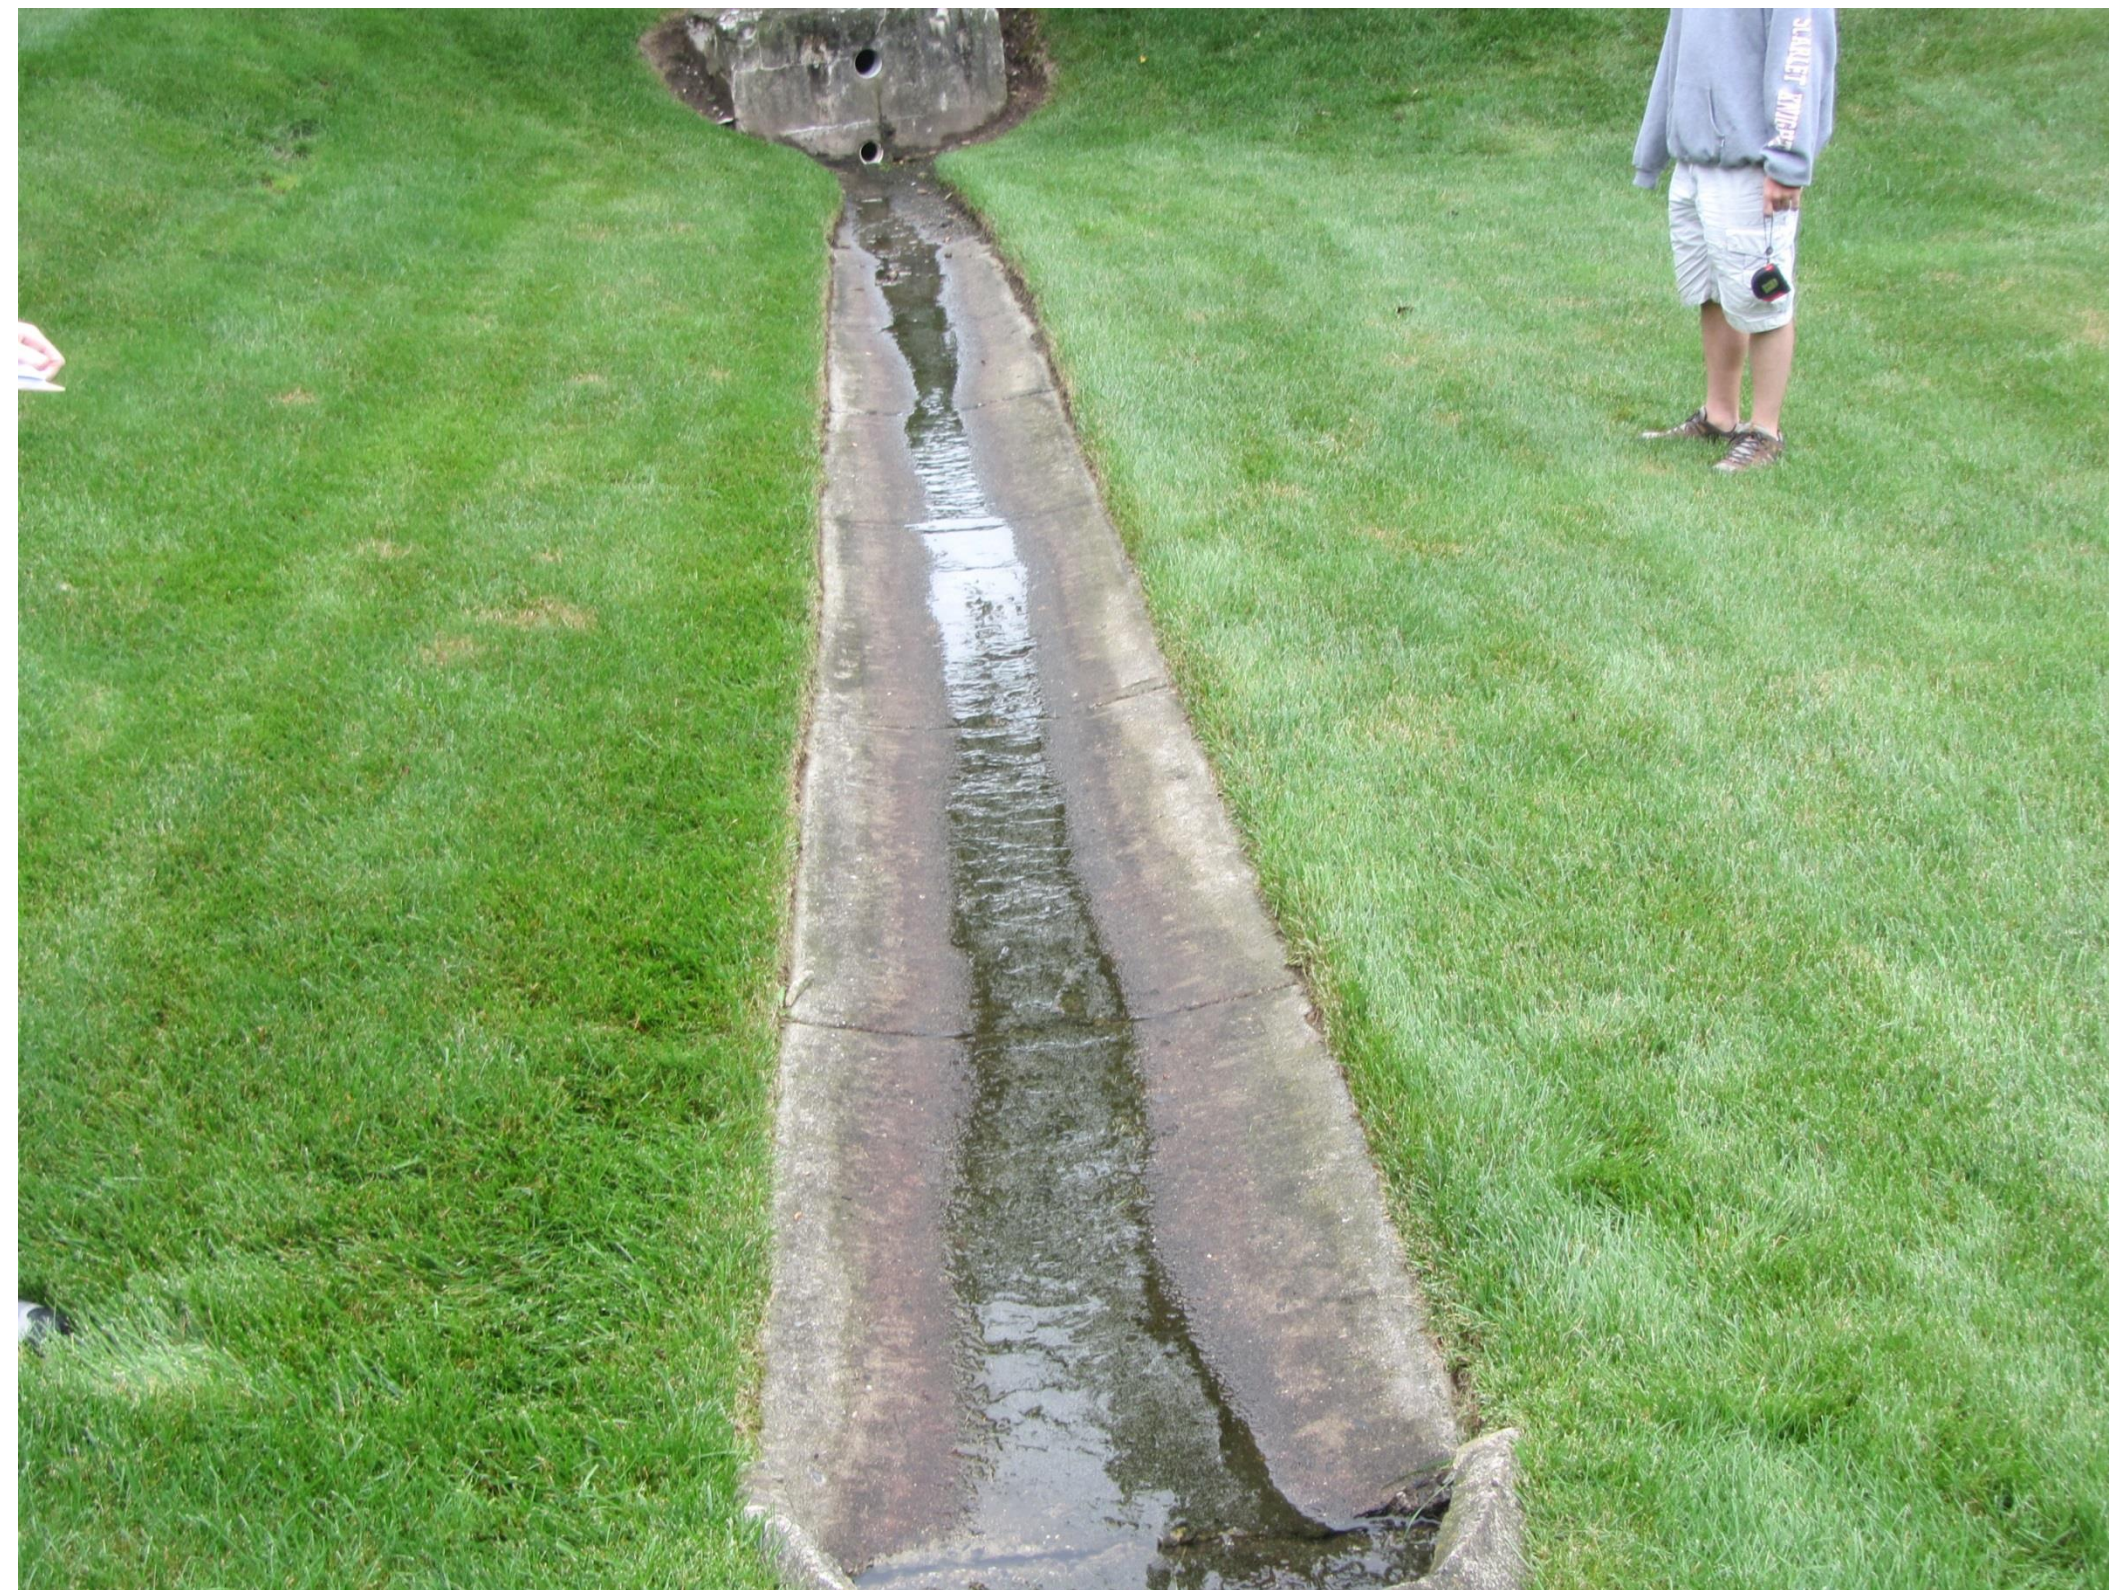
Basin bottom looking west
