**Hamilton Township (Mercer County)
Stormwater Basin Assessment Summary
Past Priority Addendum (Year 5B)**

Developed by the Rutgers Cooperative Extension Water Resources Program
Funded by Hamilton Township, Mercer County, New Jersey

November 27, 2019

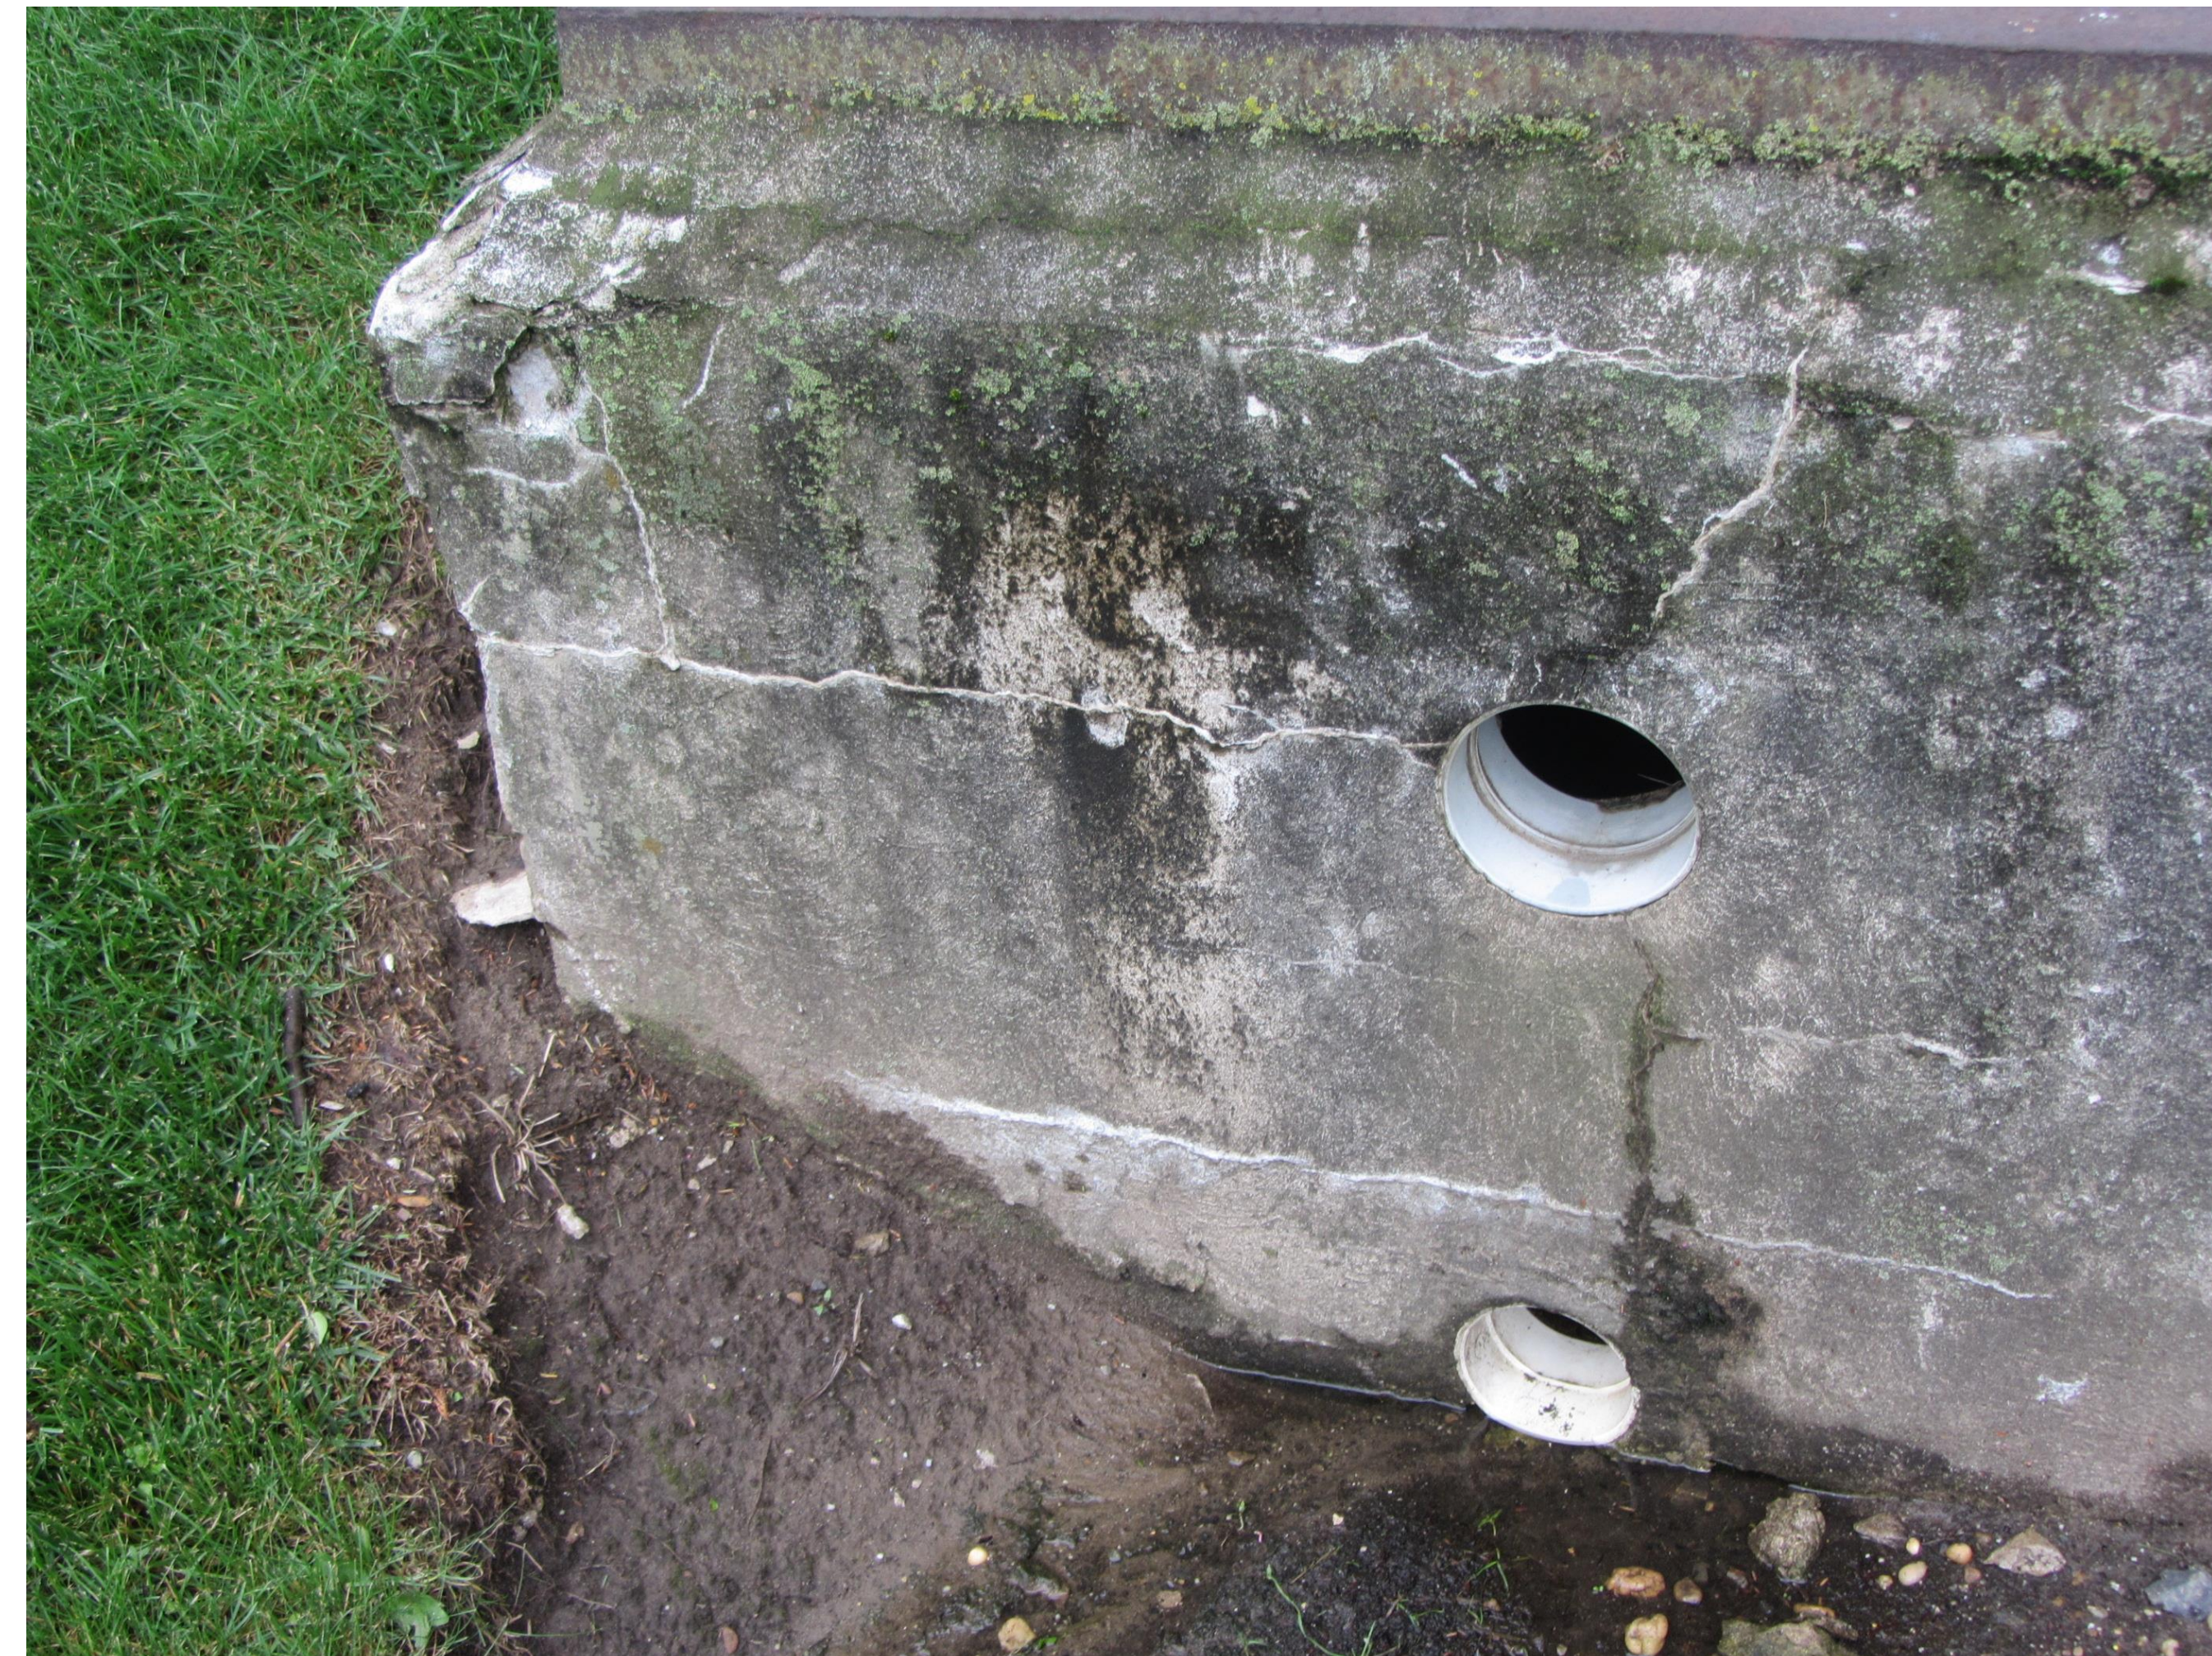
Outlet structure with slumping and breakage

- Basin in overall good condition
- Outlet structure has some structural damage with water flowing under the low flow orifice, repair suggested to ensure it is operating as intended
- Low flow channel could be removed to allow more infiltration
- Naturalization by reducing mowing would provide additional benefits

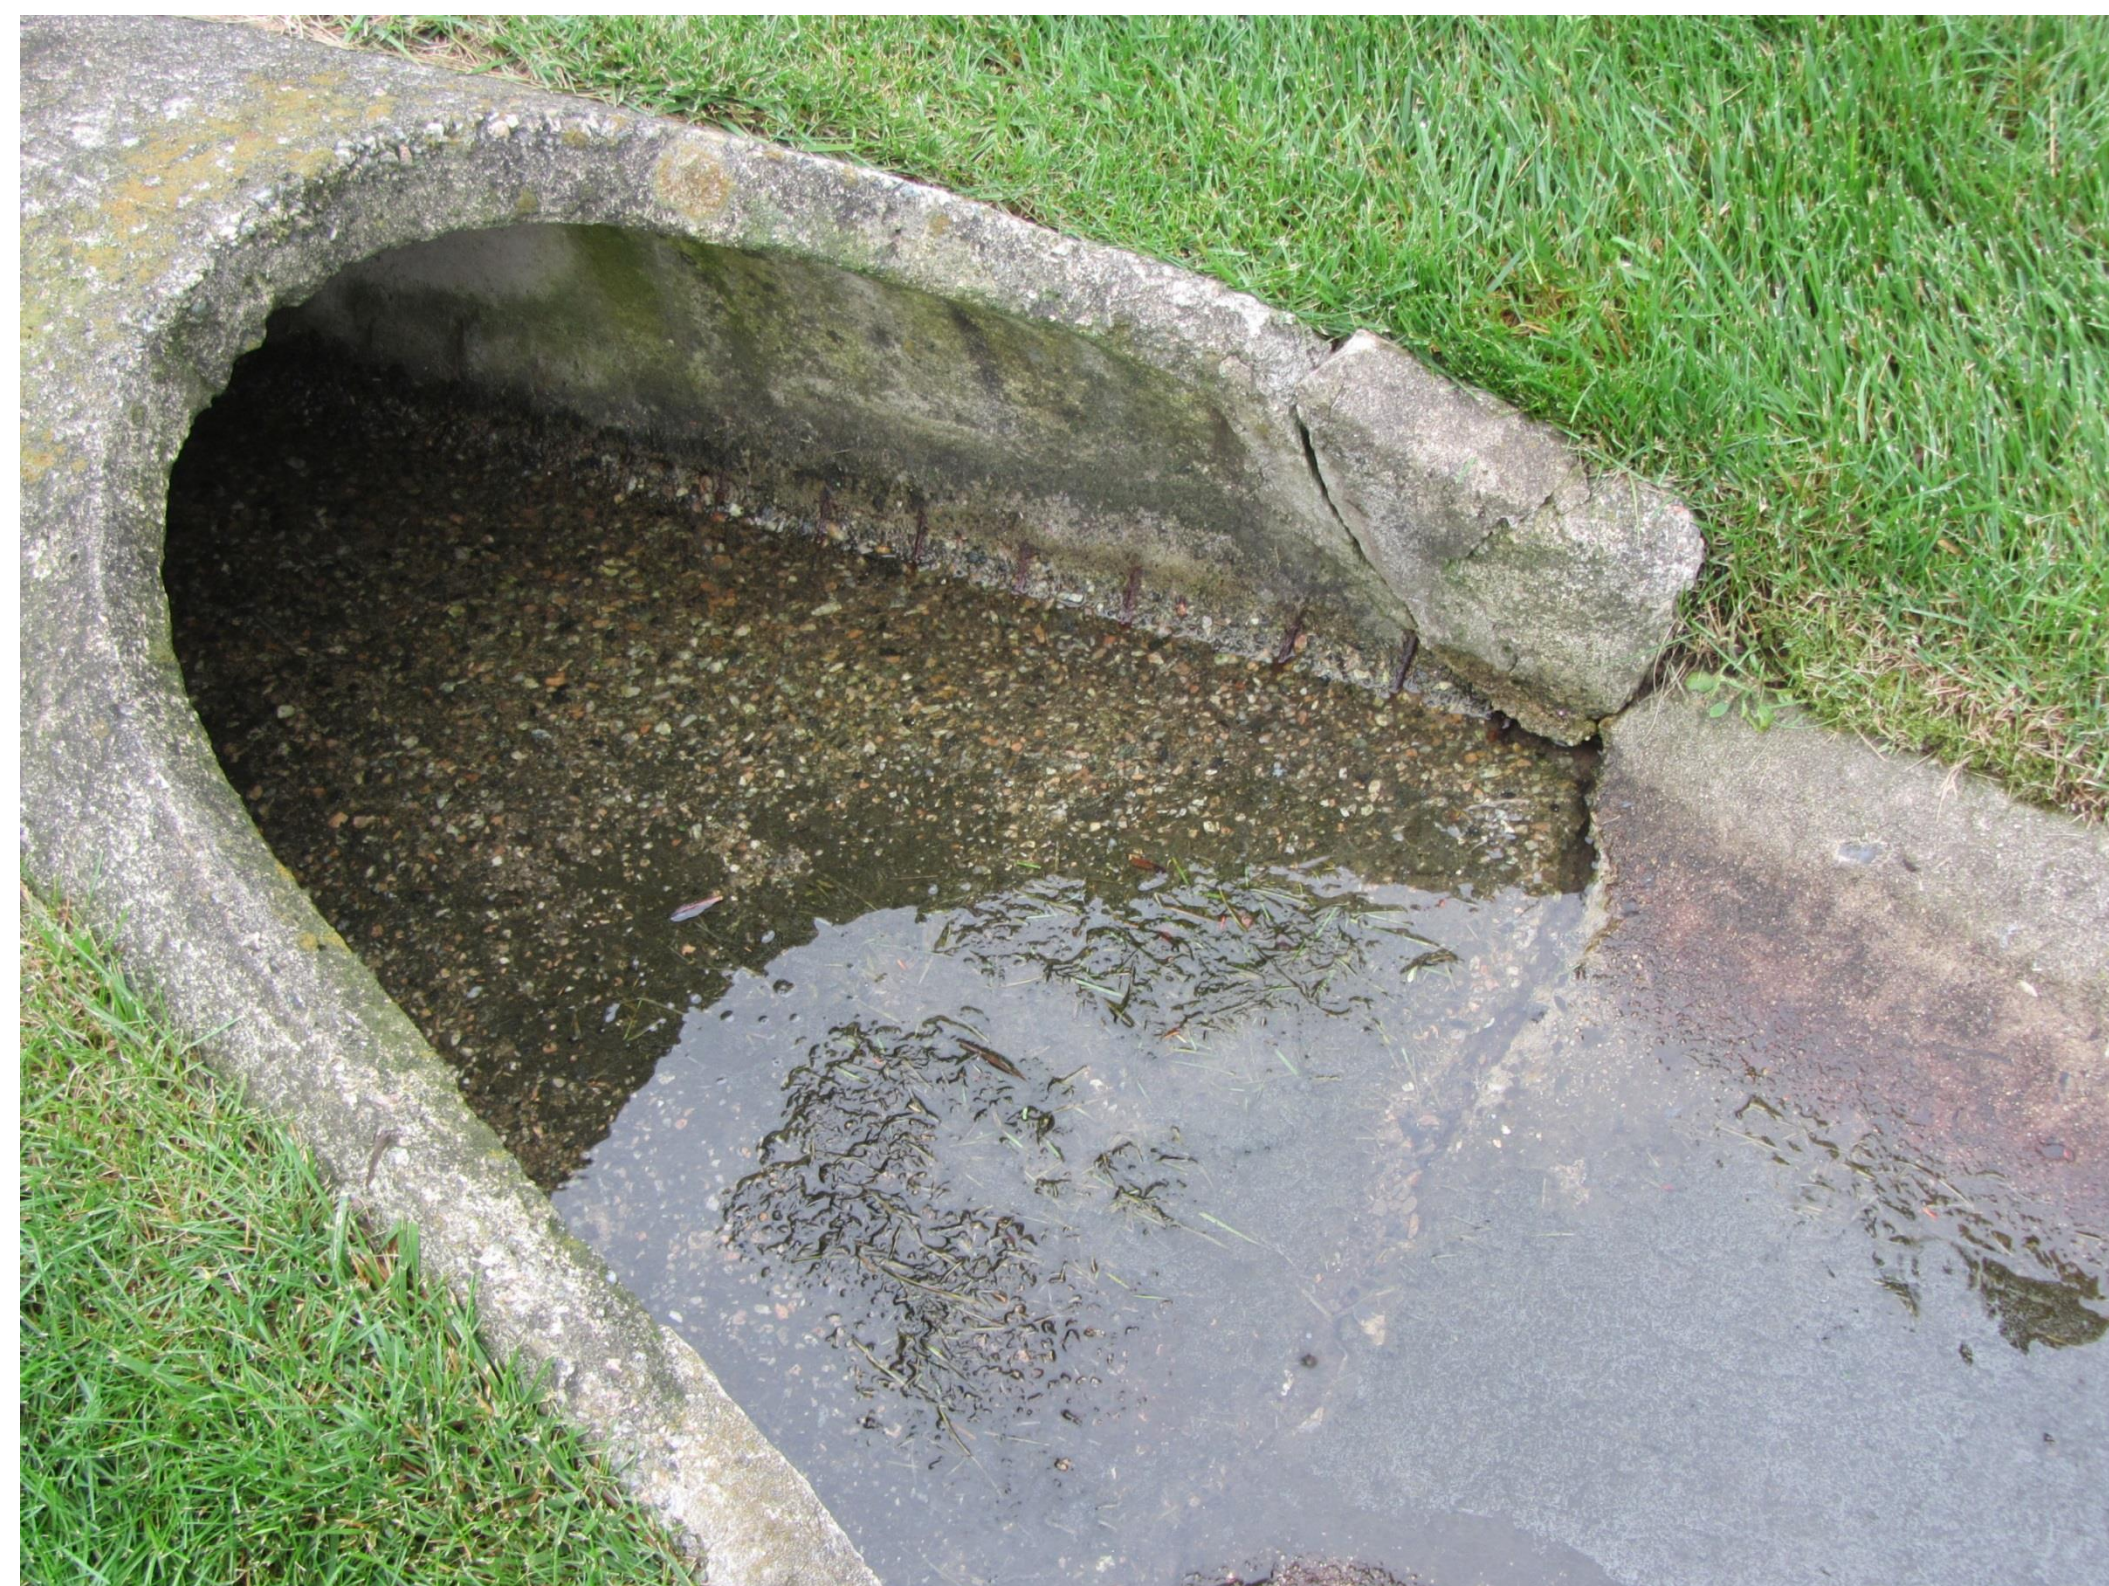
Inlet structure breakage

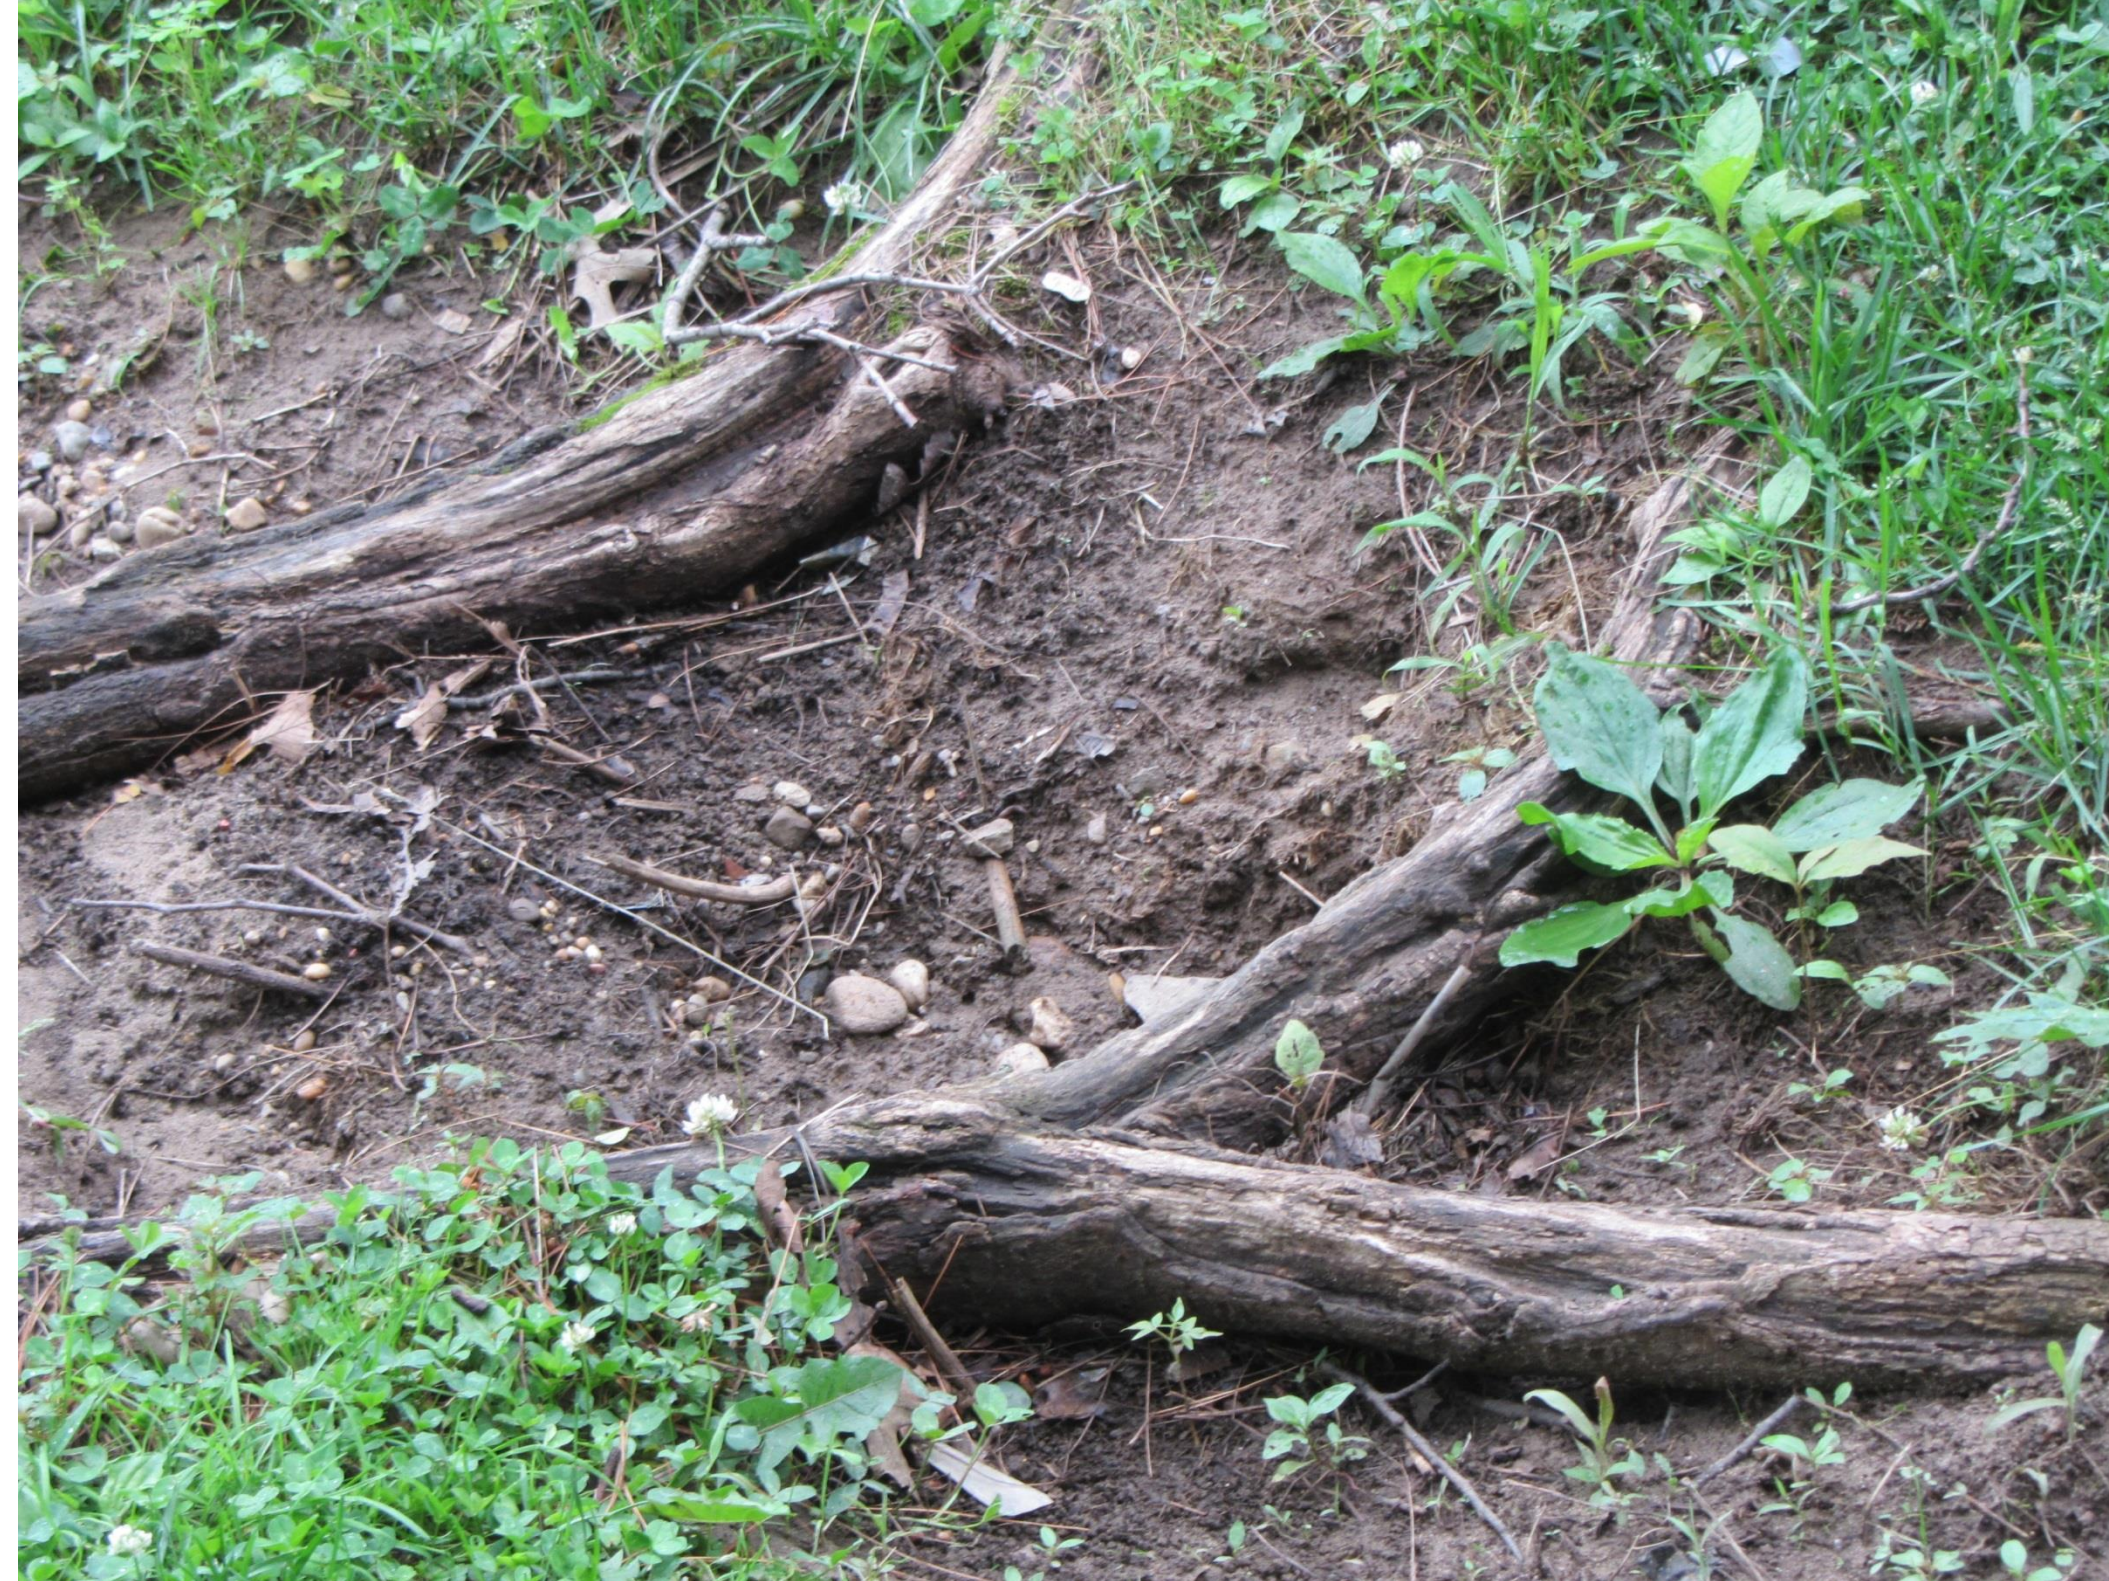
Severe erosion in swale inlet

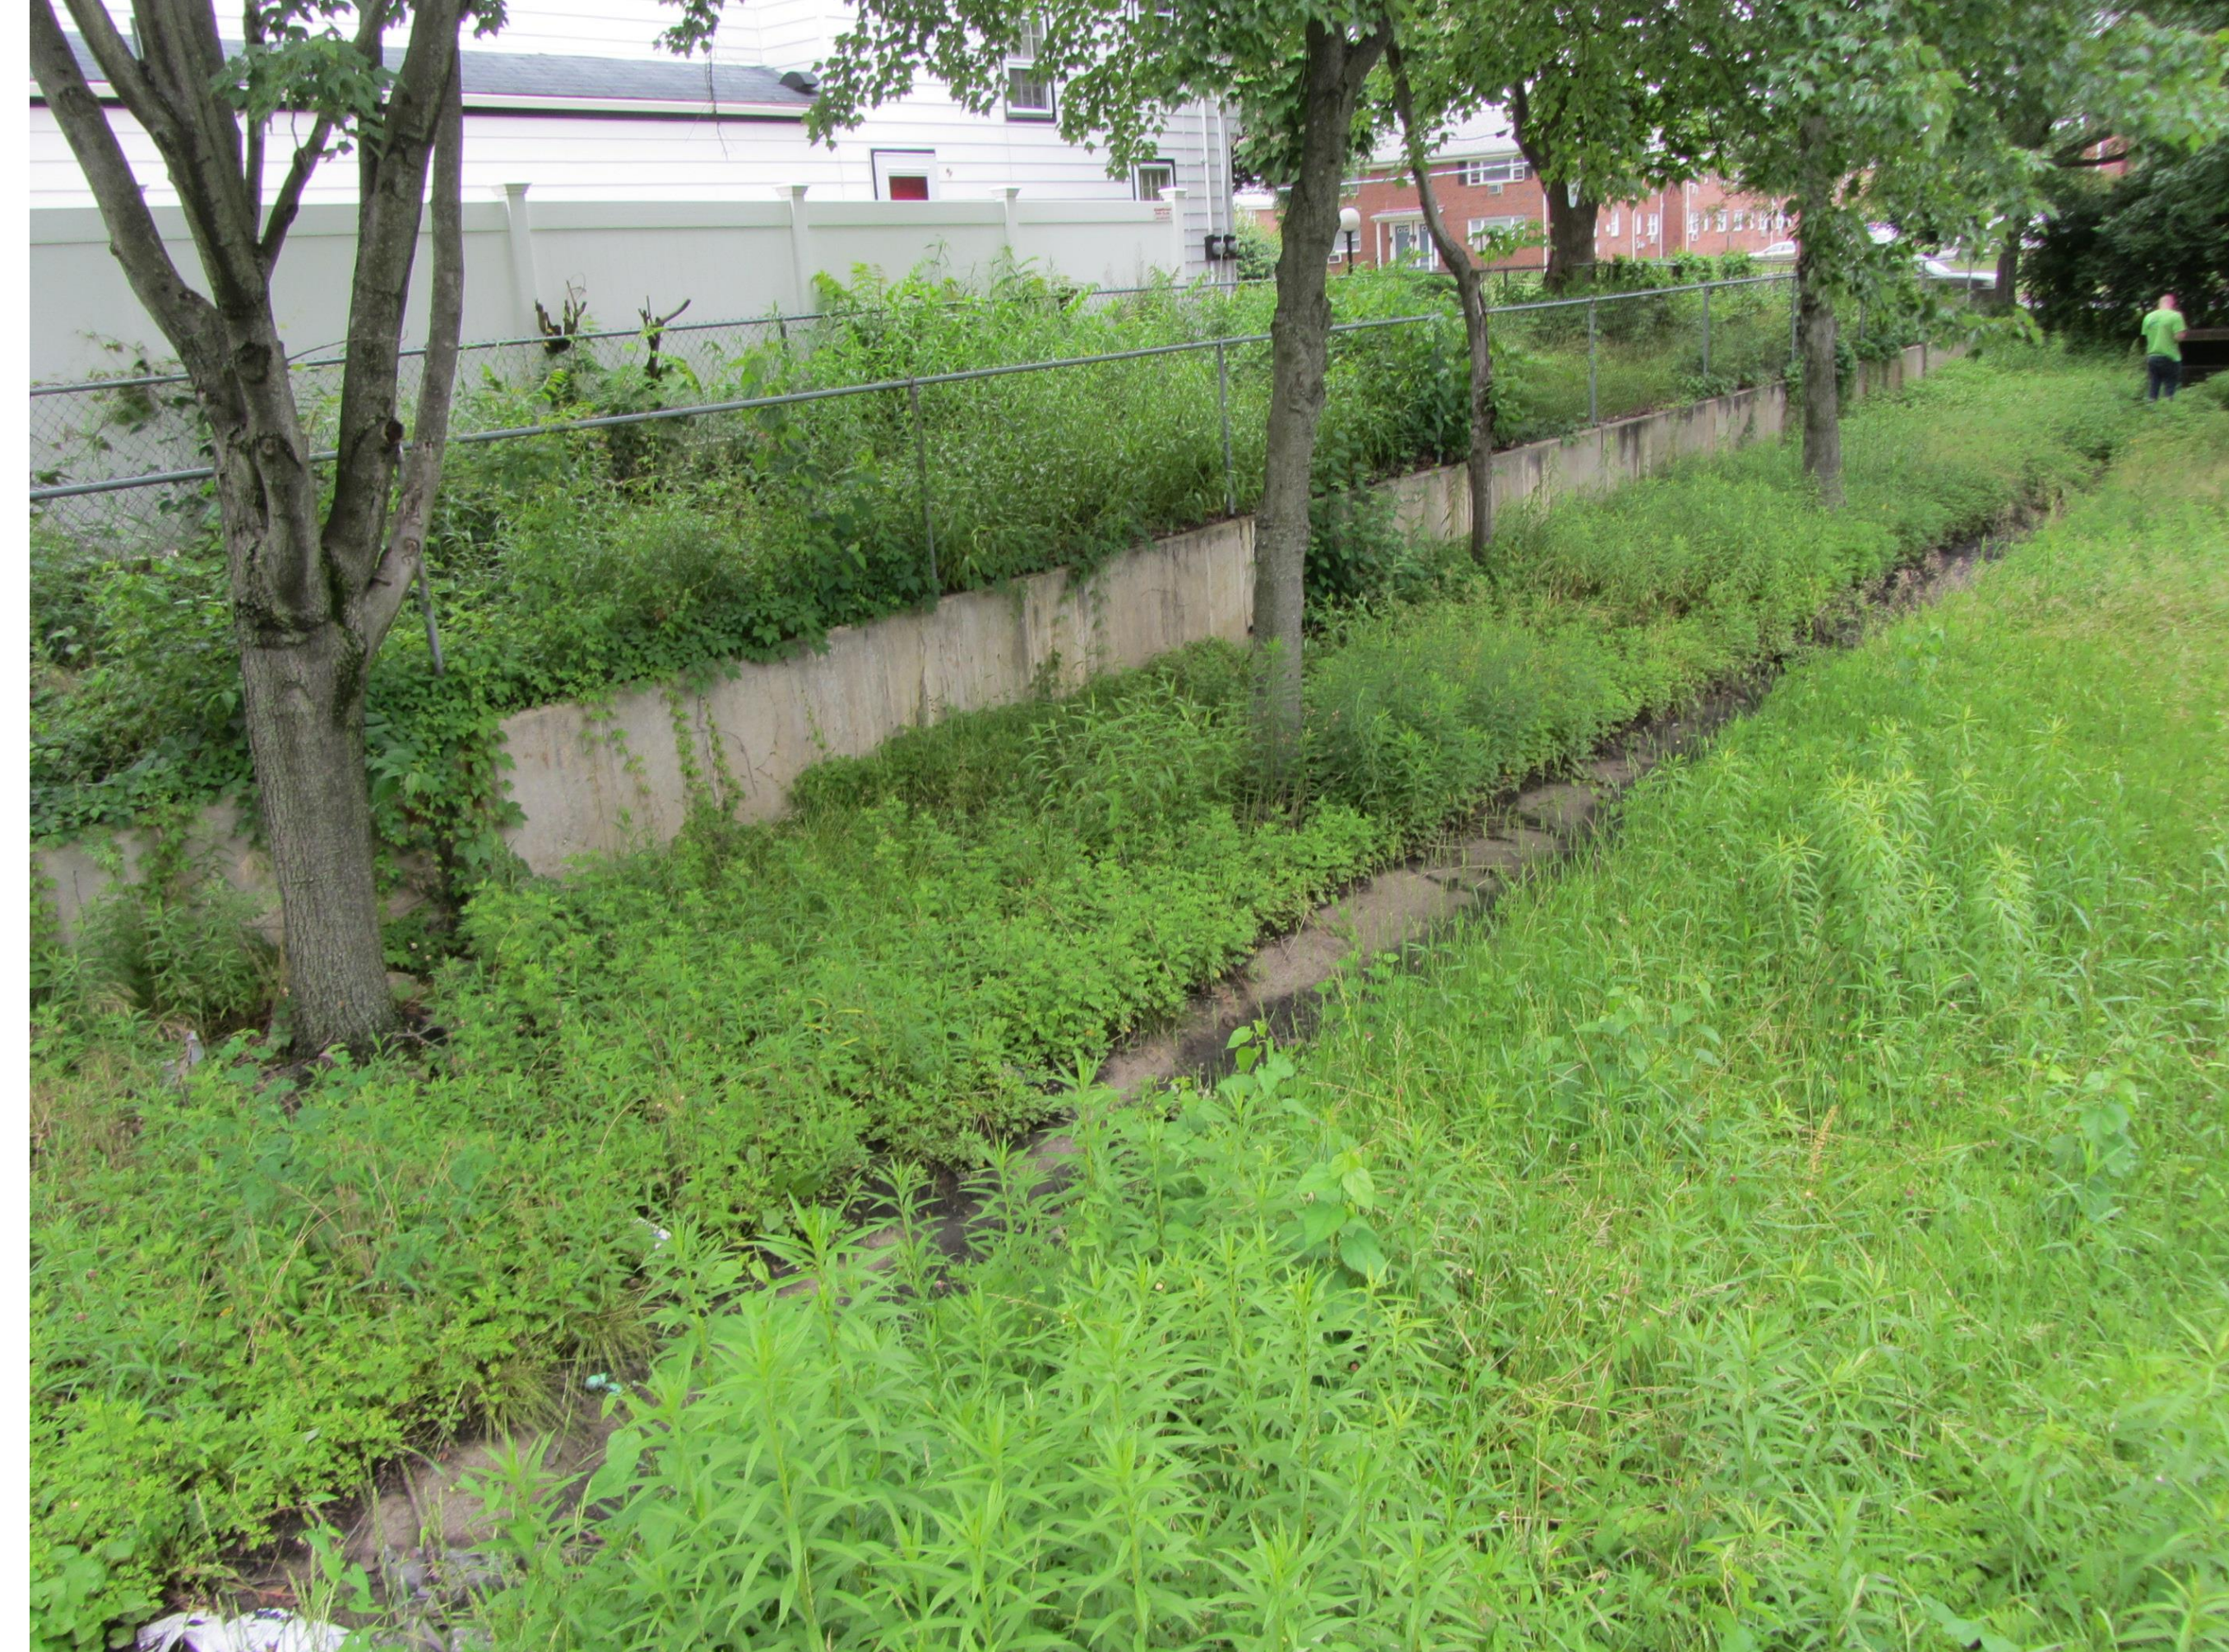
Basin bottom looking north

- Basin overall in good condition
- Significant amounts of trash present in basin
- Lot flow channel can be removed and replaced with stone channel to promote infiltration

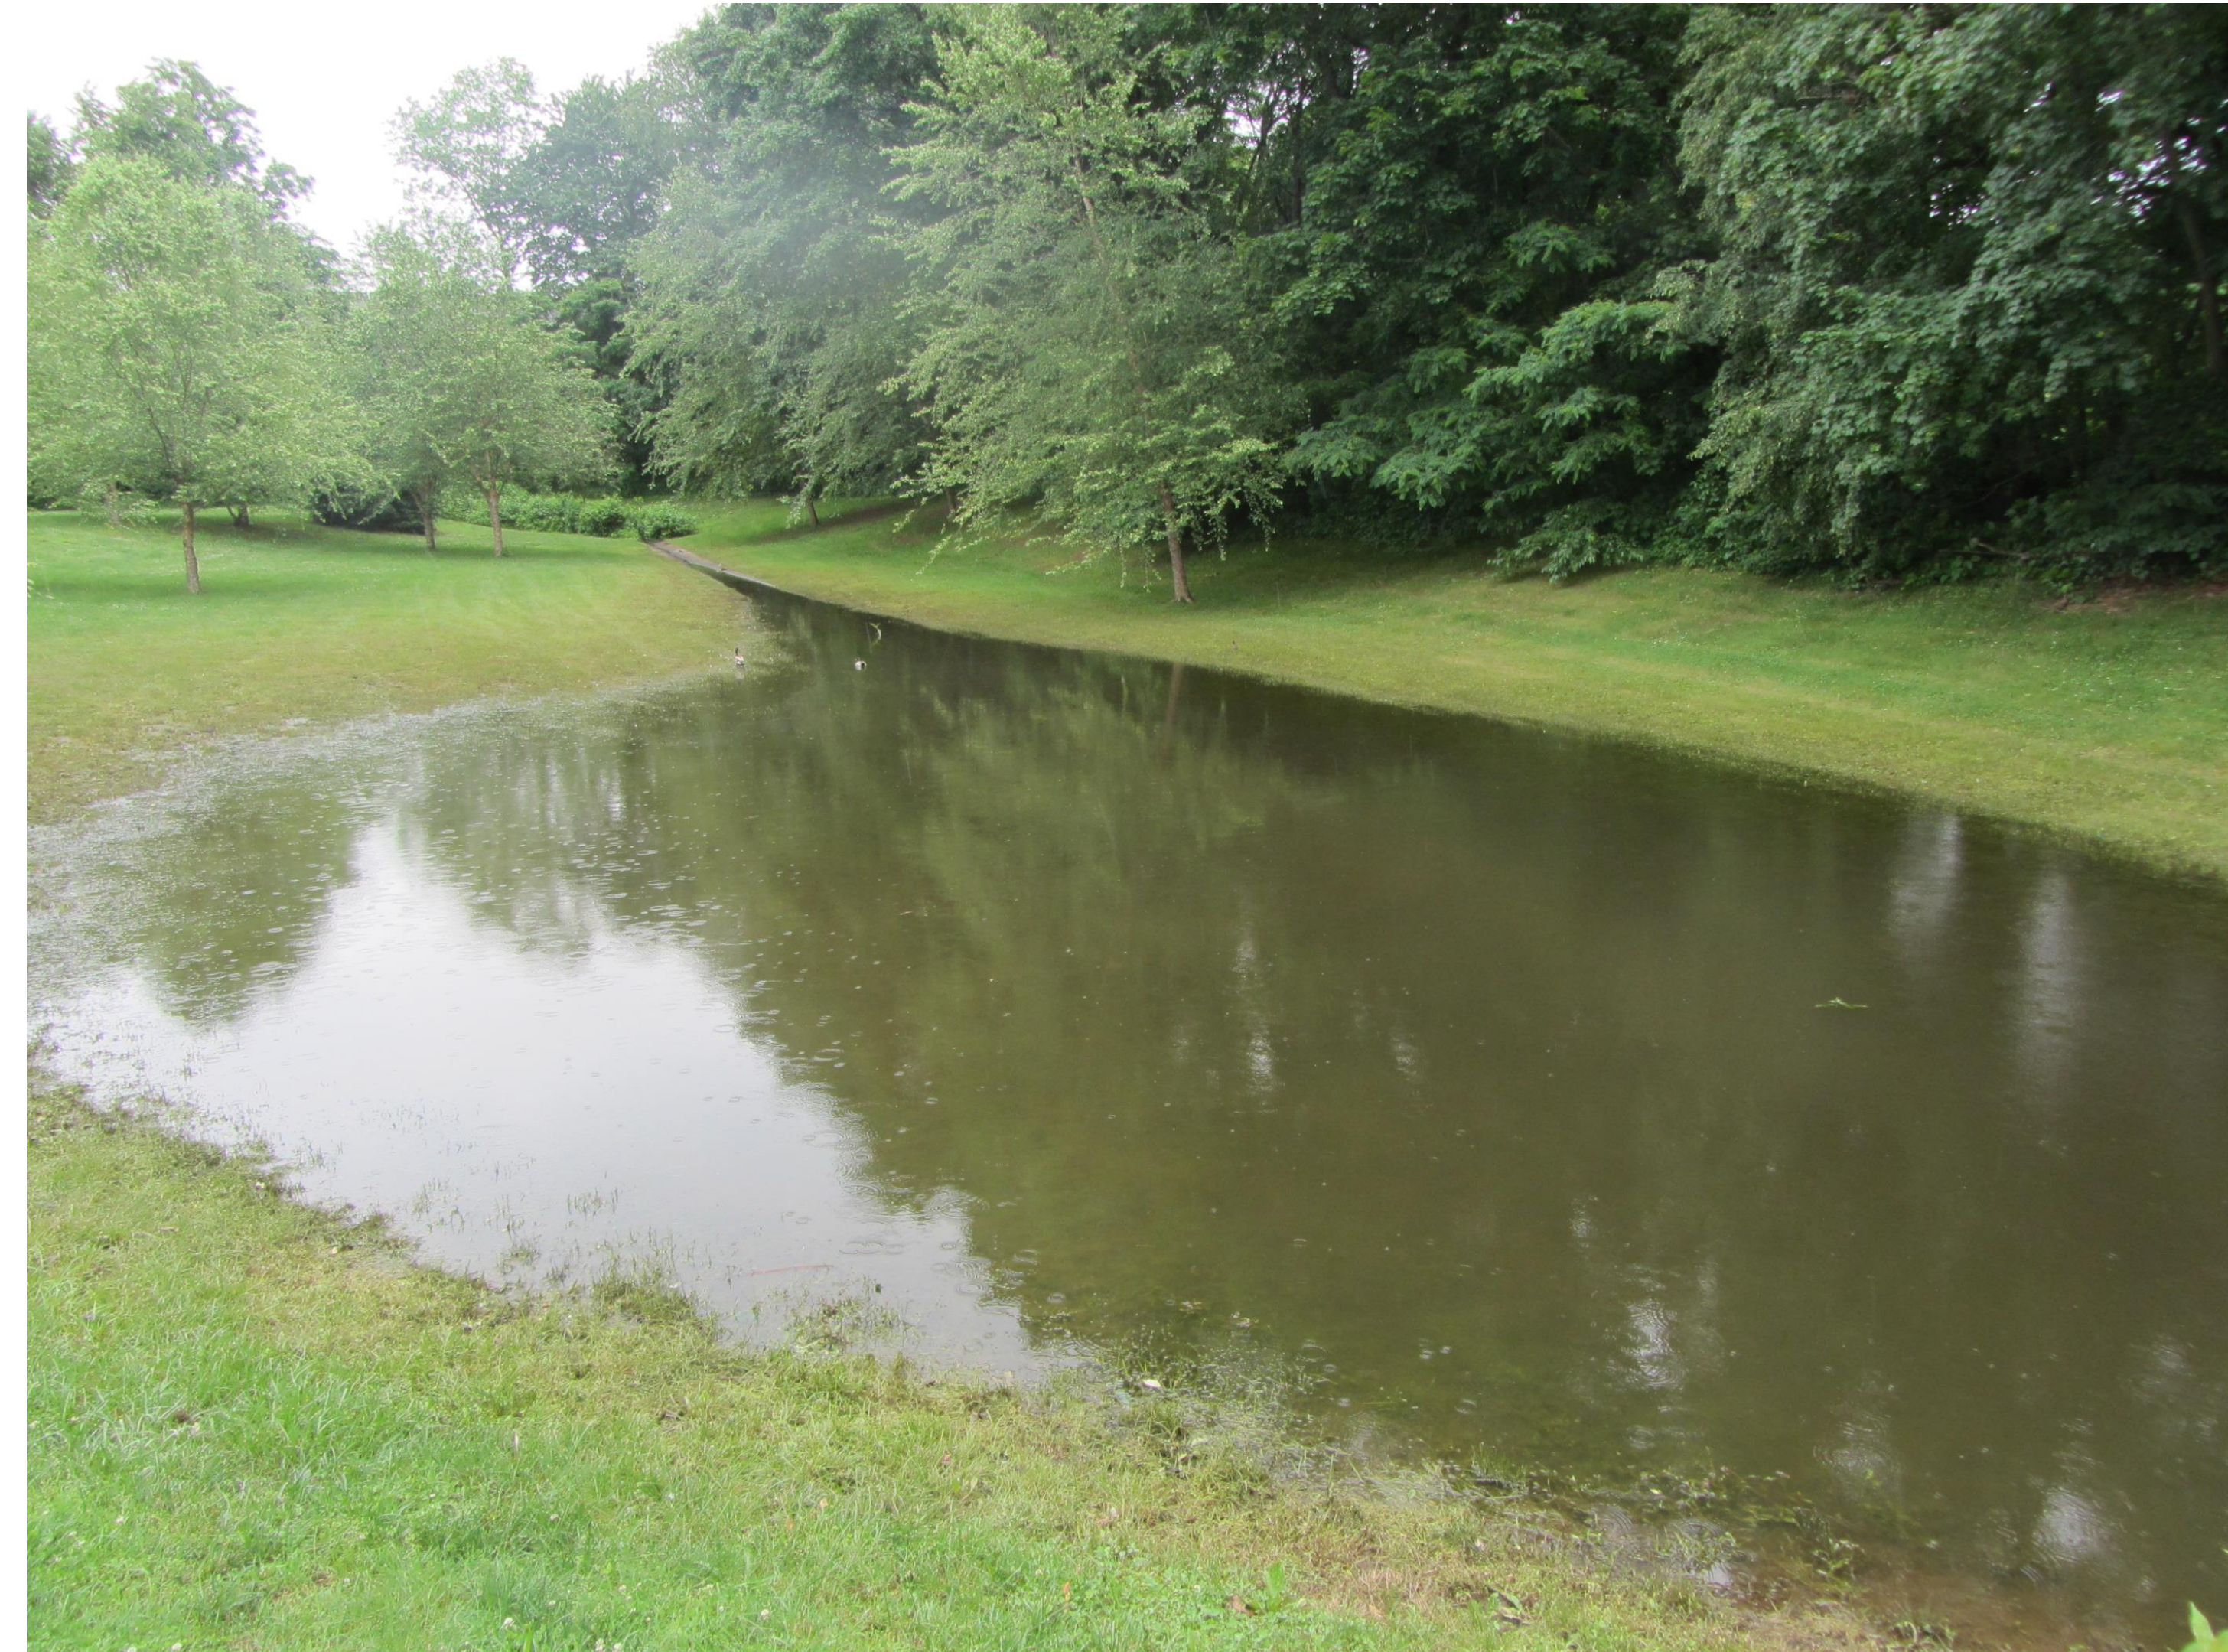
Severe ponding in basin

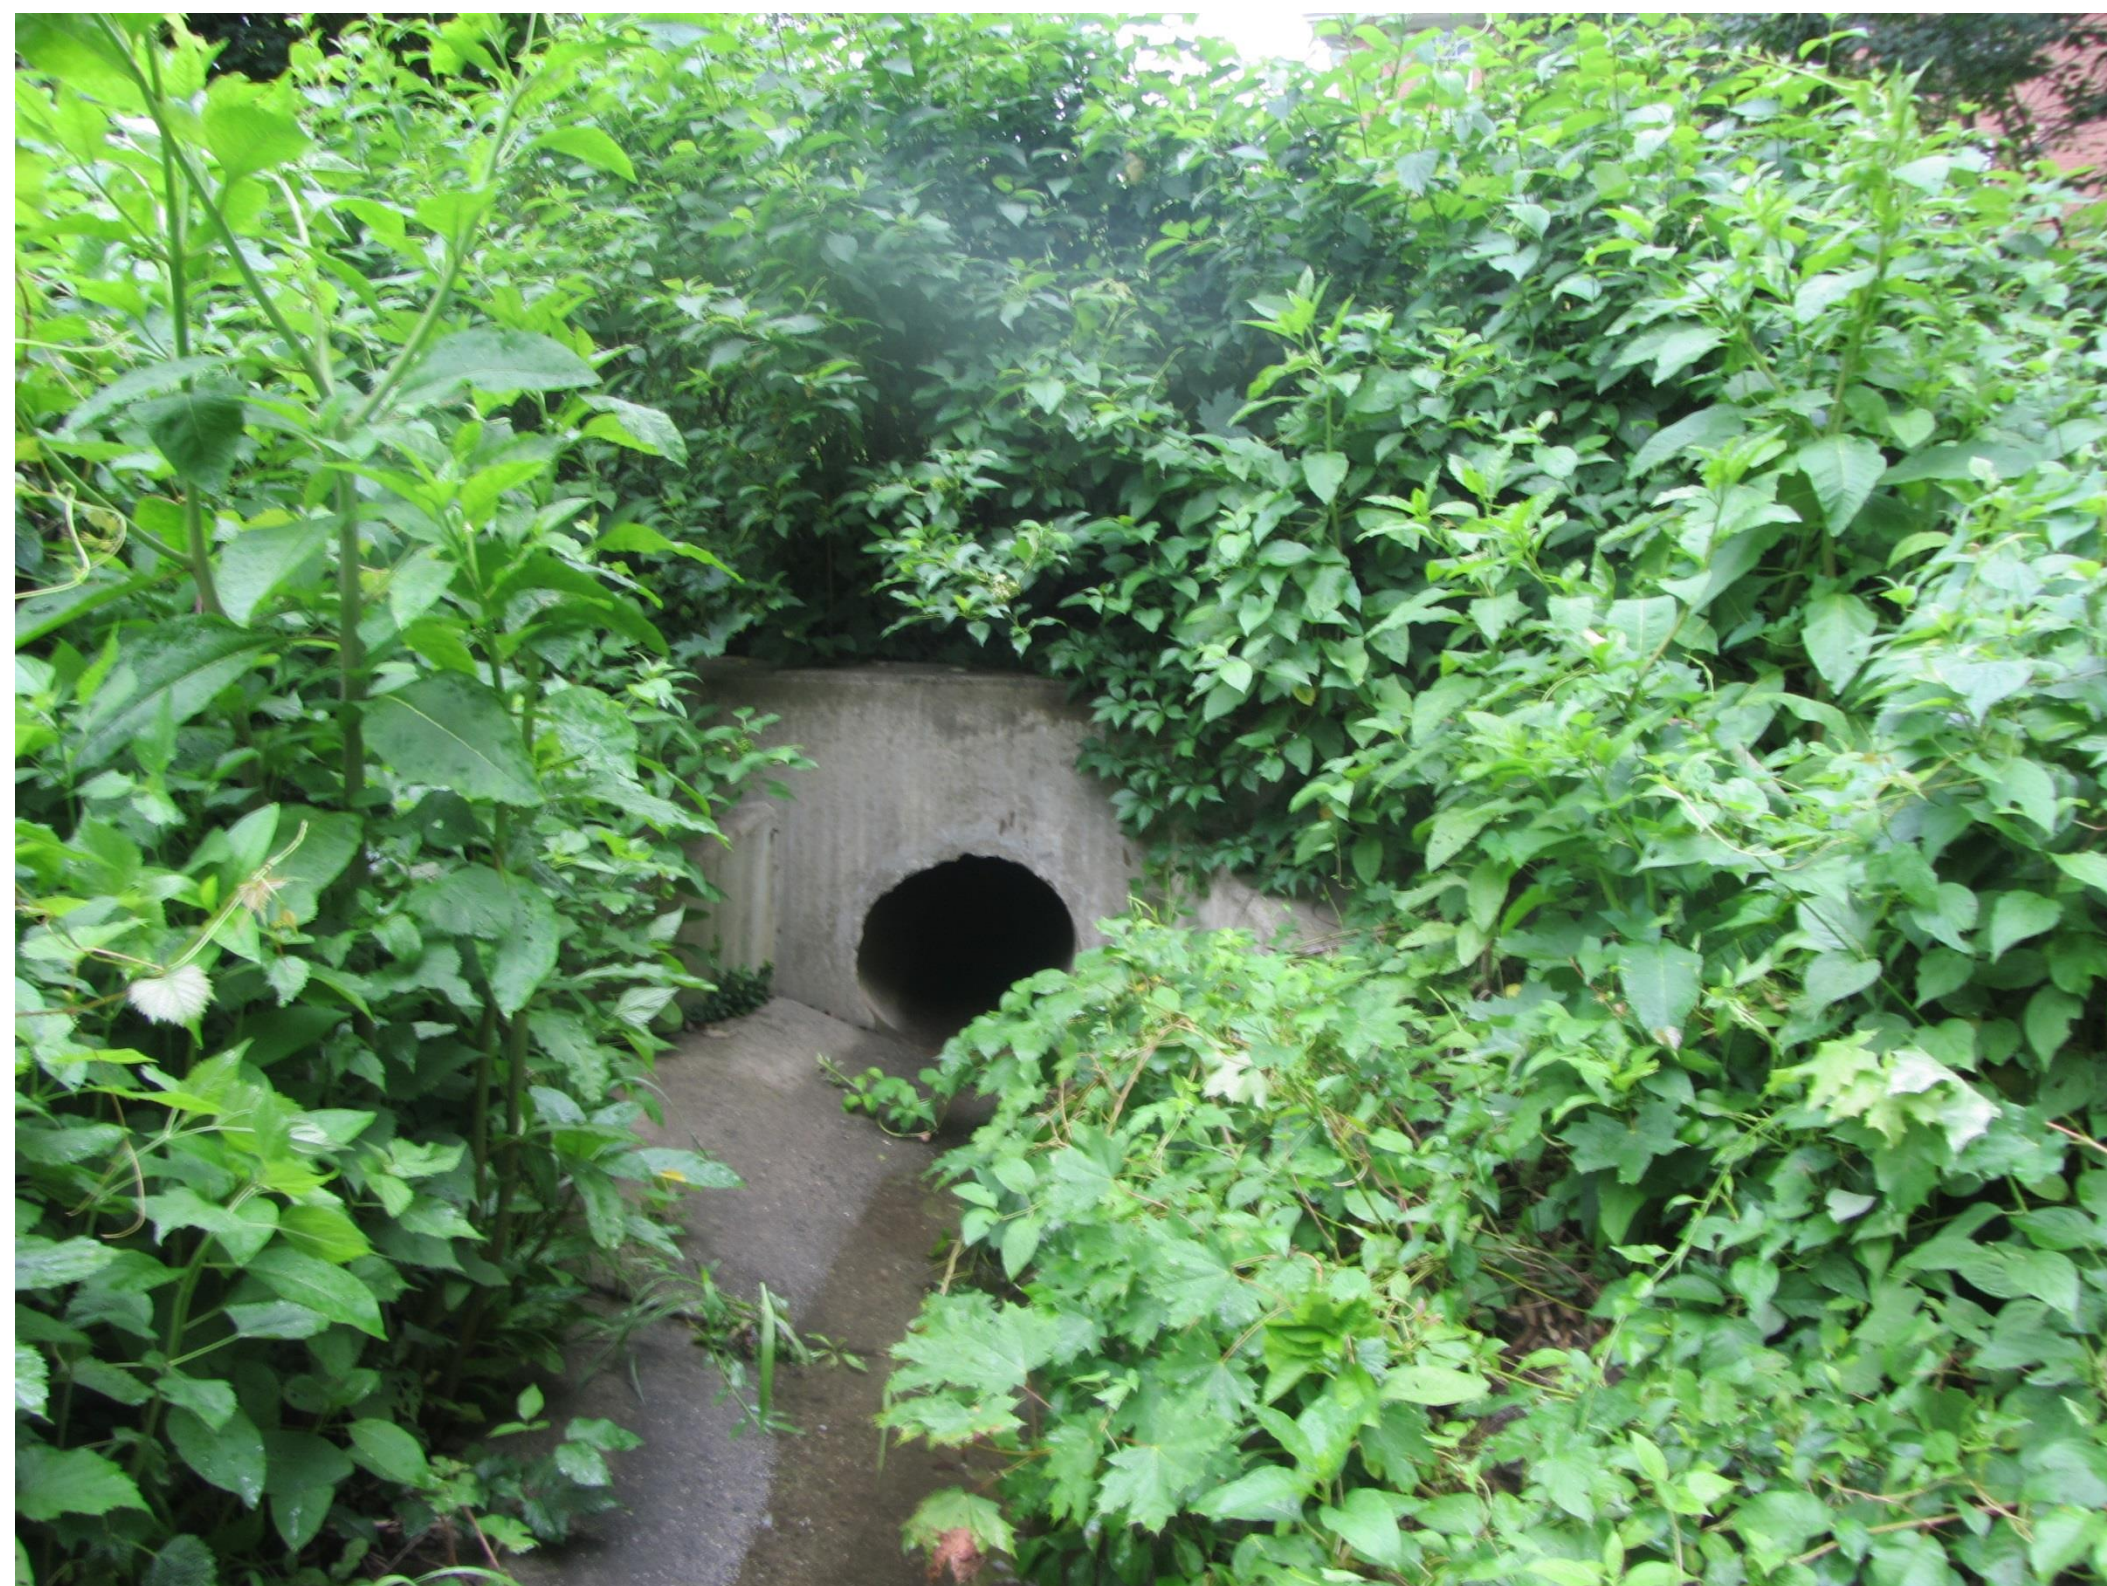
Plant growth around inlet
