**Hamilton Township (Mercer County)
Stormwater Basin Assessment Summary
Past Priority Addendum (Year 5B)**

Developed by the Rutgers Cooperative Extension Water Resources Program
Funded by Hamilton Township, Mercer County, New Jersey

November 27, 2019

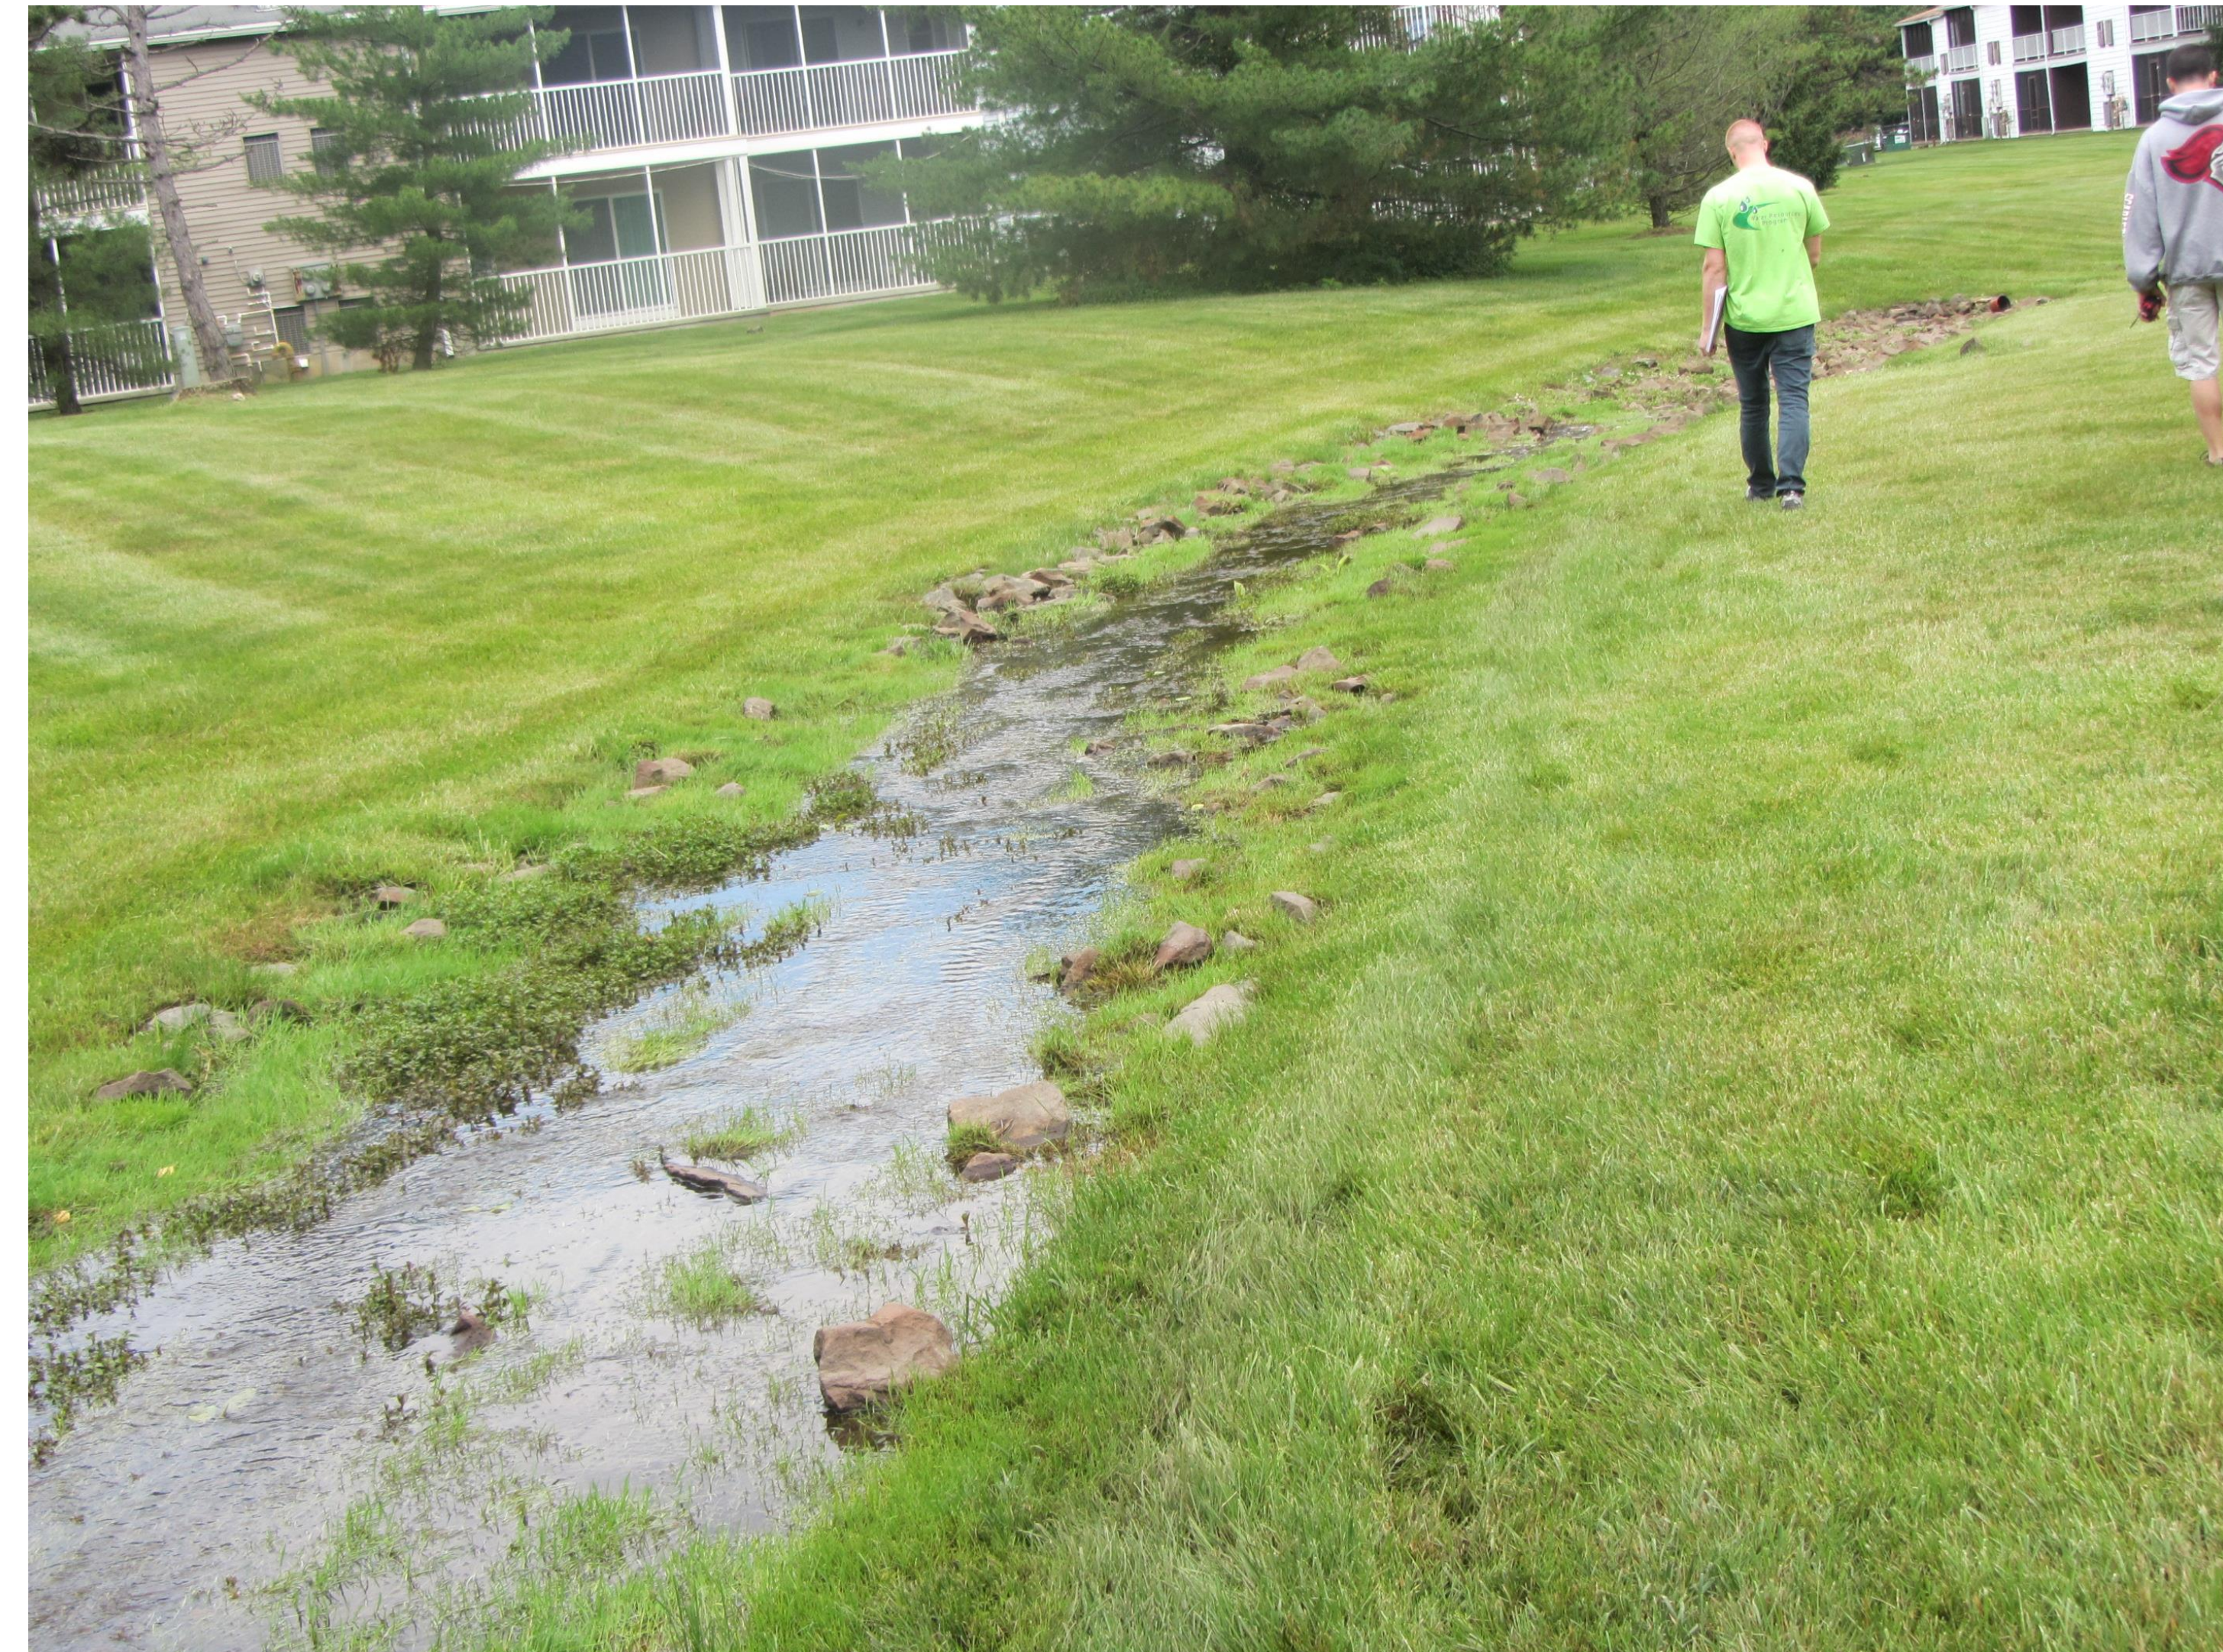
Basin bottom looking north

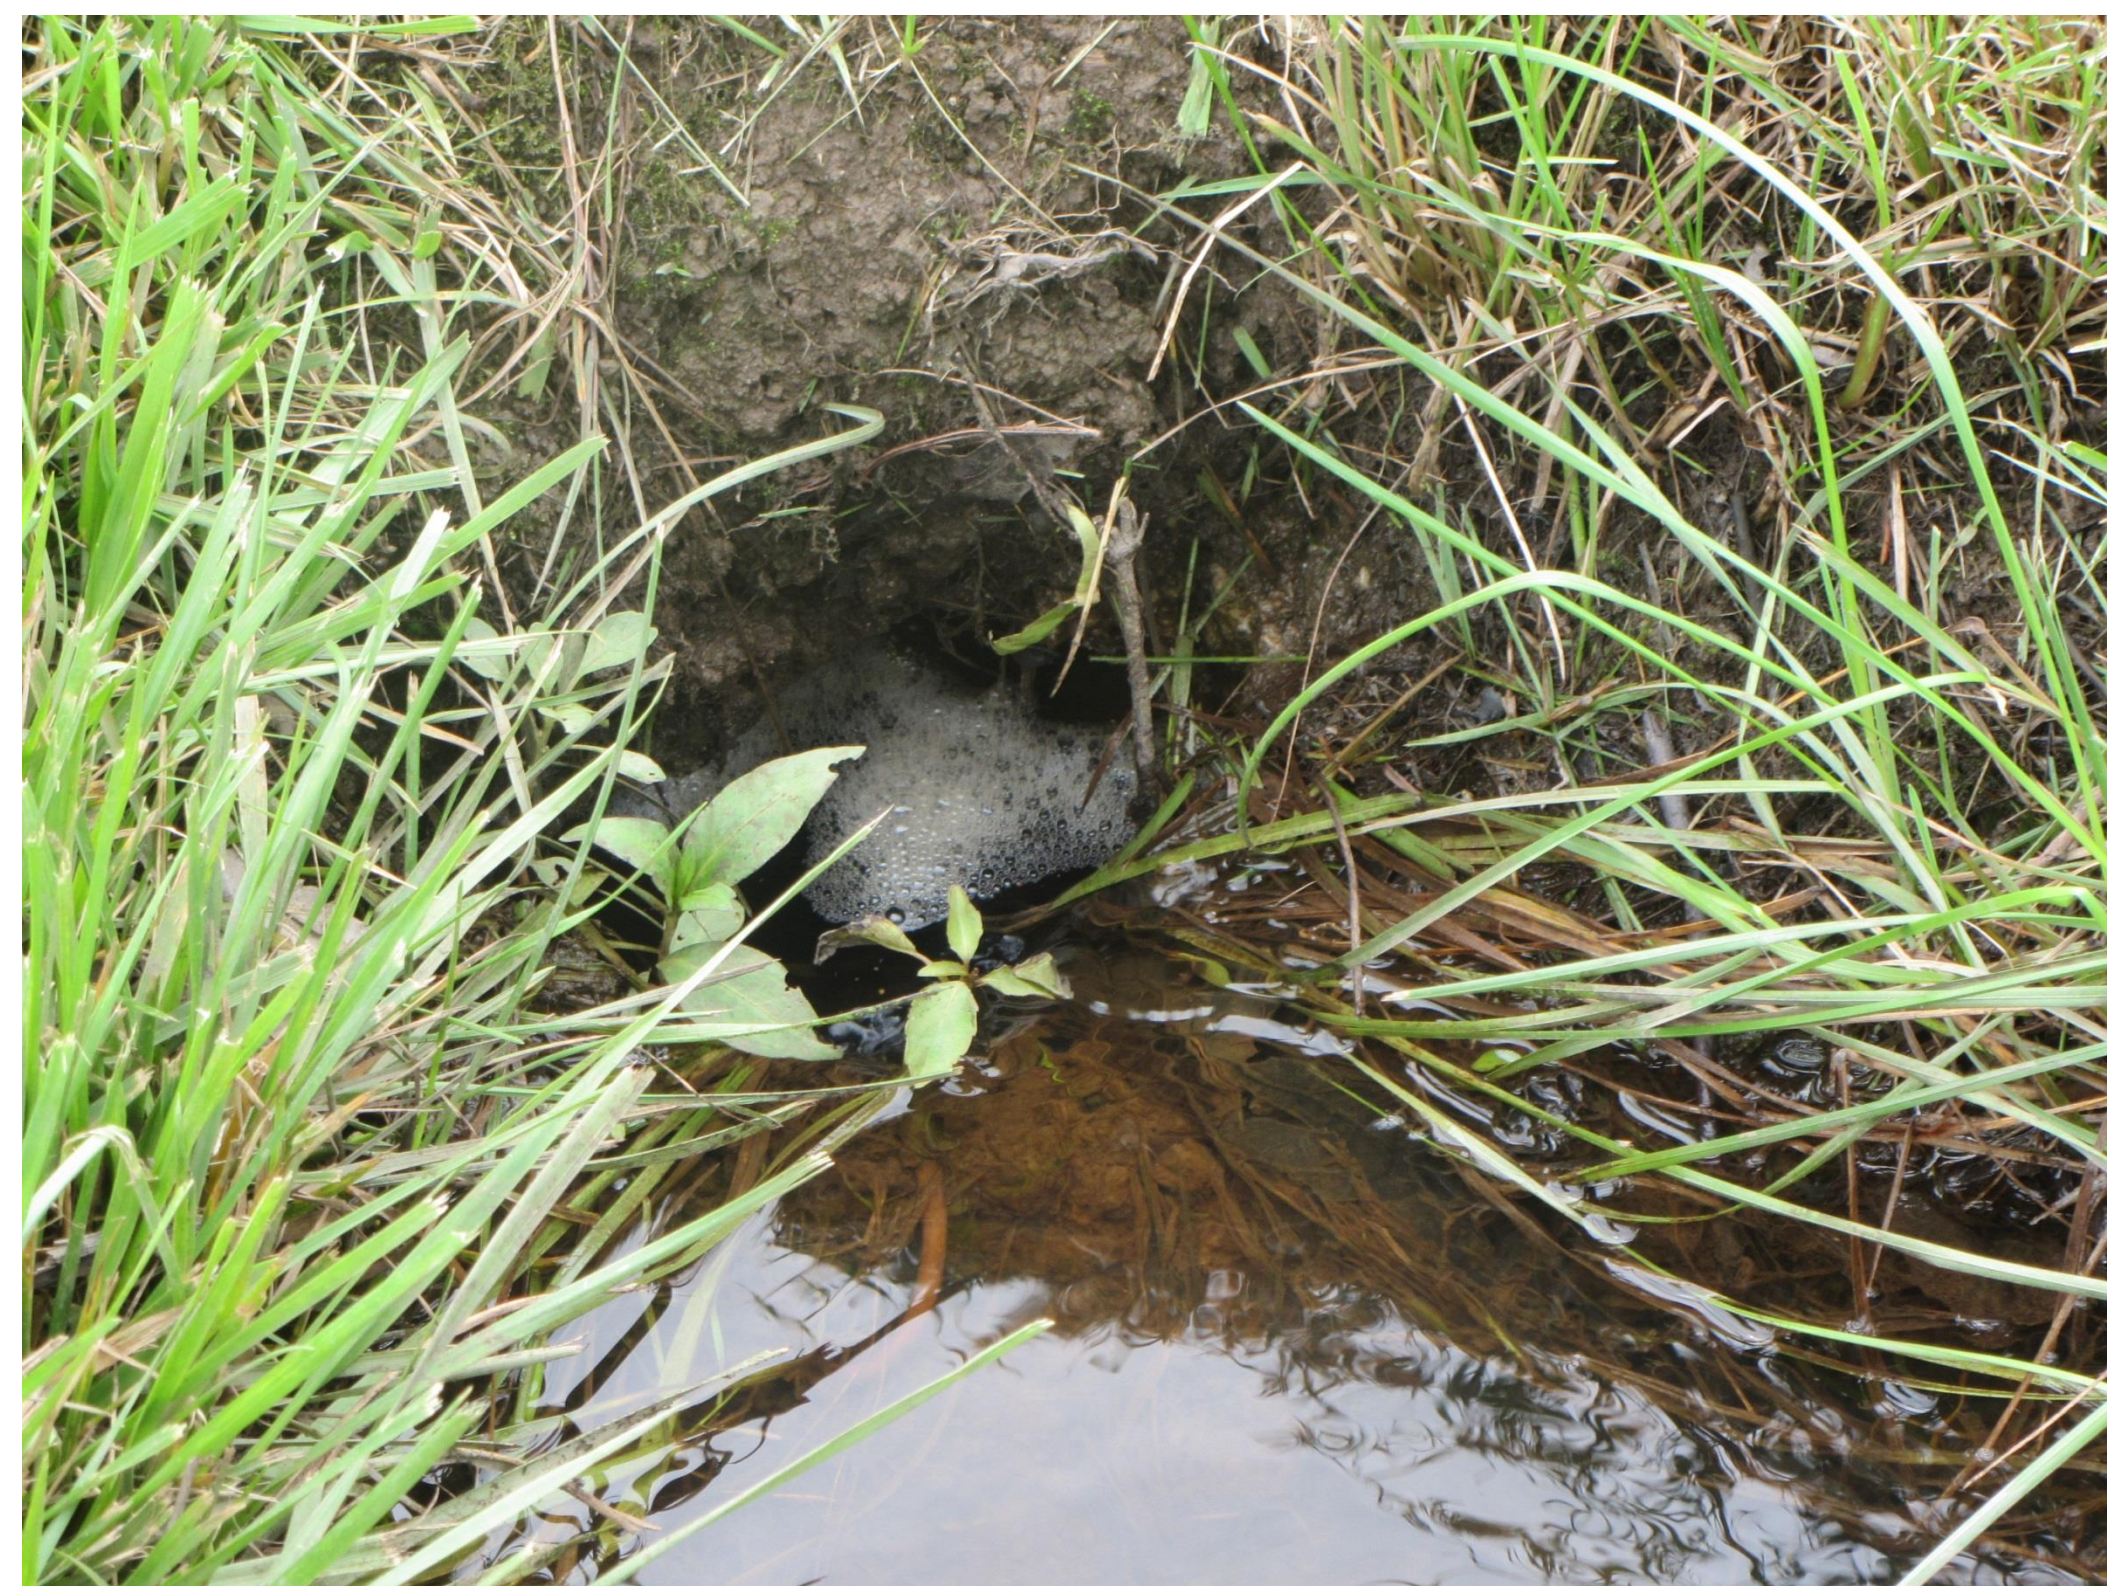
Water exiting through hole

- Basin intercepts a natural stream
- Water is exiting through cracks in the sides of the outlet rather than the grate
- Water is exiting through a hole in the ground before reaching the outlet

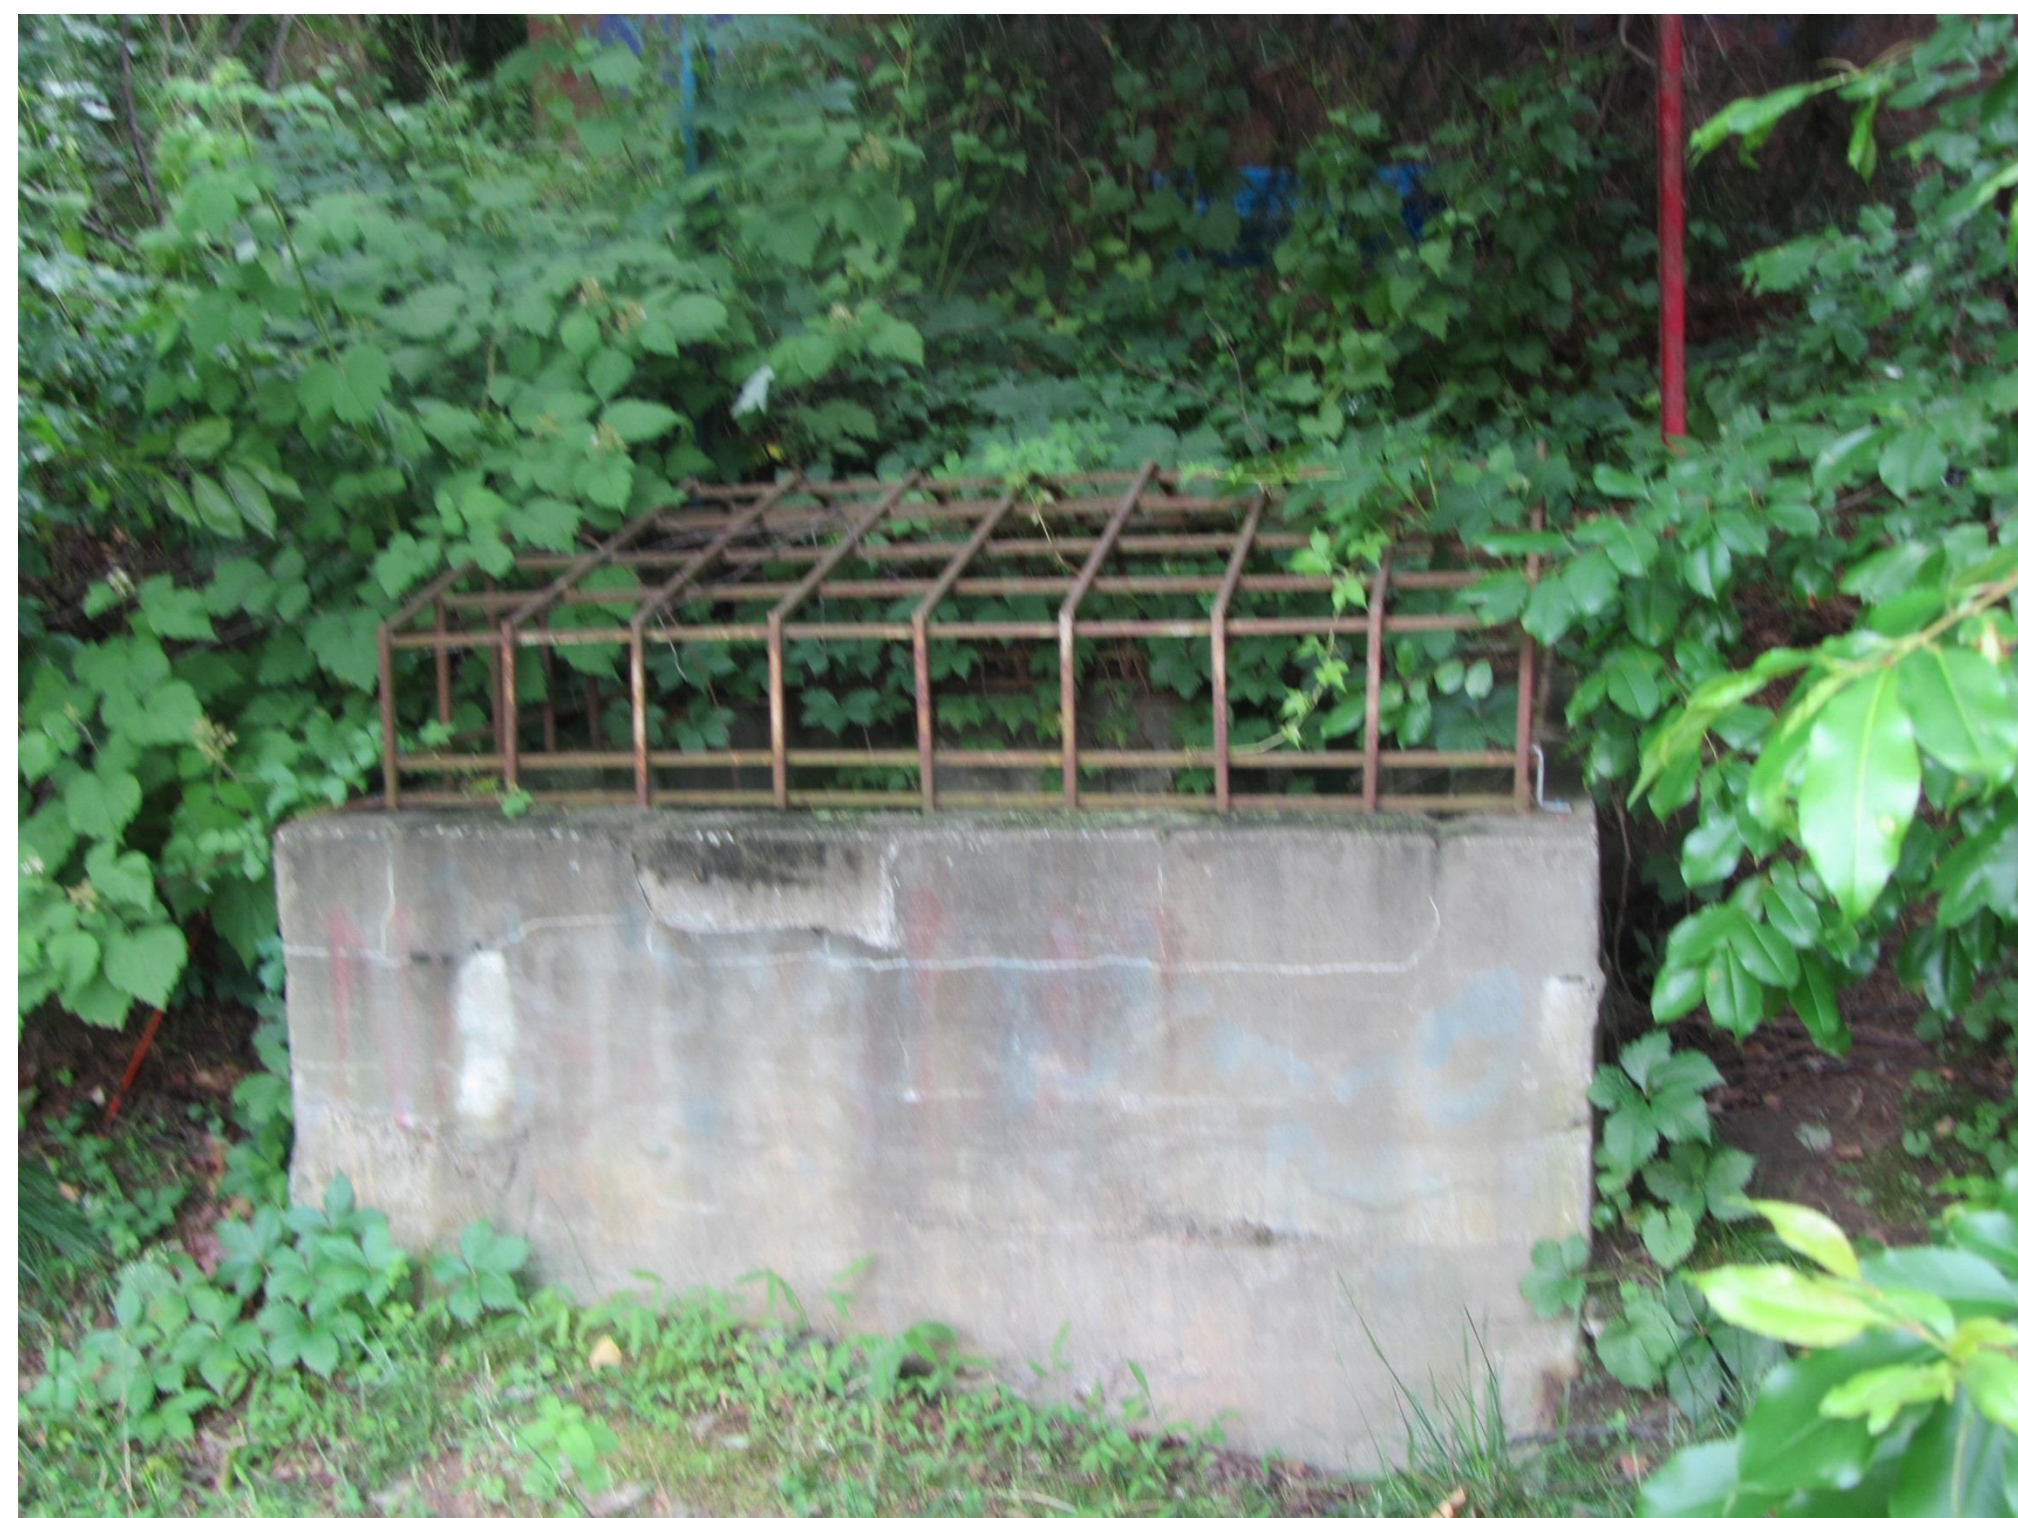
Excessive growth around outlet structure

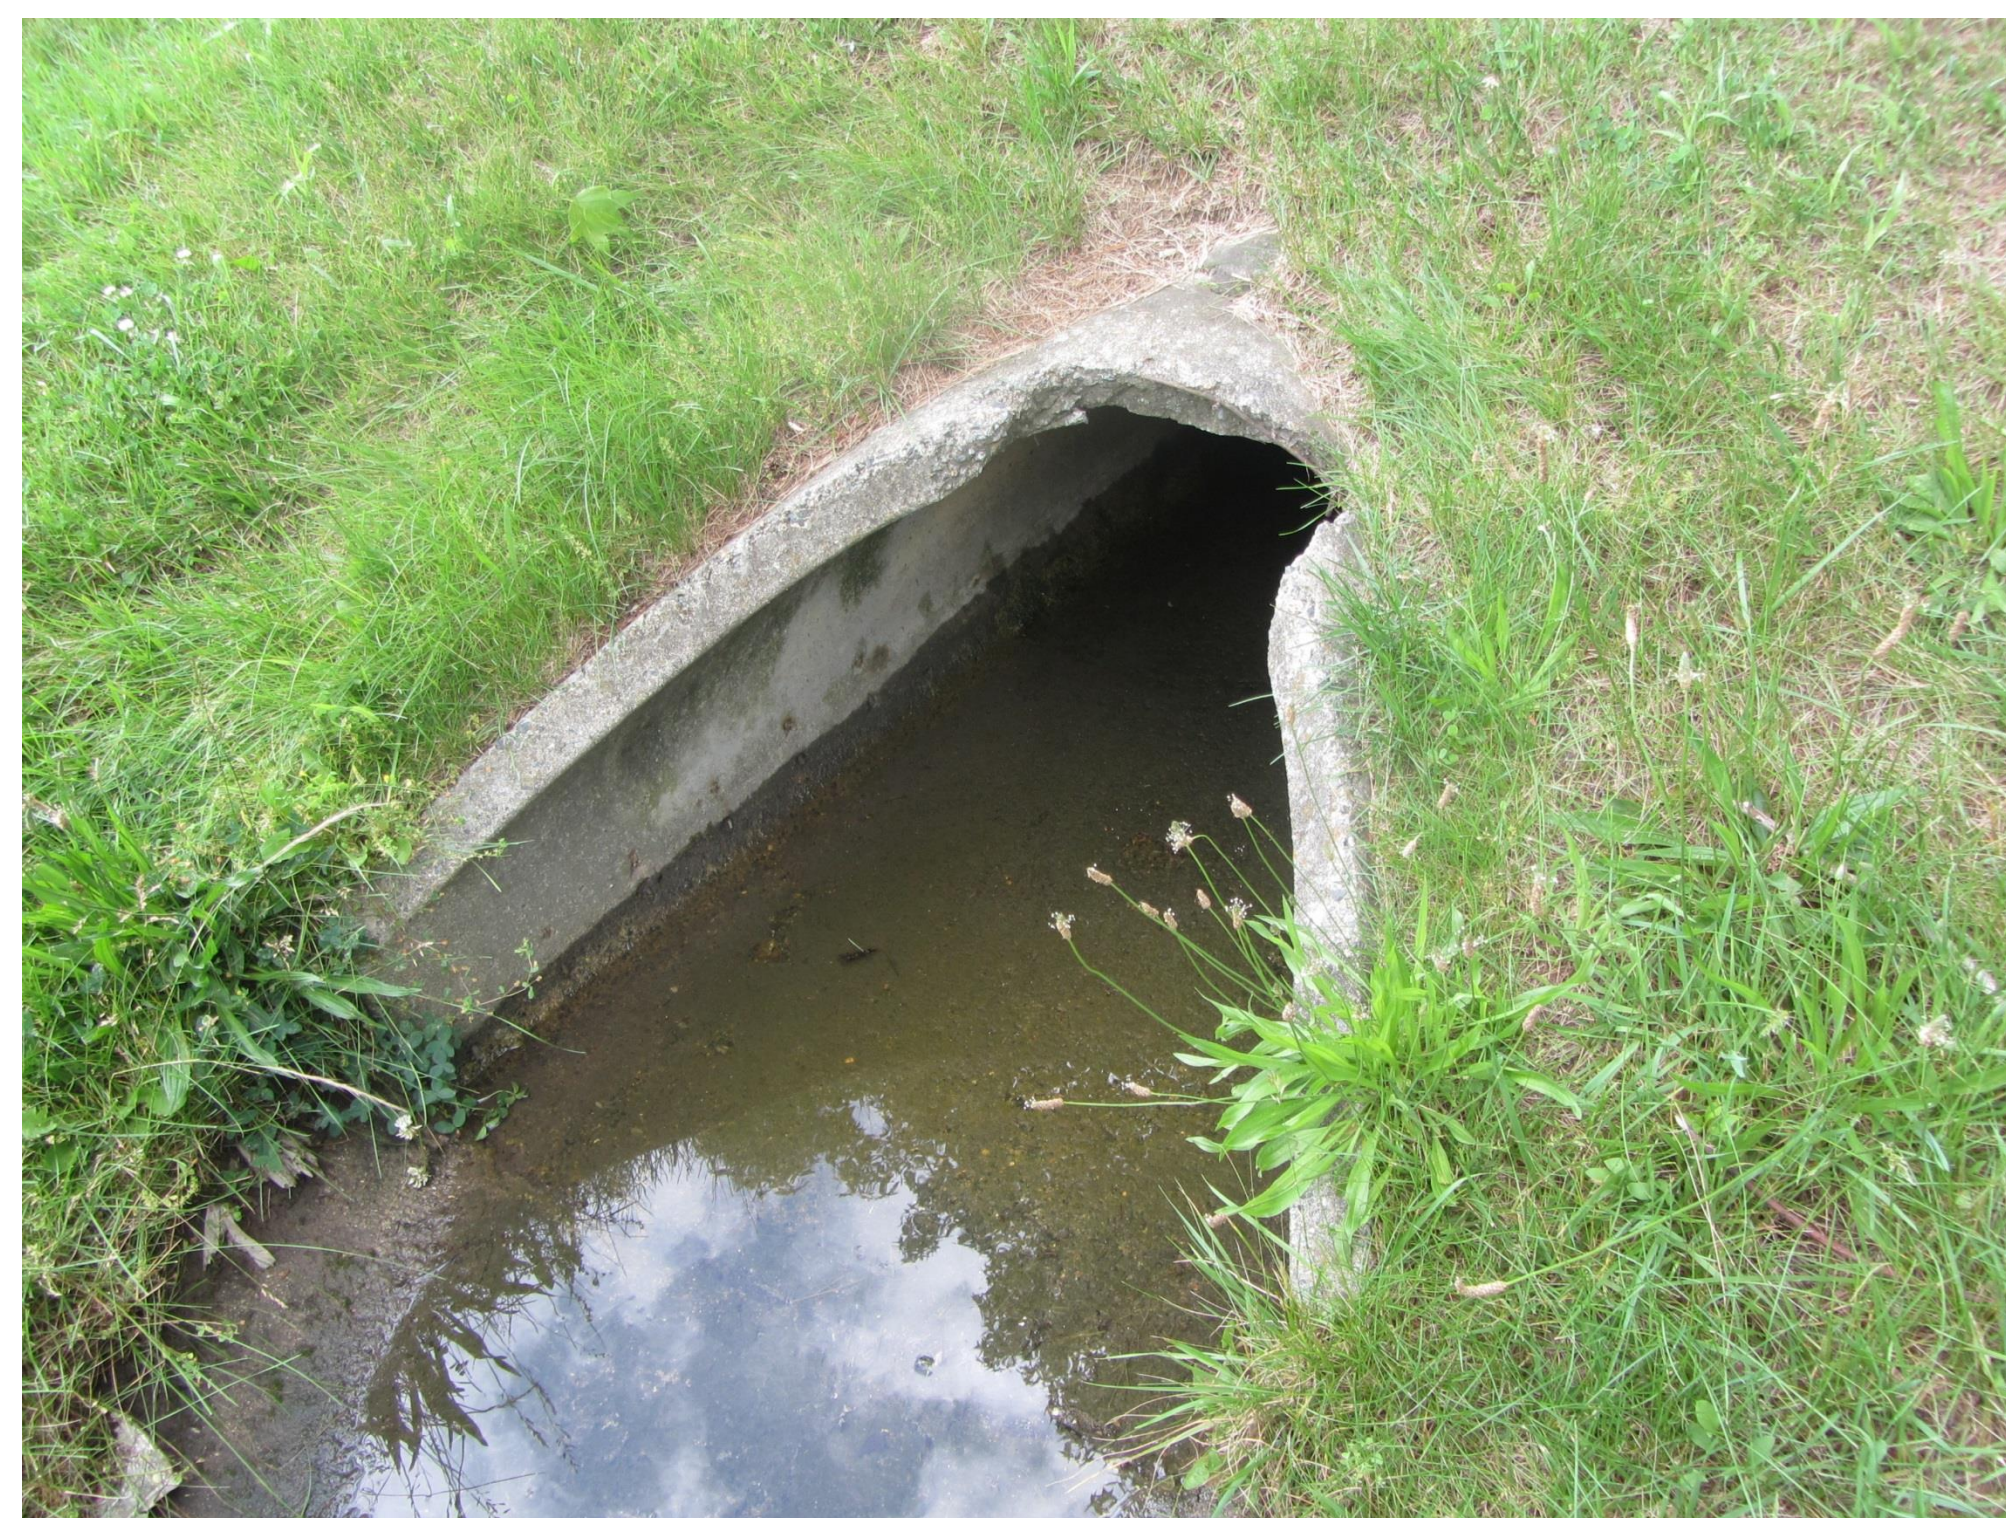
Breakage on northeastern inlet

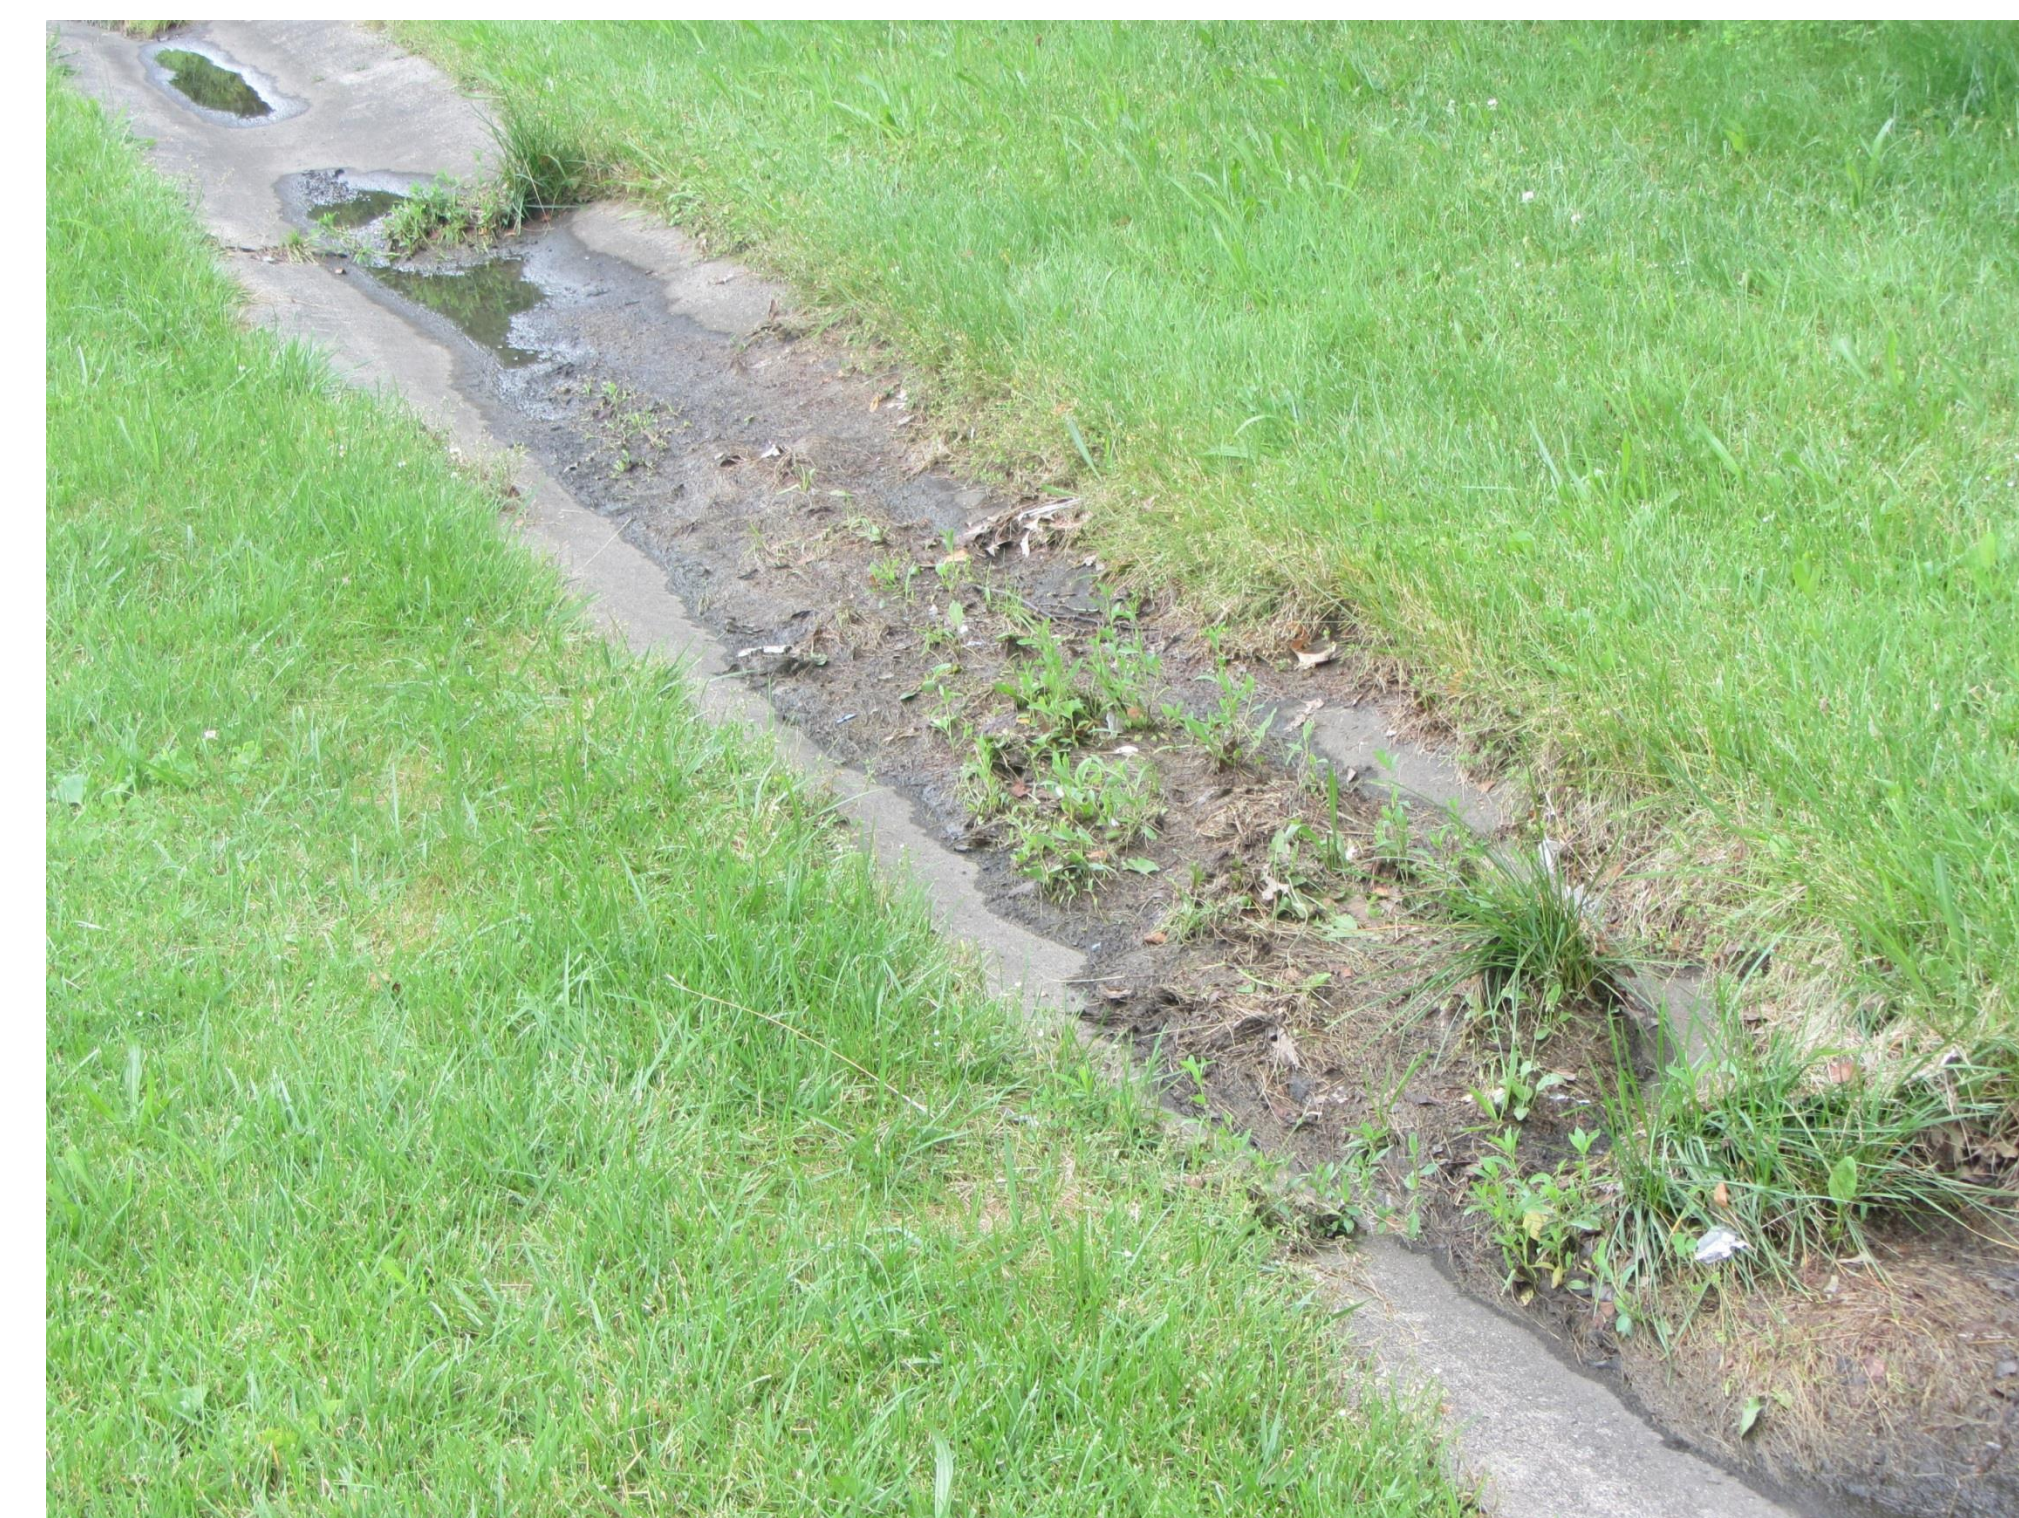
Excess sediment in low flow channel

- Some vegetation growing within low flow channel
- Clean buildup in low flow channel
- Opportunity to remove low flow channel and replace with rock channel to help deal with standing water issues

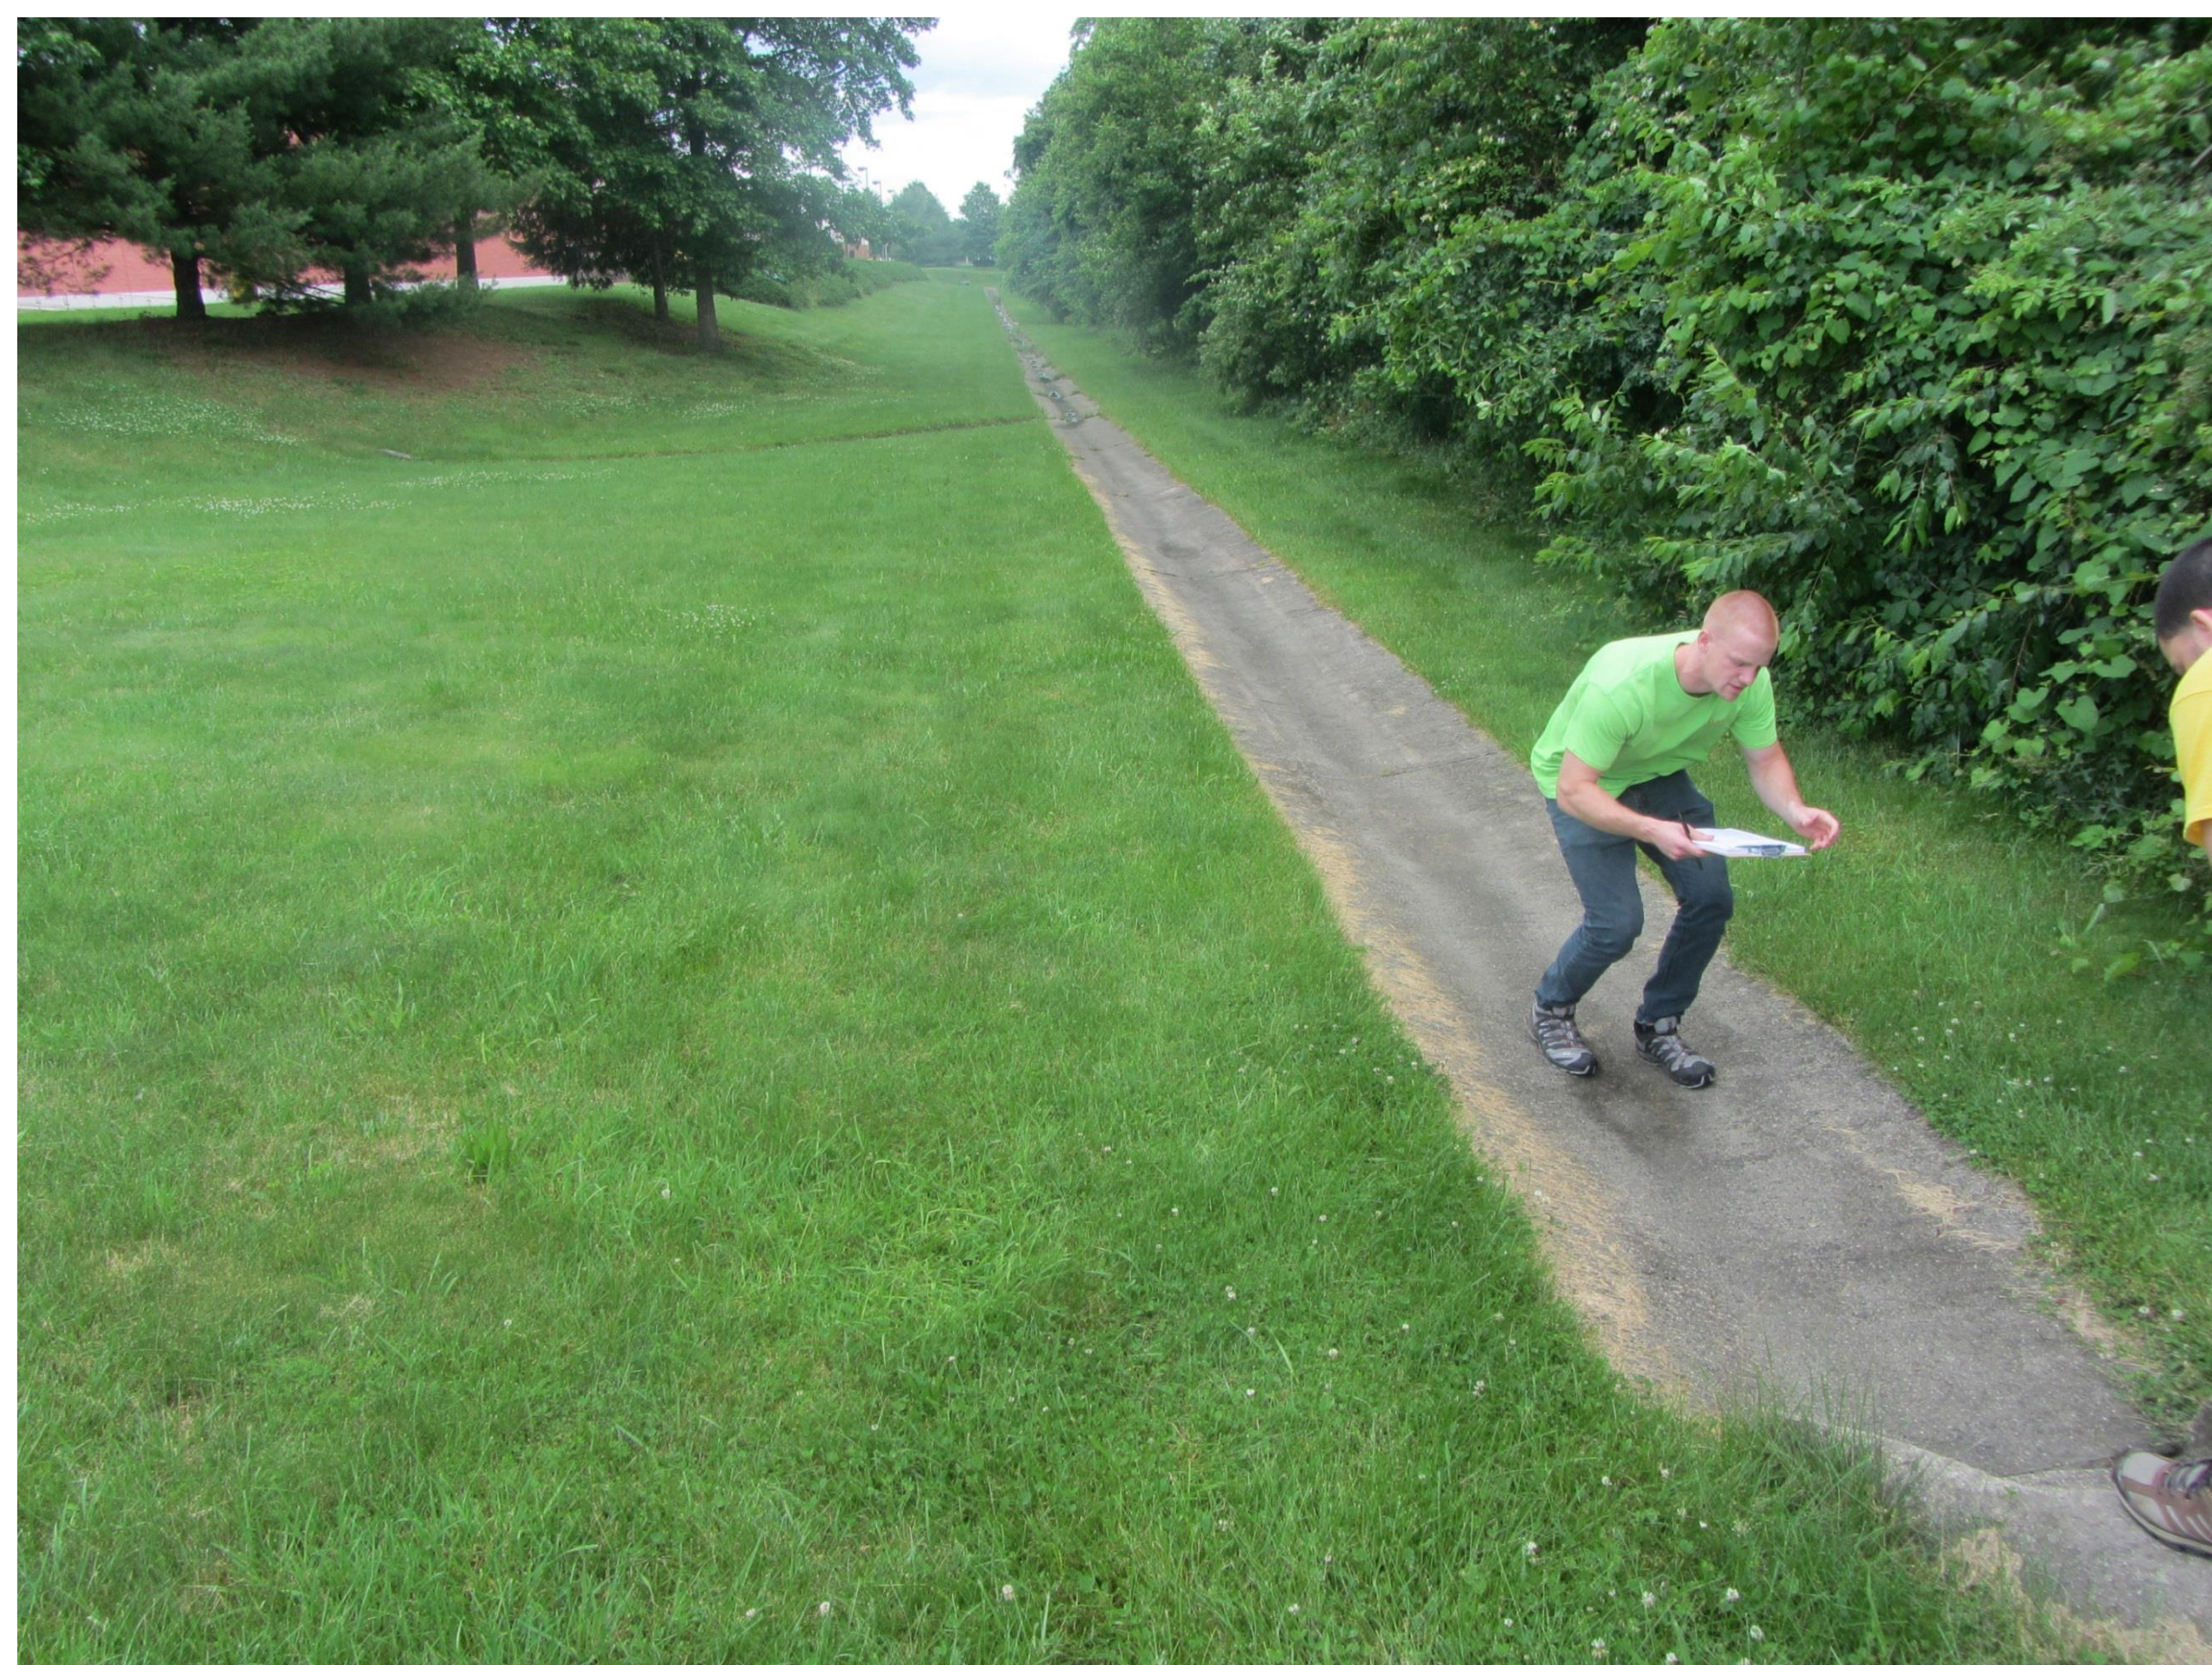
Basin bottom looking east
