**Hamilton Township (Mercer County)
Stormwater Basin Assessment Summary
Past Priority Addendum (Year 5B)**

Developed by the Rutgers Cooperative Extension Water Resources Program
Funded by Hamilton Township, Mercer County, New Jersey

November 27, 2019

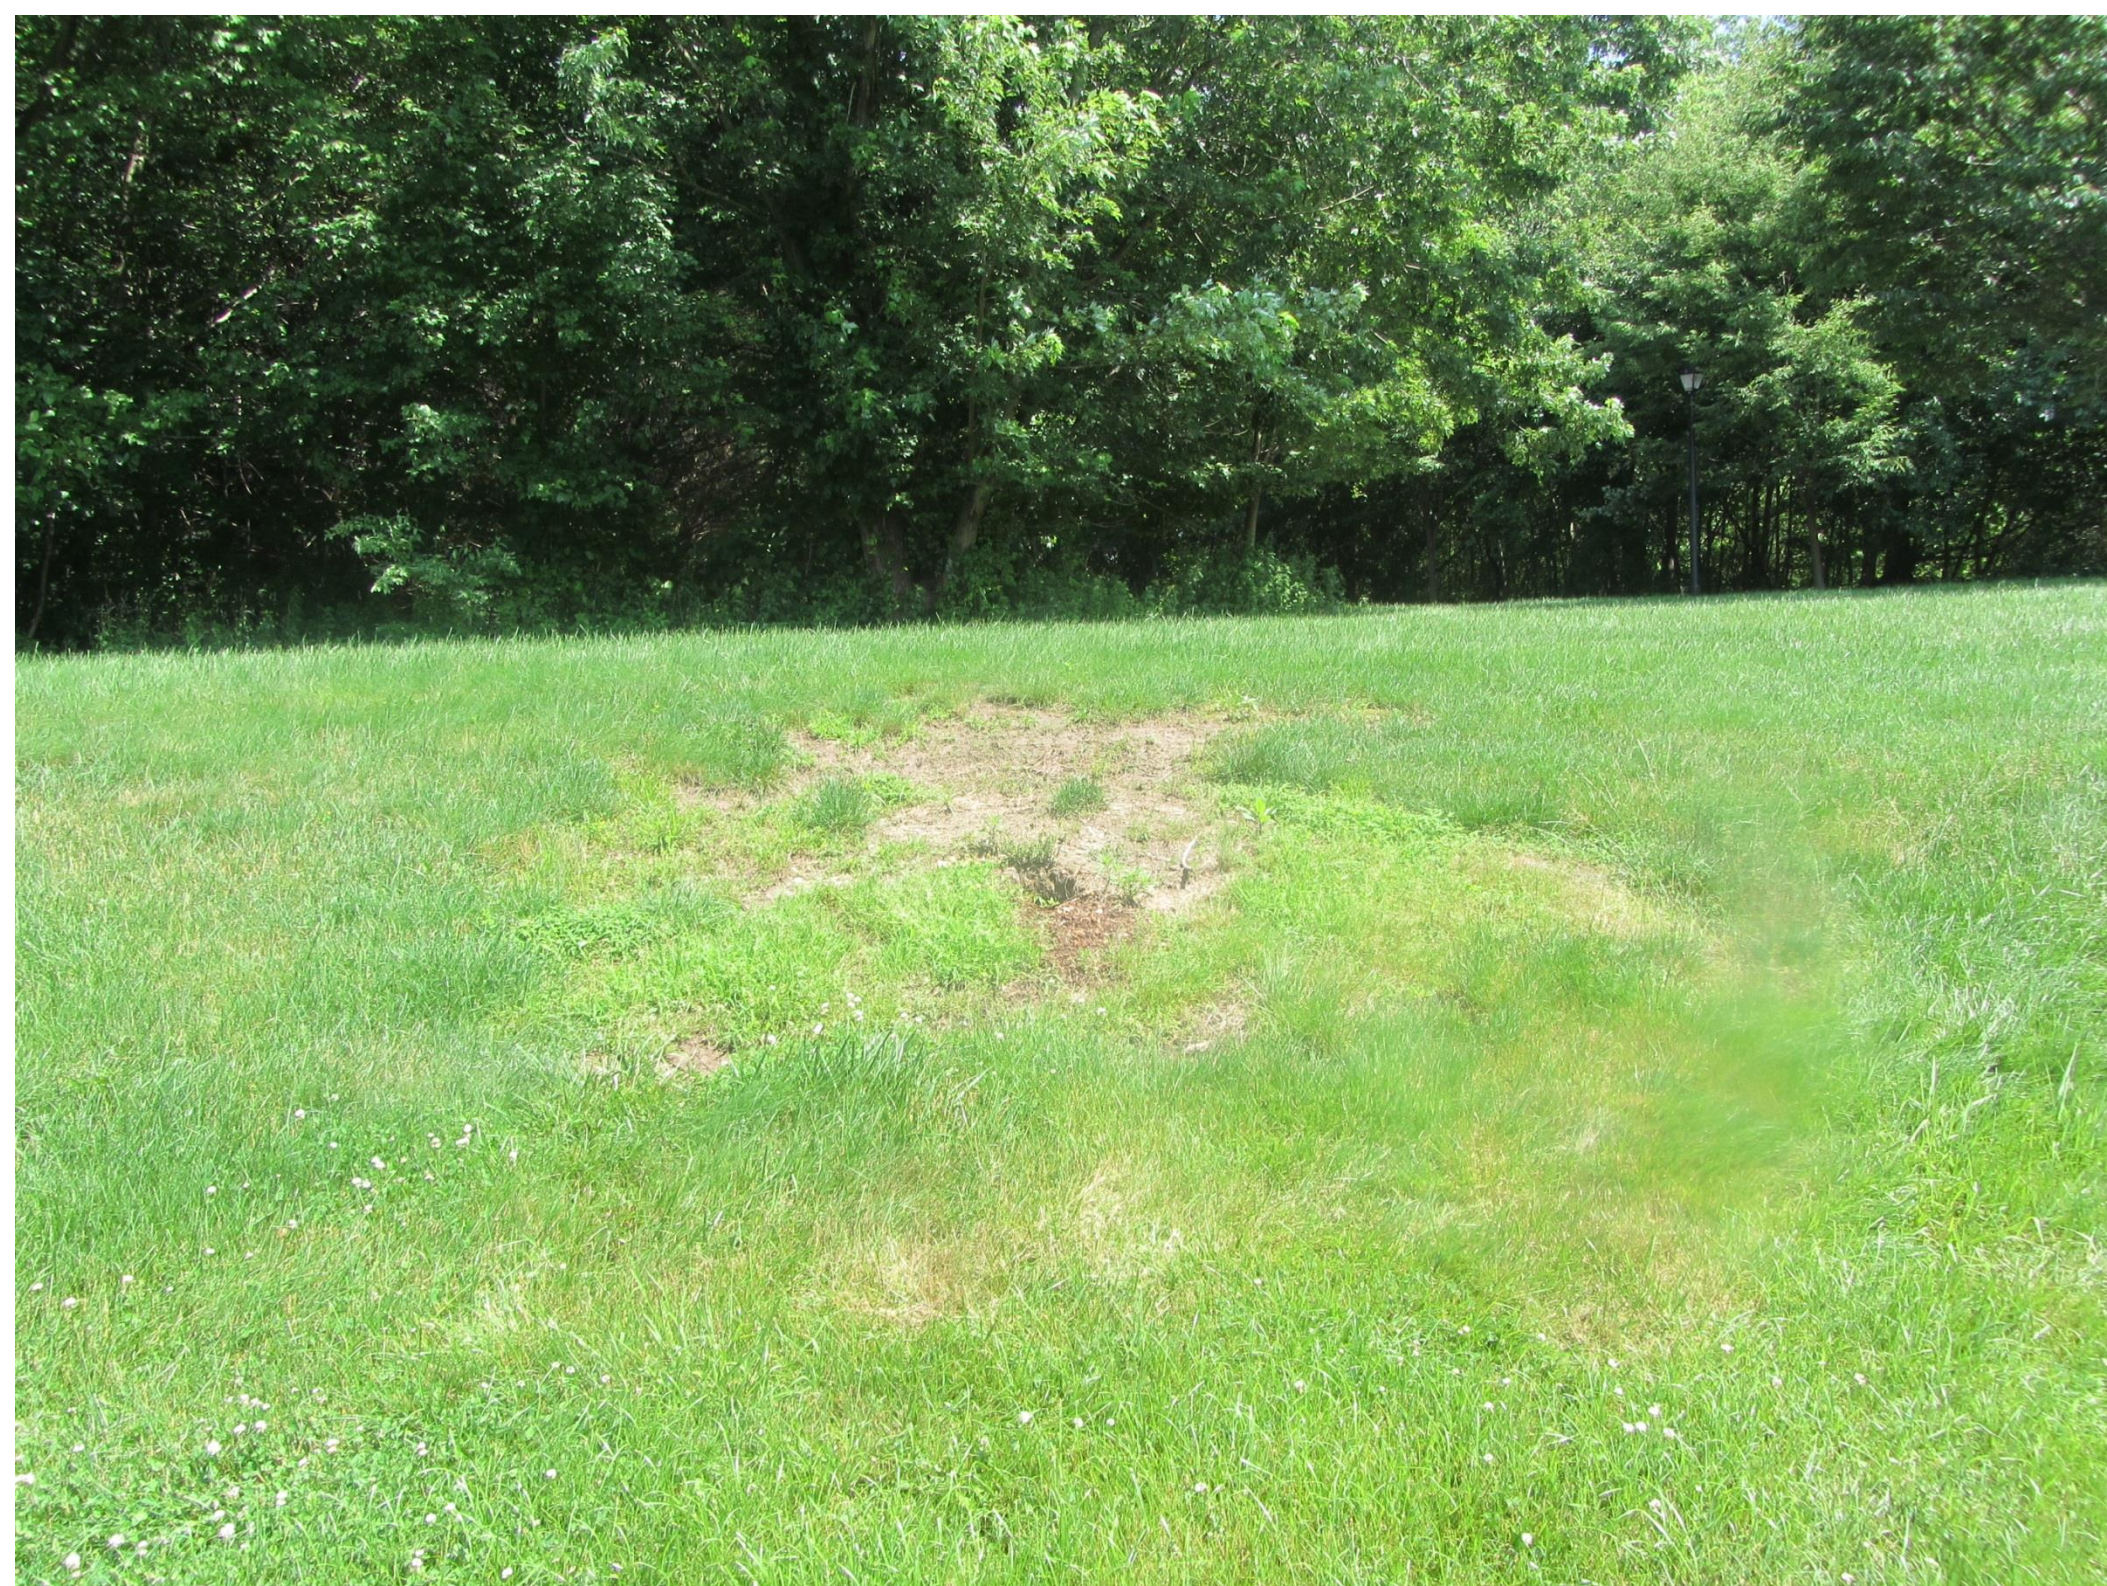
Bare spot on eastern embankment

- Outlet has minor cracks
- There is excess sediment accumulated and standing water in the low flow channel
- There is excess sediment accumulated in the outlet low flow orifice
- Eastern embankment has a large bare spot

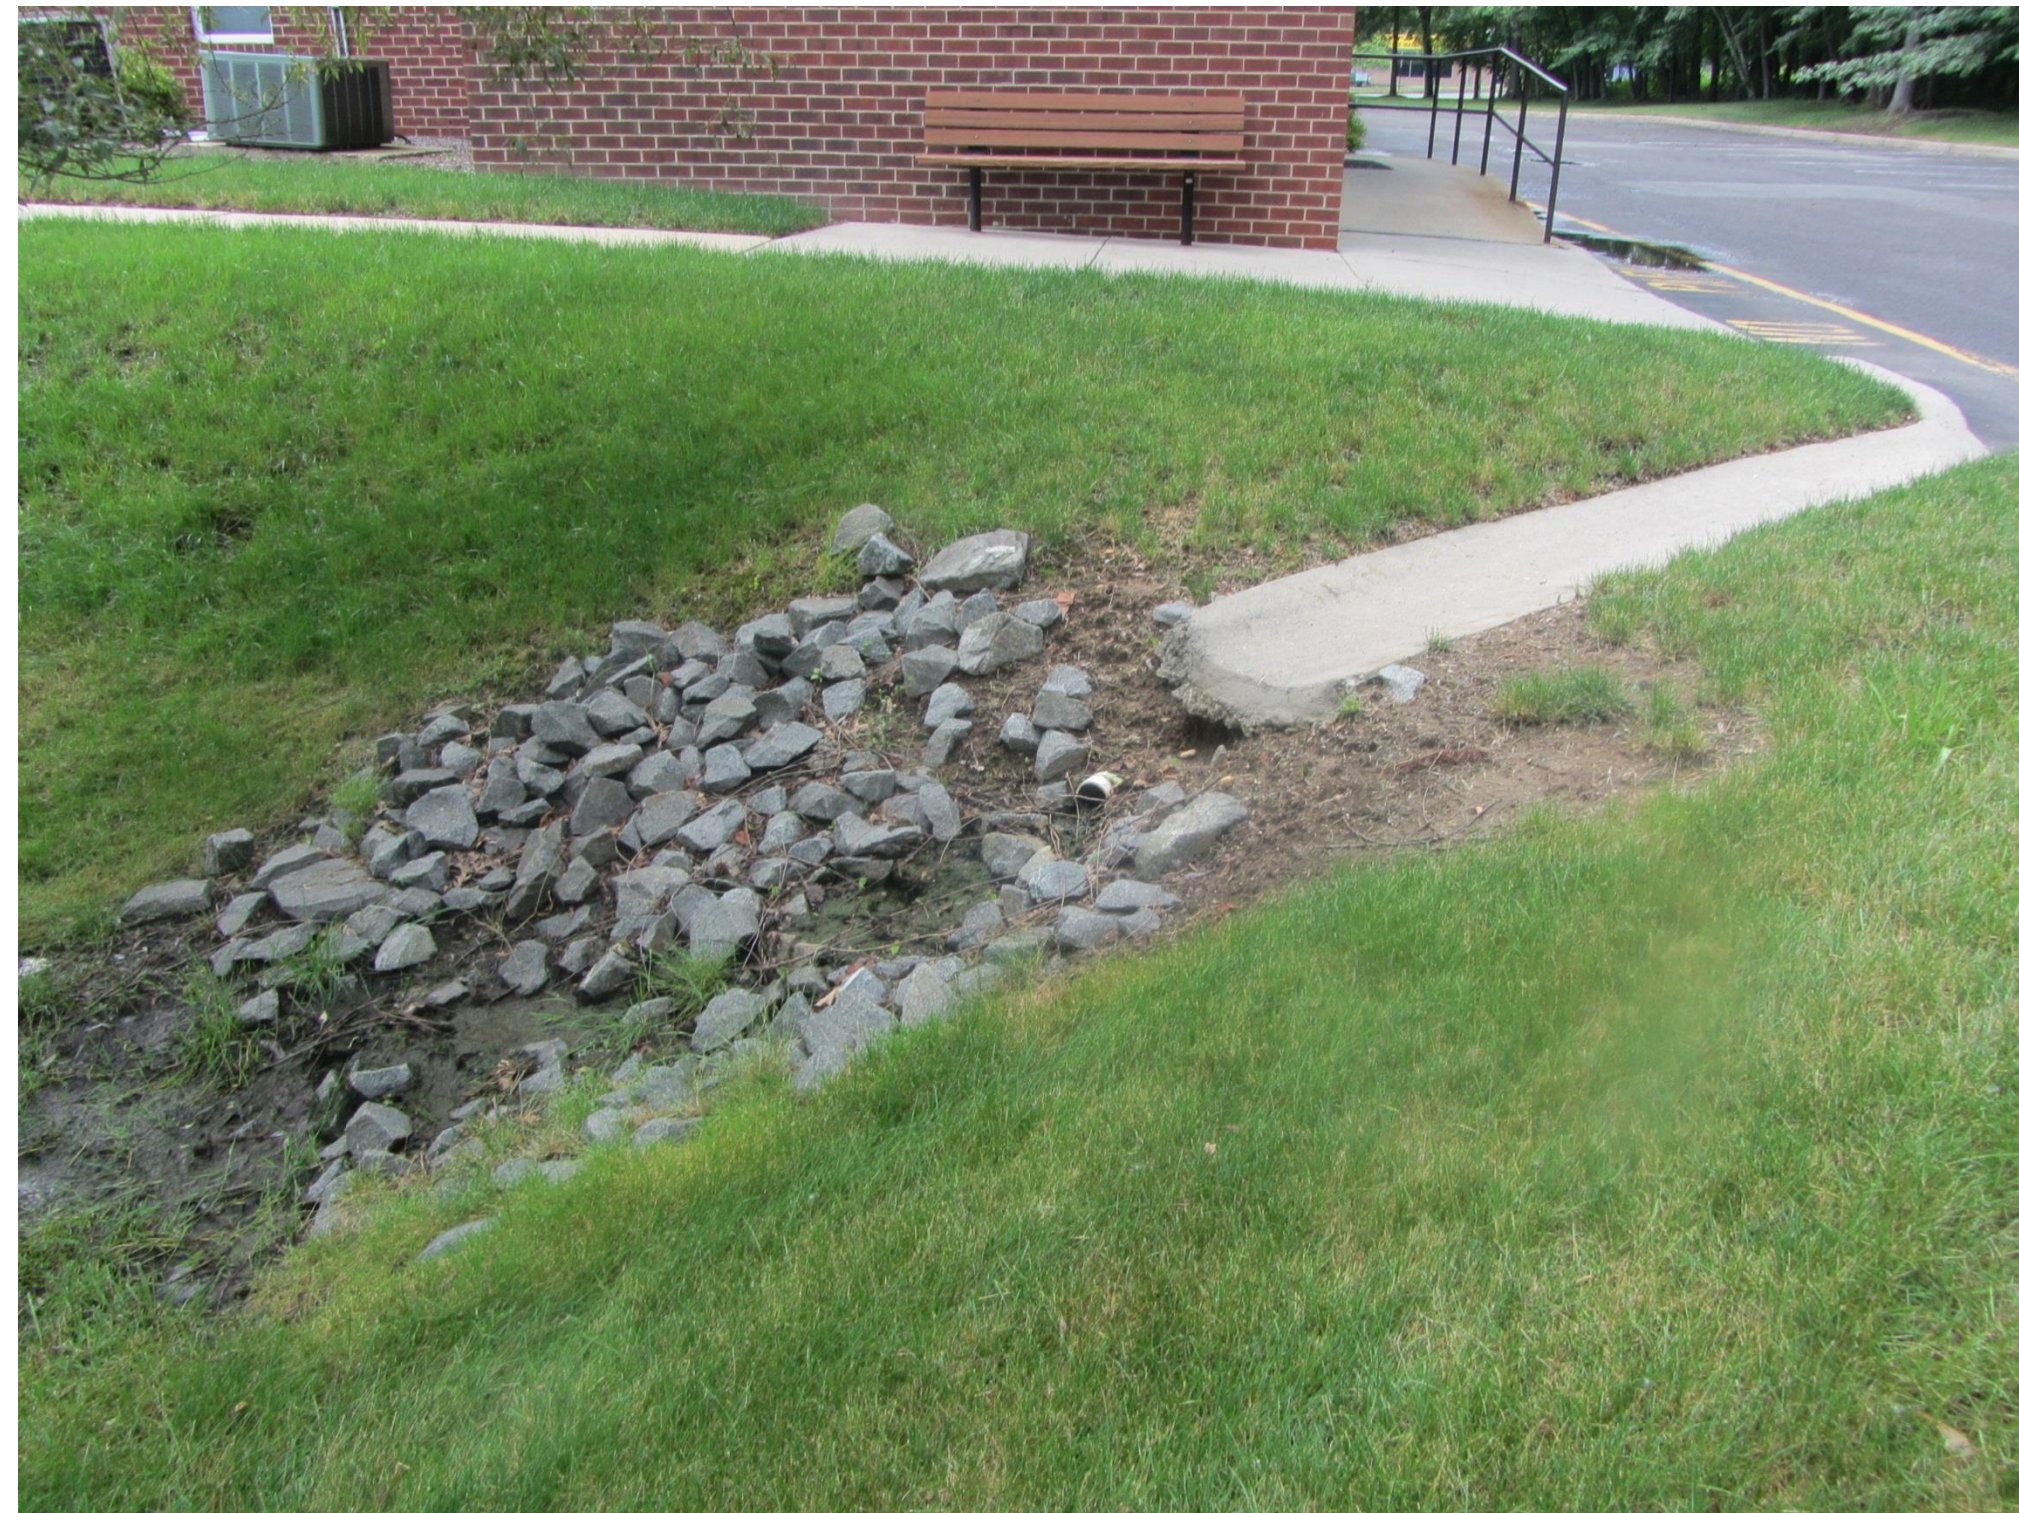
Erosion around northeastern inlet

- Curb cut inlets have severe erosion
- Outlet low flow orifice is blocked by rip-rap
- Outlet structure has minor cracks in parging that should be monitored

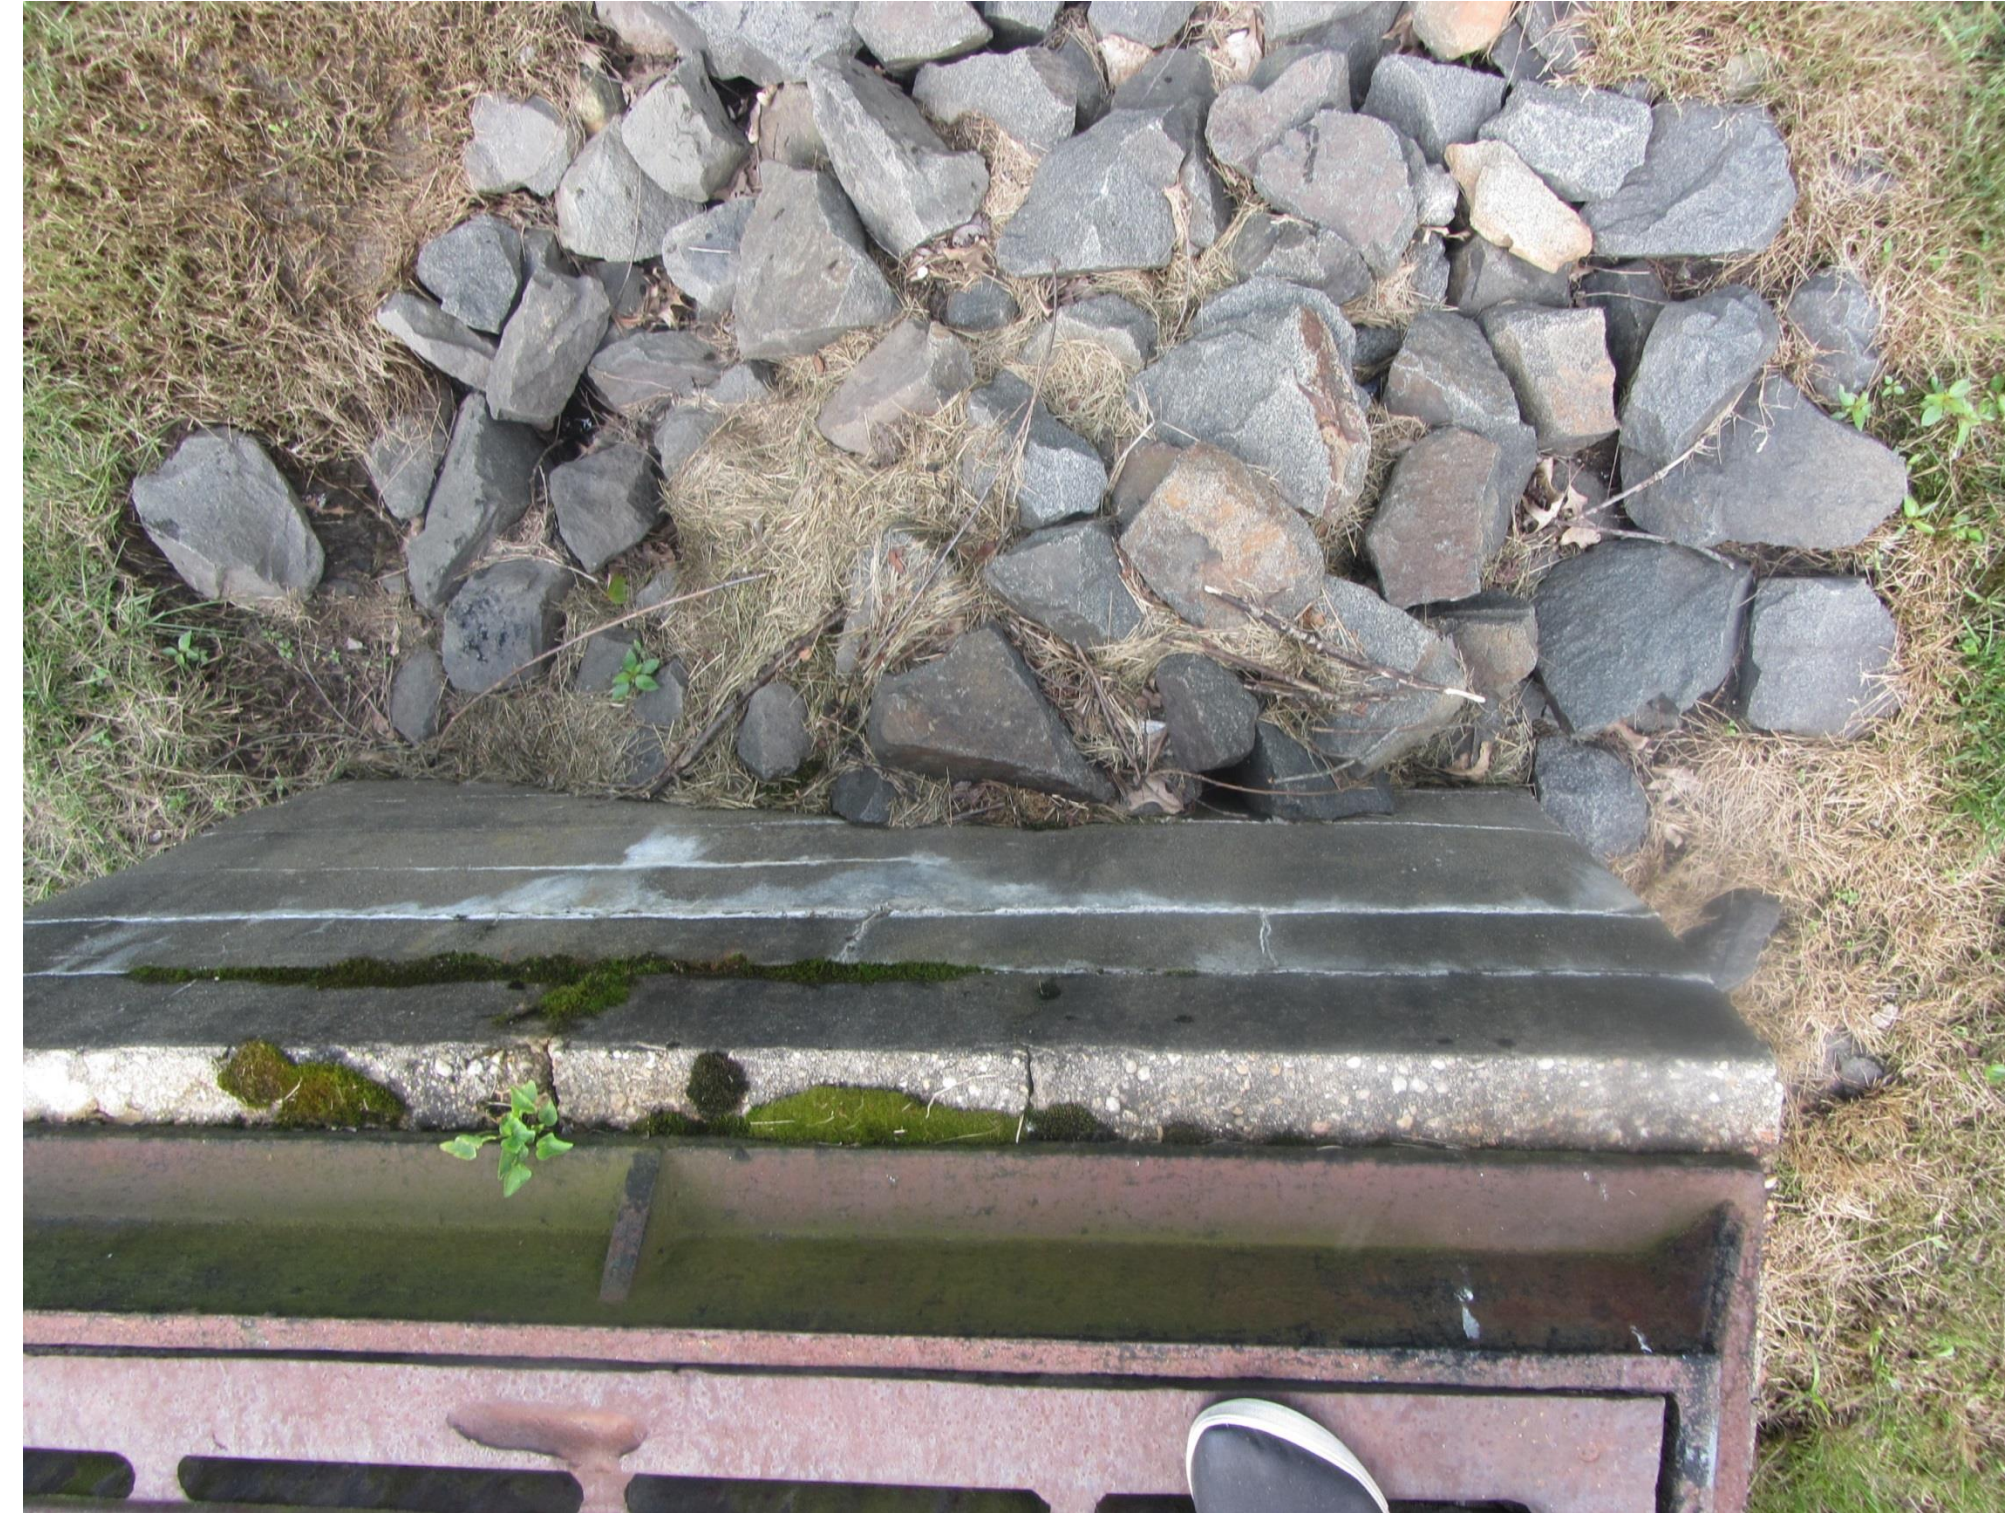
Rip-rap blocking low flow orifice

- Three curb cuts leading into the basin
- Low flow outlet blocked by riprap, should be redistributed

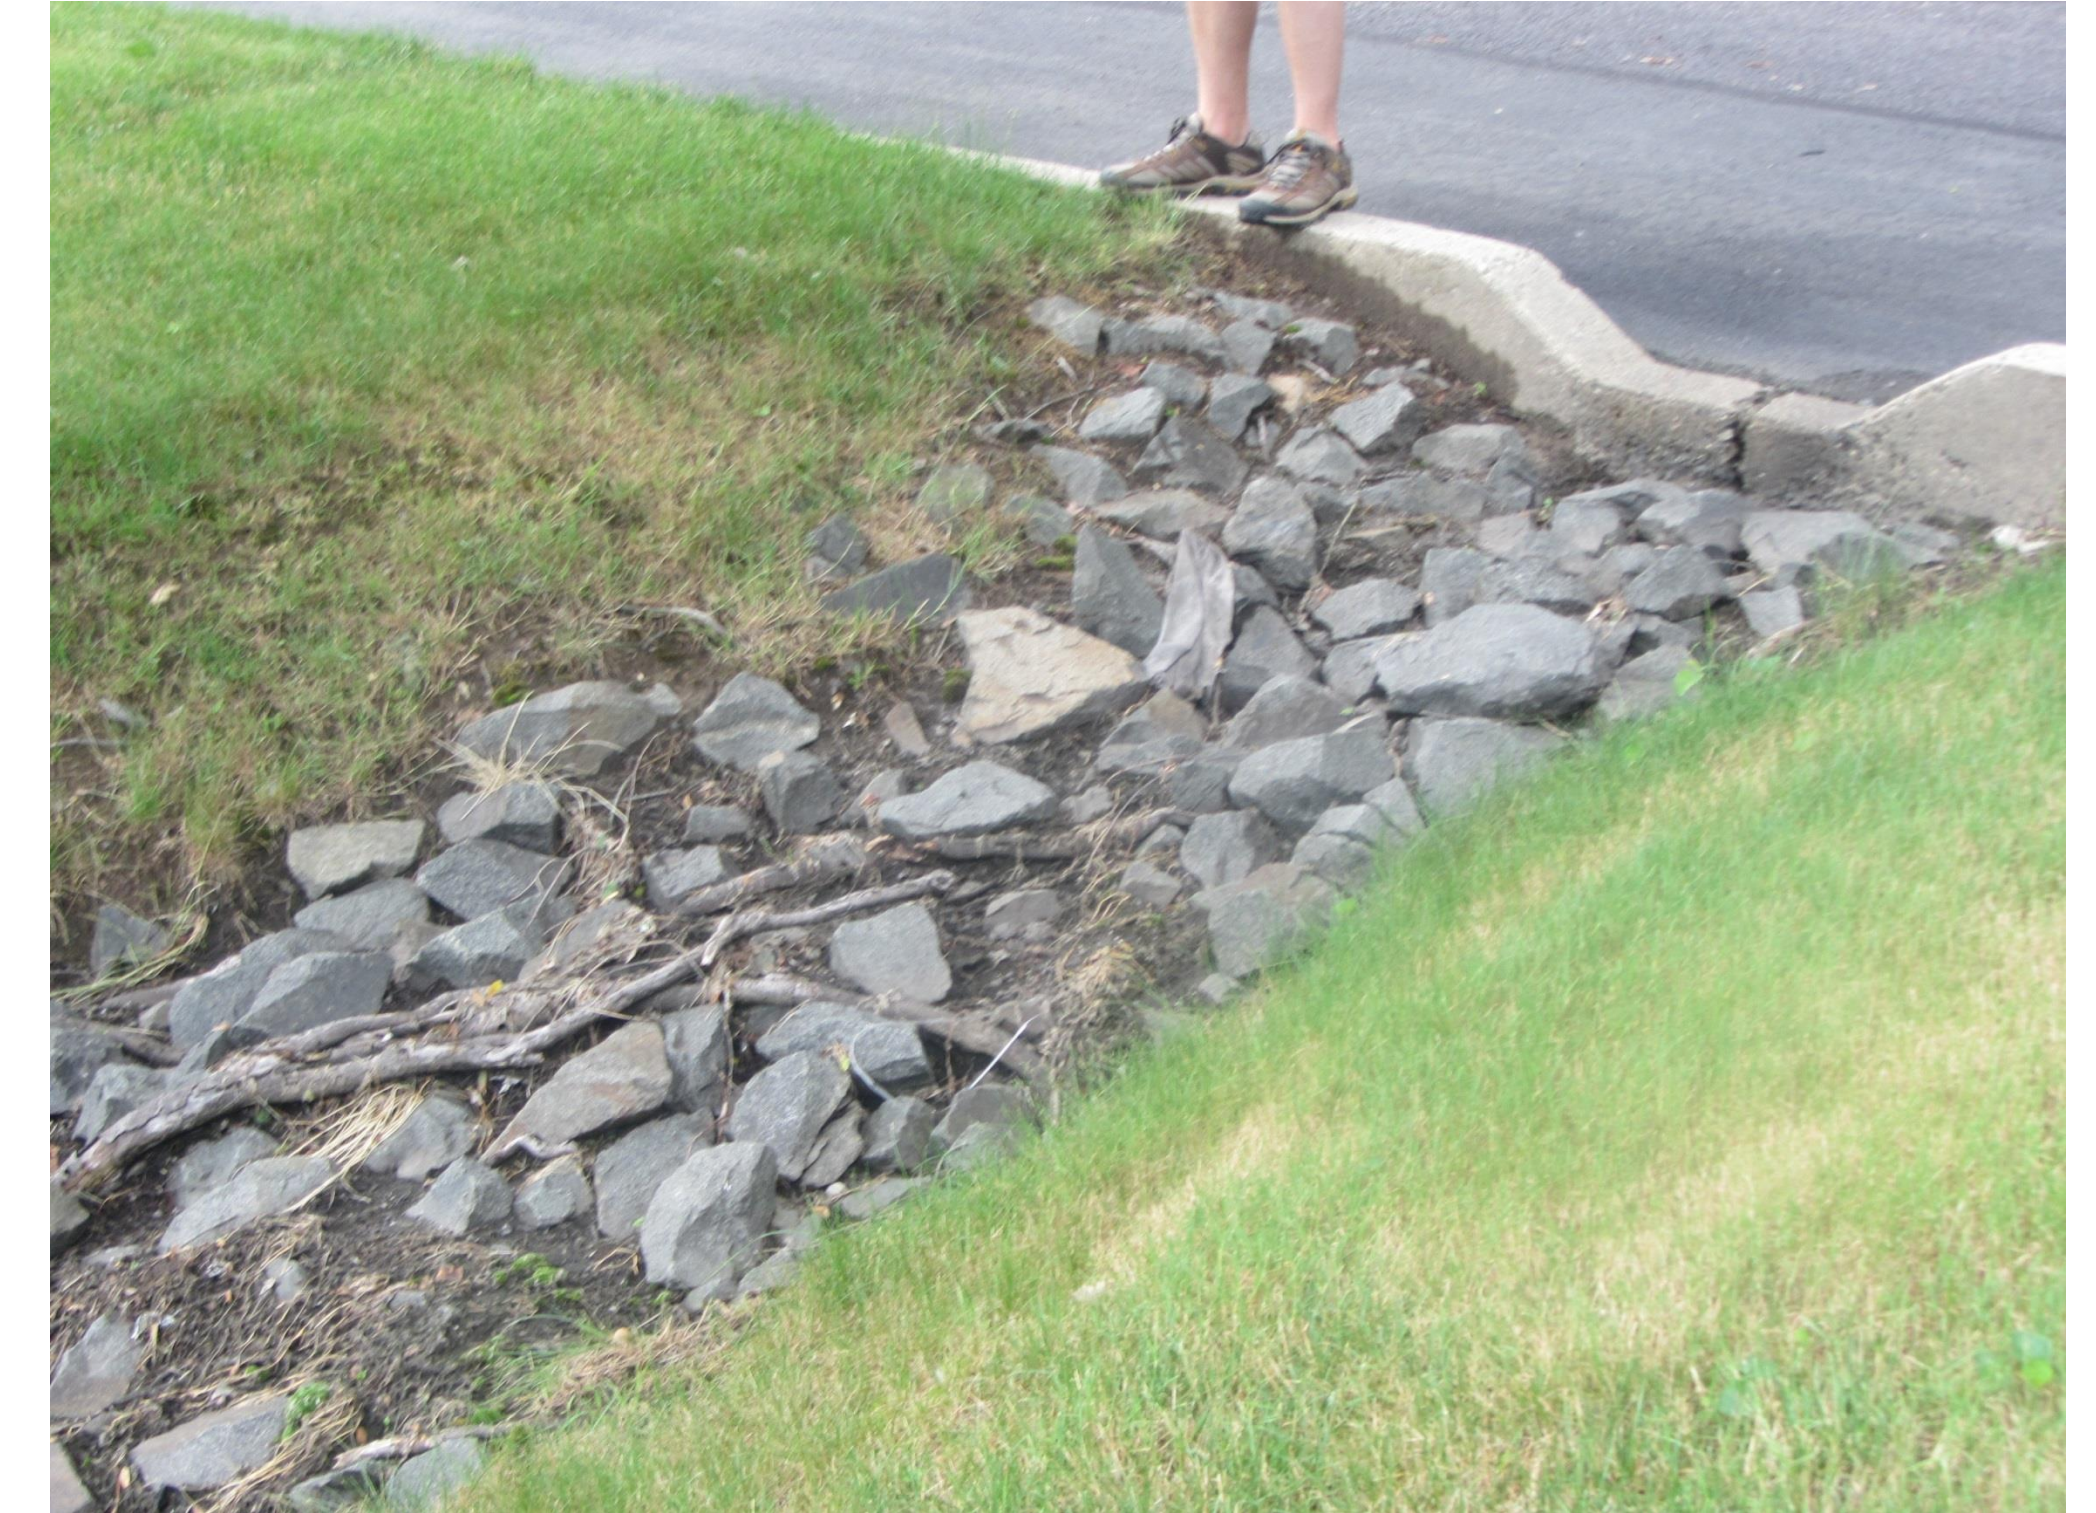
Erosion around southeastern inlet

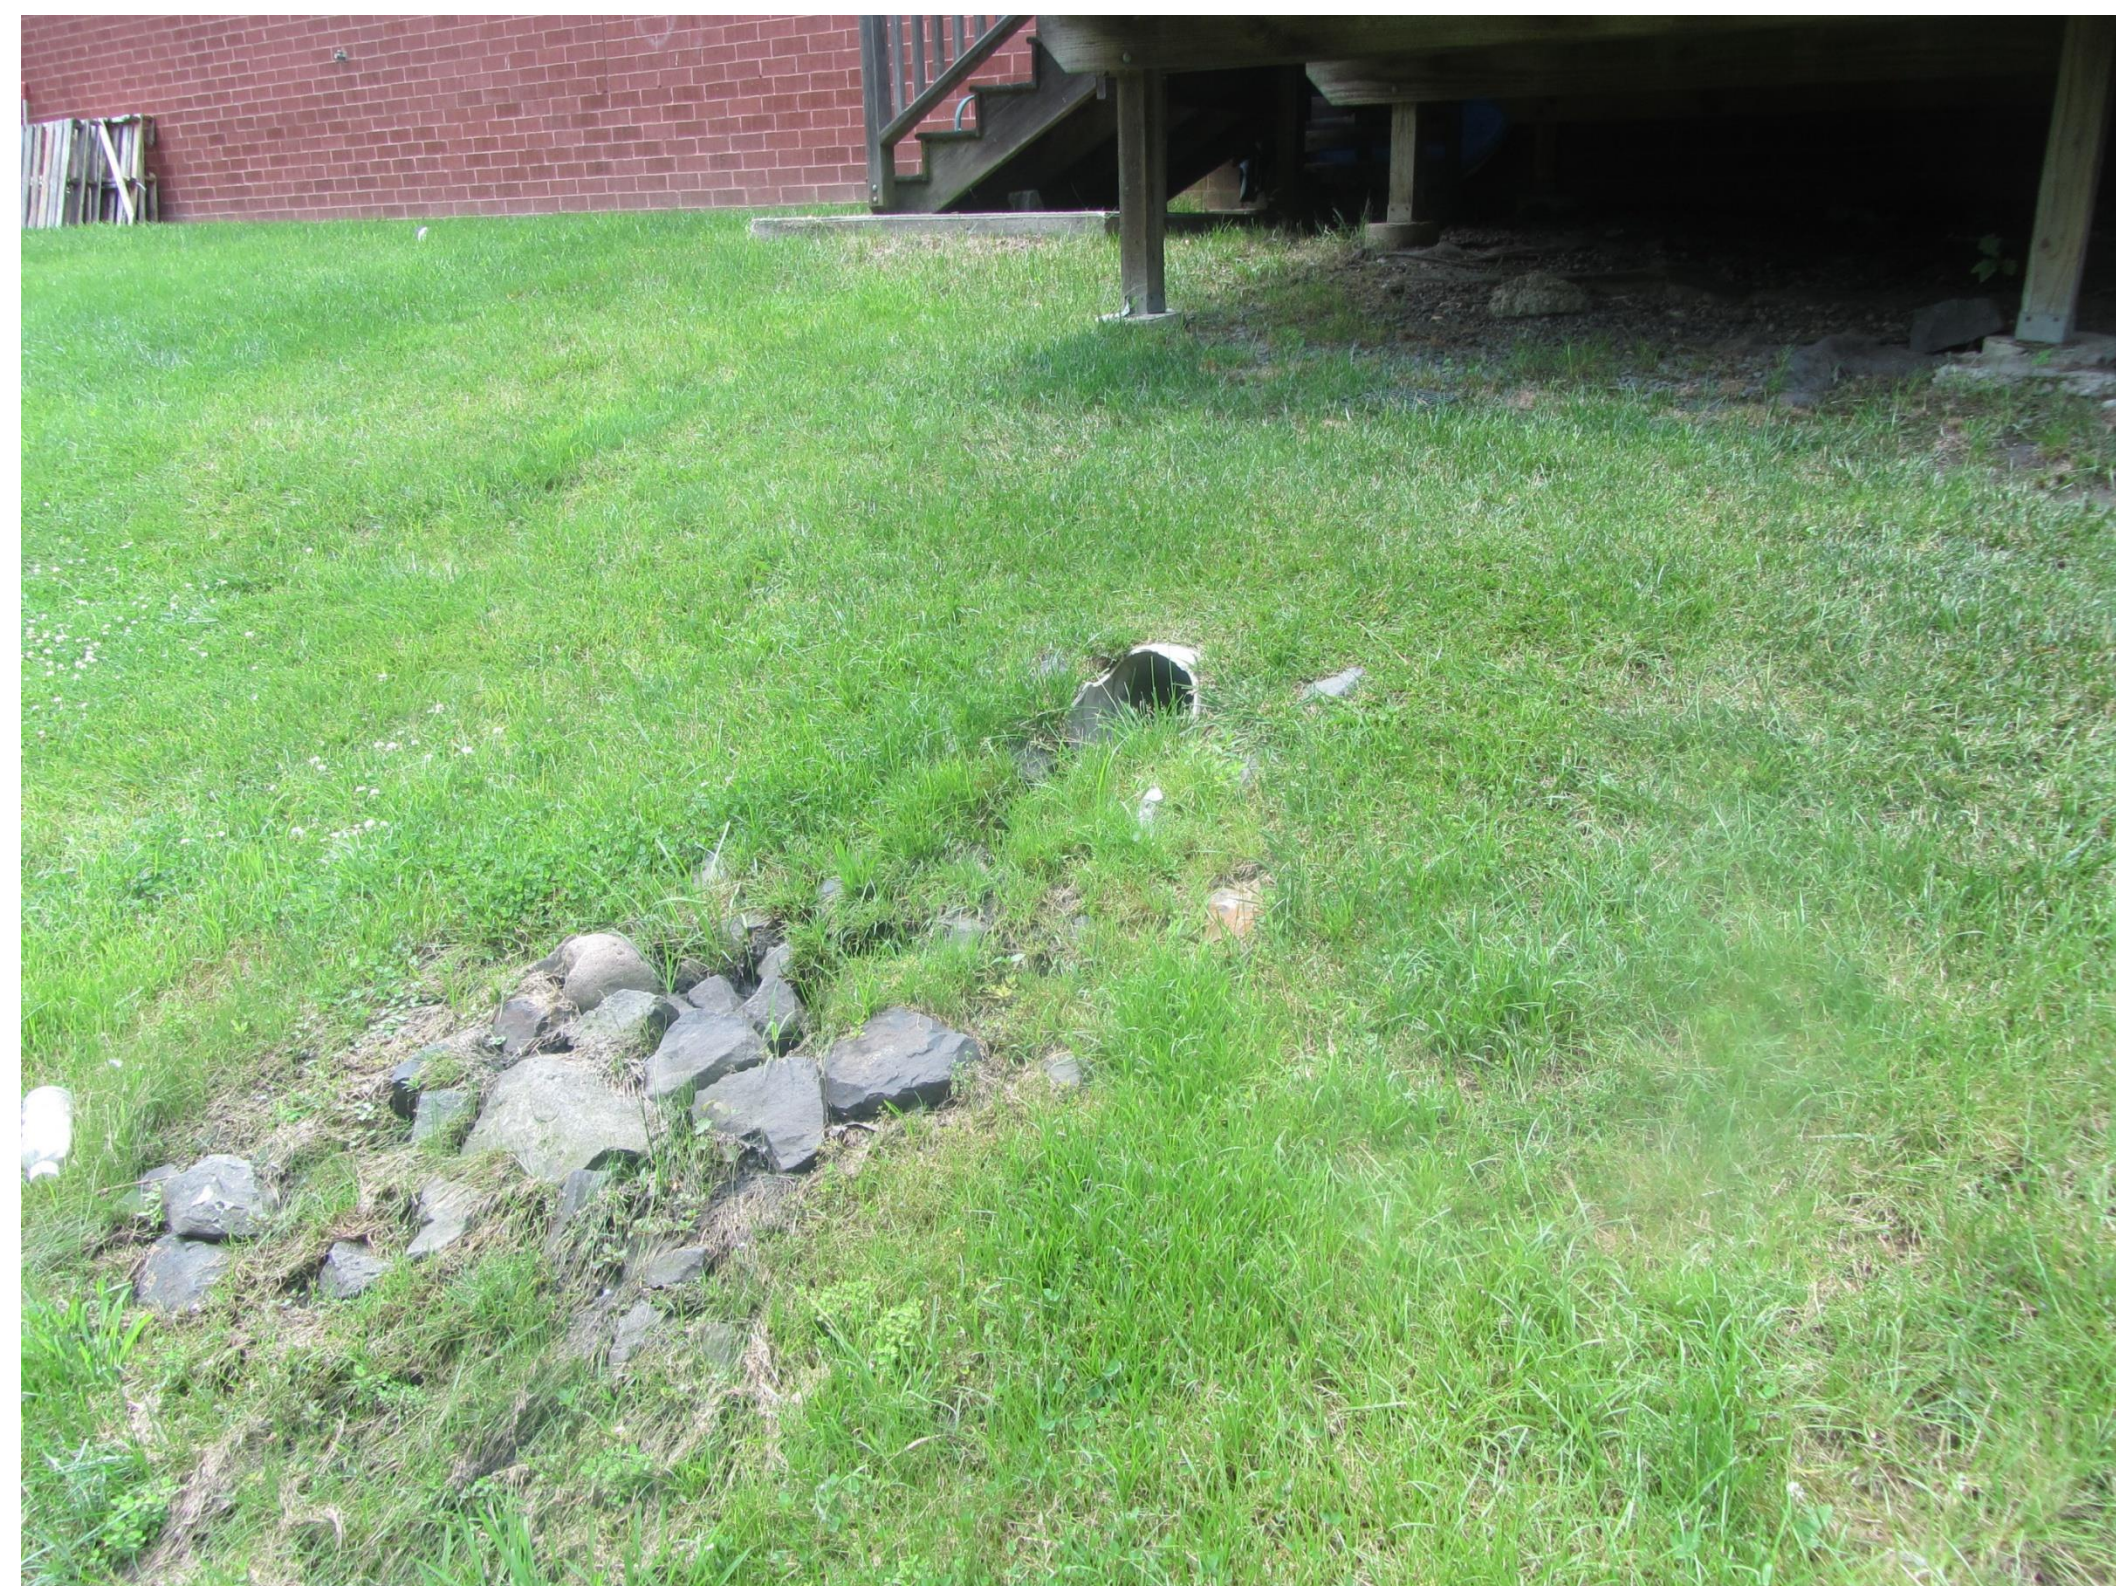
Erosion in front of inlet

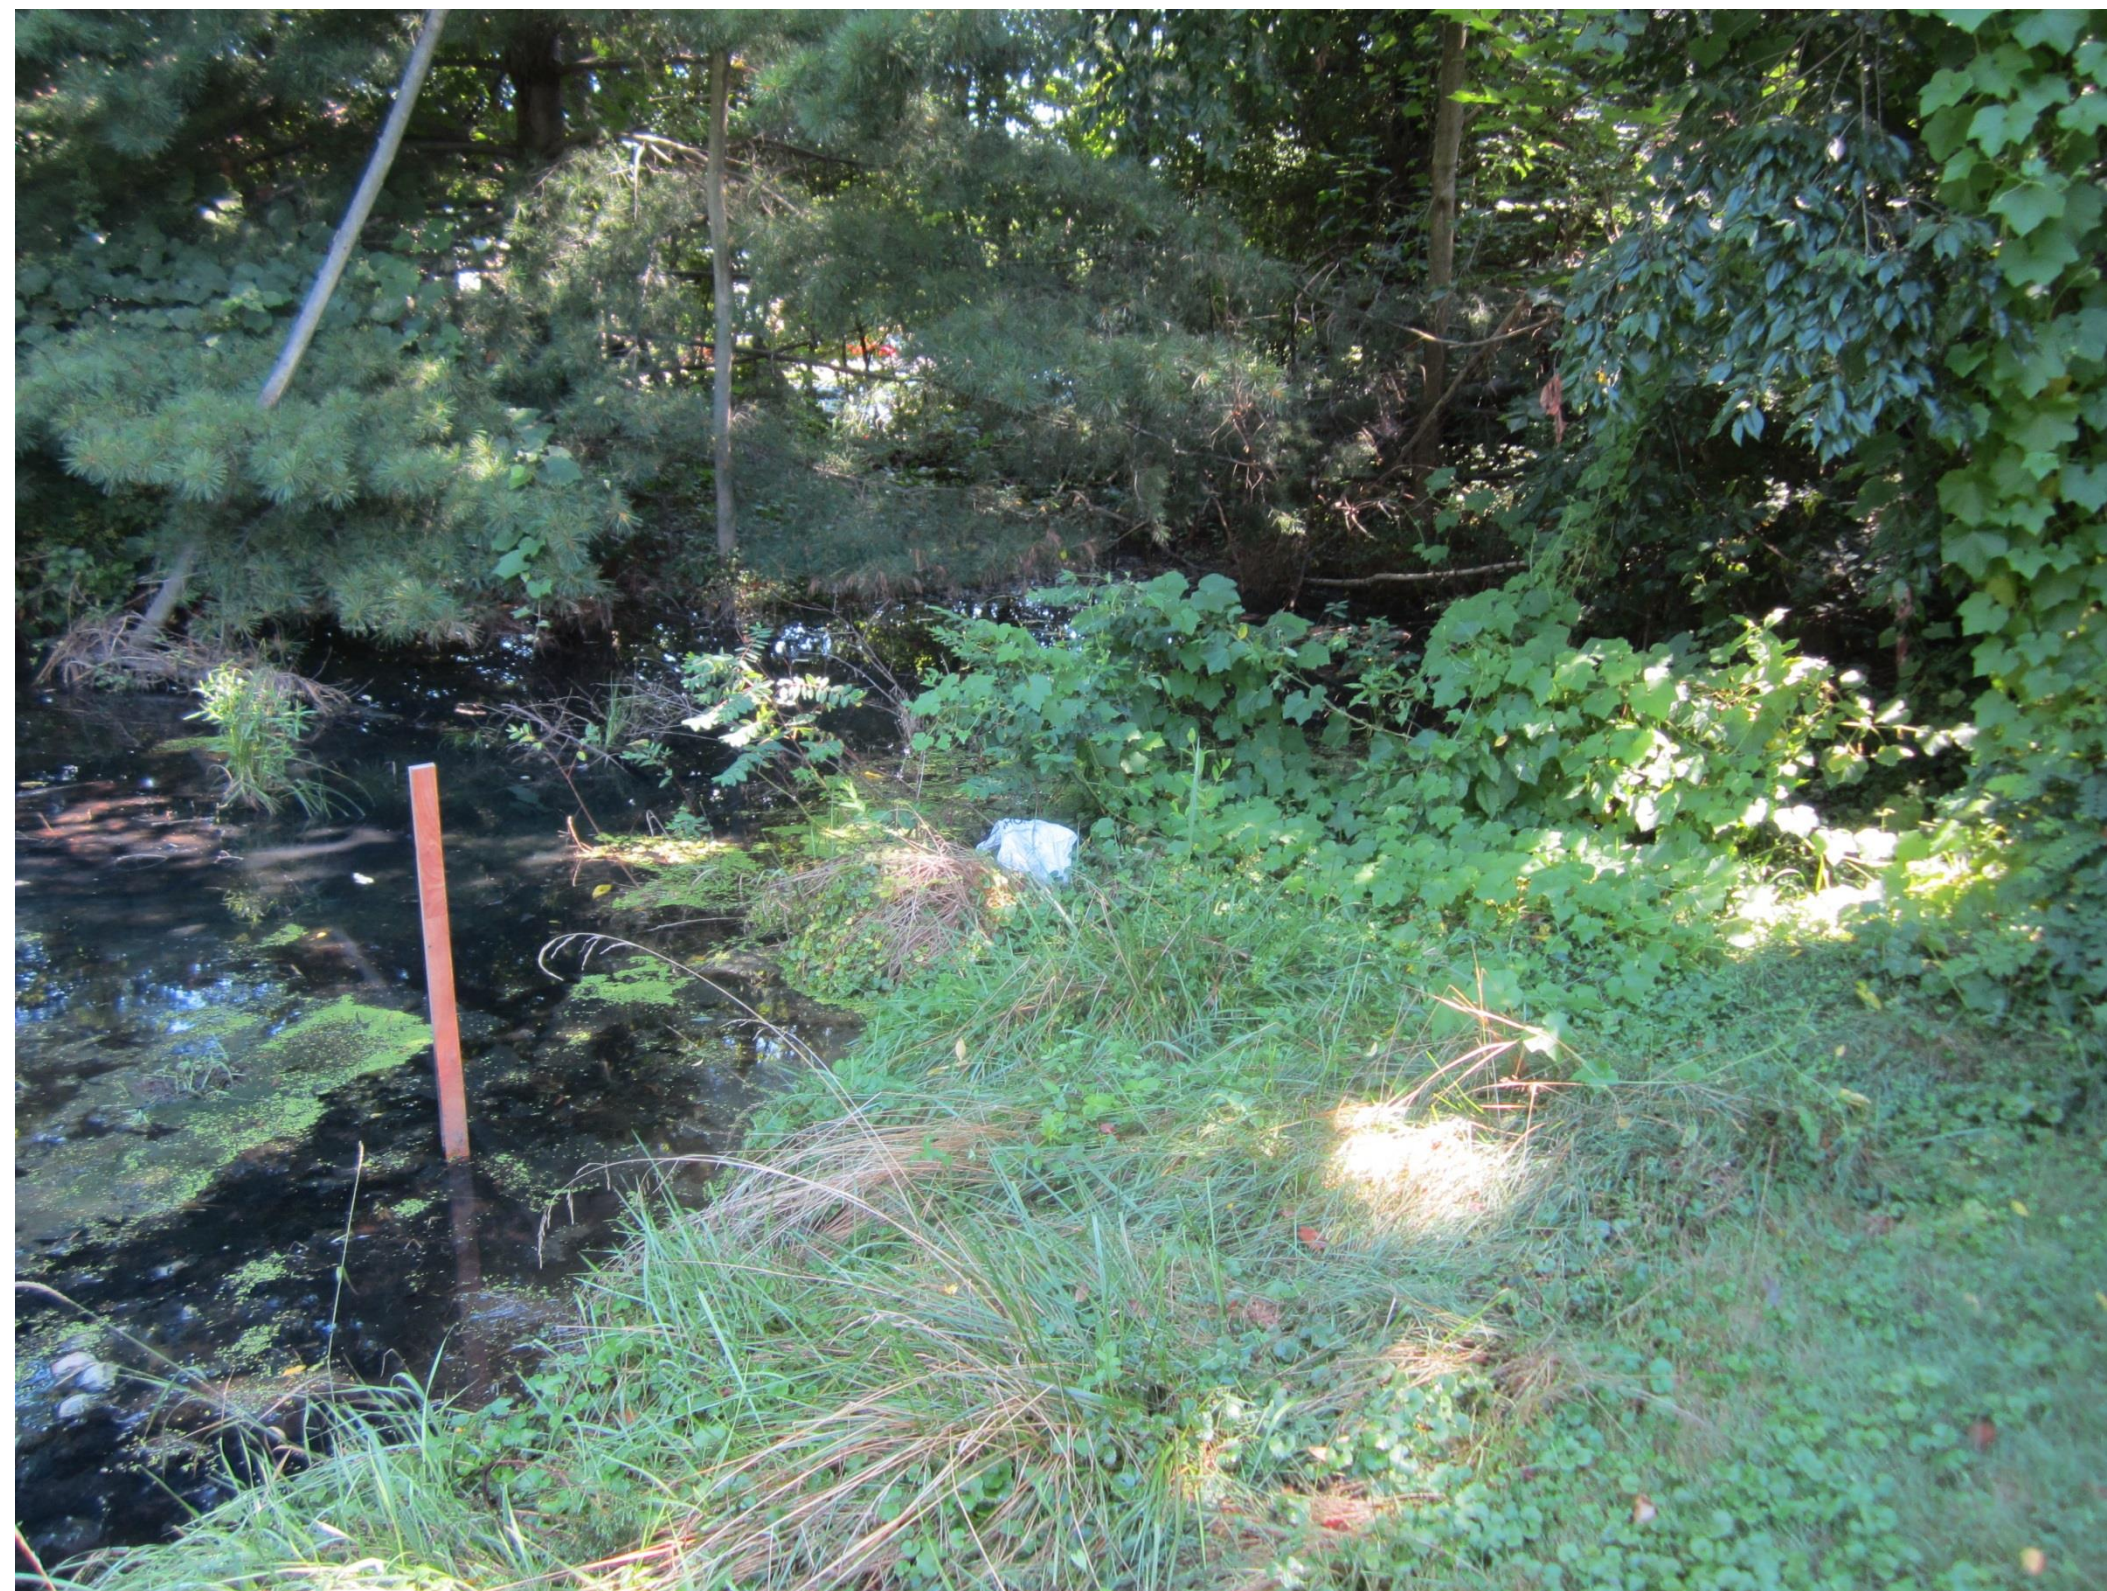
Area where basin discharges to woods

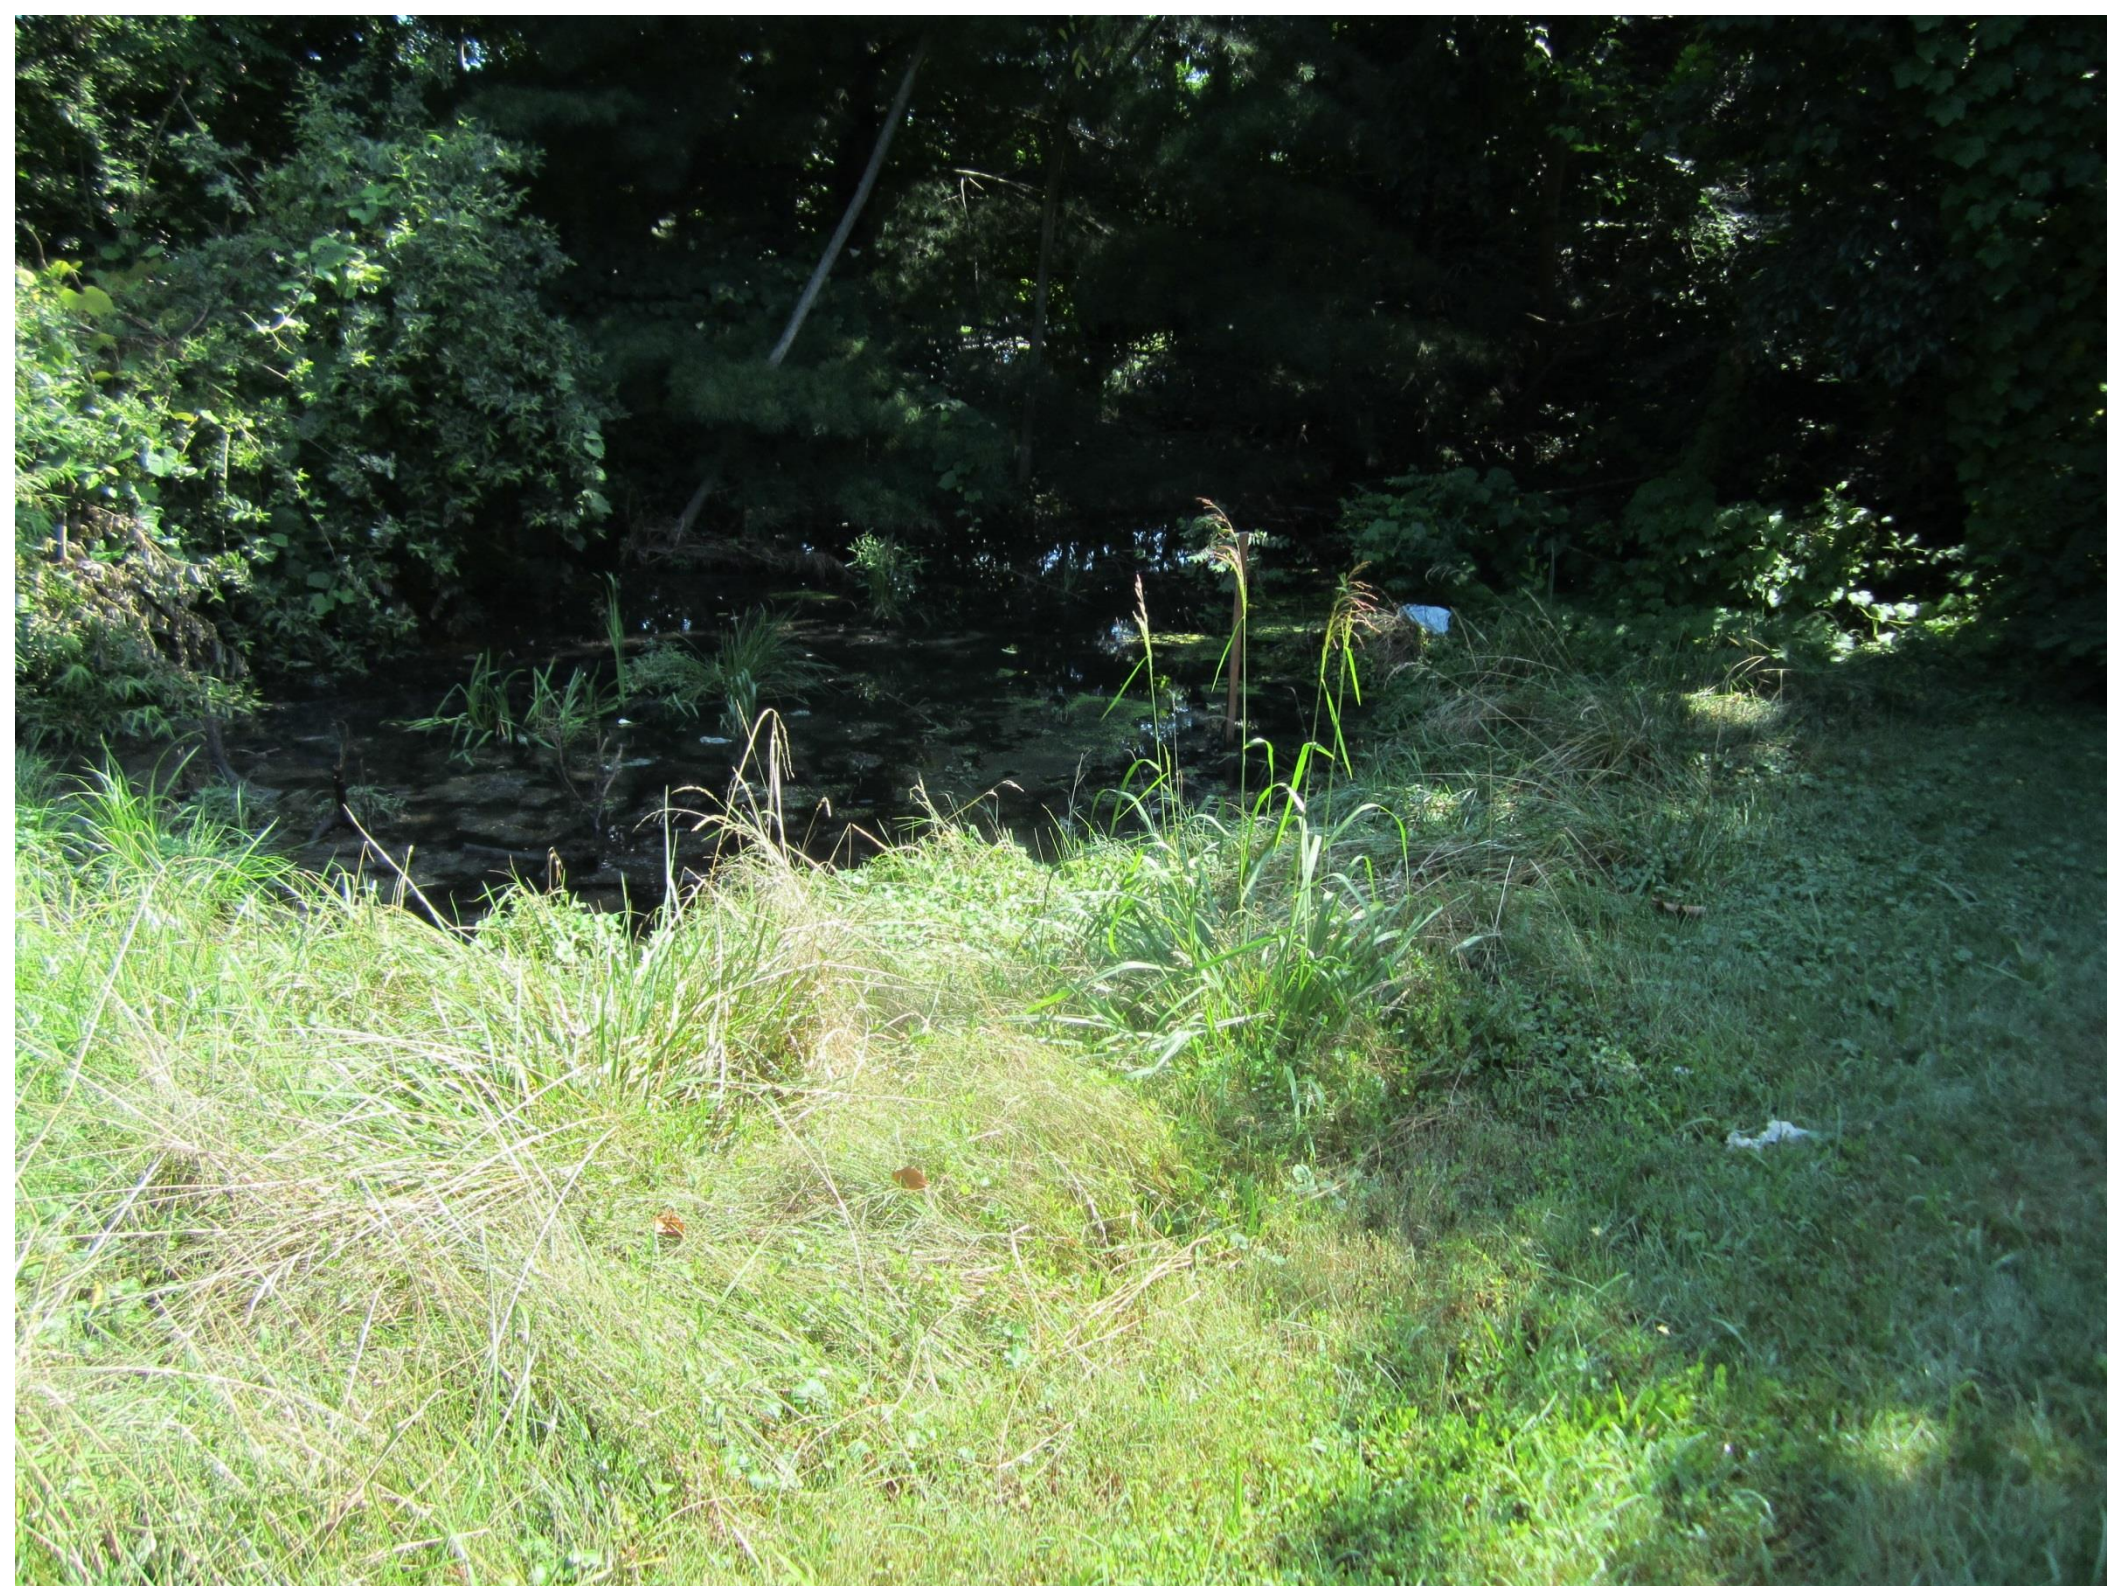
Ponding with algae growth
