**Hamilton Township (Mercer County)
Stormwater Basin Assessment Summary
Past Priority Addendum (Year 5B)**

Developed by the Rutgers Cooperative Extension Water Resources Program
Funded by Hamilton Township, Mercer County, New Jersey

November 27, 2019

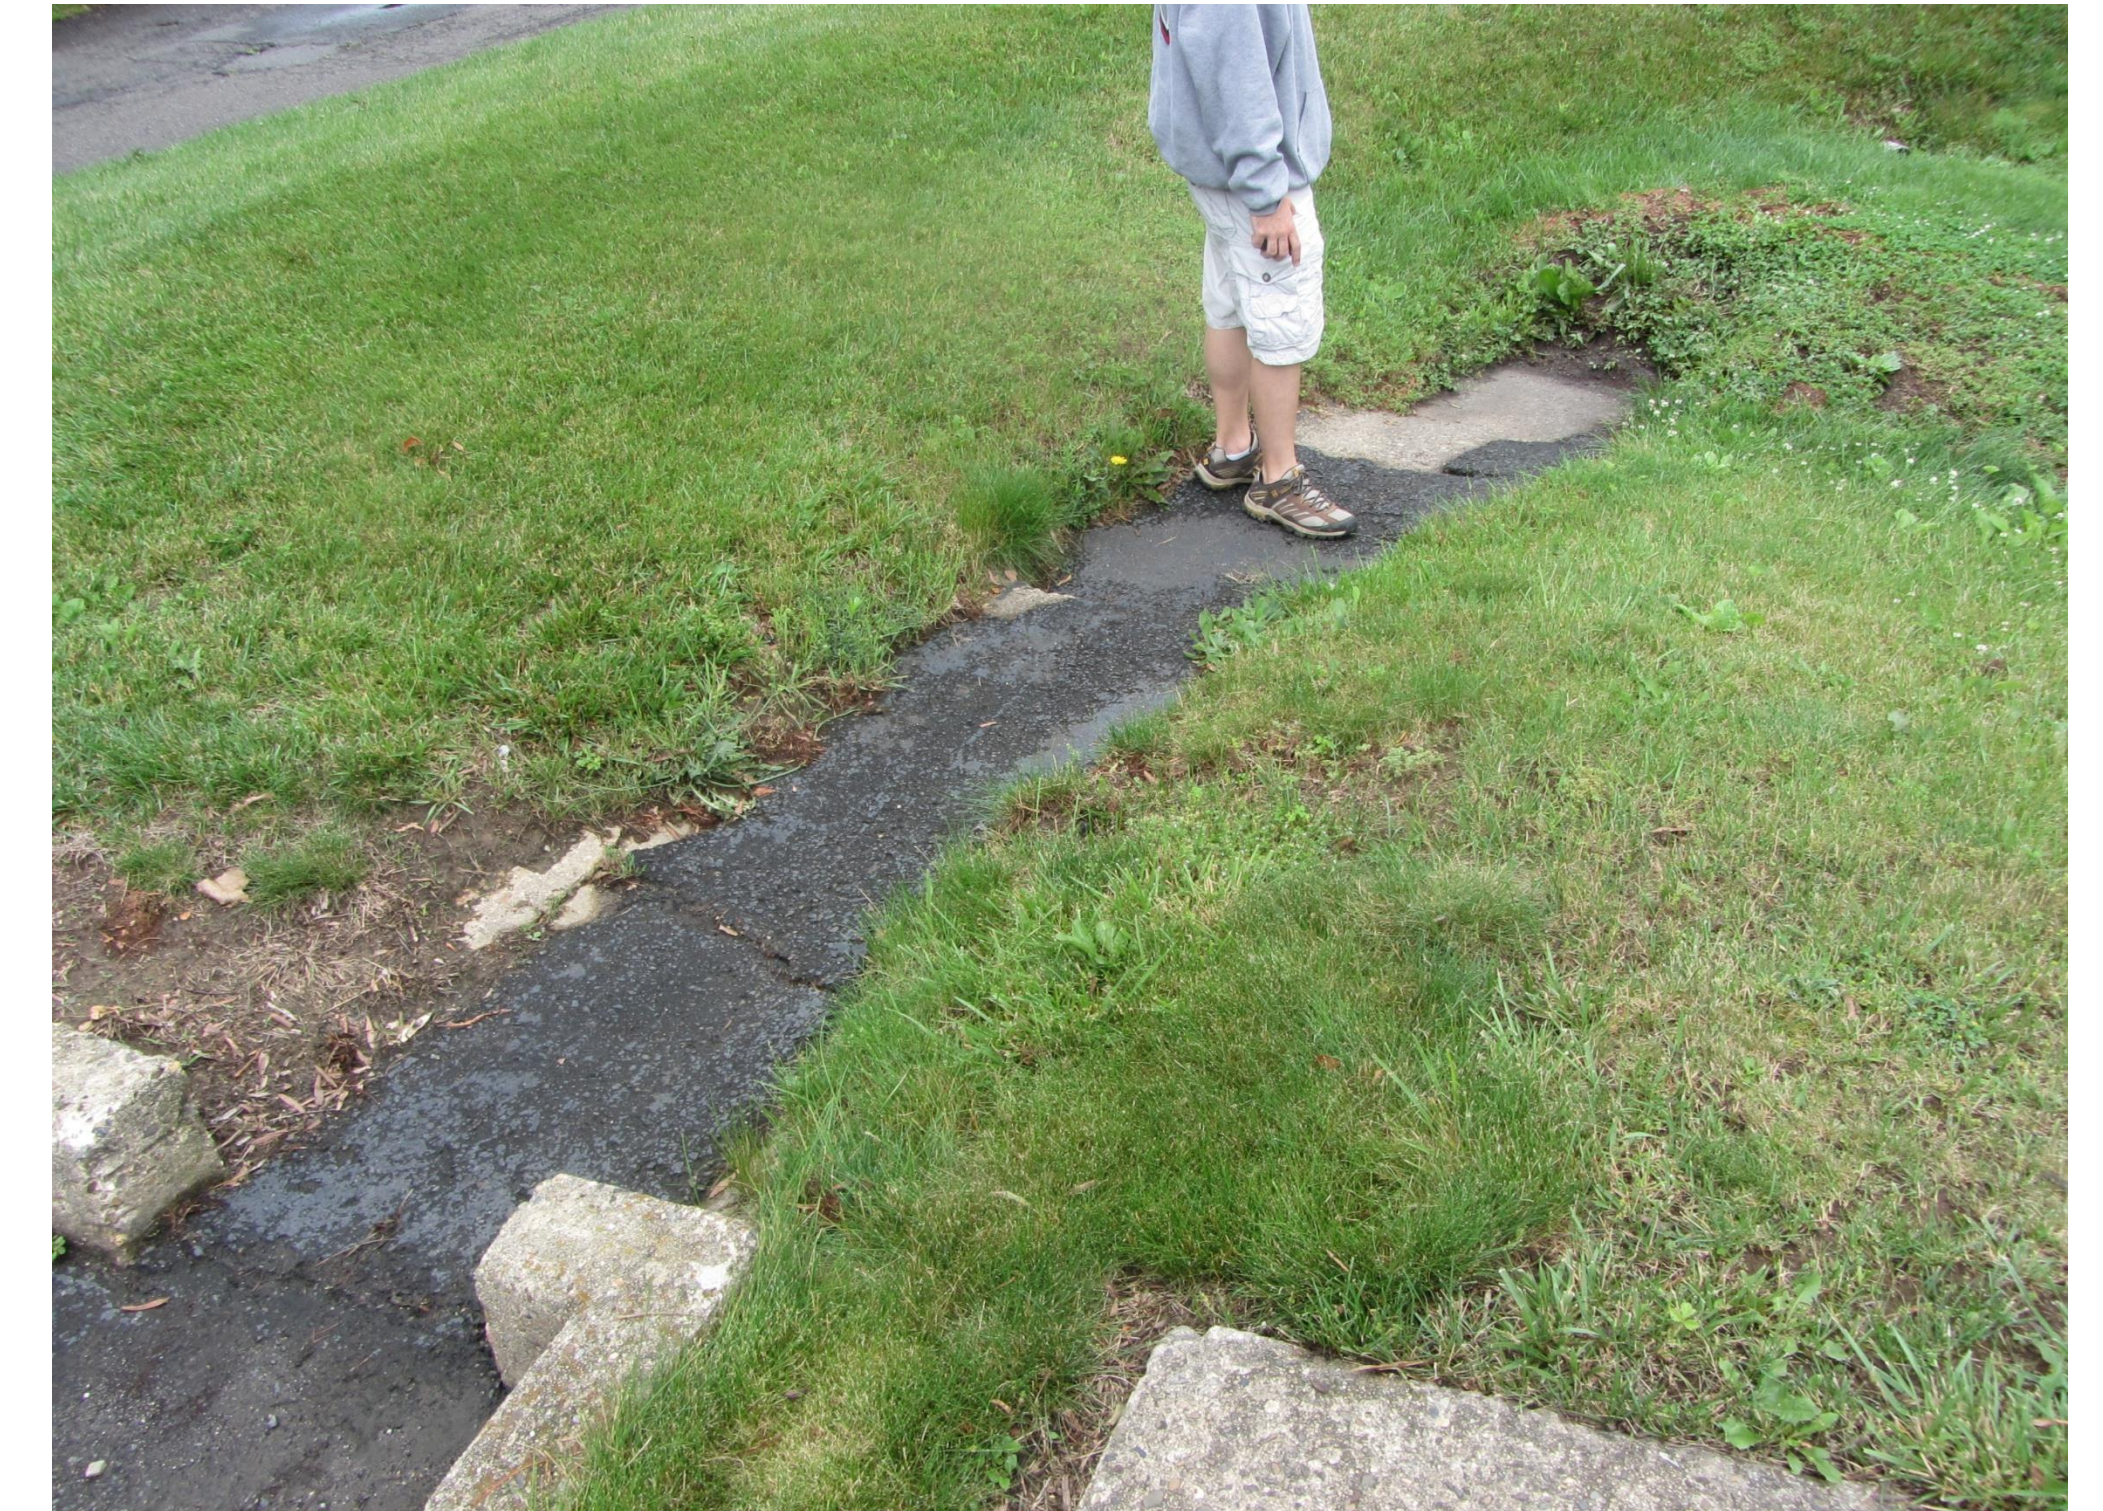
Erosion and breakage at inlet

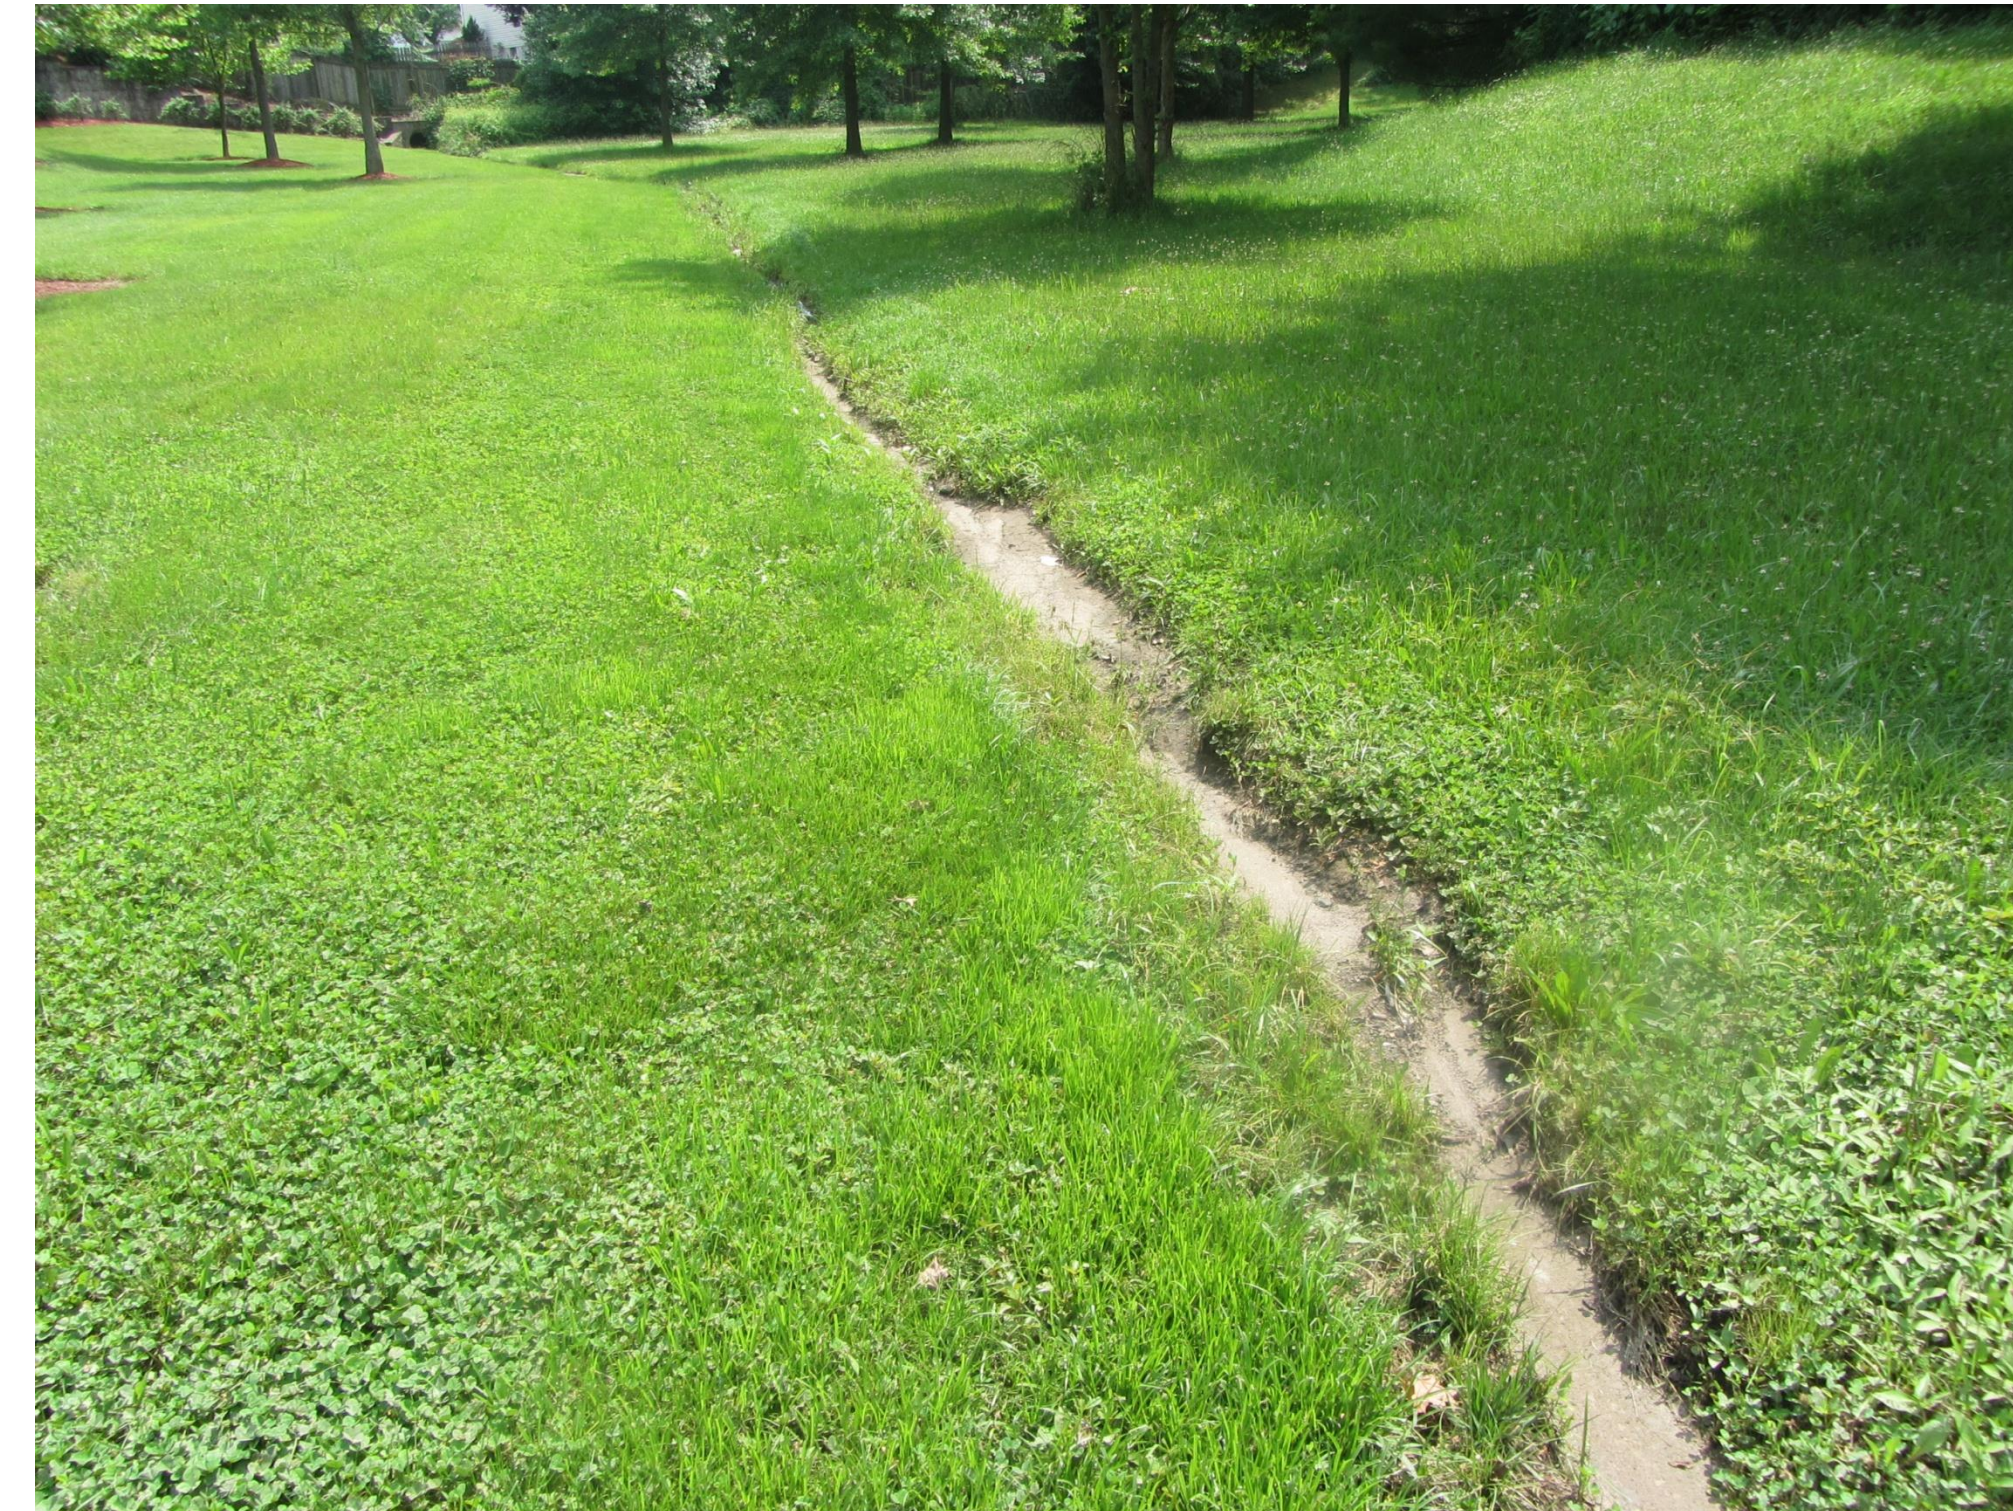
Sediment accumulation in low flow channel

- Low flow channel largely filled with sediment
- Either clear low flow channels or replace with rock channel

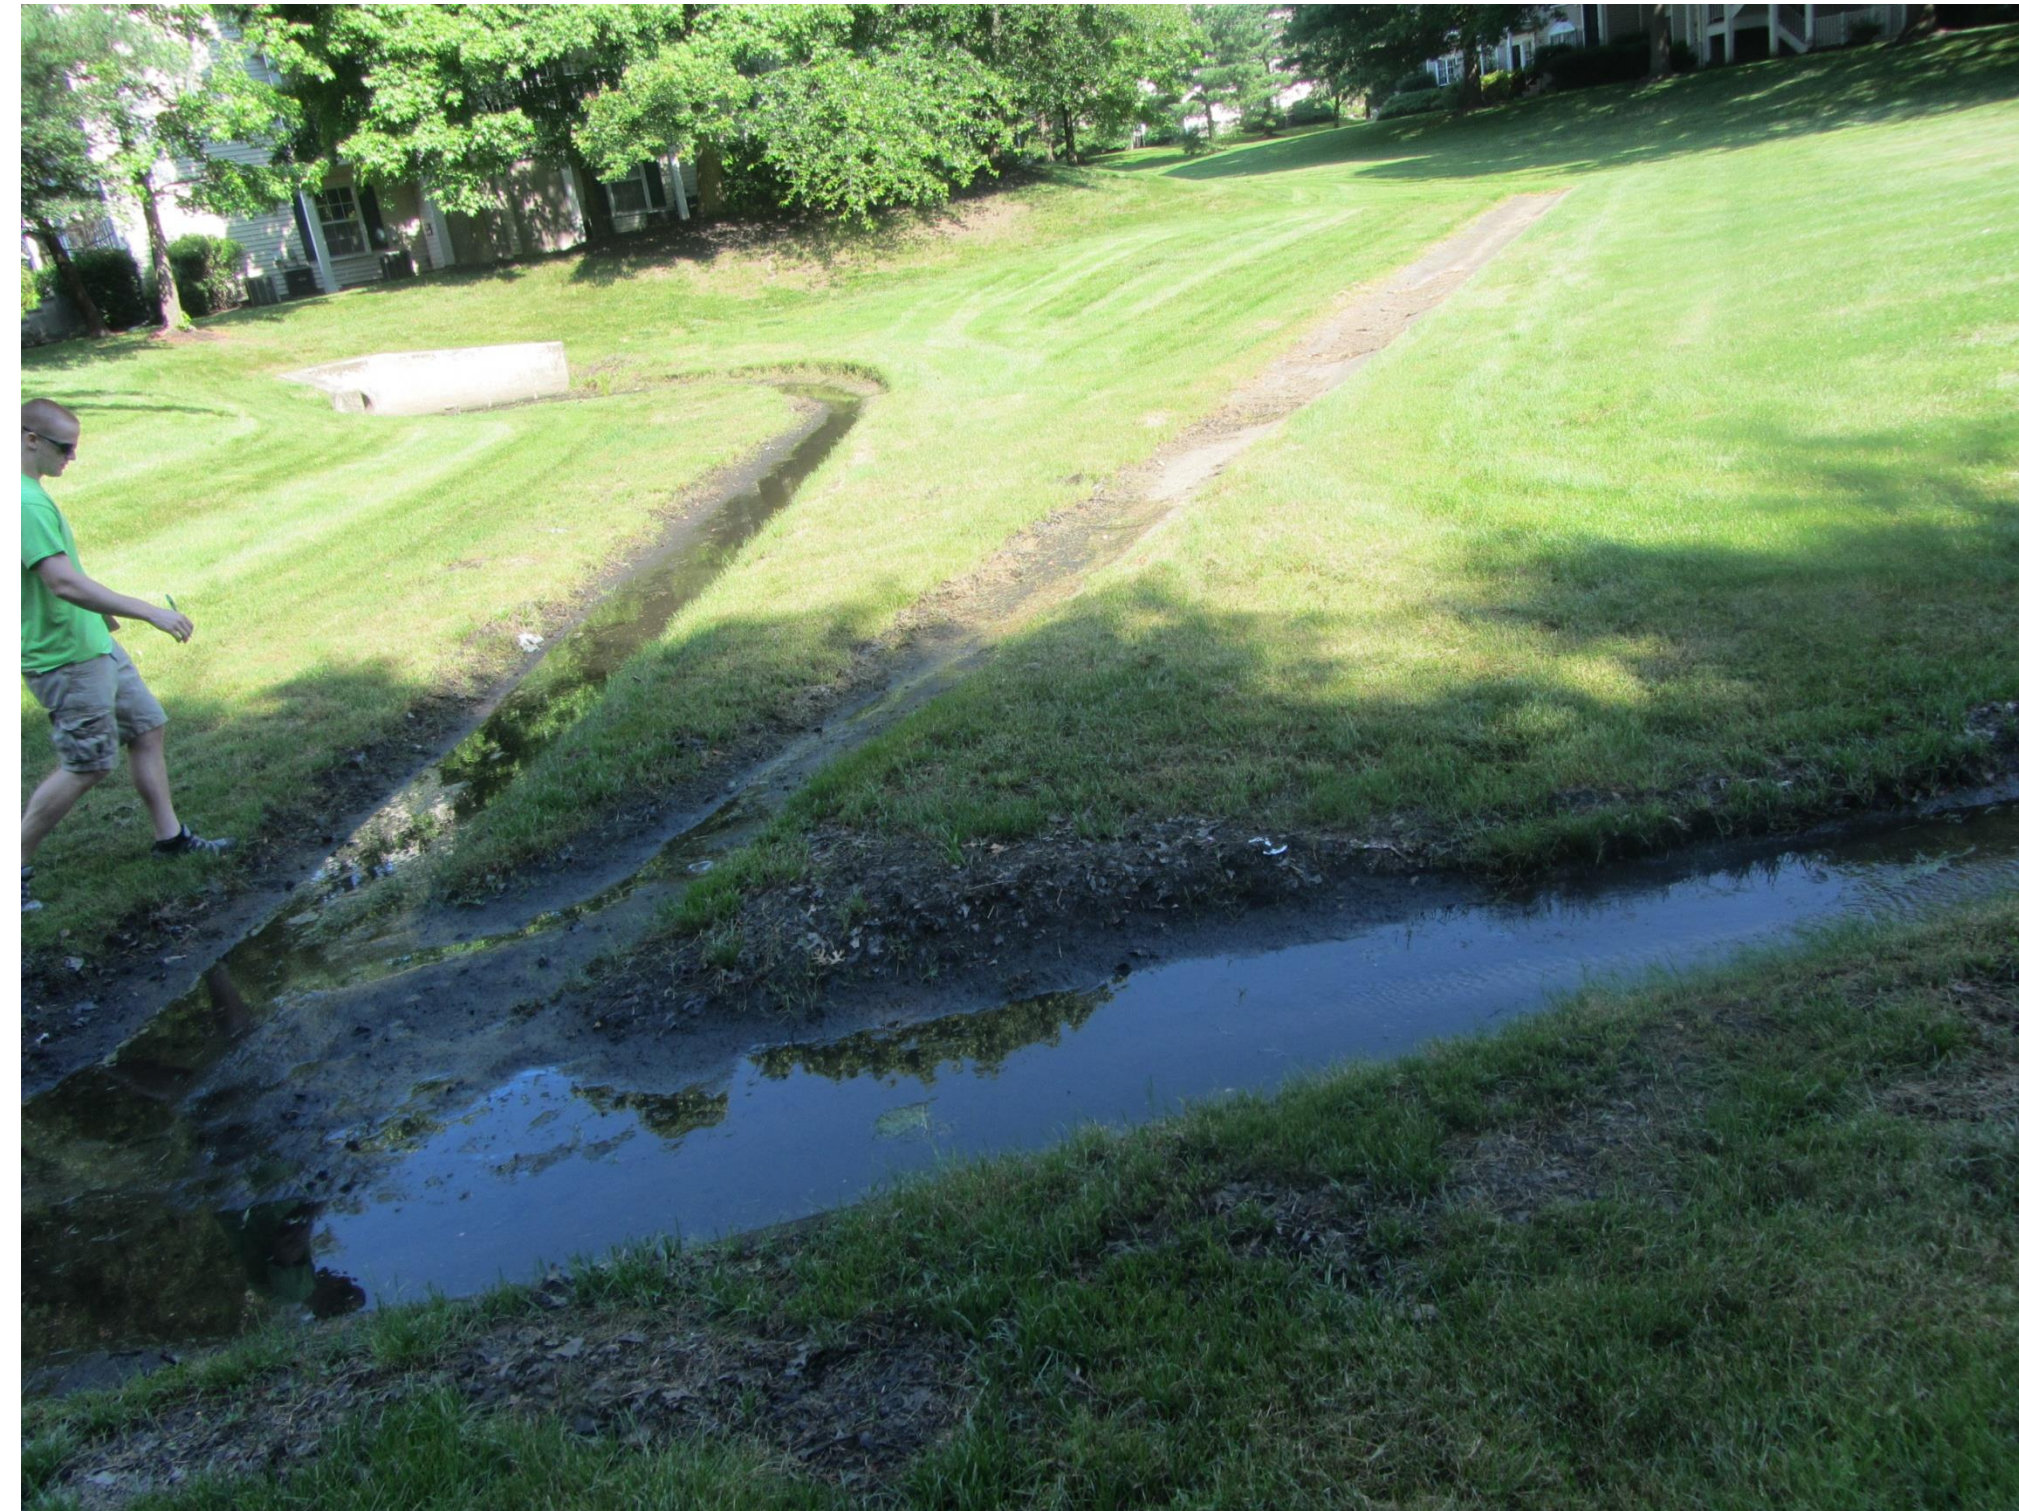
Excess sediment in low flow channels

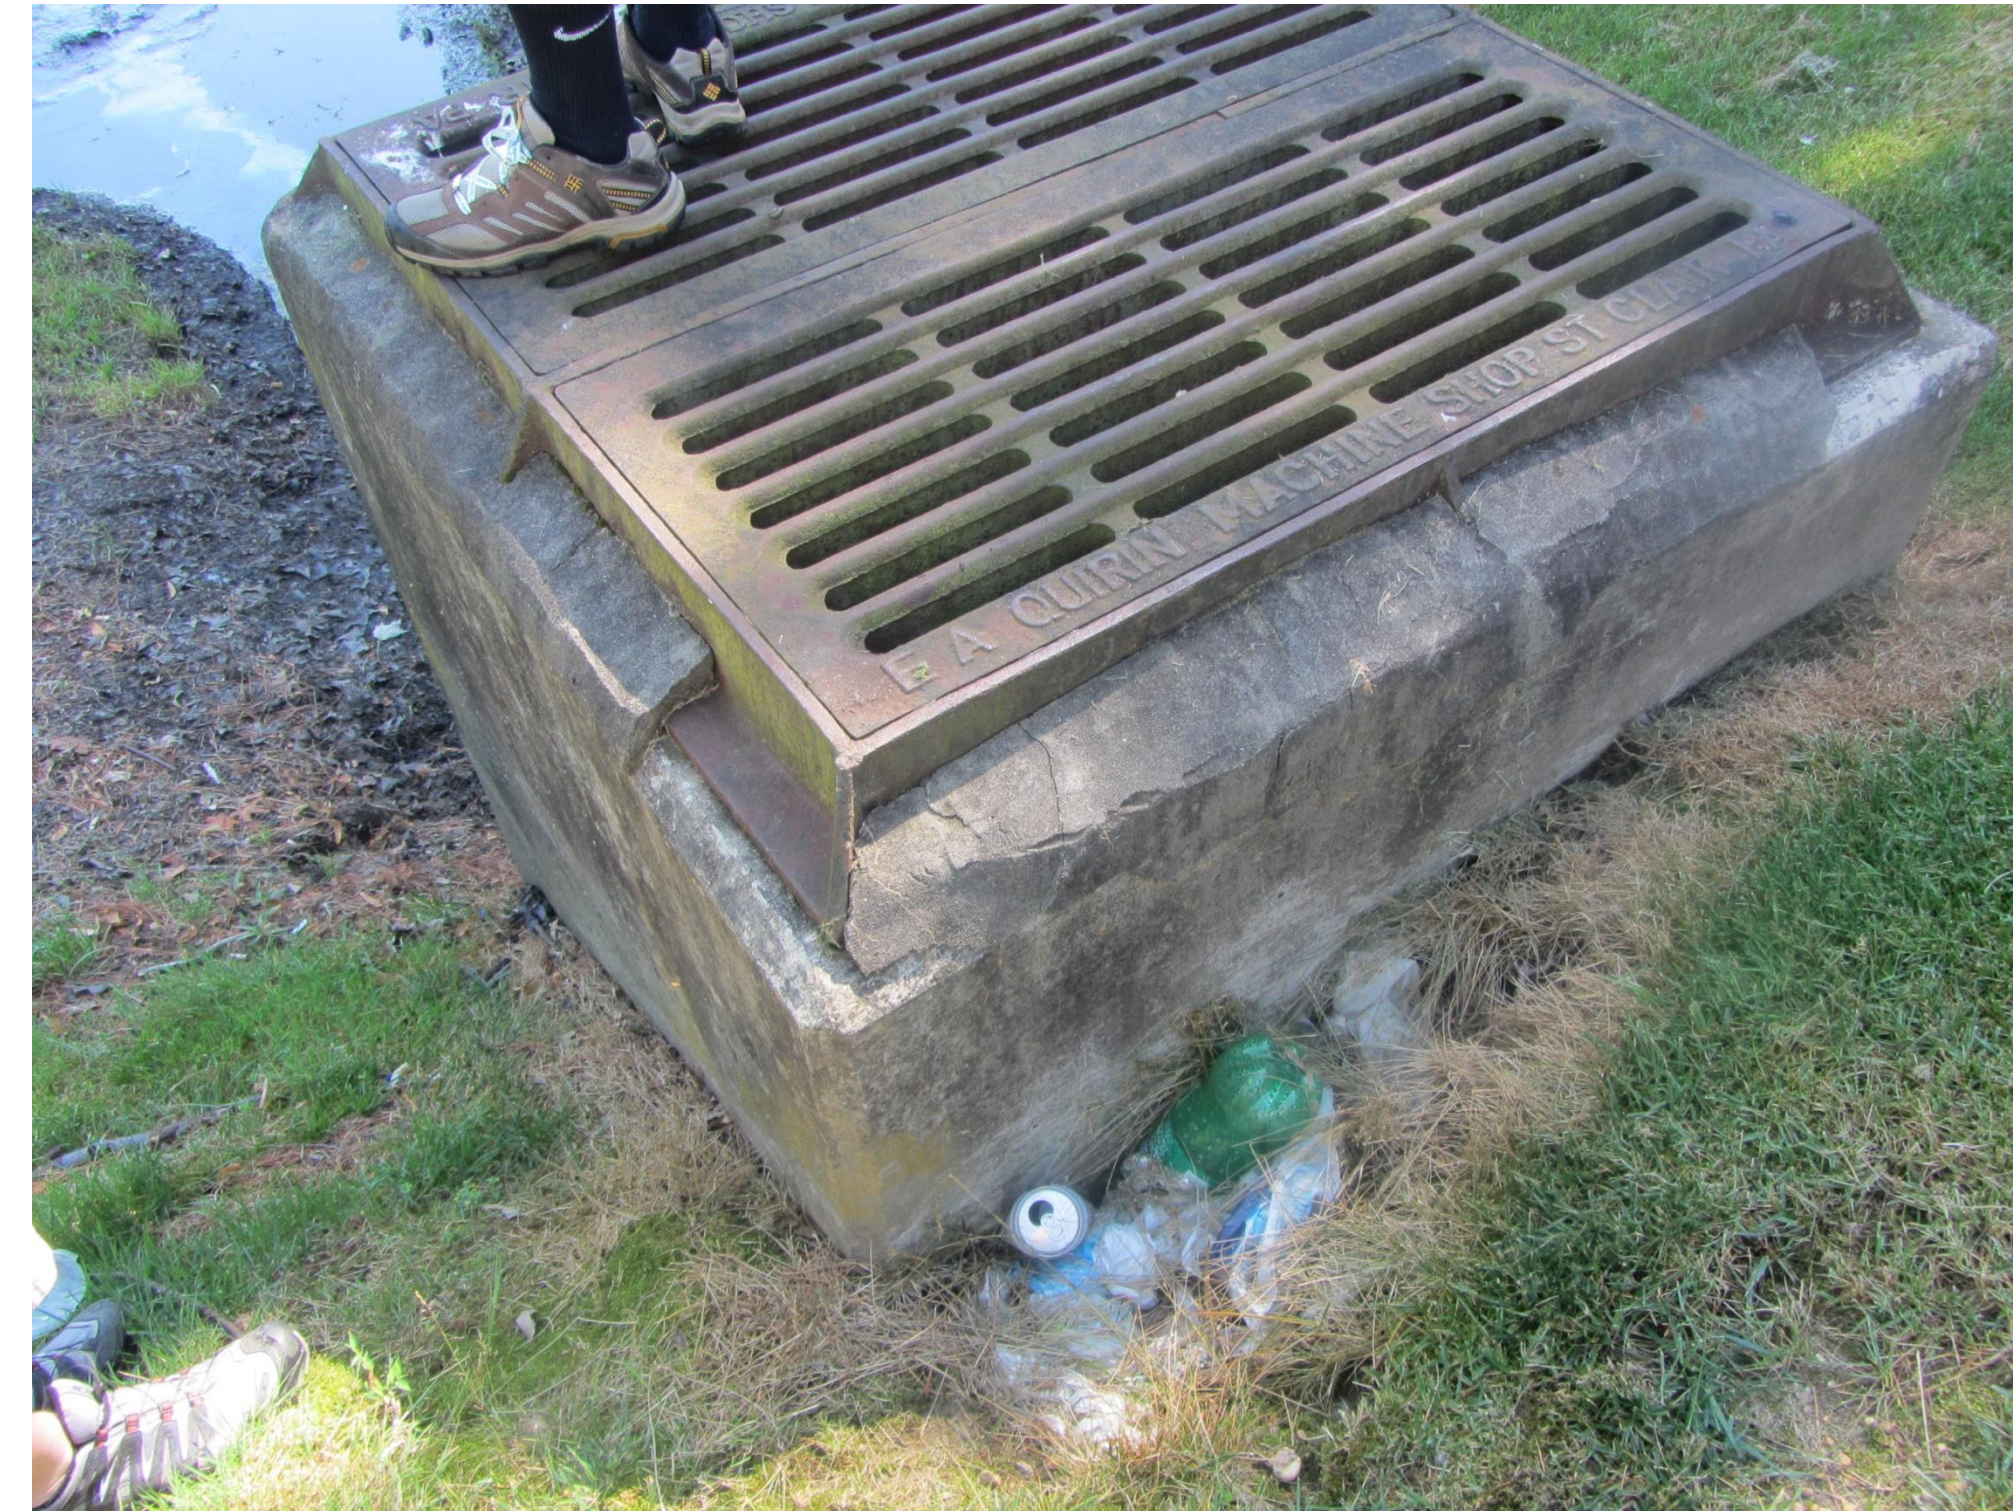
Slumping behind outlet structure

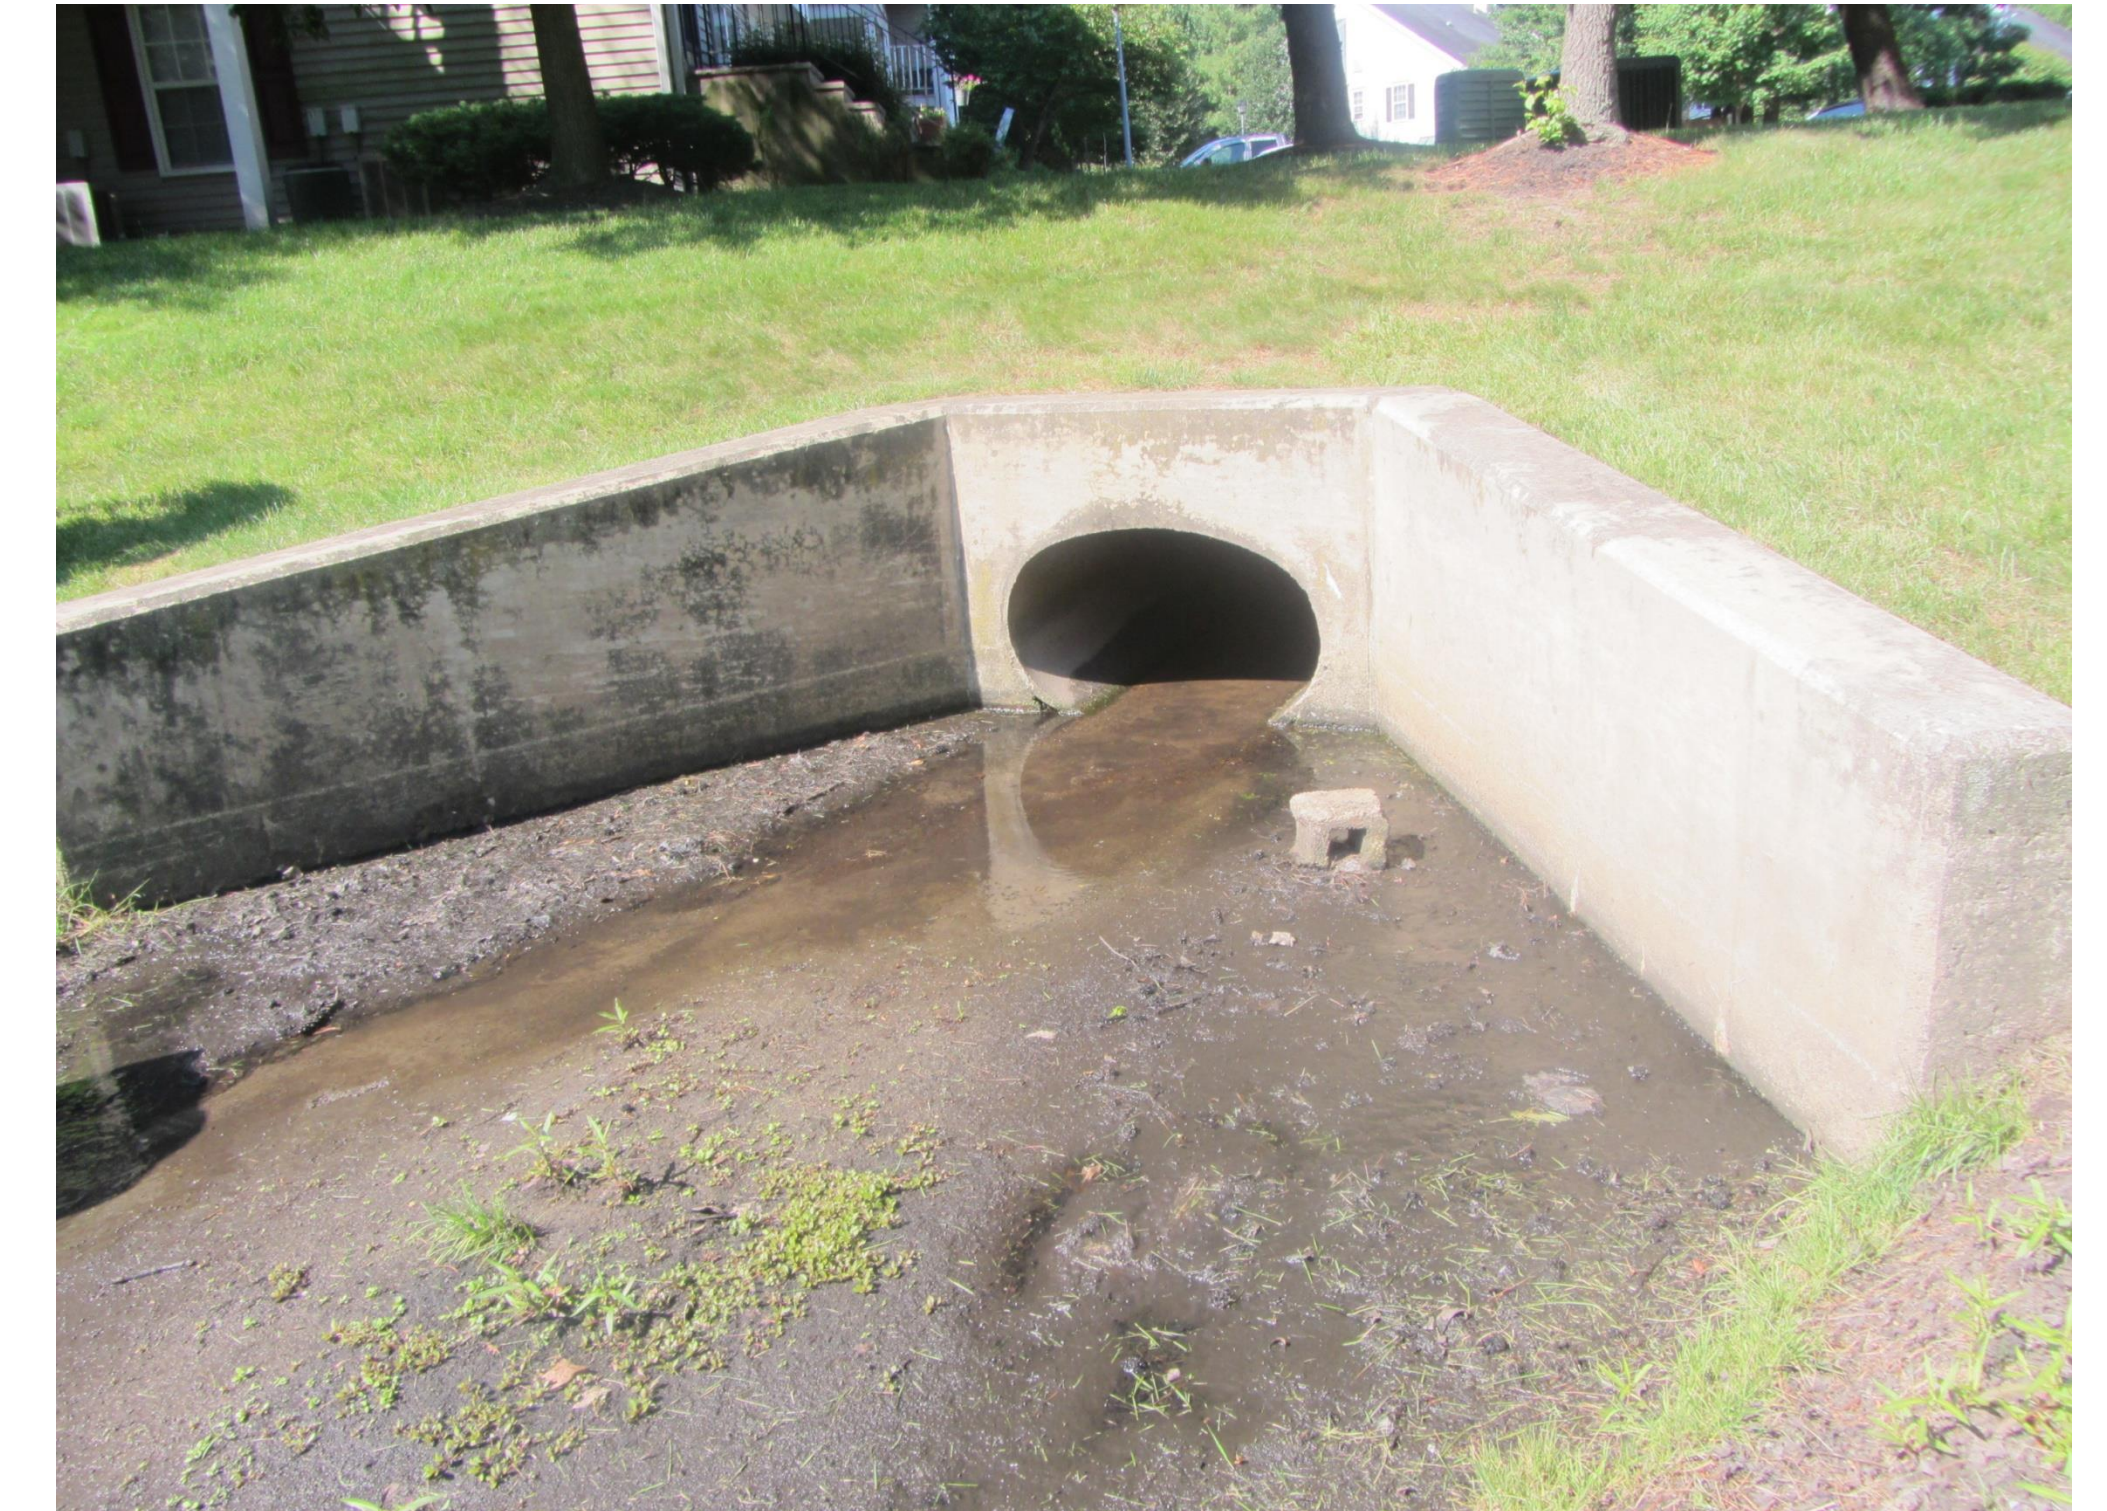
Sediment accumulated in front of inlet

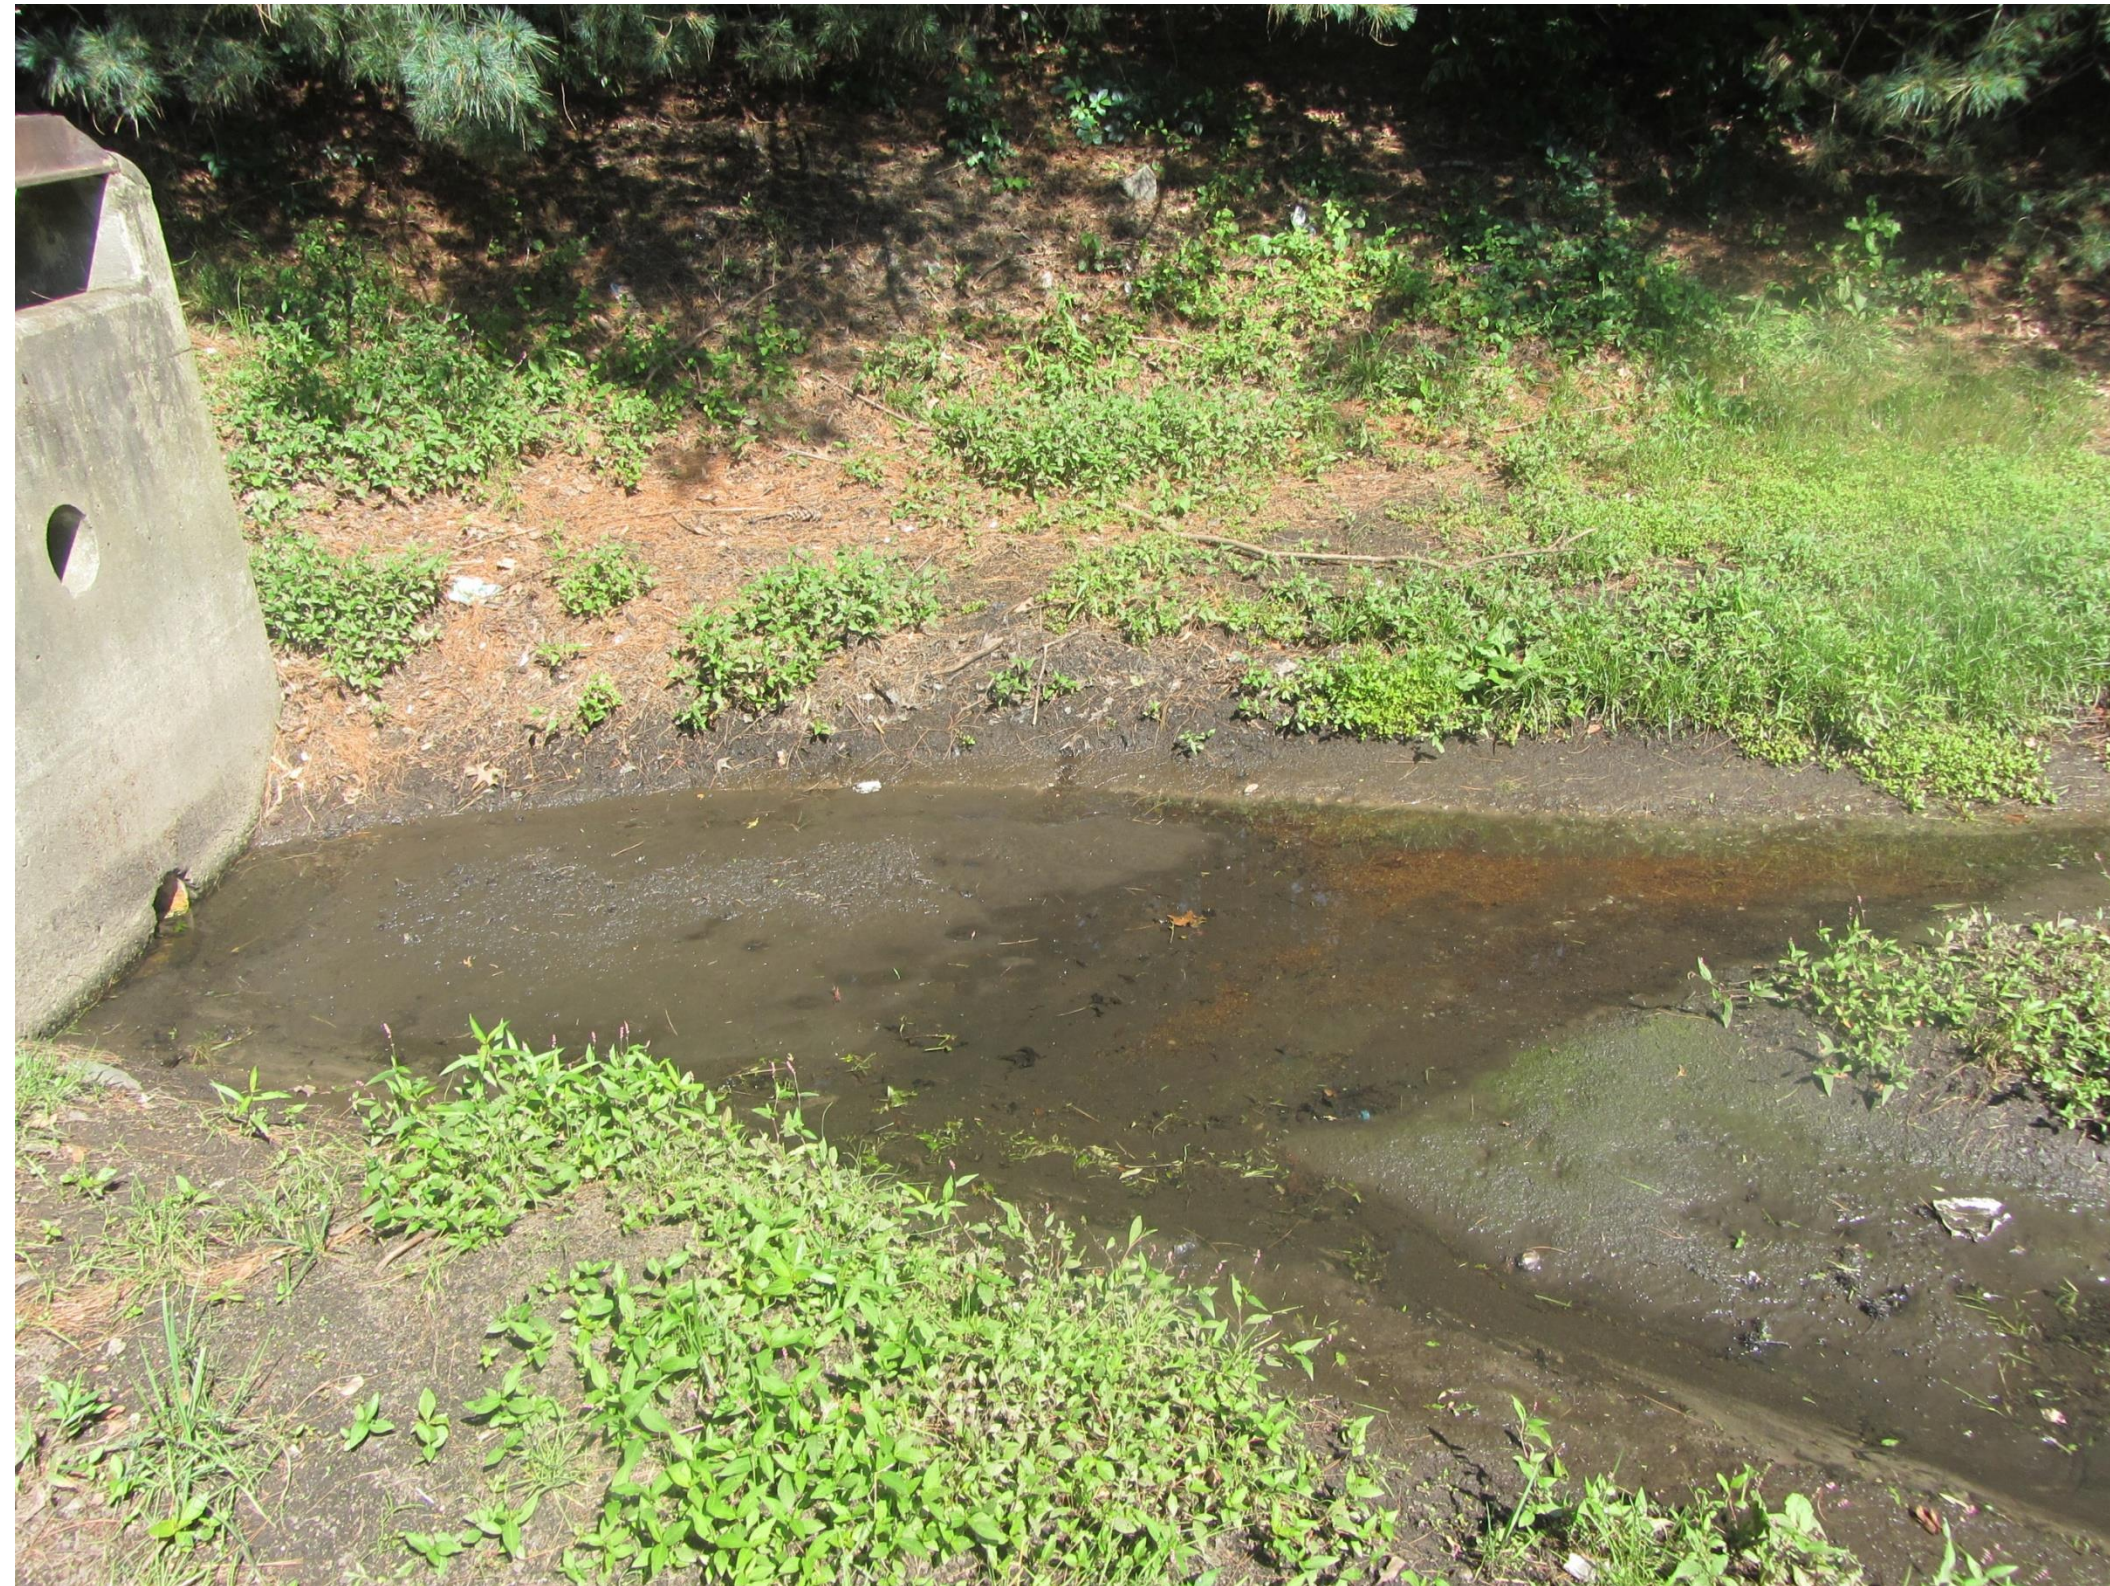
Sediment accumulated in front of outlet

- Significant standing water in low flow channel likely caused by blockages in the low flow orifice at the outlet
- Clear outlet structure and replace low flow with stone channel to allow infiltration

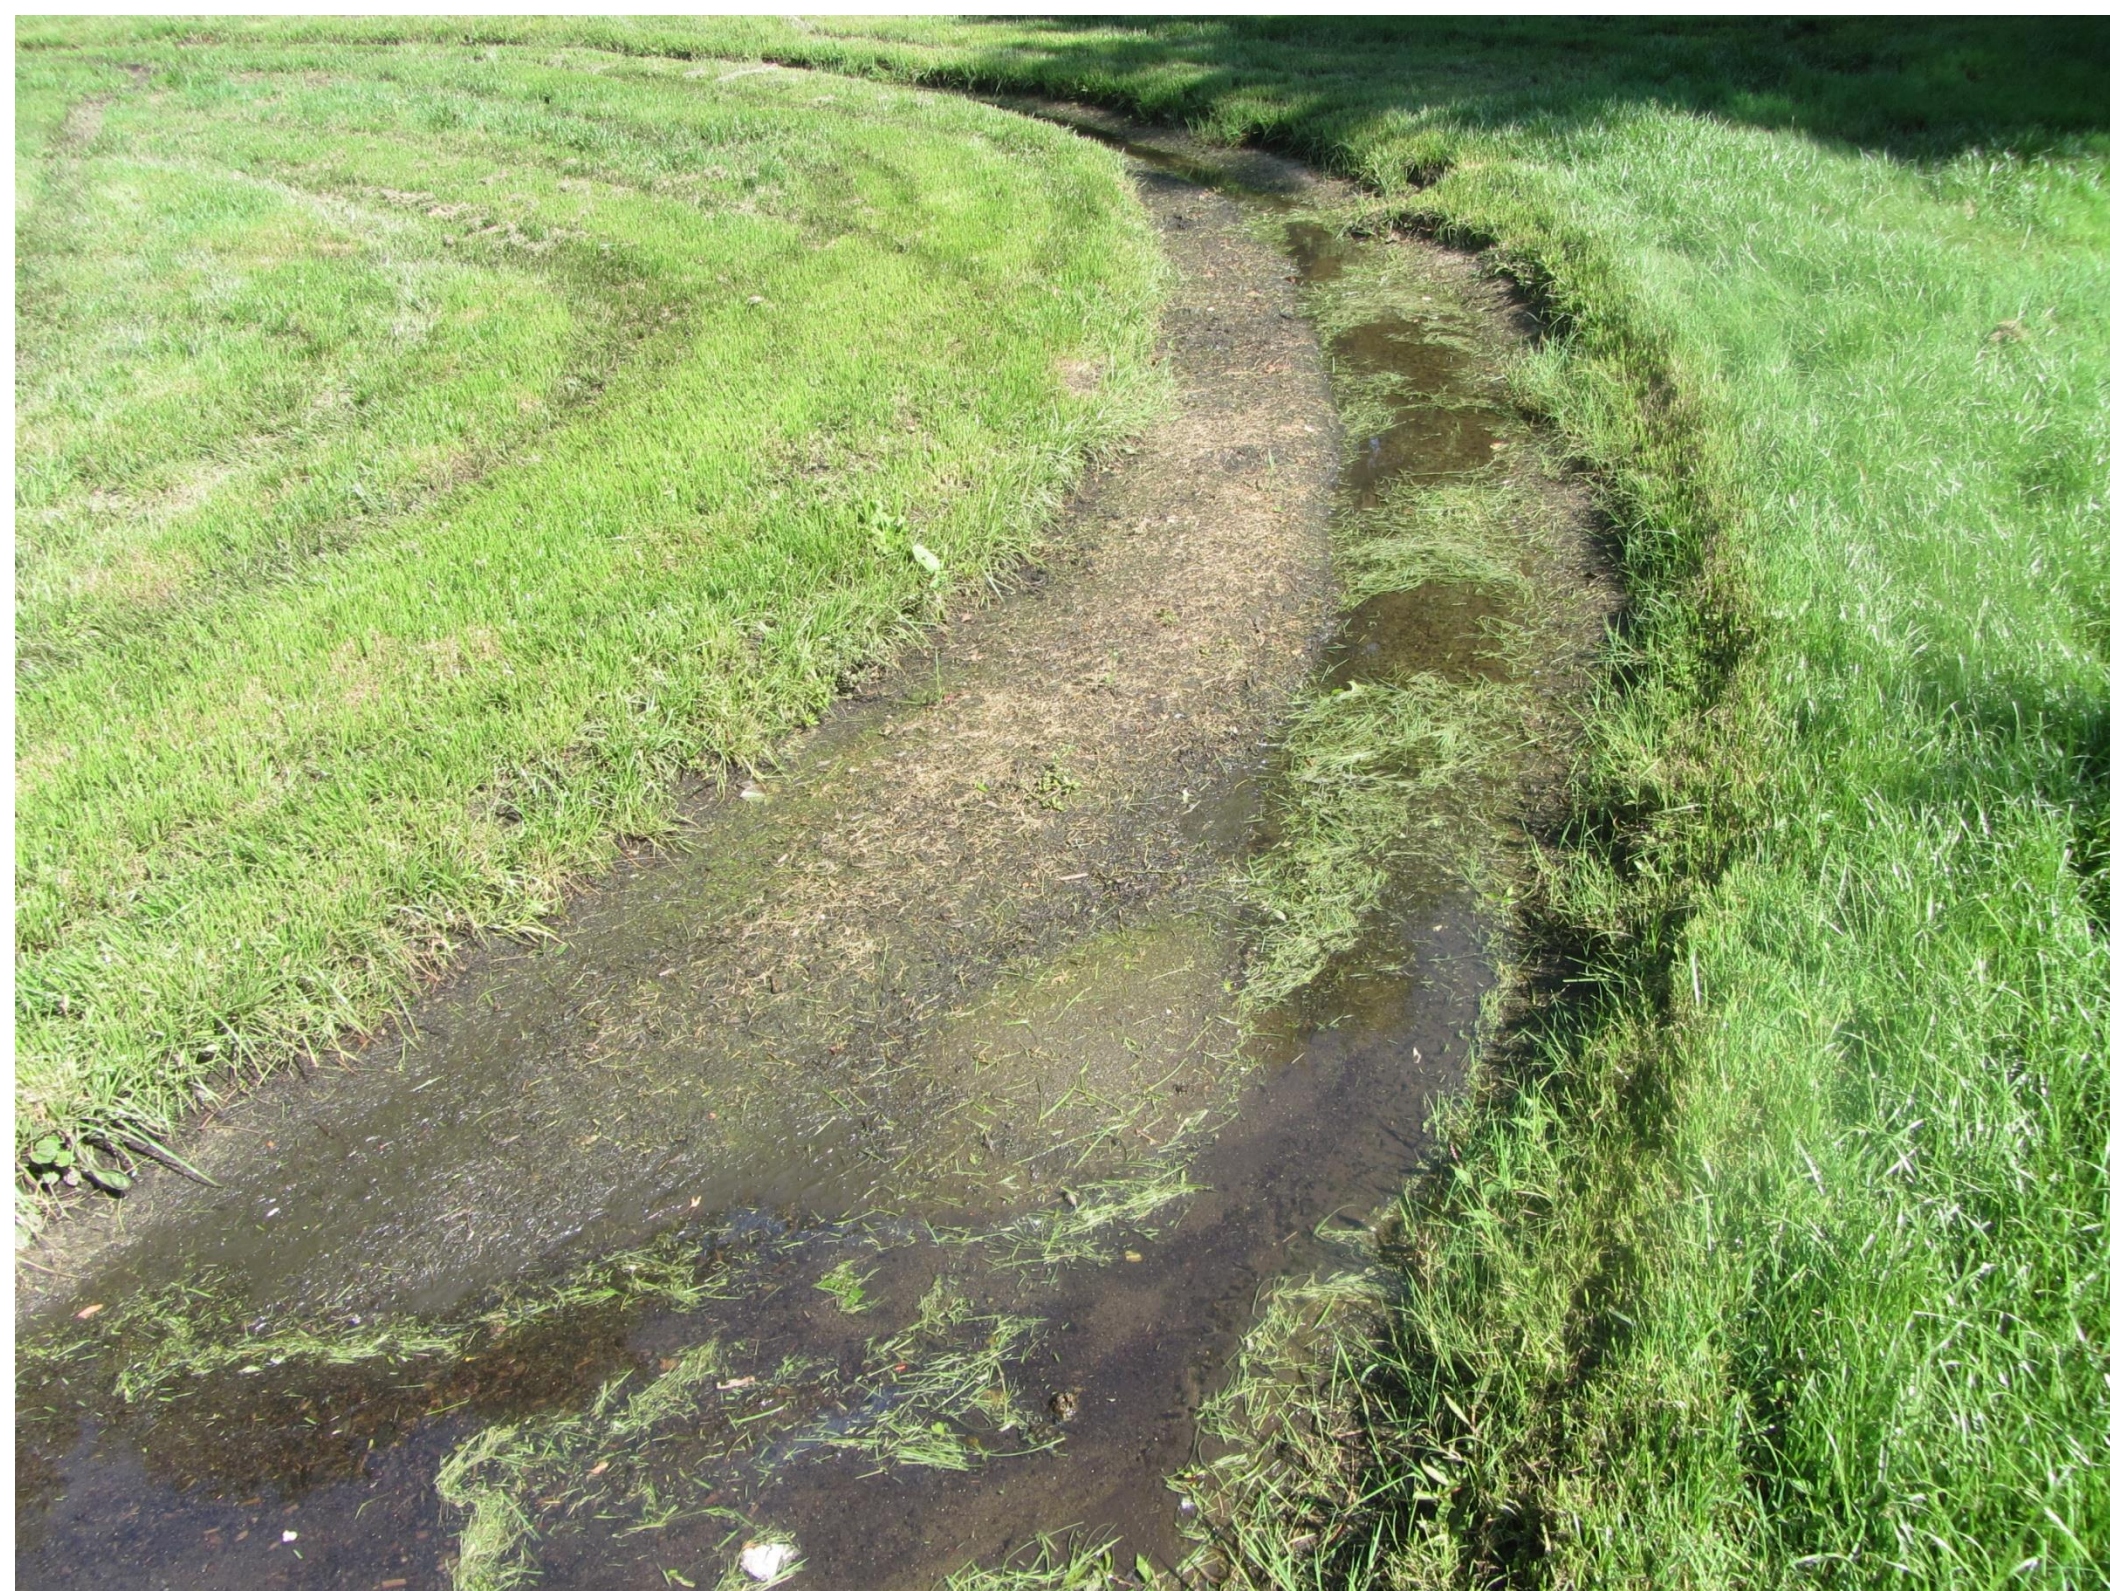
Excess sediment in low flow channel
