**Hamilton Township (Mercer County)
Stormwater Basin Assessment Summary
Past Priority Addendum (Year 5B)**

Developed by the Rutgers Cooperative Extension Water Resources Program
Funded by Hamilton Township, Mercer County, New Jersey

November 27, 2019

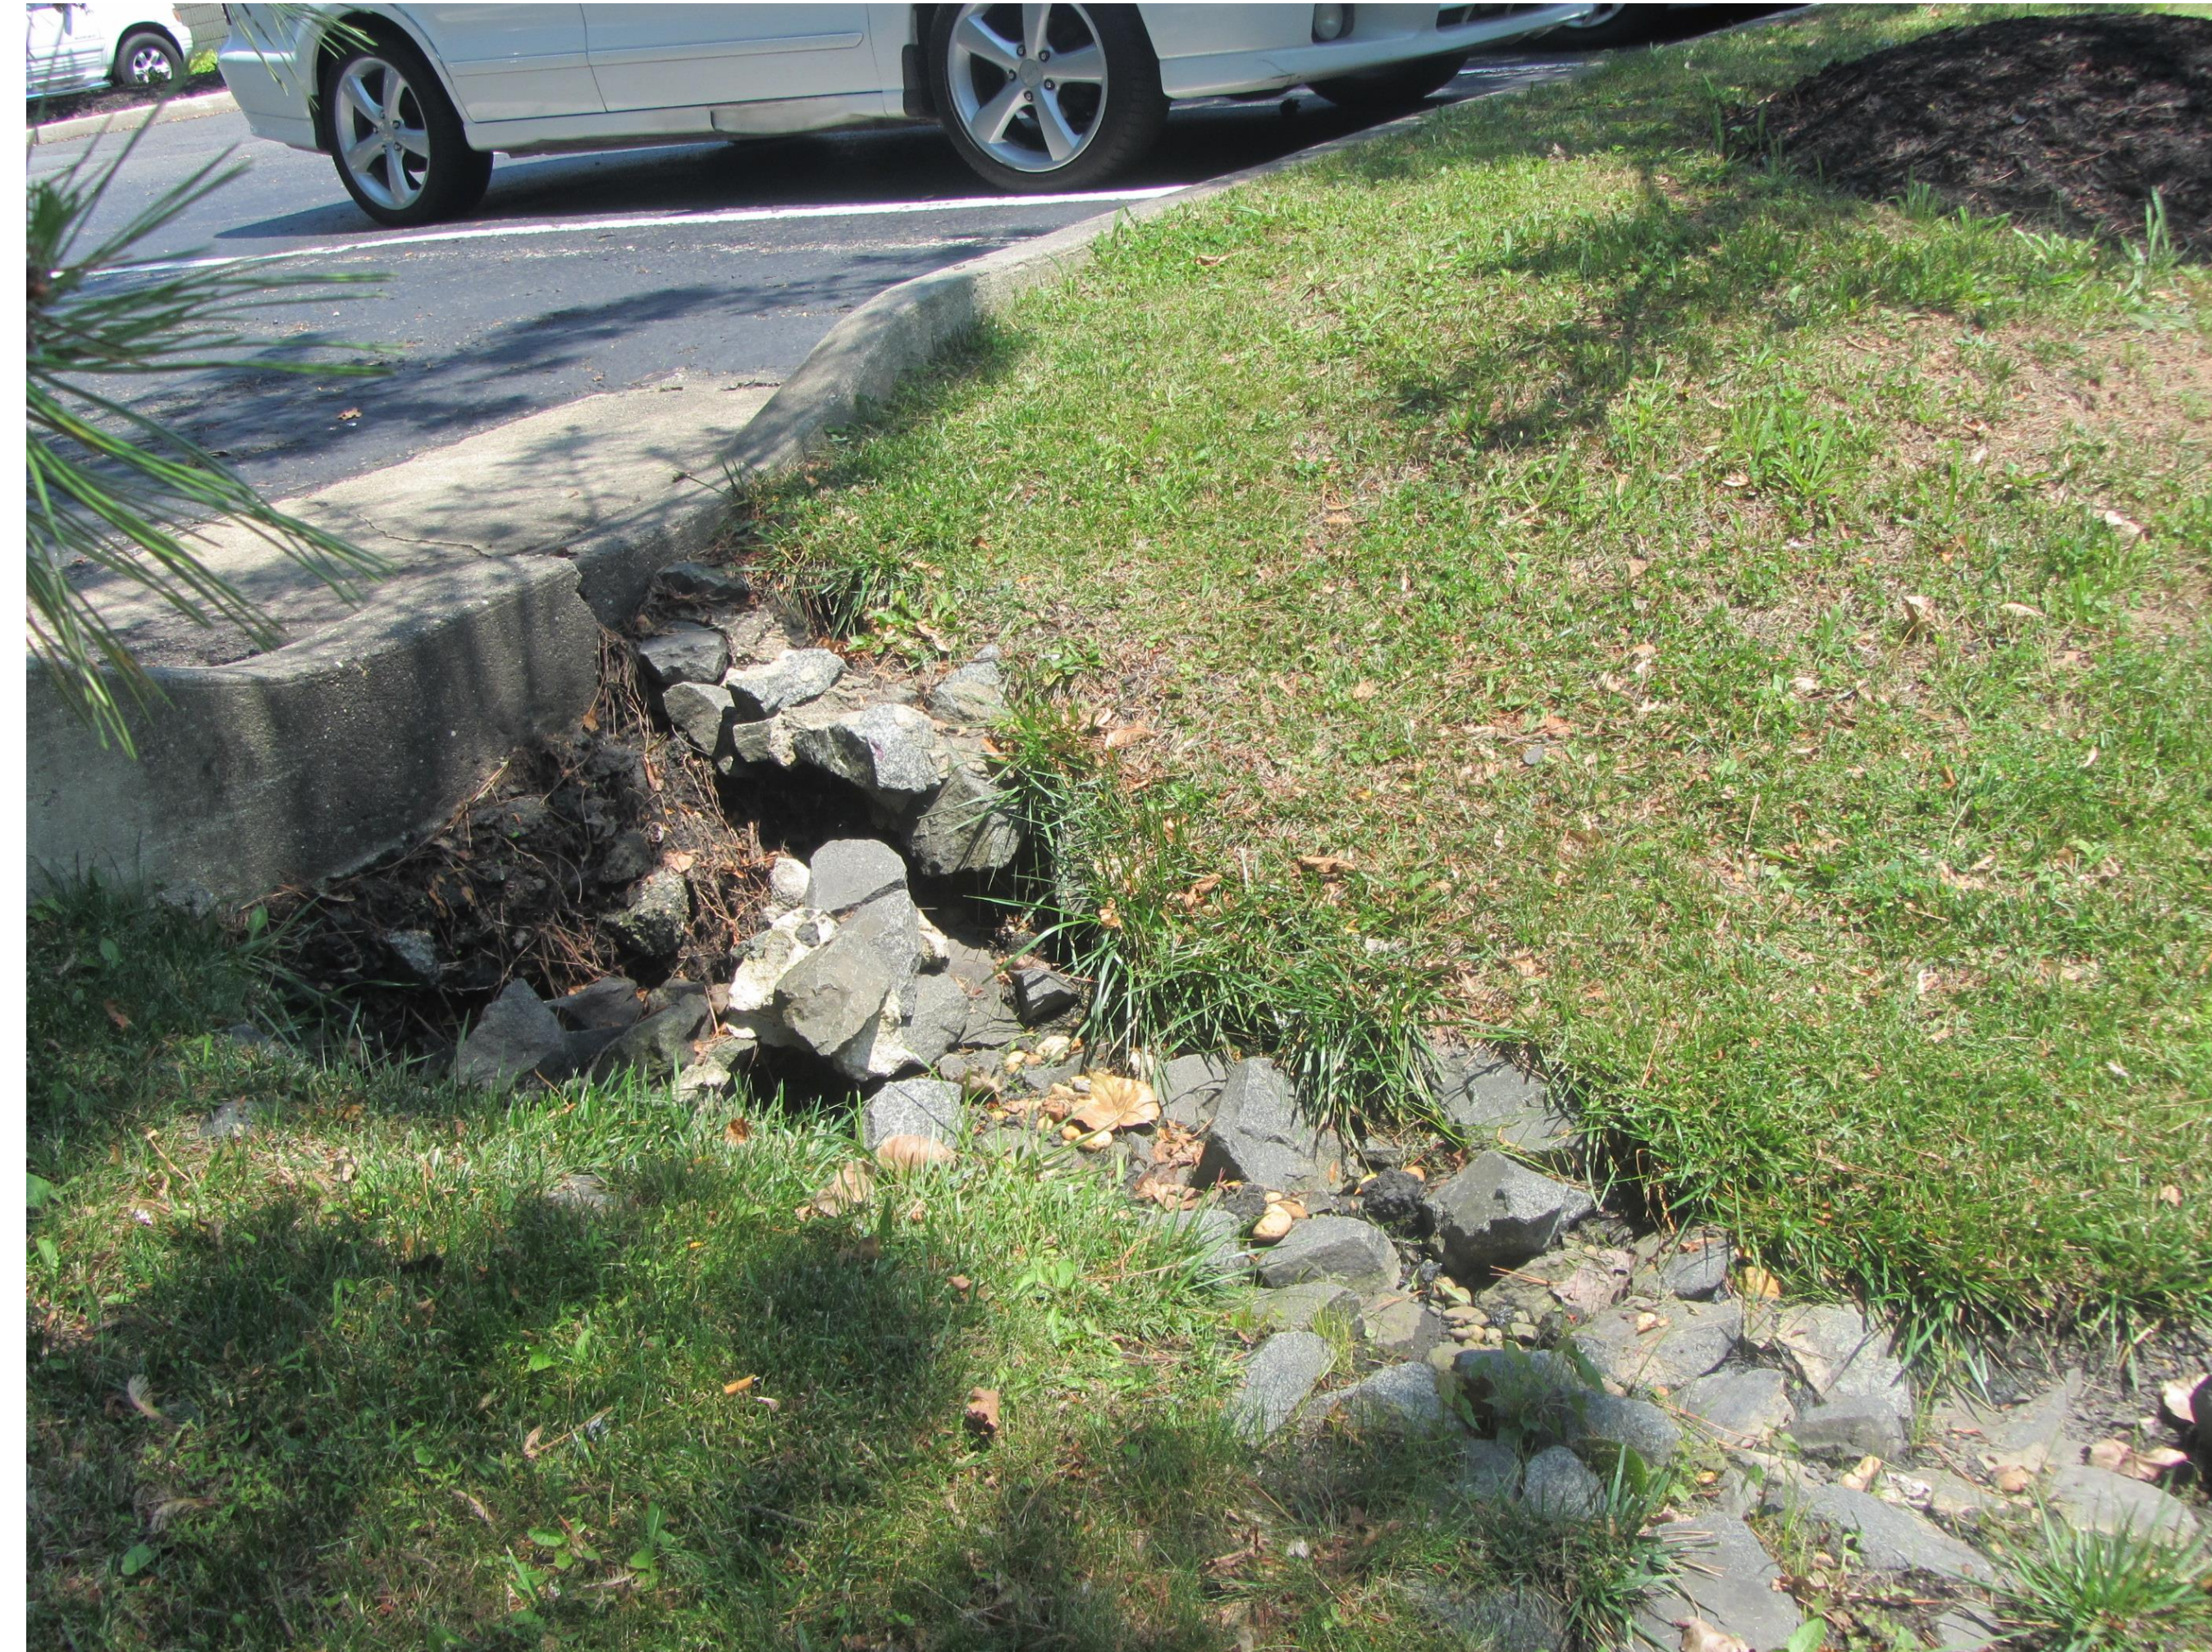
Erosion at curb cut inlet

- The basin allows infiltration of stormwater
- Curb cut inlet has severe erosion and breakage
- Outlet pipe has breakage, there is debris and rip rap restricting the flow of water and woody tree growth in proximity of outlet

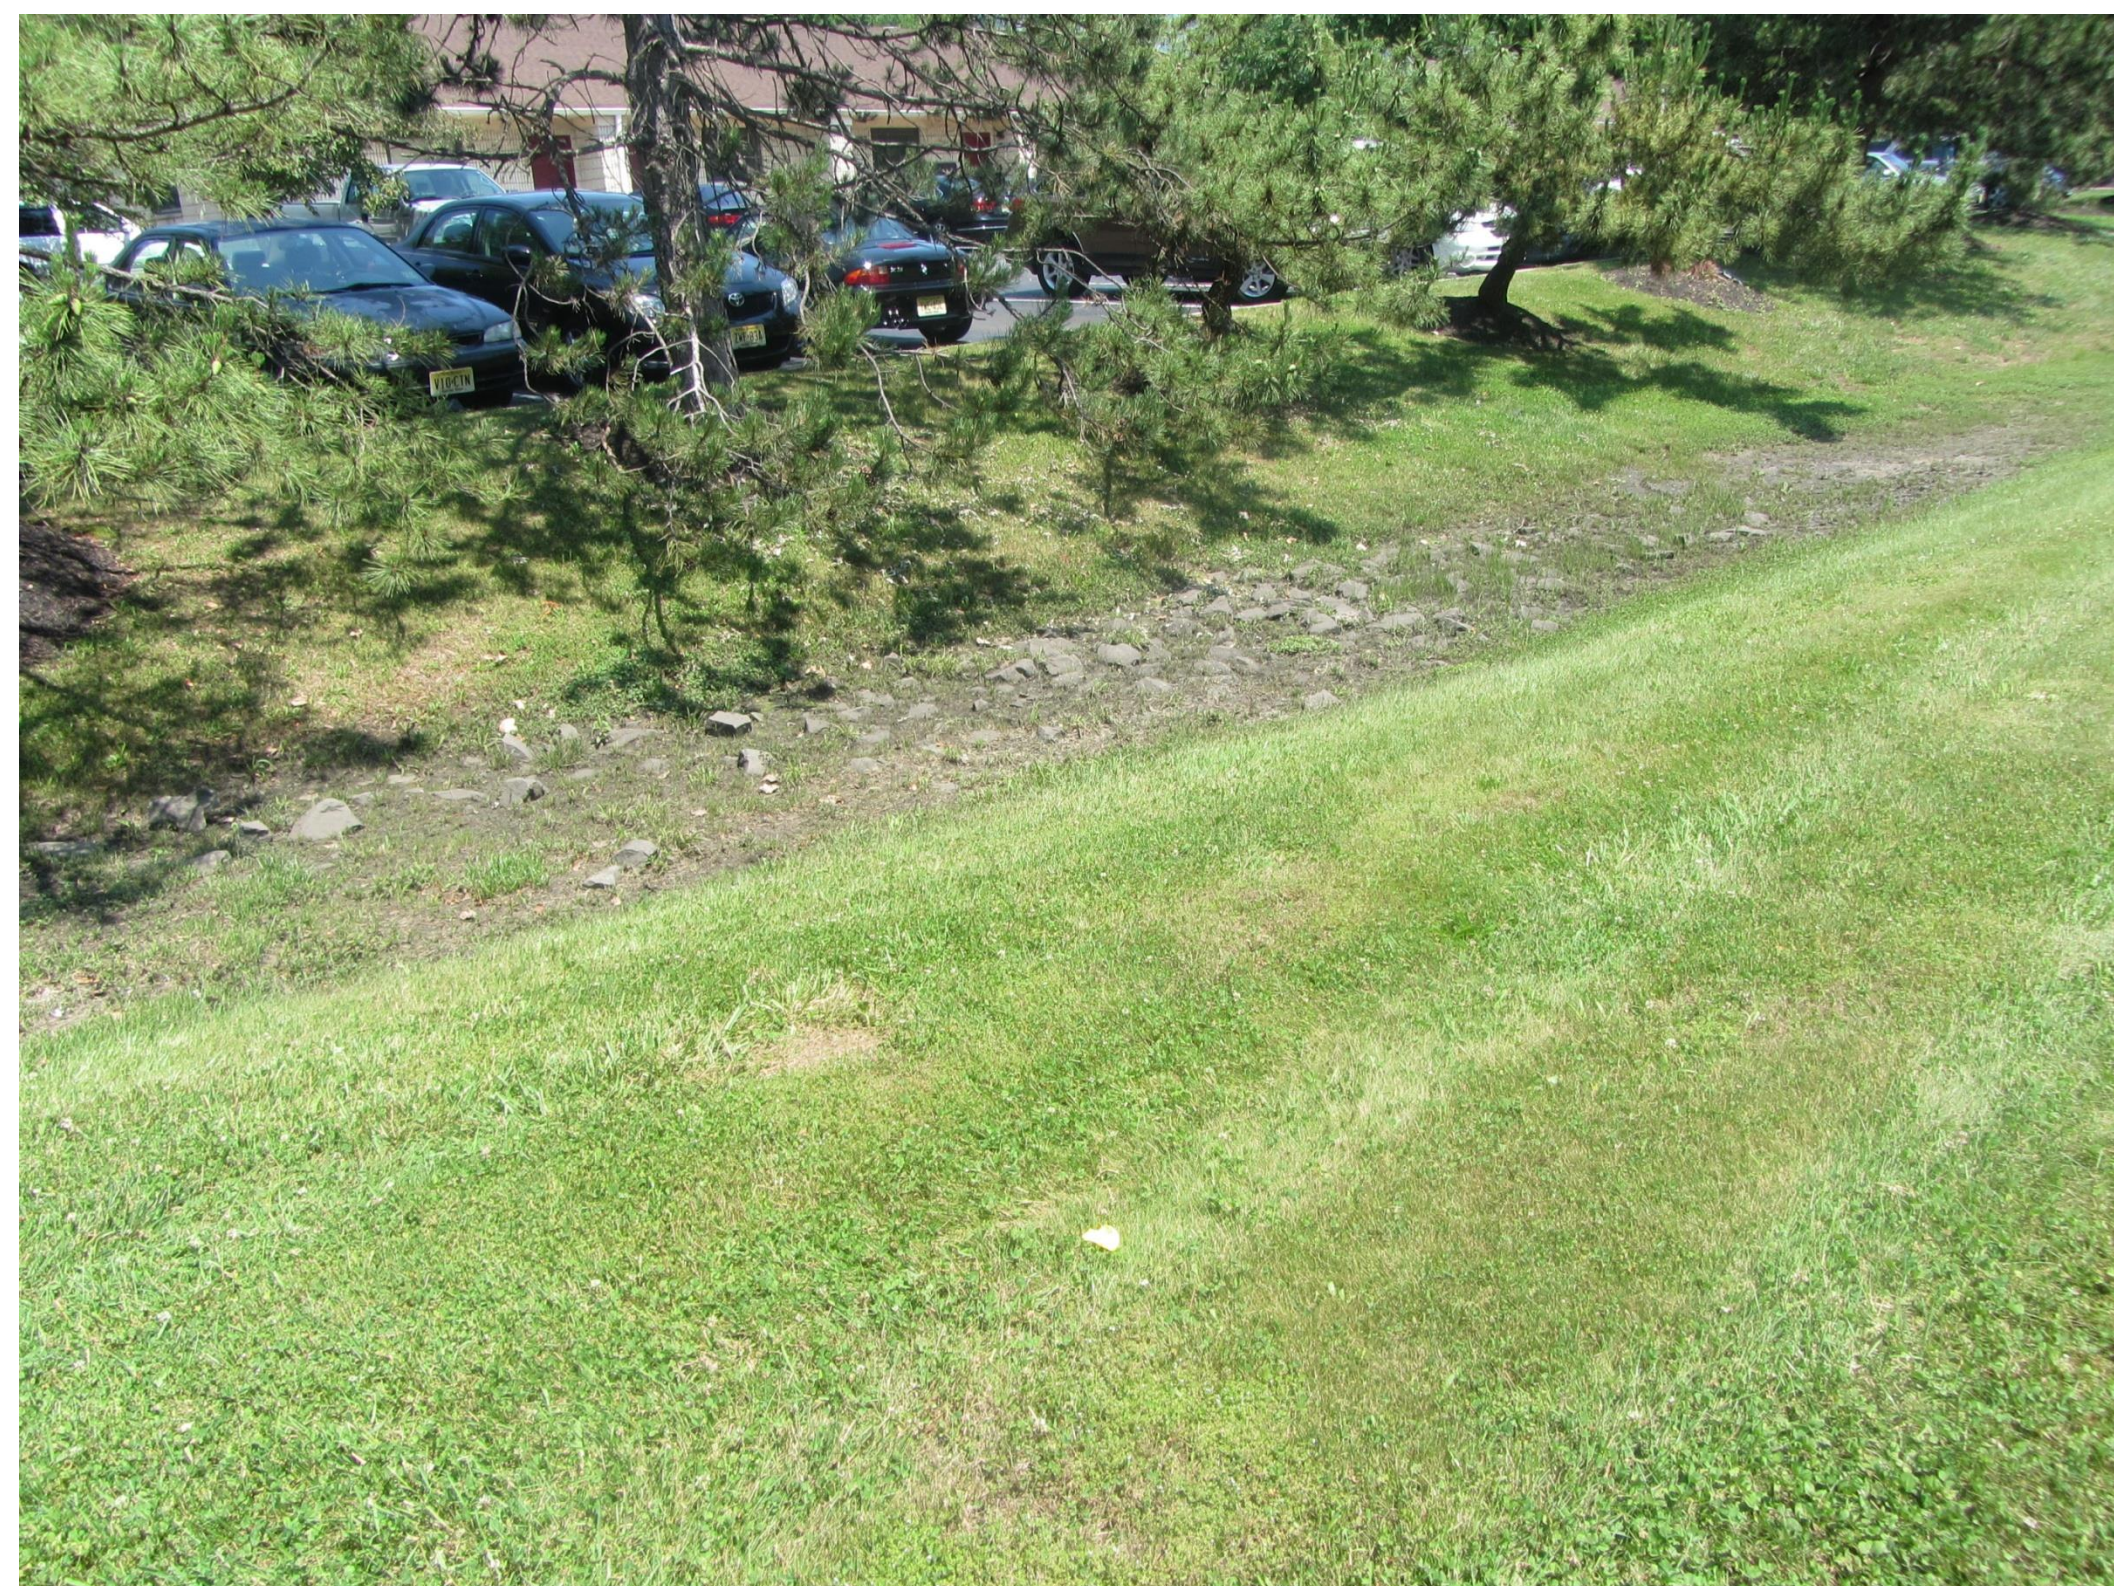
Basin bottom looking north

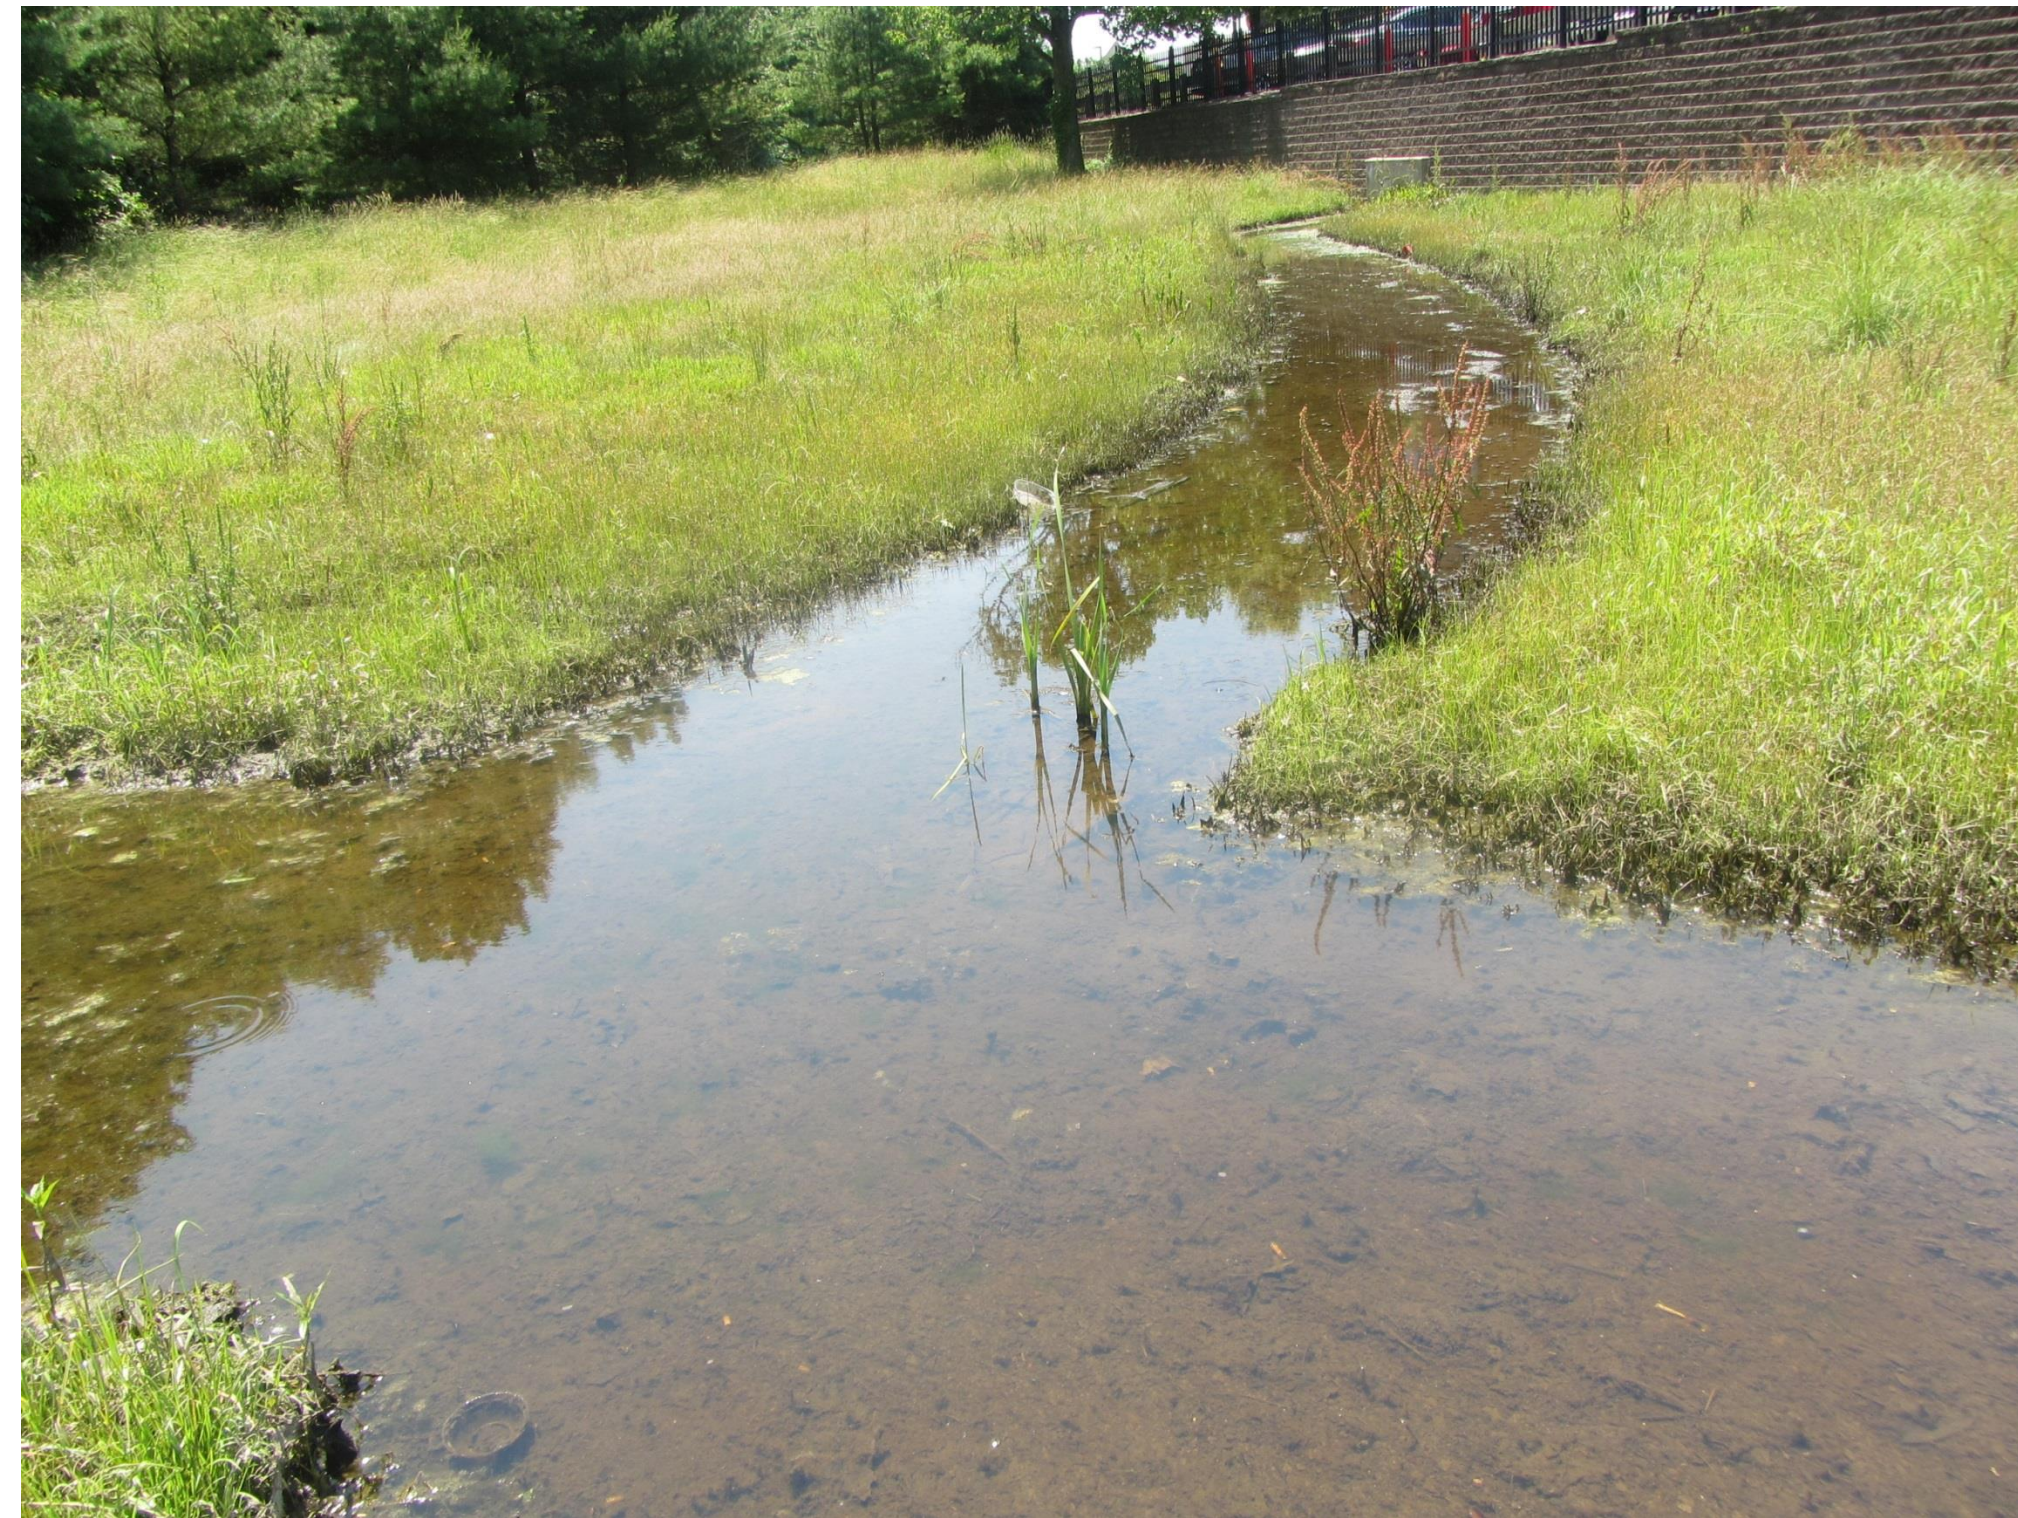
Standing water in low flow channels

- There is excess sediment accumulated and standing water in the low flow channels with algal growth
- Outlet structure has excessive plant growth around it and the low flow orifice is severely clogged, restricting the flow of water
- The southern inlet has some cracks and breakage

- Conditions appears somewhat improved from the conditions in 2013
- Sediment needs to be removed from the low channel as it is restricting flow
- Opportunity to replace low flow channel with rock channel

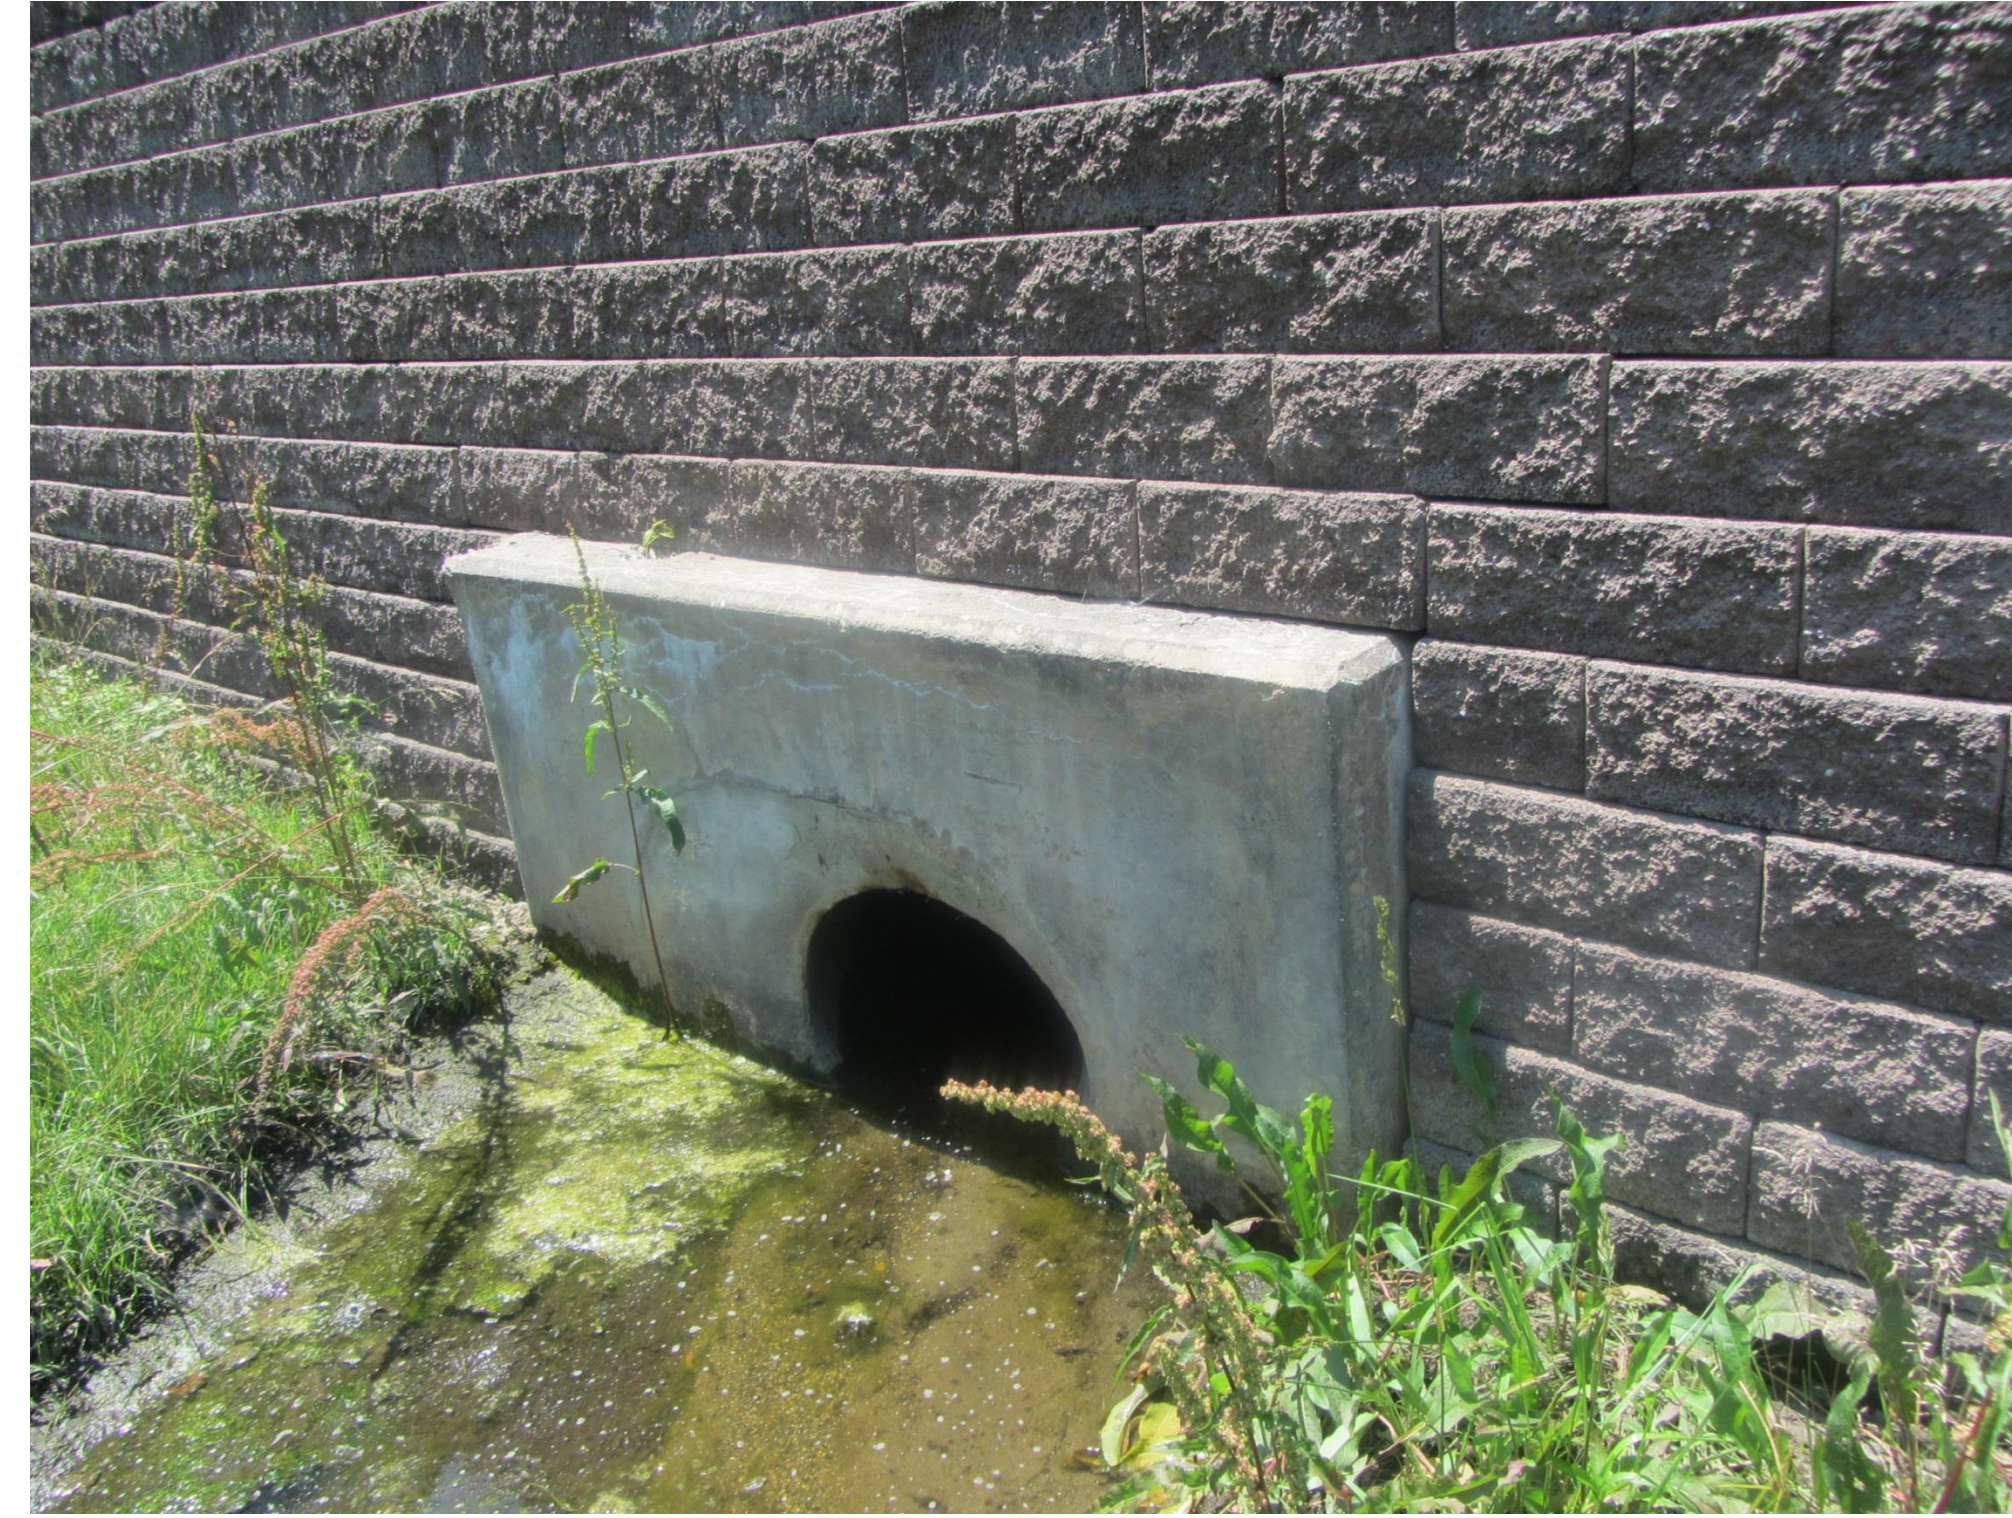
Southern inlet structure

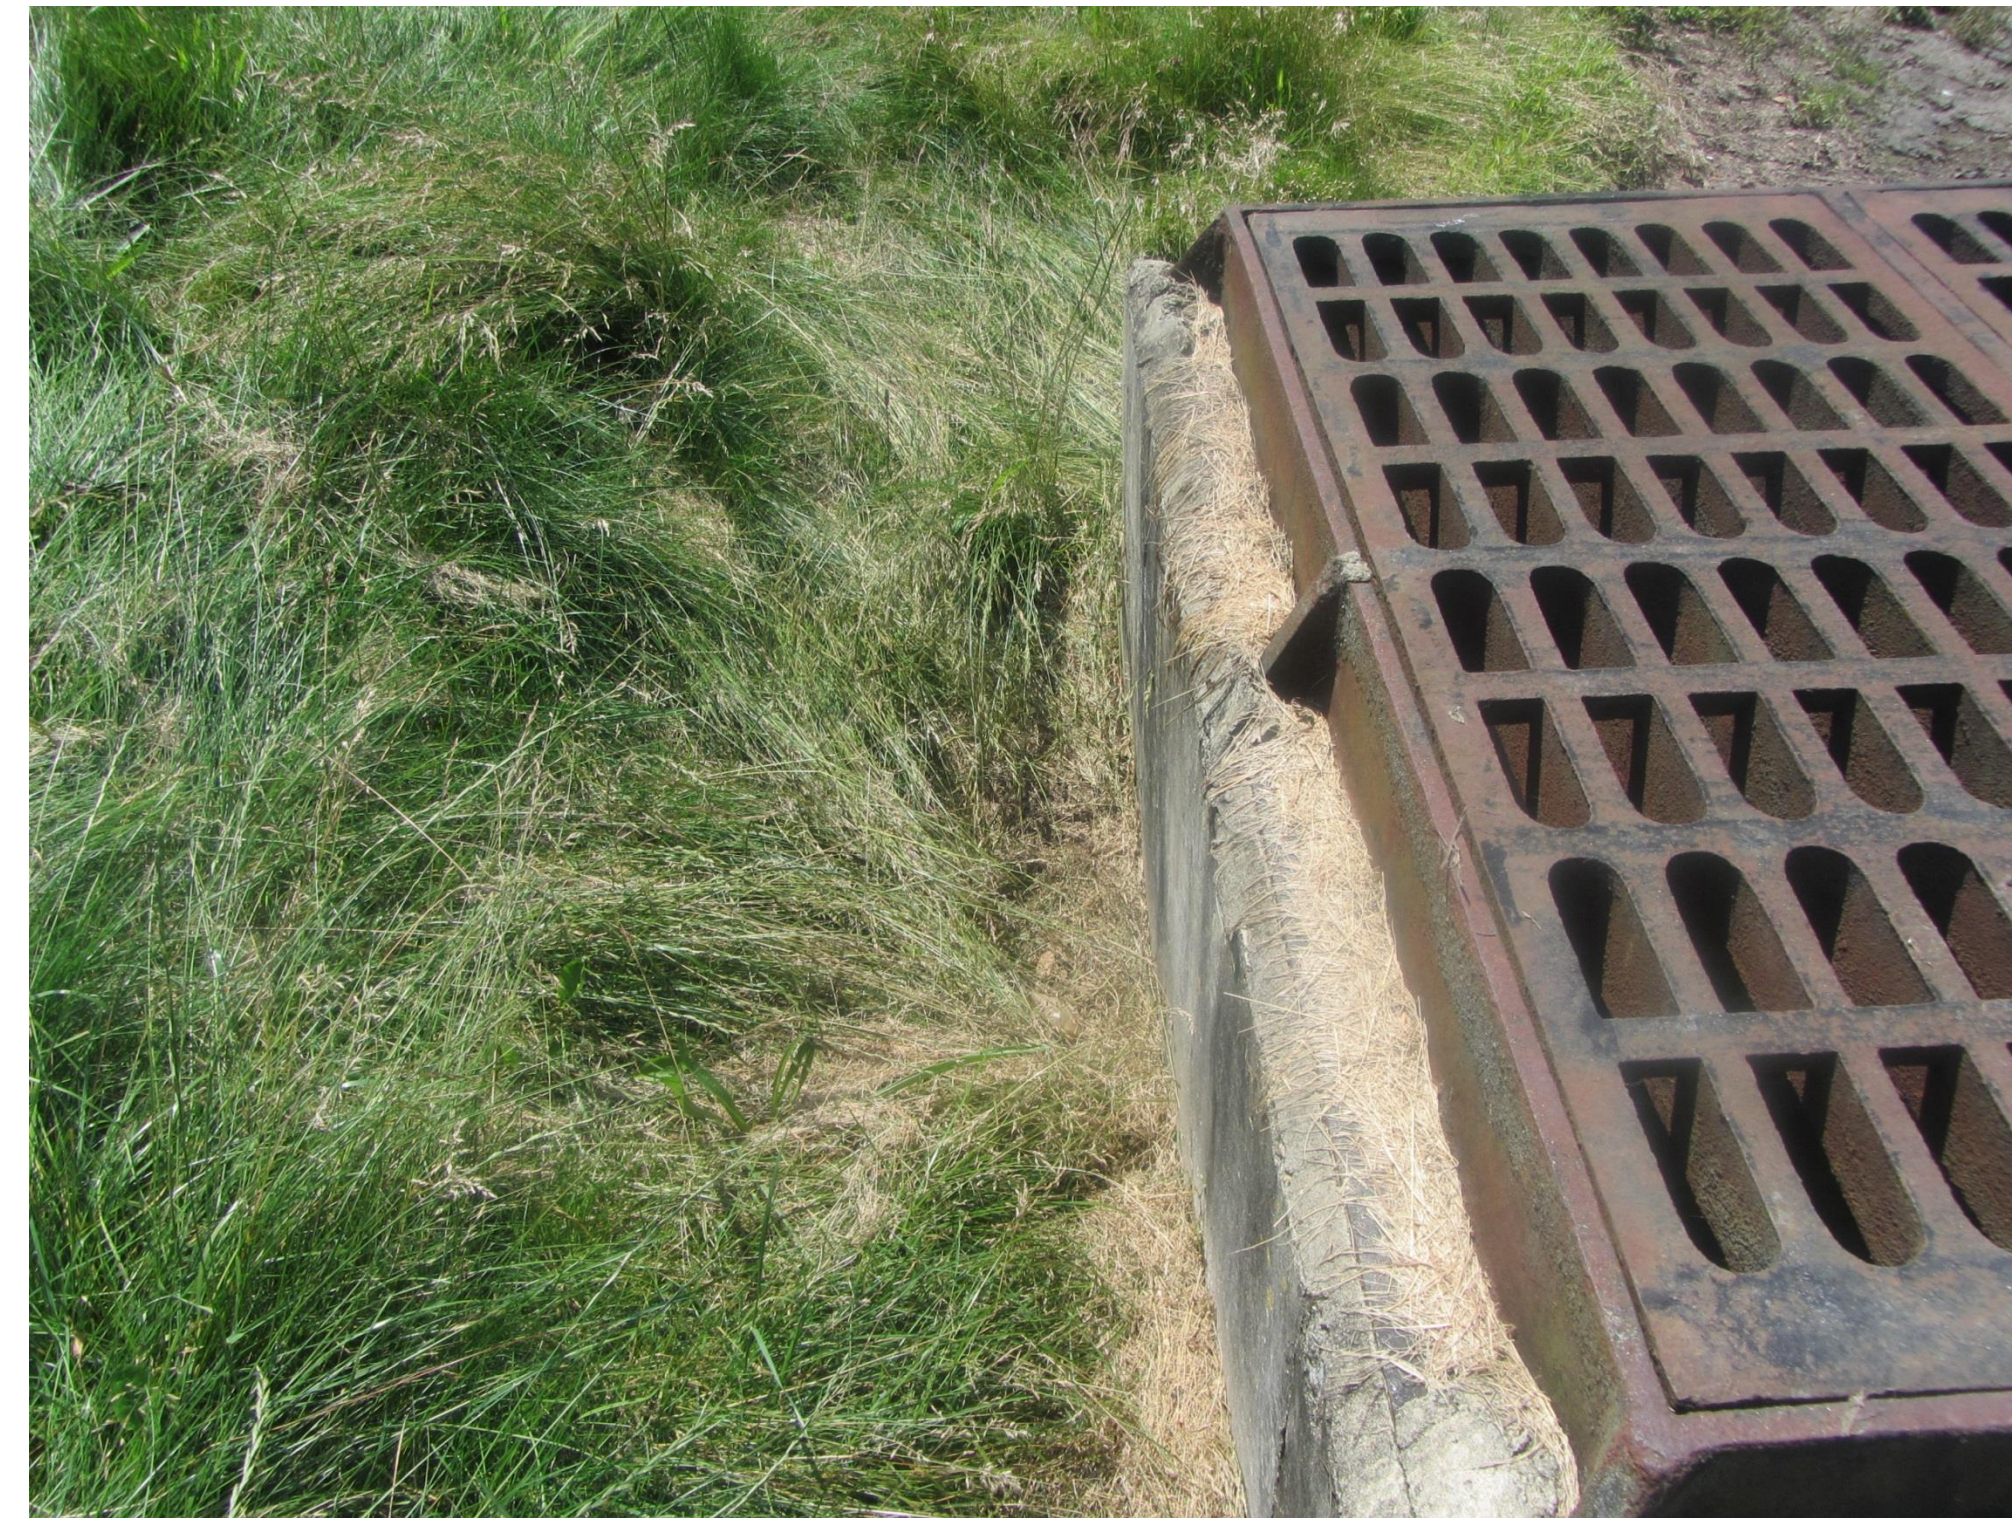
Slumping behind outlet

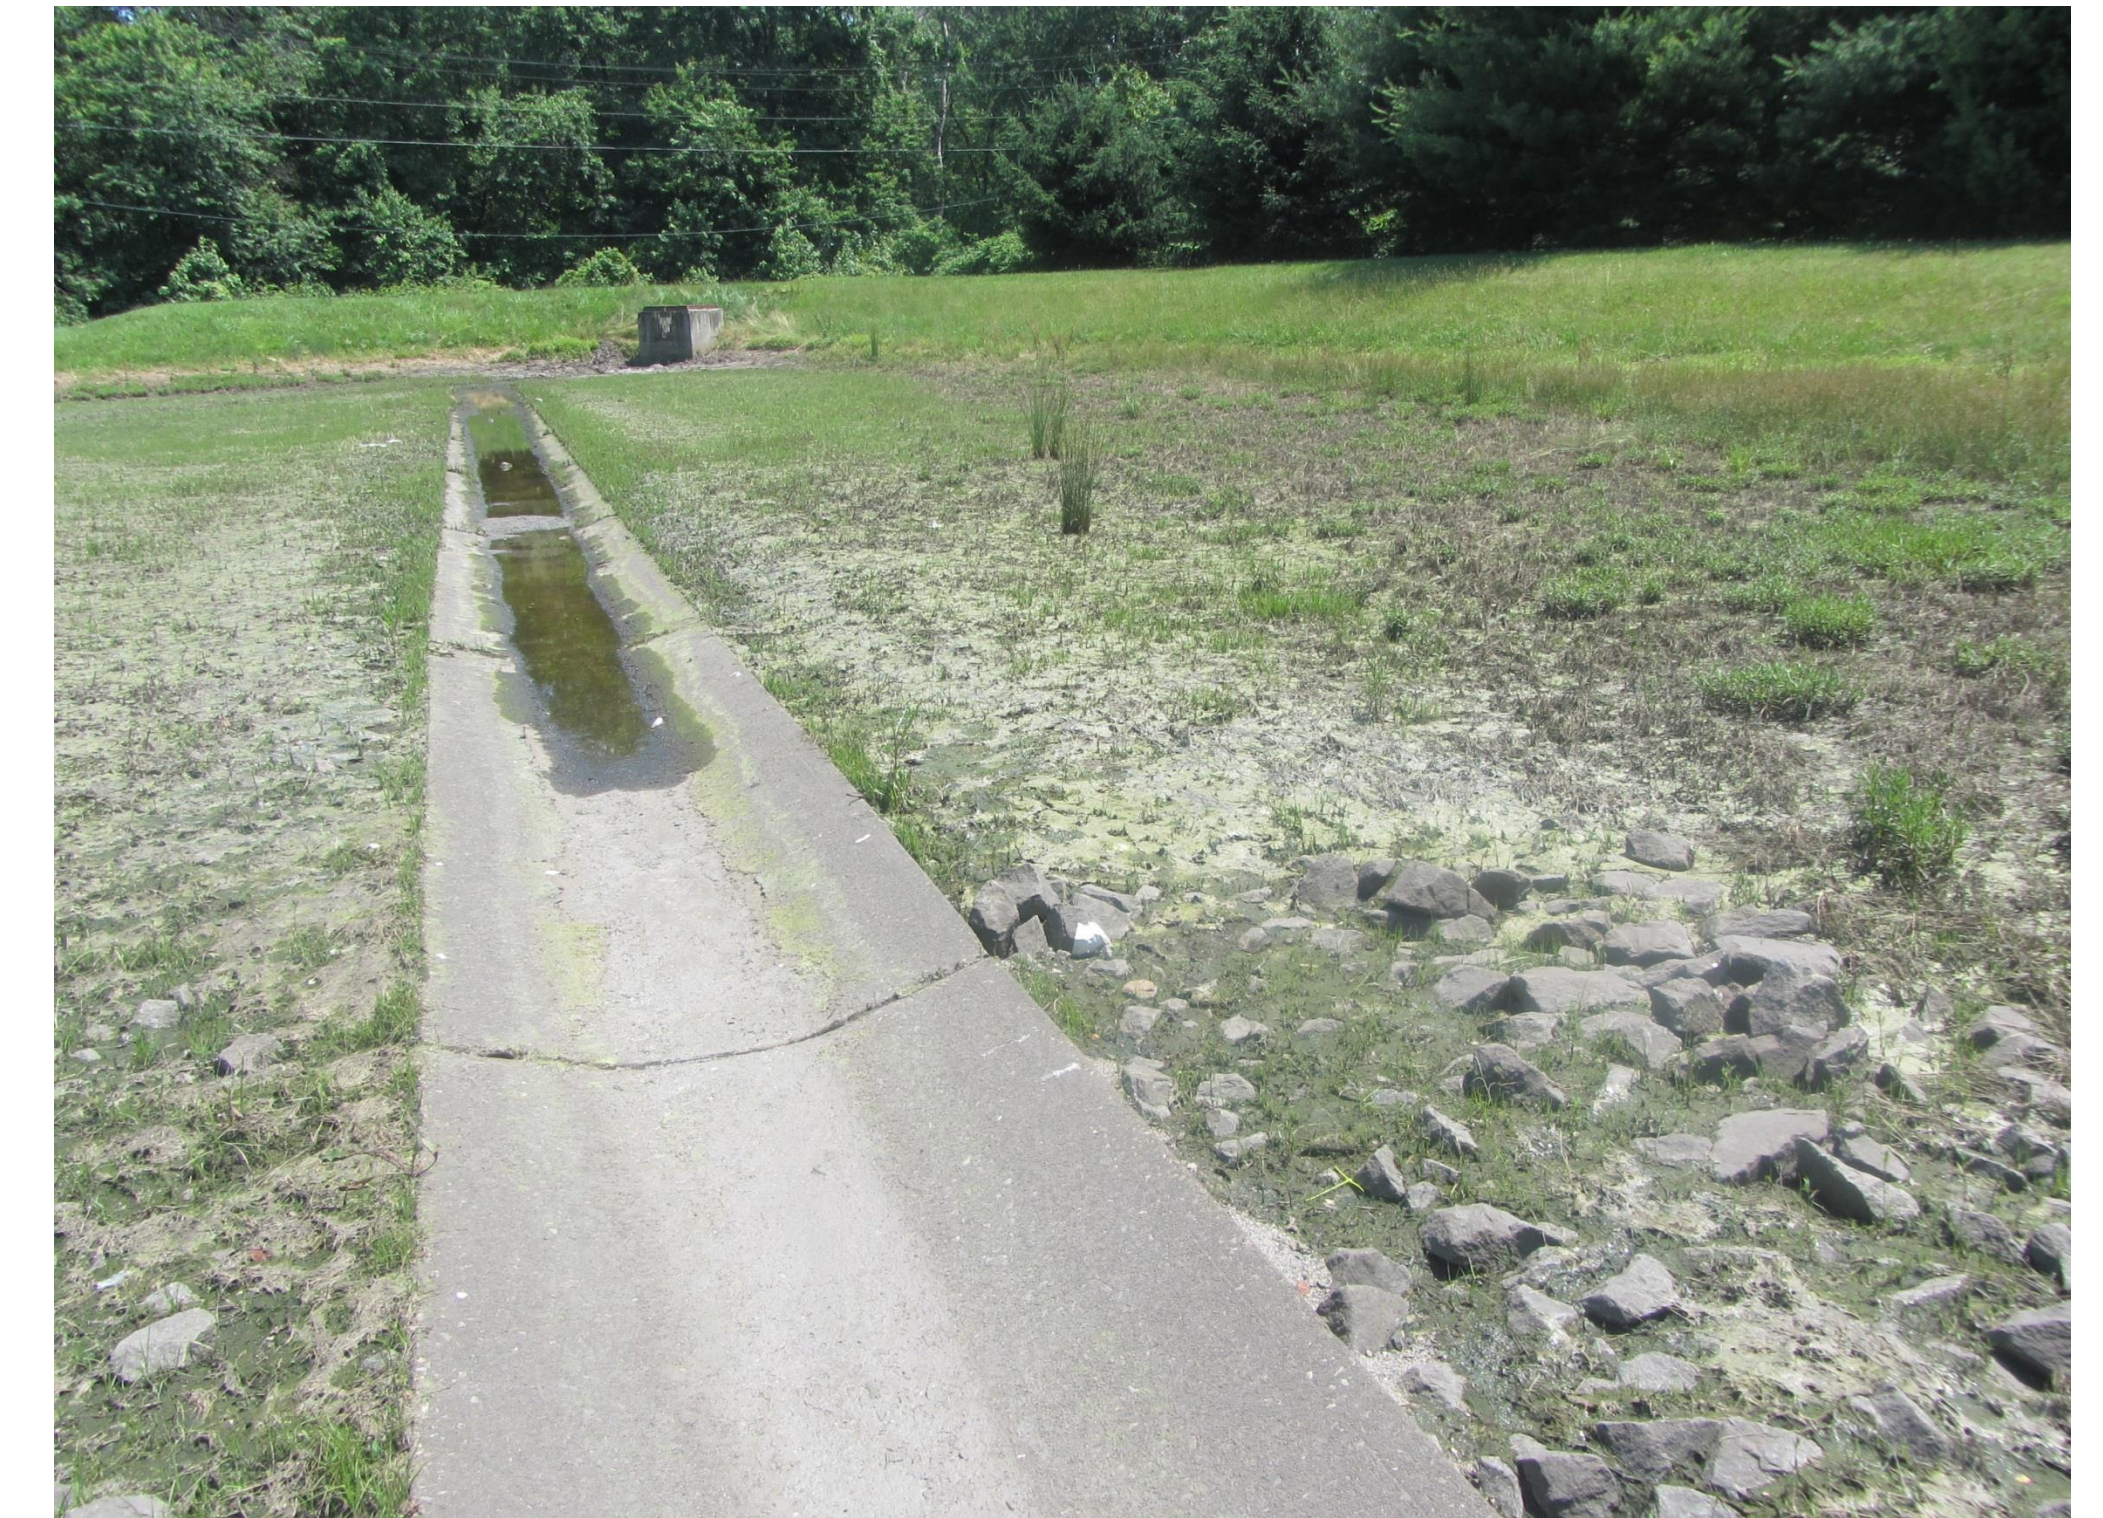
Exposed earth alongside low flow channel

- There is sediment build up in the basin that should be removed
- Naturalize with herbaceous plants

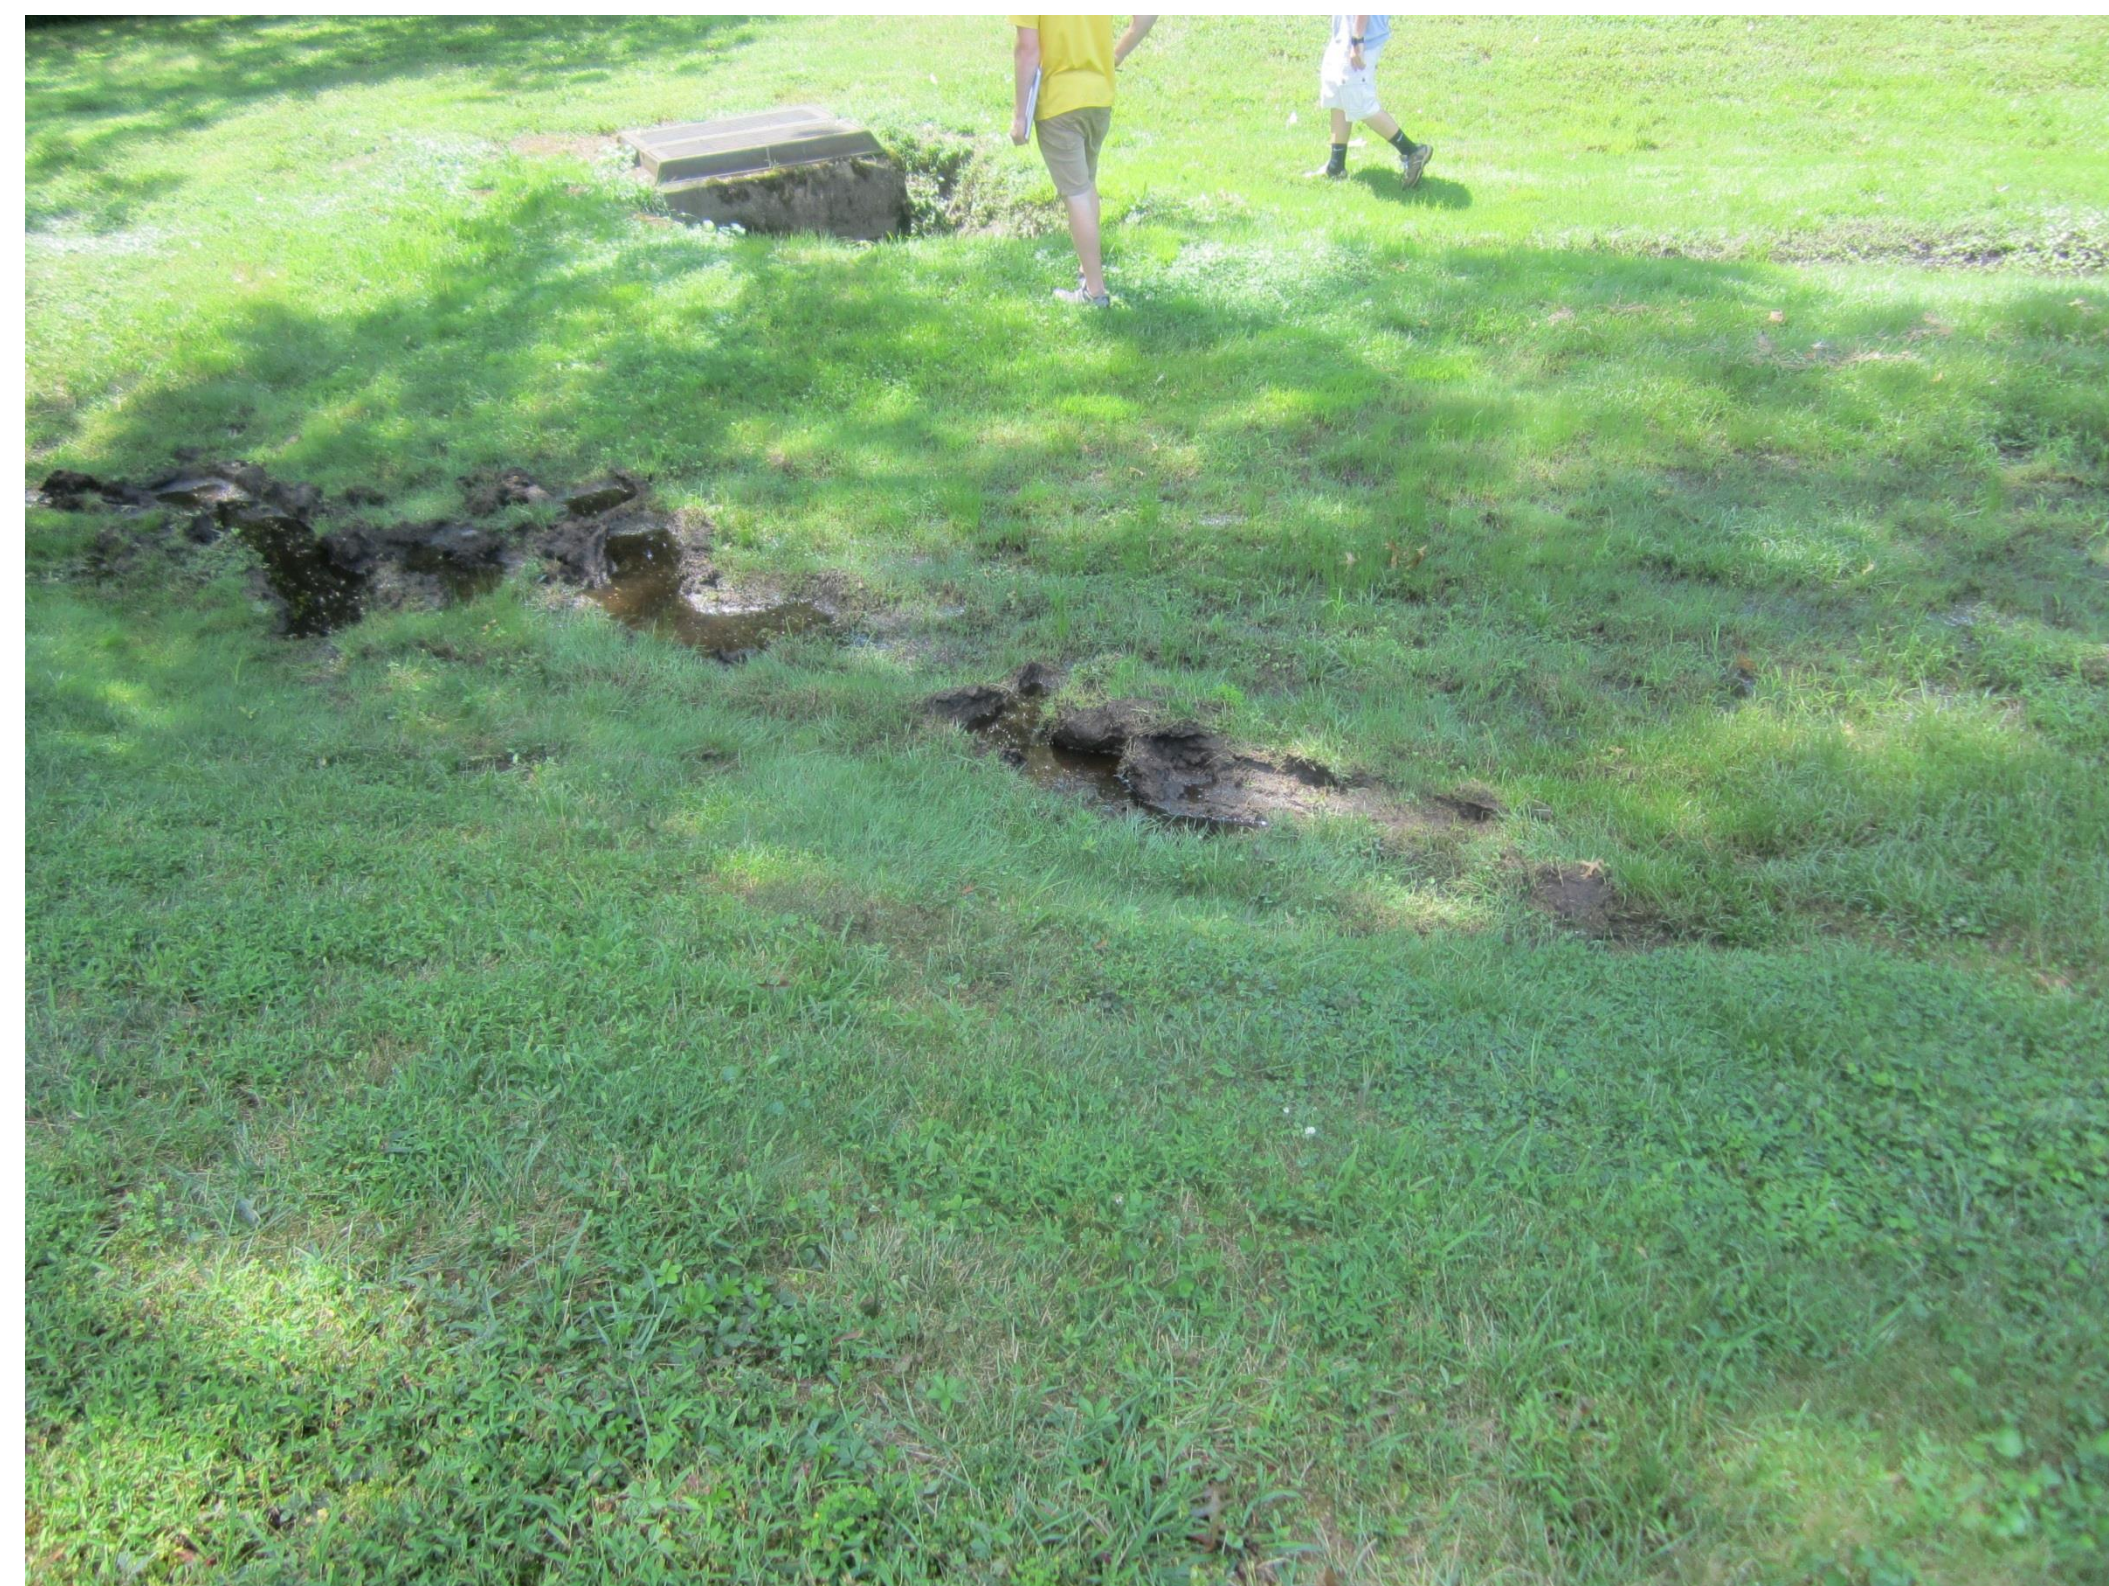
Erosion in basin bottom

- Outlet structure is in need of replacement; there is excessive erosion and excessive sediment accumulated around it
- There is standing water in the low flow channel and basin bottom

- Outlet concrete structure is in need of replacement, there is some sheen on surface of water and brown sediment on bottom present in concrete flow channel.
- Opportunity to also replace low flow channel with stone to allow more infiltration
