**Hamilton Township (Mercer County)
Stormwater Basin Assessment Summary
Past Priority Addendum (Year 5B)**

Developed by the Rutgers Cooperative Extension Water Resources Program
Funded by Hamilton Township, Mercer County, New Jersey

November 27, 2019

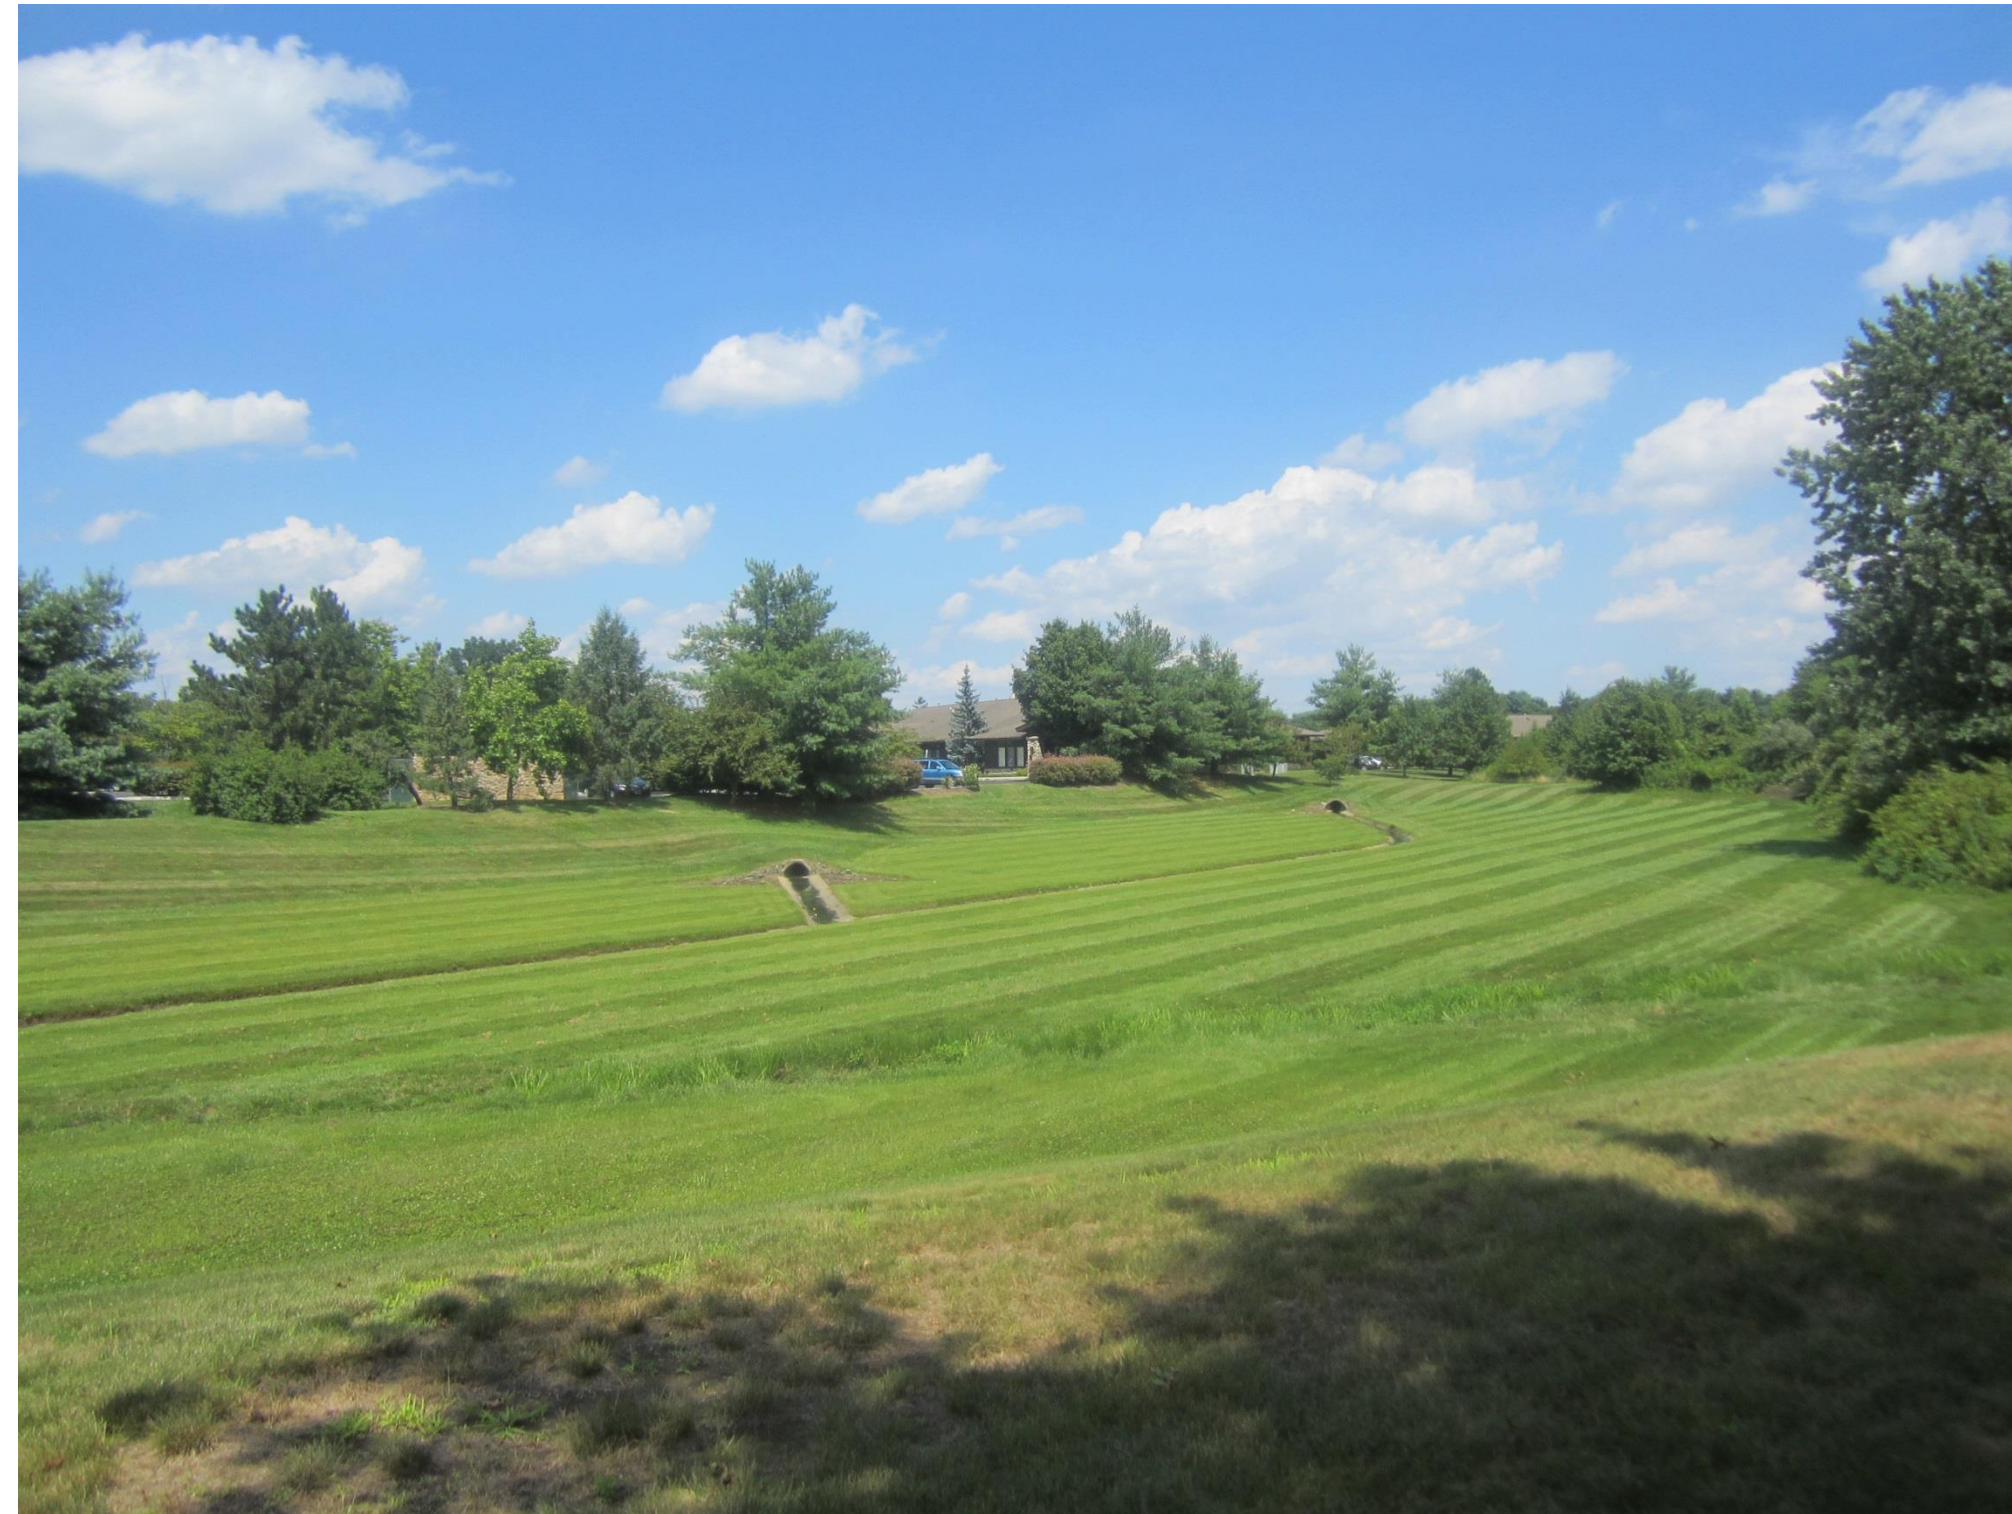
Basin bottom looking northeast

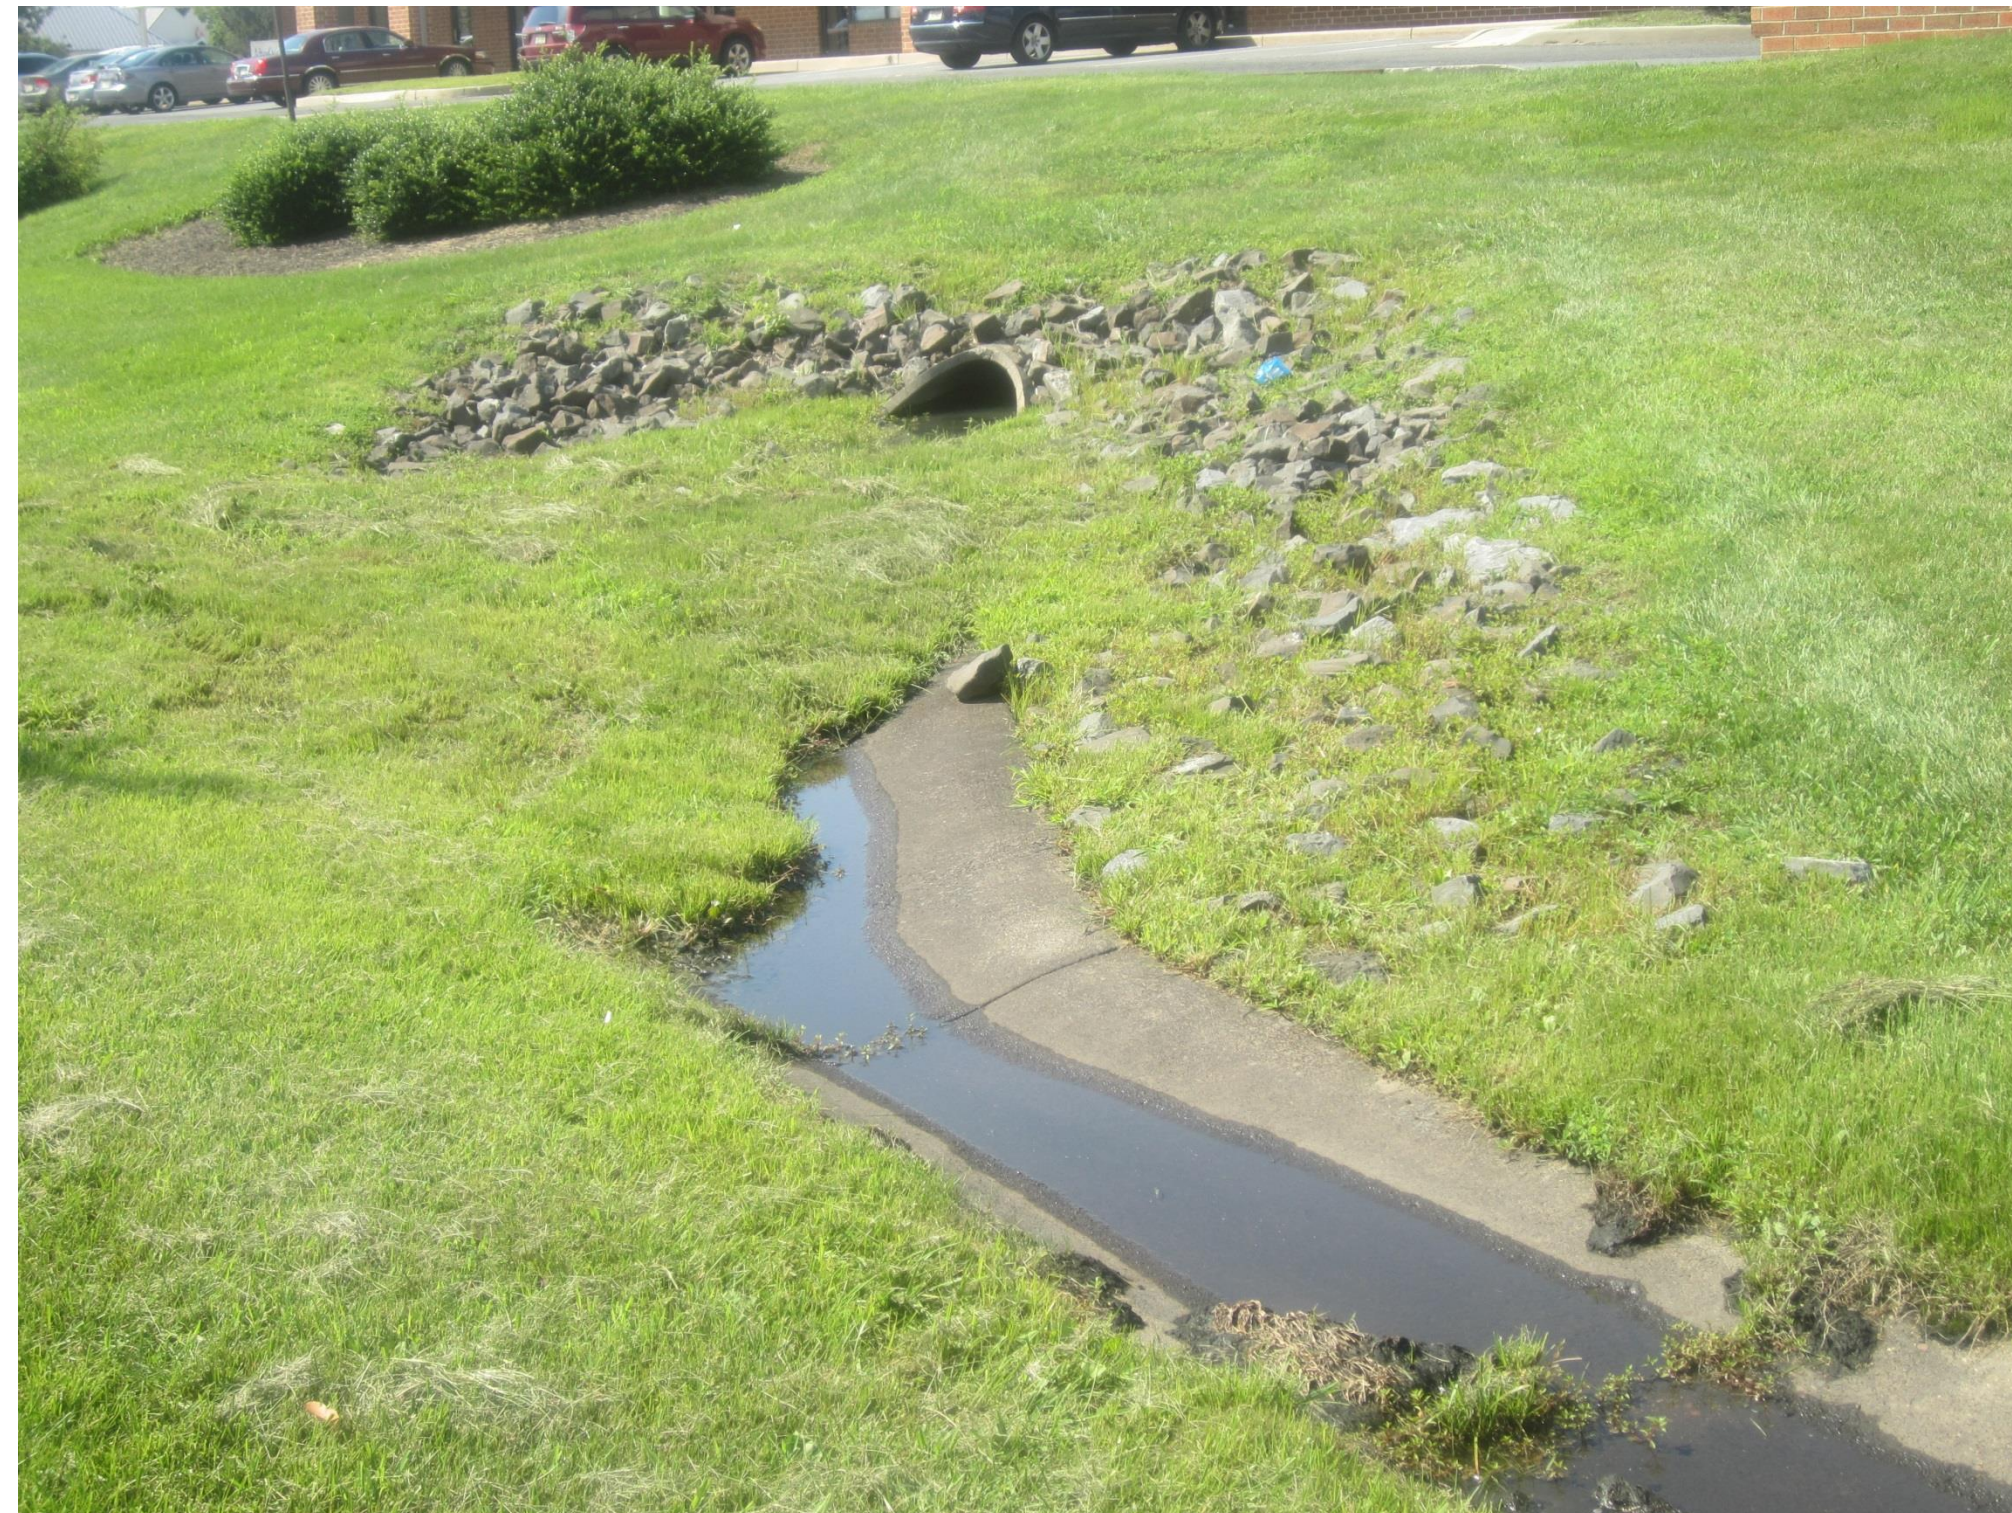
Inlet and low flow covered in sediment

- There is excess sediment accumulated in some of the inlets and in the low flow channel to the point that the some of the channel is no longer visible
- The outlet has some breakage and cracks in parging; the structure should be repaired or replaced

- Five inlets with low flow channel
- Low flow channel has been cleared since last assessment, but some sediment has accumulated again and some minor standing water present
- Clean out concrete flow channels and repair outlet structure that is still damaged from last assessment

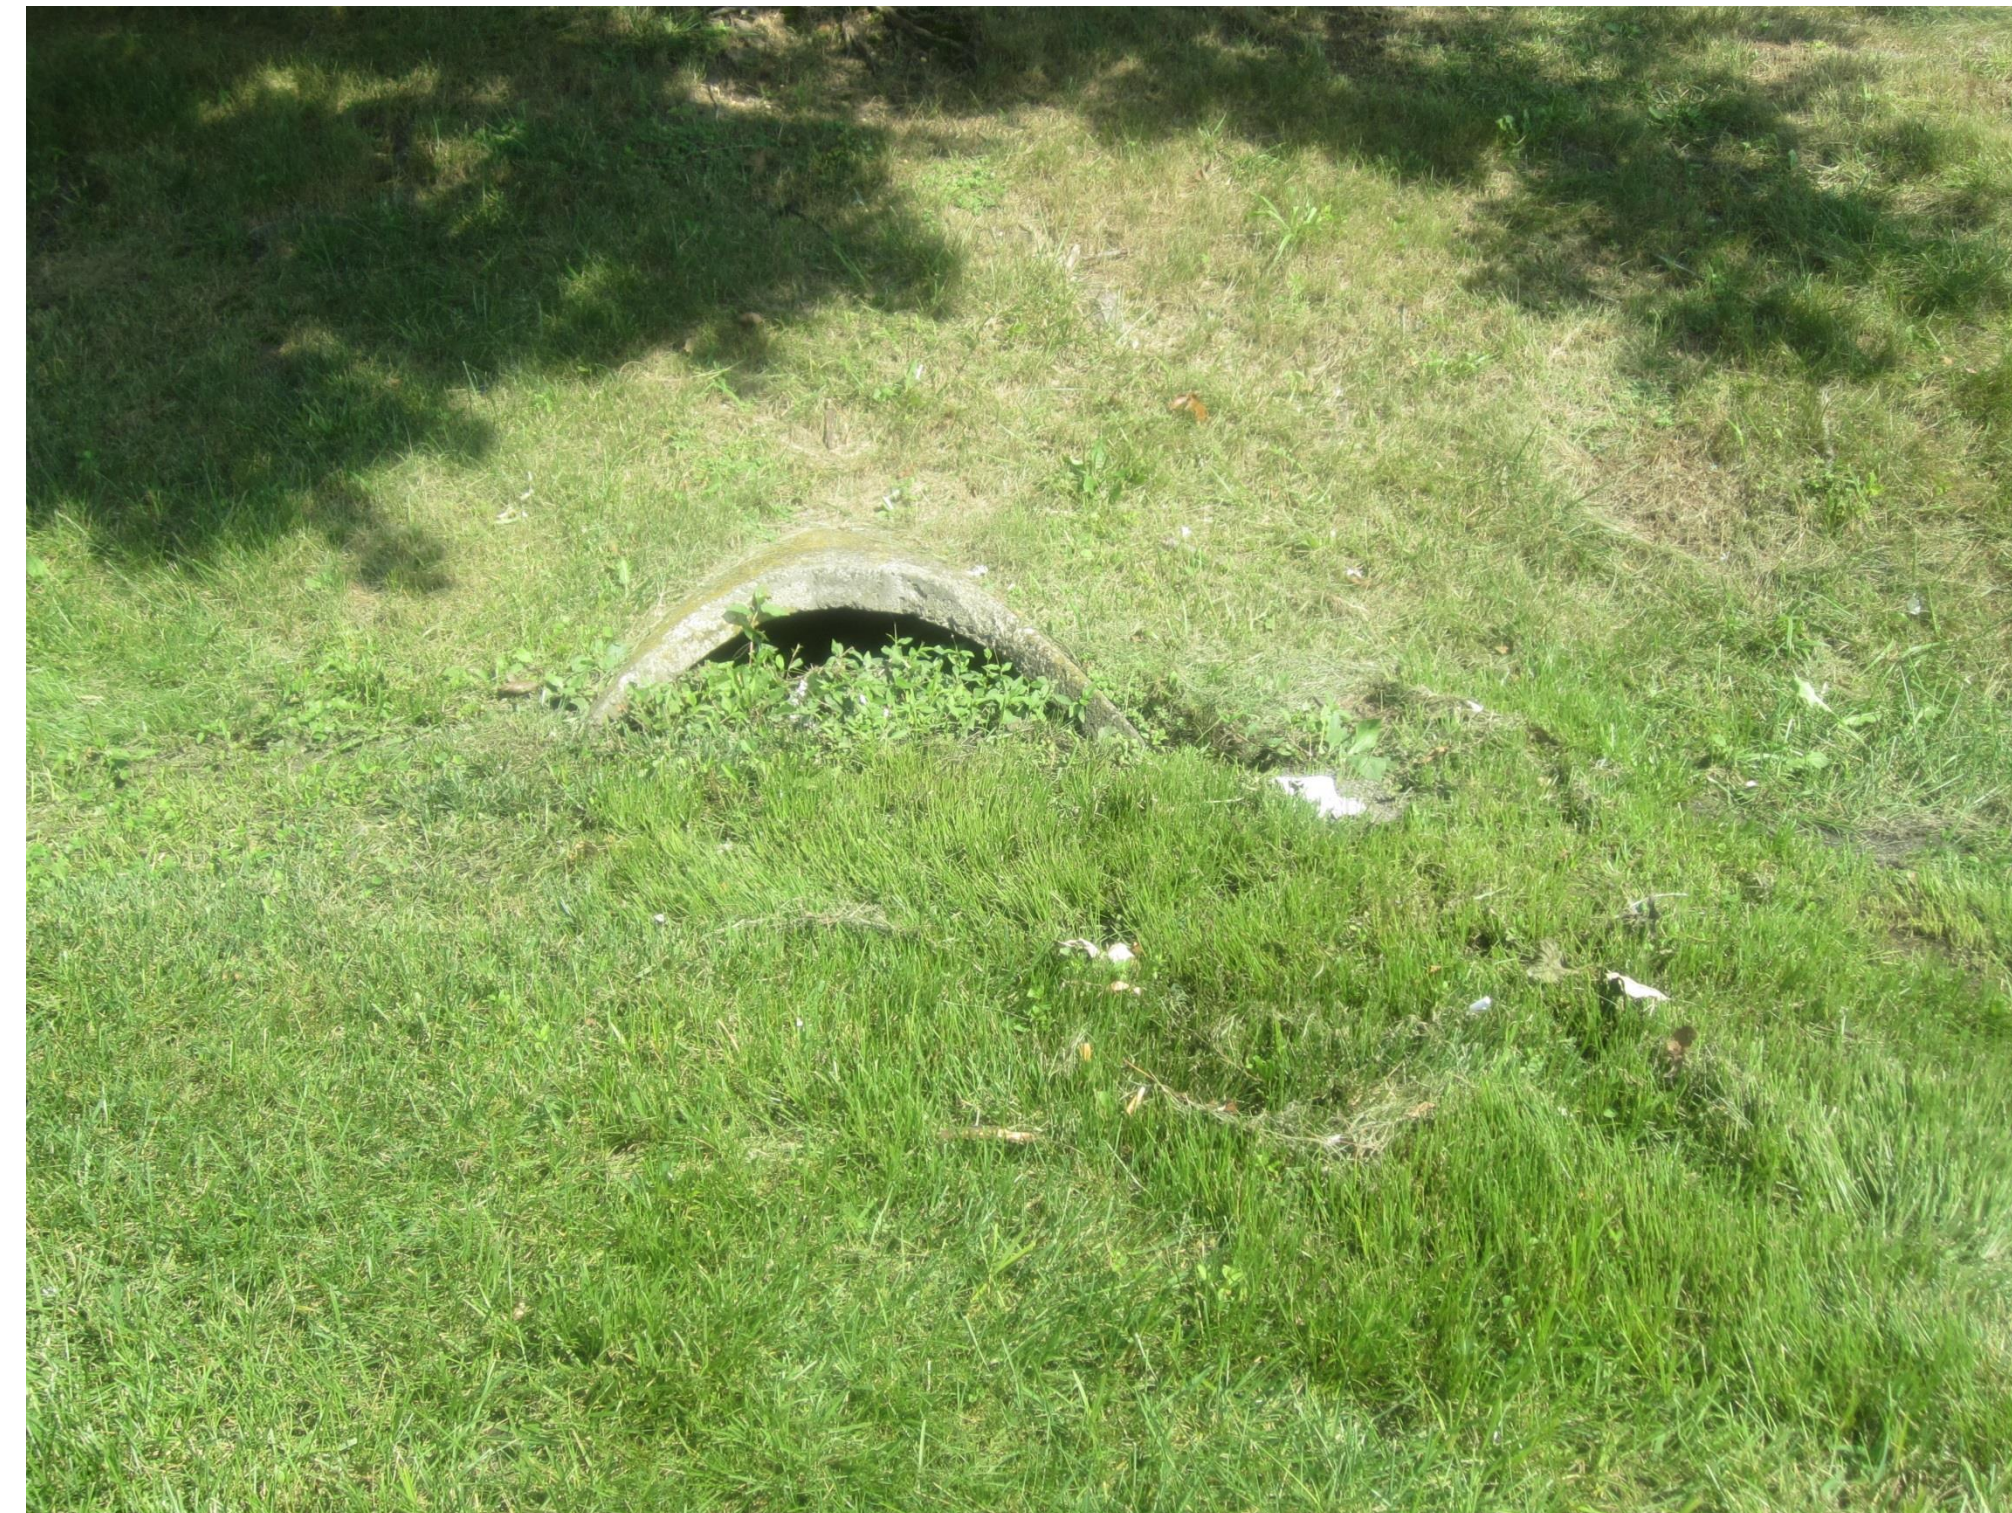
Inlet filled with sediment

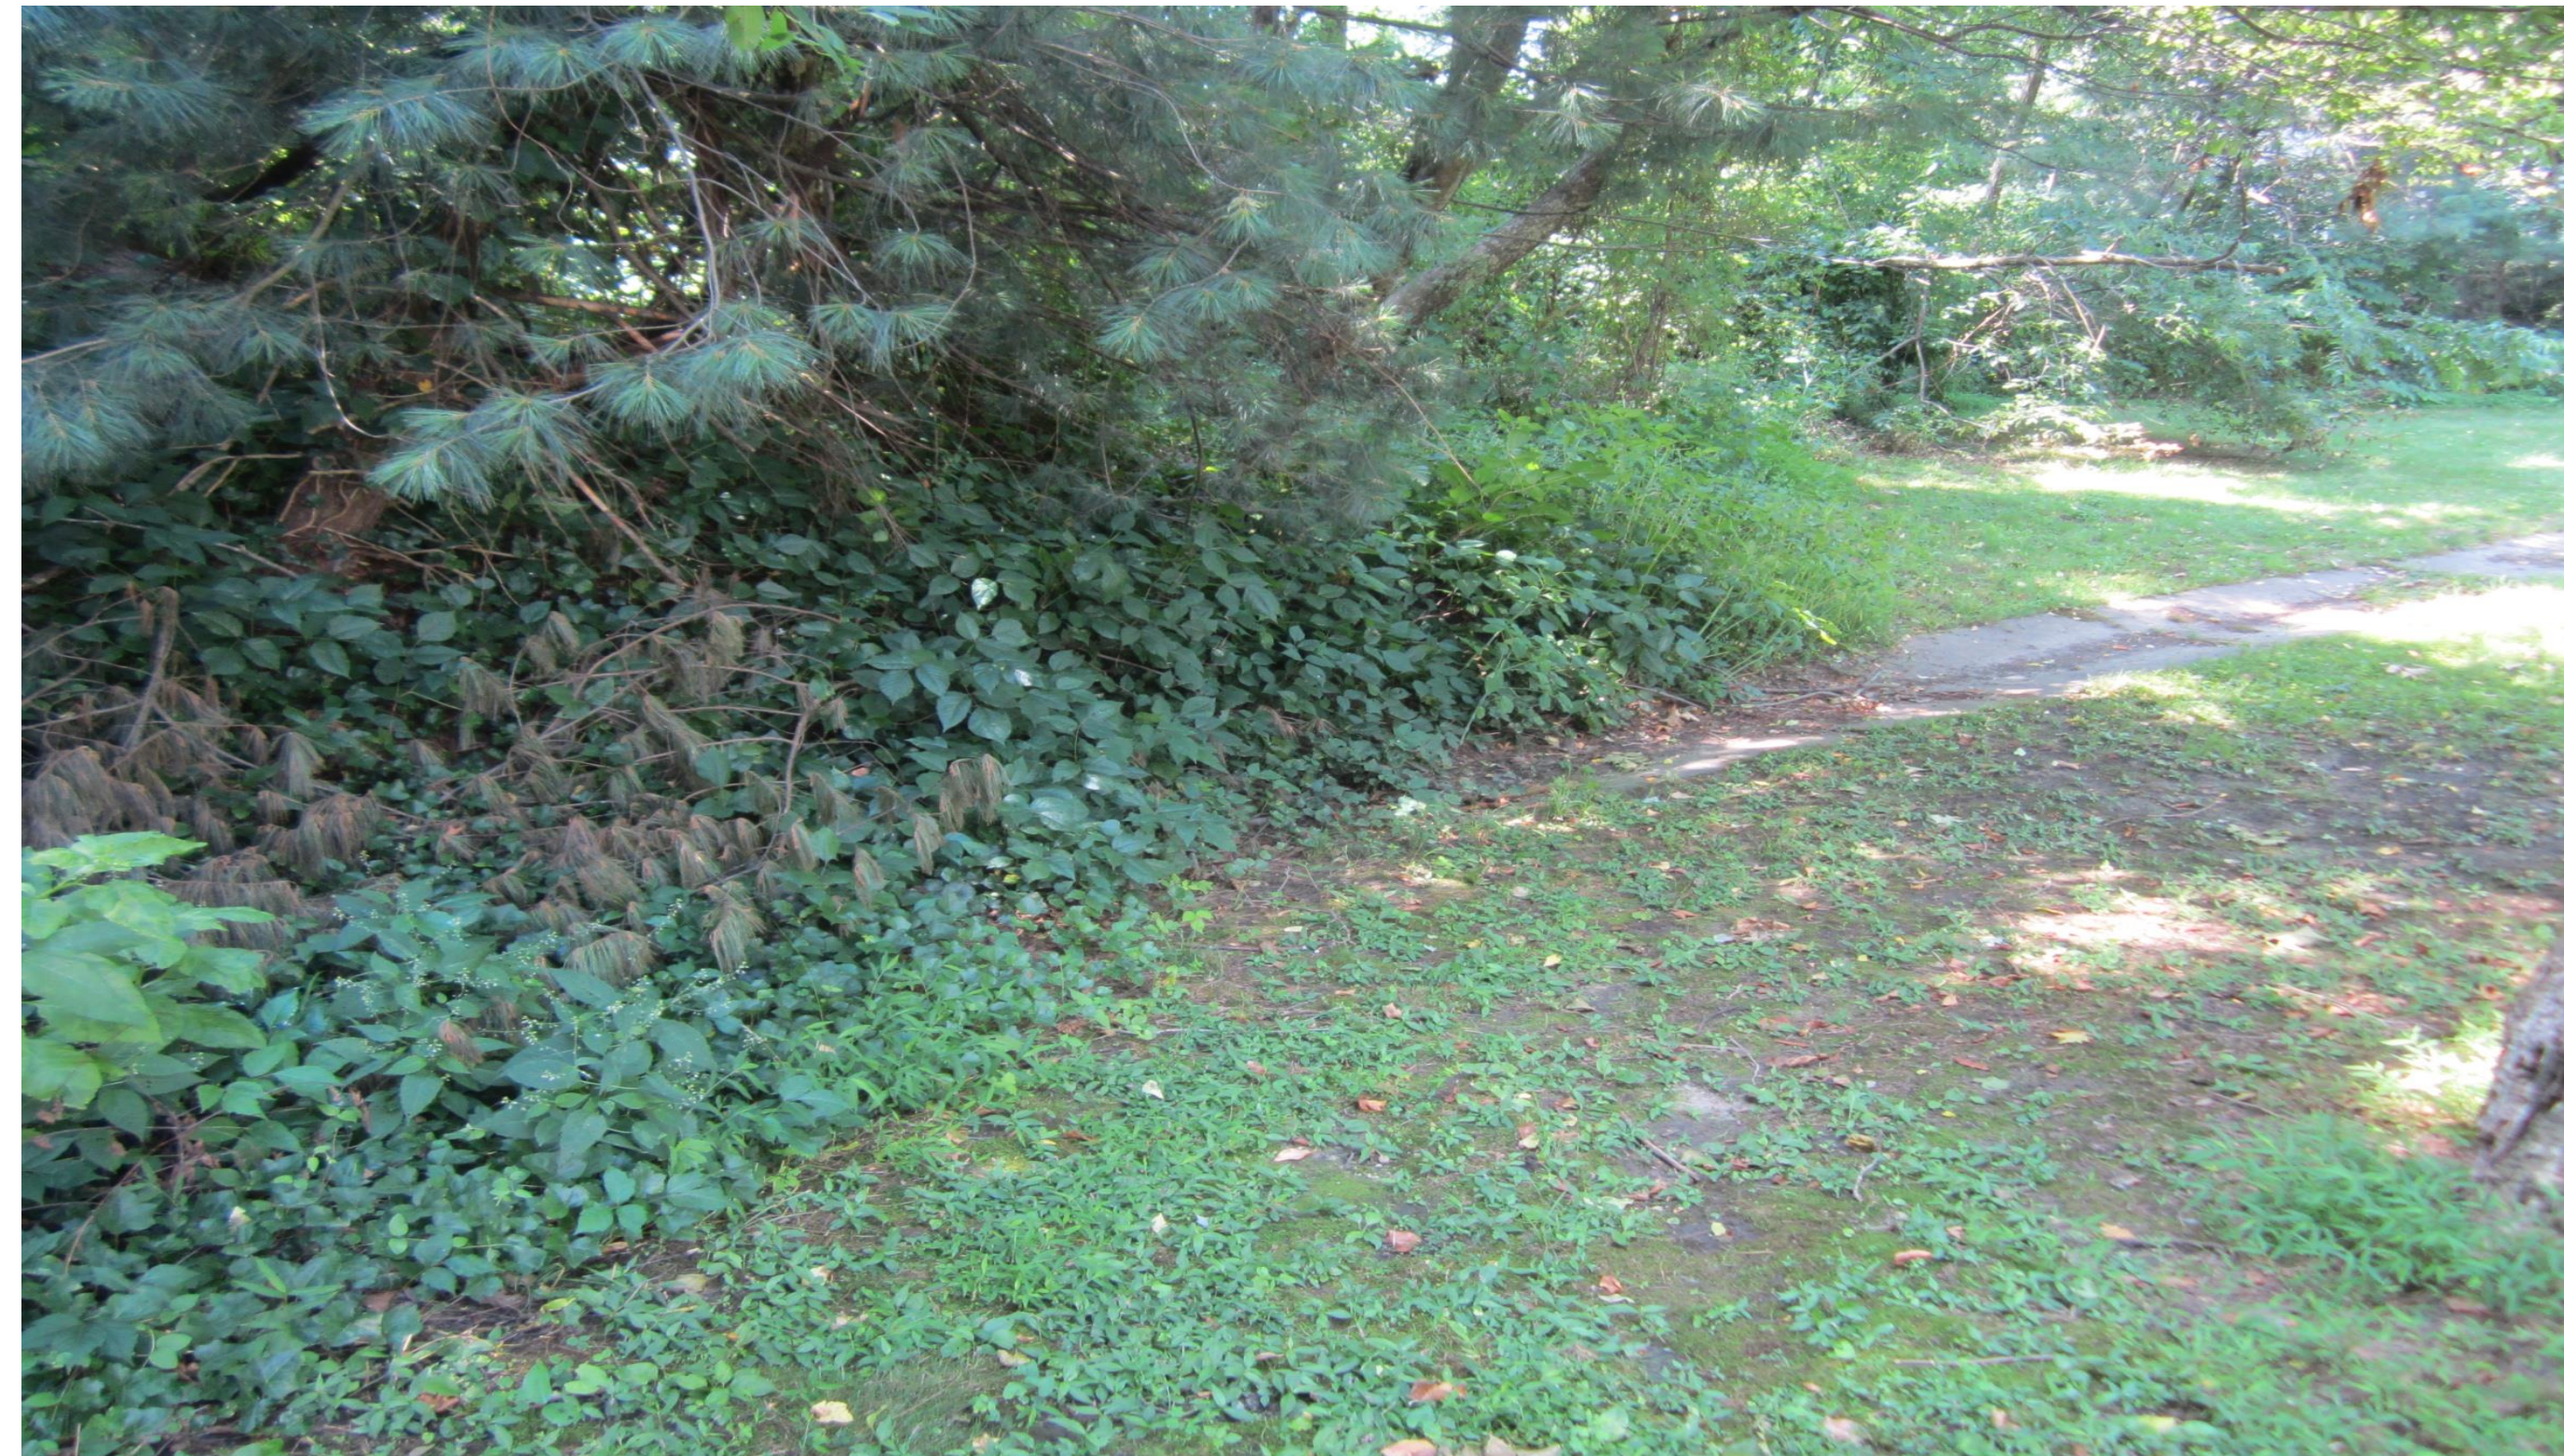
Low flow channel

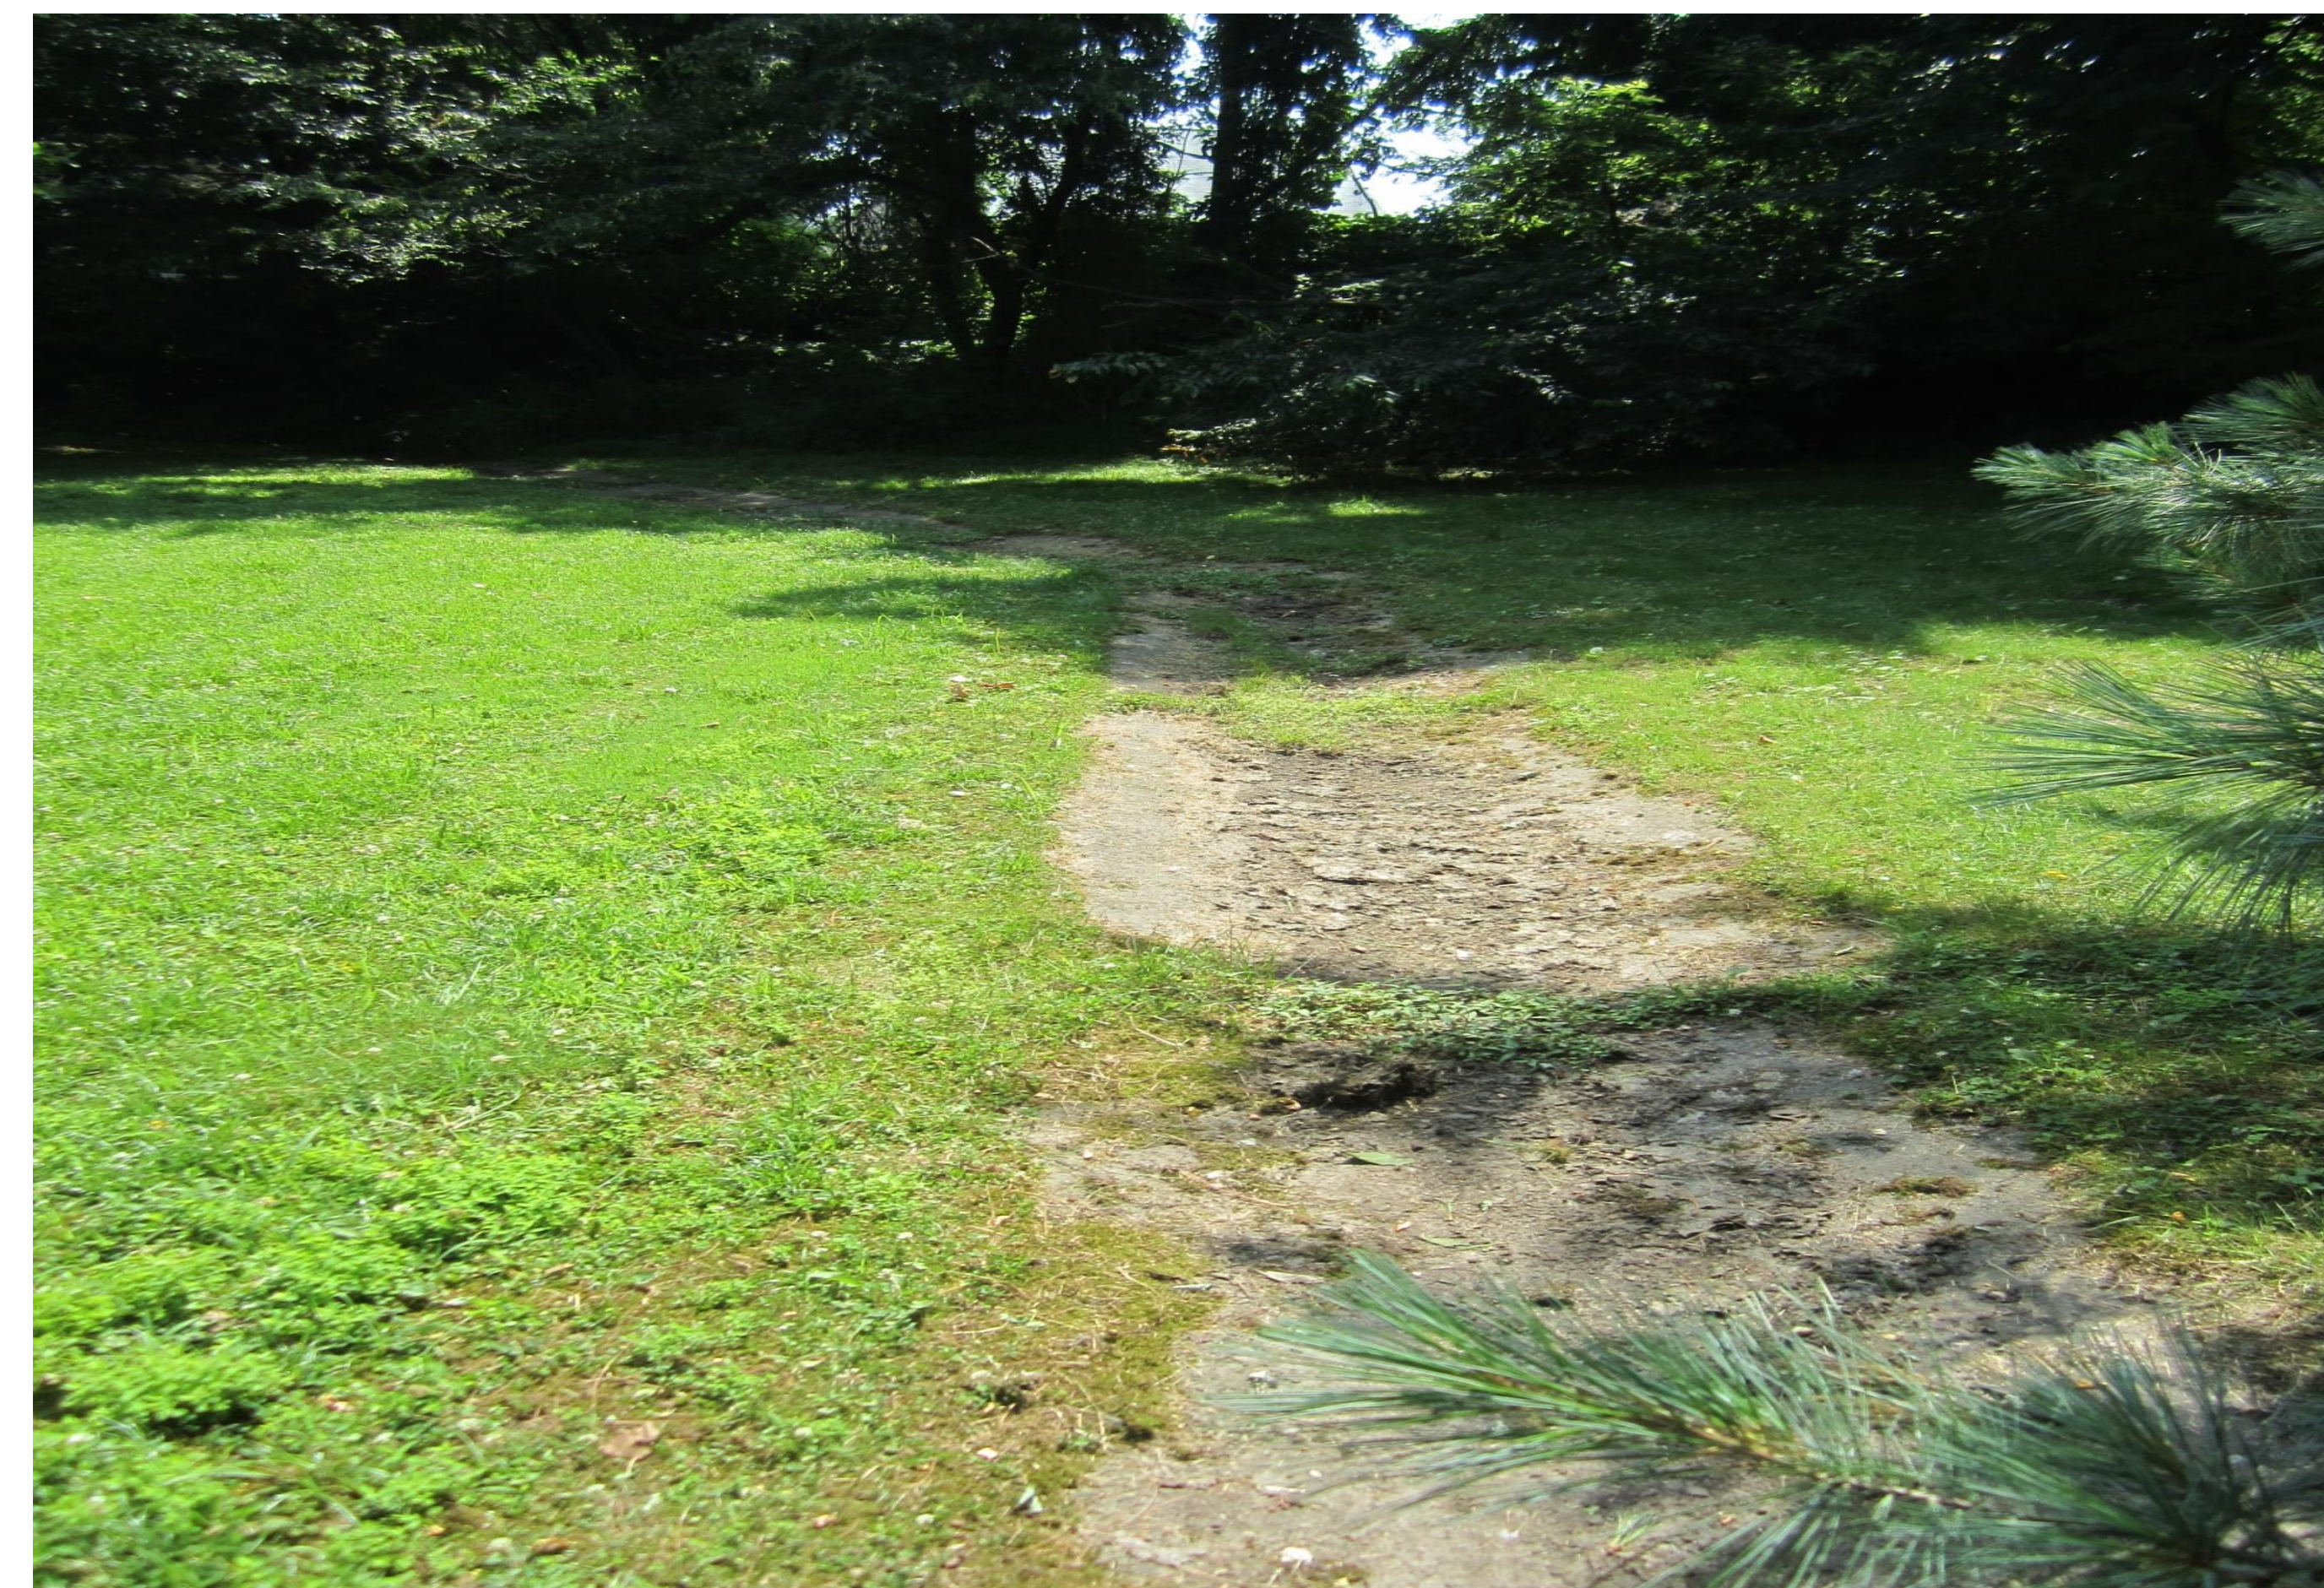
Low flow channel looking east
