**Hamilton Township (Mercer County)
Stormwater Basin Assessment Summary
Past Priority Addendum (Year 5B)**

Developed by the Rutgers Cooperative Extension Water Resources Program
Funded by Hamilton Township, Mercer County, New Jersey

November 27, 2019

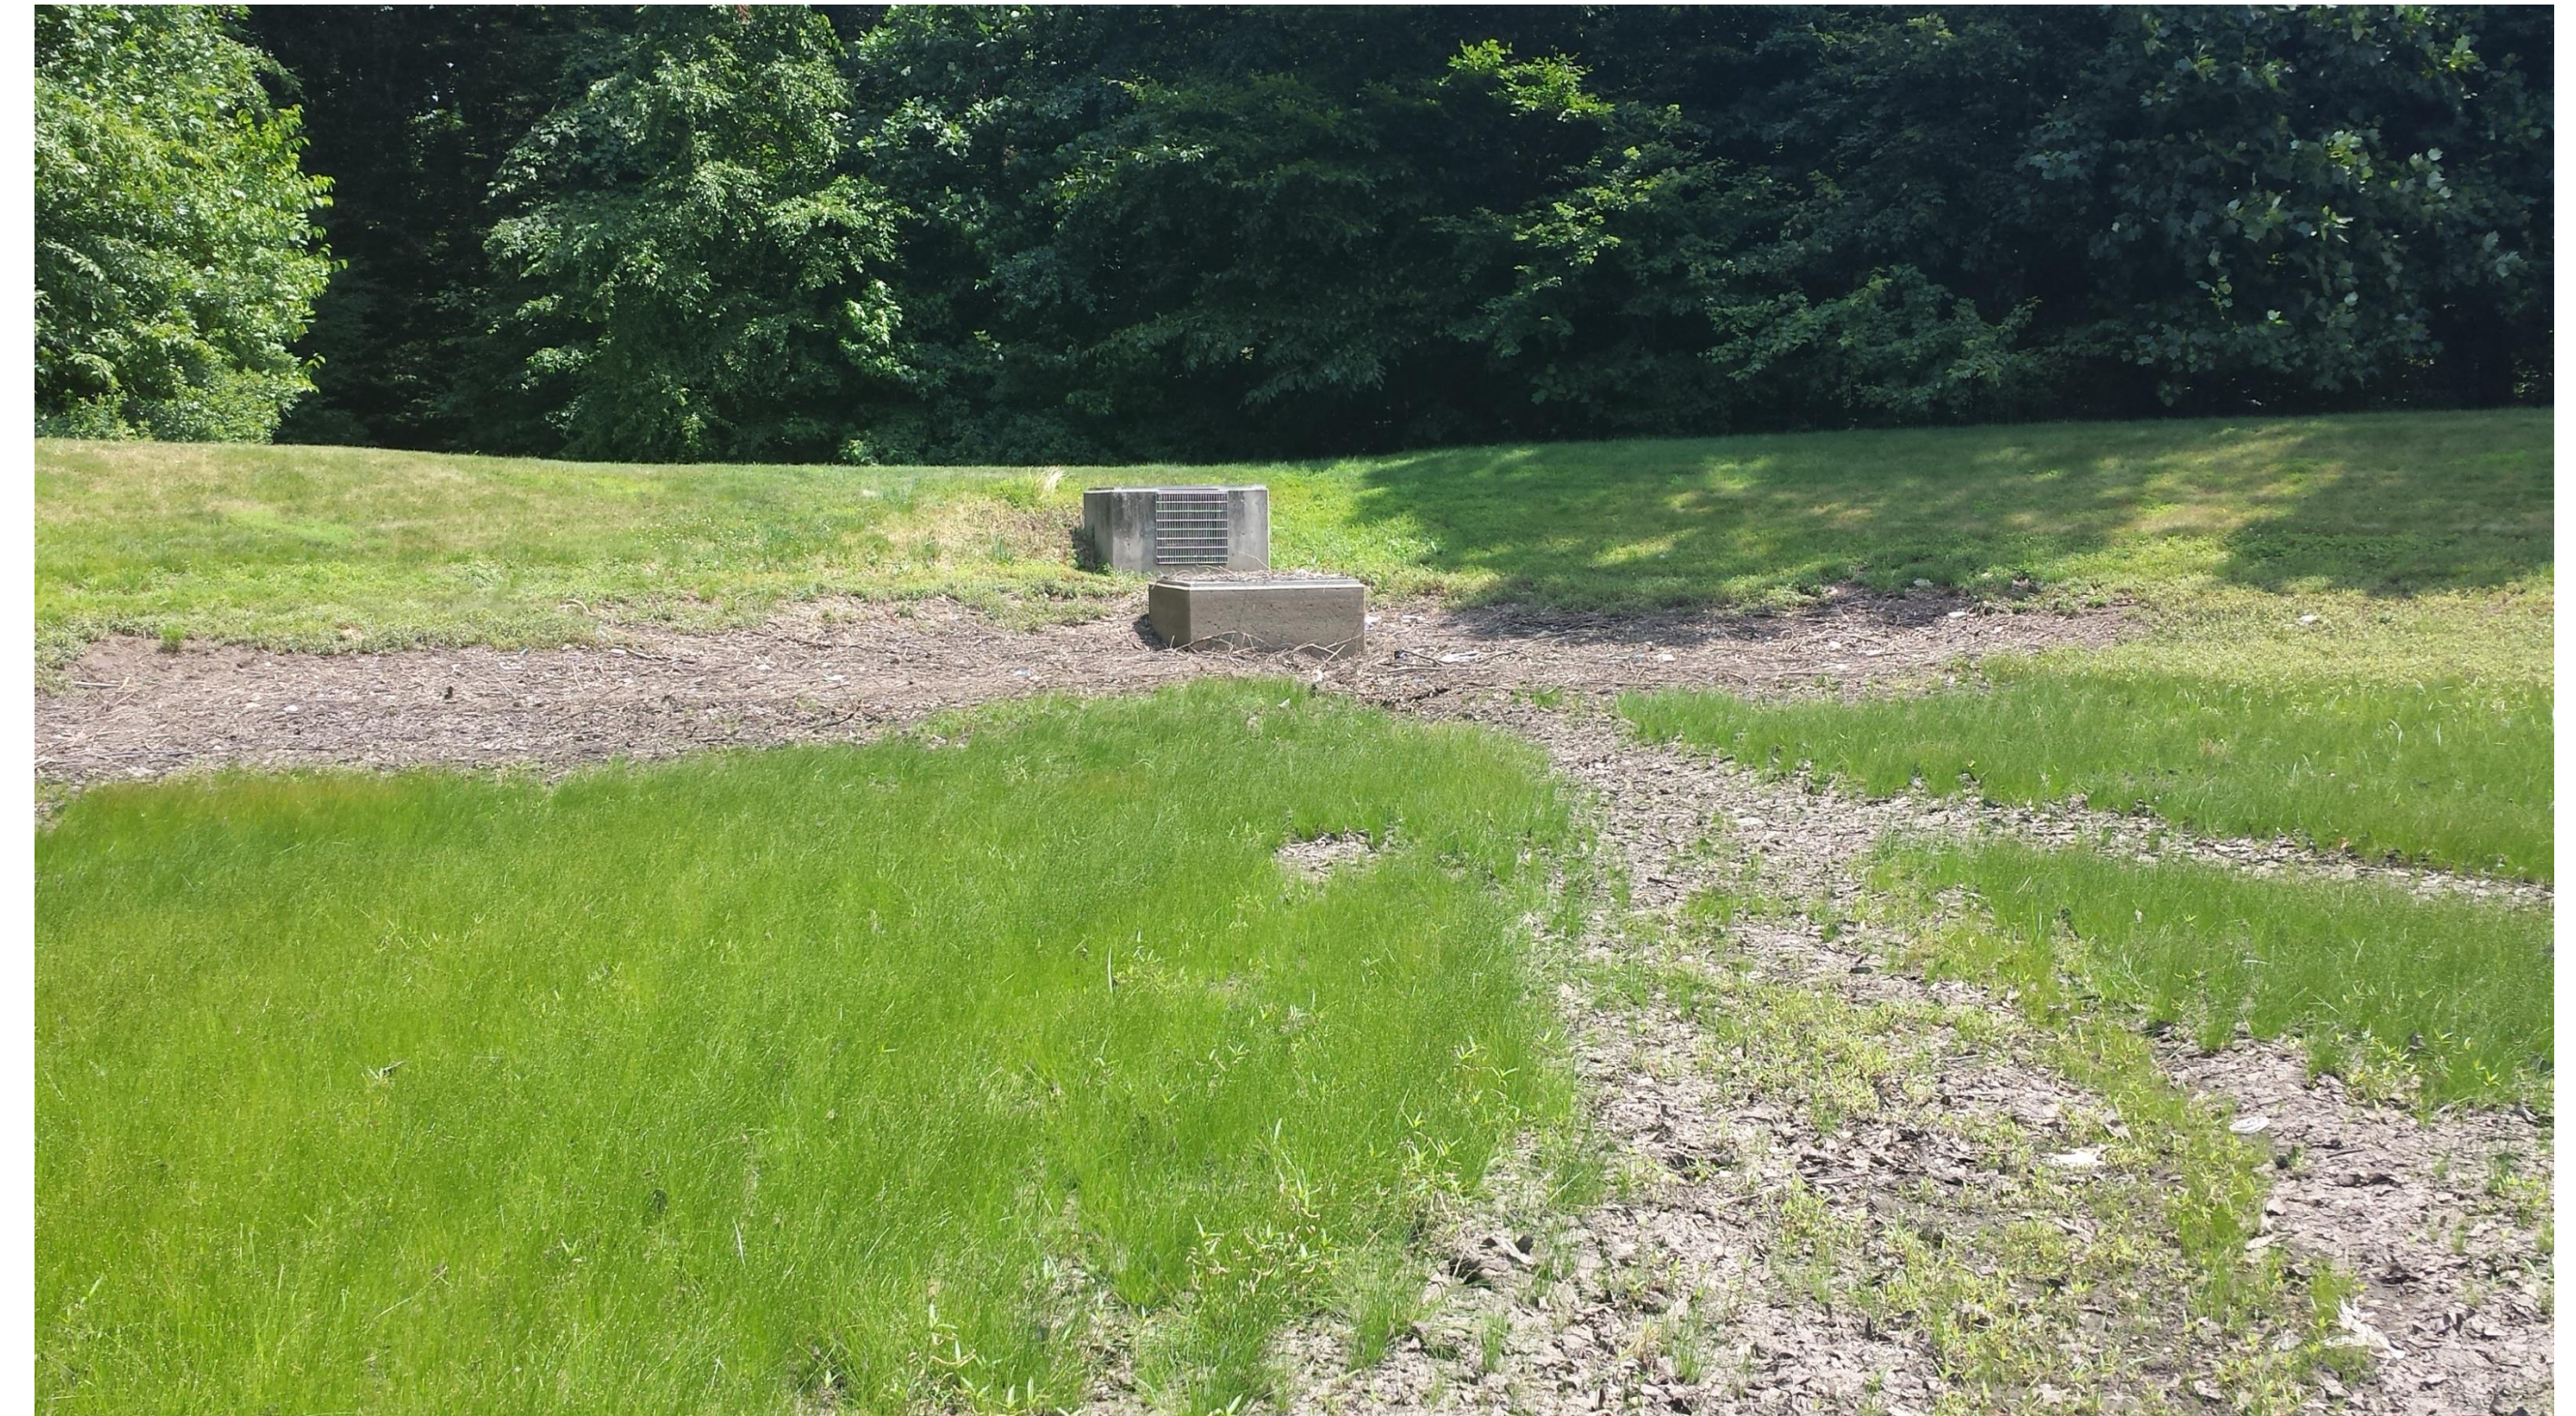
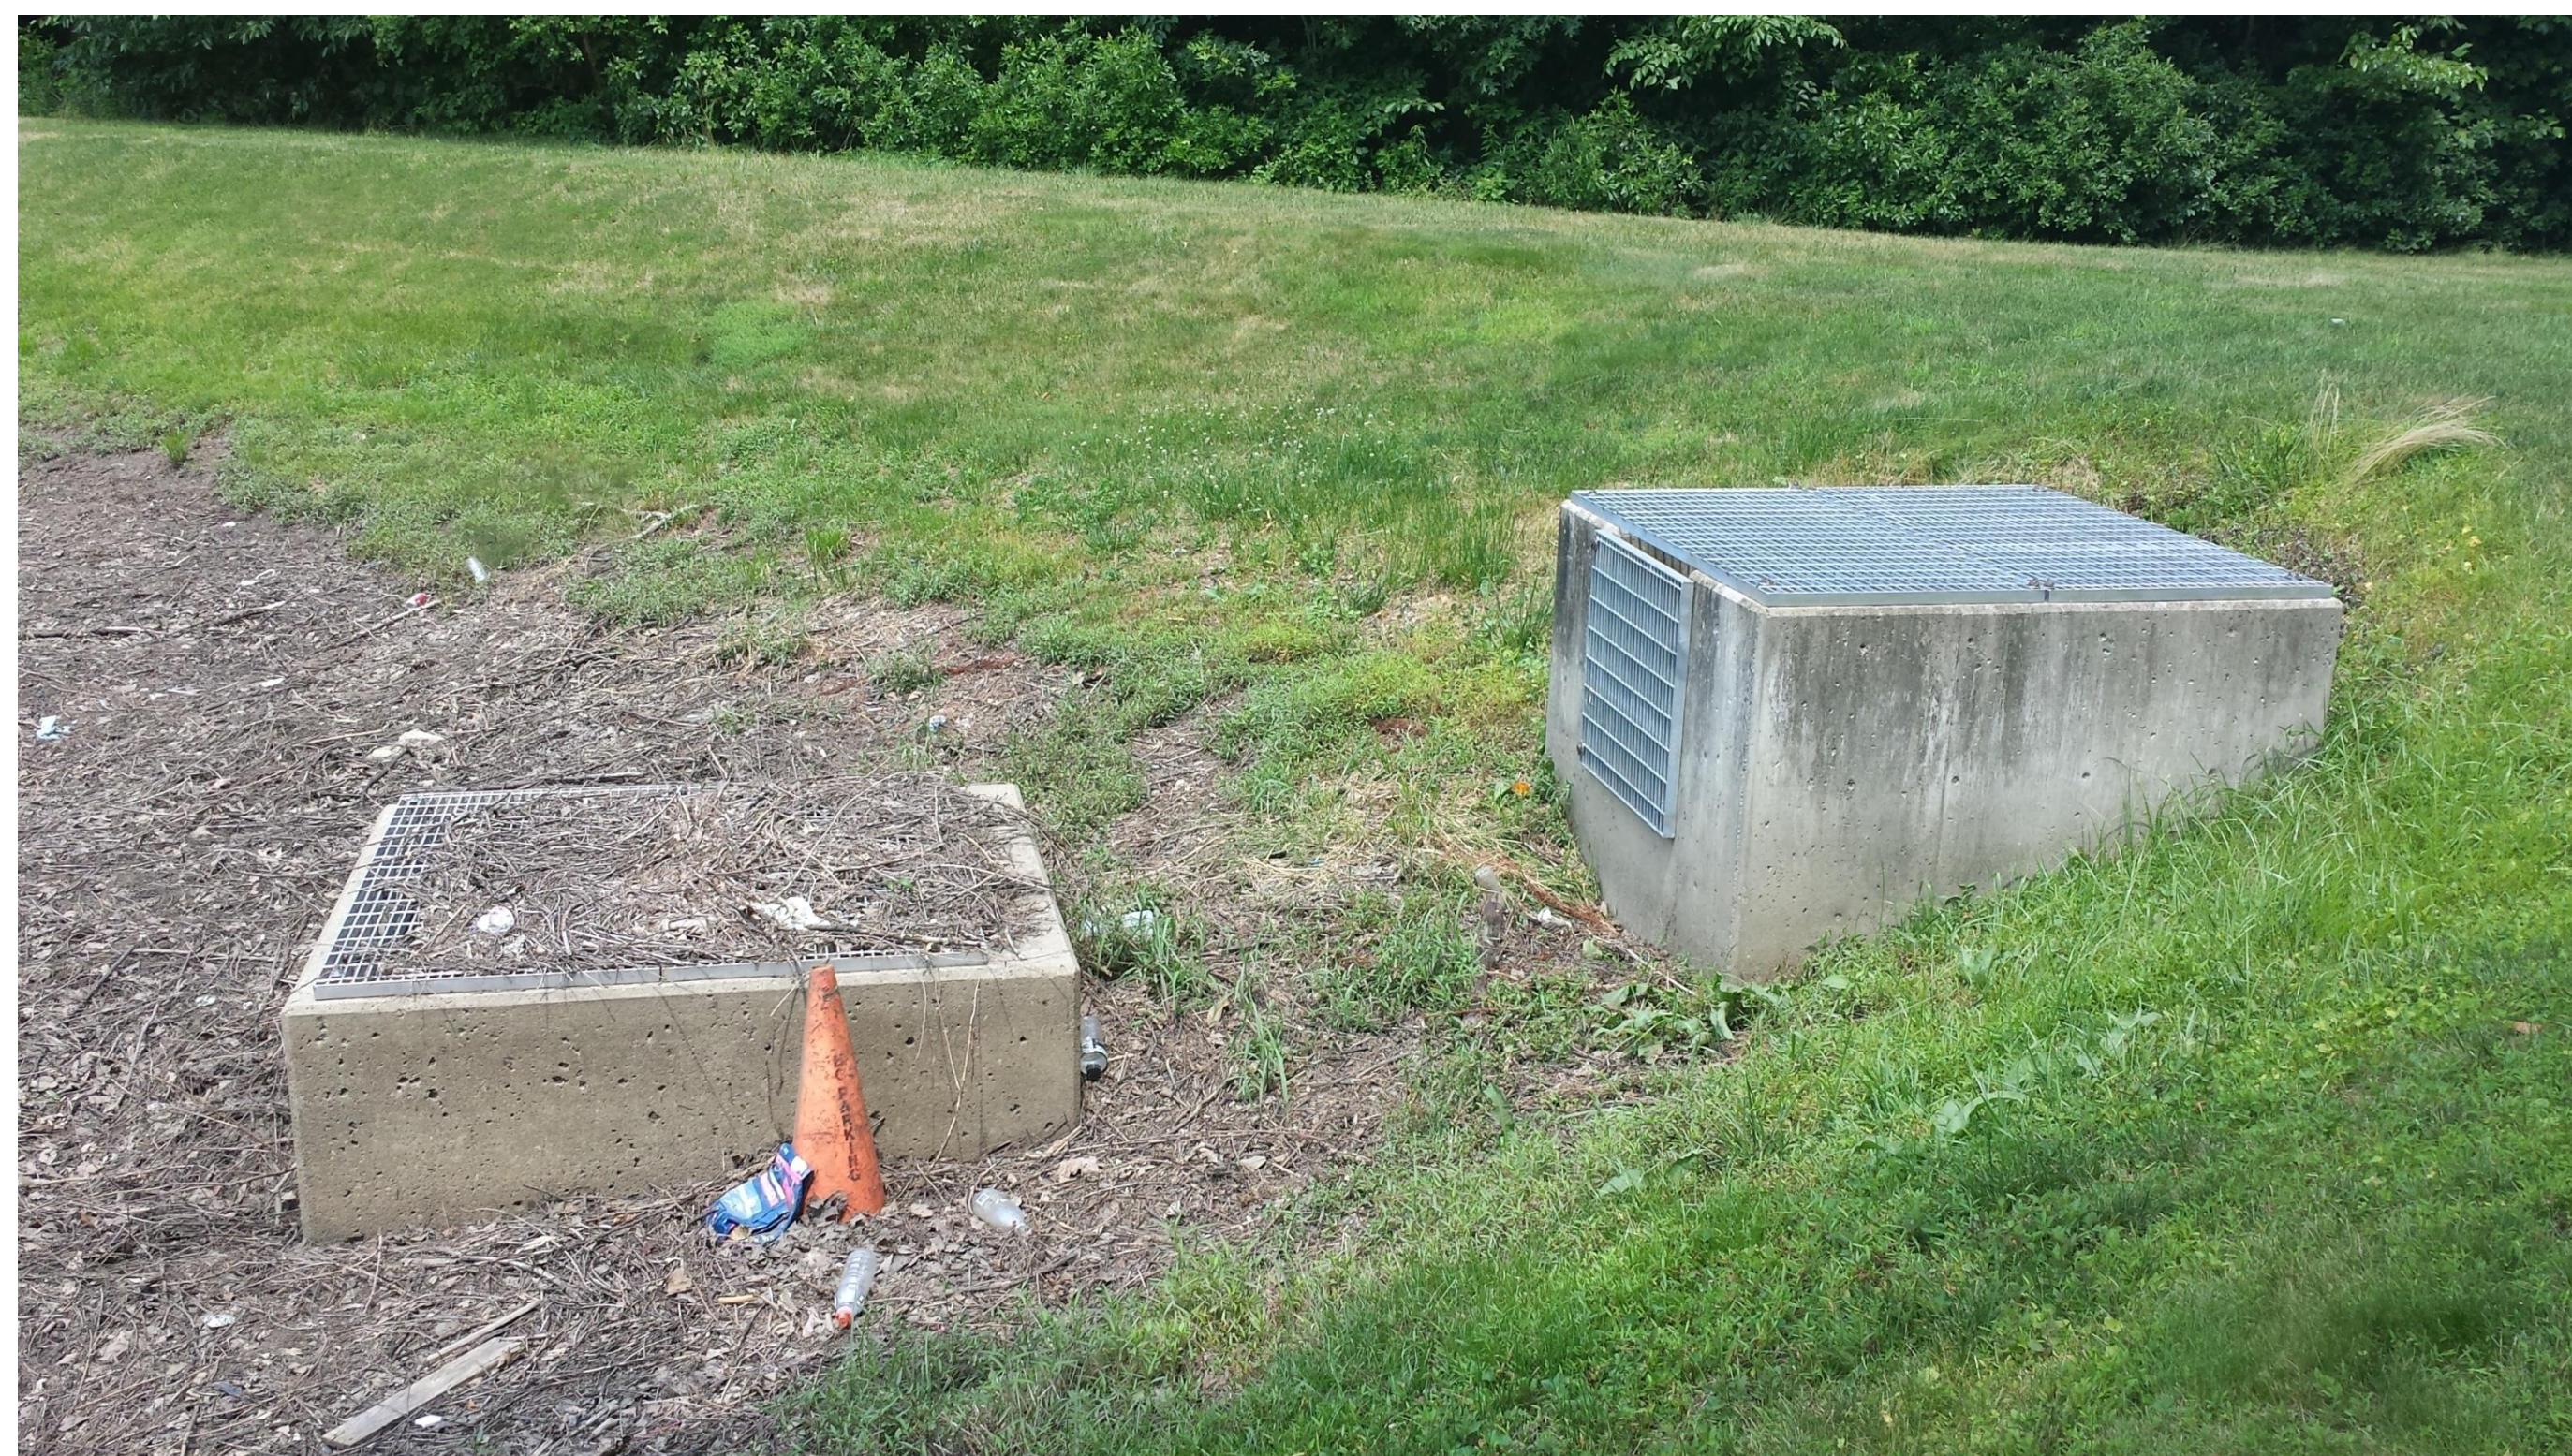
Front view of outlet

Side view of outlet

- Excessive sediment in low flow channel and basin bottom
- Trash rack broken and placed inside outlet structure
- Area near outlet has strong odor

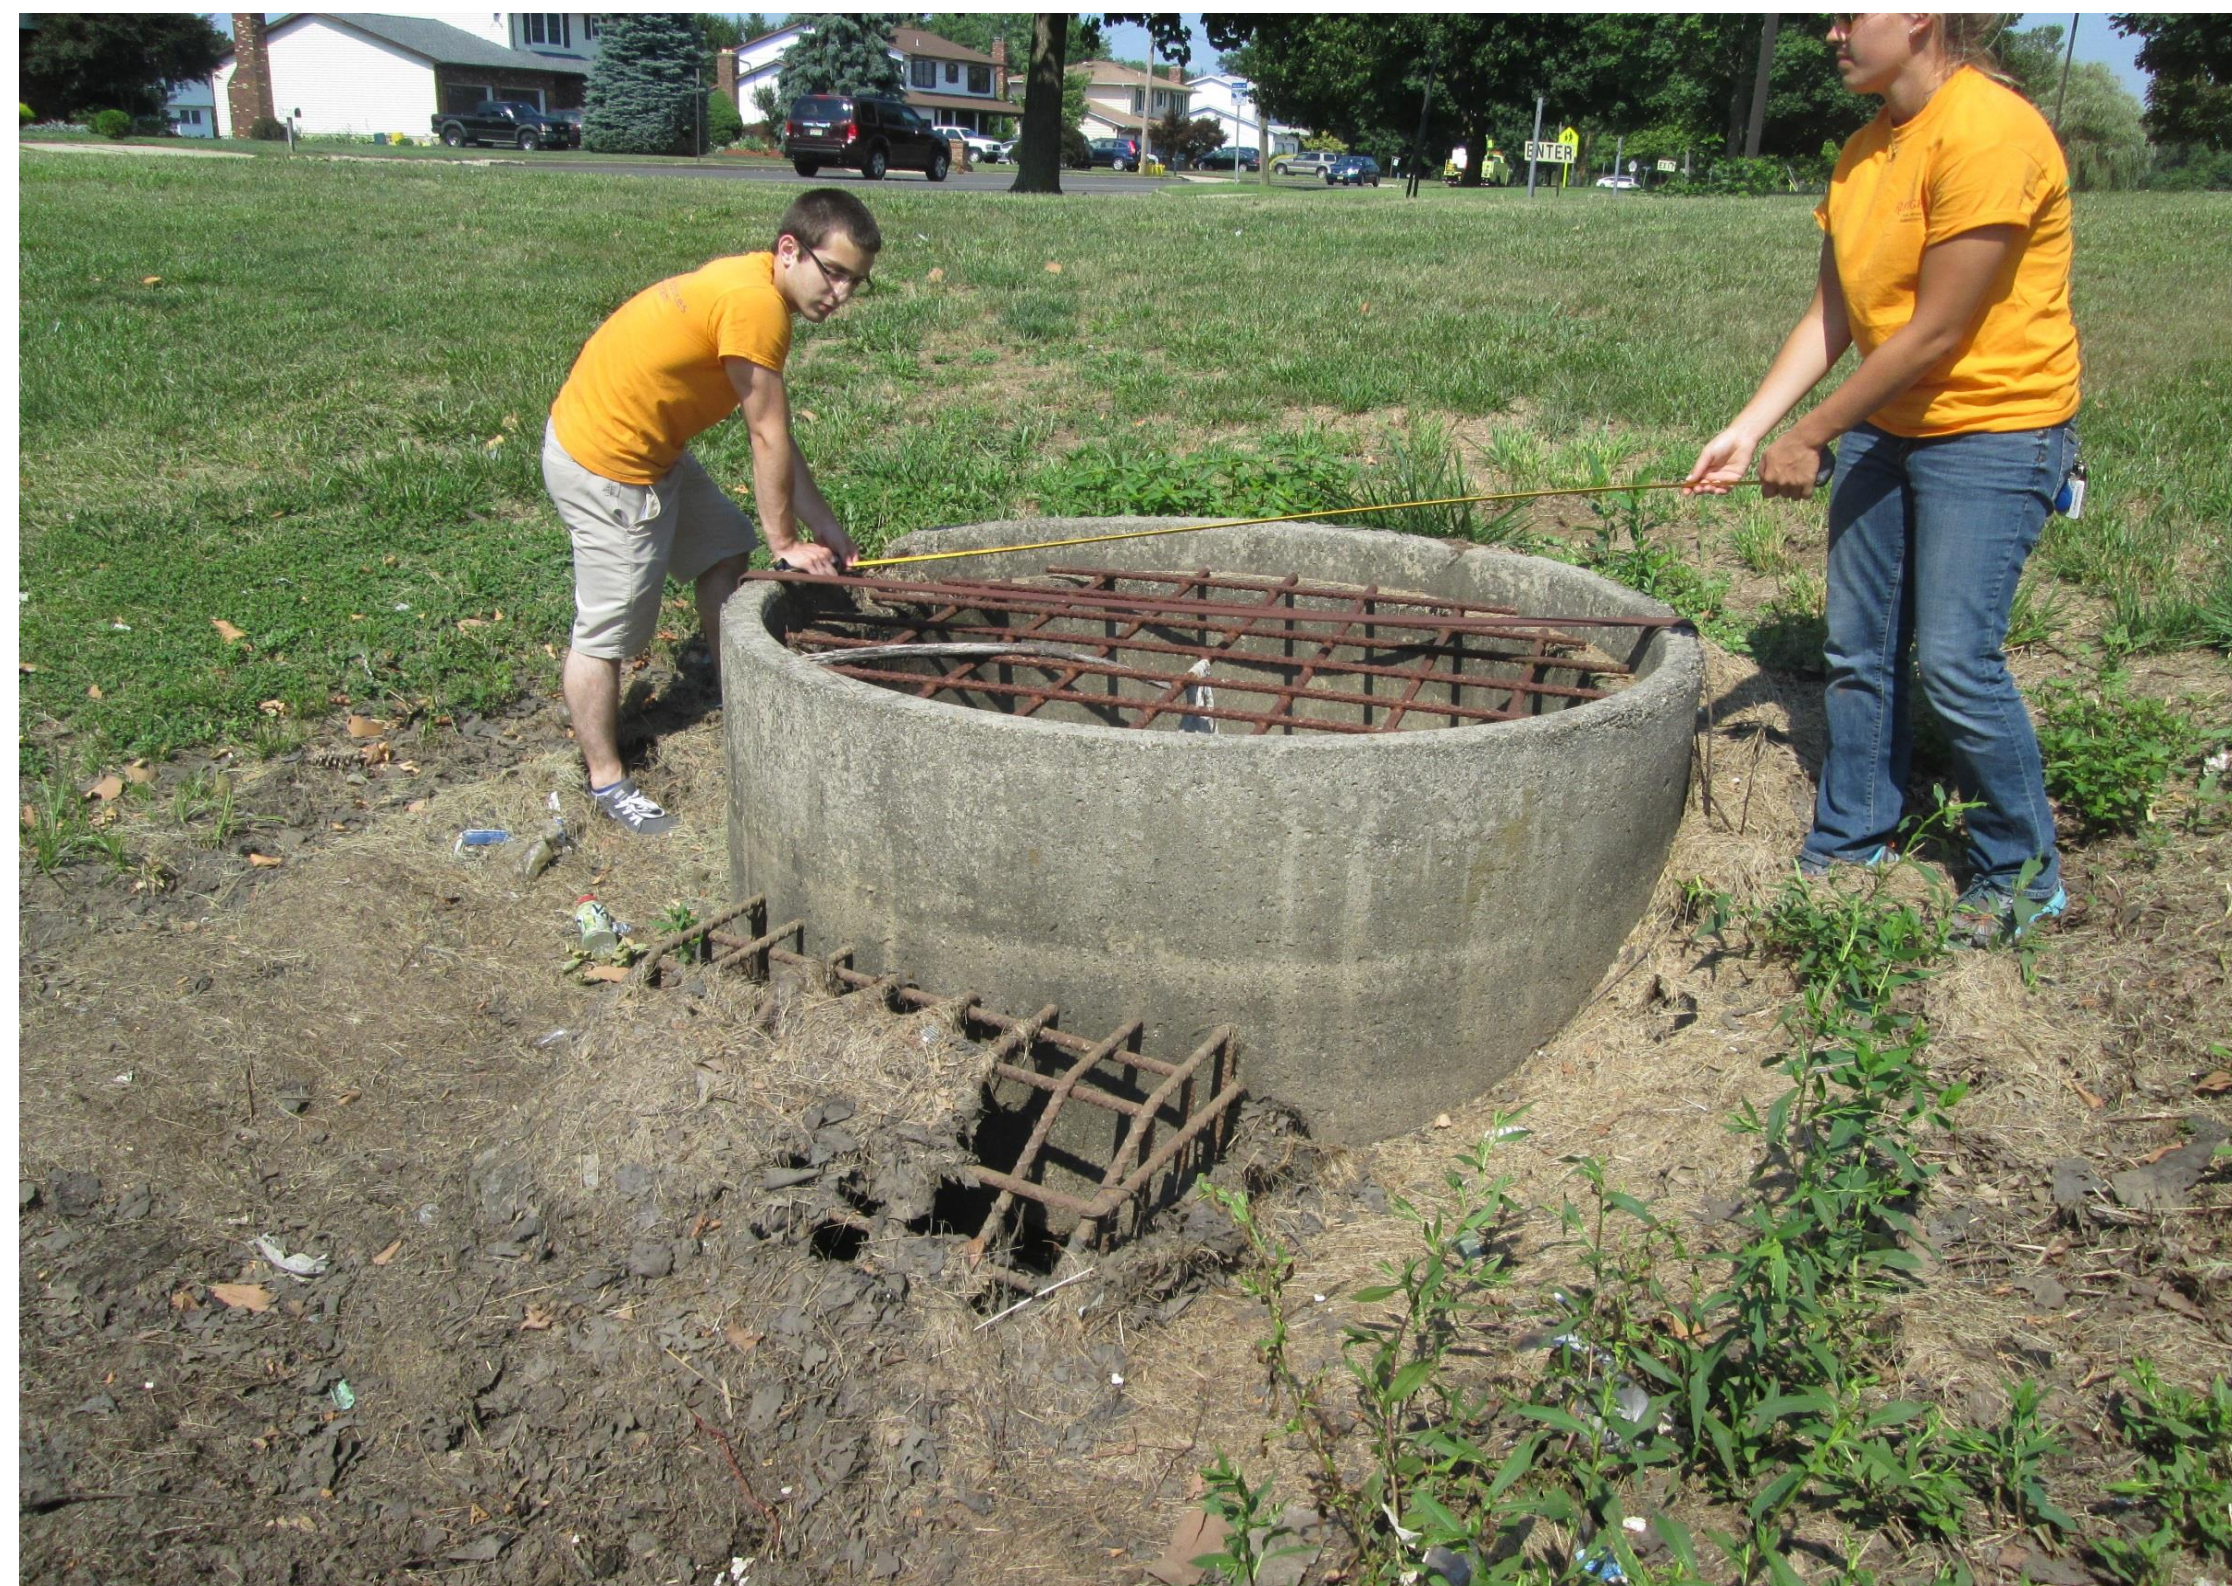
Degraded outlet structure

- Detention basin with large erosion and sediment build up
- Repair and maintain the area by removing unwanted plants and sediment
- Replace low flow channel with stone to allow infiltration

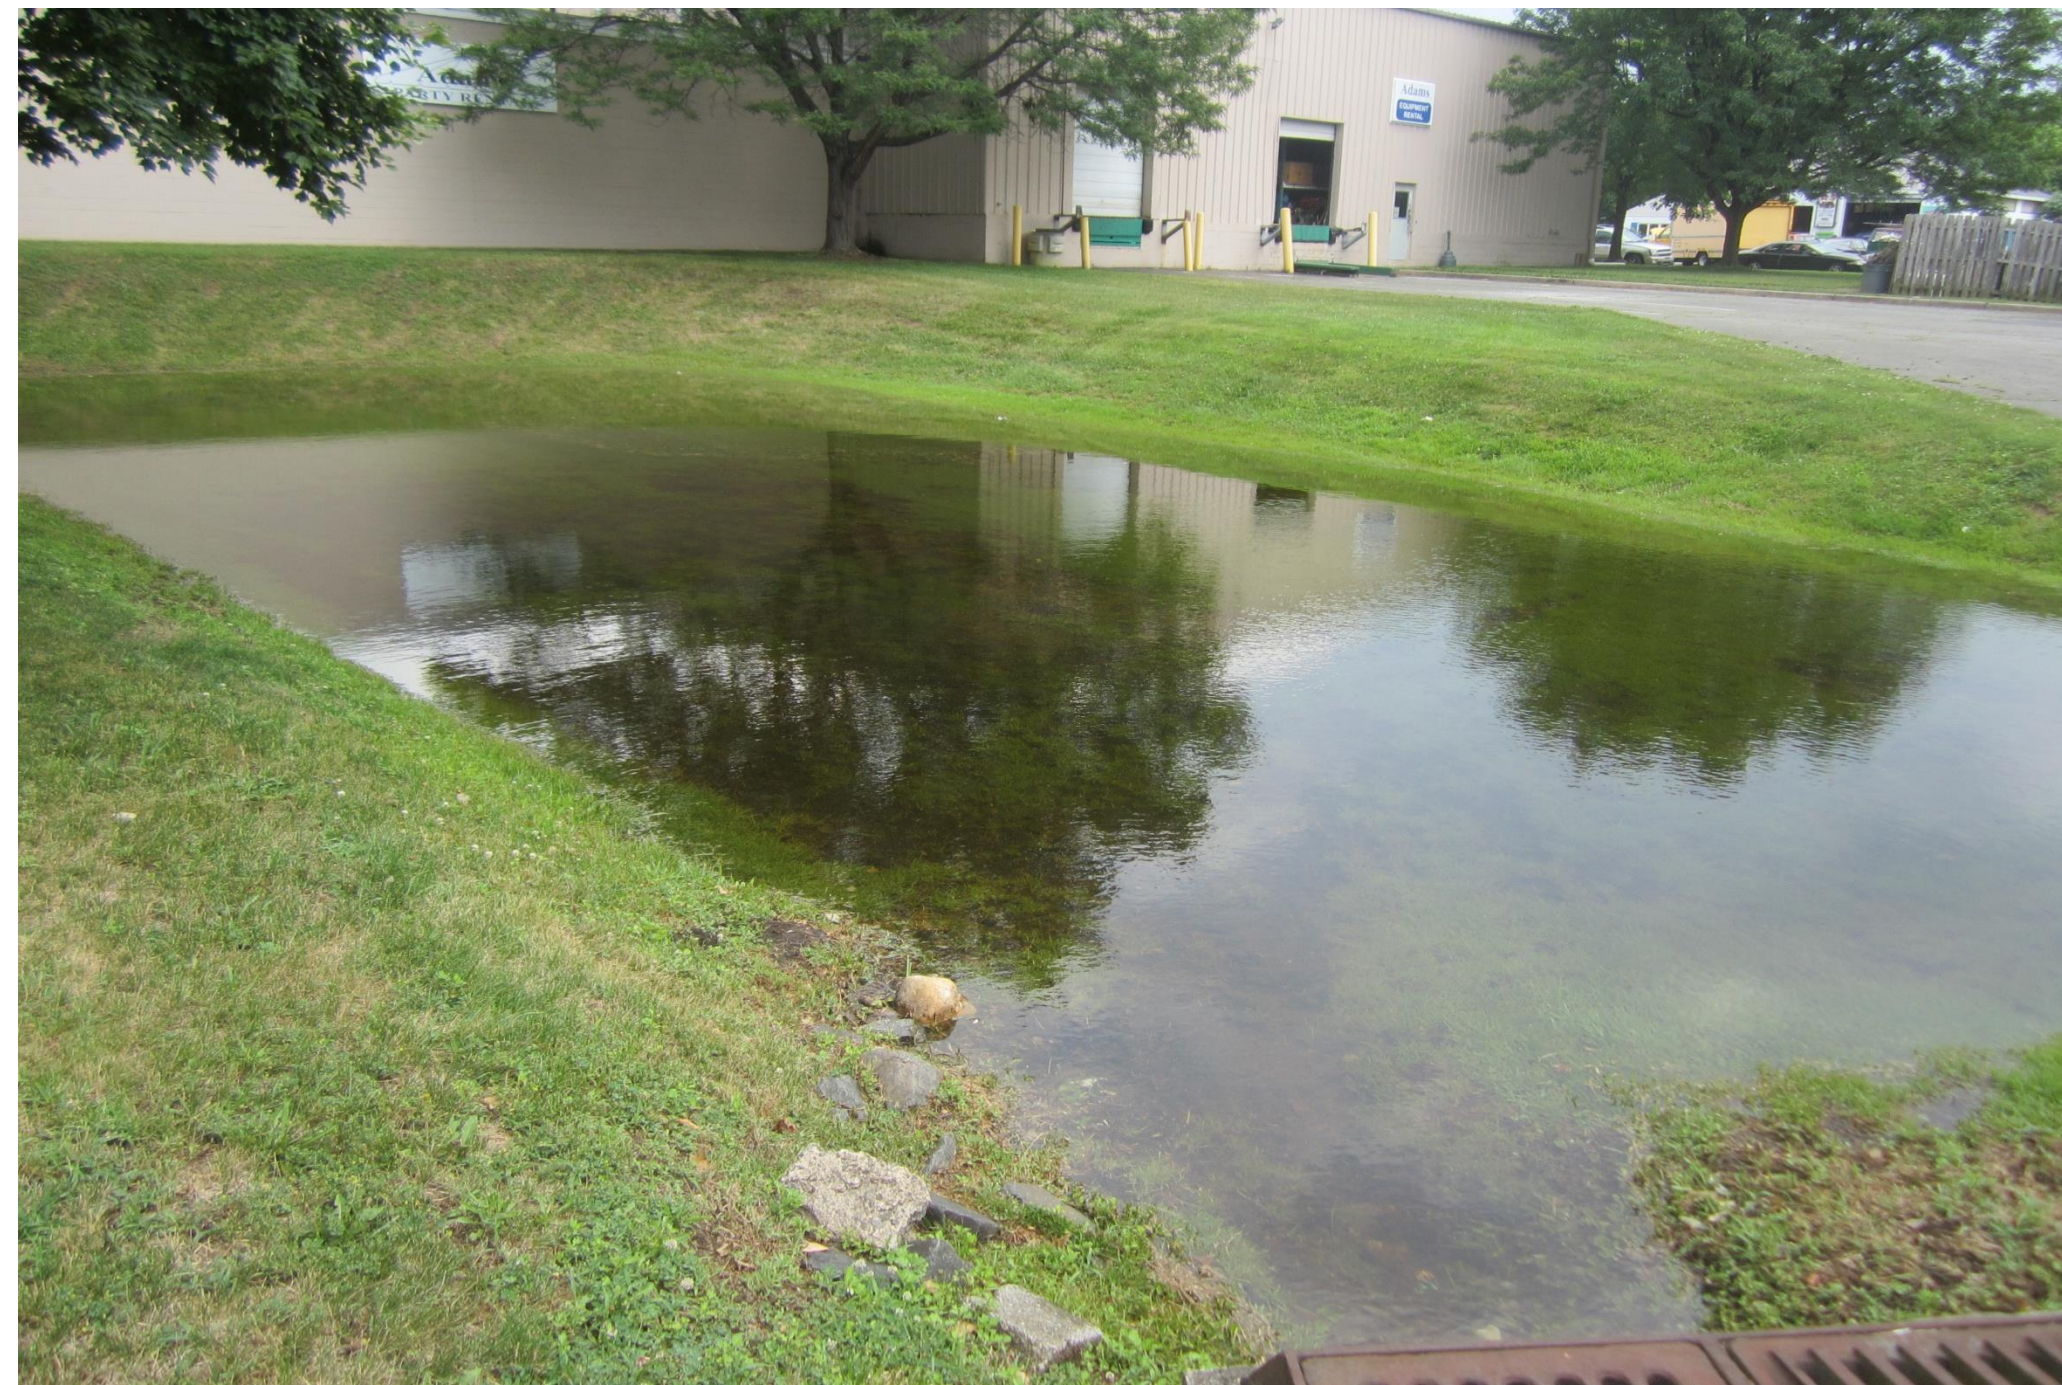
Severe ponding in basin

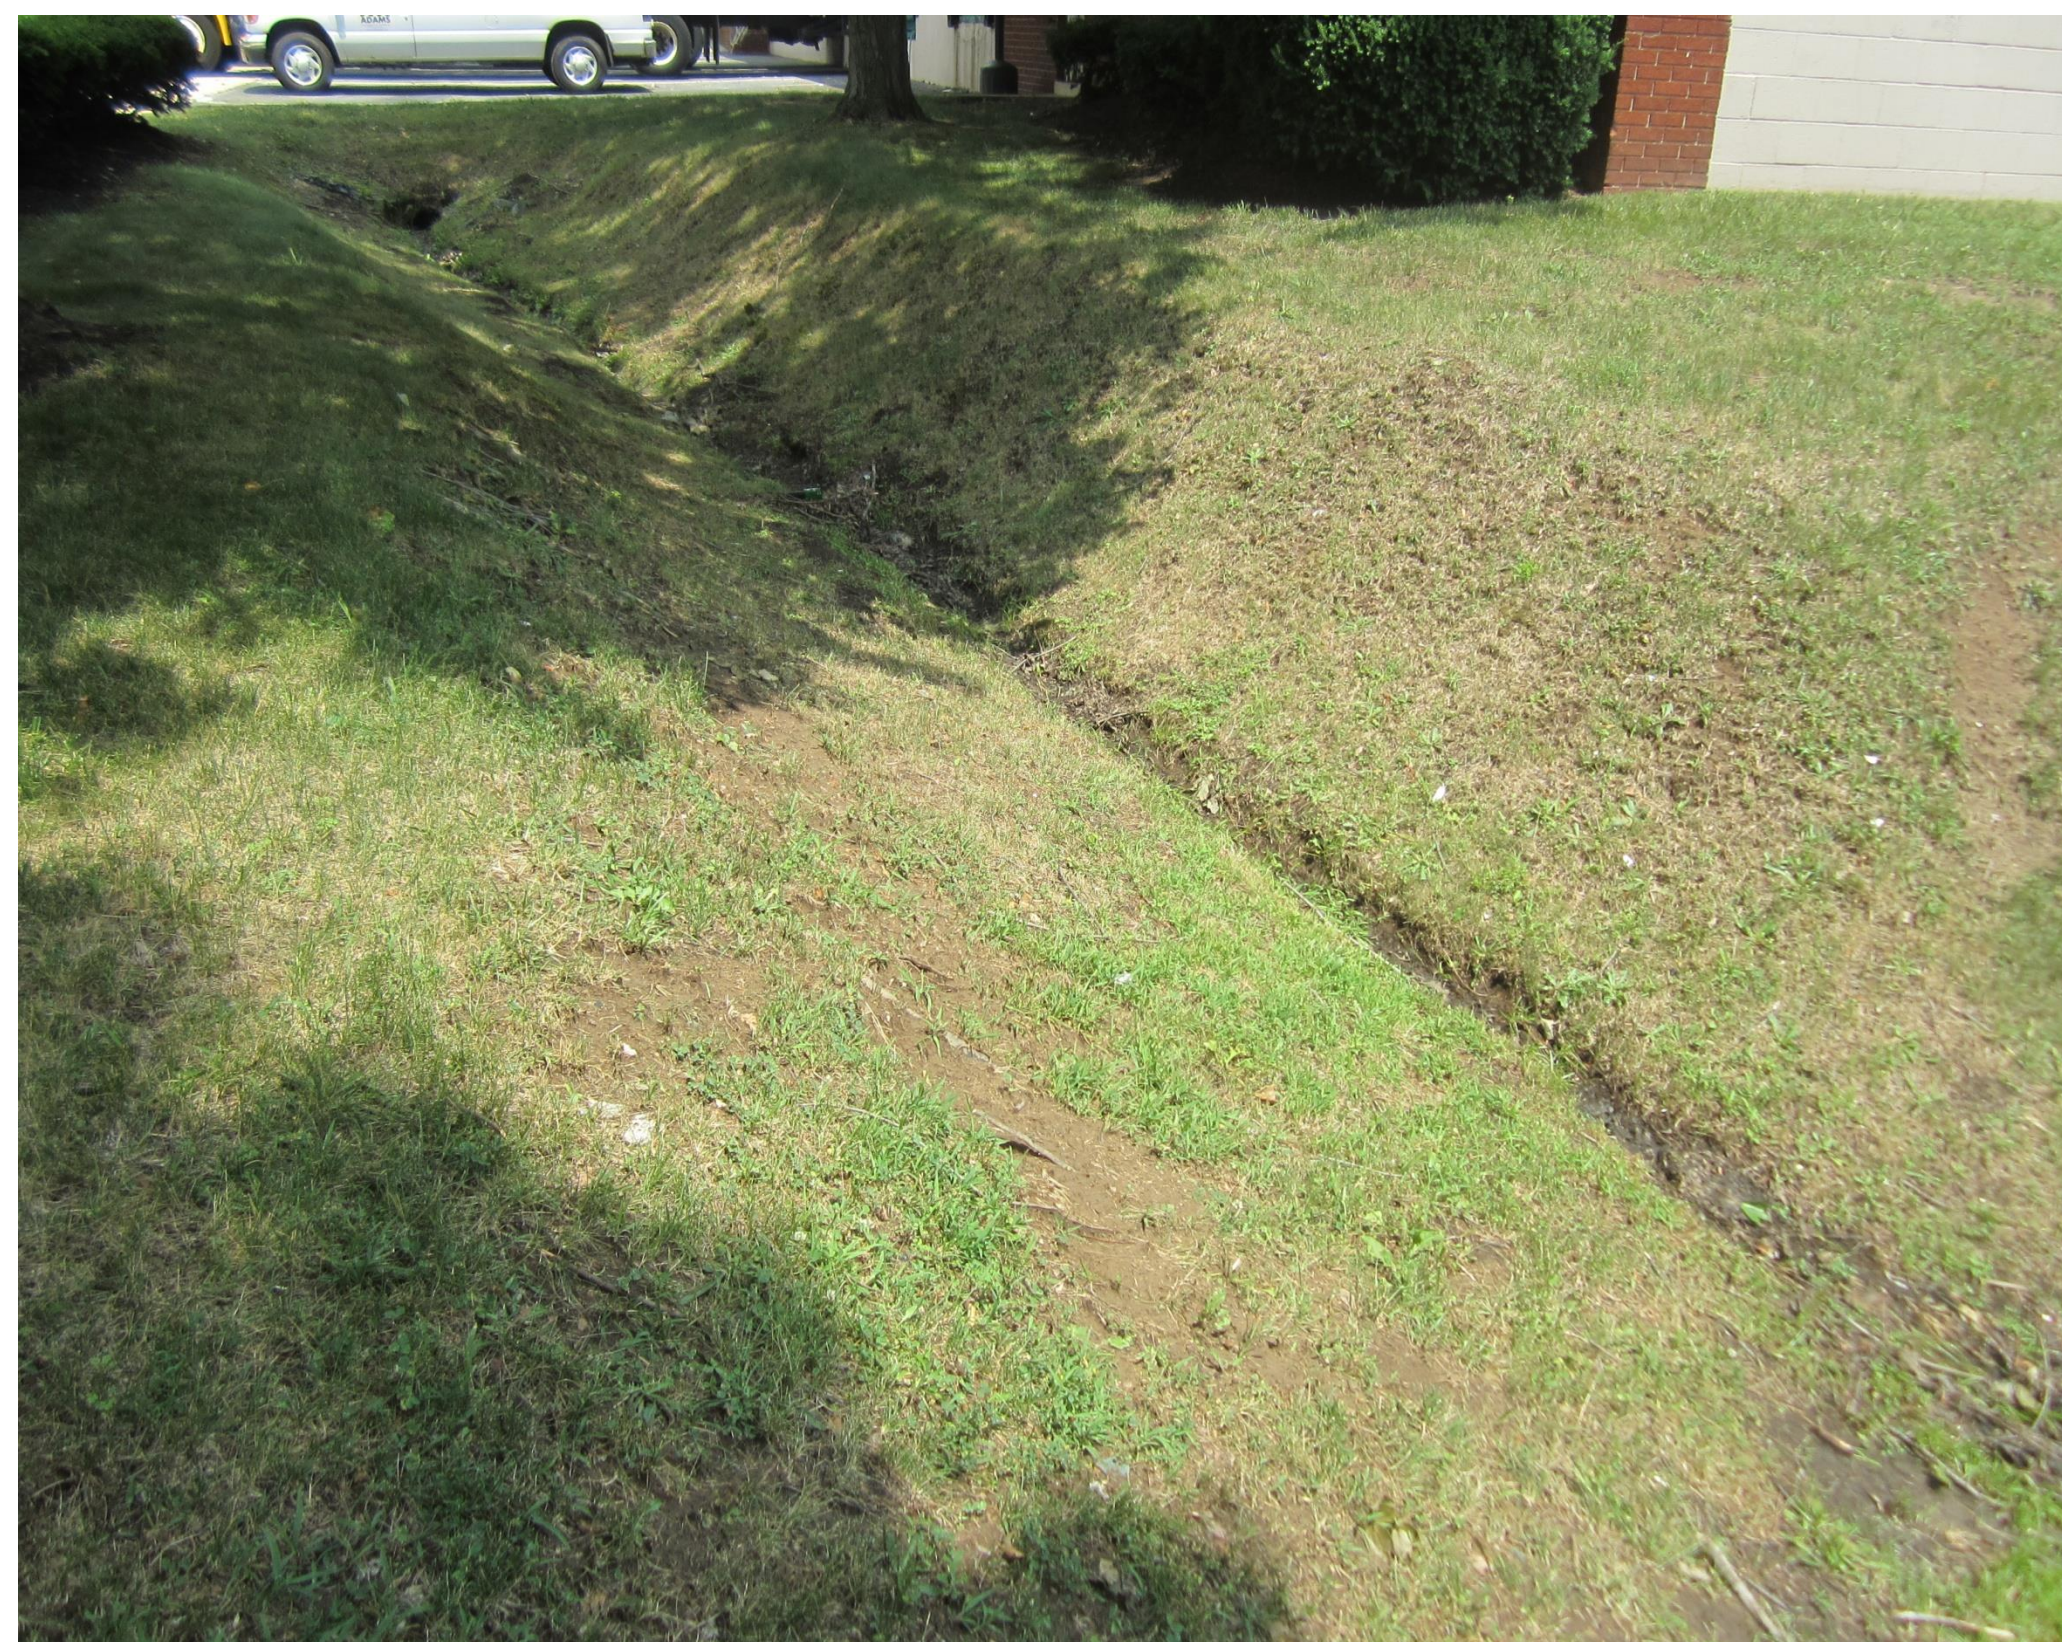
Eroded swale bottom

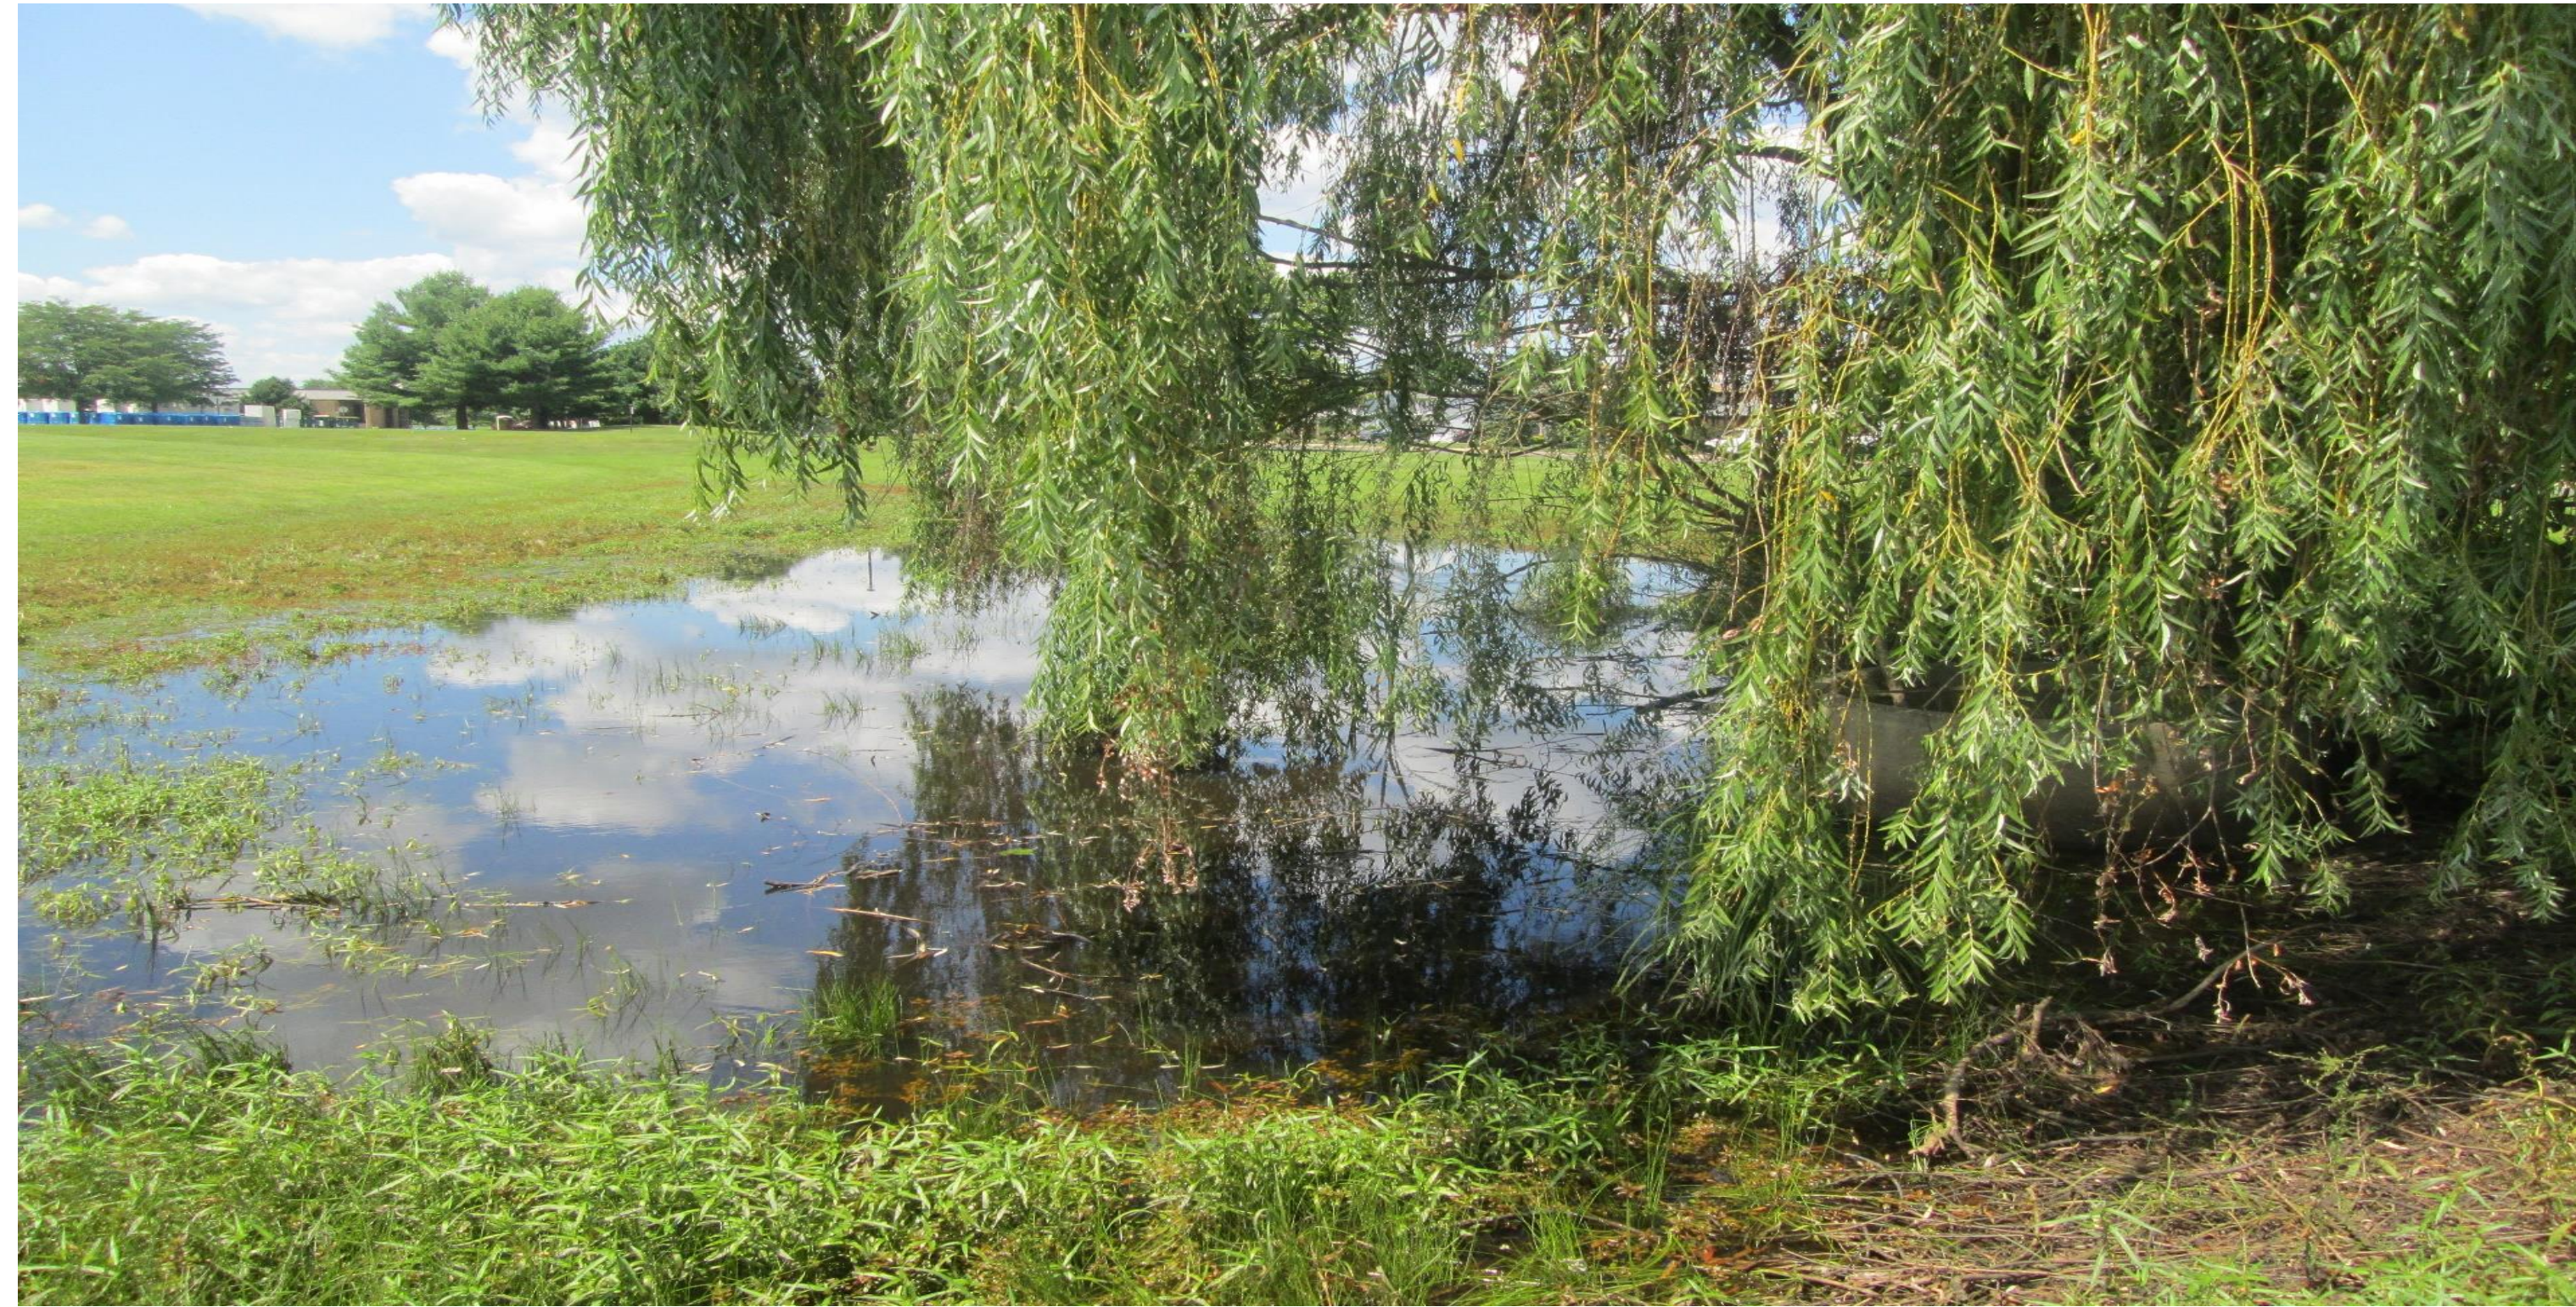
Overview of Basin

- Basin has large volume of water remaining, unimproved from the previous assessment
- Outlet structure is not working properly, needs repair/redesign
- Look at adding soil remediation to convert to an infiltration basin
