**Hamilton Township (Mercer County)
Stormwater Basin Assessment Summary
Past Priority Addendum (Year 5B)**

Developed by the Rutgers Cooperative Extension Water Resources Program
Funded by Hamilton Township, Mercer County, New Jersey

November 27, 2019

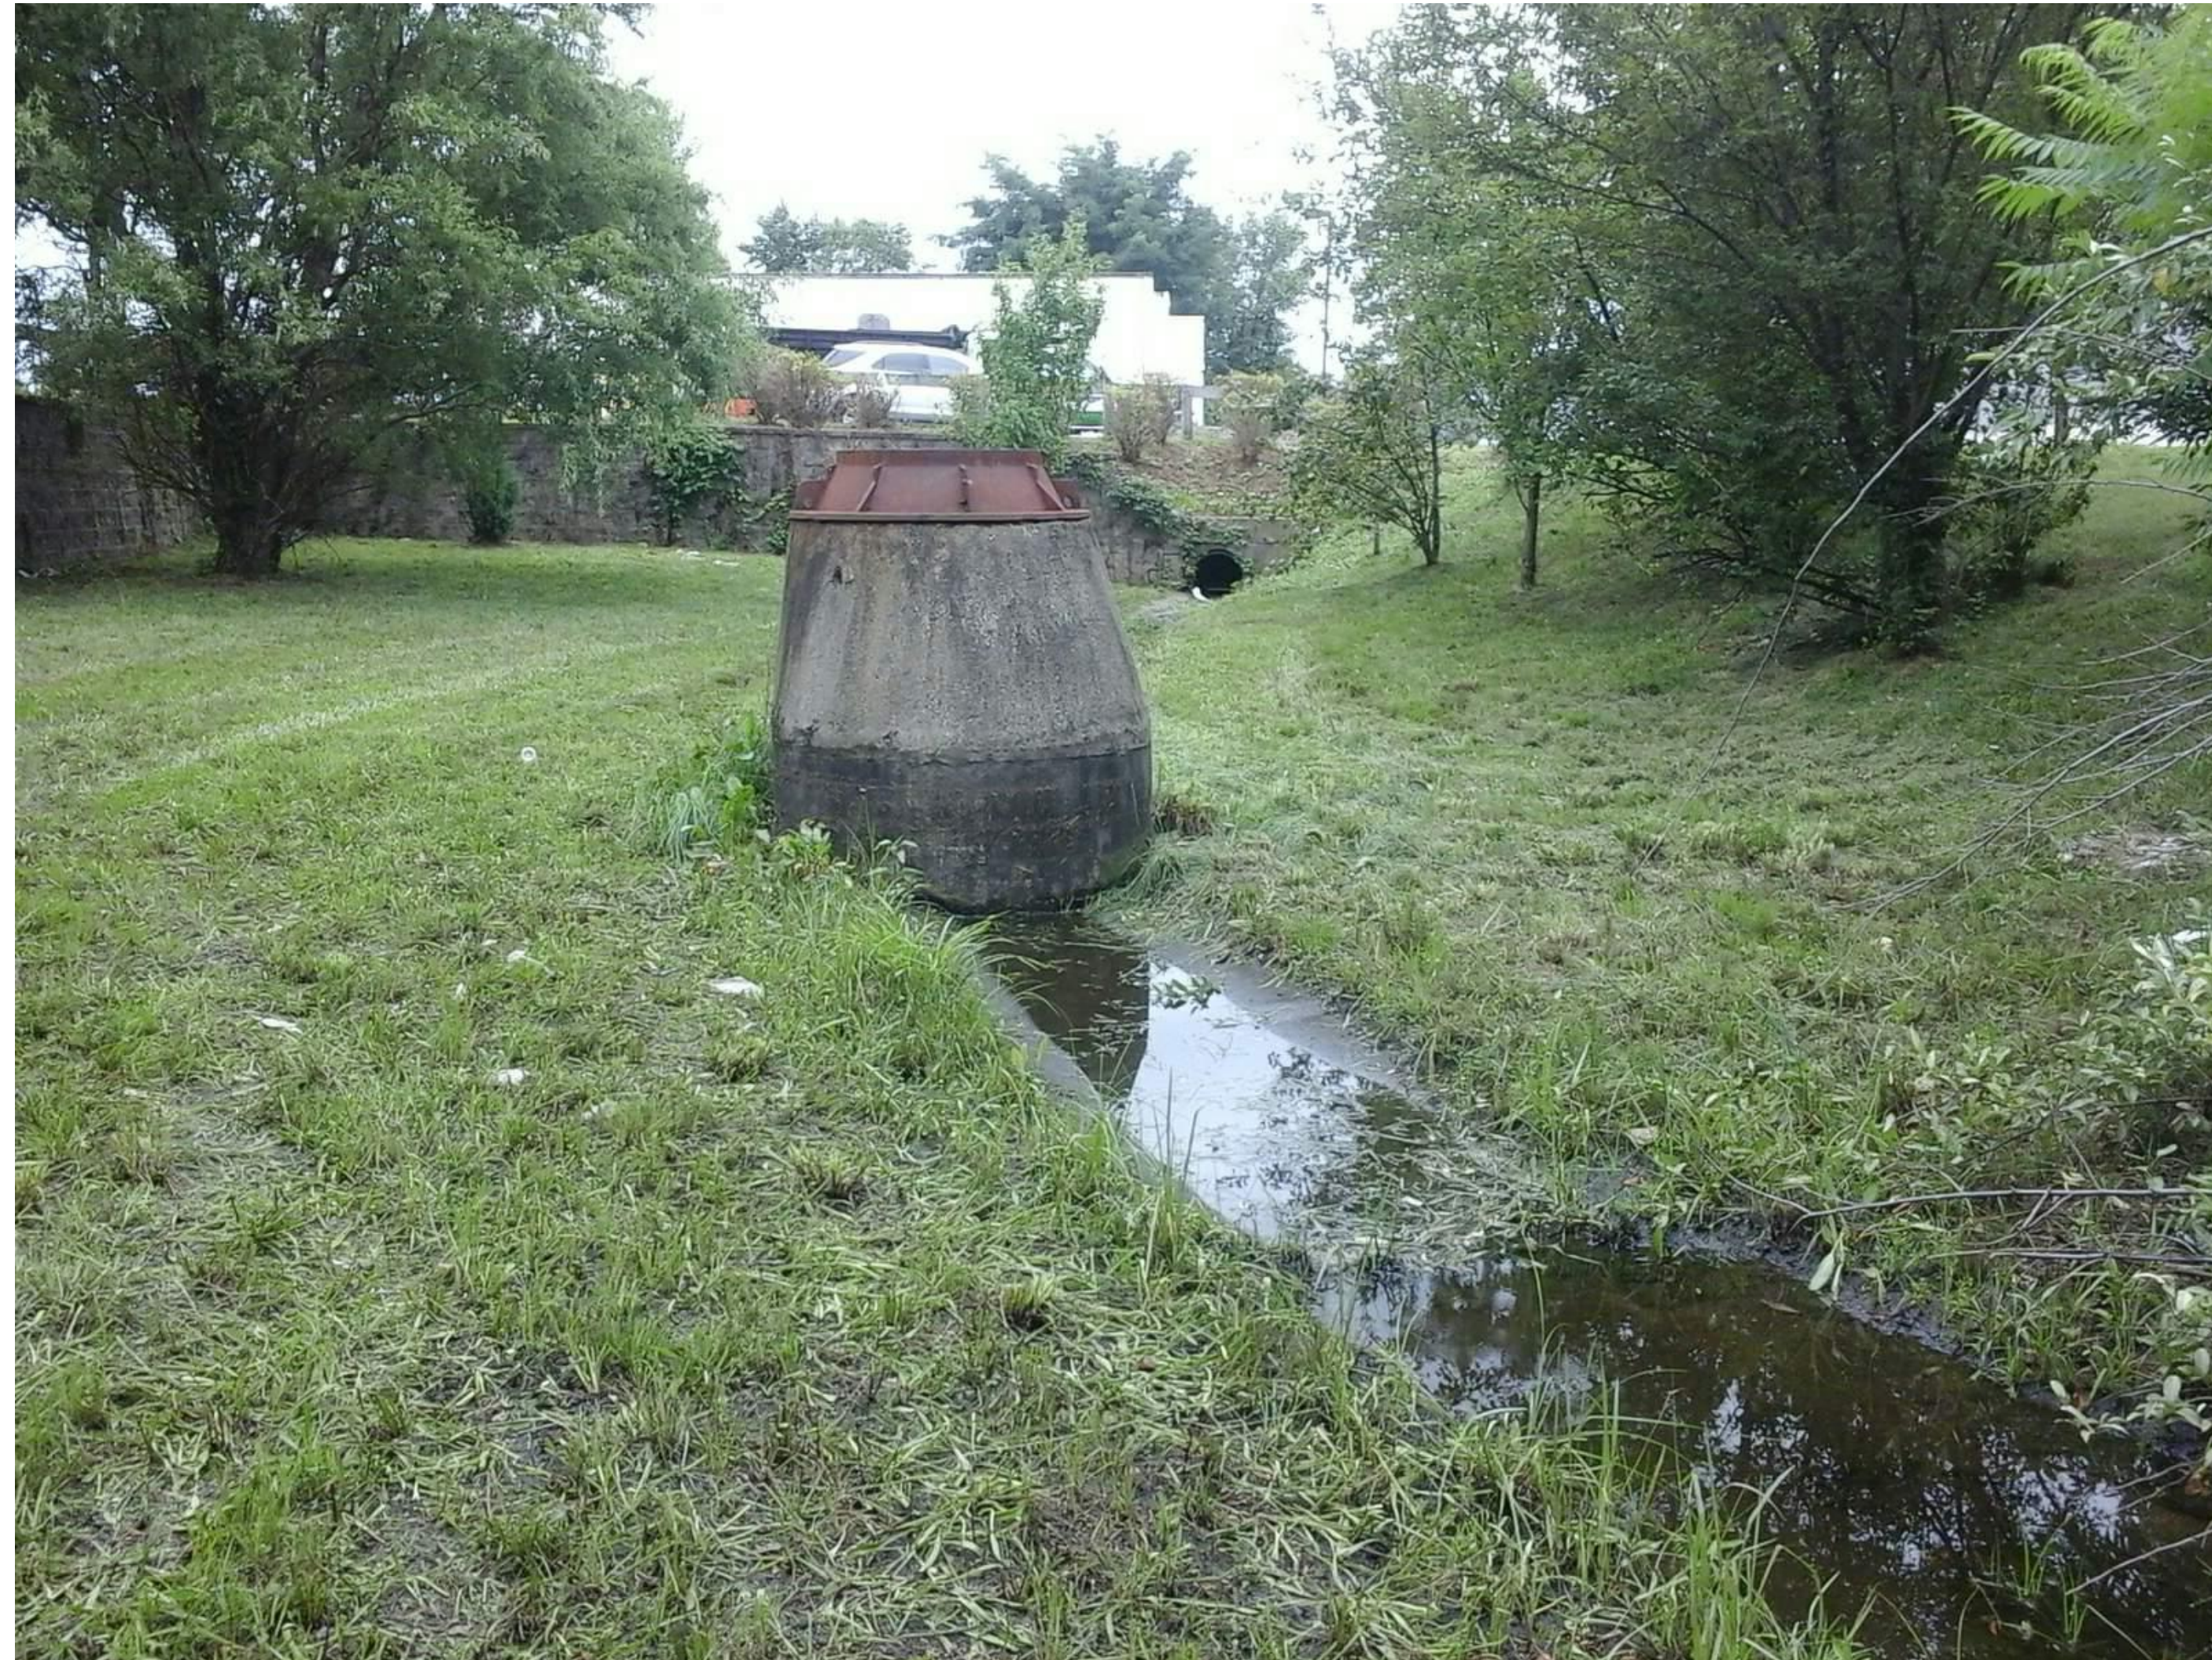
Overview of basin

- Low flow channels had standing water present and stagnant
- Outlet structure may need to be replaced in near future
- Woody plants growing near outlet structure
- Stone lined channel can be used to replace low flow channel

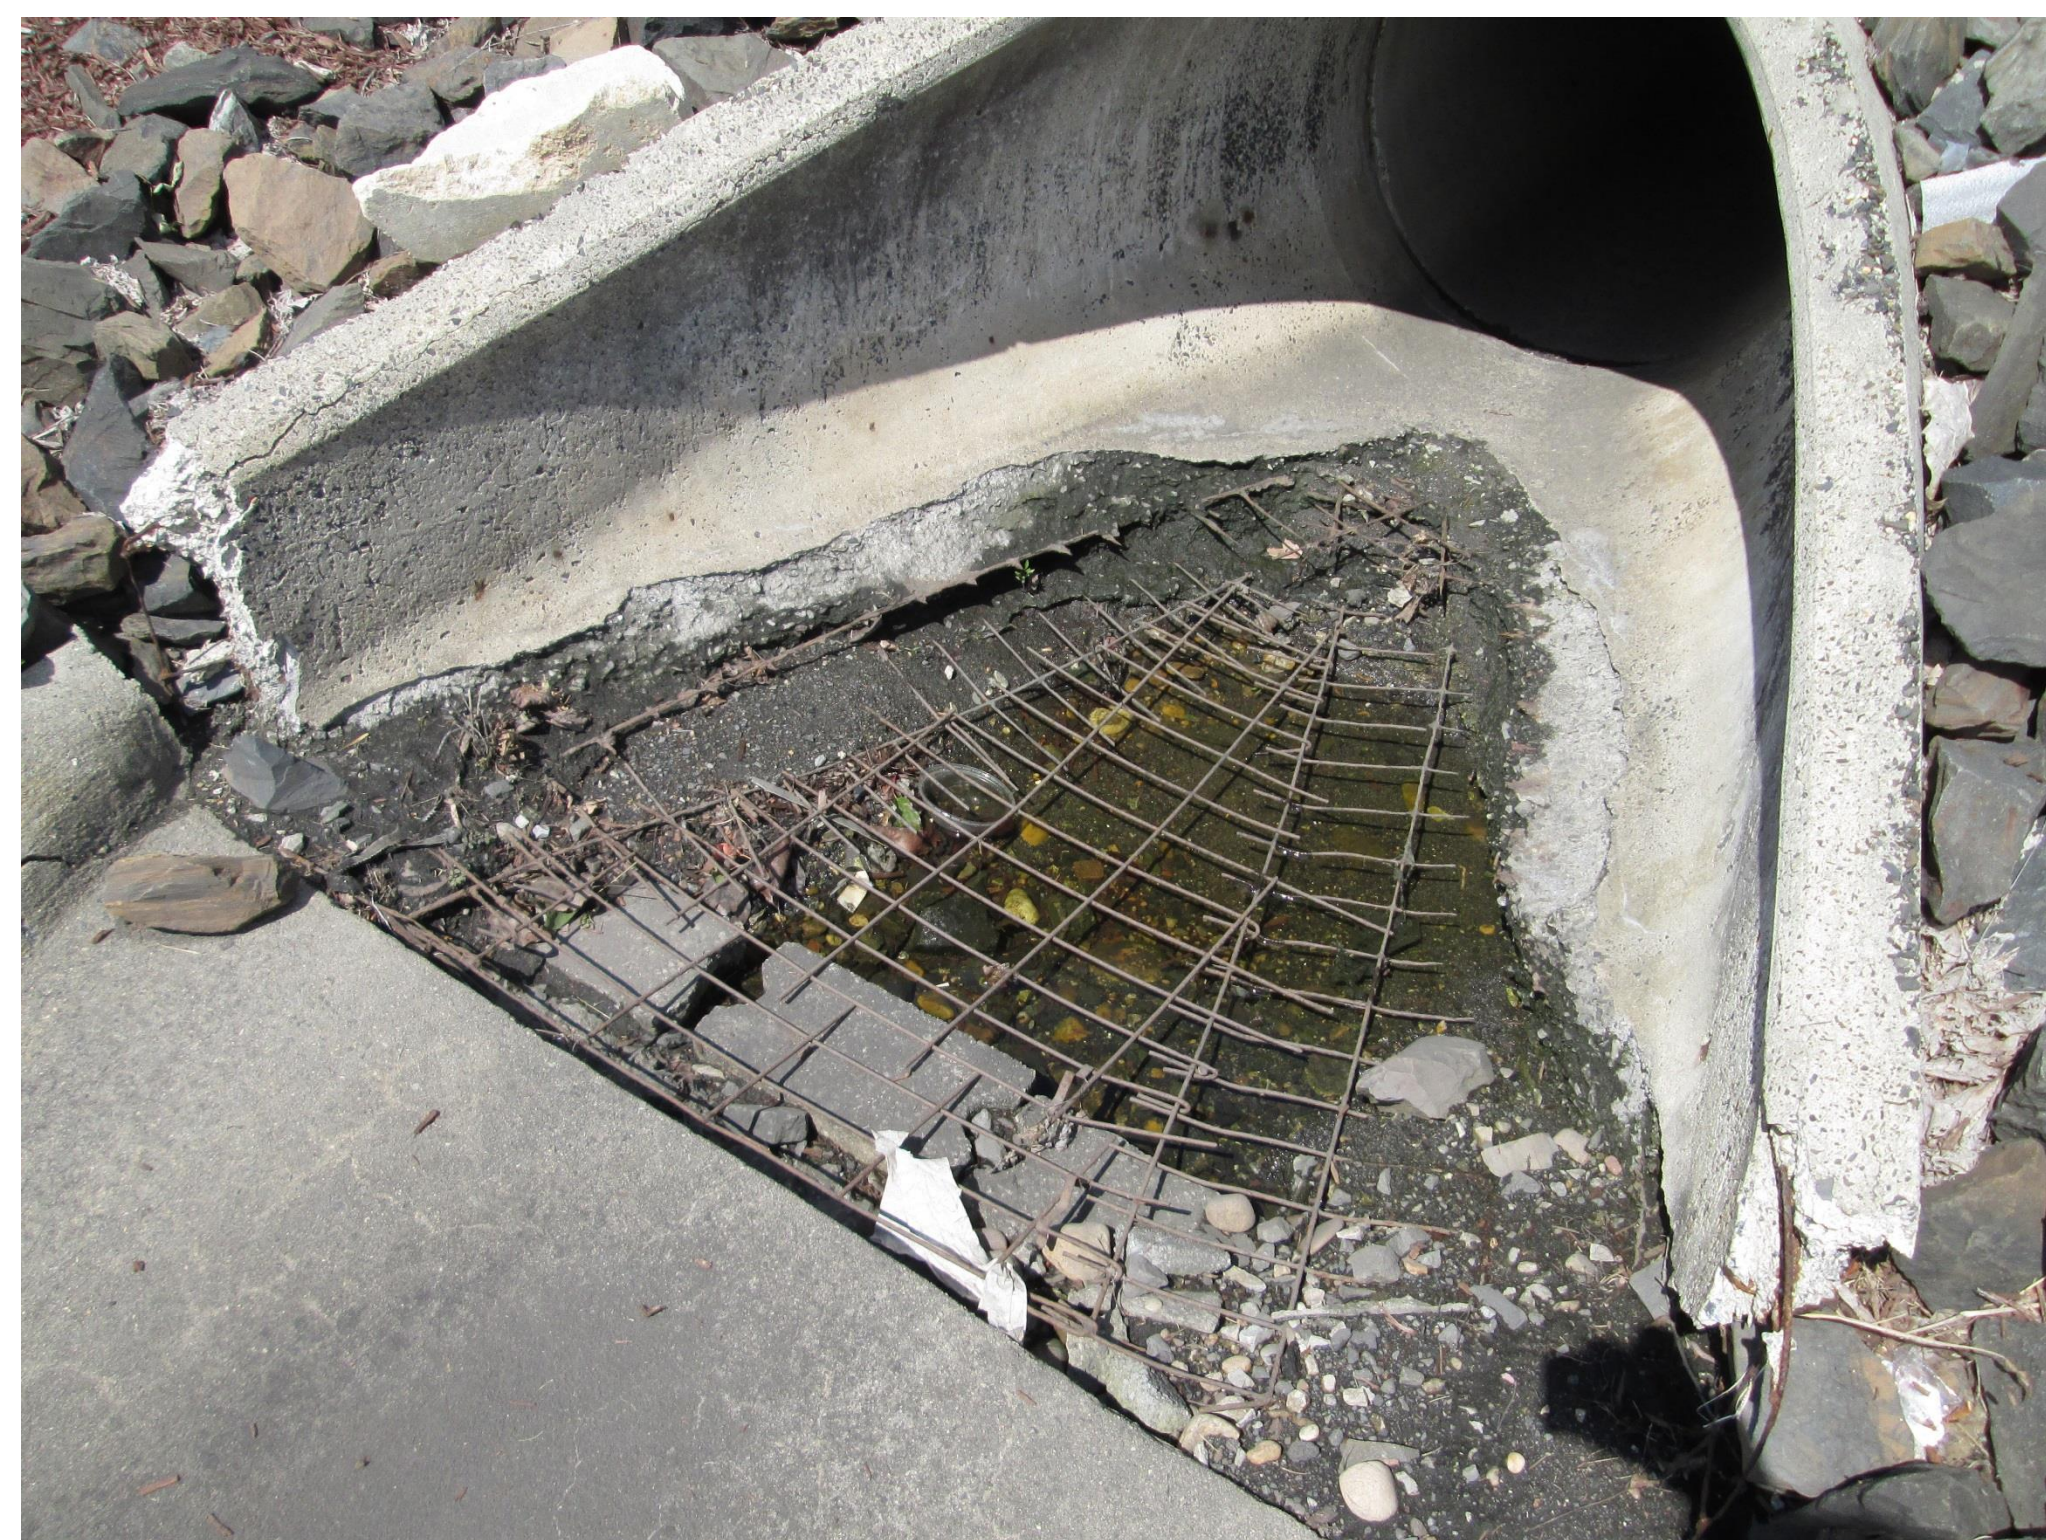
Erosion of inlet

- Sediment and litter inside and surrounding outlet
- Erosion of all inlet structures
- Retrofit low flow channels with stone channels and reduce mowing to allow for better infiltration

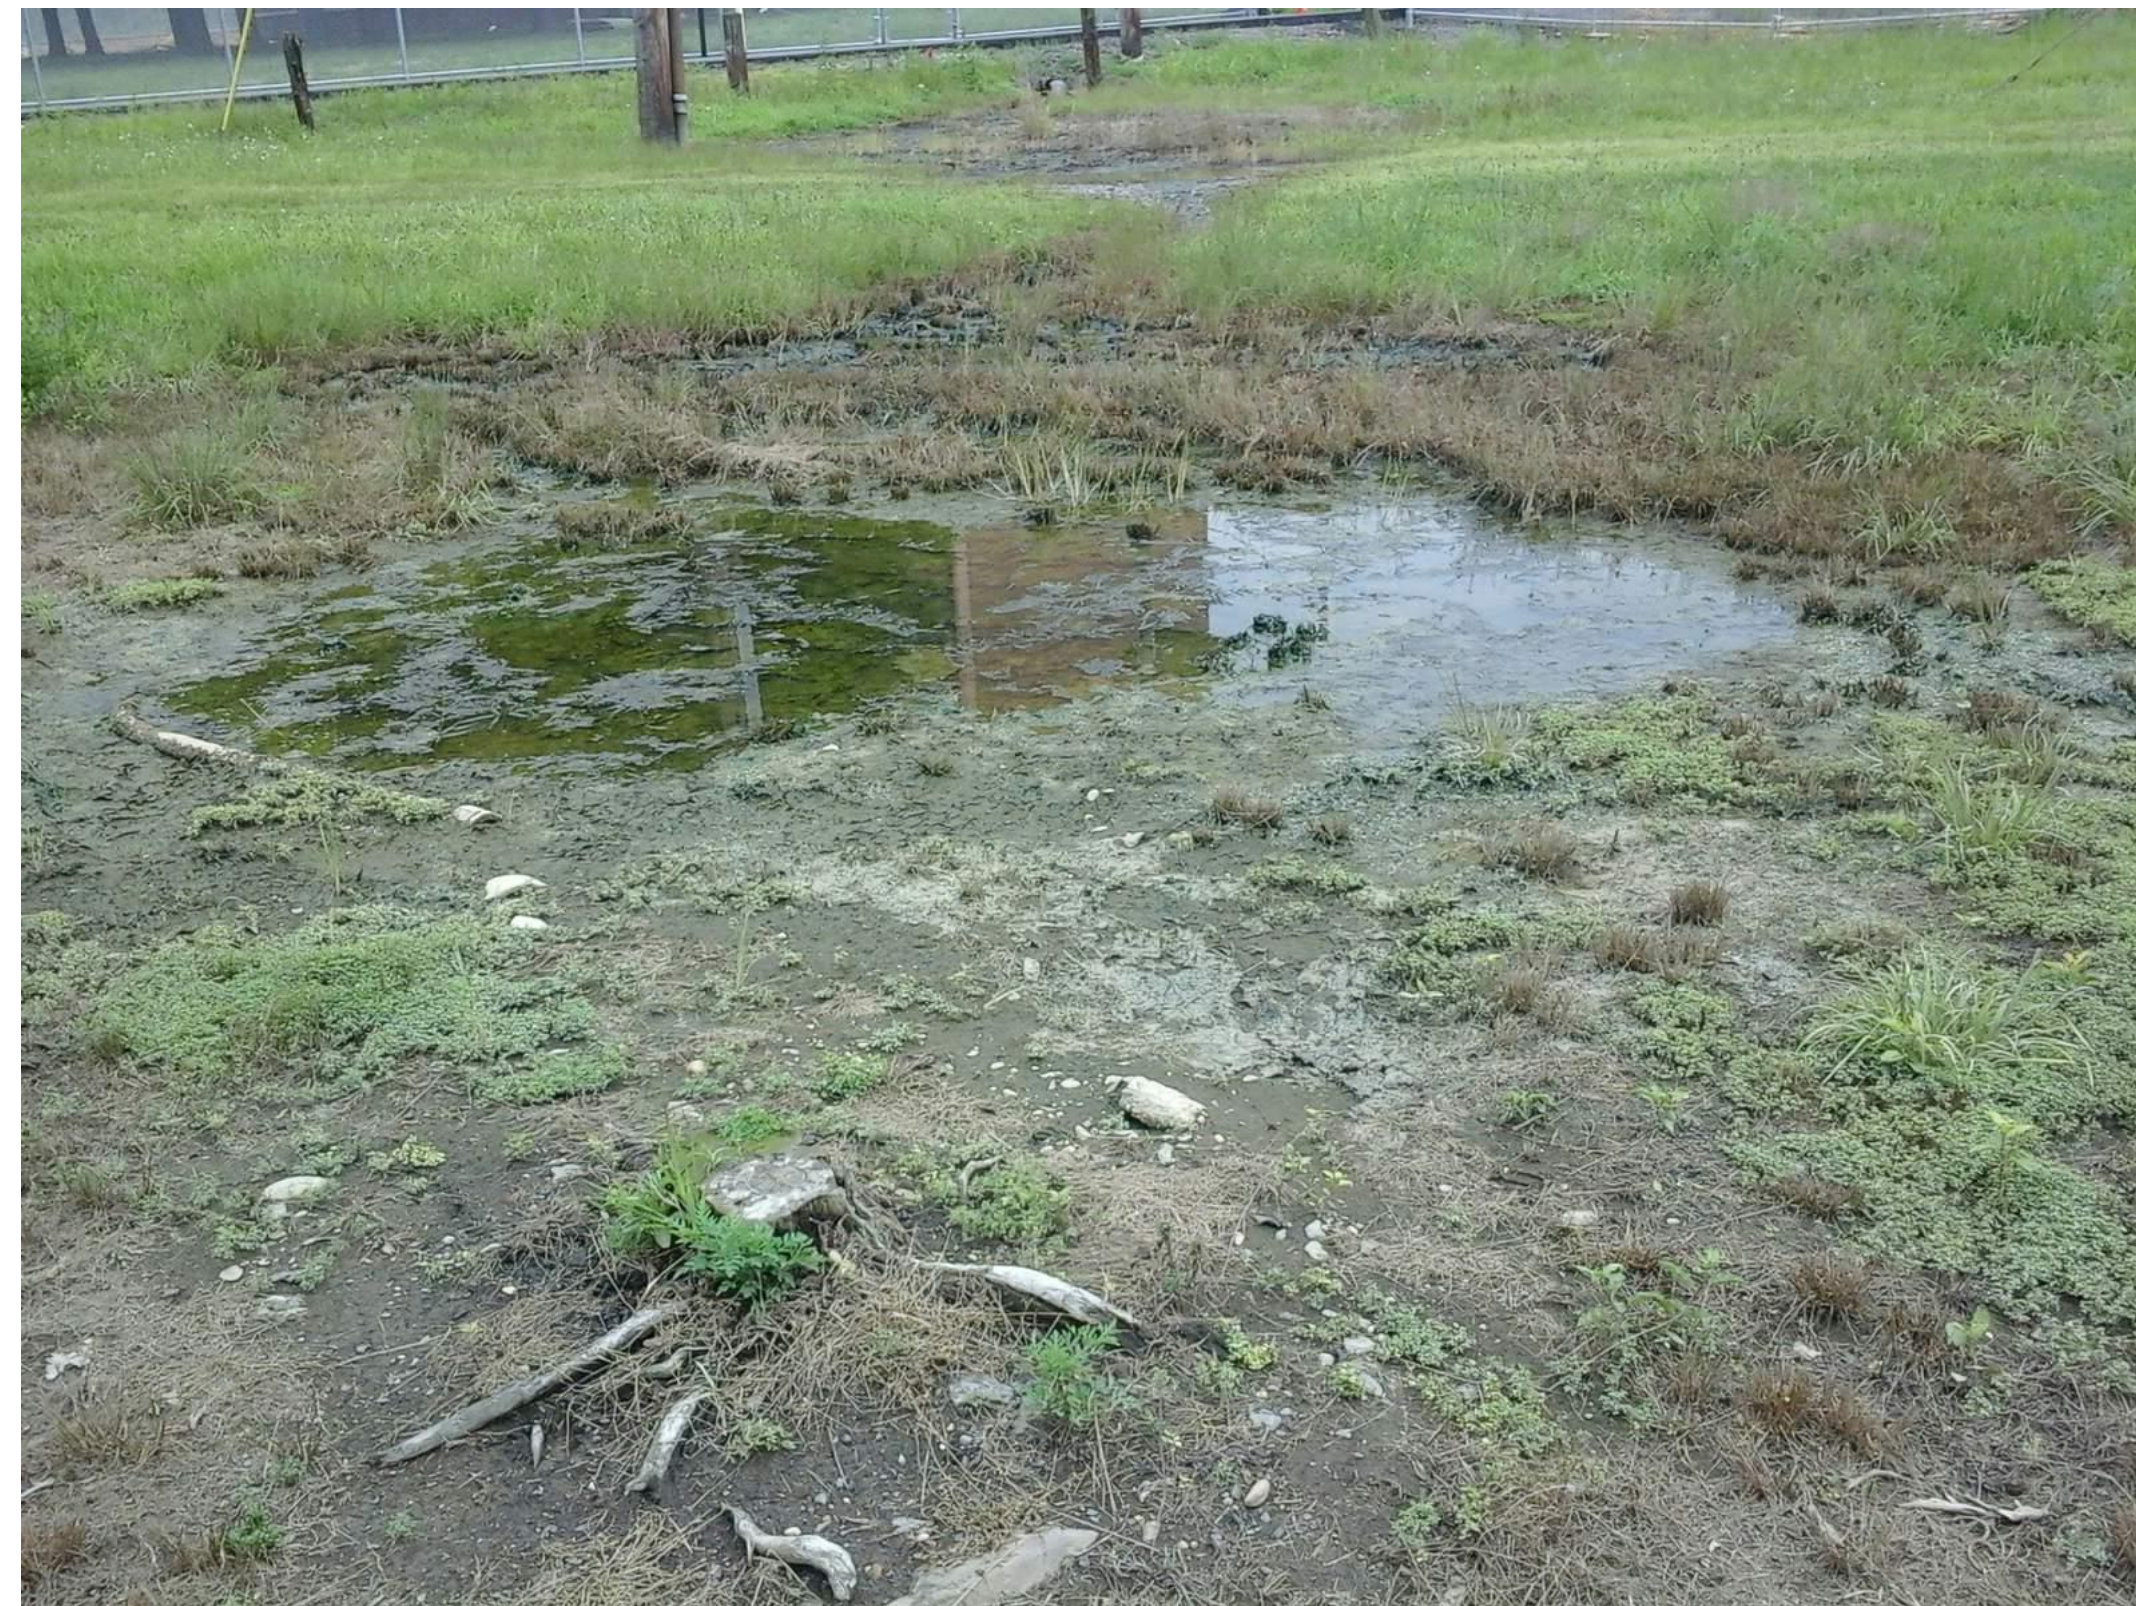
Overview of basin

- Standing water present
- Basin near environmental clean up site
- Amend soil to improve infiltration and reduce standing water
- Plant with woody vegetation to improve infiltration

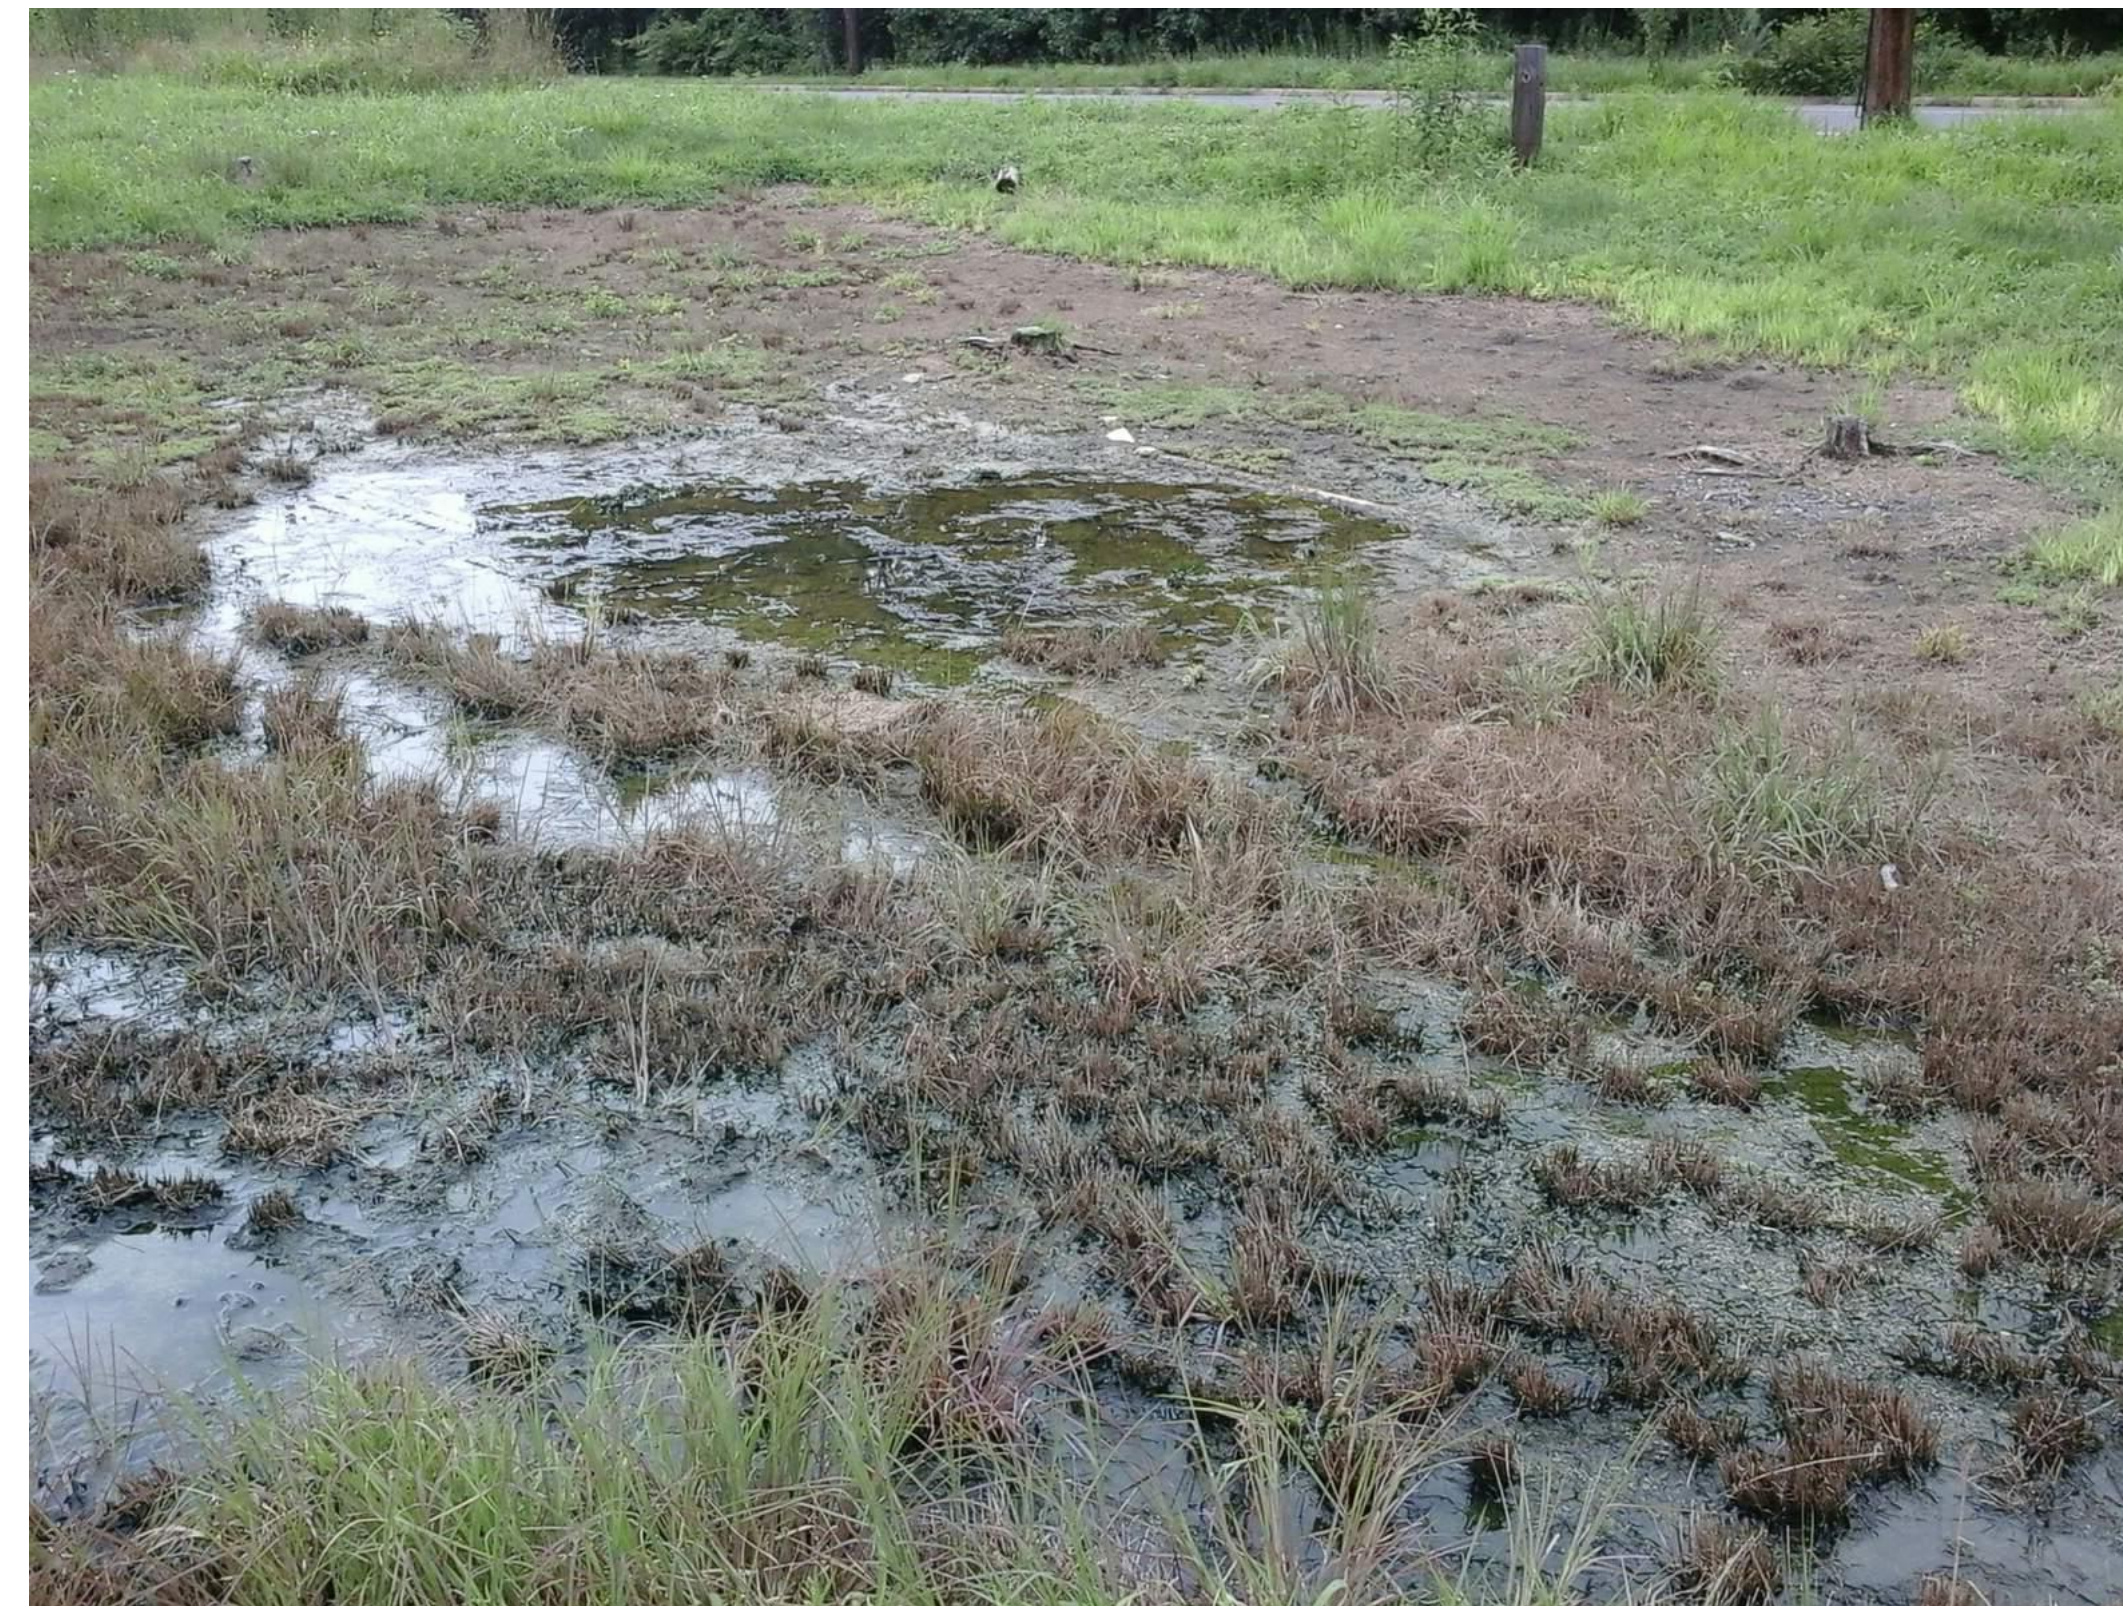
Inlet pipe from road
