## Hamilton Township (Mercer County)

# REVIEW AND EVALUATION OF TOTAL MAXIMUM DAILY LOADS (TMDLs)

Developed by the Rutgers Cooperative Extension Water Resources Program  
Funded by Hamilton Township, Mercer County, New Jersey

December 5, 2019

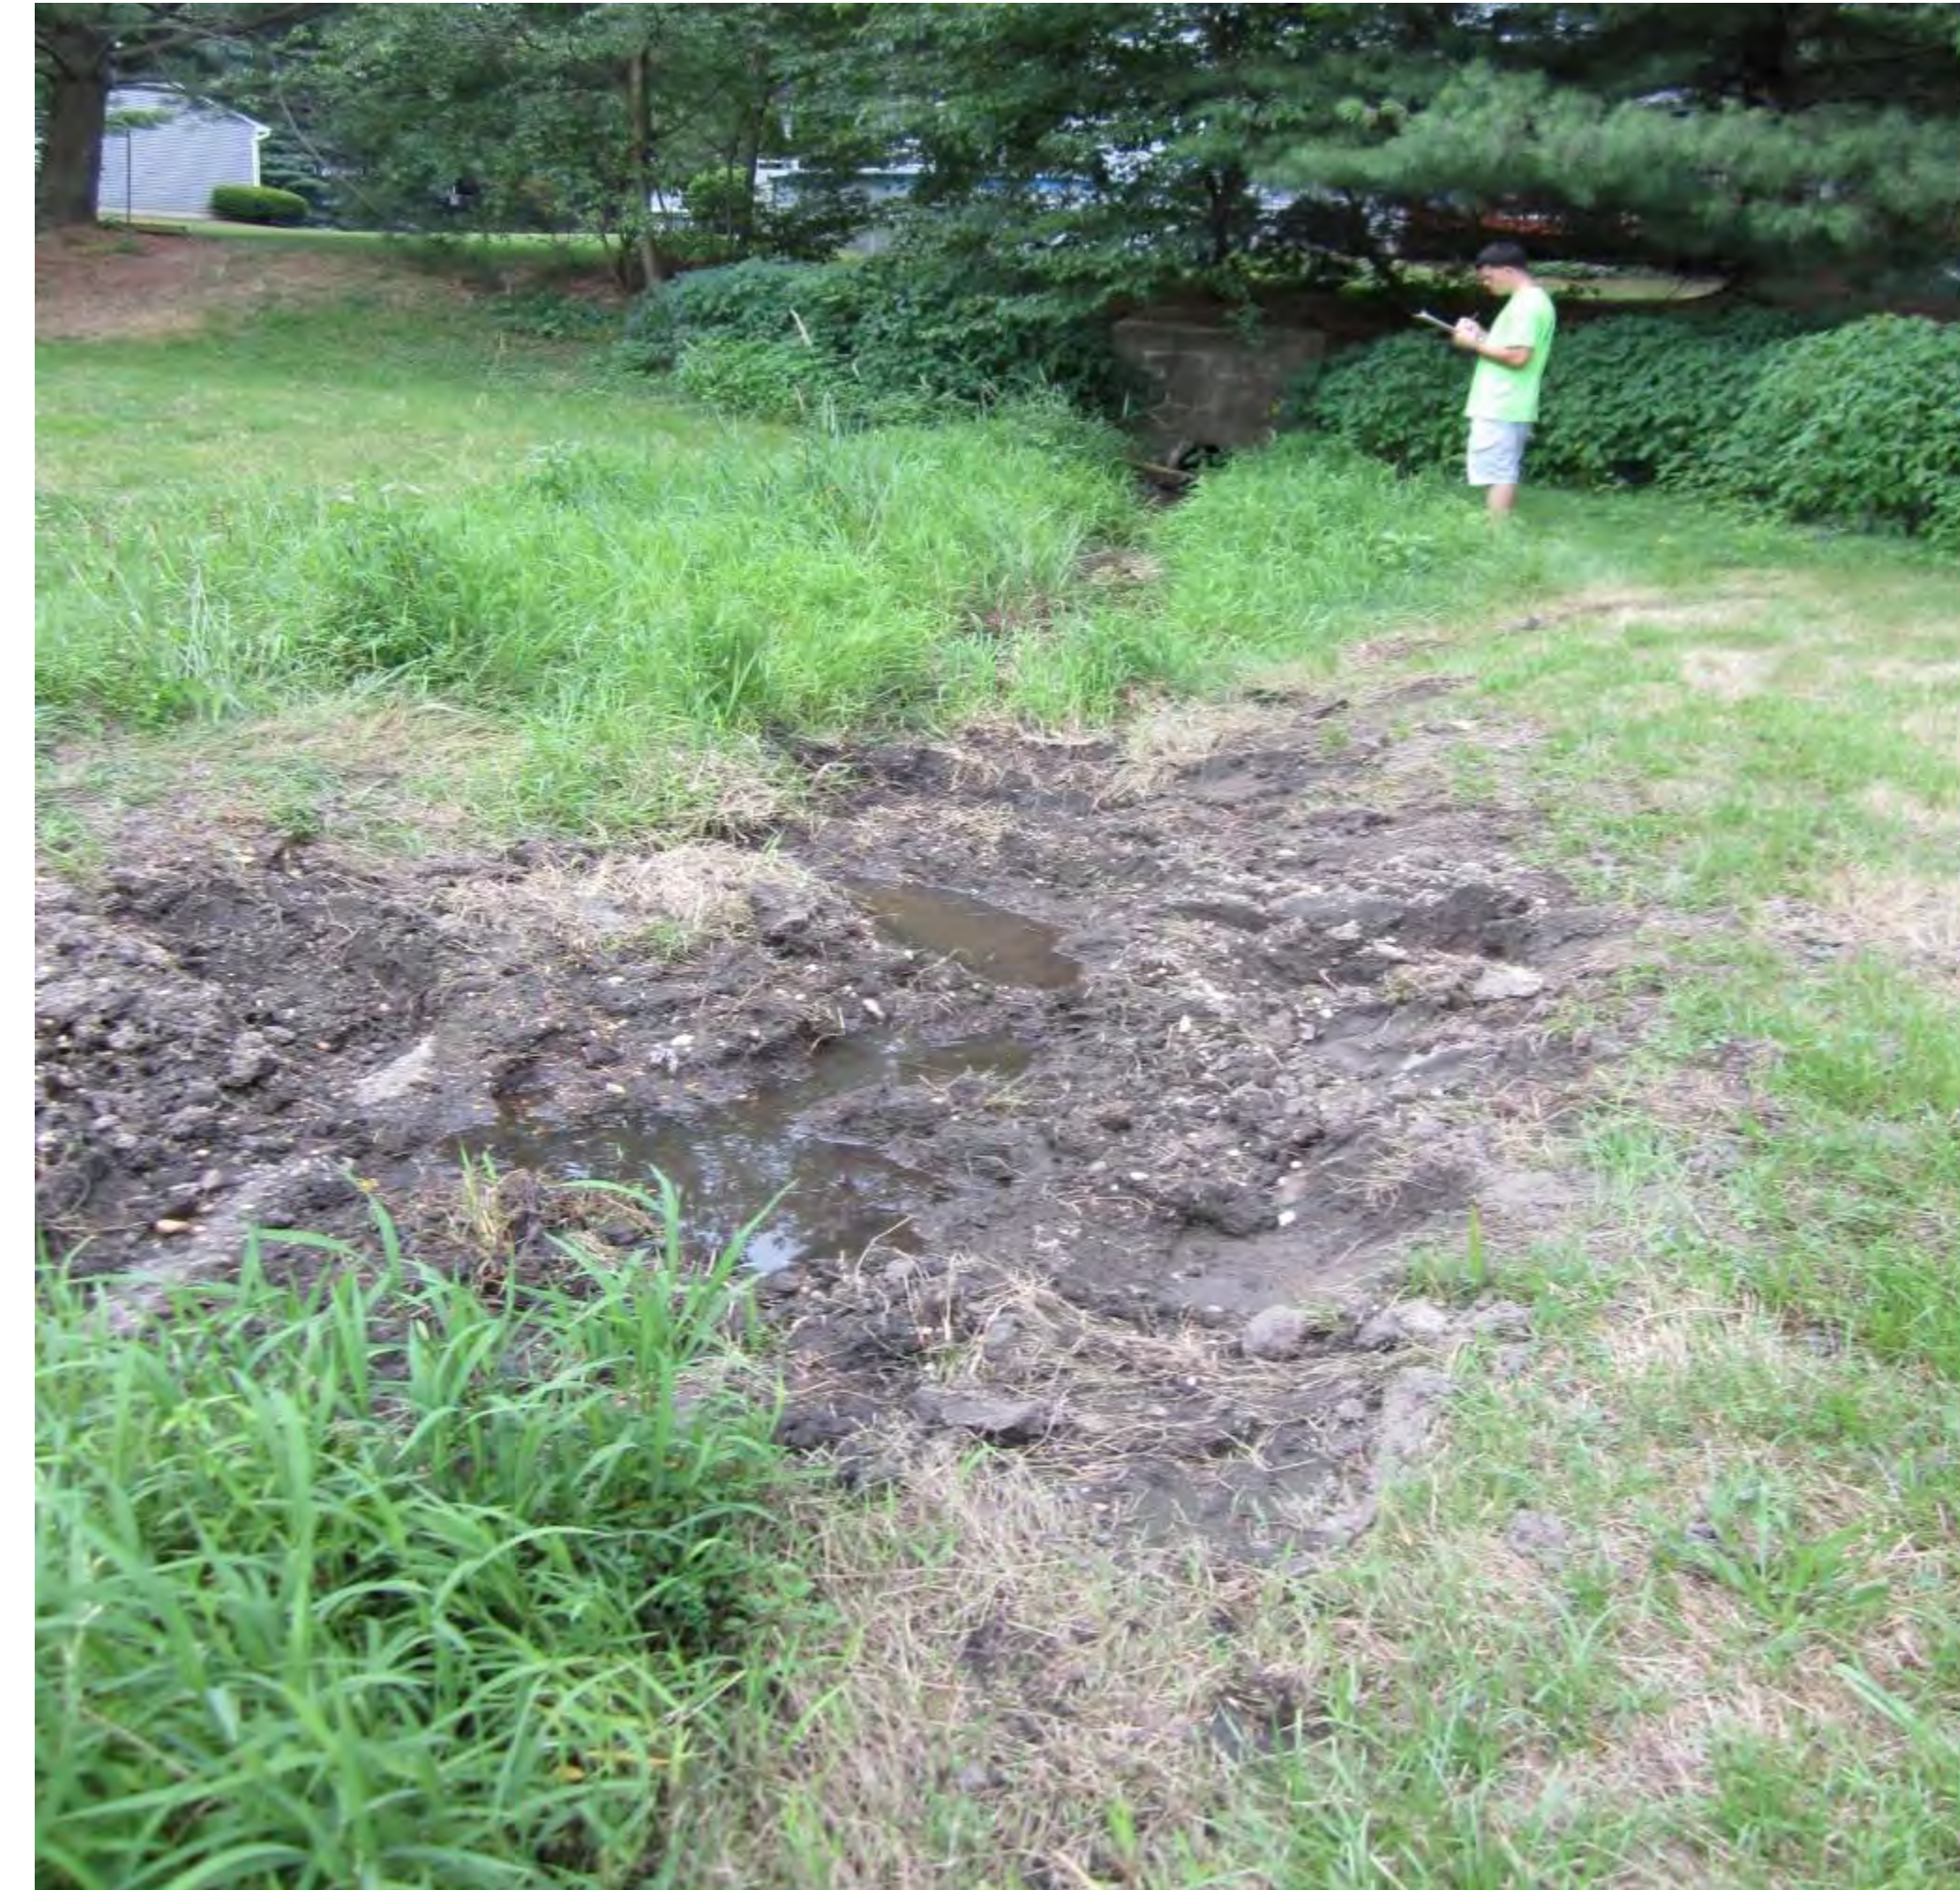
Clogged low flow and outlet.

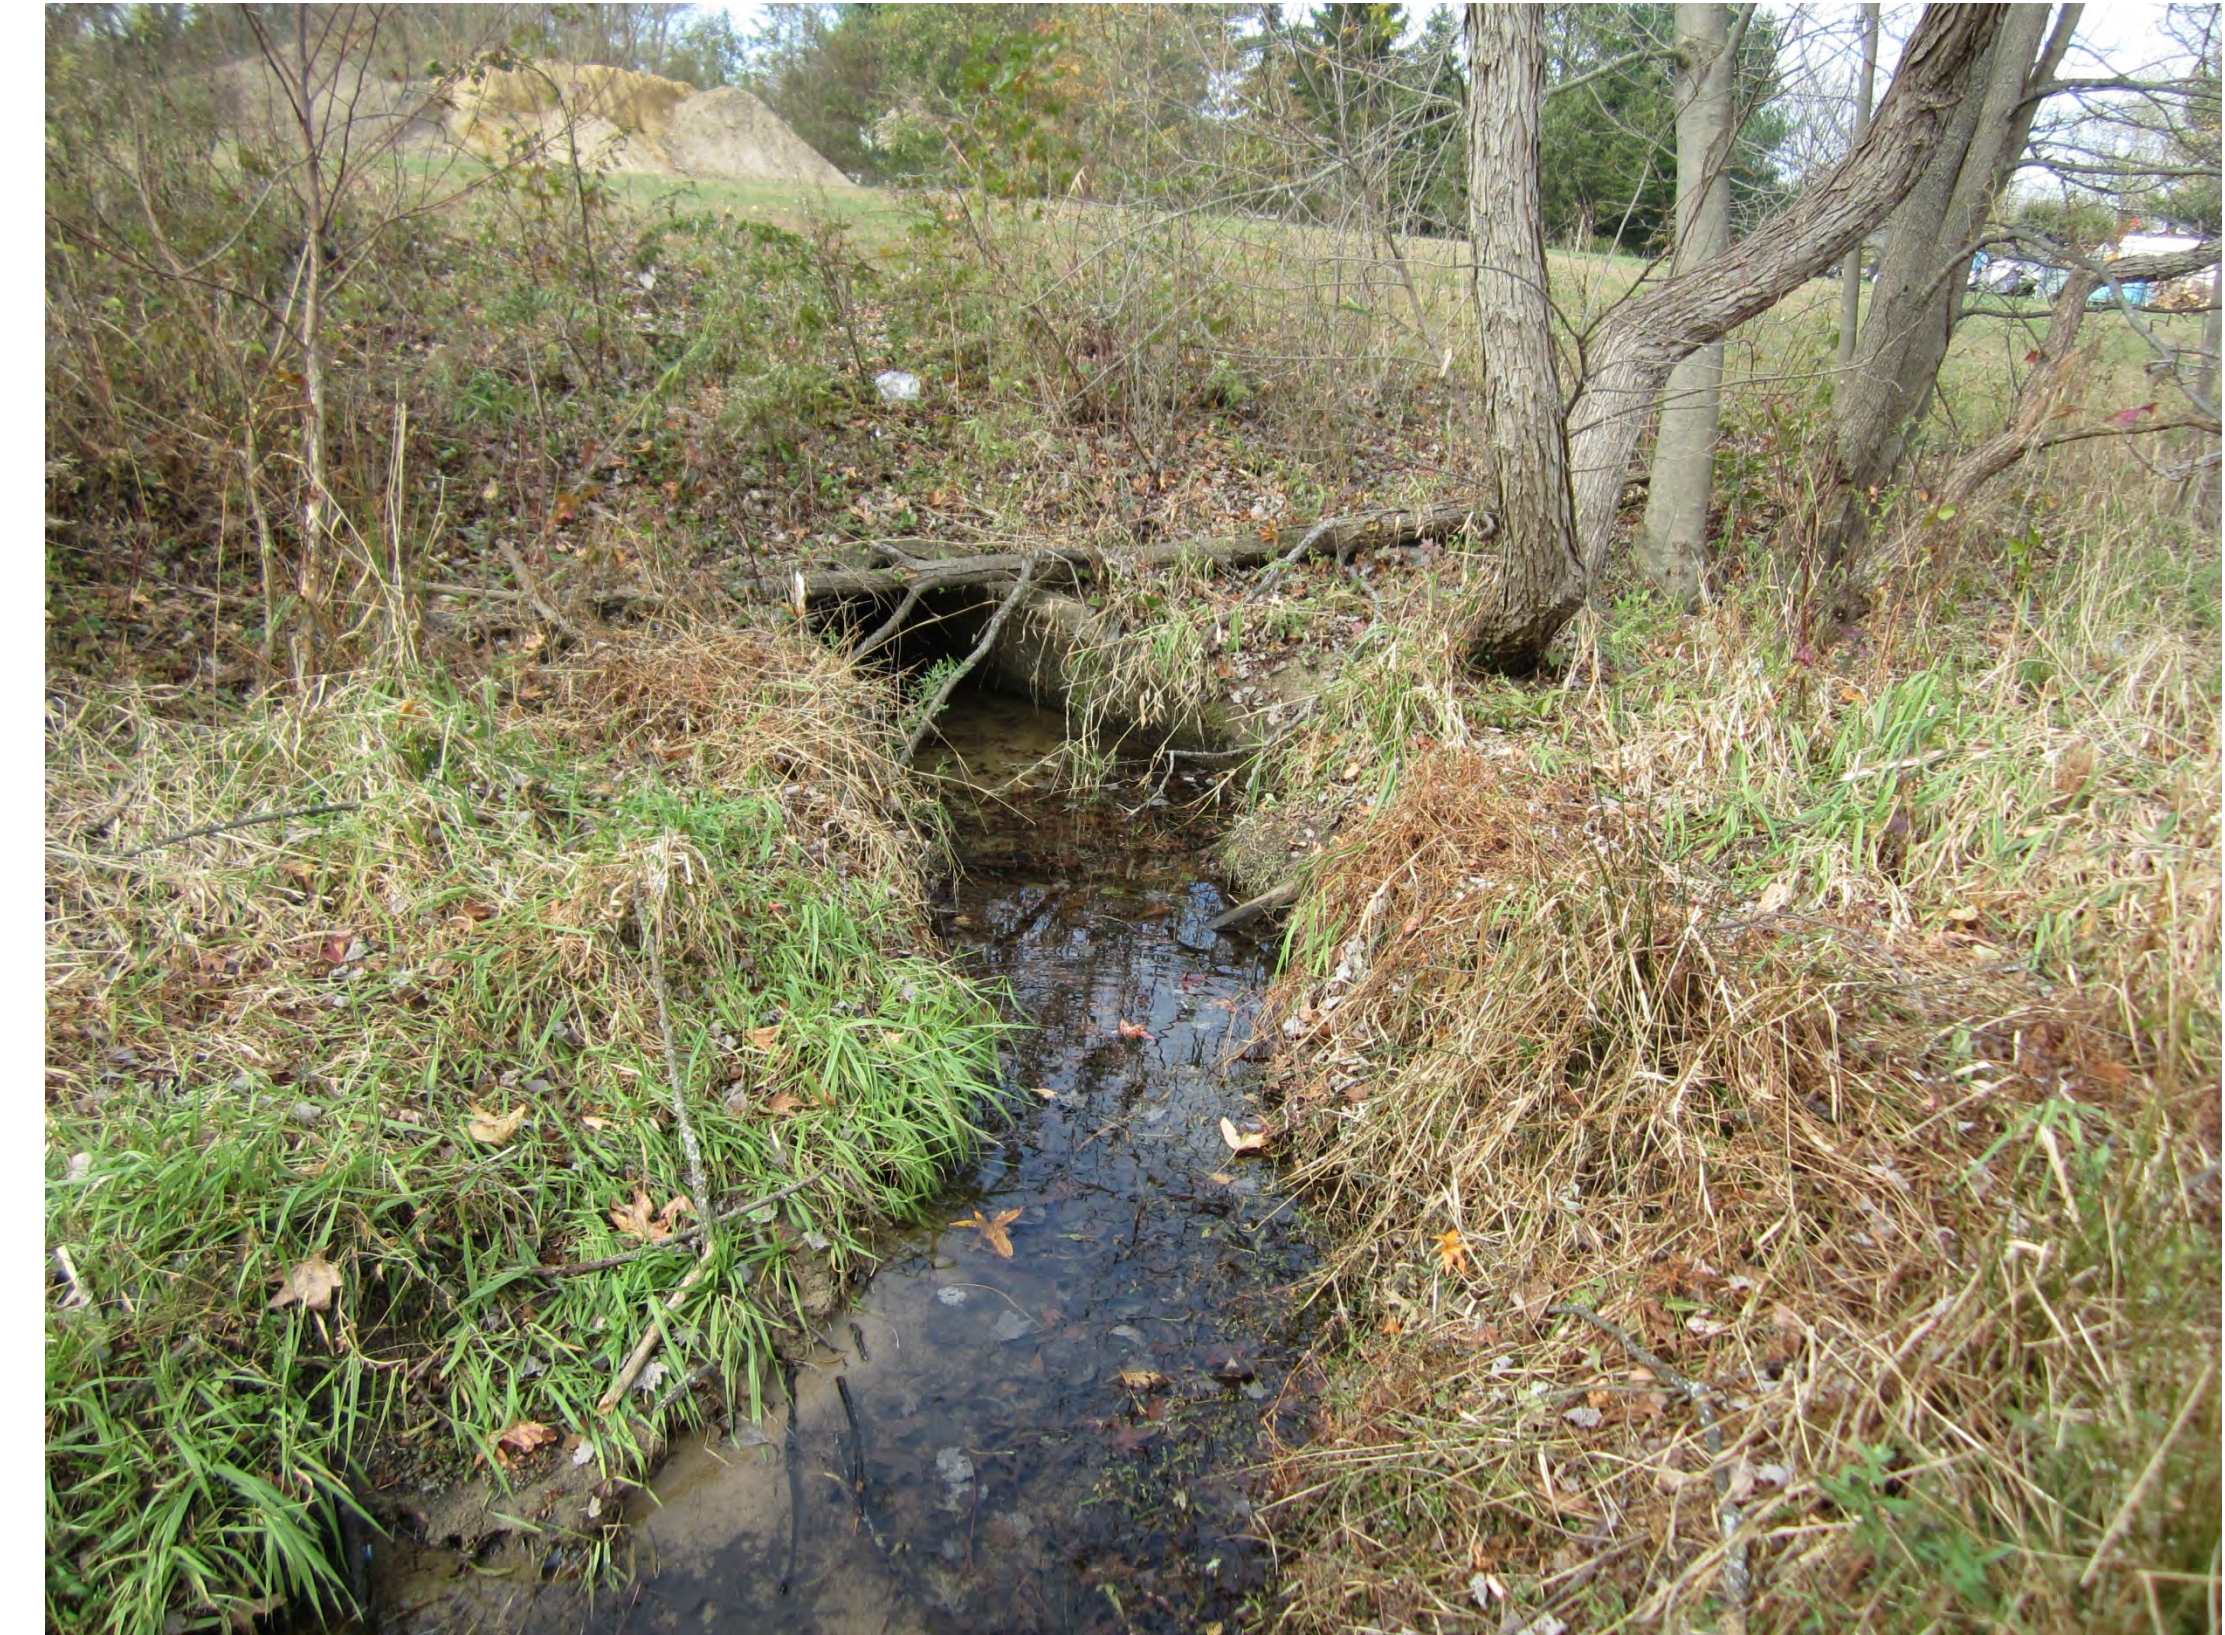
Inlet and erosion

- Basin is naturalized with dense vegetation
- Inlets and outlets are inaccessible due to vegetation growth in warm months
- Invasive plant species present including Phragmites and Purple Loosestrife
- Erosion present

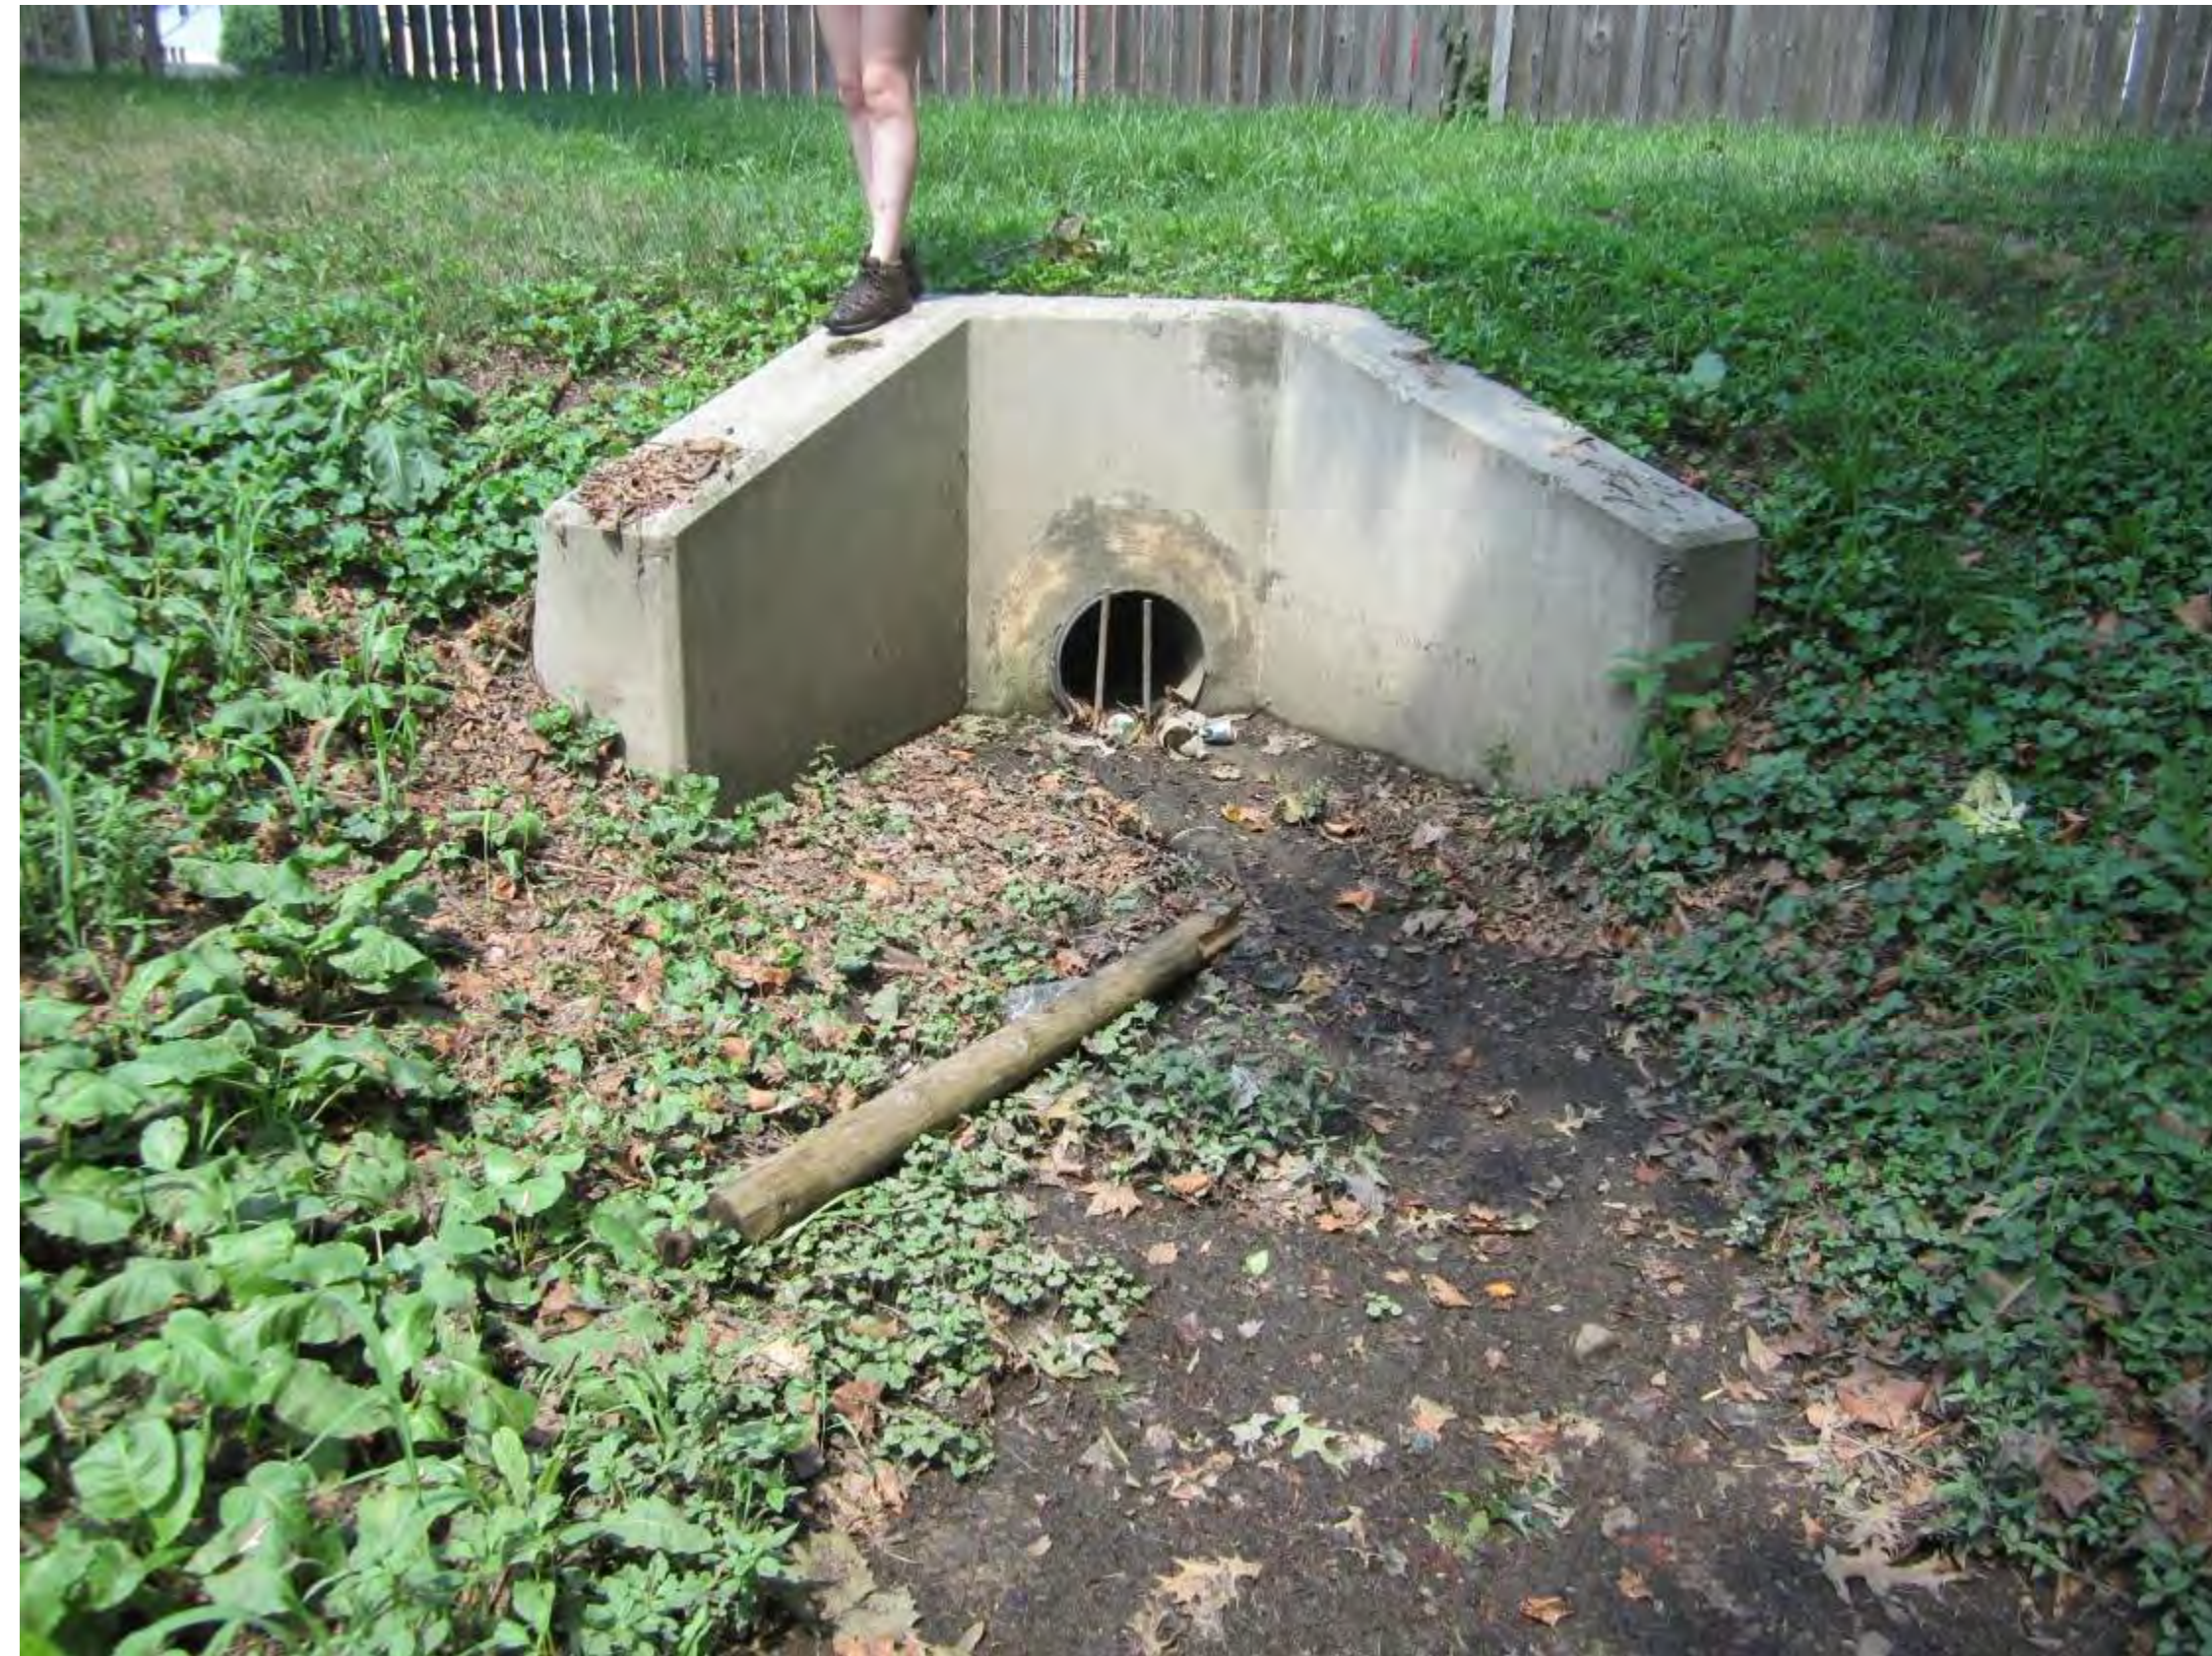
Inlet clogged with sediment

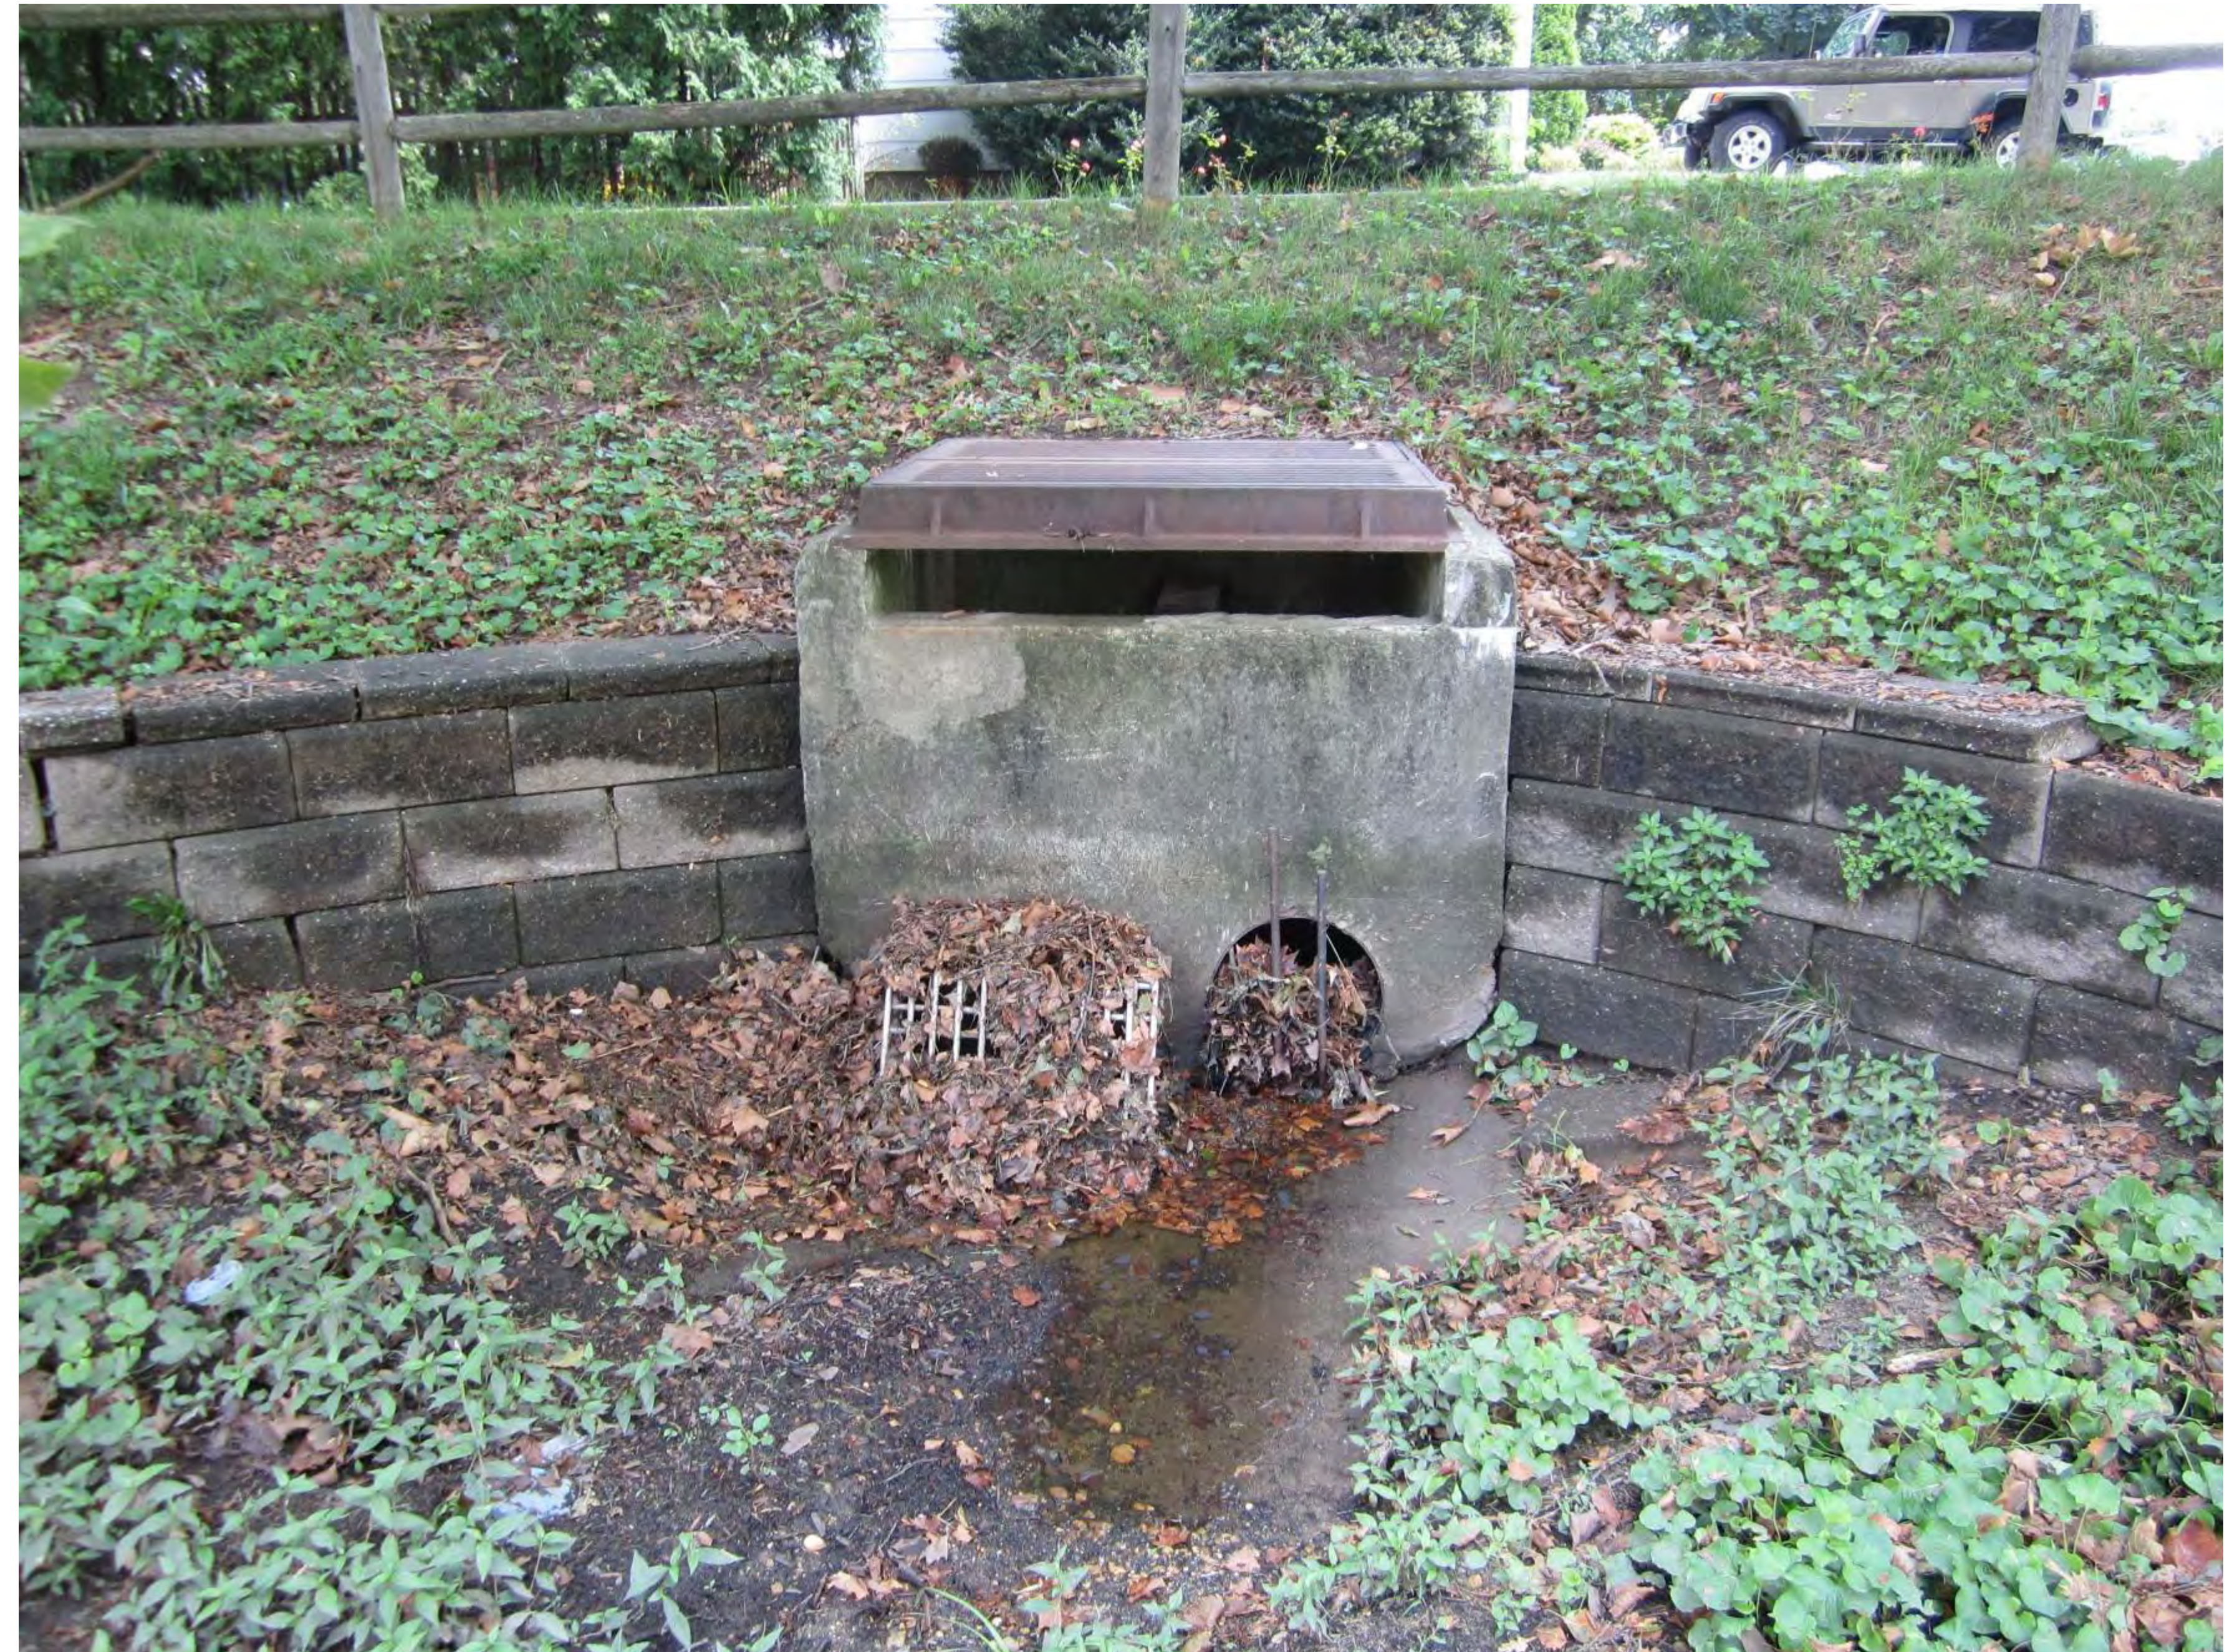
Clogged outlet structure

- Basin in overall good condition
- Some slight scouring along main flow channel
- Outlet clogged with leaves

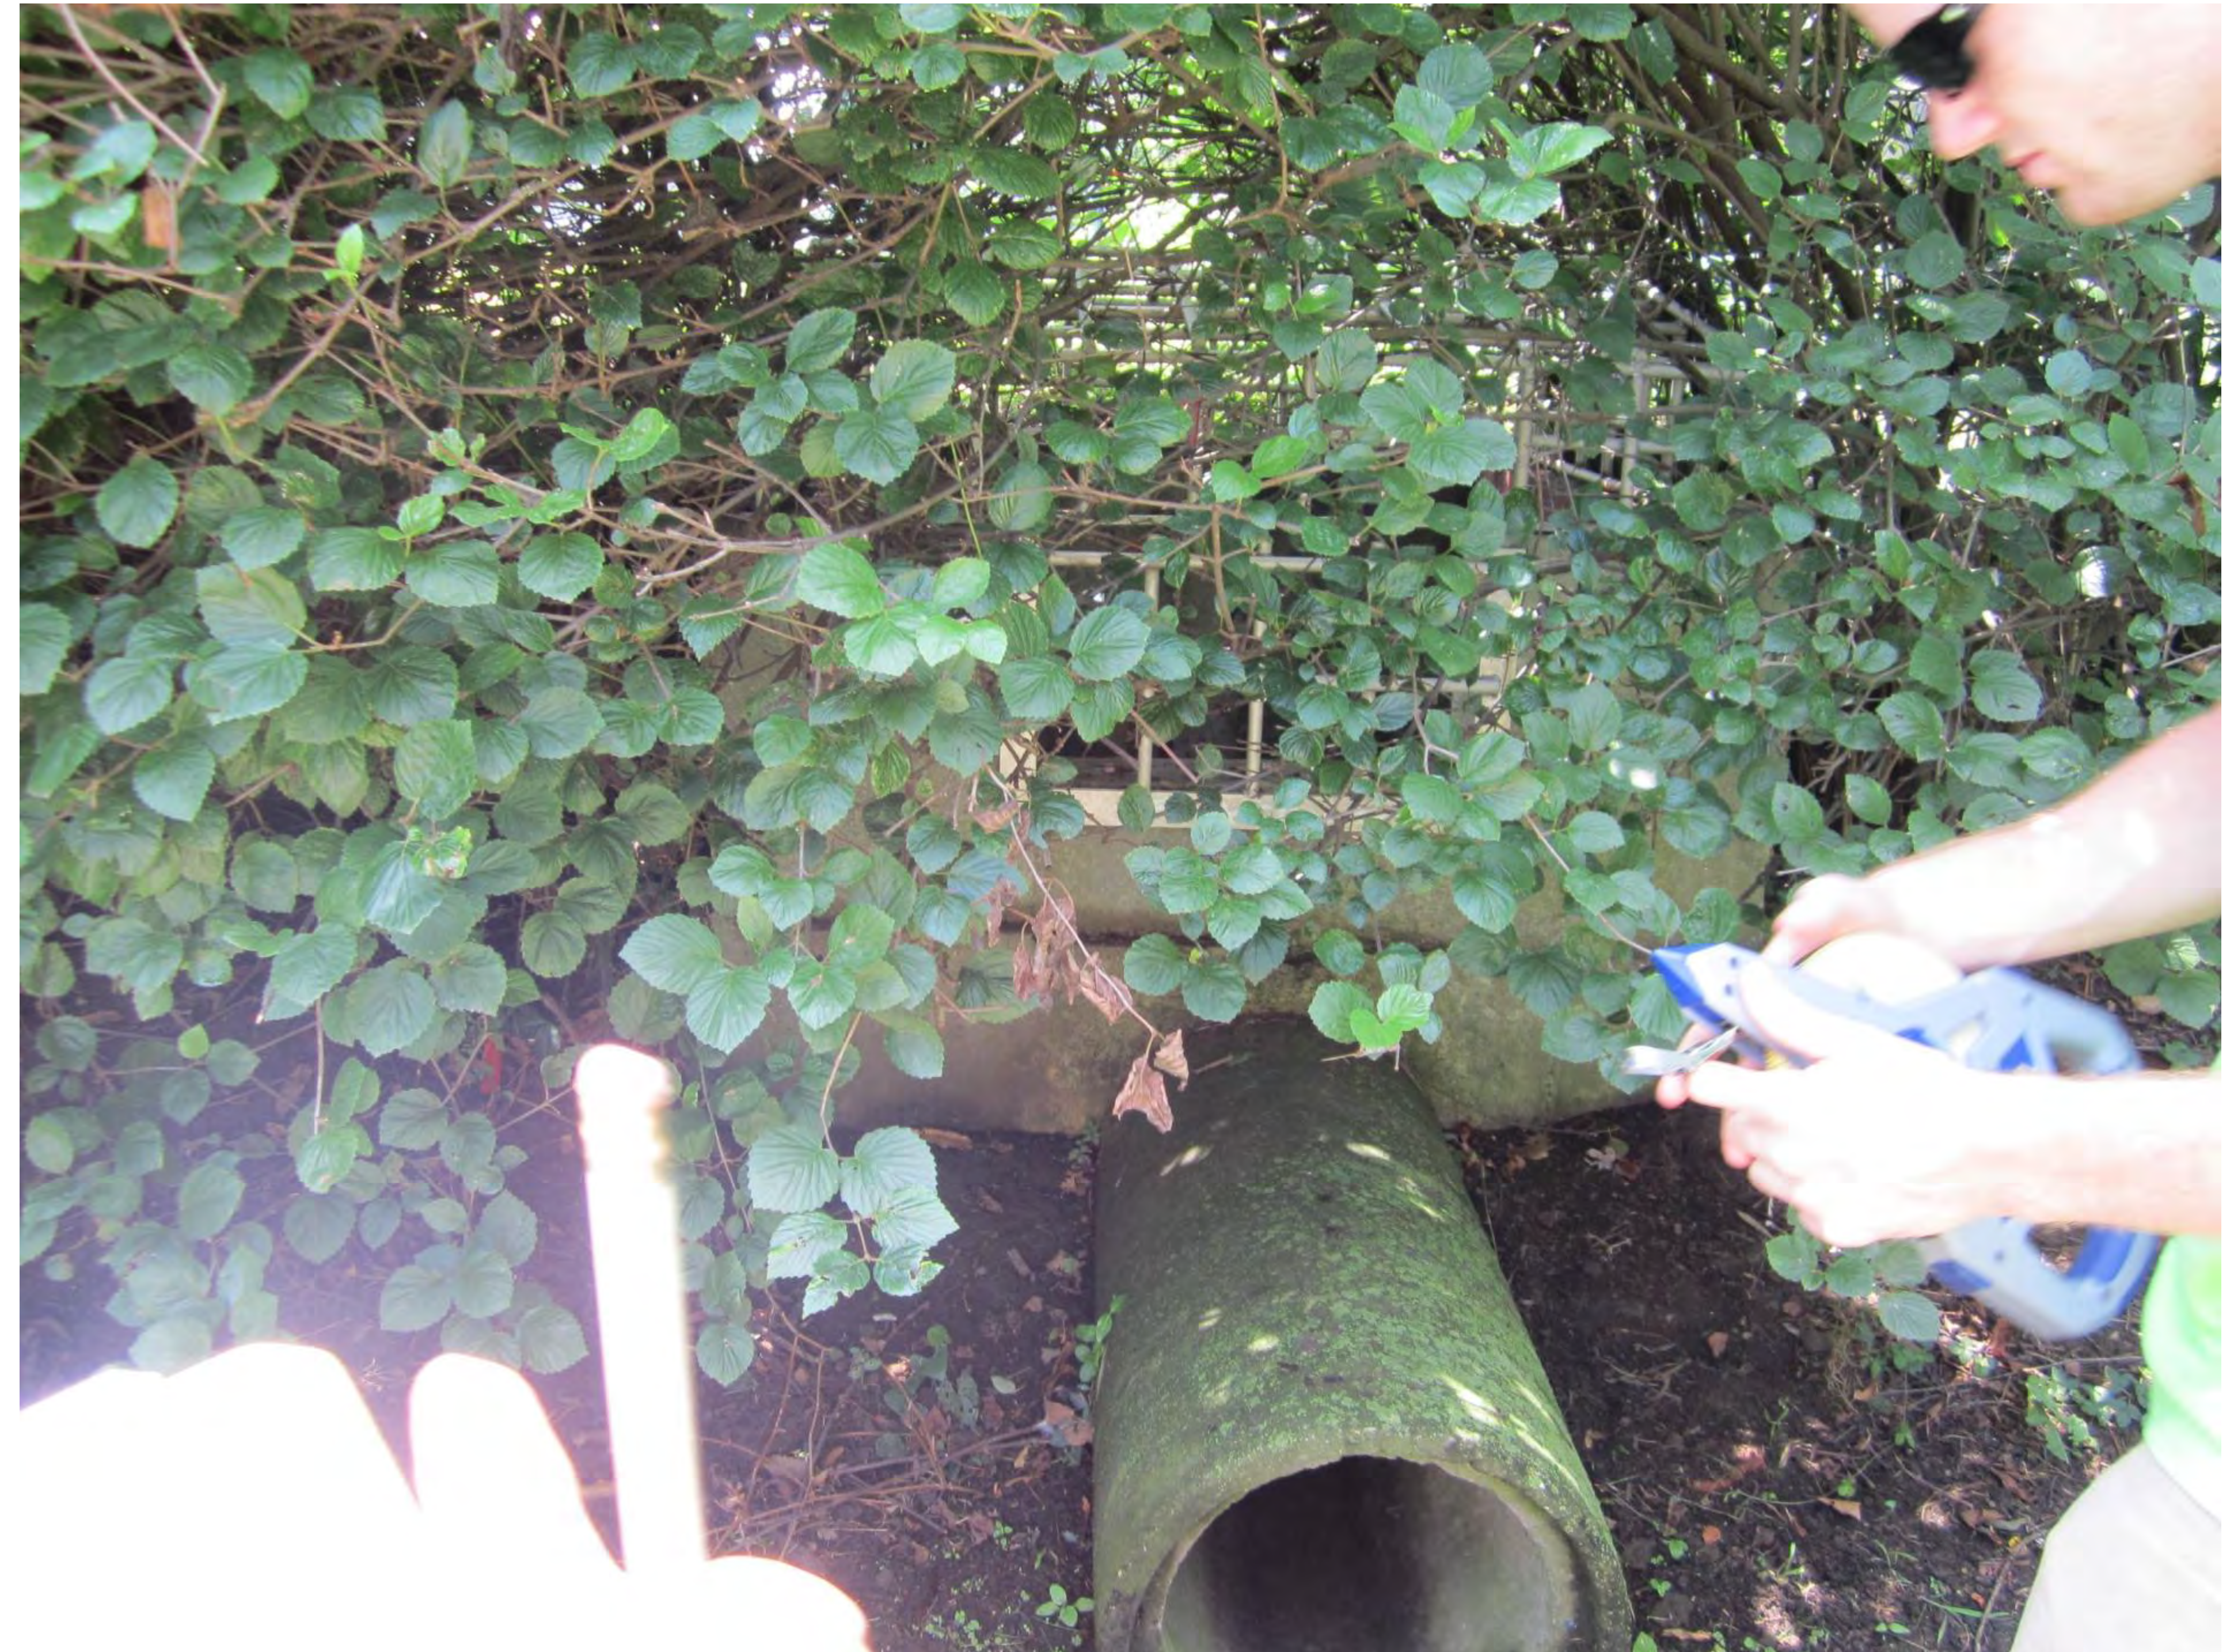
Woody vegetation growth around outlet

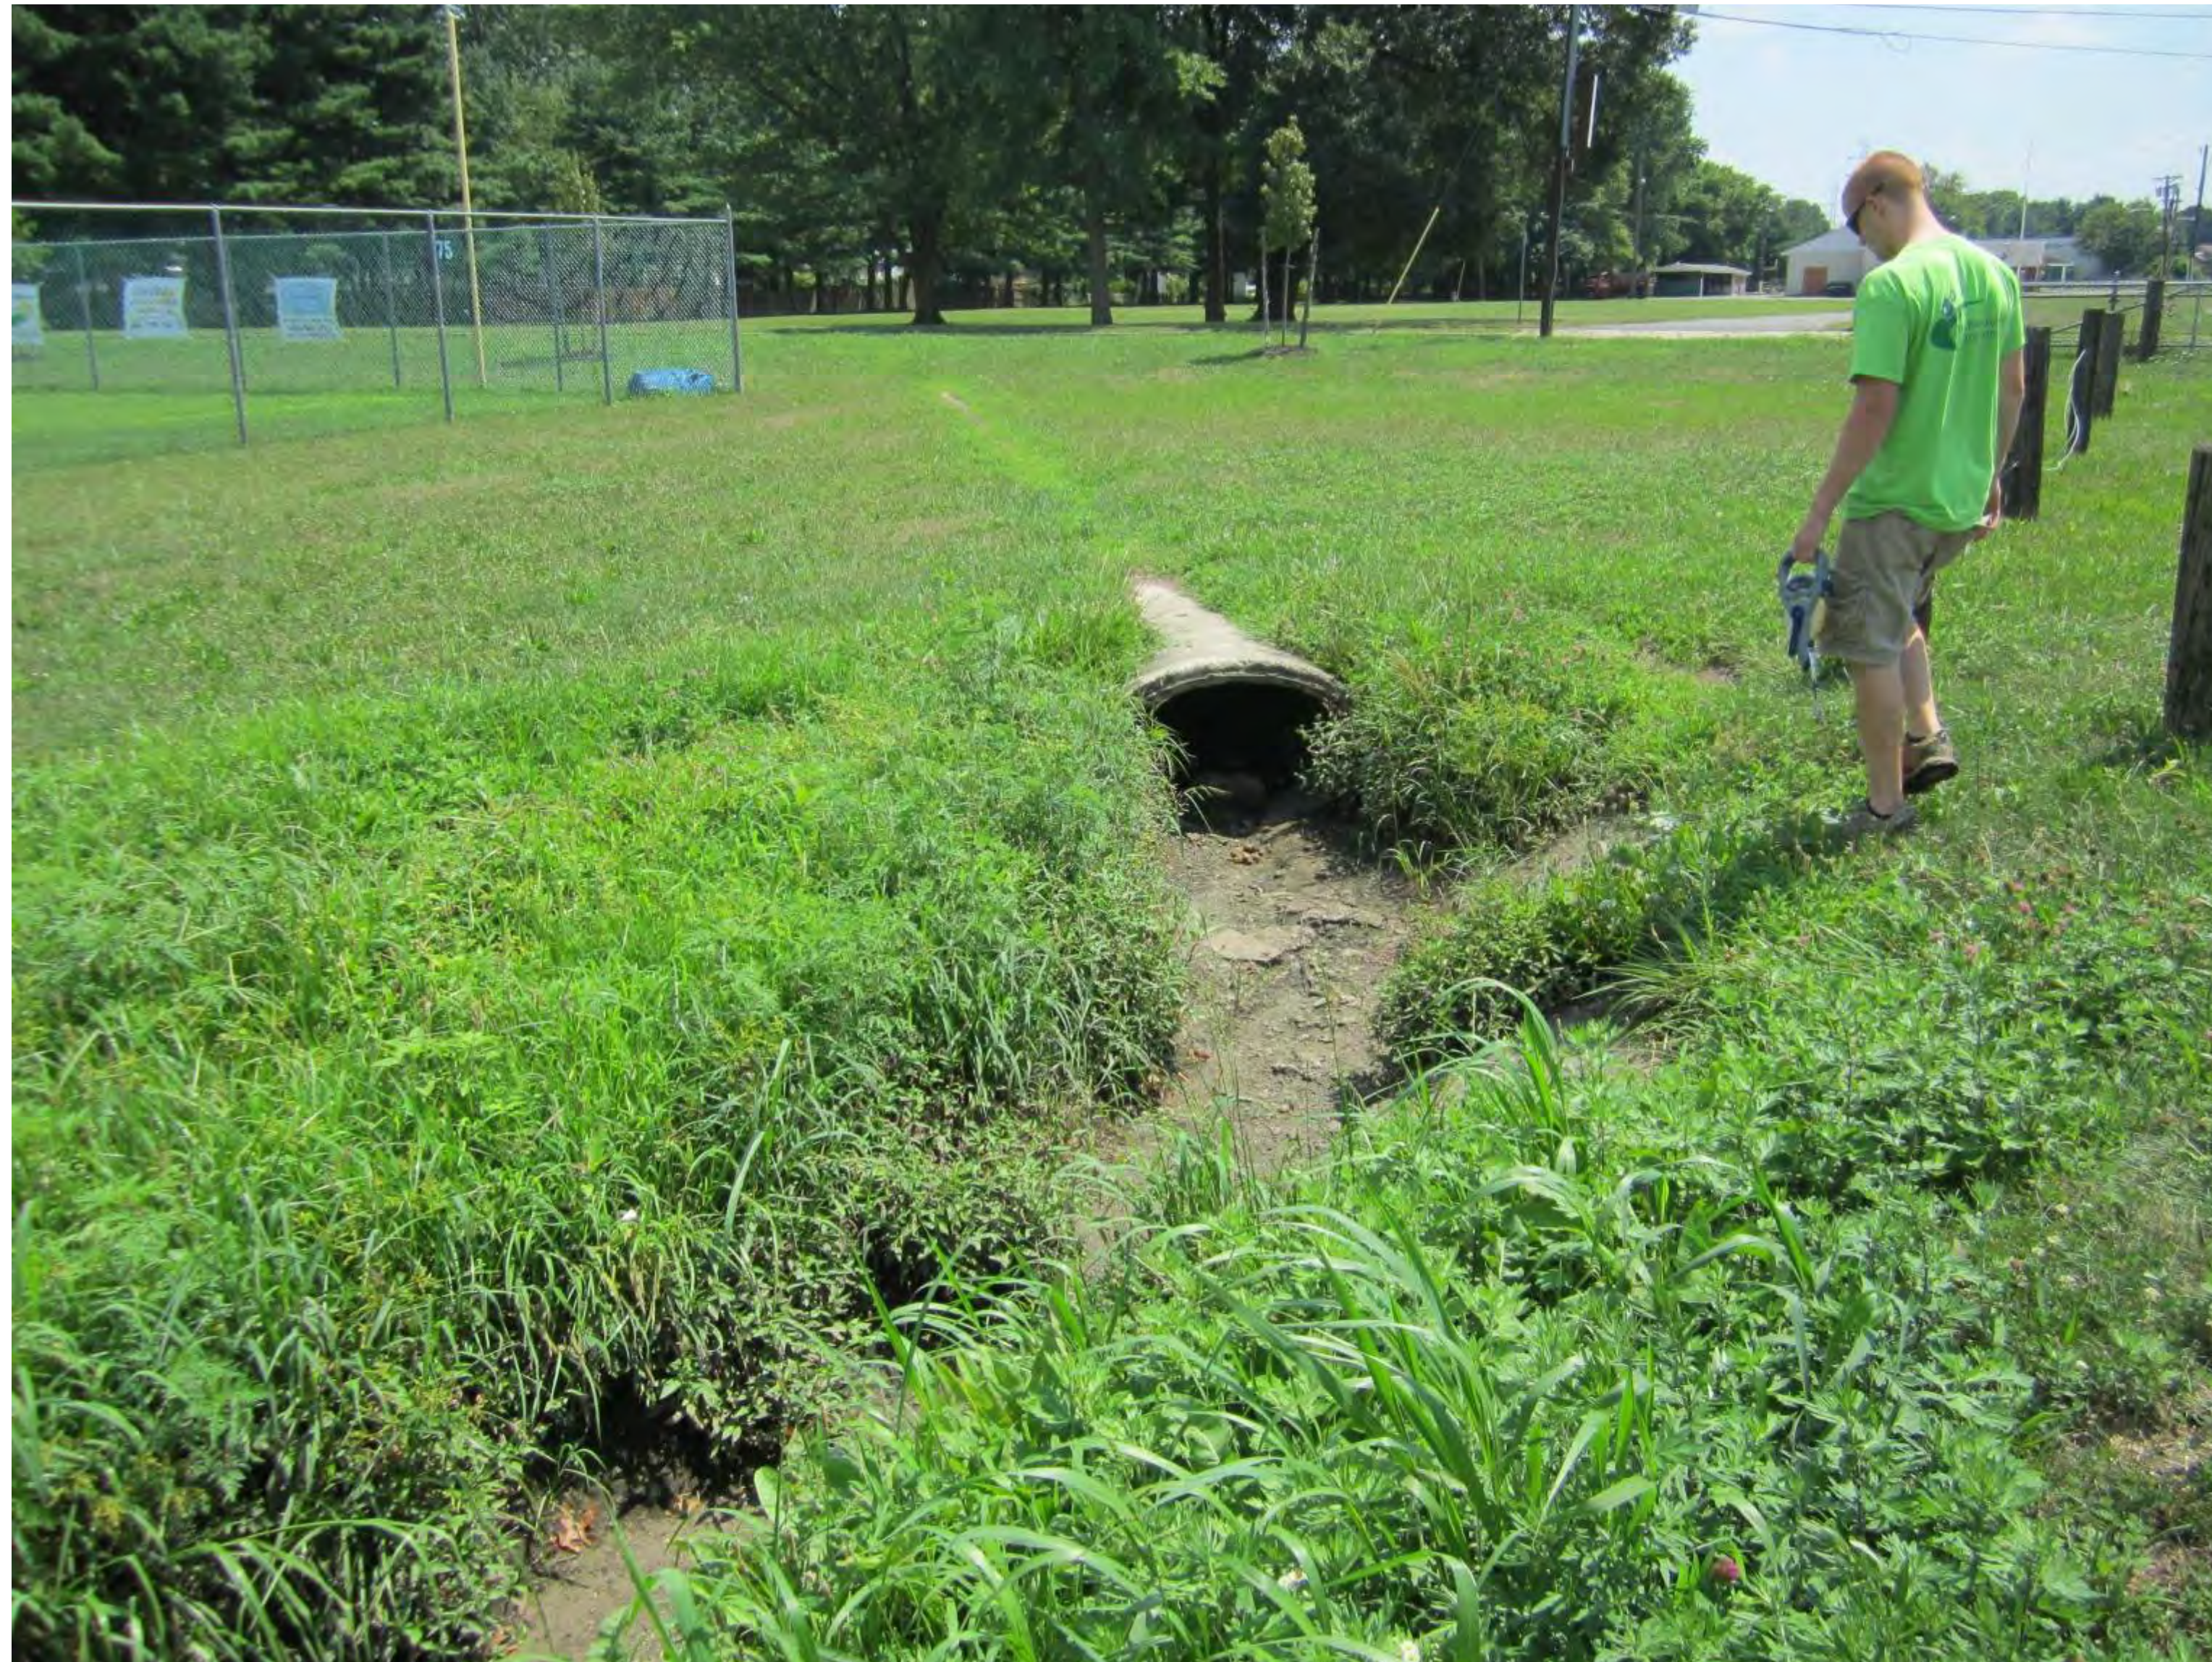
Inlet with sediment accumulation
