## Hamilton Township (Mercer County)

# REVIEW AND EVALUATION OF TOTAL MAXIMUM DAILY LOADS (TMDLs)

Developed by the Rutgers Cooperative Extension Water Resources Program  
Funded by Hamilton Township, Mercer County, New Jersey

December 5, 2019

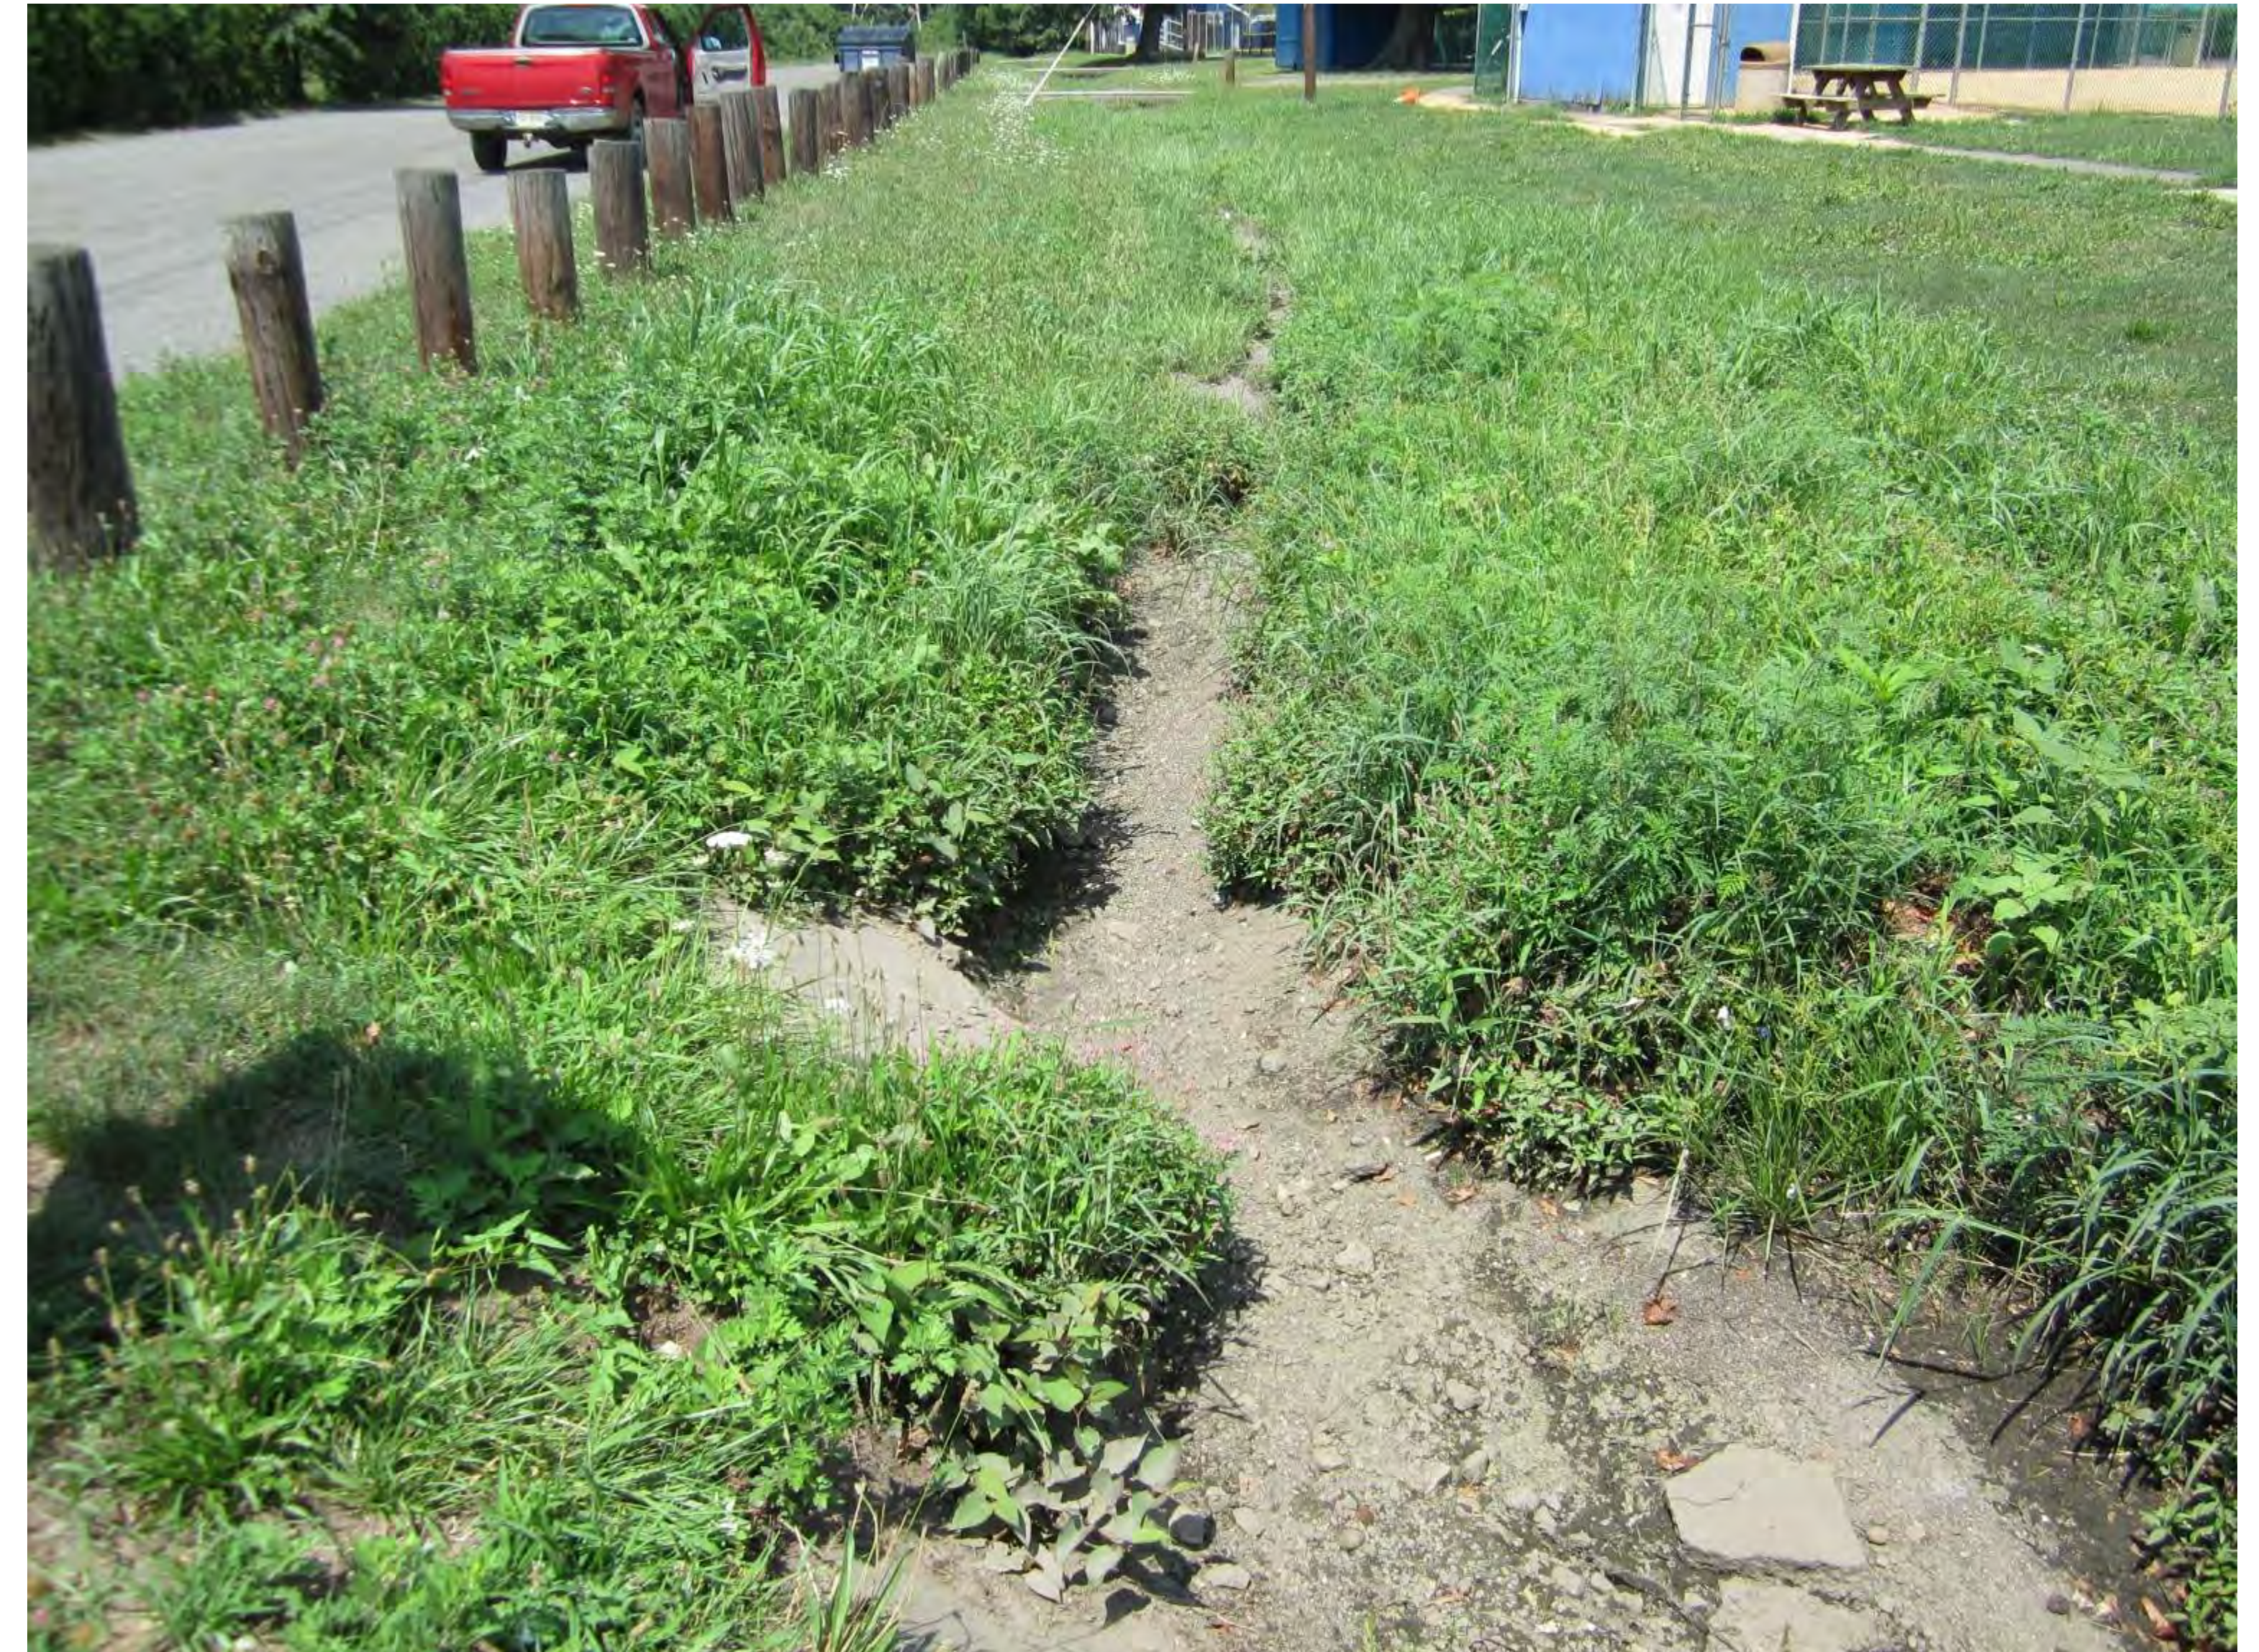
Basin bottom with erosion

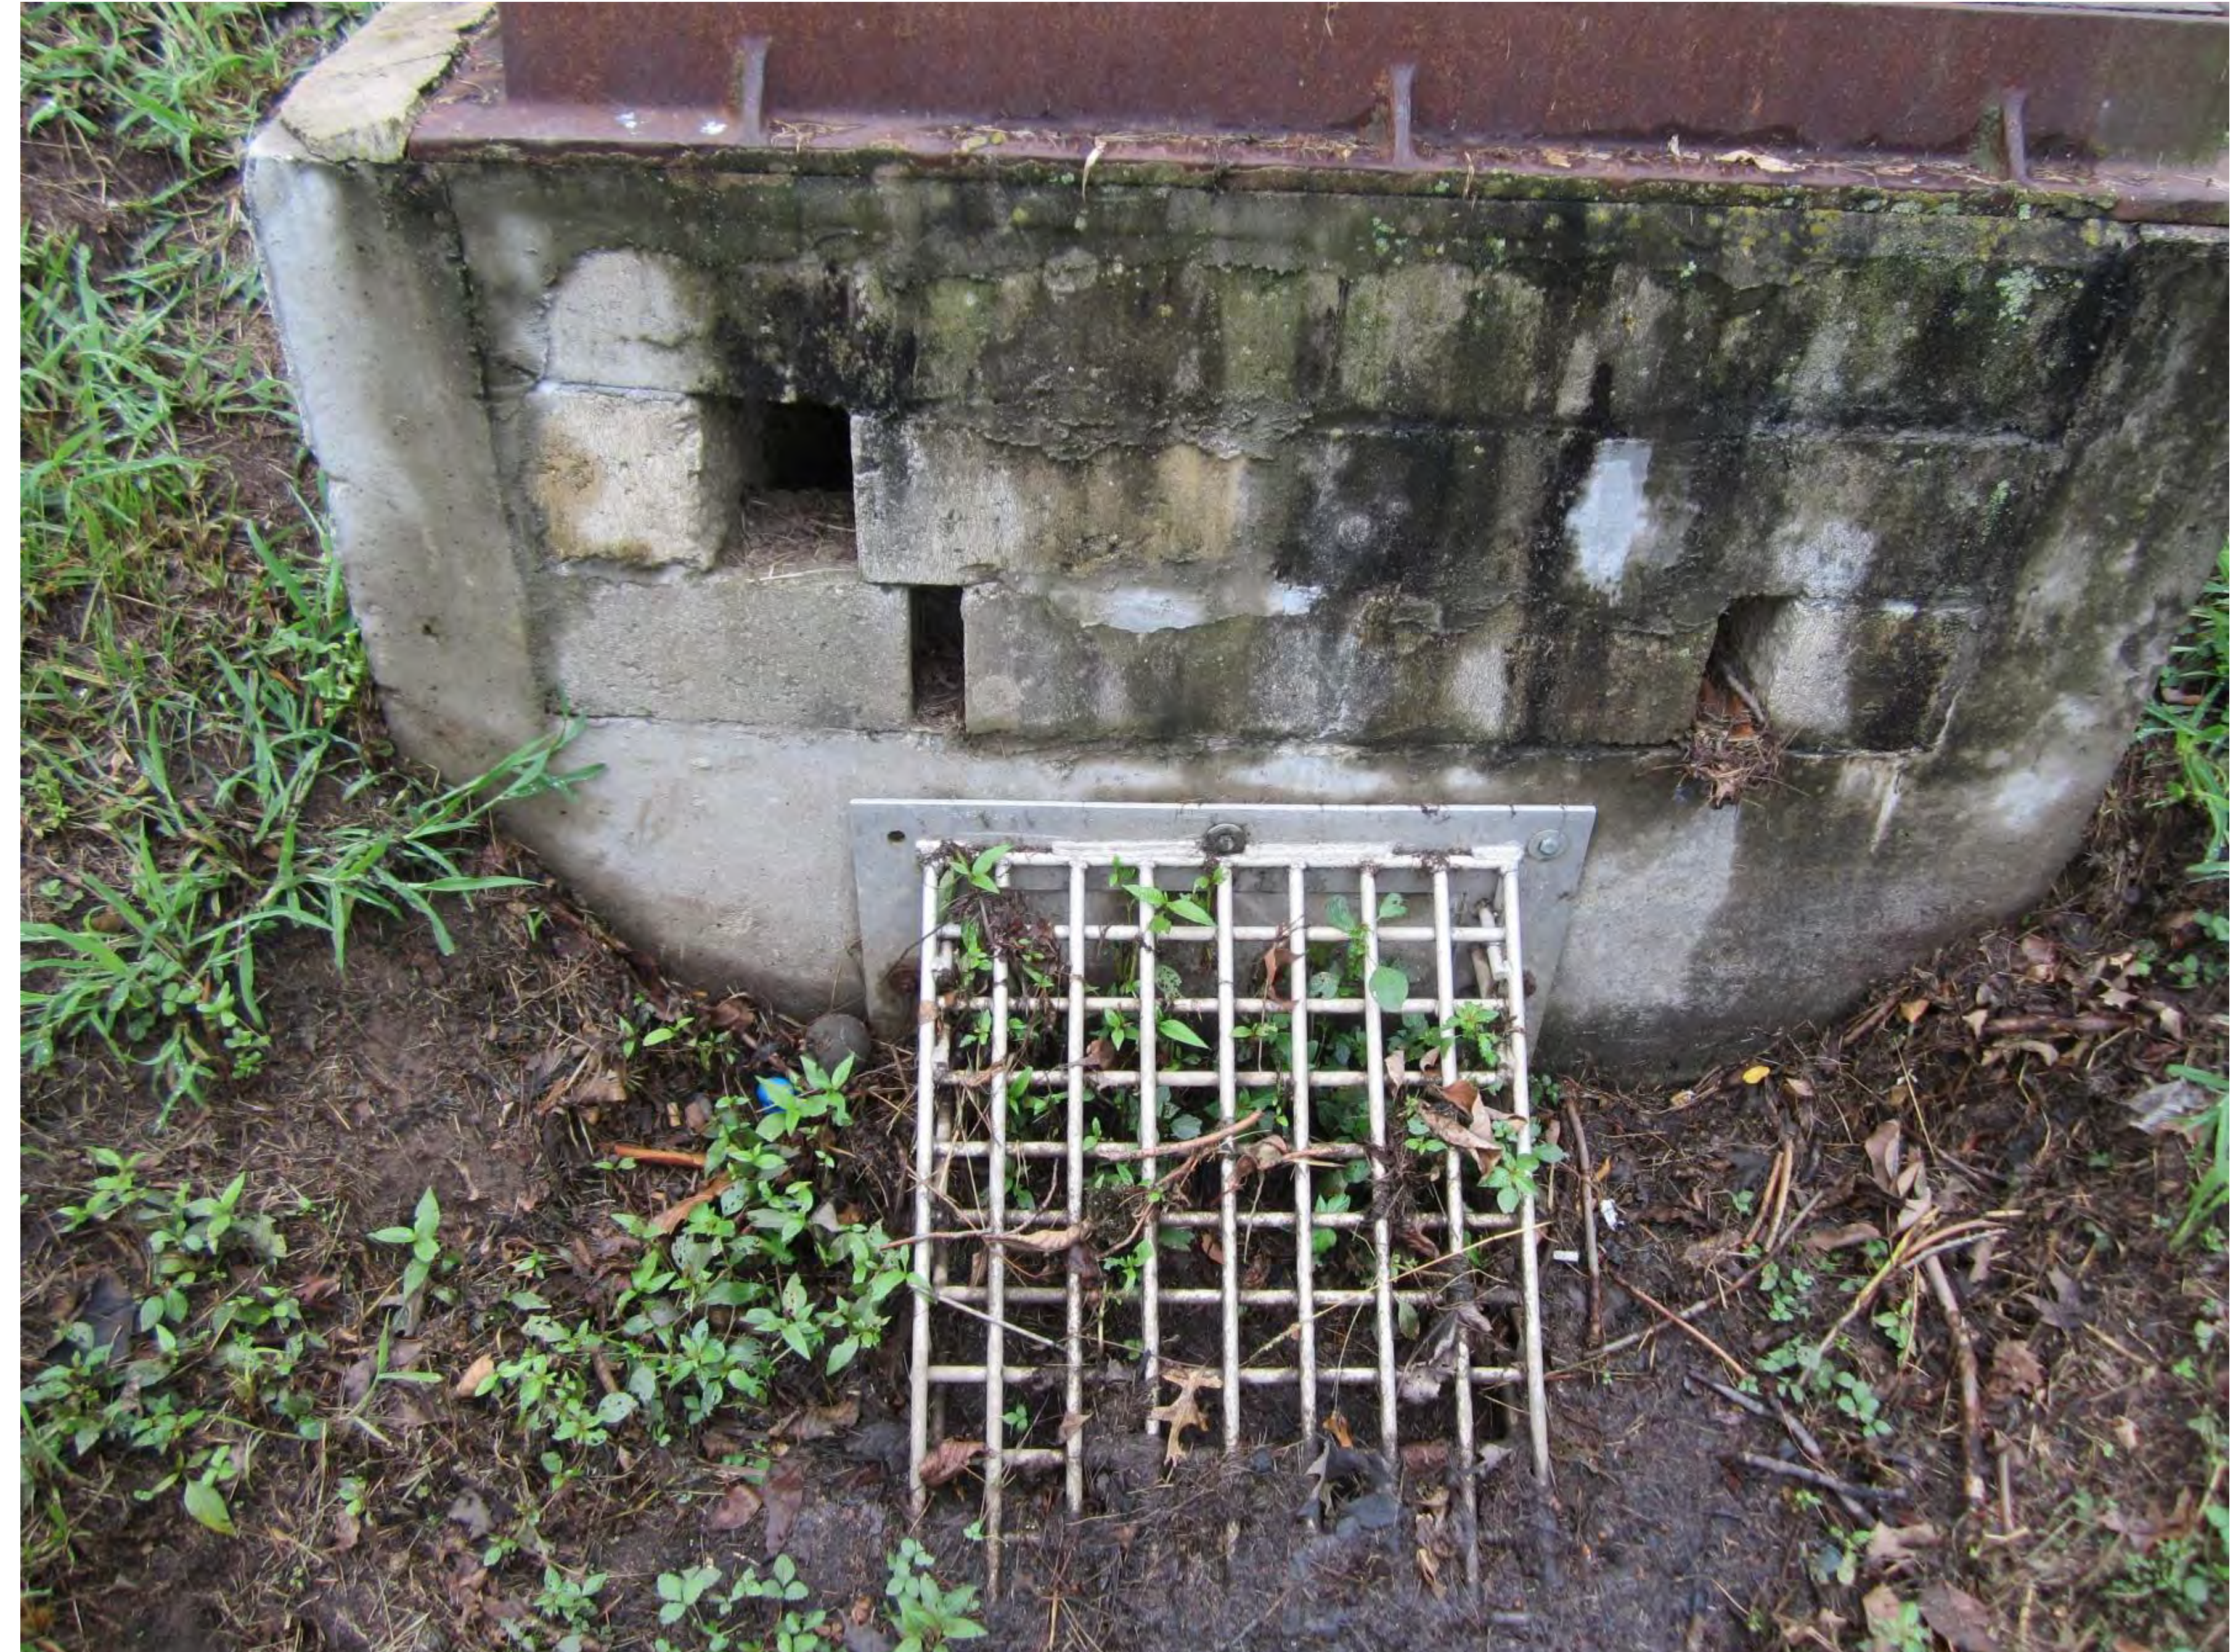
Clogged trash rack at outlet

- Standing water in low flow channel
- Outlet has structural damage and trash rack is clogged with sediment/debris

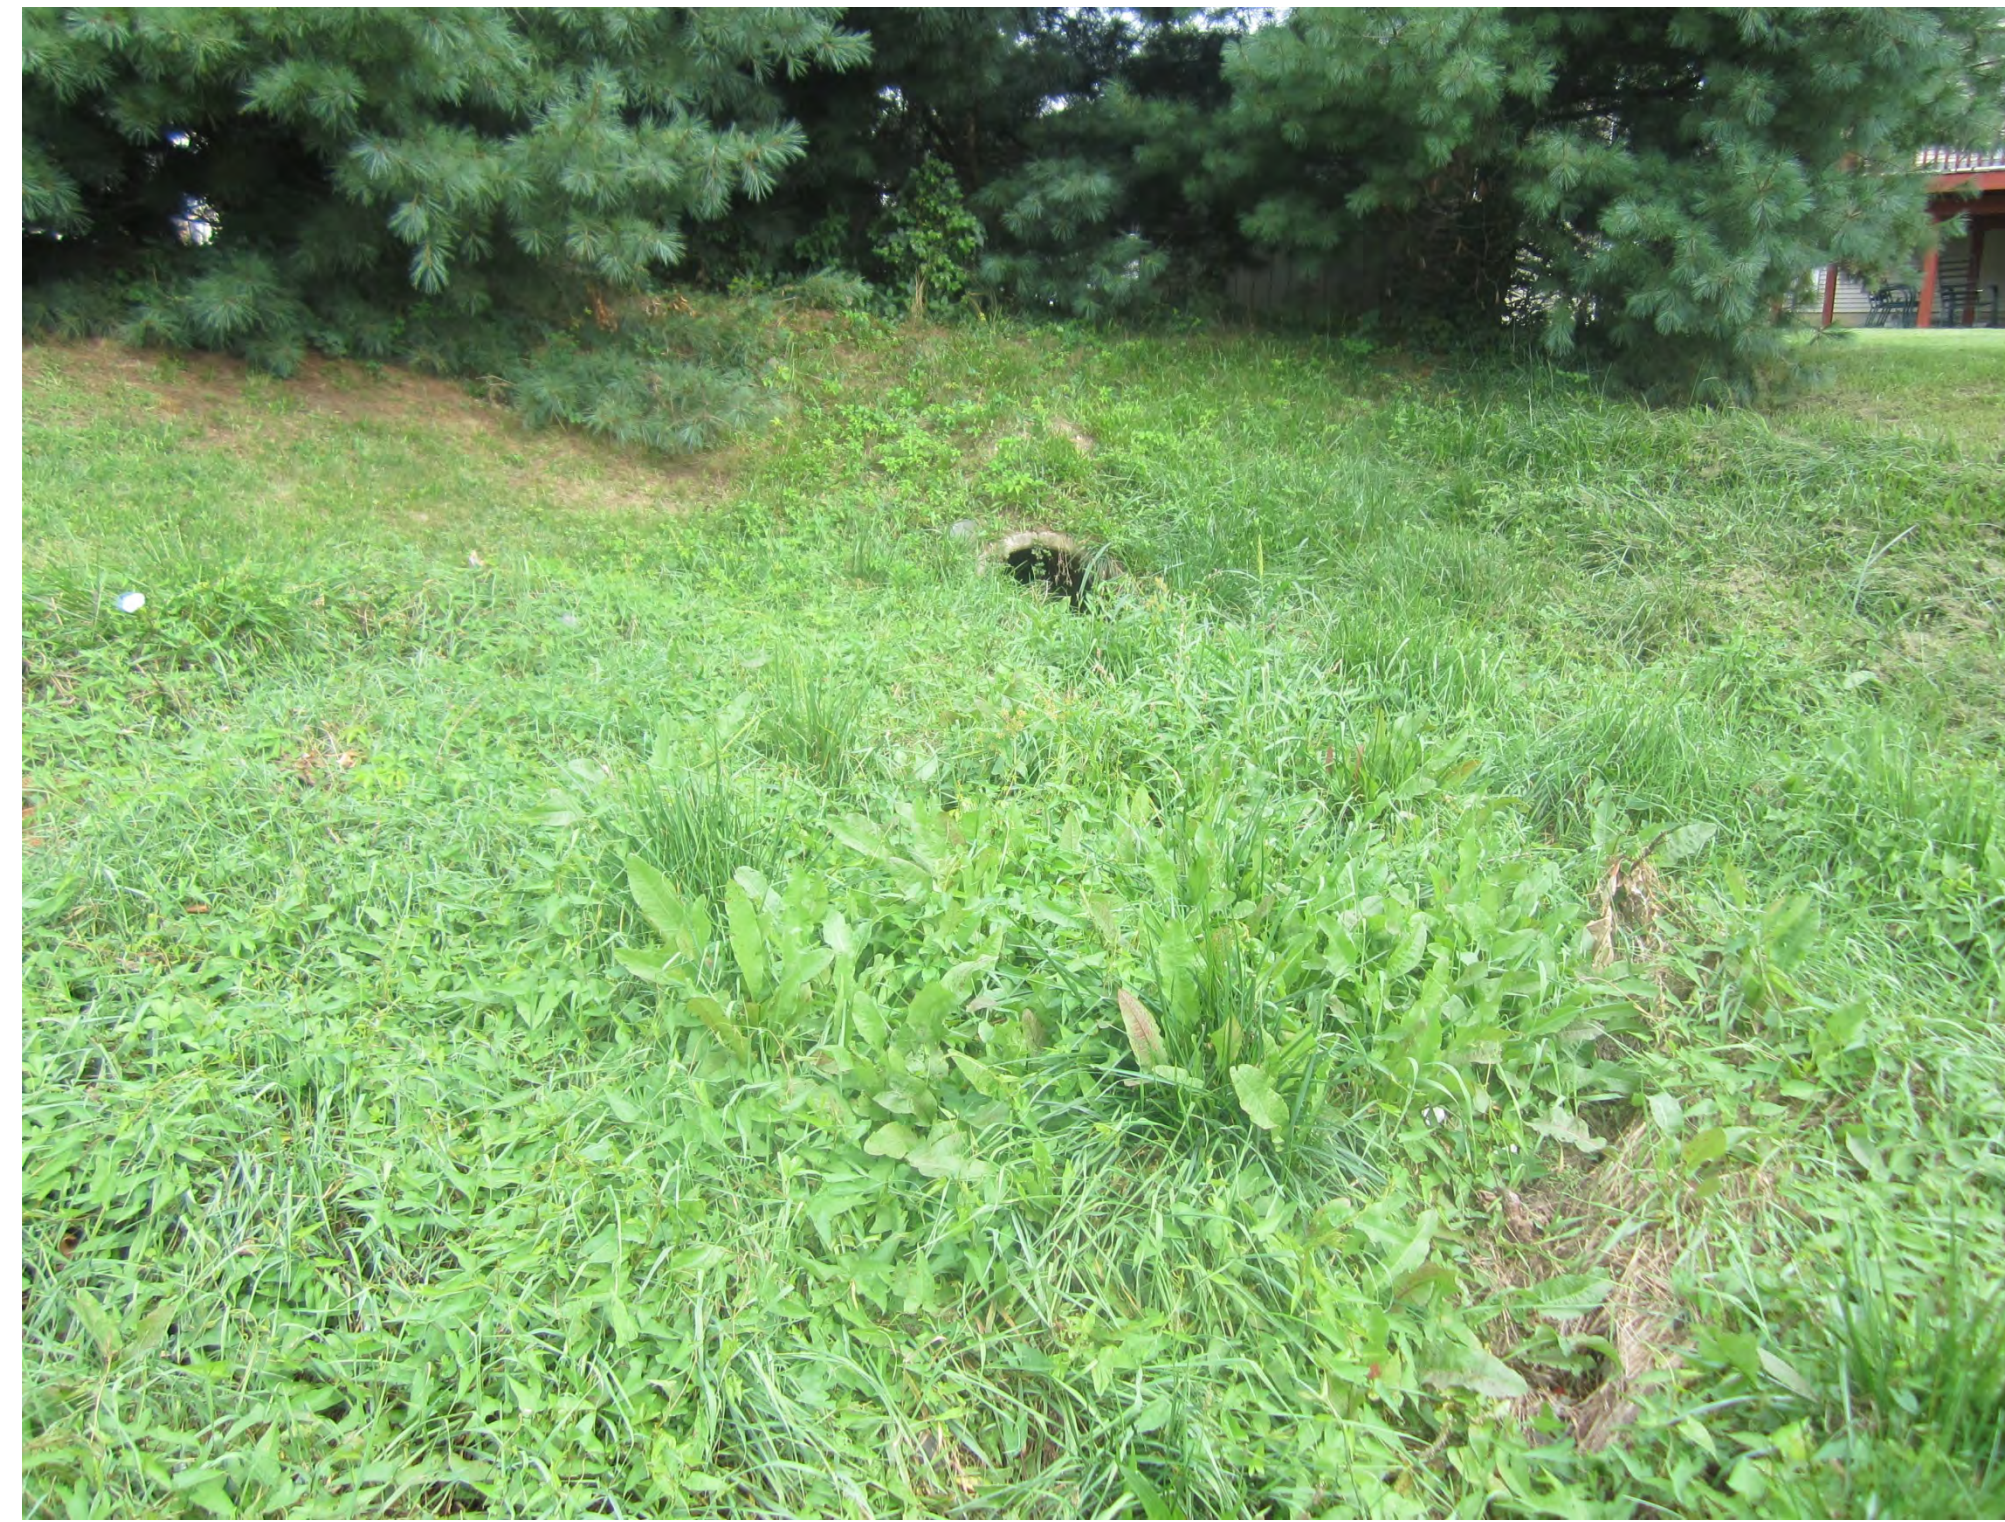
Inlet structure and overgrown rip-rap apron

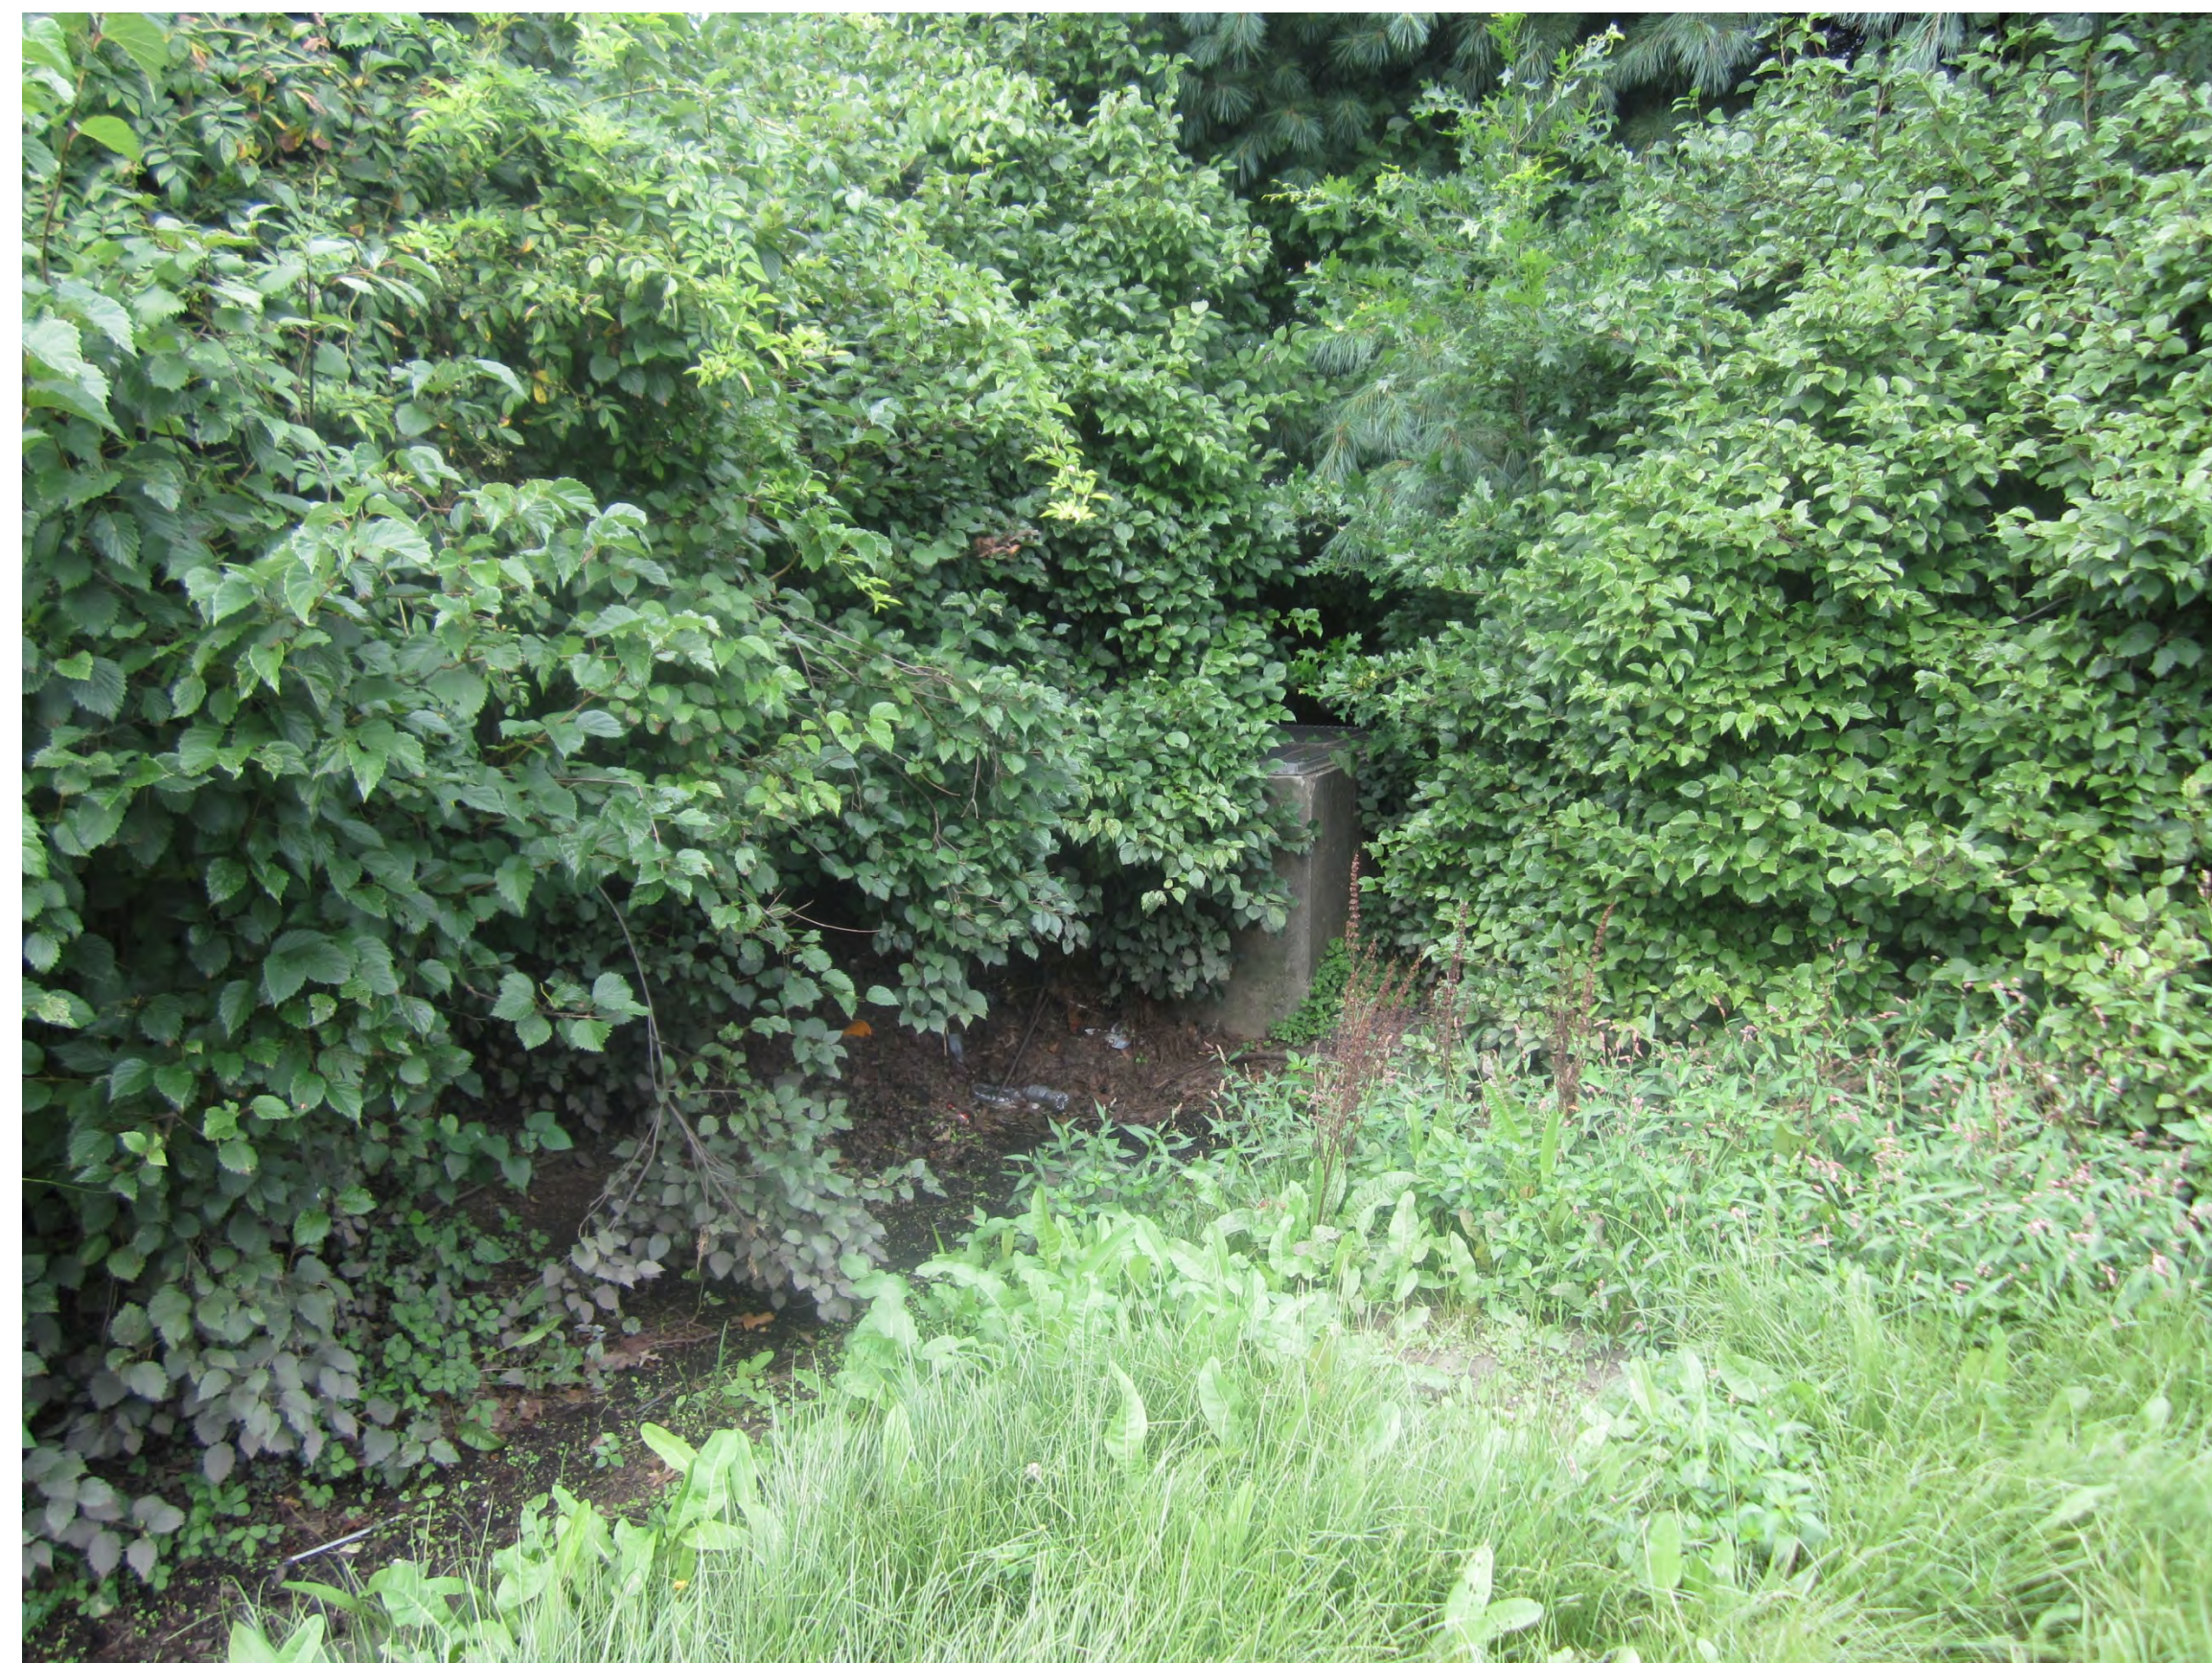
Overgrown outlet structure

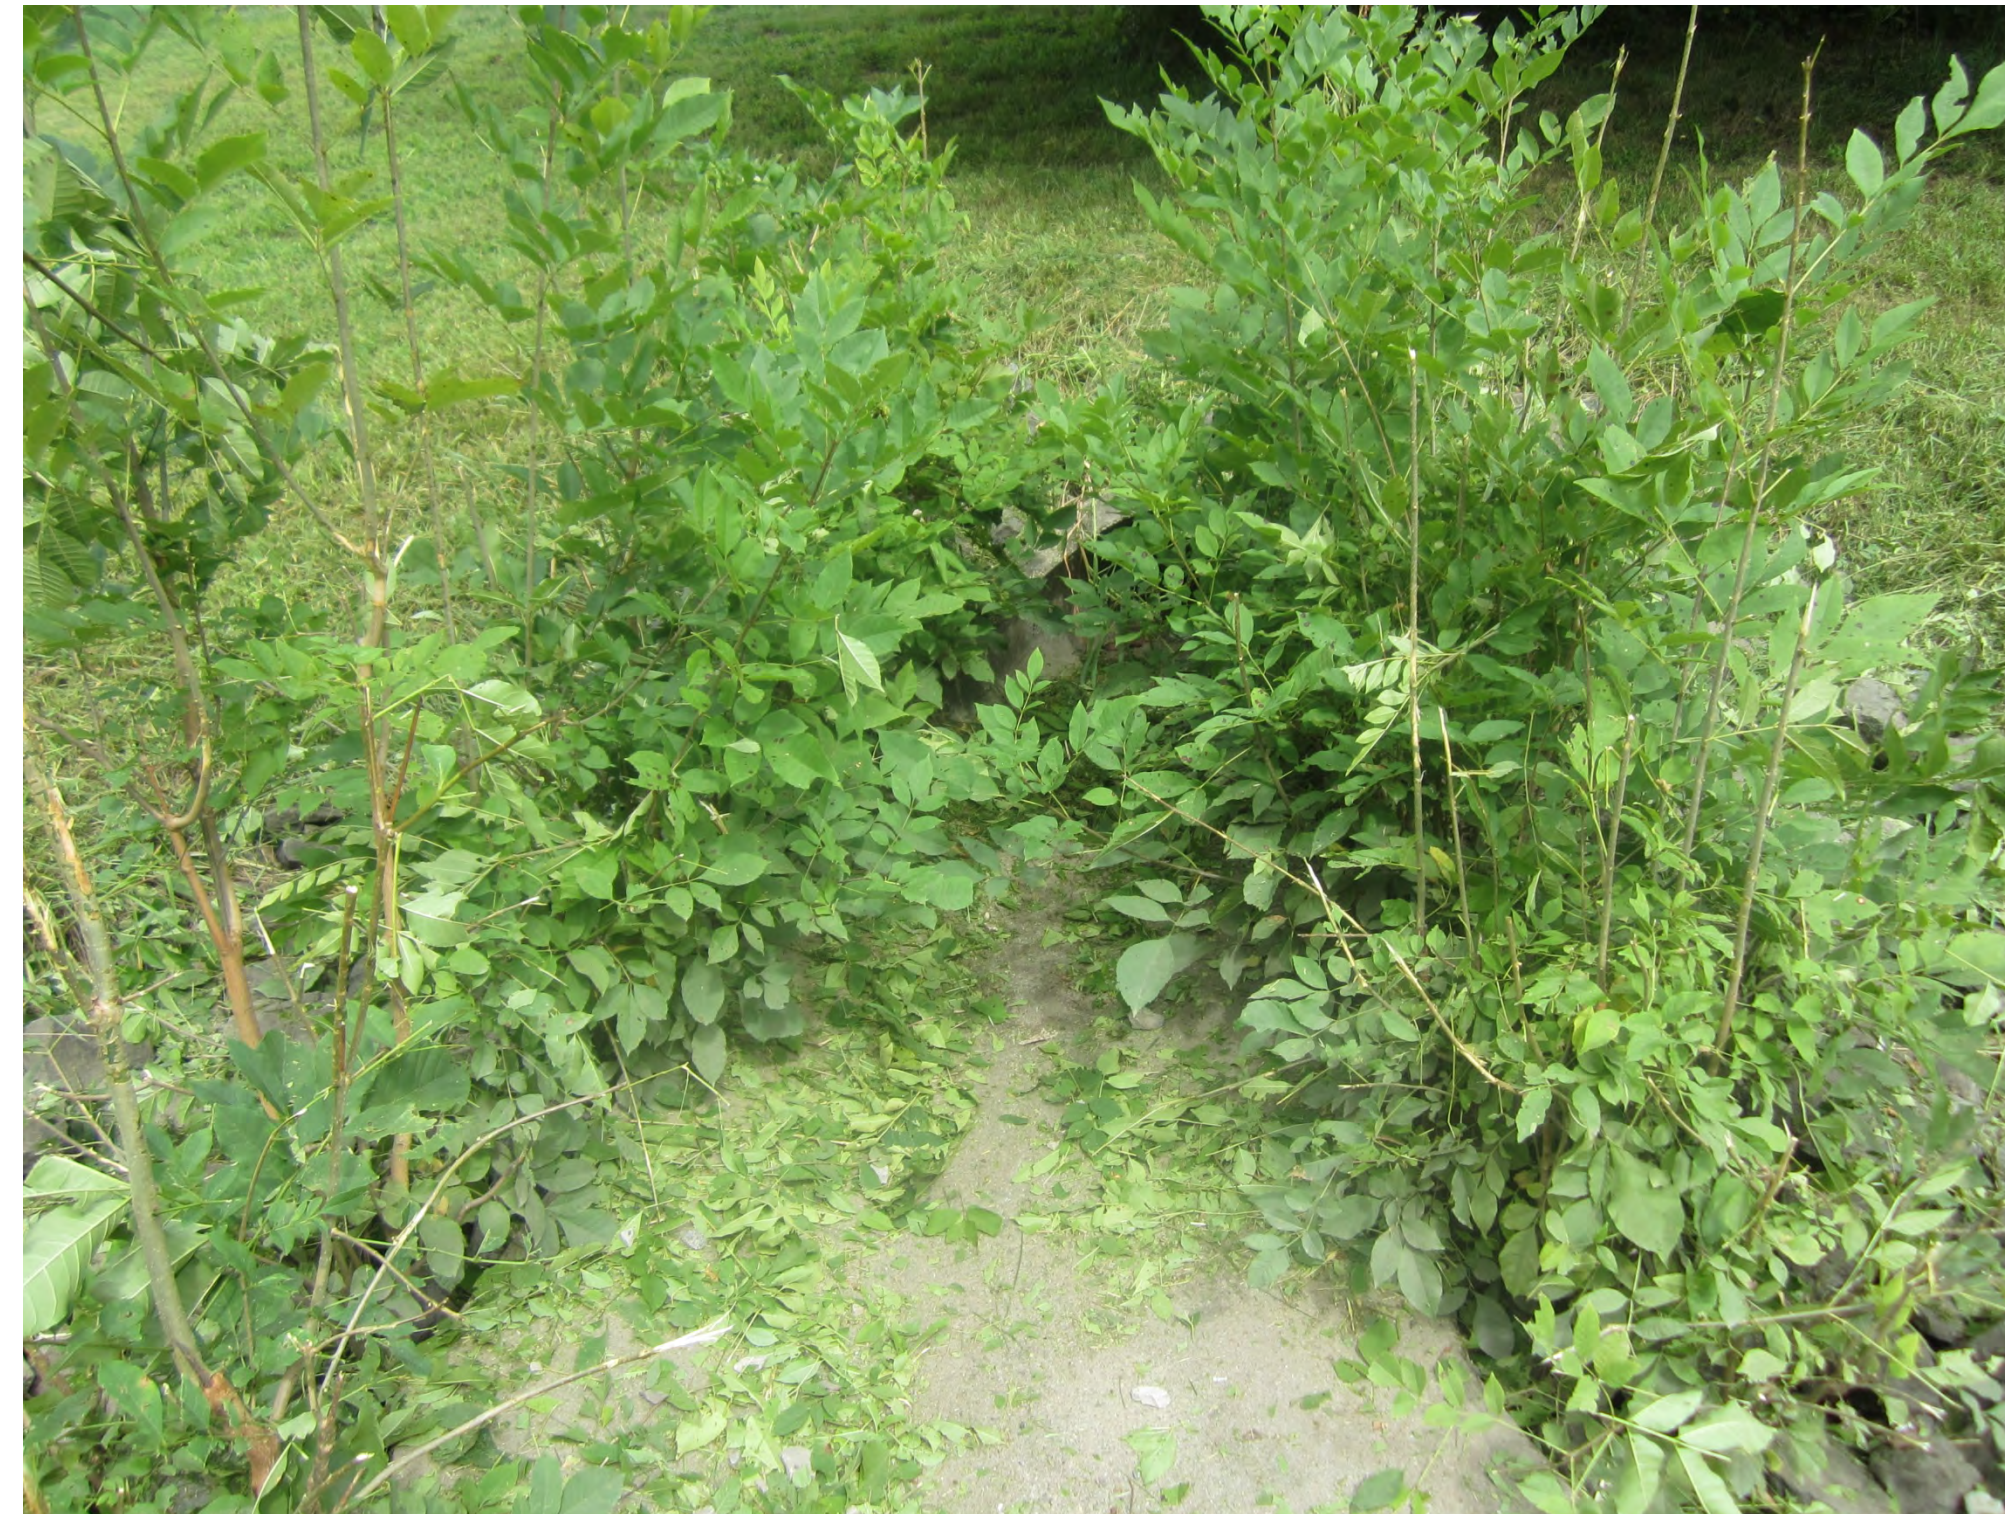
Overgrown inlet structure

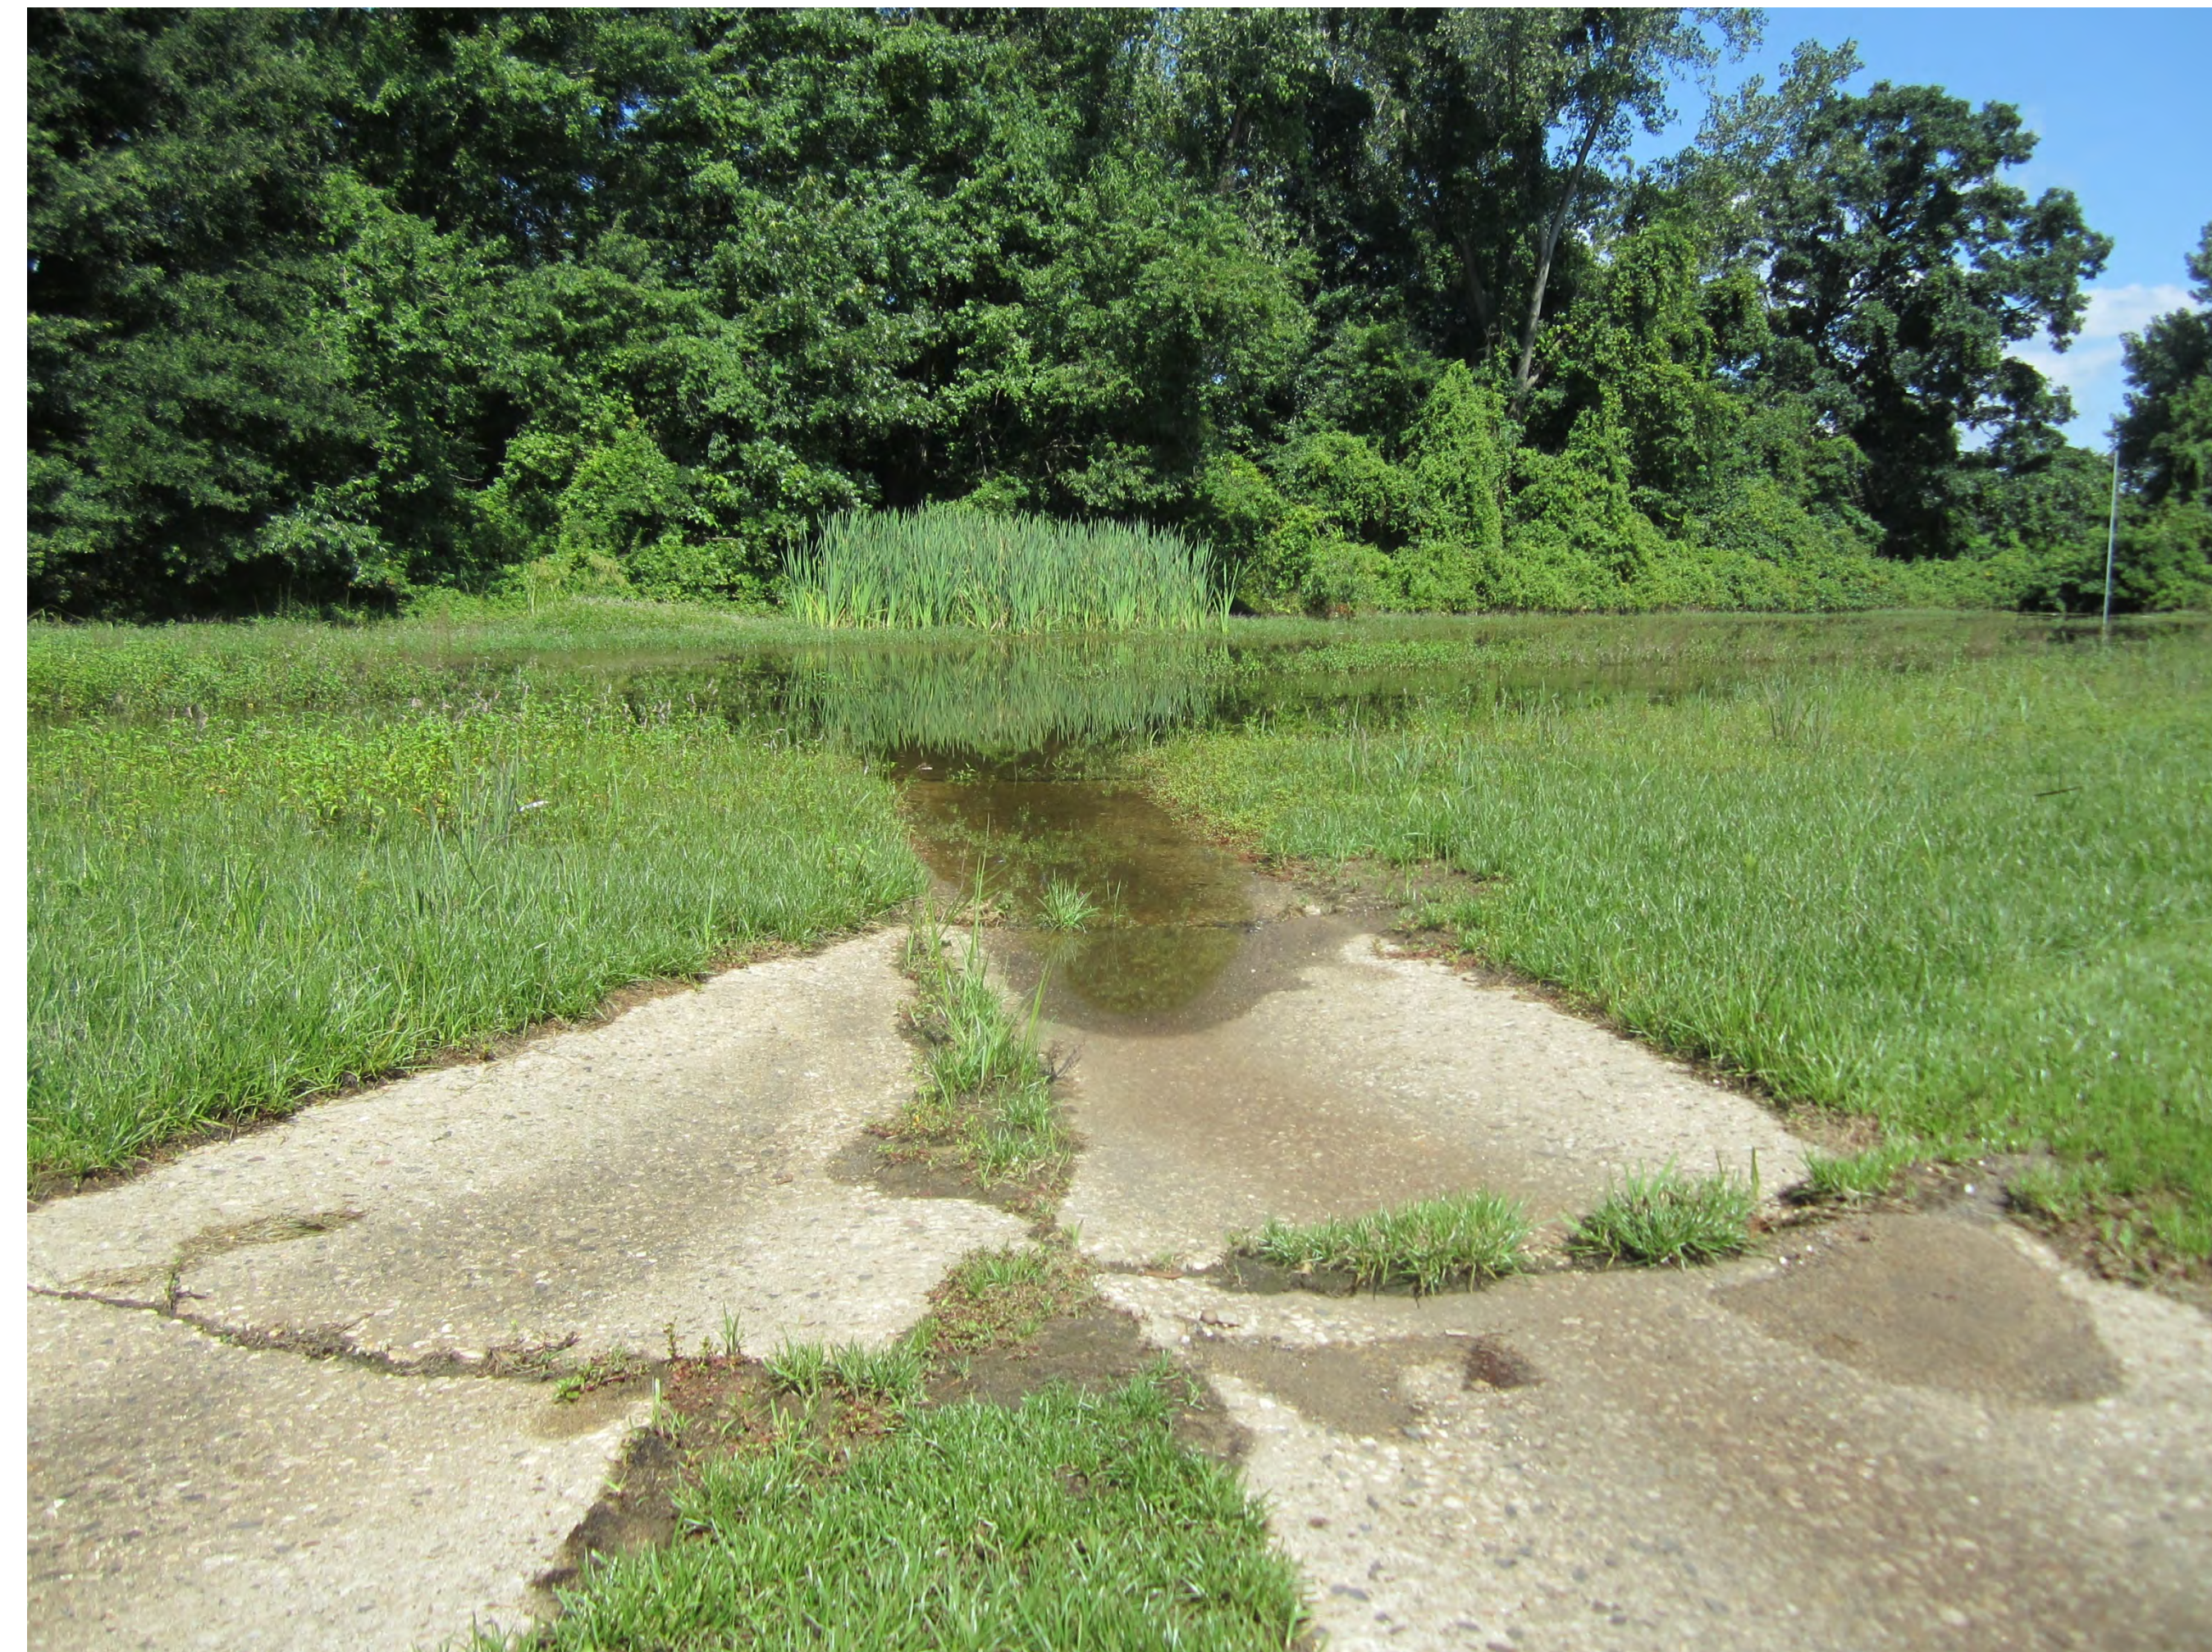
Basin bottom looking west

- There is excessive ponding in the basin bottom, ponding reaches depths of about three feet
- Outlet is overgrown by brush, it is located in the northern corner. The outlet is clogged with sediment, causing the ponding in the basin
- There is concrete deterioration on both inlets
