## Hamilton Township (Mercer County)

# REVIEW AND EVALUATION OF TOTAL MAXIMUM DAILY LOADS (TMDLs)

Developed by the Rutgers Cooperative Extension Water Resources Program  
Funded by Hamilton Township, Mercer County, New Jersey

December 5, 2019

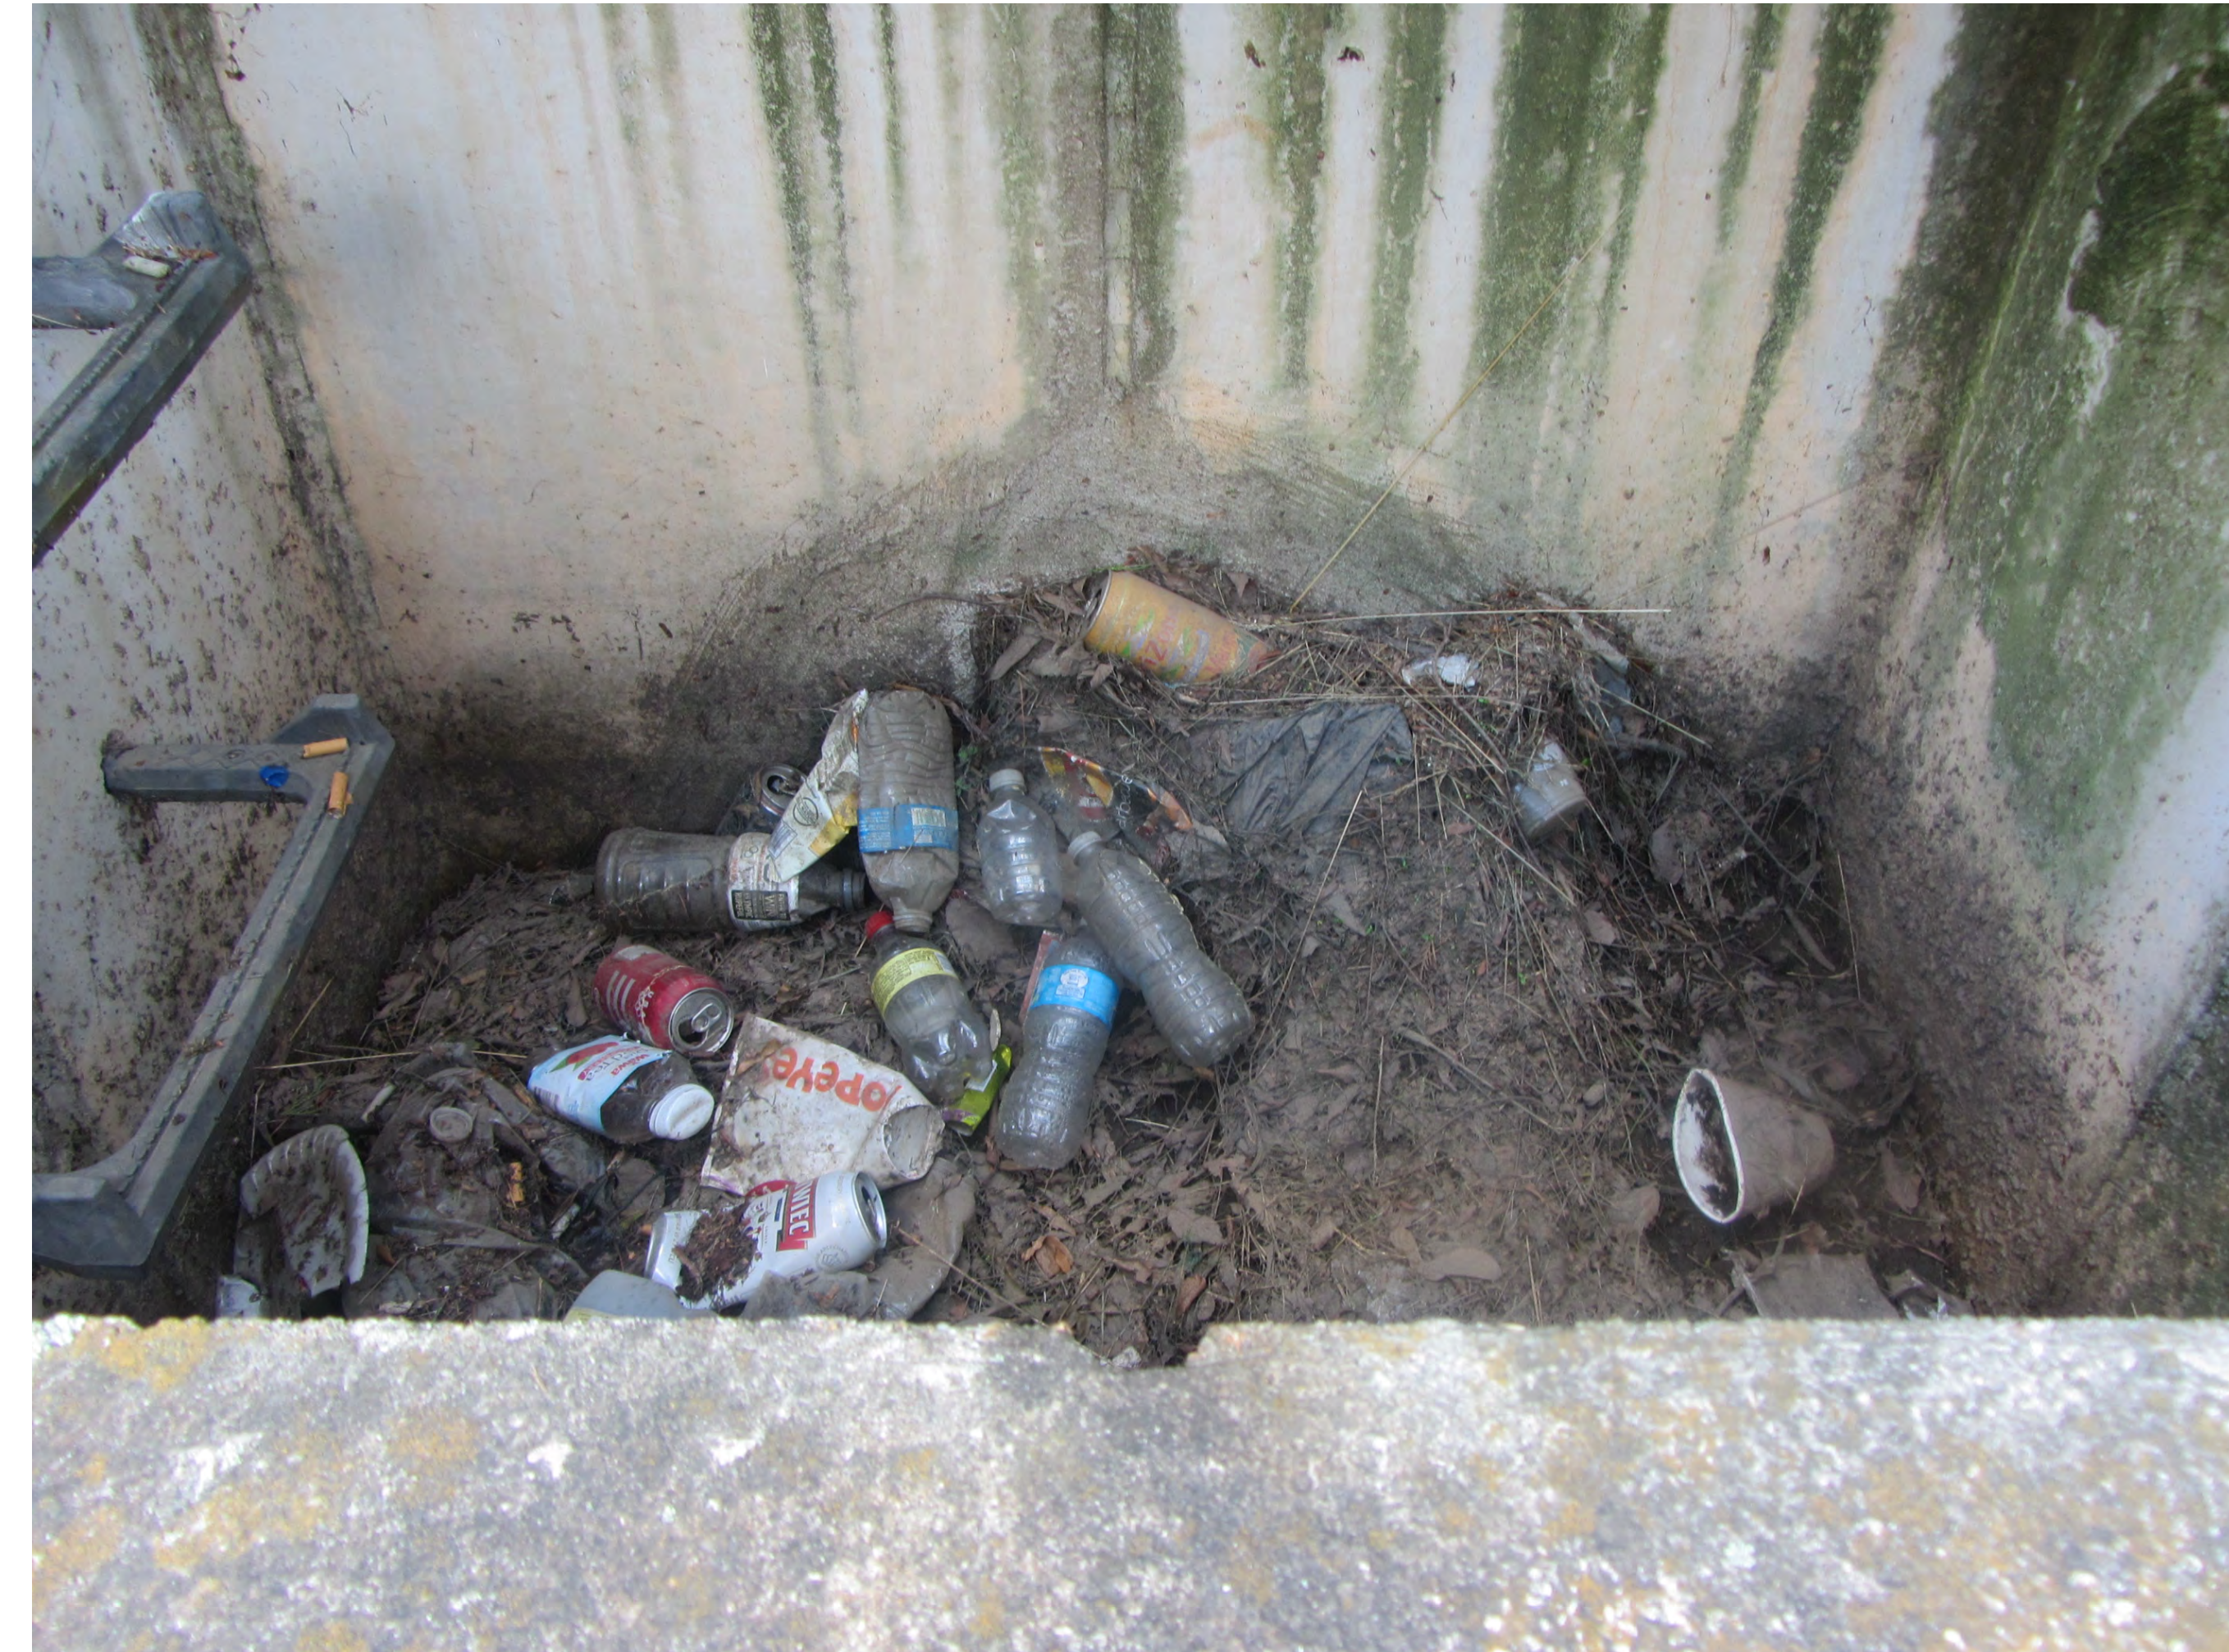
Litter and debris accumulated inside outlet

- Excessive sediment build up in front of outlet structure, grass growing over low flow channel
- Excess sediment and litter should be removed
- Opportunity to replace low flow channel with a stone channel to promote infiltration

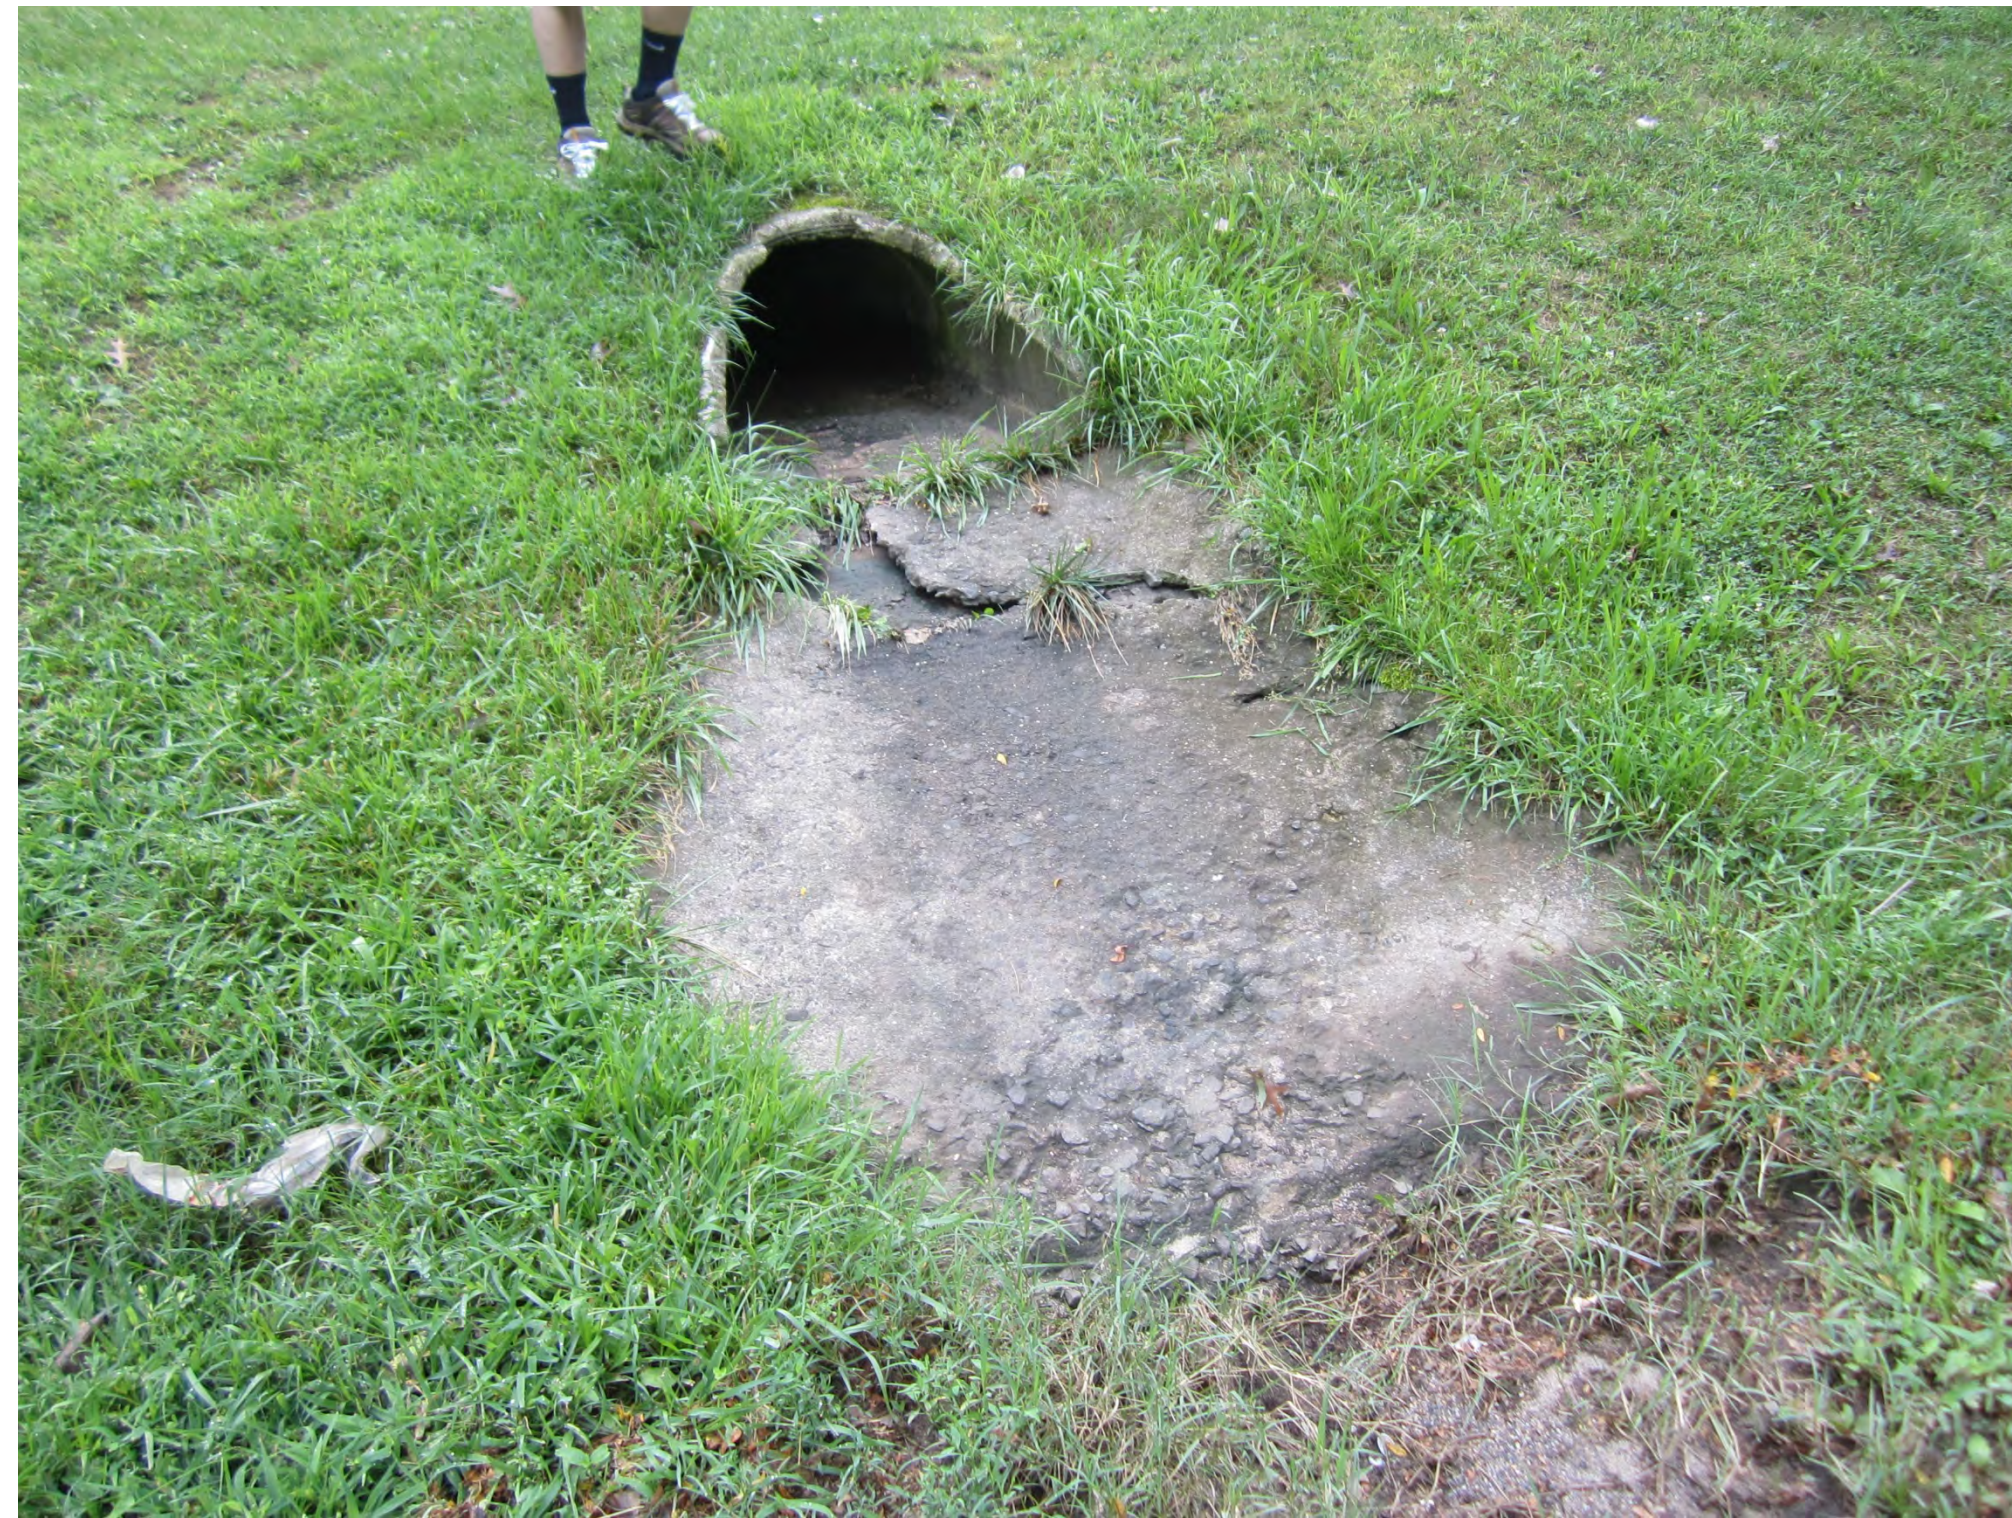
Northeastern inlet structure

- The southern inlet is about halfway filled with sediment
- The northeastern inlet is in need of replacement
- The basin bottom has many gullies throughout and excess sediment accumulation
- There is standing water and erosion in front of the outlet

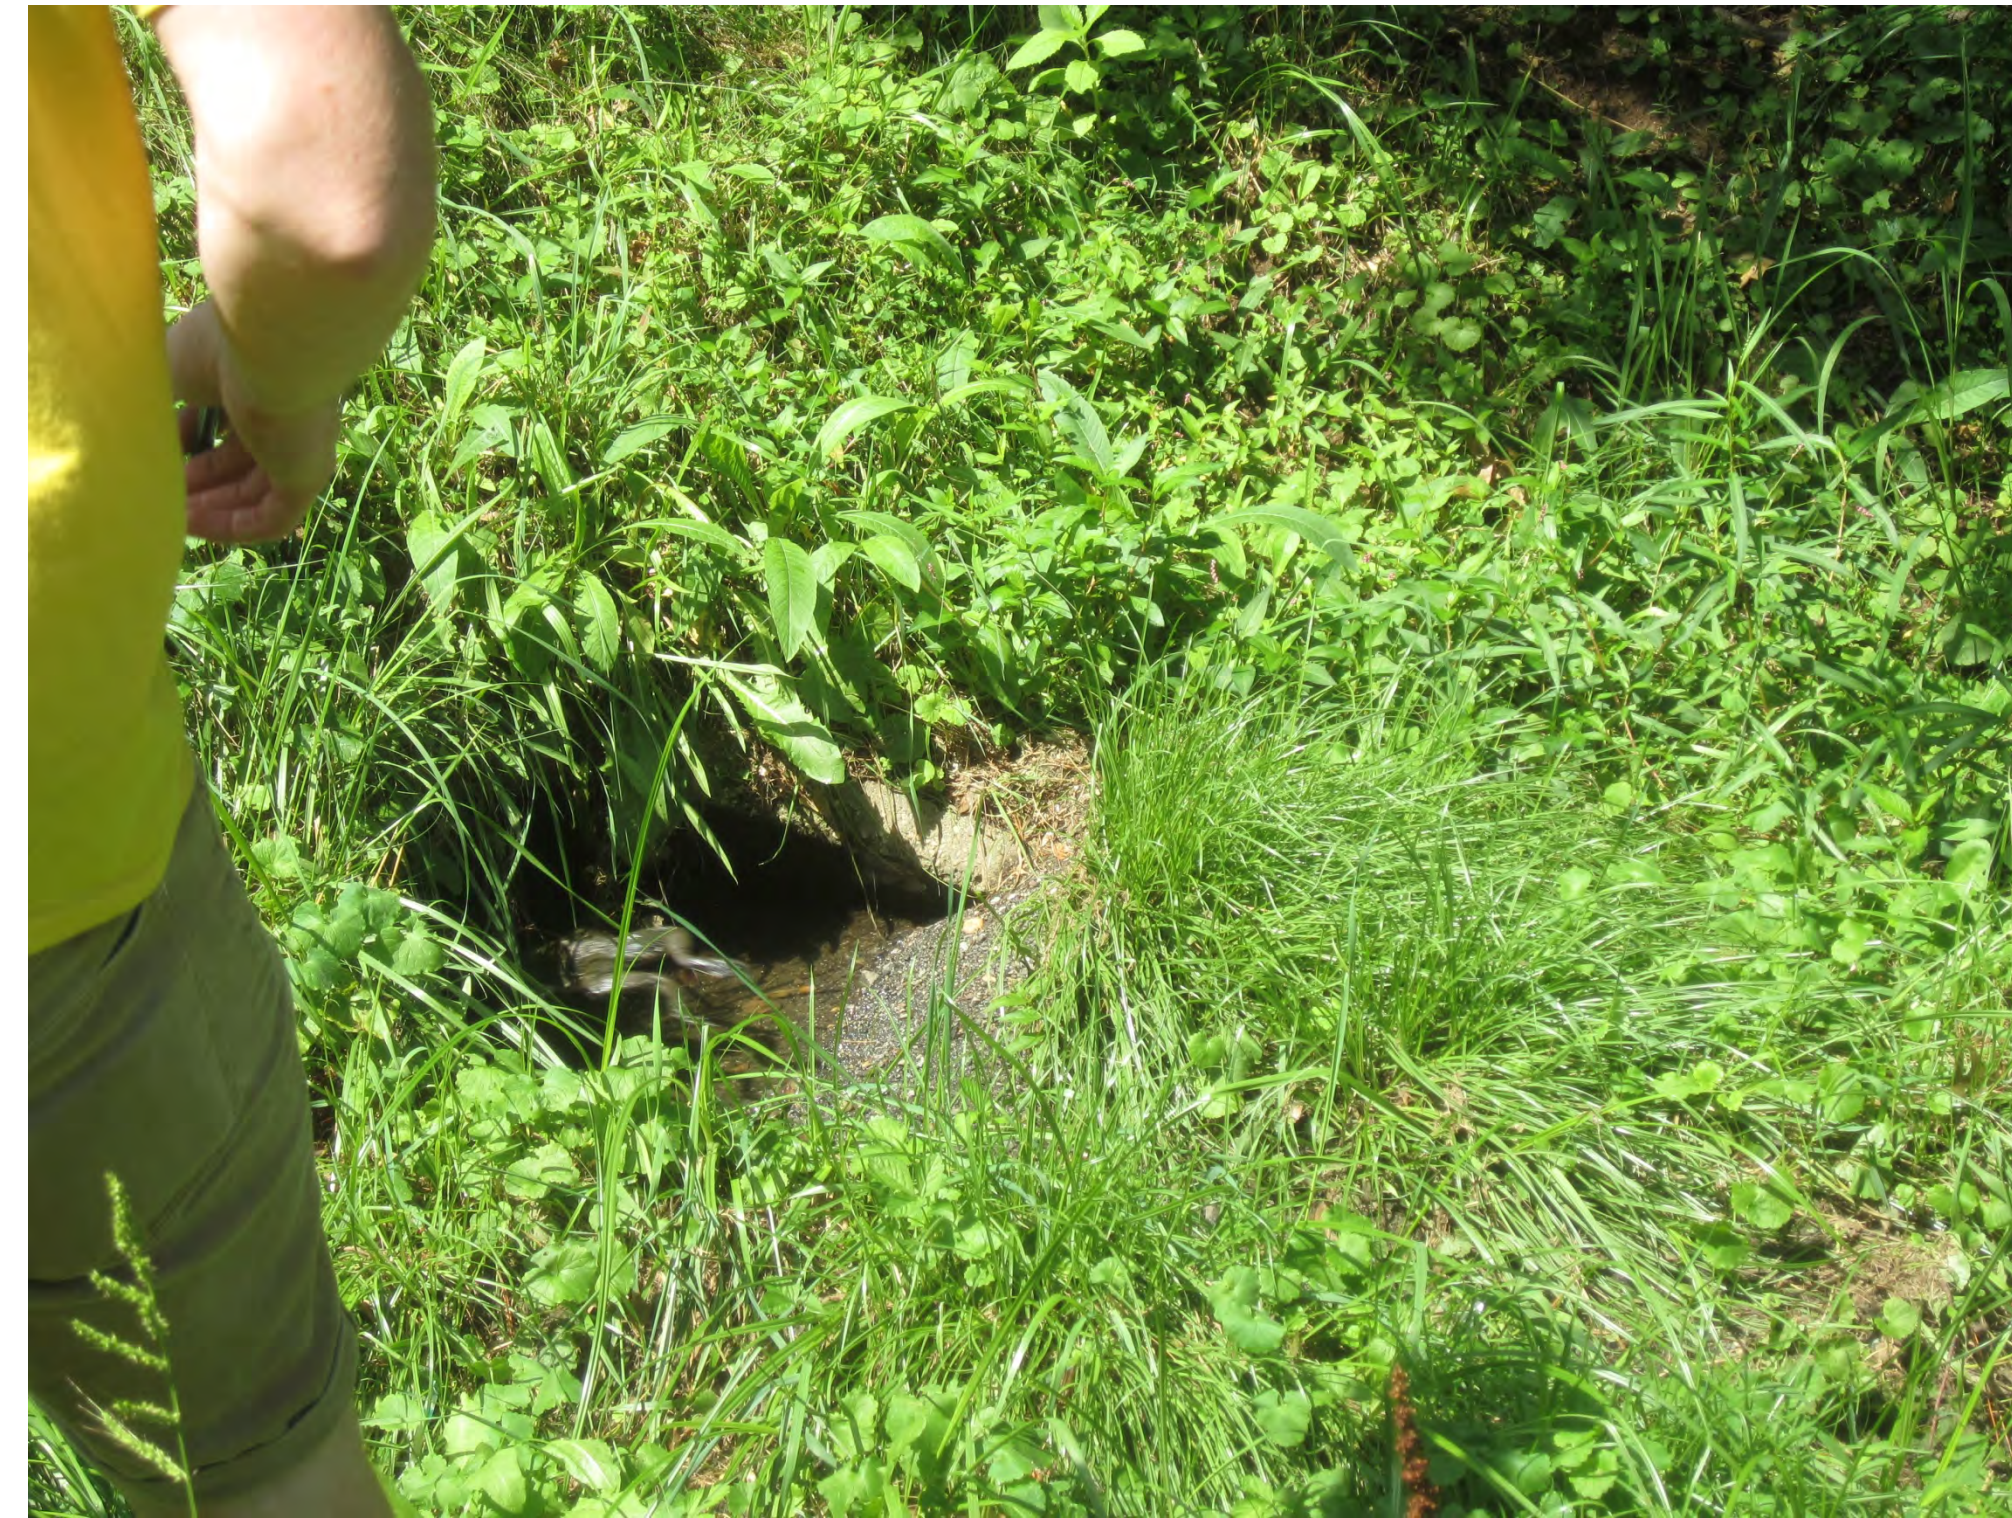
Southern inlet structure filled with sediment

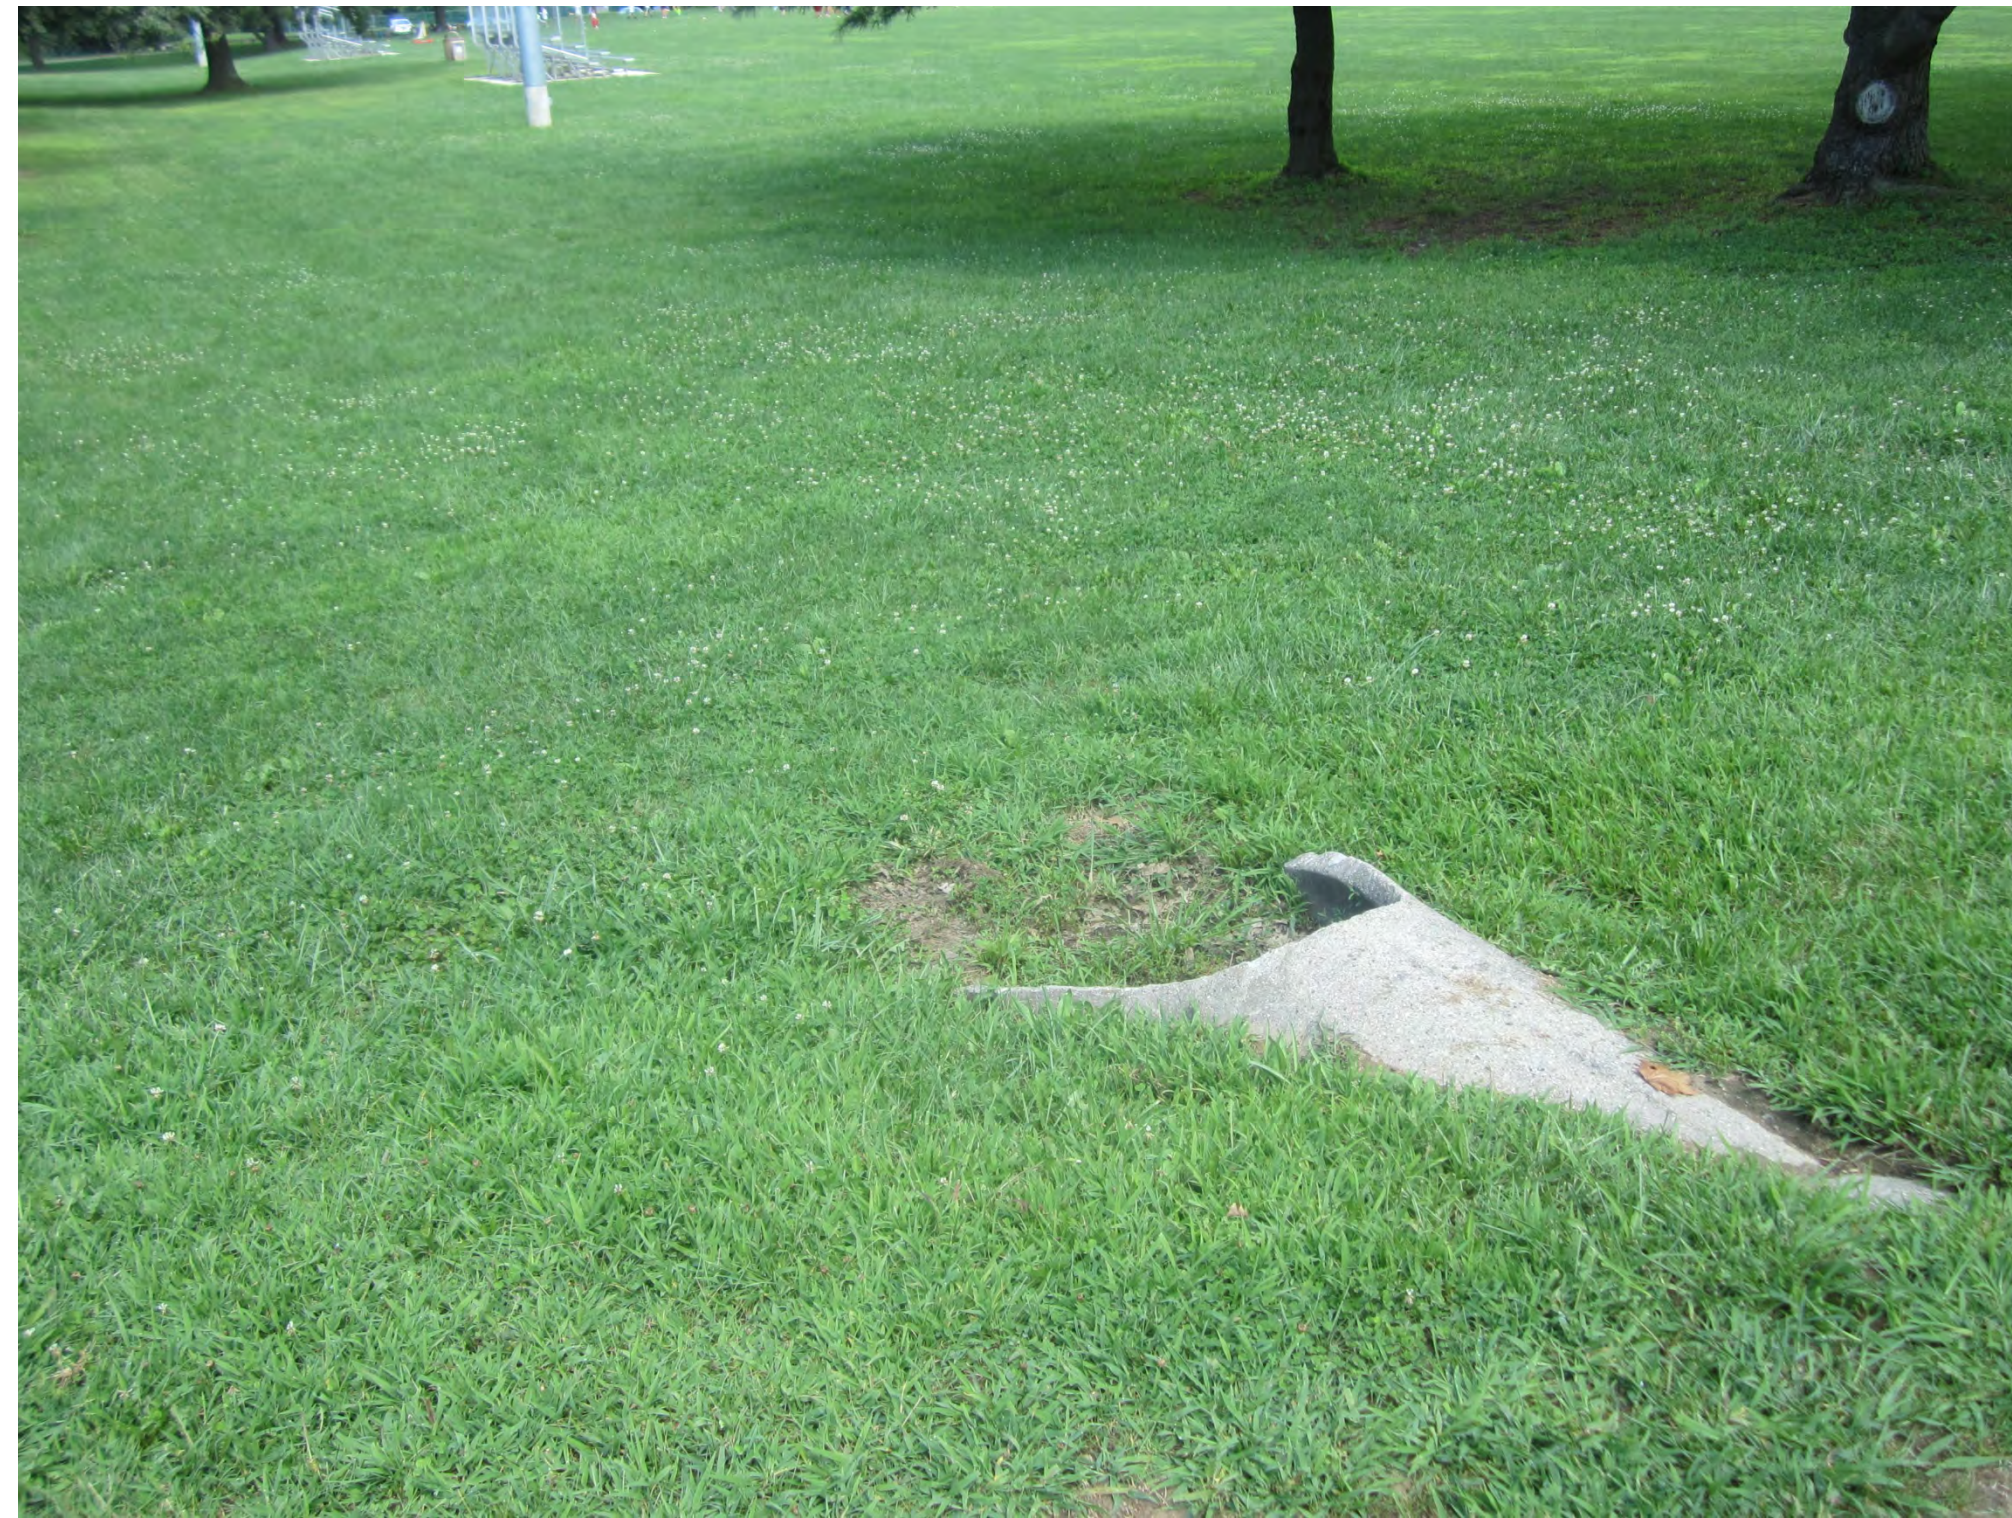
Basin #159 bottom looking west

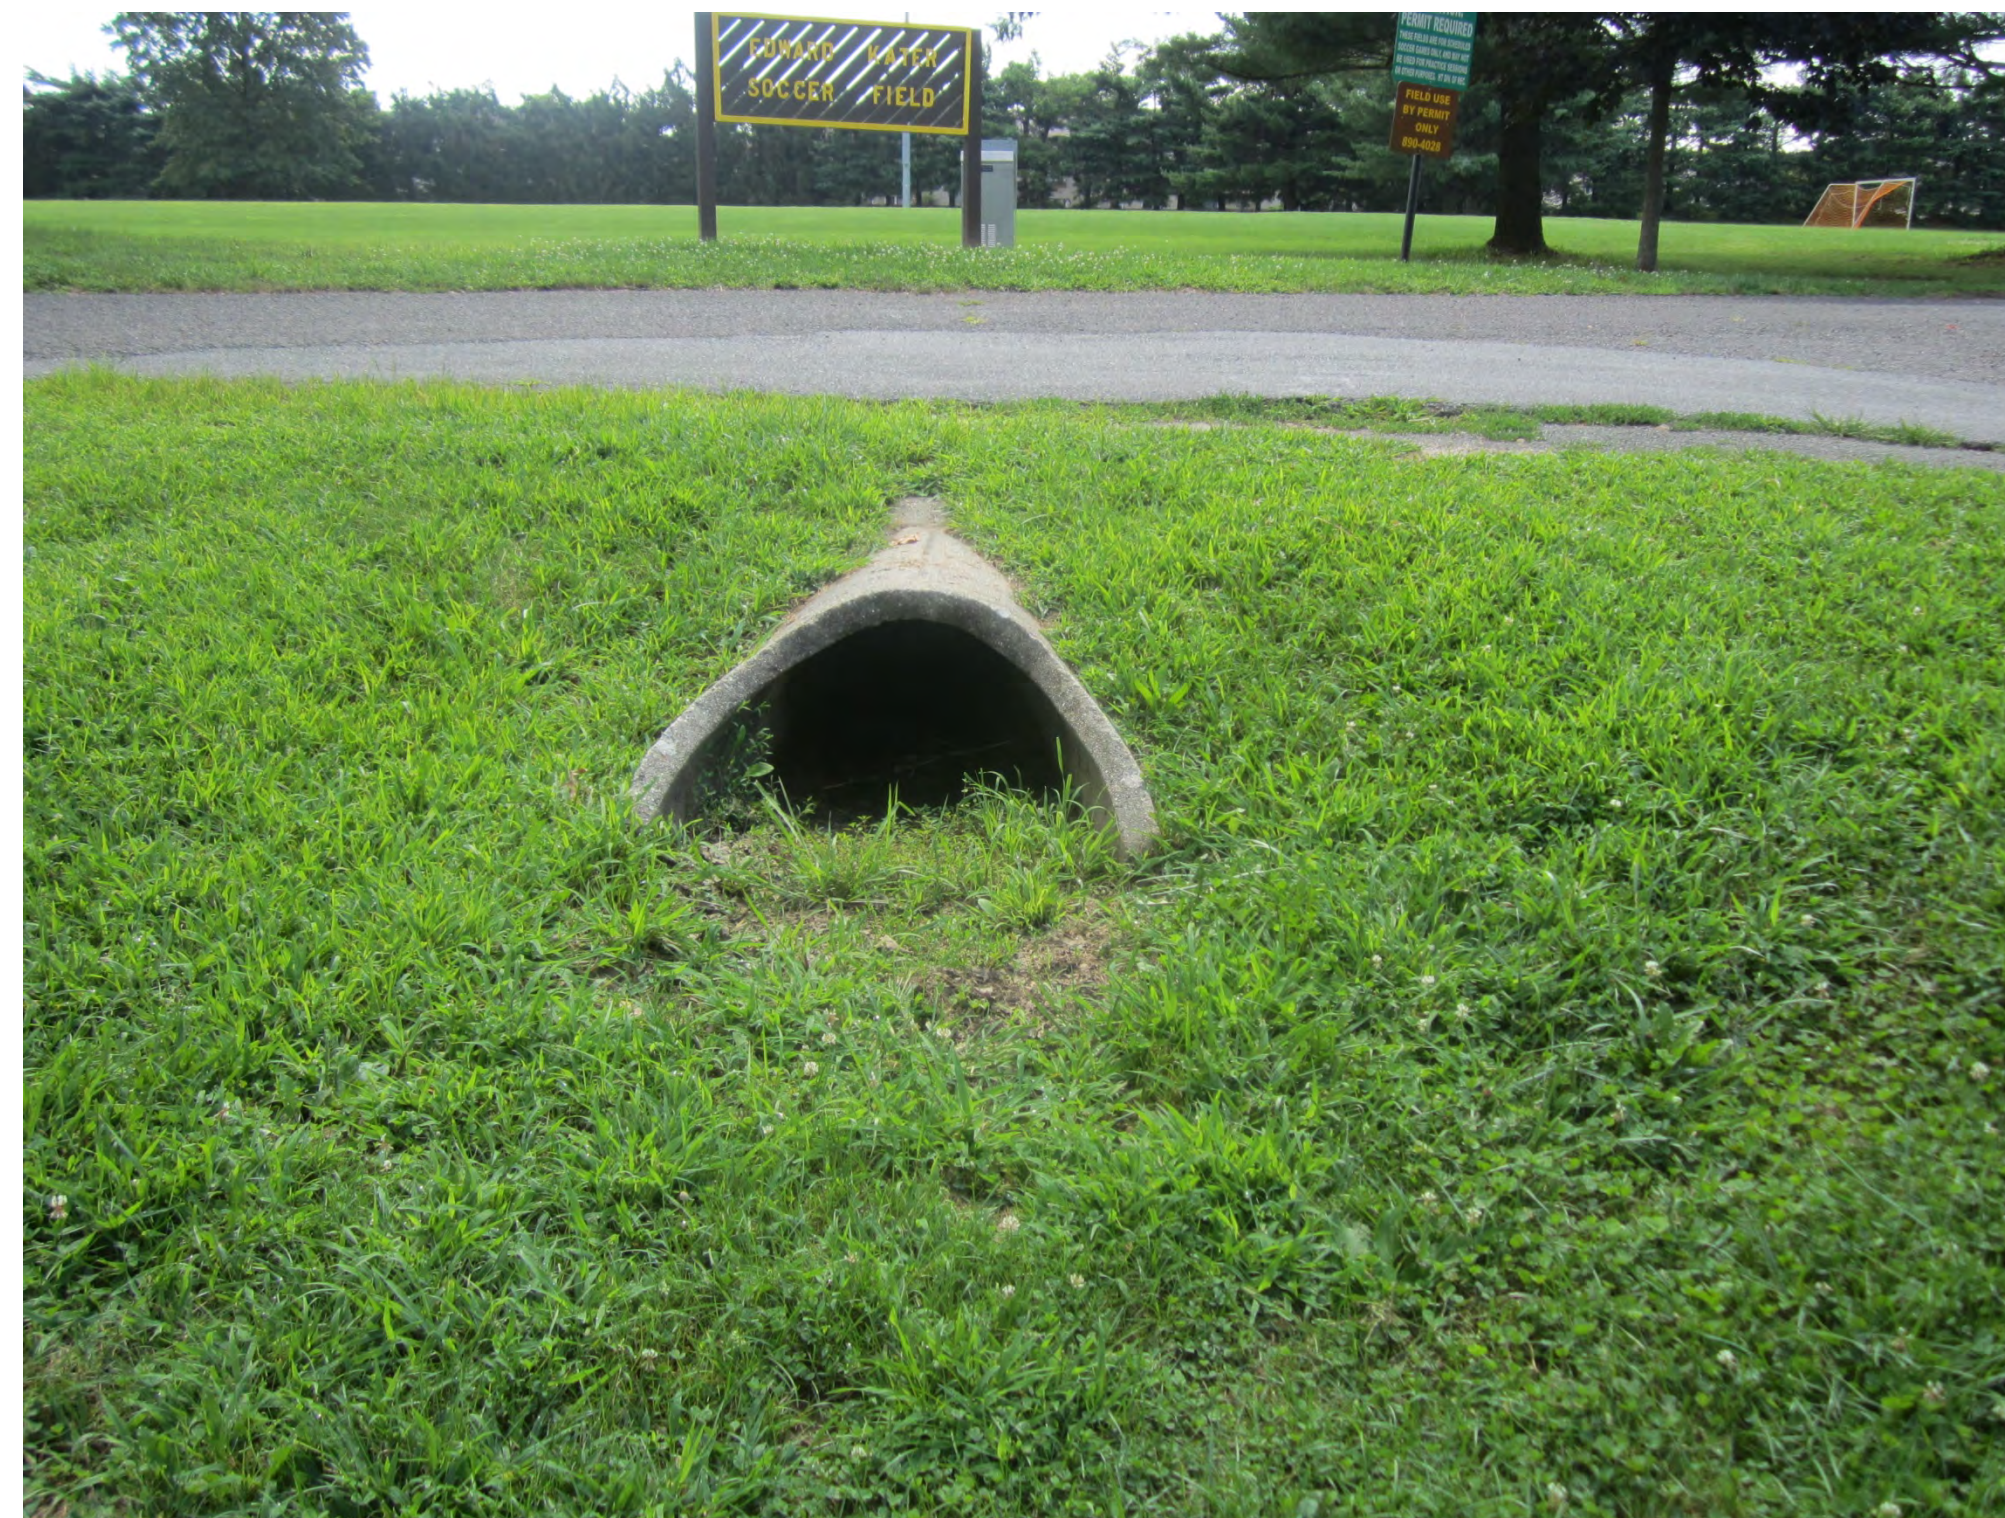
Basin #159 inlet structure

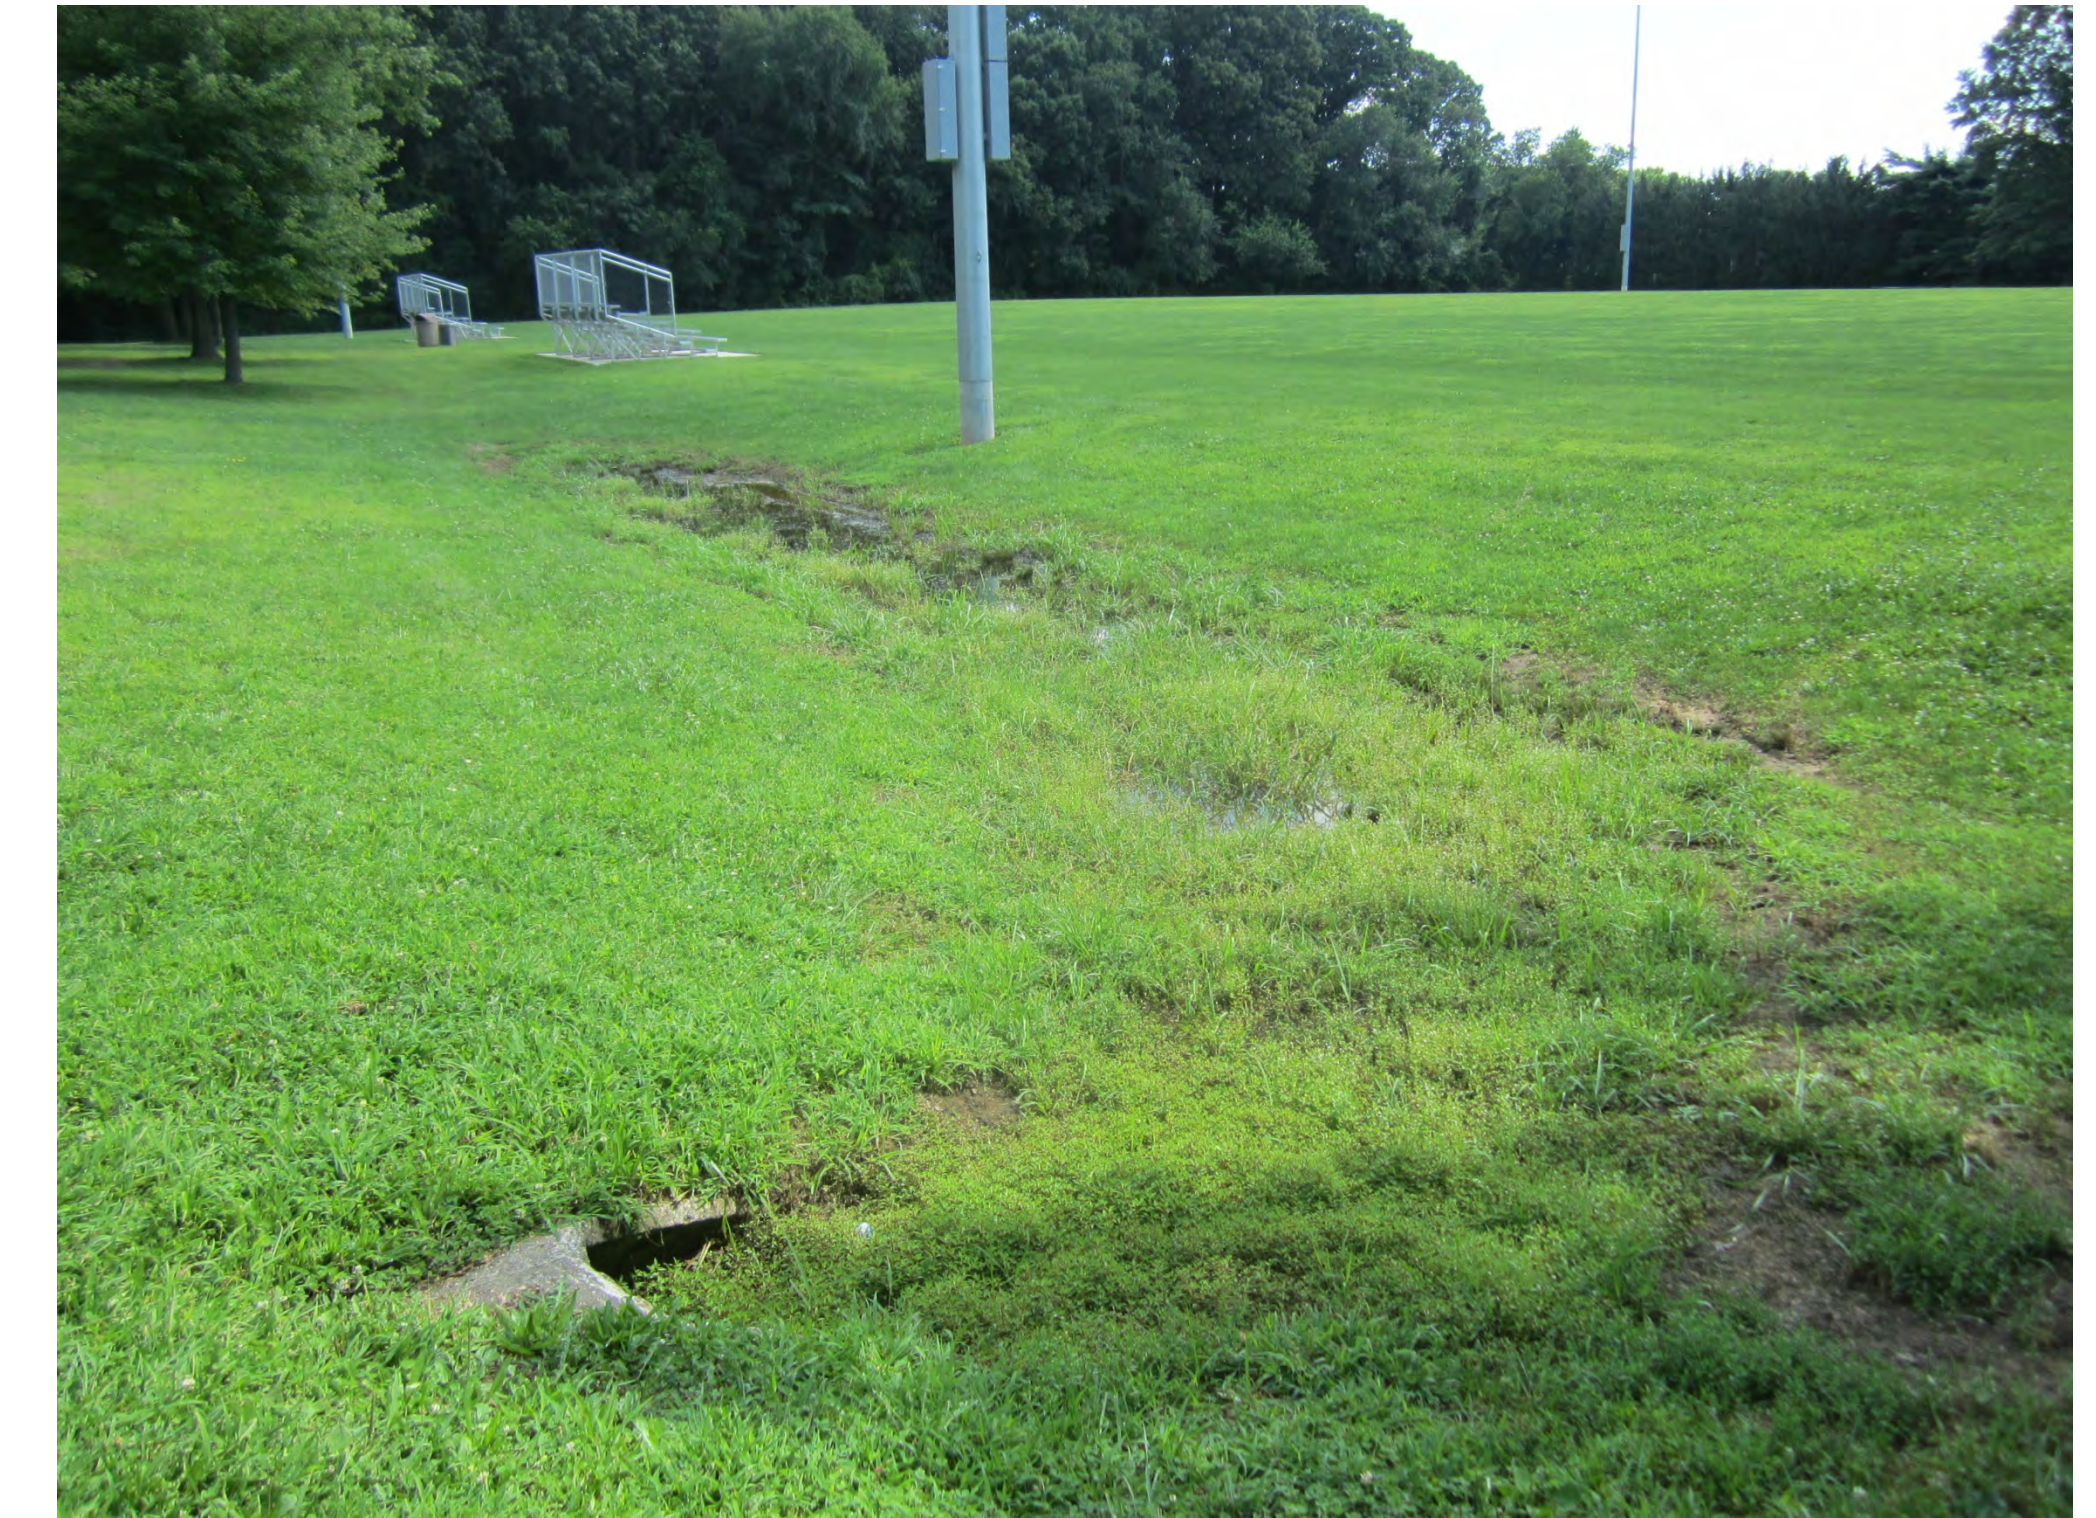
Basin #160 bottom looking north

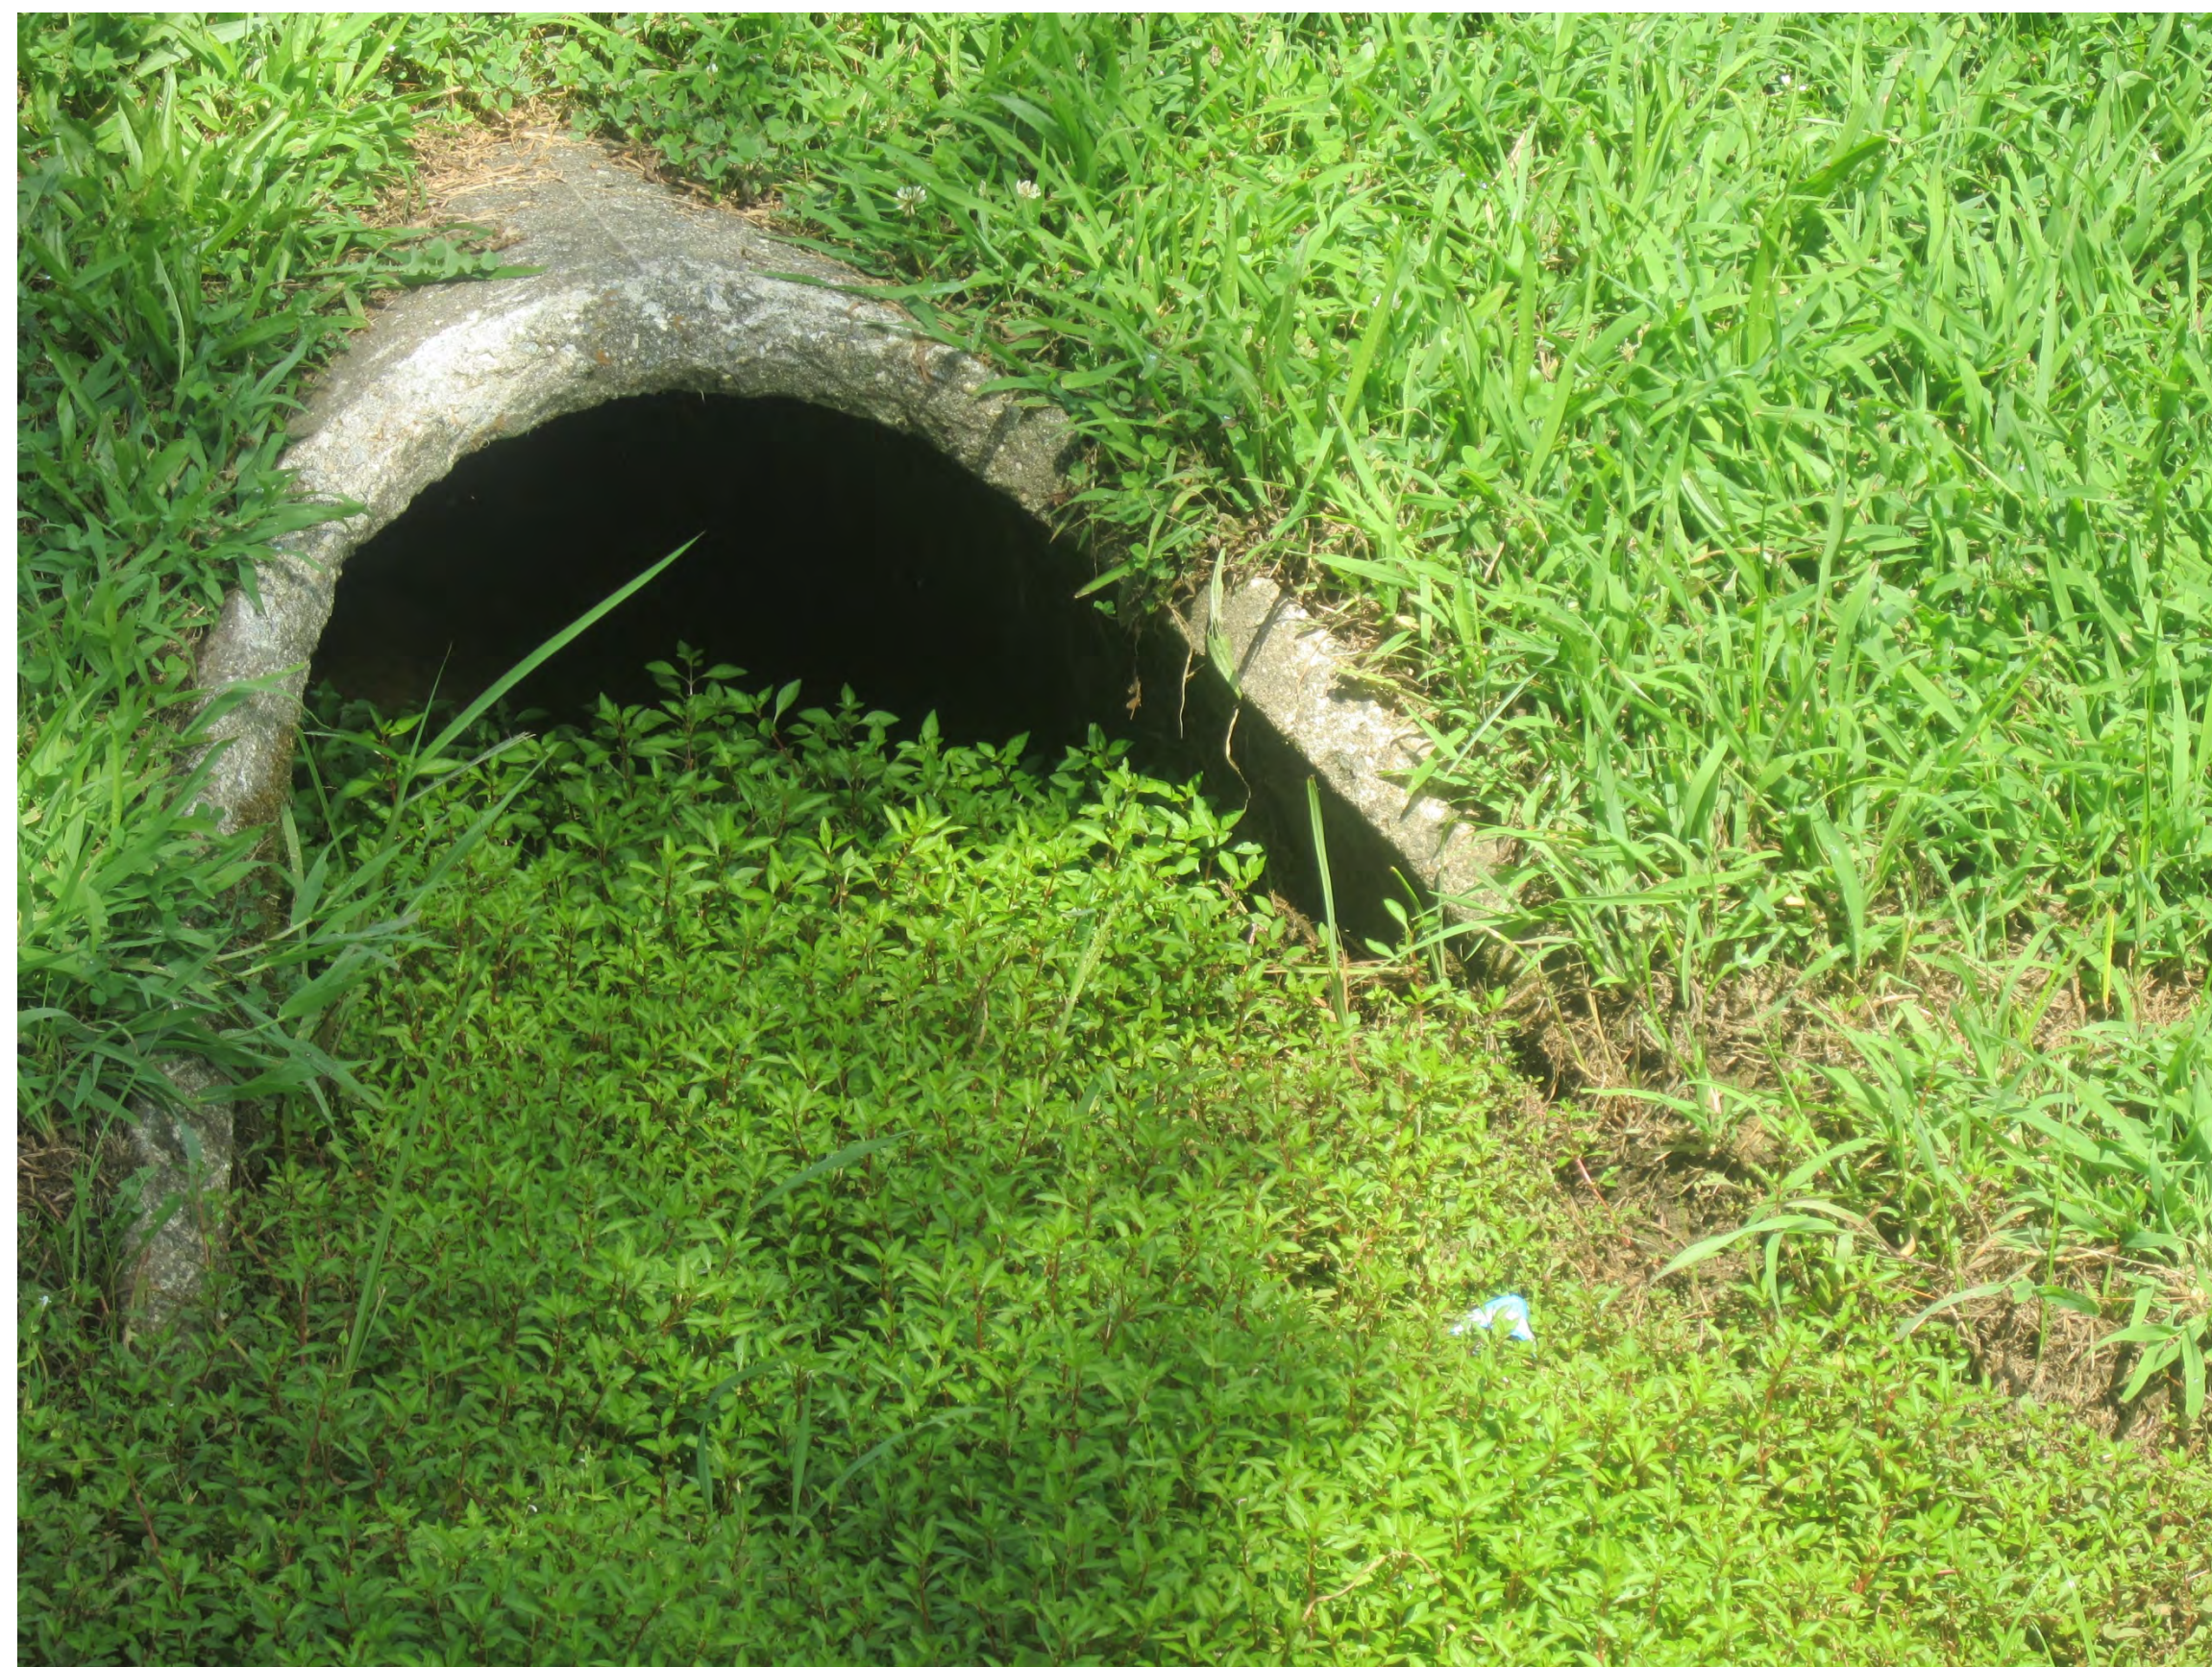
Basin #160 outlet structure
