## Hamilton Township (Mercer County)

# REVIEW AND EVALUATION OF TOTAL MAXIMUM DAILY LOADS (TMDLs)

Developed by the Rutgers Cooperative Extension Water Resources Program  
Funded by Hamilton Township, Mercer County, New Jersey

December 5, 2019

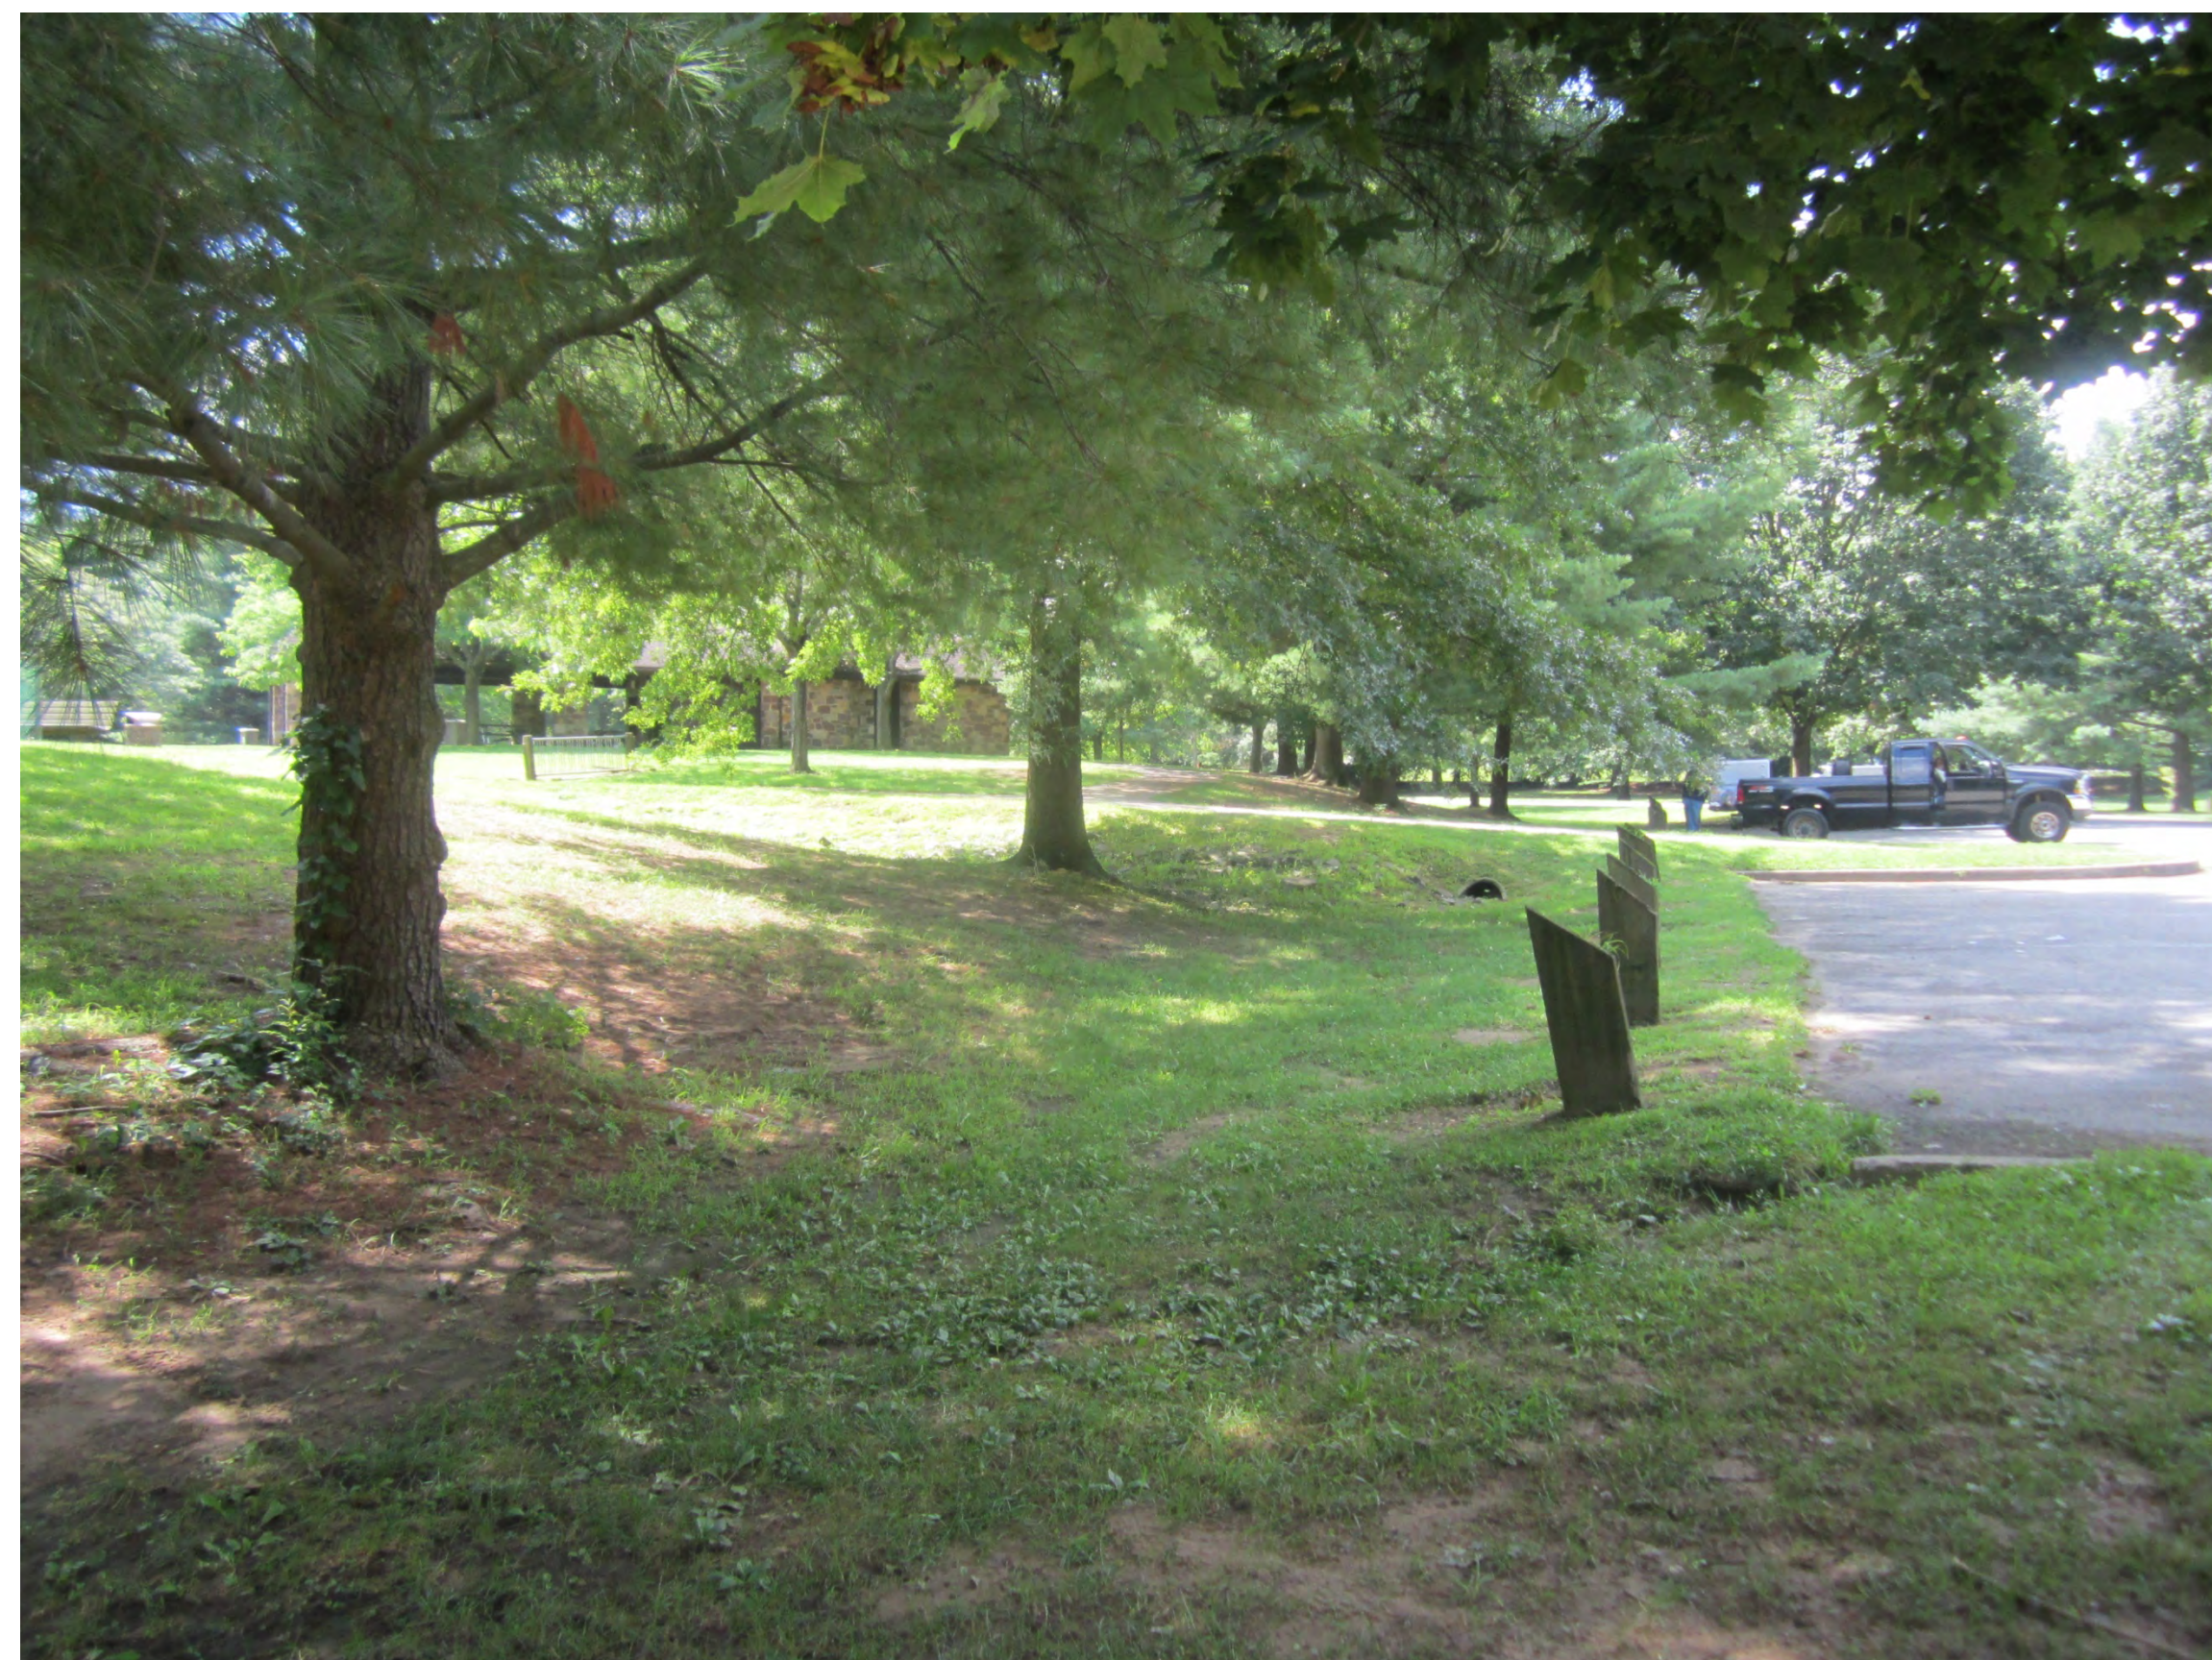
Swale that conveys two inlets to basin

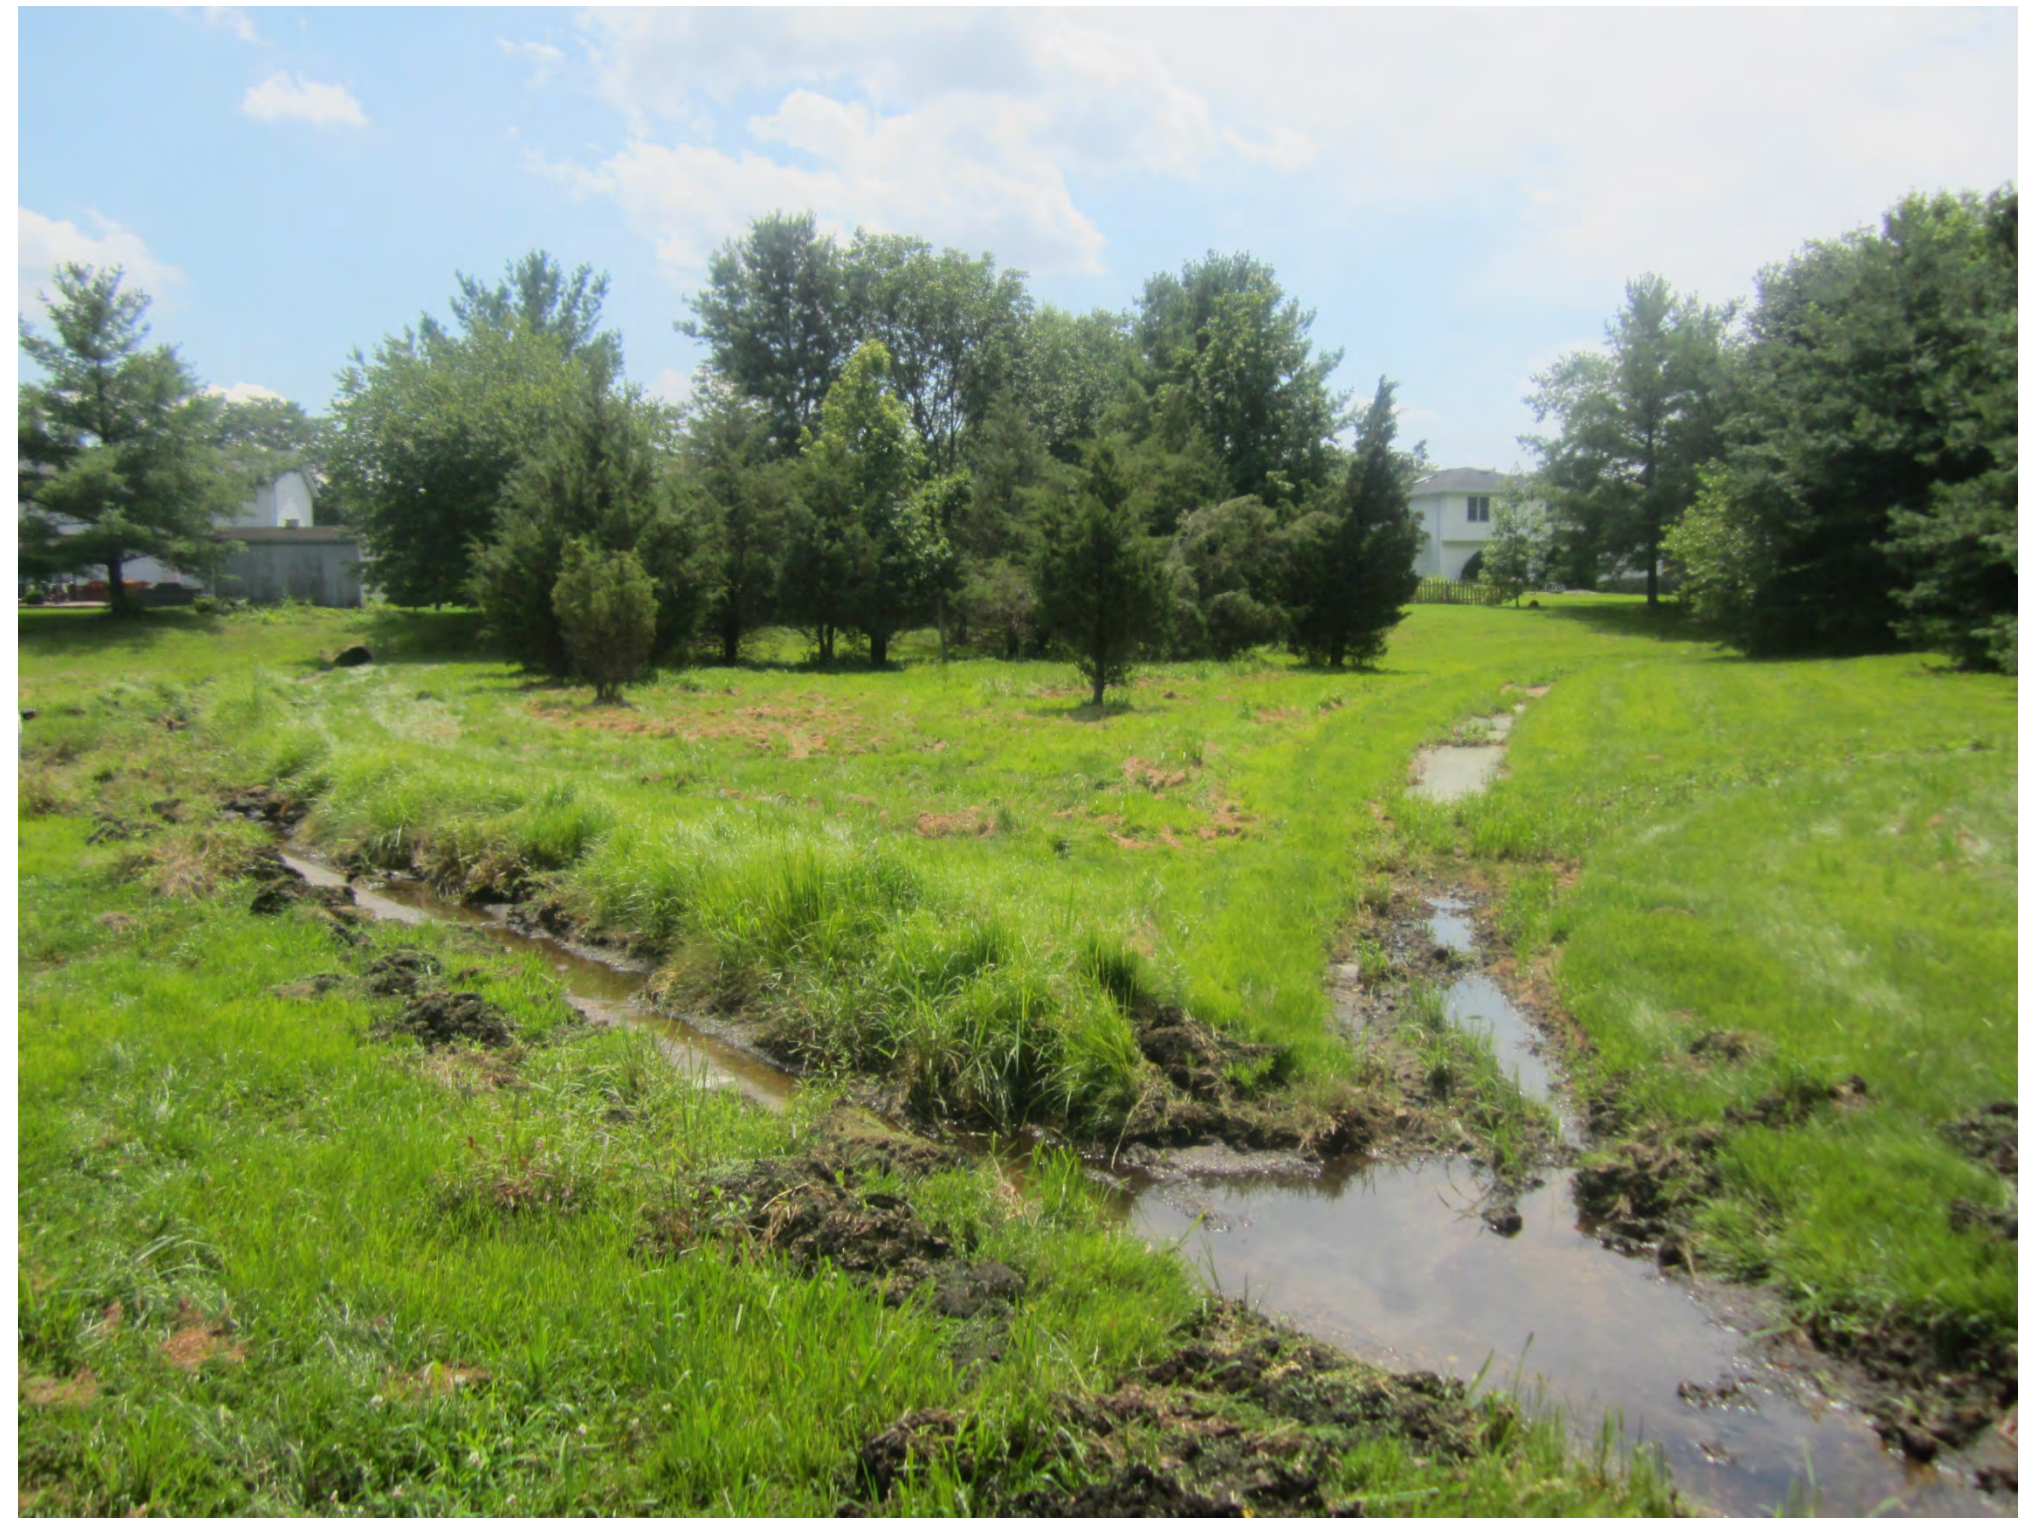
Basin bottom looking east

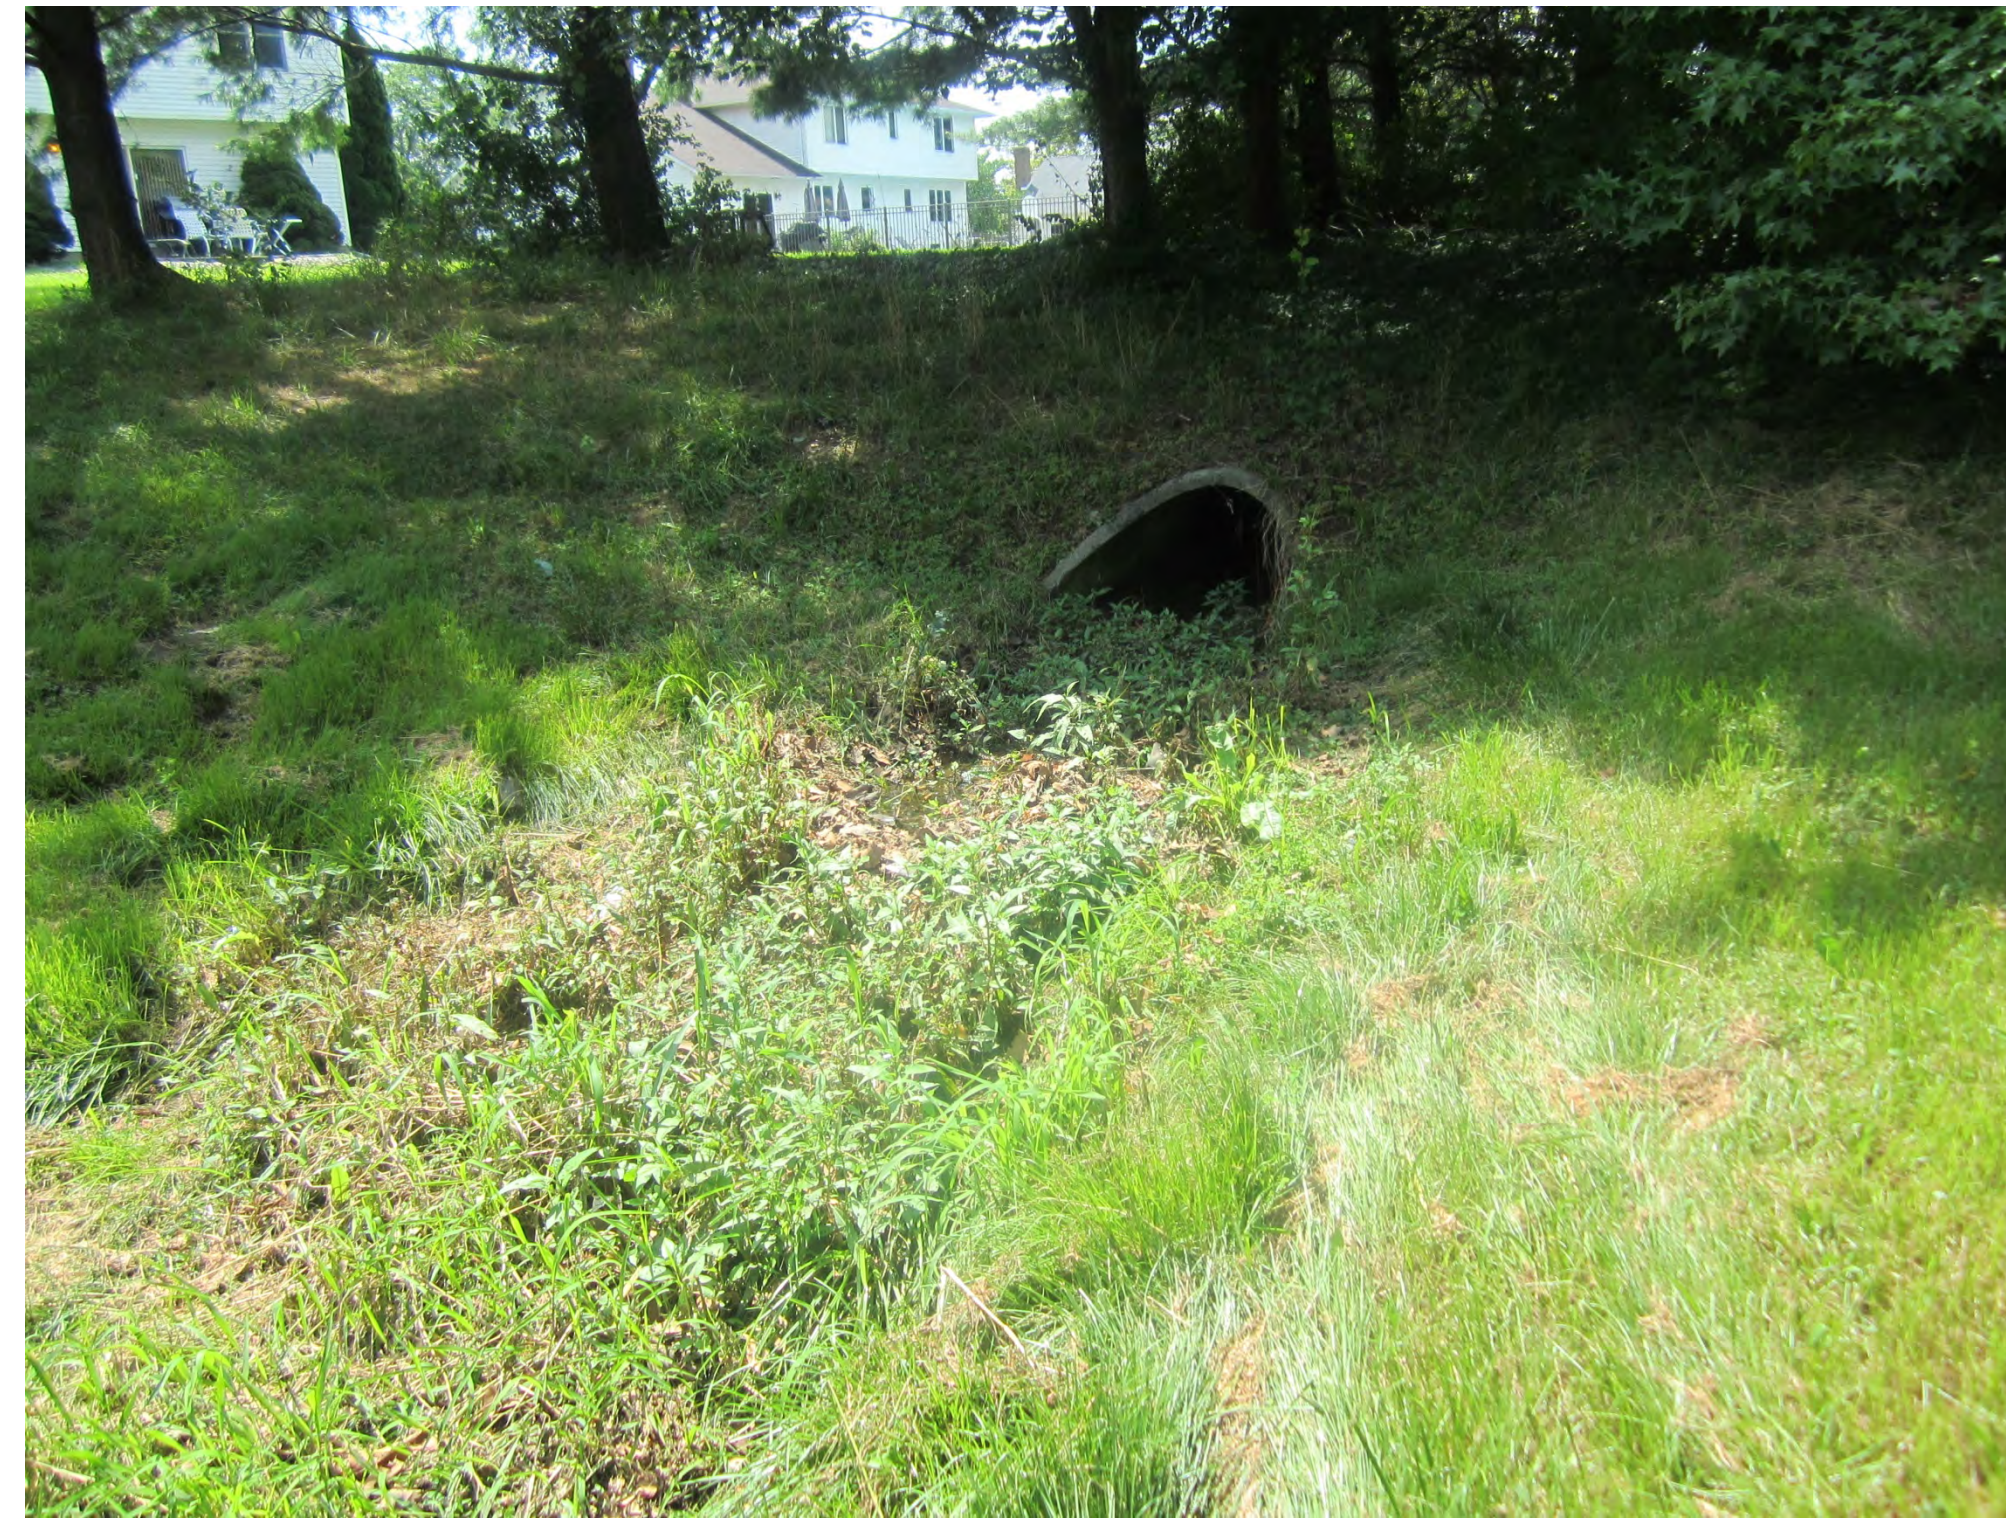
Excessive sediment in front of inlet

- Low flow channels in basin are clogged with accumulated sediment; there is ponding in the channels that appears very stagnant
- It appears that sediment was removed from the low flow channel, but left in the basin. The sediment needs to be hauled away.
- The inlet structures all have excessive sediment accumulated in front of them
- The southwestern inlet has some concrete deterioration and should be replaced
- The outlet structure is missing a trash rack and has some cracks in parging

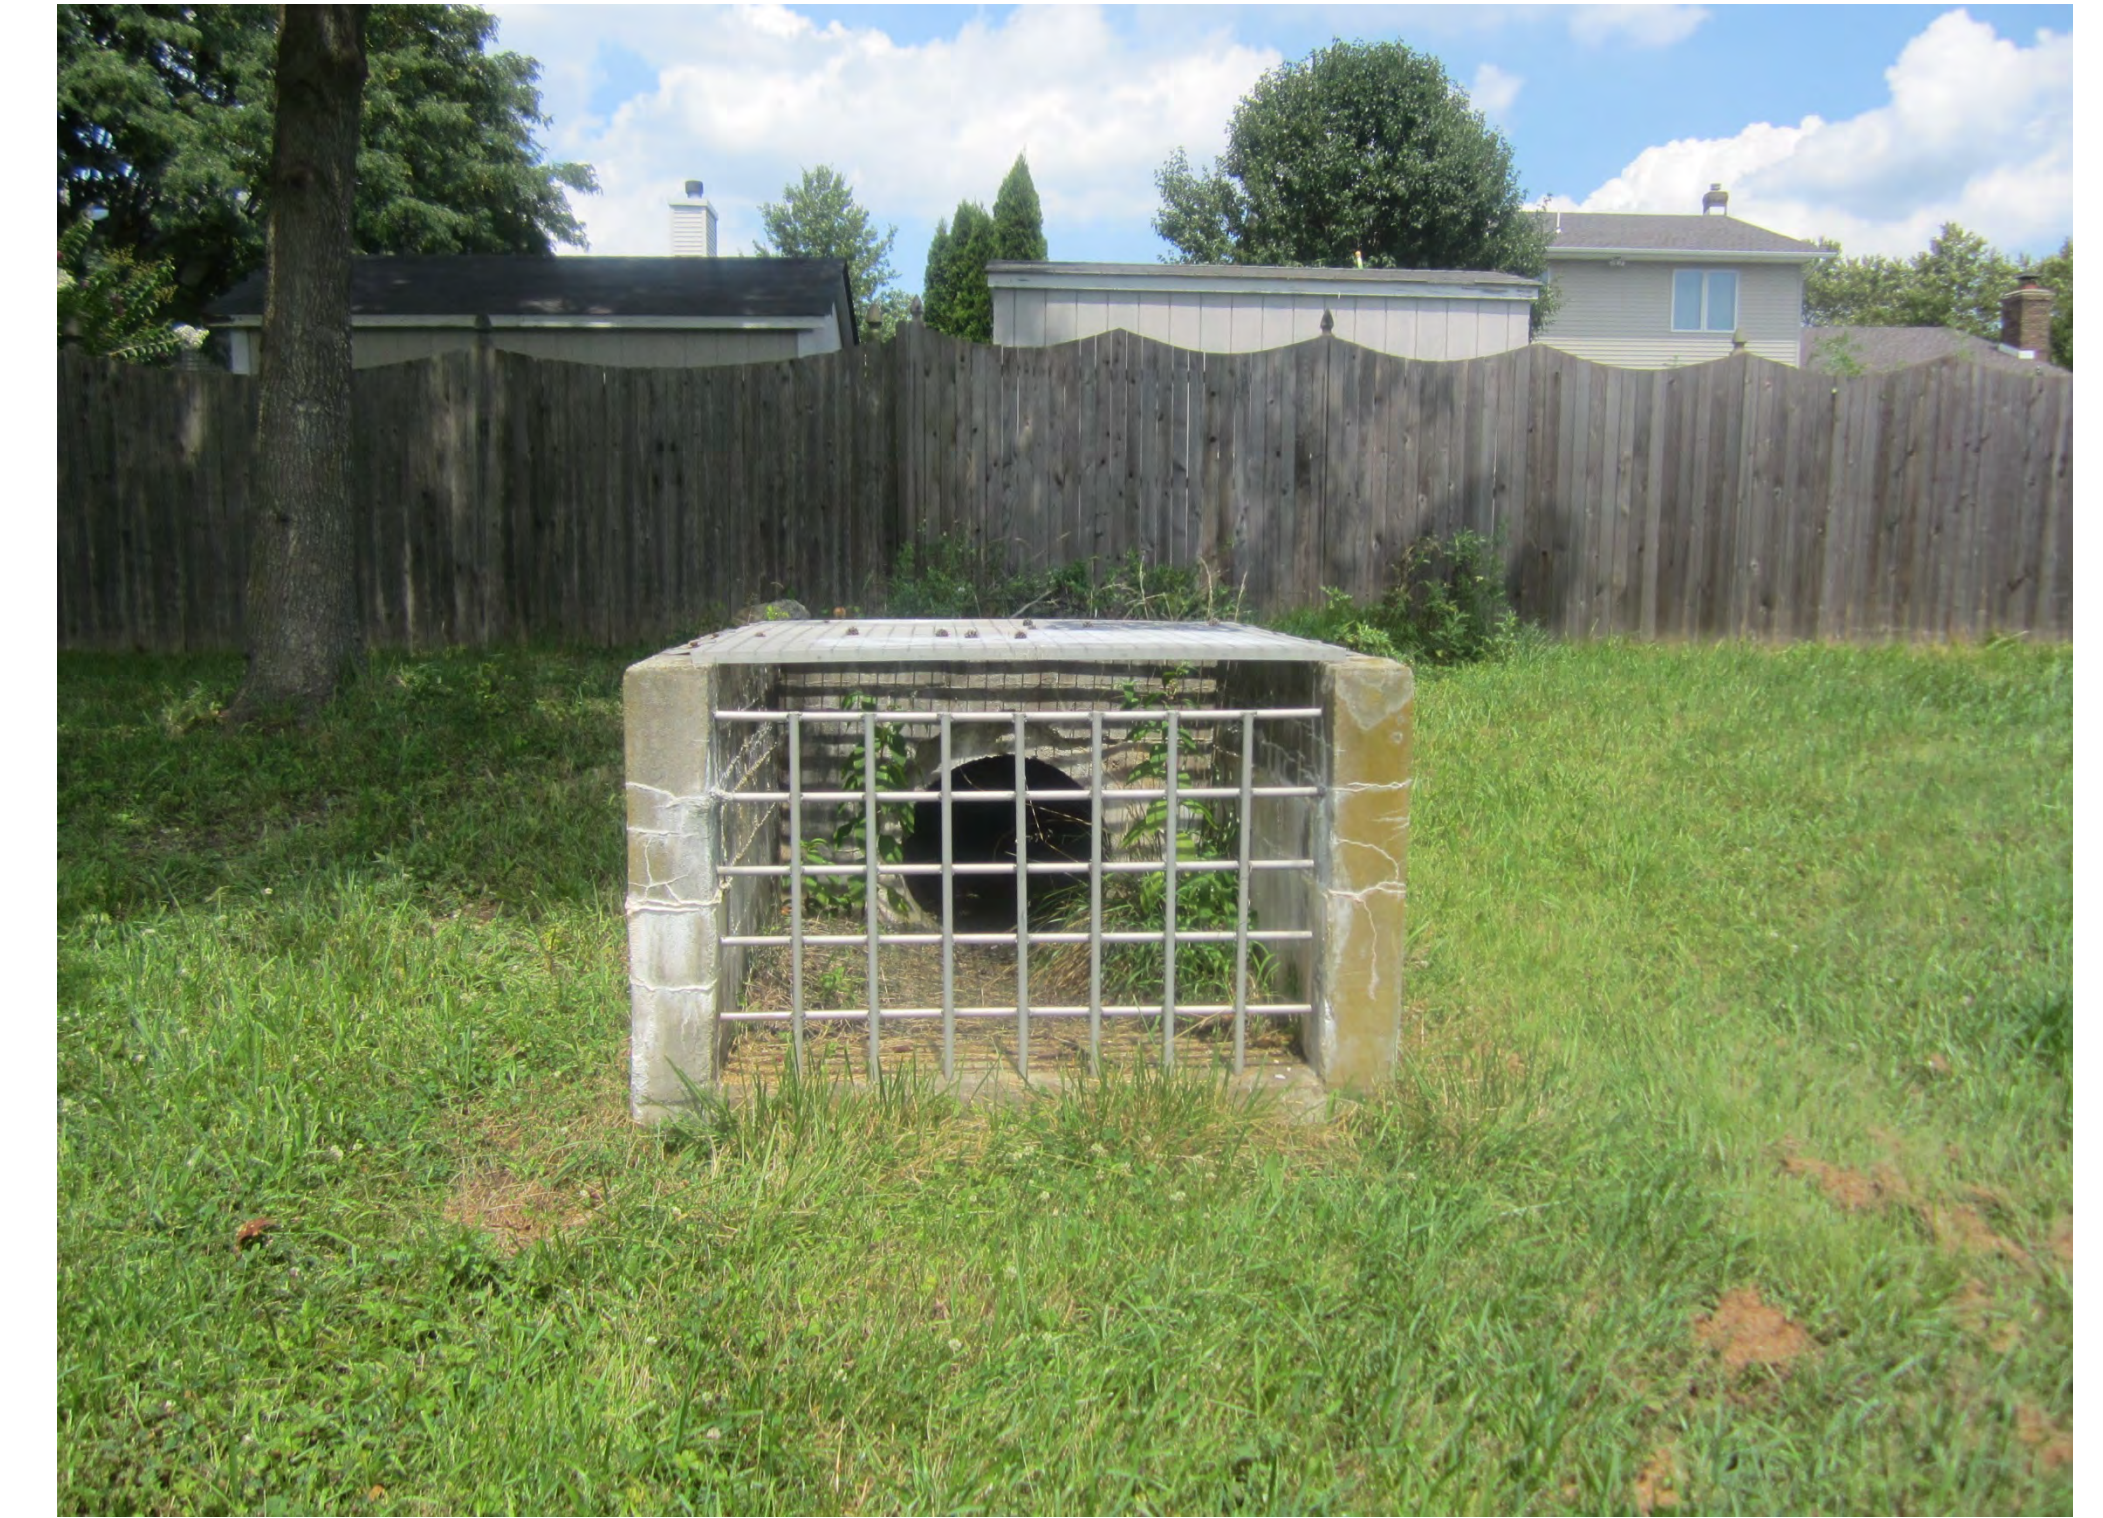
Secondary emergency overflow

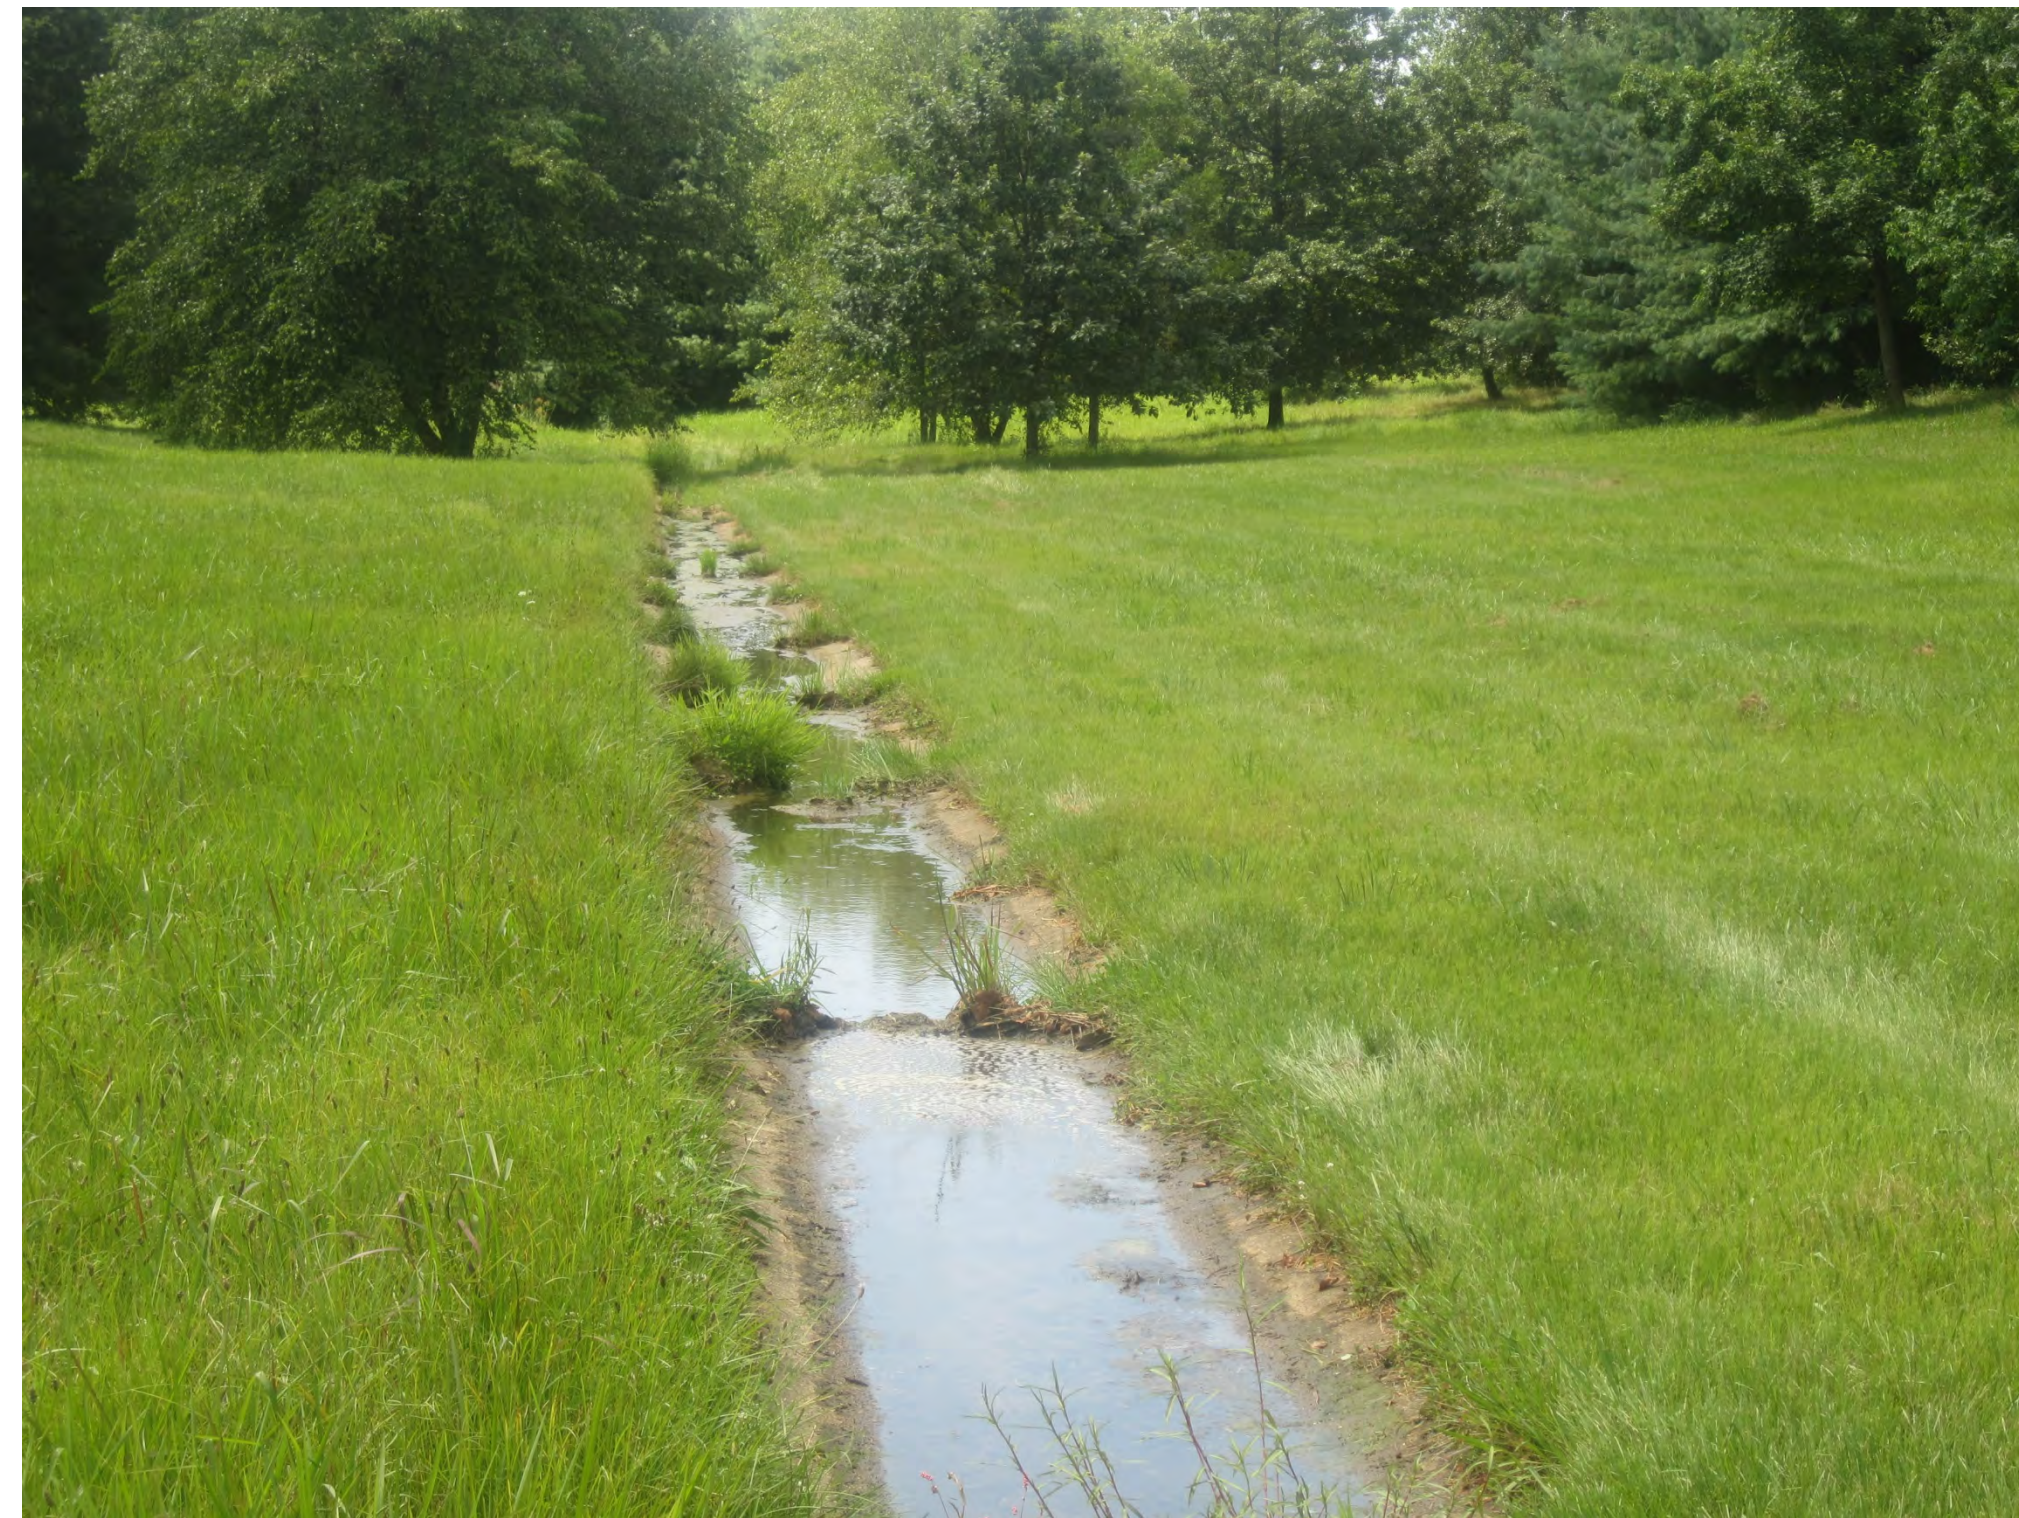
Basin bottom looking northwest

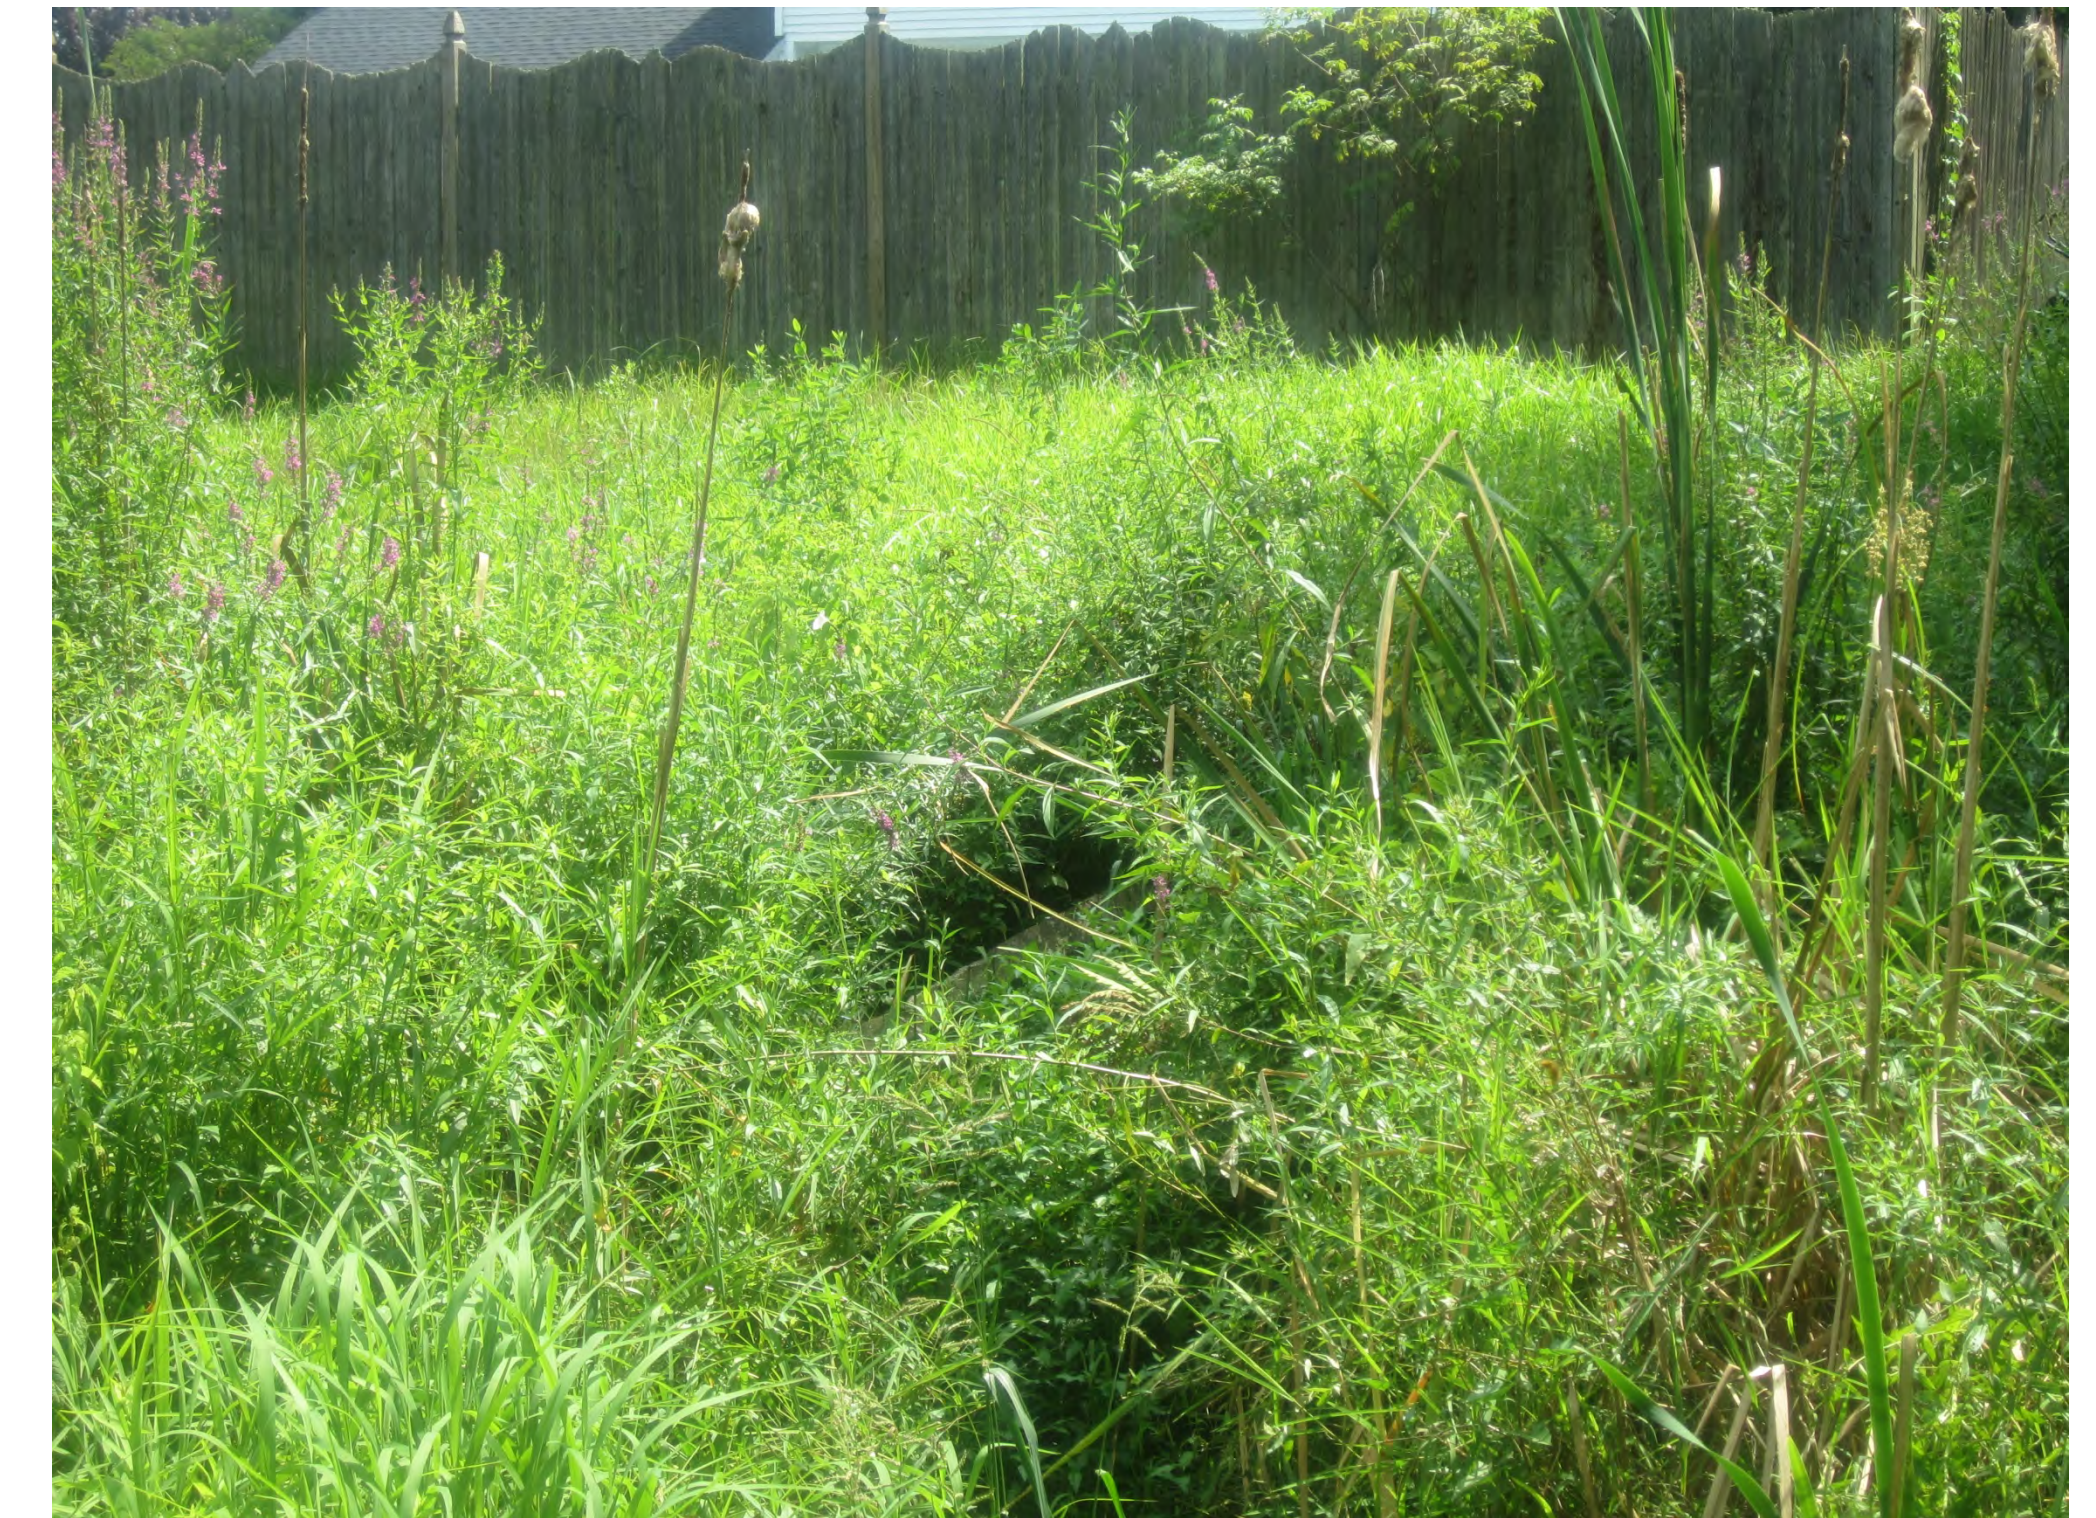
Overgrown western inlet

- There is excess sediment accumulated and standing water in the low flow channel
- The eastern and western inlets both have excess sediment accumulation and are overgrown with various types of vegetation
- The outlet structure has cracks in parging, the trash rack is broken, and the water is not discharging from the outlet causing the entire basin to back up

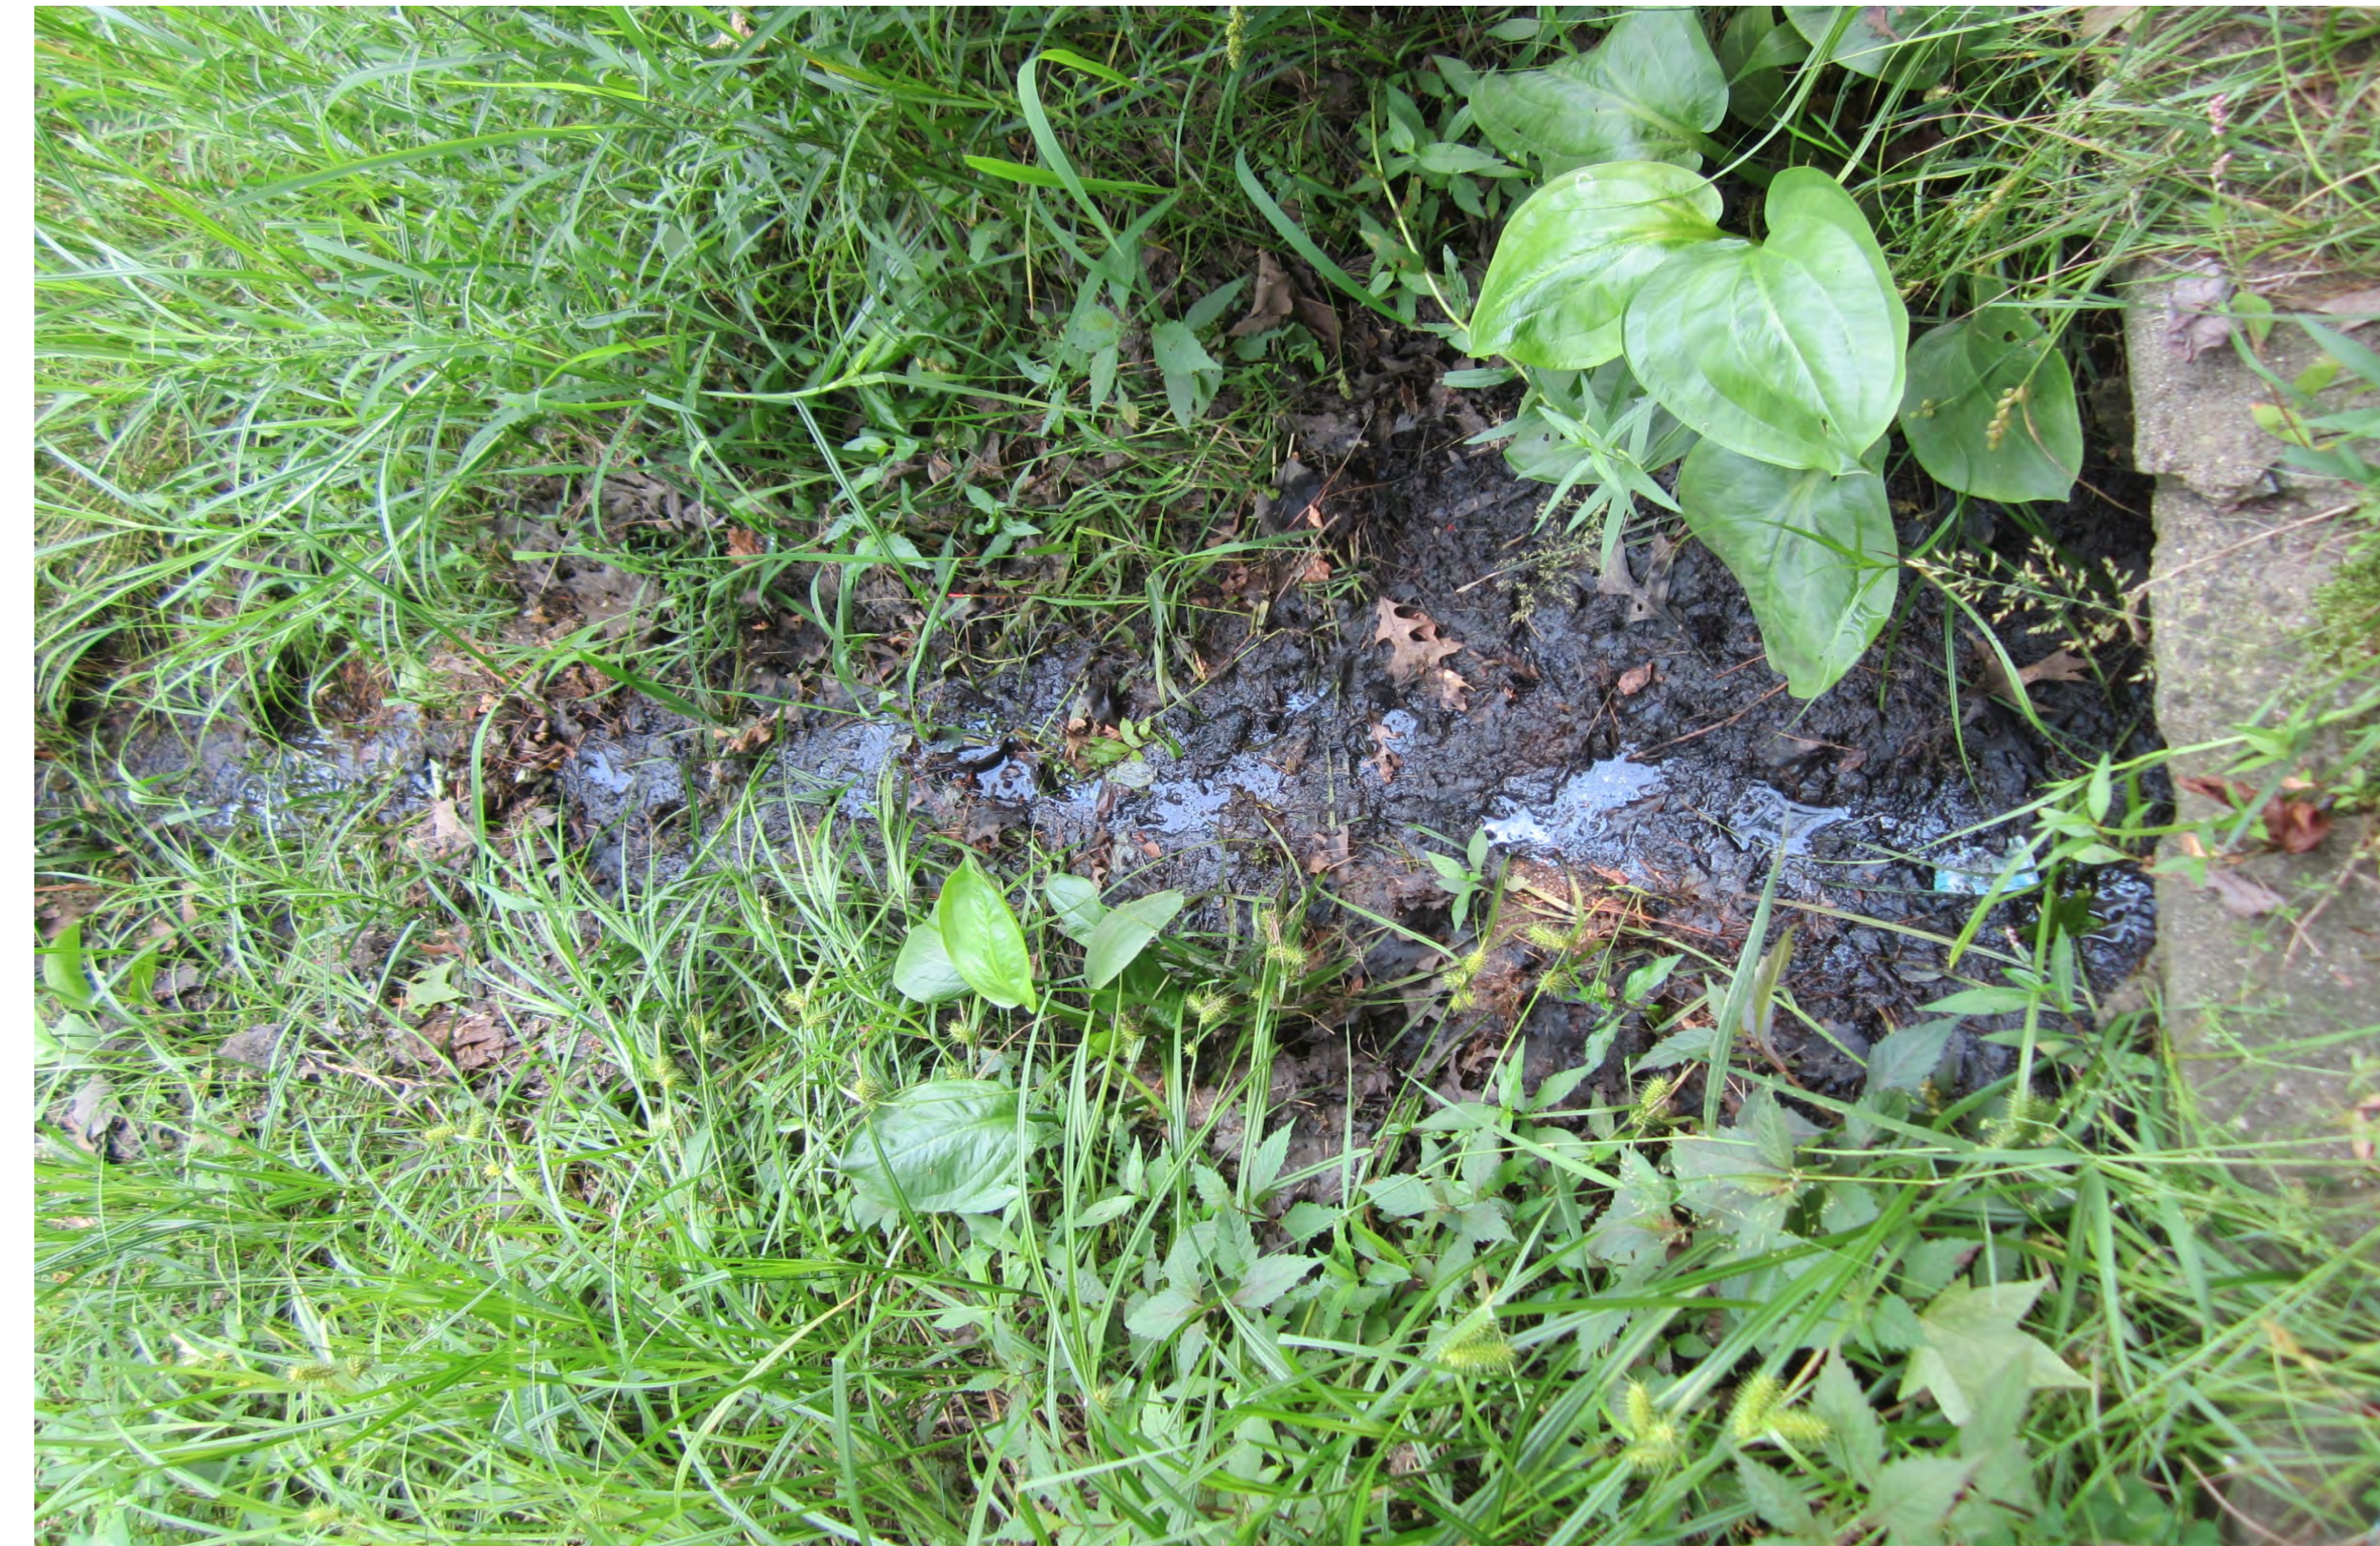
Low flow channel near outlet

- Standing water and sediment in basin bottom and low flow channel
- Basin appears to be treated as infiltration basin
- Naturalized basin bottom
