## Hamilton Township (Mercer County)

# REVIEW AND EVALUATION OF TOTAL MAXIMUM DAILY LOADS (TMDLs)

Developed by the Rutgers Cooperative Extension Water Resources Program  
Funded by Hamilton Township, Mercer County, New Jersey

December 5, 2019

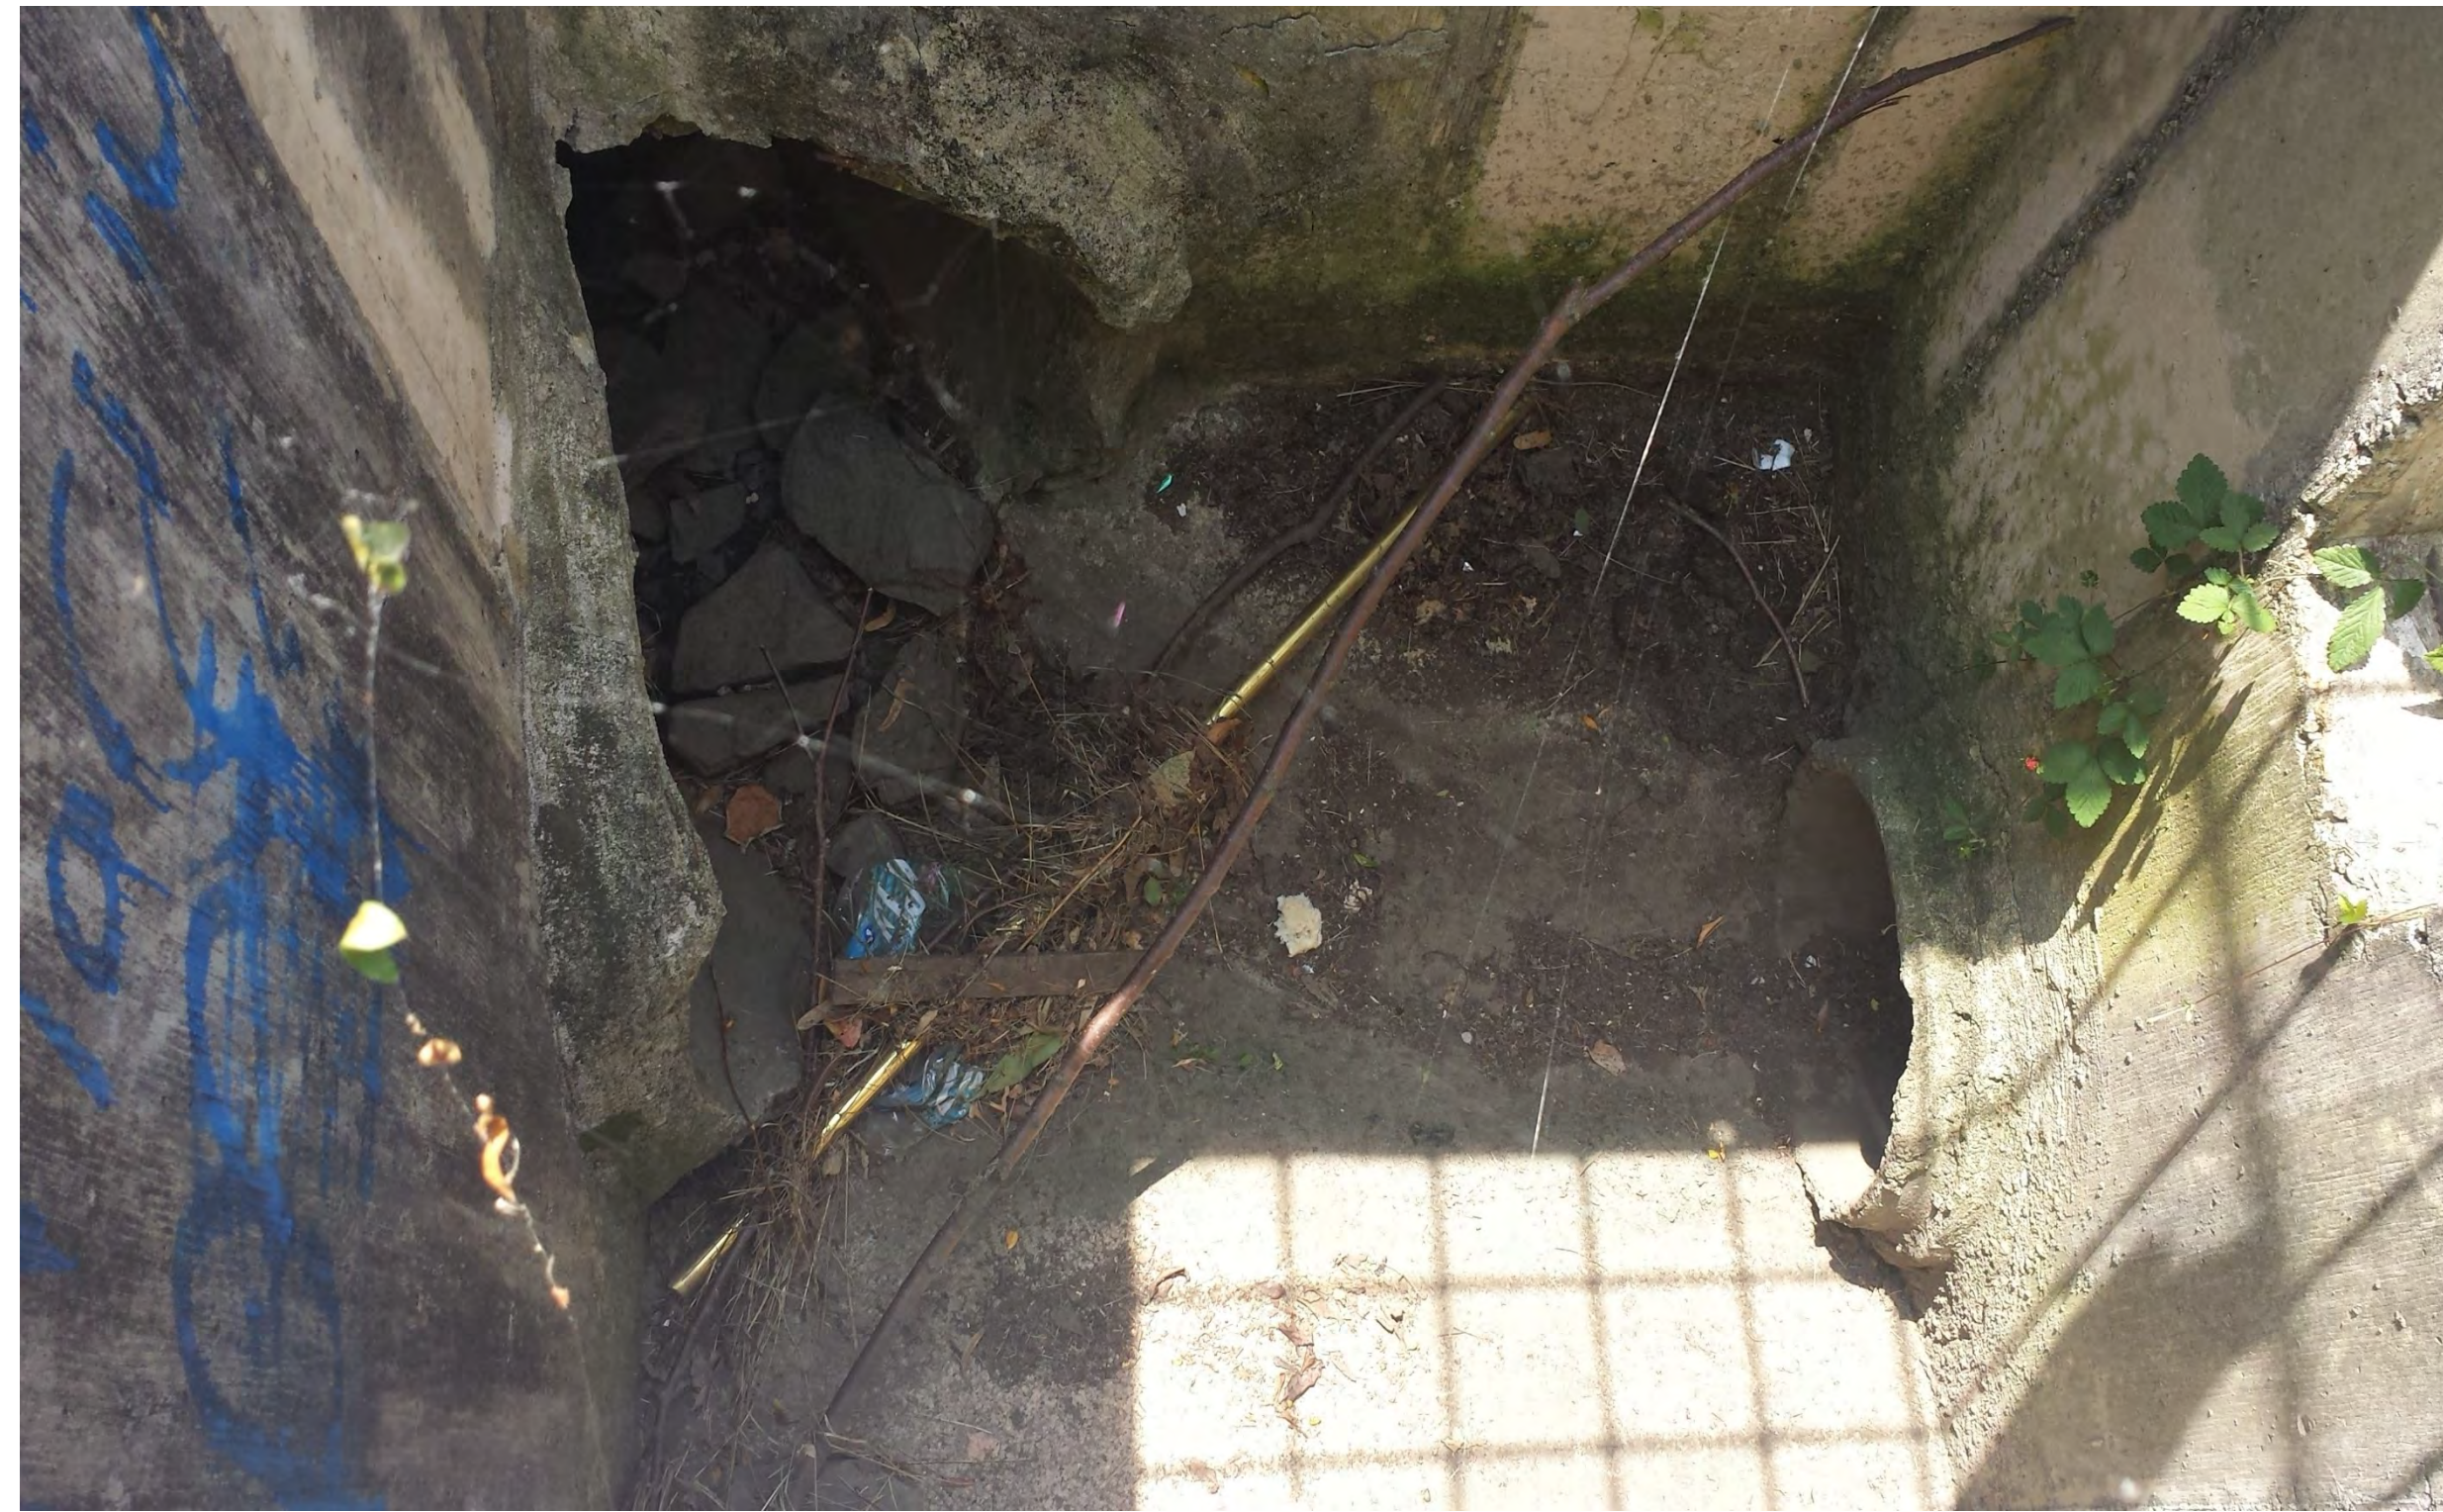
Inside of outlet

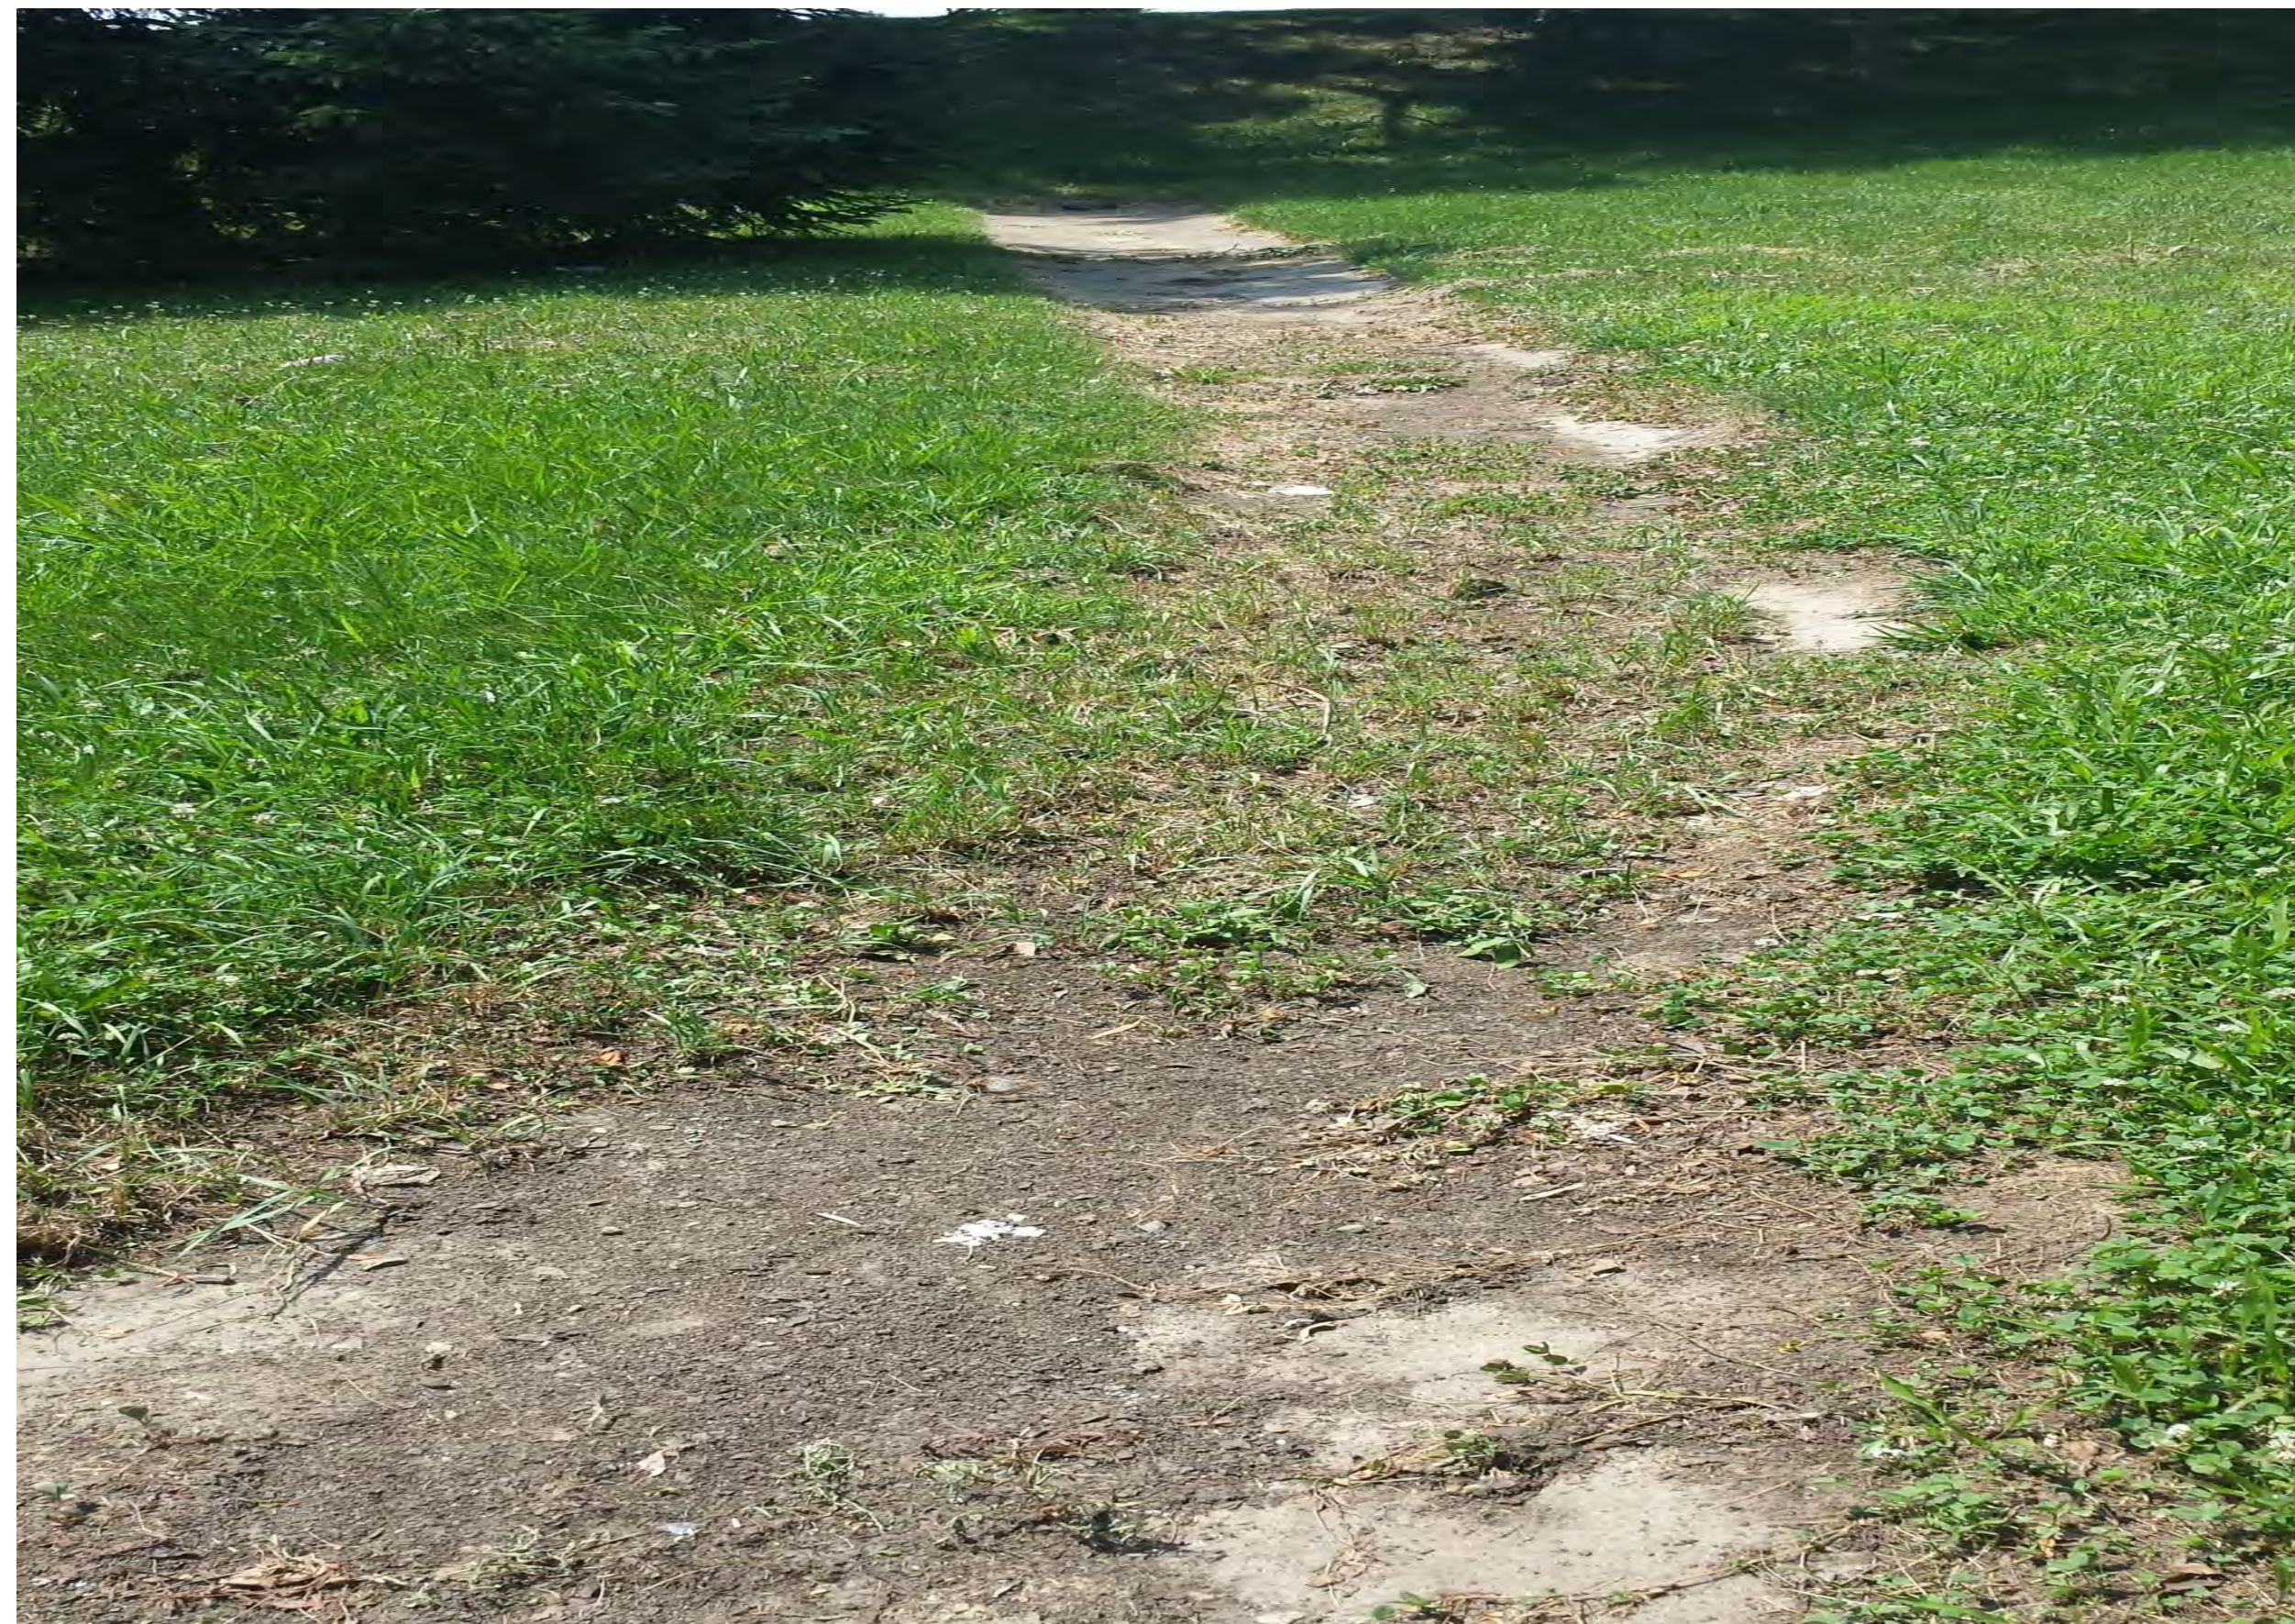
Overgrown on low flow channel

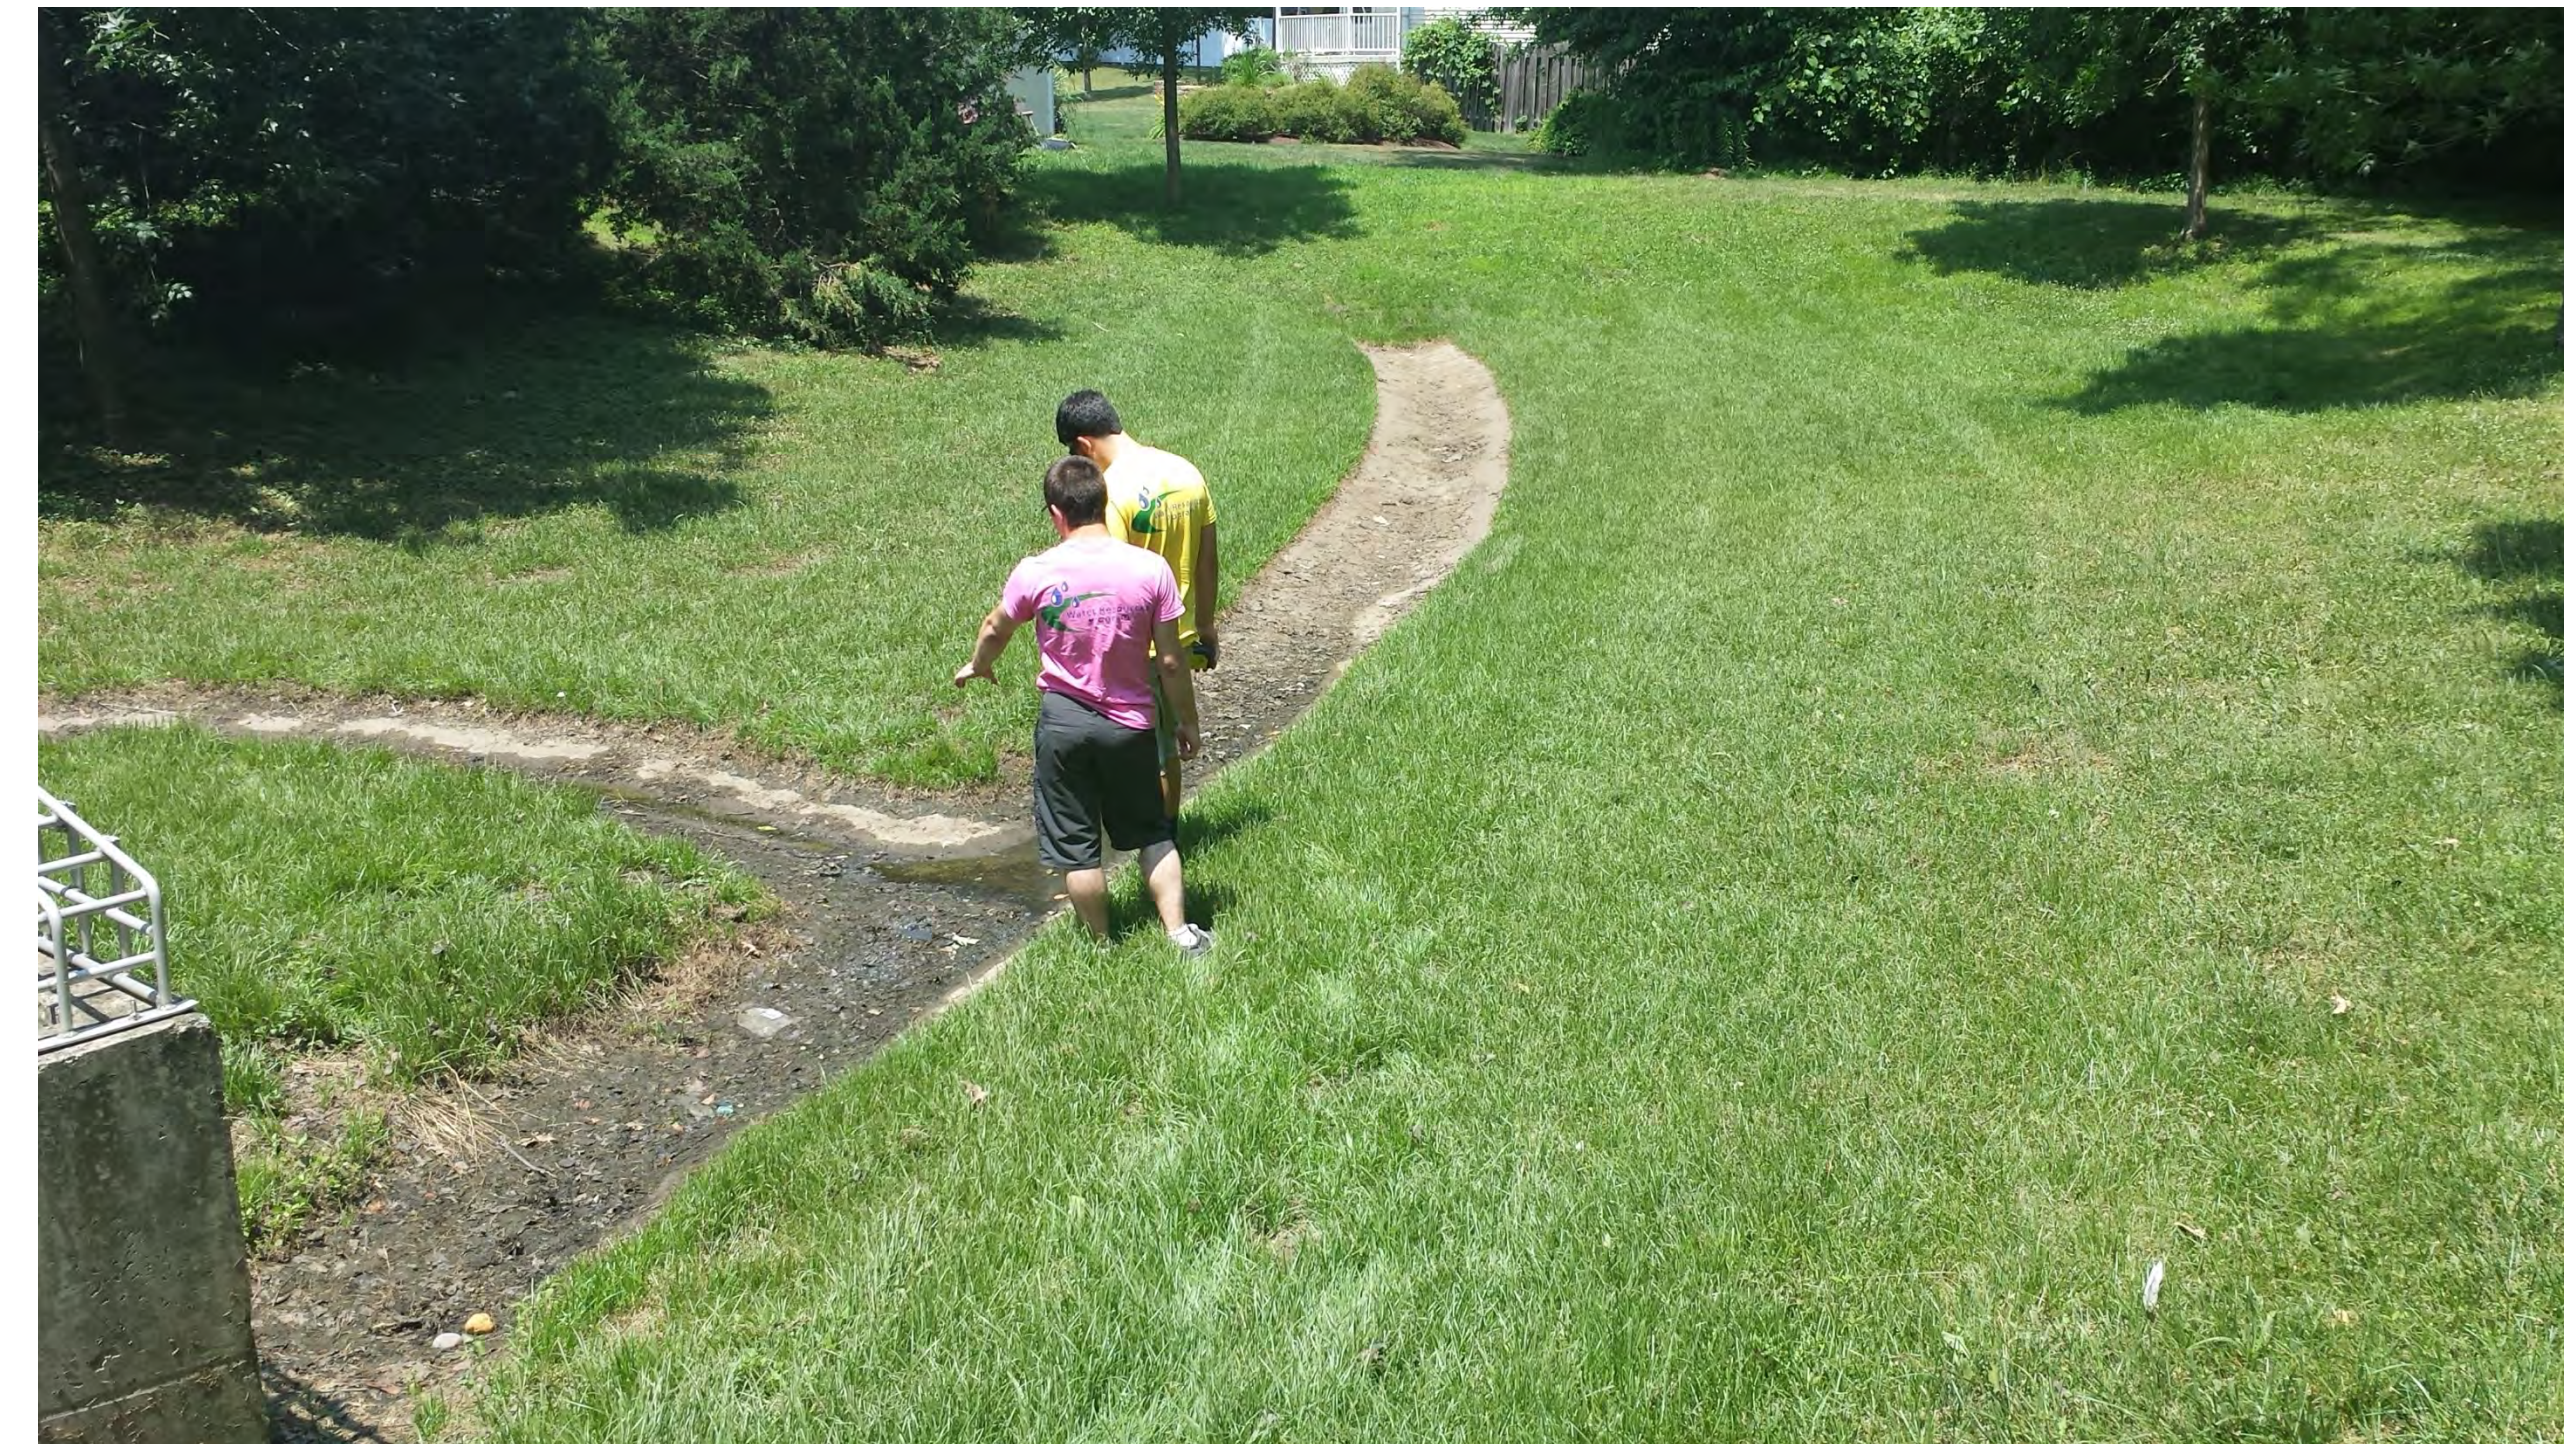
Sediment in low flow channel

- Erosion present in basin
- Slight standing water in low flow channels
- Remove low flow channel to allow more infiltration
- Naturalize with herbaceous plants to help reduce erosion

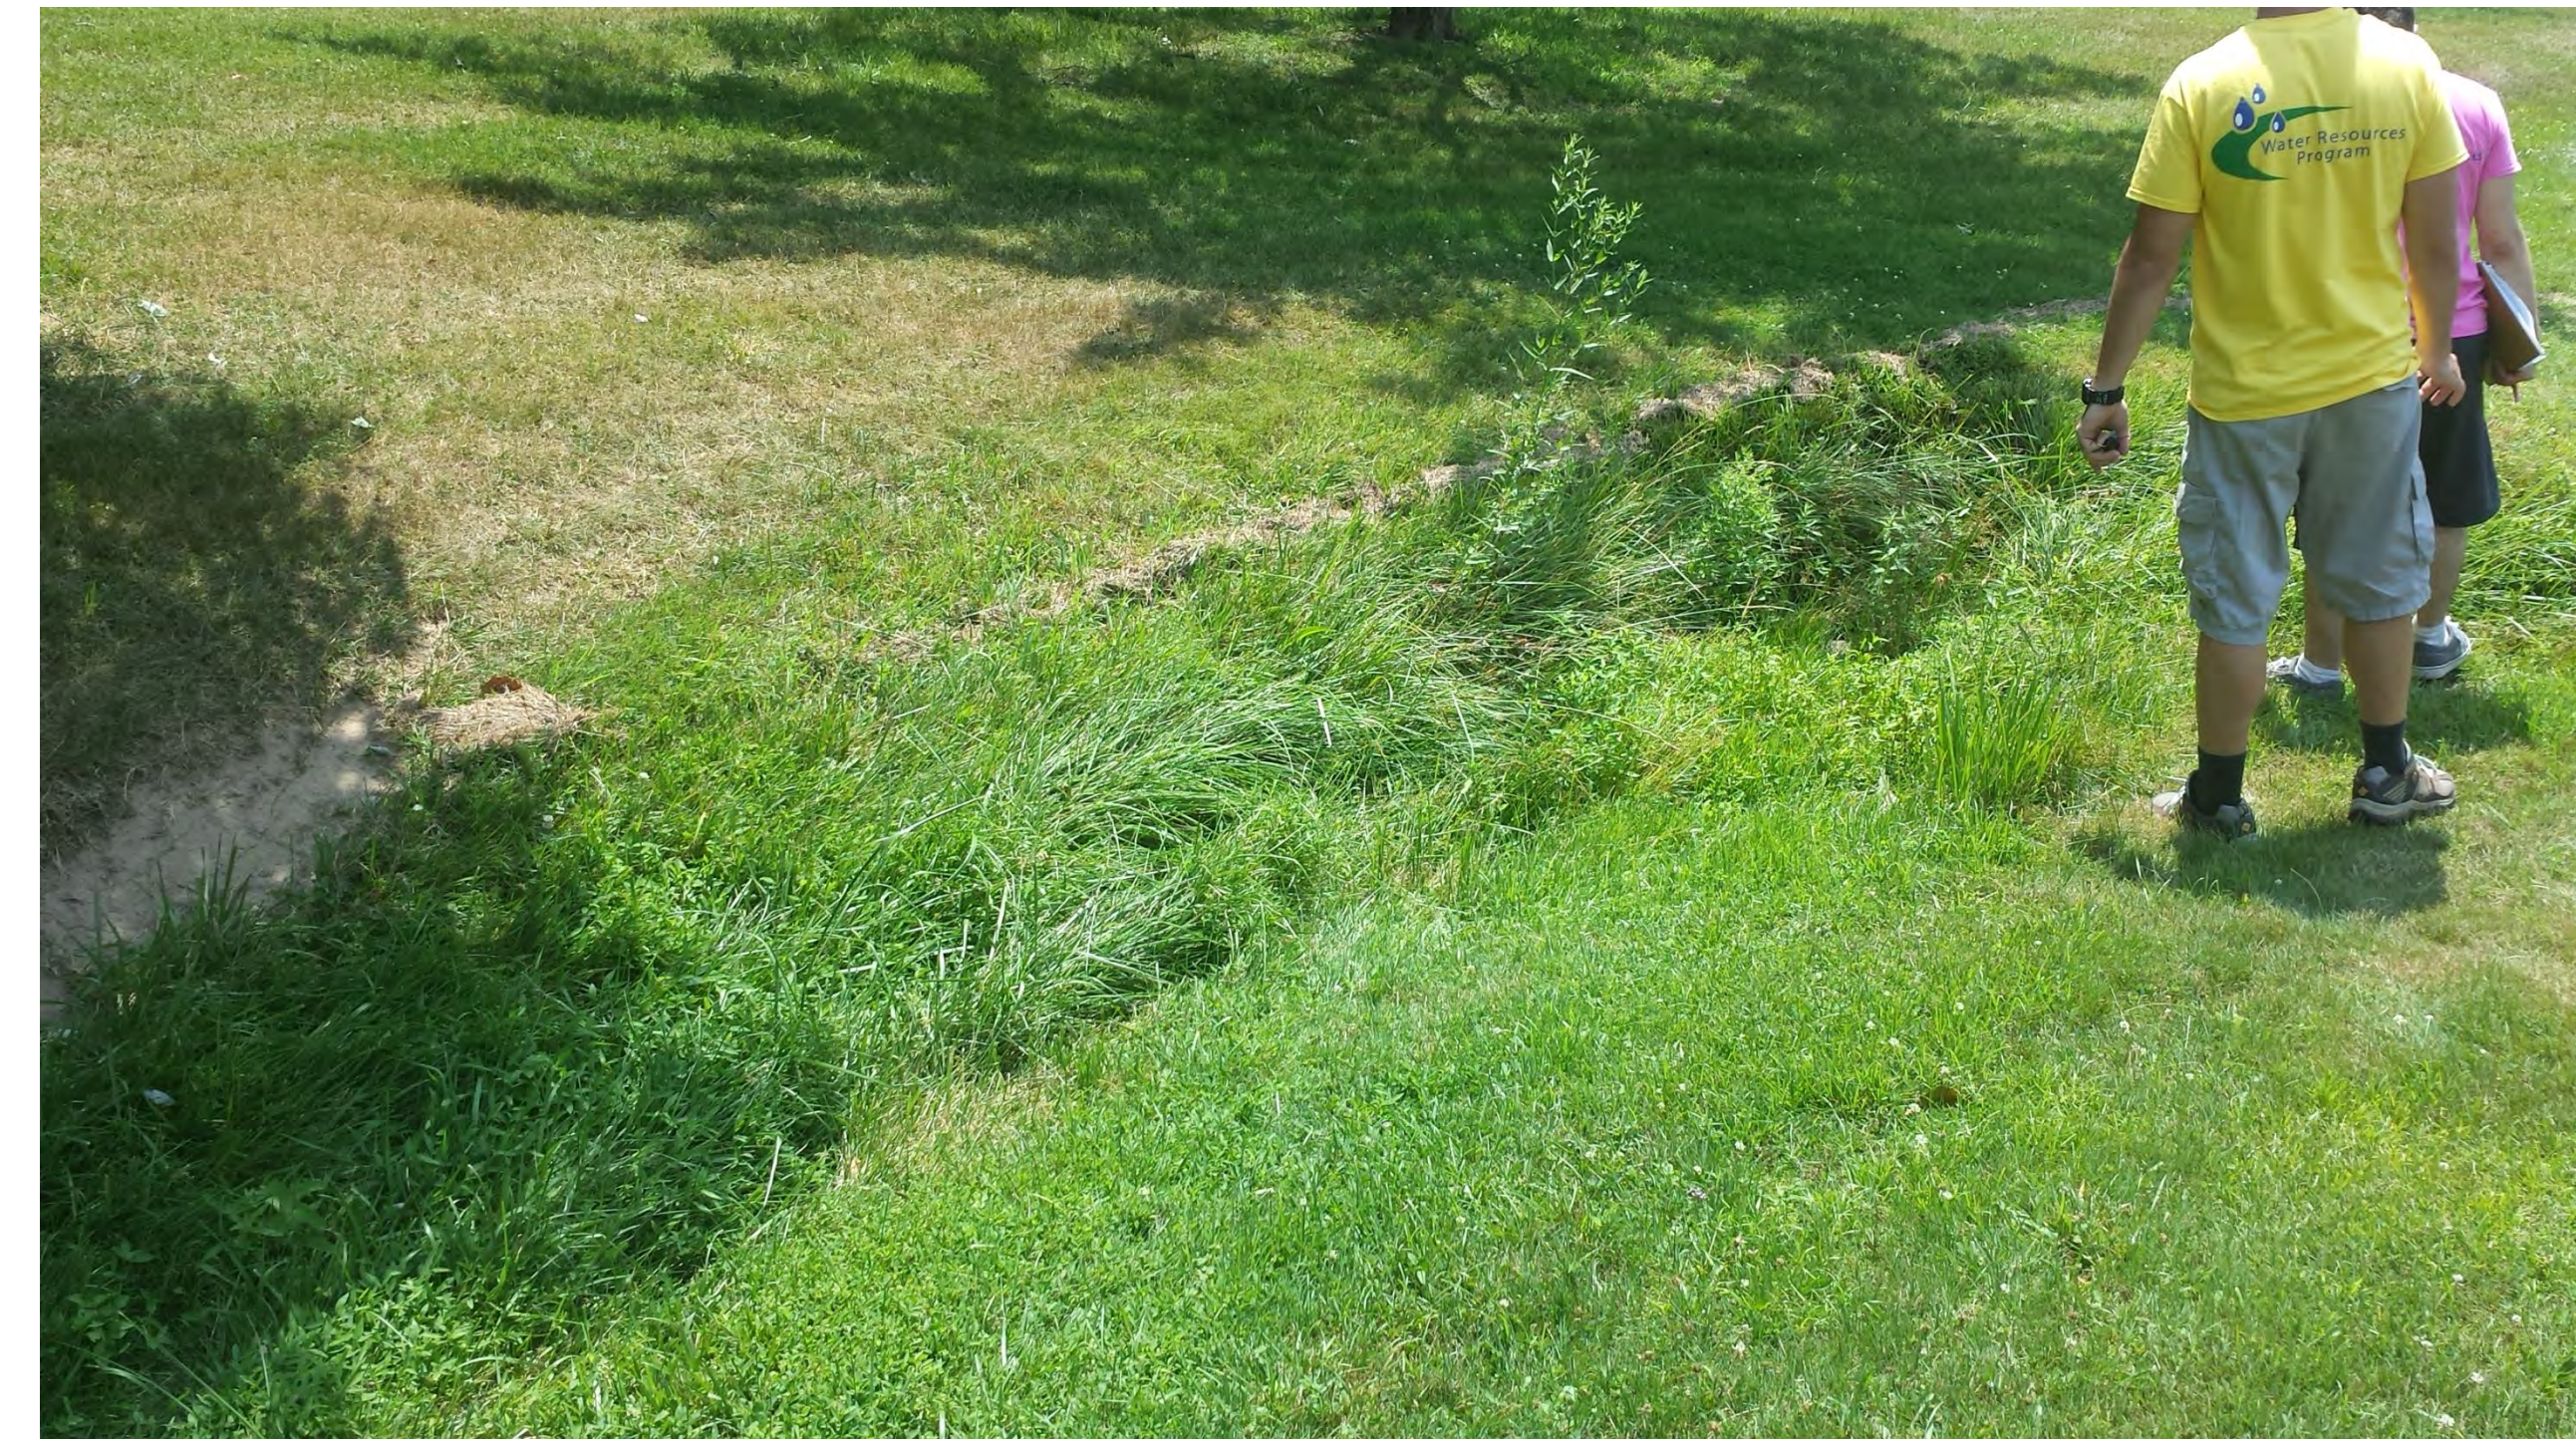
Swale feature lading to basin

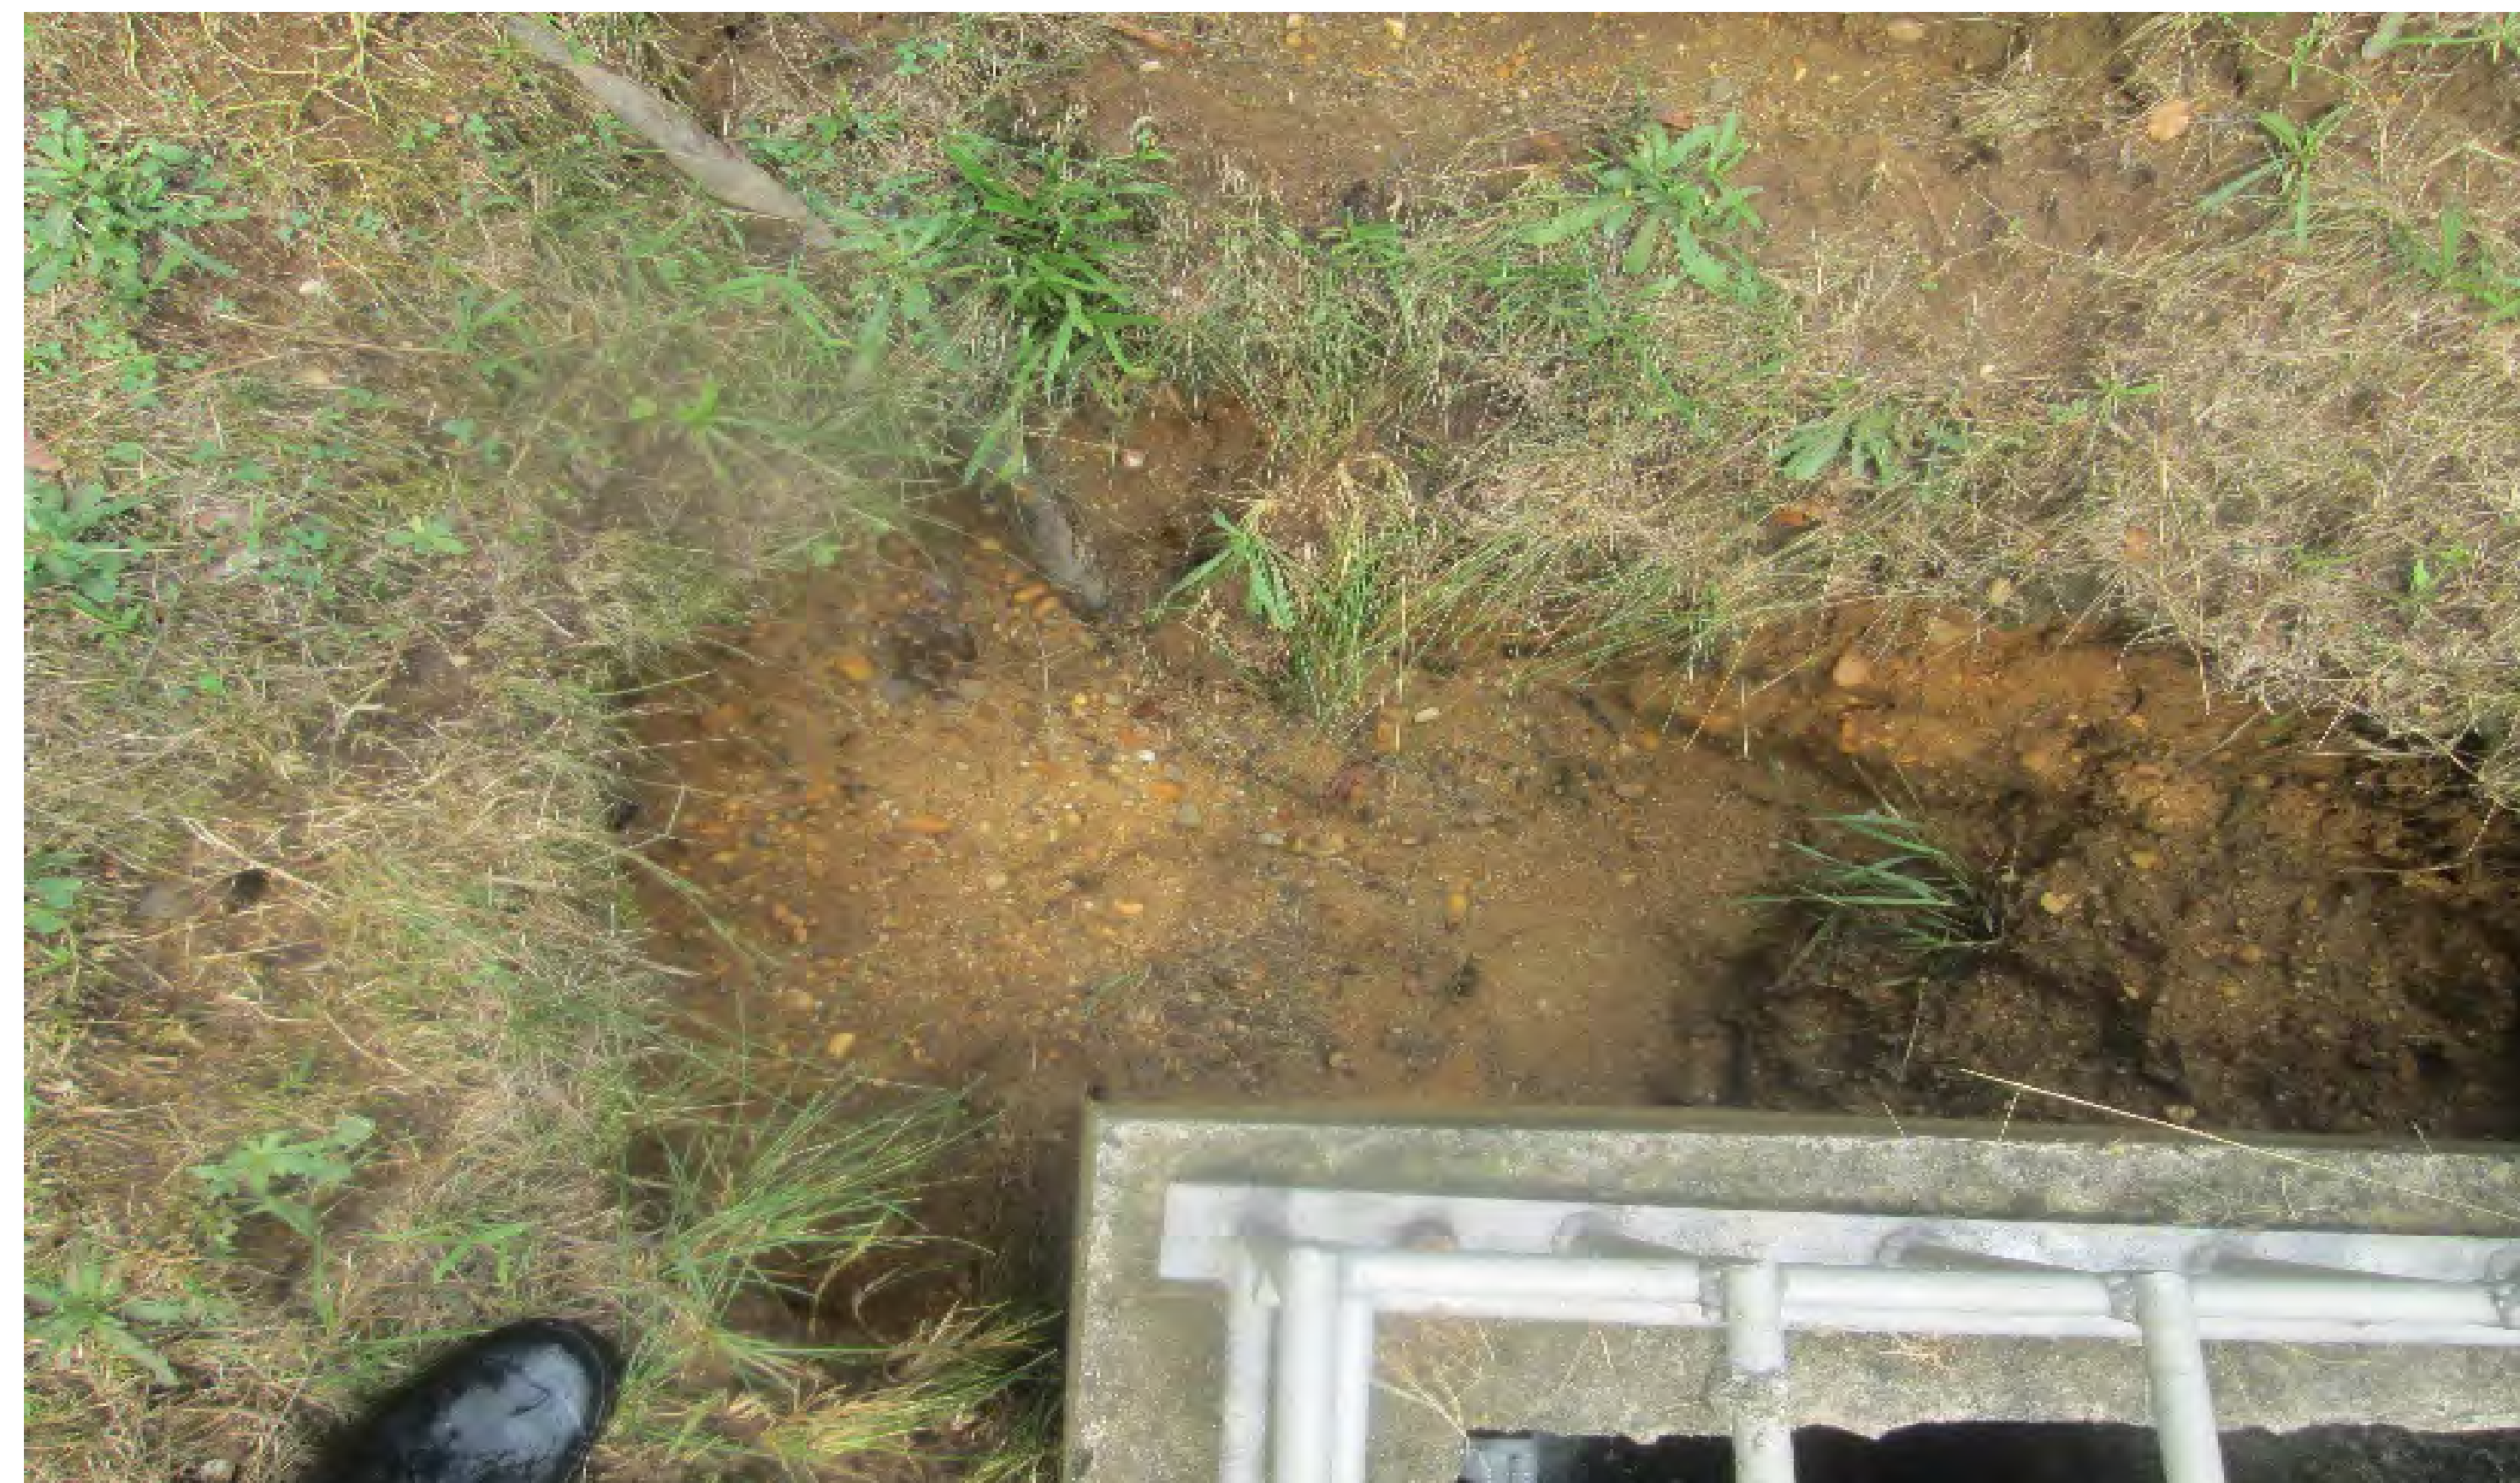
Erosion near outlet structure

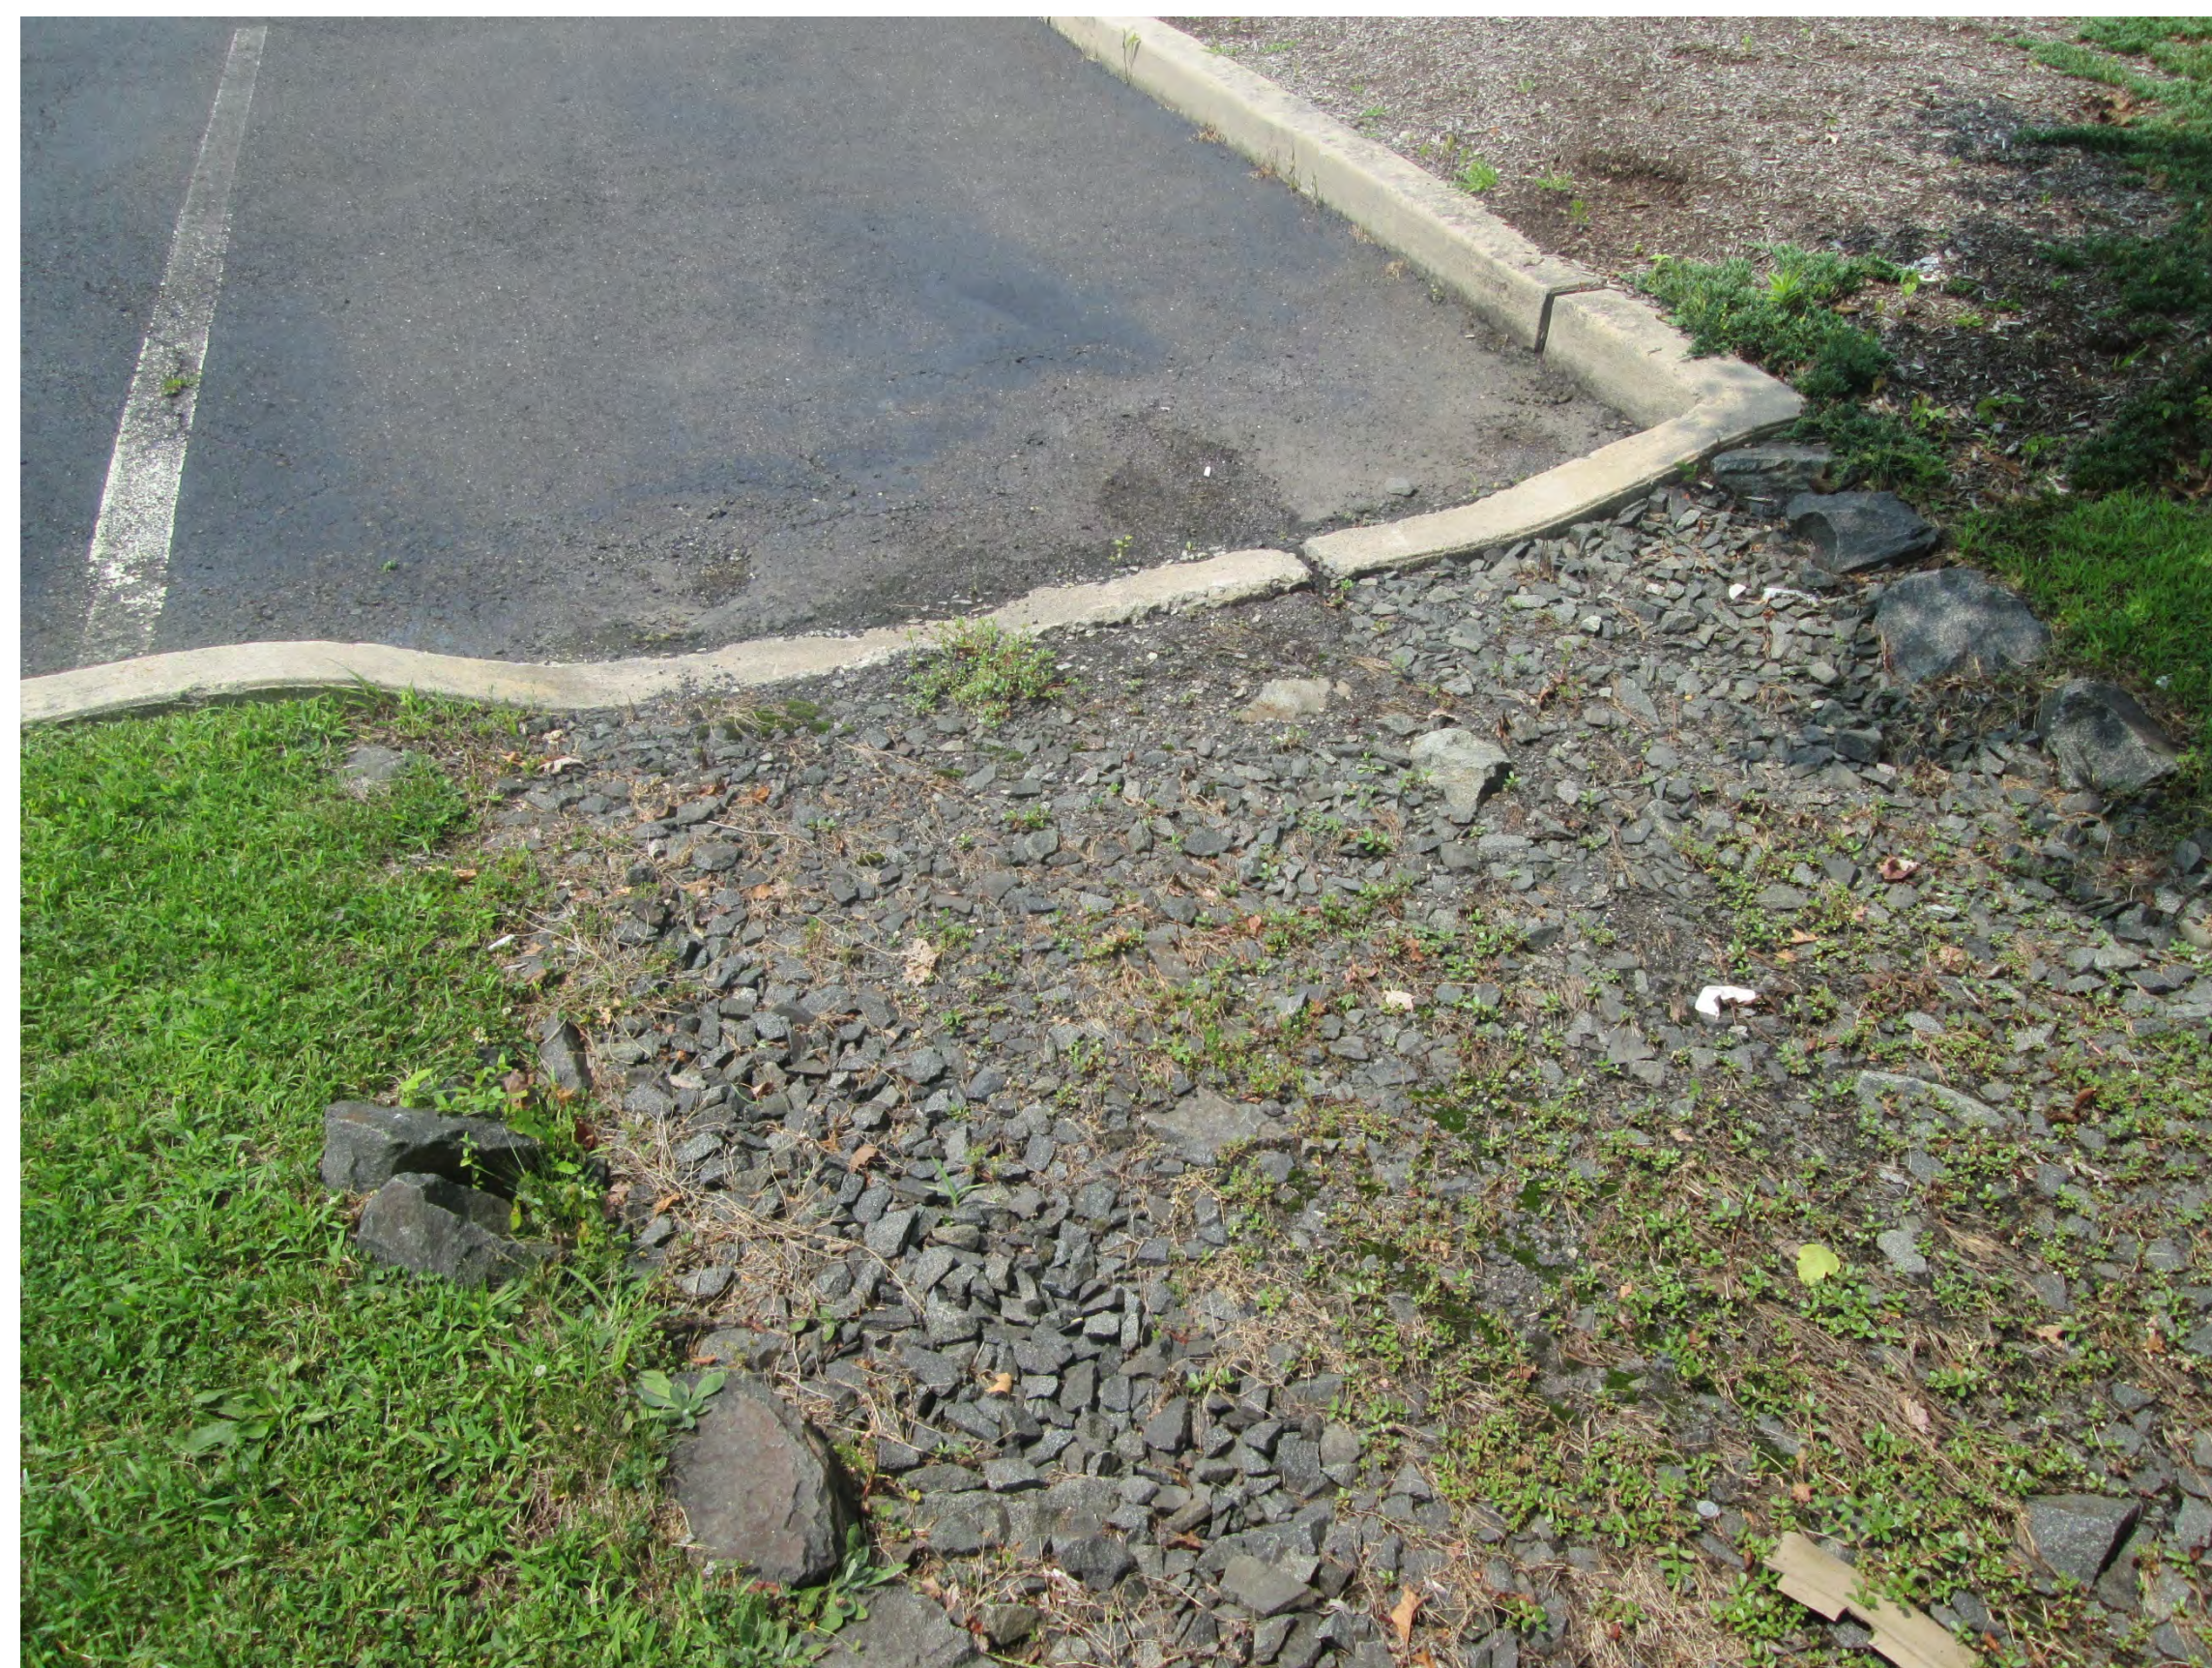
Curb-cut leading to basin
