## Hamilton Township (Mercer County)

# REVIEW AND EVALUATION OF TOTAL MAXIMUM DAILY LOADS (TMDLs)

Developed by the Rutgers Cooperative Extension Water Resources Program  
Funded by Hamilton Township, Mercer County, New Jersey

December 5, 2019

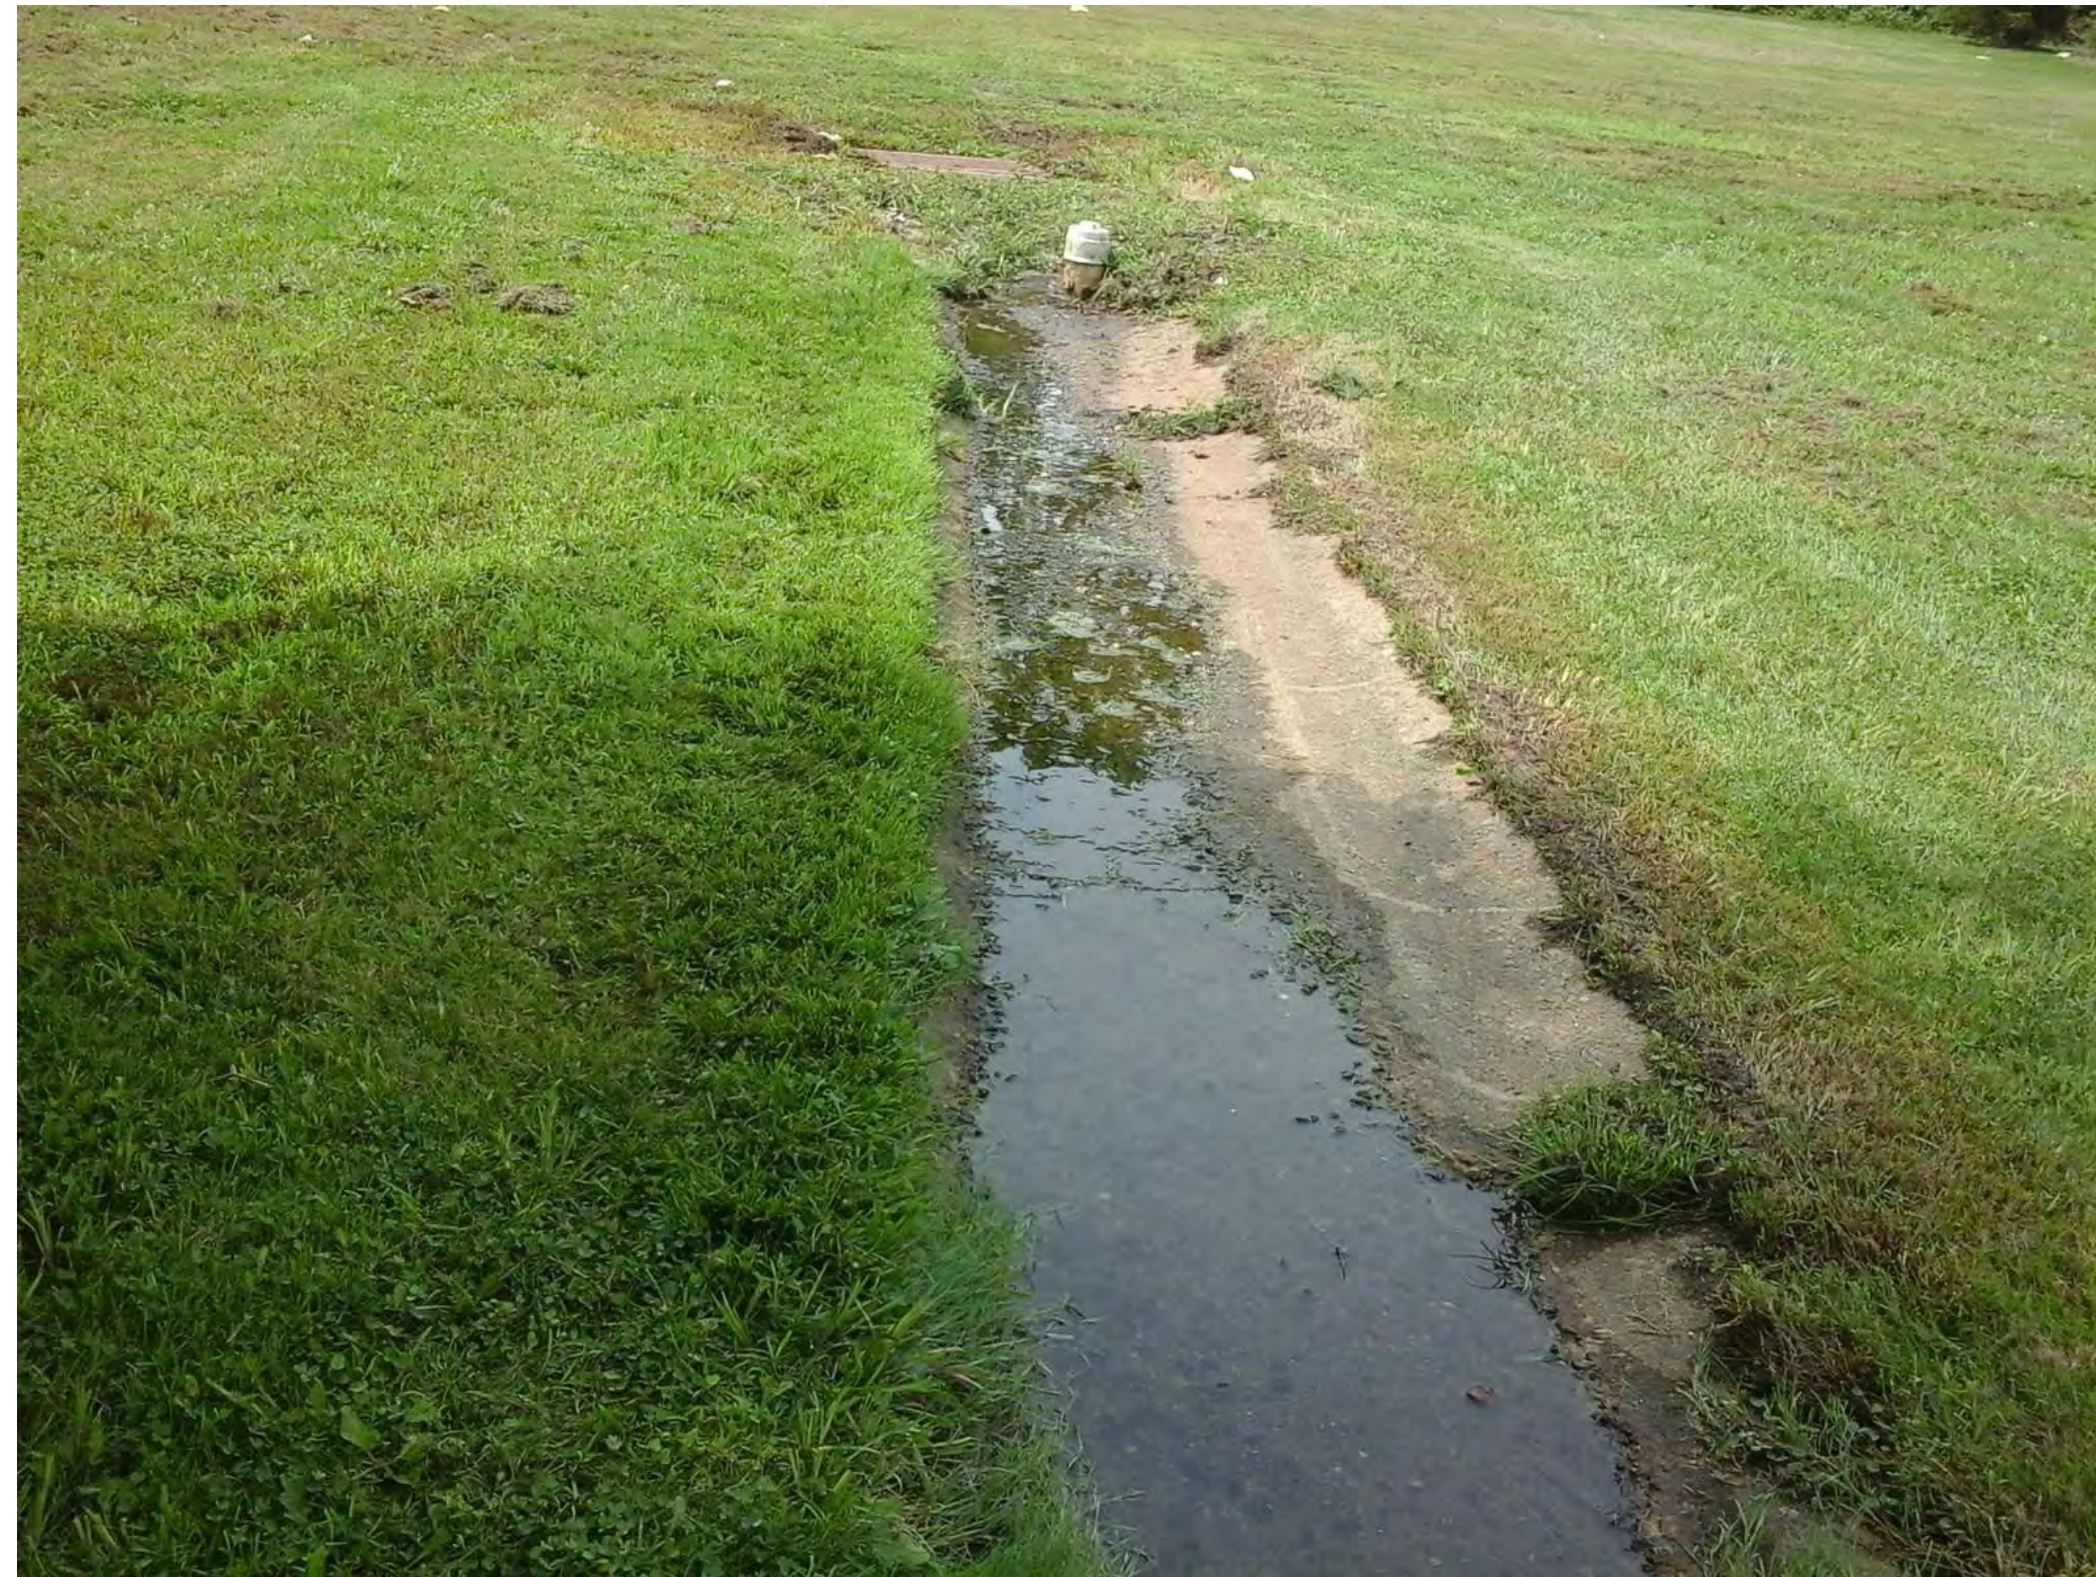
Low flow channel leading to catch basin

- Two low flow channels lead to a catch basin
- Basin can be naturalized using a stone lined channel to replace the low flow channel
- Reduce mowing and raise catch basin at the end of the low flow channels to allow better infiltration

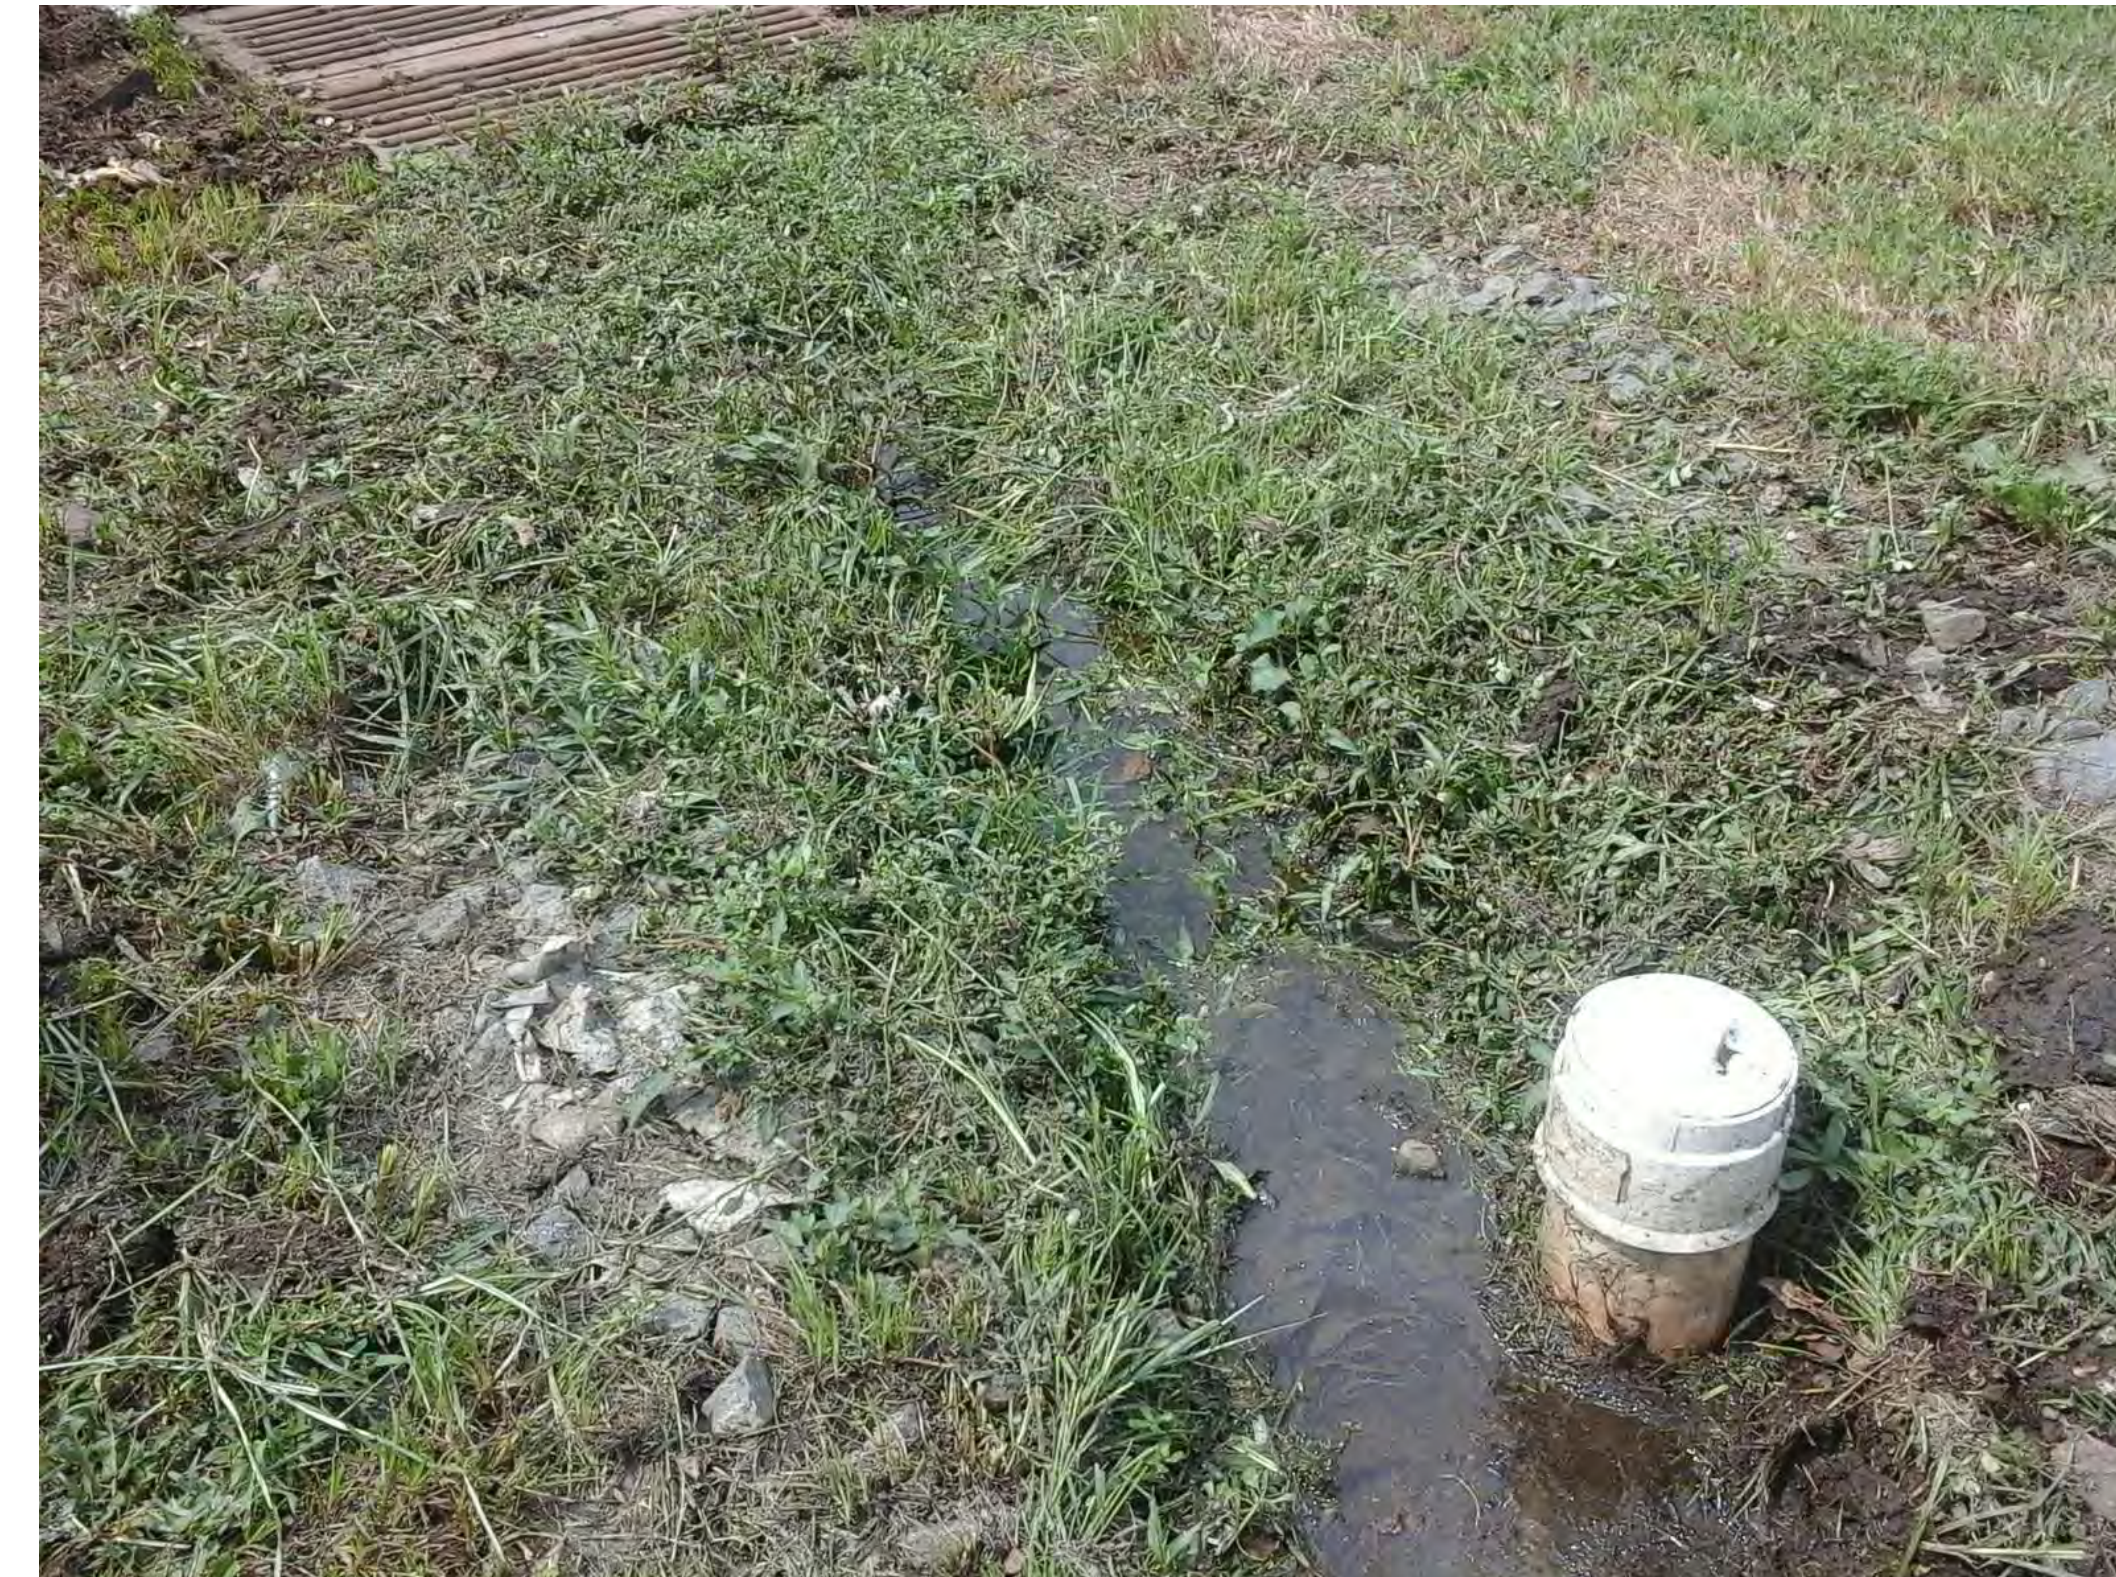
Clean out in low flow channel

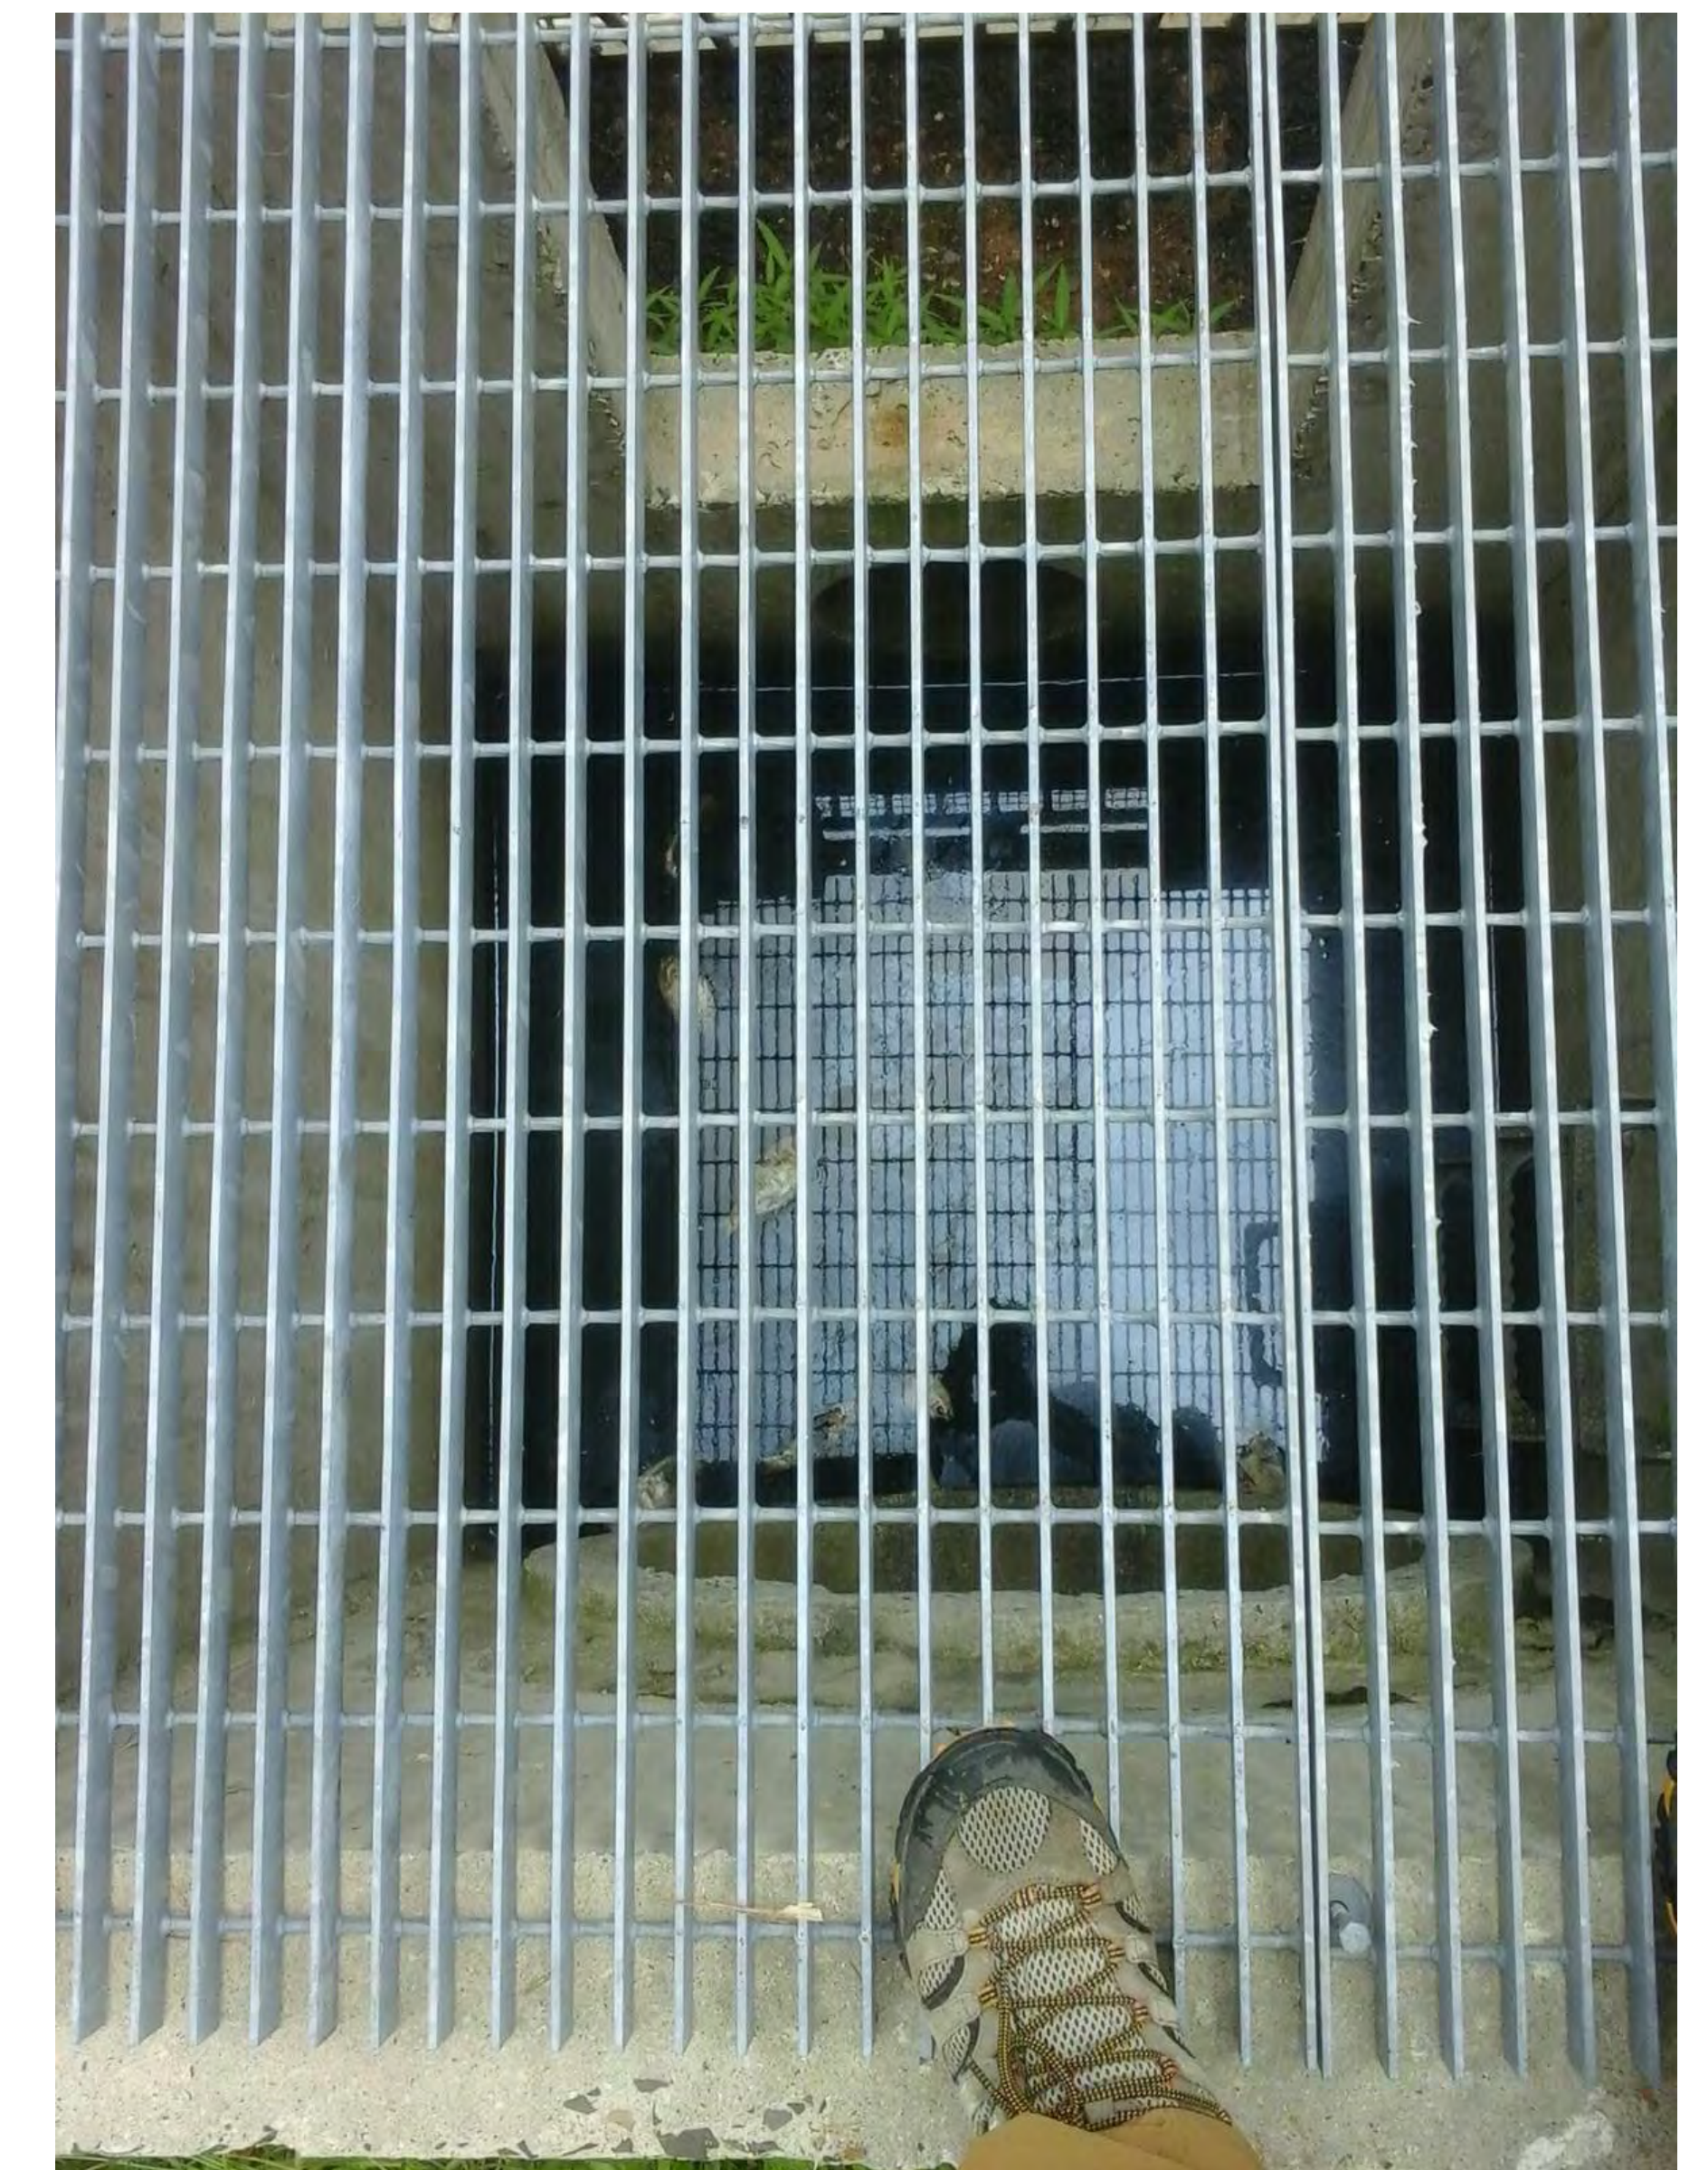
Fish in outlet structure

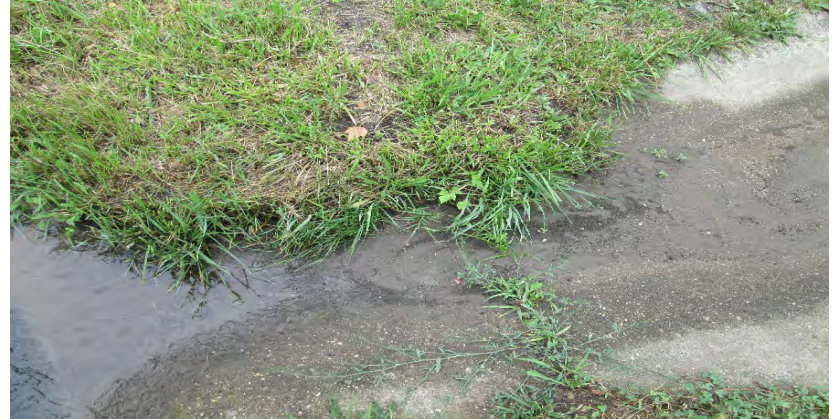
Low flow channel

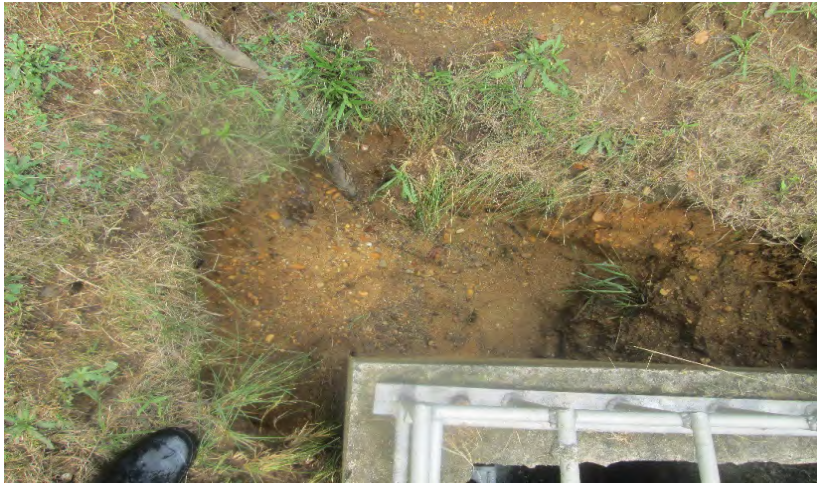
Erosion near outlet structure
