Hamilton Township (Mercer County) Stormwater Basin Assessment Summary (Year 1)

Developed by the Rutgers Cooperative Extension Water Resources Program
Funded by Hamilton Township, Mercer County, New Jersey

December 6, 2012

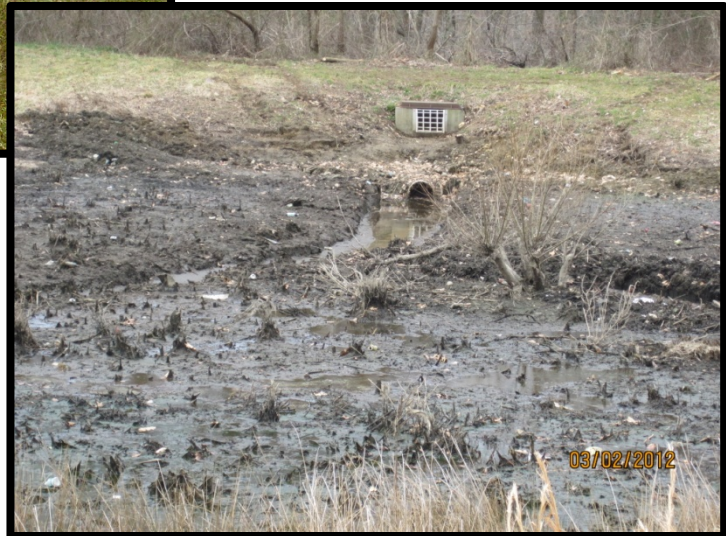
Kristopher Drive Basin After Cleaning (2012)

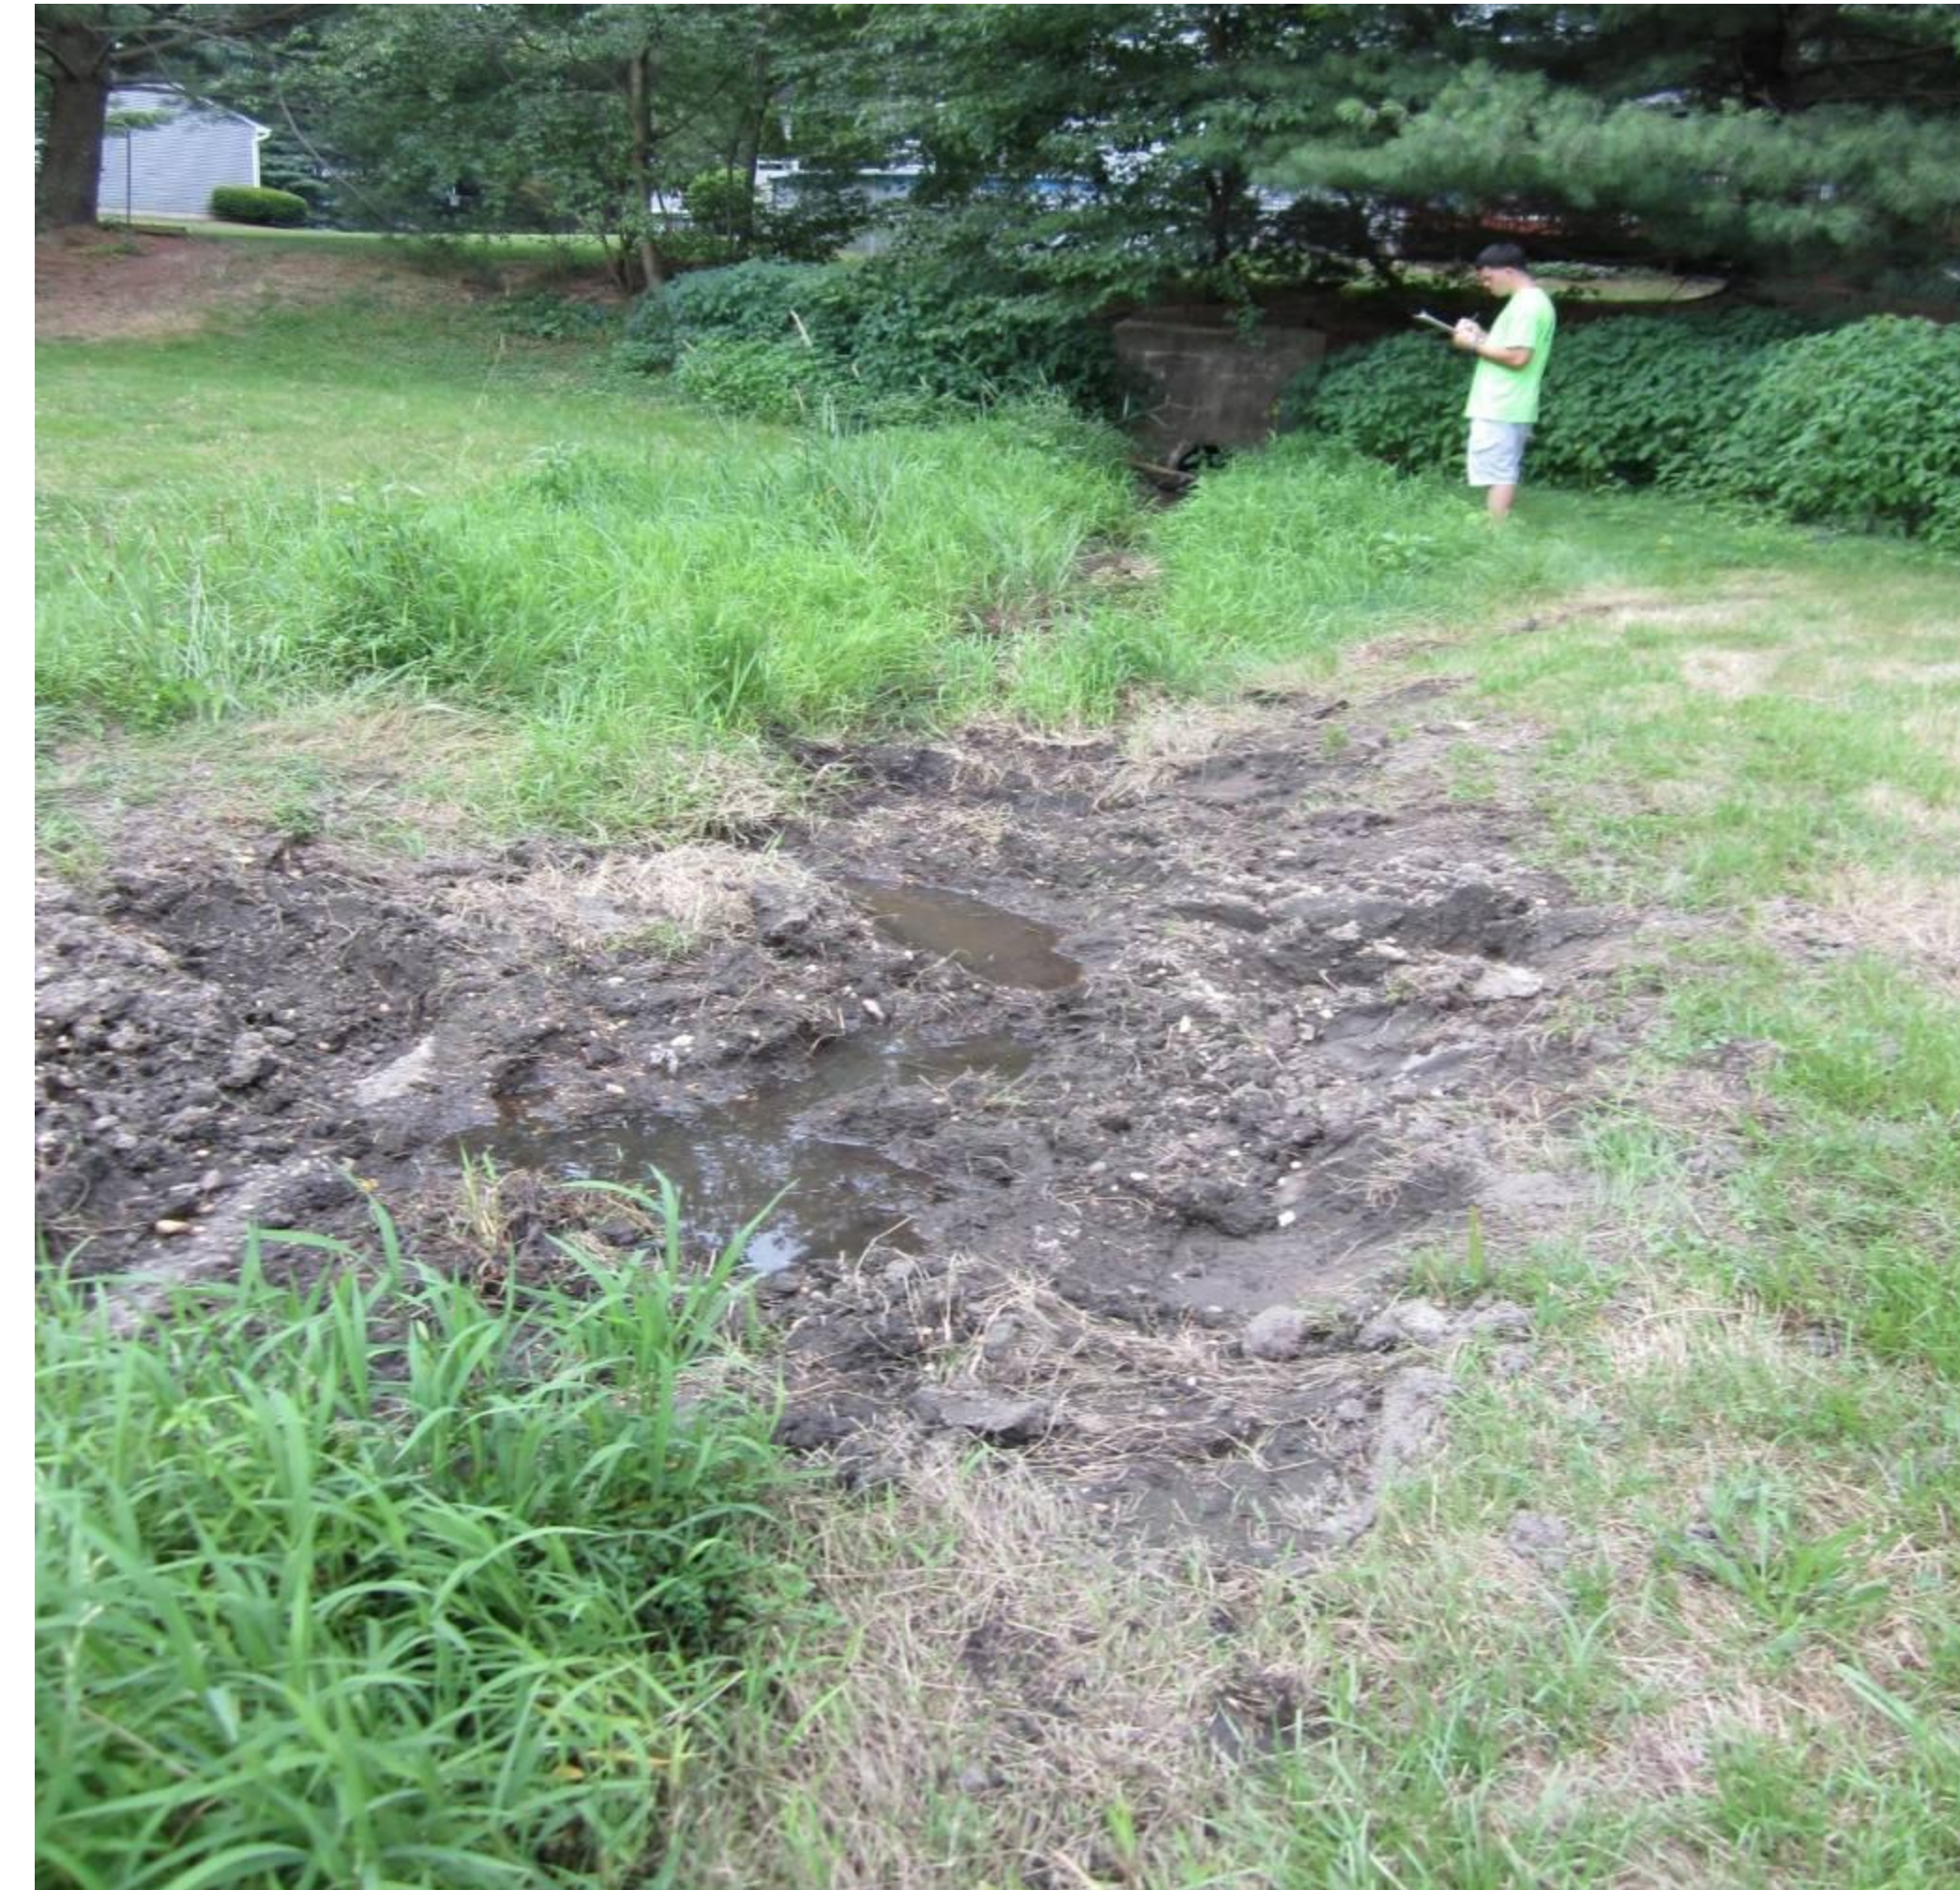
Clogged low flow and outlet.

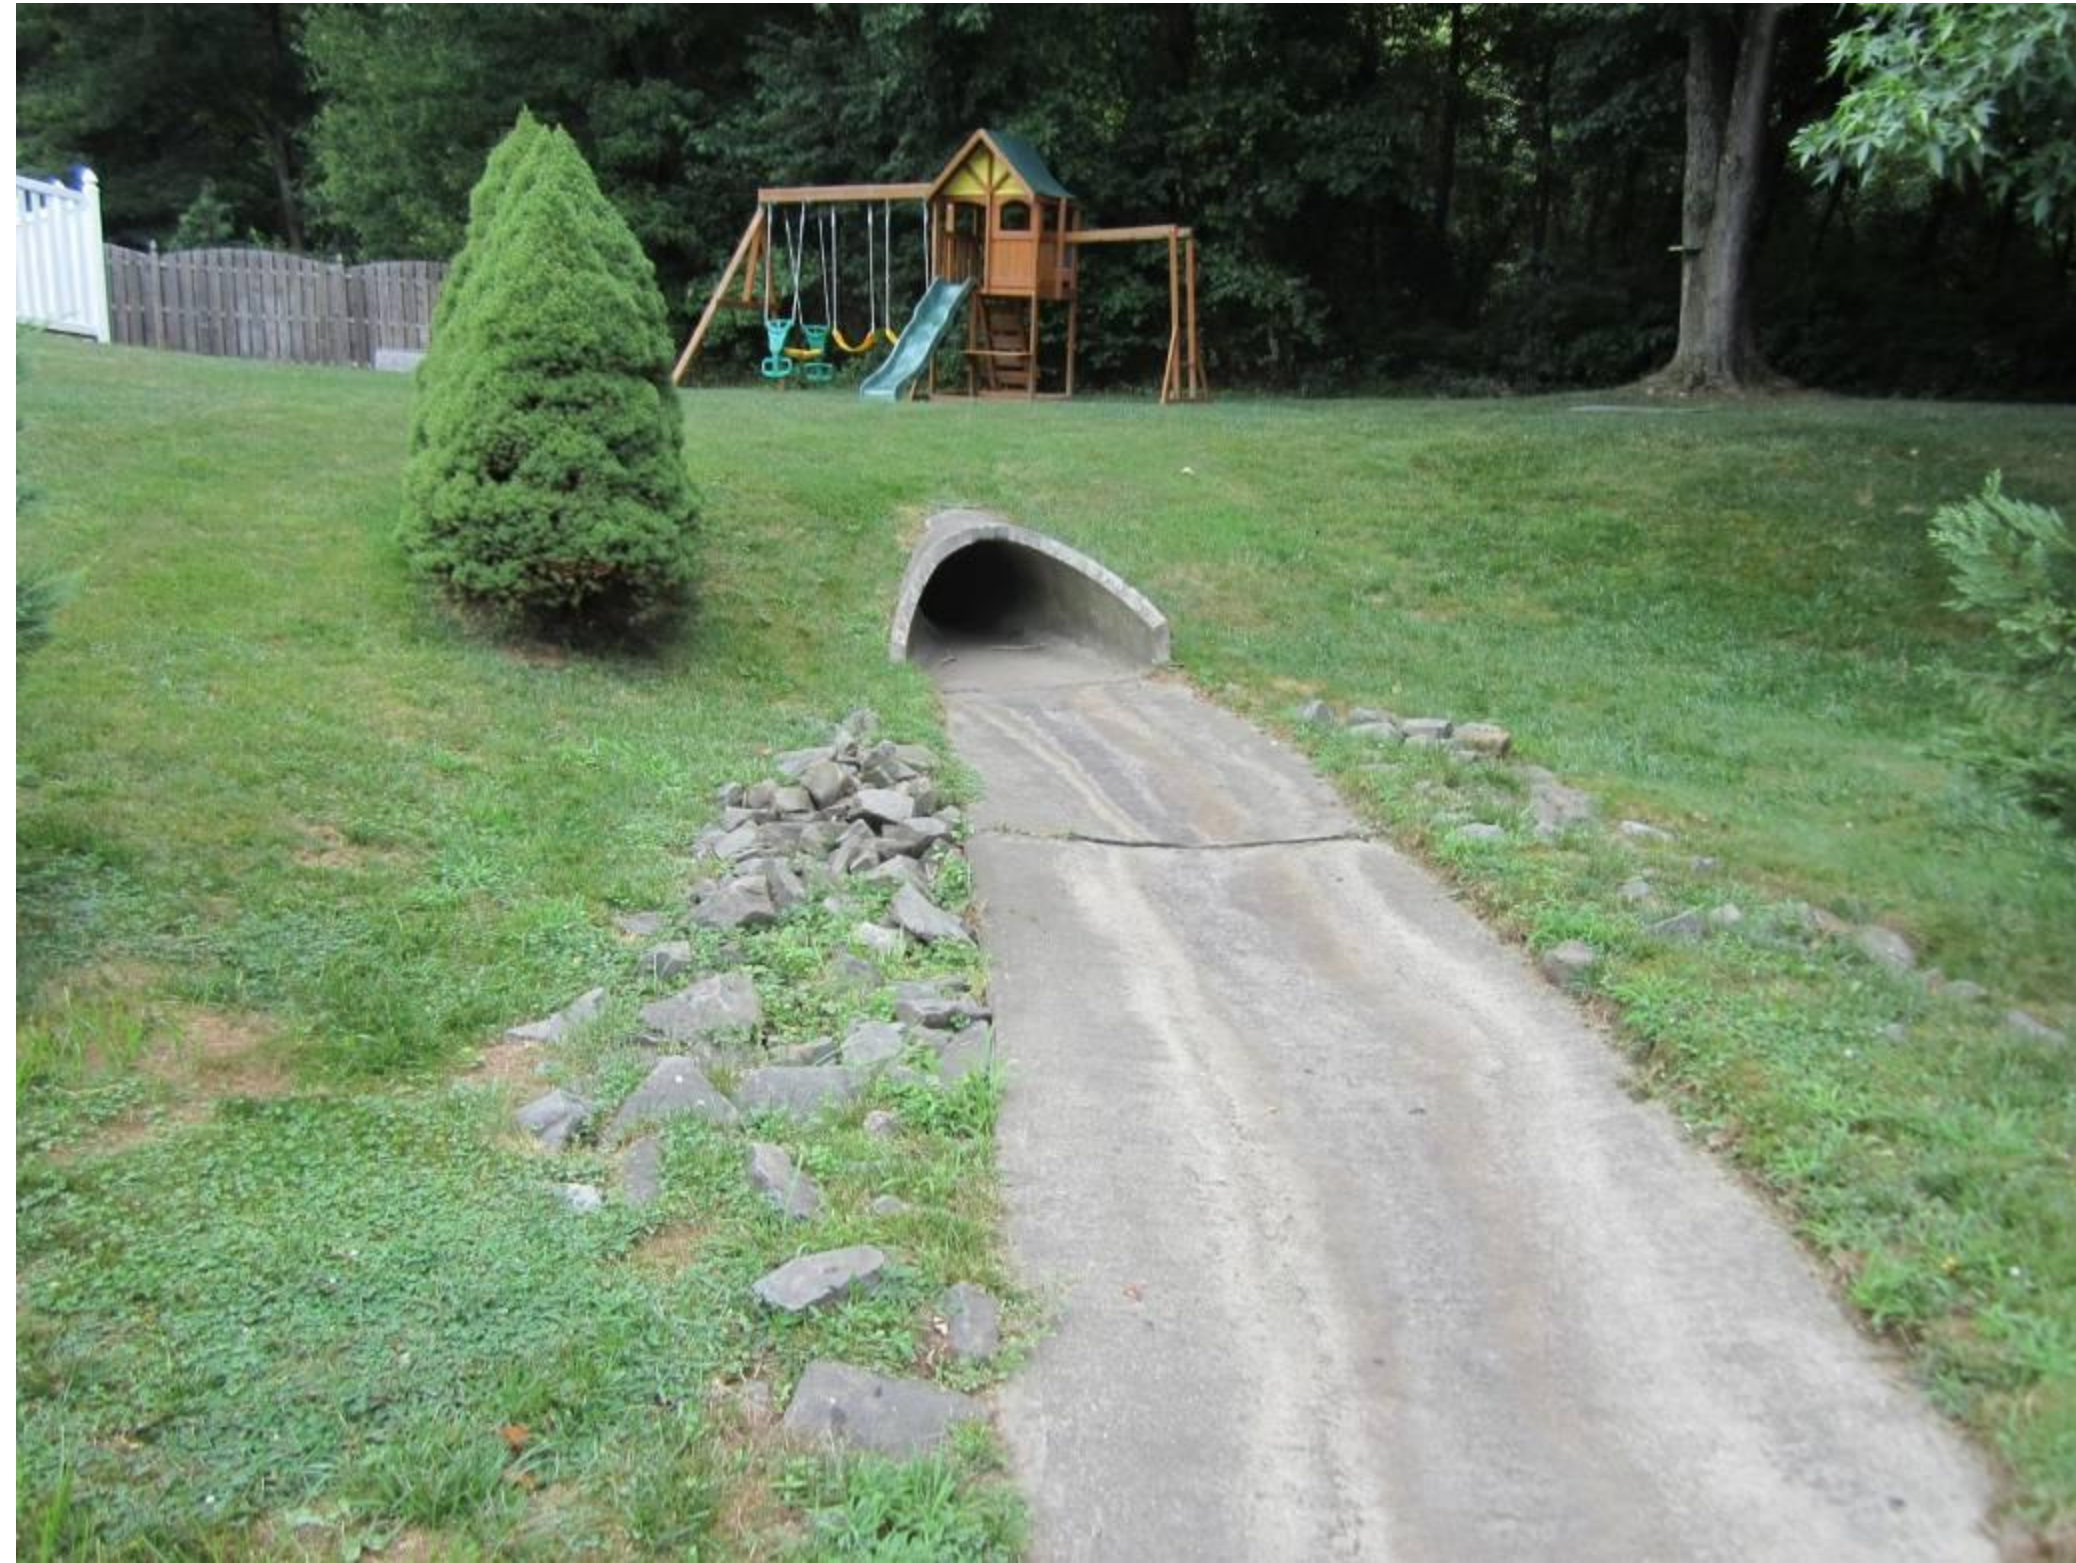
Inlet and low flow channel

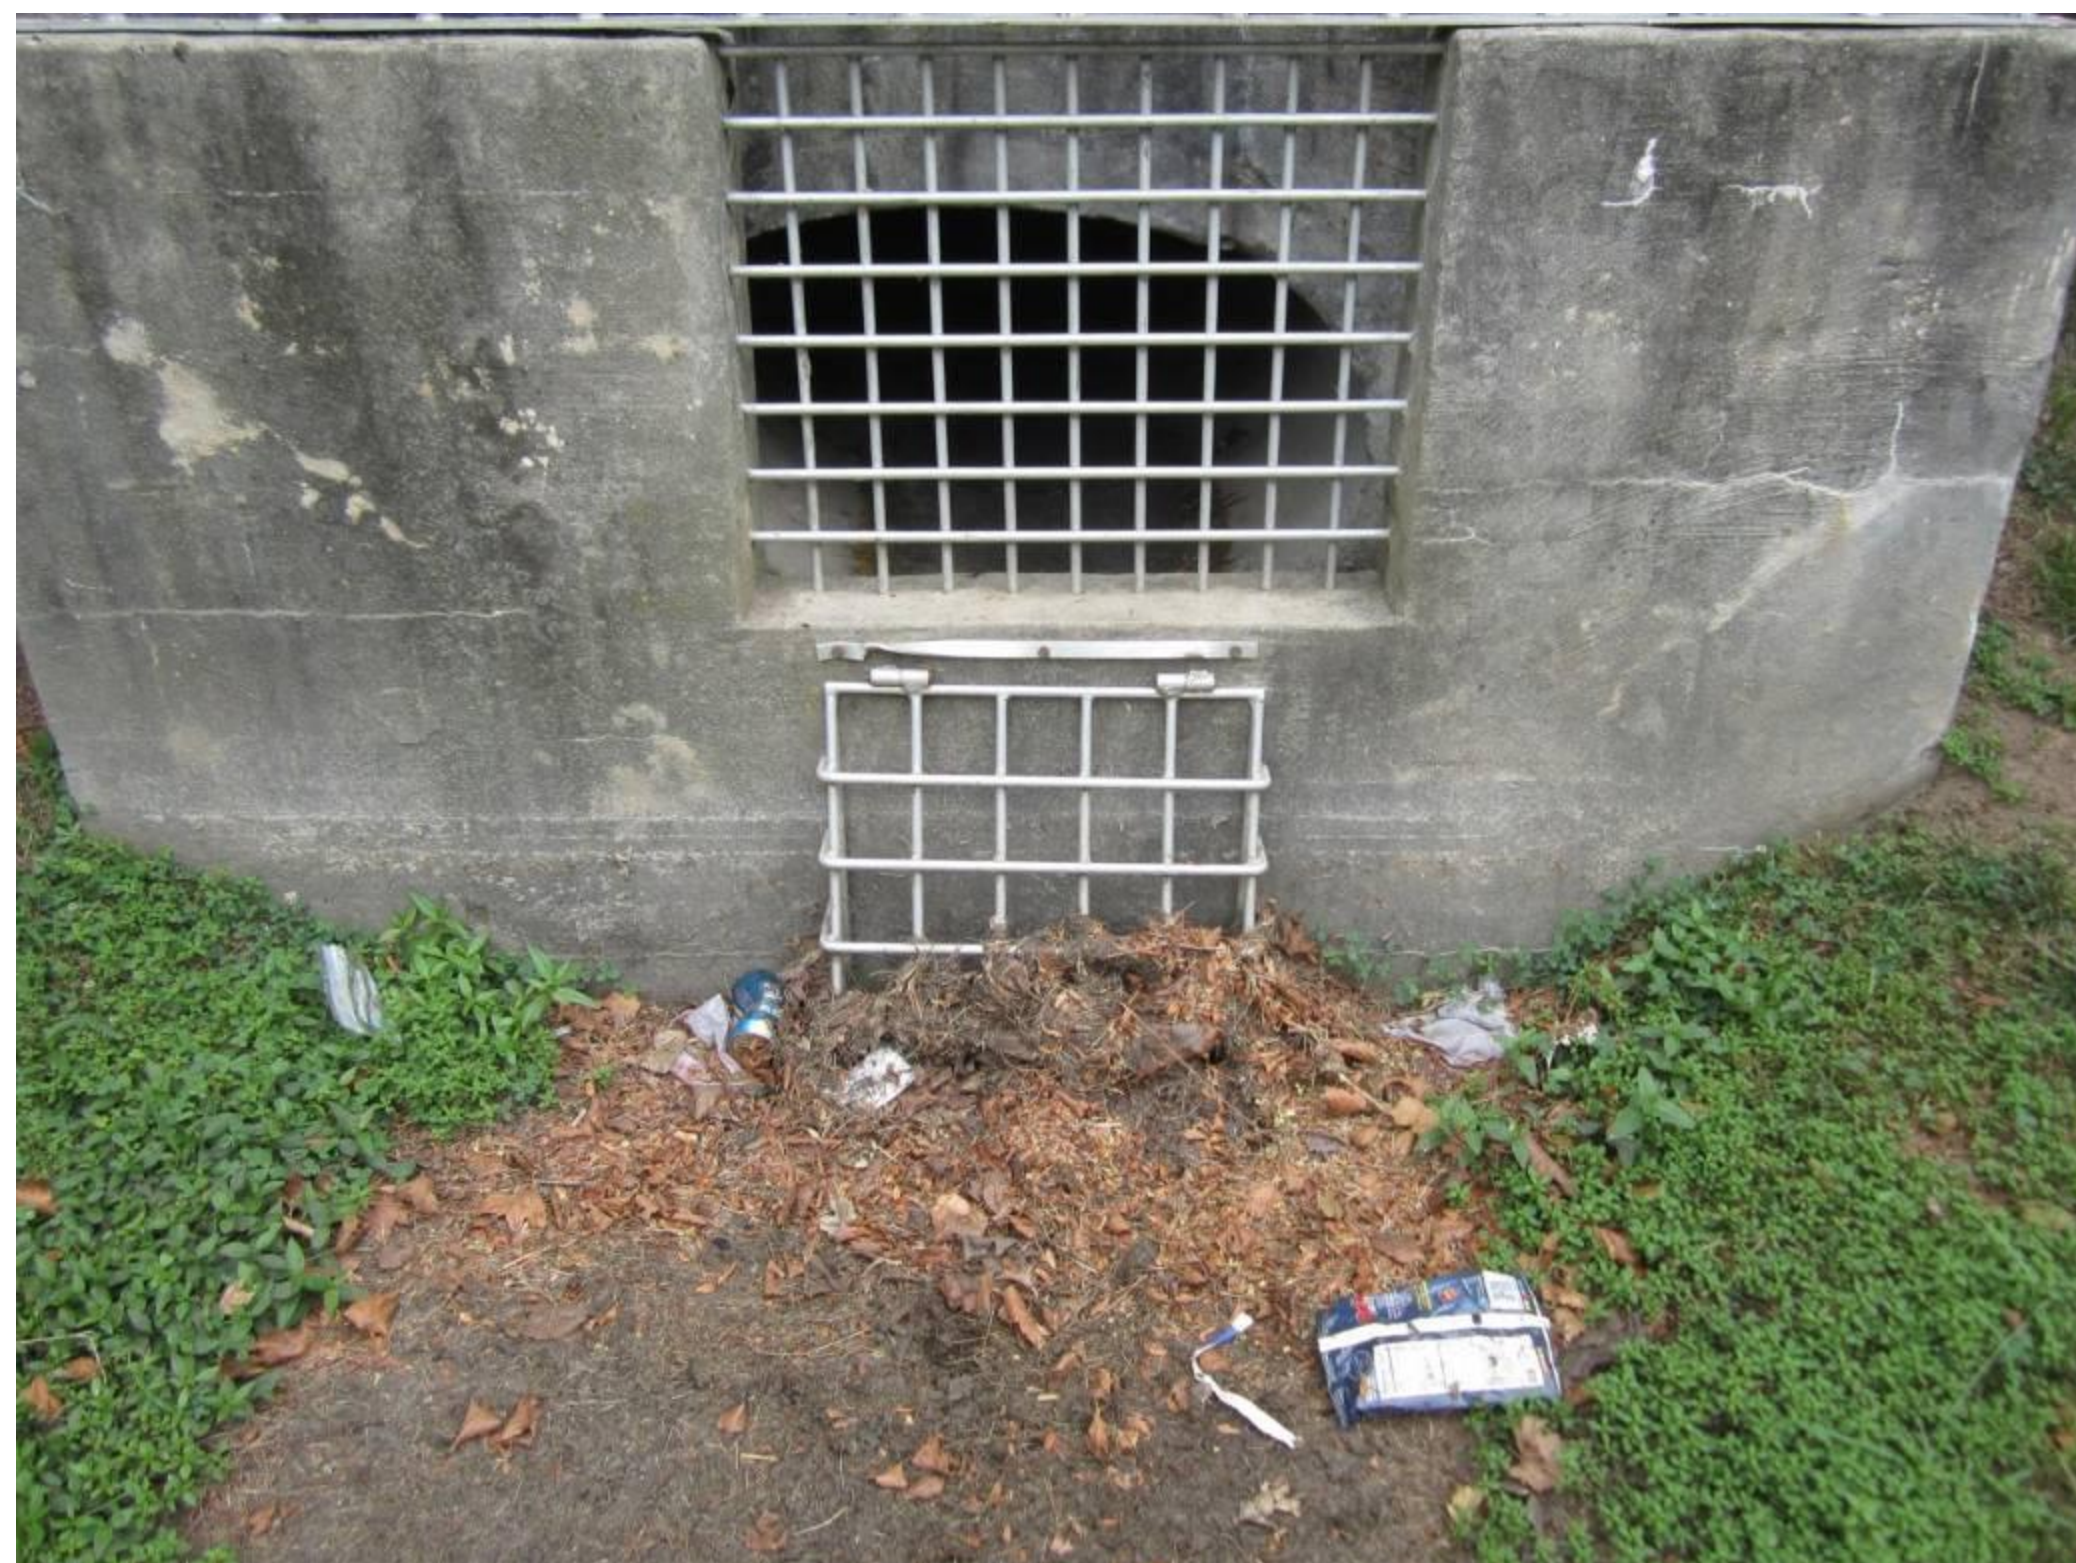
Clogged outlet grate

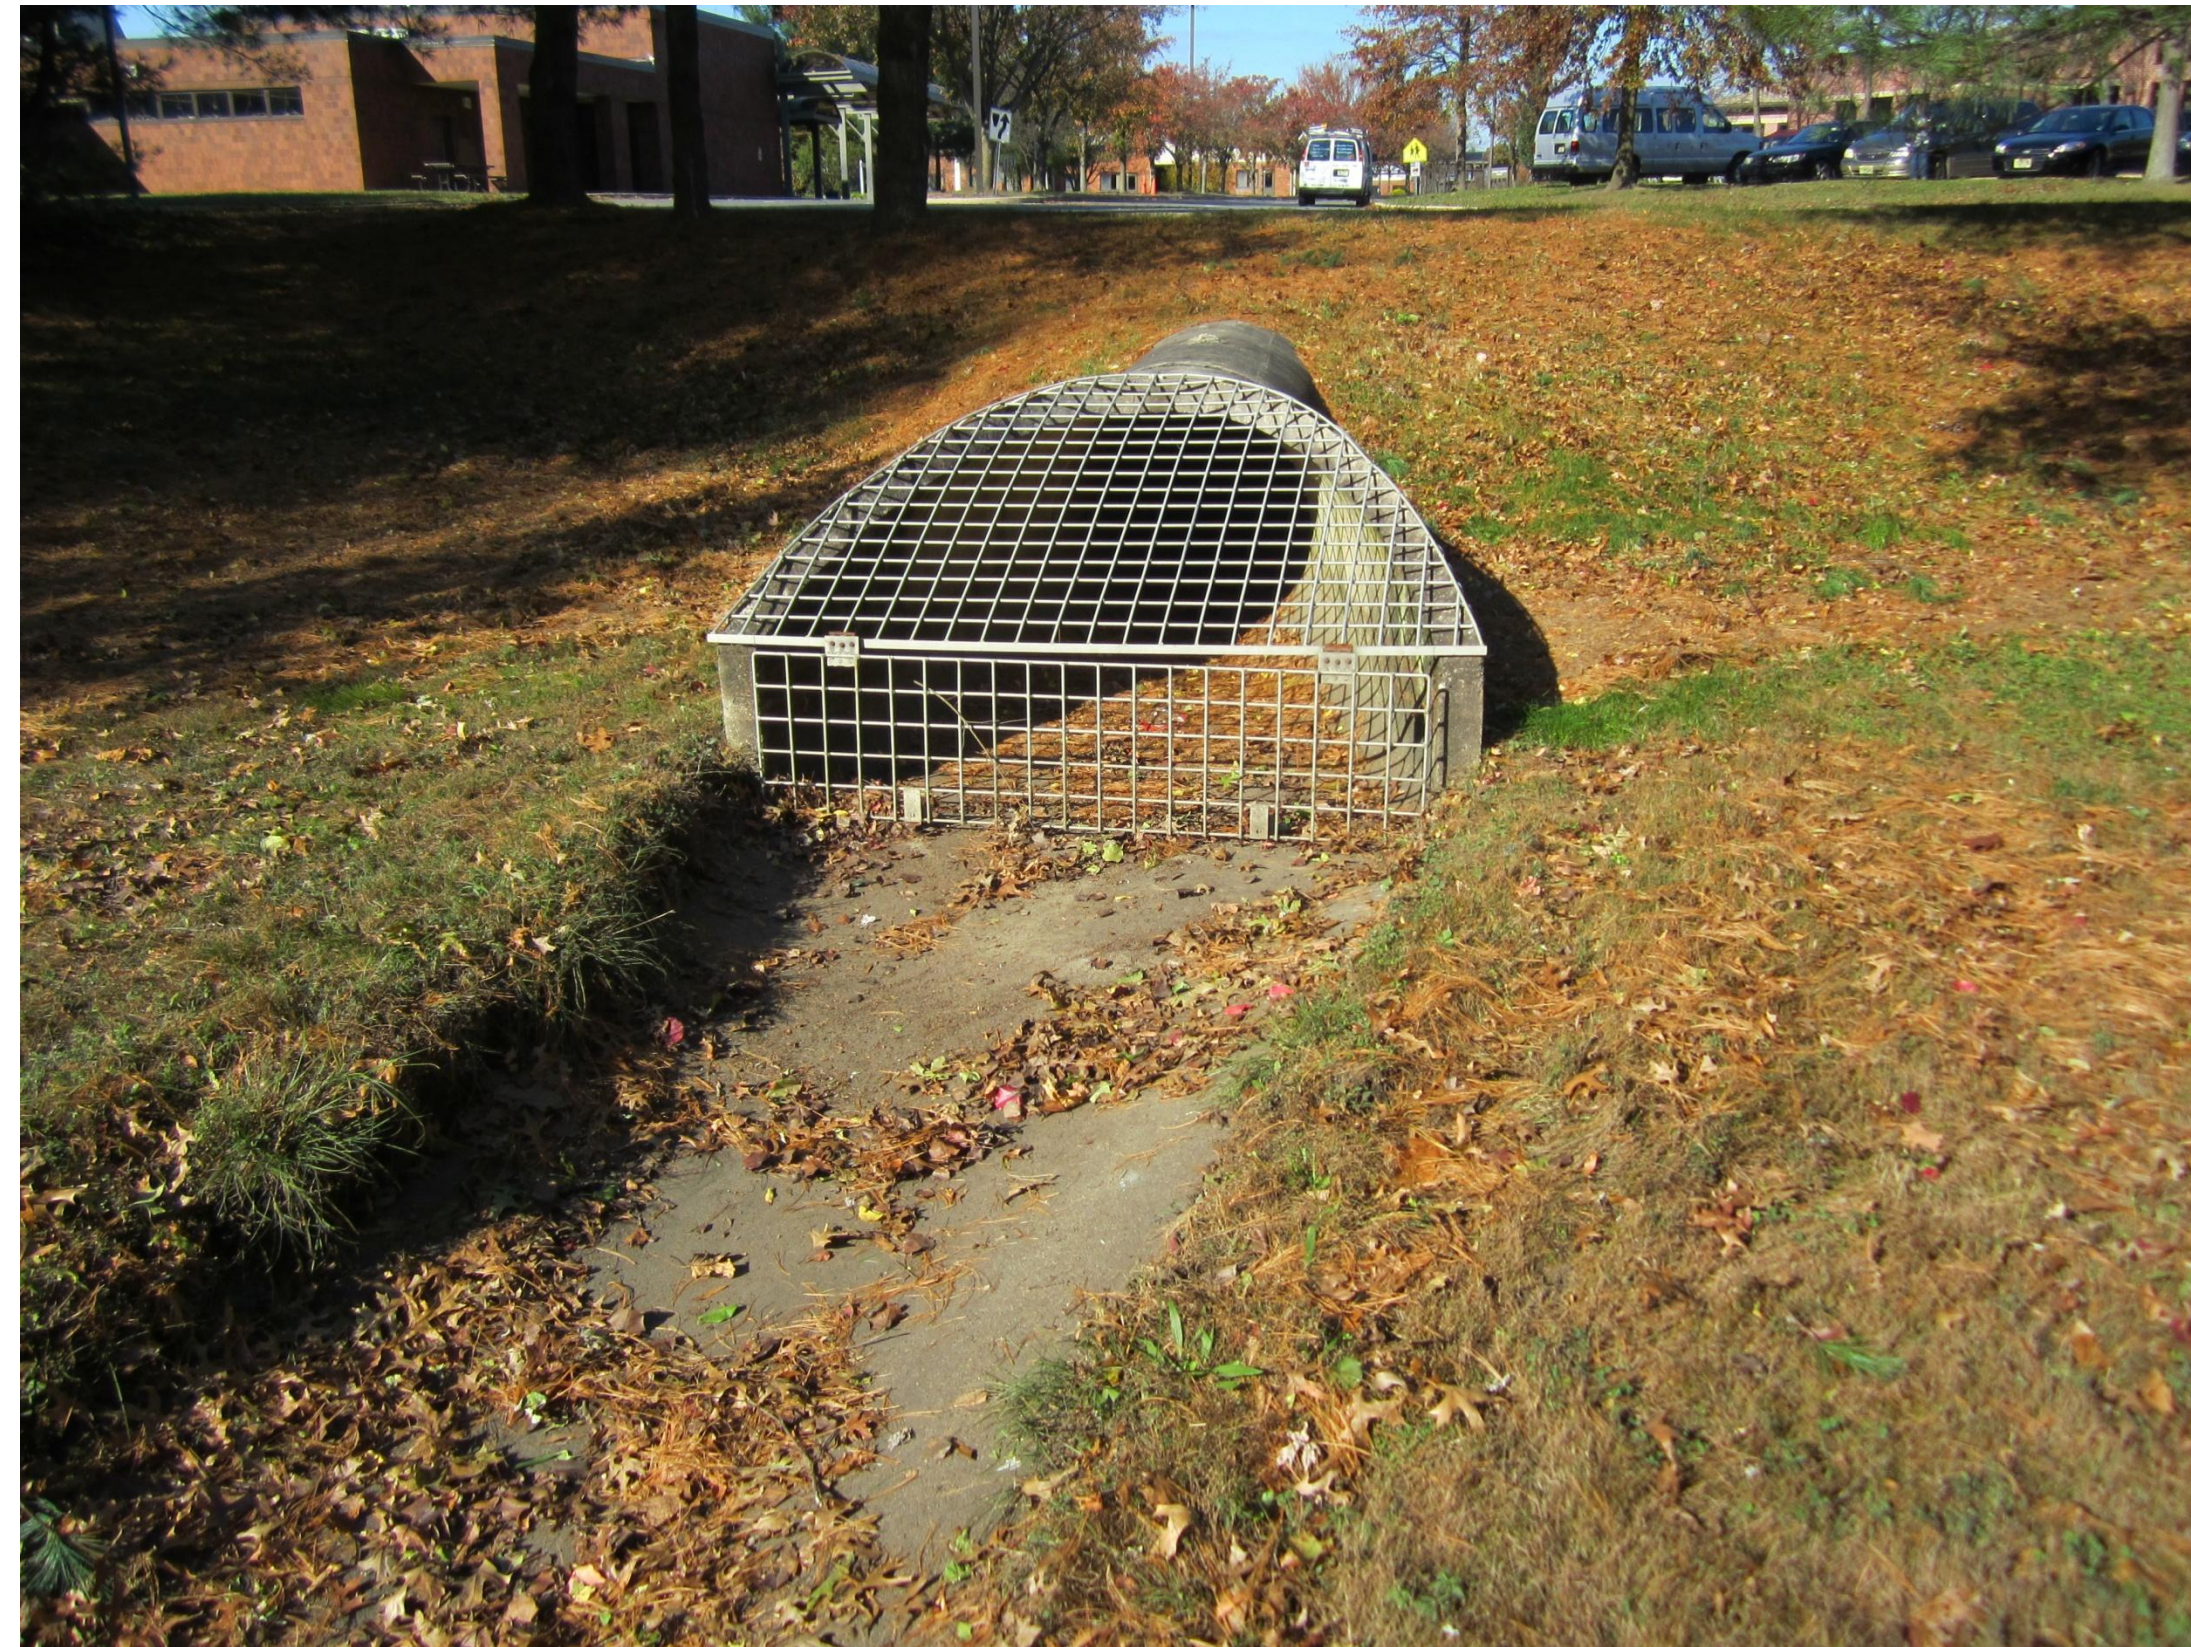
Inlet with trash rack

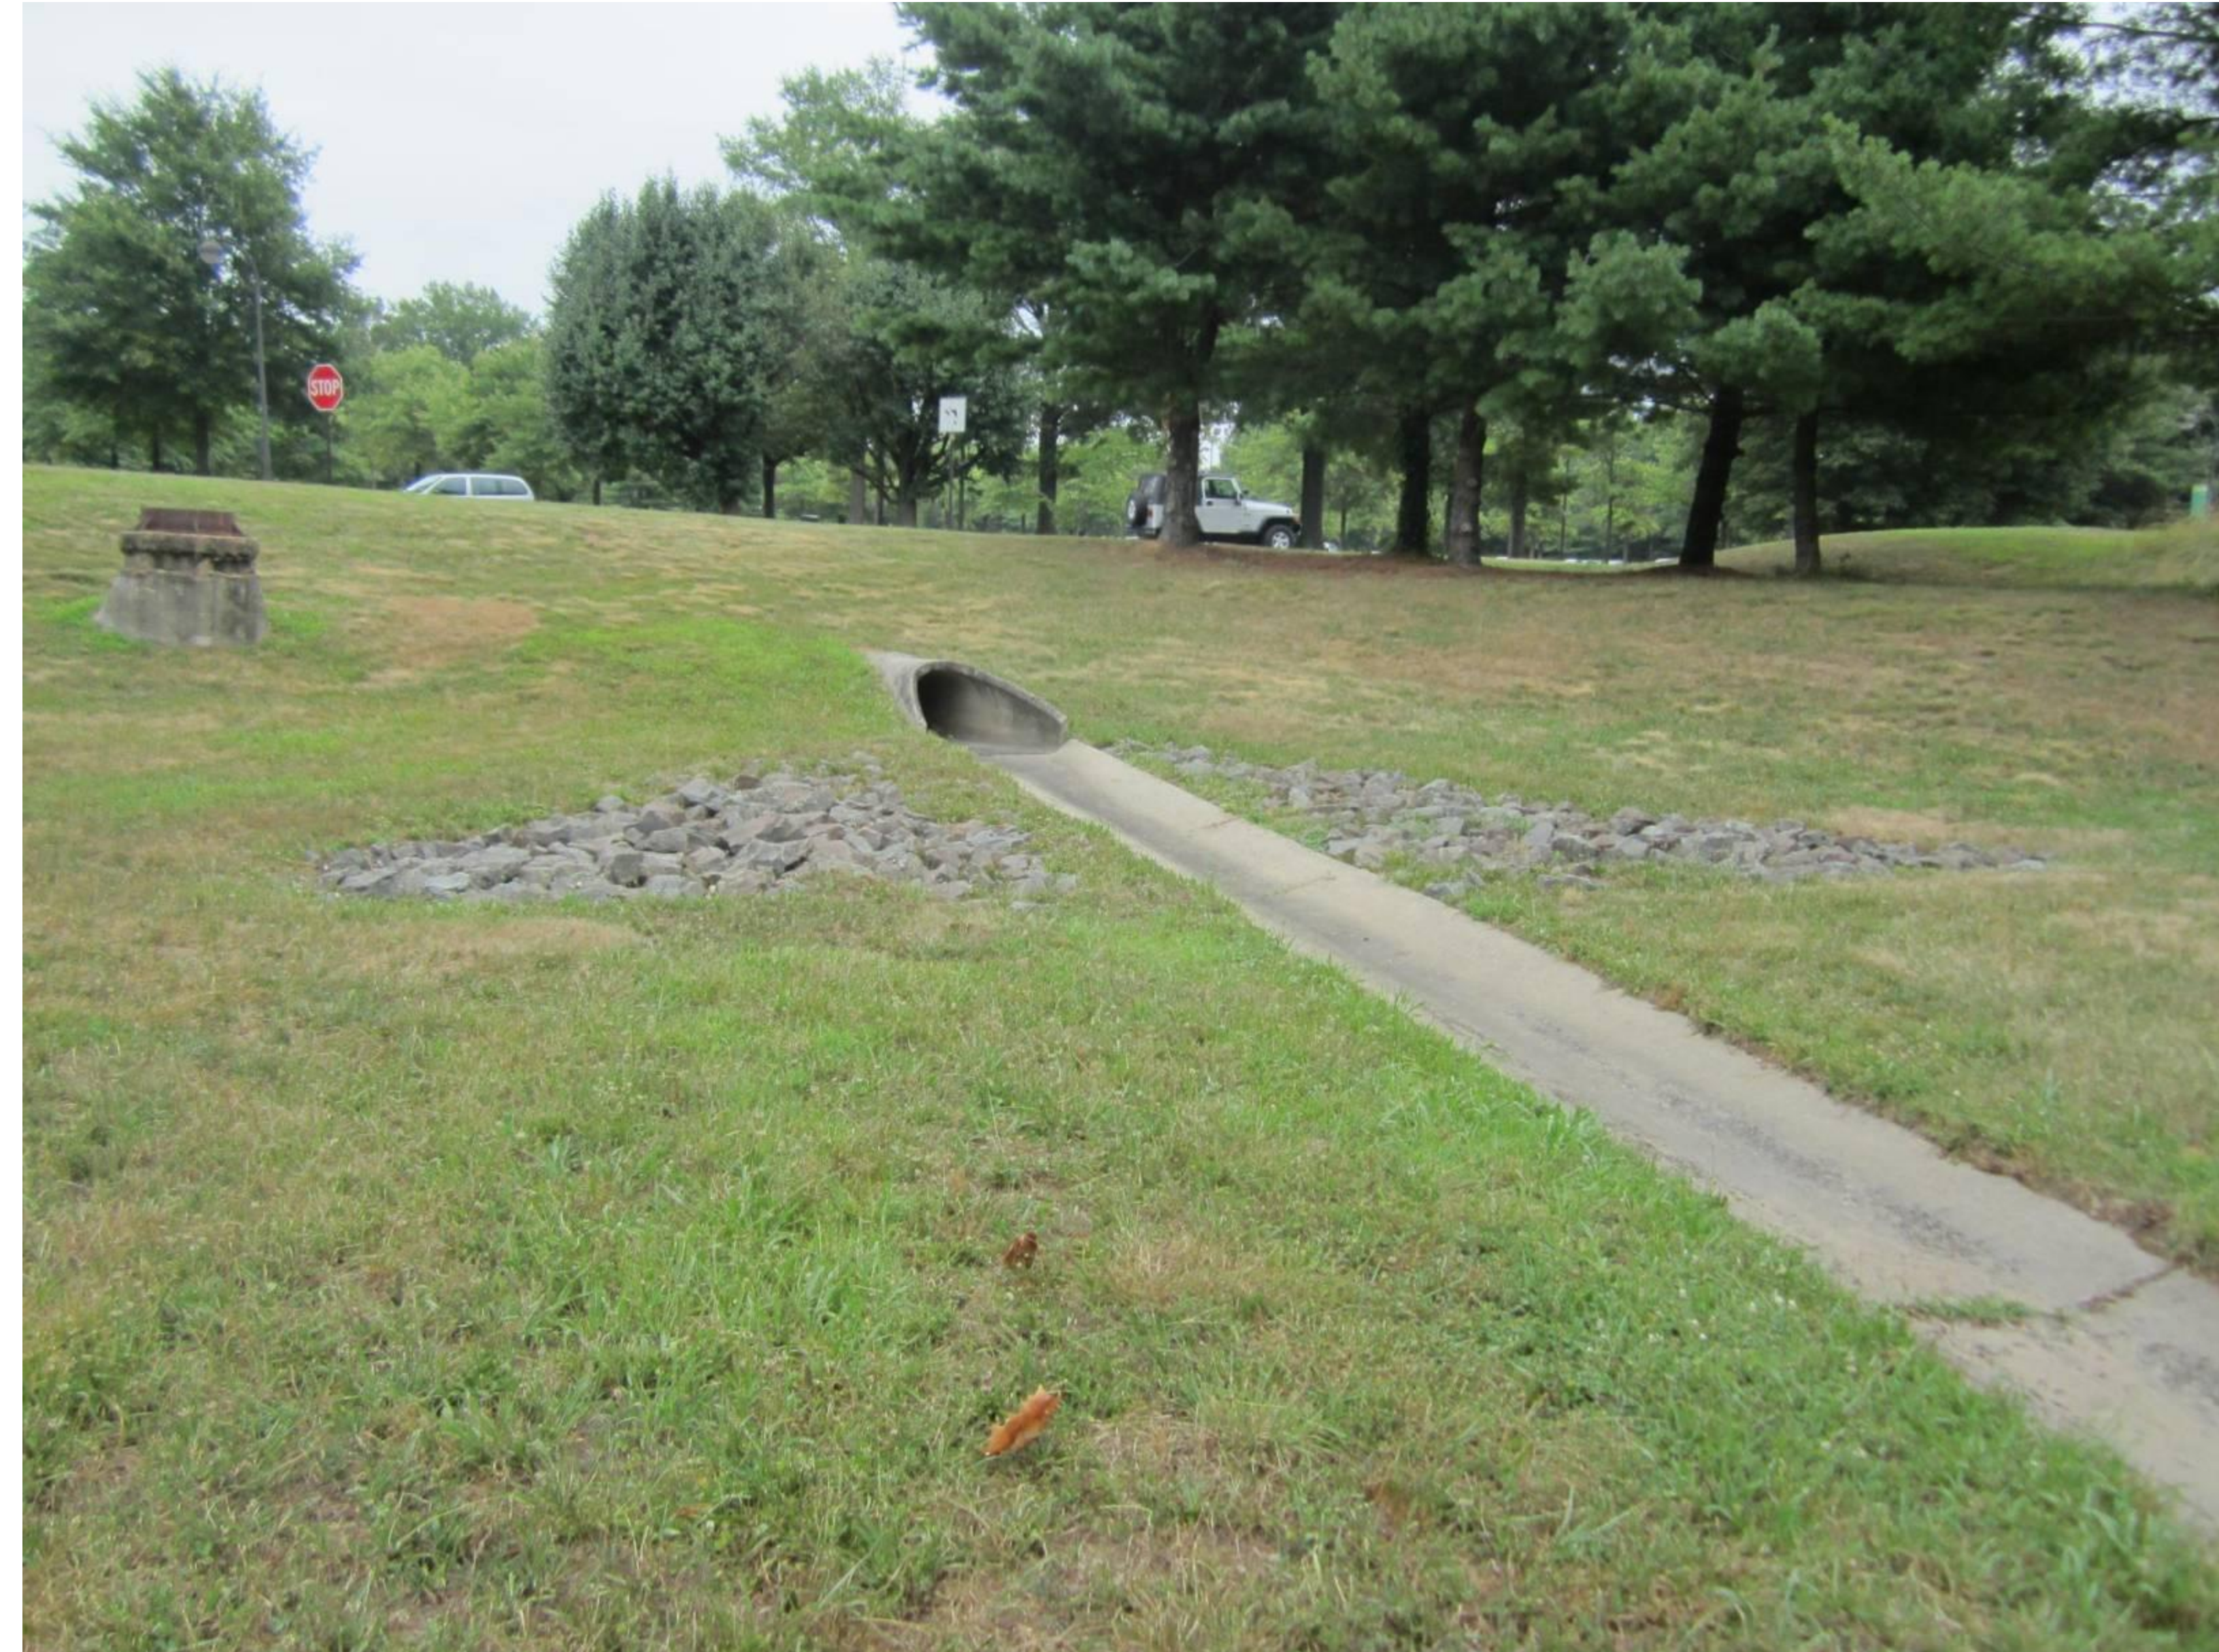
Inlet and rip rap

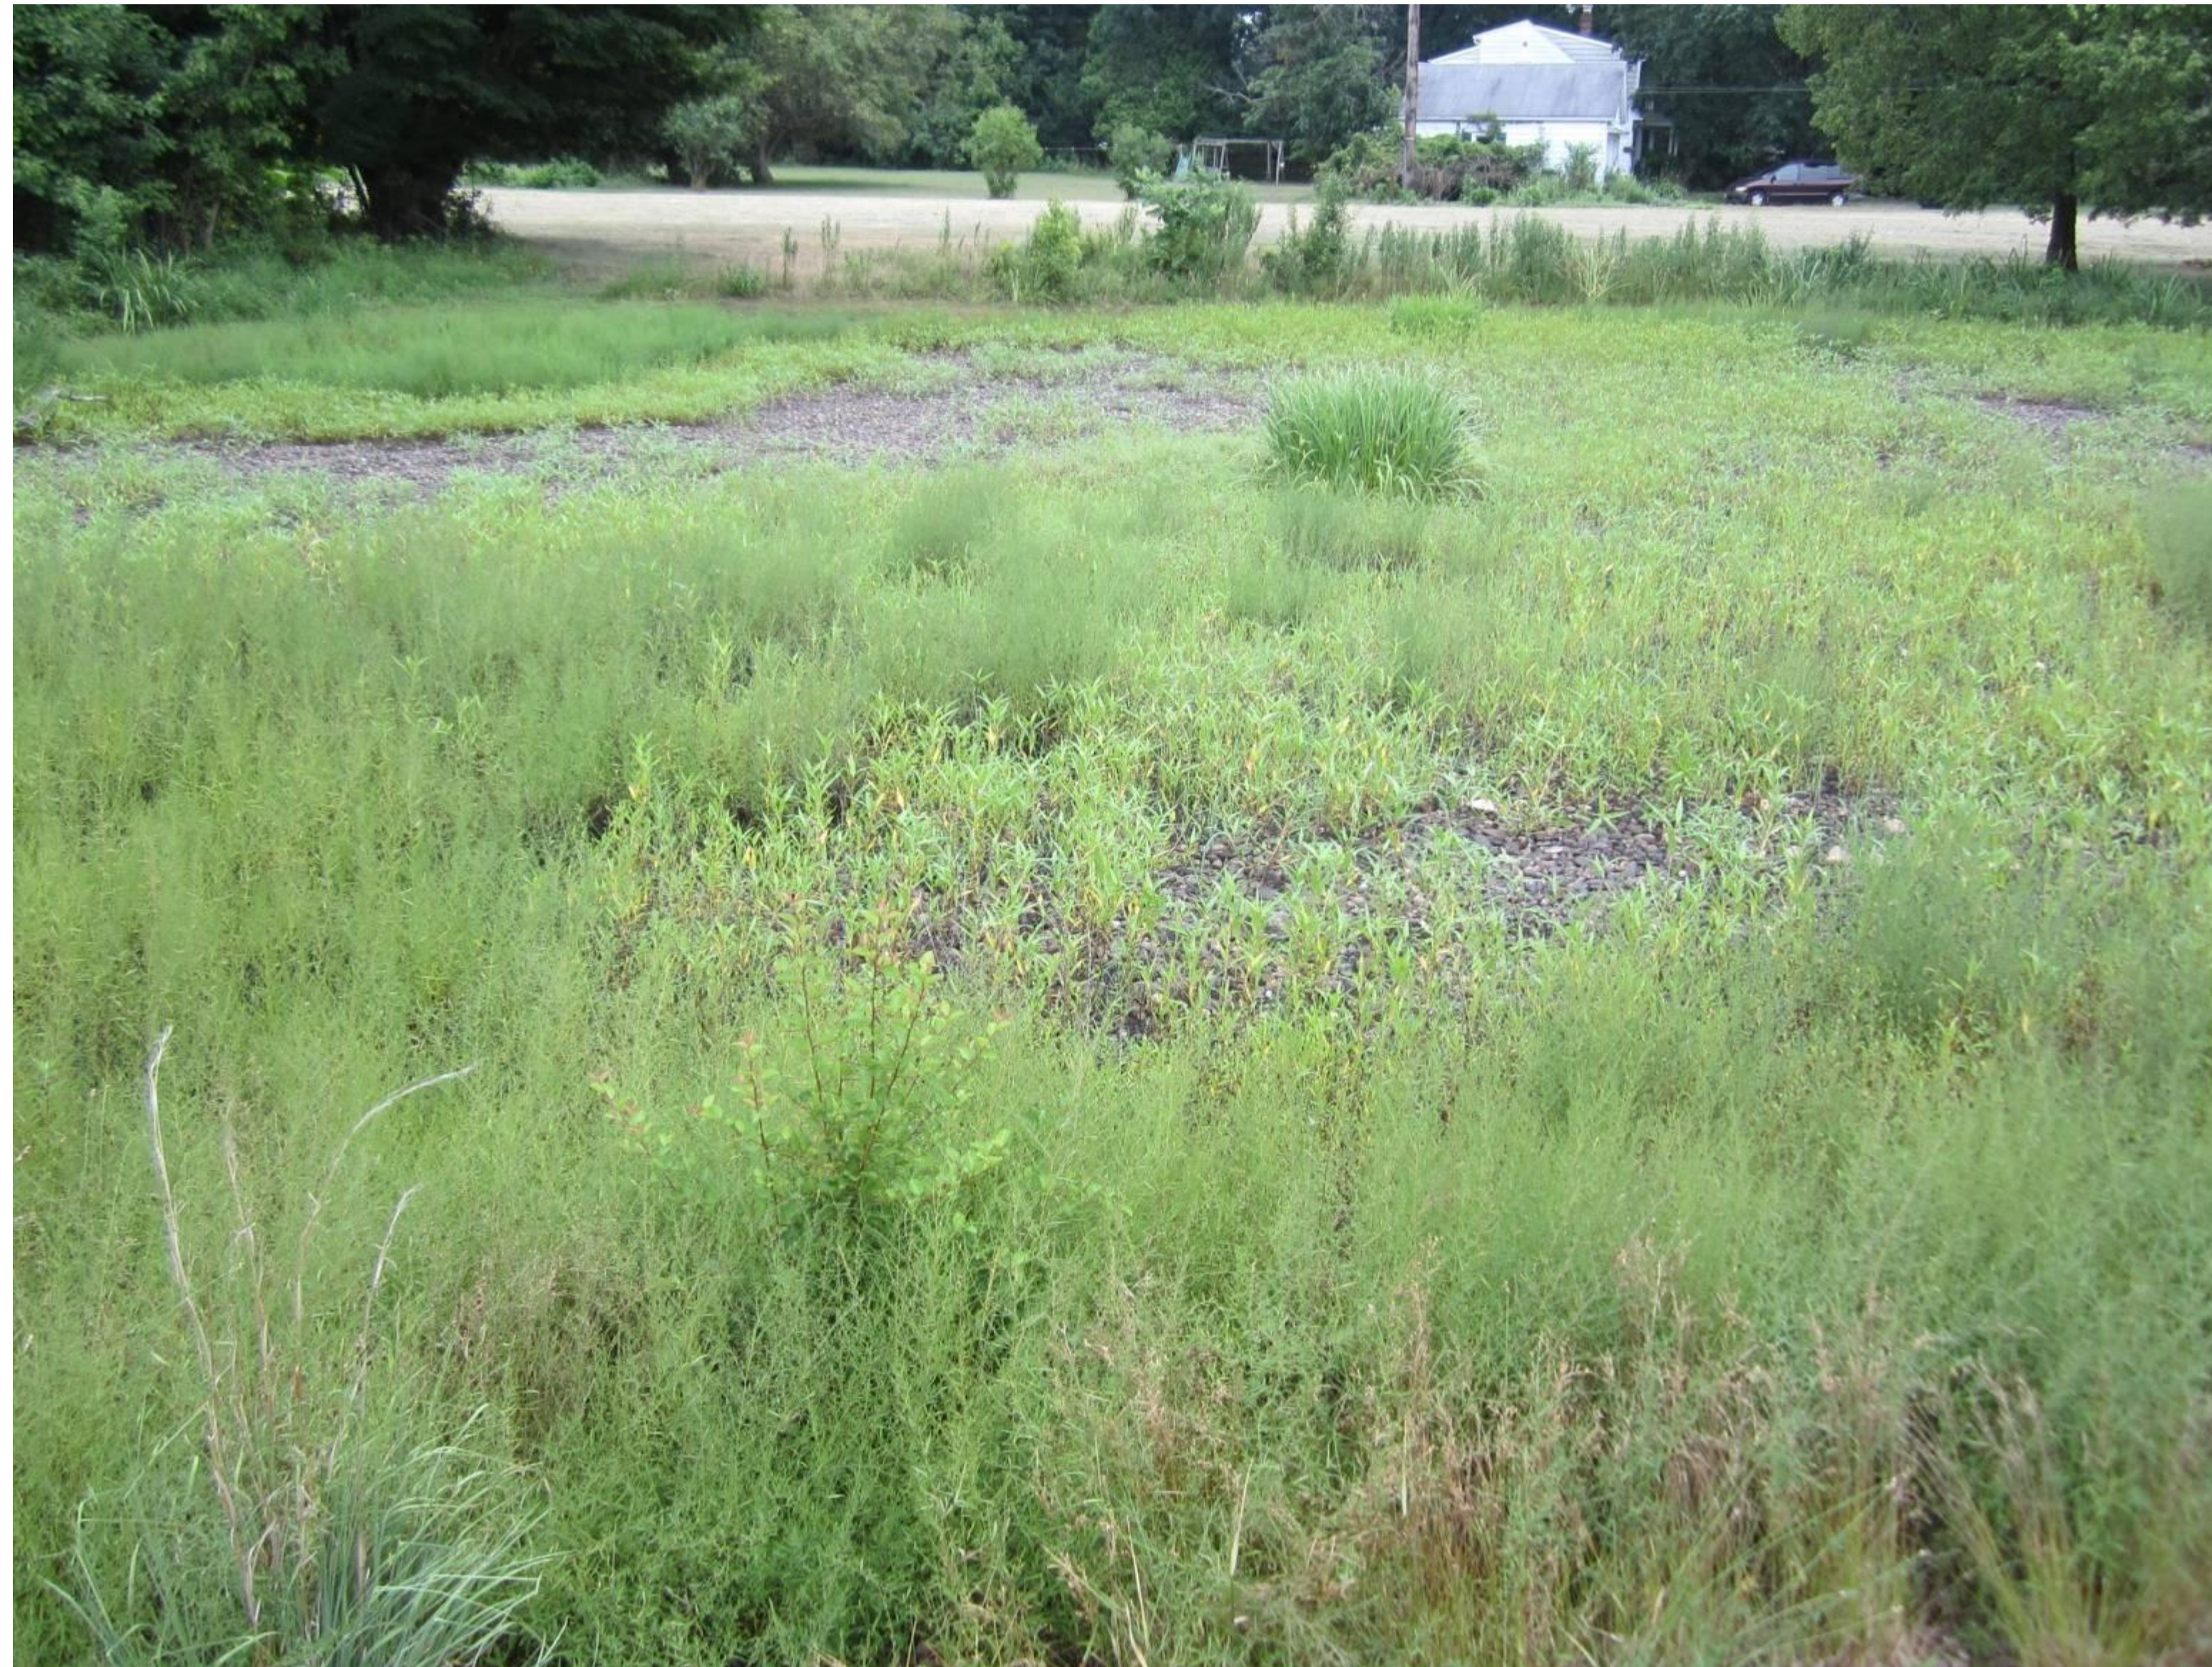
Basin bottom looking west
