Hamilton Township (Mercer County) Stormwater Basin Assessment Summary (Year 1)

Developed by the Rutgers Cooperative Extension Water Resources Program
Funded by Hamilton Township, Mercer County, New Jersey

December 6, 2012

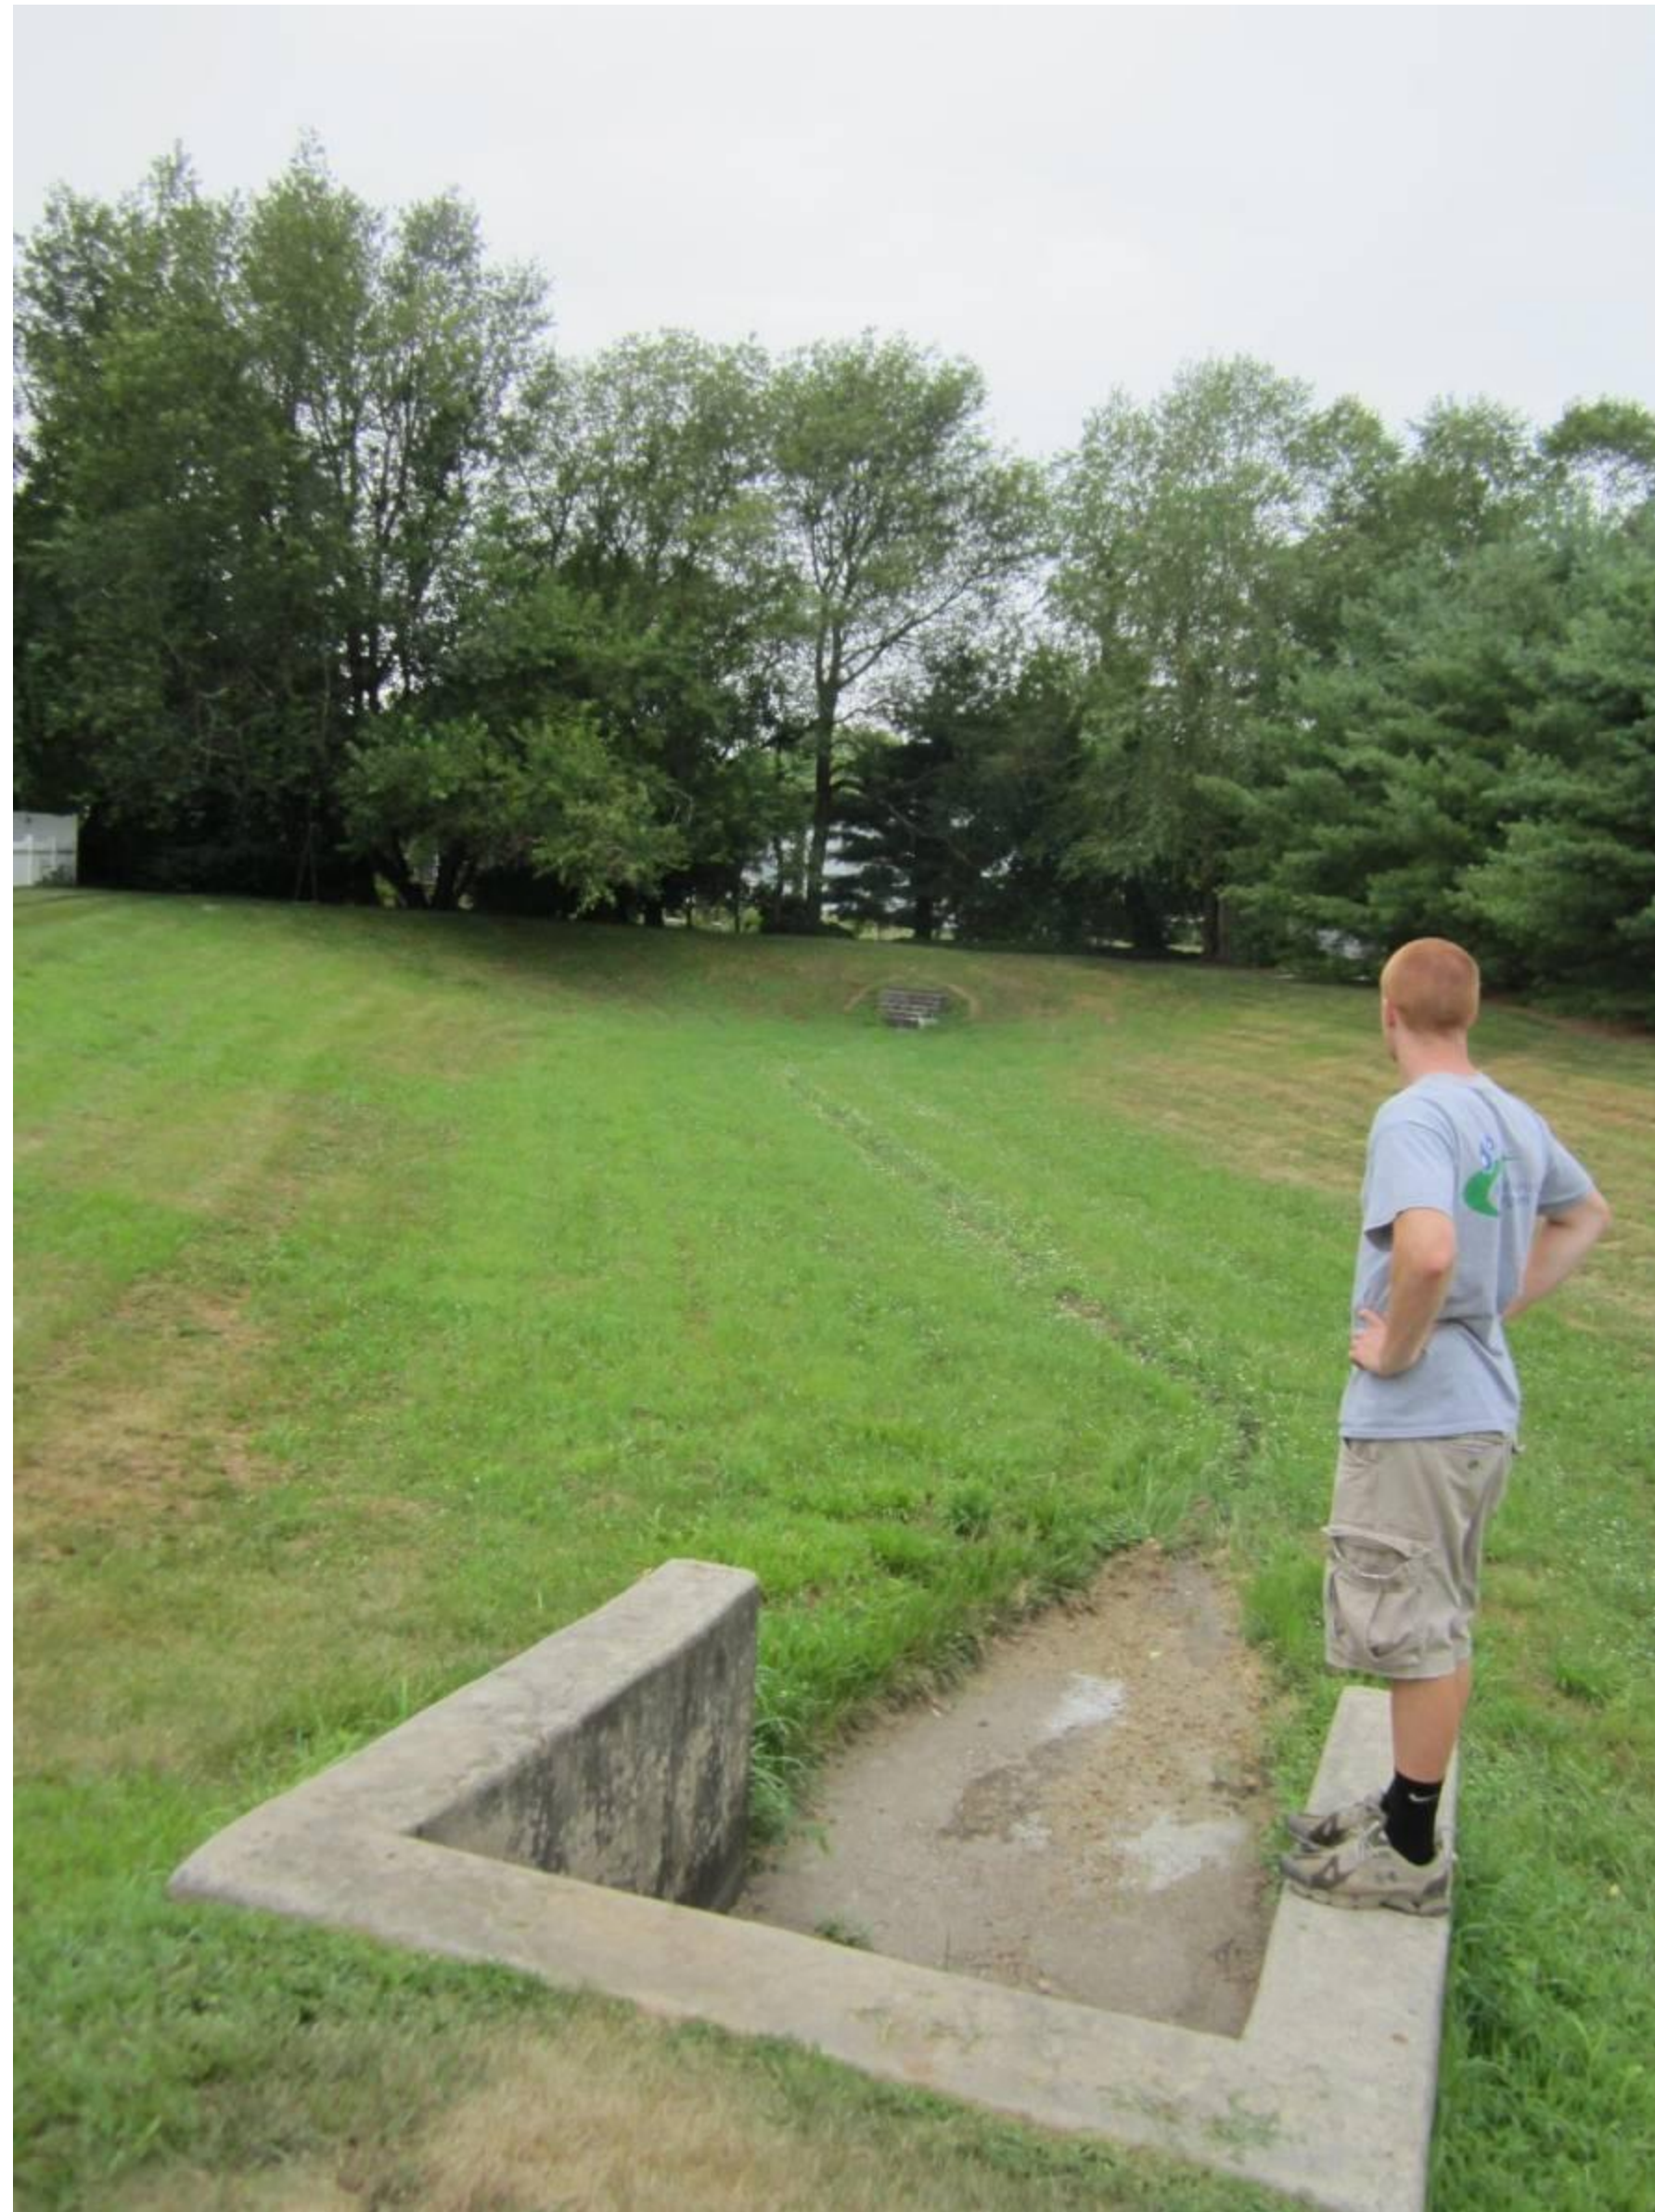
Basin bottom looking west

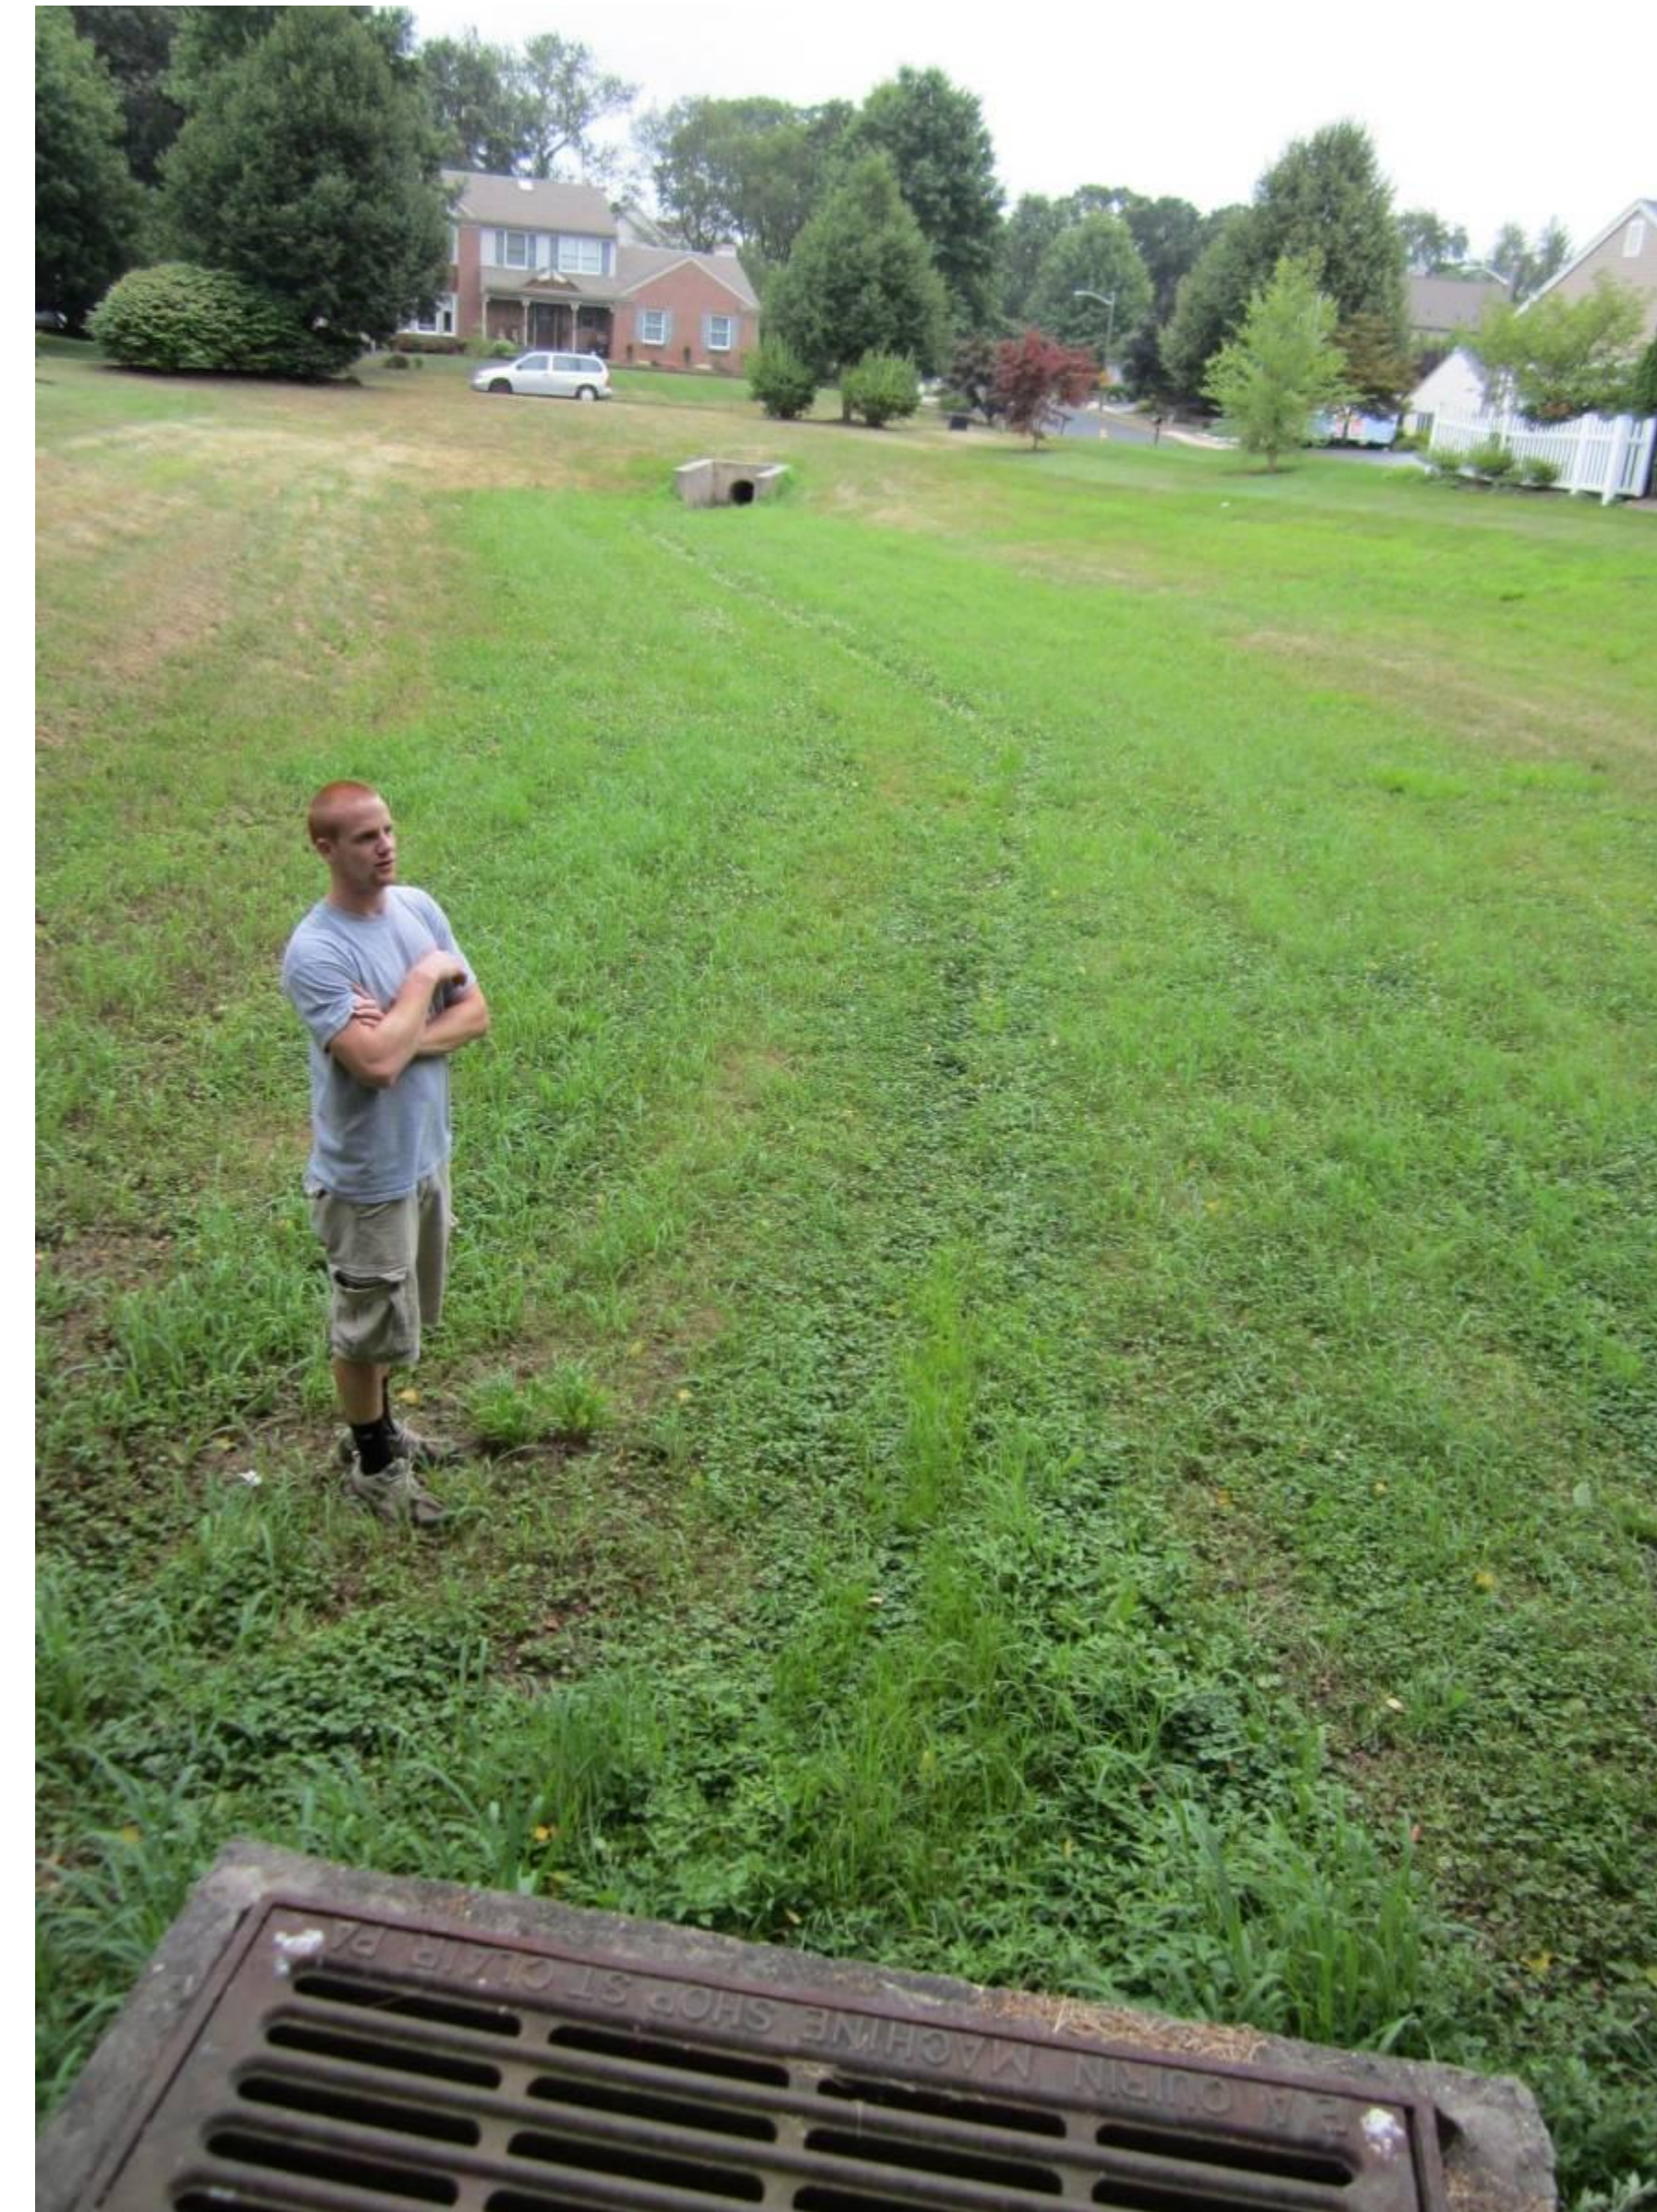
Basin bottom looking east

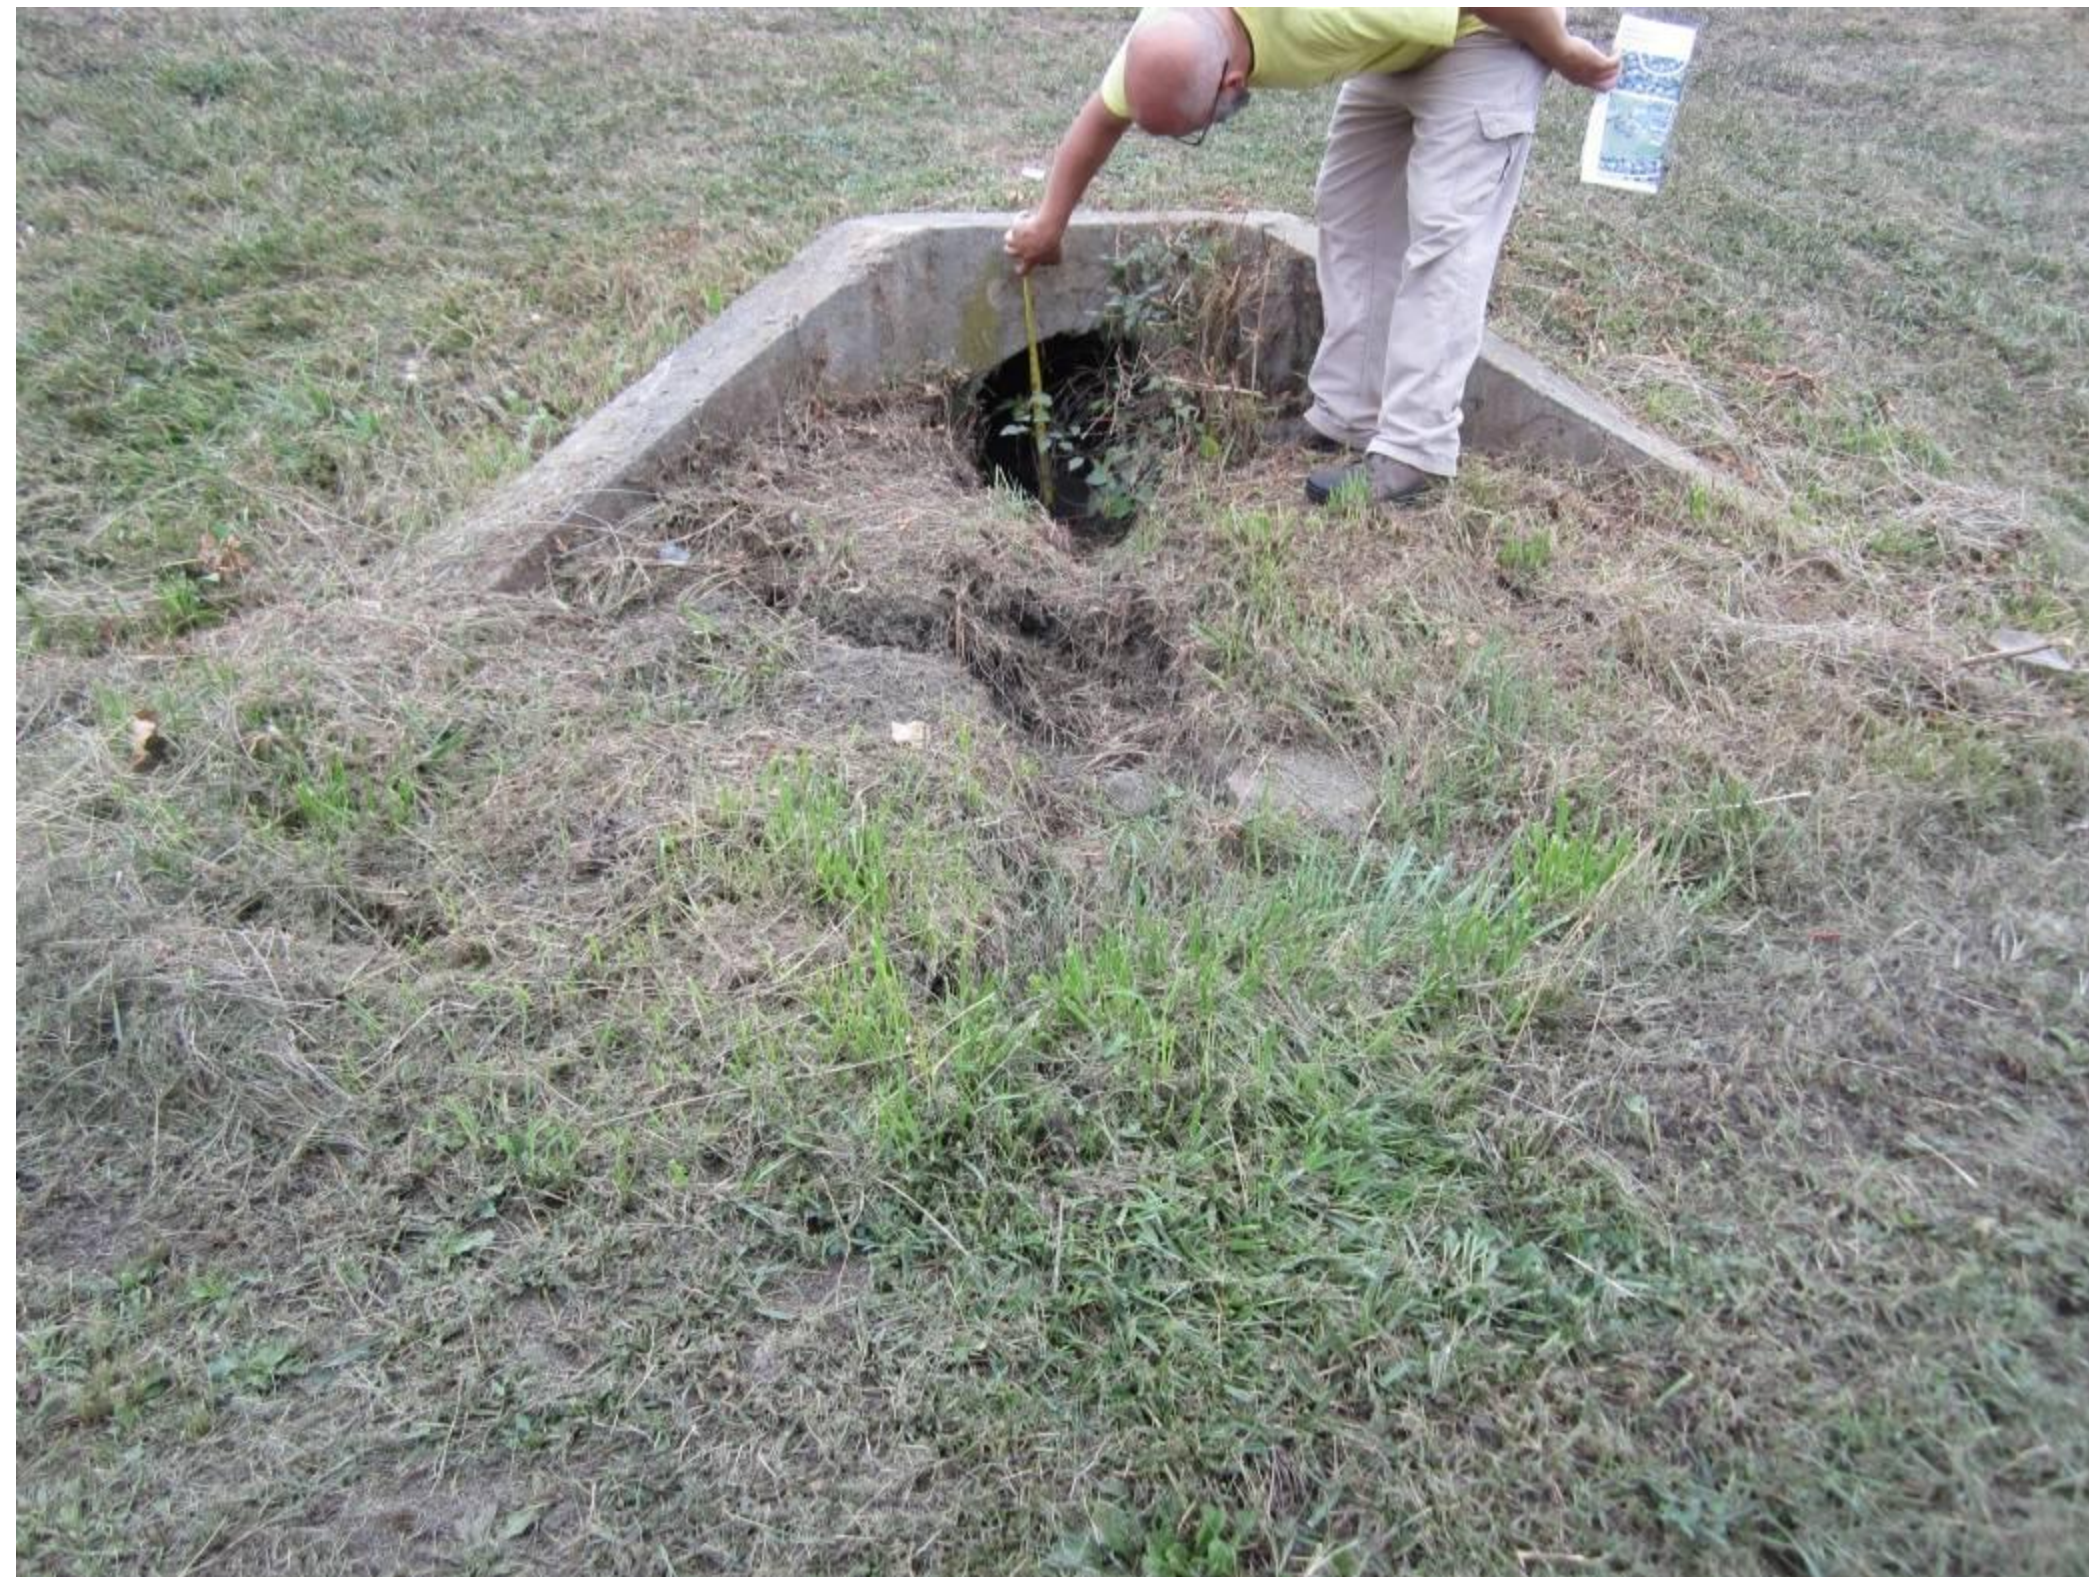
Sediment accumulation in the inlet

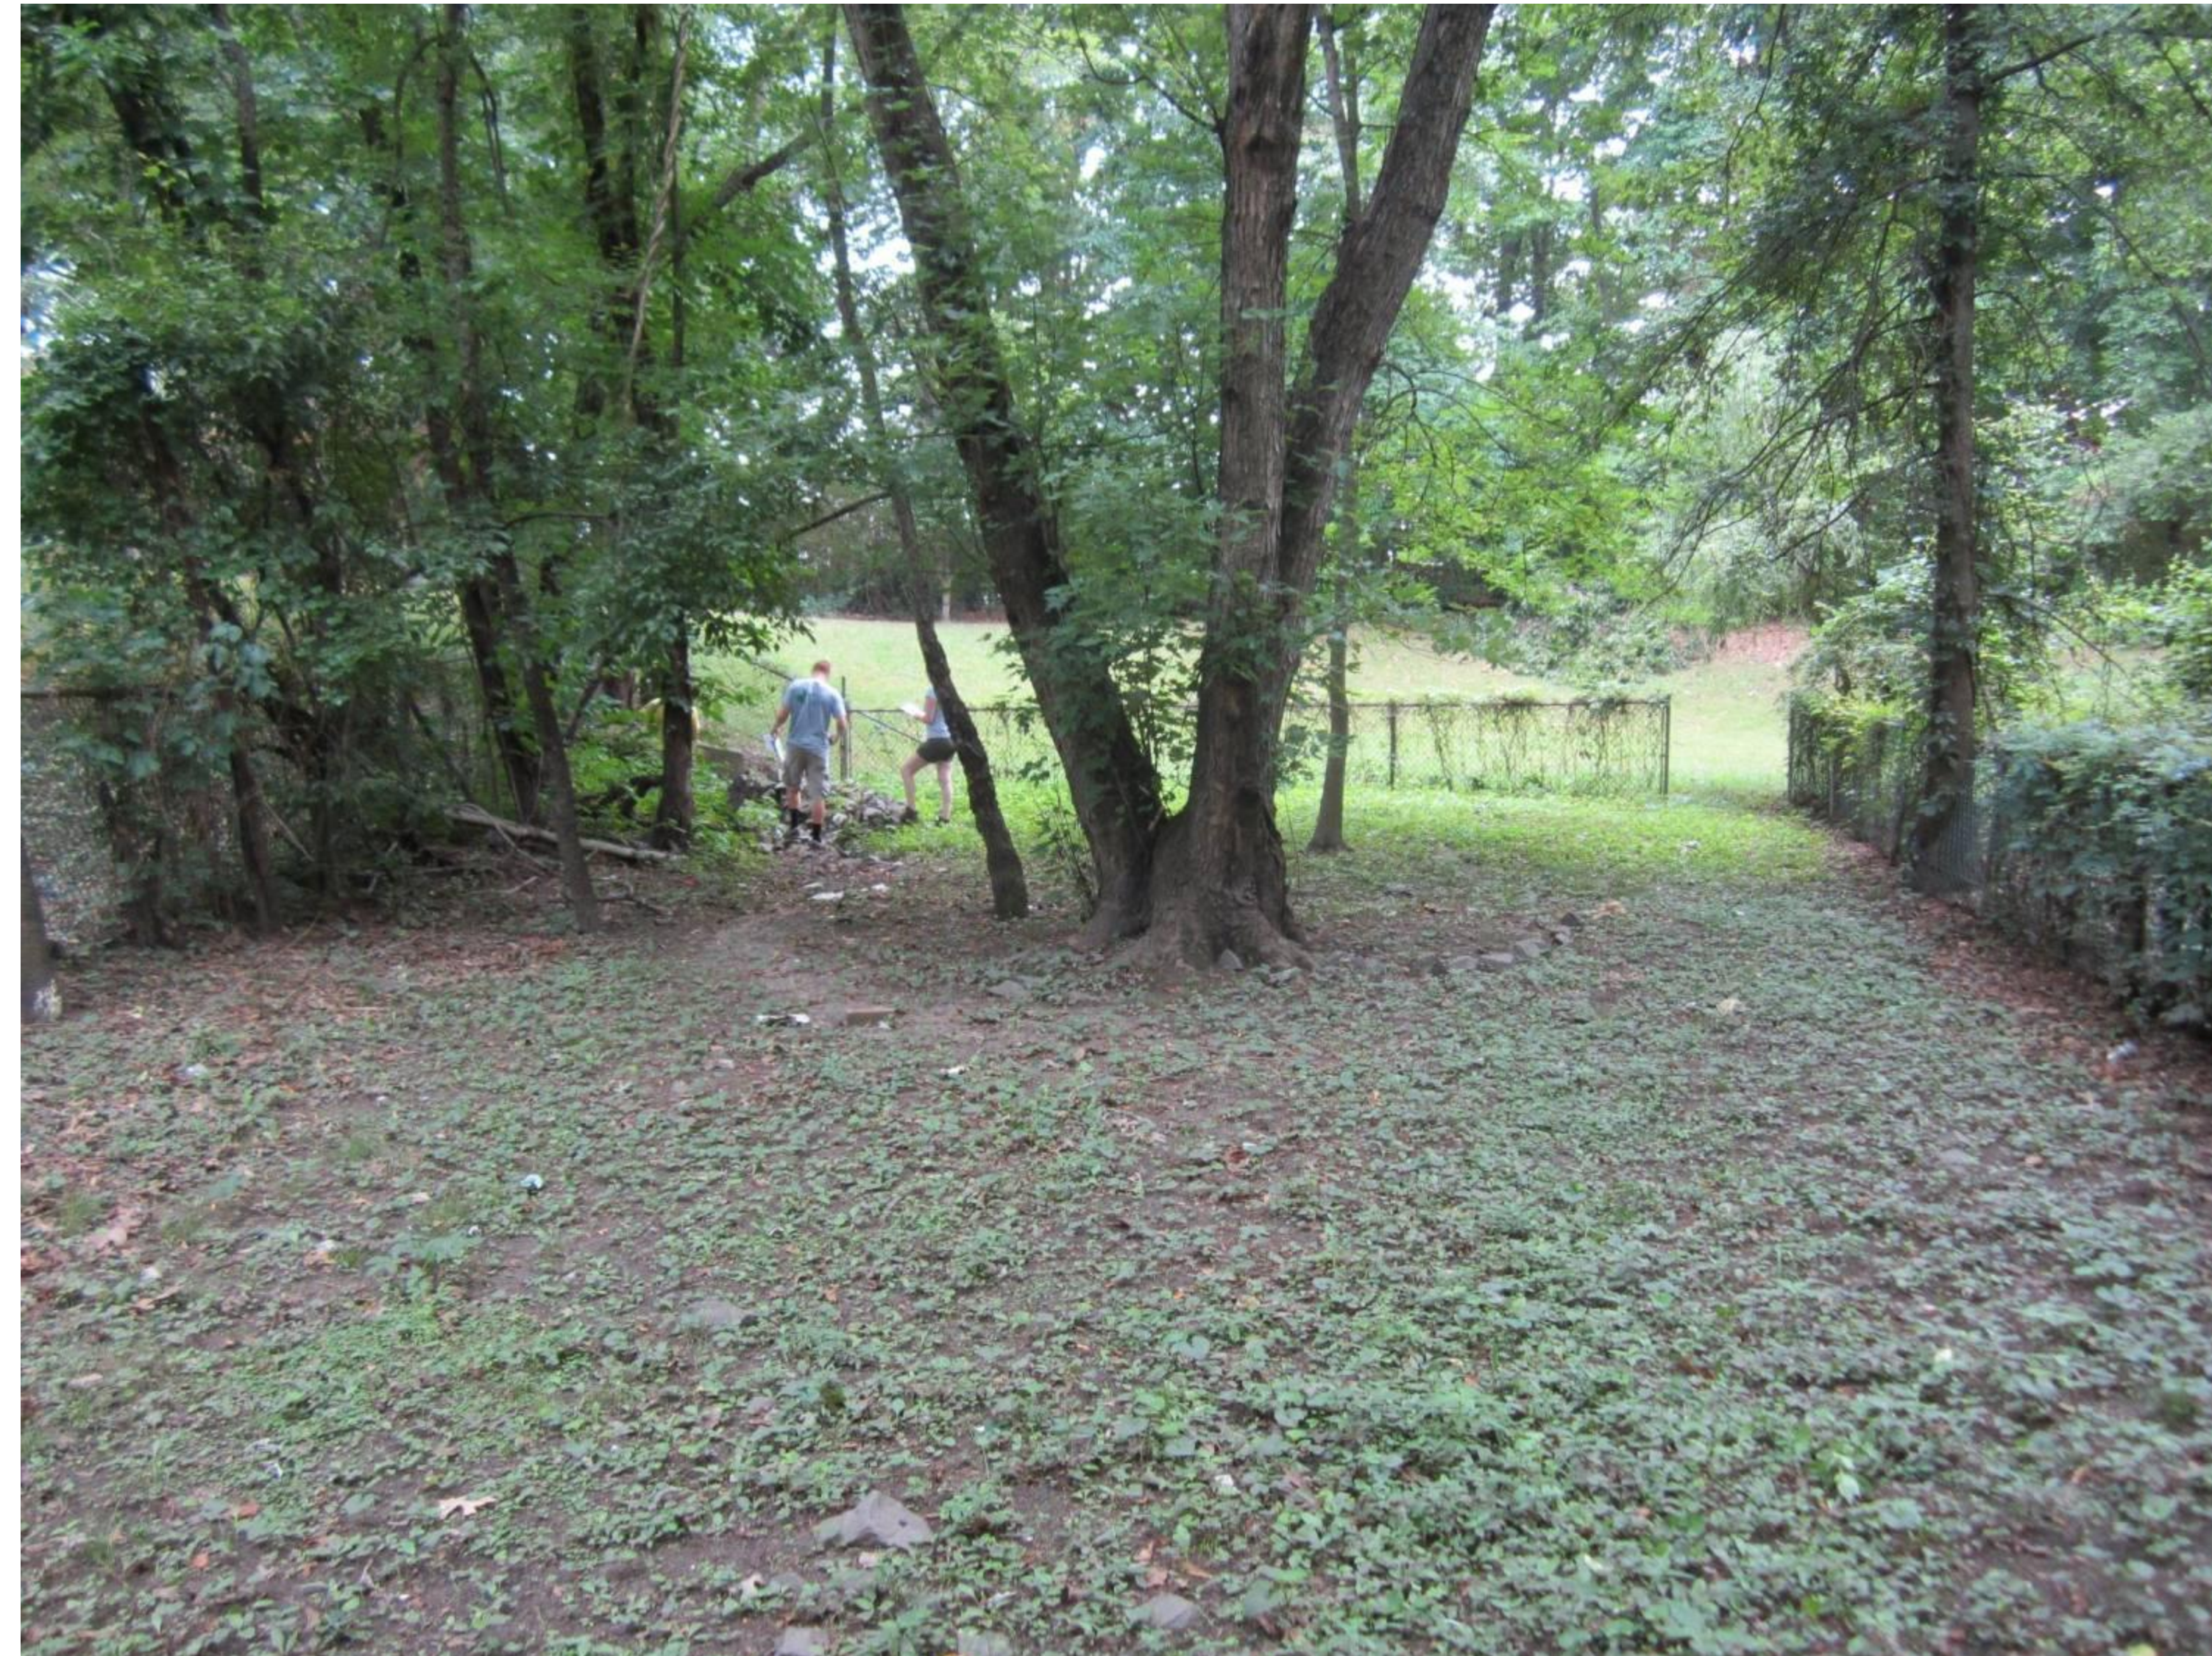
Basin bottom looking west

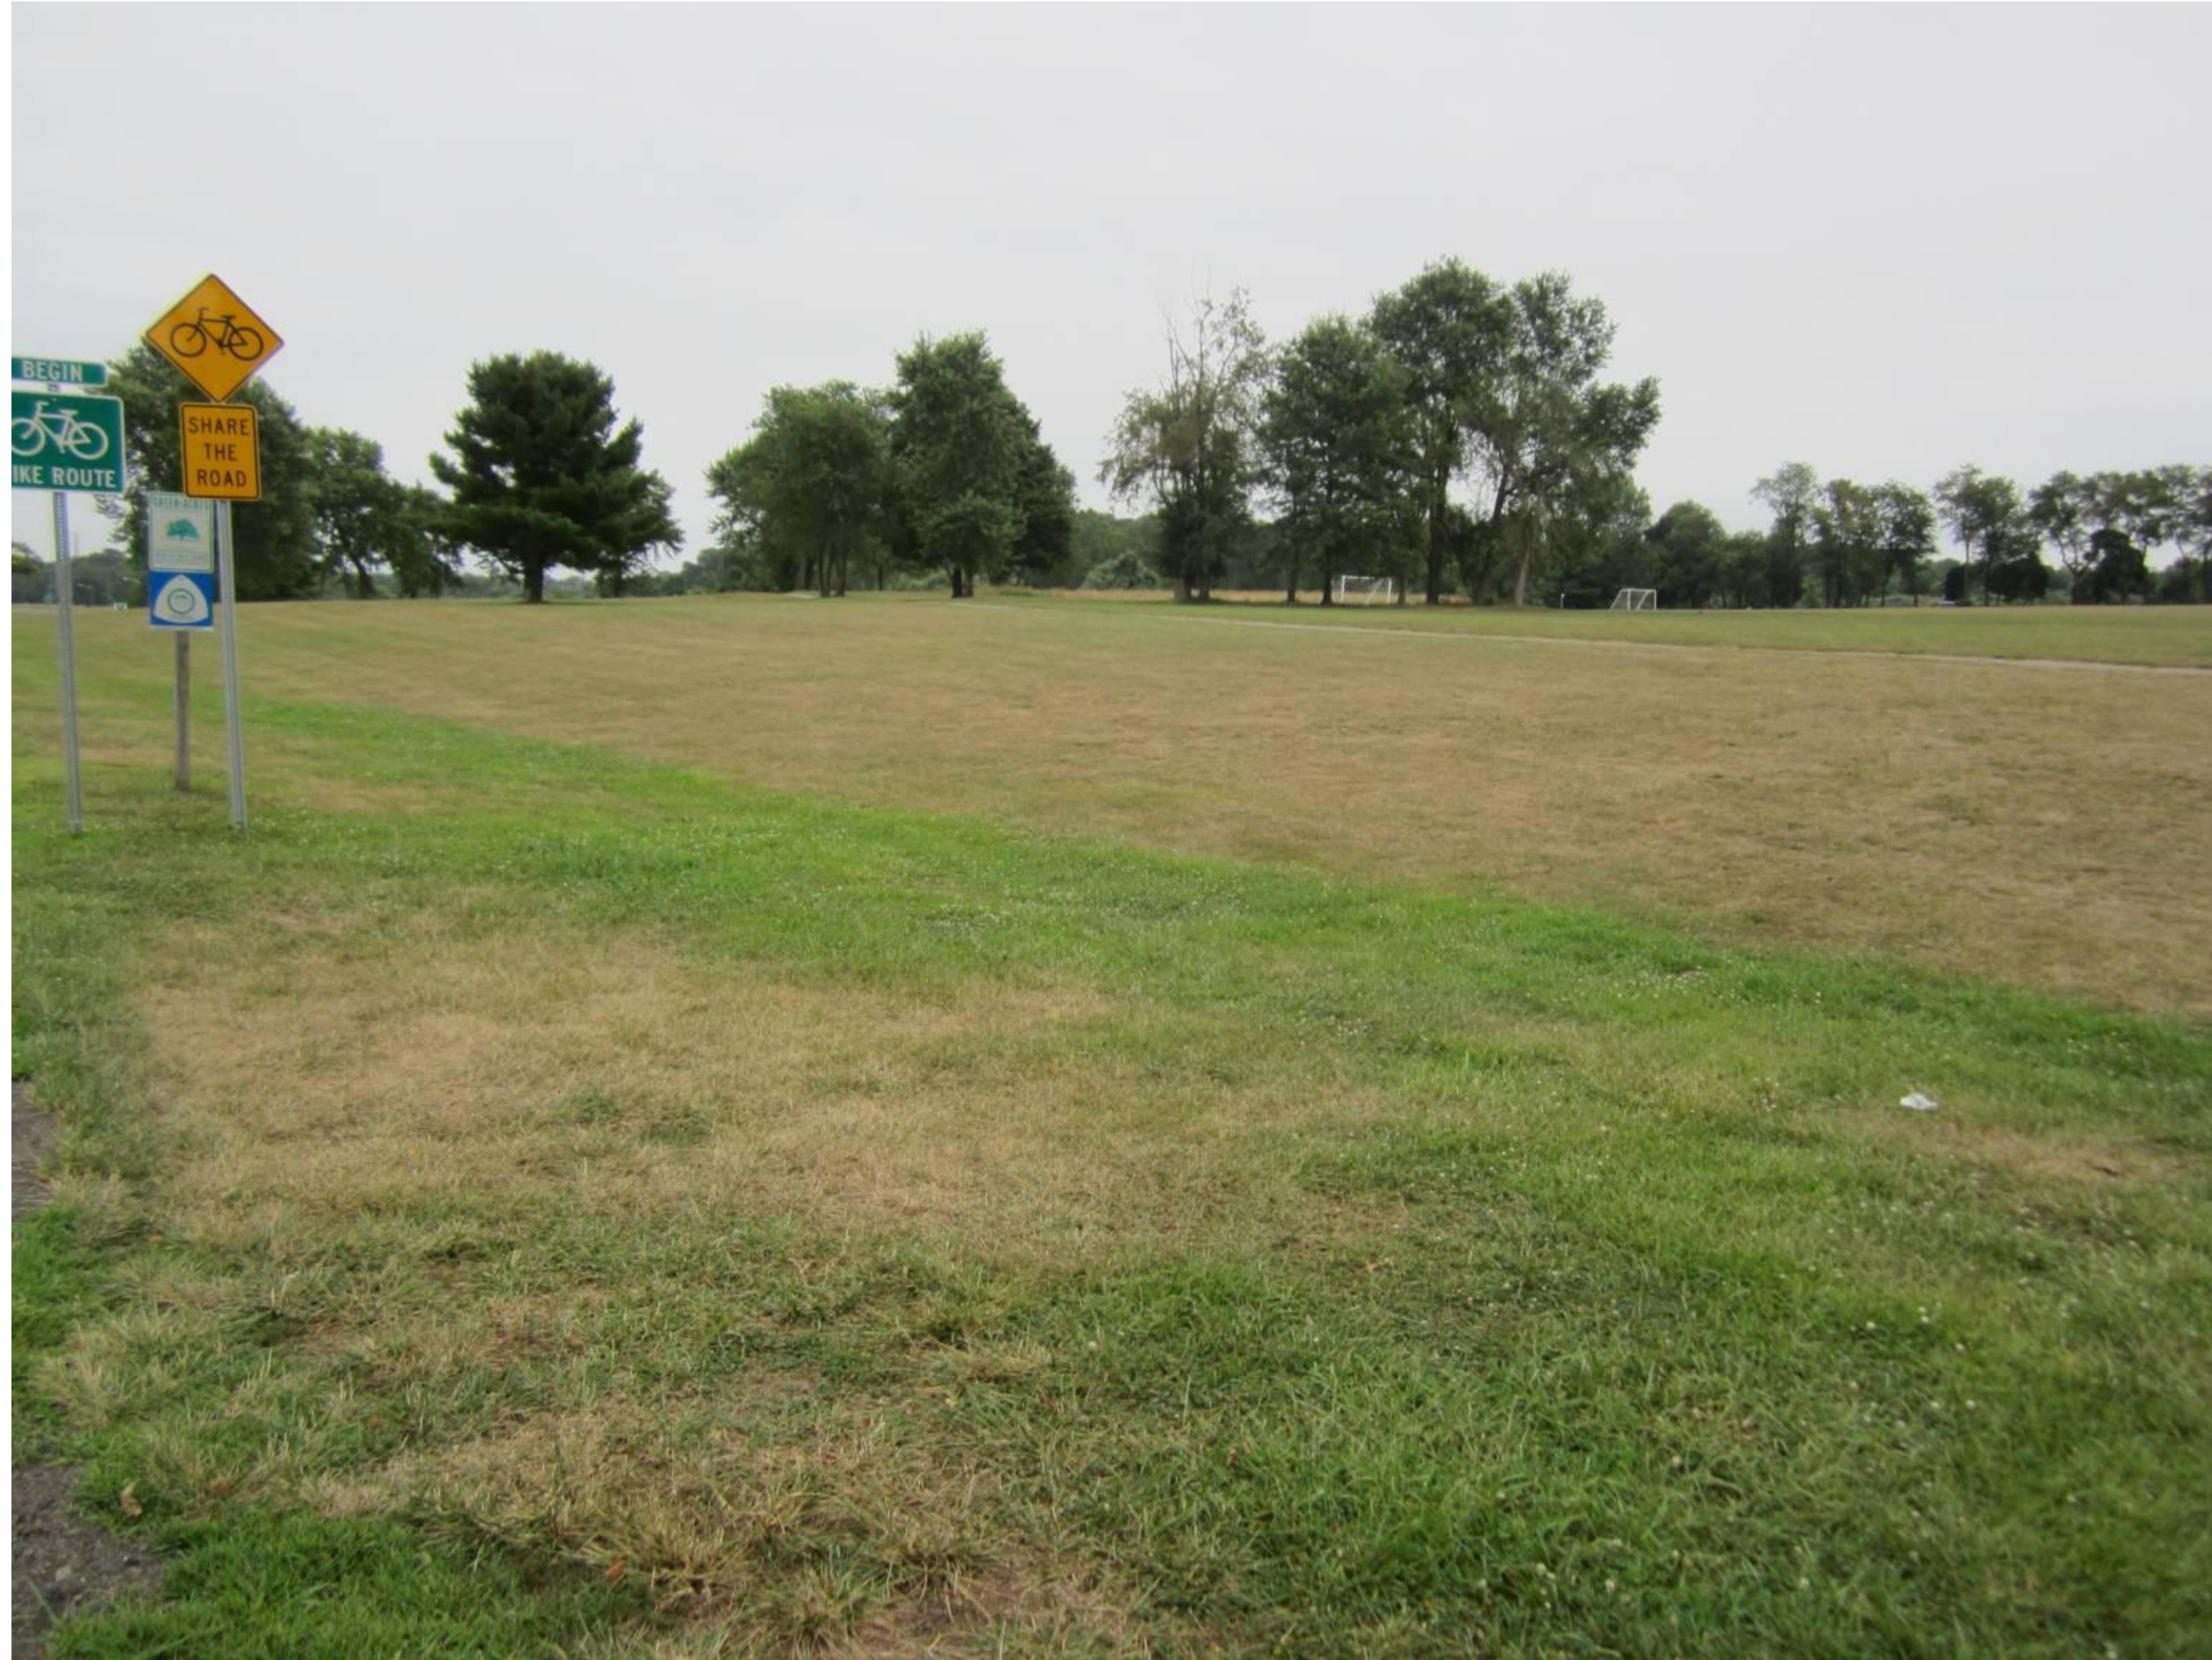
Basin bottom looking east

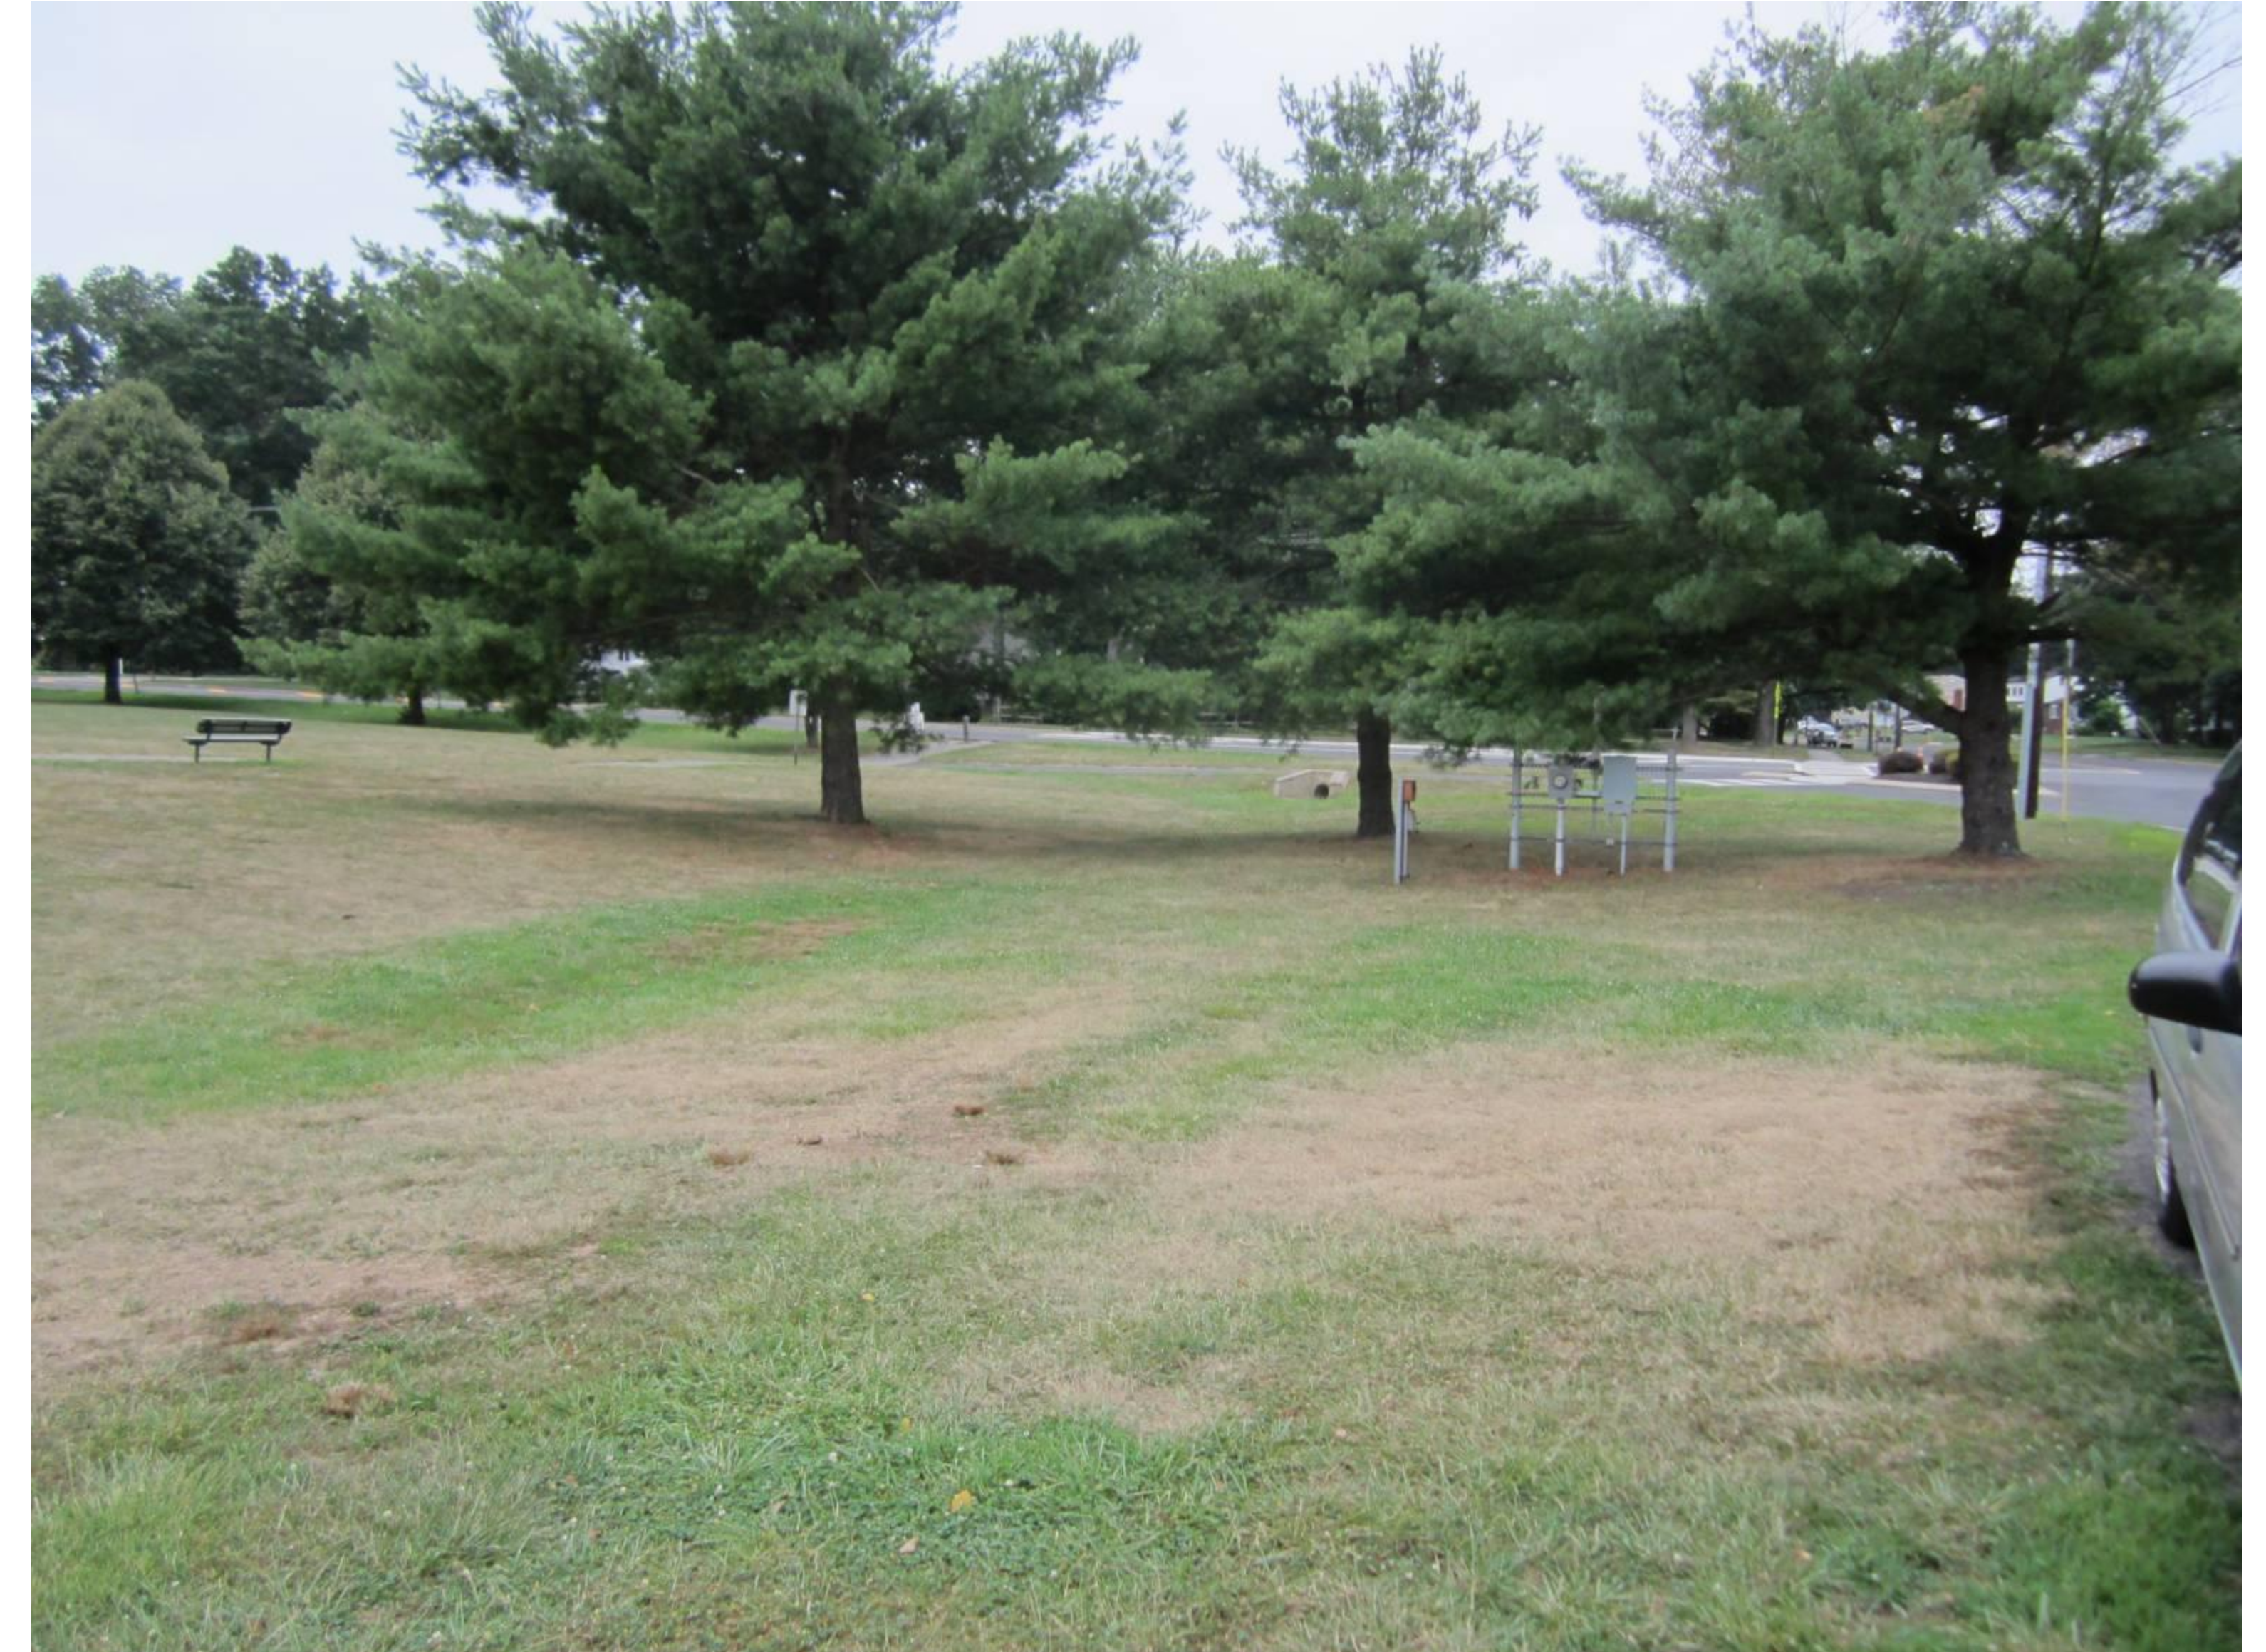
Basin bottom looking west
