Hamilton Township (Mercer County) Stormwater Basin Assessment Summary (Year 1)

Developed by the Rutgers Cooperative Extension Water Resources Program
Funded by Hamilton Township, Mercer County, New Jersey

December 6, 2012

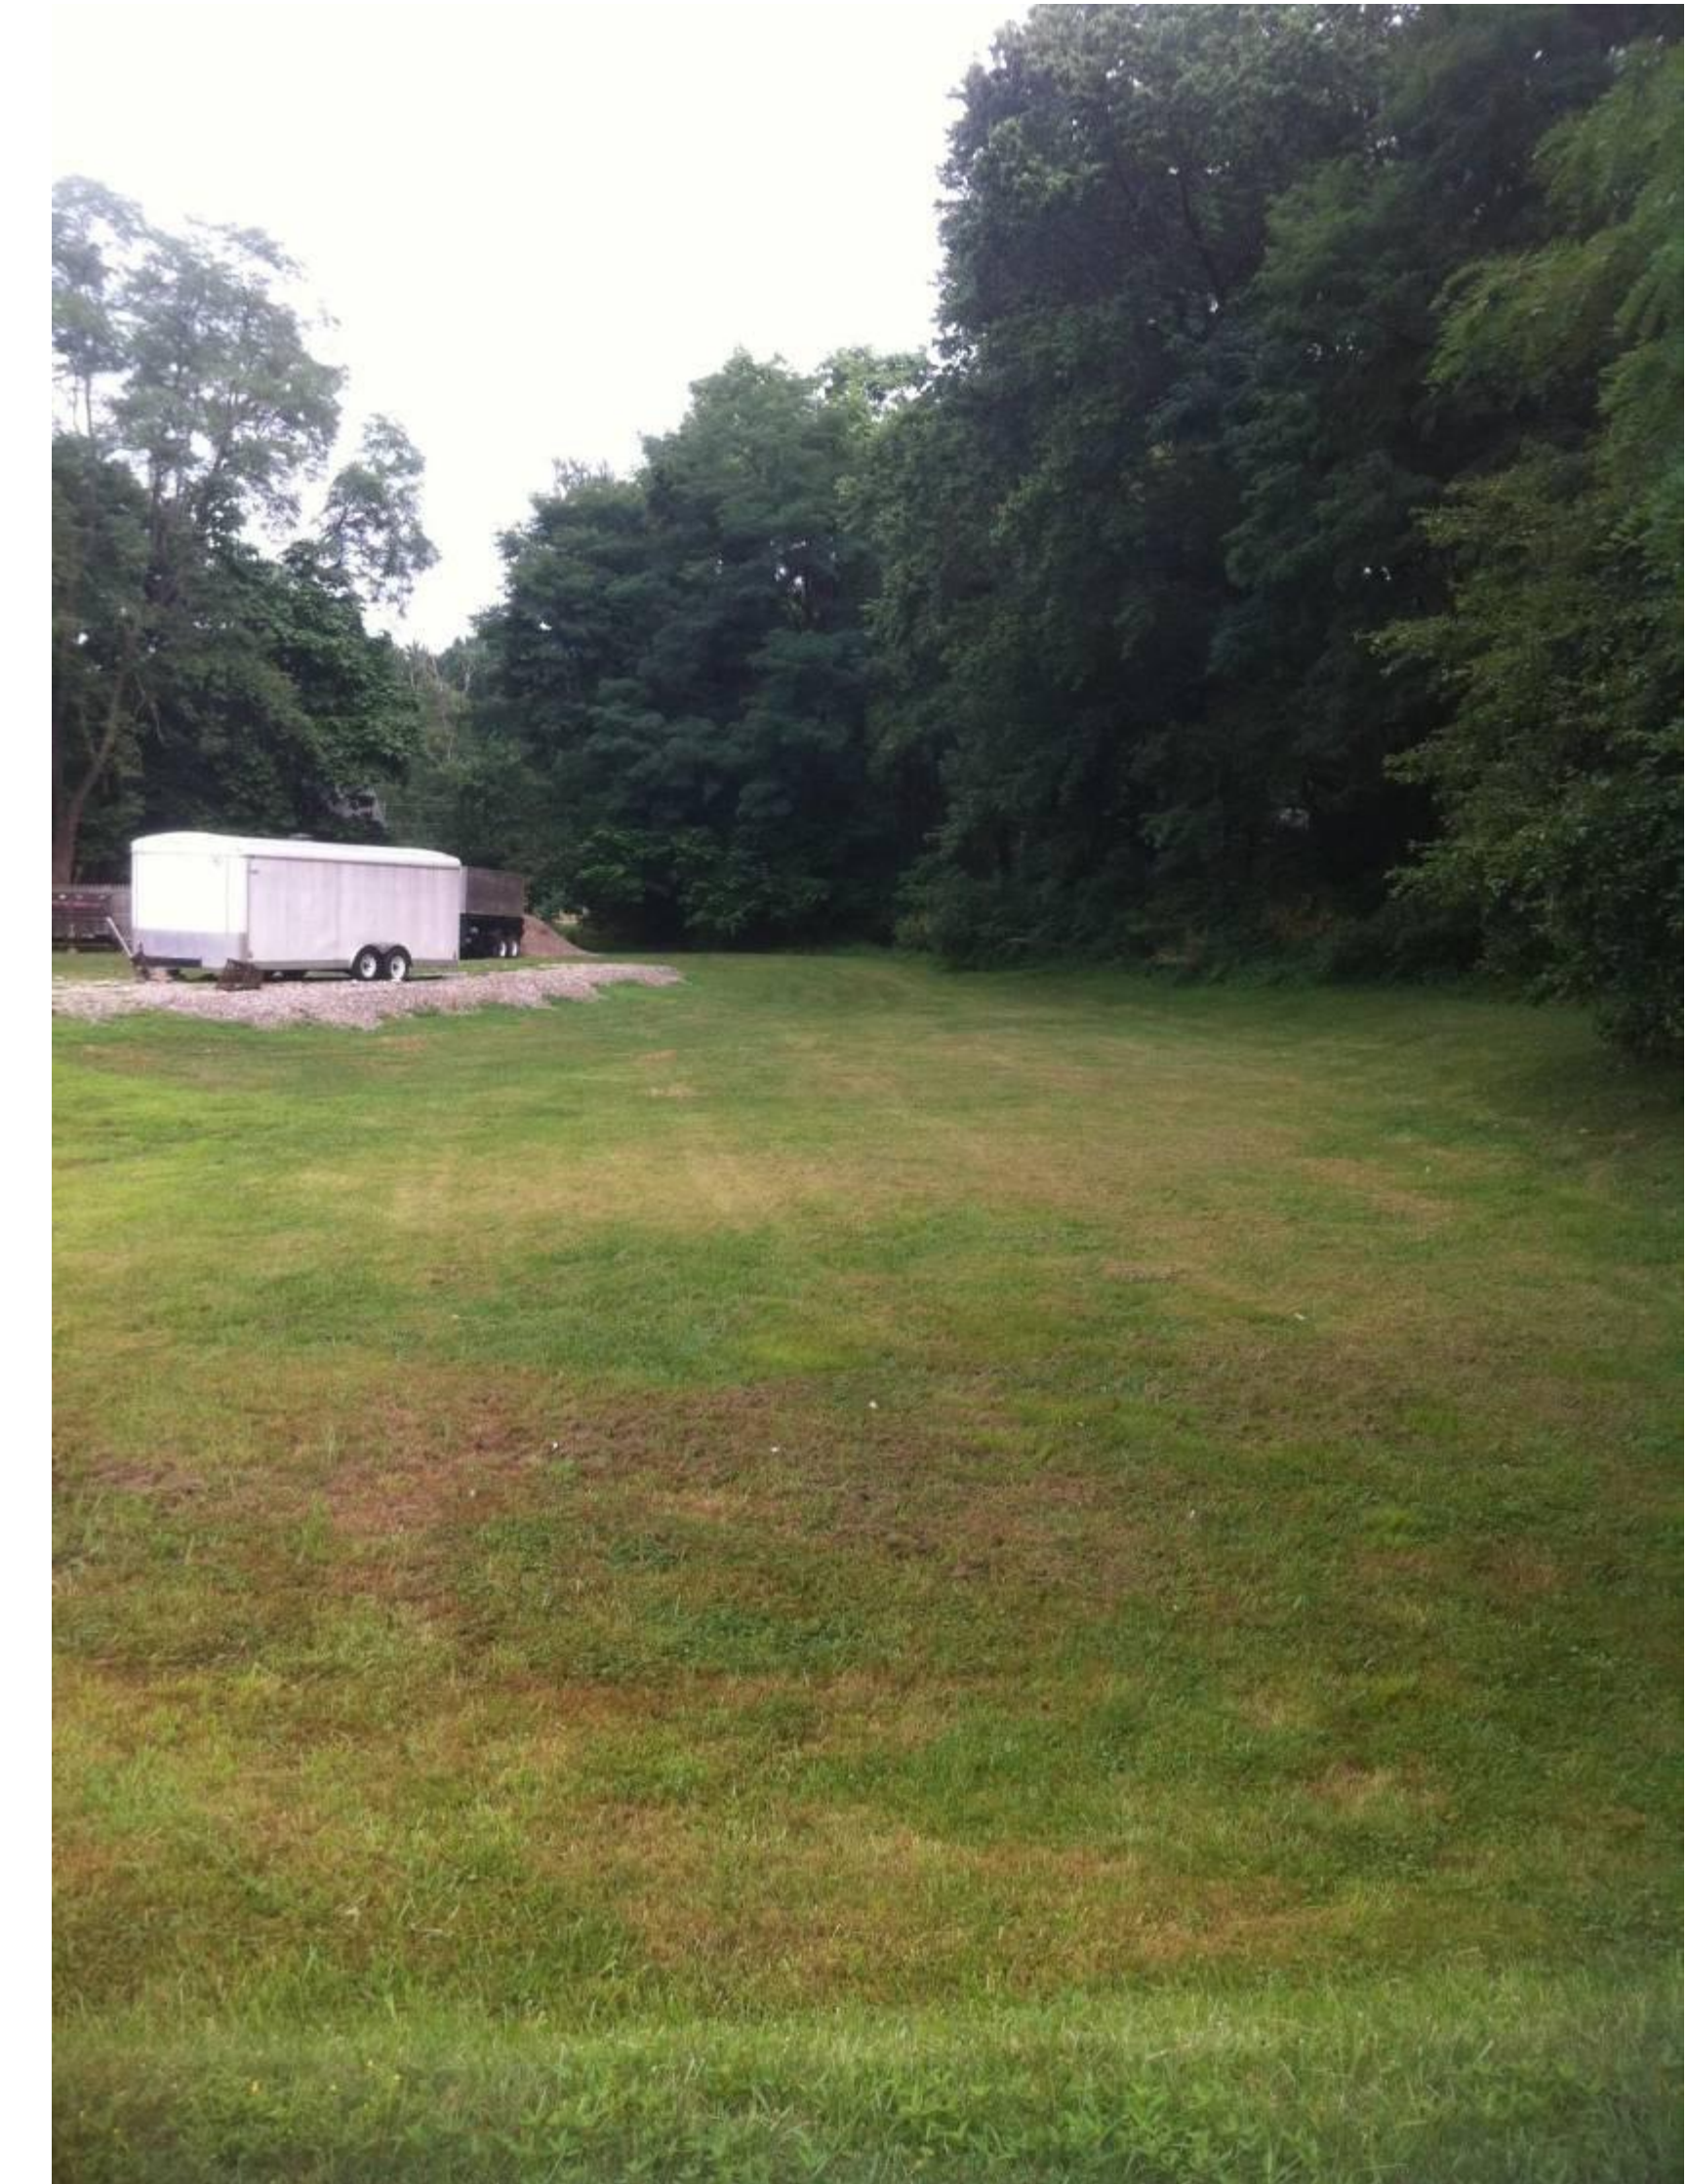
Basin bottom looking west

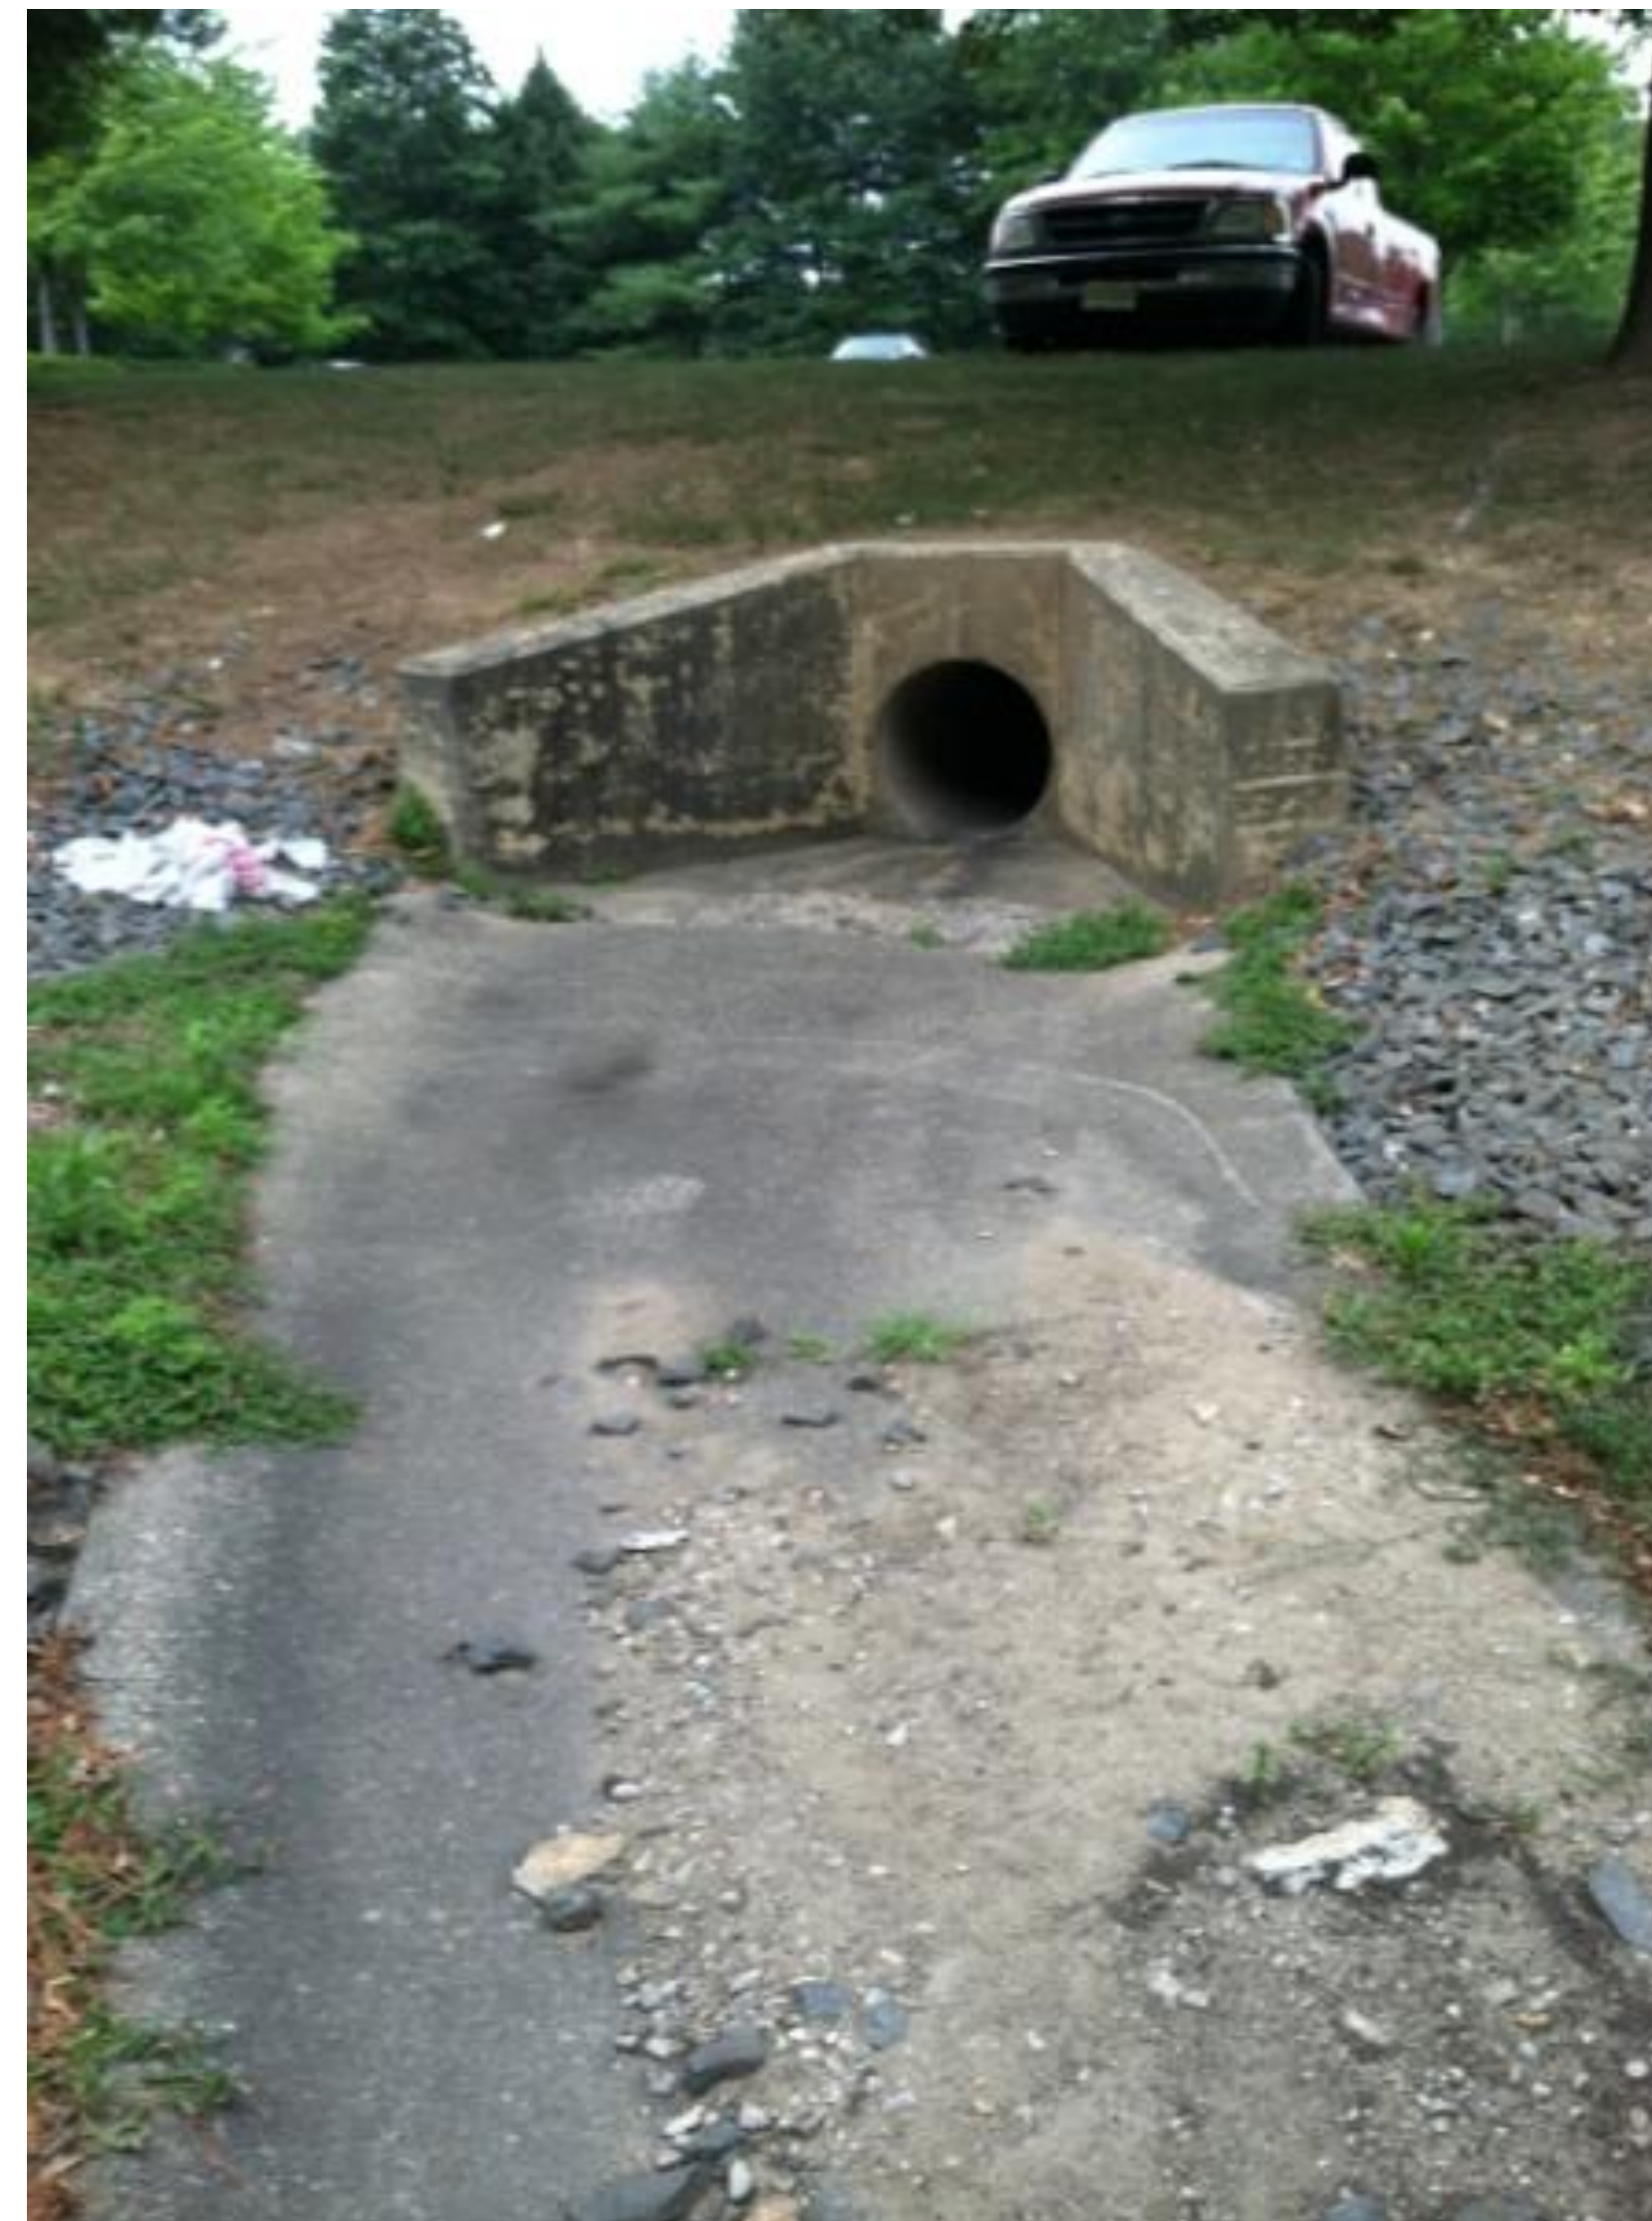
Inlet, sediment in low flow channel

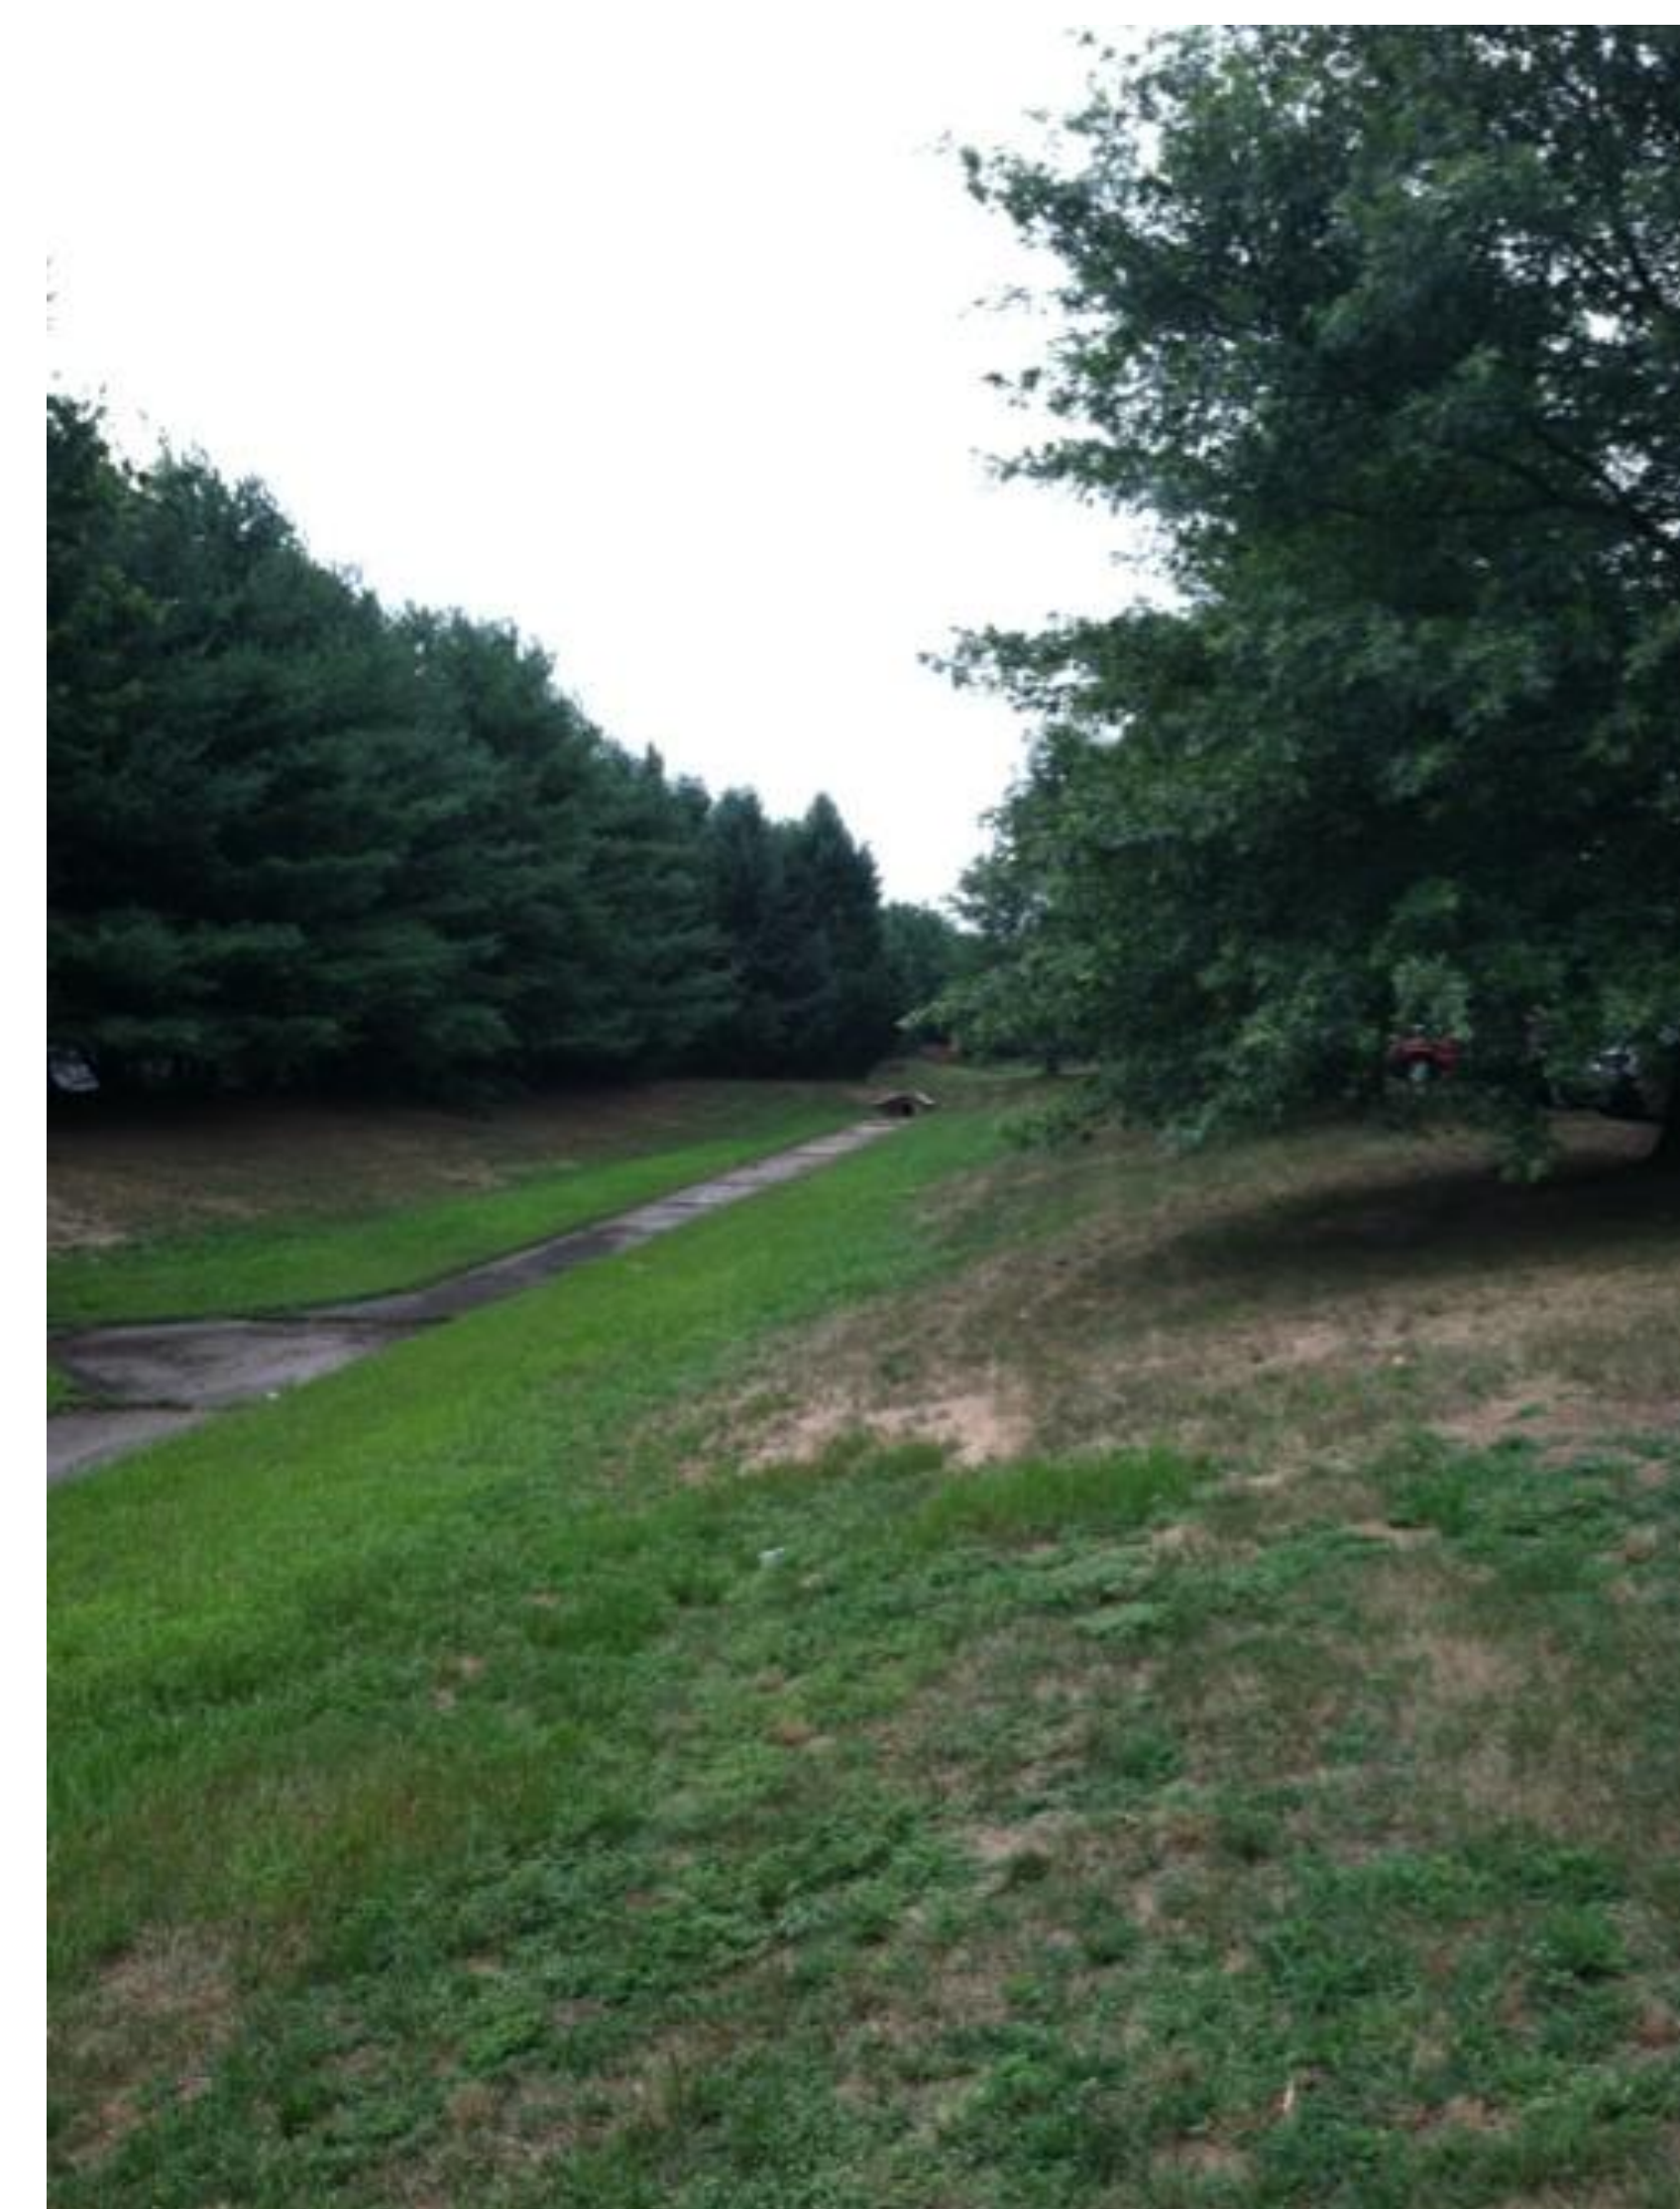
Basin bottom looking southwest

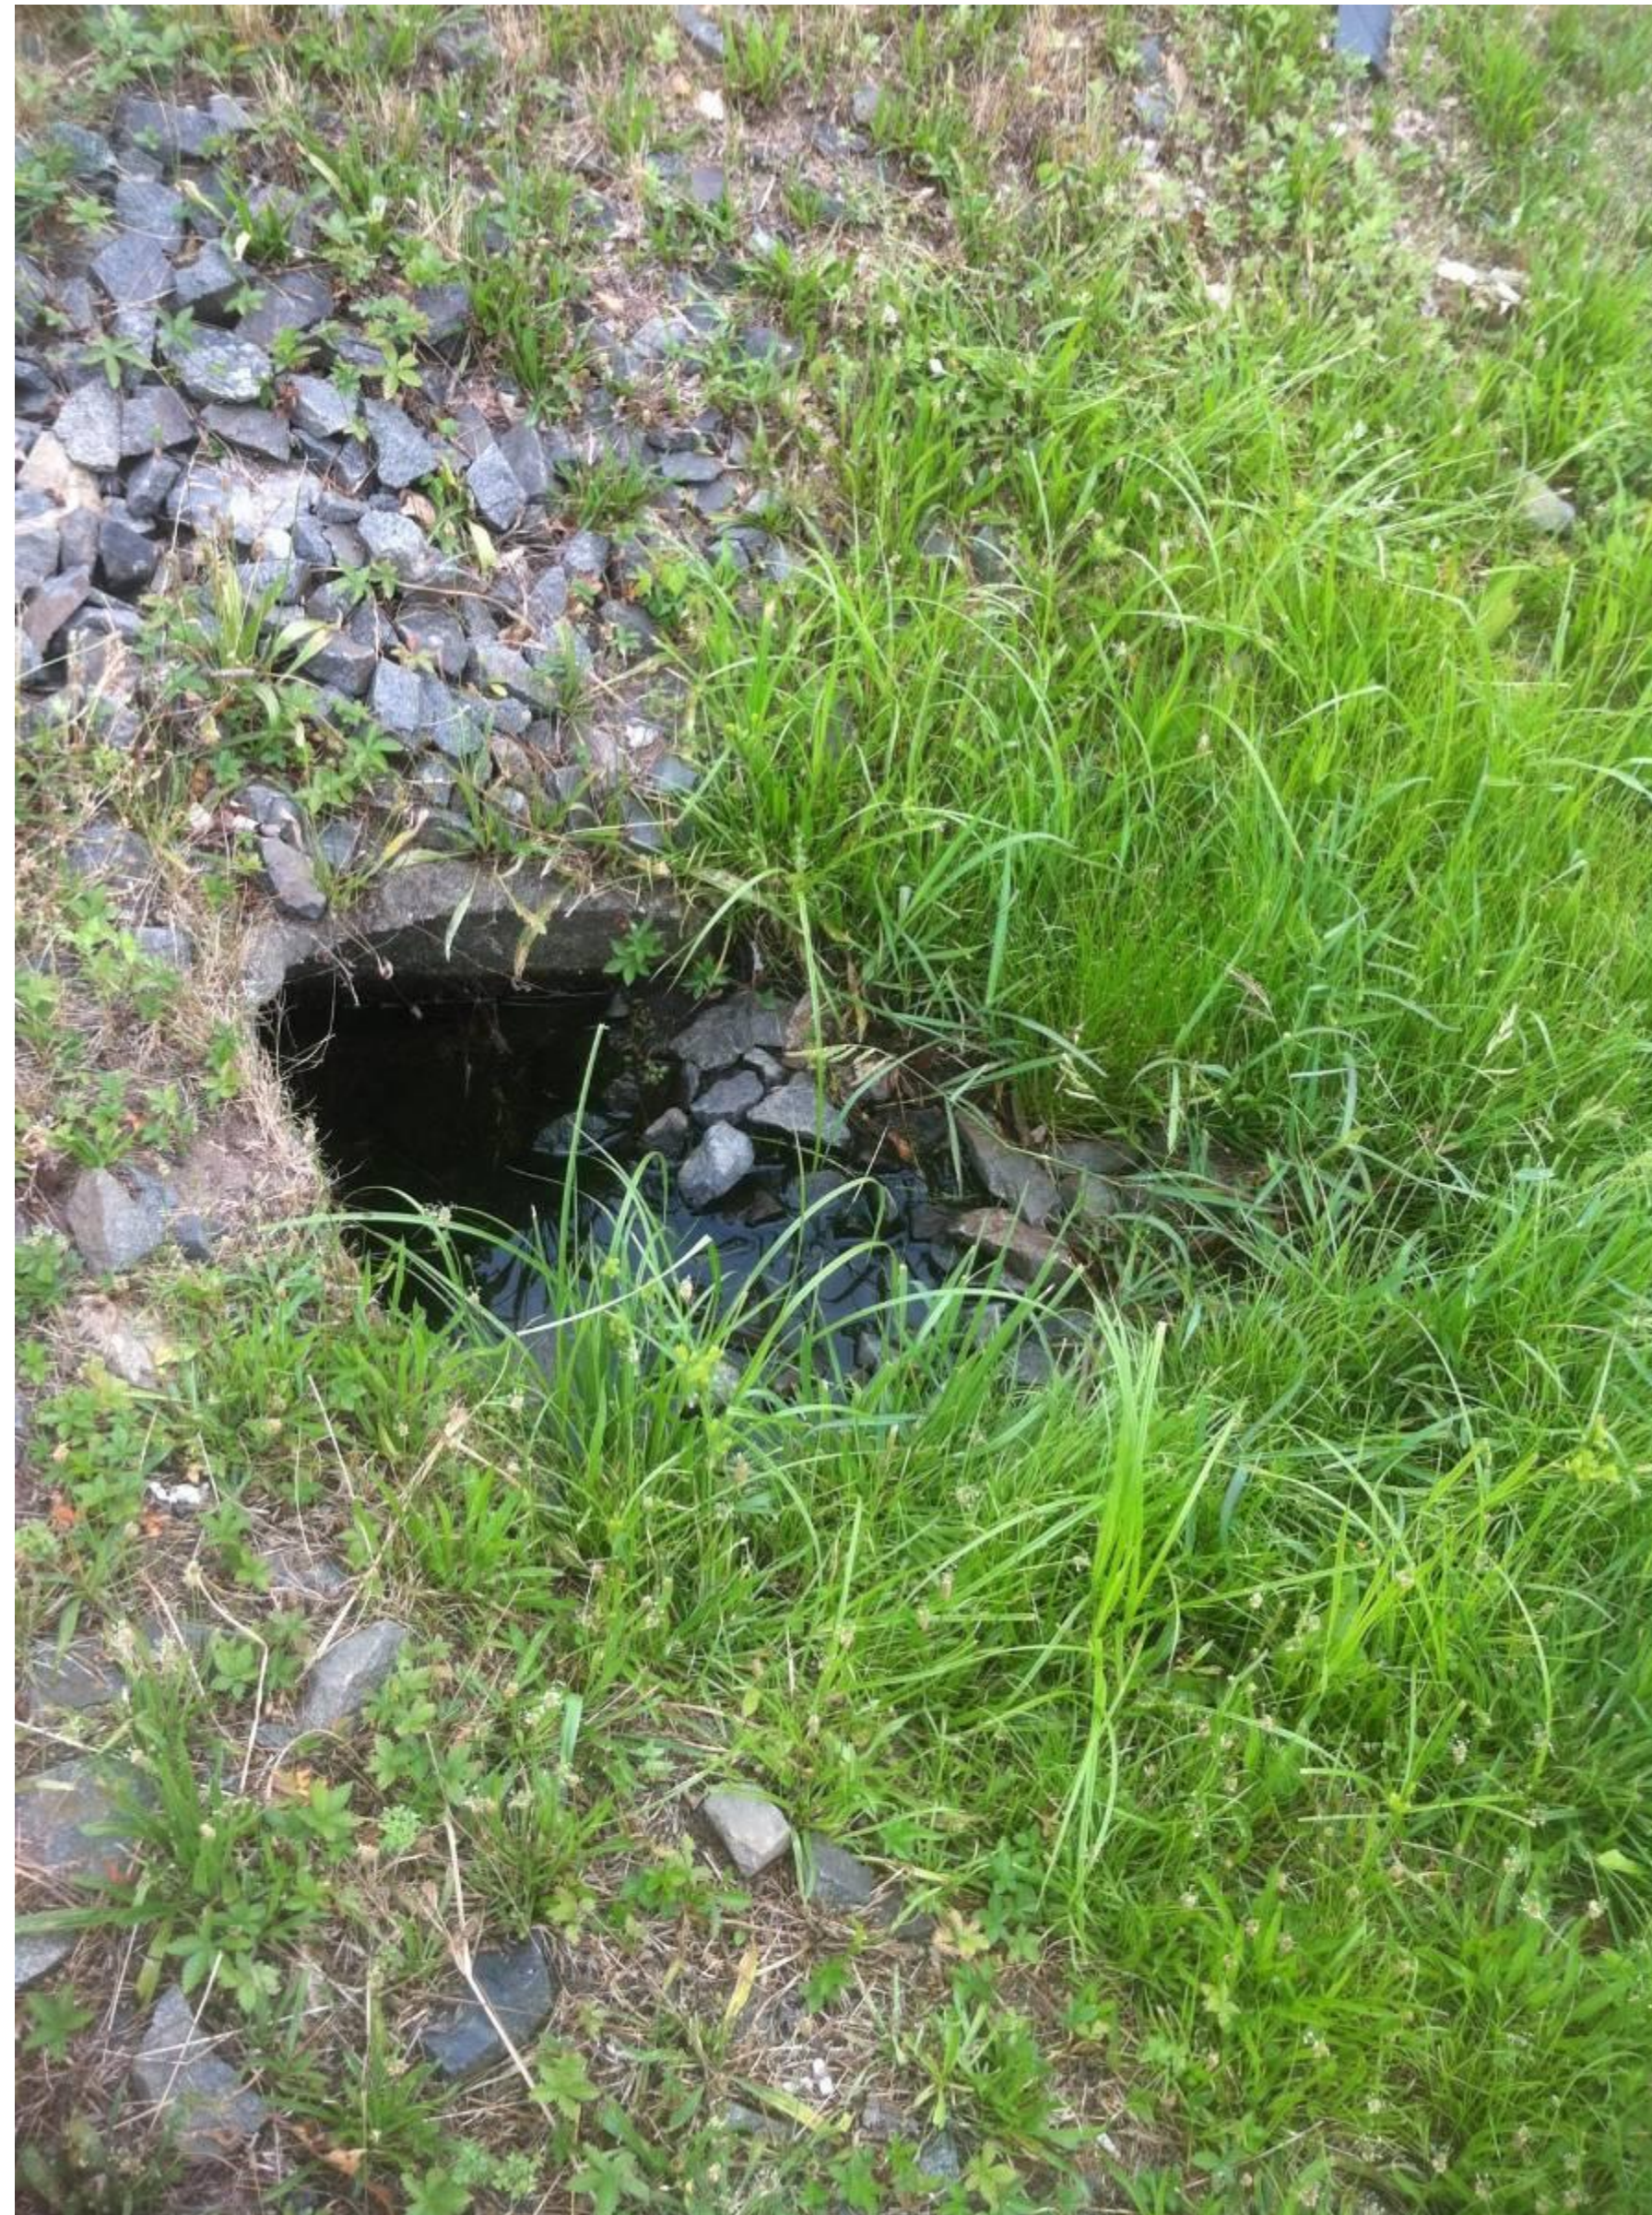
Inlet and erosion

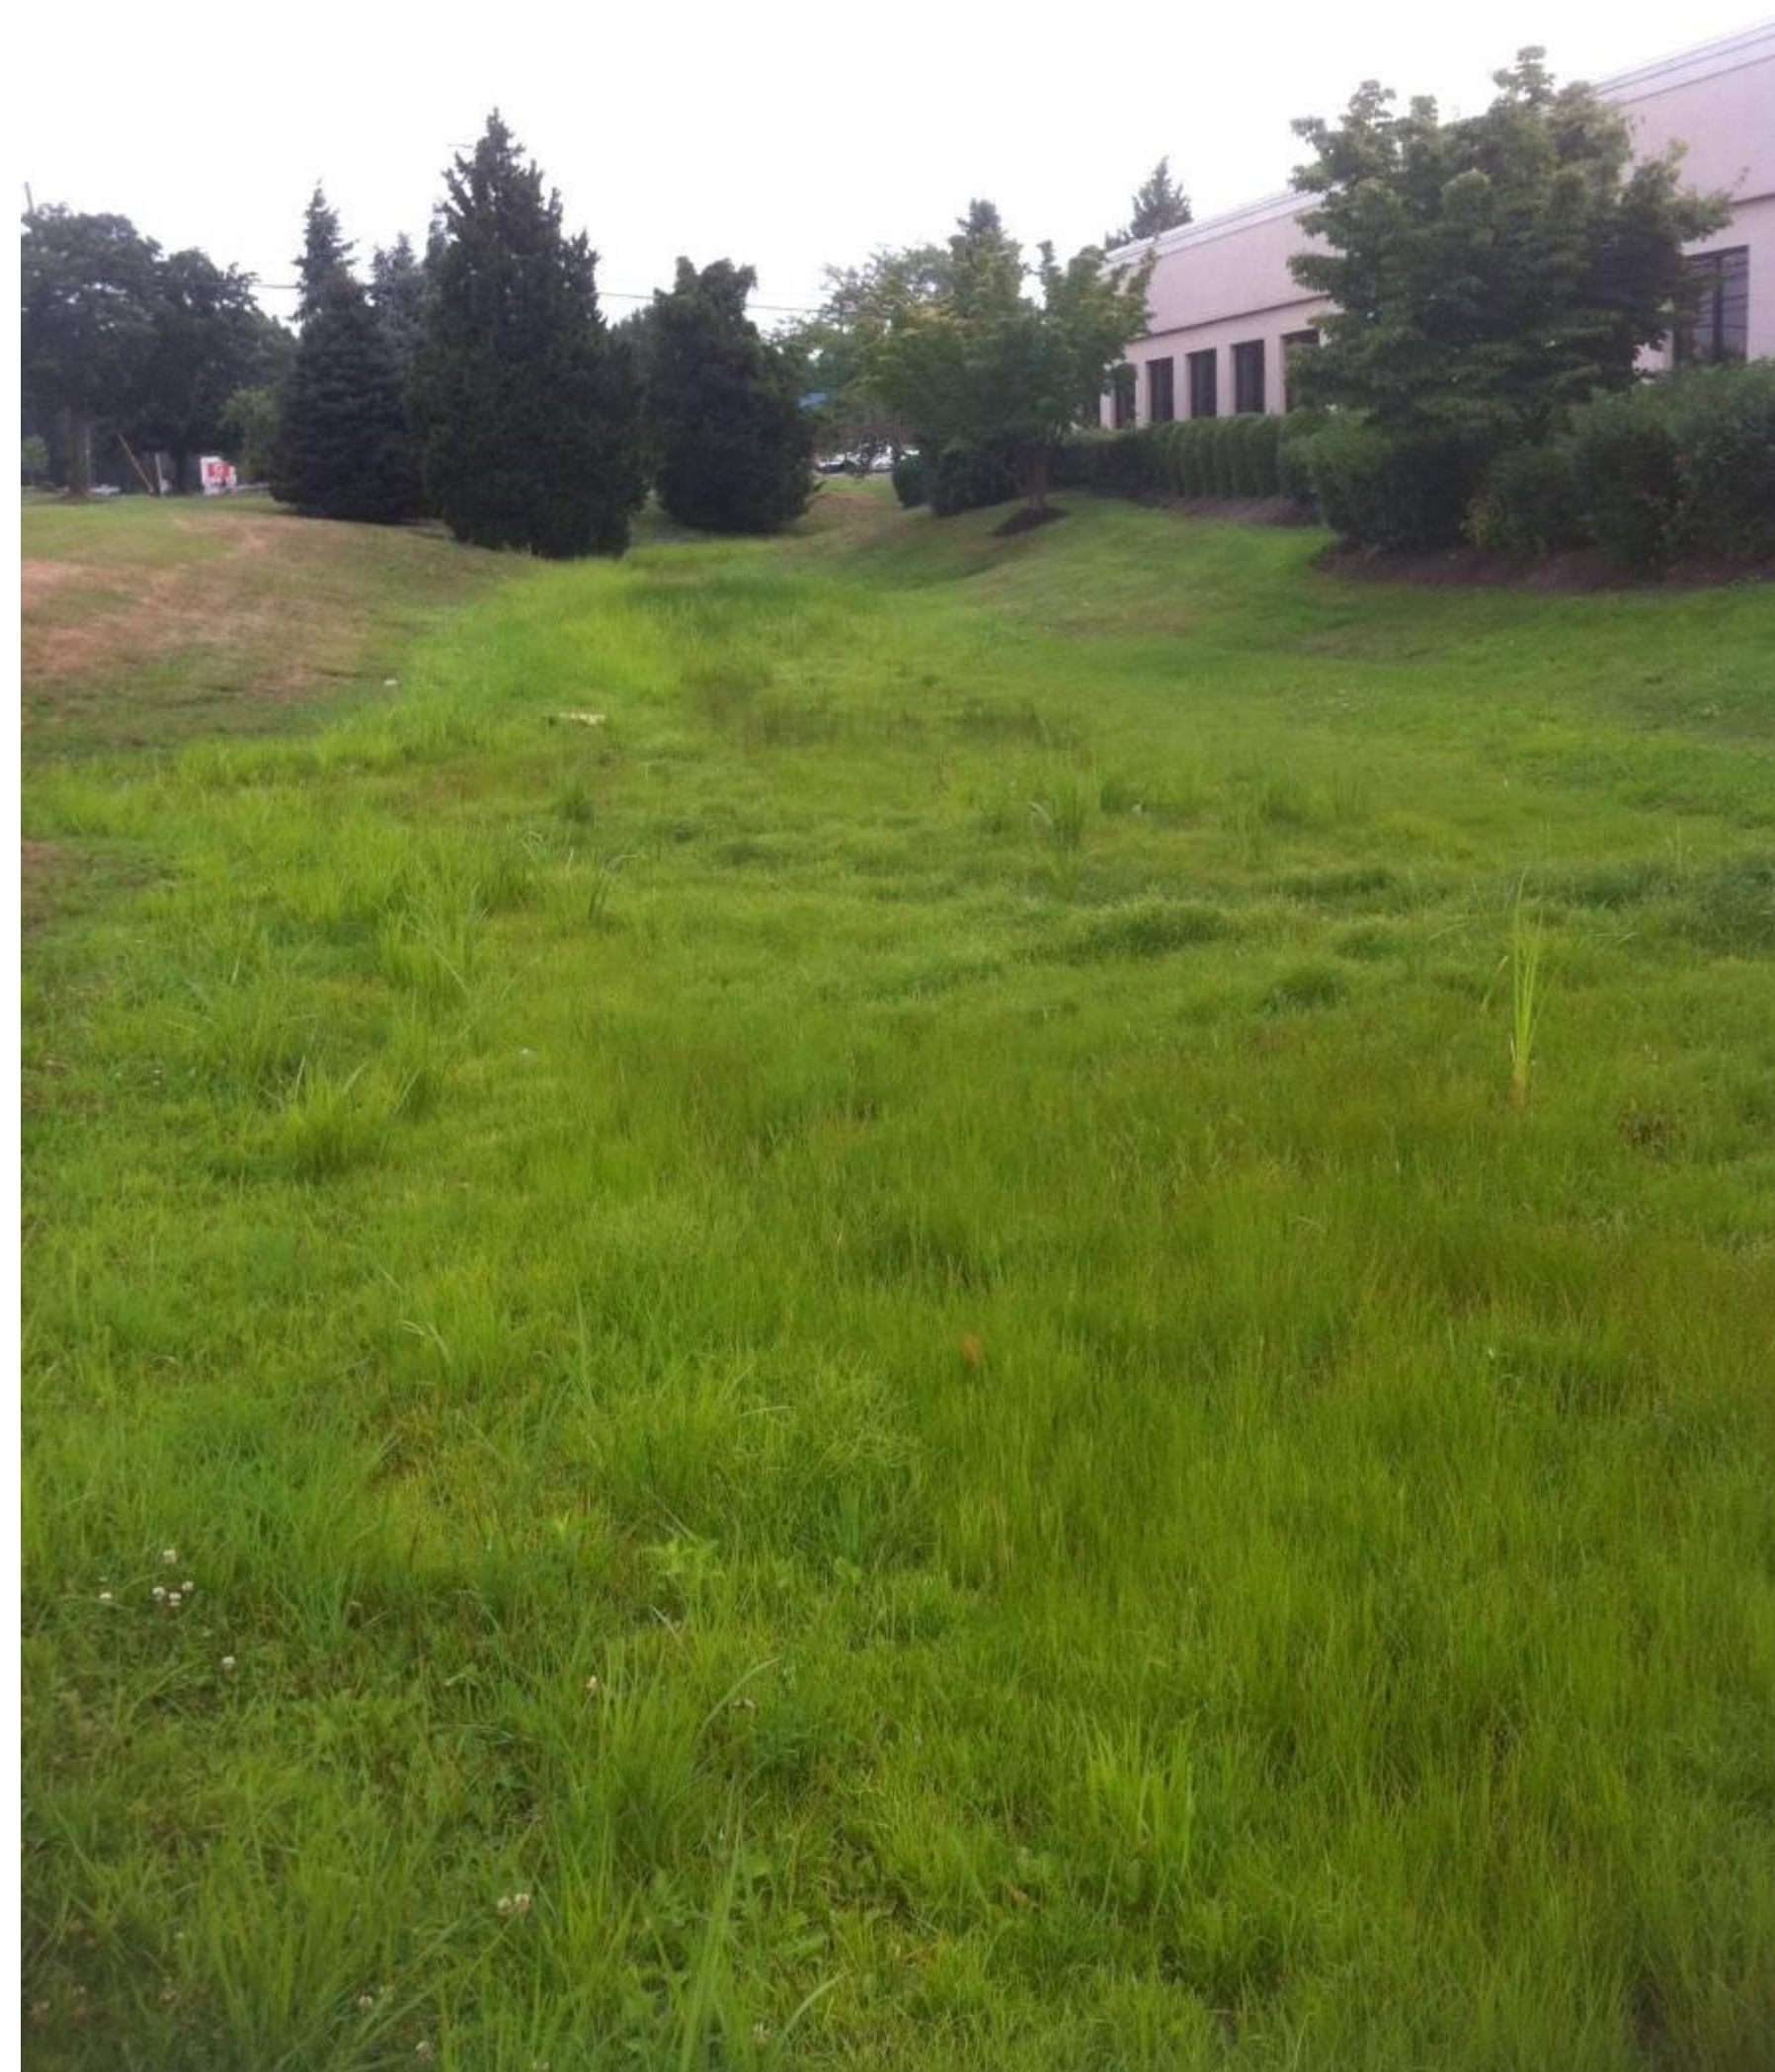
Basin bottom looking northeast

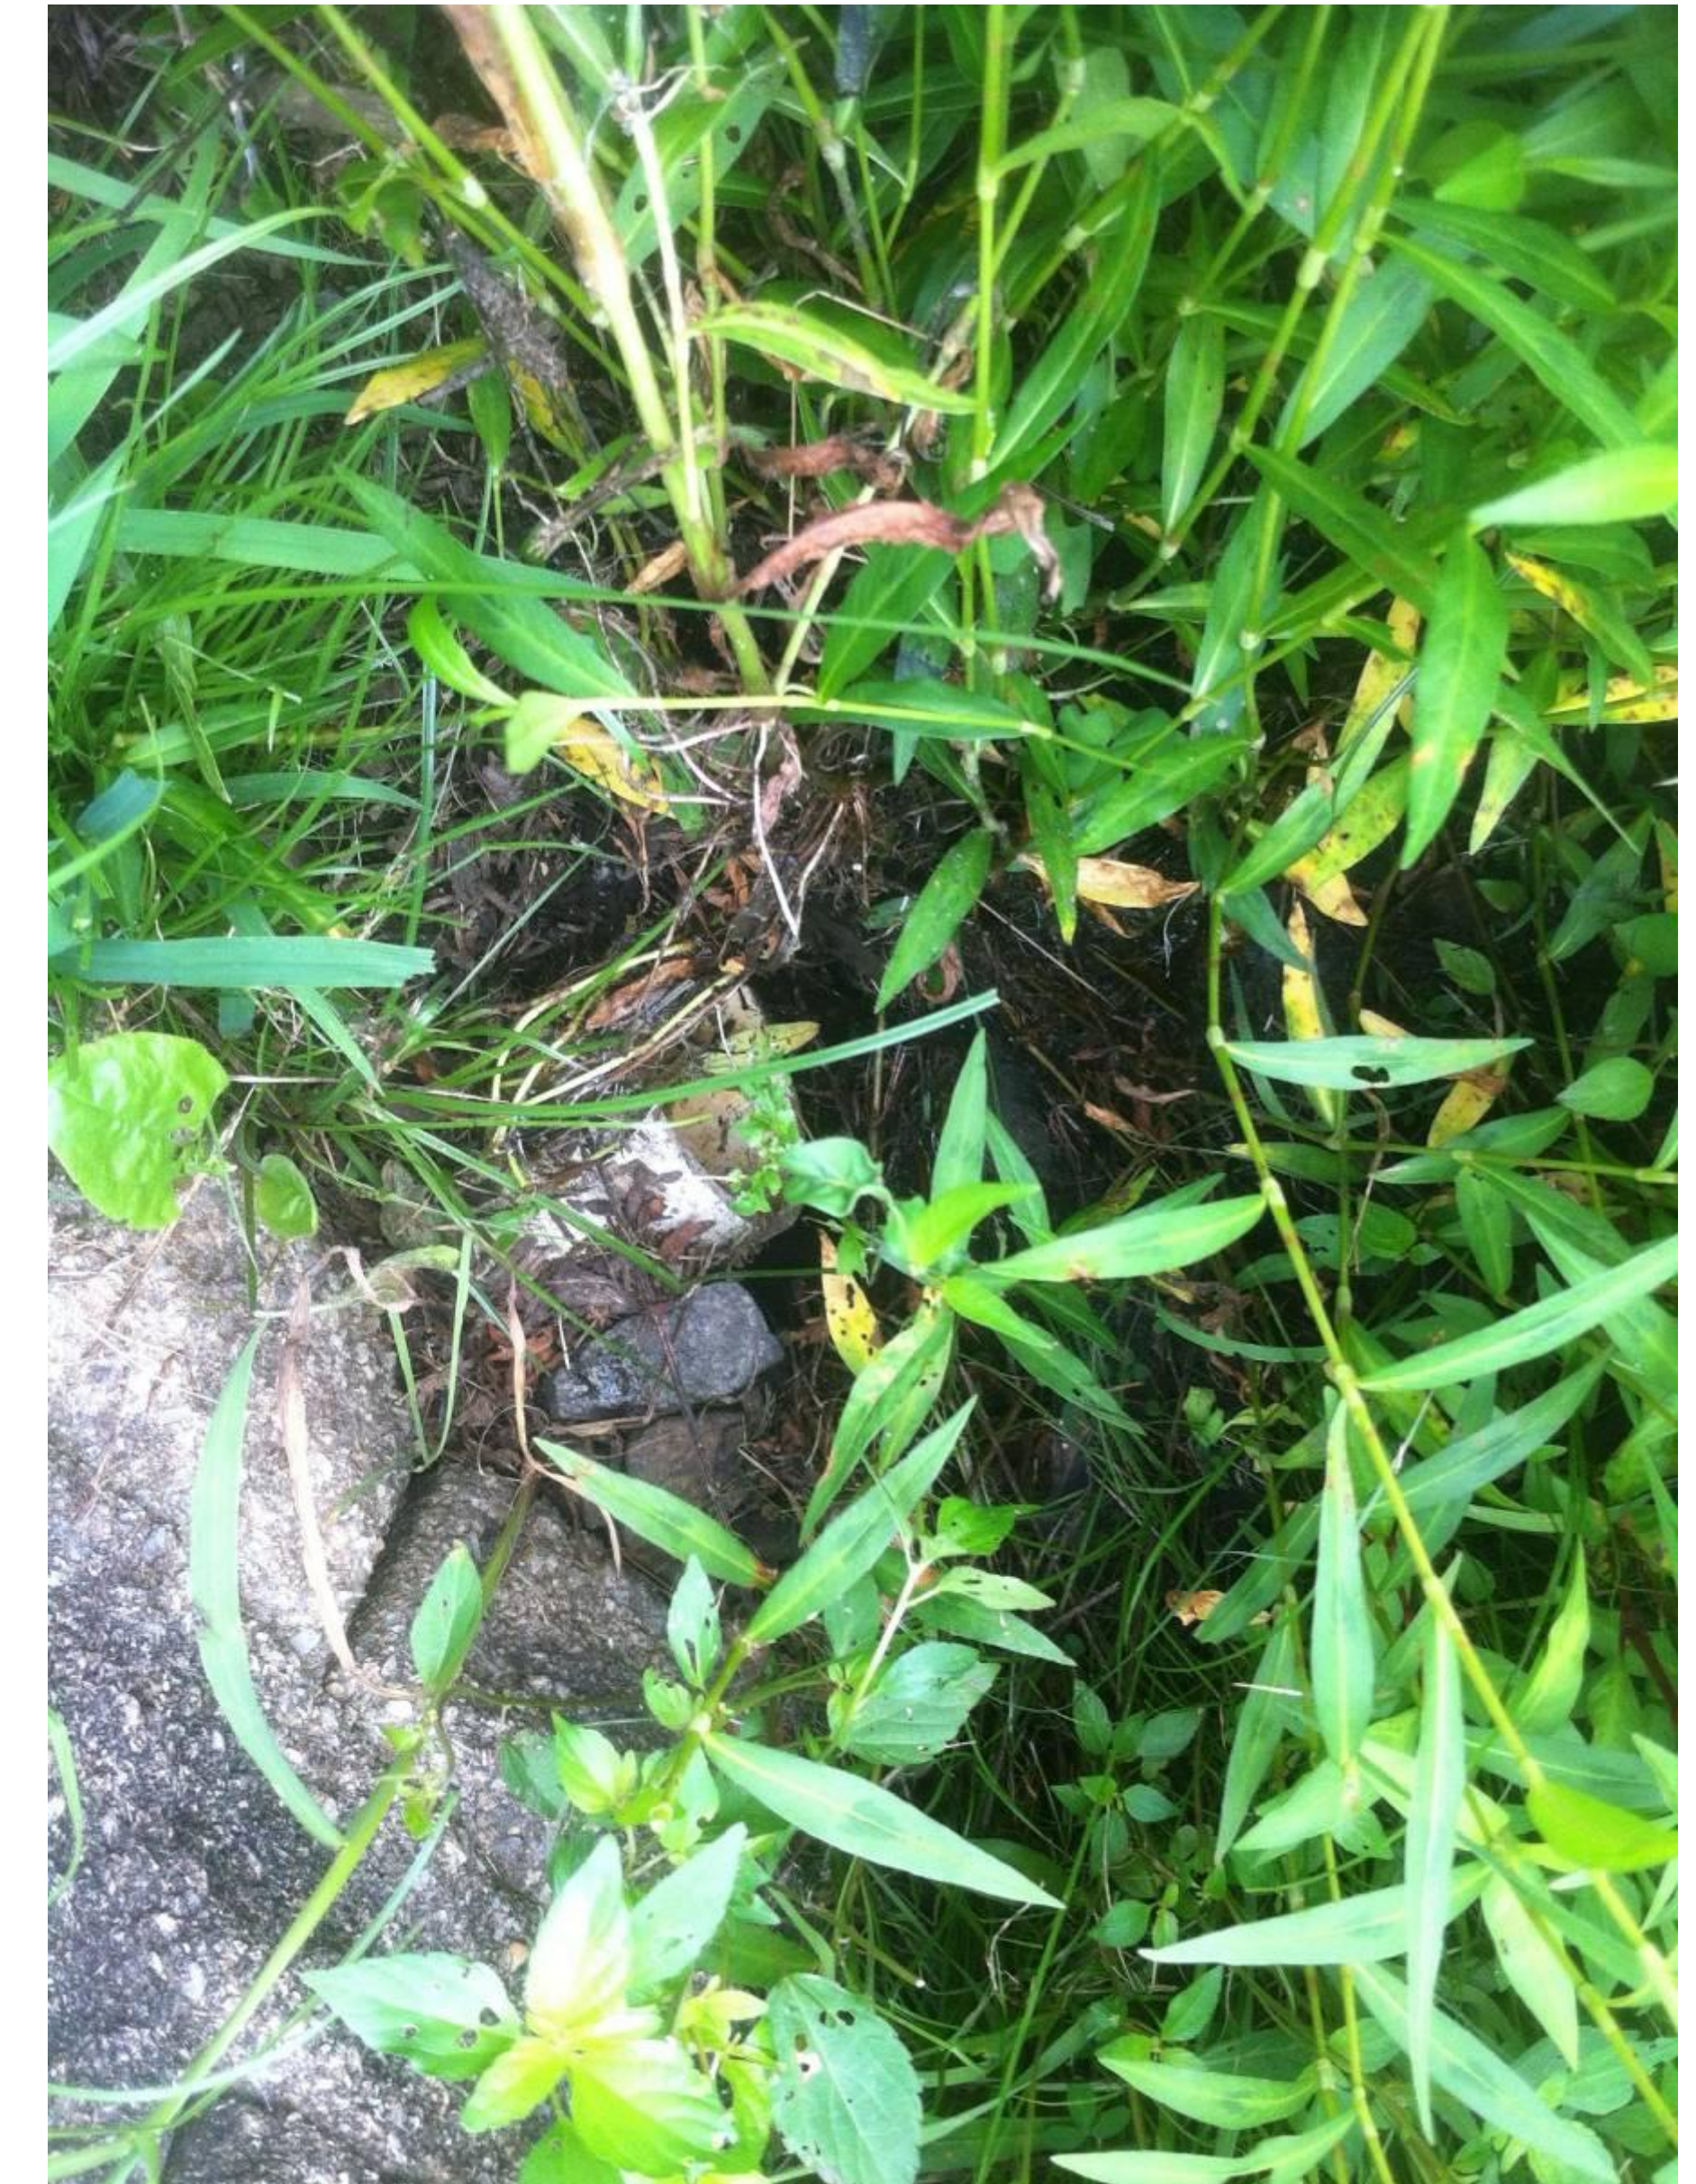
Clogged outlet orifice
