Hamilton Township (Mercer County) Stormwater Basin Assessment Summary (Year 1)

Developed by the Rutgers Cooperative Extension Water Resources Program
Funded by Hamilton Township, Mercer County, New Jersey

December 6, 2012

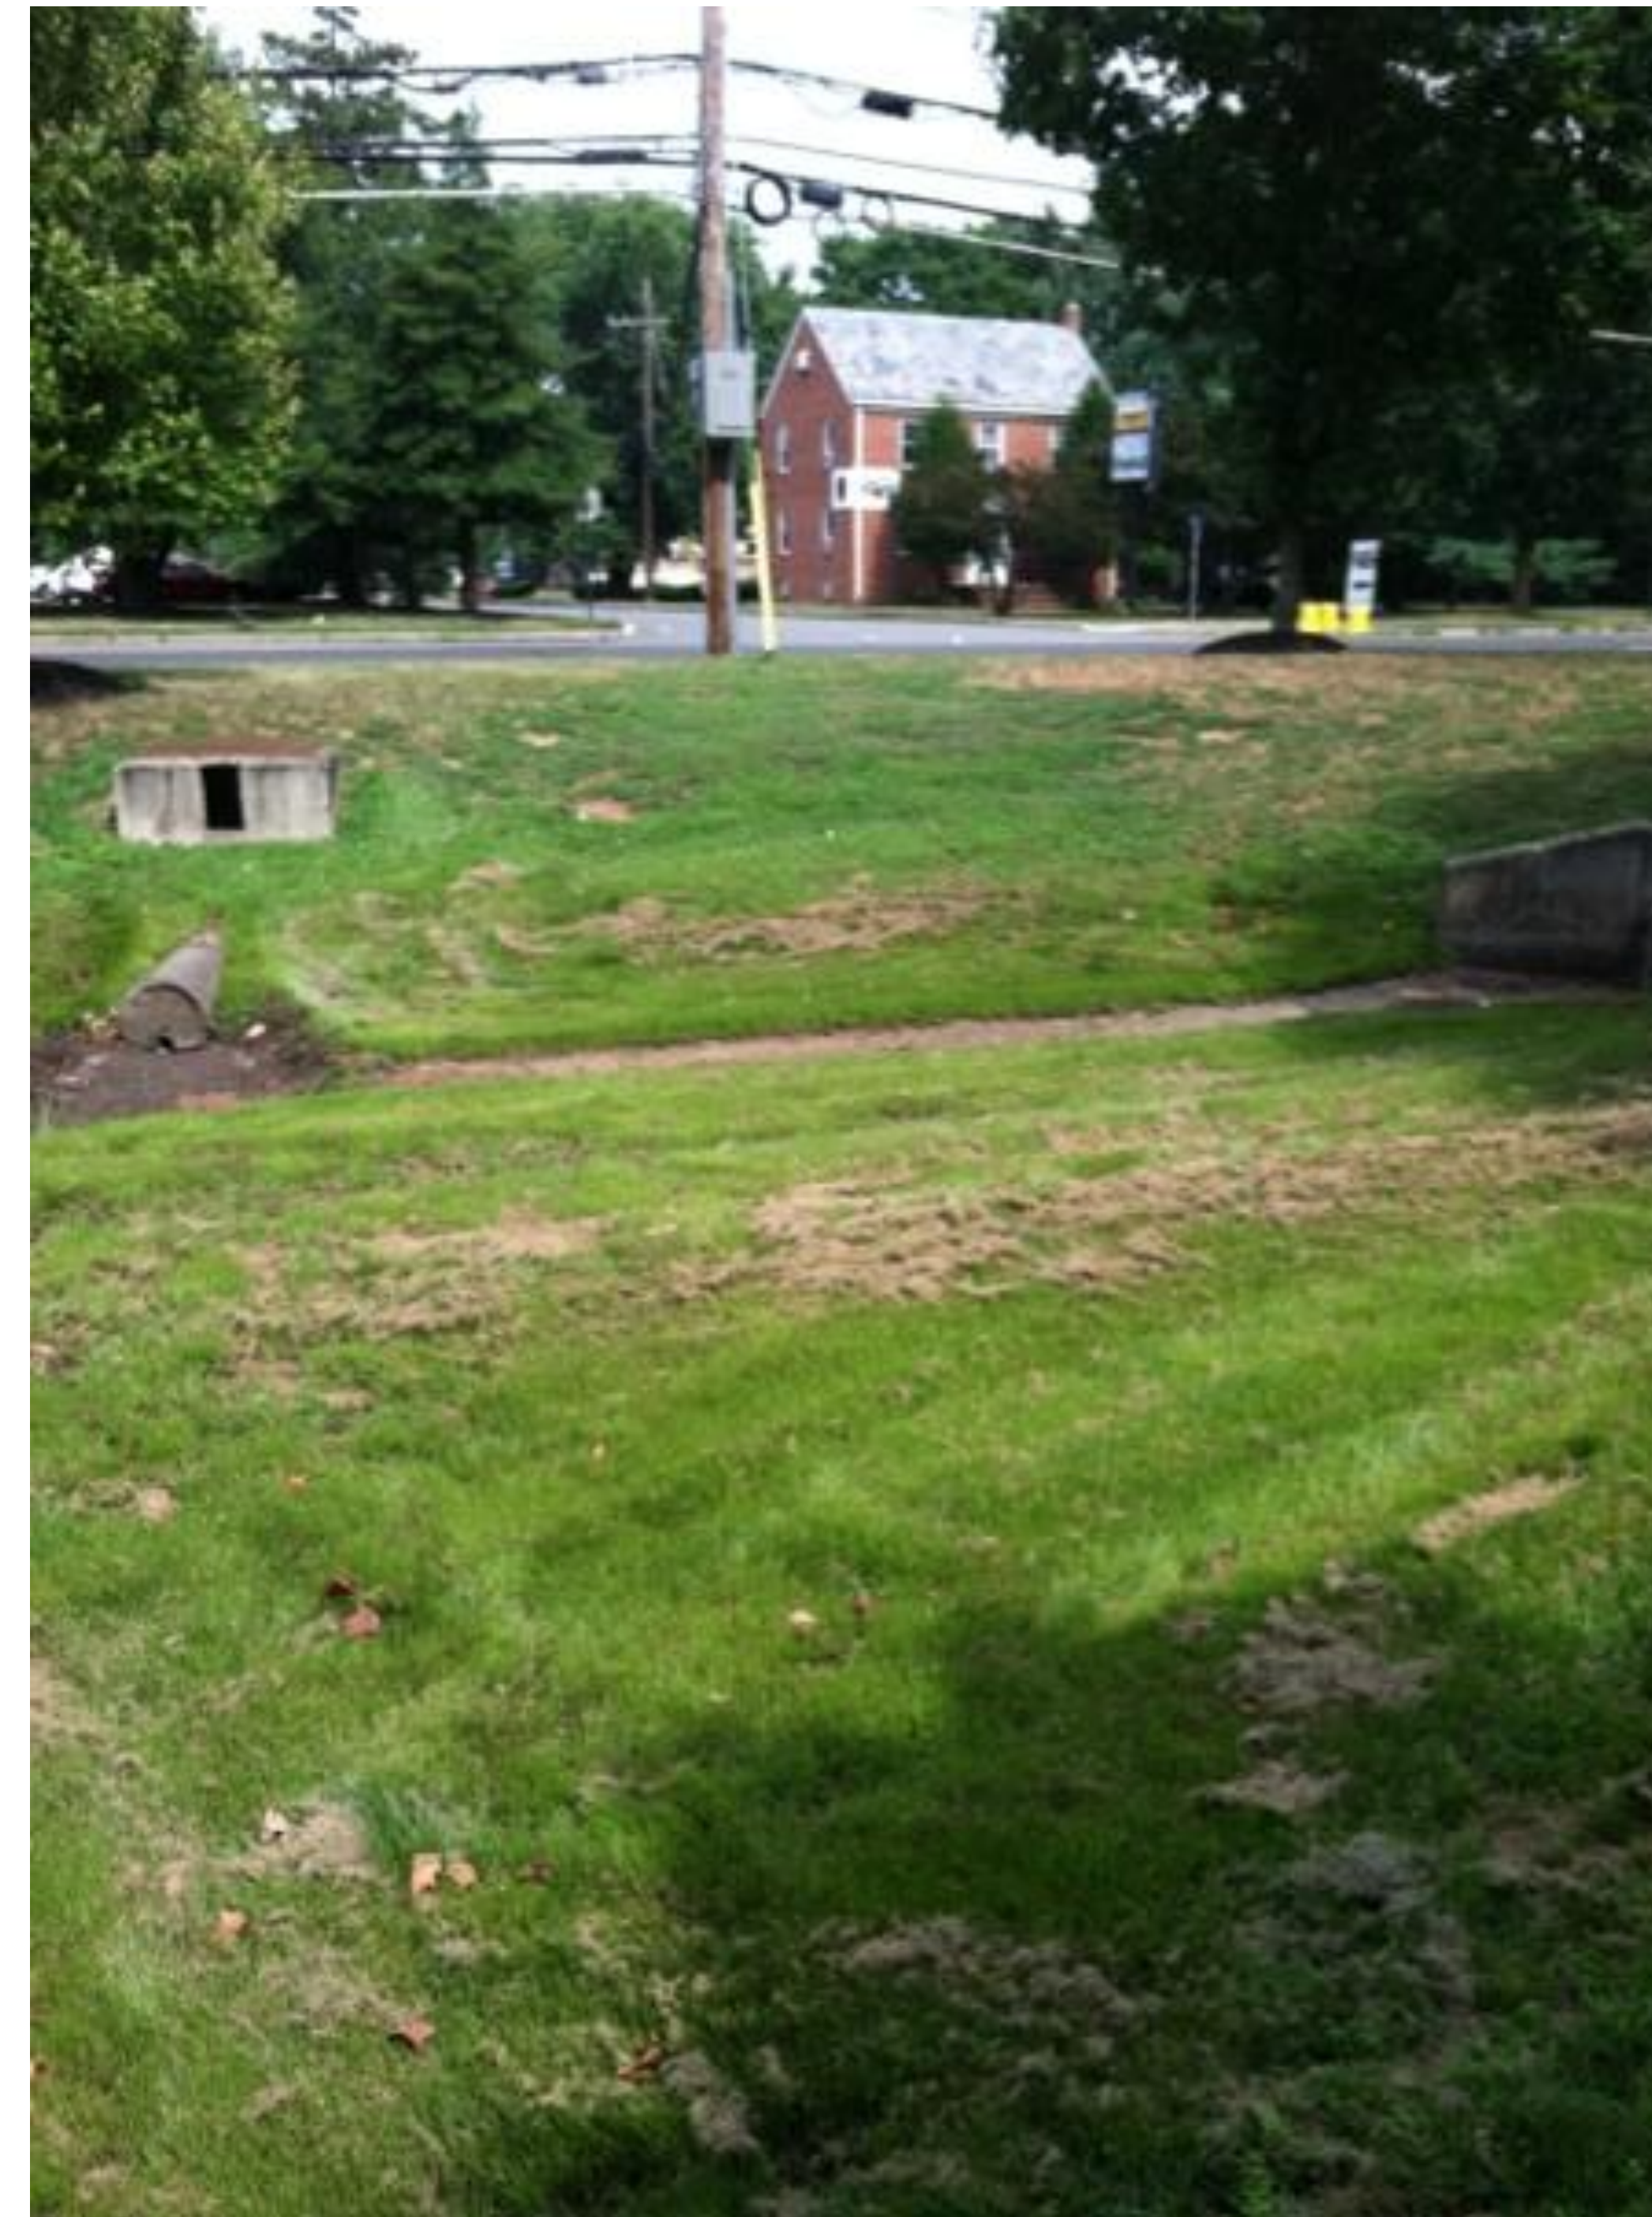
Basin bottom looking northwest

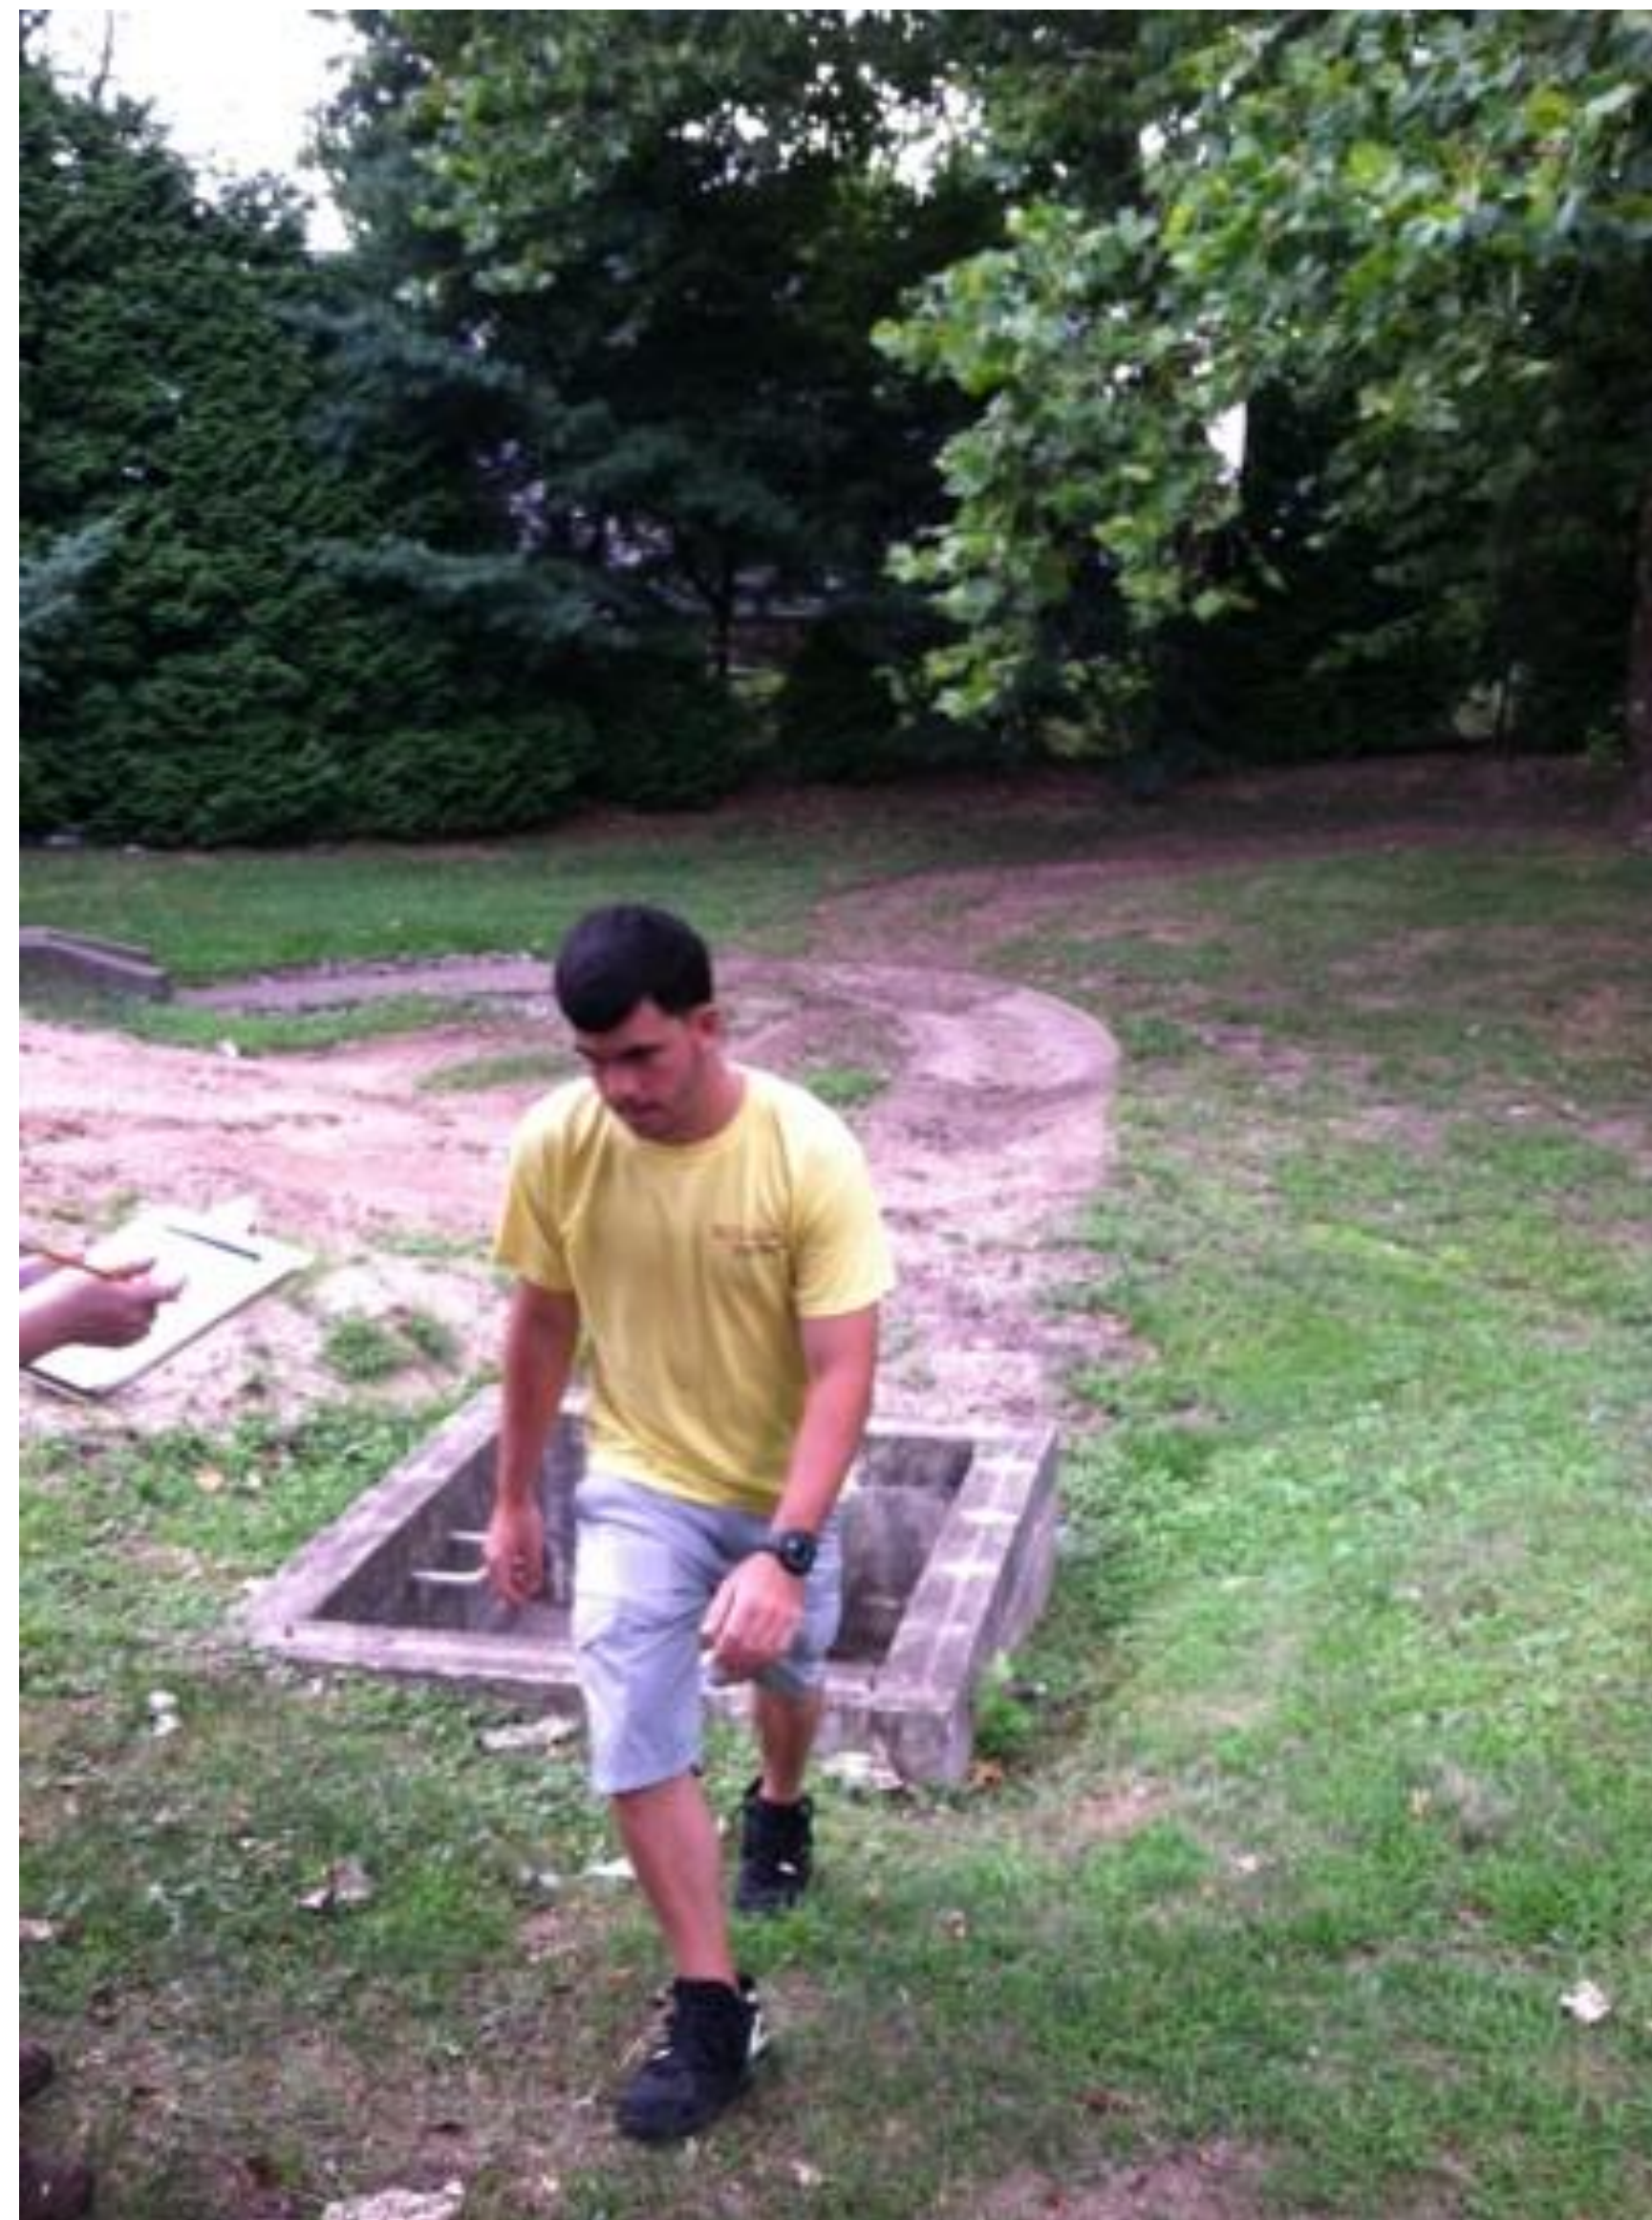
View of basin looking east

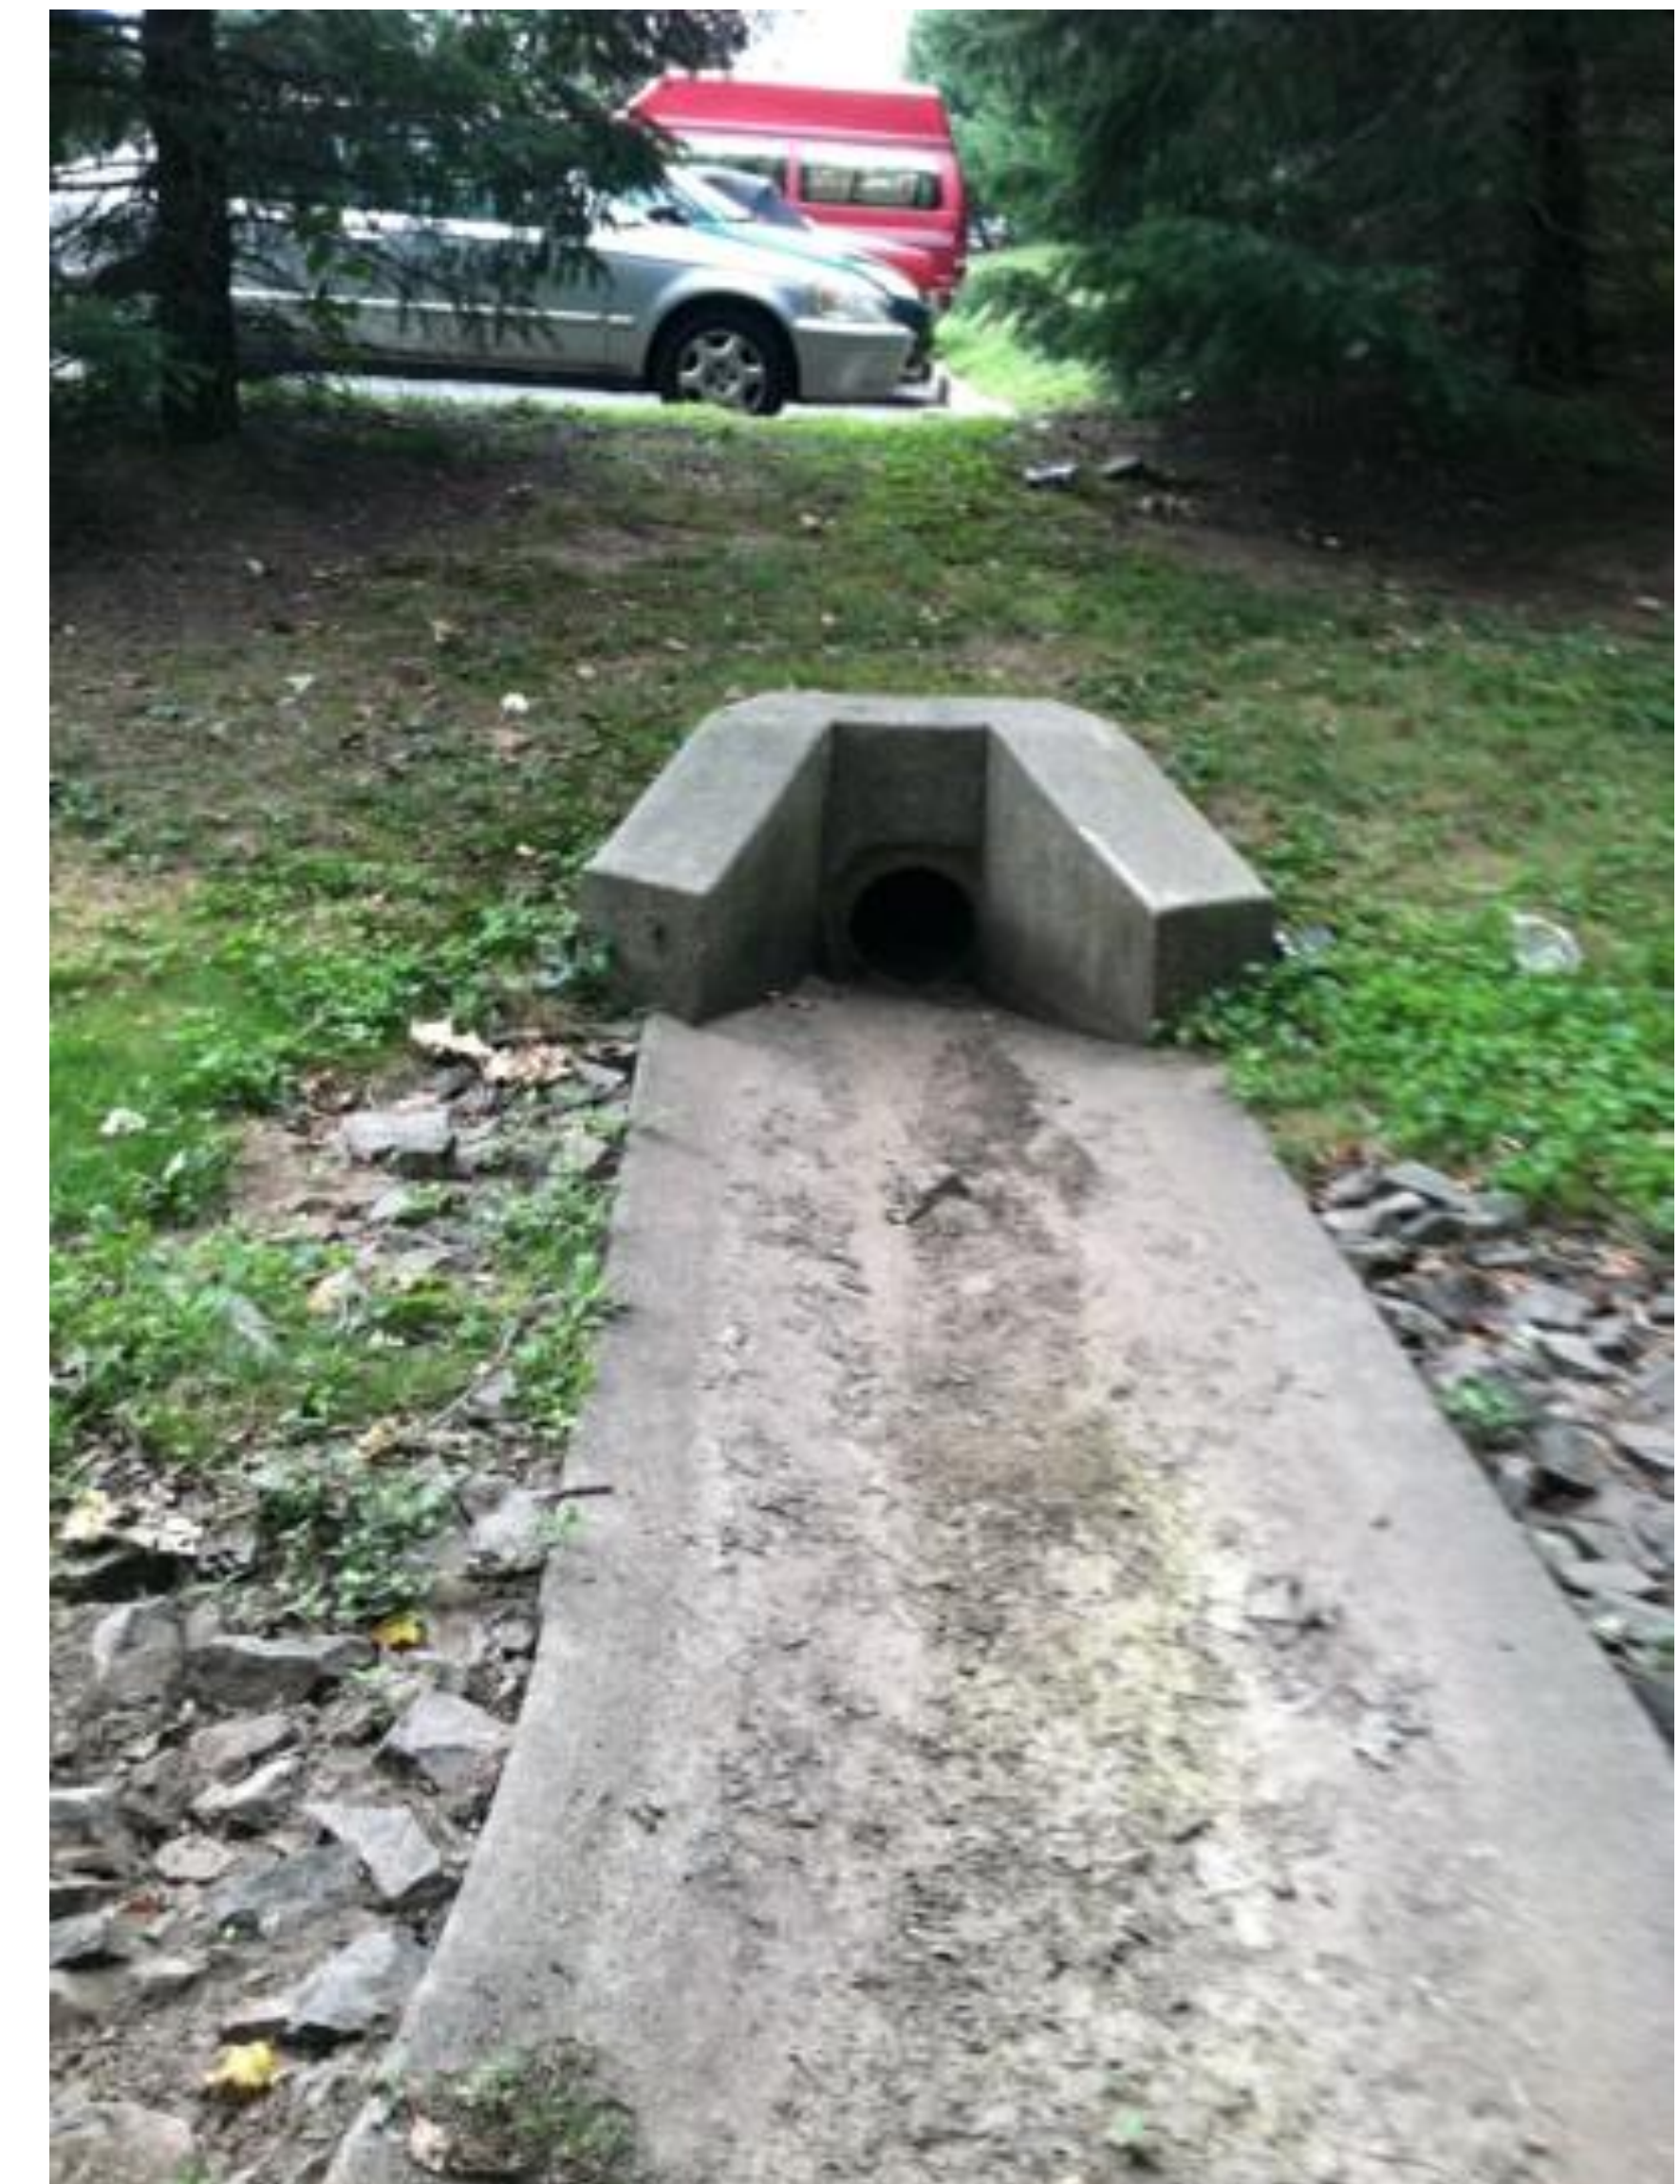
Inlet and low flow channel

- Debris and sediment accumulation in low flow channel and outlet orifice
- Grate covering missing on outlet structure, outlet structure in need of repair
- Erosion and bare soils on west and east embankments

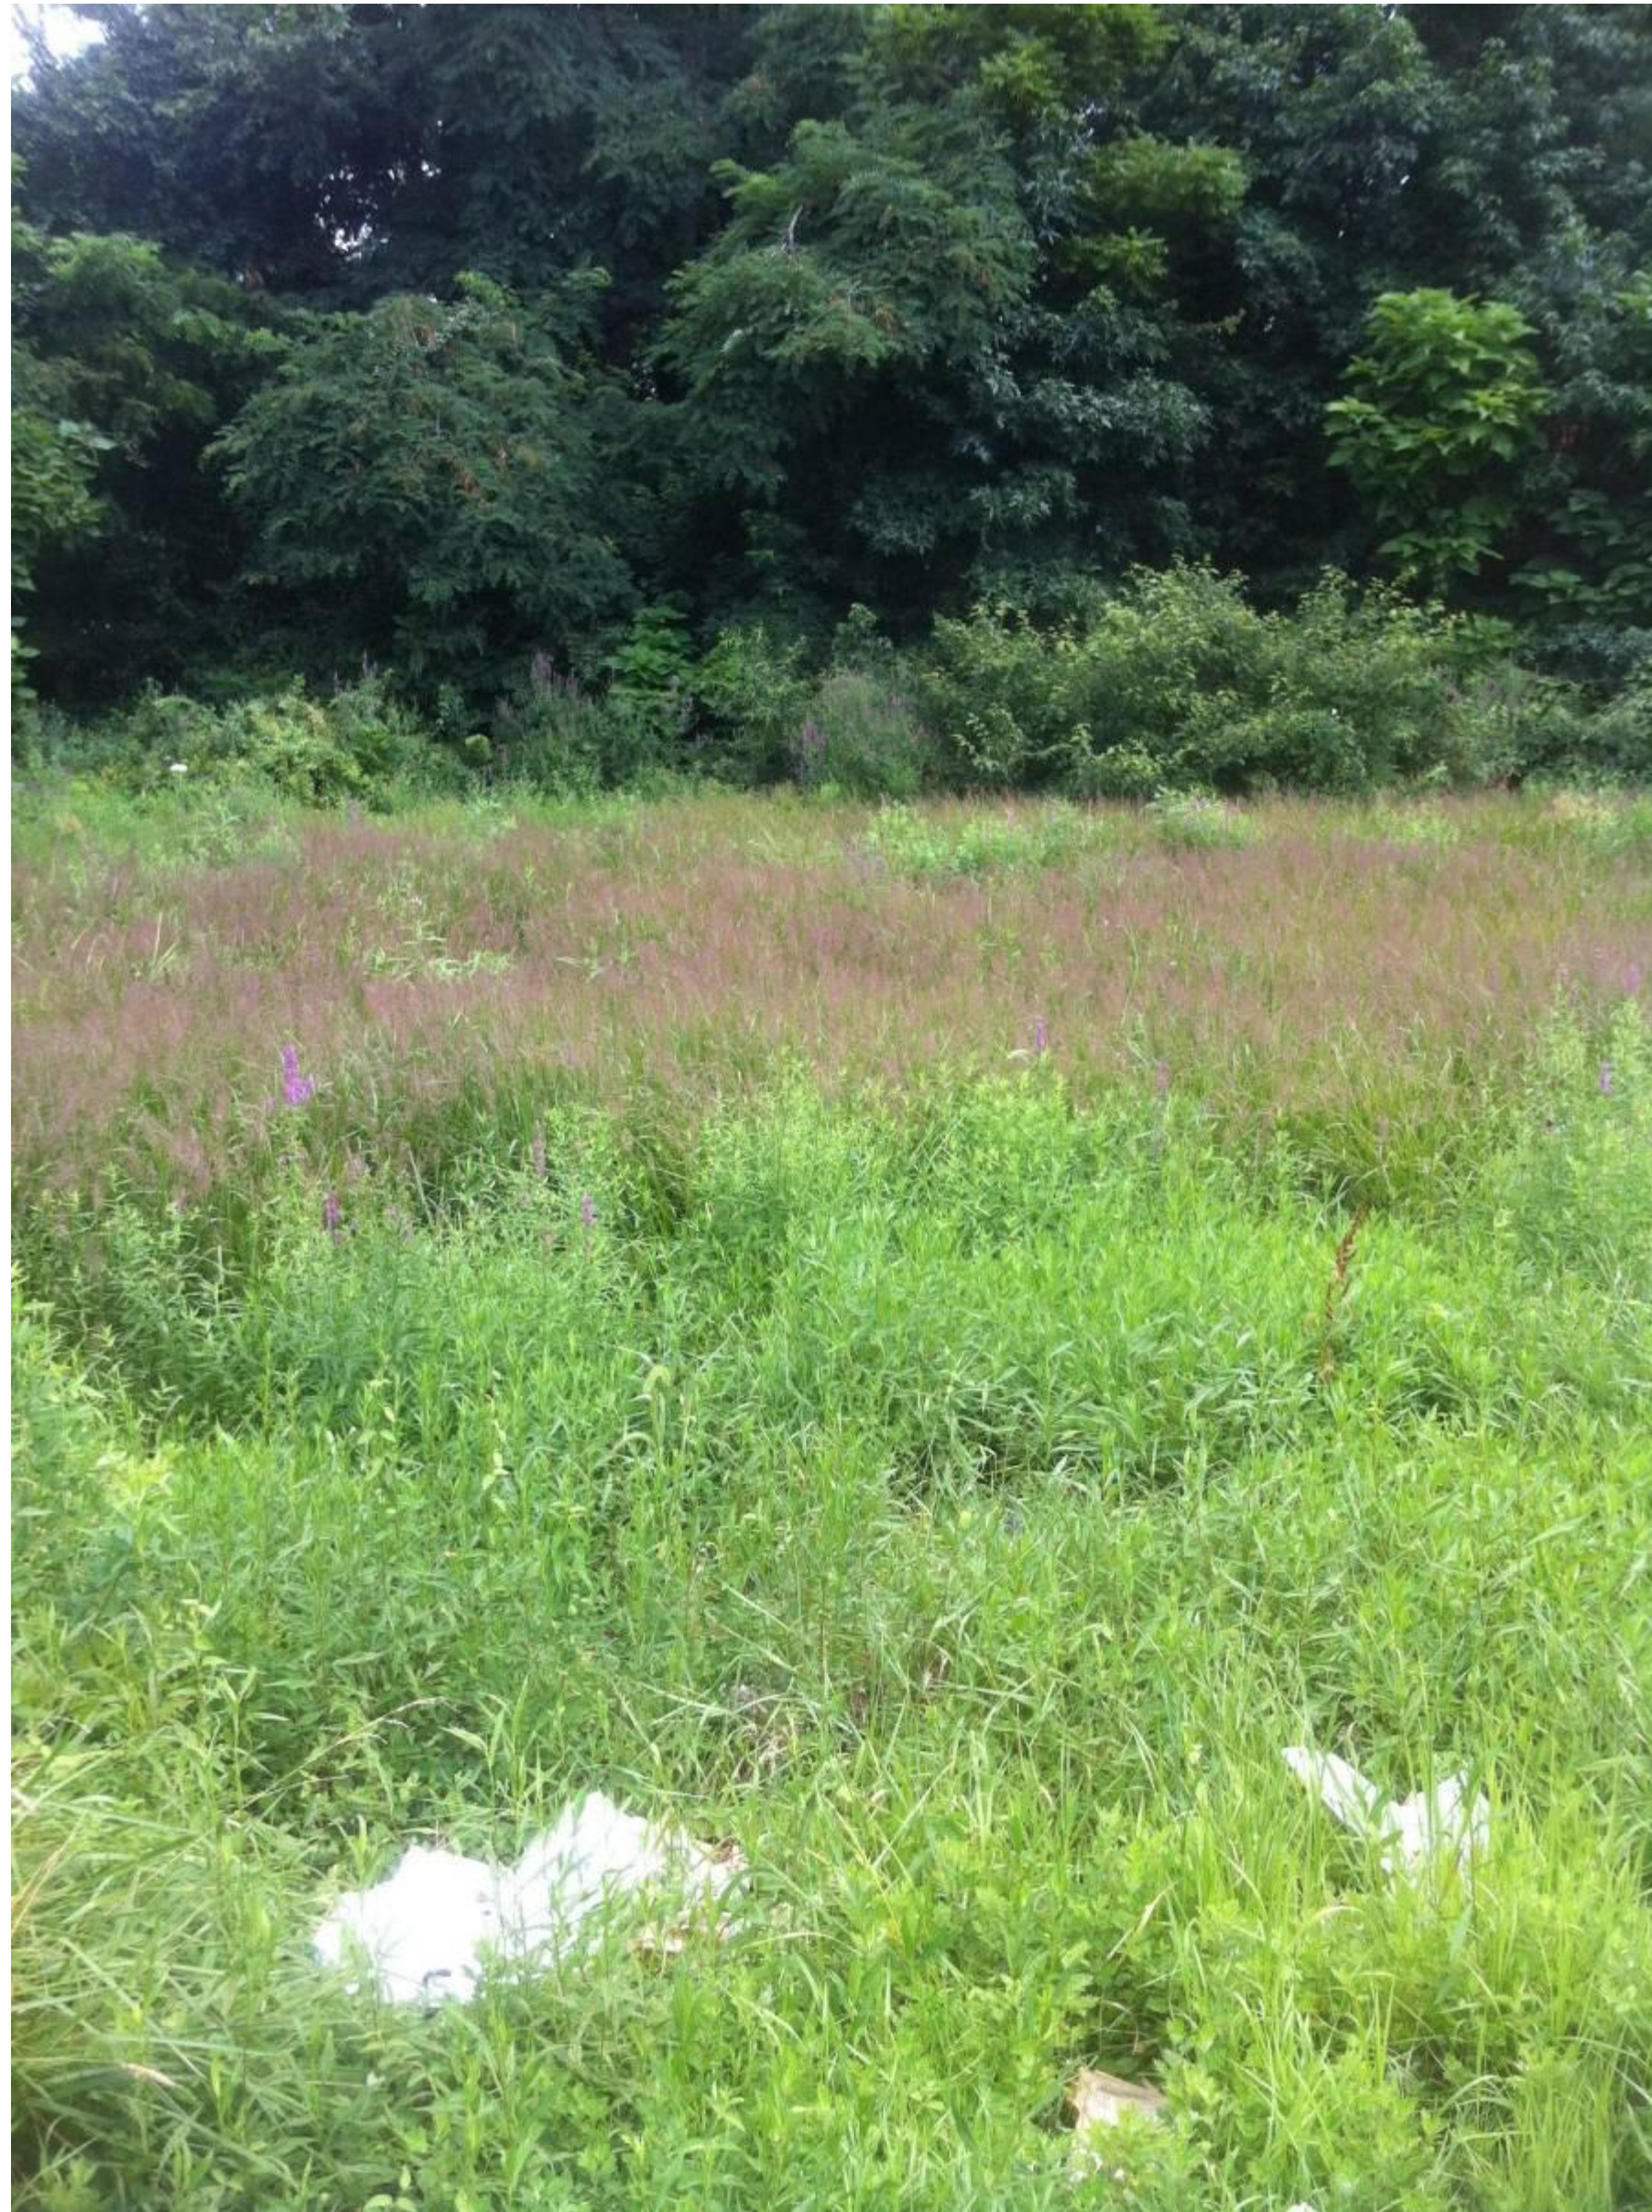
Basin bottom looking north

- Outlet has damage, signs of erosion, and woody vegetation growth
- Sediment and debris accumulation around inlet and outlet
- Invasive Purple Loosestrife colonizing basin

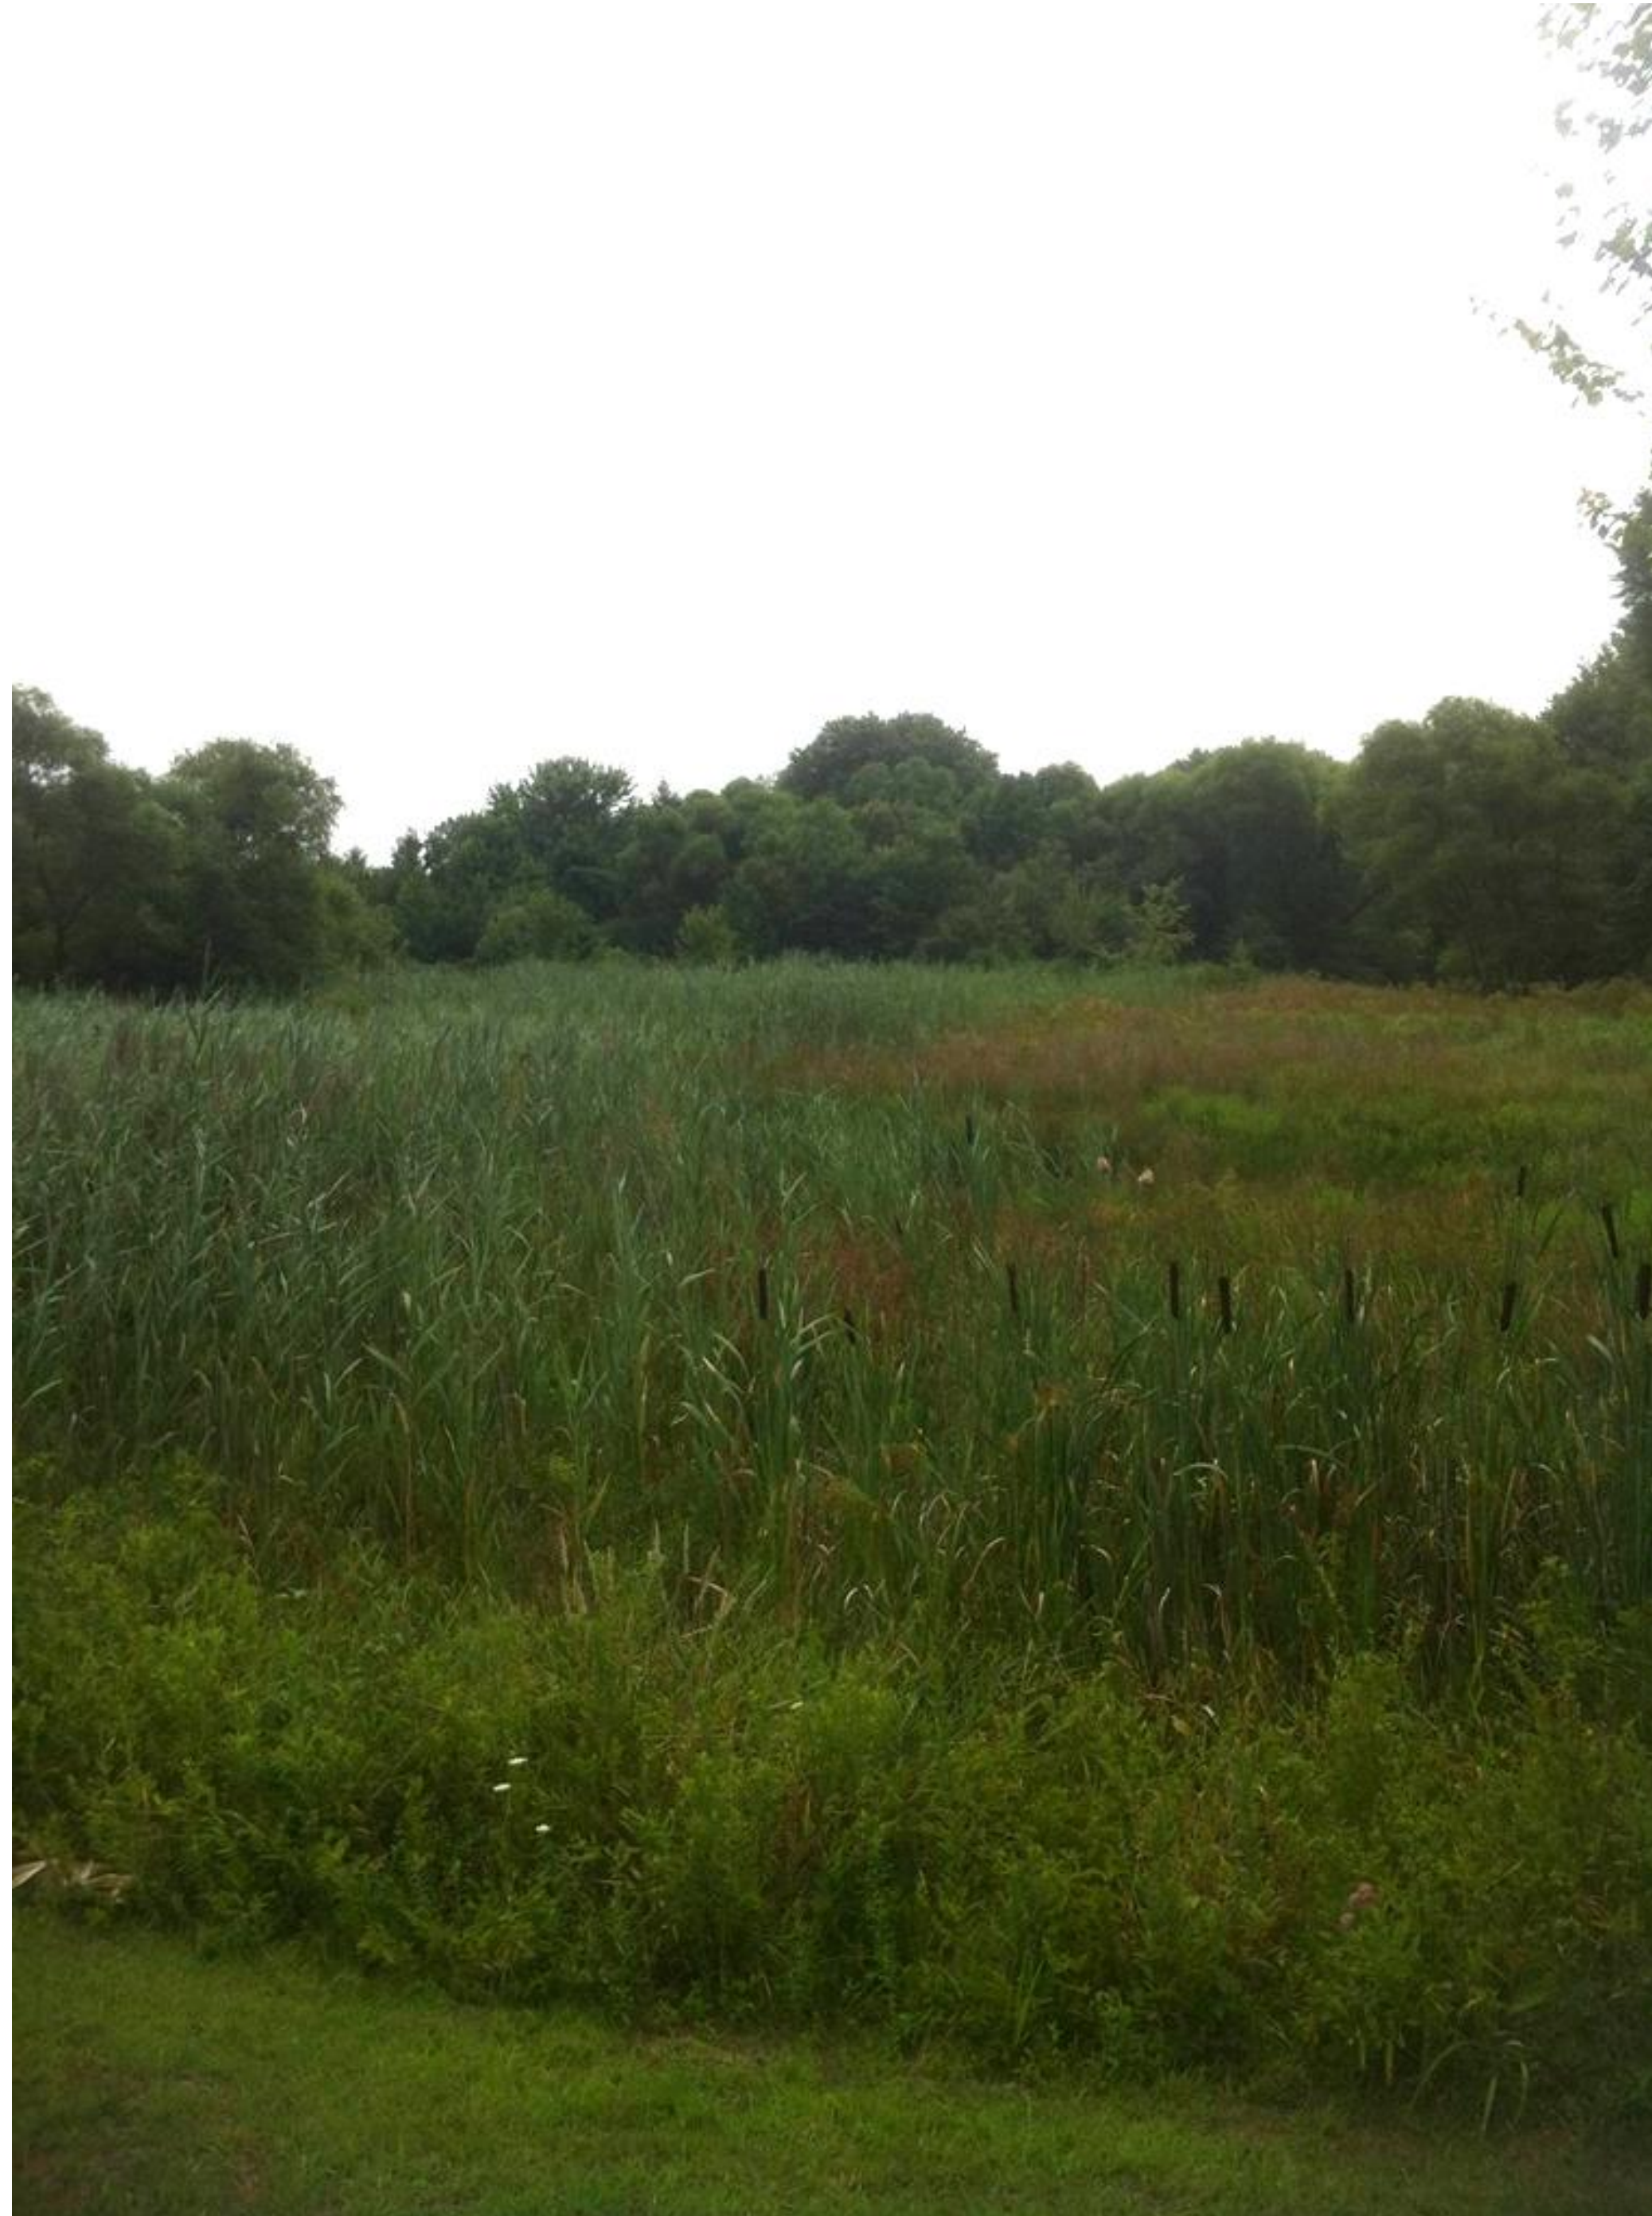
View of basin looking east

- Basin is naturalized with dense vegetation
- Inlets and outlets are inaccessible due to vegetation growth in warm months
- Invasive plant species present including Phragmites and Purple Loosestrife
- Erosion present

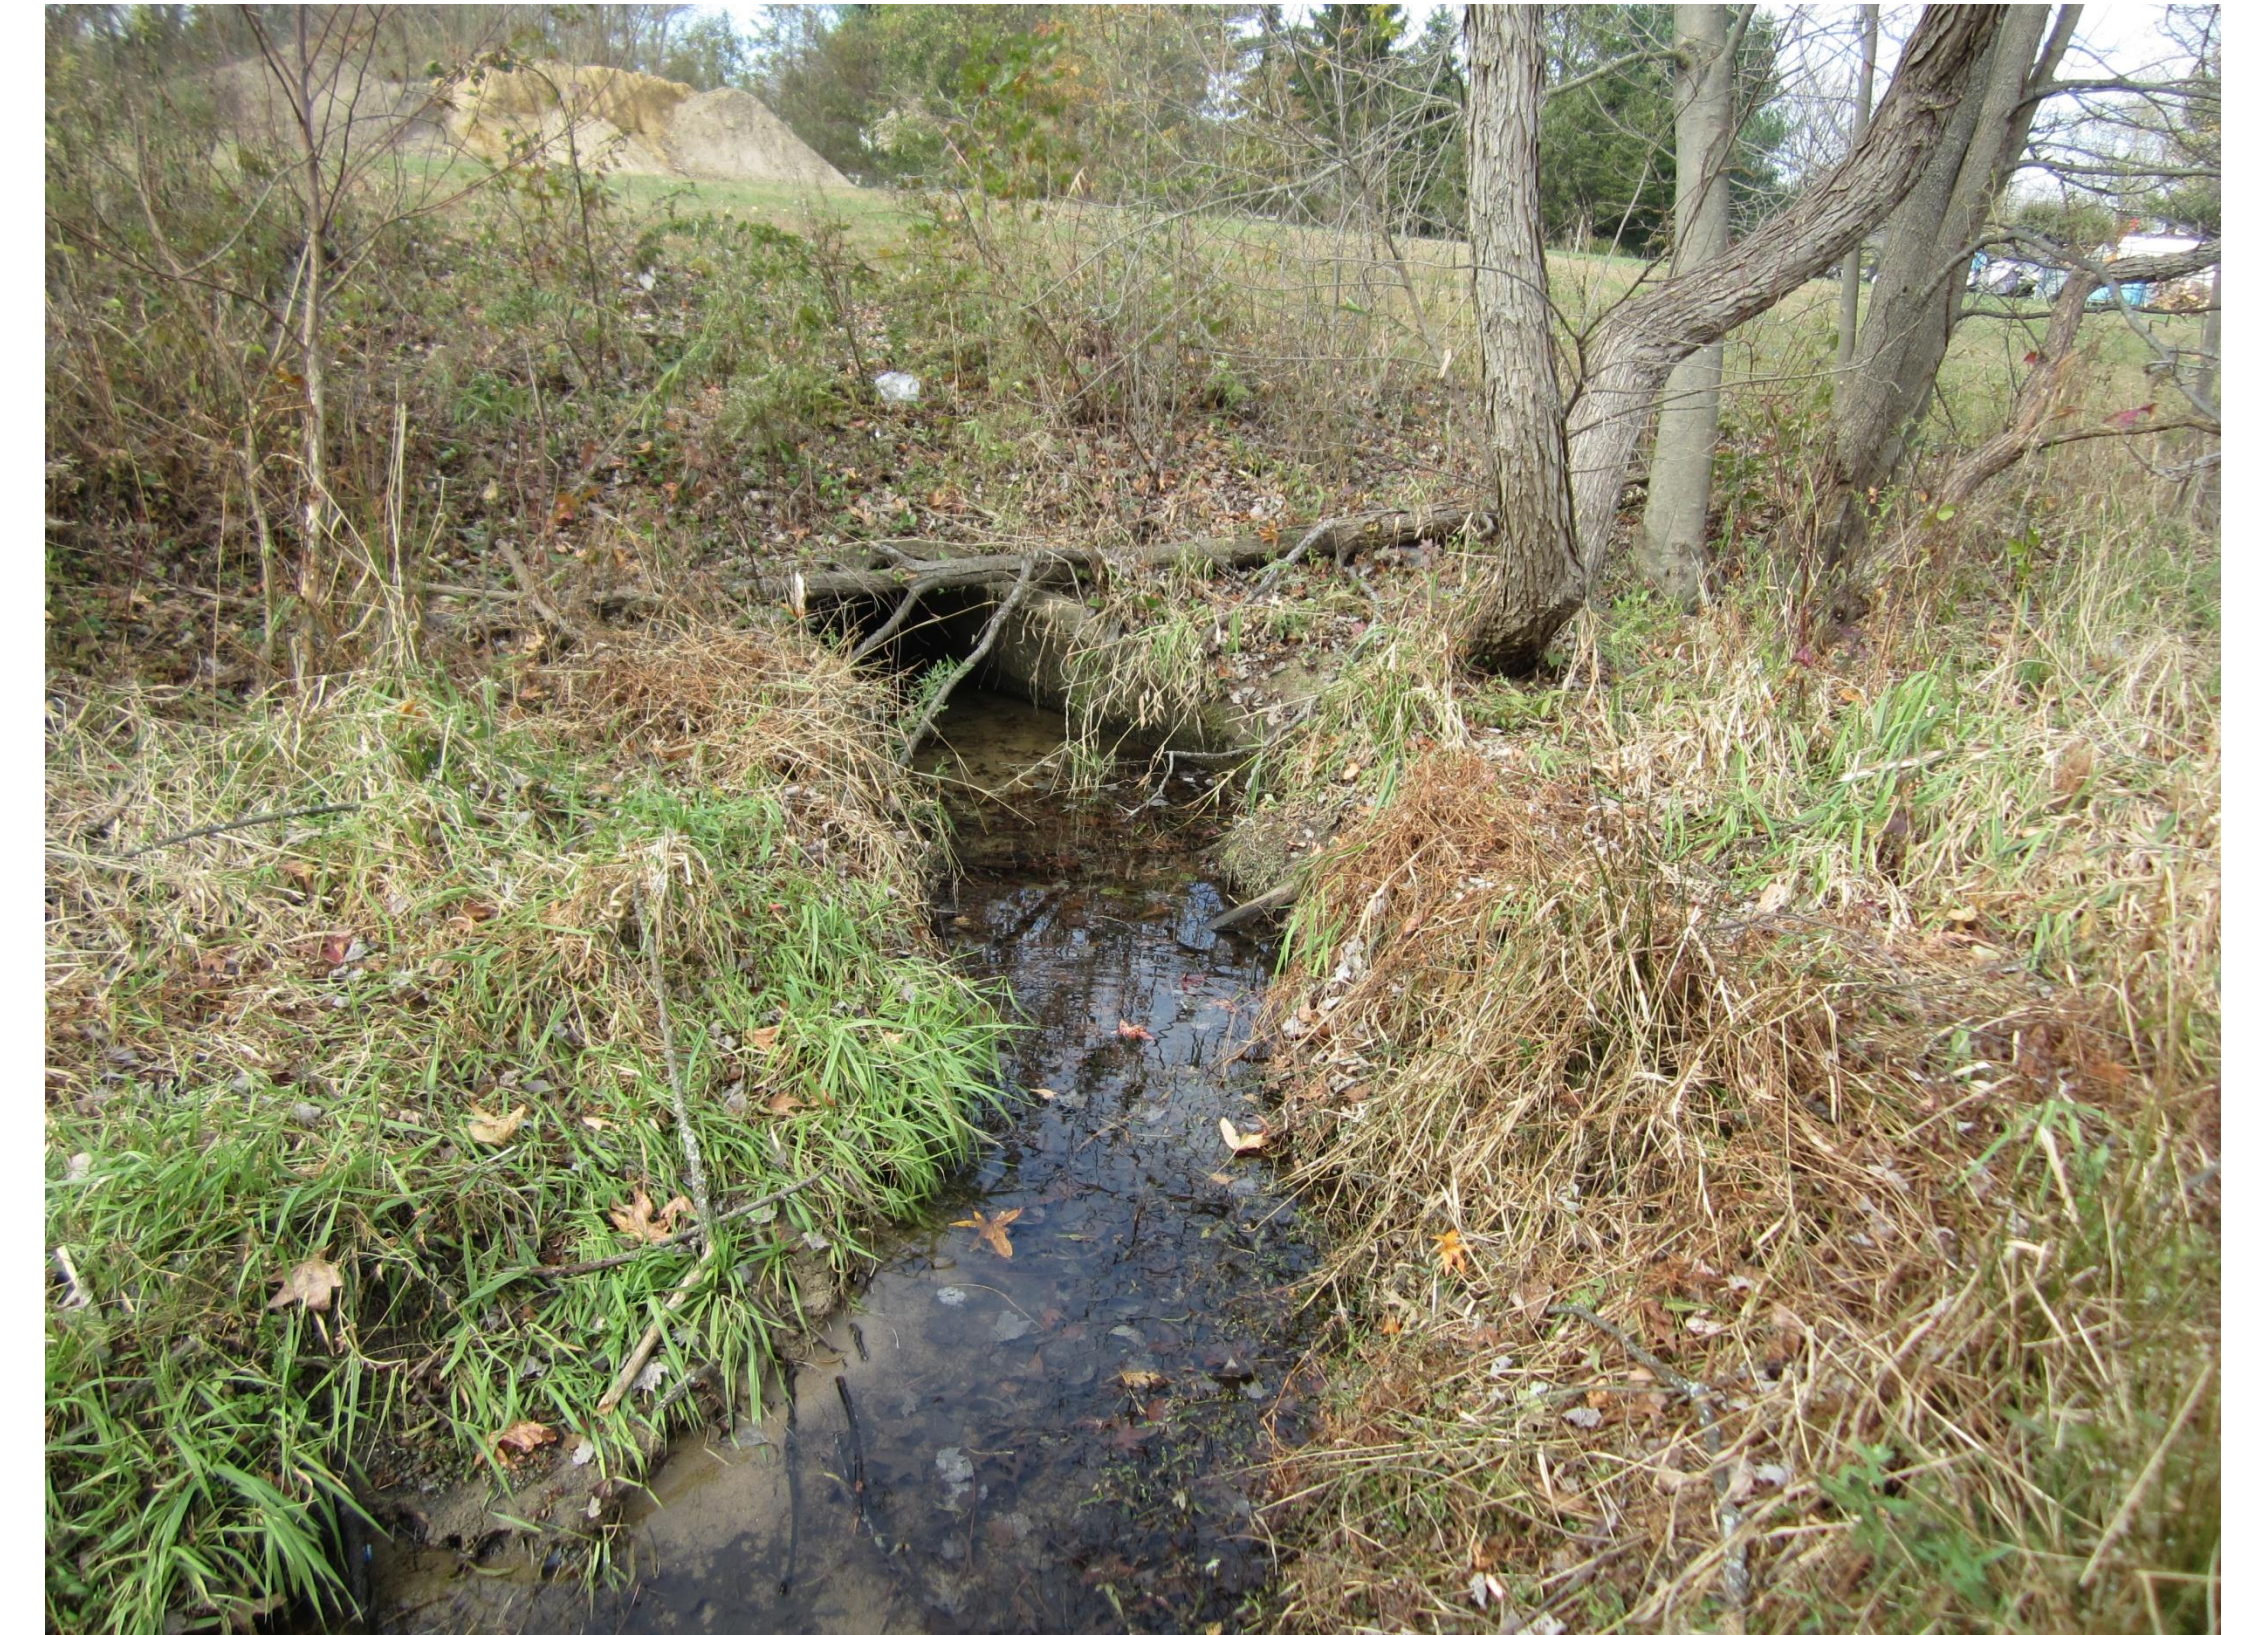
Inlet and erosion
