Hamilton Township (Mercer County) Stormwater Basin Assessment Summary (Year 1)

Developed by the Rutgers Cooperative Extension Water Resources Program
Funded by Hamilton Township, Mercer County, New Jersey

December 6, 2012

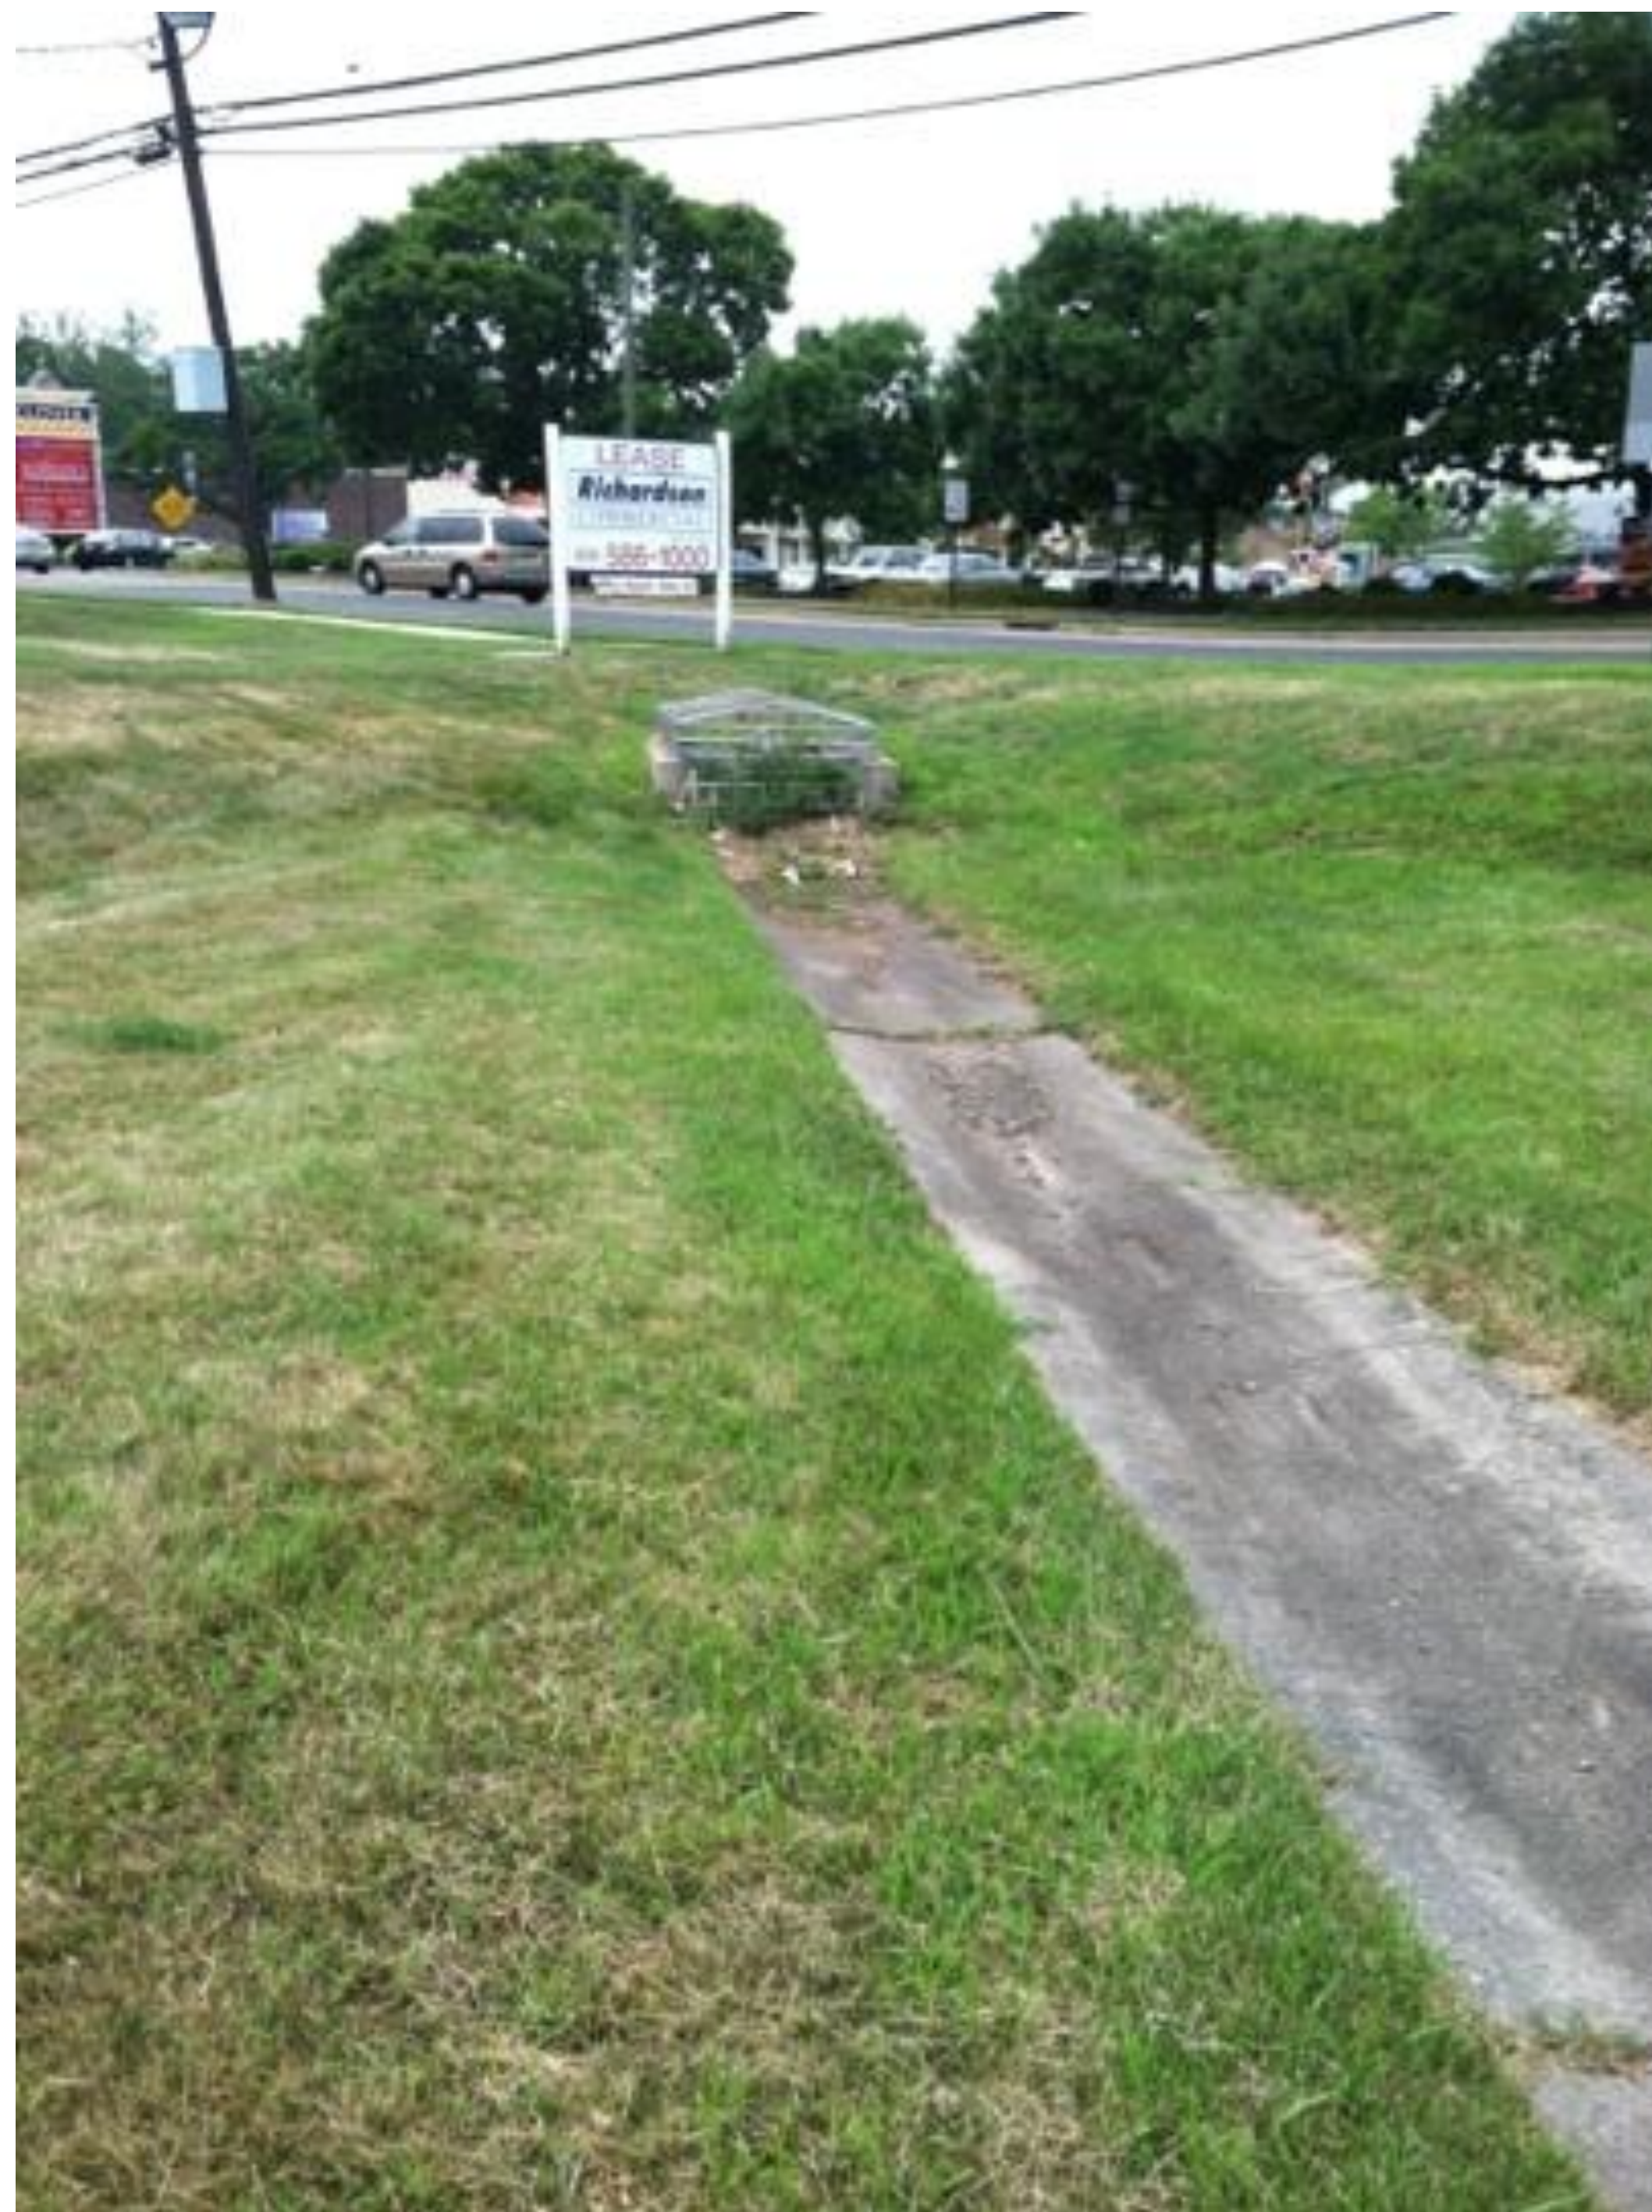
Low flow channel and clogged outlet

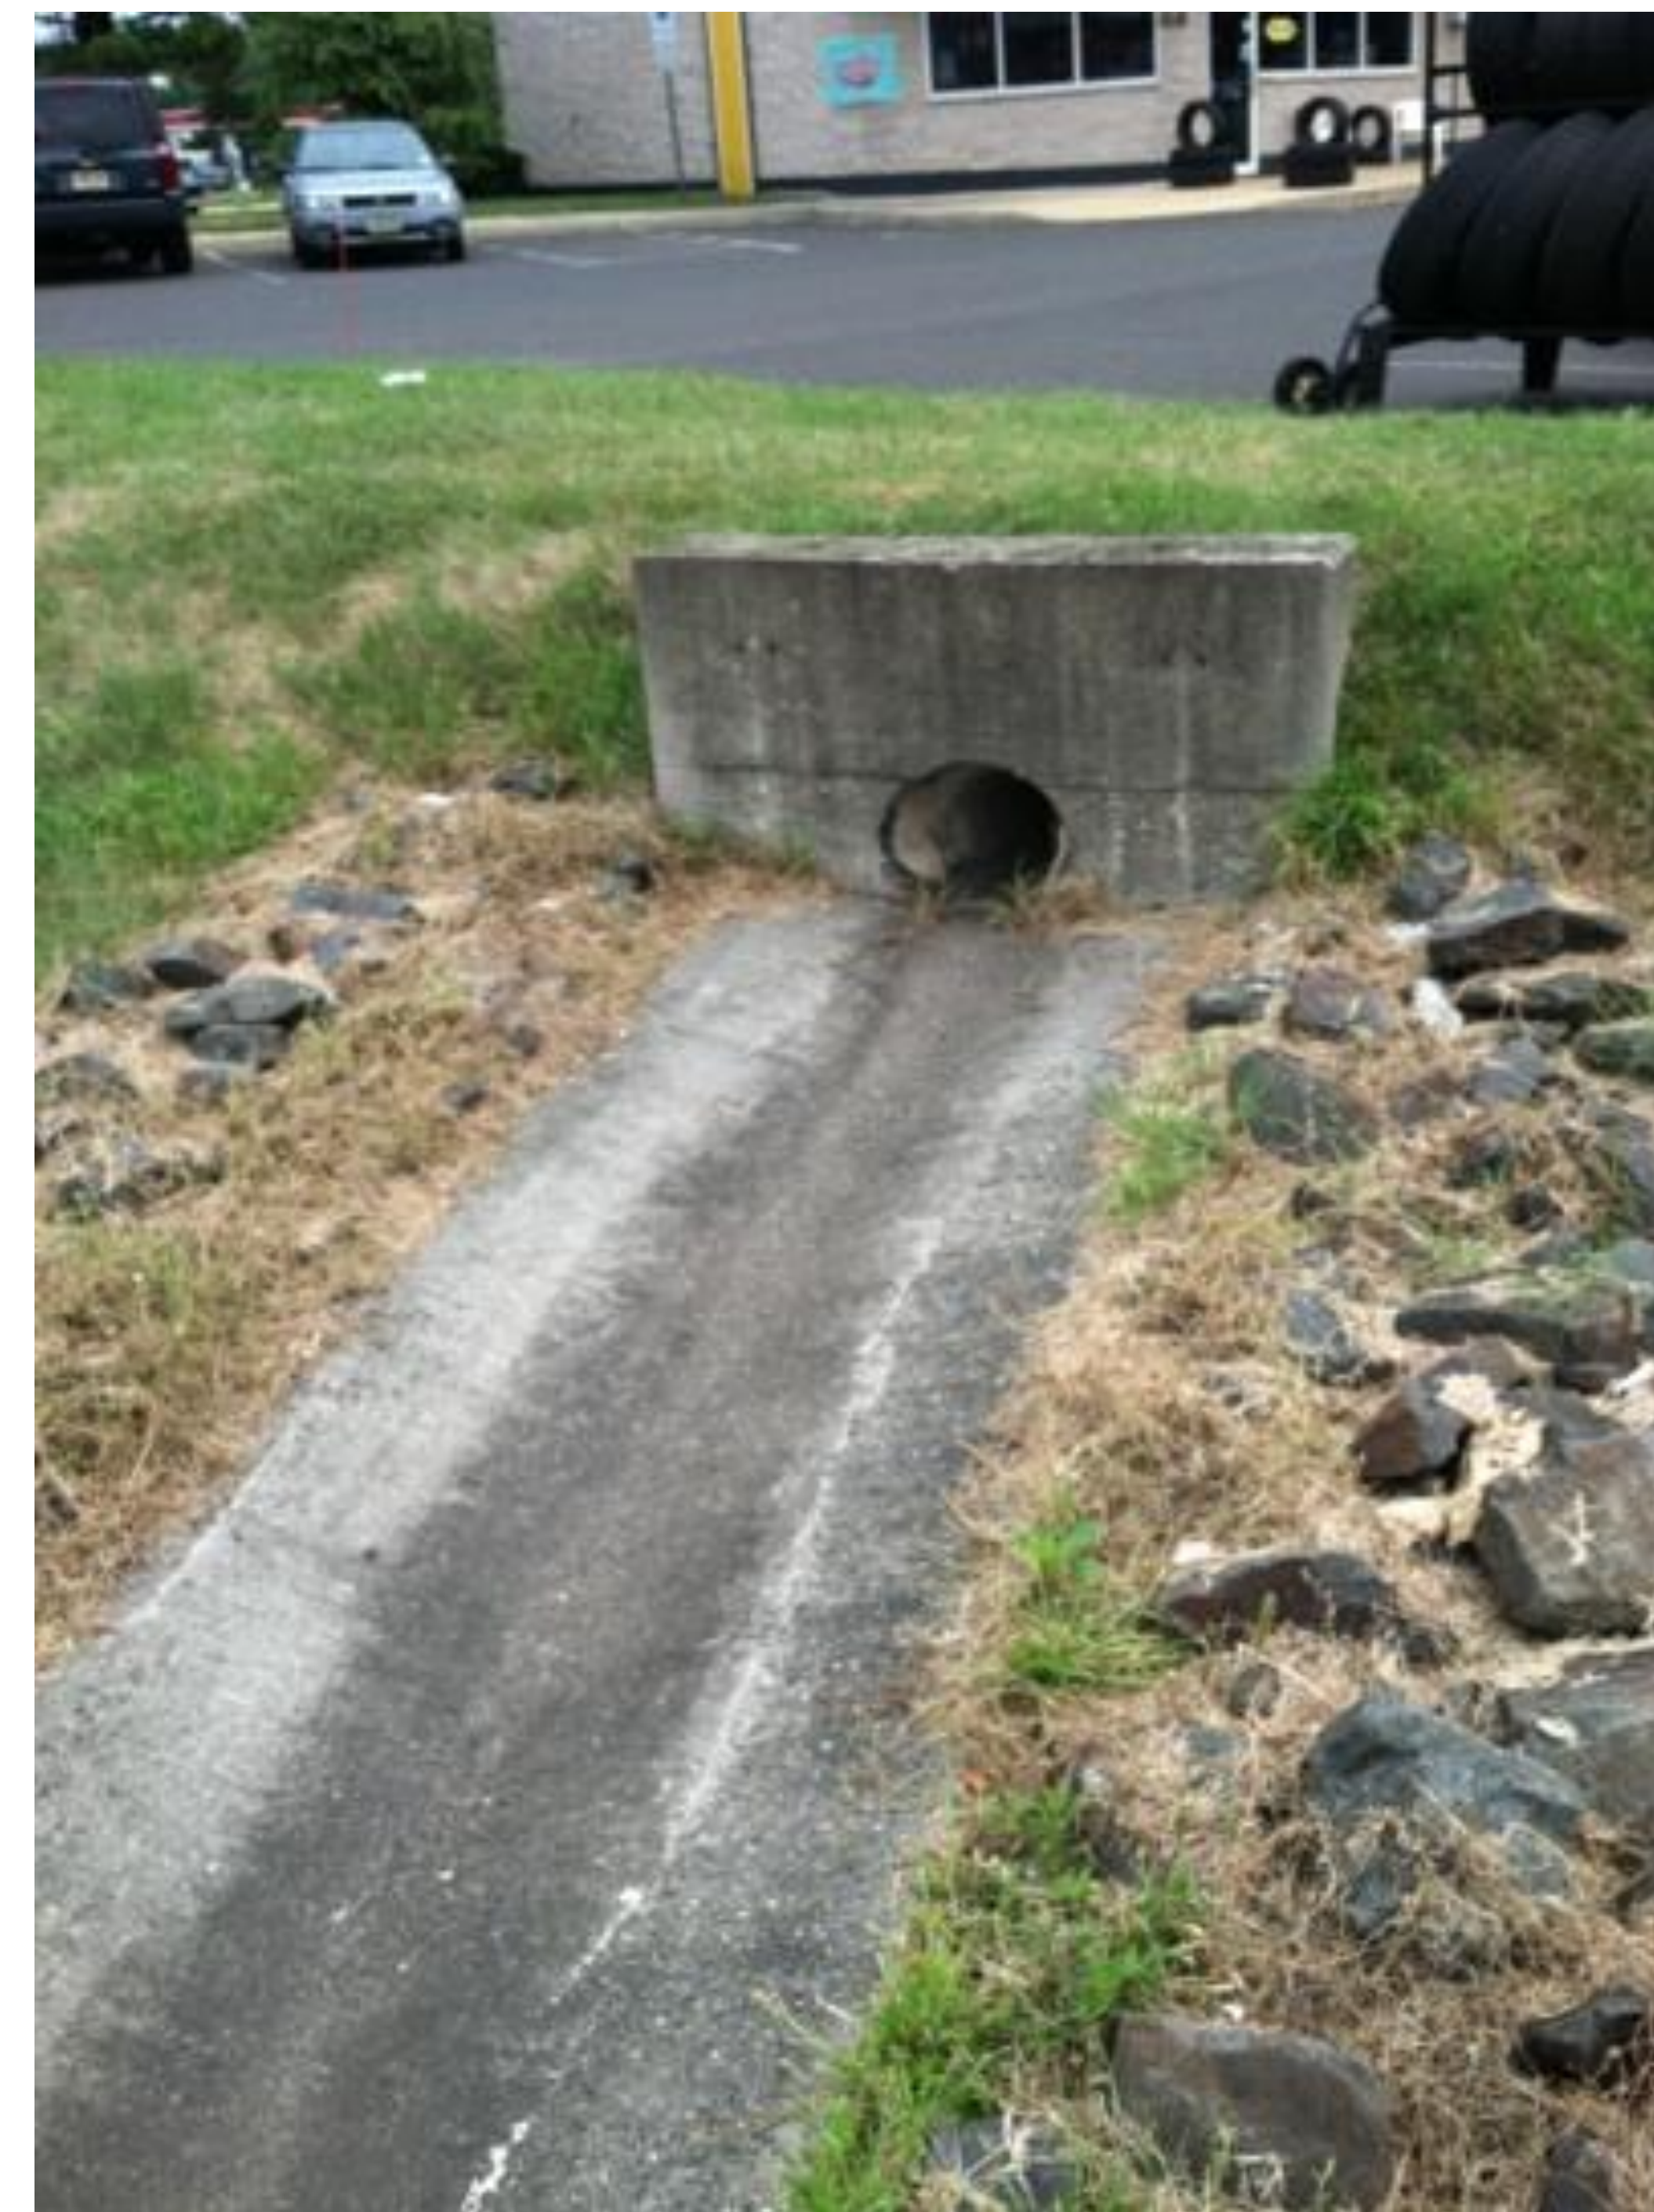
Inlet and rip rap protection

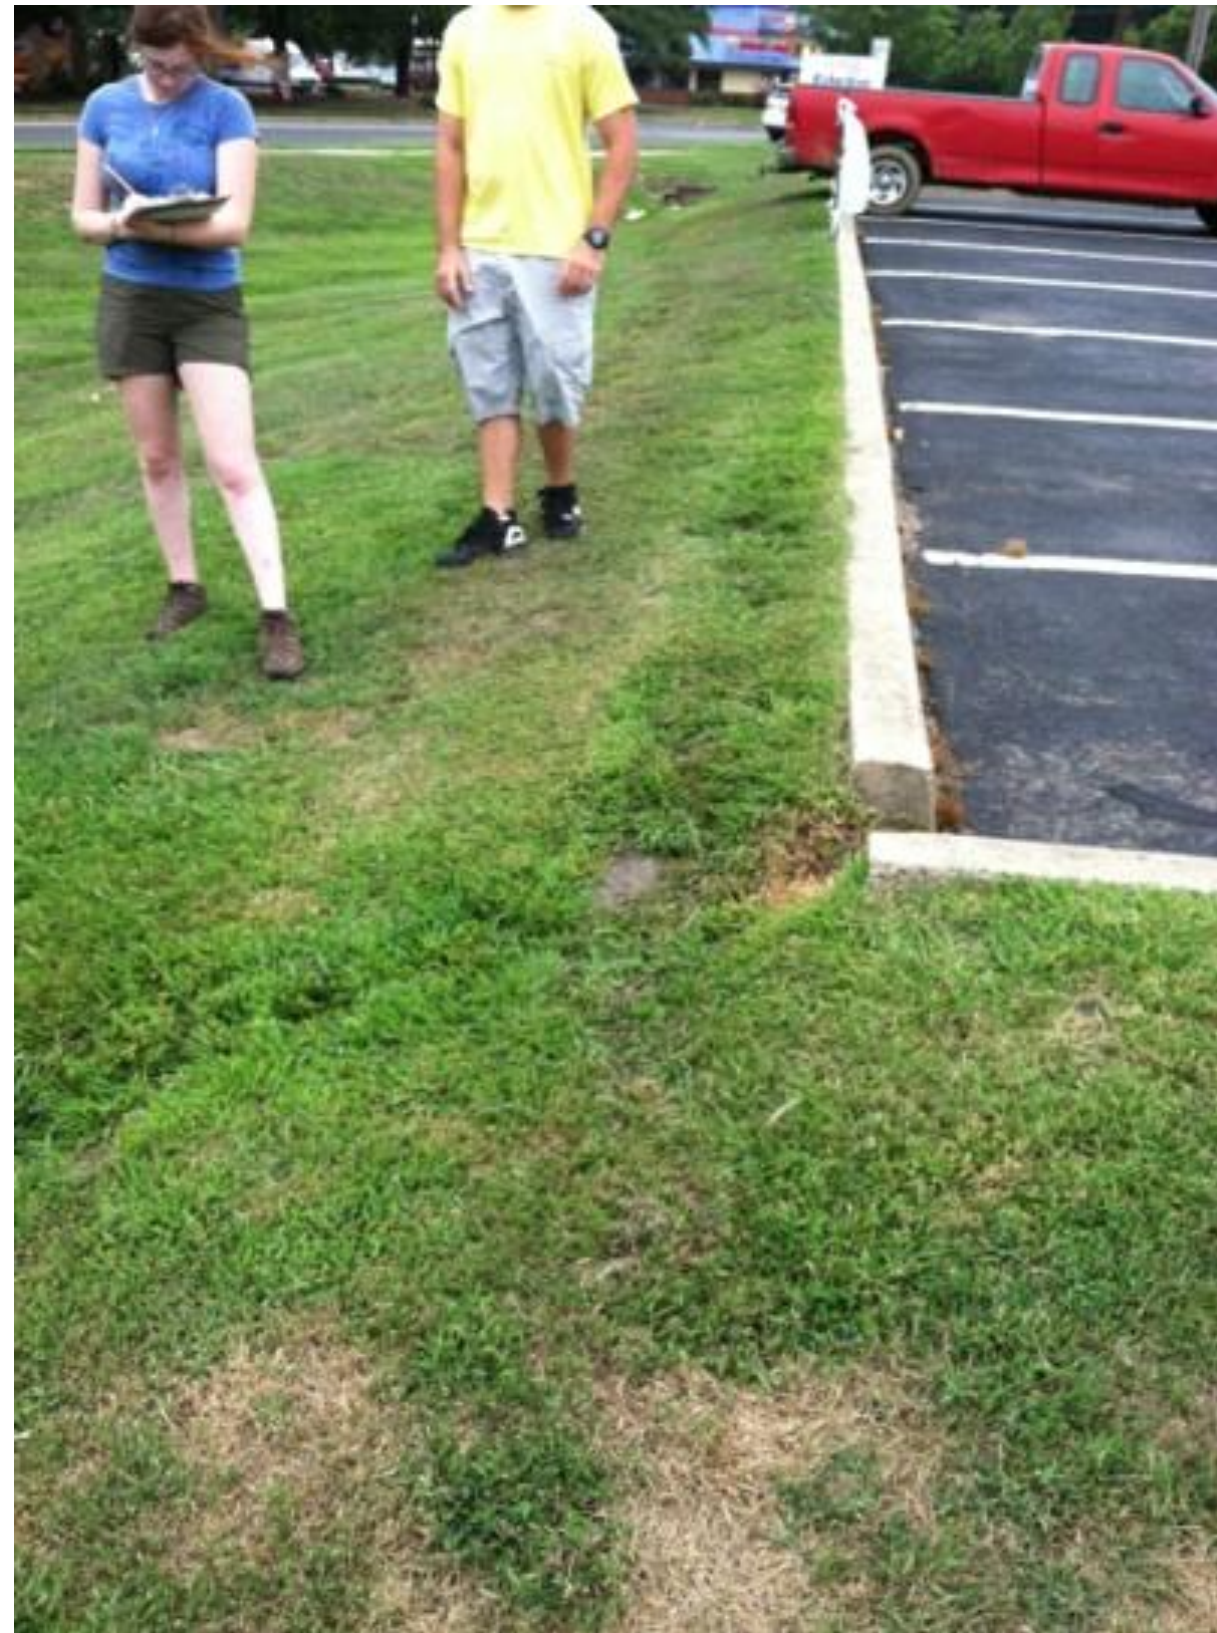
Erosion at inlet

- Curb cuts (inlets) are damaged with erosion evident
- Outlet has structural damage and erosion

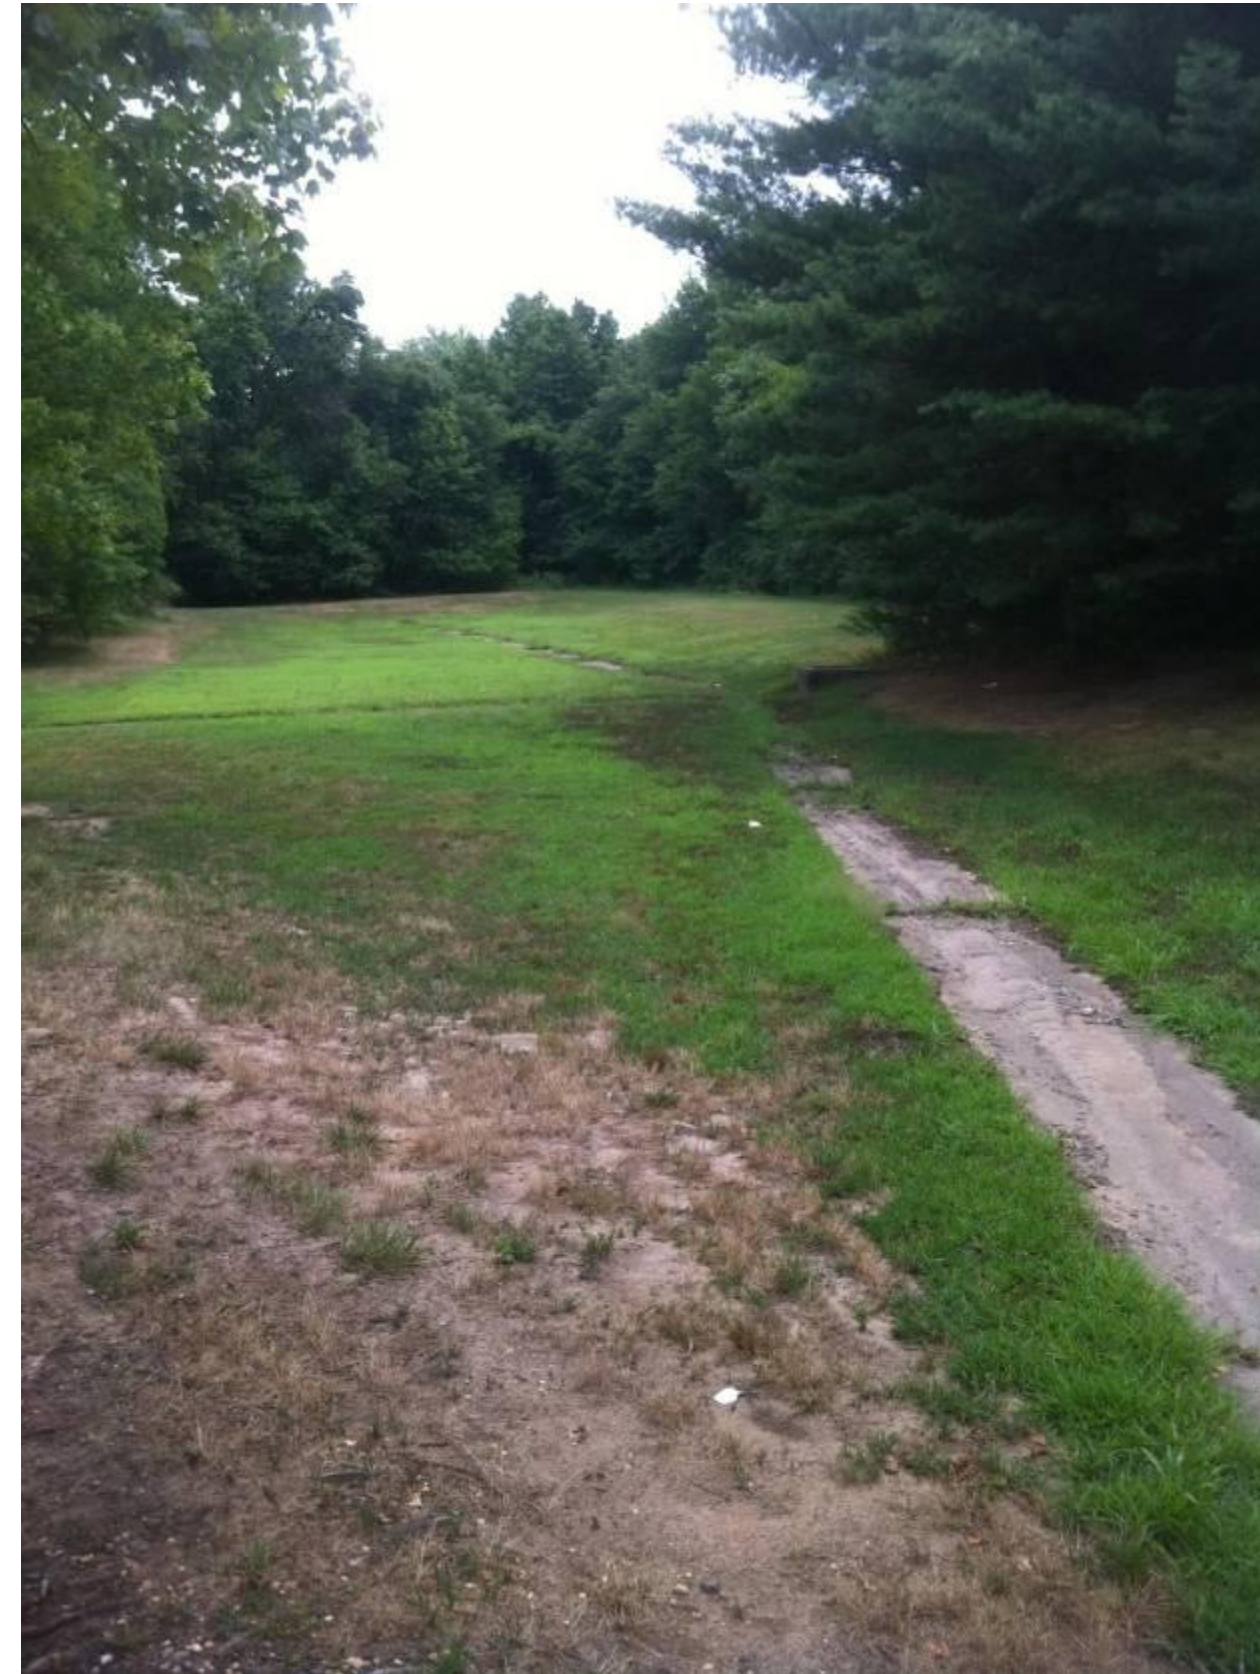
Basin bottom looking east

- Excess sediment accumulation in low flow channels
- Outlet has structural damage
- Discharges directly to Miry Run

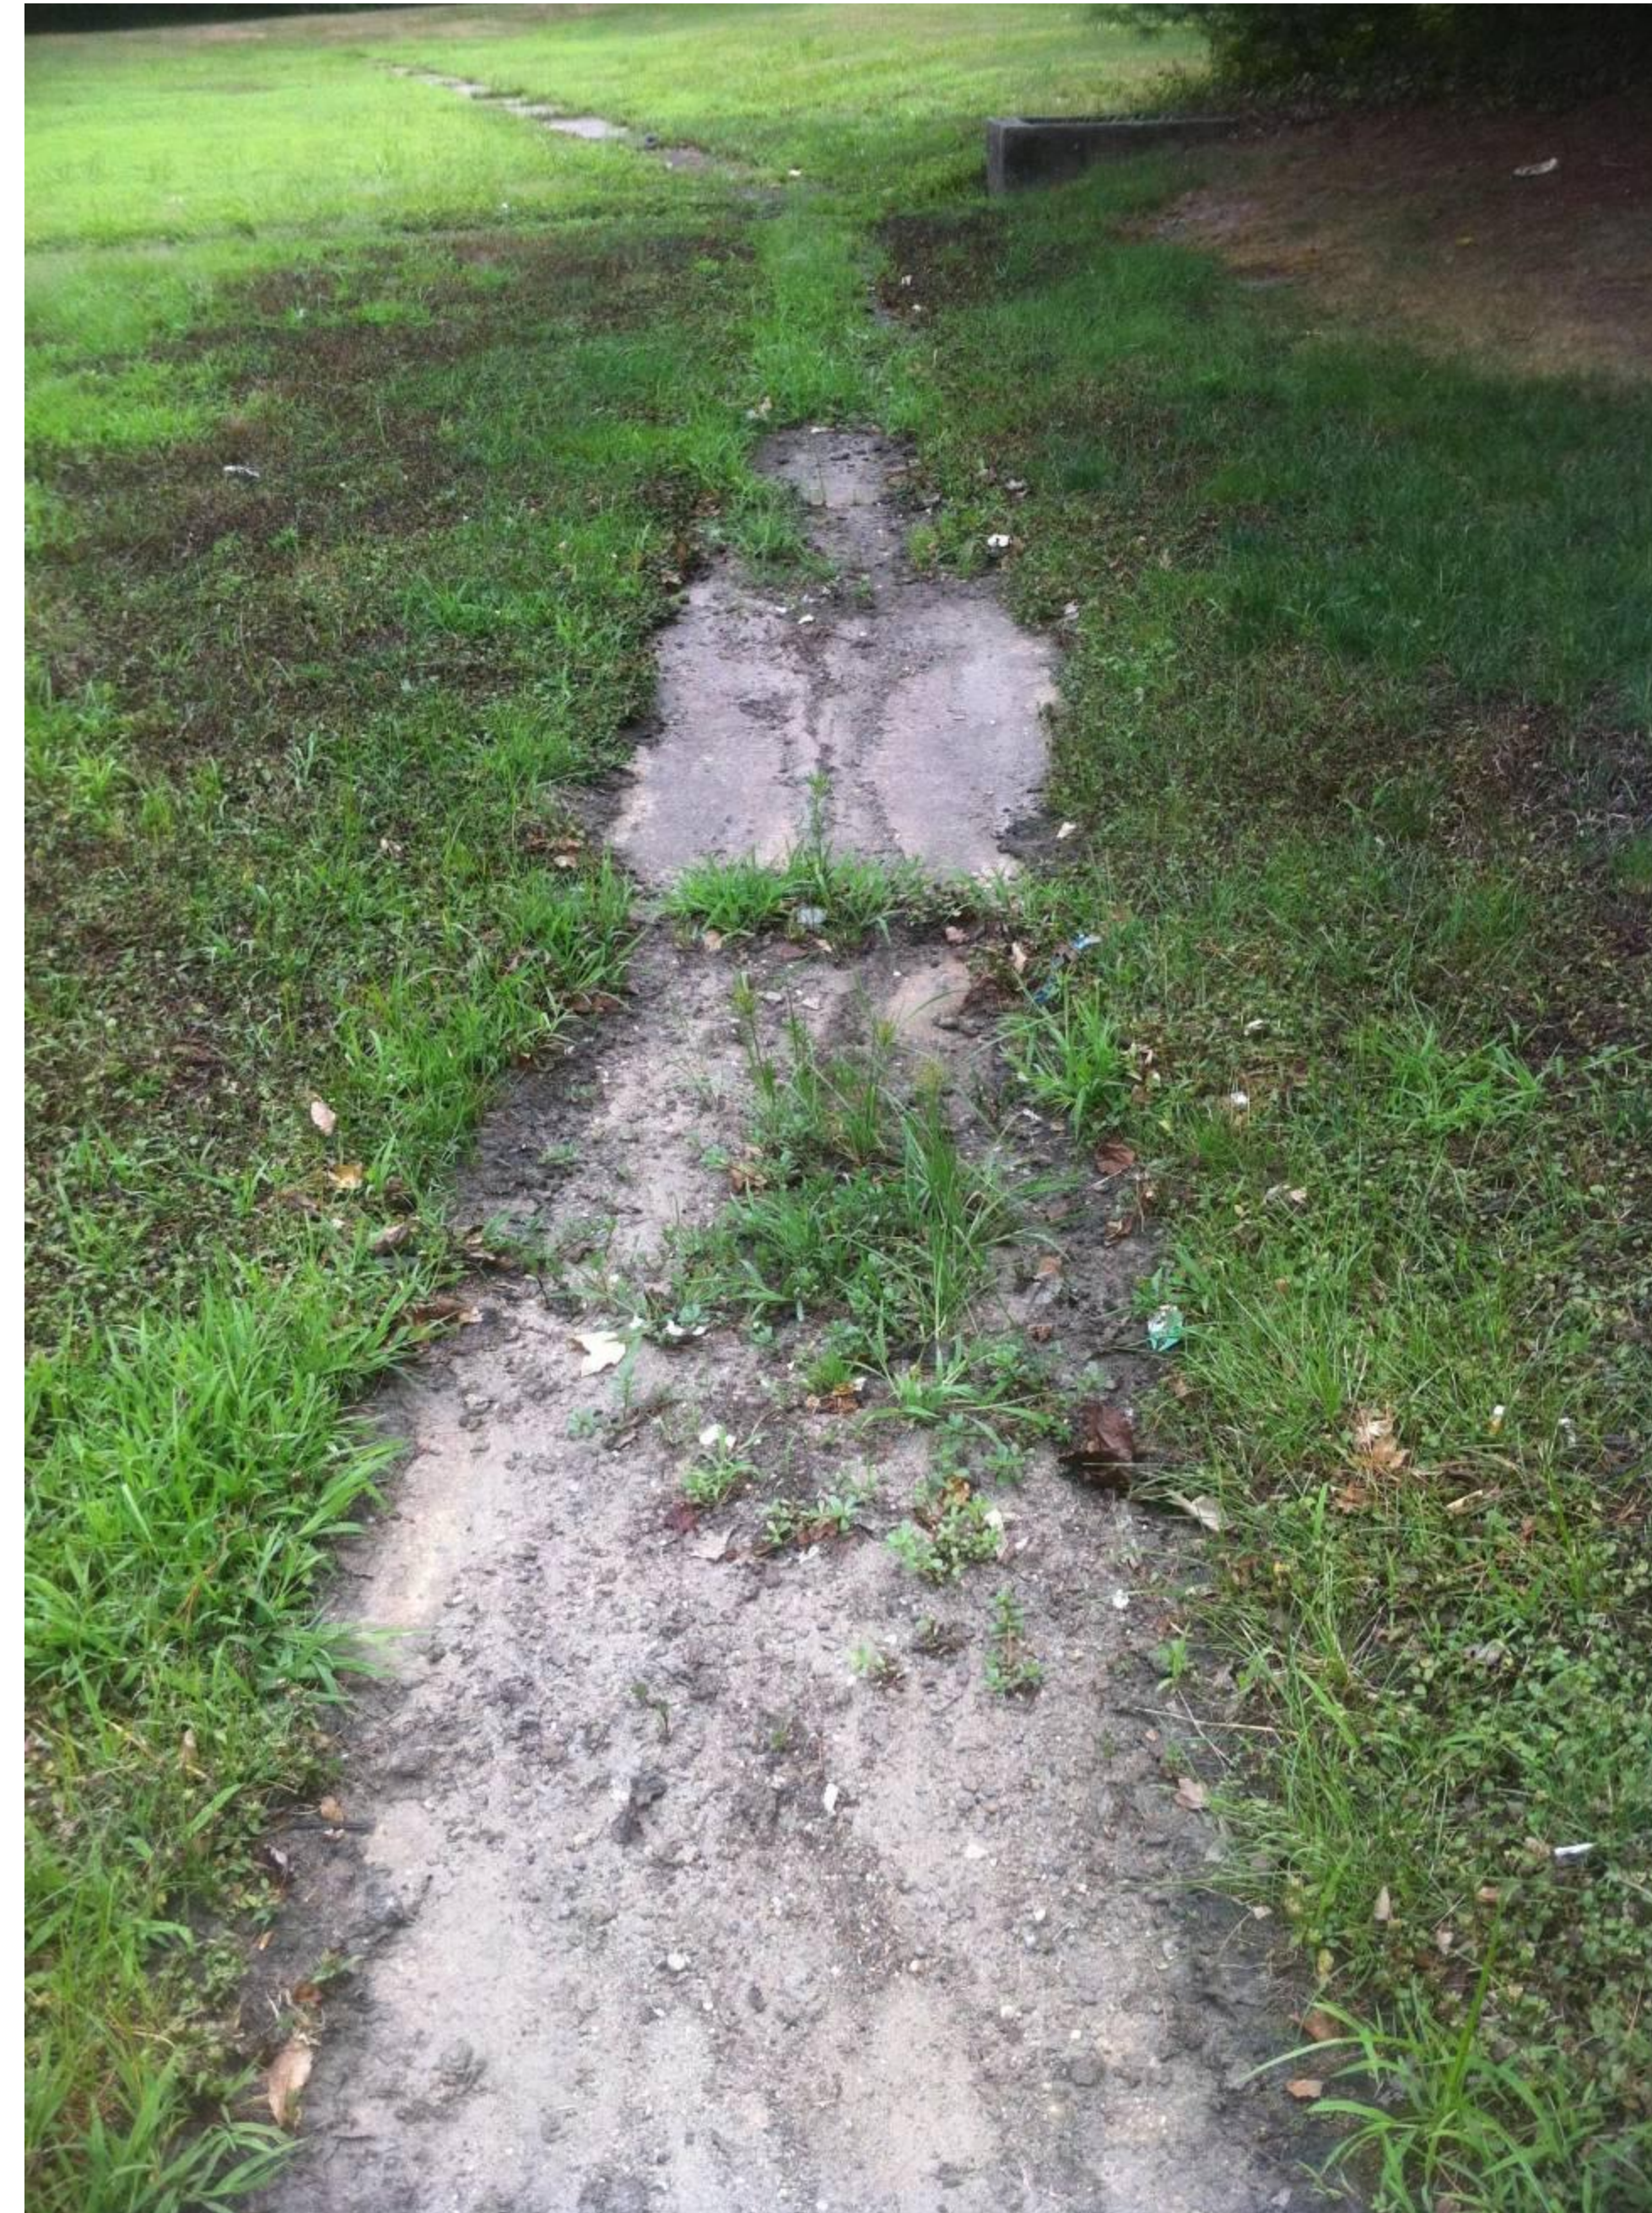
Sediment in low flow channel

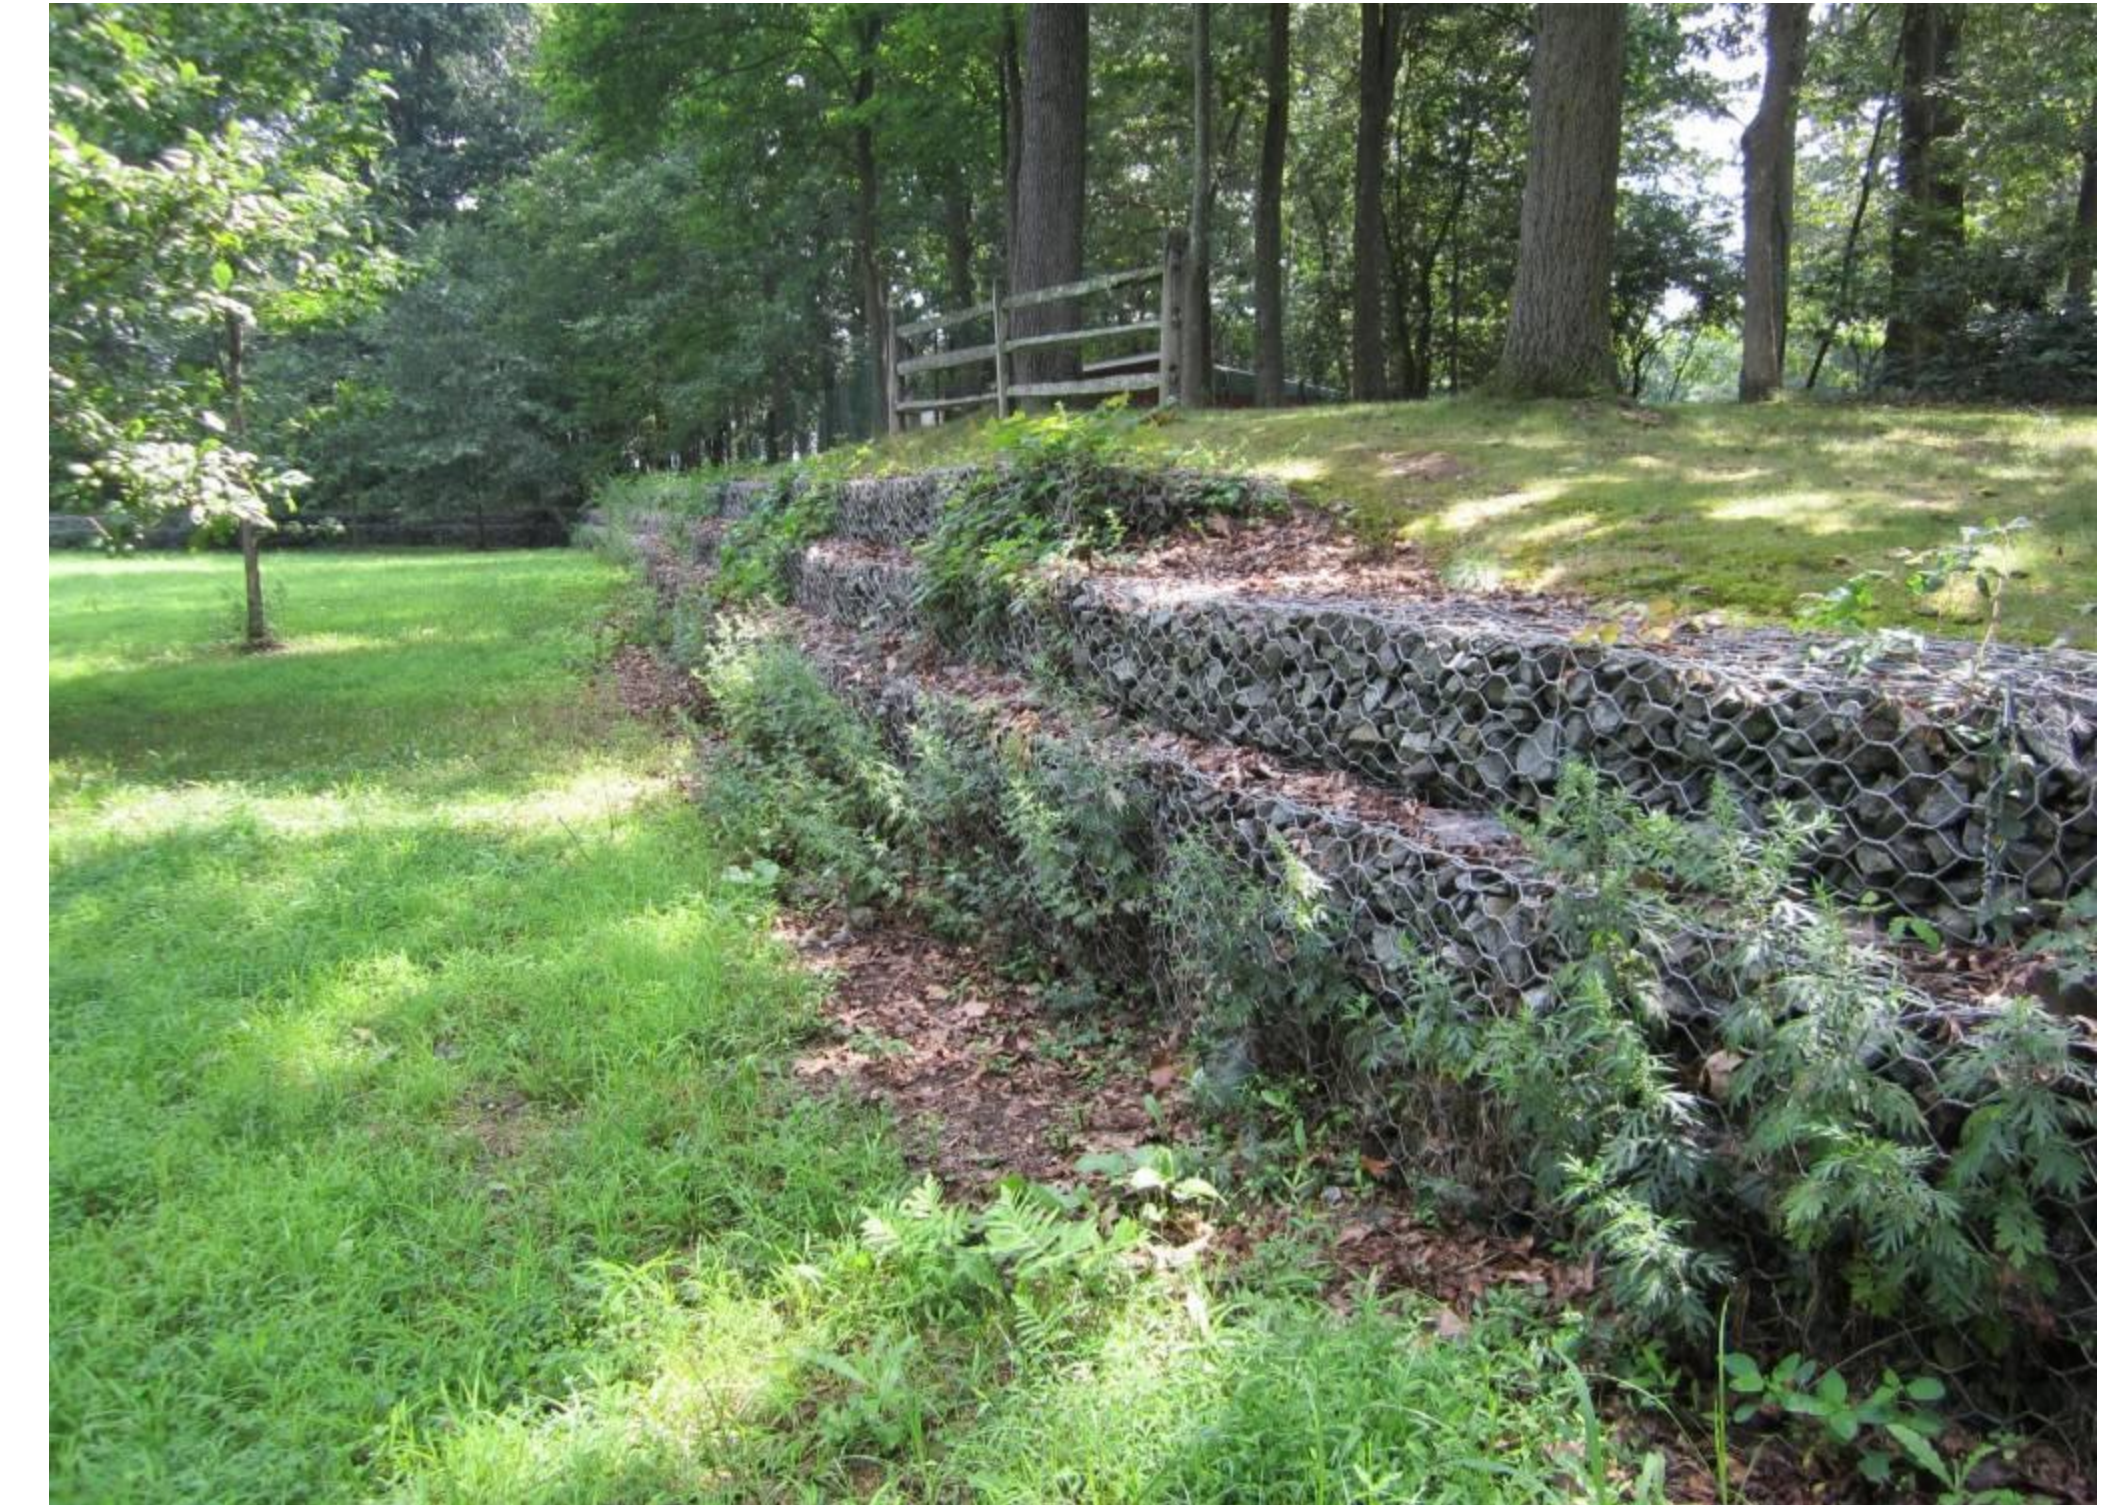
Gabion wall perimeter

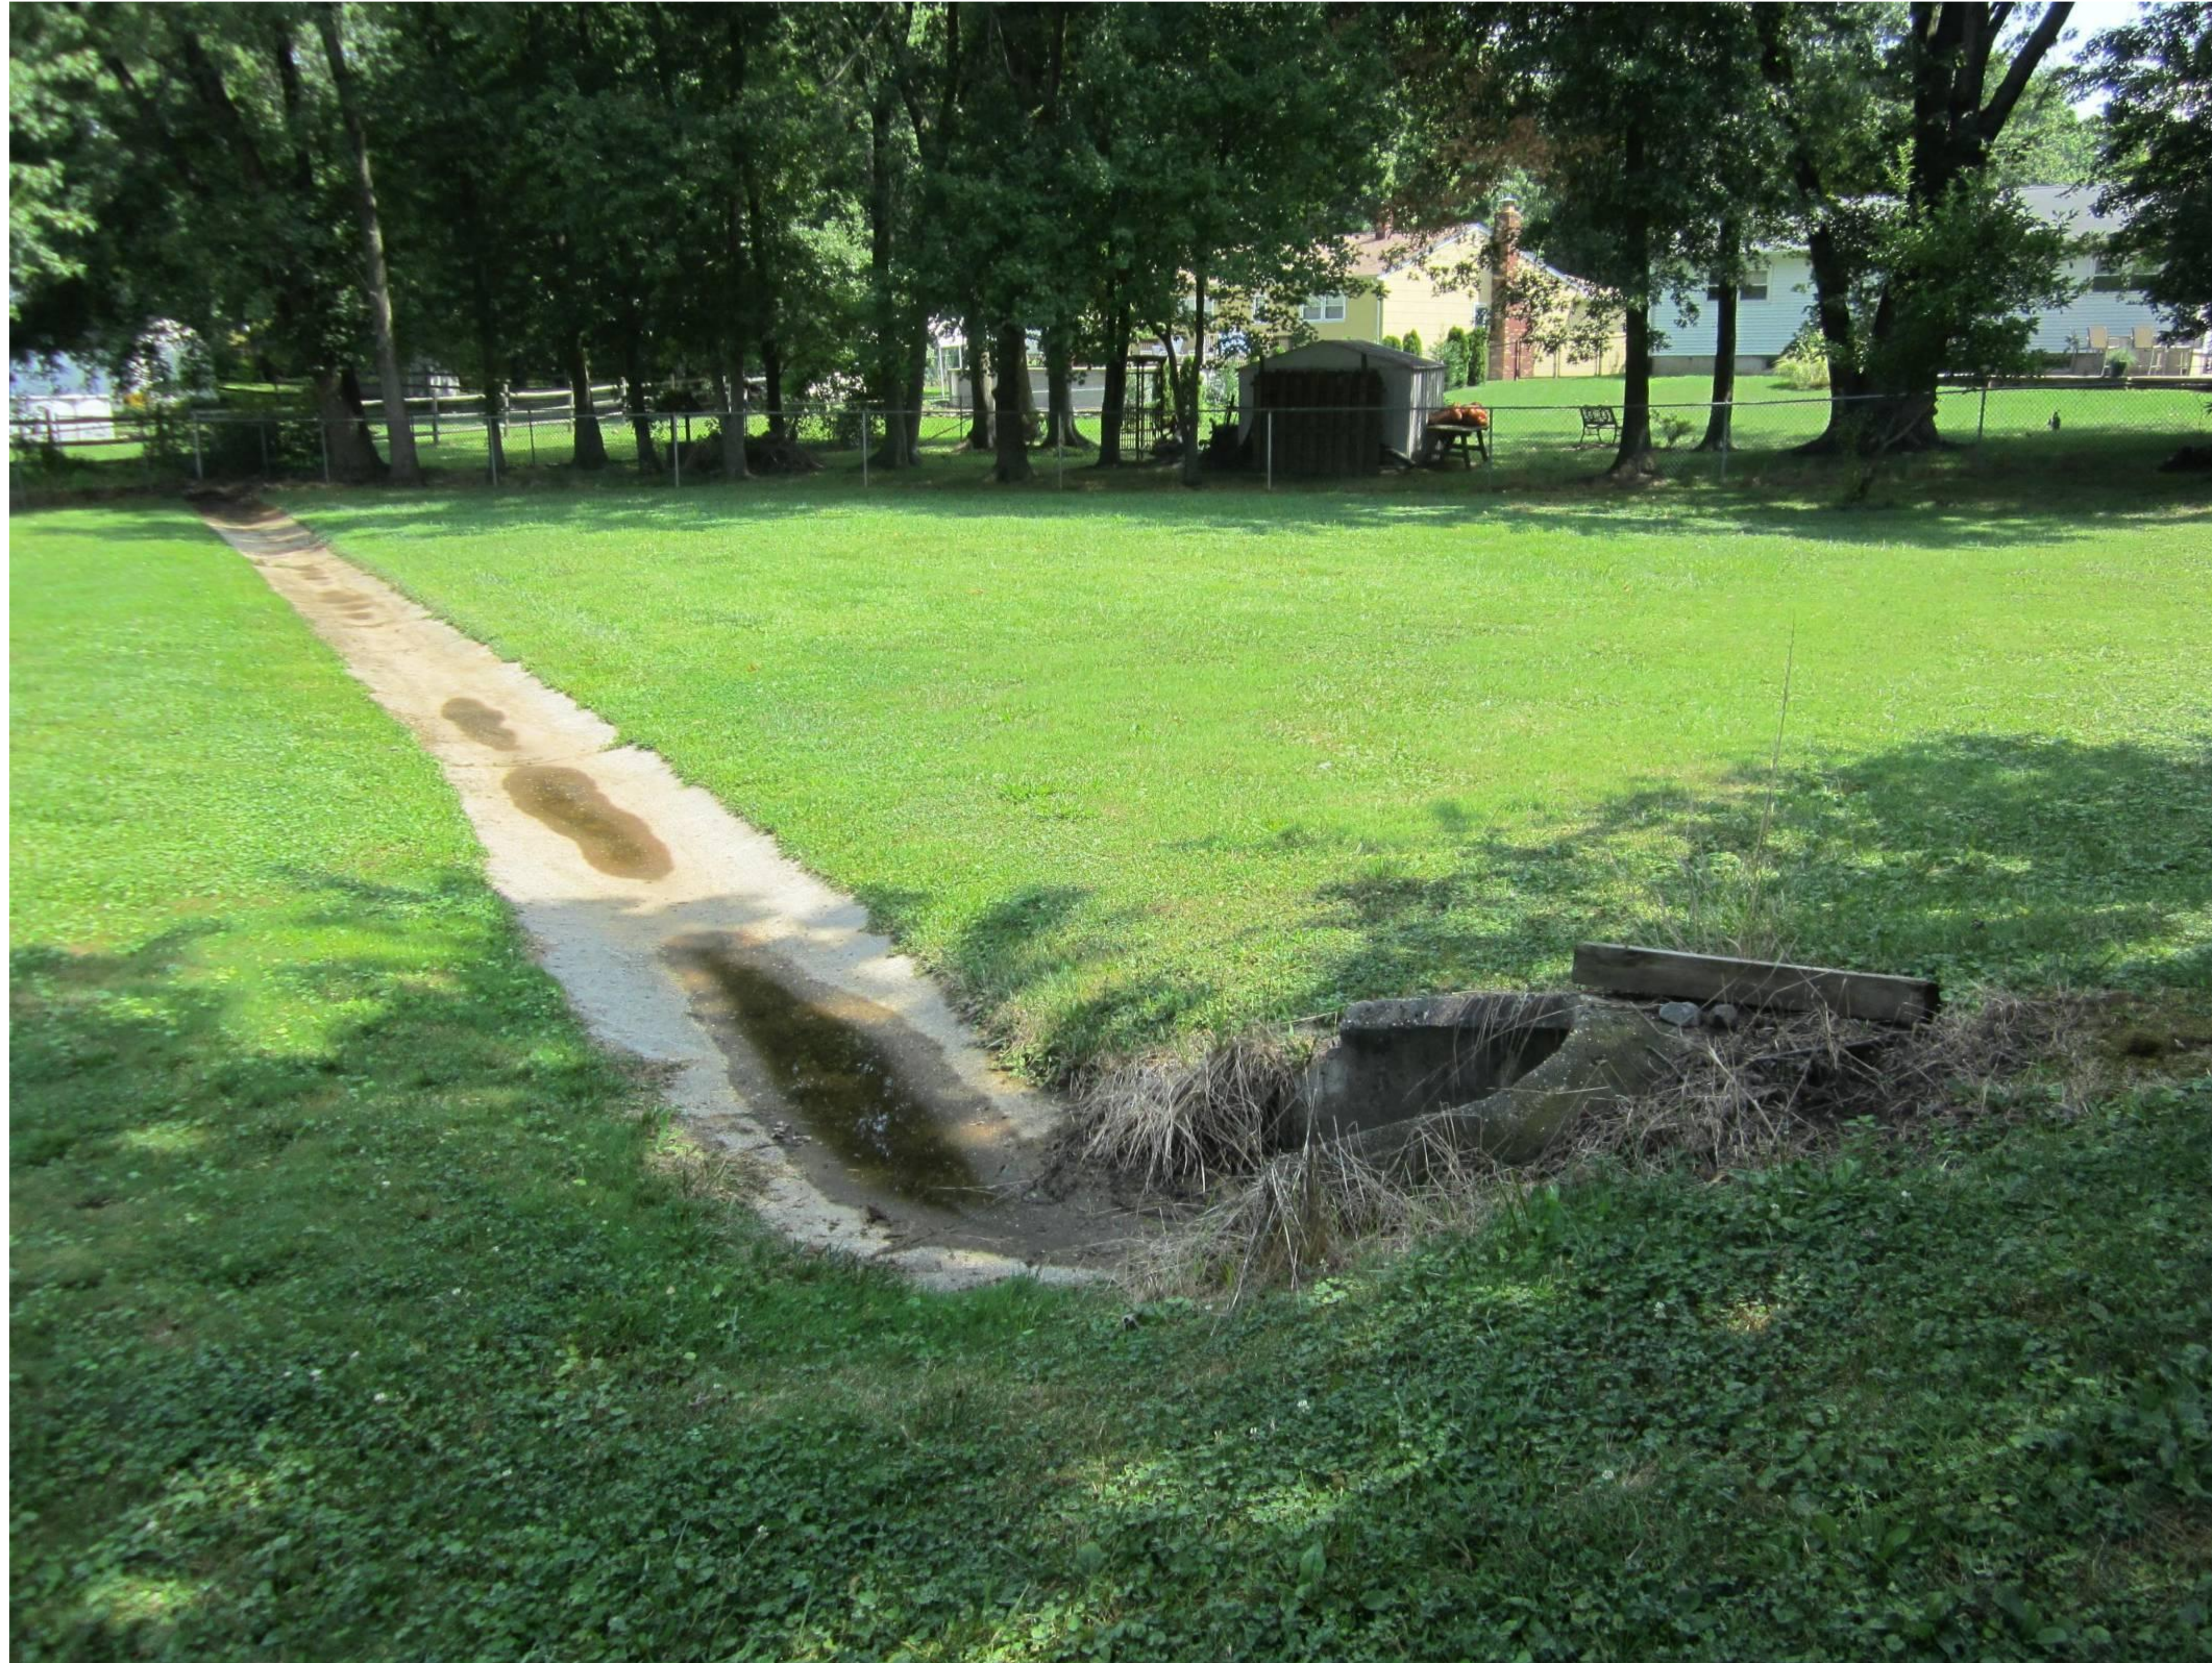
Entire Basin looking northeast
